The City of Madera

Appendix B: Facilities

Access Compliance Survey Report

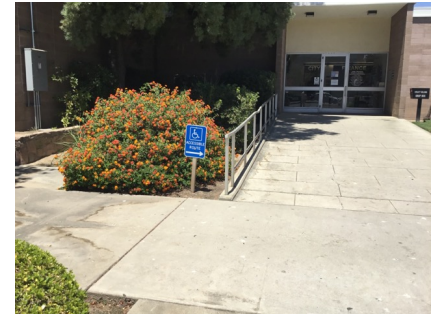
103	<ul style="list-style-type: none"> As-Built Description: Sign to provide direction to or information about building functional spaces missing or non-compliant. Proposed Solution: Provide compliant signage. Notes: 	<p>PCODE SA09NT ADAAG 91 4.1.3(16)(b) ADA 2010 216.3 CBC 2007 1117B.5.8.1.3 CBC 2019 11B-216.3</p> <p>Mitigated: <input type="radio"/> YES <input checked="" type="radio"/> NO</p>	1	JOB	\$270	\$270
-----	--	---	---	-----	-------	-------

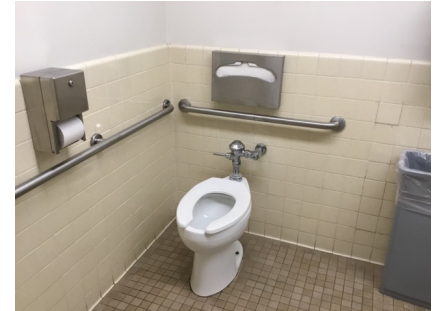
Item no., Rm no. and Name	Existing Architectural Barrier and Proposed Solution	Codes / Mitigation Info	Qty	Unit	Cost	Total
39	<ul style="list-style-type: none"> <i>As-Built Description:</i> Flush Control: Operating handle not mounted toward wide side of stall. <i>Proposed Solution:</i> Replace flush control with properly mounted accessible type, or install sensor flush. 	PCODE WB10 ADAAG 91 4.16.5 ADA 2010 604.6 CBC 2007 1115B.4.1.5 CBC 2019 11B-604.6 Mitigated: <input type="radio"/> YES <input checked="" type="radio"/> NO	1	JOB	\$1,500	\$1,500

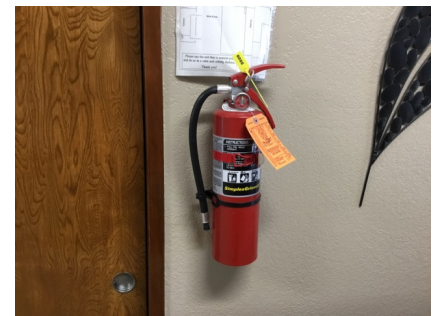
323	<ul style="list-style-type: none"> <i>As-Built Description:</i> Operable part(s) require tight grasping, pinching, or twisting of the wrist with one hand. <i>Proposed Solution:</i> Modify or replace the operable part(s) to not require tight grasping, pinching, or twisting of the wrist with one hand. <i>Notes:</i> 	PCODE IC02 ADAAG 91 4.27.4 ADA 2010 309.4 CBC 2007 1117B.6.4 CBC 2019 11B-309.4 Mitigated: <input type="radio"/> YES <input checked="" type="radio"/> NO	2	JOB	\$900	\$1,800
-----	---	---	---	-----	-------	---------

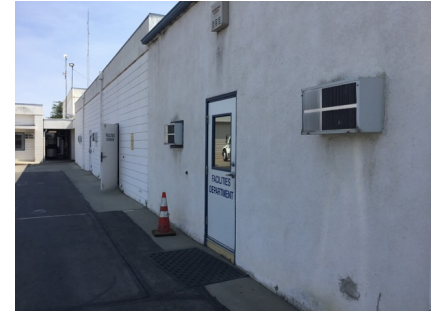
602	<ul style="list-style-type: none"> • <i>As-Built Description:</i> Protruding objects more than 4" from wall, when bottom of object more than 27" or less than 80" above finished floor. • <i>As-Built:</i> 10.0" at 66.0" at air conditioning • <i>Proposed Solution:</i> Provide cane-detectable railing to mark area of low clearance. • <i>Notes:</i> 	PCODE EG04A ADAAG 91 4.4.1 ADA 2010 307.2 CBC 2007 1133B.8.6.1 CBC 2019 11B-307.2	8	LF	\$300	\$2,400
-----	---	---	---	----	-------	---------

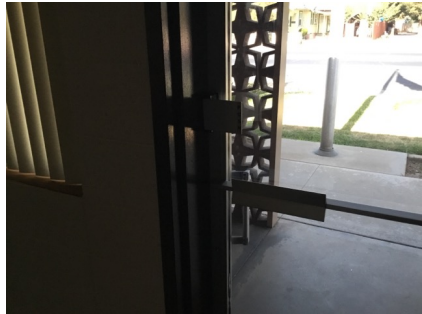
Item no., Rm no. and Name	Existing Architectural Barrier and Proposed Solution	Codes / Mitigation Info	Qty	Unit	Cost	Total
475	<ul style="list-style-type: none"> • <i>As-Built Description:</i> Door lock, latch or handle less than 34" or more than 48" above the floor (CA only: 34" to 44"). • <i>As-Built:</i> 50.0" high • <i>Proposed Solution:</i> Relocate or replace existing hardware. 	PCODE ID17 ADAAG 91 4.13.9 ADA 2010 404.2.7 CBC 2007 1133B.2.5.2 CBC 2019 11B-404.2.7 Mitigated: <input type="radio"/> YES <input checked="" type="radio"/> NO	1	JOB	\$900	\$900

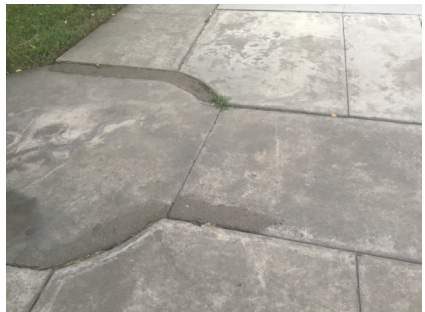
1710	<ul style="list-style-type: none"> As-Built Description: Walk: Pavement dislocation creates abrupt change in level exceeding 1/2" in accessible route. As-Built: Up to 1.0" Proposed Solution: Remove, replace or repair area of pavement sufficient to correct abrupt change in level. 	PCODE EF03 ADAAG 91 4.3.8 ADA 2010 403.4 CBC 2007 1133B.7.4 CBC 2019 11B-403.4	40	LF	\$63	\$2,520
		Mitigated: <input type="radio"/> YES <input checked="" type="radio"/> NO

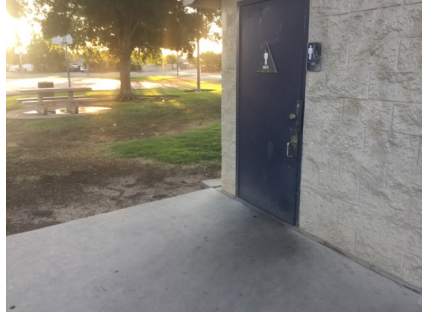
<p>1724</p> <ul style="list-style-type: none"> • <i>As-Built Description:</i> Surface of required maneuvering clearance at door slopes more than 1/4":12" (2.0%). • <i>As-Built:</i> up to 3.0% 1.0" level change • <i>Proposed Solution:</i> Modify surface slope at door. 	<p><i>PCODE ID11</i> <i>ADAAG 91 4.13.6</i> <i>ADA 2010 404.2.4.4</i> <i>CBC 2007 1133B.2.4</i> <i>CBC 2019 11B-404.2.4</i></p> <p>Mitigated: <input type="radio"/> YES <input checked="" type="radio"/> NO</p>	<p>25 SF \$120 \$3,000</p>

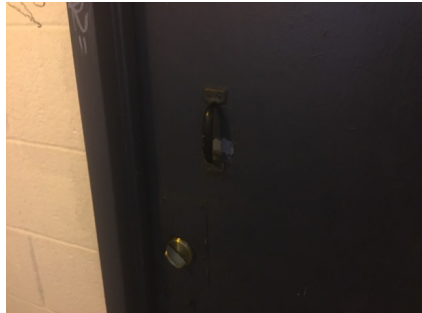
<p>1721</p> <ul style="list-style-type: none"> • <i>As-Built Description:</i> Door lock, latch or handle less than 34" or more than 48" above the floor (CA only: 34" to 44"). • <i>As-Built:</i> 50.0" high • <i>Proposed Solution:</i> Relocate or replace existing hardware. 	<p><i>PCODE ID17</i> <i>ADAAG 91 4.13.9</i> <i>ADA 2010 404.2.7</i> <i>CBC 2007 1133B.2.5.2</i> <i>CBC 2019 11B-404.2.7</i></p> <p>Mitigated: <input type="radio"/> YES <input checked="" type="radio"/> NO</p>	<p>1 JOB \$900 \$900</p>

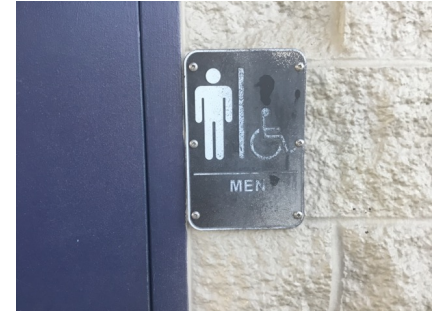
1722	<ul style="list-style-type: none"> As-Built Description: Entrance to toilet or bathing facility not identified with ADAAG compliant signage. As-Built: Braille 1.0" from characters Proposed Solution: Provide ADA compliant sign mounted at 48" min. above to baseline of the lowest Braille cells and 60" max. to baseline of the highest line of raised characters on nearest adjacent wall, on latch side of a single door (located not to cause a Braille reader to stand within the door swing). Notes: 	PCODE SA11A ADAAG 91 4.1.3(16)(a) ADA 2010 216.8 CBC 2019 11B-216.8 Mitigated: <input type="radio"/> YES <input checked="" type="radio"/> NO	1	JOB	\$270	\$270
------	--	--	---	-----	-------	-------

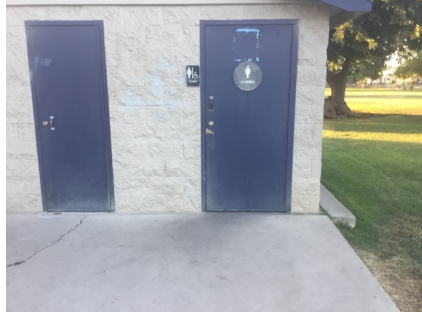
<p>1725</p> <ul style="list-style-type: none"> <i>As-Built Description:</i> Surface of required maneuvering clearance at door slopes more than 1/4":12" (2.0%). <i>As-Built:</i> Up to 3.0% 0.5" level change <i>Proposed Solution:</i> Modify surface slope at door. 	<p><i>PCODE ID11</i> ADAAG 91 4.13.6 ADA 2010 404.2.4.4 CBC 2007 1133B.2.4 CBC 2019 11B-404.2.4</p> <p>Mitigated: <input type="radio"/> YES <input checked="" type="radio"/> NO</p>	<p>25 SF \$120 \$3,000</p>

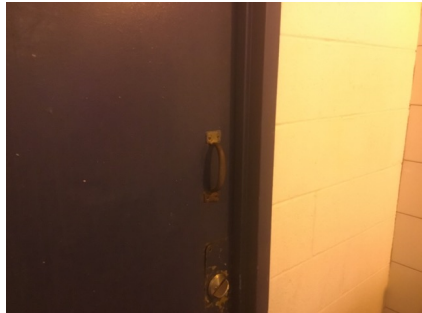
<p>1729</p> <ul style="list-style-type: none"> <i>As-Built Description:</i> Door lock, latch or handle less than 34" or more than 48" above the floor (CA only: 34" to 44"). <i>As-Built:</i> 52.0" high <i>Proposed Solution:</i> Relocate or replace existing hardware. 	<p><i>PCODE ID17</i> ADAAG 91 4.13.9 ADA 2010 404.2.7 CBC 2007 1133B.2.5.2 CBC 2019 11B-404.2.7</p> <p>Mitigated: <input type="radio"/> YES <input checked="" type="radio"/> NO</p>	<p>2 JOB \$900 \$1,800</p>

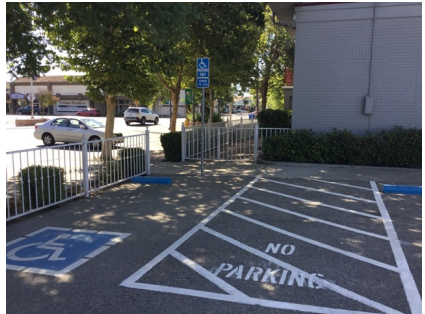
<p>182</p> <ul style="list-style-type: none"> • <i>As-Built Description:</i> Sign for accessible parking space is missing or non-compliant. • <i>Proposed Solution:</i> Provide compliant parking signage. • <i>Notes:</i> 	<p>PCODE EA04B ADAAG 91 4.6.4 ADA 2010 502.6 CBC 2007 1129B.4 CBC 2019 11B-502.6</p> <p>Mitigated: <input type="radio"/> YES <input checked="" type="radio"/> NO</p>	<p>1 JOB \$945 \$945</p>

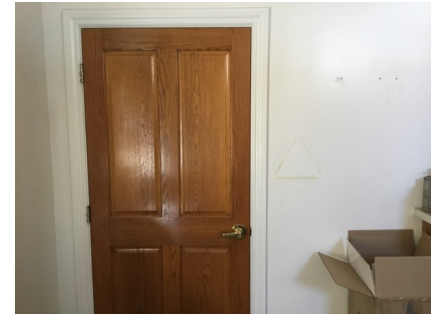
218	<ul style="list-style-type: none"> As-Built Description: Entrance to toilet or bathing facility not identified with ADAAG compliant signage. Proposed Solution: Provide ADA compliant sign mounted at 48" min. above to baseline of the lowest Braille cells and 60" max. to baseline of the highest line of raised characters on nearest adjacent wall, on latch side of a single door (located not to cause a Braille reader to stand within the door swing). 	PCODE SA11A ADAAG 91 4.1.3(16)(a) ADA 2010 216.8 CBC 2019 11B-216.8	1	JOB	\$270	\$270
-----	---	--	---	-----	-------	-------

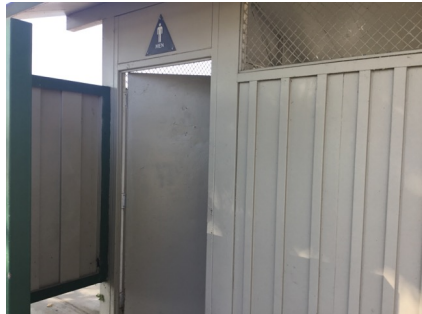
1786	<ul style="list-style-type: none"> As-Built Description: Entrance to toilet or bathing facility not identified with ADAAG compliant signage. Proposed Solution: Provide ADA compliant sign mounted at 48" min. above to baseline of the lowest Braille cells and 60" max. to baseline of the highest line of raised characters on nearest adjacent wall, on latch side of a single door (located not to cause a Braille reader to stand within the door swing). 	PCODE SA11A ADAAG 91 4.1.3(16)(a) ADA 2010 216.8 CBC 2019 11B-216.8 Mitigated: <input type="radio"/> YES <input checked="" type="radio"/> NO	1	JOB	\$270	\$270

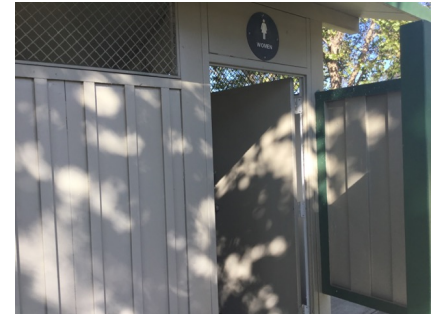
1775	<ul style="list-style-type: none"> As-Built Description: Entrance to toilet or bathing facility not identified with ADAAG compliant signage. Proposed Solution: Provide ADA compliant sign mounted at 48" min. above to baseline of the lowest Braille cells and 60" max. to baseline of the highest line of raised characters on nearest adjacent wall, on latch side of a single door (located not to cause a Braille reader to stand within the door swing). 	<p>PCODE SA11A ADAAG 91 4.1.3(16)(a) ADA 2010 216.8 CBC 2019 11B-216.8</p> <p>Mitigated: <input type="radio"/> YES <input checked="" type="radio"/> NO</p>	1	JOB	\$270	\$270
------	---	--	---	-----	-------	-------

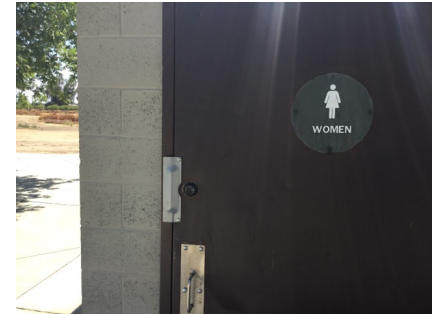
1849	<ul style="list-style-type: none"> As-Built Description: Entrance to toilet or bathing facility not identified with ADAAG compliant signage. Proposed Solution: Provide ADA compliant sign mounted at 48" min. above to baseline of the lowest Braille cells and 60" max. to baseline of the highest line of raised characters on nearest adjacent wall, on latch side of a single door (located not to cause a Braille reader to stand within the door swing). 	<p>PCODE SA11A ADAAG 91 4.1.3(16)(a) ADA 2010 216.8 CBC 2019 11B-216.8</p> <p>Mitigated: <input type="radio"/> YES <input checked="" type="radio"/> NO</p>	1	JOB	\$270	\$270
------	---	---	---	-----	-------	-------

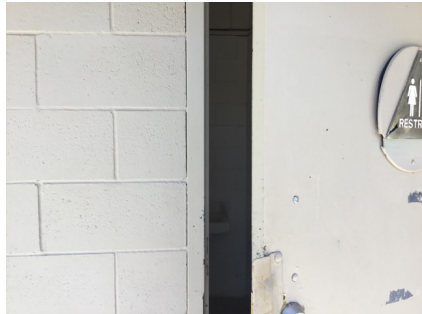
1875	<ul style="list-style-type: none"> <i>As-Built Description:</i> Entrance to toilet or bathing facility not identified with ADAAG compliant signage. <i>Proposed Solution:</i> Provide ADA compliant sign mounted at 48" min. above to baseline of the lowest Braille cells and 60" max. to baseline of the highest line of raised characters on nearest adjacent wall, on latch side of a single door (located not to cause a Braille reader to stand within the door swing). 	PCODE SA11A ADAAG 91 4.1.3(16)(a) ADA 2010 216.8 CBC 2019 11B-216.8 Mitigated: <input type="radio"/> YES <input checked="" type="radio"/> NO	1	JOB	\$270	\$270

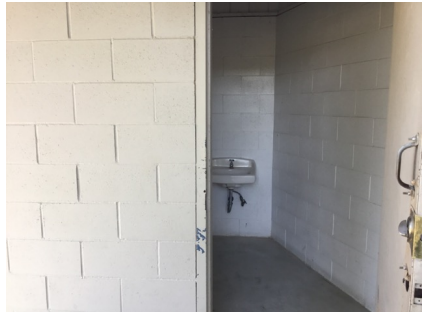
1888	<ul style="list-style-type: none"> <i>As-Built Description:</i> Entrance to toilet or bathing facility not identified with ADAAG compliant signage. <i>Proposed Solution:</i> Provide ADA compliant sign mounted at 48" min. above to baseline of the lowest Braille cells and 60" max. to baseline of the highest line of raised characters on nearest adjacent wall, on latch side of a single door (located not to cause a Braille reader to stand within the door swing). 	PCODE SA11A ADAAG 91 4.1.3(16)(a) ADA 2010 216.8 CBC 2019 11B-216.8 Mitigated: <input type="radio"/> YES <input checked="" type="radio"/> NO	1	JOB	\$270	\$270

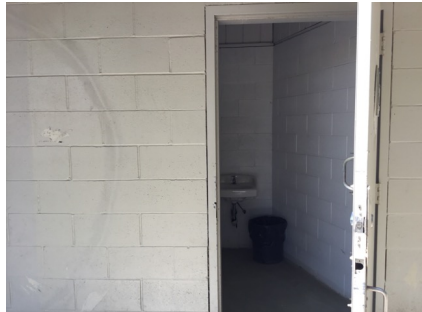
1910	<ul style="list-style-type: none"> As-Built Description: Entrance to toilet or bathing facility not identified with ADAAG compliant signage. Proposed Solution: Provide ADA compliant sign mounted at 48" min. above to baseline of the lowest Braille cells and 60" max. to baseline of the highest line of raised characters on nearest adjacent wall, on latch side of a single door (located not to cause a Braille reader to stand within the door swing). 	PCODE SA11A ADAAG 91 4.1.3(16)(a) ADA 2010 216.8 CBC 2019 11B-216.8 Mitigated: <input type="radio"/> YES <input checked="" type="radio"/> NO	1	JOB	\$270	\$270

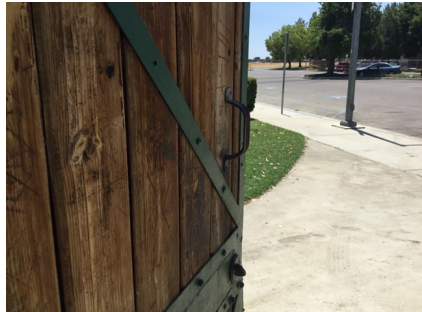
Item no., Rm no. and Name	Existing Architectural Barrier and Proposed Solution	Codes / Mitigation Info	Qty	Unit	Cost	Total
1929	<ul style="list-style-type: none"> As-Built Description: Door lock, latch or handle less than 34" or more than 48" above the floor (CA only: 34" to 44"). As-Built: 54.0" high Proposed Solution: Relocate or replace existing hardware. 	PCODE ID17 ADAAG 91 4.13.9 ADA 2010 404.2.7 CBC 2007 1133B.2.5.2 CBC 2019 11B-404.2.7 Mitigated: <input type="radio"/> YES <input checked="" type="radio"/> NO	1	JOB	\$900	\$900

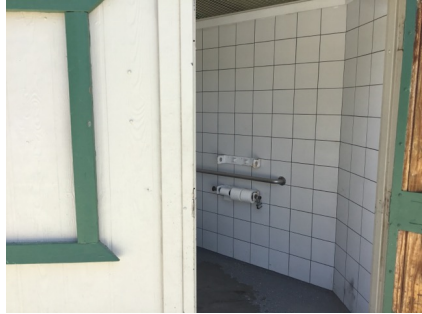
1931	<ul style="list-style-type: none"> As-Built Description: Entrance to toilet or bathing facility not identified with ADAAG compliant signage. Proposed Solution: Provide ADA compliant sign mounted at 48" min. above to baseline of the lowest Braille cells and 60" max. to baseline of the highest line of raised characters on nearest adjacent wall, on latch side of a single door (located not to cause a Braille reader to stand within the door swing). 	PCODE SA11A ADAAG 91 4.1.3(16)(a) ADA 2010 216.8 CBC 2019 11B-216.8 Mitigated: <input type="radio"/> YES <input checked="" type="radio"/> NO	1	JOB	\$270	\$270

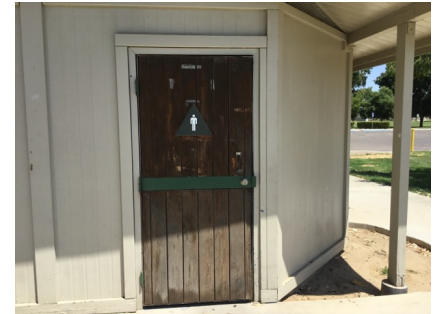
1950	<ul style="list-style-type: none"> As-Built Description: Entrance to toilet or bathing facility not identified with ADAAG compliant signage. Proposed Solution: Provide ADA compliant sign mounted at 48" min. above to baseline of the lowest Braille cells and 60" max. to baseline of the highest line of raised characters on nearest adjacent wall, on latch side of a single door (located not to cause a Braille reader to stand within the door swing). 	PCODE SA11A ADAAG 91 4.1.3(16)(a) ADA 2010 216.8 CBC 2019 11B-216.8	1	JOB	\$270	\$270
------	---	--	---	-----	-------	-------

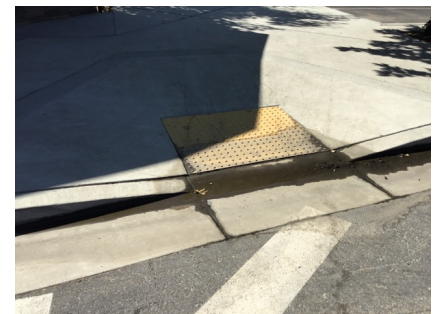
969	<ul style="list-style-type: none"> As-Built Description: Refer to notes for observation and recommendation. Proposed Solution: Notes: 	PCODE GN01 CBC 2019 11B-405.10 Mitigated: <input type="radio"/> YES <input checked="" type="radio"/> NO	1	JOB		
-----	--	--	---	-----	--	--

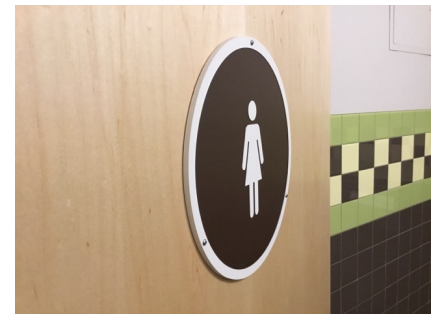
1022	<ul style="list-style-type: none"> <i>As-Built Description:</i> Required in CA only: identification symbol centered 58" to 60" high on sanitary facility door that contrasts with the door not provided (women: 12" ø circle, men: 12" triangle, unisex: combined symbol). <i>As-Built:</i> Not beveled <i>Proposed Solution:</i> Provide properly mounted sanitary facility symbol when altering area. If wheelchair accessible, include International Symbol of Accessibility on sign. 	<p>PCODE SA15 CBC 2007 1115B.6 CBC 2019 11B-703.7.2.6</p> <p>Mitigated: <input type="radio"/> YES <input checked="" type="radio"/> NO</p>	1	JOB	\$270	\$270
------	--	--	---	-----	-------	-------

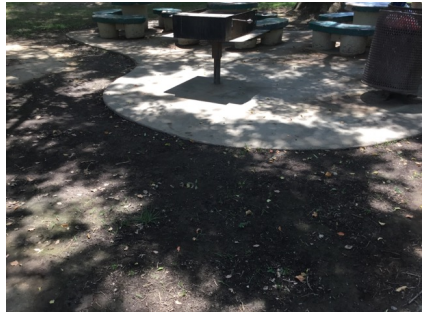
Item no., Rm no. and Name	Existing Architectural Barrier and Proposed Solution	Codes / Mitigation Info	Qty	Unit	Cost	Total
1400	<ul style="list-style-type: none"> As-Built Description: Walk: Pavement dislocation creates abrupt change in level exceeding 1/2" in accessible route. As-Built: up to 2.0" Proposed Solution: Remove, replace or repair area of pavement sufficient to correct abrupt change in level. 	PCODE EF03 ADAAG 91 4.3.8 ADA 2010 403.4 CBC 2007 1133B.7.4 CBC 2019 11B-403.4 Mitigated: <input type="radio"/> YES <input checked="" type="radio"/> NO	60	SF	\$63	\$3,780

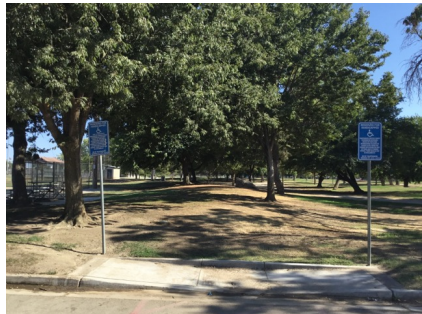
1679	<ul style="list-style-type: none"> As-Built Description: Sign for accessible parking space is missing or non-compliant. Proposed Solution: Provide compliant parking signage. 	PCODE EA04B ADAAG 91 4.6.4 ADA 2010 502.6 CBC 2007 1129B.4 CBC 2019 11B-502.6	2	JOB	\$945	\$1,890
		Mitigated: <input type="radio"/> YES <input checked="" type="radio"/> NO

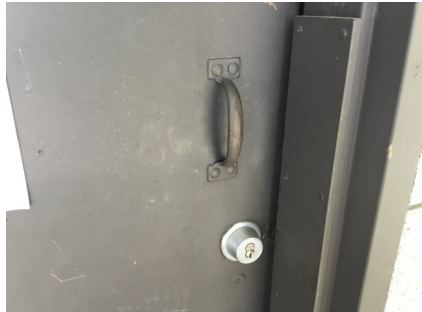
Occurs at each restroom at the hexagon.

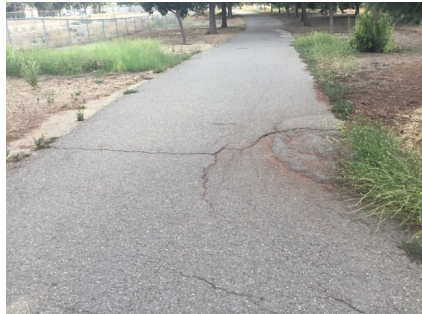
<input type="radio"/> Staff Only			
			Priority 1			
			Severity 2			
<p>Sunken asphalt at the side of the trail creates noncompliant slopes and level changes. There are 48.0" of compliant slopes to the side of these areas. Consider whether future dividing lines may put the noncompliant slopes in one of the lanes or whether the slopes are hazardous to people who do not see them.</p>

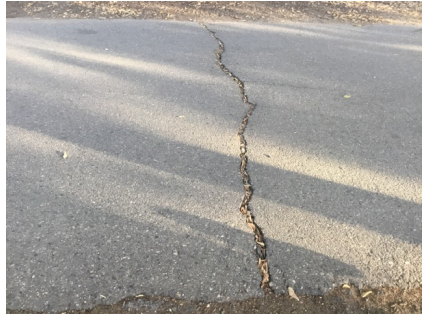
<input type="radio"/> Staff Only			
			Priority 1			
			Severity 2			
<p>Cracks nearly identical to the one shown here appear ubiquitous along the entire trail. There are also potholes up to 6.0" deep and 10.0" wide along the path and particularly at the edges of the path.</p>

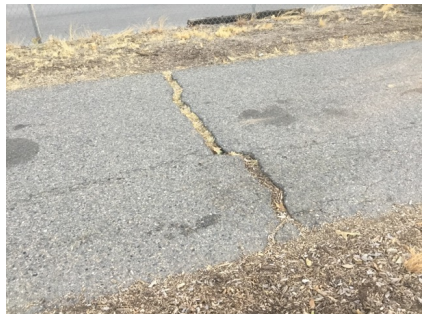
<input type="radio"/> Staff Only Priority <input checked="" type="radio"/> 1 Severity <input checked="" type="radio"/> 2 Tripping hazard.
