APPENDIX B: ACCESS COMPLIANCE SURVEY REPORT OF FACILITIES

The City of Madera

Access Compliance Survey Report

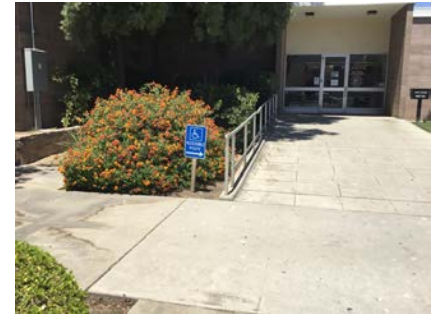
103	<ul style="list-style-type: none"> <i>As-Built Description:</i> Sign to provide direction to or information about building functional spaces missing or non-compliant. <i>Proposed Solution:</i> Provide compliant signage. <i>Notes:</i> 	<p>PCODE SA09NT ADAAG 91 4.1.3(16)(b) ADA 2010 216.3 CBC 2007 1117B.5.8.1.3 CBC 2019 11B-216.3</p> <p>Mitigated: <input type="radio"/> YES <input checked="" type="radio"/> NO</p>	1	JOB	\$270	\$270
-----	--	--	---	-----	-------	-------

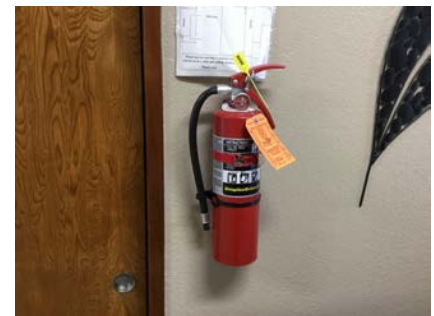
323	<ul style="list-style-type: none"> • <i>As-Built Description:</i> Operable part(s) require tight grasping, pinching, or twisting of the wrist with one hand. • <i>Proposed Solution:</i> Modify or replace the operable part(s) to not require tight grasping, pinching, or twisting of the wrist with one hand. • <i>Notes:</i> 	<p>PCODE IC02 ADAAG 91 4.27.4 ADA 2010 309.4 CBC 2007 1117B.6.4 CBC 2019 11B-309.4</p> <p>Mitigated: <input type="radio"/> YES <input checked="" type="radio"/> NO</p>	2	JOB	\$900	\$1,800
-----	---	--	---	-----	-------	---------

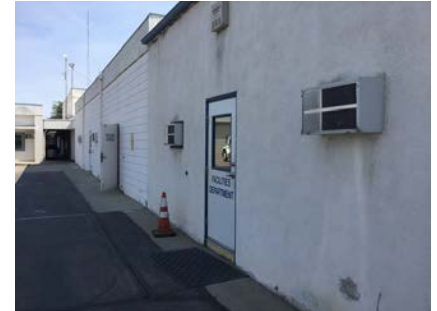
602	<ul style="list-style-type: none"> As-Built Description: Protruding objects more than 4" from wall, when bottom of object more than 27" or less than 80" above finished floor. As-Built: 10.0" at 66.0" at air conditioning Proposed Solution: Provide cane-detectable railing to mark area of low clearance. Notes: 	PCODE EG04A ADAAG 91 4.4.1 ADA 2010 307.2 CBC 2007 1133B.8.6.1 CBC 2019 11B-307.2 Mitigated: <input type="radio"/> YES <input checked="" type="radio"/> NO	8	LF	\$300	\$2,400
-----	---	---	---	----	-------	---------

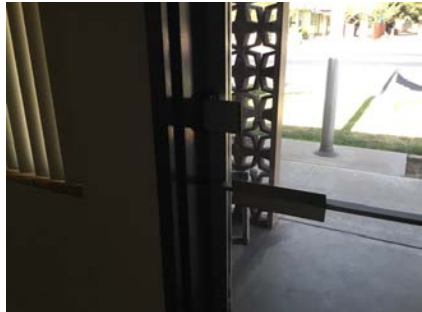
Item no., Rm no. and Name	Existing Architectural Barrier and Proposed Solution	Codes / Mitigation Info	Qty	Unit	Cost	Total
475	<ul style="list-style-type: none"> As-Built Description: Door lock, latch or handle less than 34" or more than 48" above the floor (CA only: 34" to 44"). As-Built: 50.0" high Proposed Solution: Relocate or replace existing hardware. 	PCODE ID17 ADAAG 91 4.13.9 ADA 2010 404.2.7 CBC 2007 1133B.2.5.2 CBC 2019 11B-404.2.7 Mitigated: <input type="radio"/> YES <input checked="" type="radio"/> NO	1	JOB	\$900	\$900

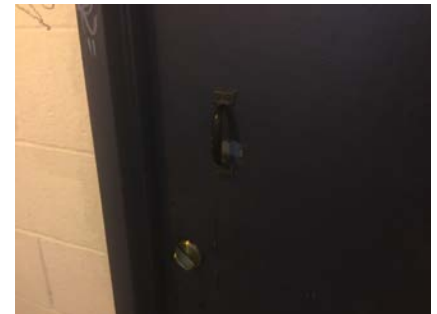
1721	<ul style="list-style-type: none"> As-Built Description: Door lock, latch or handle less than 34" or more than 48" above the floor (CA only: 34" to 44"). As-Built: 50.0" high Proposed Solution: Relocate or replace existing hardware. 	<p>PCODE ID17</p> <p>ADAAG 91 4.13.9</p> <p>ADA 2010 404.2.7</p> <p>CBC 2007 1133B.2.5.2</p> <p>CBC 2019 11B-404.2.7</p>	1	JOB	\$900	\$900
------	--	---	---	-----	-------	-------

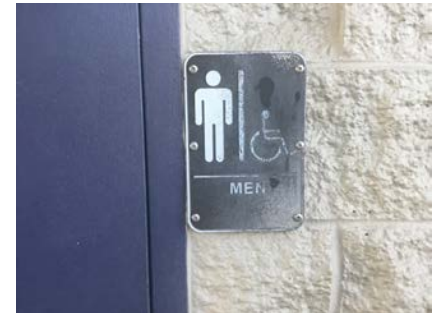
1722	<ul style="list-style-type: none"> <i>As-Built Description:</i> Entrance to toilet or bathing facility not identified with ADAAG compliant signage. <i>As-Built:</i> Braille 1.0" from characters <i>Proposed Solution:</i> Provide ADA compliant sign mounted at 48" min. above to baseline of the lowest Braille cells and 60" max. to baseline of the highest line of raised characters on nearest adjacent wall, on latch side of a single door (located not to cause a Braille reader to stand within the door swing). <i>Notes:</i> 	PCODE SA11A ADAAG 91 4.1.3(16)(a) ADA 2010 216.8 CBC 2019 11B-216.8 Mitigated: <input type="radio"/> YES <input checked="" type="radio"/> NO	1	JOB	\$270	\$270
------	--	--	---	-----	-------	-------

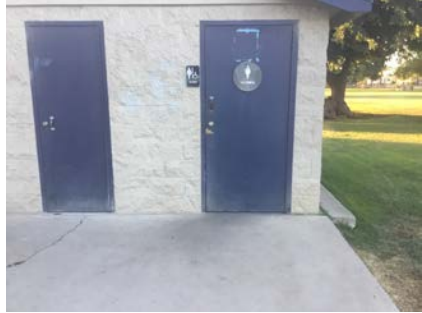
<p>1725</p> <ul style="list-style-type: none"> • <i>As-Built Description:</i> Surface of required maneuvering clearance at door slopes more than 1/4":12" (2.0%). • <i>As-Built:</i> Up to 3.0% 0.5" level change • <i>Proposed Solution:</i> Modify surface slope at door. 	<p>PCODE ID11 ADAAG 91 4.13.6 ADA 2010 404.2.4.4 CBC 2007 1133B.2.4 CBC 2019 11B-404.2.4</p> <p>Mitigated: <input type="radio"/> YES <input checked="" type="radio"/> NO</p>	<p>25 SF \$120 \$3,000</p>

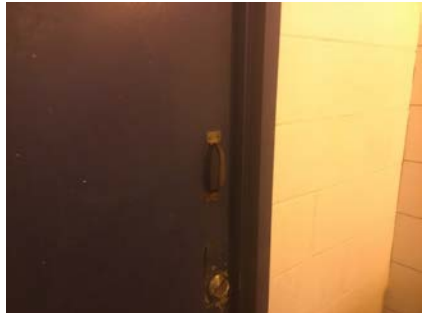
<p>1729</p> <ul style="list-style-type: none"> • <i>As-Built Description:</i> Door lock, latch or handle less than 34" or more than 48" above the floor (CA only: 34" to 44"). • <i>As-Built:</i> 52.0" high • <i>Proposed Solution:</i> Relocate or replace existing hardware. 	<p>PCODE ID17 ADAAG 91 4.13.9 ADA 2010 404.2.7 CBC 2007 1133B.2.5.2 CBC 2019 11B-404.2.7</p> <p>Mitigated: <input type="radio"/> YES <input checked="" type="radio"/> NO</p>	<p>2 JOB \$900 \$1,800</p>

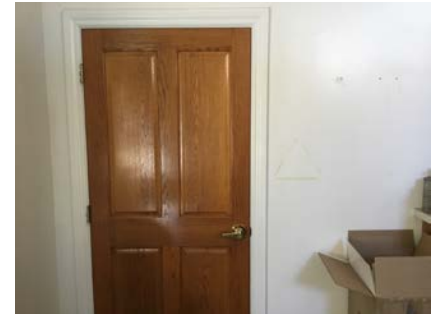
218	<ul style="list-style-type: none"> <i>As-Built Description:</i> Entrance to toilet or bathing facility not identified with ADAAG compliant signage. <i>Proposed Solution:</i> Provide ADA compliant sign mounted at 48" min. above to baseline of the lowest Braille cells and 60" max. to baseline of the highest line of raised characters on nearest adjacent wall, on latch side of a single door (located not to cause a Braille reader to stand within the door swing). 	PCODE SA11A ADAAG 91 4.1.3(16)(a) ADA 2010 216.8 CBC 2019 11B-216.8	1	JOB	\$270	\$270
-----	---	--	---	-----	-------	-------

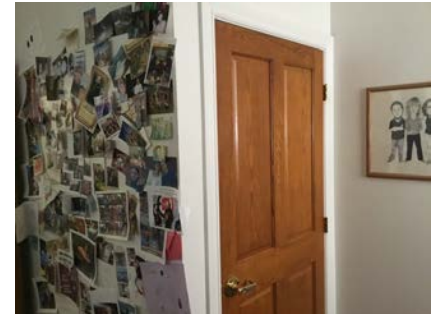
234	<ul style="list-style-type: none"> <i>As-Built Description:</i> Entrance to toilet or bathing facility not identified with ADAAG compliant signage. <i>Proposed Solution:</i> Provide ADA compliant sign mounted at 48" min. above to baseline of the lowest Braille cells and 60" max. to baseline of the highest line of raised characters on nearest adjacent wall, on latch side of a single door (located not to cause a Braille reader to stand within the door swing). 	PCODE SA11A ADAAG 91 4.1.3(16)(a) ADA 2010 216.8 CBC 2019 11B-216.8	1	JOB	\$270	\$270
-----	---	--	---	-----	-------	-------

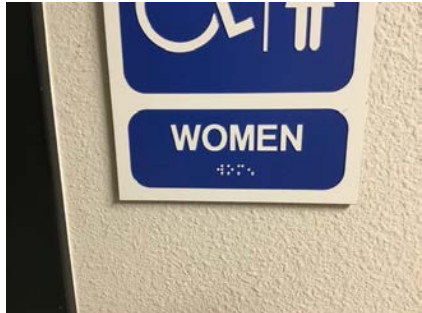
1466	<ul style="list-style-type: none"> <i>As-Built Description:</i> Entrance to toilet or bathing facility not identified with ADAAG compliant signage. <i>As-Built:</i> Not domed Braille. <i>Proposed Solution:</i> Provide ADA compliant sign mounted at 48" min. above to baseline of the lowest Braille cells and 60" max. to baseline of the highest line of raised characters on nearest adjacent wall, on latch side of a single door (located not to cause a Braille reader to stand within the door swing). 	PCODE SA11A ADAAG 91 4.1.3(16)(a) ADA 2010 216.8 CBC 2019 11B-216.8 Mitigated: <input type="radio"/> YES <input checked="" type="radio"/> NO	1	JOB	\$270	\$270

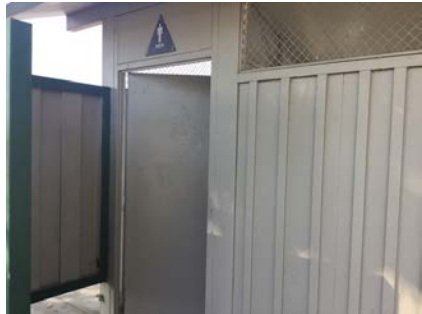
1786	<ul style="list-style-type: none"> • <i>As-Built Description:</i> Entrance to toilet or bathing facility not identified with ADAAG compliant signage. • <i>Proposed Solution:</i> Provide ADA compliant sign mounted at 48" min. above to baseline of the lowest Braille cells and 60" max. to baseline of the highest line of raised characters on nearest adjacent wall, on latch side of a single door (located not to cause a Braille reader to stand within the door swing). 	PCODE SA11A ADAAG 91 4.1.3(16)(a) ADA 2010 216.8 CBC 2019 11B-216.8 Mitigated: <input type="radio"/> YES <input checked="" type="radio"/> NO	1	JOB	\$270	\$270

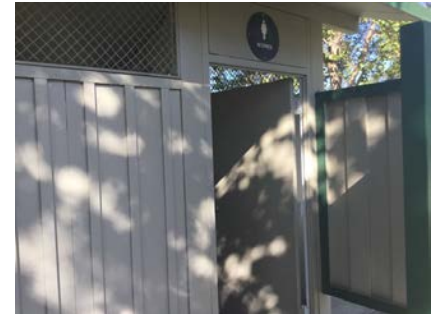
1775	<ul style="list-style-type: none"> <i>As-Built Description:</i> Entrance to toilet or bathing facility not identified with ADAAG compliant signage. <i>Proposed Solution:</i> Provide ADA compliant sign mounted at 48" min. above to baseline of the lowest Braille cells and 60" max. to baseline of the highest line of raised characters on nearest adjacent wall, on latch side of a single door (located not to cause a Braille reader to stand within the door swing). 	<p>PCODE SA11A ADAAG 91 4.1.3(16)(a) ADA 2010 216.8 CBC 2019 11B-216.8</p> <p>Mitigated: <input type="radio"/> YES <input checked="" type="radio"/> NO</p>	1	JOB	\$270	\$270
------	---	--	---	-----	-------	-------

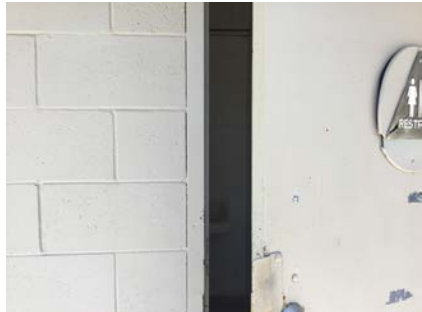
1875	<ul style="list-style-type: none"> <i>As-Built Description:</i> Entrance to toilet or bathing facility not identified with ADAAG compliant signage. <i>Proposed Solution:</i> Provide ADA compliant sign mounted at 48" min. above to baseline of the lowest Braille cells and 60" max. to baseline of the highest line of raised characters on nearest adjacent wall, on latch side of a single door (located not to cause a Braille reader to stand within the door swing). 	PCODE SA11A ADAAG 91 4.1.3(16)(a) ADA 2010 216.8 CBC 2019 11B-216.8 Mitigated: <input type="radio"/> YES <input checked="" type="radio"/> NO	1	JOB	\$270	\$270

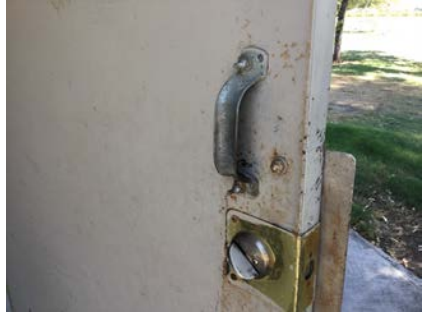
<p>1886</p> <ul style="list-style-type: none"> • <i>As-Built Description:</i> Door lock, latch or handle less than 34" or more than 48" above the floor (CA only: 34" to 44"). • <i>As-Built:</i> 53.0" high • <i>Proposed Solution:</i> Relocate or replace existing hardware. 	<p><i>PCODE ID17</i> <i>ADAAG 91 4.13.9</i> <i>ADA 2010 404.2.7</i> <i>CBC 2007 1133B.2.5.2</i> <i>CBC 2019 11B-404.2.7</i></p> <p>Mitigated: <input type="radio"/> YES <input checked="" type="radio"/> NO</p>	<p>1 JOB \$900 \$900</p>

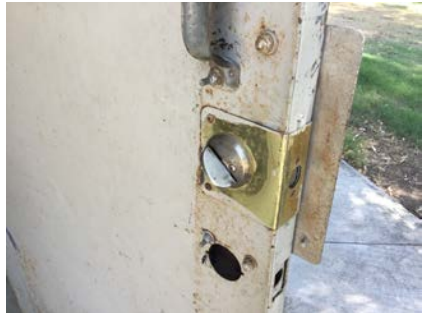
<p>1887</p> <ul style="list-style-type: none"> • <i>As-Built Description:</i> Door lock, latch or handle less than 34" or more than 48" above the floor (CA only: 34" to 44"). • <i>As-Built:</i> 48.0" high • <i>Proposed Solution:</i> Relocate or replace existing hardware. • <i>Notes:</i> 	<p><i>PCODE ID17</i> <i>ADAAG 91 4.13.9</i> <i>ADA 2010 404.2.7</i> <i>CBC 2007 1133B.2.5.2</i> <i>CBC 2019 11B-404.2.7</i></p> <p>Mitigated: <input type="radio"/> YES <input checked="" type="radio"/> NO</p>	<p>1 JOB \$900 \$900</p>

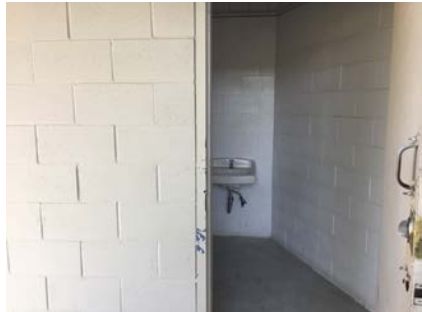
1888	<ul style="list-style-type: none"> <i>As-Built Description:</i> Entrance to toilet or bathing facility not identified with ADAAG compliant signage. <i>Proposed Solution:</i> Provide ADA compliant sign mounted at 48" min. above to baseline of the lowest Braille cells and 60" max. to baseline of the highest line of raised characters on nearest adjacent wall, on latch side of a single door (located not to cause a Braille reader to stand within the door swing). 	PCODE SA11A ADAAG 91 4.1.3(16)(a) ADA 2010 216.8 CBC 2019 11B-216.8 Mitigated: <input type="radio"/> YES <input checked="" type="radio"/> NO	1	JOB	\$270	\$270

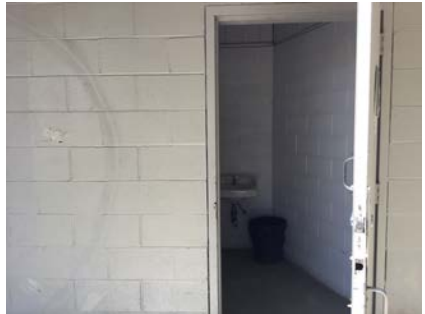
1910	<ul style="list-style-type: none"> <i>As-Built Description:</i> Entrance to toilet or bathing facility not identified with ADAAG compliant signage. <i>Proposed Solution:</i> Provide ADA compliant sign mounted at 48" min. above to baseline of the lowest Braille cells and 60" max. to baseline of the highest line of raised characters on nearest adjacent wall, on latch side of a single door (located not to cause a Braille reader to stand within the door swing). 	PCODE SA11A ADAAG 91 4.1.3(16)(a) ADA 2010 216.8 CBC 2019 11B-216.8 Mitigated: <input type="radio"/> YES <input checked="" type="radio"/> NO	1	JOB	\$270	\$270

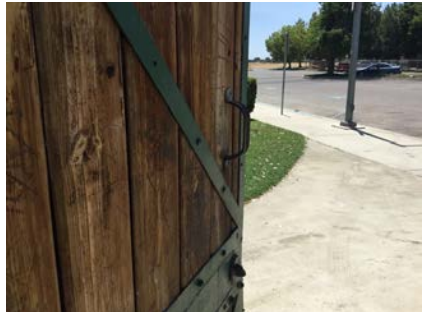
Item no., Rm no. and Name	Existing Architectural Barrier and Proposed Solution	Codes / Mitigation Info	Qty	Unit	Cost	Total
1929	<ul style="list-style-type: none"> As-Built Description: Door lock, latch or handle less than 34" or more than 48" above the floor (CA only: 34" to 44"). As-Built: 54.0" high Proposed Solution: Relocate or replace existing hardware. 	PCODE ID17 ADAAG 91 4.13.9 ADA 2010 404.2.7 CBC 2007 1133B.2.5.2 CBC 2019 11B-404.2.7 Mitigated: <input type="radio"/> YES <input checked="" type="radio"/> NO	1	JOB	\$900	\$900

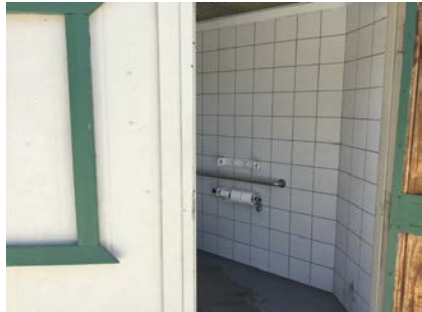
1931	<ul style="list-style-type: none"> <i>As-Built Description:</i> Entrance to toilet or bathing facility not identified with ADAAG compliant signage. <i>Proposed Solution:</i> Provide ADA compliant sign mounted at 48" min. above to baseline of the lowest Braille cells and 60" max. to baseline of the highest line of raised characters on nearest adjacent wall, on latch side of a single door (located not to cause a Braille reader to stand within the door swing). 	PCODE SA11A ADAAG 91 4.1.3(16)(a) ADA 2010 216.8 CBC 2019 11B-216.8 Mitigated: <input type="radio"/> YES <input checked="" type="radio"/> NO	1	JOB	\$270	\$270

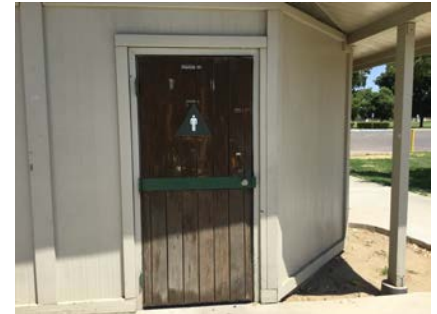
1950	<ul style="list-style-type: none"> <i>As-Built Description:</i> Entrance to toilet or bathing facility not identified with ADAAG compliant signage. <i>Proposed Solution:</i> Provide ADA compliant sign mounted at 48" min. above to baseline of the lowest Braille cells and 60" max. to baseline of the highest line of raised characters on nearest adjacent wall, on latch side of a single door (located not to cause a Braille reader to stand within the door swing). 	PCODE SA11A ADAAG 91 4.1.3(16)(a) ADA 2010 216.8 CBC 2019 11B-216.8	1	JOB	\$270	\$270
------	---	--	---	-----	-------	-------

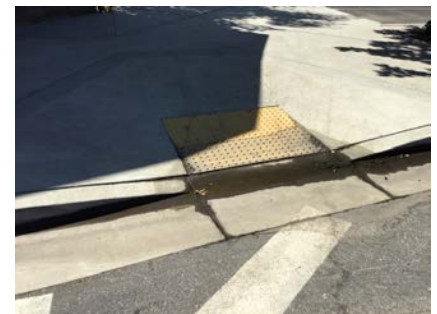
969	<ul style="list-style-type: none"> As-Built Description: Refer to notes for observation and recommendation. Proposed Solution: Notes: 	PCODE GN01 CBC 2019 11B-405.10 Mitigated: <input type="radio"/> YES <input checked="" type="radio"/> NO	1	JOB		
-----	--	---	---	-----	--	--

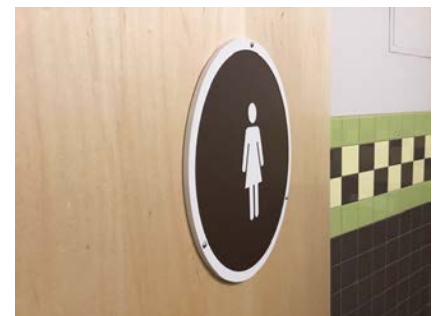
1022	<ul style="list-style-type: none"> <i>As-Built Description:</i> Required in CA only: identification symbol centered 58" to 60" high on sanitary facility door that contrasts with the door not provided (women: 12" ø circle, men: 12" triangle, unisex: combined symbol). <i>As-Built:</i> Not beveled <i>Proposed Solution:</i> Provide properly mounted sanitary facility symbol when altering area. If wheelchair accessible, include International Symbol of Accessibility on sign. 	<p>PCODE SA15 CBC 2007 1115B.6 CBC 2019 11B-703.7.2.6</p> <p>Mitigated: <input type="radio"/> YES <input checked="" type="radio"/> NO</p>	1	JOB	\$270	\$270
------	--	---	---	-----	-------	-------

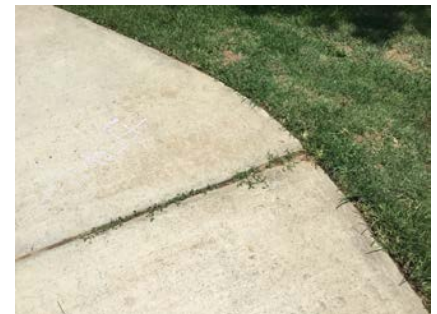
1398	<ul style="list-style-type: none"> <i>As-Built Description:</i> Walk: Pavement dislocation creates abrupt change in level exceeding 1/2" in accessible route. <i>As-Built:</i> Up to 1.0" <i>Proposed Solution:</i> Remove, replace or repair area of pavement sufficient to correct abrupt change in level. 	PCODE EF03 ADAAG 91 4.3.8 ADA 2010 403.4 CBC 2007 1133B.7.4 CBC 2019 11B-403.4 Mitigated: <input type="radio"/> YES <input checked="" type="radio"/> NO	40	LF	\$63	\$2,520
------	--	--	----	----	------	---------

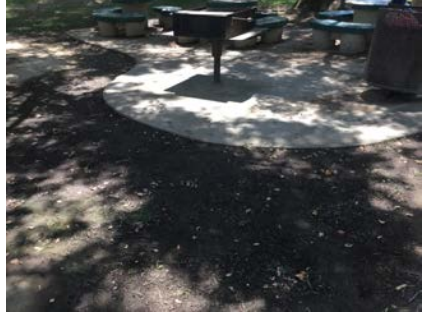
Item no., Rm no. and Name	Existing Architectural Barrier and Proposed Solution	Codes / Mitigation Info	Qty	Unit	Cost	Total
1400	<ul style="list-style-type: none"> As-Built Description: Walk: Pavement dislocation creates abrupt change in level exceeding 1/2" in accessible route. As-Built: up to 2.0" Proposed Solution: Remove, replace or repair area of pavement sufficient to correct abrupt change in level. 	PCODE EF03 ADAAG 91 4.3.8 ADA 2010 403.4 CBC 2007 1133B.7.4 CBC 2019 11B-403.4 Mitigated: <input type="radio"/> YES <input checked="" type="radio"/> NO	60	SF	\$63	\$3,780

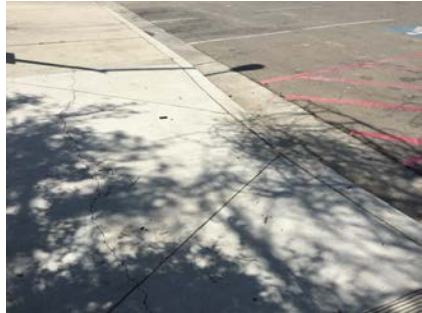
Item no., Rm no. and Name	Existing Architectural Barrier and Proposed Solution	Codes / Mitigation Info	Qty	Unit	Cost	Total
1407	<ul style="list-style-type: none"> As-Built Description: Transition from curb ramp to gutter does not have a smooth transition. As-Built: 1.0" Proposed Solution: Grind lip. 	PCODE EH02D ADAAG 91 4.7.2 ADA 2010 406.2 CBC 2007 1127B.5.3 CBC 2019 11B-406.5.8 Mitigated: <input type="radio"/> YES <input checked="" type="radio"/> NO	4	JOB	\$300	\$1,200

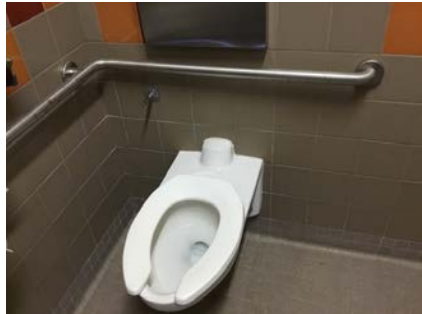
Item no., Rm no. and Name	Existing Architectural Barrier and Proposed Solution	Codes / Mitigation Info	Qty	Unit	Cost	Total
2133	<ul style="list-style-type: none"> <i>As-Built Description:</i> Flush Control: Operating handle not mounted toward wide side of stall. <i>Proposed Solution:</i> Replace flush control with properly mounted accessible type, or install sensor flush. 	PCODE WB10 ADAAG 91 4.16.5 ADA 2010 604.6 CBC 2007 1115B.4.1.5 CBC 2019 11B-604.6 Mitigated: <input type="radio"/> YES <input checked="" type="radio"/> NO	1	JOB	\$1,500	\$1,500

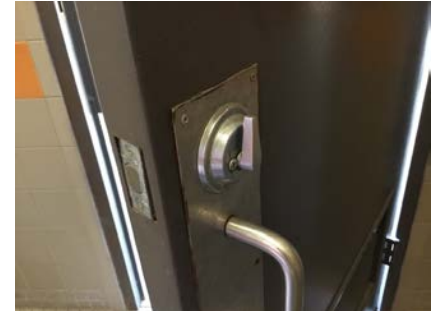
2156	<ul style="list-style-type: none"> As-Built Description: Door lock, latch or handle less than 34" or more than 48" above the floor (CA only: 34" to 44"). As-Built: 45.0" Proposed Solution: Relocate or replace existing hardware. Notes: 	PCODE ID17 ADAAG 91 4.13.9 ADA 2010 404.2.7 CBC 2007 1133B.2.5.2 CBC 2019 11B-404.2.7	1	JOB	\$900	\$900
------	---	---	---	-----	-------	-------
