The City of Madera

Appendix B: Facilities

Access Compliance Survey Report

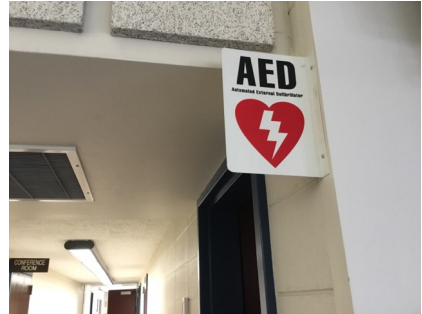
Item no., Rm no. and Name	Existing Architectural Barrier and Proposed Solution	Codes / Mitigation Info	9 Qty	10 Unit	11 Cost	12 Total
1 2 Foyer	<p>3 <u>Protrusion Limits</u></p> <p>2259 • <i>As-Built Description:</i></p> <p>4 Protruding objects more than 4" from wall, when bottom of object more than 27" or less than 80"</p> <p>5 above finished floor.</p> <p>• <i>As-Built:</i> AED sign: 7.0" at 76.0" high</p> <p>• <i>Proposed Solution:</i></p> <p>6 Remove/relocate protruding object. Patch existing surface.</p>	<p>7</p> <p>PCODE EG04</p> <p>ADAAG 91 4.4.1</p> <p>8 ADA 2010 307.2</p> <p>CBC 2007 1133B.8.6.1</p> <p>CBC 2019 11B-307.2</p> <p>Mitigated:</p> <p><input type="radio"/> YES</p> <p><input checked="" type="radio"/> NO</p>	1	JOB	\$300	\$300

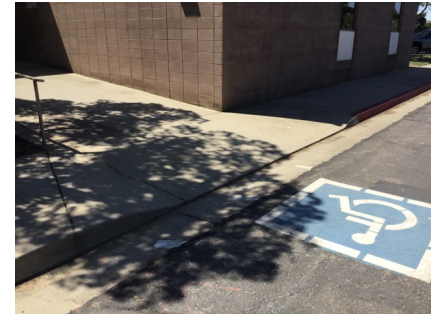
86	<ul style="list-style-type: none"> As-Built Description: Transition from curb ramp to gutter does not have a smooth transition. As-Built: 1.0" high Proposed Solution: Grind lip. 	PCODE EH02D ADAAG 91 4.7.2 ADA 2010 406.2 CBC 2007 1127B.5.3 CBC 2019 11B-406.5.8	1	JOB	\$300	\$300
----	---	---	---	-----	-------	-------

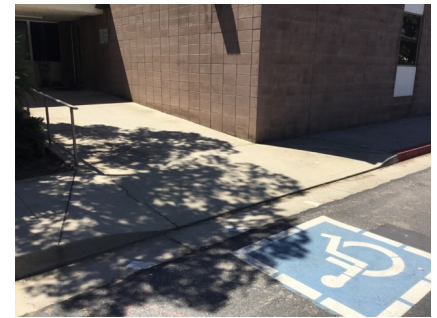
87	<ul style="list-style-type: none"> As-Built Description: Maximum slope of adjoining gutters, street surface at bottom of ramp exceeds 5% (1:20). As-Built: 9.0% Proposed Solution: Modify road/gutter slopes. Demolish existing and provide new curb ramp. 	PCODE EH02E ADAAG 91 4.7.2 ADA 2010 406.2 CBC 2007 1127B.5.3 CBC 2019 11B-406.5.8	1	JOB	\$3,750	\$3,750
----	--	---	---	-----	---------	---------

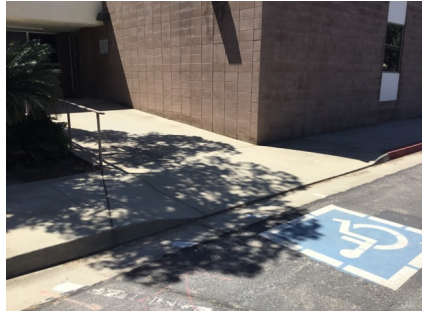
Item no., Rm no. and Name	Existing Architectural Barrier and Proposed Solution	Codes / Mitigation Info	Qty	Unit	Cost	Total
88	<ul style="list-style-type: none"> As-Built Description: Side slopes more than 1:10 (10%). As-Built: 19.0% Proposed Solution: Modify curb ramp. Demolish side slopes and replace with 1:10 side slopes if 48" level top landing is provided. 	PCODE EH05A ADAAG 91 4.7.5 ADA 2010 406.3 CBC 2007 1127B.5.3 CBC 2019 11B-406.2.2 Mitigated: <input type="radio"/> YES <input checked="" type="radio"/> NO	2	JOB	\$6,000	\$12,000

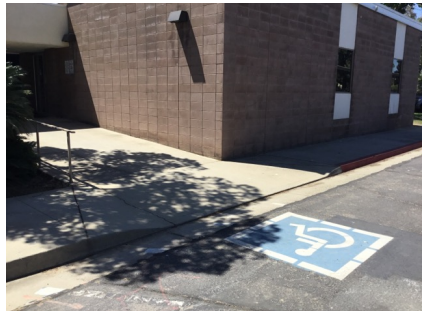
<input type="radio"/> Staff Only			
			Priority 1			
			Severity 2			
85	<ul style="list-style-type: none"> As-Built Description: Detectable warning not provided where pedestrian crosses vehicular area. Proposed Solution: Provide detectable warning surface (i.e. in-line truncated domes) at regular curb ramp. 	PCODE EH07A ADAAG 91 4.7.7 ADA 2010 705.1 CBC 2007 1127B.5.7 CBC 2019 11B-705.1.2.2 Mitigated: <input type="radio"/> YES <input checked="" type="radio"/> NO	1	JOB	\$750	\$750

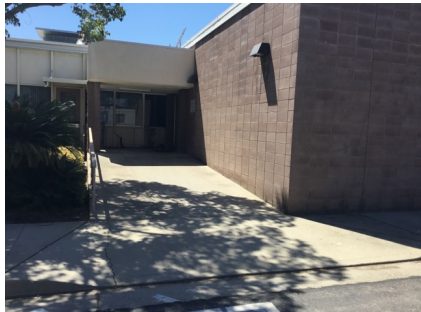
78	<ul style="list-style-type: none"> <i>As-Built Description:</i> Exterior signage at inaccessible entrances to provide direction to accessible entrances is missing or noncompliant. <i>Proposed Solution:</i> Provide signage sufficient to guide persons to accessible entrances. <i>Notes:</i> 	<p>PCODE SA01 ADAAG 91 4.1.2(7)(c) ADA 2010 216.6 CBC 2007 1117B.5.8.1.2 CBC 2019 11B-216.6</p> <p>Mitigated: <input type="radio"/> YES <input checked="" type="radio"/> NO</p>	1	JOB	\$690	\$690
----	---	--	---	-----	-------	-------

Unless this entrance is modified to be accessible consider a directional sign informing drivers where they can park to access this building.

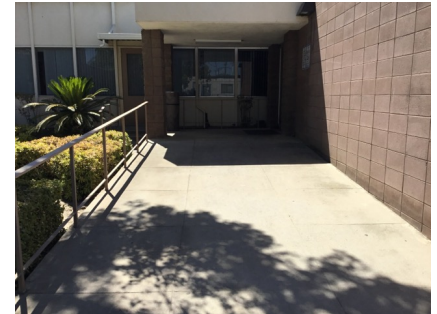
79	<ul style="list-style-type: none"> As-Built Description: Slope greater than 1:12 (8.3%). As-Built: 9.1% Proposed Solution: Modify surface. 	PCODE EB02 ADAAG 91 4.8.2 ADA 2010 405.2 CBC 2007 1133B.5.3 CBC 2019 11B-405.2	10	SF	\$300	\$3,000
----	--	--	----	----	-------	---------

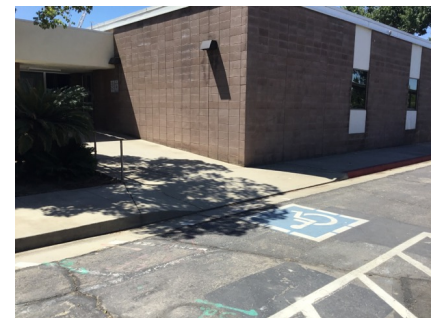
84	<ul style="list-style-type: none"> As-Built Description: Level 2% max. landing for ramp not provided. As-Built: Landing slopes 8.4% Proposed Solution: Rebuild ramp to provide landings for each ramp run with slopes no greater than 2%. Relocate the curb ramp. Notes: 	PCODE EB05A ADAAG 91 4.8.4 ADA 2010 405.7.1 CBC 2007 1133B.5.4.1 CBC 2019 11B-405.7.1	50	SF	\$300	\$15,000
----	---	---	----	----	-------	----------

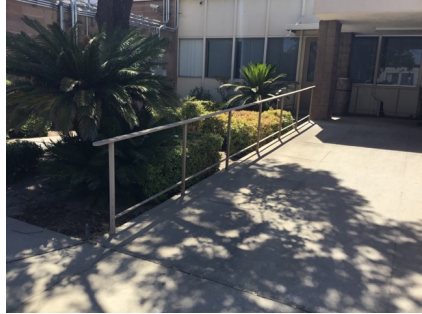
Item no., Rm no. and Name	Existing Architectural Barrier and Proposed Solution	Codes / Mitigation Info	Qty	Unit	Cost	Total
Top and Bottom Extension at						
80	<ul style="list-style-type: none"> <i>As-Built Description:</i> Ramp handrail does not extend horizontally 12" past top and / or bottom of ramp. <i>Proposed Solution:</i> Provide ramp handrail extension (cost for each extension piece). 	PCODE ED05 ADAAG 91 4.8.5(2) ADA 2010 505.10.1 CBC 2007 1133B.4.2.2 & 1133B.5.5.1 CBC 2019 11B-505.10.1	2	JOB	\$510	\$1,020
		Mitigated: <input type="radio"/> YES <input checked="" type="radio"/> NO

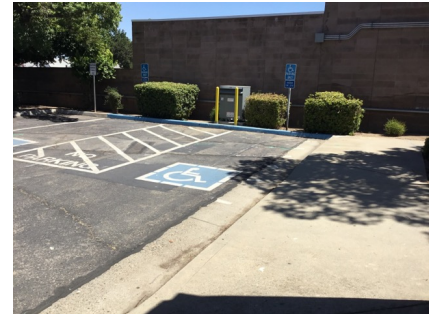
The steepest slopes are caused by the gutter slope. Other slopes are due to upheavals in the pavement and general surface slopes.

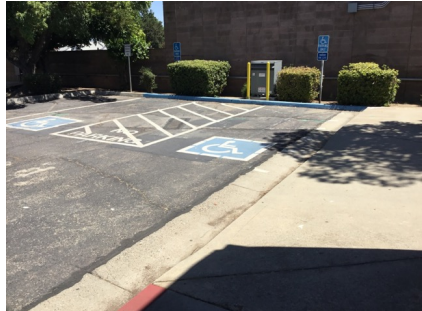
Item no., Rm no. and Name	Existing Architectural Barrier and Proposed Solution	Codes / Mitigation Info	Qty	Unit	Cost	Total
91	<ul style="list-style-type: none"> <i>As-Built Description:</i> Disabled persons must wheel or walk behind parked car(s) other than their own. <i>Proposed Solution:</i> Relocate parking and provide curb ramp to accessible route. 	PCODE EA03 ADAAG 91 Fig.9 ADA 2010 502.3 CBC 2007 1129B.3.1 CBC 2019 11B-502.7.1 Mitigated: <input type="radio"/> YES <input checked="" type="radio"/> NO	1	JOB	\$2,190	\$2,190

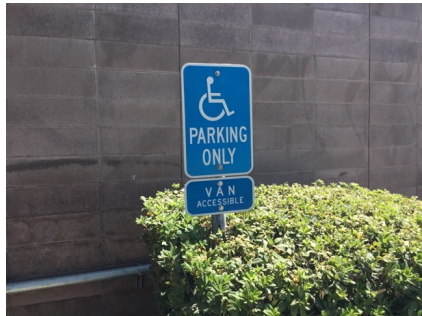
<input type="radio"/> Staff Only			
			Priority <input checked="" type="radio"/> 1			
			Severity <input checked="" type="radio"/> 3			
93	<ul style="list-style-type: none"> <i>As-Built Description:</i> Parking sign is not located between 60" and 80" above the finish floor or ground surface measured to the bottom of the sign. <i>As-Built:</i> 58.0" high <i>Proposed Solution:</i> Remount existing sign at accessible height. 	PCODE EA04H ADAAG 91 4.6.4 ADA 2010 502.7 CBC 2007 1129B.4 CBC 2019 11B-502.6 Mitigated: <input type="radio"/> YES <input checked="" type="radio"/> NO	1	JOB	\$135	\$135

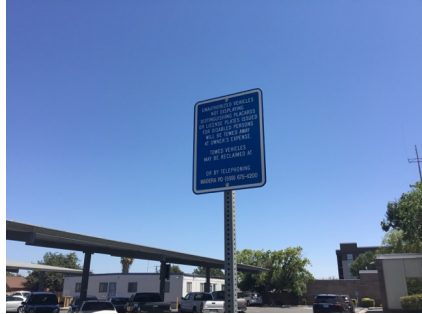
Item no., Rm no. and Name	Existing Architectural Barrier and Proposed Solution	Codes / Mitigation Info	Qty	Unit	Cost	Total
<u>Parking Signage</u>						
94	<ul style="list-style-type: none"> • <i>As-Built Description:</i> No "Tow Away" sign at parking lot entrance (required in CA only). • <i>As-Built:</i> Incomplete. Does not comply w current verbiage. • <i>Proposed Solution:</i> Provide "Tow Away" sign at parking lot entrance when altering area. 	<p>PCODE EA04C</p> <p>CBC 2007 1129B.4</p> <p>CBC 2019 11B-502.8.2</p> <p>Mitigated:</p> <p><input type="radio"/> YES</p> <p><input checked="" type="radio"/> NO</p>	1	JOB	\$975	\$975

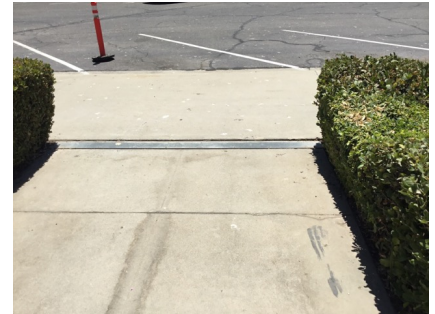
- 102
- As-Built Description:**
Walk: Pavement dislocation creates abrupt change in level exceeding 1/2" in accessible route.
 - As-Built:** 1.0"
 - Proposed Solution:**
Remove, replace or repair area of pavement sufficient to correct abrupt change in level.

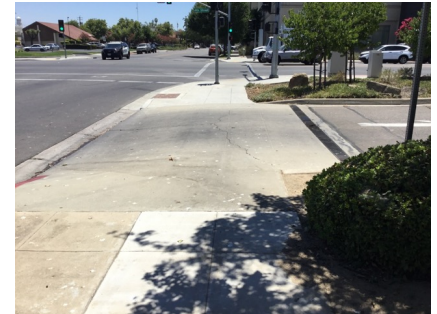
117	<ul style="list-style-type: none"> • <i>As-Built Description:</i> 36" wide band of truncated domes not provided at walkway or crossing adjoining a vehicular way, if surfaces are not separated by a curb, railing, or other element. • <i>Proposed Solution:</i> Provide 36" wide, contrasting color, band of truncated domes between pedestrian and vehicular area. • <i>Notes:</i> 	<p>PCODE EG09 ADAAG 91 4.29.5 CBC 2007 1133B.8.5 CBC 2019 11B-705.1.2.5</p> <p>Mitigated: <input type="radio"/> YES <input checked="" type="radio"/> NO</p>	30	LF	\$81	\$2,430
-----	--	--	----	----	------	---------

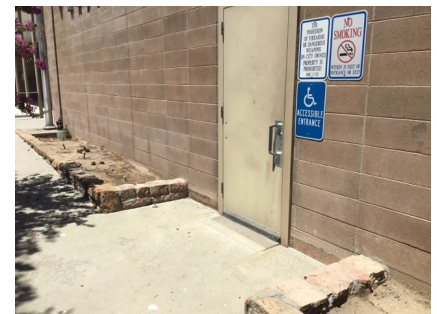
95	<ul style="list-style-type: none"> • <i>As-Built Description:</i> Surface of required maneuvering clearance at door slopes more than 1/4":12" (2.0%). • <i>As-Built:</i> 3.0% • <i>Proposed Solution:</i> Modify surface slope at door. 	<p>PCODE ID11 ADAAG 91 4.13.6 ADA 2010 404.2.4.4 CBC 2007 1133B.2.4 CBC 2019 11B-404.2.4</p> <p>Mitigated: <input type="radio"/> YES <input checked="" type="radio"/> NO</p>	5	SF	\$120	\$600
----	---	---	---	----	-------	-------

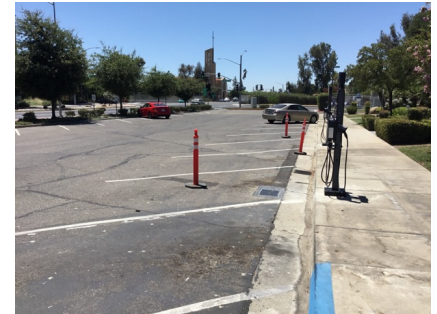
114	<ul style="list-style-type: none"> As-Built Description: Electric Vehicle is not located on an accessible route. Proposed Solution: Modify or relocate Electric Vehicle space so that it connects to the accessible route. Notes: 	<p>PCODE EV03</p> <p>CBC 2019 11B-812.5.1</p> <p>Mitigated:</p> <p><input type="radio"/> YES</p> <p><input checked="" type="radio"/> NO</p>	1	JOB	\$1,050	\$1,050
-----	---	--	---	-----	---------	---------

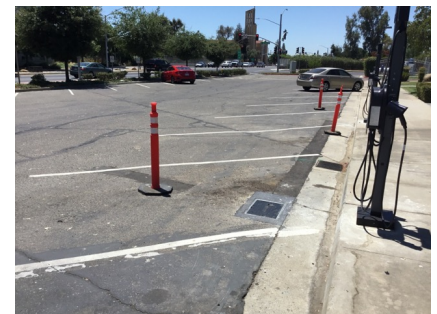
115	<ul style="list-style-type: none"> As-Built Description: Electric Vehicle space has slope greater than 1/4":12" (2%). As-Built: Up to 8.0%. 11.0% at gutter. Proposed Solution: Modify slope at Electric Vehicle space to provide a slope of 2% maximum. Notes: 	<p>PCODE EV01</p> <p>CBC 2019 11B-812.3</p> <p>Mitigated:</p> <p><input type="radio"/> YES</p> <p><input checked="" type="radio"/> NO</p>	360	SF	\$36	\$12,960
-----	--	--	-----	----	------	----------

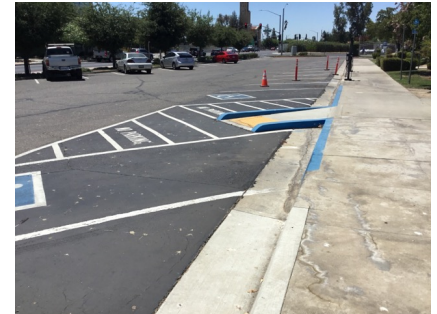
109	<ul style="list-style-type: none"> As-Built Description: Accessible parking space has slope greater than 1/4":12" (2%). As-Built: 3.0% to 11.0% at gutter. Proposed Solution: Modify slope at accessible parking space. 	PCODE EA05 ADAAG 91 4.6.3 ADA 2010 502.4 CBC 2007 1129B.3.3 CBC 2019 11B-502.4	150	SF	\$36	\$5,400
-----	---	--	-----	----	------	---------

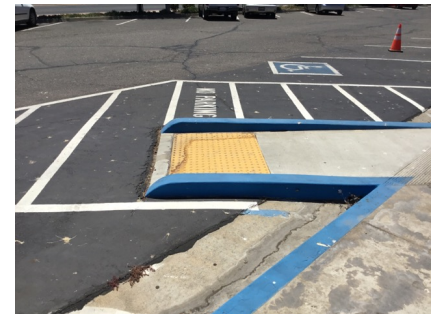
111	<ul style="list-style-type: none"> As-Built Description: Access aisle at accessible parking space has slope greater than 1/4":12" (2%). Proposed Solution: Demolish existing and provide new curb ramp outside of the access aisle. Notes: 	PCODE EA05BNT ADAAG 91 4.6.3 ADA 2010 502.4 CBC 2007 1129B.3.3 CBC 2019 11B-502.4	1	JOB	\$7,500	\$7,500
-----	---	---	---	-----	---------	---------

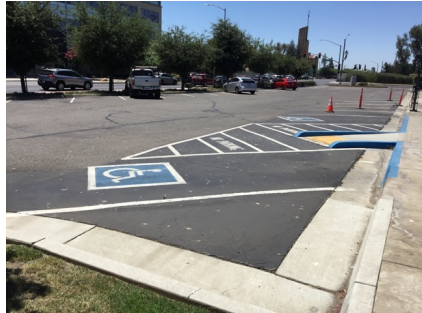
Item no., Rm no. and Name	Existing Architectural Barrier and Proposed Solution	Codes / Mitigation Info	Qty	Unit	Cost	Total
106	<ul style="list-style-type: none"> As-Built Description: Accessible parking space does not have 5' wide access aisle; 8' wide for van accessible aisle. Proposed Solution: Modify parking aisle(s) to create accessible space by restriping. Notes: 	PCODE EA02B ADAAG 91 4.6.3 ADA 2010 502.3 CBC 2007 1129B.3.1 CBC 2019 11B-502.2; 11B-502.3.1 Mitigated: <input type="radio"/> YES <input checked="" type="radio"/> NO	1	JOB	\$600	\$600

<input type="radio"/> Staff Only			
			Priority <input checked="" type="radio"/> 1			
			Severity <input checked="" type="radio"/> 3			
<p>Access aisle does not extend the length of the spaces.</p>						
108	<ul style="list-style-type: none"> As-Built Description: CA only: The area within the blue borderlines not marked with hatched lines a maximum of 36" on center. Proposed Solution: Restripe to provide hatched lines at 36" on center within access aisle. Notes: 	PCODE EA04I CBC 2007 1129B.3.1 CBC 2019 11B-502.3.3 Mitigated: <input type="radio"/> YES <input checked="" type="radio"/> NO	2	JOB	\$300	\$600

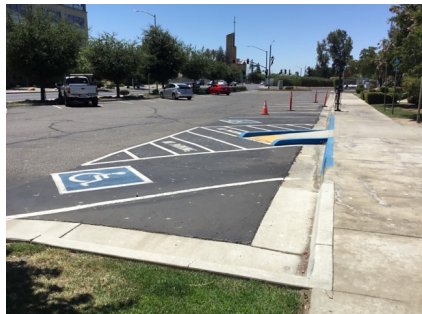
<input type="radio"/> Staff Only			
			Priority <input checked="" type="radio"/> 1			
			Severity <input checked="" type="radio"/> 3			
<p>Not diagonal.</p>

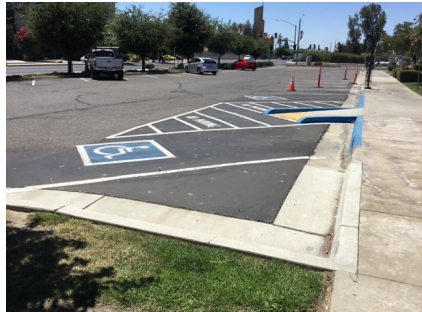
Item no., Rm no. and Name	Existing Architectural Barrier and Proposed Solution	Codes / Mitigation Info	Qty	Unit	Cost	Total
107	<ul style="list-style-type: none"> As-Built Description: An accessible parking space shall be outlined or painted blue (required in CA only). Proposed Solution: Identify accessible parking space using blue markings. 	PCODE EA04K CBC 2019 11B-502.6 Mitigated: <input type="radio"/> YES <input checked="" type="radio"/> NO	2	JOB	\$360	\$720

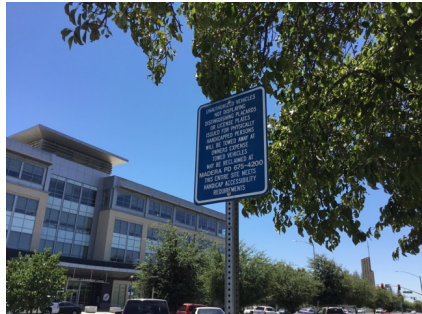
Parking Signage

116	<ul style="list-style-type: none"> As-Built Description: No "Tow Away" sign at parking lot entrance (required in CA only). Proposed Solution: Provide "Tow Away" sign at parking lot entrance when altering area. Notes: 	PCODE EA04C CBC 2007 1129B.4 CBC 2019 11B-502.8.2 Mitigated: <input type="radio"/> YES <input checked="" type="radio"/> NO	1	JOB	\$975	\$975

Verbiage. Size.

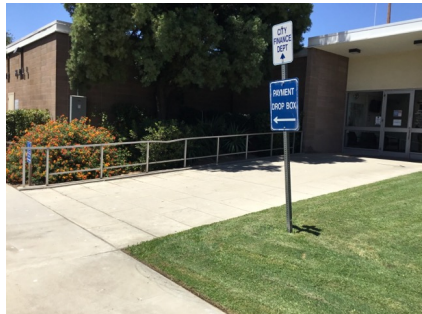
Ramp

104	<ul style="list-style-type: none"> <i>As-Built Description:</i> Slope not steep but greater than 1:20 (5.0 %) without handrails. <i>Proposed Solution:</i> Provide handrails for ramp. <i>Notes:</i> 	<p>PCODE EB03 ADAAG 91 4.8.1 ADA 2010 405.1 CBC 2007 1133B.5.5.1 CBC 2019 11B-405.8</p> <p>Mitigated: <input type="radio"/> YES <input checked="" type="radio"/> NO</p>	60	LF	\$225	\$13,500
-----	---	--	----	----	-------	----------

Multiple barriers on existing handrail. No handrail on one side.

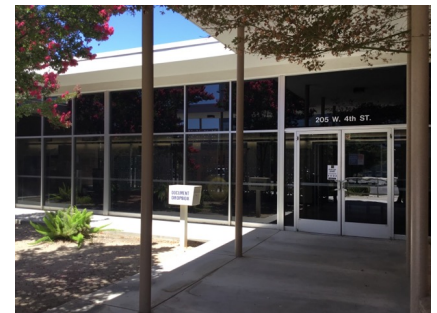
98	<ul style="list-style-type: none"> As-Built Description: Accessible building entrance when not all are accessible not identified with a sign showing the International Symbol of Accessibility. Proposed Solution: Provide building entrance sign that shows international symbol at accessible entrance. Notes: 	<p>PCODE SA12 ADAAG 91 4.1.2(7)(c) ADA 2010 216.6 CBC 2007 1127B.3 CBC 2019 11B-216.6</p> <p>Mitigated: <input type="radio"/> YES <input checked="" type="radio"/> NO</p>	1	JOB	\$150	\$150
----	--	--	---	-----	-------	-------

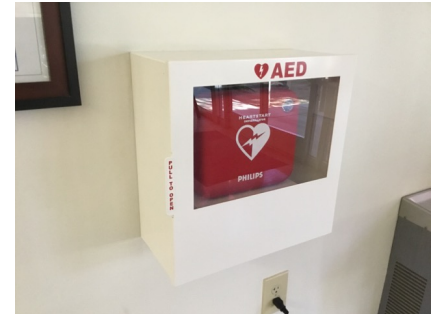
Protrusion Limits

18	<ul style="list-style-type: none"> As-Built Description: Protruding objects more than 4" from wall, when bottom of object more than 27" or less than 80" above finished floor. As-Built: AED: 7.2" at 41.0" high Proposed Solution: Remove/relocate protruding object. Patch existing surface. 	PCODE EG04 ADAAG 91 4.4.1 ADA 2010 307.2 CBC 2007 1133B.8.6.1 CBC 2019 11B-307.2 Mitigated: <input type="radio"/> YES <input checked="" type="radio"/> NO	3	JOB	\$300	\$900
----	--	---	---	-----	-------	-------

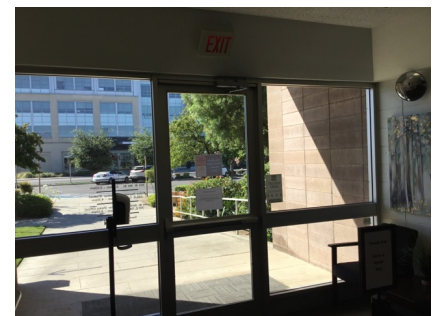
Signage

50	<ul style="list-style-type: none"> As-Built Description: At final exit door to exterior: Where required exit signs are installed, signs to provide exiting information for people with vision impairment are not provided. Proposed Solution: Provide raised letter/Braille "EXIT" sign at door. 	PCODE SA10A ADAAG 91 4.1.3(16) ADA 2010 216.4.1 CBC 2007 1011.3 CBC 2019 11B-216.4.1 Mitigated: <input type="radio"/> YES <input checked="" type="radio"/> NO	10	JOB	\$270	\$2,700
----	--	---	----	-----	-------	---------

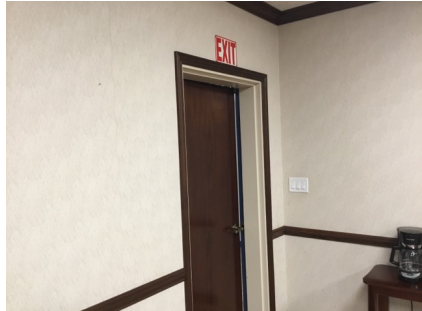
Item no., Rm no. and Name	Existing Architectural Barrier and Proposed Solution	Codes / Mitigation Info	Qty	Unit	Cost	Total
51	<ul style="list-style-type: none"> As-Built Description: At door leading into exit corridor: Where required exit signs are installed, signs to provide exiting information for people with vision impairment are not provided. Proposed Solution: Provide raised letter/Braille "EXIT ROUTE" sign at door. 	PCODE SA10D ADAAG 91 4.1.3(16) ADA 2010 216.4.1 CBC 2007 1011.3 CBC 2019 11B-216.4.1 Mitigated: <input type="radio"/> YES <input checked="" type="radio"/> NO	10	JOB	\$270	\$2,700

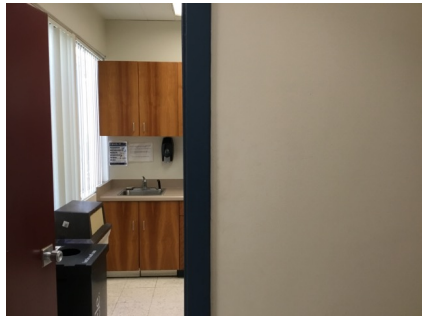
<input type="radio"/> Staff Only			
			Priority <input checked="" type="radio"/> 2			
			Severity <input checked="" type="radio"/> 3			
59	<ul style="list-style-type: none"> As-Built Description: Existing sign designating permanent room or space is noncompliant. Proposed Solution: Provide compliant signage. 	PCODE SA13 ADAAG 91 4.1.3(16)(a) ADA 2010 216.2 CBC 2007 1117B.5 CBC 2019 11B-216.2 Mitigated: <input type="radio"/> YES <input checked="" type="radio"/> NO	30	JOB	\$450	\$13,500

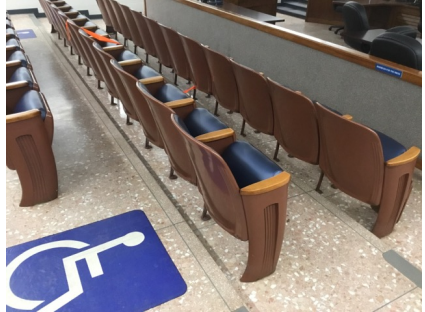
Item no., Rm no. and Name	Existing Architectural Barrier and Proposed Solution	Codes / Mitigation Info	Qty	Unit	Cost	Total
4	<ul style="list-style-type: none"> <i>As-Built Description:</i> CA only: Less than one percent of total seats have at least 24" clear leg space between the front of the seat and any obstruction to accommodate semi-ambulant individuals. <i>As-Built:</i> 12.0" leg space at semi ambulant seats. 46 seats in auditorium. <i>Proposed Solution:</i> Relocate seats to provide 24" clear leg room for semi-ambulant individuals. 	PCODE GE01D CBC 2007 1104B.3.8 CBC 2019 11B-221.6 Mitigated: <input type="radio"/> YES <input checked="" type="radio"/> NO	1	EA	\$15,000	\$15,000

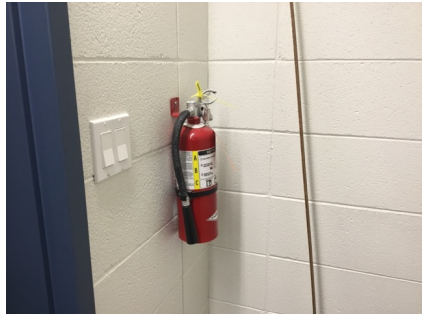
Reach Range

11	<ul style="list-style-type: none"> <i>As-Built Description:</i> Reach height to control or access point, where side approach is available, exceeds 48" or is less than 15" in height, or exceeds 10" in depth. <i>As-Built:</i> 57.0" high <i>Proposed Solution:</i> Modify equipment or mounting. 	PCODE IE02 ADAAG 91 4.2.6 ADA 2010 308.3.1 CBC 2007 1118B.6 CBC 2019 11B-308.3 Mitigated: <input type="radio"/> YES <input checked="" type="radio"/> NO	1	JOB	\$300	\$300

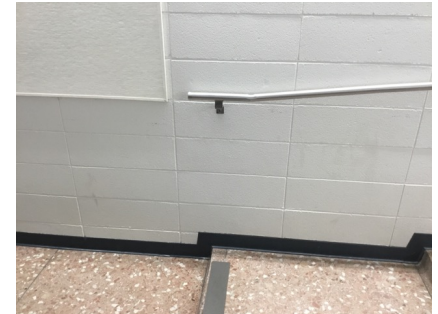
Top & Bottom Extension at Stairs

8	<ul style="list-style-type: none"> As-Built Description: Stair handrail does not extend horizontally 12" minimum beyond top nosing, and one tread width sloped, plus 12" minimum horizontally beyond the bottom nosing. As-Built: 4.0" extension Proposed Solution: Extend stair handrail at top and bottom (cost for each extension piece). 	<p>PCODE ED06</p> <p>ADAAG 91 4.9.4(2)</p> <p>ADA 2010 505.10.2; 505.10.3</p> <p>CBC 2007 1133B.4.2.2</p> <p>CBC 2019 11B-505.10.2; 11B-505.10.3</p>	4	JOB	\$510	\$2,040
---	--	--	---	-----	-------	---------

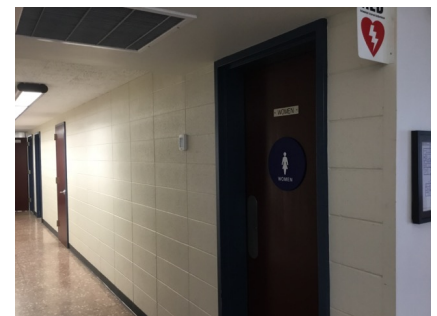
- *As-Built Description:*
Sign to provide direction to or information about building functional spaces missing or non-compliant.
- *Proposed Solution:*
Provide compliant signage.
- *Notes:*

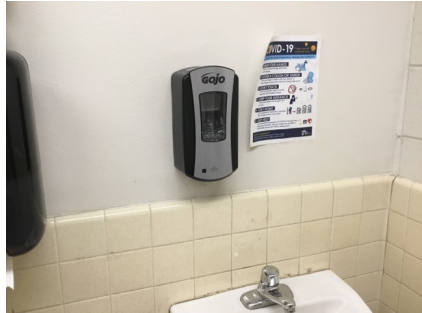
Item no., Rm no. and Name	Existing Architectural Barrier and Proposed Solution	Codes / Mitigation Info	Qty	Unit	Cost	Total
35	<ul style="list-style-type: none"> • <i>As-Built Description:</i> Dispensers in sanitary facilities, such as for towels, soap, sanitary napkins, seat covers, etc., and waste receptacles more than 48" (CA only: 40") from floor to highest operating slot or control. • <i>As-Built:</i> 49.0" high • <i>Proposed Solution:</i> Relocate existing restroom accessories. 	PCODE WG01A ADAAG 91 4.23.7 ADA 2010 308.2.1 CBC 2007 1115B.8.3 CBC 2019 11B-603.5 Mitigated: <input type="radio"/> YES <input checked="" type="radio"/> NO	1	JOB	\$300	\$300

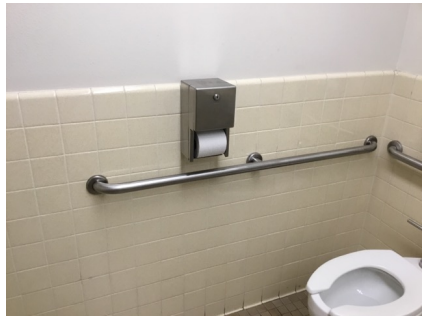
<input type="radio"/> Staff Only						
Priority <input checked="" type="radio"/> 3						
Severity <input checked="" type="radio"/> 2						
31	<ul style="list-style-type: none"> • <i>As-Built Description:</i> Toilet paper dispenser less than 15" (CA: 19") or more than 48" above floor or not within 7" to 9" from front of water closet (Note: CA pre-2010 is allowed within 12" from front of water closet). • <i>Proposed Solution:</i> Relocate or provide new toilet paper dispenser. 	PCODE WG02 ADAAG 91 4.16.6 ADA 2010 604.7 CBC 2007 1115B.8.4 CBC 2019 11B-604.7 Mitigated: <input type="radio"/> YES <input checked="" type="radio"/> NO	1	JOB	\$225	\$225

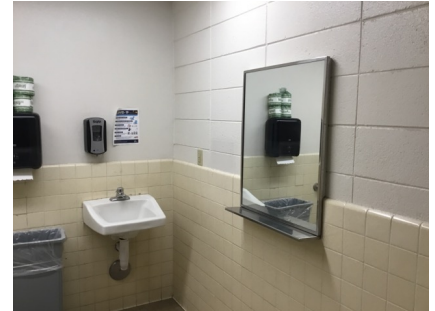
Item no., Rm no. and Name	Existing Architectural Barrier and Proposed Solution	Codes / Mitigation Info	Qty	Unit	Cost	Total
38	<ul style="list-style-type: none"> <i>As-Built Description:</i> Bottom of flat, not tilted mirror not located above lavatories or countertops mounted with bottom edge more than 35" above floor or top edge less than 74" above floor. <i>As-Built:</i> 40.75" high <i>Proposed Solution:</i> Relocate or provide new accessible mirror. 	PCODE WG03B ADAAG 91 4.19.6 ADA 2010 603.3 CBC 2007 1115B.8.1 CBC 2019 11B-603.3	1	JOB	\$450	\$450
		Mitigated: <input type="radio"/> YES <input checked="" type="radio"/> NO				
			<input type="radio"/> Staff Only			
			Priority <input checked="" type="radio"/> 3			
			Severity <input checked="" type="radio"/> 3

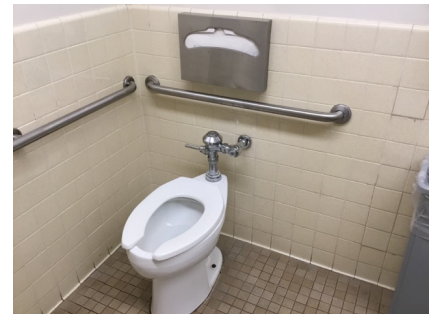
Grab Bars

32	<ul style="list-style-type: none"> <i>As-Built Description:</i> The rear wall grab is less than 36" min. or does not extend from the centerline of the water closet 12" min. on one side and 24" min. on the other side. <i>As-Built:</i> Extends 21.0" on wide side <i>Proposed Solution:</i> Provide or relocate accessible rear grab bar. <i>Notes:</i> 	PCODE WB07B ADAAG 91 4.17.6 ADA 2010 604.5.2 CBC 2007 1115B.4.1.3.2 CBC 2019 11B-604.5.2	1	JOB	\$1,020	\$1,020
		Mitigated: <input type="radio"/> YES <input checked="" type="radio"/> NO				
			<input type="radio"/> Staff Only			
			Priority <input checked="" type="radio"/> 3			
			Severity <input checked="" type="radio"/> 3

This element complies with Safe Harbor if altered or constructed before March 15, 2012. .

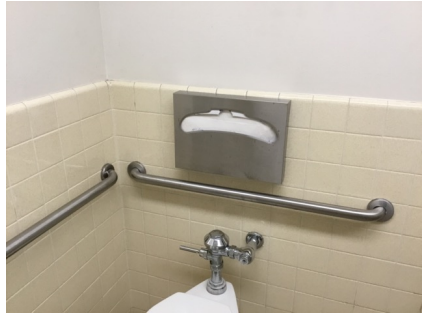
Item no., Rm no. and Name	Existing Architectural Barrier and Proposed Solution	Codes / Mitigation Info	Qty	Unit	Cost	Total
36	<ul style="list-style-type: none"> <i>As-Built Description:</i> Accessories/dispensers in accessible stall located closer than 1-1/2" below or 12" above grab bar impedes its use. <i>As-Built:</i> SCD: 1.6" above grab bar <i>Proposed Solution:</i> Relocate accessories/dispensers to be no closer than 1-1/2" below and 12" above grab bars (except if accessories are recessed, flush with wall, and have no sharp edges). 	PCODE WB07I ADAAG 91 4.26.2 ADA 2010 609.3 CBC 2007 1133B.4.2.5 CBC 2019 11B-609.3 Mitigated: <input type="radio"/> YES <input checked="" type="radio"/> NO	1	JOB	\$225	\$225

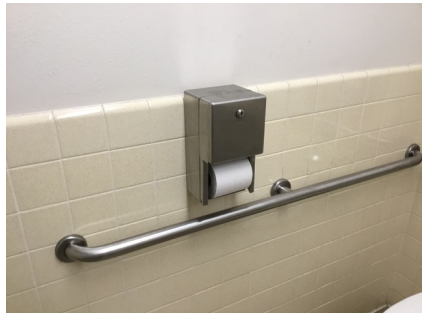
<input type="radio"/> Staff Only			
			Priority <input checked="" type="radio"/> 3			
			Severity <input checked="" type="radio"/> 4			
37	<ul style="list-style-type: none"> <i>As-Built Description:</i> Accessories/dispensers in accessible stall located closer than 1-1/2" below or 12" above grab bar impedes its use. <i>As-Built:</i> TPD: 2.7" above grab bar <i>Proposed Solution:</i> Relocate accessories/dispensers to be no closer than 1-1/2" below and 12" above grab bars (except if accessories are recessed, flush with wall, and have no sharp edges). 	PCODE WB07I ADAAG 91 4.26.2 ADA 2010 609.3 CBC 2007 1133B.4.2.5 CBC 2019 11B-609.3 Mitigated: <input type="radio"/> YES <input checked="" type="radio"/> NO	1	JOB	\$225	\$225

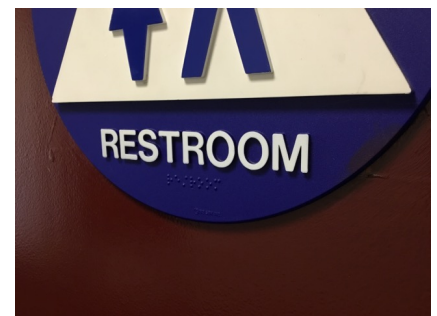
- *As-Built Description:*
Entrance to toilet or bathing facility not identified with ADAAG compliant signage.
- *As-Built:* **1/16" between raised characters.**
- *Proposed Solution:*
Provide ADA compliant sign mounted at 48" min. above to baseline of the lowest Braille cells and 60" max. to baseline of the highest line of raised characters on nearest adjacent wall, on latch side of a single door (located not to cause a Braille reader to stand within the door swing).
- *Notes:*

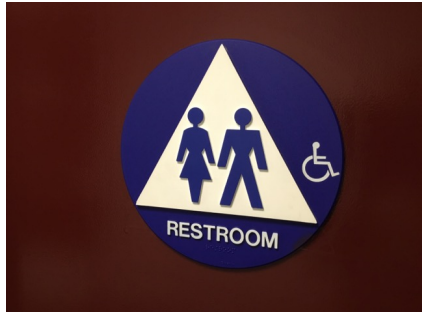
Item no., Rm no. and Name	Existing Architectural Barrier and Proposed Solution	Codes / Mitigation Info	Qty	Unit	Cost	Total
28	<ul style="list-style-type: none"> <i>As-Built Description:</i> Required in CA only: identification symbol centered 58" to 60" high on sanitary facility door that contrasts with the door not provided (women: 12" ø circle, men: 12" triangle, unisex: combined symbol). <i>As-Built:</i> Not beveled or radiused. <i>Proposed Solution:</i> Provide properly mounted sanitary facility symbol when altering area. If wheelchair accessible, include International Symbol of Accessibility on sign. 	<p>PCODE SA15</p> <p>CBC 2007 1115B.6</p> <p>CBC 2019 11B-703.7.2.6</p> <p>Mitigated:</p> <p><input type="radio"/> YES</p> <p><input checked="" type="radio"/> NO</p>	1	JOB	\$270	\$270

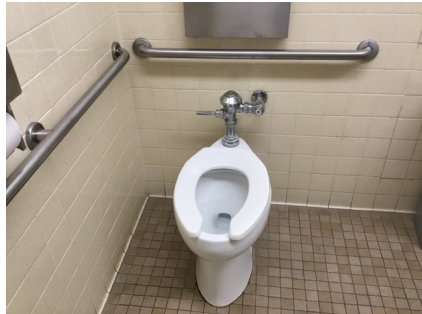
Water Closet

30	<ul style="list-style-type: none"> <i>As-Built Description:</i> Water closet not 16"-18" (CA: 17"-18") from near side wall to center line of water closet (2010 ADAAG: 16"-18"). <i>As-Built:</i> 18.6" o.c. <i>Proposed Solution:</i> Relocate existing water closet and plumbing, remount with offset closet flange to provide 18" max. from side wall. 	<p>PCODE WB02C</p> <p>ADAAG 91 Fig. 28</p> <p>ADA 2010 604.2</p> <p>CBC 2007 1115B.4.1.1</p> <p>CBC 2019 11B-604.2</p> <p>Mitigated:</p> <p><input type="radio"/> YES</p> <p><input checked="" type="radio"/> NO</p>	1	JOB	\$1,500	\$1,500
----	---	---	---	-----	---------	---------

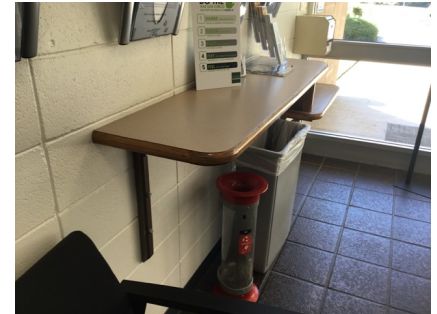
Protrusion Limits

43	<ul style="list-style-type: none"> As-Built Description: Protruding objects more than 4" from wall, when bottom of object more than 27" or less than 80" above finished floor. As-Built: Shelf/writing surface: 14.5" at 41.0" high Proposed Solution: Remove/relocate protruding object. Patch existing surface. 	PCODE EG04 ADAAG 91 4.4.1 ADA 2010 307.2 CBC 2007 1133B.8.6.1 CBC 2019 11B-307.2	1	JOB	\$300	\$300
----	---	--	---	-----	-------	-------

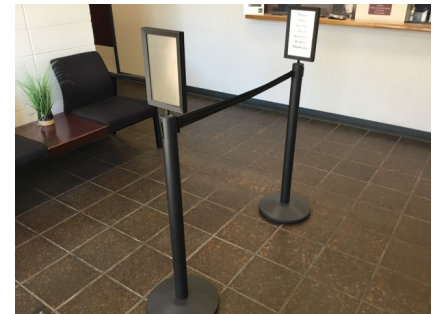
46	<ul style="list-style-type: none"> As-Built Description: Protruding objects more than 4" from wall, when bottom of object more than 27" or less than 80" above finished floor. As-Built: Stanchions 37.0" Proposed Solution: Provide cane-detectable railing to mark area of low clearance. 	PCODE EG04A ADAAG 91 4.4.1 ADA 2010 307.2 CBC 2007 1133B.8.6.1 CBC 2019 11B-307.2	4	LF	\$300	\$1,200
----	---	---	---	----	-------	---------

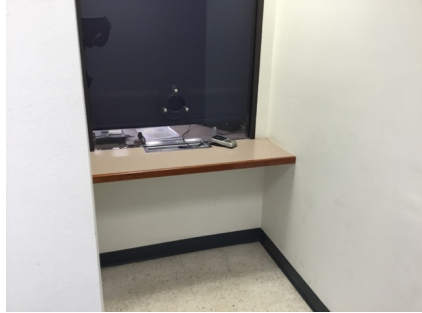
Public Counter

<p>42</p> <ul style="list-style-type: none"> <i>As-Built Description:</i> Sales and service counter: Accessible section not provided (knee space min. 27" high x 19" deep x 30" wide) <i>As-Built:</i> 14.5" deep <i>Proposed Solution:</i> Retrofit existing counter to provide accessible seating section. Interim solution: Provide auxiliary counter, table, or clipboard. 	<p>PCODE IN03A ADAAG 91 4.32.3 & 4 ADA 2010 306.3; 904.4 CBC 2007 1122B.3 & 4 CBC 2019 11B-306.3; 11B-904.4</p> <p>Mitigated: <input type="radio"/> YES <input checked="" type="radio"/> NO</p>	<p>1 JOB \$6,000 \$6,000</p>

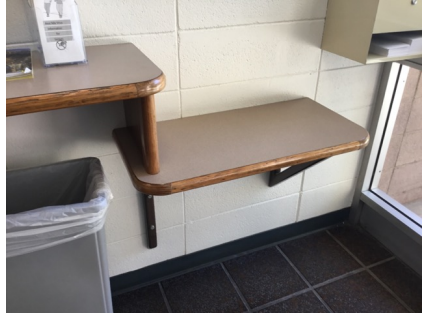
<p>44</p> <ul style="list-style-type: none"> <i>As-Built Description:</i> Sales and service counter: Accessible section not provided (knee space min. 27" high x 19" deep x 30" wide) <i>As-Built:</i> 16.0" deep <i>Proposed Solution:</i> Retrofit existing counter to provide accessible seating section. Interim solution: Provide auxiliary counter, table, or clipboard. 	<p>PCODE IN03A ADAAG 91 4.32.3 & 4 ADA 2010 306.3; 904.4 CBC 2007 1122B.3 & 4 CBC 2019 11B-306.3; 11B-904.4</p> <p>Mitigated: <input type="radio"/> YES <input checked="" type="radio"/> NO</p>	<p>1 JOB \$6,000 \$6,000</p>

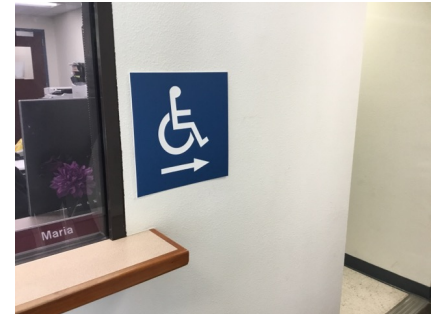
- 49 • *As-Built Description:*
Sign to provide direction to or information about building functional spaces missing or non-compliant.
- *Proposed Solution:*
Provide compliant signage.
- *Notes:*

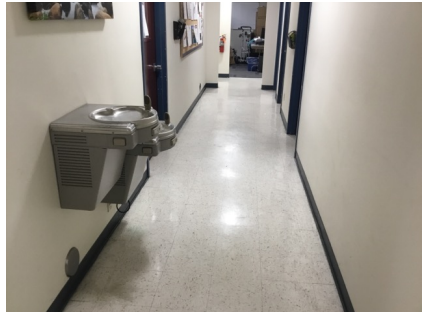
Item no., Rm no. and Name	Existing Architectural Barrier and Proposed Solution	Codes / Mitigation Info	Qty	Unit	Cost	Total
72	<ul style="list-style-type: none"> As-Built Description: Drinking fountain lacks protection for visually impaired persons. Proposed Solution: Provide cane-detectable rails. 	PCODE IA05C ADAAG 91 4.4.1 ADA 2010 307.2 CBC 2007 1115B.4.6.3 CBC 2019 11B-307.2 Mitigated: <input type="radio"/> YES <input checked="" type="radio"/> NO	1	JOB	\$1,500	\$1,500

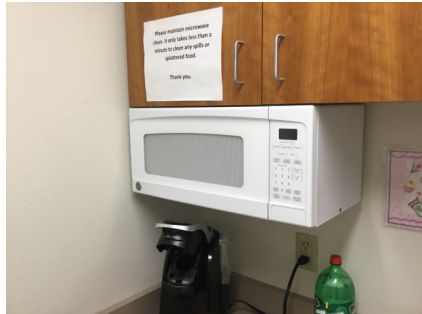
Reach Range

71	<ul style="list-style-type: none"> As-Built Description: Reach height to control or access point, where side approach is available, exceeds 48" or is less than 15" in height, or exceeds 10" in depth. As-Built: 59.0" high Proposed Solution: Modify equipment or mounting. 	PCODE IE02 ADAAG 91 4.2.6 ADA 2010 308.3.1 CBC 2007 1118B.6 CBC 2019 11B-308.3 Mitigated: <input type="radio"/> YES <input checked="" type="radio"/> NO	1	JOB	\$300	\$300

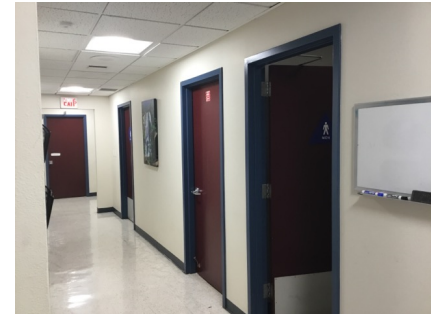
Multiple accommodation restroom not accessible; multiple compliance violations.

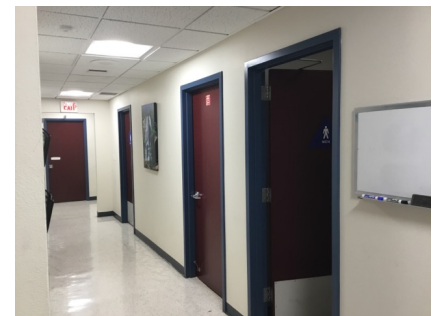
Sign to provide direction to or information about building functional spaces missing or non-compliant.

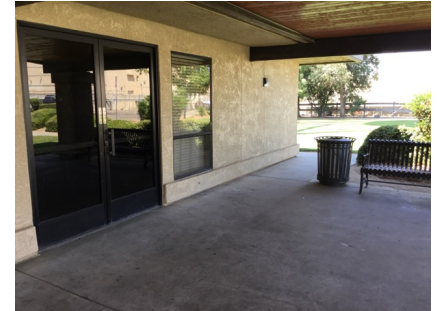
365	<ul style="list-style-type: none"> • <i>As-Built Description:</i> Cross slope more than 1":48" (2.083%). • <i>As-Built:</i> Up to 3.5% • <i>Proposed Solution:</i> Modify cross slope. • <i>Notes:</i> 	PCODE EF07 ADAAG 91 4.3.7 ADA 2010 403.3 CBC 2007 1133B.7.1.3 CBC 2019 11B-403.3	32	SF	\$75	\$2,400
-----	---	--	----	----	------	---------

The cross slope extends into the door maneuvering clearance.

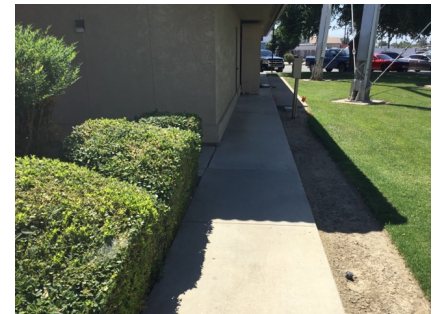
367	<ul style="list-style-type: none"> • <i>As-Built Description:</i> Cross slope more than 1":48" (2.083%). • <i>As-Built:</i> 3.5% • <i>Proposed Solution:</i> Modify cross slope. 	PCODE EF07 ADAAG 91 4.3.7 ADA 2010 403.3 CBC 2007 1133B.7.1.3 CBC 2019 11B-403.3	20	SF	\$75	\$1,500
-----	--	--	----	----	------	---------

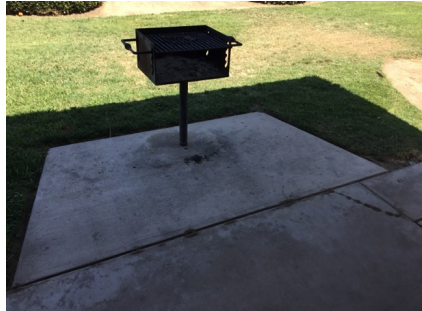
Item no., Rm no. and Name	Existing Architectural Barrier and Proposed Solution	Codes / Mitigation Info	Qty	Unit	Cost	Total
368	<ul style="list-style-type: none"> As-Built Description: Cross slope more than 1":48" (2.083%). As-Built: 2.3% Proposed Solution: Modify cross slope. 	PCODE EF07 ADAAG 91 4.3.7 ADA 2010 403.3 CBC 2007 1133B.7.1.3 CBC 2019 11B-403.3 Mitigated: <input type="radio"/> YES <input checked="" type="radio"/> NO	12	SF	\$75	\$900

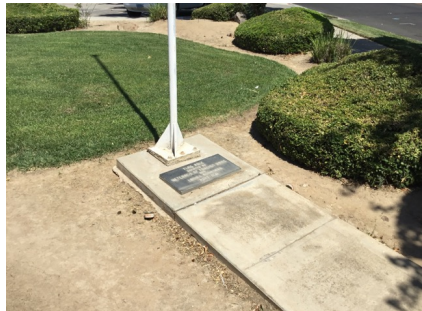
<input type="radio"/> Staff Only			
			Priority <input checked="" type="radio"/> 1			
			Severity <input checked="" type="radio"/> 4			
373	<ul style="list-style-type: none"> As-Built Description: Cross slope more than 1":48" (2.083%). Proposed Solution: Modify cross slope. Notes: 	PCODE EF07 ADAAG 91 4.3.7 ADA 2010 403.3 CBC 2007 1133B.7.1.3 CBC 2019 11B-403.3 Mitigated: <input type="radio"/> YES <input checked="" type="radio"/> NO	5	SF	\$75	\$375

<input type="radio"/> Staff Only			
			Priority <input checked="" type="radio"/> 1			
			Severity <input checked="" type="radio"/> 3			
<p>Clear floor space slopes 4.0%.</p>

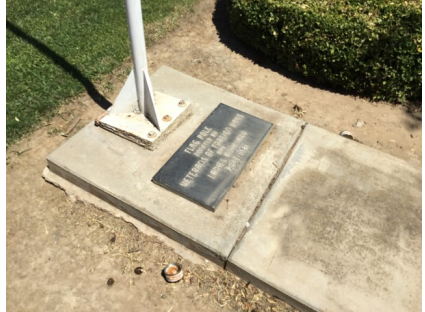
Item no., Rm no. and Name	Existing Architectural Barrier and Proposed Solution	Codes / Mitigation Info	Qty	Unit	Cost	Total
371	<ul style="list-style-type: none"> As-Built Description: Cross slope more than 1":48" (2.083%). Proposed Solution: Relocate existing plaque. Notes: 	PCODE EF07NT ADAAG 91 4.3.7 ADA 2010 403.3 CBC 2007 1133B.7.1.3 CBC 2019 11B-403.3 Mitigated: <input type="radio"/> YES <input checked="" type="radio"/> NO	25	SF	\$75	\$1,875

Clear floor space at flag pole obstructed.

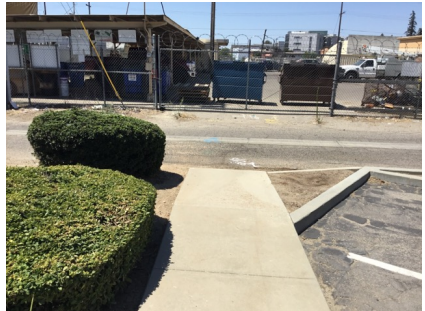
Curb Ramp

380	<ul style="list-style-type: none"> As-Built Description: Slope greater than 1:12 (8.3%). As-Built: 11.0% Proposed Solution: Demolish existing and provide new curb ramp. 	PCODE EH02A ADAAG 91 4.7.2 ADA 2010 406.1 CBC 2007 1127B.5.3 CBC 2019 11B-406.2.1 Mitigated: <input type="radio"/> YES <input checked="" type="radio"/> NO	1	JOB	\$7,500	\$7,500

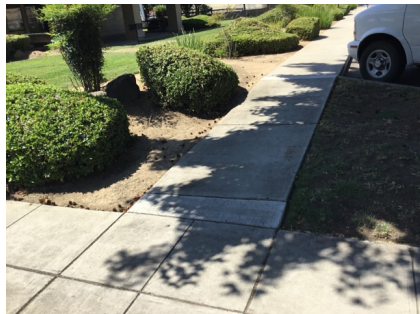
Item no., Rm no. and Name	Existing Architectural Barrier and Proposed Solution	Codes / Mitigation Info	Qty	Unit	Cost	Total
358	<ul style="list-style-type: none"> <i>As-Built Description:</i> Detectable warning not provided where pedestrian crosses vehicular area. <i>Proposed Solution:</i> Provide detectable warning surface (i.e. in-line truncated domes) at regular curb ramp. 	PCODE EH07A ADAAG 91 4.7.7 ADA 2010 705.1 CBC 2007 1127B.5.7 CBC 2019 11B-705.1.2.2 Mitigated: <input type="radio"/> YES <input checked="" type="radio"/> NO	1	JOB	\$750	\$750

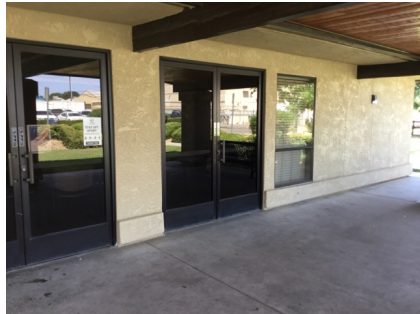
Door

366	<ul style="list-style-type: none"> <i>As-Built Description:</i> Surface of required maneuvering clearance at door slopes more than 1/4":12" (2.0%). <i>As-Built:</i> 4.0% <i>Proposed Solution:</i> Modify surface slope at door. 	PCODE ID11 ADAAG 91 4.13.6 ADA 2010 404.2.4.4 CBC 2007 1133B.2.4 CBC 2019 11B-404.2.4 Mitigated: <input type="radio"/> YES <input checked="" type="radio"/> NO	30	SF	\$120	\$3,600

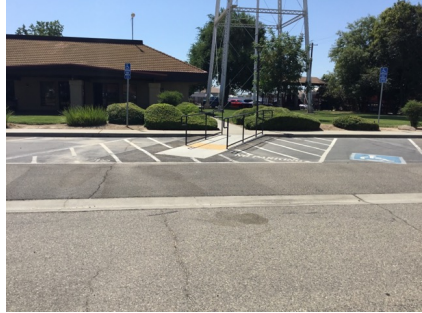
Floor or Ground Surfaces

<p>362</p> <ul style="list-style-type: none"> • <i>As-Built Description:</i> Accessible parking space has slope greater than 1/4":12" (2%). • <i>As-Built:</i> Up to 9.0% • <i>Proposed Solution:</i> Modify slope at accessible parking space. 	<p>PCODE EA05 ADAAG 91 4.6.3 ADA 2010 502.4 CBC 2007 1129B.3.3 CBC 2019 11B-502.4</p> <p>Mitigated: <input type="radio"/> YES <input checked="" type="radio"/> NO</p>	<p>150 SF \$36 \$5,400</p>

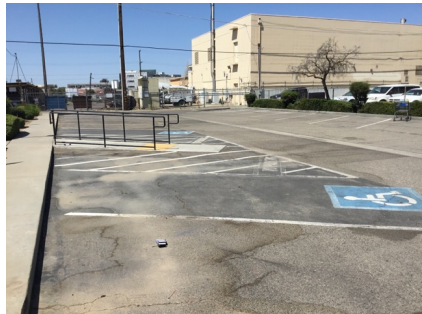
Parking

<p>361</p> <ul style="list-style-type: none"> • <i>As-Built Description:</i> Accessible parking space smaller than 8' wide (CA only: 9' x 18'). • <i>As-Built:</i> 110.0" • <i>Proposed Solution:</i> Modify parking space(s) to create accessible space. 	<p>PCODE EA02A ADAAG 91 4.6.3 ADA 2010 502.2 CBC 2007 1129B.3.1 CBC 2019 11B-502.2</p> <p>Mitigated: <input type="radio"/> YES <input checked="" type="radio"/> NO</p>	<p>2 JOB \$600 \$1,200</p>

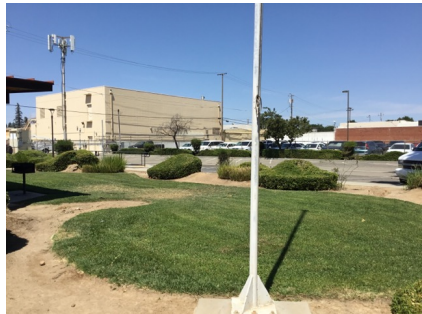
Reach Range

370	<ul style="list-style-type: none"> <i>As-Built Description:</i> Reach height to control or access point, exceeds 48" or is less than 15". <i>As-Built:</i> 69.0" high <i>Proposed Solution:</i> Modify equipment or mounting. 	<p>PCODE IE01</p> <p>ADAAG 91 4.2.5</p> <p>ADA 2010 308.2.1</p> <p>CBC 2007 1118B.5</p> <p>CBC 2019 11B-308.2.1</p> <p>Mitigated:</p> <p><input type="radio"/> YES</p> <p><input checked="" type="radio"/> NO</p>	1	JOB	\$300	\$300
-----	---	--	---	-----	-------	-------

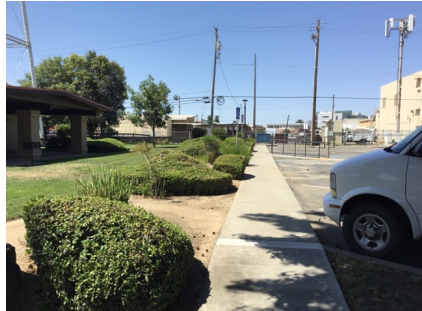
Item no., Rm no. and Name	Existing Architectural Barrier and Proposed Solution	Codes / Mitigation Info	Qty	Unit	Cost	Total
356	<ul style="list-style-type: none"> • <i>As-Built Description:</i> Walk more than 36" but less than 48" wide (required in CA only). • <i>As-Built:</i> 47.0" wide • <i>Proposed Solution:</i> Enlarge width of walk to 48". 	<p>PCODE EF08</p> <p>CBC 2007 1133B.7.1</p> <p>CBC 2019 11B-403.5.1.3</p> <p>Mitigated:</p> <p><input type="radio"/> YES</p> <p><input checked="" type="radio"/> NO</p>	100	SF	\$135	\$13,500

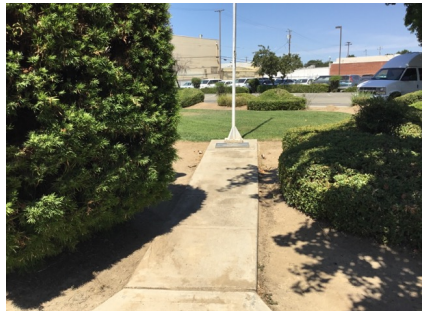
<input type="radio"/> Staff Only			
			<p>Priority <input checked="" type="radio"/> 1</p> <p>Severity <input checked="" type="radio"/> 4</p>			
369	<ul style="list-style-type: none"> • <i>As-Built Description:</i> Walk more than 36" but less than 48" wide (required in CA only). • <i>As-Built:</i> 35" wide • <i>Proposed Solution:</i> Enlarge width of walk to 48". 	<p>PCODE EF08</p> <p>CBC 2007 1133B.7.1</p> <p>CBC 2019 11B-403.5.1.3</p> <p>Mitigated:</p> <p><input type="radio"/> YES</p> <p><input checked="" type="radio"/> NO</p>	50	SF	\$135	\$6,750

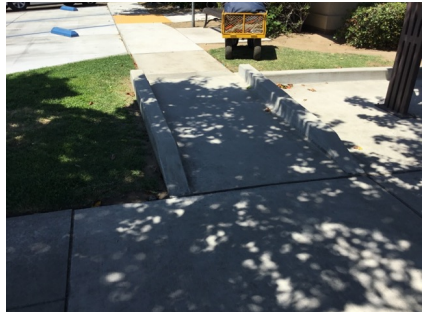
Item no., Rm no. and Name	Existing Architectural Barrier and Proposed Solution	Codes / Mitigation Info	Qty	Unit	Cost	Total
375	<ul style="list-style-type: none"> <i>As-Built Description:</i> Detectable warning not provided where pedestrian crosses vehicular area. <i>Proposed Solution:</i> Provide detectable warning surface (i.e. in-line truncated domes) at regular curb ramp. 	PCODE EH07A ADAAG 91 4.7.7 ADA 2010 705.1 CBC 2007 1127B.5.7 CBC 2019 11B-705.1.2.2 Mitigated: <input type="radio"/> YES <input checked="" type="radio"/> NO	1	JOB	\$750	\$750

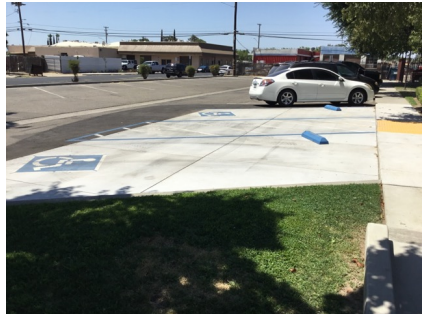
Parking

376	<ul style="list-style-type: none"> <i>As-Built Description:</i> Accessible parking space smaller than 8' wide (CA only: 9' x 18'). <i>As-Built:</i> 123.0" <i>Proposed Solution:</i> Modify parking space(s) to create accessible space. 	PCODE EA02A ADAAG 91 4.6.3 ADA 2010 502.2 CBC 2007 1129B.3.1 CBC 2019 11B-502.2 Mitigated: <input type="radio"/> YES <input checked="" type="radio"/> NO	2	JOB	\$600	\$1,200

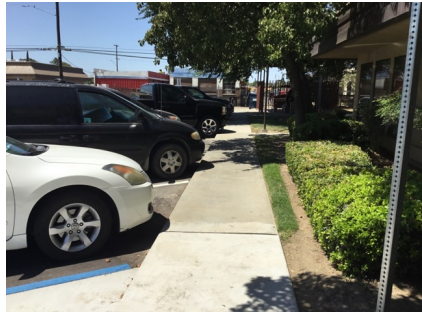
Item no., Rm no. and Name	Existing Architectural Barrier and Proposed Solution	Codes / Mitigation Info	Qty	Unit	Cost	Total
377	<ul style="list-style-type: none"> As-Built Description: Wheel stops not provided to prevent the encroachment of vehicles over the required clear width of an adjacent accessible route. Proposed Solution: Provide wheel stops to prevent encroachment. 	PCODE EA04L CBC 2019 11B-502.7.2 Mitigated: <input type="radio"/> YES <input checked="" type="radio"/> NO	8	JOB	\$225	\$1,800

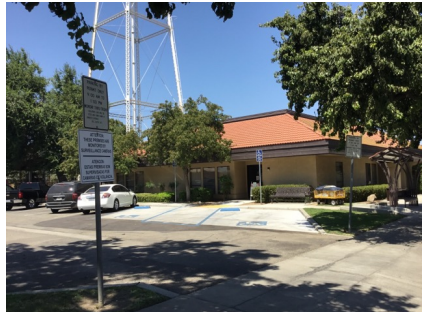
Parking Signage

381	<ul style="list-style-type: none"> As-Built Description: No "Tow Away" sign at parking lot entrance (required in CA only). Proposed Solution: Provide "Tow Away" sign at parking lot entrance when altering area. 	PCODE EA04C CBC 2007 1129B.4 CBC 2019 11B-502.8.2 Mitigated: <input type="radio"/> YES <input checked="" type="radio"/> NO	1	JOB	\$975	\$975

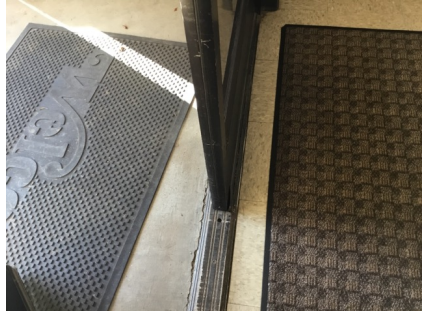
Door Threshold

<p>330</p> <ul style="list-style-type: none"> • <i>As-Built Description:</i> Door inaccessible due to threshold or step at door exceeding 1/2". • <i>As-Built:</i> 0.75" • <i>Proposed Solution:</i> Modify threshold. 	<p>PCODE ID02A ADAAG 91 4.13.8 ADA 2010 404.2.5 CBC 2007 1133B.2.4.1 CBC 2019 11B-404.2.5</p> <p>Mitigated: <input type="radio"/> YES <input checked="" type="radio"/> NO</p>	<p>4 JOB \$1,200 \$4,800</p>

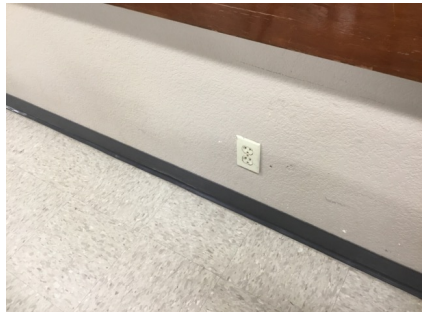
Electrical

<p>335</p> <ul style="list-style-type: none"> • <i>As-Built Description:</i> Electric switch or control mounted less than 15" measured to the bottom of the outlet box or greater than 48 inches measured to the top of the outlet box. • <i>As-Built:</i> 12.0" high • <i>Proposed Solution:</i> Relocate light switches or control to between 15" and 48" height. • <i>Notes:</i> 	<p>PCODE IC01 ADAAG 91 4.2.5 & 6 ADA 2010 308.2.1 & 308.2.2 CBC 2007 1117B.6.3 CBC 2019 11B-308.2.1 & 11B-308.2.2</p> <p>Mitigated: <input type="radio"/> YES <input checked="" type="radio"/> NO</p>	<p>4 JOB \$900 \$3,600</p>

This element complies with Safe Harbor if altered or constructed before March 15, 2012. The dimensional requirements in this CBC citation applied from the 2010 CBC to the code cycle at the time of this survey.

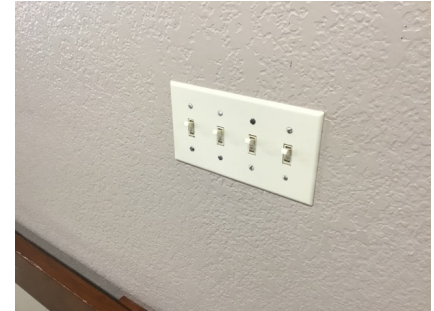
336	<ul style="list-style-type: none"> <i>As-Built Description:</i> Electric switch or control mounted less than 15" measured to the bottom of the outlet box or greater than 48 inches measured to the top of the outlet box. <i>As-Built:</i> 49.25" to top of box. <i>Proposed Solution:</i> Relocate light switches or control to between 15" and 48" height. <i>Notes:</i> 	PCODE IC01 ADAAG 91 4.2.5 & 6 ADA 2010 308.2.1 & 308.2.2 CBC 2007 1117B.6.3 CBC 2019 11B-308.2.1 & 11B-308.2.2 Mitigated: <input type="radio"/> YES <input checked="" type="radio"/> NO	1	JOB	\$900	\$900
-----	--	--	---	-----	-------	-------

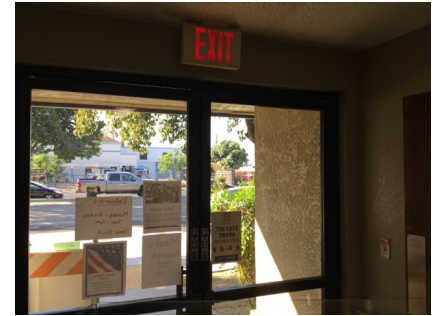
328	<ul style="list-style-type: none"> <i>As-Built Description:</i> At final exit door to exterior: Where required exit signs are installed, signs to provide exiting information for people with vision impairment are not provided. <i>Proposed Solution:</i> Provide raised letter/Braille "EXIT" sign at door. 	<p>PCODE SA10A ADAAG 91 4.1.3(16) ADA 2010 216.4.1 CBC 2007 1011.3 CBC 2019 11B-216.4.1</p> <p>Mitigated: <input type="radio"/> YES <input checked="" type="radio"/> NO</p>	6	JOB	\$270	\$1,620
-----	--	--	---	-----	-------	---------

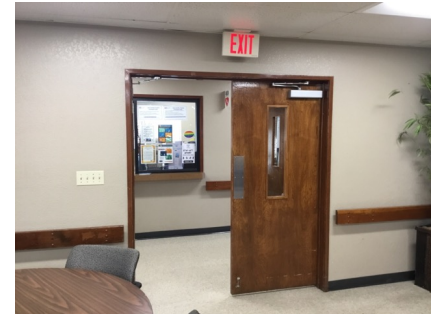
329	<ul style="list-style-type: none"> <i>As-Built Description:</i> At door leading into exit corridor: Where required exit signs are installed, signs to provide exiting information for people with vision impairment are not provided. <i>Proposed Solution:</i> Provide raised letter/Braille "EXIT ROUTE" sign at door. 	<p>PCODE SA10D ADAAG 91 4.1.3(16) ADA 2010 216.4.1 CBC 2007 1011.3 CBC 2019 11B-216.4.1</p> <p>Mitigated: <input type="radio"/> YES <input checked="" type="radio"/> NO</p>	3	JOB	\$270	\$810
-----	--	--	---	-----	-------	-------

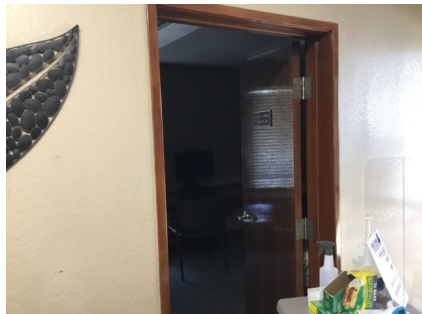
Item no., Rm no. and Name	Existing Architectural Barrier and Proposed Solution	Codes / Mitigation Info	Qty	Unit	Cost	Total
327	<ul style="list-style-type: none"> <i>As-Built Description:</i> Existing sign designating permanent room or space is noncompliant. <i>Proposed Solution:</i> Provide compliant signage. 	PCODE SA13 ADAAG 91 4.1.3(16)(a) ADA 2010 216.2 CBC 2007 1117B.5 CBC 2019 11B-216.2 Mitigated: <input type="radio"/> YES <input checked="" type="radio"/> NO	12	JOB	\$450	\$5,400

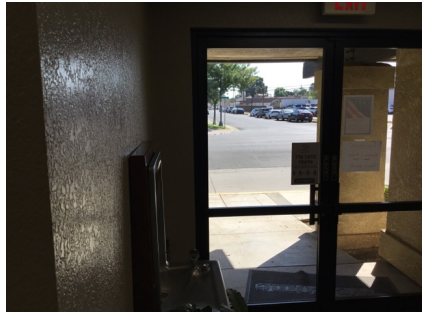
Item no., Rm no. and Name	Existing Architectural Barrier and Proposed Solution	Codes / Mitigation Info	Qty	Unit	Cost	Total
346	<ul style="list-style-type: none"> <i>As-Built Description:</i> Front approach: At push side, door does not have clear and level maneuvering space measuring door width x 48" (door width plus 12" if door has both, latch and closer). <i>As-Built:</i> 30.0" <i>Proposed Solution:</i> Remove or relocate drinking fountain. 	PCODE ID24A ADAAG 91 Fig. 25(a) ADA 2010 404.2.4 CBC 2007 11B-26A(a) CBC 2019 11B-404.2.4 Mitigated: <input type="radio"/> YES <input checked="" type="radio"/> NO	1	JOB	\$1,500	\$1,500

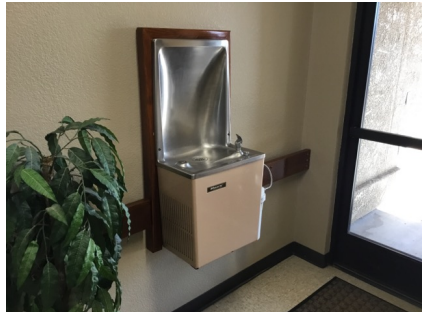
Drinking Fountain

345	<ul style="list-style-type: none"> <i>As-Built Description:</i> Where only one drinking fountain is provided per floor: Fountain is not accessible to individuals who use wheelchairs, or to those who have difficulty bending or stooping. <i>Proposed Solution:</i> Provide additional fountain or hi-lo combination fountain. 	PCODE IA01A ADAAG 91 4.1.3(10)(a) ADA 2010 211.1 CBC 2007 1115B.4.6.1 CBC 2019 11B-211.1 Mitigated: <input type="radio"/> YES <input checked="" type="radio"/> NO	1	JOB	\$6,000	\$6,000

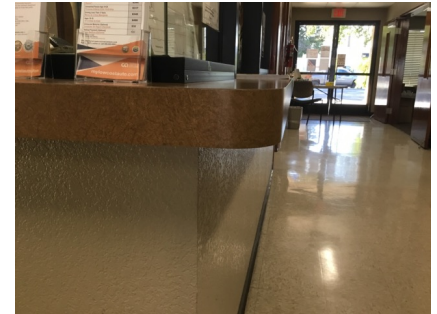
Protrusion Limits

340	<ul style="list-style-type: none"> As-Built Description: Protruding objects more than 4" from wall, when bottom of object more than 27" or less than 80" above finished floor. As-Built: Service counter: 5.5" to 6.5" at 34.5" high Proposed Solution: Provide cane detectable side panels. 	PCODE EG04 ADAAG 91 4.4.1 ADA 2010 307.2 CBC 2007 1133B.8.6.1 CBC 2019 11B-307.2	1	JOB	\$1,200	\$1,200
-----	--	--	---	-----	---------	---------

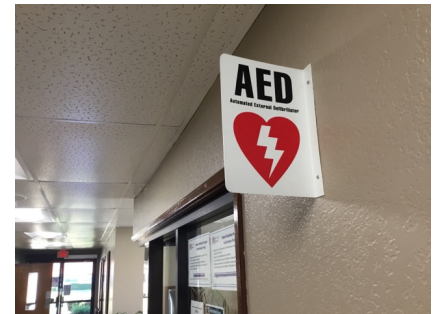
341	<ul style="list-style-type: none"> As-Built Description: Protruding objects more than 4" from wall, when bottom of object more than 27" or less than 80" above finished floor. As-Built: AED sign: 7.0" at 75.5" high Proposed Solution: Remove/relocate protruding object. Patch existing surface. 	PCODE EG04 ADAAG 91 4.4.1 ADA 2010 307.2 CBC 2007 1133B.8.6.1 CBC 2019 11B-307.2	1	JOB	\$300	\$300
-----	---	--	---	-----	-------	-------

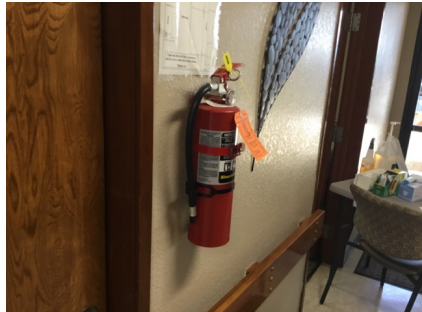
Item no., Rm no. and Name	Existing Architectural Barrier and Proposed Solution	Codes / Mitigation Info	Qty	Unit	Cost	Total
344	<ul style="list-style-type: none"> As-Built Description: Protruding objects more than 4" from wall, when bottom of object more than 27" or less than 80" above finished floor. As-Built: FE: 5.2" at 52" high Proposed Solution: Remove/relocate protruding object. Patch existing surface. 	PCODE EG04 ADAAG 91 4.4.1 ADA 2010 307.2 CBC 2007 1133B.8.6.1 CBC 2019 11B-307.2 Mitigated: <input type="radio"/> YES <input checked="" type="radio"/> NO	2	JOB	\$300	\$600
