The City of Madera

Appendix B: Facilities

Access Compliance Survey Report

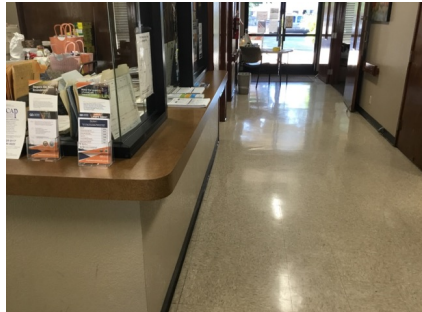
Public Counter

339	<ul style="list-style-type: none"> As-Built Description: Service counter (stand-up): Accessible section min. 36" length and 36" max. height (in CA: 28" to 34" high) not provided. As-Built: 37.7" high Proposed Solution: Retrofit existing counter to provide accessible section. Interim solution: Provide auxiliary counter, table, or clipboard. 	PCODE IN03 ADAAG 91 7.2(2) ADA 2010 904.4 CBC 2007 1122B.4 CBC 2019 11B-904.4 Mitigated: <input type="radio"/> YES <input checked="" type="radio"/> NO	1	JOB	\$6,000	\$6,000

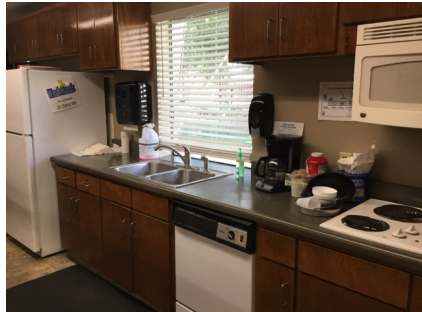
Item no., Rm no. and Name	Existing Architectural Barrier and Proposed Solution	Codes / Mitigation Info	Qty	Unit	Cost	Total
353	<ul style="list-style-type: none"> As-Built Description: Reach height to control or access point, where side approach is available, exceeds 48" or is less than 15" in height, or exceeds 10" in depth. As-Built: Obstructed reach to items by 37.0" countertop. Proposed Solution: Modify equipment or mounting. 	PCODE IE02 ADAAG 91 4.2.6 ADA 2010 308.3.1 CBC 2007 1118B.6 CBC 2019 11B-308.3 Mitigated: <input type="radio"/> YES <input checked="" type="radio"/> NO	1	JOB	\$300	\$300

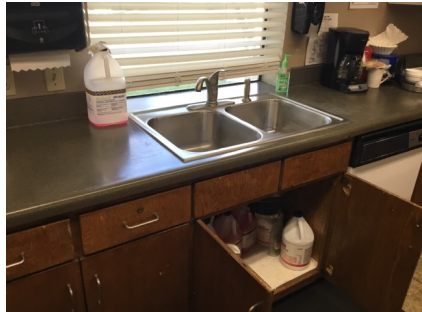
351	<ul style="list-style-type: none"> As-Built Description: Sink rim higher than 34" above floor. As-Built: 37.0" high Proposed Solution: Remodel sink cabinet to lower sink. 	PCODE IN06 ADAAG 91 4.24.2 ADA 2010 606.3 CBC 2007 1115B.4.7.1 CBC 2019 11B-606.3 Mitigated: <input type="radio"/> YES <input checked="" type="radio"/> NO	1	JOB	\$5,250	\$5,250

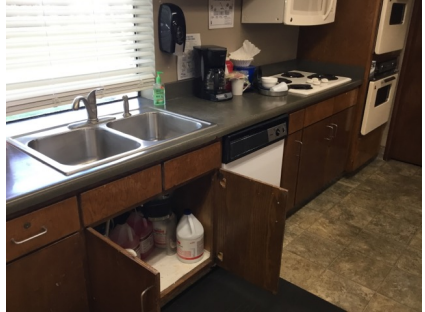
Item no., Rm no. and Name	Existing Architectural Barrier and Proposed Solution	Codes / Mitigation Info	Qty	Unit	Cost	Total
350	<ul style="list-style-type: none"> • <i>As-Built Description:</i> Sink does not have knee space min. 27" high x 19" deep x 30" wide. • <i>Proposed Solution:</i> Remodel sink cabinet. 	PCODE IN06A ADAAG 91 4.24.3 ADA 2010 606.2 CBC 2007 1115B.4.7.1 CBC 2019 11B-606.2 Mitigated: <input type="radio"/> YES <input checked="" type="radio"/> NO	1	JOB	\$5,250	\$5,250

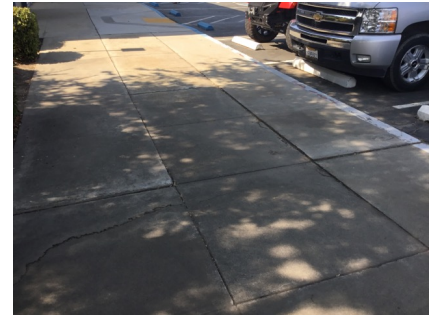
- 584
- As-Built Description:**
Walk: Pavement dislocation creates abrupt change in level exceeding 1/2" in accessible route.
 - As-Built:** **1.0"**
 - Proposed Solution:**
Remove, replace or repair area of pavement sufficient to correct abrupt change in level.

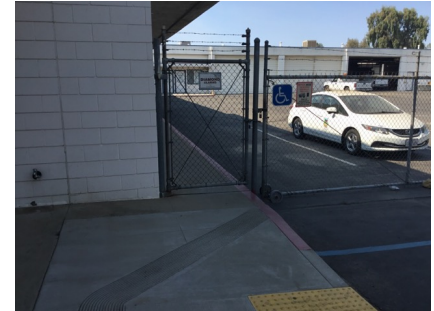
Item no., Rm no. and Name	Existing Architectural Barrier and Proposed Solution	Codes / Mitigation Info	Qty	Unit	Cost	Total
579	<ul style="list-style-type: none"> As-Built Description: Surface of required maneuvering clearance at door slopes more than 1/4":12" (2.0%). As-Built: 9.5% Proposed Solution: Modify surface slope at door. Notes: 	PCODE ID11 ADAAG 91 4.13.6 ADA 2010 404.2.4.4 CBC 2007 1133B.2.4 CBC 2019 11B-404.2.4	.5	SF	\$120	\$60

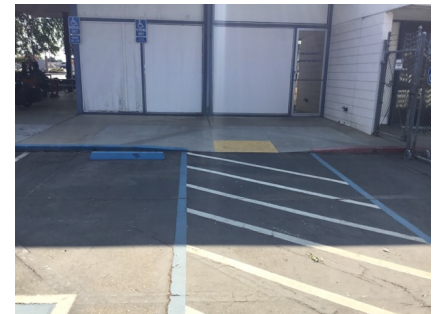
Floor or Ground Surfaces

580	<ul style="list-style-type: none"> As-Built Description: Accessible parking space has slope greater than 1/4":12" (2%). As-Built: 4.3% Proposed Solution: Modify slope at accessible parking space. 	PCODE EA05 ADAAG 91 4.6.3 ADA 2010 502.4 CBC 2007 1129B.3.3 CBC 2019 11B-502.4	100	SF	\$36	\$3,600
-----	---	--	-----	----	------	---------

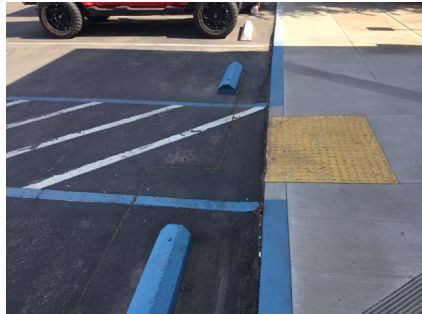
Item no., Rm no. and Name	Existing Architectural Barrier and Proposed Solution	Codes / Mitigation Info	Qty	Unit	Cost	Total
583	<ul style="list-style-type: none"> As-Built Description: Accessible parking space has slope greater than 1/4":12" (2%). As-Built: 5.8% Proposed Solution: Modify slope at accessible parking space. 	PCODE EA05 ADAAG 91 4.6.3 ADA 2010 502.4 CBC 2007 1129B.3.3 CBC 2019 11B-502.4 Mitigated: <input type="radio"/> YES <input checked="" type="radio"/> NO	10	SF	\$36	\$360

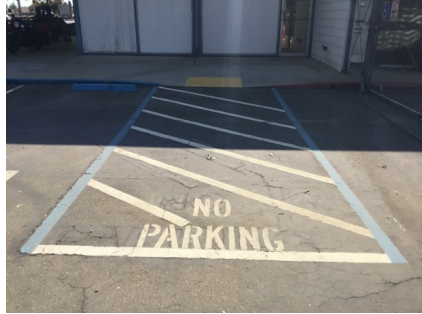
Parking

581	<ul style="list-style-type: none"> As-Built Description: Accessible parking space does not have 5' wide access aisle; 8' wide for van accessible aisle. As-Built: 95.5" wide Proposed Solution: Modify parking aisle(s) to create accessible space by restriping. 	PCODE EA02B ADAAG 91 4.6.3 ADA 2010 502.3 CBC 2007 1129B.3.1 CBC 2019 11B-502.2; 11B-502.3.1 Mitigated: <input type="radio"/> YES <input checked="" type="radio"/> NO	1	JOB	\$600	\$600

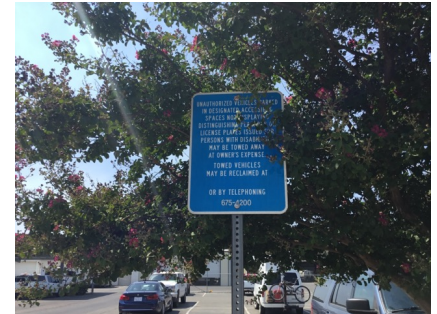
Parking Signage

609	<ul style="list-style-type: none"> As-Built Description: No "Tow Away" sign at parking lot entrance (required in CA only). Proposed Solution: Provide "Tow Away" sign at parking lot entrance when altering area. Notes: 	<p>PCODE EA04C</p> <p>CBC 2007 1129B.4</p> <p>CBC 2019 11B-502.8.2</p> <p>Mitigated:</p> <p><input type="radio"/> YES</p> <p><input checked="" type="radio"/> NO</p>	1	JOB	\$975	\$975
-----	--	---	---	-----	-------	-------

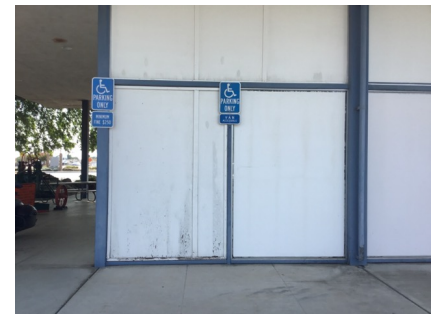
Reclaim location. Sign is difficult to see trim tree.

582	<ul style="list-style-type: none"> As-Built Description: CA only: Additional Sign or additional language below the symbol of accessibility stating "Minimum Fine \$250" not provided. Proposed Solution: Provide compliant parking signage that includes fine information. 	<p>PCODE EA04G</p> <p>CBC 2007 1129B.4</p> <p>CBC 2019 11B-502.6.2</p> <p>Mitigated:</p> <p><input type="radio"/> YES</p> <p><input checked="" type="radio"/> NO</p>	1	JOB	\$300	\$300
-----	--	---	---	-----	-------	-------

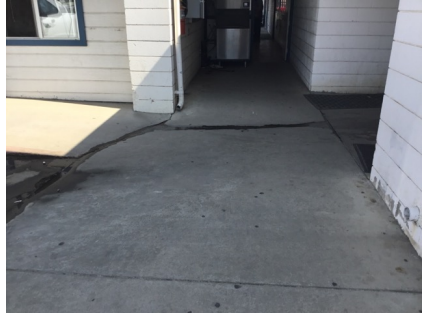
<p>587</p> <ul style="list-style-type: none"> As-Built Description: Cross slope more than 1":48" (2.083%). As-Built: Up to 4.5% Proposed Solution: Modify cross slope. 	<p>PCODE EF07 ADAAG 91 4.3.7 ADA 2010 403.3 CBC 2007 1133B.7.1.3 CBC 2019 11B-403.3</p> <p>Mitigated:</p> <p><input type="radio"/> YES <input checked="" type="radio"/> NO</p>	<p>200 SF \$75 \$15,000</p>

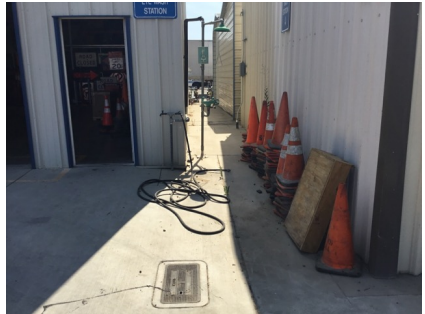
<p>604</p> <ul style="list-style-type: none"> As-Built Description: Cross slope more than 1":48" (2.083%). As-Built: 5.7% Proposed Solution: Modify cross slope. Notes: 	<p>PCODE EF07 ADAAG 91 4.3.7 ADA 2010 403.3 CBC 2007 1133B.7.1.3 CBC 2019 11B-403.3</p> <p>Mitigated:</p> <p><input type="radio"/> YES <input checked="" type="radio"/> NO</p>	<p>60 SF \$75 \$4,500</p>

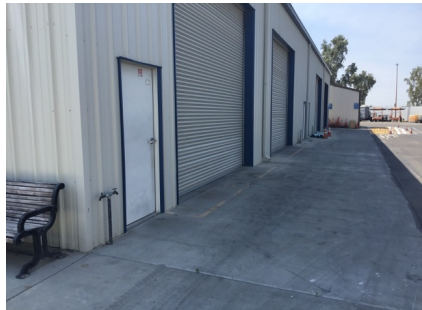
<input type="radio"/> Staff Only			
			Priority 1			
			Severity 4			
603	<ul style="list-style-type: none"> As-Built Description: Surface of required maneuvering clearance at door slopes more than 1/4":12" (2.0%). As-Built: 3.6%. Dimensions vary. Proposed Solution: Modify surface slope at door. Notes: 	PCODE ID11 ADAAG 91 4.13.6 ADA 2010 404.2.4.4 CBC 2007 1133B.2.4 CBC 2019 11B-404.2.4 Mitigated: <input type="radio"/> YES <input checked="" type="radio"/> NO	250	SF	\$120	\$30,000

Verify whether these are maintenance areas and are not required to be on an accessible route. Occurs at entrance doors to employee workstations throughout.

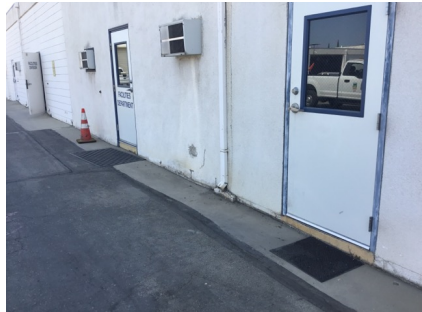
Item no., Rm no. and Name	Existing Architectural Barrier and Proposed Solution	Codes / Mitigation Info	Qty	Unit	Cost	Total
601	<ul style="list-style-type: none"> • <i>As-Built Description:</i> Door inaccessible due to threshold or step at door exceeding 1/2". • <i>As-Built:</i> 5.0" • <i>Proposed Solution:</i> Modify threshold to be no more than 1/2" by removing existing paving at door and providing landing with edge ramping (slope 1:20 max). 	PCODE ID02A ADAAG 91 4.13.8 ADA 2010 404.2.5 CBC 2007 1133B.2.4.1 CBC 2019 11B-404.2.5 Mitigated: <input type="radio"/> YES <input checked="" type="radio"/> NO	2	JOB	\$1,200	\$2,400

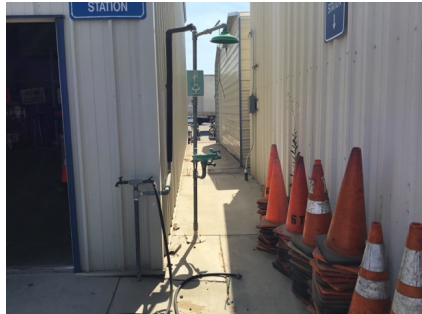
Lab

605	<ul style="list-style-type: none"> • <i>As-Built Description:</i> Minimum of at least one of each type of sink and other specialized equipment such as fume hoods, microscopes, emergency eyewash and showers, etc., associated with the special use activity is not accessible. (CA Only) • <i>As-Built:</i> Eyewash station: 41.0" high • <i>Proposed Solution:</i> Remodel existing cabinet/counter/equipment to make specialized equipment accessible to disabled persons. 	PCODE LB01B CBC 2007 1106B.2 CBC 2019 11B-805.7 Mitigated: <input type="radio"/> YES <input checked="" type="radio"/> NO	1	JOB	\$3,000	\$3,000

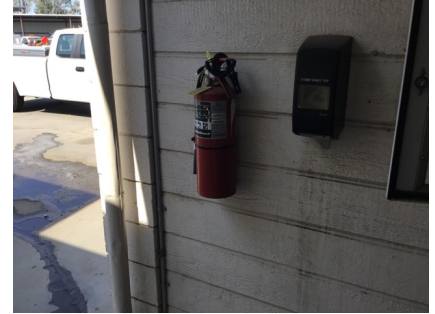
Protrusion Limits

592	<ul style="list-style-type: none"> <i>As-Built Description:</i> Protruding objects more than 4" from wall, when bottom of object more than 27" or less than 80" above finished floor. <i>As-Built:</i> FE: 6.0" at 38.5" high <i>Proposed Solution:</i> Remove/relocate protruding object. Patch existing surface. 	<p>PCODE EG04 ADAAG 91 4.4.1 ADA 2010 307.2 CBC 2007 1133B.8.6.1 CBC 2019 11B-307.2</p> <p>Mitigated: <input type="radio"/> YES <input checked="" type="radio"/> NO</p>	1	JOB	\$300	\$300
-----	--	--	---	-----	-------	-------

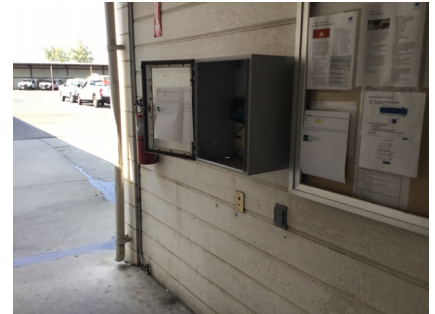
591	<ul style="list-style-type: none"> <i>As-Built Description:</i> Protruding objects more than 4" from wall, when bottom of object more than 27" or less than 80" above finished floor. <i>As-Built:</i> Utility box: 10.0" at 46.0" high <i>Proposed Solution:</i> Provide cane-detectable railing to mark area of low clearance. 	<p>PCODE EG04A ADAAG 91 4.4.1 ADA 2010 307.2 CBC 2007 1133B.8.6.1 CBC 2019 11B-307.2</p> <p>Mitigated: <input type="radio"/> YES <input checked="" type="radio"/> NO</p>	1	LF	\$300	\$300
-----	--	---	---	----	-------	-------

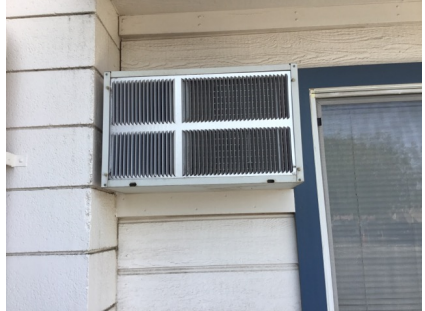
Item no., Rm no. and Name	Existing Architectural Barrier and Proposed Solution	Codes / Mitigation Info	Qty	Unit	Cost	Total
596	<ul style="list-style-type: none"> As-Built Description: Protruding objects more than 4" from wall, when bottom of object more than 27" or less than 80" above finished floor. As-Built: AC unit: 10.5" at 69.0" high Proposed Solution: Provide cane-detectable railing to mark area of low clearance. 	PCODE EG04A ADAAG 91 4.4.1 ADA 2010 307.2 CBC 2007 1133B.8.6.1 CBC 2019 11B-307.2 Mitigated: <input type="radio"/> YES <input checked="" type="radio"/> NO	4	LF	\$300	\$1,200

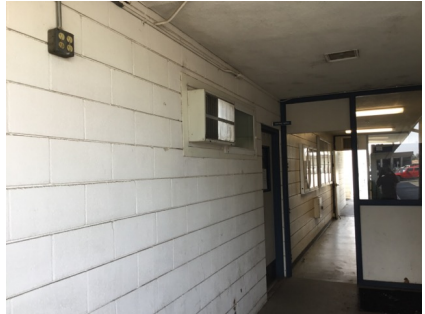
<input type="radio"/> Staff Only			
			Priority 1			
			Severity 2			
597	<ul style="list-style-type: none"> As-Built Description: Protruding objects more than 4" from wall, when bottom of object more than 27" or less than 80" above finished floor. As-Built: AC Unit: 5.0" at 70.0" high Proposed Solution: Provide cane-detectable railing to mark area of low clearance. 	PCODE EG04A ADAAG 91 4.4.1 ADA 2010 307.2 CBC 2007 1133B.8.6.1 CBC 2019 11B-307.2 Mitigated: <input type="radio"/> YES <input checked="" type="radio"/> NO	4	LF	\$300	\$1,200

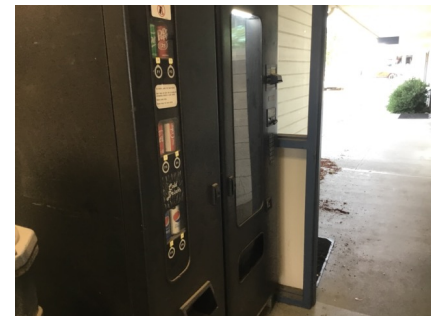
Vending Machine

593	<ul style="list-style-type: none"> • <i>As-Built Description:</i> Vending machine coin slot or dispensing outlet, more than 48" above the floor. • <i>As-Built:</i> 12.0" to the bottom of the dispenser tray. 58.0" to bill insert. • <i>Proposed Solution:</i> Advise vendor/leasing company to provide accessible vending machine with highest operable part at 48" max. 	PCODE IL02 ADAAG 91 4.2.5 ADA 2010 308.2.1 CBC 2007 1126B CBC 2019 11B-308.2.1	1	REF		
-----	---	--	---	-----	--	--

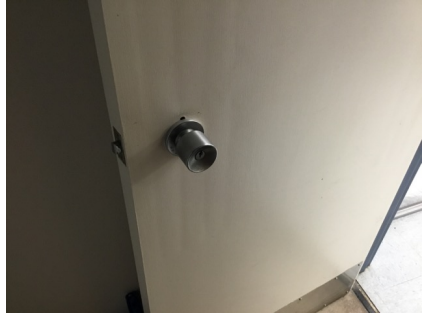
Door Hardware

<p>552</p> <ul style="list-style-type: none"> <i>As-Built Description:</i> Door does not have accessible operating hardware. <i>Proposed Solution:</i> Provide lever handle or other accessible hardware. 	<p>PCODE ID07 ADAAG 91 4.13.9 ADA 2010 404.2.7 CBC 2007 1133B.2.5.2 CBC 2019 11B-404.2.7</p> <p>Mitigated: <input type="radio"/> YES <input checked="" type="radio"/> NO</p>	<p>30 JOB \$450 \$13,500</p>

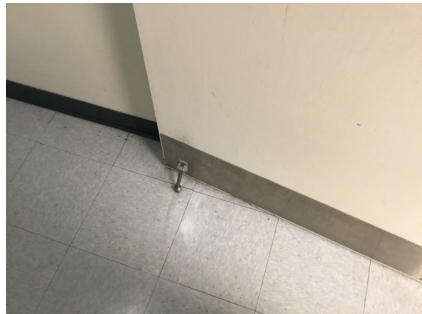
Door Stopper

<p>554</p> <ul style="list-style-type: none"> <i>As-Built Description:</i> At push side of door on accessible route, bottom 10" does not have a smooth, uninterrupted surface. <i>Proposed Solution:</i> Remove door stopper when altering area. Provide rubber wedge. <i>Notes:</i> 	<p>PCODE ID06A ADA 2010 404.2.10 CBC 2007 1133B.2.6 CBC 2019 11B-404.2.10</p> <p>Mitigated: <input type="radio"/> YES <input checked="" type="radio"/> NO</p>	<p>50 JOB \$75 \$3,750</p>

This element complies with Safe Harbor if altered or constructed before March 15, 2012. This element does not comply with the dimensional requirements in the 1981 to the current CBC.

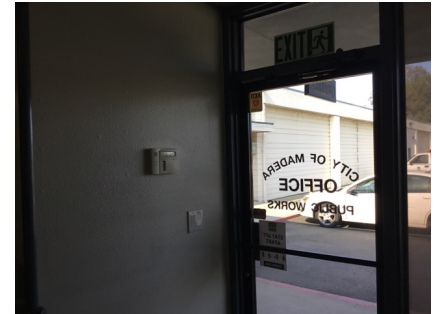
Signage

569	<ul style="list-style-type: none"> As-Built Description: At final exit door to exterior: Where required exit signs are installed, signs to provide exiting information for people with vision impairment are not provided. Proposed Solution: Provide raised letter/Braille "EXIT" sign at door. 	PCODE SA10A ADAAG 91 4.1.3(16) ADA 2010 216.4.1 CBC 2007 1011.3 CBC 2019 11B-216.4.1	20	JOB	\$270	\$5,400
-----	--	--	----	-----	-------	---------

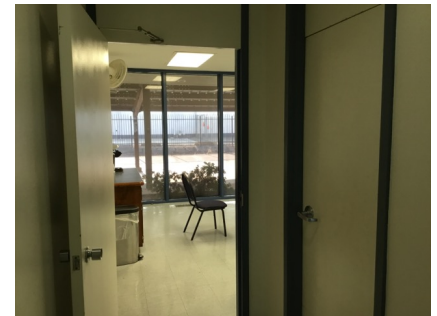
555	<ul style="list-style-type: none"> As-Built Description: Existing sign designating permanent room or space is noncompliant. Proposed Solution: Provide compliant signage. Notes: 	PCODE SA13 ADAAG 91 4.1.3(16)(a) ADA 2010 216.2 CBC 2007 1117B.5 CBC 2019 11B-216.2	20	JOB	\$450	\$9,000
-----	--	---	----	-----	-------	---------

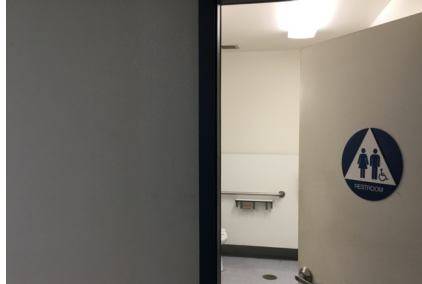
Signage

<p>541</p> <ul style="list-style-type: none"> As-Built Description: Entrance to toilet or bathing facility not identified with ADAAG compliant signage. Proposed Solution: Provide ADA compliant sign mounted at 48" min. above to baseline of the lowest Braille cells and 60" max. to baseline of the highest line of raised characters on nearest adjacent wall, on latch side of a single door (located not to cause a Braille reader to stand within the door swing). 	<p>PCODE SA11A ADAAG 91 4.1.3(16)(a) ADA 2010 216.8 CBC 2019 11B-216.8</p> <p>Mitigated: <input type="radio"/> YES <input checked="" type="radio"/> NO</p>	<p>1 JOB \$270 \$270</p>

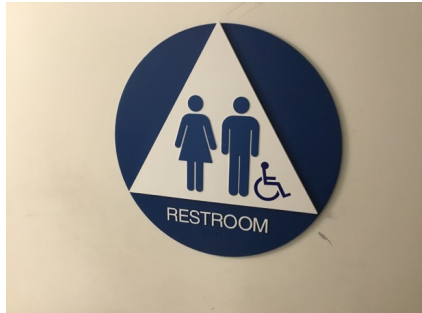
<p>540</p> <ul style="list-style-type: none"> As-Built Description: Required in CA only: identification symbol centered 58" to 60" high on sanitary facility door that contrasts with the door not provided (women: 12" ø circle, men: 12" triangle, unisex: combined symbol). As-Built: Not beveled or radiused. Proposed Solution: Provide properly mounted sanitary facility symbol when altering area. If wheelchair accessible, include International Symbol of Accessibility on sign. 	<p>PCODE SA15 CBC 2007 1115B.6 CBC 2019 11B-703.7.2.6</p> <p>Mitigated: <input type="radio"/> YES <input checked="" type="radio"/> NO</p>	<p>1 JOB \$270 \$270</p>

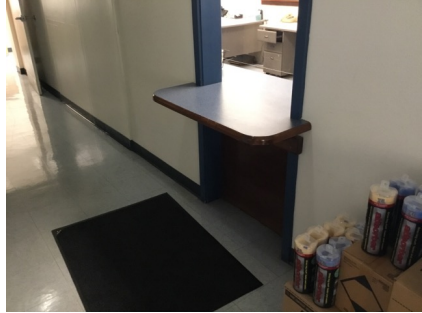
<p>560</p> <ul style="list-style-type: none"> • <i>As-Built Description:</i> Protruding objects more than 4" from wall, when bottom of object more than 27" or less than 80" above finished floor. • <i>As-Built:</i> Service counter: 12.5" at 32.0" high • <i>Proposed Solution:</i> Add cane detectable side panels. 	<p>PCODE EG04 ADAAG 91 4.4.1 ADA 2010 307.2 CBC 2007 1133B.8.6.1 CBC 2019 11B-307.2</p> <p>Mitigated:</p> <p><input type="radio"/> YES <input checked="" type="radio"/> NO</p>	<p>1 JOB \$600 \$600</p>

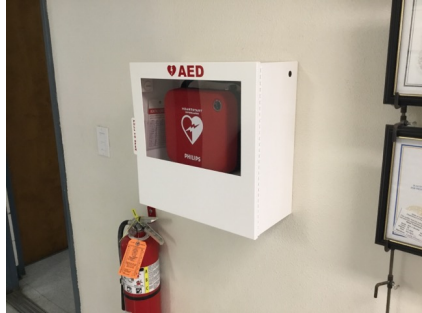
<p>565</p> <ul style="list-style-type: none"> • <i>As-Built Description:</i> Protruding objects more than 4" from wall, when bottom of object more than 27" or less than 80" above finished floor. • <i>As-Built:</i> AED: 7.0" at 43.5" high • <i>Proposed Solution:</i> Remove/relocate protruding object. Patch existing surface. 	<p>PCODE EG04 ADAAG 91 4.4.1 ADA 2010 307.2 CBC 2007 1133B.8.6.1 CBC 2019 11B-307.2</p> <p>Mitigated:</p> <p><input type="radio"/> YES <input checked="" type="radio"/> NO</p>	<p>1 JOB \$300 \$300</p>

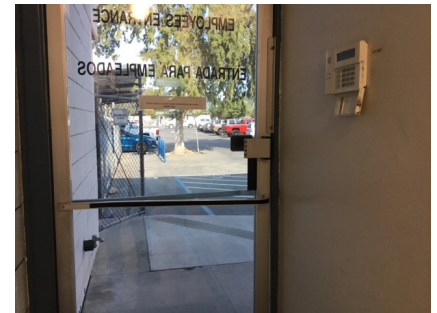
- 573
- *As-Built Description:*
Door lock, latch or handle less than 34" or more than 48" above the floor (CA only: 34" to 44").
 - *As-Built:* **51.0" high**
 - *Proposed Solution:*
Relocate or replace existing hardware.

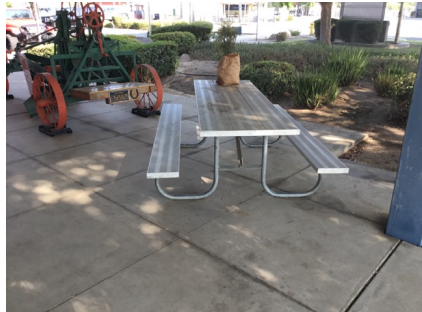
Item no., Rm no. and Name	Existing Architectural Barrier and Proposed Solution	Codes / Mitigation Info	Qty	Unit	Cost	Total
575	<ul style="list-style-type: none"> As-Built Description: Accessible non-fixed table or desk (top 28" to 34" high; knee space at least 27" high x 19" deep x 30" wide) not provided. Proposed Solution: Provide table or desk with accessible dimensions when purchasing new furniture. 	PCODE IN02A ADAAG 91 4.32.3 & .4 ADA 2010 306.1 CBC 2007 1122B.3 & 4 CBC 2019 11B-306.1 & 11B-902.3 Mitigated: <input type="radio"/> YES <input checked="" type="radio"/> NO	1	JOB	\$4,800	\$4,800

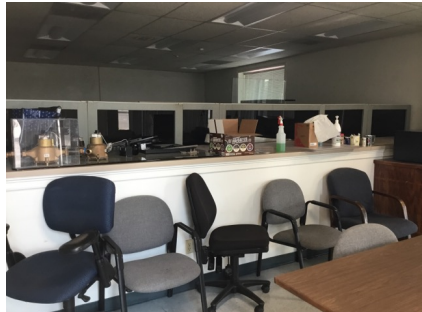
Public Counter

571	<ul style="list-style-type: none"> As-Built Description: Service counter (stand-up): Accessible section min. 36" length and 36" max. height (in CA: 28" to 34" high) not provided. As-Built: 42.0" Proposed Solution: Retrofit existing counter to provide accessible section. Interim solution: Provide auxiliary counter, table, or clipboard. Notes: 	PCODE IN03 ADAAG 91 7.2(2) ADA 2010 904.4 CBC 2007 1122B.4 CBC 2019 11B-904.4 Mitigated: <input type="radio"/> YES <input checked="" type="radio"/> NO	1	JOB	\$6,000	\$6,000

<input type="radio"/> Staff Only						
Priority <input checked="" type="radio"/> 4 Severity <input checked="" type="radio"/> 3						
<p>Appears unused ad counter.</p>

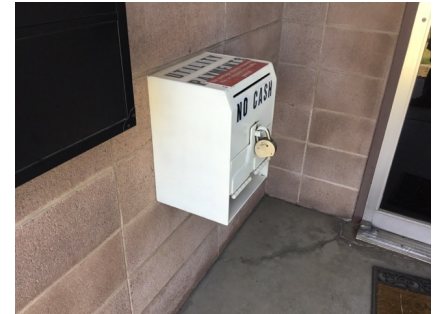
502	<ul style="list-style-type: none"> As-Built Description: Protruding objects more than 4" from wall, when bottom of object more than 27" or less than 80" above finished floor. As-Built: Metal box: 13.0" at 31.0" high Proposed Solution: Remove/relocate protruding object. Patch existing surface. 	PCODE EG04 ADAAG 91 4.4.1 ADA 2010 307.2 CBC 2007 1133B.8.6.1 CBC 2019 11B-307.2	1	JOB	\$300	\$300
-----	---	--	---	-----	-------	-------

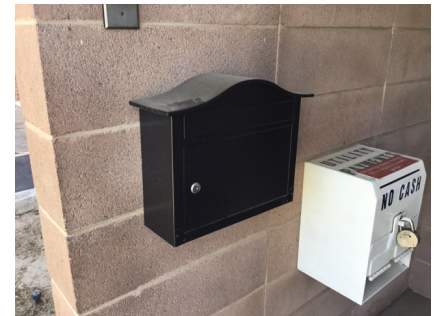
505	<ul style="list-style-type: none"> As-Built Description: Protruding objects more than 4" from wall, when bottom of object more than 27" or less than 80" above finished floor. As-Built: Metal box: 6.0" at 51.0" high Proposed Solution: Remove/relocate protruding object. Patch existing surface. 	PCODE EG04 ADAAG 91 4.4.1 ADA 2010 307.2 CBC 2007 1133B.8.6.1 CBC 2019 11B-307.2	1	JOB	\$300	\$300
-----	--	--	---	-----	-------	-------

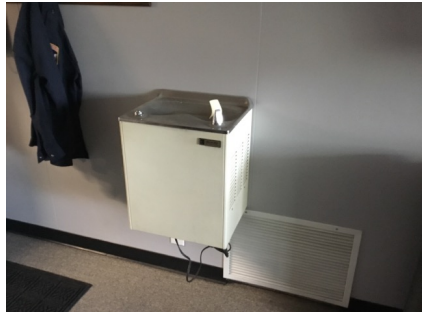
Item no., Rm no. and Name	Existing Architectural Barrier and Proposed Solution	Codes / Mitigation Info	Qty	Unit	Cost	Total
2	<ul style="list-style-type: none"> <i>As-Built Description:</i> Drinking fountain lacks protection for visually impaired persons. <i>Proposed Solution:</i> Provide cane-detectable rails. 	PCODE IA05C ADAAG 91 4.4.1 ADA 2010 307.2 CBC 2007 1115B.4.6.3 CBC 2019 11B-307.2 Mitigated: <input type="radio"/> YES <input checked="" type="radio"/> NO	1	JOB	\$1,500	\$1,500

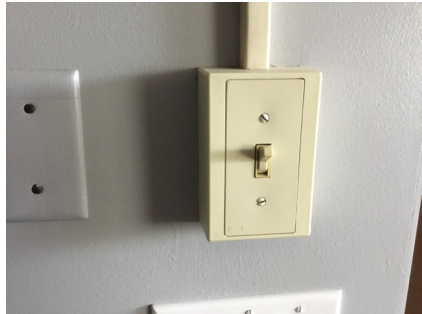
Electrical

465	<ul style="list-style-type: none"> <i>As-Built Description:</i> Electric switch or control mounted less than 15" measured to the bottom of the outlet box or greater than 48 inches measured to the top of the outlet box. <i>As-Built:</i> Fan switch 58" high <i>Proposed Solution:</i> Relocate light switches or control to between 15" and 48" height. 	PCODE IC01 ADAAG 91 4.2.5 & 6 ADA 2010 308.2.1 & 308.2.2 CBC 2007 1117B.6.3 CBC 2019 11B-308.2.1 & 11B-308.2.2 Mitigated: <input type="radio"/> YES <input checked="" type="radio"/> NO	1	JOB	\$900	\$900

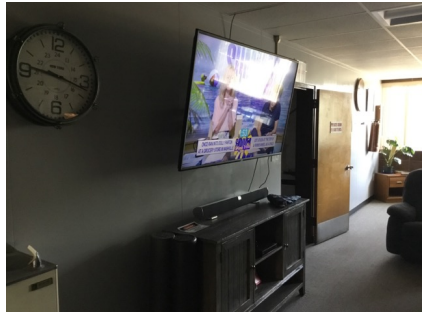
Item no., Rm no. and Name	Existing Architectural Barrier and Proposed Solution	Codes / Mitigation Info	Qty	Unit	Cost	Total
467	<ul style="list-style-type: none"> As-Built Description: Protruding objects more than 4" from wall, when bottom of object more than 27" or less than 80" above finished floor. As-Built: TV: 13.0" at 70.0" Proposed Solution: Provide cane-detectable railing to mark area of low clearance. 	PCODE EG04A ADAAG 91 4.4.1 ADA 2010 307.2 CBC 2007 1133B.8.6.1 CBC 2019 11B-307.2 Mitigated: <input type="radio"/> YES <input checked="" type="radio"/> NO	6	LF	\$300	\$1,800

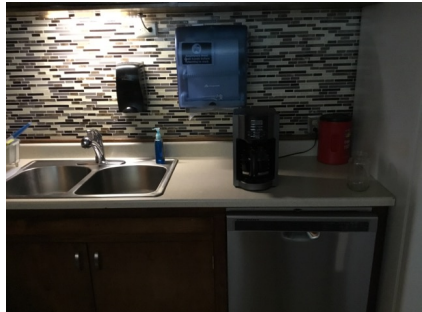
Reach Range

463	<ul style="list-style-type: none"> As-Built Description: Reach height to control or access point, where side approach is available, exceeds 48" or is less than 15" in height, or exceeds 10" in depth. As-Built: 36.0" high obstructed side reach. Proposed Solution: Modify equipment or mounting. 	PCODE IE02 ADAAG 91 4.2.6 ADA 2010 308.3.1 CBC 2007 1118B.6 CBC 2019 11B-308.3 Mitigated: <input type="radio"/> YES <input checked="" type="radio"/> NO	1	JOB	\$300	\$300

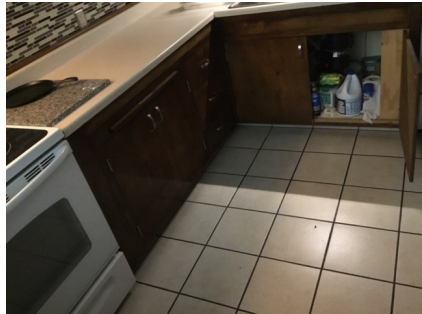
Item no., Rm no. and Name	Existing Architectural Barrier and Proposed Solution	Codes / Mitigation Info	Qty	Unit	Cost	Total
461	<ul style="list-style-type: none"> • <i>As-Built Description:</i> Sink does not have knee space min. 27" high x 19" deep x 30" wide. • <i>Proposed Solution:</i> Remodel sink cabinet. 	PCODE IN06A ADAAG 91 4.24.3 ADA 2010 606.2 CBC 2007 1115B.4.7.1 CBC 2019 11B-606.2 Mitigated: <input type="radio"/> YES <input checked="" type="radio"/> NO	1	JOB	\$5,250	\$5,250

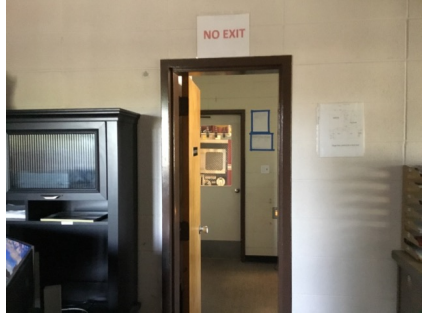
Door Clearance

500	<ul style="list-style-type: none"> • <i>As-Built Description:</i> Door on accessible route has less than 32" clear and 80" (78" min. to closer if provided) opening width when 90° open. • <i>As-Built:</i> 22.0" clear • <i>Proposed Solution:</i> Provide new, larger door and frame with new accessible hardware. 	PCODE ID01 ADAAG 91 4.13.5 ADA 2010 404.2.3 CBC 2007 1133B.1.1.1.1 CBC 2019 11B-404.2.3 Mitigated: <input type="radio"/> YES <input checked="" type="radio"/> NO	1	JOB	\$7,800	\$7,800

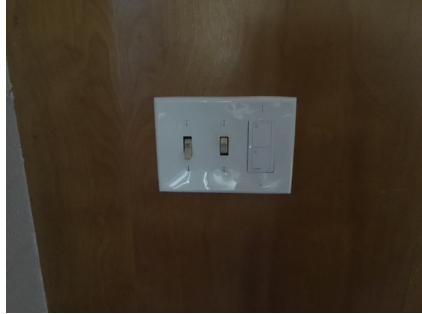
Electrical

<p>476</p> <ul style="list-style-type: none"> • <i>As-Built Description:</i> Electric switch or control mounted less than 15" measured to the bottom of the outlet box or greater than 48 inches measured to the top of the outlet box. • <i>As-Built:</i> 54.0" high • <i>Proposed Solution:</i> Relocate light switches or control to between 15" and 48" height. • <i>Notes:</i> 	<p>PCODE IC01 ADAAG 91 4.2.5 & 6 ADA 2010 308.2.1 & 308.2.2 CBC 2007 1117B.6.3 CBC 2019 11B-308.2.1 & 11B-308.2.2</p> <p>Mitigated: <input type="radio"/> YES <input checked="" type="radio"/> NO</p>	<p>1 JOB \$900 \$900</p>

<p><input checked="" type="radio"/> Staff Only</p> <p>Priority 1</p> <p>Severity 3</p> <p>This element complies with Safe Harbor if altered or constructed before March 15, 2012. This element does not comply with the dimensional requirements in the 1981 to the current CBC.</p>
--	--	--

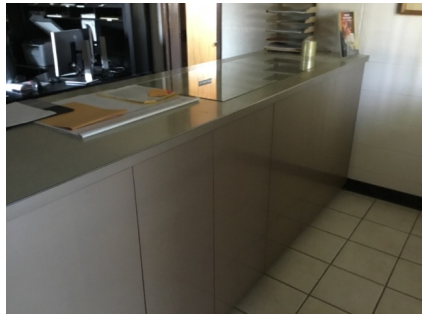
Public Counter

<p>477</p> <ul style="list-style-type: none"> • <i>As-Built Description:</i> Service counter (stand-up): Accessible section min. 36" length and 36" max. height (in CA: 28" to 34" high) not provided. • <i>As-Built:</i> 42.0" high • <i>Proposed Solution:</i> Retrofit existing counter to provide accessible section. Interim solution: Provide auxiliary counter, table, or clipboard. 	<p>PCODE IN03 ADAAG 91 7.2(2) ADA 2010 904.4 CBC 2007 1122B.4 CBC 2019 11B-904.4</p> <p>Mitigated: <input type="radio"/> YES <input checked="" type="radio"/> NO</p>	<p>1 JOB \$6,000 \$6,000</p>

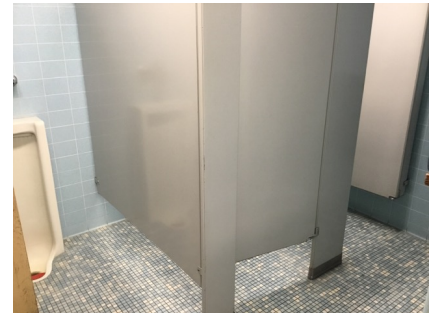
- 479
- *As-Built Description:*
Multiple accommodation restroom not accessible; multiple compliance violations.
 - *As-Built:* **137.0" x 133.0"**
 - *Proposed Solution:*
Remodel area to provide accessible restroom with one accessible stall, lavatory (and one urinal at Men's).
 - *Notes:*

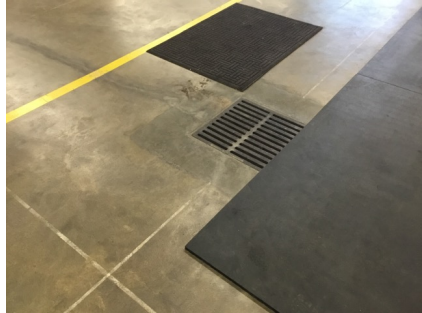
Floor or Ground Surface

<p>487</p> <ul style="list-style-type: none"> <i>As-Built Description:</i> Walk: Grating has grid openings greater than 1/2" along the line of traffic flow. <i>Proposed Solution:</i> Provide new grating, with grid openings 1/2" max. along the line of traffic flow. 	<p>PCODE EF04 ADAAG 91 4.3.6; 4.5.4 ADA 2010 403.2; 302.3 CBC 2007 1133B.7.2 CBC 2019 11B-403.2; 11B-302.3</p> <p>Mitigated: <input type="radio"/> YES <input checked="" type="radio"/> NO</p>	<p>1 SF \$240 \$240</p>

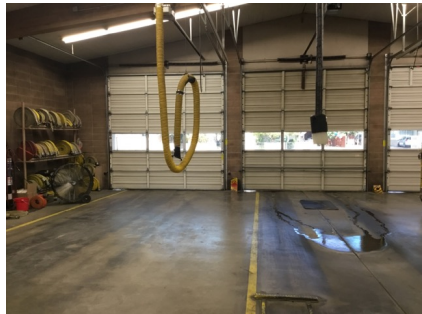
Protrusion Limits

<p>489</p> <ul style="list-style-type: none"> <i>As-Built Description:</i> Protruding objects more than 4" from wall, when bottom of object more than 27" or less than 80" above finished floor. <i>As-Built:</i> 60.0" high <i>Proposed Solution:</i> Remove/relocate protruding object. Patch existing surface. <i>Notes:</i> 	<p>PCODE EG04 ADAAG 91 4.4.1 ADA 2010 307.2 CBC 2007 1133B.8.6.1 CBC 2019 11B-307.2</p> <p>Mitigated: <input type="radio"/> YES <input checked="" type="radio"/> NO</p>	<p>1 JOB \$300 \$300</p>

Ensure movable cords and hoses are retracted or extended during tours.

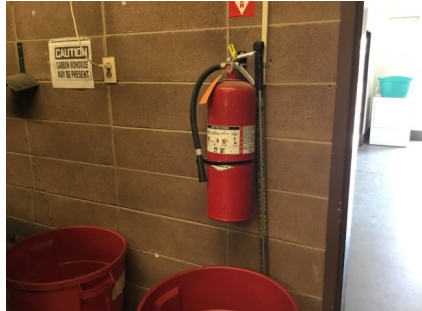
Item no., Rm no. and Name	Existing Architectural Barrier and Proposed Solution	Codes / Mitigation Info	Qty	Unit	Cost	Total
491	<ul style="list-style-type: none"> As-Built Description: Protruding objects more than 4" from wall, when bottom of object more than 27" or less than 80" above finished floor. As-Built: FE: 8.0" at 36.0" high Proposed Solution: Remove/relocate protruding object. Patch existing surface. 	PCODE EG04 ADAAG 91 4.4.1 ADA 2010 307.2 CBC 2007 1133B.8.6.1 CBC 2019 11B-307.2 Mitigated: <input type="radio"/> YES <input checked="" type="radio"/> NO	7	JOB	\$300	\$2,100

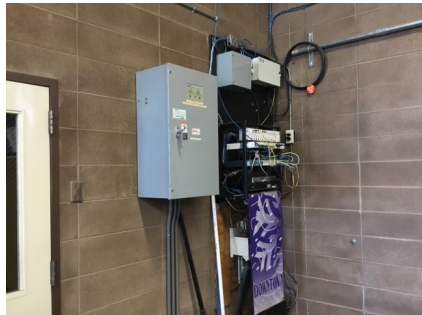
<input type="radio"/> Staff Only			
			Priority <input checked="" type="radio"/> 4			
			Severity <input checked="" type="radio"/> 3			
486	<ul style="list-style-type: none"> As-Built Description: Protruding objects more than 4" from wall, when bottom of object more than 27" or less than 80" above finished floor. As-Built: Electrical utility box: 12.0" at 57.0" high Proposed Solution: Provide cane-detectable railing to mark area of low clearance. Notes: 	PCODE EG04A ADAAG 91 4.4.1 ADA 2010 307.2 CBC 2007 1133B.8.6.1 CBC 2019 11B-307.2 Mitigated: <input type="radio"/> YES <input checked="" type="radio"/> NO	6	LF	\$300	\$1,800

<input type="radio"/> Staff Only			
			Priority <input checked="" type="radio"/> 4			
			Severity <input checked="" type="radio"/> 1			
<p>This item does not appear to be in an exit. However consider if tours are conducted in the bay some form of protection may be warranted.</p>

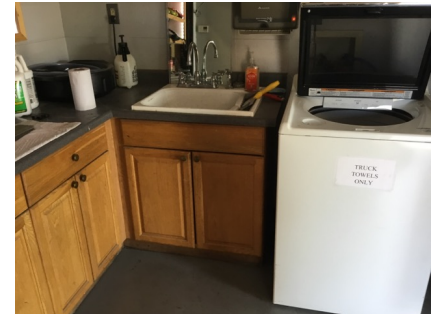
492	<ul style="list-style-type: none"> As-Built Description: Sink rim higher than 34" above floor. As-Built: 37.0" high Proposed Solution: Remodel sink cabinet to lower sink. 	PCODE IN06 ADAAG 91 4.24.2 ADA 2010 606.3 CBC 2007 1115B.4.7.1 CBC 2019 11B-606.3	1	JOB	\$5,250	\$5,250
-----	--	---	---	-----	---------	---------

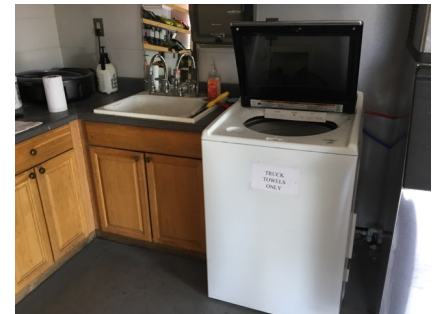
493	<ul style="list-style-type: none"> As-Built Description: Sink does not have clear floor space in front to allow for forward approach. Proposed Solution: Relocate existing washer. Notes: 	PCODE IN06ANT ADAAG 91 4.24.3 ADA 2010 606.2 CBC 2007 1115B.4.7.1 CBC 2019 11B-606.2	1	JOB	\$5,250	\$5,250
-----	--	--	---	-----	---------	---------

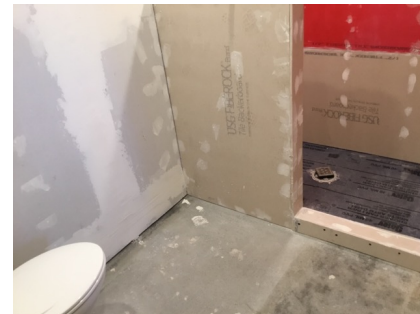
- 499 • *As-Built Description:*
Single accommodation restroom not accessible; multiple compliance violations.
- *As-Built:* **59.5" x 109.0"**
- *Proposed Solution:*
Remodel area to provide single-occupant accessible restroom.

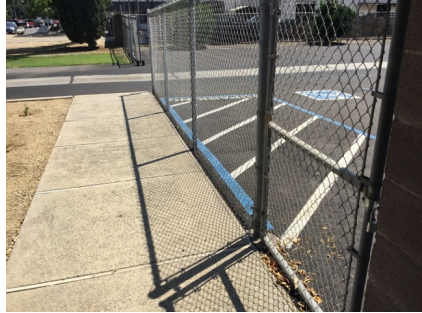
Parking

670	<ul style="list-style-type: none"> <i>As-Built Description:</i> Disabled persons must wheel or walk behind parked car(s) other than their own. <i>Proposed Solution:</i> Provide locking gate that can be used from the parking or Relocate parking and provide curb ramp to accessible route. 	PCODE EA03 ADAAG 91 Fig.9 ADA 2010 502.3 CBC 2007 1129B.3.1 CBC 2019 11B-502.7.1 Mitigated: <input type="radio"/> YES <input checked="" type="radio"/> NO	1	JOB	\$2,190	\$2,190
-----	--	---	---	-----	---------	---------

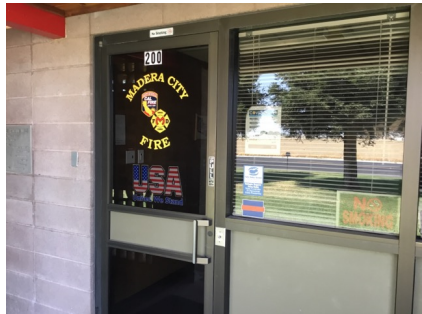
Signage

672	<ul style="list-style-type: none"> <i>As-Built Description:</i> Sign showing the International Symbol of Accessibility (ISA) not provided at all accessible building entrances. <i>Proposed Solution:</i> Provide building entrance signage with ISA signage at accessible entrance. <i>Notes:</i> 	PCODE SA12A ADAAG 91 28 CFR 35.163 ADA 2010 (b) 216.6 CBC 2007 1127B.3 CBC 2019 11B-216.6 Mitigated: <input type="radio"/> YES <input checked="" type="radio"/> NO	1	JOB	\$150	\$150
-----	---	--	---	-----	-------	-------

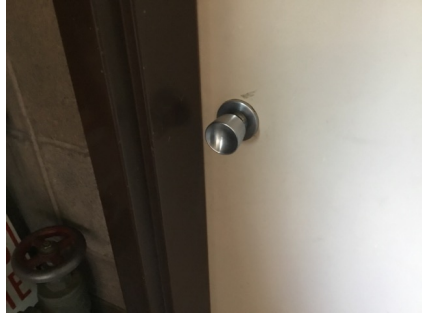
Door Hardware

658	<ul style="list-style-type: none"> <i>As-Built Description:</i> Door does not have accessible operating hardware. <i>Proposed Solution:</i> Provide lever handle or other accessible hardware. 	<p>PCODE ID07</p> <p>ADAAG 91 4.13.9</p> <p>ADA 2010 404.2.7</p> <p>CBC 2007 1133B.2.5.2</p> <p>CBC 2019 11B-404.2.7</p> <p>Mitigated:</p> <p><input type="radio"/> YES</p> <p><input checked="" type="radio"/> NO</p>	20	JOB	\$450	\$9,000
-----	--	---	----	-----	-------	---------

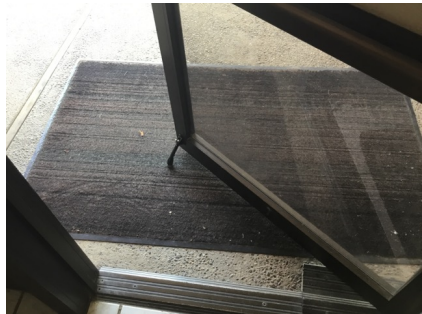
Door Stopper

665	<ul style="list-style-type: none"> <i>As-Built Description:</i> At push side of door on accessible route, bottom 10" does not have a smooth, uninterrupted surface. <i>Proposed Solution:</i> Remove door stopper when altering area. Provide rubber wedge. <i>Notes:</i> 	<p>PCODE ID06A</p> <p>ADA 2010 404.2.10</p> <p>CBC 2007 1133B.2.6</p> <p>CBC 2019 11B-404.2.10</p> <p>Mitigated:</p> <p><input type="radio"/> YES</p> <p><input checked="" type="radio"/> NO</p>	10	JOB	\$75	\$750
-----	--	---	----	-----	------	-------

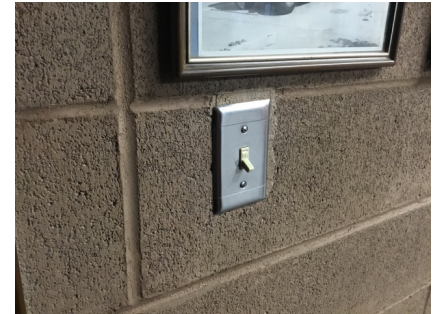
Electrical

652	<ul style="list-style-type: none"> <i>As-Built Description:</i> Electric switch or control mounted less than 15" measured to the bottom of the outlet box or greater than 48 inches measured to the top of the outlet box. <i>As-Built:</i> 54.0" high <i>Proposed Solution:</i> Relocate light switches or control to between 15" and 48" height. <i>Notes:</i> 	<p>PCODE IC01 ADAAG 91 4.2.5 & 6 ADA 2010 308.2.1 & 308.2.2 CBC 2007 1117B.6.3 CBC 2019 11B-308.2.1 & 11B-308.2.2</p> <p>Mitigated: <input type="radio"/> YES <input checked="" type="radio"/> NO</p>	20	JOB	\$900	\$18,000
-----	---	--	----	-----	-------	----------

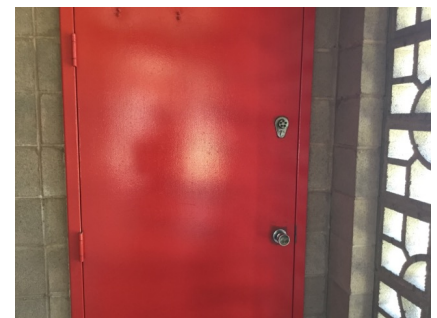
Signage

673	<ul style="list-style-type: none"> <i>As-Built Description:</i> Existing sign designating permanent room or space is noncompliant. <i>Proposed Solution:</i> Provide compliant signage. 	<p>PCODE SA13 ADAAG 91 4.1.3(16)(a) ADA 2010 216.2 CBC 2007 1117B.5 CBC 2019 11B-216.2</p> <p>Mitigated: <input type="radio"/> YES <input checked="" type="radio"/> NO</p>	20	JOB	\$450	\$9,000
-----	---	---	----	-----	-------	---------

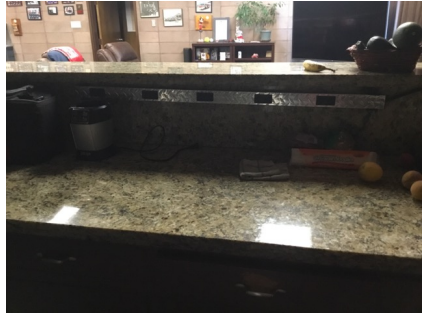
Item no., Rm no. and Name	Existing Architectural Barrier and Proposed Solution	Codes / Mitigation Info	Qty	Unit	Cost	Total
648	<ul style="list-style-type: none"> As-Built Description: Reach height to control or access point, where side approach is available, exceeds 48" or is less than 15" in height, or exceeds 10" in depth. As-Built: 25.0" deep and 36.0" high obstruction Proposed Solution: Modify equipment or mounting. 	PCODE IE02 ADAAG 91 4.2.6 ADA 2010 308.3.1 CBC 2007 1118B.6 CBC 2019 11B-308.3 Mitigated: <input type="radio"/> YES <input checked="" type="radio"/> NO	1	JOB	\$300	\$300

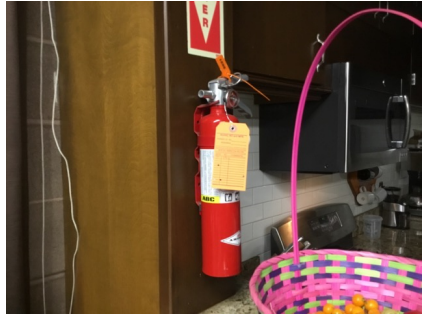
<input checked="" type="checkbox"/> Staff Only			
			Priority 4			
			Severity 4			
651	<ul style="list-style-type: none"> As-Built Description: Reach height to control or access point, where side approach is available, exceeds 48" or is less than 15" in height, or exceeds 10" in depth. As-Built: FE: 67.0" high Proposed Solution: Mount lower than 48" and higher than 15". 	PCODE IE02 ADAAG 91 4.2.6 ADA 2010 308.3.1 CBC 2007 1118B.6 CBC 2019 11B-308.3 Mitigated: <input type="radio"/> YES <input checked="" type="radio"/> NO	1	JOB	\$300	\$300

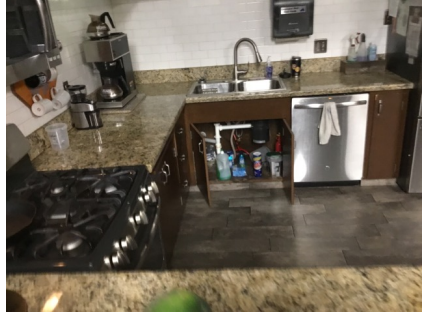
Item no., Rm no. and Name	Existing Architectural Barrier and Proposed Solution	Codes / Mitigation Info	Qty	Unit	Cost	Total
644	<ul style="list-style-type: none"> • <i>As-Built Description:</i> Sink does not have knee space min. 27" high x 19" deep x 30" wide. • <i>Proposed Solution:</i> Remodel sink cabinet. 	PCODE IN06A ADAAG 91 4.24.3 ADA 2010 606.2 CBC 2007 1115B.4.7.1 CBC 2019 11B-606.2 Mitigated: <input type="radio"/> YES <input checked="" type="radio"/> NO	1	JOB	\$5,250	\$5,250

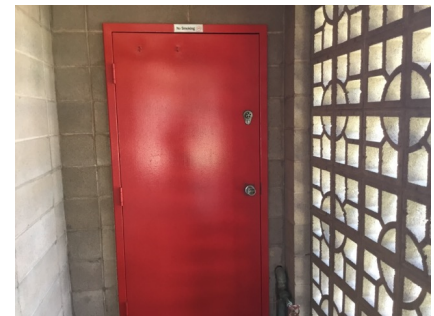
674 • *As-Built Description:*
 Exterior signage at inaccessible entrances to provide direction to accessible entrances is missing or noncompliant.
 • *Proposed Solution:*
 Provide signage sufficient to guide persons to the front bay for access.

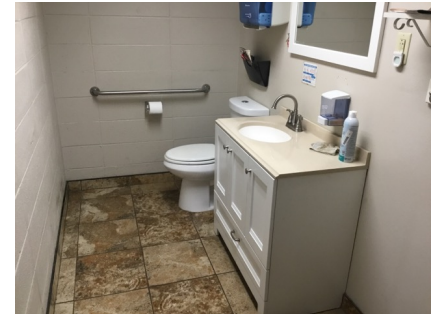
Single accommodation restroom not accessible; multiple compliance violations.

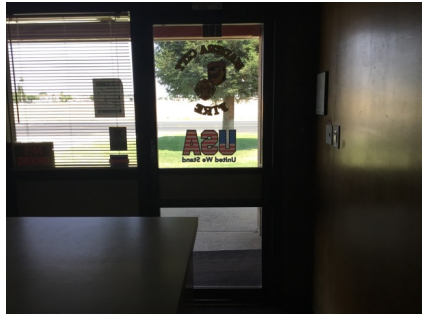
Staff says, entry cabinets can be removed.

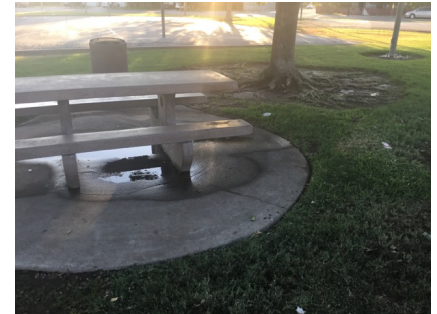
Picnic Area

1734	<ul style="list-style-type: none"> <i>As-Built Description:</i> No hard-surfaced accessible spaces at picnic table, B.B.Q. grill and/or bench. <i>Proposed Solution:</i> Provide paved accessible spaces for sitting and turning at picnic table, B.B.Q. grill and/or bench. <i>Notes:</i> 	<p>PCODE NA07</p> <p>CBC 2007 1132B.1</p> <p>CBC 2019 11B-246.5</p> <p>Mitigated:</p> <p><input type="radio"/> YES</p> <p><input checked="" type="radio"/> NO</p>	100	SF	\$18	\$1,800
------	---	--	-----	----	------	---------

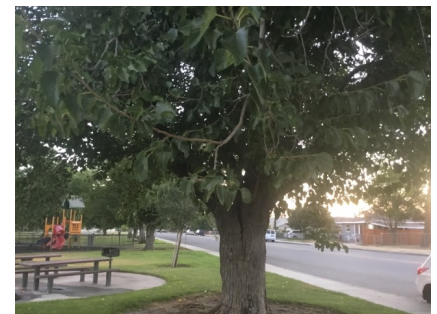
Protrusion Limits

1711	<ul style="list-style-type: none"> <i>As-Built Description:</i> Protruding objects more than 4" from wall, when bottom of object more than 27" or less than 80" above finished floor. <i>Proposed Solution:</i> Trim vegetation. 	<p>PCODE EG04</p> <p>ADAAG 91 4.4.1</p> <p>ADA 2010 307.2</p> <p>CBC 2007 1133B.8.6.1</p> <p>CBC 2019 11B-307.2</p> <p>Mitigated:</p> <p><input type="radio"/> YES</p> <p><input checked="" type="radio"/> NO</p>	8	JOB	\$300	\$2,400
------	--	--	---	-----	-------	---------

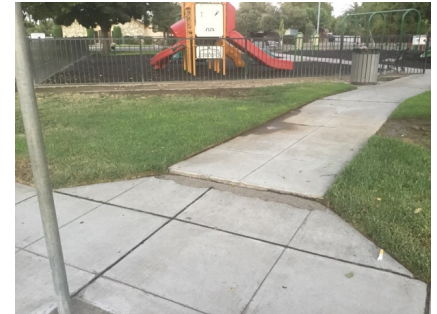
- 1709
- As-Built Description:**
Walk: Pavement dislocation creates abrupt change in level exceeding 1/2" in accessible route.
 - As-Built:** 2.0"
 - Proposed Solution:**
Remove, replace or repair area of pavement sufficient to correct abrupt change in level.

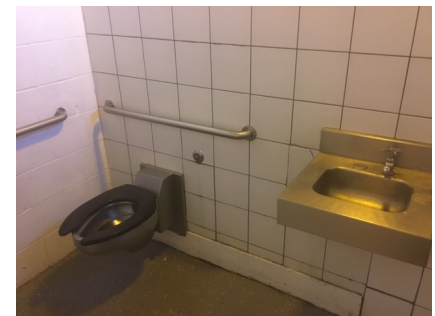
1719	<ul style="list-style-type: none"> As-Built Description: 60" min. clearance around a water closet measured perpendicular from the side wall not provided (Fixtures are not allowed to overlap this clearance). As-Built: 53.5" to lavatory Proposed Solution: Remove adjacent fixture and remodel restroom as needed. Notes: 	PCODE WB01A ADA 2010 604.3.1; 604.3.2 CBC 2007 1115B.7.1.3 CBC 2019 11B-604.3.1; 11B-604.3.2 Mitigated: <input type="radio"/> YES <input checked="" type="radio"/> NO	1	JOB	\$6,000	\$6,000
------	---	--	---	-----	---------	---------

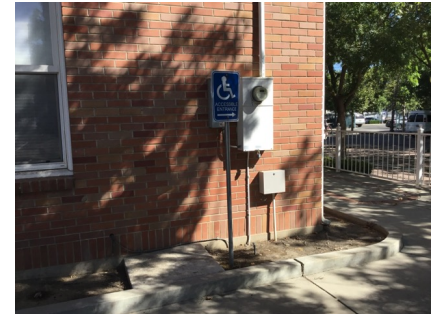
- 185
- *As-Built Description:*
Refer to notes for observation and recommendation.
 - *Proposed Solution:*
 - *Notes:*

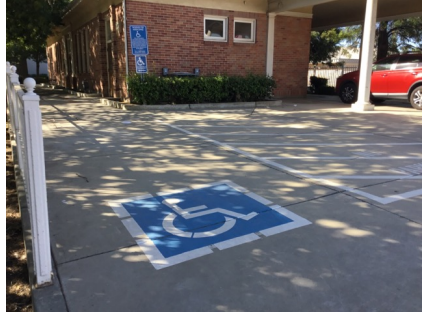
<p>171</p> <ul style="list-style-type: none"> • <i>As-Built Description:</i> Accessible parking space has slope greater than 1/4":12" (2%). • <i>As-Built:</i> Up to 4.8% • <i>Proposed Solution:</i> Modify slope at accessible parking space. 	<p>PCODE EA05 ADAAG 91 4.6.3 ADA 2010 502.4 CBC 2007 1129B.3.3 CBC 2019 11B-502.4</p> <p>Mitigated: <input type="radio"/> YES <input checked="" type="radio"/> NO</p>	<p>200 SF \$36 \$7,200</p>

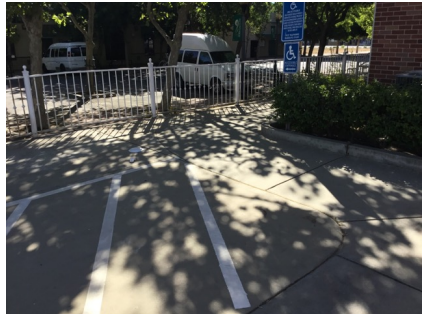
<p>174</p> <ul style="list-style-type: none"> • <i>As-Built Description:</i> Wheel stops provided do not effectively prevent the encroachment of vehicles over the required clear width of an adjacent accessible route. • <i>Proposed Solution:</i> Install wheel stops to effectively prevent encroachment. 	<p>PCODE EA04J CBC 2019 11B-502.7.2</p> <p>Mitigated: <input type="radio"/> YES <input checked="" type="radio"/> NO</p>	<p>1 JOB \$225 \$225</p>

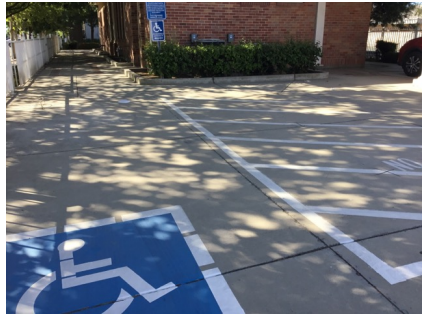
Item no., Rm no. and Name	Existing Architectural Barrier and Proposed Solution	Codes / Mitigation Info	Qty	Unit	Cost	Total
173	<ul style="list-style-type: none"> As-Built Description: An accessible parking space shall be outlined or painted blue (required in CA only). Proposed Solution: Identify accessible parking space using blue markings. 	PCODE EA04K CBC 2019 11B-502.6 Mitigated: <input type="radio"/> YES <input checked="" type="radio"/> NO	1	JOB	\$360	\$360

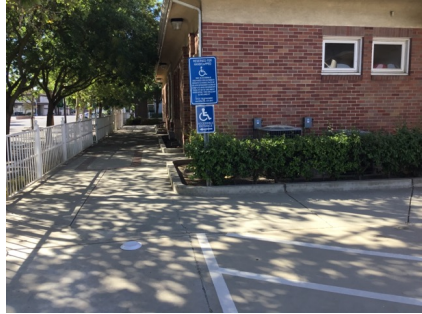
172	<ul style="list-style-type: none"> As-Built Description: Sign relating to parking privileges for disabled persons is non-compliant. Proposed Solution: Provide compliant parking signage that does not contain the word "Handicapped". Notes: 	PCODE EA04F ADA 2010 502.6 CBC 2007 VC §22511.9. CBC 2019 11B-502.6 Mitigated: <input type="radio"/> YES <input checked="" type="radio"/> NO	1	JOB	\$300	\$300

Also no fine sign.

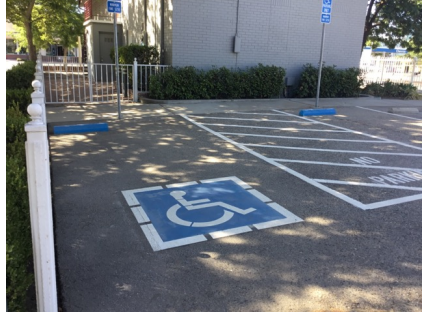
<p>180</p> <ul style="list-style-type: none"> • <i>As-Built Description:</i> Accessible parking space has slope greater than 1/4":12" (2%). • <i>As-Built:</i> Up to 4.0% • <i>Proposed Solution:</i> Modify slope at accessible parking space. 	<p>PCODE EA05 ADAAG 91 4.6.3 ADA 2010 502.4 CBC 2007 1129B.3.3 CBC 2019 11B-502.4</p> <p>Mitigated: <input type="radio"/> YES <input checked="" type="radio"/> NO</p>	<p>200 SF \$36 \$7,200</p>

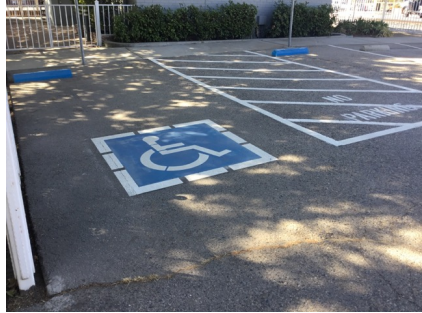
<p>181</p> <ul style="list-style-type: none"> <i>As-Built Description:</i> An accessible parking space shall be outlined or painted blue (required in CA only). <i>Proposed Solution:</i> Identify accessible parking space using blue markings. 	<p>PCODE EA04K</p> <p>CBC 2019 11B-502.6</p> <p>Mitigated:</p> <p><input type="radio"/> YES</p> <p><input checked="" type="radio"/> NO</p>	<p>1 JOB \$360 \$360</p>

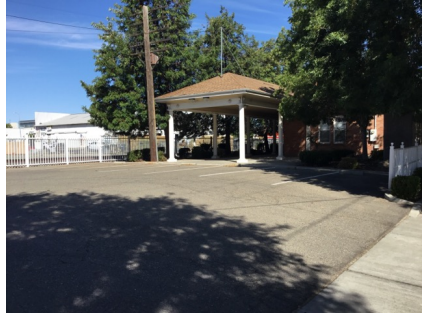
<p>179</p> <ul style="list-style-type: none"> <i>As-Built Description:</i> Accessible parking space(s) not located close to the nearest possible entrance on an accessible route. <i>Proposed Solution:</i> Relocate accessible parking space(s). 	<p>PCODE EA06</p> <p>ADAAG 91 4.6.2</p> <p>ADA 2010 208.3</p> <p>CBC 2007 1129B.1</p> <p>CBC 2019 11B-208.3.1</p> <p>Mitigated:</p> <p><input type="radio"/> YES</p> <p><input checked="" type="radio"/> NO</p>	<p>1 JOB \$3,000 \$3,000</p>

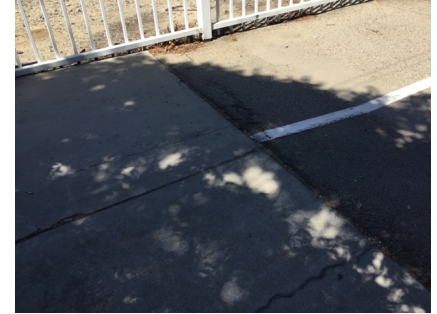
- 252 • *As-Built Description:*
Walk: Pavement dislocation creates abrupt change in level exceeding 1/2" in accessible route.
- *As-Built:* **2.0"**
- *Proposed Solution:*
Remove, replace or repair area of pavement sufficient to correct abrupt change in level.

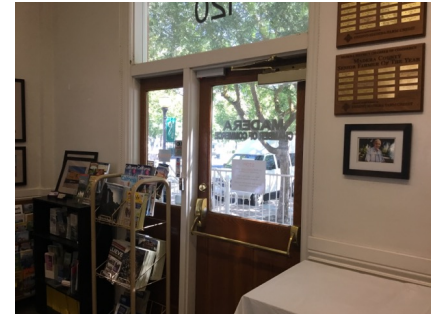
208	<ul style="list-style-type: none"> As-Built Description: At final exit door to exterior: Where required exit signs are installed, signs to provide exiting information for people with vision impairment are not provided. Proposed Solution: Provide raised letter/Braille "EXIT" sign at door. 	<p>PCODE SA10A ADAAG 91 4.1.3(16) ADA 2010 216.4.1 CBC 2007 1011.3 CBC 2019 11B-216.4.1</p> <p>Mitigated: <input type="radio"/> YES <input checked="" type="radio"/> NO</p>	4	JOB	\$270	\$1,080
-----	--	--	---	-----	-------	---------

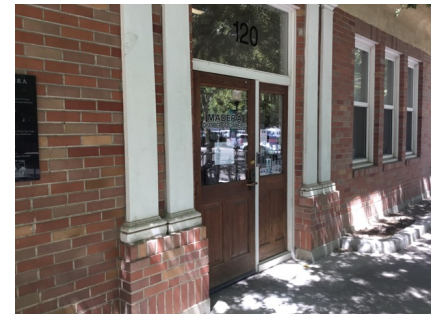
250	<ul style="list-style-type: none"> As-Built Description: Accessible building entrance when not all are accessible not identified with a sign showing the International Symbol of Accessibility. Proposed Solution: Provide building entrance sign that shows international symbol at accessible entrance. Notes: 	<p>PCODE SA12 ADAAG 91 4.1.2(7)(c) ADA 2010 216.6 CBC 2007 1127B.3 CBC 2019 11B-216.6</p> <p>Mitigated: <input type="radio"/> YES <input checked="" type="radio"/> NO</p>	4	JOB	\$150	\$600
-----	--	--	---	-----	-------	-------

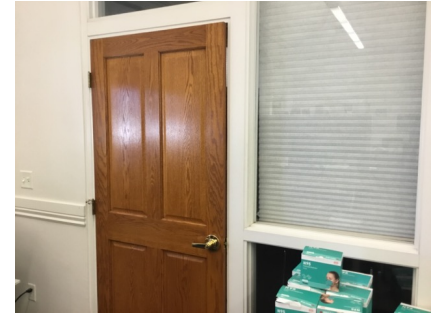
Item no., Rm no. and Name	Existing Architectural Barrier and Proposed Solution	Codes / Mitigation Info	Qty	Unit	Cost	Total
209	<ul style="list-style-type: none"> <i>As-Built Description:</i> Existing sign designating permanent room or space is noncompliant. <i>Proposed Solution:</i> Provide compliant signage. 	PCODE SA13 ADAAG 91 4.1.3(16)(a) ADA 2010 216.2 CBC 2007 1117B.5 CBC 2019 11B-216.2 Mitigated: <input type="radio"/> YES <input checked="" type="radio"/> NO	15	JOB	\$450	\$6,750

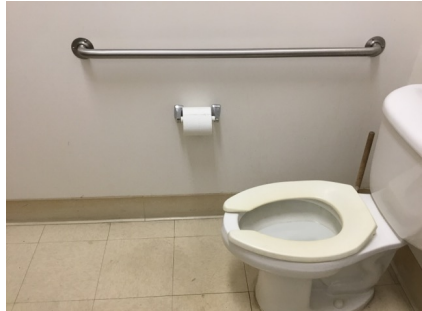
Item no., Rm no. and Name	Existing Architectural Barrier and Proposed Solution	Codes / Mitigation Info	Qty	Unit	Cost	Total
193	<ul style="list-style-type: none"> As-Built Description: Toilet paper dispenser less than 15" (CA: 19") or more than 48" above floor or not within 7" to 9" from front of water closet (Note: CA pre-2010 is allowed within 12" from front of water closet). As-Built: 4.0" in front. Proposed Solution: Relocate or provide new toilet paper dispenser. 	PCODE WG02 ADAAG 91 4.16.6 ADA 2010 604.7 CBC 2007 1115B.8.4 CBC 2019 11B-604.7 Mitigated: <input type="radio"/> YES <input checked="" type="radio"/> NO	1	JOB	\$225	\$225

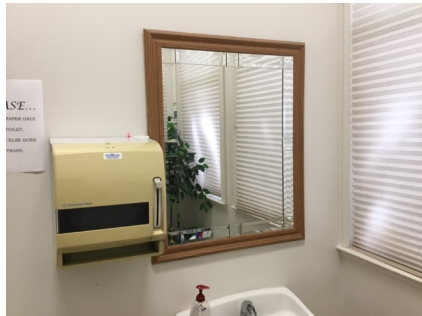
<input type="radio"/> Staff Only			
			Priority <input checked="" type="radio"/> 3			
			Severity <input checked="" type="radio"/> 3			
200	<ul style="list-style-type: none"> As-Built Description: Bottom of mirror located above lavatories or countertops more than 40" above floor. As-Built: 45.7" high Proposed Solution: Relocate or provide new accessible mirror. 	PCODE WG03 ADAAG 91 4.19.6 ADA 2010 603.3 CBC 2007 1115B.8.1 CBC 2019 11B-603.3 Mitigated: <input type="radio"/> YES <input checked="" type="radio"/> NO	1	JOB	\$450	\$450

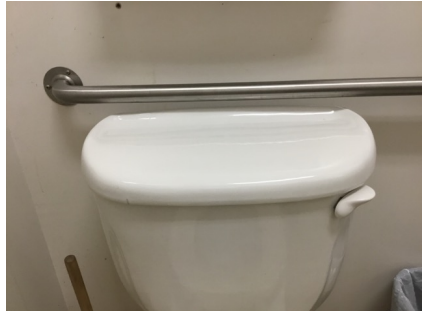
Item no., Rm no. and Name	Existing Architectural Barrier and Proposed Solution	Codes / Mitigation Info	Qty	Unit	Cost	Total
194	<ul style="list-style-type: none"> • <i>As-Built Description:</i> Accessories/dispensers in accessible stall located closer than 1-1/2" below or 12" above grab bar impedes its use. • <i>As-Built:</i> 0.5" below the grab bar • <i>Proposed Solution:</i> Raise the grab bar. 	PCODE WB07I ADAAG 91 4.26.2 ADA 2010 609.3 CBC 2007 1133B.4.2.5 CBC 2019 11B-609.3 Mitigated: <input type="radio"/> YES <input checked="" type="radio"/> NO	1	JOB	\$225	\$225
