The City of Madera

Appendix B: Facilities

Access Compliance Survey Report

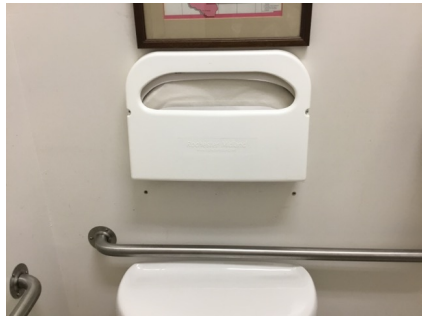
<input type="radio"/> Staff Only						
Priority <input checked="" type="radio"/> 3						
Severity <input checked="" type="radio"/> 4						
195	<ul style="list-style-type: none"> • <i>As-Built Description:</i> Accessories/dispensers in accessible stall located closer than 1-1/2" below or 12" above grab bar impedes its use. • <i>As-Built:</i> SCD: 7.7" above grab bar • <i>Proposed Solution:</i> Relocate accessories/dispensers within applicable reach range and to be no closer than 1-1/2" below and 12" above grab bars (except if accessories are recessed, flush with wall, and have no sharp edges). 	PCODE WB07I ADAAG 91 4.26.2 ADA 2010 609.3 CBC 2007 1133B.4.2.5 CBC 2019 11B-609.3 Mitigated: <input type="radio"/> YES <input checked="" type="radio"/> NO	1	JOB	\$225	\$225

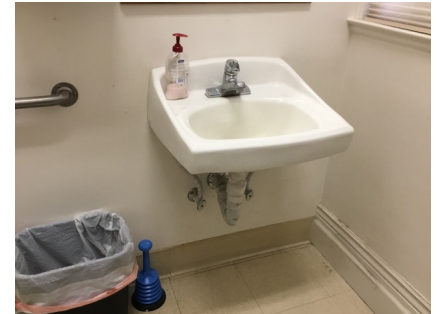
Lavatory

201	<ul style="list-style-type: none"> • <i>As-Built Description:</i> Knee clearance 27" min. high starting 8" back from the front edge of the lavatory towards the wall is not provided. • <i>As-Built:</i> 26.7" knee high • <i>Proposed Solution:</i> Remount compliant fixture to accessible height. 	<p>PCODE WD04A ADAAG 91 Fig. 31 ADA 2010 306.3.3 CBC 2007 1115B.4.3 CBC 2019 11B-306.3.3</p>	1	JOB	\$3,000	\$3,000
-----	--	---	---	-----	---------	----------------

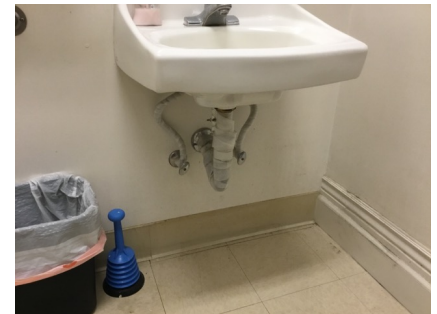
202	<ul style="list-style-type: none"> • <i>As-Built Description:</i> Hot or sharp-surfaced water/drain pipe not insulated or covered. • <i>Proposed Solution:</i> Insulate or cover water/drain pipe. 	<p>PCODE WD05 ADAAG 91 4.19.4 ADA 2010 606.5 CBC 2007 1115B.4.3.4 CBC 2019 11B-606.5</p>	1	JOB	\$360	\$360
-----	--	---	---	-----	-------	--------------

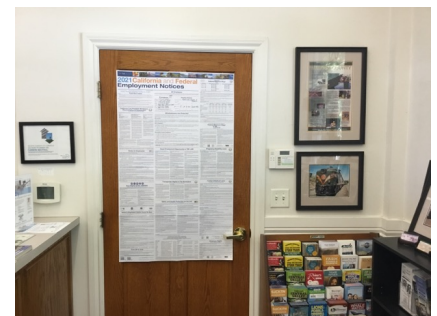
- 189
- *As-Built Description:*
Entrance to toilet or bathing facility not identified with ADAAG compliant signage.
 - *Proposed Solution:*
Provide ADA compliant sign mounted at 48" min. above to baseline of the lowest Braille cells and 60" max. to baseline of the highest line of raised characters on nearest adjacent wall, on latch side of a single door (located not to cause a Braille reader to stand within the door swing).

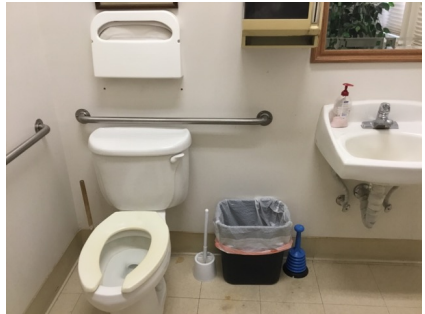
Toilet Stall

199	<ul style="list-style-type: none"> As-Built Description: 60" min. clearance around a water closet measured perpendicular from the side wall not provided (Fixtures are not allowed to overlap this clearance). As-Built: 51.0" to lavatory Proposed Solution: Relocate adjacent fixture and remodel restroom as needed. Notes: 	PCODE WB01A ADA 2010 604.3.1; 604.3.2 CBC 2007 1115B.7.1.3 CBC 2019 11B-604.3.1; 11B-604.3.2 Mitigated: <input type="radio"/> YES <input checked="" type="radio"/> NO	1	JOB	\$6,000	\$6,000
-----	---	---	---	-----	---------	---------

This element complies with Safe Harbor if altered or constructed before March 15, 2012. This element does not comply with the dimensional requirements in the 1981 to the current CBC.

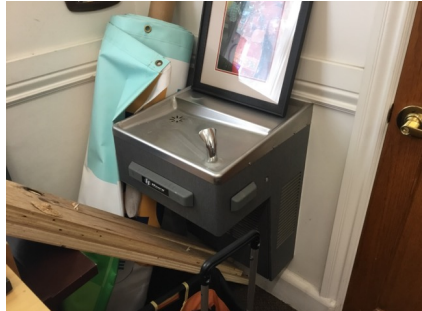
Item no., Rm no. and Name	Existing Architectural Barrier and Proposed Solution	Codes / Mitigation Info	Qty	Unit	Cost	Total
204	<ul style="list-style-type: none"> <i>As-Built Description:</i> Wall- and post-mounted cantilevered units: Knee space not provided at drinking fountain (27" high, 8" deep, 30" wide from front of drinking fountain). Unit in good condition. <i>As-Built:</i> 26.0" knee high <i>Proposed Solution:</i> Remount fountain at accessible height. 	PCODE IA02A ADAAG 91 4.15.5(1) ADA 2010 602.2 CBC 2007 1115B.4.6.2 CBC 2019 11B-602.2 Mitigated: <input type="radio"/> YES <input checked="" type="radio"/> NO	1	JOB	\$1,500	\$1,500

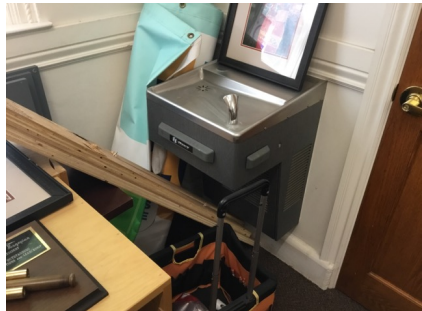
<input type="radio"/> Staff Only						
Priority <input checked="" type="radio"/> 4						
Severity <input checked="" type="radio"/> 2						
206	<ul style="list-style-type: none"> <i>As-Built Description:</i> Drinking fountain lacks protection for visually impaired persons. <i>Proposed Solution:</i> Provide cane-detectable rails. 	PCODE IA05C ADAAG 91 4.4.1 ADA 2010 307.2 CBC 2007 1115B.4.6.3 CBC 2019 11B-307.2 Mitigated: <input type="radio"/> YES <input checked="" type="radio"/> NO	1	JOB	\$1,500	\$1,500

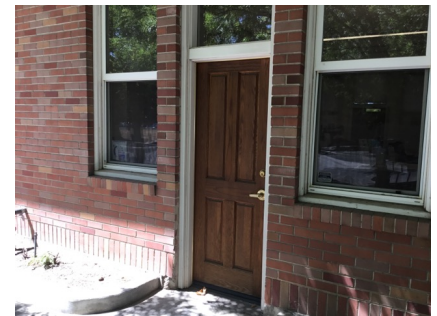
249 • *As-Built Description:*
 Exterior signage at inaccessible entrances to provide direction to accessible entrances is missing or noncompliant.

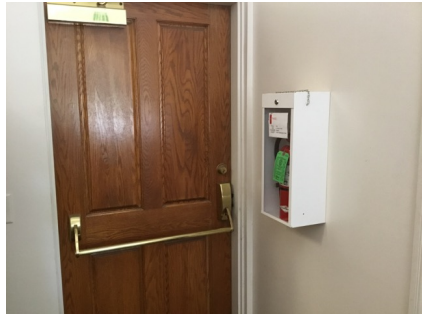
Item no., Rm no. and Name	Existing Architectural Barrier and Proposed Solution	Codes / Mitigation Info	Qty	Unit	Cost	Total
216	<ul style="list-style-type: none"> As-Built Description: Front approach: At push side, door does not have clear and level maneuvering space measuring door width x 48" (door width plus 12" if door has both, latch and closer). Proposed Solution: Remove or relocate furniture or storage items. Notes: 	PCODE ID24A ADAAG 91 Fig. 25(a) ADA 2010 404.2.4 CBC 2007 11B-26A(a) CBC 2019 11B-404.2.4 Mitigated: <input type="radio"/> YES <input checked="" type="radio"/> NO	1	JOB	\$150	\$150

Exit door.

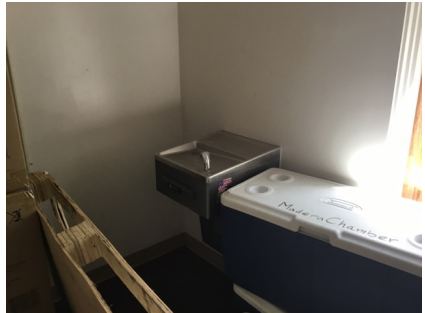
Drinking Fountain

214	<ul style="list-style-type: none"> As-Built Description: Where only one drinking fountain is provided per floor: Fountain is not accessible to individuals who use wheelchairs, or to those who have difficulty bending or stooping. Proposed Solution: Provide additional fountain or hi-lo combination fountain. 	PCODE IA01A ADAAG 91 4.1.3(10)(a) ADA 2010 211.1 CBC 2007 1115B.4.6.1 CBC 2019 11B-211.1 Mitigated: <input type="radio"/> YES <input checked="" type="radio"/> NO	1	JOB	\$6,000	\$6,000

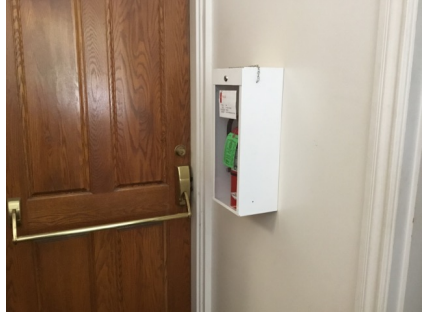
Protrusion Limits

<p>215</p> <ul style="list-style-type: none"> • <i>As-Built Description:</i> Protruding objects more than 4" from wall, when bottom of object more than 27" or less than 80" above finished floor. • <i>As-Built:</i> FE Cabinet: 6.25" at 42.6" high • <i>Proposed Solution:</i> Remove/relocate protruding object. Patch existing surface. 	<p>PCODE EG04 ADAAG 91 4.4.1 ADA 2010 307.2 CBC 2007 1133B.8.6.1 CBC 2019 11B-307.2</p> <p>Mitigated: <input type="radio"/> YES <input checked="" type="radio"/> NO</p>	<p>1 JOB \$300 \$300</p>

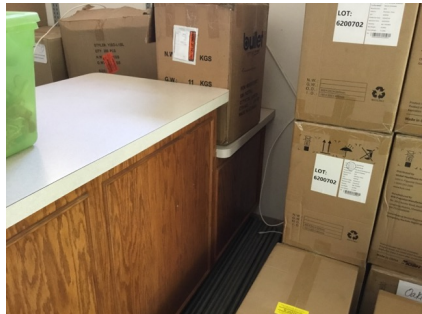
Public Counter

<p>213</p> <ul style="list-style-type: none"> • <i>As-Built Description:</i> Service counter (stand-up): Accessible section min. 36" length and 36" max. height (in CA: 28" to 34" high) not provided. • <i>As-Built:</i> 28.0" long. • <i>Proposed Solution:</i> Retrofit existing counter to provide accessible section. Interim solution: Provide auxiliary counter, table, or clipboard. 	<p>PCODE IN03 ADAAG 91 7.2(2) ADA 2010 904.4 CBC 2007 1122B.4 CBC 2019 11B-904.4</p> <p>Mitigated: <input type="radio"/> YES <input checked="" type="radio"/> NO</p>	<p>1 JOB \$6,000 \$6,000</p>

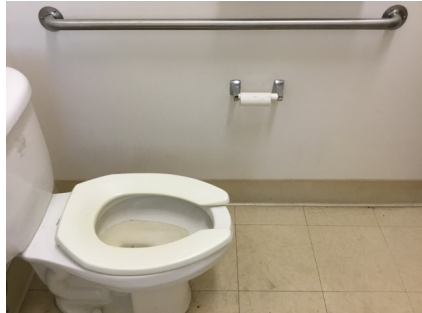
Item no., Rm no. and Name	Existing Architectural Barrier and Proposed Solution	Codes / Mitigation Info	Qty	Unit	Cost	Total
223	<ul style="list-style-type: none"> • <i>As-Built Description:</i> Toilet paper dispenser less than 15" (CA: 19") or more than 48" above floor or not within 7" to 9" from front of water closet (Note: CA pre-2010 is allowed within 12" from front of water closet). • <i>As-Built:</i> 4.0" in front. • <i>Proposed Solution:</i> Relocate or provide new toilet paper dispenser. 	PCODE WG02 ADAAG 91 4.16.6 ADA 2010 604.7 CBC 2007 1115B.8.4 CBC 2019 11B-604.7 Mitigated: <input type="radio"/> YES <input checked="" type="radio"/> NO	1	JOB	\$225	\$225

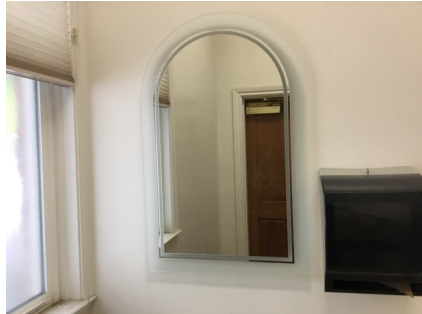
<input checked="" type="checkbox"/> Staff Only						
Priority <input checked="" type="radio"/> 3						
Severity <input checked="" type="radio"/> 3						
228	<ul style="list-style-type: none"> • <i>As-Built Description:</i> Bottom of mirror located above lavatories or countertops more than 40" above floor. • <i>As-Built:</i> 48.0" high • <i>Proposed Solution:</i> Relocate or provide new accessible mirror. 	PCODE WG03 ADAAG 91 4.19.6 ADA 2010 603.3 CBC 2007 1115B.8.1 CBC 2019 11B-603.3 Mitigated: <input type="radio"/> YES <input checked="" type="radio"/> NO	1	JOB	\$450	\$450

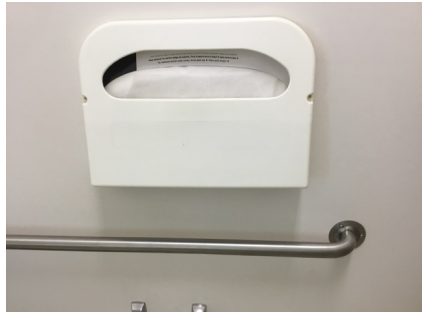
Item no., Rm no. and Name	Existing Architectural Barrier and Proposed Solution	Codes / Mitigation Info	Qty	Unit	Cost	Total
222	<ul style="list-style-type: none"> As-Built Description: Accessories/dispensers in accessible stall located closer than 1-1/2" below or 12" above grab bar impedes its use. As-Built: SCD: 5.0" above grab bar Proposed Solution: Relocate accessories/dispensers within applicable reach range and to be no closer than 1-1/2" below and 12" above grab bars (except if accessories are recessed, flush with wall, and have no sharp edges). 	PCODE WB07I ADAAG 91 4.26.2 ADA 2010 609.3 CBC 2007 1133B.4.2.5 CBC 2019 11B-609.3 Mitigated: <input type="radio"/> YES <input checked="" type="radio"/> NO	1	JOB	\$225	\$225

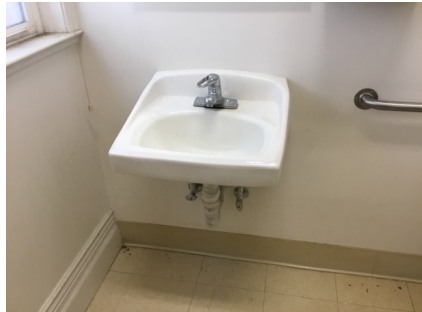
Lavatory

229	<ul style="list-style-type: none"> As-Built Description: Knee clearance 27" min. high starting 8" back from the front edge of the lavatory towards the wall is not provided. As-Built: 26.6" knee high Proposed Solution: Remount compliant fixture to accessible height. 	PCODE WD04A ADAAG 91 Fig. 31 ADA 2010 306.3.3 CBC 2007 1115B.4.3 CBC 2019 11B-306.3.3 Mitigated: <input type="radio"/> YES <input checked="" type="radio"/> NO	1	JOB	\$3,000	\$3,000

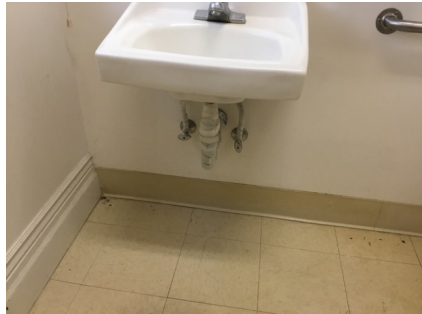
Item no., Rm no. and Name	Existing Architectural Barrier and Proposed Solution	Codes / Mitigation Info	Qty	Unit	Cost	Total
230	<ul style="list-style-type: none"> <i>As-Built Description:</i> Hot or sharp-surfaced water/drain pipe not insulated or covered. <i>Proposed Solution:</i> Insulate or cover water/drain pipe. 	PCODE WD05 ADAAG 91 4.19.4 ADA 2010 606.5 CBC 2007 1115B.4.3.4 CBC 2019 11B-606.5 Mitigated: <input type="radio"/> YES <input checked="" type="radio"/> NO	1	JOB	\$360	\$360

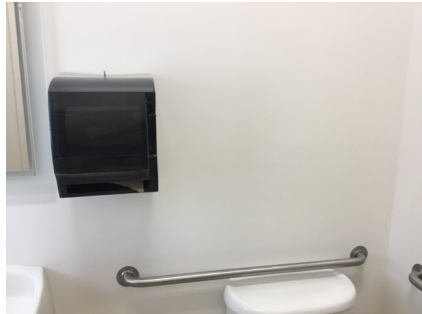
Protrusion Limits

226	<ul style="list-style-type: none"> <i>As-Built Description:</i> Protruding objects more than 4" from wall, when bottom of object more than 27" or less than 80" above finished floor. <i>Proposed Solution:</i> Remove/relocate protruding object. Patch existing surface. 	PCODE EG04 ADAAG 91 4.4.1 ADA 2010 307.2 CBC 2007 1133B.8.6.1 CBC 2019 11B-307.2 Mitigated: <input type="radio"/> YES <input checked="" type="radio"/> NO	1	JOB	\$300	\$300

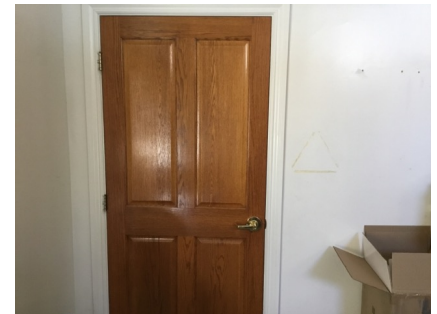
219	<ul style="list-style-type: none"> As-Built Description: Required in CA only: identification symbol centered 58" to 60" high on sanitary facility door that contrasts with the door not provided (women: 12" ø circle, men: 12" triangle, unisex: combined symbol). Proposed Solution: Provide properly mounted sanitary facility symbol when altering area. If wheelchair accessible, include International Symbol of Accessibility on sign. 	PCODE SA15 CBC 2007 1115B.6 CBC 2019 11B-703.7.2.6	1	JOB	\$270	\$270
-----	---	--	---	-----	-------	-------

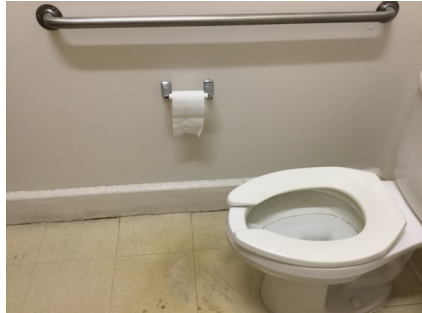
Item no., Rm no. and Name	Existing Architectural Barrier and Proposed Solution	Codes / Mitigation Info	Qty	Unit	Cost	Total
244	<ul style="list-style-type: none"> • <i>As-Built Description:</i> Toilet paper dispenser less than 15" (CA: 19") or more than 48" above floor or not within 7" to 9" from front of water closet (Note: CA pre-2010 is allowed within 12" from front of water closet). • <i>As-Built:</i> 4.0" in front • <i>Proposed Solution:</i> Relocate or provide new toilet paper dispenser. 	PCODE WG02 ADAAG 91 4.16.6 ADA 2010 604.7 CBC 2007 1115B.8.4 CBC 2019 11B-604.7 Mitigated: <input type="radio"/> YES <input checked="" type="radio"/> NO	1	JOB	\$225	\$225

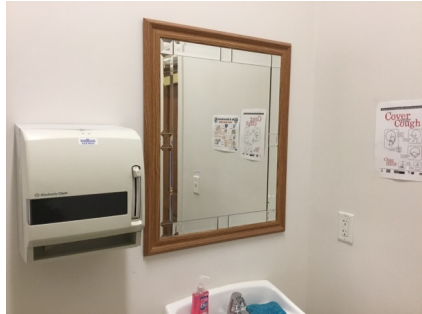
<input type="radio"/> Staff Only Priority 3 Severity 3			
241	<ul style="list-style-type: none"> • <i>As-Built Description:</i> Bottom of mirror located above lavatories or countertops more than 40" above floor. • <i>As-Built:</i> 46.2" high • <i>Proposed Solution:</i> Relocate or provide new accessible mirror. 	PCODE WG03 ADAAG 91 4.19.6 ADA 2010 603.3 CBC 2007 1115B.8.1 CBC 2019 11B-603.3 Mitigated: <input type="radio"/> YES <input checked="" type="radio"/> NO	1	JOB	\$450	\$450

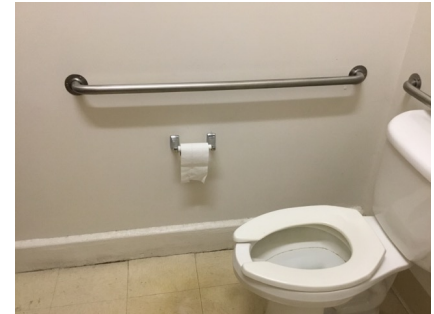
243	<ul style="list-style-type: none"> As-Built Description: Side grab bar less than 42" long, or located more than 12 inches max. from the rear wall, or extending less than 54" from rear wall (CA only: front end min. 24" in front of water closet). As-Built: Extends 49.0" Proposed Solution: Provide or relocate accessible side grab bar. 	<p>PCODE WB07A ADAAG 91 Fig. 29(b) ADA 2010 604.5.1 CBC 2007 1115B.4.1.3.1 CBC 2019 11B-604.5.1</p> <p>Mitigated: <input type="radio"/> YES <input checked="" type="radio"/> NO</p>	1	JOB	\$780	\$780
-----	---	--	---	-----	-------	-------

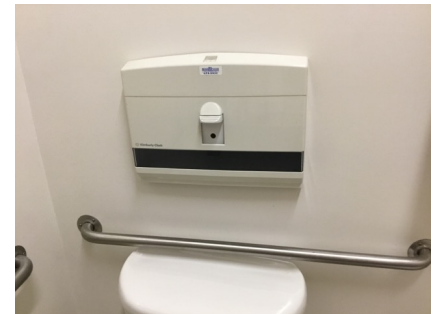
240	<ul style="list-style-type: none"> As-Built Description: Accessories/dispensers in accessible stall located closer than 1-1/2" below or 12" above grab bar impedes its use. As-Built: SCD: 6.5" above grab bar Proposed Solution: Relocate accessories/dispensers within applicable reach range and to be no closer than 1-1/2" below and 12" above grab bars (except if accessories are recessed, flush with wall, and have no sharp edges). 	<p>PCODE WB07I ADAAG 91 4.26.2 ADA 2010 609.3 CBC 2007 1133B.4.2.5 CBC 2019 11B-609.3</p> <p>Mitigated: <input type="radio"/> YES <input checked="" type="radio"/> NO</p>	1	JOB	\$225	\$225
-----	---	--	---	-----	-------	-------

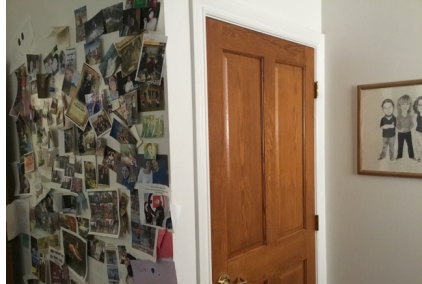
<p>234</p> <ul style="list-style-type: none"> As-Built Description: Entrance to toilet or bathing facility not identified with ADAAG compliant signage. Proposed Solution: Provide ADA compliant sign mounted at 48" min. above to baseline of the lowest Braille cells and 60" max. to baseline of the highest line of raised characters on nearest adjacent wall, on latch side of a single door (located not to cause a Braille reader to stand within the door swing). 	<p>PCODE SA11A ADAAG 91 4.1.3(16)(a) ADA 2010 216.8 CBC 2019 11B-216.8</p> <p>Mitigated: <input type="radio"/> YES <input checked="" type="radio"/> NO</p>	<p>1 JOB \$270 \$270</p>

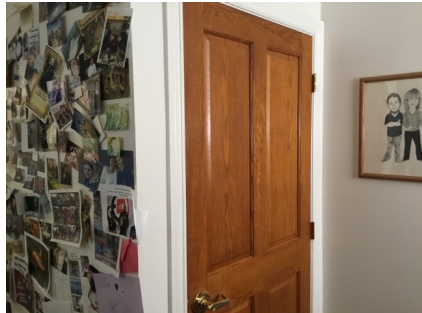
<p>235</p> <ul style="list-style-type: none"> As-Built Description: Required in CA only: identification symbol centered 58" to 60" high on sanitary facility door that contrasts with the door not provided (women: 12" ø circle, men: 12" triangle, unisex: combined symbol). Proposed Solution: Provide properly mounted sanitary facility symbol when altering area. If wheelchair accessible, include International Symbol of Accessibility on sign. 	<p>PCODE SA15 CBC 2007 1115B.6 CBC 2019 11B-703.7.2.6</p> <p>Mitigated: <input type="radio"/> YES <input checked="" type="radio"/> NO</p>	<p>1 JOB \$270 \$270</p>

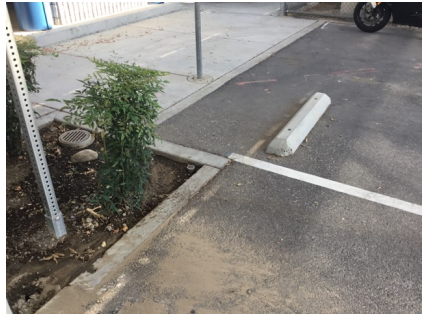
Item no., Rm no. and Name	Existing Architectural Barrier and Proposed Solution	Codes / Mitigation Info	Qty	Unit	Cost	Total
1535	<ul style="list-style-type: none"> As-Built Description: 36" wide band of truncated domes not provided at walkway or crossing adjoining a vehicular way, if surfaces are not separated by a curb, railing, or other element. Proposed Solution: Provide 36" wide, contrasting color, band of truncated domes between pedestrian and vehicular area. 	PCODE EG09 ADAAG 91 4.29.5 CBC 2007 1133B.8.5 CBC 2019 11B-705.1.2.5 Mitigated: <input type="radio"/> YES <input checked="" type="radio"/> NO	50	LF	\$81	\$4,050

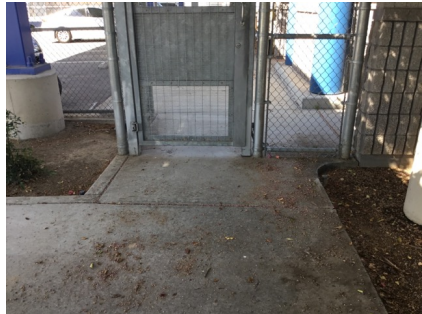
1529	<ul style="list-style-type: none"> As-Built Description: At push side of door on accessible route, bottom 10" does not have a smooth, uninterrupted surface. Proposed Solution: Provide 10" min. "kick plate" covering width of door when altering area. 	PCODE ID06 ADA 2010 404.2.10 CBC 2007 1133B.2.6 CBC 2019 11B-404.2.10 Mitigated: <input type="radio"/> YES <input checked="" type="radio"/> NO	1	JOB	\$300	\$300

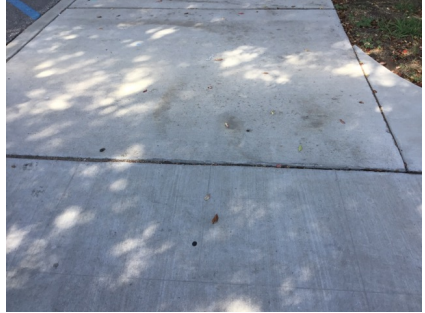
<p>1528</p> <ul style="list-style-type: none"> As-Built Description: Walk: Grating has grid openings greater than 1/2" along the line of traffic flow. As-Built: Gaps 1.0" x 1.0" Proposed Solution: Fill gaps. 	<p>PCODE EF04 ADAAG 91 4.3.6; 4.5.4 ADA 2010 403.2; 302.3 CBC 2007 1133B.7.2 CBC 2019 11B-403.2; 11B-302.3</p> <p>Mitigated: <input type="radio"/> YES <input checked="" type="radio"/> NO</p>	<p>10 LF \$240 \$2,400</p>

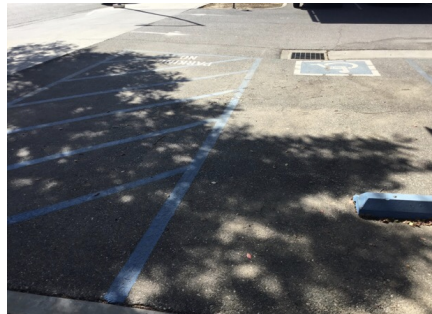
<p>1524</p> <ul style="list-style-type: none"> As-Built Description: Accessible parking space has slope greater than 1/4":12" (2%). As-Built: Up to 5.0% Proposed Solution: Modify slope at accessible parking space. 	<p>PCODE EA05 ADAAG 91 4.6.3 ADA 2010 502.4 CBC 2007 1129B.3.3 CBC 2019 11B-502.4</p> <p>Mitigated: <input type="radio"/> YES <input checked="" type="radio"/> NO</p>	<p>300 SF \$36 \$10,800</p>

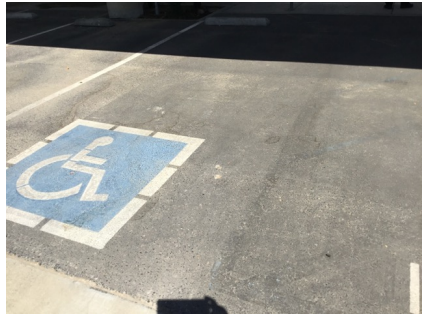
Item no., Rm no. and Name	Existing Architectural Barrier and Proposed Solution	Codes / Mitigation Info	Qty	Unit	Cost	Total
1530	<ul style="list-style-type: none"> As-Built Description: Accessible parking space has slope greater than 1/4":12" (2%). As-Built: 2.5% Proposed Solution: Modify slope at accessible parking space. 	PCODE EA05 ADAAG 91 4.6.3 ADA 2010 502.4 CBC 2007 1129B.3.3 CBC 2019 11B-502.4 Mitigated: <input type="radio"/> YES <input checked="" type="radio"/> NO	60	SF	\$36	\$2,160

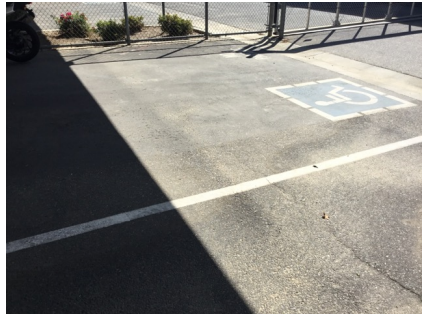
1534	<ul style="list-style-type: none"> As-Built Description: Accessible parking space does not have 5' wide access aisle; 8' wide for van accessible aisle. As-Built: Space and aisle together are 16.0' wide. Proposed Solution: Modify parking aisle(s) to create accessible space by restriping. 	PCODE EA02B ADAAG 91 4.6.3 ADA 2010 502.3 CBC 2007 1129B.3.1 CBC 2019 11B-502.2; 11B-502.3.1 Mitigated: <input type="radio"/> YES <input checked="" type="radio"/> NO	1	JOB	\$600	\$600

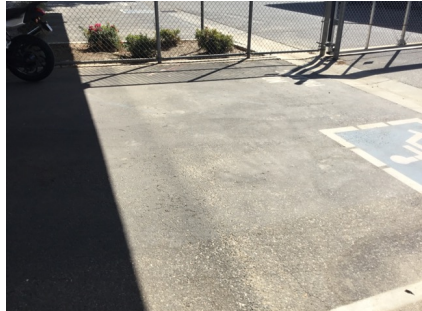
Item no., Rm no. and Name	Existing Architectural Barrier and Proposed Solution	Codes / Mitigation Info	Qty	Unit	Cost	Total
1531	<ul style="list-style-type: none"> As-Built Description: An accessible parking space shall be outlined or painted blue (required in CA only). Proposed Solution: Identify accessible parking space using blue markings. 	PCODE EA04K CBC 2019 11B-502.6 Mitigated: <input type="radio"/> YES <input checked="" type="radio"/> NO	1	JOB	\$360	\$360

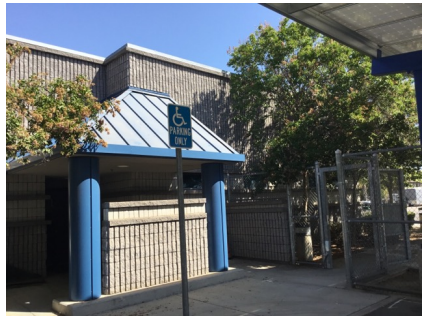
<input checked="" type="checkbox"/> Staff Only			
			Priority <input checked="" type="radio"/> 1			
			Severity <input checked="" type="radio"/> 3			
1533	<ul style="list-style-type: none"> As-Built Description: No van parking provided (one in every 6 or fraction of 6 accessible spaces, but not less than one). Proposed Solution: Provide van parking space(s) by restriping; provide van sign. 	PCODE EA07 ADAAG 91 4.1.2(5)(b) ADA 2010 208.2; 502.1 CBC 2007 1129B.3.2 CBC 2019 11B-208.2.4 Mitigated: <input type="radio"/> YES <input checked="" type="radio"/> NO	1	JOB	\$1,050	\$1,050

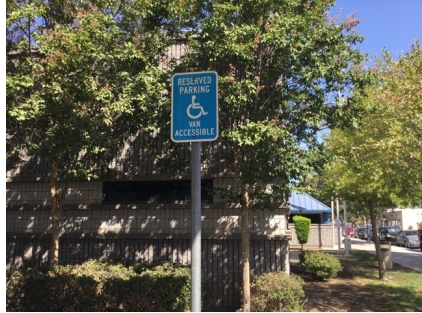
1526	<ul style="list-style-type: none"> <i>As-Built Description:</i> No "Tow Away" sign at parking lot entrance (required in CA only). <i>Proposed Solution:</i> Provide "Tow Away" sign at parking lot entrance when altering area. 	<p>PCODE EA04C</p> <p>CBC 2007 1129B.4</p> <p>CBC 2019 11B-502.8.2</p> <p>Mitigated:</p> <p><input type="radio"/> YES</p> <p><input checked="" type="radio"/> NO</p>	1	JOB	\$975	\$975

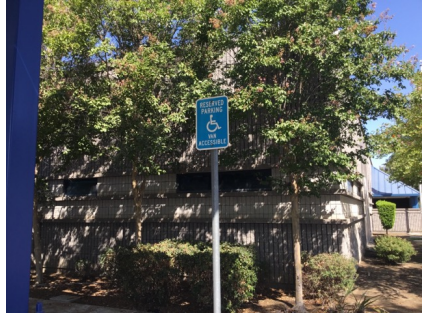
1525	<ul style="list-style-type: none"> <i>As-Built Description:</i> CA only: Additional Sign or additional language below the symbol of accessibility stating "Minimum Fine \$250" not provided. <i>Proposed Solution:</i> Provide compliant parking signage that includes fine information. 	<p>PCODE EA04G</p> <p>CBC 2007 1129B.4</p> <p>CBC 2019 11B-502.6.2</p> <p>Mitigated:</p> <p><input type="radio"/> YES</p> <p><input checked="" type="radio"/> NO</p>	1	JOB	\$300	\$300

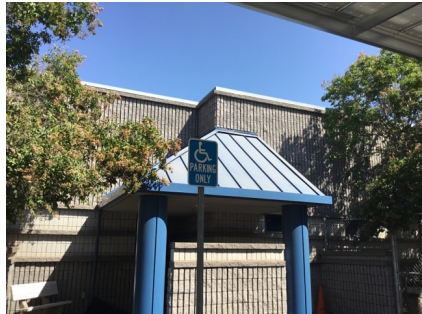
Item no., Rm no. and Name	Existing Architectural Barrier and Proposed Solution	Codes / Mitigation Info	Qty	Unit	Cost	Total
1532	<ul style="list-style-type: none"> As-Built Description: CA only: Additional Sign or additional language below the symbol of accessibility stating "Minimum Fine \$250" not provided. Proposed Solution: Provide compliant parking signage that includes fine information. 	PCODE EA04G CBC 2007 1129B.4 CBC 2019 11B-502.6.2 Mitigated: <input type="radio"/> YES <input checked="" type="radio"/> NO	1	JOB	\$300	\$300

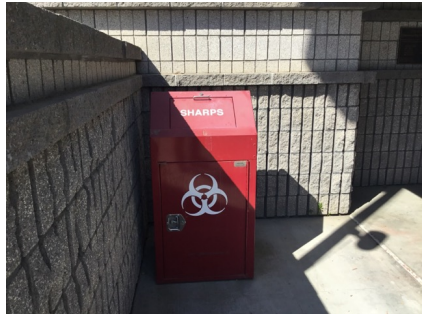
1523	<ul style="list-style-type: none"> As-Built Description: Reach height to control or access point, where side approach is available, exceeds 48" or is less than 15" in height, or exceeds 10" in depth. As-Built: 49.5" high Proposed Solution: Modify equipment or mounting. Notes: 	PCODE IE02 ADAAG 91 4.2.6 ADA 2010 308.3.1 CBC 2007 1118B.6 CBC 2019 11B-308.3 Mitigated: <input type="radio"/> YES <input checked="" type="radio"/> NO	1	JOB	\$300	\$300

This element complied with Safe Harbor and the CBC if altered or constructed before March 15, 2012.

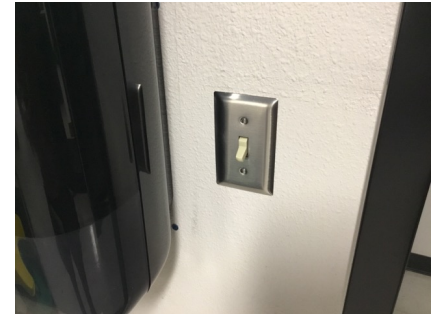
1477	<ul style="list-style-type: none"> • <i>As-Built Description:</i> Electric switch or control mounted less than 15" measured to the bottom of the outlet box or greater than 48 inches measured to the top of the outlet box. • <i>As-Built:</i> 48.25" high 50.0" to top of box • <i>Proposed Solution:</i> Relocate light switches or control to between 15" and 48" height. • <i>Notes:</i> 	<p>PCODE IC01 ADAAG 91 4.2.5 & 6 ADA 2010 308.2.1 & 308.2.2 CBC 2007 1117B.6.3 CBC 2019 11B-308.2.1 & 11B-308.2.2</p> <p>Mitigated: <input type="radio"/> YES <input checked="" type="radio"/> NO</p>	30	JOB	\$900	\$27,000
------	---	--	----	-----	-------	----------

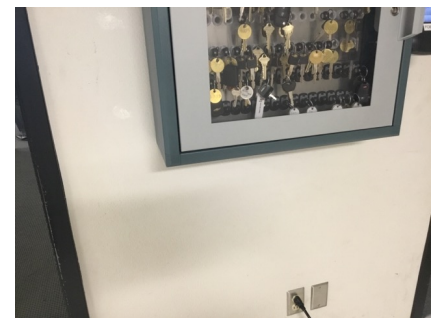
1468	<ul style="list-style-type: none"> • <i>As-Built Description:</i> Protruding objects more than 4" from wall, when bottom of object more than 27" or less than 80" above finished floor. • <i>As-Built:</i> Key cabinet: 8.0" at 45.0" high • <i>Proposed Solution:</i> Remove/relocate protruding object. Patch existing surface. • <i>Notes:</i> 	<p>PCODE EG04 ADAAG 91 4.4.1 ADA 2010 307.2 CBC 2007 1133B.8.6.1 CBC 2019 11B-307.2</p> <p>Mitigated: <input type="radio"/> YES <input checked="" type="radio"/> NO</p>	1	JOB	\$300	\$300
------	--	--	---	-----	-------	-------

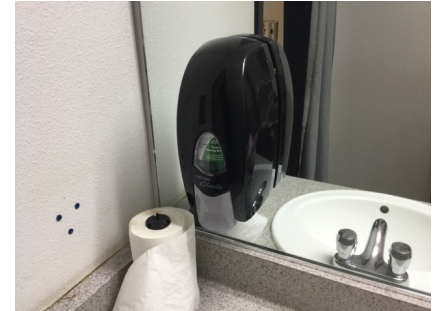
1443	<ul style="list-style-type: none"> As-Built Description: Dispensers in sanitary facilities, such as for towels, soap, sanitary napkins, seat covers, etc., and waste receptacles more than 48" (CA only: 40") from floor to highest operating slot or control. As-Built: Shower room SD: 42.0" high Proposed Solution: Relocate existing restroom accessories. Notes: 	PCODE WG01A ADAAG 91 4.23.7 ADA 2010 308.2.1 CBC 2007 1115B.8.3 CBC 2019 11B-603.5	1	JOB	\$300	\$300
------	--	--	---	-----	-------	-------

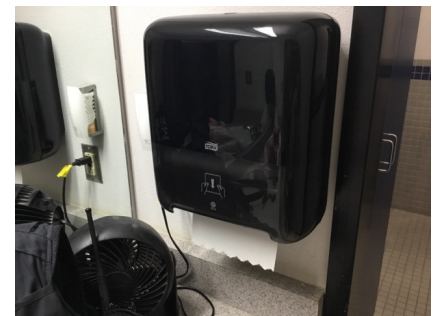
1444	<ul style="list-style-type: none"> As-Built Description: Dispensers in sanitary facilities, such as for towels, soap, sanitary napkins, seat covers, etc., and waste receptacles more than 48" (CA only: 40") from floor to highest operating slot or control. As-Built: Shower room PTD: 45.0" high Proposed Solution: Relocate existing restroom accessories. Notes: 	PCODE WG01A ADAAG 91 4.23.7 ADA 2010 308.2.1 CBC 2007 1115B.8.3 CBC 2019 11B-603.5	1	JOB	\$300	\$300
------	---	--	---	-----	-------	-------

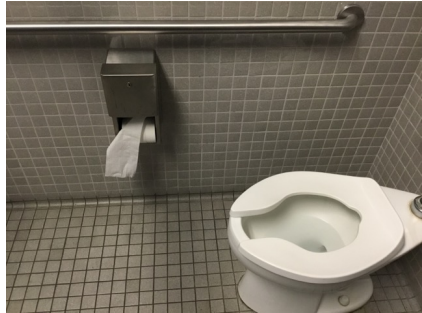
Item no., Rm no. and Name	Existing Architectural Barrier and Proposed Solution	Codes / Mitigation Info	Qty	Unit	Cost	Total
1435	<ul style="list-style-type: none"> As-Built Description: Toilet paper dispenser less than 15" (CA: 19") or more than 48" above floor or not within 7" to 9" from front of water closet (Note: CA pre-2010 is allowed within 12" from front of water closet). As-Built: 10.0" in front. Proposed Solution: Relocate or provide new toilet paper dispenser. 	PCODE WG02 ADAAG 91 4.16.6 ADA 2010 604.7 CBC 2007 1115B.8.4 CBC 2019 11B-604.7 Mitigated: <input type="radio"/> YES <input checked="" type="radio"/> NO	1	JOB	\$225	\$225

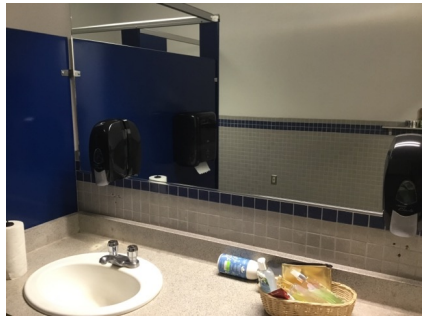
<input checked="" type="checkbox"/> Staff Only						
Priority 3						
Severity 4						
1429	<ul style="list-style-type: none"> As-Built Description: Bottom of mirror located above lavatories or countertops more than 40" above floor. As-Built: 45.5" high Proposed Solution: Relocate or provide new accessible mirror. 	PCODE WG03 ADAAG 91 4.19.6 ADA 2010 603.3 CBC 2007 1115B.8.1 CBC 2019 11B-603.3 Mitigated: <input type="radio"/> YES <input checked="" type="radio"/> NO	1	JOB	\$450	\$450

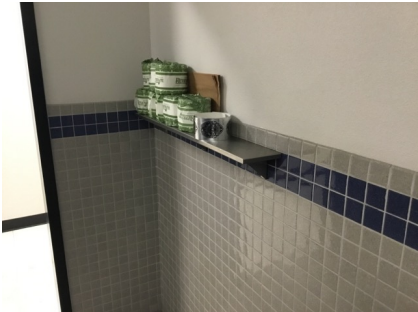
Item no., Rm no. and Name	Existing Architectural Barrier and Proposed Solution	Codes / Mitigation Info	Qty	Unit	Cost	Total
1436	<ul style="list-style-type: none"> As-Built Description: Protruding objects more than 4" from wall, when bottom of object more than 27" or less than 80" above finished floor. As-Built: Shelf: 5.0" at 47.0" high Proposed Solution: Remove/relocate protruding object. Patch existing surface. 	PCODE EG04 ADAAG 91 4.4.1 ADA 2010 307.2 CBC 2007 1133B.8.6.1 CBC 2019 11B-307.2 Mitigated: <input type="radio"/> YES <input checked="" type="radio"/> NO	1	JOB	\$300	\$300

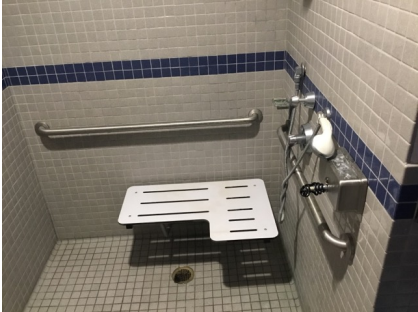
1440	<ul style="list-style-type: none"> As-Built Description: Shower not accessible; multiple compliance violations. Proposed Solution: Provide accessible shower. Notes: 	PCODE WF01 ADAAG 91 4.21 ADA 2010 608.1 CBC 2019 11B-608.1 Mitigated: <input type="radio"/> YES <input checked="" type="radio"/> NO	1	JOB	\$12,000	\$12,000

Incorrect configuration.

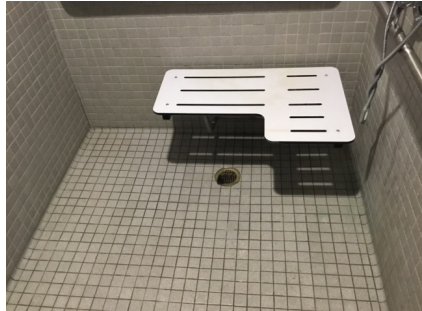
Item no., Rm no. and Name	Existing Architectural Barrier and Proposed Solution	Codes / Mitigation Info	Qty	Unit	Cost	Total
1438	<ul style="list-style-type: none"> <i>As-Built Description:</i> Floor surface sloped greater than 2.0% (1:48) due to drain. <i>As-Built:</i> 4.0% <i>Proposed Solution:</i> Remodel floor surface to compliance. 	PCODE WF06A ADA 2010 608.9 CBC 2019 11B-608.9 Mitigated: <input type="radio"/> YES <input checked="" type="radio"/> NO	1	JOB	\$1,500	\$1,500

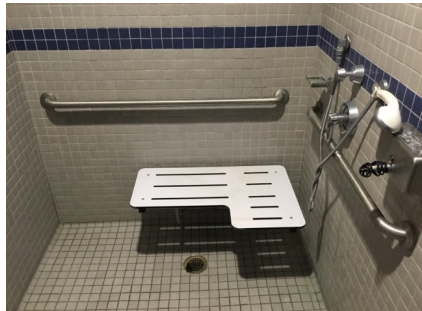
<input checked="" type="checkbox"/> Staff Only			
			Priority 3			
			Severity 3			
1439	<ul style="list-style-type: none"> <i>As-Built Description:</i> ADAAG: L-shaped shower seat extending the full depth of the stall does not have a seat located 1-1/2" max. from the wall and/or have the front of the seat (nearest to the opening) extend 16" max. from the wall. The back of the seat (against the back wall) shall extend 23" max. from the side wall and shall be 15" max. deep. <i>As-Built:</i> 4.5" from wall and below grab bar. <i>Proposed Solution:</i> Provide new, or relocate, folding wall-mounted shower seat. 	PCODE WF07AREF ADAAG 91 4.21.3 ADA 2010 610.3.2 CBC 2007 1115B.4.4.8.1 CBC 2019 11B-610.3.2 Mitigated: <input type="radio"/> YES <input checked="" type="radio"/> NO	1	JOB	\$1,650	\$1,650

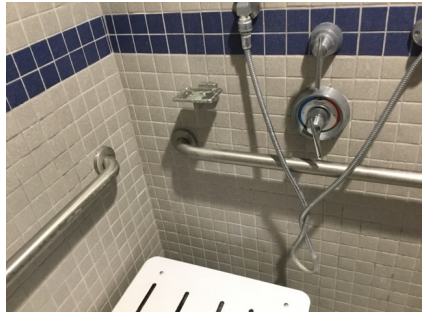
Item no., Rm no. and Name	Existing Architectural Barrier and Proposed Solution	Codes / Mitigation Info	Qty	Unit	Cost	Total
1441	<ul style="list-style-type: none"> As-Built Description: Grab bar not mounted between 33" to 36" above the shower floor. Proposed Solution: Remount grab bar in shower. Notes: 	PCODE WF08 ADAAG 91 Fig. 37(a) ADA 2010 608.3 CBC 2007 1115B.4.4.8.2 CBC 2019 11B-608.3 Mitigated: <input type="radio"/> YES <input checked="" type="radio"/> NO	1	JOB	\$1,500	\$1,500

Grab bar 6.2" from wall.

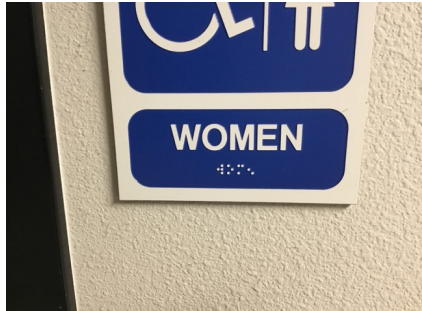
1466	<ul style="list-style-type: none"> As-Built Description: Entrance to toilet or bathing facility not identified with ADAAG compliant signage. As-Built: Not domed Braille. Proposed Solution: Provide ADA compliant sign mounted at 48" min. above to baseline of the lowest Braille cells and 60" max. to baseline of the highest line of raised characters on nearest adjacent wall, on latch side of a single door (located not to cause a Braille reader to stand within the door swing). 	PCODE SA11A ADAAG 91 4.1.3(16)(a) ADA 2010 216.8 CBC 2019 11B-216.8 Mitigated: <input type="radio"/> YES <input checked="" type="radio"/> NO	1	JOB	\$270	\$270

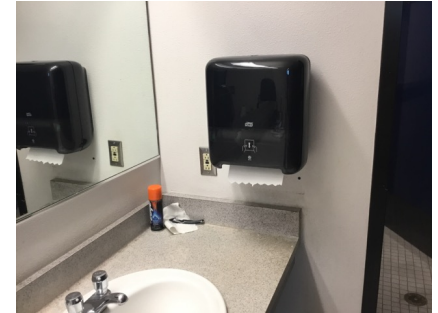
1449	<ul style="list-style-type: none"> As-Built Description: Dispensers in sanitary facilities, such as for towels, soap, sanitary napkins, seat covers, etc., and waste receptacles more than 48" (CA only: 40") from floor to highest operating slot or control. As-Built: PTD: 45.0" high Proposed Solution: Relocate existing restroom accessories. Notes: 	PCODE WG01A ADAAG 91 4.23.7 ADA 2010 308.2.1 CBC 2007 1115B.8.3 CBC 2019 11B-603.5	1	JOB	\$300	\$300
------	---	--	---	-----	-------	-------

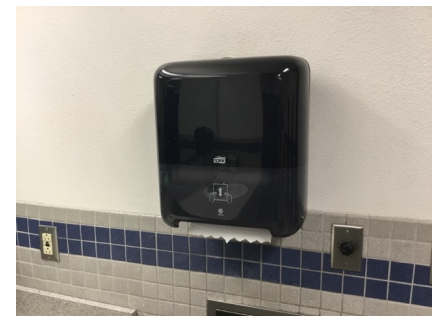
1457	<ul style="list-style-type: none"> As-Built Description: Dispensers in sanitary facilities, such as for towels, soap, sanitary napkins, seat covers, etc., and waste receptacles more than 48" (CA only: 40") from floor to highest operating slot or control. As-Built: PTD: 51.0" high Proposed Solution: Relocate existing restroom accessories. 	PCODE WG01A ADAAG 91 4.23.7 ADA 2010 308.2.1 CBC 2007 1115B.8.3 CBC 2019 11B-603.5	1	JOB	\$300	\$300
------	---	--	---	-----	-------	-------

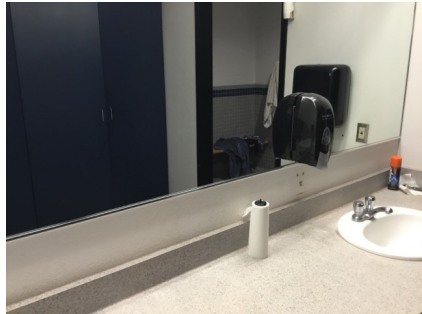
Item no., Rm no. and Name	Existing Architectural Barrier and Proposed Solution	Codes / Mitigation Info	Qty	Unit	Cost	Total
1448	<ul style="list-style-type: none"> As-Built Description: Bottom of mirror located above lavatories or countertops more than 40" above floor. As-Built: 45.0" high Proposed Solution: Relocate or provide new accessible mirror. Notes: 	PCODE WG03 ADAAG 91 4.19.6 ADA 2010 603.3 CBC 2007 1115B.8.1 CBC 2019 11B-603.3 Mitigated: <input type="radio"/> YES <input checked="" type="radio"/> NO	1	JOB	\$450	\$450

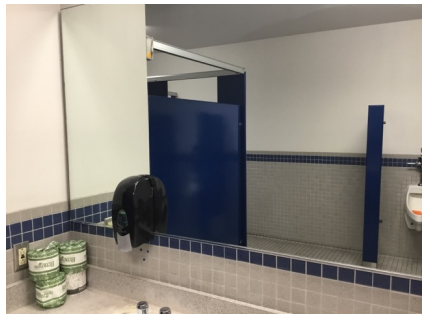
1459	<ul style="list-style-type: none"> As-Built Description: Bottom of mirror located above lavatories or countertops more than 40" above floor. As-Built: 45.0" high Proposed Solution: Relocate or provide new accessible mirror. 	PCODE WG03 ADAAG 91 4.19.6 ADA 2010 603.3 CBC 2007 1115B.8.1 CBC 2019 11B-603.3 Mitigated: <input type="radio"/> YES <input checked="" type="radio"/> NO	1	JOB	\$450	\$450

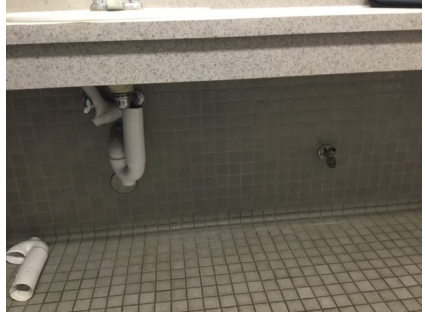
Item no., Rm no. and Name	Existing Architectural Barrier and Proposed Solution	Codes / Mitigation Info	Qty	Unit	Cost	Total
1461	<ul style="list-style-type: none"> <i>As-Built Description:</i> Hot or sharp-surfaced water/drain pipe not insulated or covered. <i>Proposed Solution:</i> Insulate or cover water/drain pipe. 	PCODE WD05 ADAAG 91 4.19.4 ADA 2010 606.5 CBC 2007 1115B.4.3.4 CBC 2019 11B-606.5 Mitigated: <input type="radio"/> YES <input checked="" type="radio"/> NO	1	JOB	\$360	\$360

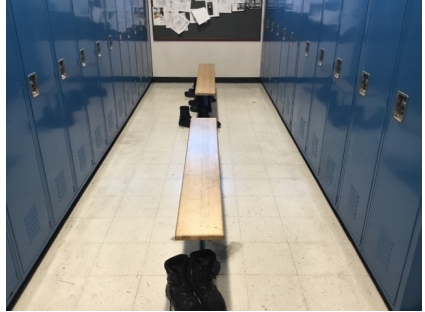
1446	<ul style="list-style-type: none"> <i>As-Built Description:</i> No section of bench provided adjacent to designated accessible locker, measuring minimum 20-24" deep, 48" wide, and 17-19" high, and fixed to a wall along the longer dimension. <i>Proposed Solution:</i> Provide a new bench, fixed to a wall along the longer dimension, close to the accessible locker. 	PCODE GG03 ADAAG 91 4.35.4 ADA 2010 803.4 CBC 2007 1117B.8 CBC 2019 11B-803.4 Mitigated: <input type="radio"/> YES <input checked="" type="radio"/> NO	1	JOB	\$2,250	\$2,250

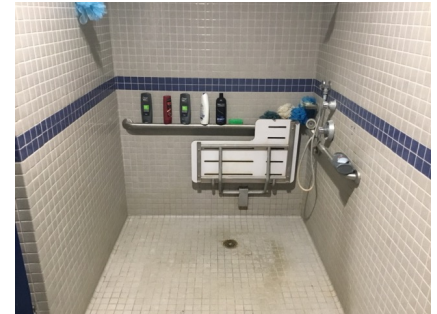
- 1455 • *As-Built Description:*
Shower not accessible; multiple compliance violations.
- *Proposed Solution:*
Provide accessible shower.
- *Notes:*

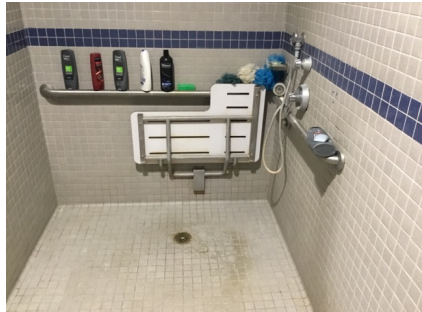
Item no., Rm no. and Name	Existing Architectural Barrier and Proposed Solution	Codes / Mitigation Info	Qty	Unit	Cost	Total
1454	<ul style="list-style-type: none"> As-Built Description: ADAAG: L-shaped shower seat extending the full depth of the stall does not have a seat located 1-1/2" max. from the wall and/or have the front of the seat (nearest to the opening) extend 16" max. from the wall. The back of the seat (against the back wall) shall extend 23" max. from the side wall and shall be 15" max. deep. As-Built: 4.5" from wall. Below grab bar. Proposed Solution: Provide new, or relocate, folding wall-mounted shower seat. 	PCODE WF07AREF ADAAG 91 4.21.3 ADA 2010 610.3.2 CBC 2007 1115B.4.4.8.1 CBC 2019 11B-610.3.2 Mitigated: <input type="radio"/> YES <input checked="" type="radio"/> NO	1	JOB	\$1,650	\$1,650

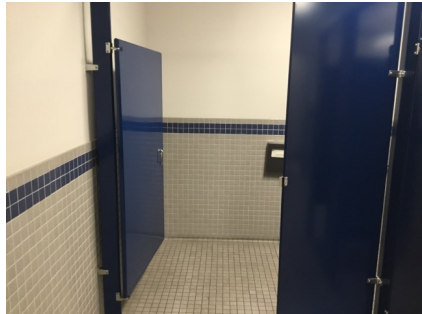
1462	<ul style="list-style-type: none"> As-Built Description: Stall door to accessible compartment not self closing. Proposed Solution: Adjust closer. 	PCODE WB05B ADAAG 91 4.22.4 ADA 2010 604.8.1.2 CBC 2007 1115B.3.1.4.4 CBC 2019 11B-604.8.1.2 Mitigated: <input type="radio"/> YES <input checked="" type="radio"/> NO	1	JOB	\$75	\$75

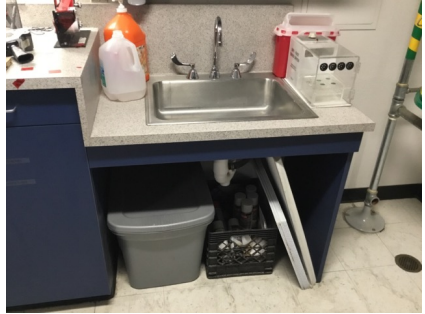
Item no., Rm no. and Name	Existing Architectural Barrier and Proposed Solution	Codes / Mitigation Info	Qty	Unit	Cost	Total
Lavatory						
1475	<ul style="list-style-type: none"> As-Built Description: Lavatory: Fixture rim or counter height more than 34" above floor. As-Built: 34.5" high Proposed Solution: Remount compliant fixture at accessible height. 	PCODE WD02A ADAAG 91 4.19.2 ADA 2010 606.3 CBC 2007 1115B.4.3 CBC 2019 11B-606.3	1	JOB	\$2,700	\$2,700
		Mitigated: <input type="radio"/> YES <input checked="" type="radio"/> NO

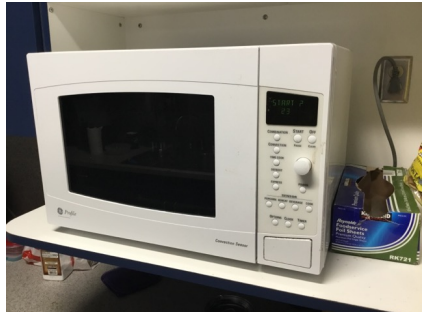
Item no., Rm no. and Name	Existing Architectural Barrier and Proposed Solution	Codes / Mitigation Info	Qty	Unit	Cost	Total
1480	<ul style="list-style-type: none"> As-Built Description: Reach height to control or access point, where side approach is available, exceeds 48" or is less than 15" in height, or exceeds 10" in depth. As-Built: 57.0" high Proposed Solution: Modify equipment or mounting. 	PCODE IE02 ADAAG 91 4.2.6 ADA 2010 308.3.1 CBC 2007 1118B.6 CBC 2019 11B-308.3 Mitigated: <input type="radio"/> YES <input checked="" type="radio"/> NO	1	JOB	\$300	\$300

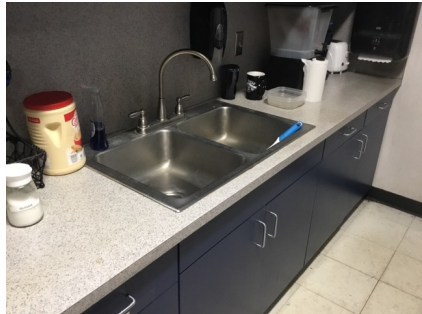
1478	<ul style="list-style-type: none"> As-Built Description: Sink rim higher than 34" above floor. As-Built: 34.2" high Proposed Solution: Remodel sink cabinet to lower sink. 	PCODE IN06 ADAAG 91 4.24.2 ADA 2010 606.3 CBC 2007 1115B.4.7.1 CBC 2019 11B-606.3 Mitigated: <input type="radio"/> YES <input checked="" type="radio"/> NO	1	JOB	\$5,250	\$5,250

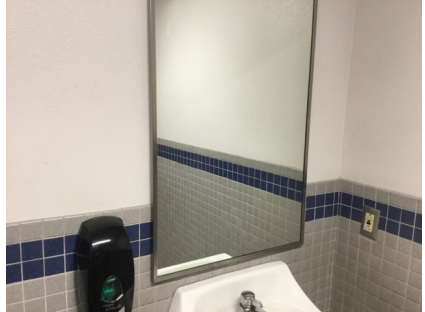
Item no., Rm no. and Name	Existing Architectural Barrier and Proposed Solution	Codes / Mitigation Info	Qty	Unit	Cost	Total
1488	<ul style="list-style-type: none"> As-Built Description: Bottom of mirror located above lavatories or countertops more than 40" above floor. As-Built: 40.5" high Proposed Solution: Relocate or provide new accessible mirror. 	PCODE WG03 ADAAG 91 4.19.6 ADA 2010 603.3 CBC 2007 1115B.8.1 CBC 2019 11B-603.3 Mitigated: <input type="radio"/> YES <input checked="" type="radio"/> NO	1	JOB	\$450	\$450

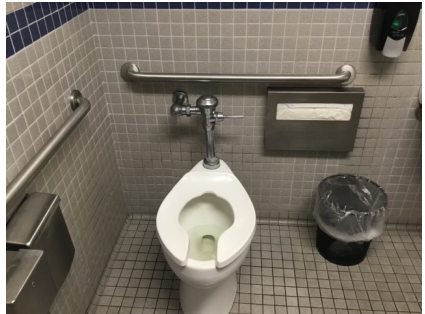
Grab Bars

1491	<ul style="list-style-type: none"> As-Built Description: The rear wall grab is less than 36" min. or does not extend from the centerline of the water closet 12" min. on one side and 24" min. on the other side. As-Built: Extends 21.5" on wide side Proposed Solution: Provide or relocate accessible rear grab bar. Notes: 	PCODE WB07B ADAAG 91 4.17.6 ADA 2010 604.5.2 CBC 2007 1115B.4.1.3.2 CBC 2019 11B-604.5.2 Mitigated: <input type="radio"/> YES <input checked="" type="radio"/> NO	1	JOB	\$1,020	\$1,020

This element complies with Safe Harbor if altered or constructed before March 15, 2012. .

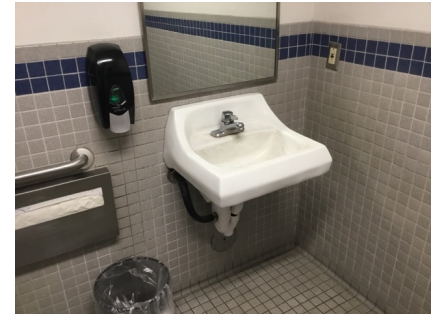
Lavatory

1489	<ul style="list-style-type: none"> As-Built Description: Wheelchair clearance under lavatory apron or lavatory counter front edge less than 29" high. As-Built: 28.75" high Proposed Solution: Remount compliant fixture to accessible height. Notes: 	PCODE WD03A ADAAG 91 4.19.2 ADA 2010 606.3 CBC 2007 1115B.4.3.3 CBC 2019 11B-306.3.1	1	JOB	\$3,000	\$3,000
------	--	--	---	-----	---------	---------

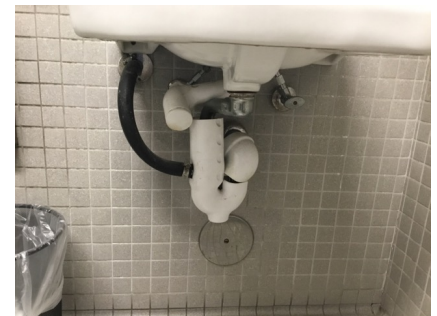
1490	<ul style="list-style-type: none"> As-Built Description: Hot or sharp-surfaced water/drain pipe not insulated or covered. Proposed Solution: Insulate or cover water/drain pipe. 	PCODE WD05 ADAAG 91 4.19.4 ADA 2010 606.5 CBC 2007 1115B.4.3.4 CBC 2019 11B-606.5	1	JOB	\$360	\$360
------	--	---	---	-----	-------	-------

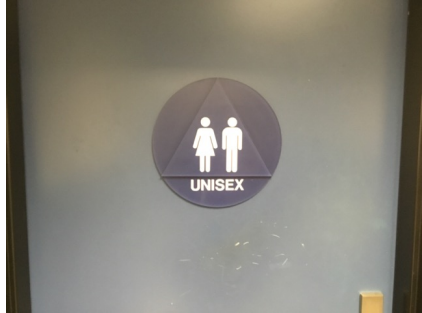
Signage

1485	<ul style="list-style-type: none"> <i>As-Built Description:</i> Required in CA only: identification symbol centered 58" to 60" high on sanitary facility door that contrasts with the door not provided (women: 12" ø circle, men: 12" triangle, unisex: combined symbol). <i>As-Built:</i> Not beveled. No contrast. <i>Proposed Solution:</i> Provide properly mounted sanitary facility symbol when altering area. If wheelchair accessible, include International Symbol of Accessibility on sign. 	<p>PCODE SA15</p> <p>CBC 2007 1115B.6</p> <p>CBC 2019 11B-703.7.2.6</p> <p>Mitigated:</p> <p><input type="radio"/> YES</p> <p><input checked="" type="radio"/> NO</p>	1	JOB	\$270	\$270
------	--	--	---	-----	-------	-------

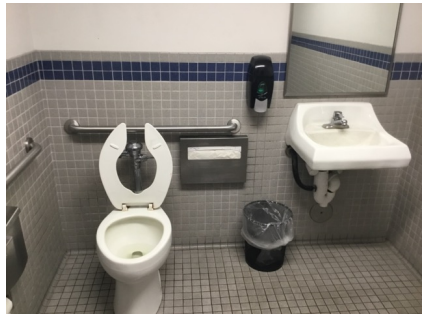
Toilet Stall

1487	<ul style="list-style-type: none"> <i>As-Built Description:</i> 60" min. clearance around a water closet measured perpendicular from the side wall not provided (Fixtures are not allowed to overlap this clearance). <i>As-Built:</i> 53.5" to lavatory <i>Proposed Solution:</i> Relocate adjacent fixture and remodel restroom as needed. <i>Notes:</i> 	<p>PCODE WB01A</p> <p>ADA 2010 604.3.1; 604.3.2</p> <p>CBC 2007 1115B.7.1.3</p> <p>CBC 2019 11B-604.3.1; 11B-604.3.2</p> <p>Mitigated:</p> <p><input type="radio"/> YES</p> <p><input checked="" type="radio"/> NO</p>	1	JOB	\$6,000	\$6,000
------	---	---	---	-----	---------	---------

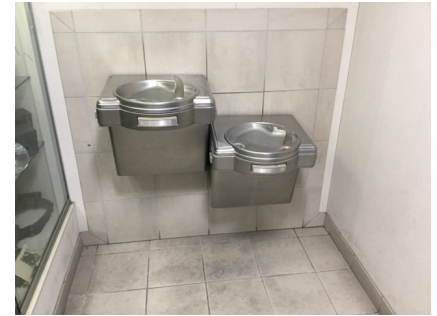
- 1498
- *As-Built Description:*
Wall- and post-mounted cantilevered units: Knee space not provided at drinking fountain (27" high, 8" deep, 30" wide from front of drinking fountain). Unit in good condition.
 - *As-Built:* **25.75" knee high**
 - *Proposed Solution:*
Remount fountain at accessible height.

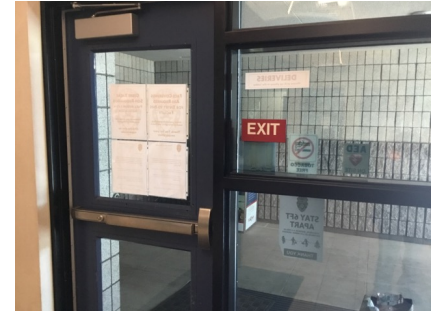
1497	<ul style="list-style-type: none"> <i>As-Built Description:</i> Sign not located on latch side of door and/or not located at 48" min. above to baseline of the lowest Braille cells and 60" max. to baseline of the highest line of raised characters. <i>As-Built:</i> Sign reader not within 3.0" of sign. <i>Proposed Solution:</i> Install sign on shim. <i>Notes:</i> 	PCODE SA07 ADAAG 91 4.30.6 ADA 2010 703.4.1 CBC 2007 1117B.5.7 CBC 2019 11B-703.4.1	1	JOB	\$150	\$150
------	---	---	---	-----	-------	-------

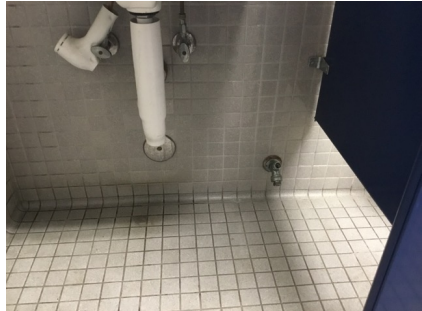
Item no., Rm no. and Name	Existing Architectural Barrier and Proposed Solution	Codes / Mitigation Info	Qty	Unit	Cost	Total
1505	<ul style="list-style-type: none"> <i>As-Built Description:</i> Hot or sharp-surfaced water/drain pipe not insulated or covered. <i>Proposed Solution:</i> Insulate or cover water/drain pipe. 	PCODE WD05 ADAAG 91 4.19.4 ADA 2010 606.5 CBC 2007 1115B.4.3.4 CBC 2019 11B-606.5 Mitigated: <input type="radio"/> YES <input checked="" type="radio"/> NO	1	JOB	\$360	\$360

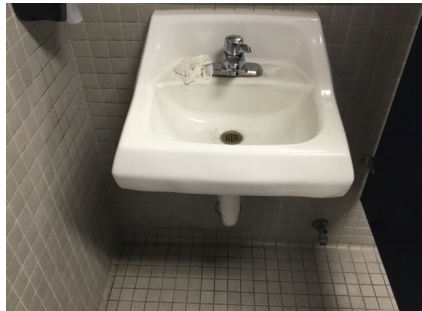
<input type="radio"/> Staff Only			
			Priority <input checked="" type="radio"/> 3			
			Severity <input checked="" type="radio"/> 3			
1507	<ul style="list-style-type: none"> <i>As-Built Description:</i> Lavatory: Self-closing faucet at accessible lavatory does not remain open for at least 10 seconds. <i>Proposed Solution:</i> Adjust self-closing faucet at accessible lavatory. 	PCODE WD07 ADAAG 91 4.19.5 ADA 2010 606.4 CBC 2007 1115B.4.3 CBC 2019 11B-606.4 Mitigated: <input type="radio"/> YES <input checked="" type="radio"/> NO	1	JOB	\$150	\$150

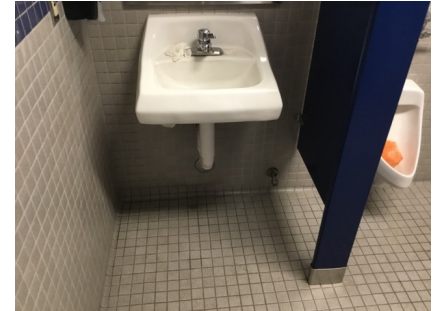
1506	<ul style="list-style-type: none"> As-Built Description: Lavatory/sink not accessible due to location within an inaccessible alcove of less than 36" wide. Proposed Solution: Remodel partitions to provide necessary maneuvering space within the alcove. Notes: 	PCODE WD11 ADA 2010 305.7.1 CBC 2019 11B-305.7.1 Mitigated: <input type="radio"/> YES <input checked="" type="radio"/> NO	1	JOB	\$1,500	\$1,500
------	---	---	---	-----	---------	---------

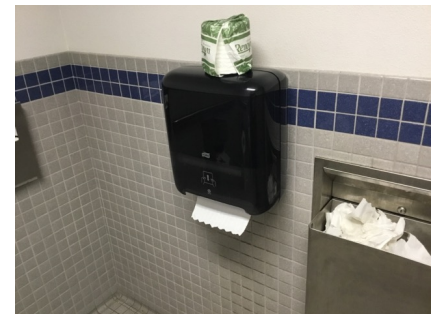
Protrusion Limits

1500	<ul style="list-style-type: none"> As-Built Description: Protruding objects more than 4" from wall, when bottom of object more than 27" or less than 80" above finished floor. As-Built: PTD: 8.0" at 35.0" high Proposed Solution: Remove/relocate protruding object. Patch existing surface. 	PCODE EG04 ADAAG 91 4.4.1 ADA 2010 307.2 CBC 2007 1133B.8.6.1 CBC 2019 11B-307.2 Mitigated: <input type="radio"/> YES <input checked="" type="radio"/> NO	1	JOB	\$300	\$300
------	--	---	---	-----	-------	-------

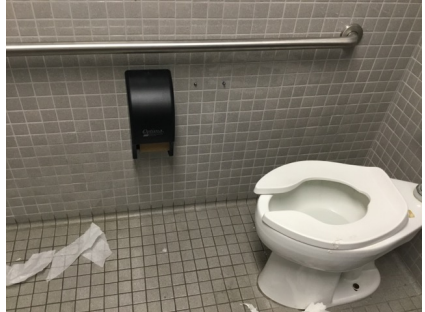
Accessories

<p>1518</p> <ul style="list-style-type: none"> • <i>As-Built Description:</i> Toilet paper dispenser less than 15" (CA: 19") or more than 48" above floor or not within 7" to 9" from front of water closet (Note: CA pre-2010 is allowed within 12" from front of water closet). • <i>As-Built:</i> 12.0" in front. • <i>Proposed Solution:</i> Relocate or provide new toilet paper dispenser. 	<p>PCODE WG02 ADAAG 91 4.16.6 ADA 2010 604.7 CBC 2007 1115B.8.4 CBC 2019 11B-604.7</p>	<p>1 JOB \$225 \$225</p>
--	---	---------------------------------

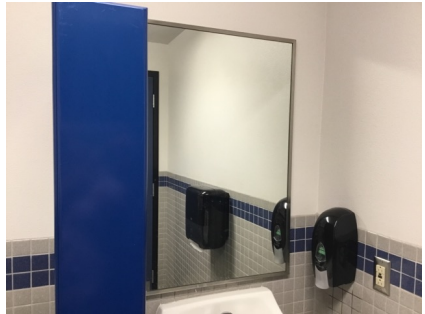
<p>1517</p> <ul style="list-style-type: none"> • <i>As-Built Description:</i> Bottom of mirror located above lavatories or countertops more than 40" above floor. • <i>As-Built:</i> 40.7" high • <i>Proposed Solution:</i> Relocate or provide new accessible mirror. 	<p>PCODE WG03 ADAAG 91 4.19.6 ADA 2010 603.3 CBC 2007 1115B.8.1 CBC 2019 11B-603.3</p>	<p>1 JOB \$450 \$450</p>
--	---	---------------------------------

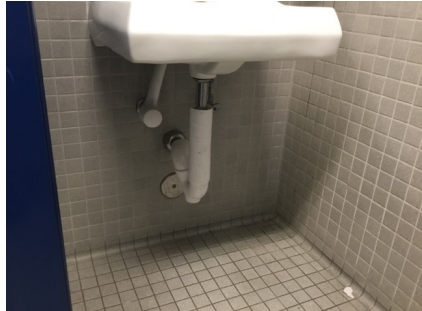
Item no., Rm no. and Name	Existing Architectural Barrier and Proposed Solution	Codes / Mitigation Info	Qty	Unit	Cost	Total
1516	<ul style="list-style-type: none"> • <i>As-Built Description:</i> Hot or sharp-surfaced water/drain pipe not insulated or covered. • <i>Proposed Solution:</i> Insulate or cover water/drain pipe. 	PCODE WD05 ADAAG 91 4.19.4 ADA 2010 606.5 CBC 2007 1115B.4.3.4 CBC 2019 11B-606.5 Mitigated: <input type="radio"/> YES <input checked="" type="radio"/> NO	1	JOB	\$360	\$360

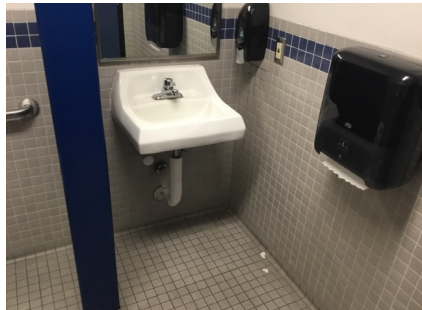
<input type="radio"/> Staff Only						
Priority <input checked="" type="radio"/> 3						
Severity <input checked="" type="radio"/> 3						
1513	<ul style="list-style-type: none"> • <i>As-Built Description:</i> Lavatory/sink not accessible due to location within an inaccessible alcove of less than 36" wide. • <i>Proposed Solution:</i> Remodel partitions to provide necessary maneuvering space within the alcove. • <i>Notes:</i> 	PCODE WD11 ADA 2010 305.7.1 CBC 2019 11B-305.7.1 Mitigated: <input type="radio"/> YES <input checked="" type="radio"/> NO	1	JOB	\$1,500	\$1,500

<input type="radio"/> Staff Only						
Priority <input checked="" type="radio"/> 3						
Severity <input checked="" type="radio"/> 2						
<p>34.0" wide x 24.5" deep alcove. 25.0" wide including paper towel dispenser. Remove partition.</p>

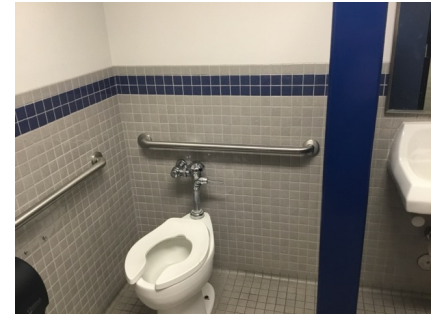
1510	<ul style="list-style-type: none"> As-Built Description: 60" min. clearance around a water closet measured perpendicular from the side wall not provided (Fixtures are not allowed to overlap this clearance). As-Built: 43.0" to partition. Proposed Solution: Remove adjacent fixture and provide new enclosure at accessible water closet. 	<p>PCODE WB01A ADA 2010 604.3.1; 604.3.2 CBC 2007 1115B.7.1.3 CBC 2019 11B-604.3.1; 11B-604.3.2</p> <p>Mitigated: <input type="radio"/> YES <input checked="" type="radio"/> NO</p>	1	JOB	\$6,000	\$6,000
------	---	---	---	-----	---------	---------
