The City of Madera

Appendix B: Facilities

Access Compliance Survey Report

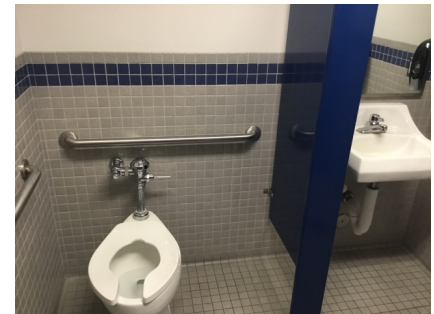
1511	<ul style="list-style-type: none"> As-Built Description: 60" min. clearance around a water closet measured perpendicular from the side wall not provided (Fixtures are not allowed to overlap this clearance). As-Built: 54.0" Proposed Solution: Remove adjacent fixture and provide new enclosure at accessible water closet. Notes: 	<p>PCODE WB01A ADA 2010 604.3.1; 604.3.2 CBC 2007 1115B.7.1.3 CBC 2019 11B-604.3.1; 11B-604.3.2</p> <p>Mitigated: <input type="radio"/> YES <input checked="" type="radio"/> NO</p>	1	JOB	\$6,000	\$6,000
------	---	---	---	-----	---------	---------

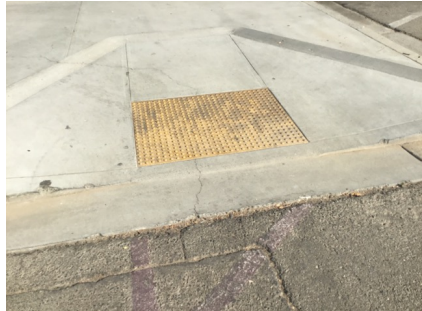
Item no., Rm no. and Name	Existing Architectural Barrier and Proposed Solution	Codes / Mitigation Info	Qty	Unit	Cost	Total
1804	<ul style="list-style-type: none"> • <i>As-Built Description:</i> Maximum slope of adjoining gutters, street surface at bottom of ramp exceeds 5% (1:20). • <i>As-Built:</i> 7.3% • <i>Proposed Solution:</i> Modify road/gutter slopes. Demolish existing and provide new curb ramp. 	PCODE EH02E ADAAG 91 4.7.2 ADA 2010 406.2 CBC 2007 1127B.5.3 CBC 2019 11B-406.5.8 Mitigated: <input type="radio"/> YES <input checked="" type="radio"/> NO	1	JOB	\$3,750	\$3,750

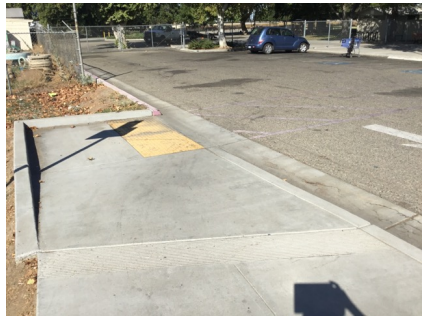
<input type="radio"/> Staff Only			
			Priority <input checked="" type="radio"/> 1			
			Severity <input checked="" type="radio"/> 4			
1807	<ul style="list-style-type: none"> • <i>As-Built Description:</i> Maximum slope of adjoining gutters, street surface at bottom of ramp exceeds 5% (1:20). • <i>As-Built:</i> 8.0% • <i>Proposed Solution:</i> Modify road/gutter slopes. Demolish existing and provide new curb ramp. 	PCODE EH02E ADAAG 91 4.7.2 ADA 2010 406.2 CBC 2007 1127B.5.3 CBC 2019 11B-406.5.8 Mitigated: <input type="radio"/> YES <input checked="" type="radio"/> NO	1	JOB	\$3,750	\$3,750

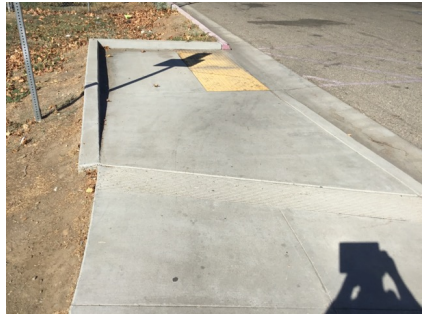
Item no., Rm no. and Name	Existing Architectural Barrier and Proposed Solution	Codes / Mitigation Info	Qty	Unit	Cost	Total
1808	<ul style="list-style-type: none"> As-Built Description: Cross slope greater than 2%. As-Built: 5.0% Proposed Solution: Demolish existing and provide new curb ramp. 	PCODE EH02F ADAAG 91 4.8.6 ADA 2010 405.3 CBC 2007 1133B.5.3.1 CBC 2019 11B-406.5.7 Mitigated: <input type="radio"/> YES <input checked="" type="radio"/> NO	1	JOB	\$7,500	\$7,500

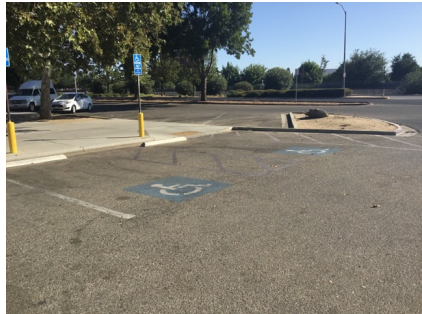
1799	<ul style="list-style-type: none"> As-Built Description: Accessible parking space has slope greater than 1/4":12" (2%). As-Built: Up to 6.1% Proposed Solution: Modify slope at accessible parking space. 	PCODE EA05 ADAAG 91 4.6.3 ADA 2010 502.4 CBC 2007 1129B.3.3 CBC 2019 11B-502.4 Mitigated: <input type="radio"/> YES <input checked="" type="radio"/> NO	450	SF	\$36	\$16,200

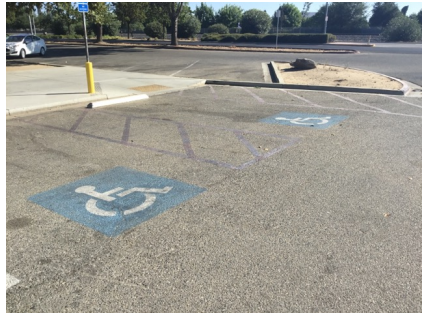
1801	<ul style="list-style-type: none"> As-Built Description: The words "NO PARKING" not painted on the ground within loading and unloading access aisle (12" min high white letters), located so that it is visible to traffic enforcement officials (required in CA only). Proposed Solution: Provide the words "NO PARKING" in each access aisle, painted in 12" high letters, when altering area. 	PCODE EA04D CBC 2007 1129B.3.1 CBC 2019 11B-502.3.3 Mitigated: <input type="radio"/> YES <input checked="" type="radio"/> NO	2	JOB	\$300	\$600
------	--	--	---	-----	-------	-------

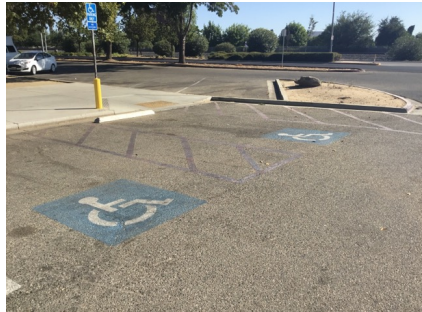
Item no., Rm no. and Name	Existing Architectural Barrier and Proposed Solution	Codes / Mitigation Info	Qty	Unit	Cost	Total
1800	<ul style="list-style-type: none"> As-Built Description: An accessible parking space shall be outlined or painted blue (required in CA only). Proposed Solution: Identify accessible parking space using blue markings. 	PCODE EA04K CBC 2019 11B-502.6 Mitigated: <input type="radio"/> YES <input checked="" type="radio"/> NO	2	JOB	\$360	\$720

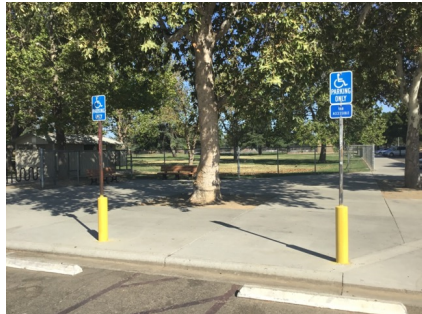
1802	<ul style="list-style-type: none"> As-Built Description: No "Tow Away" sign at parking lot entrance (required in CA only). Proposed Solution: Provide "Tow Away" sign at parking lot entrance when altering area. 	PCODE EA04C CBC 2007 1129B.4 CBC 2019 11B-502.8.2 Mitigated: <input type="radio"/> YES <input checked="" type="radio"/> NO	1	JOB	\$975	\$975

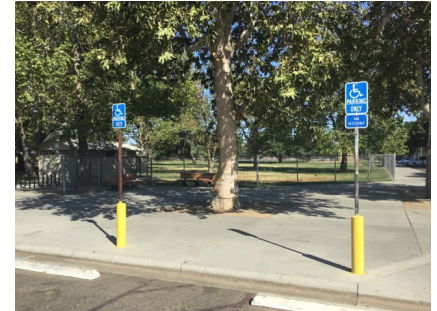
1803	<ul style="list-style-type: none"> <i>As-Built Description:</i> CA only: Additional Sign or additional language below the symbol of accessibility stating "Minimum Fine \$250" not provided. <i>Proposed Solution:</i> Provide compliant parking signage that includes fine information. 	<p>PCODE EA04G</p> <p>CBC 2007 1129B.4</p> <p>CBC 2019 11B-502.6.2</p> <p>Mitigated:</p> <p><input type="radio"/> YES</p> <p><input checked="" type="radio"/> NO</p>	2	JOB	\$300	\$600
------	--	---	---	-----	-------	-------

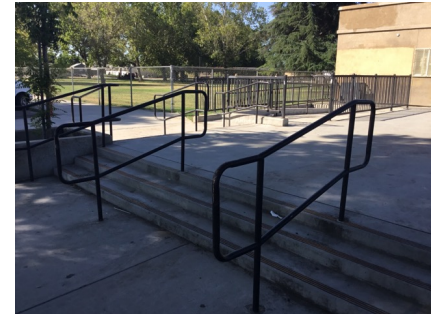
1811	<ul style="list-style-type: none"> • <i>As-Built Description:</i> Stair handrail does not extend horizontally 12" minimum beyond top nosing, and one tread width sloped, plus 12" minimum horizontally beyond the bottom nosing. • <i>As-Built:</i> 10.0" to bend. 12+" to center of down tube. Includes ramp. • <i>Proposed Solution:</i> Extend stair handrail at top and bottom (cost for each extension piece). 	<p>PCODE ED06 ADAAG 91 4.9.4(2) ADA 2010 505.10.2; 505.10.3 CBC 2007 1133B.4.2.2 CBC 2019 11B-505.10.2; 11B-505.10.3</p> <p>Mitigated: <input type="radio"/> YES <input checked="" type="radio"/> NO</p>	16	JOB	\$510	\$8,160
------	---	--	----	-----	-------	---------

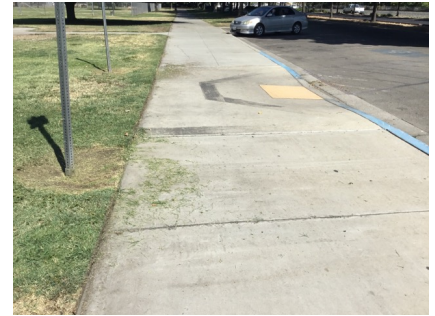
- 1839
- *As-Built Description:*
Walk: Pavement dislocation creates abrupt change in level exceeding 1/2" in accessible route.
 - *As-Built:* **0.7"**
 - *Proposed Solution:*
Remove, replace or repair area of pavement sufficient to correct abrupt change in level.

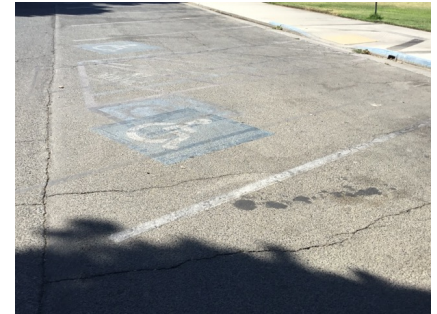
1816	<ul style="list-style-type: none"> As-Built Description: Accessible parking space smaller than 8' wide (CA only: 9' x 18'). As-Built: Approximately 170.0" long reduced by diagonal parking access aisle. Proposed Solution: Stripe straight in parking. 	PCODE EA02A ADAAG 91 4.6.3 ADA 2010 502.2 CBC 2007 1129B.3.1 CBC 2019 11B-502.2	2	JOB	\$600	\$1,200
------	--	---	---	-----	-------	---------

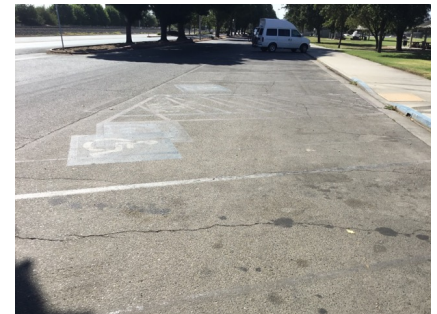
1817	<ul style="list-style-type: none"> As-Built Description: An accessible parking space shall be outlined or painted blue (required in CA only). Proposed Solution: Identify accessible parking space using blue markings. 	PCODE EA04K CBC 2019 11B-502.6	1	JOB	\$360	\$360
------	---	-----------------------------------	---	-----	-------	-------

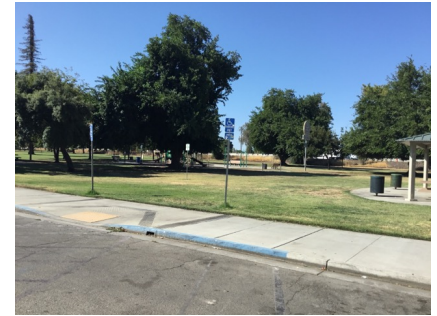
1815	<ul style="list-style-type: none"> <i>As-Built Description:</i> No "Tow Away" sign at parking lot entrance (required in CA only). <i>Proposed Solution:</i> Provide "Tow Away" sign at parking lot entrance when altering area. 	<p>PCODE EA04C</p> <p>CBC 2007 1129B.4</p> <p>CBC 2019 11B-502.8.2</p> <p>Mitigated:</p> <p><input type="radio"/> YES</p> <p><input checked="" type="radio"/> NO</p>	1	JOB	\$975	\$975
------	---	---	---	-----	-------	-------

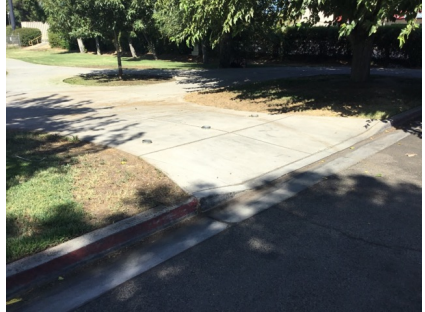
Item no., Rm no. and Name	Existing Architectural Barrier and Proposed Solution	Codes / Mitigation Info	Qty	Unit	Cost	Total
1832	<ul style="list-style-type: none"> <i>As-Built Description:</i> Maximum slope of adjoining gutters, street surface at bottom of ramp exceeds 5% (1:20). <i>As-Built:</i> 11.0% <i>Proposed Solution:</i> Modify road/gutter slopes. Demolish existing and provide new curb ramp. 	PCODE EH02E ADAAG 91 4.7.2 ADA 2010 406.2 CBC 2007 1127B.5.3 CBC 2019 11B-406.5.8 Mitigated: <input type="radio"/> YES <input checked="" type="radio"/> NO	1	JOB	\$3,750	\$3,750

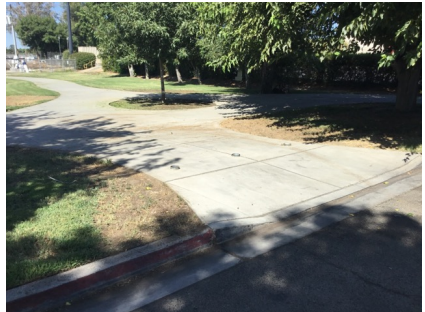
Detectable Warning

1830	<ul style="list-style-type: none"> <i>As-Built Description:</i> 36" wide band of truncated domes not provided at walkway or crossing adjoining a vehicular way, if surfaces are not separated by a curb, railing, or other element. <i>Proposed Solution:</i> Provide 36" wide, contrasting color, band of truncated domes between pedestrian and vehicular area. 	PCODE EG09 ADAAG 91 4.29.5 CBC 2007 1133B.8.5 CBC 2019 11B-705.1.2.5 Mitigated: <input type="radio"/> YES <input checked="" type="radio"/> NO	10	LF	\$81	\$810

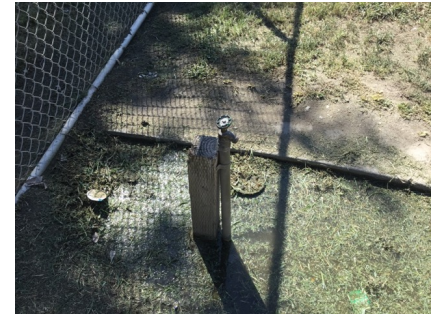
PCODE IC02
ADAAG 91 4.27.4
ADA 2010 309.4
CBC 2007 1117B.6.4
CBC 2019 11B-309.4

• *Proposed Solution:*
Modify or replace the operable part(s) to not require tight grasping, pinching, or twisting of the wrist with one hand.

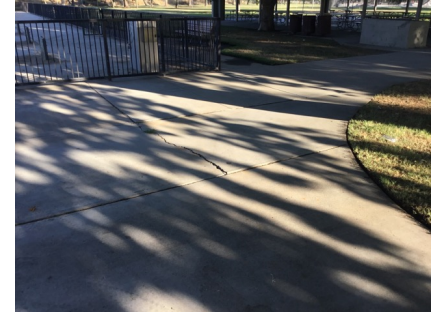
- 2019
- As-Built Description:*
Walk: Pavement dislocation creates abrupt change in level exceeding 1/2" in accessible route.
 - As-Built:* **Up to 1.0"**
 - Proposed Solution:*
Remove, replace or repair area of pavement sufficient to correct abrupt change in level.

PCODE EF03
 ADAAG 91 4.3.8
 ADA 2010 403.4
 CBC 2007 1133B.7.4
 CBC 2019 11B-403.4

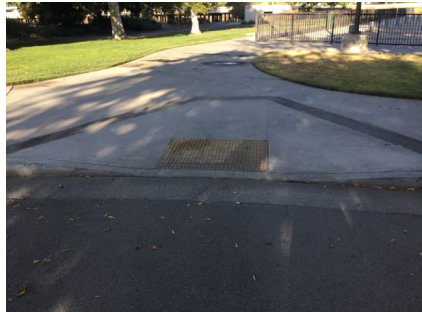
Item no., Rm no. and Name	Existing Architectural Barrier and Proposed Solution	Codes / Mitigation Info	Qty	Unit	Cost	Total
2017	<ul style="list-style-type: none"> As-Built Description: Transition from curb ramp to gutter does not have a smooth transition. As-Built: 0.5" Proposed Solution: Grind lip. 	PCODE EH02D ADAAG 91 4.7.2 ADA 2010 406.2 CBC 2007 1127B.5.3 CBC 2019 11B-406.5.8 Mitigated: <input type="radio"/> YES <input checked="" type="radio"/> NO	1	JOB	\$300	\$300

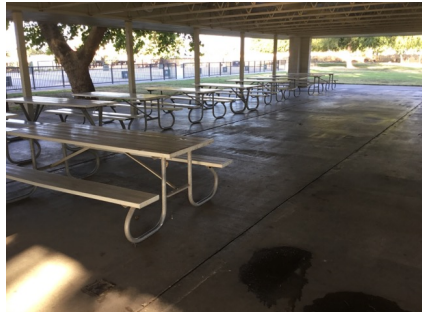
Non-Fixed Desk

2016	<ul style="list-style-type: none"> As-Built Description: Accessible non-fixed table or desk (top 28" to 34" high; knee space at least 27" high x 19" deep x 30" wide) not provided. As-Built: 200 seats, 0 accessible provided. Proposed Solution: Provide table or desk with accessible dimensions when purchasing new furniture. 	PCODE IN02A ADAAG 91 4.32.3 & .4 ADA 2010 306.1 CBC 2007 1122B.3 & 4 CBC 2019 11B-306.1 & 11B-902.3 Mitigated: <input type="radio"/> YES <input checked="" type="radio"/> NO	10	JOB	\$1,500	\$15,000

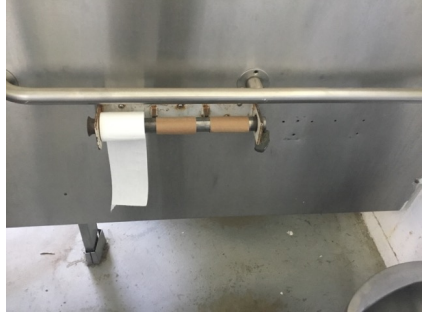
Grab Bars

<p>1756</p> <ul style="list-style-type: none"> <i>As-Built Description:</i> Side grab bar less than 42" long, or located more than 12 inches max. from the rear wall, or extending less than 54" from rear wall (CA only: front end min. 24" in front of water closet). <i>As-Built:</i> Extends 51.0" <i>Proposed Solution:</i> Provide or relocate accessible side grab bar. 	<p>PCODE WB07A ADAAG 91 Fig. 29(b) ADA 2010 604.5.1 CBC 2007 1115B.4.1.3.1 CBC 2019 11B-604.5.1</p> <p>Mitigated: <input type="radio"/> YES <input checked="" type="radio"/> NO</p>	<p>1 JOB \$780 \$780</p>

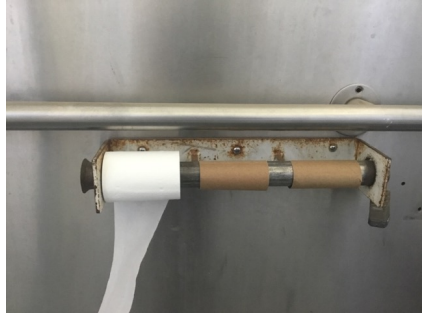
<p>1755</p> <ul style="list-style-type: none"> <i>As-Built Description:</i> Accessories/dispensers in accessible stall located closer than 1-1/2" below or 12" above grab bar impedes its use. <i>As-Built:</i> TPD: 1.0" below grab bar <i>Proposed Solution:</i> Relocate accessories/dispensers within applicable reach range and to be no closer than 1-1/2" below and 12" above grab bars (except if accessories are recessed, flush with wall, and have no sharp edges). 	<p>PCODE WB07I ADAAG 91 4.26.2 ADA 2010 609.3 CBC 2007 1133B.4.2.5 CBC 2019 11B-609.3</p> <p>Mitigated: <input type="radio"/> YES <input checked="" type="radio"/> NO</p>	<p>1 JOB \$225 \$225</p>

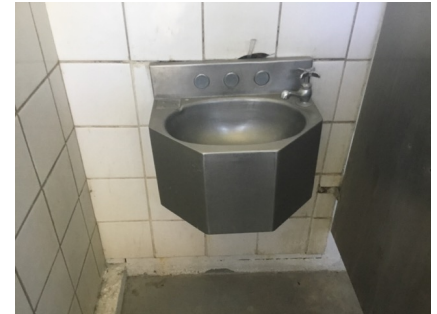
Lavatory

1759	<ul style="list-style-type: none"> • <i>As-Built Description:</i> Knee clearance 27" min. high starting 8" back from the front edge of the lavatory towards the wall is not provided. • <i>As-Built:</i> 24.0". knee high 12.0" deep toe clearance. • <i>Proposed Solution:</i> Provide new accessible lavatory. Remodel restroom as needed. 	<p>PCODE WD04 ADAAG 91 Fig. 31 ADA 2010 306.3.3 CBC 2007 1115B.4.3 CBC 2019 11B-306.3.3</p> <p>Mitigated: <input type="radio"/> YES <input checked="" type="radio"/> NO</p>	1	JOB	\$6,000	\$6,000
------	---	--	---	-----	---------	---------

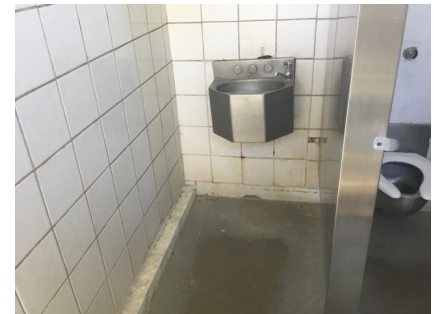
1758	<ul style="list-style-type: none"> • <i>As-Built Description:</i> Lavatory/sink not accessible due to location within an inaccessible alcove of less than 36" wide. • <i>Proposed Solution:</i> Remodel partitions to provide necessary maneuvering space within the alcove. • <i>Notes:</i> 	<p>PCODE WD11 ADA 2010 305.7.1 CBC 2019 11B-305.7.1</p> <p>Mitigated: <input type="radio"/> YES <input checked="" type="radio"/> NO</p>	1	REF		
------	---	--	---	-----	--	--

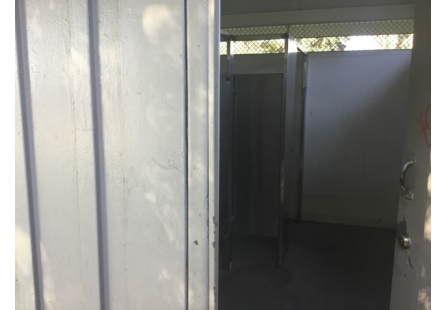
- 1760
- *As-Built Description:*
Entrance to toilet or bathing facility not identified with ADAAG compliant signage.
 - *Proposed Solution:*
Provide ADA compliant sign mounted at 48" min. above to baseline of the lowest Braille cells and 60" max. to baseline of the highest line of raised characters on nearest adjacent wall, on latch side of a single door (located not to cause a Braille reader to stand within the door swing).

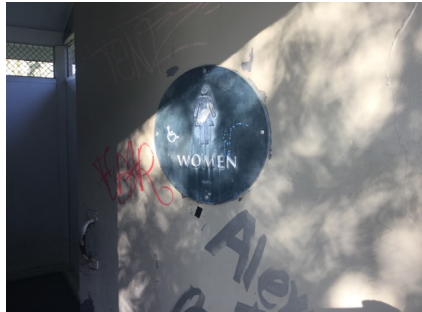
Item no., Rm no. and Name	Existing Architectural Barrier and Proposed Solution	Codes / Mitigation Info	Qty	Unit	Cost	Total
1761	<ul style="list-style-type: none"> As-Built Description: Required in CA only: identification symbol centered 58" to 60" high on sanitary facility door that contrasts with the door not provided (women: 12" ø circle, men: 12" triangle, unisex: combined symbol). As-Built: 62.0" high o.c. Proposed Solution: Provide properly mounted sanitary facility symbol when altering area. If wheelchair accessible, include International Symbol of Accessibility on sign. 	PCODE SA15 CBC 2007 1115B.6 CBC 2019 11B-703.7.2.6 Mitigated: <input type="radio"/> YES <input checked="" type="radio"/> NO	1	JOB	\$270	\$270

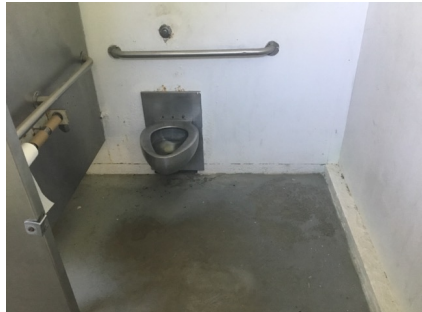
Toilet Stall

1751	<ul style="list-style-type: none"> As-Built Description: Toilet stall less than 60" wide. As-Built: 58.75" wide Proposed Solution: Provide new accessible stall. 	PCODE WB06 ADAAG 91 4.17.3 ADA 2010 604.8.1.1 CBC 2007 1115B.3.1.4.1 CBC 2019 11B-604.8.1.1 Mitigated: <input type="radio"/> YES <input checked="" type="radio"/> NO	1	JOB	\$4,500	\$4,500

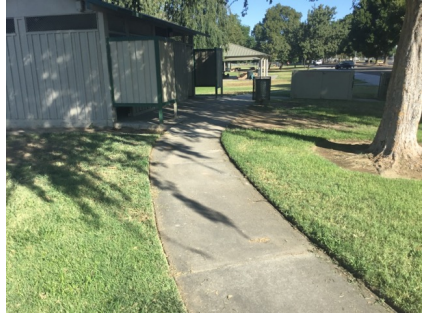
Cross Slope

<p>1774</p> <ul style="list-style-type: none"> As-Built Description: Cross slope more than 1":48" (2.083%). As-Built: Up to 3.9% Proposed Solution: Modify cross slope. 	<p>PCODE EF07 ADAAG 91 4.3.7 ADA 2010 403.3 CBC 2007 1133B.7.1.3 CBC 2019 11B-403.3</p> <p>Mitigated:</p> <p><input type="radio"/> YES <input checked="" type="radio"/> NO</p>	<p>160 SF \$75 \$12,000</p>

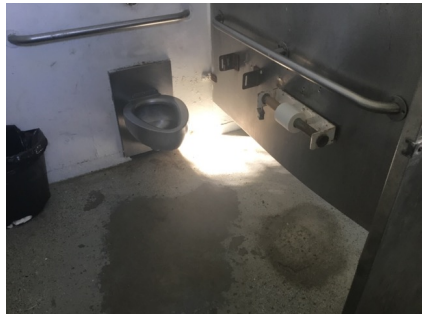
Door Swing

<p>1771</p> <ul style="list-style-type: none"> As-Built Description: Front approach: At push side, door does not have clear and level maneuvering space measuring door width x 48" (door width plus 12" if door has both, latch and closer). As-Built: 47.5" Proposed Solution: Install lower profile water closet or provide relocated new door and frame; remodel walls as needed. 	<p>PCODE ID24B ADAAG 91 Fig. 25(a) ADA 2010 404.2.4 CBC 2007 11B-26A(a) CBC 2019 11B-404.2.4</p> <p>Mitigated:</p> <p><input type="radio"/> YES <input checked="" type="radio"/> NO</p>	<p>1 JOB \$7,800 \$7,800</p>

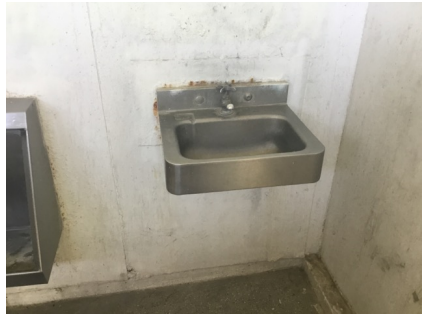
Item no., Rm no. and Name	Existing Architectural Barrier and Proposed Solution	Codes / Mitigation Info	Qty	Unit	Cost	Total
1764	<ul style="list-style-type: none"> • <i>As-Built Description:</i> Knee clearance 27" min. high starting 8" back from the front edge of the lavatory towards the wall is not provided. • <i>As-Built:</i> 15.0" deep toe clearance • <i>Proposed Solution:</i> Provide new accessible lavatory. Remodel restroom as needed. 	PCODE WD04 ADAAG 91 Fig. 31 ADA 2010 306.3.3 CBC 2007 1115B.4.3 CBC 2019 11B-306.3.3 Mitigated: <input type="radio"/> YES <input checked="" type="radio"/> NO	1	JOB	\$6,000	\$6,000

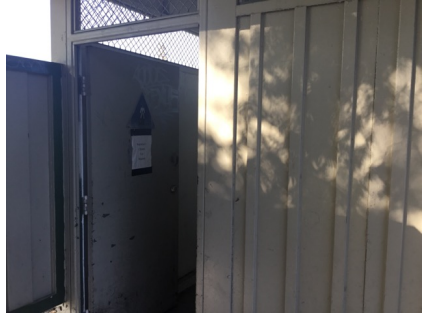
Signage

1762	<ul style="list-style-type: none"> • <i>As-Built Description:</i> Required in CA only: identification symbol centered 58" to 60" high on sanitary facility door that contrasts with the door not provided (women: 12" ø circle, men: 12" triangle, unisex: combined symbol). • <i>Proposed Solution:</i> Provide properly mounted sanitary facility symbol when altering area. If wheelchair accessible, include International Symbol of Accessibility on sign. 	PCODE SA15 CBC 2007 1115B.6 CBC 2019 11B-703.7.2.6 Mitigated: <input type="radio"/> YES <input checked="" type="radio"/> NO	1	JOB	\$270	\$270

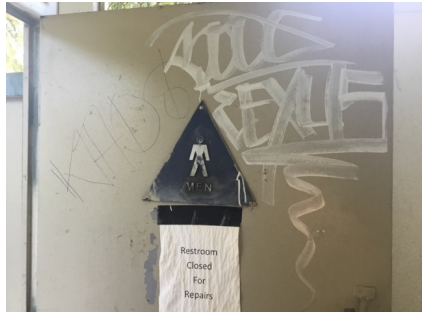
Item no., Rm no. and Name	Existing Architectural Barrier and Proposed Solution	Codes / Mitigation Info	Qty	Unit	Cost	Total
1763	<ul style="list-style-type: none"> • <i>As-Built Description:</i> Required in CA only: identification symbol centered 58" to 60" high on sanitary facility door that contrasts with the door not provided (women: 12" ø circle, men: 12" triangle, unisex: combined symbol). • <i>As-Built:</i> 65.0" high o.c. • <i>Proposed Solution:</i> Provide properly mounted sanitary facility symbol when altering area. If wheelchair accessible, include International Symbol of Accessibility on sign. 	PCODE SA15 CBC 2007 1115B.6 CBC 2019 11B-703.7.2.6 Mitigated: <input type="radio"/> YES <input checked="" type="radio"/> NO	1	JOB	\$270	\$270

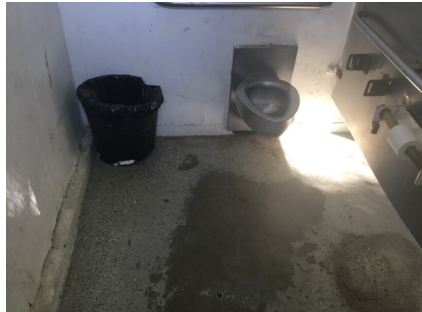
Toilet Stall

1770	<ul style="list-style-type: none"> • <i>As-Built Description:</i> Toilet stall less than 60" wide. • <i>As-Built:</i> 57.5" wide • <i>Proposed Solution:</i> Provide new accessible stall. 	PCODE WB06 ADAAG 91 4.17.3 ADA 2010 604.8.1.1 CBC 2007 1115B.3.1.4.1 CBC 2019 11B-604.8.1.1 Mitigated: <input type="radio"/> YES <input checked="" type="radio"/> NO	1	JOB	\$4,500	\$4,500

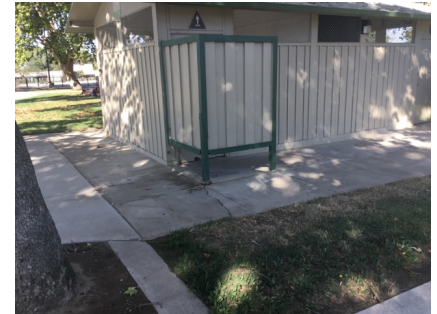
• *Proposed Solution:*
Remove, replace or repair area of pavement sufficient to correct abrupt change in level.

PCODE EF03
ADAAG 91 4.3.8
ADA 2010 403.4
CBC 2007 1133B.7.4
CBC 2019 11B-403.4

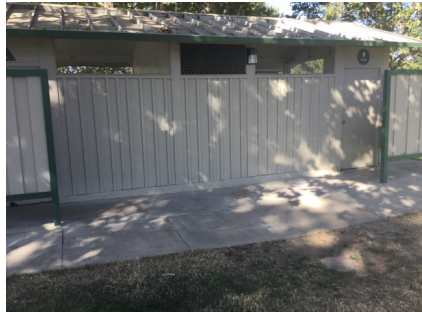
Item no., Rm no. and Name	Existing Architectural Barrier and Proposed Solution	Codes / Mitigation Info	Qty	Unit	Cost	Total
1798	<ul style="list-style-type: none"> As-Built Description: Cross slope more than 1":48" (2.083%). As-Built: Up to 3.1% Proposed Solution: Modify cross slope. 	PCODE EF07 ADAAG 91 4.3.7 ADA 2010 403.3 CBC 2007 1133B.7.1.3 CBC 2019 11B-403.3 Mitigated: <input type="radio"/> YES <input checked="" type="radio"/> NO	60	SF	\$75	\$4,500

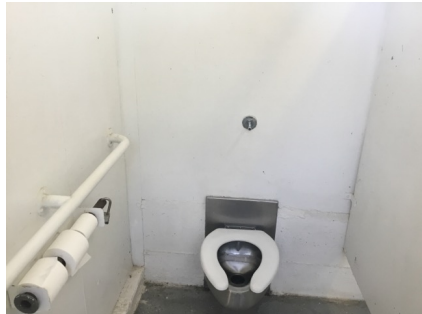
Grab Bars

1794	<ul style="list-style-type: none"> As-Built Description: Grab bars not provided or are not code compliant. Proposed Solution: Provide accessible grab bars. 	PCODE WB07 ADAAG 91 4.17.6 ADA 2010 604.5 CBC 2007 1115B.4.1.3 CBC 2019 11B-604.5 Mitigated: <input type="radio"/> YES <input checked="" type="radio"/> NO	1	JOB	\$1,500	\$1,500

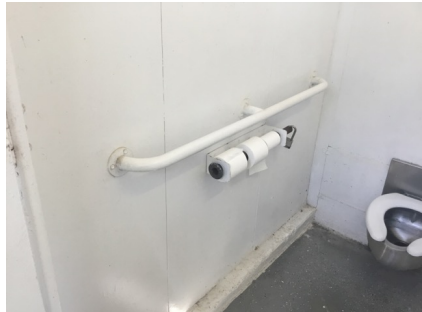
Item no., Rm no. and Name	Existing Architectural Barrier and Proposed Solution	Codes / Mitigation Info	Qty	Unit	Cost	Total
1795	<ul style="list-style-type: none"> As-Built Description: Grab bars not at 33" to 36" from floor As-Built: 37.0" high Proposed Solution: Relocate accessible grab bars. 	PCODE WB07C ADAAG 91 4.16.4 ADA 2010 609.4 CBC 2007 1115B.4.1.3.1 & 2 CBC 2019 11B-609.4 Mitigated: <input type="radio"/> YES <input checked="" type="radio"/> NO	1	JOB	\$780	\$780

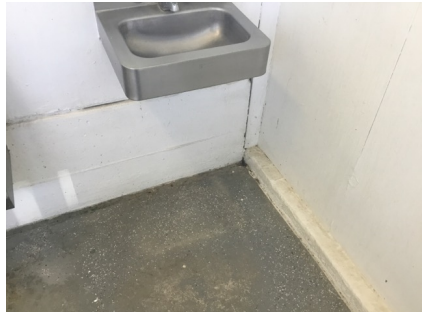
Lavatory

1788	<ul style="list-style-type: none"> As-Built Description: Clear floor space, 30" x 48" in front of fixture, extending 19" max. under the lavatory, not provided (CA only: Less than 18" from side wall to centerline of lavatory). As-Built: 16.5" o.c. Proposed Solution: Provide new accessible lavatory. Remodel restroom as needed. Notes: 	PCODE WD01 ADAAG 91 4.19.3 ADA 2010 606.2 CBC 2007 1115B.4.3 CBC 2019 11B-606.2, 11B-606.6 Mitigated: <input type="radio"/> YES <input checked="" type="radio"/> NO	1	JOB	\$10,200	\$10,200

Complies with Safe Harbor and/or CBC if altered or constructed before January 2008.

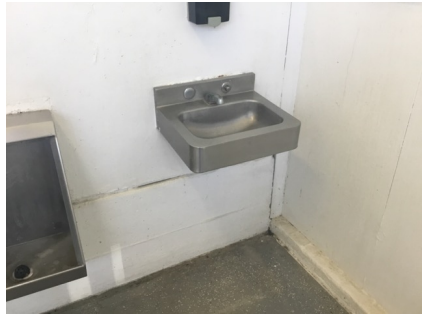
Item no., Rm no. and Name	Existing Architectural Barrier and Proposed Solution	Codes / Mitigation Info	Qty	Unit	Cost	Total
1789	<ul style="list-style-type: none"> As-Built Description: Knee clearance 27" min. high starting 8" back from the front edge of the lavatory towards the wall is not provided. As-Built: 15.0" deep toe clearance. Proposed Solution: Provide new accessible lavatory. Remodel restroom as needed. 	PCODE WD04 ADAAG 91 Fig. 31 ADA 2010 306.3.3 CBC 2007 1115B.4.3 CBC 2019 11B-306.3.3 Mitigated: <input type="radio"/> YES <input checked="" type="radio"/> NO	1	JOB	\$6,000	\$6,000

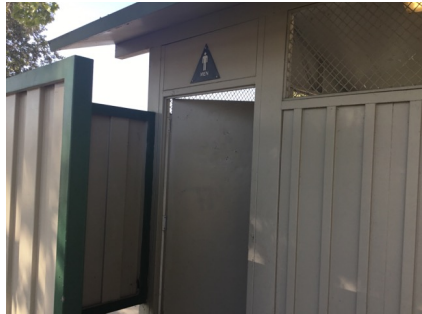
Item no., Rm no. and Name	Existing Architectural Barrier and Proposed Solution	Codes / Mitigation Info	Qty	Unit	Cost	Total
1785	<ul style="list-style-type: none"> As-Built Description: Required in CA only: identification symbol centered 58" to 60" high on sanitary facility door that contrasts with the door not provided (women: 12" ø circle, men: 12" triangle, unisex: combined symbol). Proposed Solution: Provide properly mounted sanitary facility symbol when altering area. If wheelchair accessible, include International Symbol of Accessibility on sign. 	PCODE SA15 CBC 2007 1115B.6 CBC 2019 11B-703.7.2.6 Mitigated: <input type="radio"/> YES <input checked="" type="radio"/> NO	1	JOB	\$270	\$270

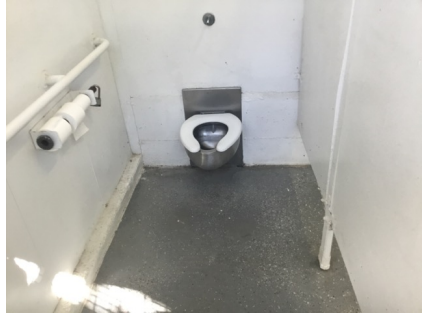
Toilet Stall

1792	<ul style="list-style-type: none"> As-Built Description: Toilet stall less than 60" wide. As-Built: 43.0" wide Proposed Solution: Provide new accessible stall. 	PCODE WB06 ADAAG 91 4.17.3 ADA 2010 604.8.1.1 CBC 2007 1115B.3.1.4.1 CBC 2019 11B-604.8.1.1 Mitigated: <input type="radio"/> YES <input checked="" type="radio"/> NO	1	JOB	\$4,500	\$4,500

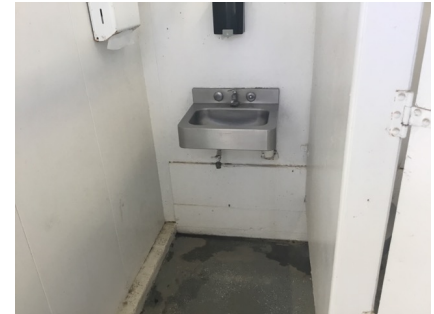
Lavatory

1782	<ul style="list-style-type: none"> As-Built Description: Knee clearance 27" min. high starting 8" back from the front edge of the lavatory towards the wall is not provided. As-Built: 15.0" deep toe clearance. Proposed Solution: Provide new accessible lavatory. Remodel restroom as needed. 	<p>PCODE WD04 ADAAG 91 Fig. 31 ADA 2010 306.3.3 CBC 2007 1115B.4.3 CBC 2019 11B-306.3.3</p> <p>Mitigated: <input type="radio"/> YES <input checked="" type="radio"/> NO</p>	1	JOB	\$6,000	\$6,000
------	--	--	---	-----	---------	---------

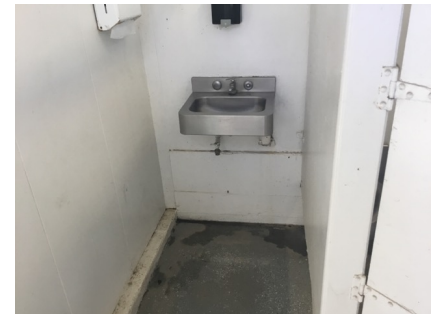
1781	<ul style="list-style-type: none"> As-Built Description: Lavatory/sink not accessible due to location within an inaccessible alcove of less than 36" wide. Proposed Solution: Remodel partitions to provide necessary maneuvering space within the alcove. Notes: 	<p>PCODE WD11 ADA 2010 305.7.1 CBC 2019 11B-305.7.1</p> <p>Mitigated: <input type="radio"/> YES <input checked="" type="radio"/> NO</p>	1	REF		
------	--	--	---	-----	--	--

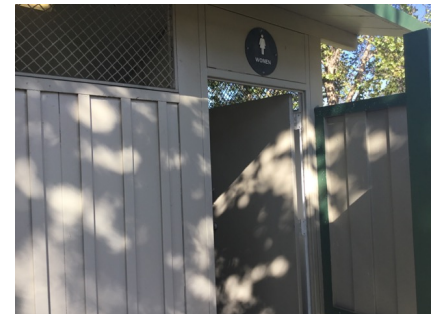
1776	<ul style="list-style-type: none"> As-Built Description: Required in CA only: identification symbol centered 58" to 60" high on sanitary facility door that contrasts with the door not provided (women: 12" ø circle, men: 12" triangle, unisex: combined symbol). Proposed Solution: Provide properly mounted sanitary facility symbol when altering area. If wheelchair accessible, include International Symbol of Accessibility on sign. 	<p>PCODE SA15 CBC 2007 1115B.6 CBC 2019 11B-703.7.2.6</p> <p>Mitigated: <input type="radio"/> YES <input checked="" type="radio"/> NO</p>	1	JOB	\$270	\$270
------	---	--	---	-----	-------	-------

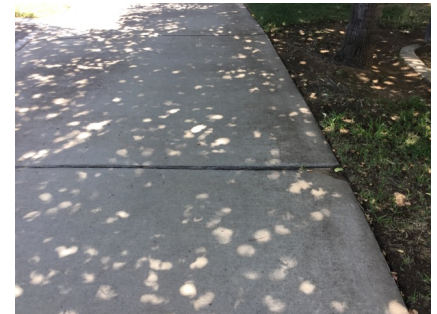
- 1874
- *As-Built Description:*
Walk: Pavement dislocation creates abrupt change in level exceeding 1/2" in accessible route.
 - *As-Built: Up to 1.0"*
 - *Proposed Solution:*
Remove, replace or repair area of pavement sufficient to correct abrupt change in level.

PCODE EF03
 ADAAG 91 4.3.8
 ADA 2010 403.4
 CBC 2007 1133B.7.4
 CBC 2019 11B-403.4

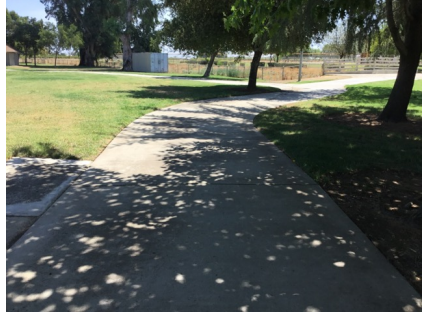
Cross Slope

1873	<ul style="list-style-type: none"> As-Built Description: Cross slope more than 1":48" (2.083%). As-Built: Up to 4.0% Proposed Solution: Modify cross slope. 	<p>PCODE EF07 ADAAG 91 4.3.7 ADA 2010 403.3 CBC 2007 1133B.7.1.3 CBC 2019 11B-403.3</p> <p>Mitigated: <input type="radio"/> YES <input checked="" type="radio"/> NO</p>	1000	SF	\$75	\$75,000
------	---	--	------	----	------	----------

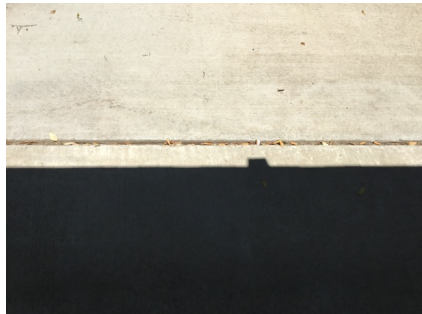
1914	<ul style="list-style-type: none"> As-Built Description: Walk: Grating has grid openings greater than 1/2" along the line of traffic flow. As-Built: 1.0" wide x 1.0" deep Proposed Solution: Fill gaps. 	<p>PCODE EF04 ADAAG 91 4.3.6; 4.5.4 ADA 2010 403.2; 302.3 CBC 2007 1133B.7.2 CBC 2019 11B-403.2; 11B-302.3</p> <p>Mitigated: <input type="radio"/> YES <input checked="" type="radio"/> NO</p>	120	LF	\$60	\$7,200
------	--	---	-----	----	------	---------

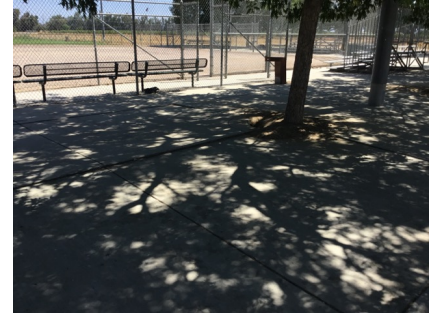
- 1865
- *As-Built Description:*
Walk: Pavement dislocation creates abrupt change in level exceeding 1/2" in accessible route.
 - *As-Built:* **Up to 2.0"**
 - *Proposed Solution:*
Remove, replace or repair area of pavement sufficient to correct abrupt change in level.

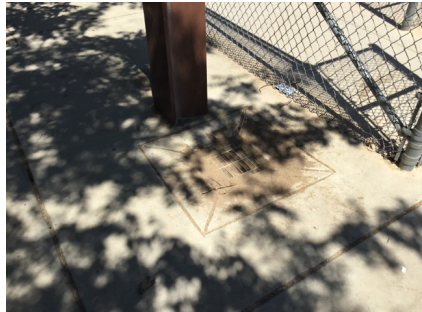
Item no., Rm no. and Name	Existing Architectural Barrier and Proposed Solution	Codes / Mitigation Info	Qty	Unit	Cost	Total
1867	<ul style="list-style-type: none"> As-Built Description: Cross slope more than 1":48" (2.083%). As-Built: 14.0% Proposed Solution: Modify cross slope. 	PCODE EF07 ADAAG 91 4.3.7 ADA 2010 403.3 CBC 2007 1133B.7.1.3 CBC 2019 11B-403.3 Mitigated: <input type="radio"/> YES <input checked="" type="radio"/> NO	30	SF	\$75	\$2,250

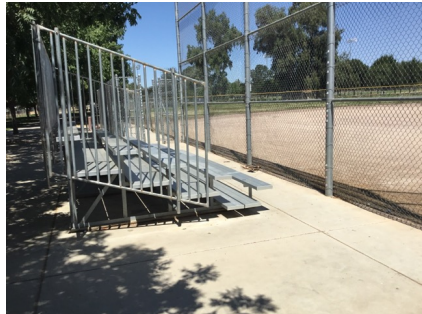
Disabled Seating

1858	<ul style="list-style-type: none"> As-Built Description: Wheelchair space (33"x48") not provided at fixed seating with forward or rear approach. (NOTE: Space must be adjacent to regular seating; can provide easily removable fixed seat). Proposed Solution: Relocate bleachers. Notes: 	PCODE GB01A ADAAG 91 4.1.3(19)(a) ADA 2010 221.2 CBC 2007 1104B.3.6 CBC 2019 11B-221.2 Mitigated: <input type="radio"/> YES <input checked="" type="radio"/> NO	4	JOB	\$1,350	\$5,400

Wheelchair seats block circulation path.

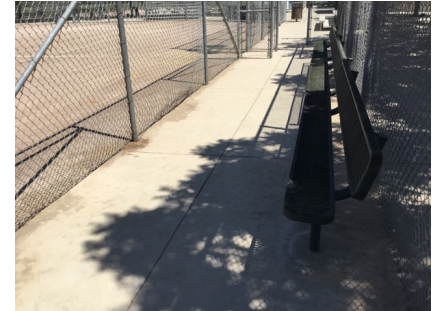
1868	<ul style="list-style-type: none"> As-Built Description: Wheelchair space (33"x48") not provided at fixed seating with forward or rear approach. (NOTE: Space must be adjacent to regular seating; can provide easily removable fixed seat). Proposed Solution: Remove fixed seating and provide wheelchair space plus necessary maneuvering clearance. Notes: 	PCODE GB01A ADAAG 91 4.1.3(19)(a) ADA 2010 221.2 CBC 2007 1104B.3.6 CBC 2019 11B-221.2 Mitigated: <input type="radio"/> YES <input checked="" type="radio"/> NO	4	JOB	\$1,350	\$5,400
------	--	---	---	-----	---------	---------

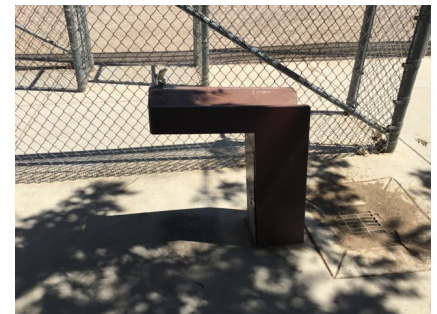
Drinking Fountain

1862	<ul style="list-style-type: none"> As-Built Description: Where only one drinking fountain is provided per floor: Fountain is not accessible to individuals who use wheelchairs, or to those who have difficulty bending or stooping. Proposed Solution: Provide additional fountain or hi-lo combination fountain. 	PCODE IA01A ADAAG 91 4.1.3(10)(a) ADA 2010 211.1 CBC 2007 1115B.4.6.1 CBC 2019 11B-211.1 Mitigated: <input type="radio"/> YES <input checked="" type="radio"/> NO	4	JOB	\$6,000	\$24,000
------	--	---	---	-----	---------	----------

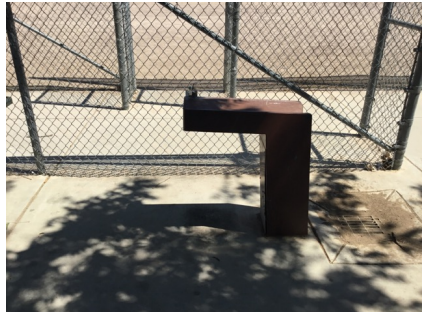
Item no., Rm no. and Name	Existing Architectural Barrier and Proposed Solution	Codes / Mitigation Info	Qty	Unit	Cost	Total
1863	<ul style="list-style-type: none"> <i>As-Built Description:</i> Drinking fountain lacks protection for visually impaired persons. <i>Proposed Solution:</i> Provide cane-detectable rails. 	PCODE IA05C ADAAG 91 4.4.1 ADA 2010 307.2 CBC 2007 1115B.4.6.3 CBC 2019 11B-307.2 Mitigated: <input type="radio"/> YES <input checked="" type="radio"/> NO	8	JOB	\$1,500	\$12,000

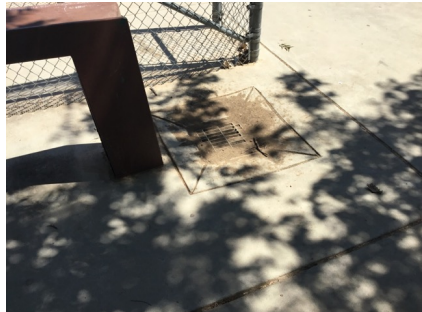
1864	<ul style="list-style-type: none"> <i>As-Built Description:</i> Walk: Grating has grid openings greater than 1/2" along the line of traffic flow. <i>As-Built:</i> 1.0" x 4.0" <i>Proposed Solution:</i> Provide new grating, with grid openings 1/2" max. along the line of traffic flow. 	PCODE EF04 ADAAG 91 4.3.6; 4.5.4 ADA 2010 403.2; 302.3 CBC 2007 1133B.7.2 CBC 2019 11B-403.2; 11B-302.3 Mitigated: <input type="radio"/> YES <input checked="" type="radio"/> NO	8	SF	\$240	\$1,920

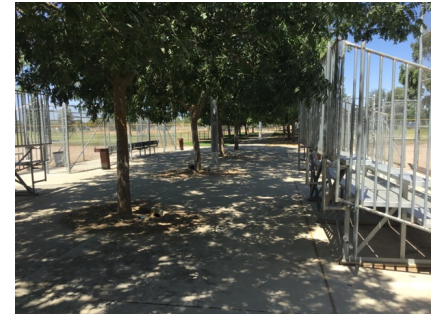
Protrusion Limits

1859	<ul style="list-style-type: none"> <i>As-Built Description:</i> Protruding objects more than 4" from wall, when bottom of object more than 27" or less than 80" above finished floor. <i>Proposed Solution:</i> Trim vegetation. 	PCODE EG04 ADAAG 91 4.4.1 ADA 2010 307.2 CBC 2007 1133B.8.6.1 CBC 2019 11B-307.2	10	JOB	\$300	\$3,000
------	--	--	----	-----	-------	---------

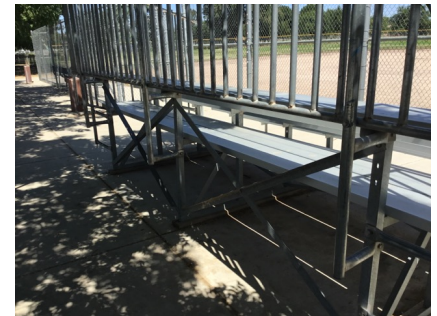
1860	<ul style="list-style-type: none"> <i>As-Built Description:</i> Protruding objects more than 4" from wall, when bottom of object more than 27" or less than 80" above finished floor. <i>As-Built:</i> Bleacher: 9.0" at 47.0" high <i>Proposed Solution:</i> Add cane detection. 	PCODE EG04 ADAAG 91 4.4.1 ADA 2010 307.2 CBC 2007 1133B.8.6.1 CBC 2019 11B-307.2	4	JOB	\$300	\$1,200
------	---	--	---	-----	-------	---------

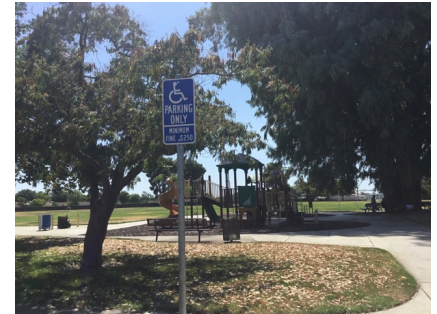
- 1973
- *As-Built Description:*
Sign for accessible parking space is missing or non-compliant.
 - *Proposed Solution:*
Provide compliant parking signage.
 - *Notes:*

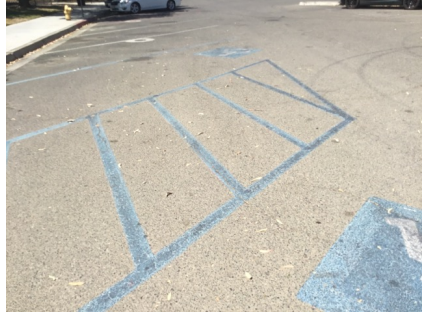
Item no., Rm no. and Name	Existing Architectural Barrier and Proposed Solution	Codes / Mitigation Info	Qty	Unit	Cost	Total
1971	<ul style="list-style-type: none"> As-Built Description: The words "NO PARKING" not painted on the ground within loading and unloading access aisle (12" min high white letters), located so that it is visible to traffic enforcement officials (required in CA only). Proposed Solution: Provide the words "NO PARKING" in each access aisle, painted in 12" high letters, when altering area. 	PCODE EA04D CBC 2007 1129B.3.1 CBC 2019 11B-502.3.3 Mitigated: <input type="radio"/> YES <input checked="" type="radio"/> NO	1	JOB	\$300	\$300

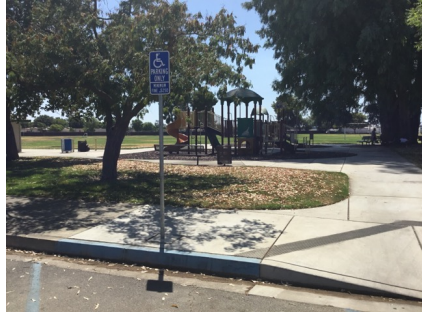
Parking Signage

1974	<ul style="list-style-type: none"> As-Built Description: No "Tow Away" sign at parking lot entrance (required in CA only). Proposed Solution: Provide "Tow Away" sign at parking lot entrance when altering area. 	PCODE EA04C CBC 2007 1129B.4 CBC 2019 11B-502.8.2 Mitigated: <input type="radio"/> YES <input checked="" type="radio"/> NO	1	JOB	\$975	\$975

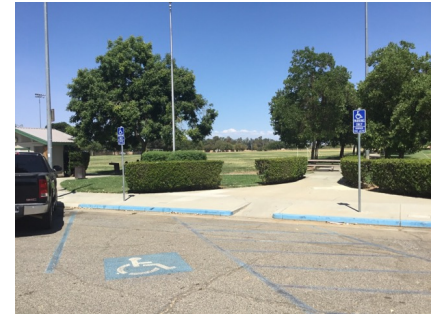
- 1975
- *As-Built Description:*
Sign for accessible parking space is missing or non-compliant.
 - *Proposed Solution:*
Provide compliant parking signage.
 - *Notes:*

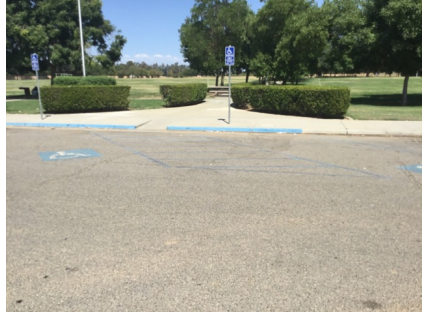
Consider straight in parking.

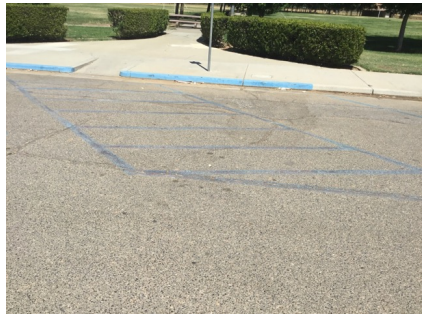
1976	<ul style="list-style-type: none"> • <i>As-Built Description:</i> The words "NO PARKING" not painted on the ground within loading and unloading access aisle (12" min high white letters), located so that it is visible to traffic enforcement officials (required in CA only). • <i>Proposed Solution:</i> Provide the words "NO PARKING" in each access aisle, painted in 12" high letters, when altering area. 	<p>PCODE EA04D CBC 2007 1129B.3.1 CBC 2019 11B-502.3.3</p> <p>Mitigated: <input type="radio"/> YES <input checked="" type="radio"/> NO</p>	1	JOB	\$300	\$300
------	--	---	---	-----	-------	-------

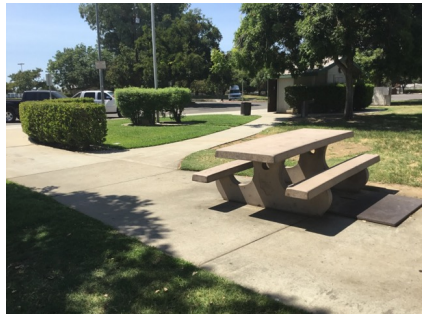
1981	<ul style="list-style-type: none"> <i>As-Built Description:</i> Walk more than 36" but less than 48" wide (required in CA only). <i>As-Built:</i> 44.0" wide at picnic table. <i>Proposed Solution:</i> Enlarge width of walk to 48". <i>Notes:</i> 	<p>PCODE EF08</p> <p>CBC 2007 1133B.7.1</p> <p>CBC 2019 11B-403.5.1.3</p> <p>Mitigated:</p> <p><input type="radio"/> YES</p> <p><input checked="" type="radio"/> NO</p>	5	SF	\$135	\$675
------	--	--	---	----	-------	-------

The table appears to temporarily cover a hole.

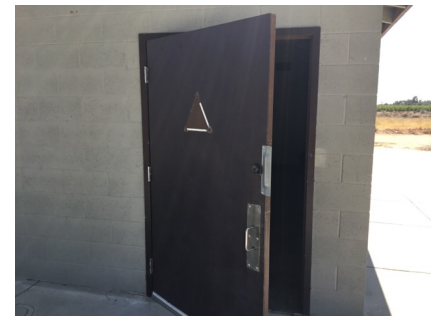
- 1841
- *As-Built Description:*
Entrance to toilet or bathing facility not identified with ADAAG compliant signage.
 - *Proposed Solution:*
Provide ADA compliant sign mounted at 48" min. above to baseline of the lowest Braille cells and 60" max. to baseline of the highest line of raised characters on nearest adjacent wall, on latch side of a single door (located not to cause a Braille reader to stand within the door swing).

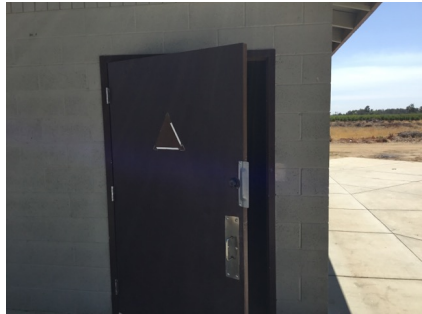
Item no., Rm no. and Name	Existing Architectural Barrier and Proposed Solution	Codes / Mitigation Info	Qty	Unit	Cost	Total
1840	<ul style="list-style-type: none"> As-Built Description: Required in CA only: identification symbol centered 58" to 60" high on sanitary facility door that contrasts with the door not provided (women: 12" ø circle, men: 12" triangle, unisex: combined symbol). Proposed Solution: Provide properly mounted sanitary facility symbol when altering area. If wheelchair accessible, include International Symbol of Accessibility on sign. 	PCODE SA15 CBC 2007 1115B.6 CBC 2019 11B-703.7.2.6 Mitigated: <input type="radio"/> YES <input checked="" type="radio"/> NO	1	JOB	\$270	\$270

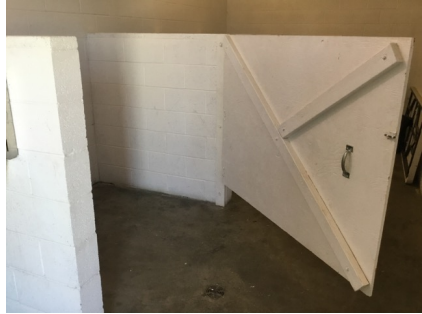
Stall Door

1846	<ul style="list-style-type: none"> As-Built Description: Stall door to accessible compartment not self closing. Proposed Solution: Adjust closer. 	PCODE WB05B ADAAG 91 4.22.4 ADA 2010 604.8.1.2 CBC 2007 1115B.3.1.4.4 CBC 2019 11B-604.8.1.2 Mitigated: <input type="radio"/> YES <input checked="" type="radio"/> NO	1	JOB	\$75	\$75

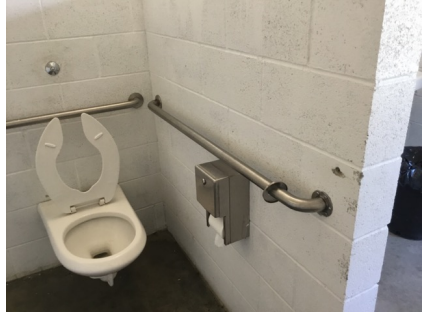
Grab Bars

<p>1855</p> <ul style="list-style-type: none"> <i>As-Built Description:</i> Side grab bar less than 42" long, or located more than 12 inches max. from the rear wall, or extending less than 54" from rear wall (CA only: front end min. 24" in front of water closet). <i>As-Built:</i> Extends 52.0" <i>Proposed Solution:</i> Provide or relocate accessible side grab bar. 	<p>PCODE WB07A ADAAG 91 Fig. 29(b) ADA 2010 604.5.1 CBC 2007 1115B.4.1.3.1 CBC 2019 11B-604.5.1</p> <p>Mitigated: <input type="radio"/> YES <input checked="" type="radio"/> NO</p>	<p>1 JOB \$780 \$780</p>

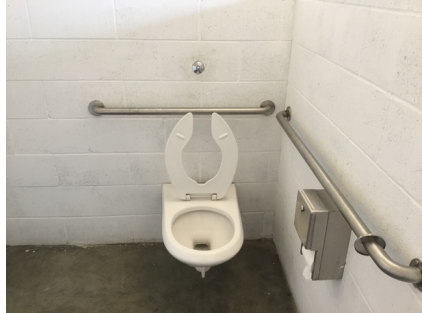
<p>1856</p> <ul style="list-style-type: none"> <i>As-Built Description:</i> The rear wall grab is less than 36" min. or does not extend from the centerline of the water closet 12" min. on one side and 24" min. on the other side. <i>As-Built:</i> Extends 22.0" on wide side <i>Proposed Solution:</i> Provide or relocate accessible rear grab bar. <i>Notes:</i> 	<p>PCODE WB07B ADAAG 91 4.17.6 ADA 2010 604.5.2 CBC 2007 1115B.4.1.3.2 CBC 2019 11B-604.5.2</p> <p>Mitigated: <input type="radio"/> YES <input checked="" type="radio"/> NO</p>	<p>1 JOB \$1,020 \$1,020</p>

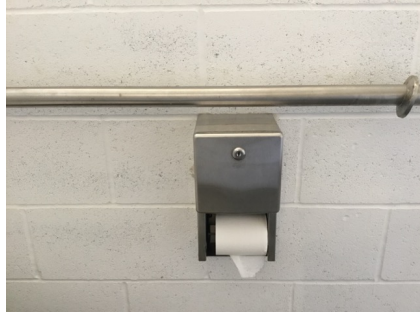
Item no., Rm no. and Name	Existing Architectural Barrier and Proposed Solution	Codes / Mitigation Info	Qty	Unit	Cost	Total
1857	<ul style="list-style-type: none"> • <i>As-Built Description:</i> Accessories/dispensers in accessible stall located closer than 1-1/2" below or 12" above grab bar impedes its use. • <i>As-Built:</i> TPD: 1.0" below grab bar • <i>Proposed Solution:</i> Relocate accessories/dispensers within applicable reach range and to be no closer than 1-1/2" below and 12" above grab bars (except if accessories are recessed, flush with wall, and have no sharp edges). 	PCODE WB07I ADAAG 91 4.26.2 ADA 2010 609.3 CBC 2007 1133B.4.2.5 CBC 2019 11B-609.3 Mitigated: <input type="radio"/> YES <input checked="" type="radio"/> NO	1	JOB	\$225	\$225

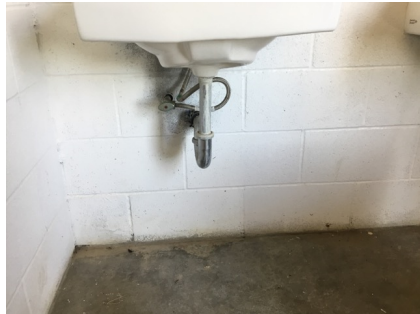
1851	<ul style="list-style-type: none"> • <i>As-Built Description:</i> Hot or sharp-surfaced water/drain pipe not insulated or covered. • <i>Proposed Solution:</i> Insulate or cover water/drain pipe. 	PCODE WD05 ADAAG 91 4.19.4 ADA 2010 606.5 CBC 2007 1115B.4.3.4 CBC 2019 11B-606.5 Mitigated: <input type="radio"/> YES <input checked="" type="radio"/> NO	1	JOB	\$360	\$360

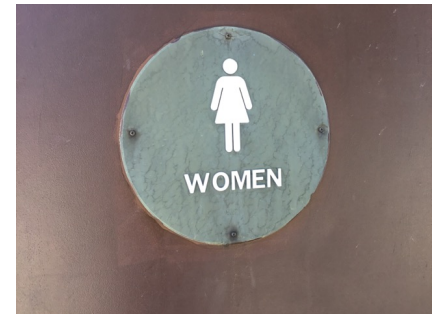
1850	<ul style="list-style-type: none"> As-Built Description: Required in CA only: identification symbol centered 58" to 60" high on sanitary facility door that contrasts with the door not provided (women: 12" ø circle, men: 12" triangle, unisex: combined symbol). As-Built: 61.5" Proposed Solution: Provide properly mounted sanitary facility symbol when altering area. If wheelchair accessible, include International Symbol of Accessibility on sign. 	<p>PCODE SA15 CBC 2007 1115B.6 CBC 2019 11B-703.7.2.6</p> <p>Mitigated: <input type="radio"/> YES <input checked="" type="radio"/> NO</p>	1	JOB	\$270	\$270
------	---	--	---	-----	-------	-------

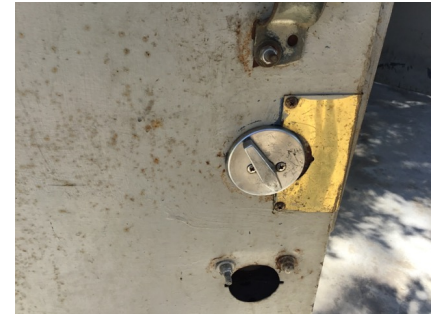
- 1884
- *As-Built Description:*
Door lock, latch or handle less than 34" or more than 48" above the floor (CA only: 34" to 44").
 - *As-Built:* **48.0" high**
 - *Proposed Solution:*
Relocate or replace existing hardware.
 - *Notes:*

PCODE ID17
 ADAAG 91 4.13.9
 ADA 2010 404.2.7
 CBC 2007 1133B.2.5.2
 CBC 2019 11B-404.2.7

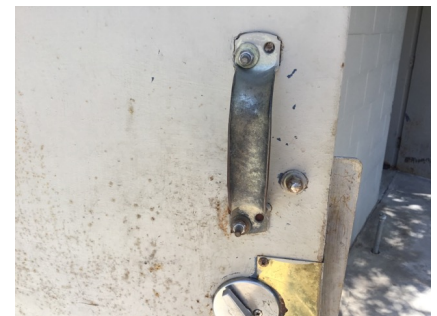
- 1885
- *As-Built Description:*
Door lock, latch or handle less than 34" or more than 48" above the floor (CA only: 34" to 44").
 - *As-Built:* **53.0" high**
 - *Proposed Solution:*
Relocate or replace existing hardware.

PCODE ID17
 ADAAG 91 4.13.9
 ADA 2010 404.2.7
 CBC 2007 1133B.2.5.2
 CBC 2019 11B-404.2.7

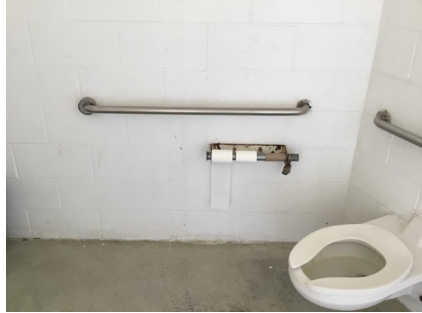
<p>1881</p> <ul style="list-style-type: none"> <i>As-Built Description:</i> Side grab bar less than 42" long, or located more than 12 inches max. from the rear wall, or extending less than 54" from rear wall (CA only: front end min. 24" in front of water closet). <i>As-Built:</i> Extends 52.0" <i>Proposed Solution:</i> Provide or relocate accessible side grab bar. 	<p><i>PCODE</i> WB07A <i>ADAAG 91</i> Fig. 29(b) <i>ADA 2010</i> 604.5.1 <i>CBC 2007</i> 1115B.4.1.3.1 <i>CBC 2019</i> 11B-604.5.1</p> <p>Mitigated: <input type="radio"/> YES <input checked="" type="radio"/> NO</p>	<p>1 JOB \$780 \$780</p>

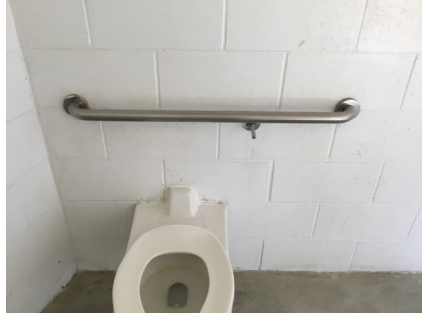
<p>1880</p> <ul style="list-style-type: none"> <i>As-Built Description:</i> The rear wall grab is less than 36" min. or does not extend from the centerline of the water closet 12" min. on one side and 24" min. on the other side. <i>As-Built:</i> Extends 23.0" on wide side <i>Proposed Solution:</i> Provide or relocate accessible rear grab bar. <i>Notes:</i> 	<p><i>PCODE</i> WB07B <i>ADAAG 91</i> 4.17.6 <i>ADA 2010</i> 604.5.2 <i>CBC 2007</i> 1115B.4.1.3.2 <i>CBC 2019</i> 11B-604.5.2</p> <p>Mitigated: <input type="radio"/> YES <input checked="" type="radio"/> NO</p>	<p>1 JOB \$1,020 \$1,020</p>

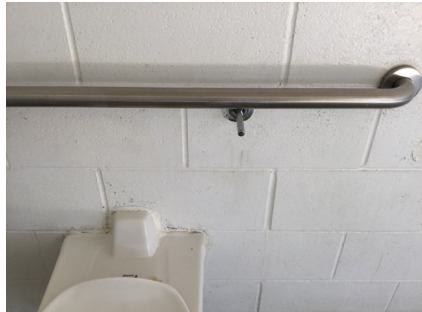
Item no., Rm no. and Name	Existing Architectural Barrier and Proposed Solution	Codes / Mitigation Info	Qty	Unit	Cost	Total
1883	<ul style="list-style-type: none"> As-Built Description: Accessories/dispensers in accessible stall located closer than 1-1/2" below or 12" above grab bar impedes its use. As-Built: Flush control: 1.3" below grab bar Proposed Solution: Raise the grab bar. 	PCODE WB07I ADAAG 91 4.26.2 ADA 2010 609.3 CBC 2007 1133B.4.2.5 CBC 2019 11B-609.3 Mitigated: <input type="radio"/> YES <input checked="" type="radio"/> NO	1	JOB	\$225	\$225

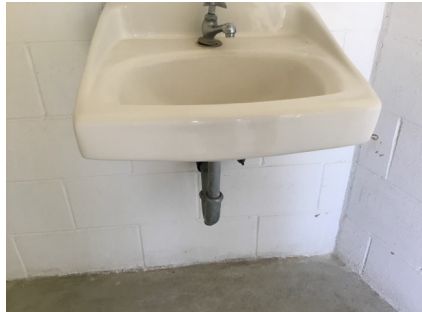
1877	<ul style="list-style-type: none"> As-Built Description: Wheelchair clearance under lavatory apron or lavatory counter front edge less than 29" high. As-Built: 28.7" high Proposed Solution: Remount compliant fixture to accessible height. Notes: 	PCODE WD03A ADAAG 91 4.19.2 ADA 2010 606.3 CBC 2007 1115B.4.3.3 CBC 2019 11B-306.3.1 Mitigated: <input type="radio"/> YES <input checked="" type="radio"/> NO	1	JOB	\$3,000	\$3,000

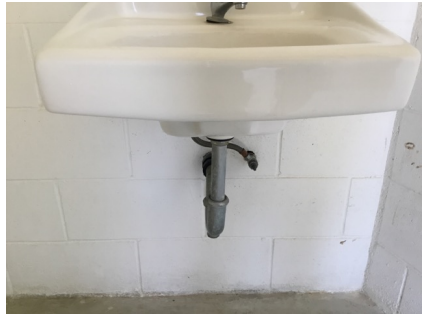
Item no., Rm no. and Name	Existing Architectural Barrier and Proposed Solution	Codes / Mitigation Info	Qty	Unit	Cost	Total
1878	<ul style="list-style-type: none"> <i>As-Built Description:</i> Hot or sharp-surfaced water/drain pipe not insulated or covered. <i>Proposed Solution:</i> Insulate or cover water/drain pipe. 	PCODE WD05 ADAAG 91 4.19.4 ADA 2010 606.5 CBC 2007 1115B.4.3.4 CBC 2019 11B-606.5 Mitigated: <input type="radio"/> YES <input checked="" type="radio"/> NO	1	JOB	\$360	\$360

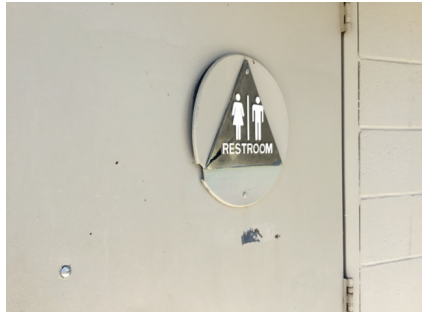
Item no., Rm no. and Name	Existing Architectural Barrier and Proposed Solution	Codes / Mitigation Info	Qty	Unit	Cost	Total
1876	<ul style="list-style-type: none"> <i>As-Built Description:</i> Required in CA only: identification symbol centered 58" to 60" high on sanitary facility door that contrasts with the door not provided (women: 12" ø circle, men: 12" triangle, unisex: combined symbol). <i>As-Built:</i> Not contrast. 64.0" high o.c. <i>Proposed Solution:</i> Provide properly mounted sanitary facility symbol when altering area. If wheelchair accessible, include International Symbol of Accessibility on sign. 	PCODE SA15 CBC 2007 1115B.6 CBC 2019 11B-703.7.2.6 Mitigated: <input type="radio"/> YES <input checked="" type="radio"/> NO	1	JOB	\$270	\$270

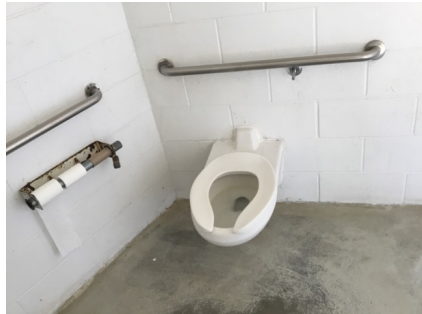
1879	<ul style="list-style-type: none"> <i>As-Built Description:</i> Water closet not 16"-18" (CA: 17"-18") from near side wall to center line of water closet (2010 ADAAG: 16"-18"). <i>As-Built:</i> 19.0" to 26.0" due to diagonal wall. <i>Proposed Solution:</i> Relocate existing water closet and plumbing, remount with offset closet flange to provide 18" max. from side wall. Adjust side wall as needed. 	PCODE WB02C ADAAG 91 Fig. 28 ADA 2010 604.2 CBC 2007 1115B.4.1.1 CBC 2019 11B-604.2 Mitigated: <input type="radio"/> YES <input checked="" type="radio"/> NO	1	JOB	\$3,000	\$3,000

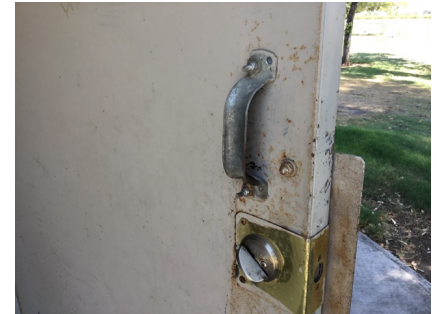
- *As-Built Description:*
Door lock, latch or handle less than 34" or more than 48" above the floor (CA only: 34" to 44").
- *As-Built:* **53.0" high**
- *Proposed Solution:*
Relocate or replace existing hardware.

PCODE ID17
 ADAAG 91 4.13.9
 ADA 2010 404.2.7
 CBC 2007 1133B.2.5.2
 CBC 2019 11B-404.2.7

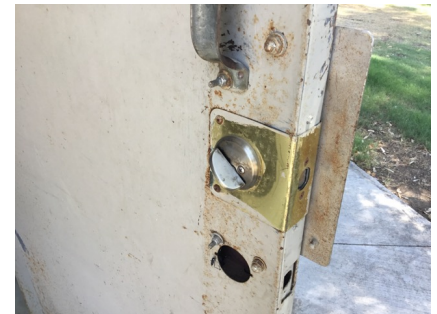
- *As-Built Description:*
Door lock, latch or handle less than 34" or more than 48" above the floor (CA only: 34" to 44").
- *As-Built:* **48.0" high**
- *Proposed Solution:*
Relocate or replace existing hardware.
- **Notes:**

PCODE ID17
 ADAAG 91 4.13.9
 ADA 2010 404.2.7
 CBC 2007 1133B.2.5.2
 CBC 2019 11B-404.2.7
