The City of Madera

Appendix B: Facilities

Access Compliance Survey Report

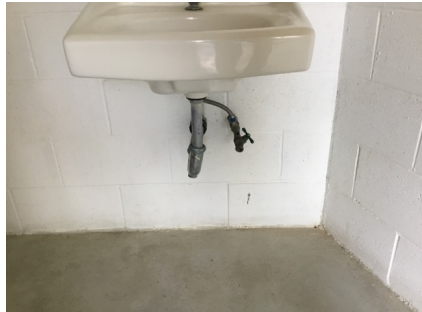
Item no., Rm no. and Name	Existing Architectural Barrier and Proposed Solution	Codes / Mitigation Info	Qty	Unit	Cost	Total
1895	<ul style="list-style-type: none"> <i>As-Built Description:</i> Hot or sharp-surfaced water/drain pipe not insulated or covered. <i>Proposed Solution:</i> Insulate or cover water/drain pipe. 	PCODE WD05 ADAAG 91 4.19.4 ADA 2010 606.5 CBC 2007 1115B.4.3.4 CBC 2019 11B-606.5 Mitigated: <input type="radio"/> YES <input checked="" type="radio"/> NO	1	JOB	\$360	\$360

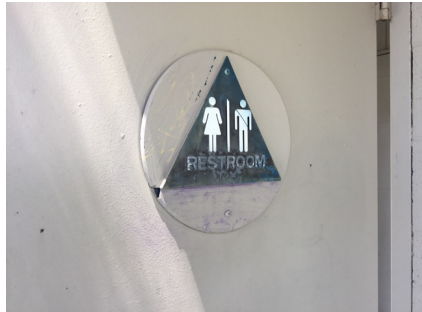
Item no., Rm no. and Name	Existing Architectural Barrier and Proposed Solution	Codes / Mitigation Info	Qty	Unit	Cost	Total
1889	<ul style="list-style-type: none"> As-Built Description: Required in CA only: identification symbol centered 58" to 60" high on sanitary facility door that contrasts with the door not provided (women: 12" ø circle, men: 12" triangle, unisex: combined symbol). As-Built: Not contrast 65.0" high o.c. Proposed Solution: Provide properly mounted sanitary facility symbol when altering area. If wheelchair accessible, include International Symbol of Accessibility on sign. 	PCODE SA15 CBC 2007 1115B.6 CBC 2019 11B-703.7.2.6 Mitigated: <input type="radio"/> YES <input checked="" type="radio"/> NO	1	JOB	\$270	\$270

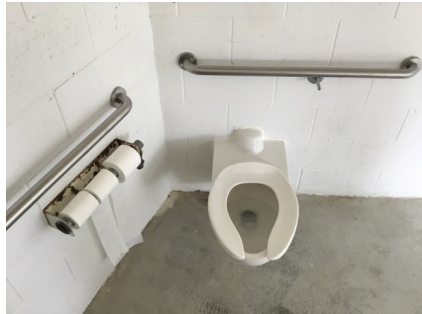
1892	<ul style="list-style-type: none"> As-Built Description: Water closet not 16"-18" (CA: 17"-18") from near side wall to center line of water closet (2010 ADAAG: 16"-18"). As-Built: 16.75" to 26.0" o.c. Proposed Solution: Relocate existing water closet and plumbing, remount with offset closet flange to provide 18" max. from side wall. Adjust wall as needed. 	PCODE WB02C ADAAG 91 Fig. 28 ADA 2010 604.2 CBC 2007 1115B.4.1.1 CBC 2019 11B-604.2 Mitigated: <input type="radio"/> YES <input checked="" type="radio"/> NO	1	JOB	\$3,000	\$3,000

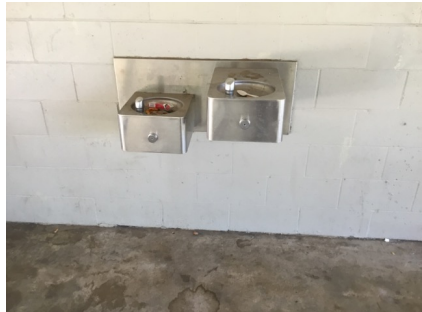
Item no., Rm no. and Name	Existing Architectural Barrier and Proposed Solution	Codes / Mitigation Info	Qty	Unit	Cost	Total
1913	<ul style="list-style-type: none"> As-Built Description: Drinking fountain lacks protection for visually impaired persons. Proposed Solution: Provide cane-detectable rails. 	PCODE IA05C ADAAG 91 4.4.1 ADA 2010 307.2 CBC 2007 1115B.4.6.3 CBC 2019 11B-307.2 Mitigated: <input type="radio"/> YES <input checked="" type="radio"/> NO	1	JOB	\$1,500	\$1,500

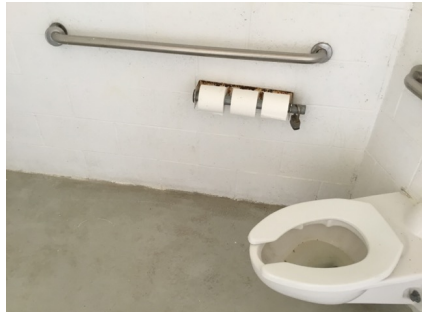
1907	<ul style="list-style-type: none"> As-Built Description: Side grab bar less than 42" long, or located more than 12 inches max. from the rear wall, or extending less than 54" from rear wall (CA only: front end min. 24" in front of water closet). As-Built: Extends 51.0" Proposed Solution: Provide or relocate accessible side grab bar. 	PCODE WB07A ADAAG 91 Fig. 29(b) ADA 2010 604.5.1 CBC 2007 1115B.4.1.3.1 CBC 2019 11B-604.5.1 Mitigated: <input type="radio"/> YES <input checked="" type="radio"/> NO	1	JOB	\$780	\$780

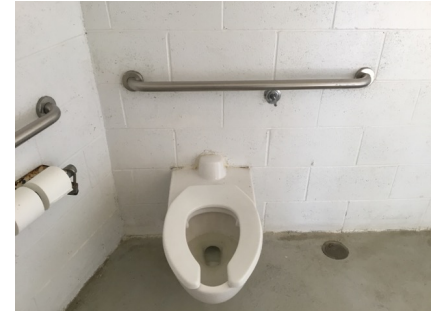
Item no., Rm no. and Name	Existing Architectural Barrier and Proposed Solution	Codes / Mitigation Info	Qty	Unit	Cost	Total
1905	<ul style="list-style-type: none"> <i>As-Built Description:</i> The rear wall grab is less than 36" min. or does not extend from the centerline of the water closet 12" min. on one side and 24" min. on the other side. <i>As-Built:</i> Extends 22.5" on wide side <i>Proposed Solution:</i> Provide or relocate accessible rear grab bar. 	PCODE WB07B ADAAG 91 4.17.6 ADA 2010 604.5.2 CBC 2007 1115B.4.1.3.2 CBC 2019 11B-604.5.2	1	JOB	\$1,020	\$1,020
		Mitigated: <input type="radio"/> YES <input checked="" type="radio"/> NO				
		<input type="radio"/> Staff Only				
		Priority <input checked="" type="radio"/> 3				
		Severity <input checked="" type="radio"/> 4

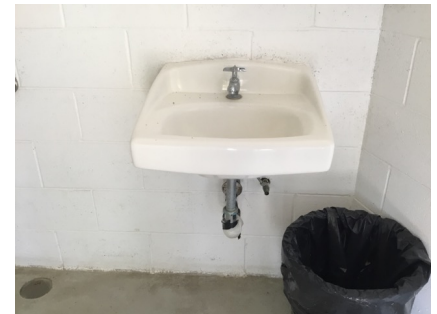
1909	<ul style="list-style-type: none"> <i>As-Built Description:</i> Wheelchair clearance under lavatory apron or lavatory counter front edge less than 29" high. <i>As-Built:</i> 28.8" high <i>Proposed Solution:</i> Remount compliant fixture to accessible height. Notes: 	PCODE WD03A ADAAG 91 4.19.2 ADA 2010 606.3 CBC 2007 1115B.4.3.3 CBC 2019 11B-306.3.1	1	JOB	\$3,000	\$3,000
		Mitigated: <input type="radio"/> YES <input checked="" type="radio"/> NO				
		<input type="radio"/> Staff Only				
		Priority <input checked="" type="radio"/> 3				
		Severity <input checked="" type="radio"/> 3

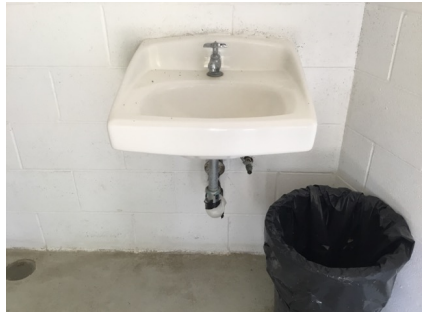
Item no., Rm no. and Name	Existing Architectural Barrier and Proposed Solution	Codes / Mitigation Info	Qty	Unit	Cost	Total
1908	<ul style="list-style-type: none"> As-Built Description: Hot or sharp-surfaced water/drain pipe not insulated or covered. Proposed Solution: Insulate or cover water/drain pipe. 	PCODE WD05 ADAAG 91 4.19.4 ADA 2010 606.5 CBC 2007 1115B.4.3.4 CBC 2019 11B-606.5 Mitigated: <input type="radio"/> YES <input checked="" type="radio"/> NO	1	JOB	\$360	\$360

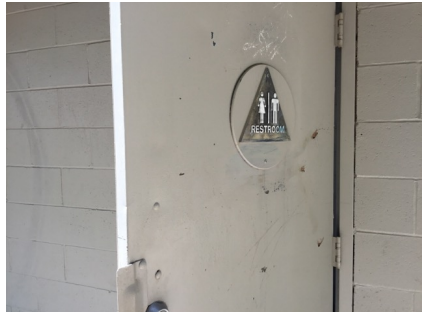
Item no., Rm no. and Name	Existing Architectural Barrier and Proposed Solution	Codes / Mitigation Info	Qty	Unit	Cost	Total
1911	<ul style="list-style-type: none"> <i>As-Built Description:</i> Required in CA only: identification symbol centered 58" to 60" high on sanitary facility door that contrasts with the door not provided (women: 12" ø circle, men: 12" triangle, unisex: combined symbol). <i>As-Built:</i> Not contrast. 65.0" high o.c. <i>Proposed Solution:</i> Provide properly mounted sanitary facility symbol when altering area. If wheelchair accessible, include International Symbol of Accessibility on sign. 	PCODE SA15 CBC 2007 1115B.6 CBC 2019 11B-703.7.2.6 Mitigated: <input type="radio"/> YES <input checked="" type="radio"/> NO	1	JOB	\$270	\$270

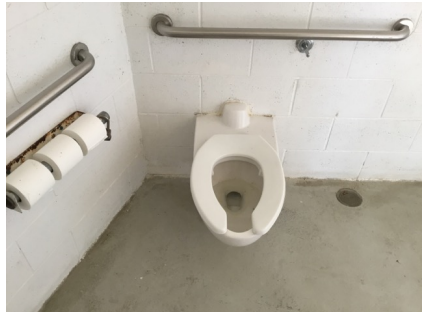
1906	<ul style="list-style-type: none"> <i>As-Built Description:</i> Water closet not 16"-18" (CA: 17"-18") from near side wall to center line of water closet (2010 ADAAG: 16"-18"). <i>As-Built:</i> 18.0" to 28.0" o.c. <i>Proposed Solution:</i> Relocate existing water closet and plumbing, remount with offset closet flange to provide 18" max. from side wall. Adjust wall as needed. 	PCODE WB02C ADAAG 91 Fig. 28 ADA 2010 604.2 CBC 2007 1115B.4.1.1 CBC 2019 11B-604.2 Mitigated: <input type="radio"/> YES <input checked="" type="radio"/> NO	1	JOB	\$3,000	\$3,000

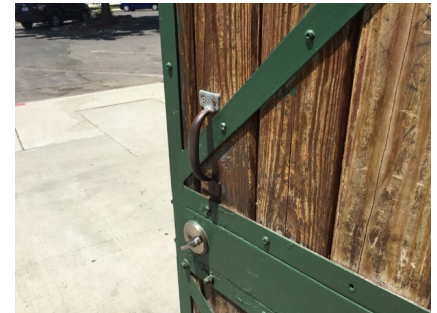
- 1928
- *As-Built Description:*
Door lock, latch or handle less than 34" or more than 48" above the floor (CA only: 34" to 44").
 - *As-Built:* **48.0" high**
 - *Proposed Solution:*
Relocate or replace existing hardware.
 - *Notes:*

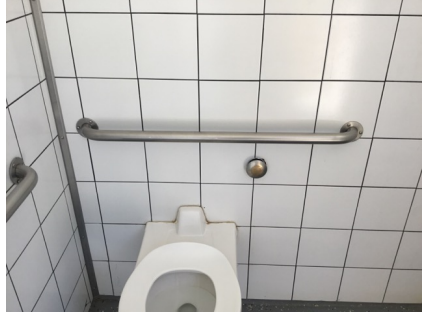
<p>1925</p> <ul style="list-style-type: none"> <i>As-Built Description:</i> The rear wall grab is less than 36" min. or does not extend from the centerline of the water closet 12" min. on one side and 24" min. on the other side. <i>As-Built:</i> Extends 22.0" on wide side <i>Proposed Solution:</i> Provide or relocate accessible rear grab bar. <i>Notes:</i> 	<p>PCODE WB07B ADAAG 91 4.17.6 ADA 2010 604.5.2 CBC 2007 1115B.4.1.3.2 CBC 2019 11B-604.5.2</p> <p>Mitigated: <input type="radio"/> YES <input checked="" type="radio"/> NO</p>	<p>1 JOB \$1,020 \$1,020</p>

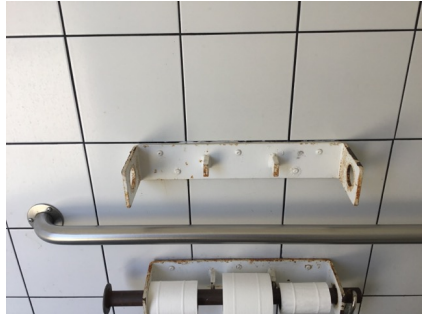
<p>1924</p> <ul style="list-style-type: none"> <i>As-Built Description:</i> Accessories/dispensers in accessible stall located closer than 1-1/2" below or 12" above grab bar impedes its use. <i>As-Built:</i> TPD: 3.0" above grab bar <i>Proposed Solution:</i> Relocate accessories/dispensers within applicable reach range and to be no closer than 1-1/2" below and 12" above grab bars (except if accessories are recessed, flush with wall, and have no sharp edges). 	<p>PCODE WB07I ADAAG 91 4.26.2 ADA 2010 609.3 CBC 2007 1133B.4.2.5 CBC 2019 11B-609.3</p> <p>Mitigated: <input type="radio"/> YES <input checked="" type="radio"/> NO</p>	<p>1 JOB \$225 \$225</p>

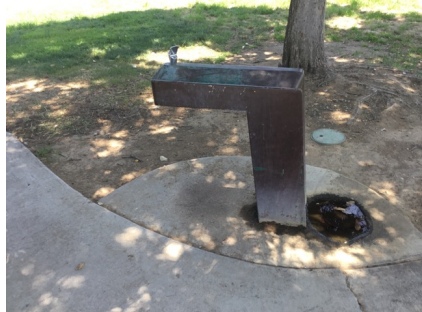
1938	<ul style="list-style-type: none"> As-Built Description: Where only one drinking fountain is provided per floor: Fountain is not accessible to individuals who use wheelchairs, or to those who have difficulty bending or stooping. Proposed Solution: Provide additional fountain or hi-lo combination fountain. 	PCODE IA01A ADAAG 91 4.1.3(10)(a) ADA 2010 211.1 CBC 2007 1115B.4.6.1 CBC 2019 11B-211.1 Mitigated: <input type="radio"/> YES <input checked="" type="radio"/> NO	1	JOB	\$6,000	\$6,000

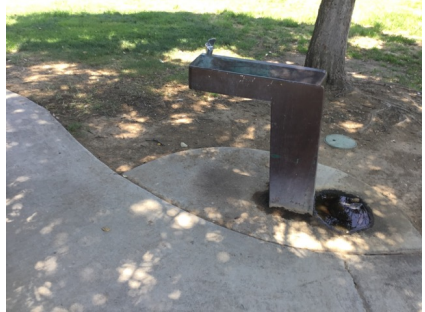
Item no., Rm no. and Name	Existing Architectural Barrier and Proposed Solution	Codes / Mitigation Info	Qty	Unit	Cost	Total
1939	<ul style="list-style-type: none"> <i>As-Built Description:</i> Drinking fountain lacks protection for visually impaired persons. <i>Proposed Solution:</i> Provide cane-detectable rails. 	PCODE IA05C ADAAG 91 4.4.1 ADA 2010 307.2 CBC 2007 1115B.4.6.3 CBC 2019 11B-307.2 Mitigated: <input type="radio"/> YES <input checked="" type="radio"/> NO	1	JOB	\$1,500	\$1,500

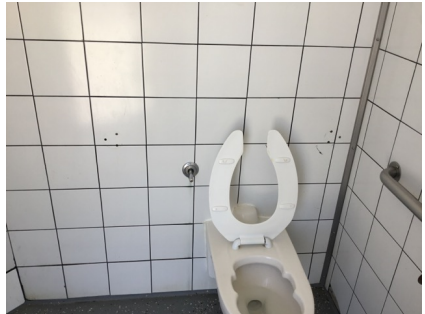
1933	<ul style="list-style-type: none"> <i>As-Built Description:</i> Grab bars not provided or are not code compliant. <i>Proposed Solution:</i> Provide accessible grab bars. 	PCODE WB07 ADAAG 91 4.17.6 ADA 2010 604.5 CBC 2007 1115B.4.1.3 CBC 2019 11B-604.5 Mitigated: <input type="radio"/> YES <input checked="" type="radio"/> NO	1	JOB	\$1,500	\$1,500

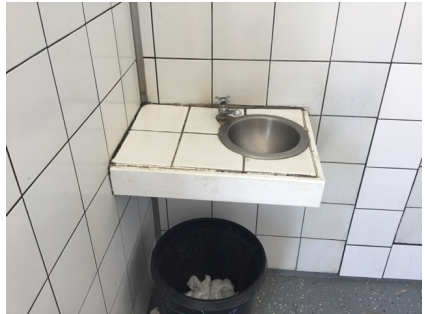
1936	<ul style="list-style-type: none"> As-Built Description: Clear floor space, 30" x 48" in front of fixture, extending 19" max. under the lavatory, not provided (CA only: Less than 18" from side wall to centerline of lavatory). As-Built: 17.25" o.c. Proposed Solution: Provide new accessible lavatory. Remodel restroom as needed. Notes: 	PCODE WD01 ADAAG 91 4.19.3 ADA 2010 606.2 CBC 2007 1115B.4.3 CBC 2019 11B-606.2, 11B-606.6 Mitigated: <input type="radio"/> YES <input checked="" type="radio"/> NO	1	JOB	\$3,000	\$3,000
------	---	---	---	-----	---------	---------

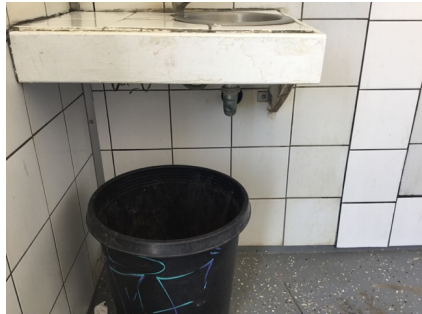
Item no., Rm no. and Name	Existing Architectural Barrier and Proposed Solution	Codes / Mitigation Info	Qty	Unit	Cost	Total
1935	<ul style="list-style-type: none"> As-Built Description: Hot or sharp-surfaced water/drain pipe not insulated or covered. Proposed Solution: Insulate or cover water/drain pipe. 	PCODE WD05 ADAAG 91 4.19.4 ADA 2010 606.5 CBC 2007 1115B.4.3.4 CBC 2019 11B-606.5 Mitigated: <input type="radio"/> YES <input checked="" type="radio"/> NO	1	JOB	\$360	\$360

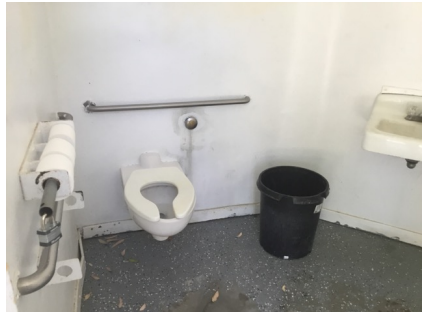
Item no., Rm no. and Name	Existing Architectural Barrier and Proposed Solution	Codes / Mitigation Info	Qty	Unit	Cost	Total
1961	<ul style="list-style-type: none"> As-Built Description: 60" min. clearance around a water closet measured perpendicular from the side wall not provided (Fixtures are not allowed to overlap this clearance). As-Built: 51.0" to diagonal wall Proposed Solution: Relocate adjacent fixture and remodel restroom as needed. 	PCODE WB01A ADA 2010 604.3.1; 604.3.2 CBC 2007 1115B.7.1.3 CBC 2019 11B-604.3.1; 11B-604.3.2 Mitigated: <input type="radio"/> YES <input checked="" type="radio"/> NO	1	JOB	\$3,000	\$3,000

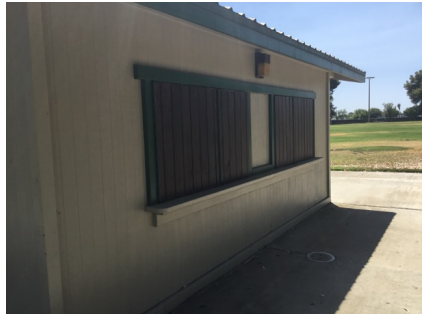
1962	<ul style="list-style-type: none"> As-Built Description: Food tray pass-thru at institutional cafeteria has lower edge higher than 34" above floor. As-Built: 36.0" high. Proposed Solution: Remodel pass-thru and counter to be 34" max. above floor. 	PCODE FB04 ADAAG 91 5.2 ADA 2010 902.3 CBC 2007 1122B.4 CBC 2019 11B-902.3 Mitigated: <input type="radio"/> YES <input checked="" type="radio"/> NO	15	JOB	\$9,900	\$148,500

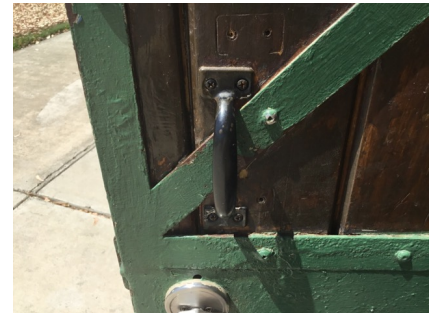
- 1952
- *As-Built Description:*
Door lock, latch or handle less than 34" or more than 48" above the floor (CA only: 34" to 44").
 - *As-Built:* **48.0" high**
 - *Proposed Solution:*
Relocate or replace existing hardware.
 - *Notes:*

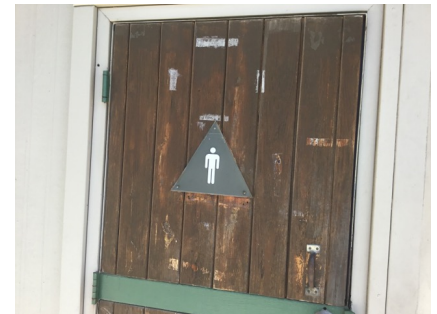
1951	<ul style="list-style-type: none"> As-Built Description: Required in CA only: identification symbol centered 58" to 60" high on sanitary facility door that contrasts with the door not provided (women: 12" ø circle, men: 12" triangle, unisex: combined symbol). As-Built: 61.0" high o.c. Proposed Solution: Provide properly mounted sanitary facility symbol when altering area. If wheelchair accessible, include International Symbol of Accessibility on sign. 	PCODE SA15 CBC 2007 1115B.6 CBC 2019 11B-703.7.2.6	1	JOB	\$270	\$270
------	--	--	---	-----	-------	-------

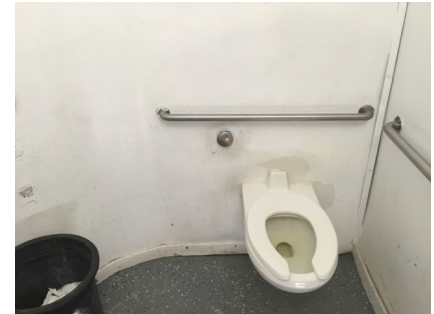
1955	<ul style="list-style-type: none"> As-Built Description: 60" min. clearance around a water closet measured perpendicular from the side wall not provided (Fixtures are not allowed to overlap this clearance). As-Built: 43.0" to diagonal wall. Proposed Solution: Remodel restroom. Notes: 	<p>PCODE WB01A</p> <p>ADA 2010 604.3.1; 604.3.2</p> <p>CBC 2007 1115B.7.1.3</p> <p>CBC 2019 11B-604.3.1; 11B-604.3.2</p> <p>Mitigated:</p> <p><input type="radio"/> YES</p> <p><input checked="" type="radio"/> NO</p>	1	JOB	\$3,000	\$3,000
------	---	--	---	-----	---------	---------

This element complies with Safe Harbor if altered or constructed before March 15, 2012. This element does not comply with the dimensional requirements in the 1981 to the current CBC.

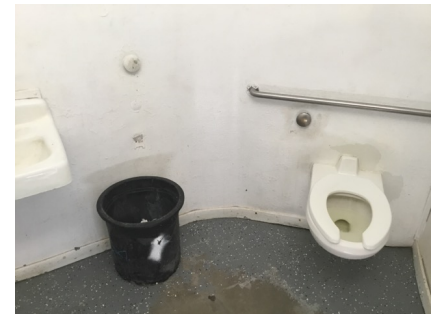
1956	<ul style="list-style-type: none"> As-Built Description: 60" min. clearance around a water closet measured perpendicular from the side wall not provided (Fixtures are not allowed to overlap this clearance). As-Built: 59.5" to lavatory Proposed Solution: Relocate adjacent fixture and remodel restroom as needed. Notes: 	<p>PCODE WB01A</p> <p>ADA 2010 604.3.1; 604.3.2</p> <p>CBC 2007 1115B.7.1.3</p> <p>CBC 2019 11B-604.3.1; 11B-604.3.2</p> <p>Mitigated:</p> <p><input type="radio"/> YES</p> <p><input checked="" type="radio"/> NO</p>	1	JOB	\$3,000	\$3,000
------	---	--	---	-----	---------	---------

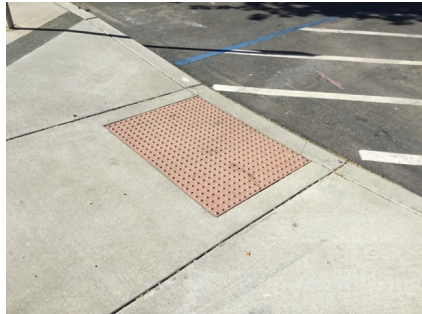
Domes 6.0” from sides.

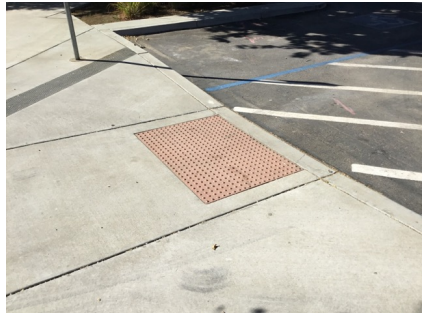
Detectable warning not contrast.

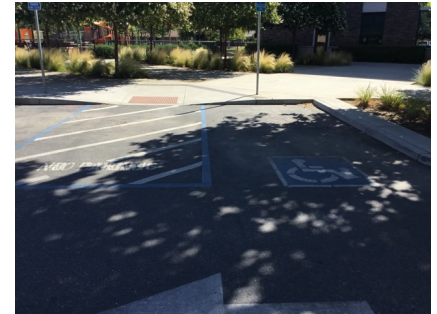
972	<ul style="list-style-type: none"> As-Built Description: Accessible parking space has slope greater than 1/4":12" (2%). As-Built: 5.0% Proposed Solution: Modify slope at accessible parking space. Notes: 	PCODE EA05 ADAAG 91 4.6.3 ADA 2010 502.4 CBC 2007 1129B.3.3 CBC 2019 11B-502.4 Mitigated: <input type="radio"/> YES <input checked="" type="radio"/> NO	30	SF	\$36	\$1,080
-----	---	---	----	----	------	---------

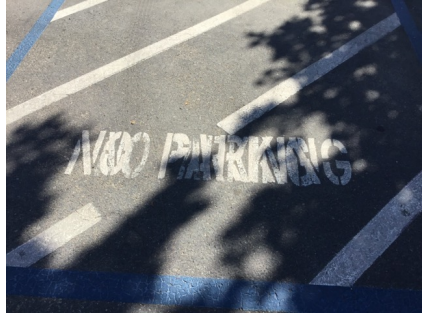
Illegible.

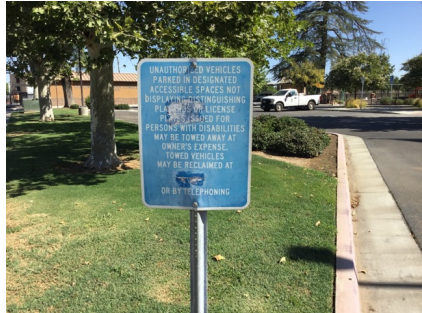
Info. Words obscured.

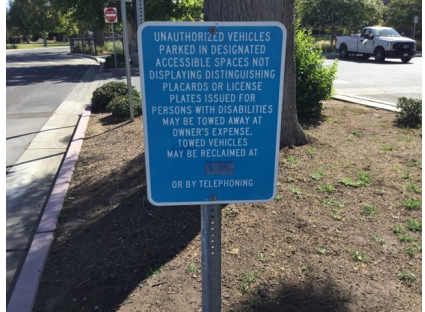
Item no., Rm no. and Name	Existing Architectural Barrier and Proposed Solution	Codes / Mitigation Info	Qty	Unit	Cost	Total
975	<ul style="list-style-type: none"> As-Built Description: No "Tow Away" sign at parking lot entrance (required in CA only). Proposed Solution: Provide "Tow Away" sign at parking lot entrance when altering area. Notes: 	<p>PCODE EA04C</p> <p>CBC 2007 1129B.4</p> <p>CBC 2019 11B-502.8.2</p> <p>Mitigated:</p> <p><input type="radio"/> YES</p> <p><input checked="" type="radio"/> NO</p>	1	JOB	\$975	\$975

Info. Size and color.

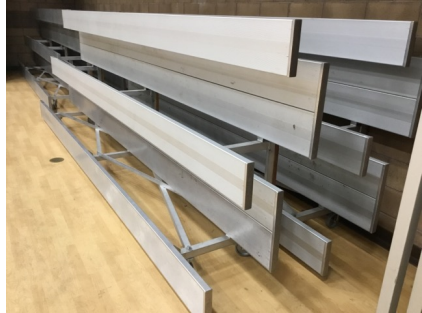
<p>977</p> <ul style="list-style-type: none"> As-Built Description: At least one fixed companion seat next to each wheelchair seating area is not provided. Proposed Solution: Provide one companion seat next to each accessible wheelchair space(s). Notes: 	<p>PCODE GE01B ADAAG 91 4.33.3 ADA 2010 221.3 CBC 2007 1104B.3.5 CBC 2019 11B-221.3</p> <p>Mitigated: <input type="radio"/> YES <input checked="" type="radio"/> NO</p>	<p>1 EA \$1,050 \$1,050</p>

No companion seat. Verify.

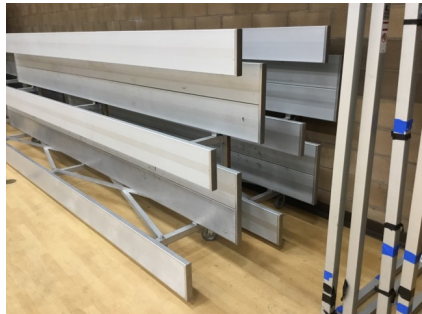
<p>976</p> <ul style="list-style-type: none"> As-Built Description: Proper amount of seating for disabled persons at public seating is not provided (>25=1; >50=2; >300=4; >500=6; +500=6=1%). Proposed Solution: Modify seating to provide clear and level wheelchair space 33" x 48" or 33" x 60", including companion seat, as required. Notes: 	<p>PCODE GE01NT ADAAG 91 4.1.2(19)a ADA 2010 221.2.1 CBC 2007 1104B.3.4.1 CBC 2019 11B-221.2.1</p> <p>Mitigated: <input type="radio"/> YES <input checked="" type="radio"/> NO</p>	<p>1 EA \$1,800 \$1,800</p>

No integral wheelchair seating. Verify.

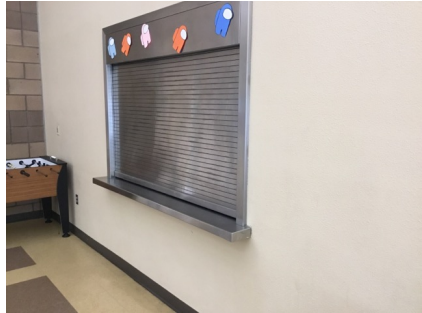
Item no., Rm no. and Name	Existing Architectural Barrier and Proposed Solution	Codes / Mitigation Info	Qty	Unit	Cost	Total
980	<ul style="list-style-type: none"> As-Built Description: Protruding objects more than 4" from wall, when bottom of object more than 27" or less than 80" above finished floor. As-Built: Service counter: 6.0" at 31.5" high Proposed Solution: Provide cane-detectable railing to mark area of low clearance. 	PCODE EG04A ADAAG 91 4.4.1 ADA 2010 307.2 CBC 2007 1133B.8.6.1 CBC 2019 11B-307.2 Mitigated: <input type="radio"/> YES <input checked="" type="radio"/> NO	7	LF	\$300	\$2,100

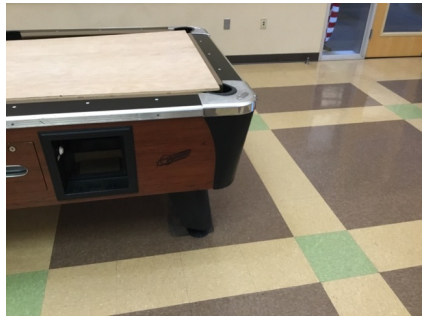
<input type="radio"/> Staff Only			
			Priority 2			
			Severity 3			
983	<ul style="list-style-type: none"> As-Built Description: Protruding objects more than 4" from wall, when bottom of object more than 27" or less than 80" above finished floor. As-Built: Pool table: 9.0" at 30.0" high Proposed Solution: Provide cane-detectable railing to mark area of low clearance. 	PCODE EG04A ADAAG 91 4.4.1 ADA 2010 307.2 CBC 2007 1133B.8.6.1 CBC 2019 11B-307.2 Mitigated: <input type="radio"/> YES <input checked="" type="radio"/> NO	24	LF	\$300	\$7,200

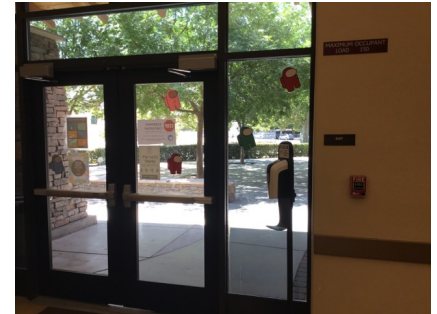
1017	<ul style="list-style-type: none"> As-Built Description: Sign not located on latch side of door and/or not located at 48" min. above to baseline of the lowest Braille cells and 60" max. to baseline of the highest line of raised characters. As-Built: Not adjacent Proposed Solution: Provide compliant signage including tactile characters and Grade II Braille on latch side of door located at compliant height. 	PCODE SA07 ADAAG 91 4.30.6 ADA 2010 703.4.1 CBC 2007 1117B.5.7 CBC 2019 11B-703.4.1	1	JOB	\$150	\$150
------	--	---	---	-----	-------	-------

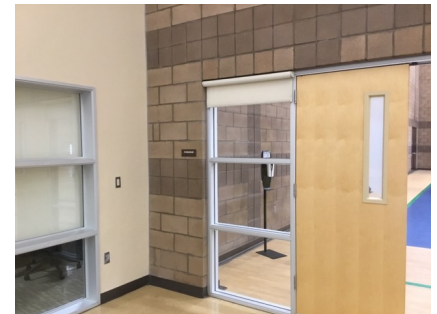
1018	<ul style="list-style-type: none"> As-Built Description: Sign not located on latch side of door and/or not located at 48" min. above to baseline of the lowest Braille cells and 60" max. to baseline of the highest line of raised characters. As-Built: Wrong side Proposed Solution: Provide compliant signage including tactile characters and Grade II Braille on latch side of door located at compliant height. 	PCODE SA07 ADAAG 91 4.30.6 ADA 2010 703.4.1 CBC 2007 1117B.5.7 CBC 2019 11B-703.4.1	1	JOB	\$150	\$150
------	--	---	---	-----	-------	-------

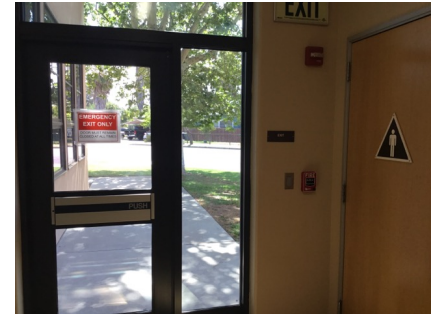
1005	<ul style="list-style-type: none"> As-Built Description: Sign not located on latch side of door and/or not located at 48" min. above to baseline of the lowest Braille cells and 60" max. to baseline of the highest line of raised characters. Proposed Solution: Provide compliant signage including tactile characters and Grade II Braille on latch side of door located at compliant height. Notes: 	<p>PCODE SA07 ADAAG 91 4.30.6 ADA 2010 703.4.1 CBC 2007 1117B.5.7 CBC 2019 11B-703.4.1</p> <p>Mitigated: <input type="radio"/> YES <input checked="" type="radio"/> NO</p>	1	JOB	\$150	\$150
------	--	---	---	-----	-------	-------

Not adjacent to door. Exit Sign is blocked when restroom doors is held open.

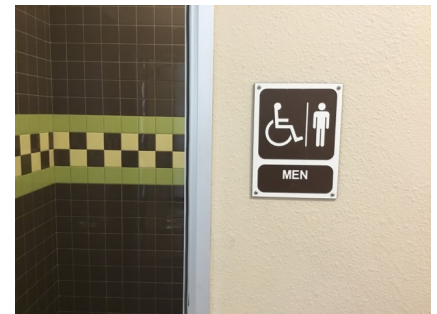
990	<ul style="list-style-type: none"> As-Built Description: Signs containing tactile characters is not located so that a clear floor space of 18" min x 18" min., centered on the tactile characters, is provided beyond the arc of any door swing between the closed position and 45 degree open position. As-Built: 7.6" to door swing Proposed Solution: Relocate compliant signage on latch side of door located at compliant height with a clear floor space. Notes: 	<p>PCODE SA07B ADA 2010 703.4.2 CBC 2019 11B-703.4.2</p> <p>Mitigated: <input type="radio"/> YES <input checked="" type="radio"/> NO</p>	1	JOB	\$150	\$150
-----	---	---	---	-----	-------	-------

Before the 2010 ADA there was no measurement defining what it meant to stand outside of the door swing, and no requirement that the CLFS be centered, therefore consider whether this condition complies with 1991 ADA and is a Safe Harbor if installed before March 15, 2012.

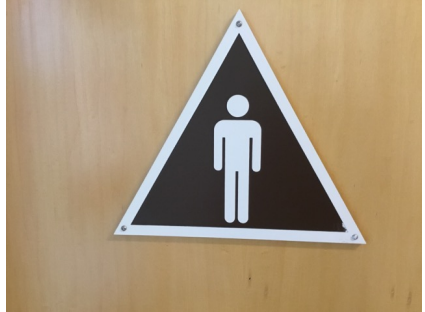
Item no., Rm no. and Name	Existing Architectural Barrier and Proposed Solution	Codes / Mitigation Info	Qty	Unit	Cost	Total
989	<ul style="list-style-type: none"> <i>As-Built Description:</i> Required in CA only: identification symbol centered 58" to 60" high on sanitary facility door that contrasts with the door not provided (women: 12" ø circle, men: 12" triangle, unisex: combined symbol). <i>As-Built:</i> No beveled or radiused. 60.4" high <i>Proposed Solution:</i> Provide properly mounted sanitary facility symbol when altering area. If wheelchair accessible, include International Symbol of Accessibility on sign. 	PCODE SA15 CBC 2007 1115B.6 CBC 2019 11B-703.7.2.6 Mitigated: <input type="radio"/> YES <input checked="" type="radio"/> NO	1	JOB	\$270	\$270

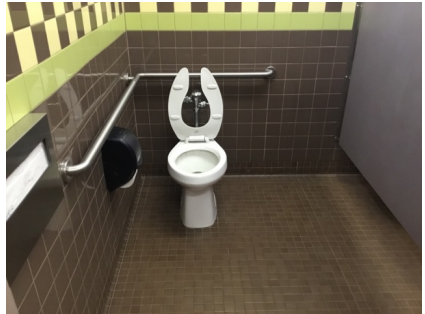
985	<ul style="list-style-type: none"> <i>As-Built Description:</i> Toilet stall less than 60" wide. <i>As-Built:</i> 59.75" <i>Proposed Solution:</i> Provide new accessible stall. 	PCODE WB06 ADAAG 91 4.17.3 ADA 2010 604.8.1.1 CBC 2007 1115B.3.1.4.1 CBC 2019 11B-604.8.1.1 Mitigated: <input type="radio"/> YES <input checked="" type="radio"/> NO	1	JOB	\$4,500	\$4,500

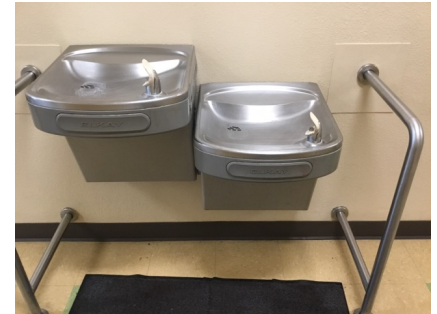
- 998
- *As-Built Description:*
Wall- and post-mounted cantilevered units: Knee space not provided at drinking fountain (27" high, 8" deep, 30" wide from front of drinking fountain). Unit in good condition.
 - *As-Built:* **26.3" knee high**
 - *Proposed Solution:*
Remount fountain at accessible height.

PCODE IA02A
 ADAAG 91 4.15.5(1)
 ADA 2010 602.2
 CBC 2007 1115B.4.6.2
 CBC 2019 11B-602.2

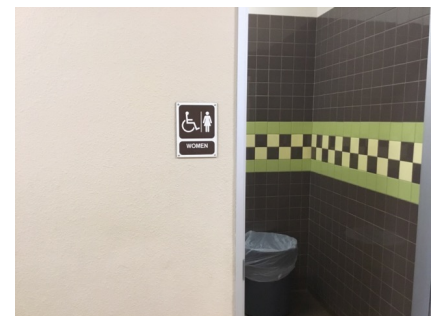
Before the 2010 ADA there was no measurement defining what it meant to stand outside of the door swing, and no requirement that the CLFS be centered, therefore consider whether this condition complies with 1991 ADA and is a Safe Harbor if installed before March 15, 2012.

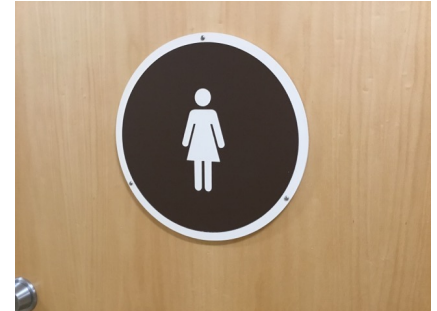
Item no., Rm no. and Name	Existing Architectural Barrier and Proposed Solution	Codes / Mitigation Info	Qty	Unit	Cost	Total
992	<ul style="list-style-type: none"> <i>As-Built Description:</i> Required in CA only: identification symbol centered 58" to 60" high on sanitary facility door that contrasts with the door not provided (women: 12" ø circle, men: 12" triangle, unisex: combined symbol). <i>As-Built:</i> Not beveled <i>Proposed Solution:</i> Provide properly mounted sanitary facility symbol when altering area. If wheelchair accessible, include International Symbol of Accessibility on sign. 	PCODE SA15 CBC 2007 1115B.6 CBC 2019 11B-703.7.2.6 Mitigated: <input type="radio"/> YES <input checked="" type="radio"/> NO	1	JOB	\$270	\$270

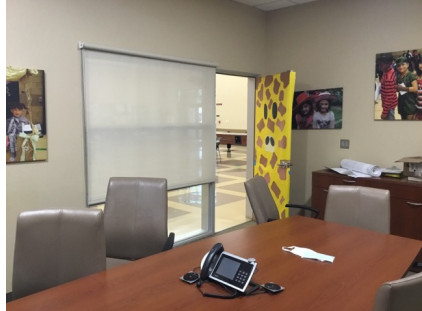
<p>1011</p> <ul style="list-style-type: none"> <i>As-Built Description:</i> At door leading into exit corridor: Where required exit signs are installed, signs to provide exiting information for people with vision impairment are not provided. <i>Proposed Solution:</i> Provide raised letter/Braille "EXIT ROUTE" sign at door. 	<p>PCODE SA10D ADAAG 91 4.1.3(16) ADA 2010 216.4.1 CBC 2007 1011.3 CBC 2019 11B-216.4.1</p> <p>Mitigated: <input type="radio"/> YES <input checked="" type="radio"/> NO</p>	<p>2 JOB \$270 \$540</p>

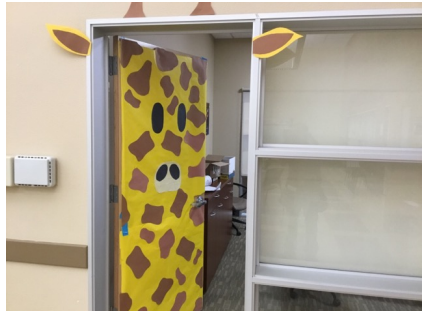
<p>1012</p> <ul style="list-style-type: none"> <i>As-Built Description:</i> Existing sign designating permanent room or space is noncompliant. <i>Proposed Solution:</i> Provide compliant signage. 	<p>PCODE SA13 ADAAG 91 4.1.3(16)(a) ADA 2010 216.2 CBC 2007 1117B.5 CBC 2019 11B-216.2</p> <p>Mitigated: <input type="radio"/> YES <input checked="" type="radio"/> NO</p>	<p>1 JOB \$450 \$450</p>

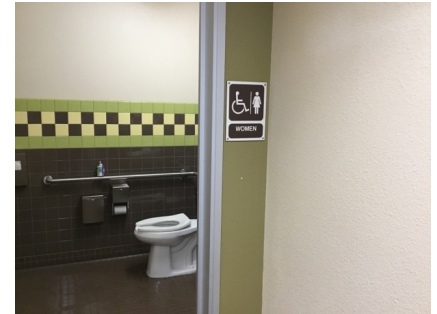
1019	<ul style="list-style-type: none"> <i>As-Built Description:</i> Signs containing tactile characters is not located so that a clear floor space of 18" min x 18" min., centered on the tactile characters, is provided beyond the arc of any door swing between the closed position and 45 degree open position. <i>As-Built:</i> Clear floor space not center <i>Proposed Solution:</i> Relocate compliant signage on latch side of door located at compliant height with a clear floor space. <i>Notes:</i> 	<p>PCODE SA07B ADA 2010 703.4.2 CBC 2019 11B-703.4.2</p> <p>Mitigated: <input type="radio"/> YES <input checked="" type="radio"/> NO</p>	1	JOB	\$150	\$150
------	---	---	---	-----	-------	-------

Before the 2010 ADA there was no measurement defining what it meant to stand outside of the door swing, and no requirement that the CLFS be centered, therefore consider whether this condition complies with 1991 ADA and is a Safe Harbor if installed before March 15, 2012.

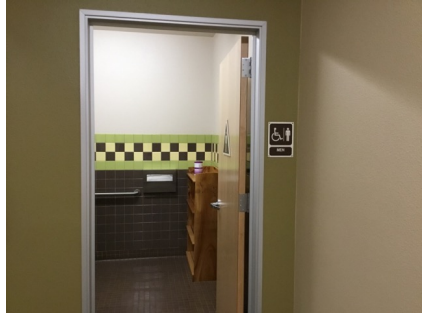
<p>1036</p> <ul style="list-style-type: none"> <i>As-Built Description:</i> Sign not located on latch side of door and/or not located at 48" min. above to baseline of the lowest Braille cells and 60" max. to baseline of the highest line of raised characters. <i>As-Built:</i> Wrong side. Clear floor space not center. <i>Proposed Solution:</i> Provide compliant signage including tactile characters and Grade II Braille on latch side of door located at compliant height. 	<p>PCODE SA07 ADAAG 91 4.30.6 ADA 2010 703.4.1 CBC 2007 1117B.5.7 CBC 2019 11B-703.4.1</p> <p>Mitigated: <input type="radio"/> YES <input checked="" type="radio"/> NO</p>	<p>1 JOB \$150 \$150</p>

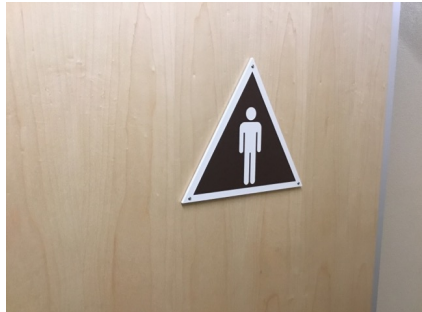
<p>1037</p> <ul style="list-style-type: none"> <i>As-Built Description:</i> Required in CA only: identification symbol centered 58" to 60" high on sanitary facility door that contrasts with the door not provided (women: 12" ø circle, men: 12" triangle, unisex: combined symbol). <i>As-Built:</i> Not beveled or radiused. <i>Proposed Solution:</i> Provide properly mounted sanitary facility symbol when altering area. If wheelchair accessible, include International Symbol of Accessibility on sign. 	<p>PCODE SA15 CBC 2007 1115B.6 CBC 2019 11B-703.7.2.6</p> <p>Mitigated: <input type="radio"/> YES <input checked="" type="radio"/> NO</p>	<p>1 JOB \$270 \$270</p>

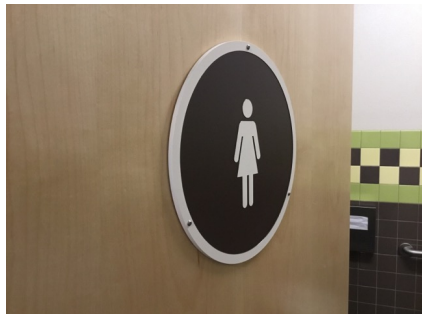
Item no., Rm no. and Name	Existing Architectural Barrier and Proposed Solution	Codes / Mitigation Info	Qty	Unit	Cost	Total
1041	<ul style="list-style-type: none"> • <i>As-Built Description:</i> Required in CA only: identification symbol centered 58" to 60" high on sanitary facility door that contrasts with the door not provided (women: 12" ø circle, men: 12" triangle, unisex: combined symbol). • <i>As-Built:</i> Not beveled. • <i>Proposed Solution:</i> Provide properly mounted sanitary facility symbol when altering area. If wheelchair accessible, include International Symbol of Accessibility on sign. 	PCODE SA15 CBC 2007 1115B.6 CBC 2019 11B-703.7.2.6 Mitigated: <input type="radio"/> YES <input checked="" type="radio"/> NO	1	JOB	\$270	\$270

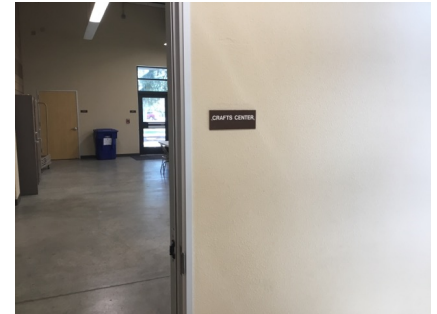
1006	<ul style="list-style-type: none"> <i>As-Built Description:</i> Sign not located on latch side of door and/or not located at 48" min. above to baseline of the lowest Braille cells and 60" max. to baseline of the highest line of raised characters. <i>As-Built:</i> 60.0" to center 60.0" to bottom of characters <i>Proposed Solution:</i> Provide compliant signage including tactile characters and Grade II Braille on latch side of door located at compliant height. 	PCODE SA07 ADAAG 91 4.30.6 ADA 2010 703.4.1 CBC 2007 1117B.5.7 CBC 2019 11B-703.4.1 Mitigated: <input type="radio"/> YES <input checked="" type="radio"/> NO	20	JOB	\$150	\$3,000
------	--	--	----	-----	-------	---------

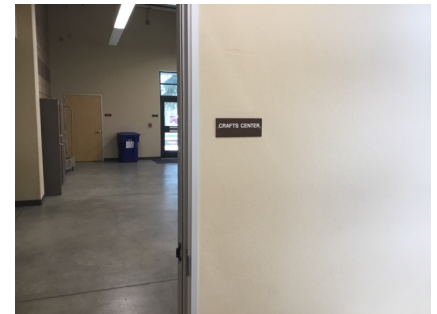
1004	<ul style="list-style-type: none"> <i>As-Built Description:</i> Signs containing tactile characters is not located so that a clear floor space of 18" min x 18" min., centered on the tactile characters, is provided beyond the arc of any door swing between the closed position and 45 degree open position. <i>As-Built:</i> Less than 9.0" to center of sign from door swing <i>Proposed Solution:</i> Relocate compliant signage on latch side of door located at compliant height with a clear floor space. Notes: 	PCODE SA07B ADA 2010 703.4.2 CBC 2019 11B-703.4.2 Mitigated: <input type="radio"/> YES <input checked="" type="radio"/> NO	1	JOB	\$150	\$150
------	---	--	---	-----	-------	-------

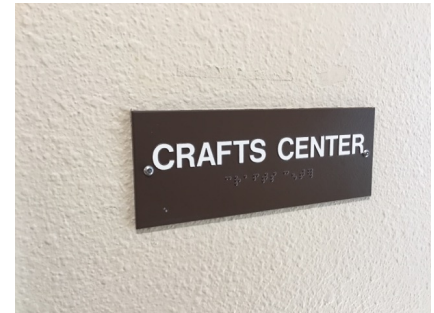
Item no., Rm no. and Name	Existing Architectural Barrier and Proposed Solution	Codes / Mitigation Info	Qty	Unit	Cost	Total
1007	<ul style="list-style-type: none"> <i>As-Built Description:</i> Existing sign designating permanent room or space is noncompliant. <i>Proposed Solution:</i> Provide compliant signage. <i>Notes:</i> 	PCODE SA13 ADAAG 91 4.1.3(16)(a) ADA 2010 216.2 CBC 2007 1117B.5 CBC 2019 11B-216.2 Mitigated: <input type="radio"/> YES <input checked="" type="radio"/> NO	20	JOB	\$450	\$9,000

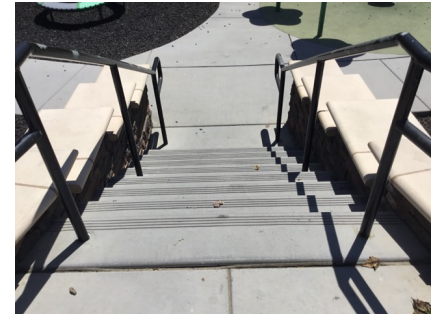
1055	<ul style="list-style-type: none"> <i>As-Built Description:</i> Landing at the top or bottom of stairway is not level or not provided. <i>Proposed Solution:</i> Remodel landings to provide a level clear floor space that extends the entire width of the ramp. 	PCODE EC10 CBC 2019 1009.8 Mitigated: <input type="radio"/> YES <input checked="" type="radio"/> NO	1	JOB	\$1,500	\$1,500
------	---	--	---	-----	---------	---------

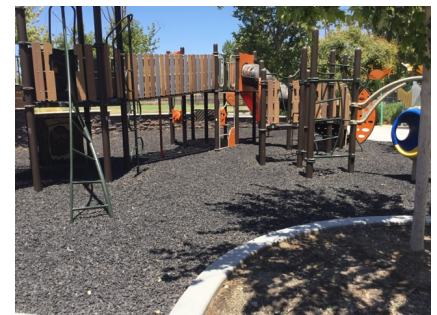
1047	<ul style="list-style-type: none"> <i>As-Built Description:</i> Ground surface complies with ASTM F1951 connecting to play equipment is not provided. Ground surface shall be inspected and maintained regularly and frequently to ensure continued compliance with ASTM F1951 <i>Proposed Solution:</i> Provide required resilient surfacing around play structure. Clear width of accessible routes connecting play components shall provide a clear width comply with section 11B-1008.2.4. 	PCODE OA01 ADAAG 91 36 CFR Part ADA 2010 1191 1008.2.6 CBC 2007 DSA 99-02 CBC 2019 11B-1008.2.6	1000	SF	\$27	\$27,000
------	--	--	------	----	------	----------

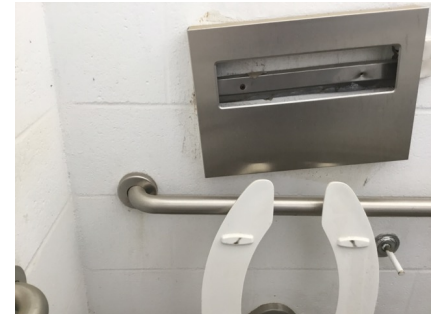
1062	<ul style="list-style-type: none"> As-Built Description: Accessories/dispensers in accessible stall located closer than 1-1/2" below or 12" above grab bar impedes its use. As-Built: SCD: 2.0" above grab bar Proposed Solution: Relocate accessories/dispensers to be no closer than 1-1/2" below and 12" above grab bars (except if accessories are recessed, flush with wall, and have no sharp edges). 	PCODE WB07I ADAAG 91 4.26.2 ADA 2010 609.3 CBC 2007 1133B.4.2.5 CBC 2019 11B-609.3 Mitigated: <input type="radio"/> YES <input checked="" type="radio"/> NO	1	JOB	\$225	\$225
------	---	---	---	-----	-------	-------

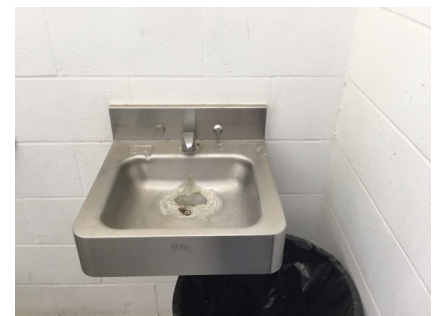
1058	<ul style="list-style-type: none"> As-Built Description: Clear floor space, 30" x 48" in front of fixture, extending 19" max. under the lavatory, not provided (CA only: Less than 18" from side wall to centerline of lavatory). As-Built: 17.5" o.c. Proposed Solution: Relocate existing lavatory. Notes: 	PCODE WD01A ADAAG 91 4.19.3 ADA 2010 606.2 CBC 2007 1115B.4.3 CBC 2019 11B-606.2, 11B-606.6 Mitigated: <input type="radio"/> YES <input checked="" type="radio"/> NO	1	JOB	\$2,700	\$2,700
------	---	--	---	-----	---------	---------

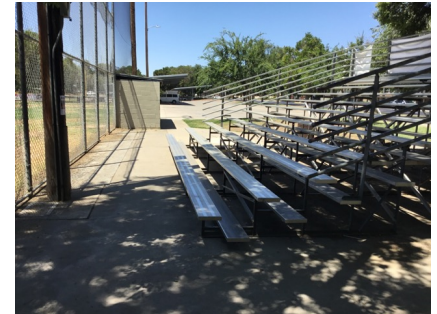
1583	<ul style="list-style-type: none"> As-Built Description: Proper amount of seating for disabled persons at public seating is not provided (>25=1; >50=2; >300=4; >500=6; +500=6=1%). Proposed Solution: Modify seating to provide clear and level wheelchair space 33" x 48" or 33" x 60", including companion seat, as required. Notes: 	<p>PCODE GE01NT ADAAG 91 4.1.2(19)a ADA 2010 221.2.1 CBC 2007 1104B.3.4.1 CBC 2019 11B-221.2.1</p> <p>Mitigated: <input type="radio"/> YES <input checked="" type="radio"/> NO</p>	1	EA	\$1,800	\$1,800
------	---	---	---	----	---------	---------

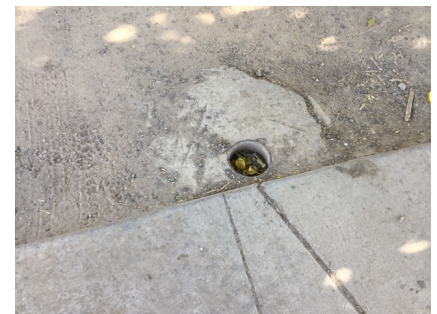
1695	<ul style="list-style-type: none"> As-Built Description: Walk: openings greater than 1/2" along the line of traffic flow. As-Built: 5.0" x 3.0" deep Proposed Solution: Fill gap/opening along the line of traffic flow. 	<p>PCODE EF04 ADAAG 91 4.3.6; 4.5.4 ADA 2010 403.2; 302.3 CBC 2007 1133B.7.2 CBC 2019 11B-403.2; 11B-302.3</p> <p>Mitigated: <input type="radio"/> YES <input checked="" type="radio"/> NO</p>	10	SF	\$240	\$2,400
------	--	--	----	----	-------	---------

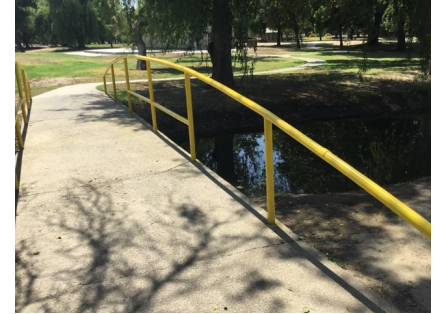
1422	<ul style="list-style-type: none"> As-Built Description: Protruding objects more than 4" from wall, when bottom of object more than 27" or less than 80" above finished floor. Proposed Solution: Remove/relocate protruding object. Patch existing surface. Notes: 	<p>PCODE EG04 ADAAG 91 4.4.1 ADA 2010 307.2 CBC 2007 1133B.8.6.1 CBC 2019 11B-307.2</p> <p>Mitigated: <input type="radio"/> YES <input checked="" type="radio"/> NO</p>	1	JOB	\$300	\$300
------	---	--	---	-----	-------	-------

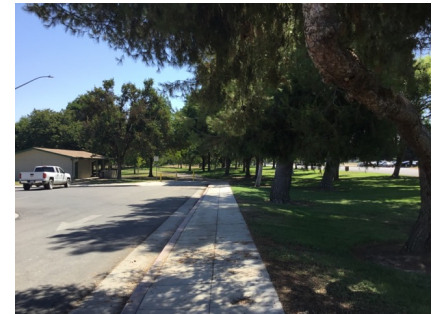
1554	<ul style="list-style-type: none"> As-Built Description: Protruding objects more than 4" from wall, when bottom of object more than 27" or less than 80" above finished floor. Proposed Solution: Trim vegetation. 	<p>PCODE EG04 ADAAG 91 4.4.1 ADA 2010 307.2 CBC 2007 1133B.8.6.1 CBC 2019 11B-307.2</p> <p>Mitigated: <input type="radio"/> YES <input checked="" type="radio"/> NO</p>	50	JOB	\$300	\$15,000
------	--	--	----	-----	-------	----------

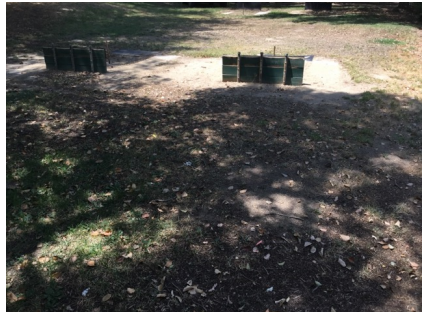
Item no., Rm no. and Name	Existing Architectural Barrier and Proposed Solution	Codes / Mitigation Info	Qty	Unit	Cost	Total
1402	<ul style="list-style-type: none"> As-Built Description: No walk / sidewalk provided to connect accessible facilities or elements that are on the same site. Proposed Solution: Grade and re sod path to horse shoe pits. Notes: 	PCODE EF13 ADAAG 91 4.3.2 ADA 2010 206.1 CBC 2007 1114B.1.2 CBC 2019 11B-206.1 Mitigated: <input type="radio"/> YES <input checked="" type="radio"/> NO	40	LF	\$135	\$5,400

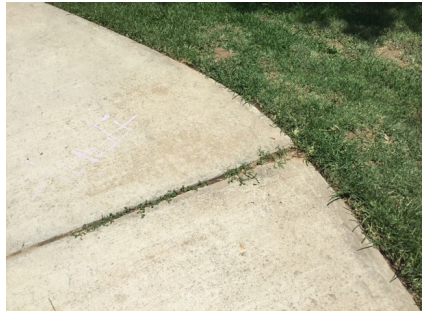
1398	<ul style="list-style-type: none"> As-Built Description: Walk: Pavement dislocation creates abrupt change in level exceeding 1/2" in accessible route. As-Built: Up to 1.0" Proposed Solution: Remove, replace or repair area of pavement sufficient to correct abrupt change in level. 	PCODE EF03 ADAAG 91 4.3.8 ADA 2010 403.4 CBC 2007 1133B.7.4 CBC 2019 11B-403.4 Mitigated: <input type="radio"/> YES <input checked="" type="radio"/> NO	40	LF	\$63	\$2,520

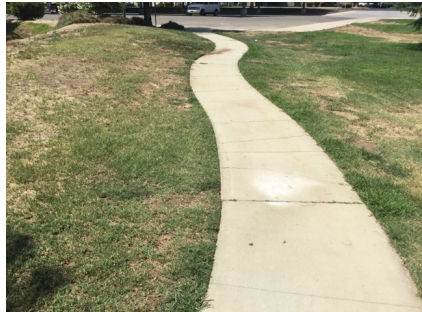
1418	<ul style="list-style-type: none"> As-Built Description: Cross slope more than 1":48" (2.083%). As-Built: Up to 3.5% Proposed Solution: Modify cross slope. 	PCODE EF07 ADAAG 91 4.3.7 ADA 2010 403.3 CBC 2007 1133B.7.1.3 CBC 2019 11B-403.3 Mitigated: <input type="radio"/> YES <input checked="" type="radio"/> NO	100	SF	\$75	\$7,500

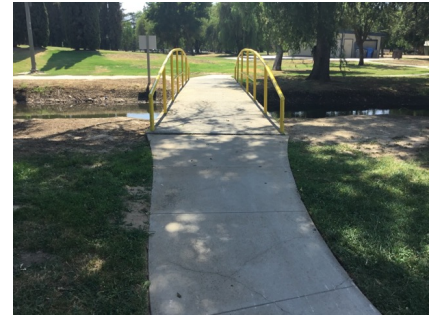
- 1420
- *As-Built Description:*
Walk: Pavement dislocation creates abrupt change in level exceeding 1/2" in accessible route.
 - *As-Built:* **1.0"**
 - *Proposed Solution:*
Remove, replace or repair area of pavement sufficient to correct abrupt change in level.

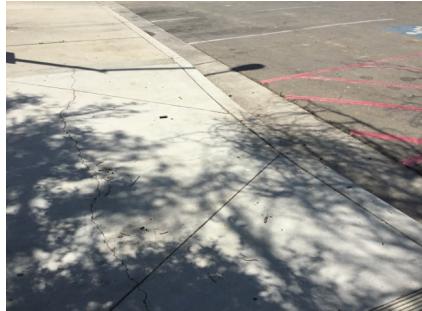
Item no., Rm no. and Name	Existing Architectural Barrier and Proposed Solution	Codes / Mitigation Info	Qty	Unit	Cost	Total
1407	<ul style="list-style-type: none"> As-Built Description: Transition from curb ramp to gutter does not have a smooth transition. As-Built: 1.0" Proposed Solution: Grind lip. 	PCODE EH02D ADAAG 91 4.7.2 ADA 2010 406.2 CBC 2007 1127B.5.3 CBC 2019 11B-406.5.8 Mitigated: <input type="radio"/> YES <input checked="" type="radio"/> NO	4	JOB	\$300	\$1,200

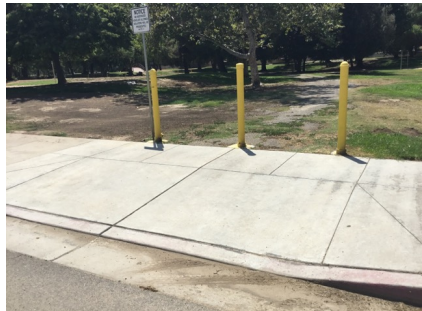
<input type="radio"/> Staff Only			
			Priority <input checked="" type="radio"/> 1			
			Severity <input checked="" type="radio"/> 2			
1415	<ul style="list-style-type: none"> As-Built Description: Side slopes more than 1:10 (10%). As-Built: 15.0% Proposed Solution: Modify curb ramp. Demolish side slopes and replace with 1:10 side slopes if 48" level top landing is provided. Notes: 	PCODE EH05A ADAAG 91 4.7.5 ADA 2010 406.3 CBC 2007 1127B.5.3 CBC 2019 11B-406.2.2 Mitigated: <input type="radio"/> YES <input checked="" type="radio"/> NO	1	JOB	\$6,000	\$6,000

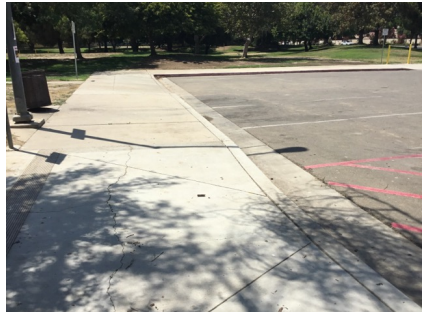
Item no., Rm no. and Name	Existing Architectural Barrier and Proposed Solution	Codes / Mitigation Info	Qty	Unit	Cost	Total
1406	<ul style="list-style-type: none"> As-Built Description: Detectable warning not provided where pedestrian crosses vehicular area. Proposed Solution: Provide detectable warning surface (i.e. in-line truncated domes) at regular curb ramp. 	PCODE EH07A ADAAG 91 4.7.7 ADA 2010 705.1 CBC 2007 1127B.5.7 CBC 2019 11B-705.1.2.2 Mitigated: <input type="radio"/> YES <input checked="" type="radio"/> NO	4	JOB	\$750	\$3,000

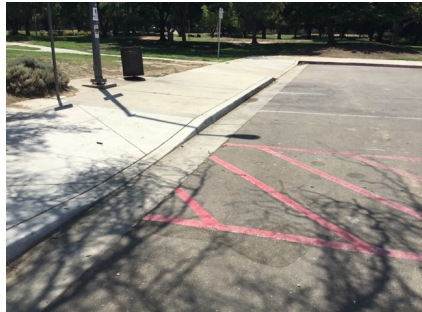
1411	<ul style="list-style-type: none"> As-Built Description: Accessible parking space has slope greater than 1/4":12" (2%). As-Built: 2.9% Proposed Solution: Modify slope at accessible parking space. 	PCODE EA05 ADAAG 91 4.6.3 ADA 2010 502.4 CBC 2007 1129B.3.3 CBC 2019 11B-502.4 Mitigated: <input type="radio"/> YES <input checked="" type="radio"/> NO	30	SF	\$36	\$1,080

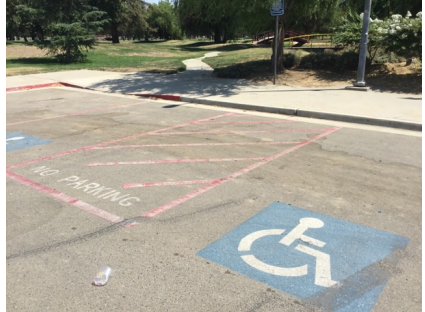
Item no., Rm no. and Name	Existing Architectural Barrier and Proposed Solution	Codes / Mitigation Info	Qty	Unit	Cost	Total
1417	<ul style="list-style-type: none"> As-Built Description: Accessible parking space has slope greater than 1/4":12" (2%). As-Built: Up to 3.3% Proposed Solution: Modify slope at accessible parking space. 	PCODE EA05 ADAAG 91 4.6.3 ADA 2010 502.4 CBC 2007 1129B.3.3 CBC 2019 11B-502.4 Mitigated: <input type="radio"/> YES <input checked="" type="radio"/> NO	50	SF	\$36	\$1,800

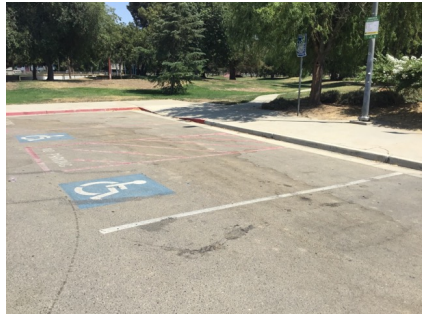
1416	<ul style="list-style-type: none"> As-Built Description: Disabled persons must wheel or walk behind parked car(s) other than their own. Proposed Solution: Relocate parking and provide curb ramp to accessible route. 	PCODE EA03 ADAAG 91 Fig.9 ADA 2010 502.3 CBC 2007 1129B.3.1 CBC 2019 11B-502.7.1 Mitigated: <input type="radio"/> YES <input checked="" type="radio"/> NO	1	JOB	\$2,190	\$2,190

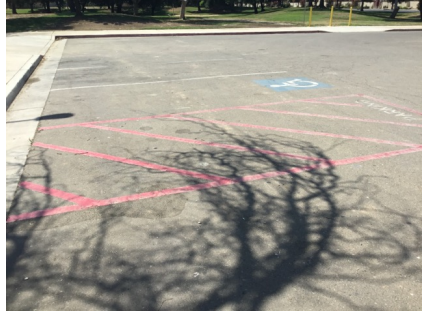
Item no., Rm no. and Name	Existing Architectural Barrier and Proposed Solution	Codes / Mitigation Info	Qty	Unit	Cost	Total
1410	<ul style="list-style-type: none"> As-Built Description: An accessible parking space shall be outlined or painted blue (required in CA only). Proposed Solution: Identify accessible parking space using blue markings. 	PCODE EA04K CBC 2019 11B-502.6 Mitigated: <input type="radio"/> YES <input checked="" type="radio"/> NO	2	JOB	\$360	\$720

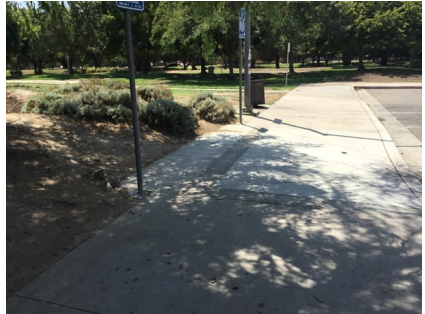
<input type="radio"/> Staff Only			
			Priority <input checked="" type="radio"/> 1			
			Severity <input checked="" type="radio"/> 3			
1412	<ul style="list-style-type: none"> As-Built Description: Wheel stops not provided to prevent the encroachment of vehicles over the required clear width of an adjacent accessible route. Proposed Solution: Provide wheel stops to prevent encroachment. Notes: 	PCODE EA04L CBC 2019 11B-502.7.2 Mitigated: <input type="radio"/> YES <input checked="" type="radio"/> NO	4	JOB	\$225	\$900

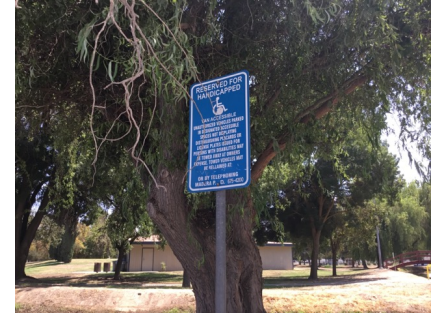
1408	<ul style="list-style-type: none"> As-Built Description: Sign relating to parking privileges for disabled persons is non-compliant. Proposed Solution: Provide compliant parking signage that does not contain the word "Handicapped". 	<p>PCODE EA04F ADA 2010 502.6 CBC 2007 VC §22511.9. CBC 2019 11B-502.6</p> <p>Mitigated: <input type="radio"/> YES <input checked="" type="radio"/> NO</p>	4	JOB	\$300	\$1,200
------	--	---	---	-----	-------	---------

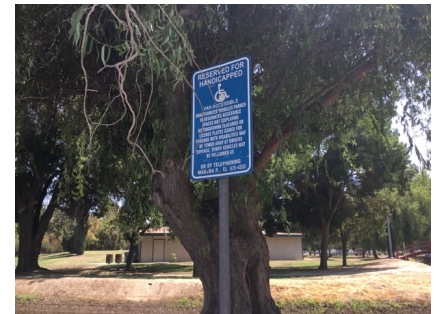
1409	<ul style="list-style-type: none"> As-Built Description: CA only: Additional Sign or additional language below the symbol of accessibility stating "Minimum Fine \$250" not provided. Proposed Solution: Provide compliant parking signage that includes fine information. 	<p>PCODE EA04G CBC 2007 1129B.4 CBC 2019 11B-502.6.2</p> <p>Mitigated: <input type="radio"/> YES <input checked="" type="radio"/> NO</p>	4	JOB	\$300	\$1,200
------	--	---	---	-----	-------	---------

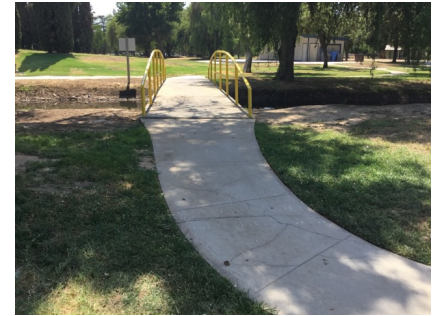
1419	<ul style="list-style-type: none"> As-Built Description: Walk: Slope greater than 1:20 (5.0%), and walk does not comply with requirements for ramps. As-Built: 6.5% Proposed Solution: Modify walk/sidewalk slope to 1:20 or less. 	PCODE EF01 ADAAG 91 4.3.7 ADA 2010 403.3 CBC 2007 1133B.7.3 CBC 2019 11B-403.3	40	SF	\$75	\$3,000
------	--	--	----	----	------	---------

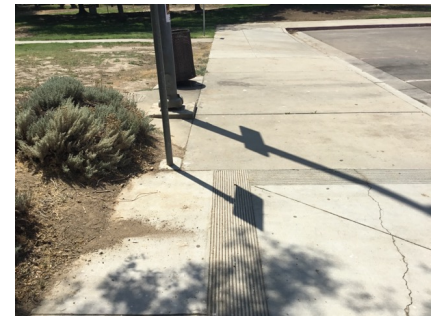
1413	<ul style="list-style-type: none"> As-Built Description: Walk more than 36" but less than 48" wide (required in CA only). As-Built: 32.0" wide Proposed Solution: Enlarge width of walk to 48". Notes: 	PCODE EF08 CBC 2007 1133B.7.1 CBC 2019 11B-403.5.1.3	10	SF	\$135	\$1,350
------	---	--	----	----	-------	---------

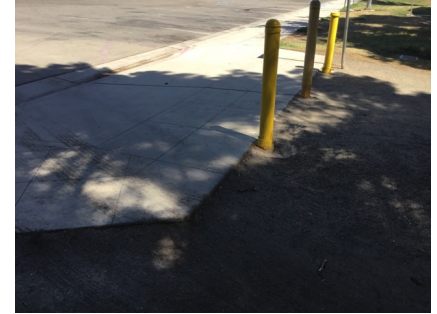
- 1555
- *As-Built Description:*
Walk: Pavement dislocation creates abrupt change in level exceeding 1/2" in accessible route.
 - *As-Built:* **Up to 3.0"**
 - *Proposed Solution:*
Remove, replace or repair area of pavement sufficient to correct abrupt change in level.
 - *Notes:*

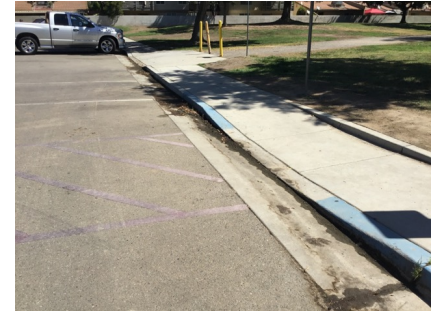
1543	<ul style="list-style-type: none"> As-Built Description: Maximum slope of adjoining gutters, street surface at bottom of ramp exceeds 5% (1:20). As-Built: Up to 9.1% Proposed Solution: Modify road/gutter slopes. Demolish existing and provide new curb ramp. 	PCODE EH02E ADAAG 91 4.7.2 ADA 2010 406.2 CBC 2007 1127B.5.3 CBC 2019 11B-406.5.8	4	JOB	\$3,750	\$15,000
------	--	---	---	-----	---------	----------

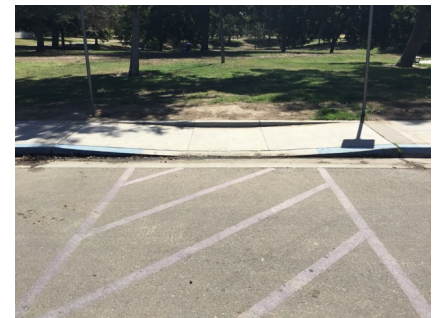
1541	<ul style="list-style-type: none"> As-Built Description: Cross slope greater than 2%. As-Built: Up to 3.8% Proposed Solution: Demolish existing and provide new curb ramp. Notes: 	PCODE EH02F ADAAG 91 4.8.6 ADA 2010 405.3 CBC 2007 1133B.5.3.1 CBC 2019 11B-406.5.7	4	JOB	\$7,500	\$30,000
------	--	---	---	-----	---------	----------

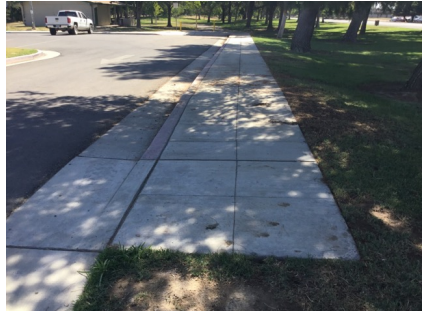
Item no., Rm no. and Name	Existing Architectural Barrier and Proposed Solution	Codes / Mitigation Info	Qty	Unit	Cost	Total
1551	<ul style="list-style-type: none"> As-Built Description: Cross slope greater than 2%. As-Built: 2.8% Proposed Solution: Demolish existing and provide new curb ramp. 	PCODE EH02F ADAAG 91 4.8.6 ADA 2010 405.3 CBC 2007 1133B.5.3.1 CBC 2019 11B-406.5.7 Mitigated: <input type="radio"/> YES <input checked="" type="radio"/> NO	1	JOB	\$7,500	\$7,500
