The City of Madera

Appendix B: Facilities

Access Compliance Survey Report

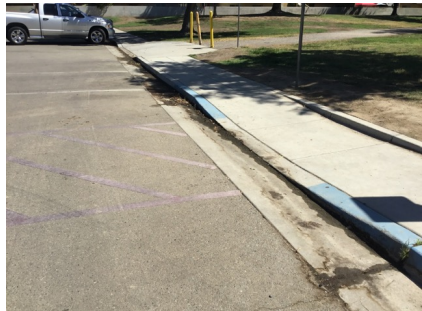
<input type="radio"/> Staff Only			
			Priority <input checked="" type="radio"/> 1			
			Severity <input checked="" type="radio"/> 4			
1542	<ul style="list-style-type: none"> As-Built Description: Detectable warning not provided where pedestrian crosses vehicular area. Proposed Solution: Provide detectable warning surface (i.e. in-line truncated domes) at regular curb ramp. 	PCODE EH07A ADAAG 91 4.7.7 ADA 2010 705.1 CBC 2007 1127B.5.7 CBC 2019 11B-705.1.2.2 Mitigated: <input type="radio"/> YES <input checked="" type="radio"/> NO	4	JOB	\$750	\$3,000

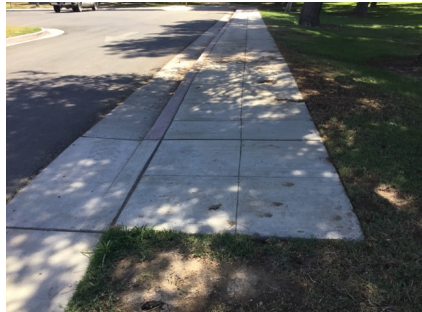
Item no., Rm no. and Name	Existing Architectural Barrier and Proposed Solution	Codes / Mitigation Info	Qty	Unit	Cost	Total
1552	<ul style="list-style-type: none"> As-Built Description: Detectable warning not provided where pedestrian crosses vehicular area. Proposed Solution: Provide detectable warning surface (i.e. in-line truncated domes) at regular curb ramp. 	PCODE EH07A ADAAG 91 4.7.7 ADA 2010 705.1 CBC 2007 1127B.5.7 CBC 2019 11B-705.1.2.2 Mitigated: <input type="radio"/> YES <input checked="" type="radio"/> NO	1	JOB	\$750	\$750

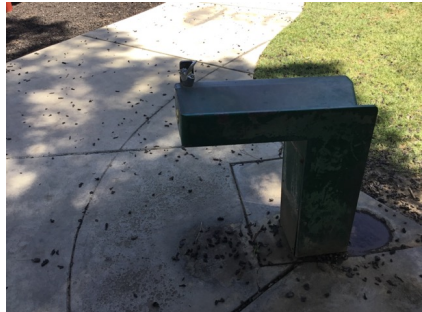
1561	<ul style="list-style-type: none"> As-Built Description: Where only one drinking fountain is provided per floor: Fountain is not accessible to individuals who use wheelchairs, or to those who have difficulty bending or stooping. Proposed Solution: Provide additional fountain or hi-lo combination fountain. 	PCODE IA01A ADAAG 91 4.1.3(10)(a) ADA 2010 211.1 CBC 2007 1115B.4.6.1 CBC 2019 11B-211.1 Mitigated: <input type="radio"/> YES <input checked="" type="radio"/> NO	1	JOB	\$6,000	\$6,000

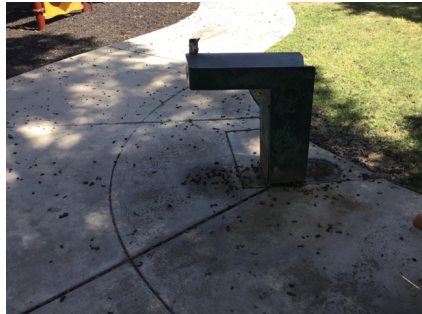
Item no., Rm no. and Name	Existing Architectural Barrier and Proposed Solution	Codes / Mitigation Info	Qty	Unit	Cost	Total
1562	<ul style="list-style-type: none"> <i>As-Built Description:</i> Drinking fountain lacks protection for visually impaired persons. <i>Proposed Solution:</i> Provide cane-detectable rails. 	PCODE IA05C ADAAG 91 4.4.1 ADA 2010 307.2 CBC 2007 1115B.4.6.3 CBC 2019 11B-307.2 Mitigated: <input type="radio"/> YES <input checked="" type="radio"/> NO	1	JOB	\$1,500	\$1,500

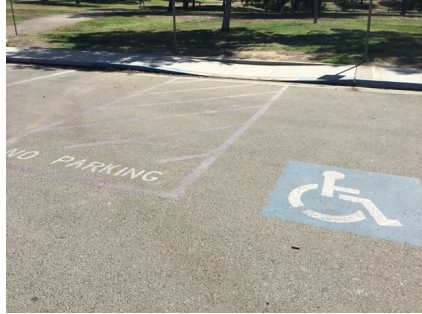
1537	<ul style="list-style-type: none"> <i>As-Built Description:</i> Accessible parking space has slope greater than 1/4":12" (2%). <i>As-Built:</i> Up to 2.7% <i>Proposed Solution:</i> Modify slope at accessible parking space. 	PCODE EA05 ADAAG 91 4.6.3 ADA 2010 502.4 CBC 2007 1129B.3.3 CBC 2019 11B-502.4 Mitigated: <input type="radio"/> YES <input checked="" type="radio"/> NO	300	SF	\$36	\$10,800

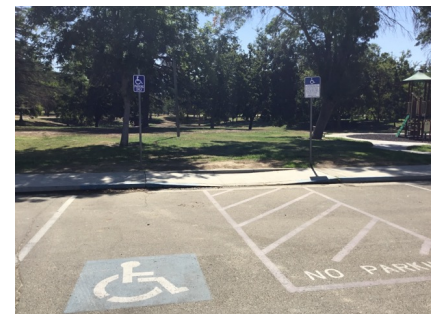
- 1536
- *As-Built Description:*
Sign for accessible parking space is missing or non-compliant.
 - *Proposed Solution:*
Provide compliant parking signage.
 - *Notes:*

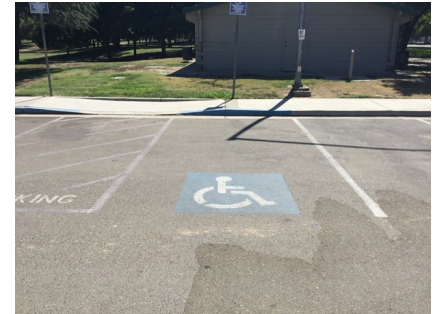
1548	<ul style="list-style-type: none"> As-Built Description: Accessible parking space smaller than 8' wide (CA only: 9' x 18'). As-Built: 107.5" wide Proposed Solution: Modify parking space(s) to create accessible space. 	PCODE EA02A ADAAG 91 4.6.3 ADA 2010 502.2 CBC 2007 1129B.3.1 CBC 2019 11B-502.2	1	JOB	\$600	\$600
------	--	---	---	-----	-------	-------

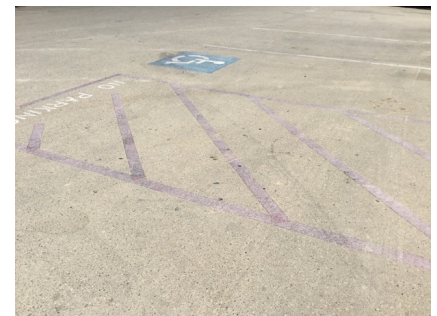
1540	<ul style="list-style-type: none"> As-Built Description: Accessible parking space does not have 5' wide access aisle; 8' wide for van accessible aisle. As-Built: 95.25" wide Proposed Solution: Modify parking aisle(s) to create accessible space by restriping. 	PCODE EA02B ADAAG 91 4.6.3 ADA 2010 502.3 CBC 2007 1129B.3.1 CBC 2019 11B-502.2; 11B-502.3.1	1	JOB	\$600	\$600
------	--	---	---	-----	-------	-------

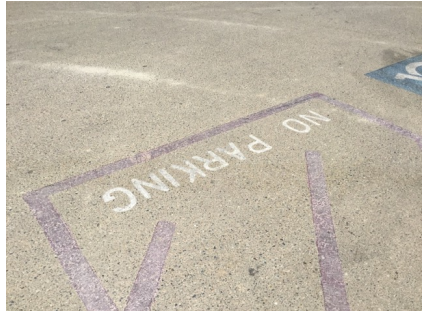
Item no., Rm no. and Name	Existing Architectural Barrier and Proposed Solution	Codes / Mitigation Info	Qty	Unit	Cost	Total
1539	<ul style="list-style-type: none"> As-Built Description: The words "NO PARKING" not painted on the ground within loading and unloading access aisle (12" min high white letters), located so that it is visible to traffic enforcement officials (required in CA only). As-Built: 9.0" Proposed Solution: Provide the words "NO PARKING" in each access aisle, painted in 12" high letters, when altering area. 	PCODE EA04D CBC 2007 1129B.3.1 CBC 2019 11B-502.3.3 Mitigated: <input type="radio"/> YES <input checked="" type="radio"/> NO	2	JOB	\$300	\$600

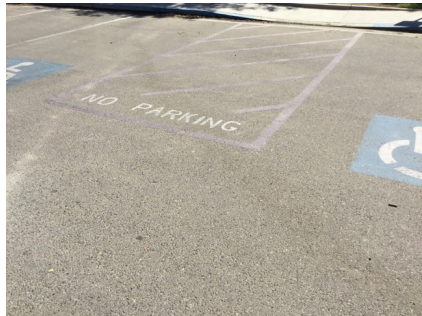
<input type="radio"/> Staff Only			
			Priority <input checked="" type="radio"/> 1			
			Severity <input checked="" type="radio"/> 4			
1538	<ul style="list-style-type: none"> As-Built Description: An accessible parking space shall be outlined or painted blue (required in CA only). Proposed Solution: Identify accessible parking space using blue markings. 	PCODE EA04K CBC 2019 11B-502.6 Mitigated: <input type="radio"/> YES <input checked="" type="radio"/> NO	2	JOB	\$360	\$720

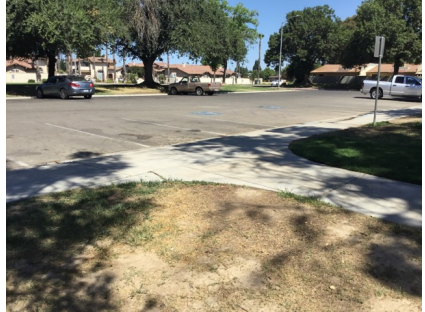
Item no., Rm no. and Name	Existing Architectural Barrier and Proposed Solution	Codes / Mitigation Info	Qty	Unit	Cost	Total
1544	<ul style="list-style-type: none"> As-Built Description: Wheel stops not provided to prevent the encroachment of vehicles over the required clear width of an adjacent accessible route. Proposed Solution: Provide wheel stops to prevent encroachment. 	PCODE EA04L CBC 2019 11B-502.7.2 Mitigated: <input type="radio"/> YES <input checked="" type="radio"/> NO	40	JOB	\$225	\$9,000

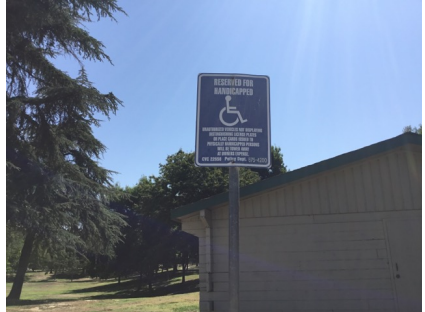
1547	<ul style="list-style-type: none"> As-Built Description: No "Tow Away" sign at parking lot entrance (required in CA only). Proposed Solution: Provide "Tow Away" sign at parking lot entrance when altering area. 	PCODE EA04C CBC 2007 1129B.4 CBC 2019 11B-502.8.2 Mitigated: <input type="radio"/> YES <input checked="" type="radio"/> NO	2	JOB	\$975	\$1,950

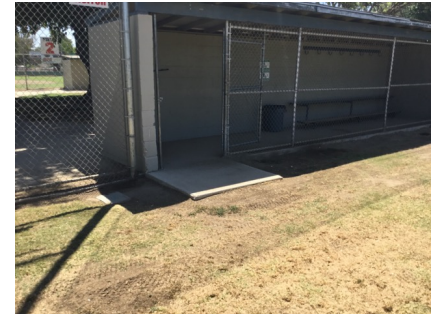
- 1575 • *As-Built Description:*
Walk: Pavement dislocation creates abrupt change in level exceeding 1/2" in accessible route.
- *As-Built:* **Up to 3.0"**
- *Proposed Solution:*
Remove, replace or repair area of pavement sufficient to correct abrupt change in level.
- *Notes:*

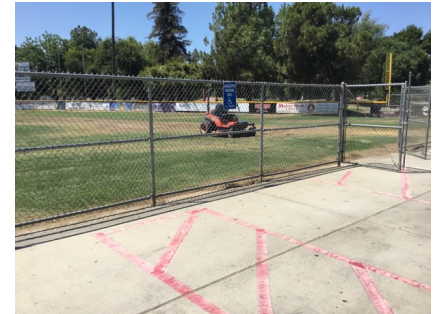
- 1572
- *As-Built Description:*
Sign for accessible parking space is missing or non-compliant.
 - *Proposed Solution:*
Provide compliant parking signage.
 - *Notes:*

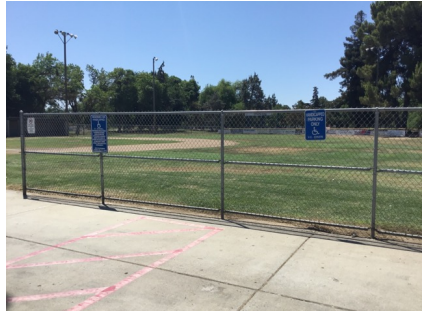
Item no., Rm no. and Name	Existing Architectural Barrier and Proposed Solution	Codes / Mitigation Info	Qty	Unit	Cost	Total
1566	<ul style="list-style-type: none"> <i>As-Built Description:</i> Parking sign is not located between 60" and 80" above the finish floor or ground surface measured to the bottom of the sign. <i>As-Built:</i> 54.0" high <i>Proposed Solution:</i> Remount existing sign at accessible height. 	PCODE EA04H ADAAG 91 4.6.4 ADA 2010 502.7 CBC 2007 1129B.4 CBC 2019 11B-502.6 Mitigated: <input type="radio"/> YES <input checked="" type="radio"/> NO	2	JOB	\$135	\$270

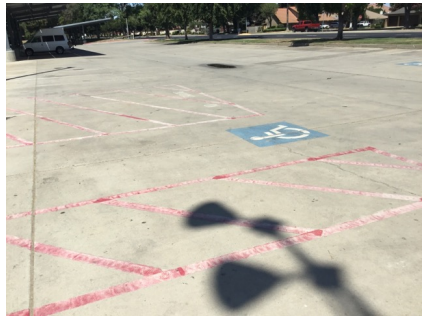
<input type="radio"/> Staff Only			
			Priority <input checked="" type="radio"/> 1			
			Severity <input checked="" type="radio"/> 4			
1570	<ul style="list-style-type: none"> <i>As-Built Description:</i> An accessible parking space shall be outlined or painted blue (required in CA only). <i>Proposed Solution:</i> Identify accessible parking space using blue markings. 	PCODE EA04K CBC 2019 11B-502.6 Mitigated: <input type="radio"/> YES <input checked="" type="radio"/> NO	2	JOB	\$360	\$720

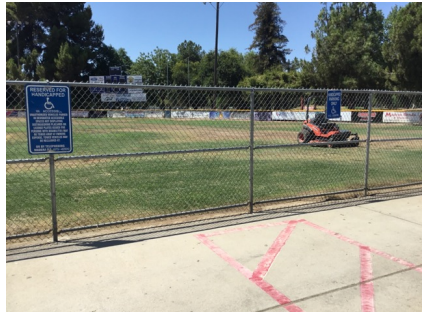
Item no., Rm no. and Name	Existing Architectural Barrier and Proposed Solution	Codes / Mitigation Info	Qty	Unit	Cost	Total
1571	<ul style="list-style-type: none"> As-Built Description: CA only: Additional Sign or additional language below the symbol of accessibility stating "Minimum Fine \$250" not provided. Proposed Solution: Provide compliant parking signage that includes fine information. 	PCODE EA04G CBC 2007 1129B.4 CBC 2019 11B-502.6.2 Mitigated: <input type="radio"/> YES <input checked="" type="radio"/> NO	2	JOB	\$300	\$600

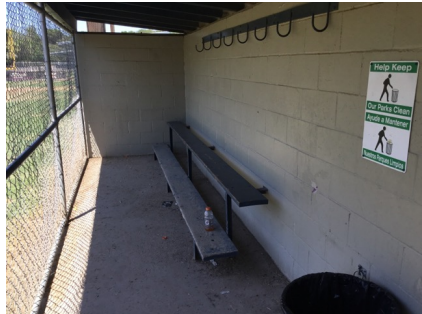
1573	<ul style="list-style-type: none"> As-Built Description: An accessible path of travel is not provided to and from all participation and activity areas, including athletic team rooms/facilities, playing fields/running tracks, baseball/softball player dugouts and sanitary/locker facilities (home and guest). Proposed Solution: Provide an accessible path of travel to all participation areas. Notes: 	PCODE GF07ANT ADAAG 91 4.1.1 (1) CBC 2007 1104B.4.3 CBC 2019 11B-206.2.18 Mitigated: <input type="radio"/> YES <input checked="" type="radio"/> NO	4	JOB	\$15,000	\$60,000

Wheelchair space at dugouts blocks circulation path. Enlarge all dugouts.

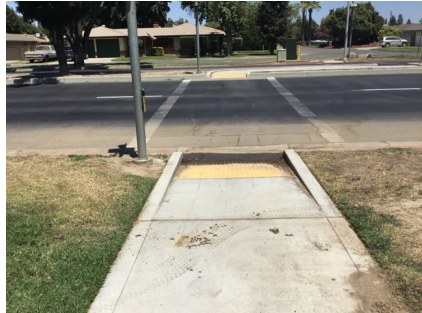
Item no., Rm no. and Name	Existing Architectural Barrier and Proposed Solution	Codes / Mitigation Info	Qty	Unit	Cost	Total
1585	<ul style="list-style-type: none"> <i>As-Built Description:</i> Maximum slope of adjoining gutters, street surface at bottom of ramp exceeds 5% (1:20). <i>As-Built:</i> 5.4% <i>Proposed Solution:</i> Modify road/gutter slopes. Demolish existing and provide new curb ramp. 	PCODE EH02E ADAAG 91 4.7.2 ADA 2010 406.2 CBC 2007 1127B.5.3 CBC 2019 11B-406.5.8 Mitigated: <input type="radio"/> YES <input checked="" type="radio"/> NO	1	JOB	\$3,750	\$3,750

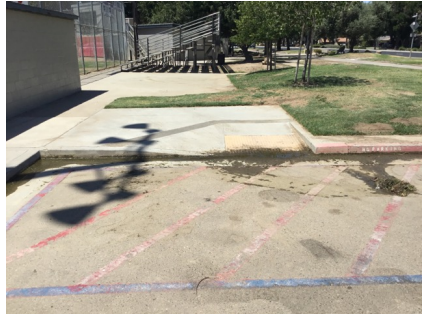
<input type="radio"/> Staff Only			
			Priority <input checked="" type="radio"/> 1			
			Severity <input checked="" type="radio"/> 4			
1591	<ul style="list-style-type: none"> <i>As-Built Description:</i> Maximum slope of adjoining gutters, street surface at bottom of ramp exceeds 5% (1:20). <i>As-Built:</i> 7.5% <i>Proposed Solution:</i> Modify road/gutter slopes. Demolish existing and provide new curb ramp. 	PCODE EH02E ADAAG 91 4.7.2 ADA 2010 406.2 CBC 2007 1127B.5.3 CBC 2019 11B-406.5.8 Mitigated: <input type="radio"/> YES <input checked="" type="radio"/> NO	1	JOB	\$3,750	\$3,750

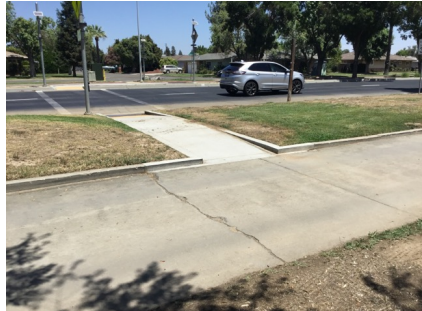
Item no., Rm no. and Name	Existing Architectural Barrier and Proposed Solution	Codes / Mitigation Info	Qty	Unit	Cost	Total
1587	<ul style="list-style-type: none"> As-Built Description: Detectable warning not provided where pedestrian crosses vehicular area. Proposed Solution: Provide detectable warning surface (i.e. in-line truncated domes) at regular curb ramp. 	PCODE EH07A ADAAG 91 4.7.7 ADA 2010 705.1 CBC 2007 1127B.5.7 CBC 2019 11B-705.1.2.2 Mitigated: <input type="radio"/> YES <input checked="" type="radio"/> NO	1	JOB	\$750	\$750

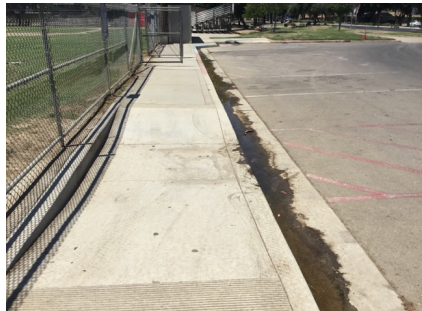
<input type="radio"/> Staff Only			
			Priority <input checked="" type="radio"/> 1			
			Severity <input checked="" type="radio"/> 3			
1595	<ul style="list-style-type: none"> As-Built Description: Detectable warning not provided where pedestrian crosses vehicular area. Proposed Solution: Provide detectable warning surface (i.e. in-line truncated domes) at regular curb ramp. 	PCODE EH07A ADAAG 91 4.7.7 ADA 2010 705.1 CBC 2007 1127B.5.7 CBC 2019 11B-705.1.2.2 Mitigated: <input type="radio"/> YES <input checked="" type="radio"/> NO	1	JOB	\$750	\$750

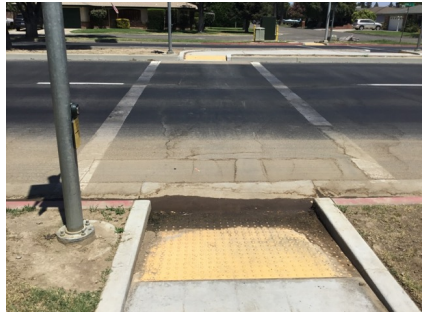
Item no., Rm no. and Name	Existing Architectural Barrier and Proposed Solution	Codes / Mitigation Info	Qty	Unit	Cost	Total
1586	<ul style="list-style-type: none"> As-Built Description: Curb ramp or 48" level space at bottom of ramp not provided. Proposed Solution: Modify bottom landing to have slope in all direction 1:48 maximum. Notes: 	PCODE EH09NT ADAAG 91 4.7.9 + 10 ADA 2010 406.5 CBC 2007 1127B.5.9 CBC 2019 11B-406.3.2	25	LF	\$60	\$1,500
		Mitigated: <input type="radio"/> YES <input checked="" type="radio"/> NO

Bottom landing slopes 7.2% running, outside of gutter.

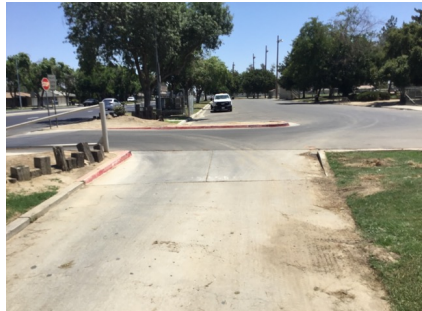
1589	<ul style="list-style-type: none"> As-Built Description: 36" wide band of truncated domes not provided at walkway or crossing adjoining a vehicular way, if surfaces are not separated by a curb, railing, or other element. Proposed Solution: Provide 36" wide, contrasting color, band of truncated domes between pedestrian and vehicular area. 	PCODE EG09 ADAAG 91 4.29.5 CBC 2007 1133B.8.5 CBC 2019 11B-705.1.2.5	20	LF	\$81	\$1,620
		Mitigated: <input type="radio"/> YES <input checked="" type="radio"/> NO

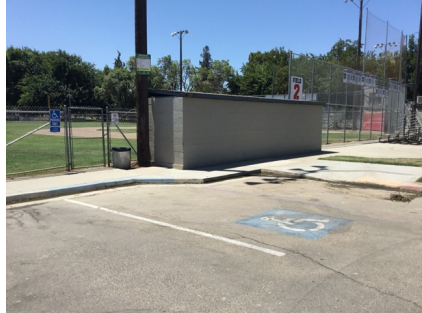
Multiple compliance issues at van space including 10.0% slope.

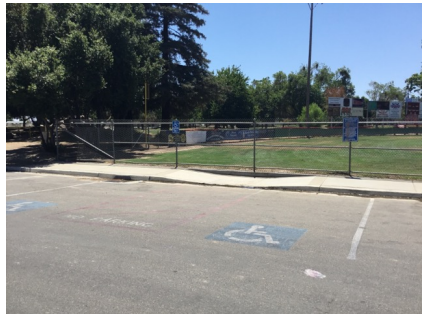
Multiple compliance issues including slopes up to 7.2% and signage at 50.0" AFF that does not include fine signs.

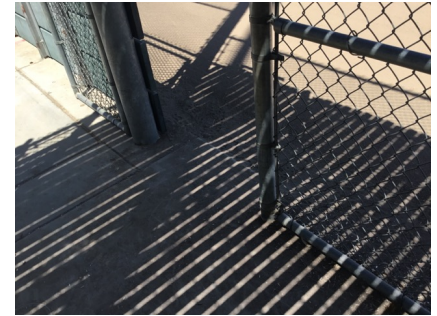
- 1630
- *As-Built Description:*
Walk: Pavement dislocation creates abrupt change in level exceeding 1/2" in accessible route.
 - *As-Built:* **1.0" at dugouts.**
 - *Proposed Solution:*
Remove, replace or repair area of pavement sufficient to correct abrupt change in level.

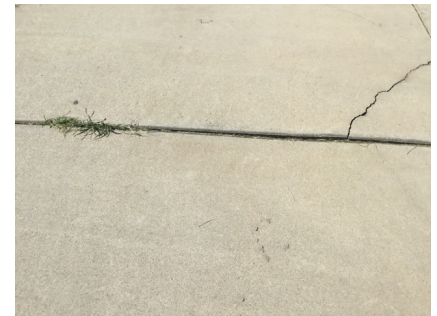
- 1675
- *As-Built Description:*
Walk: Pavement dislocation creates abrupt change in level exceeding 1/2" in accessible route.
 - *As-Built:* **Up to 1.0"**
 - *Proposed Solution:*
Remove, replace or repair area of pavement sufficient to correct abrupt change in level.

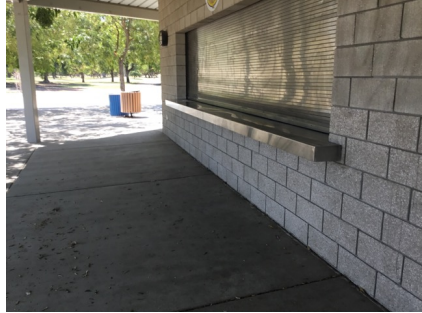
1629	<ul style="list-style-type: none"> As-Built Description: Cross slope more than 1":48" (2.083%). As-Built: 2.8% at tray slide. Proposed Solution: Modify cross slope. 	PCODE EF07 ADAAG 91 4.3.7 ADA 2010 403.3 CBC 2007 1133B.7.1.3 CBC 2019 11B-403.3 Mitigated: <input type="radio"/> YES <input checked="" type="radio"/> NO	45	SF	\$75	\$3,375

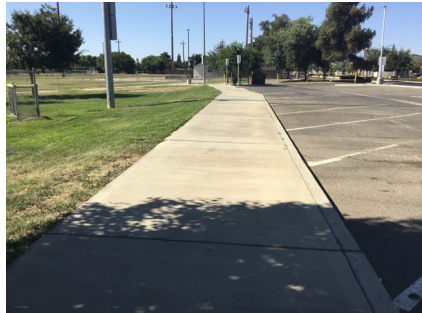
1674	<ul style="list-style-type: none"> As-Built Description: Cross slope more than 1":48" (2.083%). As-Built: Up to 5.2% Proposed Solution: Modify cross slope. 	PCODE EF07 ADAAG 91 4.3.7 ADA 2010 403.3 CBC 2007 1133B.7.1.3 CBC 2019 11B-403.3 Mitigated: <input type="radio"/> YES <input checked="" type="radio"/> NO	1500	SF	\$75	\$112,500

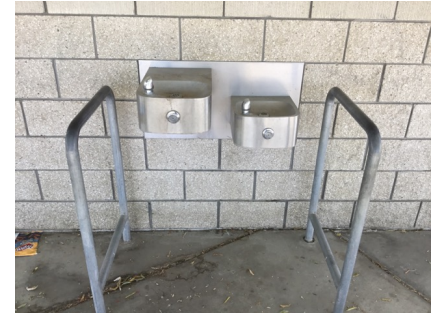
1625	<ul style="list-style-type: none"> • <i>As-Built Description:</i> 30" wide x 48" long clear floor space not provided at drinking fountain. • <i>As-Built:</i> Not centered • <i>Proposed Solution:</i> Provide clear floor space at drinking fountain. Relocate railings. • <i>Notes:</i> 	PCODE IA06 ADAAG 91 4.15.5(1)* ADA 2010 602.2 CBC 2007 1115B.4.6.2 CBC 2019 11B-602.2 Mitigated: <input type="radio"/> YES <input checked="" type="radio"/> NO	1	JOB	\$3,000	\$3,000
------	--	--	---	-----	---------	----------------

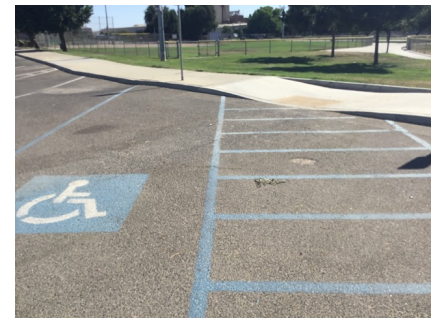
1670	<ul style="list-style-type: none"> • <i>As-Built Description:</i> Accessible parking space has slope greater than 1/4":12" (2%). • <i>As-Built:</i> Up to 4.8% • <i>Proposed Solution:</i> Modify slope at accessible parking space. 	PCODE EA05 ADAAG 91 4.6.3 ADA 2010 502.4 CBC 2007 1129B.3.3 CBC 2019 11B-502.4 Mitigated: <input type="radio"/> YES <input checked="" type="radio"/> NO	30	SF	\$36	\$1,080
------	--	---	----	----	------	----------------

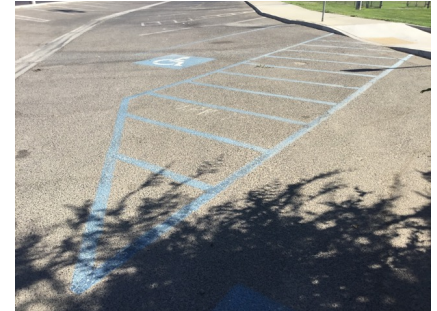
1672	<ul style="list-style-type: none"> As-Built Description: The words "NO PARKING" not painted on the ground within loading and unloading access aisle (12" min high white letters), located so that it is visible to traffic enforcement officials (required in CA only). Proposed Solution: Provide the words "NO PARKING" in each access aisle, painted in 12" high letters, when altering area. 	PCODE EA04D CBC 2007 1129B.3.1 CBC 2019 11B-502.3.3 Mitigated: <input type="radio"/> YES <input checked="" type="radio"/> NO	1	JOB	\$300	\$300
------	--	--	---	-----	-------	-------

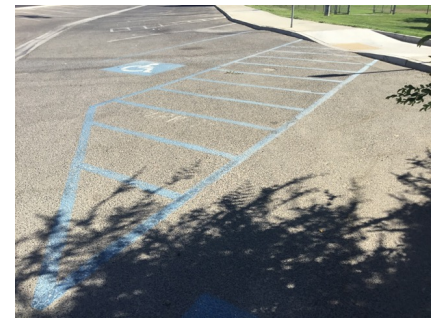
1673	<ul style="list-style-type: none"> As-Built Description: Cross hatching within access aisle is not provided or incorrect. Proposed Solution: Provide cross hatching that is 36" maximum on center and contrasting to the surface of the access aisle. Notes: 	PCODE EA04I CBC 2007 1129B.3.1 CBC 2019 11B-502.3.3 Mitigated: <input type="radio"/> YES <input checked="" type="radio"/> NO	1	JOB	\$300	\$300
------	--	--	---	-----	-------	-------

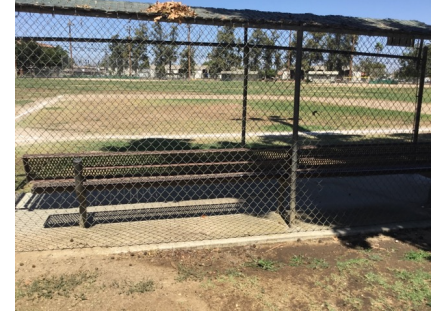
1634	<ul style="list-style-type: none"> As-Built Description: Wheelchair space (33"x48") not provided at fixed seating with forward or rear approach. (NOTE: Space must be adjacent to regular seating; can provide easily removable fixed seat). Proposed Solution: Remove fixed seating and provide wheelchair space plus necessary maneuvering clearance. Enlarge dugouts as needed. Notes: 	PCODE GB01A ADAAG 91 4.1.3(19)(a) ADA 2010 221.2 CBC 2007 1104B.3.6 CBC 2019 11B-221.2 Mitigated: <input type="radio"/> YES <input checked="" type="radio"/> NO	1	JOB	\$6,000	\$6,000
------	---	---	---	-----	---------	----------------

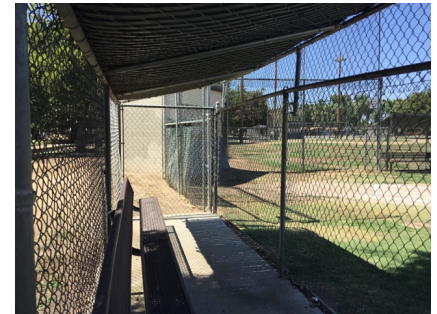
1635	<ul style="list-style-type: none"> As-Built Description: Protruding objects more than 4" from wall, when bottom of object more than 27" or less than 80" above finished floor. As-Built: 73.0" headroom in dugouts. Proposed Solution: Remove/relocate protruding object. Patch existing surface. 	PCODE EG04 ADAAG 91 4.4.1 ADA 2010 307.2 CBC 2007 1133B.8.6.1 CBC 2019 11B-307.2 Mitigated: <input type="radio"/> YES <input checked="" type="radio"/> NO	2	JOB	\$6,000	\$12,000
------	--	---	---	-----	---------	-----------------

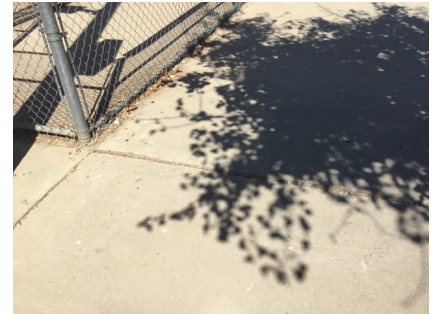
- 1641 • *As-Built Description:*
Walk: Pavement dislocation creates abrupt change in level exceeding 1/2" in accessible route.
- *As-Built:* **0.7 not beveled**
- *Proposed Solution:*
Remove, replace or repair area of pavement sufficient to correct abrupt change in level.

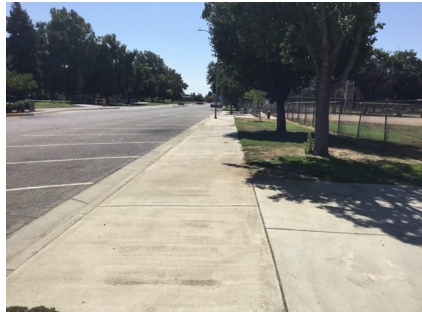
Item no., Rm no. and Name	Existing Architectural Barrier and Proposed Solution	Codes / Mitigation Info	Qty	Unit	Cost	Total
1655	<ul style="list-style-type: none"> As-Built Description: Cross slope more than 1":48" (2.083%). As-Built: 4.4% Proposed Solution: Modify cross slope. 	PCODE EF07 ADAAG 91 4.3.7 ADA 2010 403.3 CBC 2007 1133B.7.1.3 CBC 2019 11B-403.3 Mitigated: <input type="radio"/> YES <input checked="" type="radio"/> NO	500	SF	\$75	\$37,500

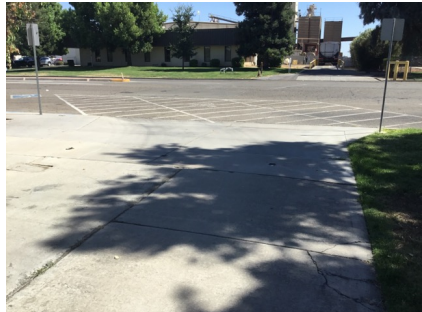
1653	<ul style="list-style-type: none"> As-Built Description: Transition from curb ramp to gutter does not have a smooth transition. As-Built: 1.0" Proposed Solution: Grind lip. Notes: 	PCODE EH02D ADAAG 91 4.7.2 ADA 2010 406.2 CBC 2007 1127B.5.3 CBC 2019 11B-406.5.8 Mitigated: <input type="radio"/> YES <input checked="" type="radio"/> NO	1	JOB	\$300	\$300

Consider whether this and others like it are intended for pedestrian traffic

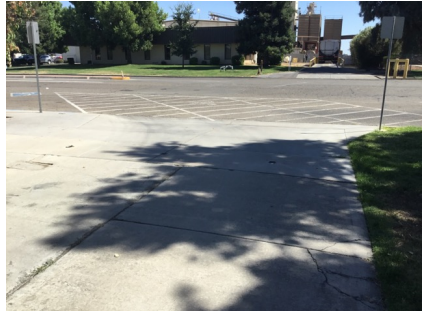
Item no., Rm no. and Name	Existing Architectural Barrier and Proposed Solution	Codes / Mitigation Info	Qty	Unit	Cost	Total
1654	<ul style="list-style-type: none"> As-Built Description: Detectable warning not provided where pedestrian crosses vehicular area. Proposed Solution: Provide detectable warning surface (i.e. in-line truncated domes) at regular curb ramp. Notes: 	PCODE EH07A ADAAG 91 4.7.7 ADA 2010 705.1 CBC 2007 1127B.5.7 CBC 2019 11B-705.1.2.2	1	JOB	\$750	\$750
		Mitigated: <input type="radio"/> YES <input checked="" type="radio"/> NO

<input type="radio"/> Staff Only			
			Priority <input checked="" type="radio"/> 1			
			Severity <input checked="" type="radio"/> 3			
<p>Consider whether this and others like it are intended for pedestrian traffic. Certainly there are no domes where pedestrians meet traffic.</p>

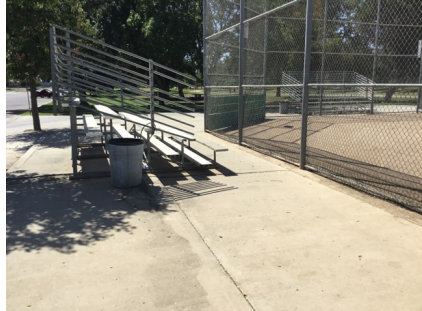
1642	<ul style="list-style-type: none"> As-Built Description: Wheelchair space (33"x48") not provided at fixed seating with forward or rear approach. (NOTE: Space must be adjacent to regular seating; can provide easily removable fixed seat). As-Built: Seating is within circulation path. Proposed Solution: Relocate bleacher and provide wheelchair space plus necessary maneuvering clearance. 	PCODE GB01A ADAAG 91 4.1.3(19)(a) ADA 2010 221.2 CBC 2007 1104B.3.6 CBC 2019 11B-221.2	1	JOB	\$1,350	\$1,350
		Mitigated: <input type="radio"/> YES <input checked="" type="radio"/> NO

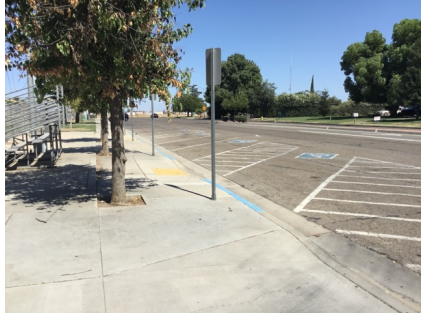
1636	<ul style="list-style-type: none"> As-Built Description: Accessible parking space smaller than 8' wide (CA only: 9' x 18'). As-Built: Diagonal spaces approximately 108.0" to 120.0" long, reduced by adjacent access aisle. Proposed Solution: Modify parking space(s) to create accessible space. 	PCODE EA02A ADAAG 91 4.6.3 ADA 2010 502.2 CBC 2007 1129B.3.1 CBC 2019 11B-502.2 Mitigated: <input type="radio"/> YES <input checked="" type="radio"/> NO	4	JOB	\$600	\$2,400
------	---	--	---	-----	-------	---------

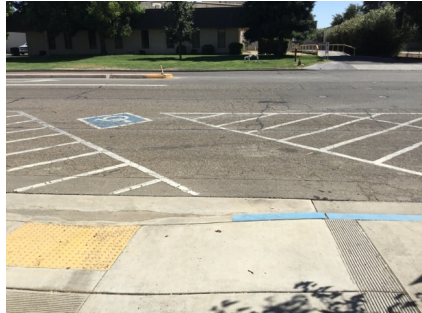
Item no., Rm no. and Name	Existing Architectural Barrier and Proposed Solution	Codes / Mitigation Info	Qty	Unit	Cost	Total
1639	<ul style="list-style-type: none"> As-Built Description: Accessible parking space smaller than 8' wide (CA only: 9' x 18'). As-Built: 96.5" wide Proposed Solution: Modify parking space(s) to create accessible space. 	PCODE EA02A ADAAG 91 4.6.3 ADA 2010 502.2 CBC 2007 1129B.3.1 CBC 2019 11B-502.2 Mitigated: <input type="radio"/> YES <input checked="" type="radio"/> NO	1	JOB	\$600	\$600

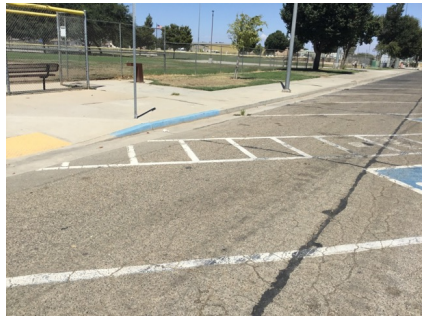
<input type="radio"/> Staff Only			
			Priority <input checked="" type="radio"/> 1			
			Severity <input checked="" type="radio"/> 2			
1638	<ul style="list-style-type: none"> As-Built Description: Cross hatching within access aisle is not provided or incorrect. Proposed Solution: Provide cross hatching that is 36" maximum on center and contrasting to the surface of the access aisle. Notes: 	PCODE EA04I CBC 2007 1129B.3.1 CBC 2019 11B-502.3.3 Mitigated: <input type="radio"/> YES <input checked="" type="radio"/> NO	2	JOB	\$300	\$600

Lines are not diagonal.

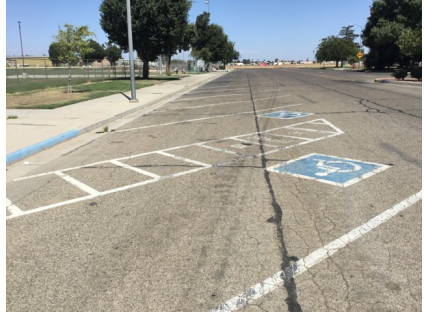
Item no., Rm no. and Name	Existing Architectural Barrier and Proposed Solution	Codes / Mitigation Info	Qty	Unit	Cost	Total
1637	<ul style="list-style-type: none"> As-Built Description: An accessible parking space shall be outlined or painted blue (required in CA only). Proposed Solution: Identify accessible parking space using blue markings. 	PCODE EA04K CBC 2019 11B-502.6 Mitigated: <input type="radio"/> YES <input checked="" type="radio"/> NO	2	JOB	\$360	\$720

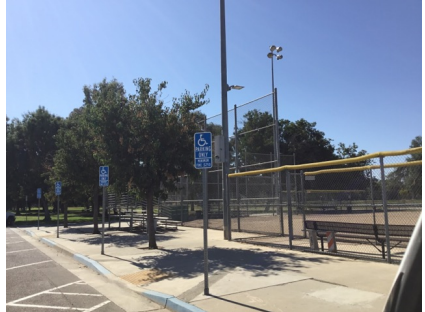
1678	<ul style="list-style-type: none"> As-Built Description: No "Tow Away" sign at parking lot entrance (required in CA only). Proposed Solution: Provide "Tow Away" sign at parking lot entrance when altering area. 	PCODE EA04C CBC 2007 1129B.4 CBC 2019 11B-502.8.2 Mitigated: <input type="radio"/> YES <input checked="" type="radio"/> NO	4	JOB	\$975	\$3,900

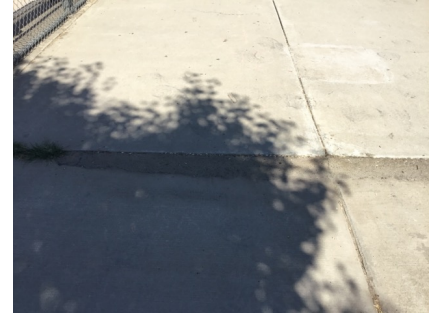
- 1656
- *As-Built Description:*
Walk: Pavement dislocation creates abrupt change in level exceeding 1/2" in accessible route.
 - *As-Built:* **Up to 0.7"**
 - *Proposed Solution:*
Remove, replace or repair area of pavement sufficient to correct abrupt change in level.

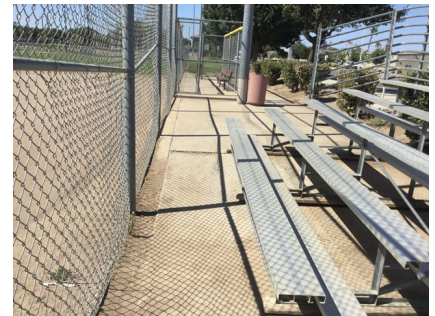
- 1659
- *As-Built Description:*
Walk: Pavement dislocation creates abrupt change in level exceeding 1/2" in accessible route.
 - *As-Built:* **2.0"**
 - *Proposed Solution:*
Remove, replace or repair area of pavement sufficient to correct abrupt change in level.

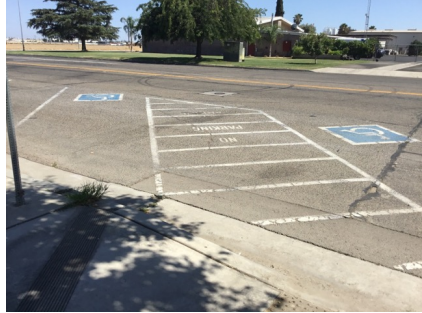
<p>1650</p> <ul style="list-style-type: none"> As-Built Description: Accessible parking space has slope greater than 1/4":12" (2%). As-Built: Up to 5.2% Proposed Solution: Modify slope at accessible parking space. 	<p>PCODE EA05 ADAAG 91 4.6.3 ADA 2010 502.4 CBC 2007 1129B.3.3 CBC 2019 11B-502.4</p> <p>Mitigated: <input type="radio"/> YES <input checked="" type="radio"/> NO</p>	<p>300 SF \$36 \$10,800</p>

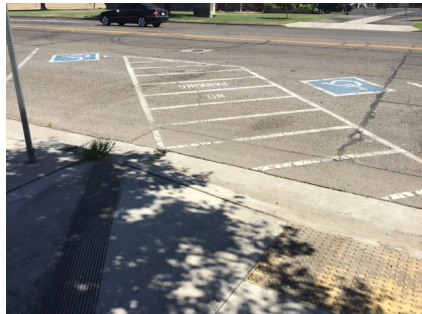
<p>1647</p> <ul style="list-style-type: none"> As-Built Description: Accessible parking space smaller than 8' wide (CA only: 9' x 18'). As-Built: Approximately 86.0" to 104.0" long limited by adjacent access aisle. Proposed Solution: Modify parking space(s) to create accessible space. 	<p>PCODE EA02A ADAAG 91 4.6.3 ADA 2010 502.2 CBC 2007 1129B.3.1 CBC 2019 11B-502.2</p> <p>Mitigated: <input type="radio"/> YES <input checked="" type="radio"/> NO</p>	<p>2 JOB \$600 \$1,200</p>

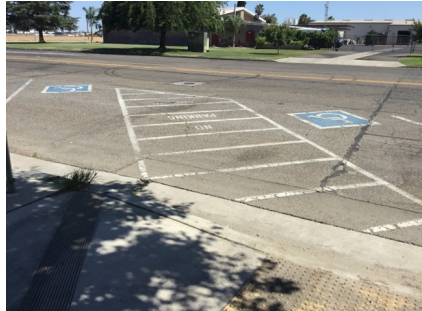
Item no., Rm no. and Name	Existing Architectural Barrier and Proposed Solution	Codes / Mitigation Info	Qty	Unit	Cost	Total
1649	<ul style="list-style-type: none"> As-Built Description: Cross hatching within access aisle is not provided or incorrect. Proposed Solution: Provide cross hatching that is 36" maximum on center and contrasting to the surface of the access aisle. Notes: 	<p>PCODE EA04I</p> <p>CBC 2007 1129B.3.1</p> <p>CBC 2019 11B-502.3.3</p> <p>Mitigated:</p> <p><input type="radio"/> YES</p> <p><input checked="" type="radio"/> NO</p>	2	JOB	\$300	\$600

Not diagonal.

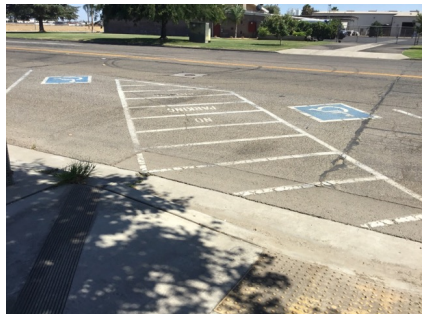
1648	<ul style="list-style-type: none"> As-Built Description: An accessible parking space shall be outlined or painted blue (required in CA only). Proposed Solution: Identify accessible parking space using blue markings. 	<p>PCODE EA04K</p> <p>CBC 2019 11B-502.6</p> <p>Mitigated:</p> <p><input type="radio"/> YES</p> <p><input checked="" type="radio"/> NO</p>	1	JOB	\$360	\$360

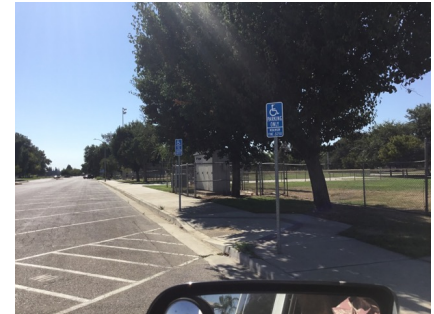
1677	<ul style="list-style-type: none"> <i>As-Built Description:</i> No "Tow Away" sign at parking lot entrance (required in CA only). <i>Proposed Solution:</i> Provide "Tow Away" sign at parking lot entrance when altering area. 	<p>PCODE EA04C</p> <p>CBC 2007 1129B.4</p> <p>CBC 2019 11B-502.8.2</p> <p>Mitigated:</p> <p><input type="radio"/> YES</p> <p><input checked="" type="radio"/> NO</p>	1	JOB	\$975	\$975
------	---	---	---	-----	-------	-------

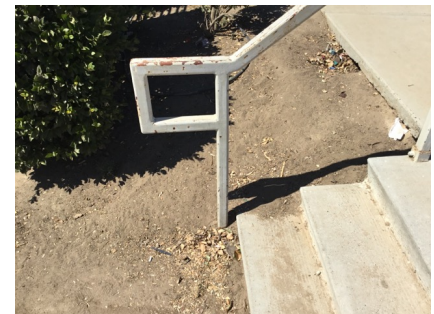
1660	<ul style="list-style-type: none"> <i>As-Built Description:</i> Stair handrail does not extend horizontally 12" minimum beyond top nosing, and one tread width sloped, plus 12" minimum horizontally beyond the bottom nosing. <i>Proposed Solution:</i> Extend stair handrail at top and bottom (cost for each extension piece). 	<p>PCODE ED06</p> <p>ADAAG 91 4.9.4(2)</p> <p>ADA 2010 505.10.2; 505.10.3</p> <p>CBC 2007 1133B.4.2.2</p> <p>CBC 2019 11B-505.10.2; 11B-505.10.3</p> <p>Mitigated:</p> <p><input type="radio"/> YES</p> <p><input checked="" type="radio"/> NO</p>	6	JOB	\$510	\$3,060
------	---	---	---	-----	-------	---------

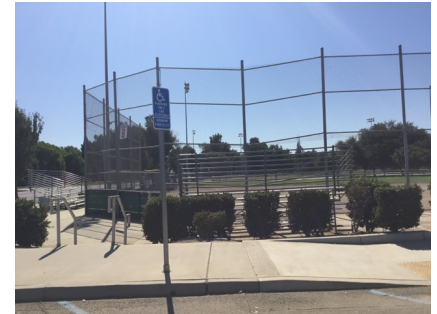
1665	<ul style="list-style-type: none"> <i>As-Built Description:</i> No "Tow Away" sign at parking lot entrance (required in CA only). <i>Proposed Solution:</i> Provide "Tow Away" sign at parking lot entrance when altering area. 	PCODE EA04C CBC 2007 1129B.4 CBC 2019 11B-502.8.2	2	JOB	\$975	\$1,950
------	---	---	---	-----	-------	---------

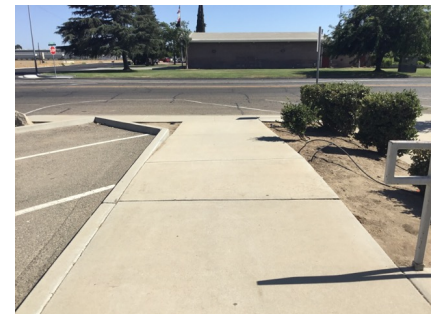
1668	<ul style="list-style-type: none"> <i>As-Built Description:</i> Slope not steep but greater than 1:20 (5.0 %) without handrails. <i>Proposed Solution:</i> Provide handrails for ramp. 	PCODE EB03 ADAAG 91 4.8.1 ADA 2010 405.1 CBC 2007 1133B.5.5.1 CBC 2019 11B-405.8	20	LF	\$225	\$4,500
------	--	--	----	----	-------	---------

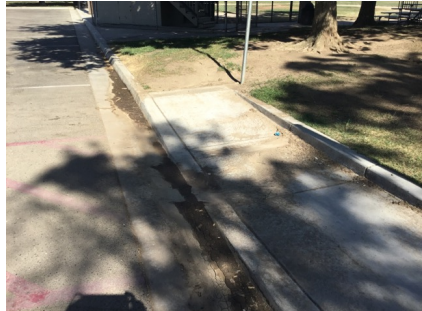
Item no., Rm no. and Name	Existing Architectural Barrier and Proposed Solution	Codes / Mitigation Info	Qty	Unit	Cost	Total
1686	<ul style="list-style-type: none"> As-Built Description: Cross slope greater than 2%. As-Built: 2.8% Proposed Solution: Demolish existing and provide new curb ramp. 	PCODE EH02F ADAAG 91 4.8.6 ADA 2010 405.3 CBC 2007 1133B.5.3.1 CBC 2019 11B-406.5.7 Mitigated: <input type="radio"/> YES <input checked="" type="radio"/> NO	1	JOB	\$7,500	\$7,500

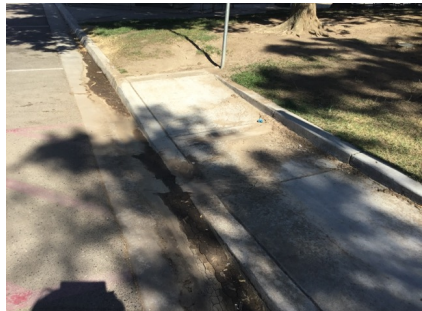
<input type="radio"/> Staff Only			
			Priority <input checked="" type="radio"/> 1			
			Severity <input checked="" type="radio"/> 4			
1687	<ul style="list-style-type: none"> As-Built Description: Detectable warning not provided where pedestrian crosses vehicular area. Proposed Solution: Provide detectable warning surface (i.e. in-line truncated domes) at regular curb ramp. 	PCODE EH07A ADAAG 91 4.7.7 ADA 2010 705.1 CBC 2007 1127B.5.7 CBC 2019 11B-705.1.2.2 Mitigated: <input type="radio"/> YES <input checked="" type="radio"/> NO	1	JOB	\$750	\$750

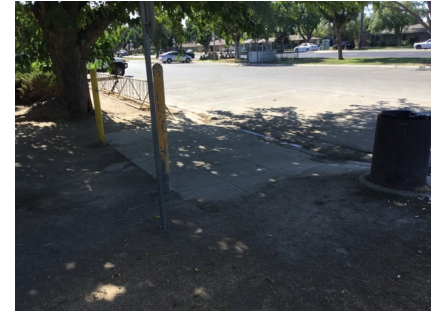
Item no., Rm no. and Name	Existing Architectural Barrier and Proposed Solution	Codes / Mitigation Info	Qty	Unit	Cost	Total
1693	<ul style="list-style-type: none"> <i>As-Built Description:</i> Detectable warning not provided where pedestrian crosses vehicular area. <i>Proposed Solution:</i> Provide detectable warning surface (i.e. in-line truncated domes) at regular curb ramp. <i>Notes:</i> 	PCODE EH07A ADAAG 91 4.7.7 ADA 2010 705.1 CBC 2007 1127B.5.7 CBC 2019 11B-705.1.2.2 Mitigated: <input type="radio"/> YES <input checked="" type="radio"/> NO	1	JOB	\$750	\$750

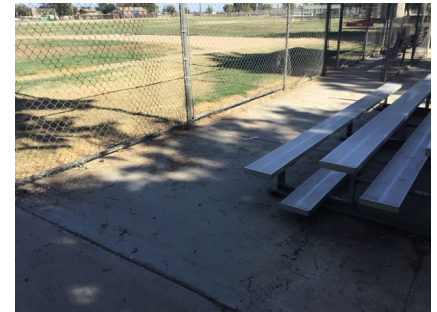
1689	<ul style="list-style-type: none"> <i>As-Built Description:</i> Wheelchair space (33"x48") not provided at fixed seating with forward or rear approach. (NOTE: Space must be adjacent to regular seating; can provide easily removable fixed seat). <i>As-Built:</i> Wheelchair space within circulation path. <i>Proposed Solution:</i> Relocate bleacher and provide wheelchair space plus necessary maneuvering clearance. 	PCODE GB01A ADAAG 91 4.1.3(19)(a) ADA 2010 221.2 CBC 2007 1104B.3.6 CBC 2019 11B-221.2 Mitigated: <input type="radio"/> YES <input checked="" type="radio"/> NO	1	JOB	\$1,350	\$1,350
------	---	---	---	-----	---------	---------

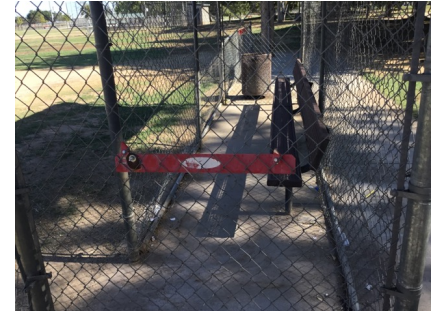
1690	<ul style="list-style-type: none"> <i>As-Built Description:</i> Wheelchair space (33"x48") not provided at fixed seating with forward or rear approach. (NOTE: Space must be adjacent to regular seating; can provide easily removable fixed seat). <i>As-Built:</i> Wheelchair space within circulation path. <i>Proposed Solution:</i> Remove fixed seating and provide wheelchair space plus necessary maneuvering clearance. Enlarge dugouts as needed. <i>Notes:</i> 	<p>PCODE GB01A ADAAG 91 4.1.3(19)(a) ADA 2010 221.2 CBC 2007 1104B.3.6 CBC 2019 11B-221.2</p> <p>Mitigated: <input type="radio"/> YES <input checked="" type="radio"/> NO</p>	2	JOB	\$6,000	\$12,000
------	--	--	---	-----	---------	----------

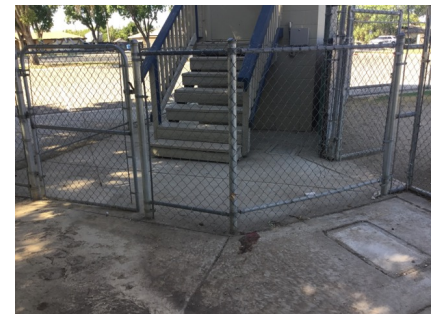
1691	<ul style="list-style-type: none"> <i>As-Built Description:</i> At push side of door on accessible route, bottom 10" does not have a smooth, uninterrupted surface. <i>Proposed Solution:</i> Provide 10" min. "kick plate" covering width of door when altering area. 	<p>PCODE ID06 ADA 2010 404.2.10 CBC 2007 1133B.2.6 CBC 2019 11B-404.2.10</p> <p>Mitigated: <input type="radio"/> YES <input checked="" type="radio"/> NO</p>	2	JOB	\$300	\$600
------	--	--	---	-----	-------	-------

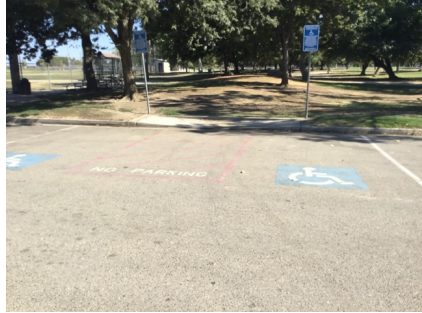
1683	<ul style="list-style-type: none"> As-Built Description: Accessible parking space has slope greater than 1/4":12" (2%). As-Built: Up to 4.1% Proposed Solution: Modify slope at accessible parking space. 	PCODE EA05 ADAAG 91 4.6.3 ADA 2010 502.4 CBC 2007 1129B.3.3 CBC 2019 11B-502.4	300	SF	\$36	\$10,800
		Mitigated: <input type="radio"/> YES <input checked="" type="radio"/> NO

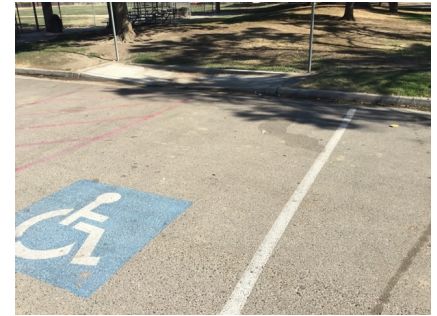
1684	<ul style="list-style-type: none"> <i>As-Built Description:</i> Accessible parking space smaller than 8' wide (CA only: 9' x 18'). <i>As-Built:</i> 107.0" wide <i>Proposed Solution:</i> Modify parking space(s) to create accessible space. 	<p>PCODE EA02A ADAAG 91 4.6.3 ADA 2010 502.2 CBC 2007 1129B.3.1 CBC 2019 11B-502.2</p>	1	JOB	\$600	\$600
------	---	--	---	-----	-------	-------

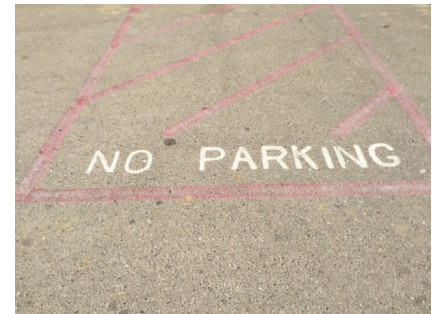
1682	<ul style="list-style-type: none"> <i>As-Built Description:</i> The words "NO PARKING" not painted on the ground within loading and unloading access aisle (12" min high white letters), located so that it is visible to traffic enforcement officials (required in CA only). <i>As-Built:</i> 8.0" high characters. <i>Proposed Solution:</i> Provide the words "NO PARKING" in each access aisle, painted in 12" high letters, when altering area. 	<p>PCODE EA04D CBC 2007 1129B.3.1 CBC 2019 11B-502.3.3</p>	1	JOB	\$300	\$300
------	---	--	---	-----	-------	-------

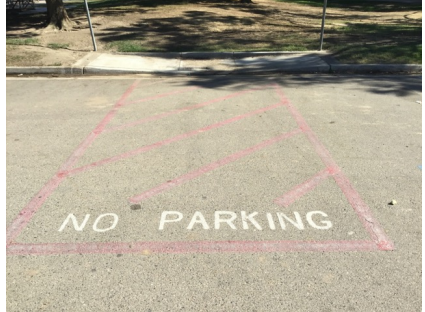
Item no., Rm no. and Name	Existing Architectural Barrier and Proposed Solution	Codes / Mitigation Info	Qty	Unit	Cost	Total
1681	<ul style="list-style-type: none"> As-Built Description: An accessible parking space shall be outlined or painted blue (required in CA only). Proposed Solution: Identify accessible parking space using blue markings. 	PCODE EA04K CBC 2019 11B-502.6 Mitigated: <input type="radio"/> YES <input checked="" type="radio"/> NO	1	JOB	\$360	\$360

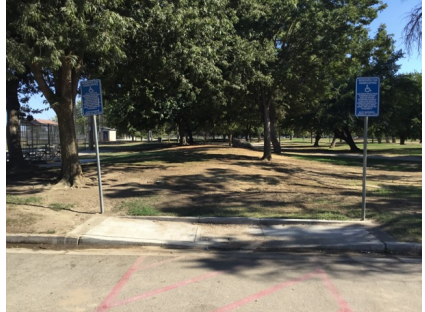
1680	<ul style="list-style-type: none"> As-Built Description: CA only: Additional Sign or additional language below the symbol of accessibility stating “Minimum Fine \$250” not provided. Proposed Solution: Provide compliant parking signage that includes fine information. 	PCODE EA04G CBC 2007 1129B.4 CBC 2019 11B-502.6.2 Mitigated: <input type="radio"/> YES <input checked="" type="radio"/> NO	2	JOB	\$300	\$600

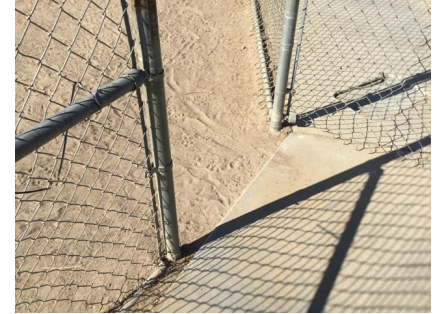
- 1698 • *As-Built Description:*
Walk: Pavement dislocation creates abrupt change in level exceeding 1/2" in accessible route.
- *As-Built:* **2.0" at dugouts.**
- *Proposed Solution:*
Remove, replace or repair area of pavement sufficient to correct abrupt change in level.

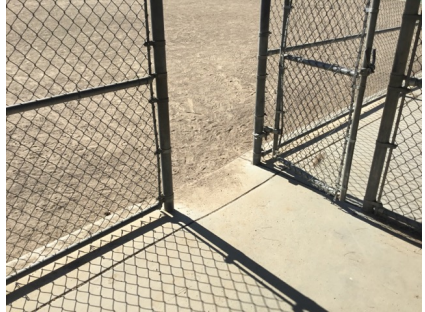
Item no., Rm no. and Name	Existing Architectural Barrier and Proposed Solution	Codes / Mitigation Info	Qty	Unit	Cost	Total
1703	<ul style="list-style-type: none"> As-Built Description: Surface of required maneuvering clearance at door slopes more than 1/4":12" (2.0%). As-Built: 8.0% Proposed Solution: Modify surface slope at door. 	PCODE ID11 ADAAG 91 4.13.6 ADA 2010 404.2.4.4 CBC 2007 1133B.2.4 CBC 2019 11B-404.2.4 Mitigated: <input type="radio"/> YES <input checked="" type="radio"/> NO	50	SF	\$120	\$6,000

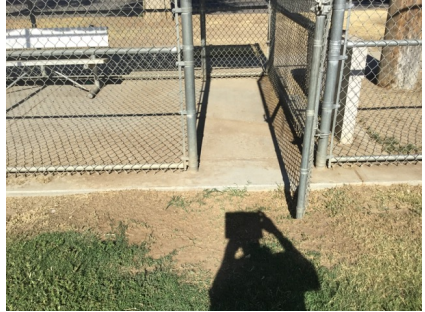
1704	<ul style="list-style-type: none"> As-Built Description: Door inaccessible due to threshold or step at door exceeding 1/2". As-Built: Up to 3.0" Proposed Solution: Modify threshold to be no more than 1/2" by removing existing paving at door and providing landing with edge ramping (slope 1:20 max). Notes: 	PCODE ID02A ADAAG 91 4.13.8 ADA 2010 404.2.5 CBC 2007 1133B.2.4.1 CBC 2019 11B-404.2.5 Mitigated: <input type="radio"/> YES <input checked="" type="radio"/> NO	4	JOB	\$1,200	\$4,800

Dugouts.

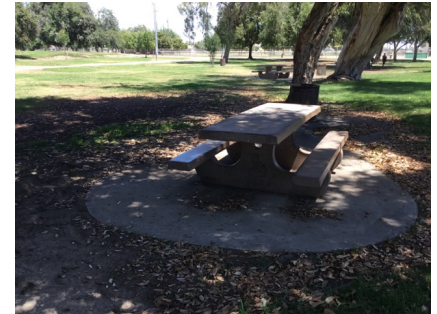
2189	<ul style="list-style-type: none"> • <i>As-Built Description:</i> Walk more than 36" but less than 48" wide (required in CA only). • <i>Proposed Solution:</i> Enlarge width of walk to 48". • <i>Notes:</i> 	<p>PCODE EF08</p> <p>CBC 2007 1133B.7.1</p> <p>CBC 2019 11B-403.5.1.3</p> <p>Mitigated:</p> <p><input type="radio"/> YES</p> <p><input checked="" type="radio"/> NO</p>	40	SF	\$135	\$5,400
------	---	--	----	----	-------	----------------

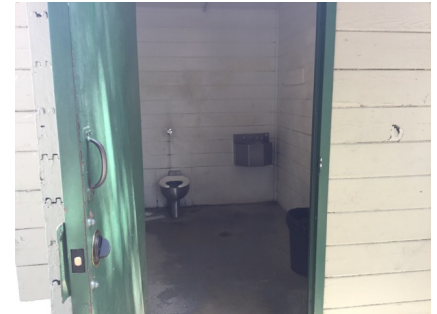
- *As-Built Description:*
Single accommodation restroom not accessible; multiple compliance violations.
- *As-Built:* **68.5” x 111.5”**
- *Proposed Solution:*
Remodel area to provide single-occupant accessible restroom.

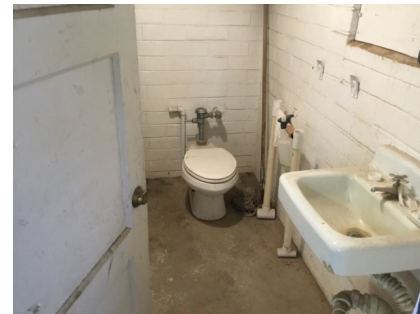
- *As-Built Description:*
Single accommodation restroom not accessible; multiple compliance violations.
- *As-Built:* **96.0" x 72.0"**
- *Proposed Solution:*
Remodel area to provide single-occupant accessible restroom.

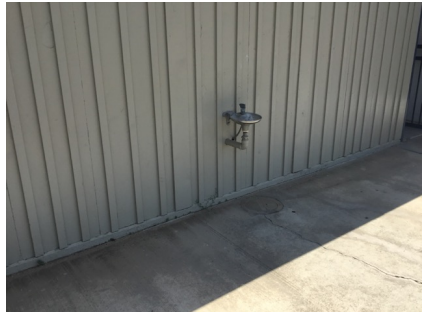
Item no., Rm no. and Name	Existing Architectural Barrier and Proposed Solution	Codes / Mitigation Info	Qty	Unit	Cost	Total
1378	<ul style="list-style-type: none"> <i>As-Built Description:</i> Drinking fountain lacks protection for visually impaired persons. <i>Proposed Solution:</i> Provide cane-detectable rails. 	PCODE IA05C ADAAG 91 4.4.1 ADA 2010 307.2 CBC 2007 1115B.4.6.3 CBC 2019 11B-307.2 Mitigated: <input type="radio"/> YES <input checked="" type="radio"/> NO	1	JOB	\$1,500	\$1,500

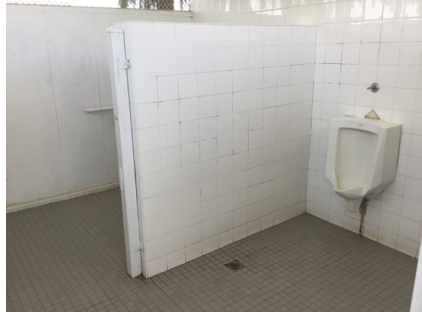
1375	<ul style="list-style-type: none"> <i>As-Built Description:</i> Multiple accommodation restroom not accessible; multiple compliance violations. <i>As-Built:</i> 140.0" x 112.0" <i>Proposed Solution:</i> Remodel area to provide accessible restroom with one accessible stall, lavatory (and one urinal at Men's). 	PCODE WA01A ADAAG 91 4.22 ADA 2010 603.1 CBC 2007 1115B.3.1 CBC 2019 11B-603.1 Mitigated: <input type="radio"/> YES <input checked="" type="radio"/> NO	2	JOB	?	\$210,000

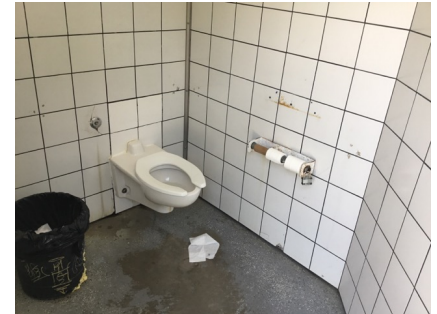
Single accommodation restroom not accessible; multiple compliance violations.

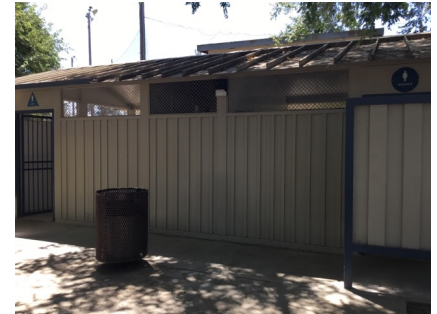
Multiple accommodation restroom not accessible; multiple compliance violations.

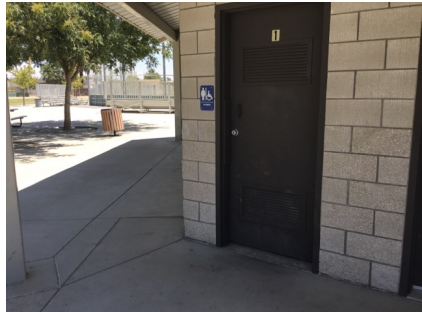
Item no., Rm no. and Name	Existing Architectural Barrier and Proposed Solution	Codes / Mitigation Info	Qty	Unit	Cost	Total
2170	<ul style="list-style-type: none"> As-Built Description: Surface of required maneuvering clearance at door slopes more than 1/4":12" (2.0%). As-Built: 3.8% Proposed Solution: Modify surface slope at door. 	PCODE ID11 ADAAG 91 4.13.6 ADA 2010 404.2.4.4 CBC 2007 1133B.2.4 CBC 2019 11B-404.2.4 Mitigated: <input type="radio"/> YES <input checked="" type="radio"/> NO	25	SF	\$120	\$3,000

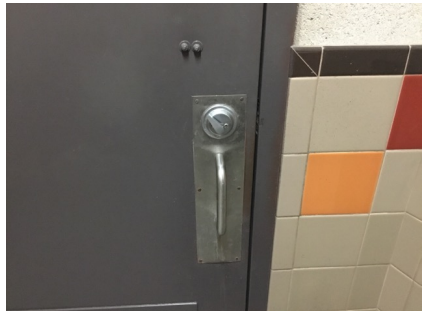
1600	<ul style="list-style-type: none"> As-Built Description: Door lock, latch or handle less than 34" or more than 48" above the floor (CA only: 34" to 44"). As-Built: 45.0" high Proposed Solution: Relocate or replace existing hardware. Notes: 	PCODE ID17 ADAAG 91 4.13.9 ADA 2010 404.2.7 CBC 2007 1133B.2.5.2 CBC 2019 11B-404.2.7 Mitigated: <input type="radio"/> YES <input checked="" type="radio"/> NO	1	JOB	\$900	\$900

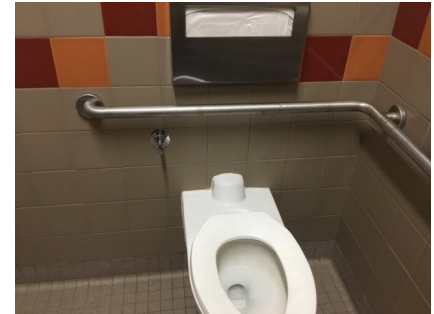
1607	<ul style="list-style-type: none"> <i>As-Built Description:</i> The rear wall grab is less than 36" min. or does not extend from the centerline of the water closet 12" min. on one side and 24" min. on the other side. <i>As-Built:</i> Extends 18.0" on wide side <i>Proposed Solution:</i> Provide new accessible rear grab bar. <i>Notes:</i> 	PCODE WB07B ADAAG 91 4.17.6 ADA 2010 604.5.2 CBC 2007 1115B.4.1.3.2 CBC 2019 11B-604.5.2	1	JOB	\$1,020	\$1,020
------	---	---	---	-----	---------	---------

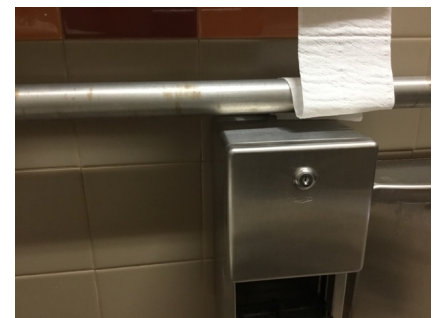
1601	<ul style="list-style-type: none"> <i>As-Built Description:</i> Accessories/dispensers in accessible stall located closer than 1-1/2" below or 12" above grab bar impedes its use. <i>As-Built:</i> TPD: 0.25" below grab bar <i>Proposed Solution:</i> Relocate accessories/dispensers within applicable reach range and to be no closer than 1-1/2" below and 12" above grab bars (except if accessories are recessed, flush with wall, and have no sharp edges). 	PCODE WB07I ADAAG 91 4.26.2 ADA 2010 609.3 CBC 2007 1133B.4.2.5 CBC 2019 11B-609.3	1	JOB	\$225	\$225
------	---	---	---	-----	-------	-------

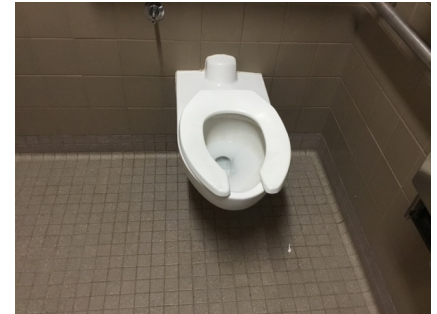
1604	<ul style="list-style-type: none"> • <i>As-Built Description:</i> Water closet not 16"-18" (CA: 17"-18") from near side wall to center line of water closet (2010 ADAAG: 16"-18"). • <i>As-Built:</i> 20.0" o.c. • <i>Proposed Solution:</i> Relocate existing water closet and plumbing, remount with offset closet flange to provide 18" max. from side wall. 	<p>PCODE WB02C ADAAG 91 Fig. 28 ADA 2010 604.2 CBC 2007 1115B.4.1.1 CBC 2019 11B-604.2</p>	1	JOB	\$1,500	\$1,500
------	---	---	---	-----	---------	---------

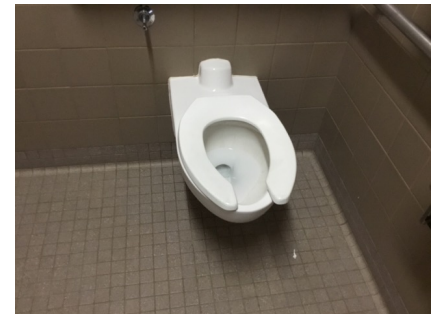
1605	<ul style="list-style-type: none"> • <i>As-Built Description:</i> Height of water closet seat less than 17" or more than 19" from floor. • <i>As-Built:</i> 19.75" high • <i>Proposed Solution:</i> Provide new accessible water closet. 	<p>PCODE WB08 ADAAG 91 4.16.3 ADA 2010 604.4 CBC 2007 1115B.4.1.4 CBC 2019 11B-604.4</p>	1	JOB	\$4,200	\$4,200
------	--	---	---	-----	---------	---------

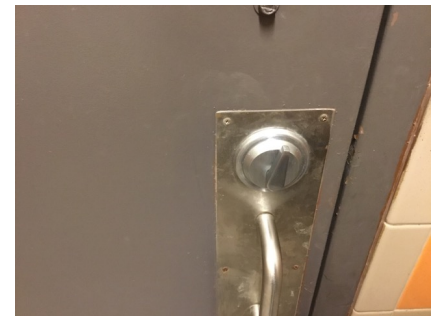
- 1615 • *As-Built Description:*
Door lock, latch or handle less than 34" or more than 48" above the floor (CA only: 34" to 44").
- *As-Built:* **45.0" high**
- *Proposed Solution:*
Relocate or replace existing hardware.
- *Notes:*

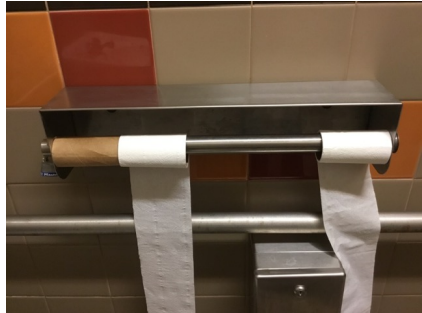
Item no., Rm no. and Name	Existing Architectural Barrier and Proposed Solution	Codes / Mitigation Info	Qty	Unit	Cost	Total
1620	<ul style="list-style-type: none"> • <i>As-Built Description:</i> Accessories/dispensers in accessible stall located closer than 1-1/2" below or 12" above grab bar impedes its use. • <i>As-Built:</i> TPD: 4.0" above grab bar • <i>Proposed Solution:</i> Relocate accessories/dispensers within applicable reach range and to be no closer than 1-1/2" below and 12" above grab bars (except if accessories are recessed, flush with wall, and have no sharp edges). 	PCODE WB07I ADAAG 91 4.26.2 ADA 2010 609.3 CBC 2007 1133B.4.2.5 CBC 2019 11B-609.3 Mitigated: <input type="radio"/> YES <input checked="" type="radio"/> NO	1	JOB	\$225	\$225
