The City of Madera

Appendix B: Facilities

Access Compliance Survey Report

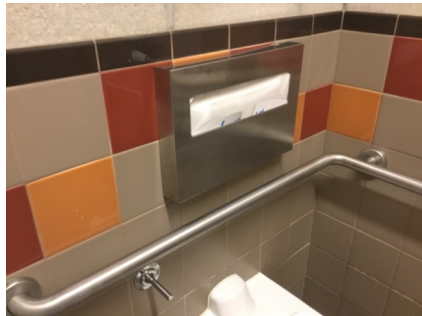
1621	<ul style="list-style-type: none"> • <i>As-Built Description:</i> Accessories/dispensers in accessible stall located closer than 1-1/2" below or 12" above grab bar impedes its use. • <i>As-Built:</i> SCD: 2.0" above grab bar • <i>Proposed Solution:</i> Relocate accessories/dispensers within applicable reach range and to be no closer than 1-1/2" below and 12" above grab bars (except if accessories are recessed, flush with wall, and have no sharp edges). 	PCODE WB07I ADAAG 91 4.26.2 ADA 2010 609.3 CBC 2007 1133B.4.2.5 CBC 2019 11B-609.3 Mitigated: <input type="radio"/> YES <input checked="" type="radio"/> NO	1	JOB	\$225	\$225

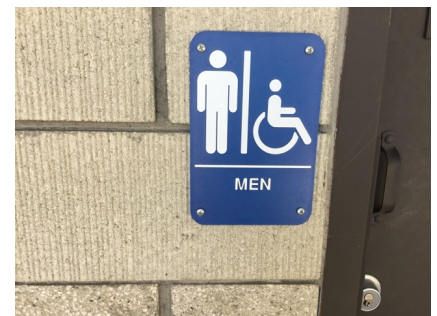
- 1612
- *As-Built Description:*
Entrance to toilet or bathing facility not identified with ADAAG compliant signage.
 - *As-Built:* **Braille 0.75" from characters.**
 - *Proposed Solution:*
Provide ADA compliant sign mounted at 48" min. above to baseline of the lowest Braille cells and 60" max. to baseline of the highest line of raised characters on nearest adjacent wall, on latch side of a single door (located not to cause a Braille reader to stand within the door swing).
 - **Notes:**

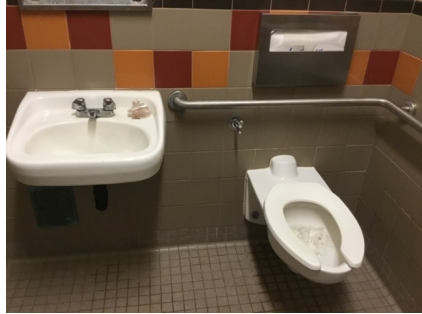
1616	<ul style="list-style-type: none"> As-Built Description: 60" min. clearance around a water closet measured perpendicular from the side wall not provided (Fixtures are not allowed to overlap this clearance). As-Built: 40.0" to lavatory Proposed Solution: Remove adjacent fixture and remodel restroom as needed. Notes: 	PCODE WB01A ADA 2010 604.3.1; 604.3.2 CBC 2007 1115B.7.1.3 CBC 2019 11B-604.3.1; 11B-604.3.2 Mitigated: <input type="radio"/> YES <input checked="" type="radio"/> NO	1	JOB	\$6,000	\$6,000
------	---	---	---	-----	---------	---------

This element complies with Safe Harbor if altered or constructed before March 15, 2012. This element does not comply with the dimensional requirements in the 1981 to the current CBC.

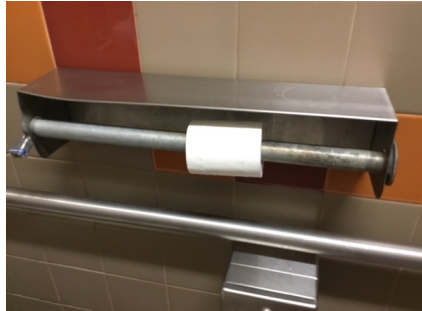
Item no., Rm no. and Name	Existing Architectural Barrier and Proposed Solution	Codes / Mitigation Info	Qty	Unit	Cost	Total
2150	<ul style="list-style-type: none"> As-Built Description: Accessories/dispensers in accessible stall located closer than 1-1/2" below or 12" above grab bar impedes its use. As-Built: PTD: 4.0" above grab bar Proposed Solution: Relocate accessories/dispensers within applicable reach range and to be no closer than 1-1/2" below and 12" above grab bars (except if accessories are recessed, flush with wall, and have no sharp edges). 	PCODE WB07I ADAAG 91 4.26.2 ADA 2010 609.3 CBC 2007 1133B.4.2.5 CBC 2019 11B-609.3 Mitigated: <input type="radio"/> YES <input checked="" type="radio"/> NO	1	JOB	\$225	\$225

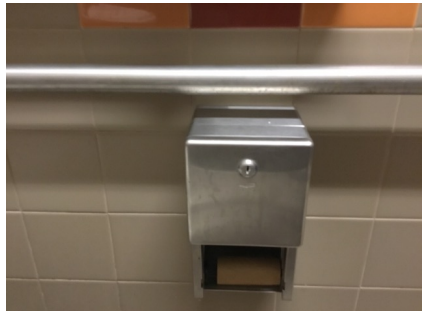
<input type="radio"/> Staff Only			
			Priority <input checked="" type="radio"/> 3			
			Severity <input checked="" type="radio"/> 4			
2151	<ul style="list-style-type: none"> As-Built Description: Accessories/dispensers in accessible stall located closer than 1-1/2" below or 12" above grab bar impedes its use. As-Built: PTD: 1.3" below grab bar Proposed Solution: Raise the grab bar. 	PCODE WB07I ADAAG 91 4.26.2 ADA 2010 609.3 CBC 2007 1133B.4.2.5 CBC 2019 11B-609.3 Mitigated: <input type="radio"/> YES <input checked="" type="radio"/> NO	1	JOB	\$225	\$225

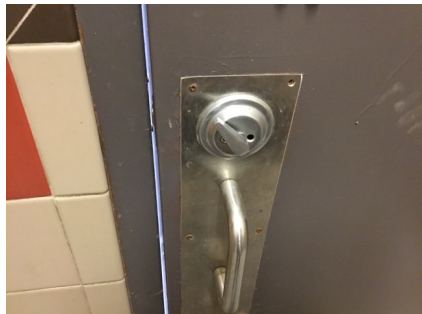
2154	<ul style="list-style-type: none"> • <i>As-Built Description:</i> Door lock, latch or handle less than 34" or more than 48" above the floor (CA only: 34" to 44"). • <i>As-Built:</i> 44.75" • <i>Proposed Solution:</i> Relocate or replace existing hardware. • <i>Notes:</i> 	PCODE ID17 ADAAG 91 4.13.9 ADA 2010 404.2.7 CBC 2007 1133B.2.5.2 CBC 2019 11B-404.2.7 Mitigated: <input type="radio"/> YES <input checked="" type="radio"/> NO	1	JOB	\$900	\$900
------	--	--	---	-----	-------	-------

This element complies with Safe Harbor if altered or constructed before March 15, 2012. The dimensional requirements in this CBC citation applied from the 1998 CBC to the code cycle at the time of this survey.

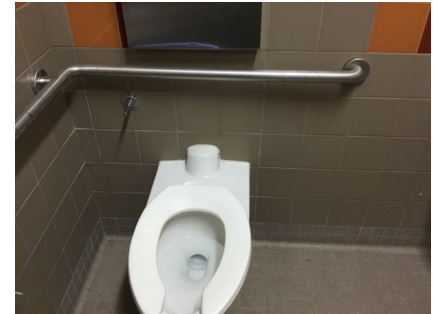
2153	<ul style="list-style-type: none"> <i>As-Built Description:</i> The rear wall grab is less than 36" min. or does not extend from the centerline of the water closet 12" min. on one side and 24" min. on the other side. <i>As-Built:</i> Extends 19.5" on wide side <i>Proposed Solution:</i> Provide or relocate accessible rear grab bar. <i>Notes:</i> 	<p>PCODE WB07B ADAAG 91 4.17.6 ADA 2010 604.5.2 CBC 2007 1115B.4.1.3.2 CBC 2019 11B-604.5.2</p> <p>Mitigated: <input type="radio"/> YES <input checked="" type="radio"/> NO</p>	1	JOB	\$1,020	\$1,020
------	---	---	---	-----	---------	----------------

This element complies with Safe Harbor if altered or constructed before March 15, 2012. .

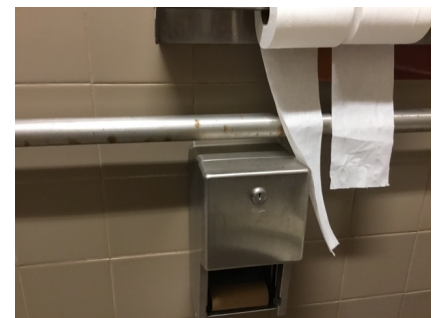
2135	<ul style="list-style-type: none"> <i>As-Built Description:</i> Accessories/dispensers in accessible stall located closer than 1-1/2" below or 12" above grab bar impedes its use. <i>As-Built:</i> PTD: 0.75" below grab bar <i>Proposed Solution:</i> Relocate accessories/dispensers within applicable reach range and to be no closer than 1-1/2" below and 12" above grab bars (except if accessories are recessed, flush with wall, and have no sharp edges). 	<p>PCODE WB07I ADAAG 91 4.26.2 ADA 2010 609.3 CBC 2007 1133B.4.2.5 CBC 2019 11B-609.3</p> <p>Mitigated: <input type="radio"/> YES <input checked="" type="radio"/> NO</p>	1	JOB	\$225	\$225
------	---	---	---	-----	-------	--------------

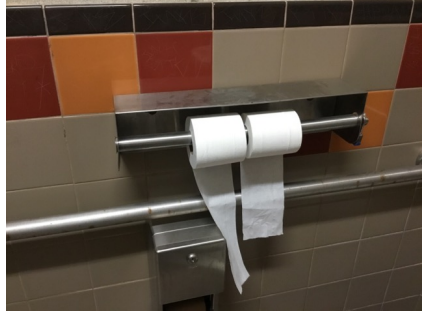
Item no., Rm no. and Name	Existing Architectural Barrier and Proposed Solution	Codes / Mitigation Info	Qty	Unit	Cost	Total
2136	<ul style="list-style-type: none"> As-Built Description: Accessories/dispensers in accessible stall located closer than 1-1/2" below or 12" above grab bar impedes its use. As-Built: PTD: 3.5" above grab bar Proposed Solution: Relocate accessories/dispensers within applicable reach range and to be no closer than 1-1/2" below and 12" above grab bars (except if accessories are recessed, flush with wall, and have no sharp edges). 	PCODE WB07I ADAAG 91 4.26.2 ADA 2010 609.3 CBC 2007 1133B.4.2.5 CBC 2019 11B-609.3 Mitigated: <input type="radio"/> YES <input checked="" type="radio"/> NO	1	JOB	\$225	\$225

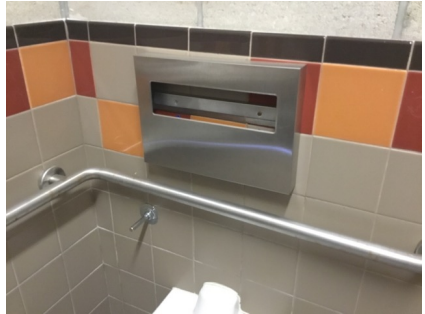
<input type="radio"/> Staff Only Priority <input checked="" type="radio"/> 3 Severity <input checked="" type="radio"/> 4			
2137	<ul style="list-style-type: none"> As-Built Description: Accessories/dispensers in accessible stall located closer than 1-1/2" below or 12" above grab bar impedes its use. As-Built: SCD: 3.0" above grab bar Proposed Solution: Relocate accessories/dispensers within applicable reach range and to be no closer than 1-1/2" below and 12" above grab bars (except if accessories are recessed, flush with wall, and have no sharp edges). 	PCODE WB07I ADAAG 91 4.26.2 ADA 2010 609.3 CBC 2007 1133B.4.2.5 CBC 2019 11B-609.3 Mitigated: <input type="radio"/> YES <input checked="" type="radio"/> NO	1	JOB	\$225	\$225

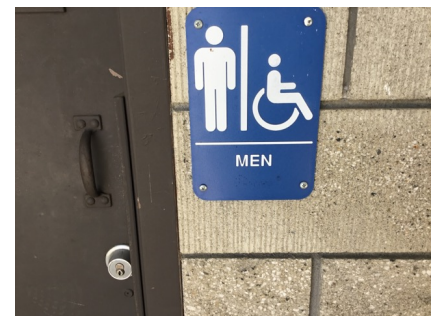
- 2129 • *As-Built Description:*
Entrance to toilet or bathing facility not identified with ADAAG compliant signage.
- *As-Built:* **Braille 1.0" from characters. 2 lines of Braille**
- *Proposed Solution:*
Provide ADA compliant sign mounted at 48" min. above to baseline of the lowest Braille cells and 60" max. to baseline of the highest line of raised characters on nearest adjacent wall, on latch side of a single door (located not to cause a Braille reader to stand within the door swing).
- **Notes:**

The same condition occurs at each restroom at the hexagon.

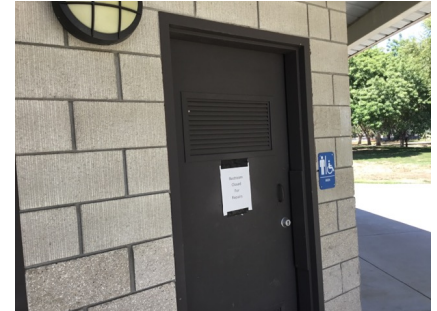
2144	<ul style="list-style-type: none"> As-Built Description: Required in CA only: identification symbol centered 58" to 60" high on sanitary facility door that contrasts with the door not provided (women: 12" ø circle, men: 12" triangle, unisex: combined symbol). Proposed Solution: Provide properly mounted sanitary facility symbol when altering area. If wheelchair accessible, include International Symbol of Accessibility on sign. Notes: 	PCODE SA15 CBC 2007 1115B.6 CBC 2019 11B-703.7.2.6 Mitigated: <input type="radio"/> YES <input checked="" type="radio"/> NO	6	JOB	\$270	\$1,620
------	--	---	---	-----	-------	---------

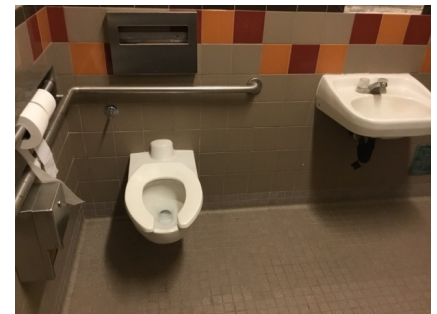
2138	<ul style="list-style-type: none"> As-Built Description: 60" min. clearance around a water closet measured perpendicular from the side wall not provided (Fixtures are not allowed to overlap this clearance). As-Built: 53.5" to lavatory Proposed Solution: Relocate adjacent fixture and remodel restroom as needed. Notes: 	PCODE WB01A ADA 2010 604.3.1; 604.3.2 CBC 2007 1115B.7.1.3 CBC 2019 11B-604.3.1; 11B-604.3.2 Mitigated: <input type="radio"/> YES <input checked="" type="radio"/> NO	1	JOB	\$6,000	\$6,000
------	---	---	---	-----	---------	---------

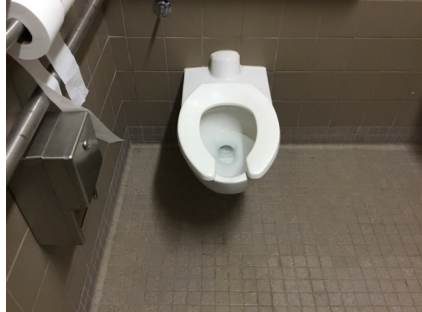
<p>2134</p> <ul style="list-style-type: none"> <i>As-Built Description:</i> Water closet not 16"-18" (CA: 17"-18") from near side wall to center line of water closet (2010 ADAAG: 16"-18"). <i>As-Built:</i> 18.5" <i>Proposed Solution:</i> Relocate existing water closet and plumbing, remount with offset closet flange to provide 18" max. from side wall. 	<p><i>PCODE</i> WB02C <i>ADAAG 91</i> Fig. 28 <i>ADA 2010</i> 604.2 <i>CBC 2007</i> 1115B.4.1.1 <i>CBC 2019</i> 11B-604.2</p>	<p>1 JOB \$1,500 \$1,500</p>

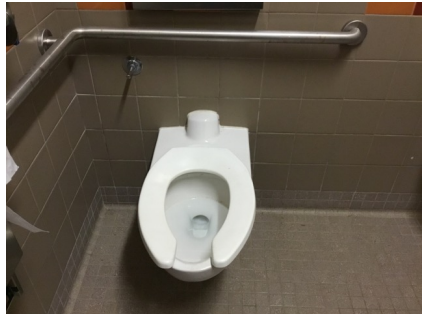
<p>2152</p> <ul style="list-style-type: none"> <i>As-Built Description:</i> Water closet not 16"-18" (CA: 17"-18") from near side wall to center line of water closet (2010 ADAAG: 16"-18"). <i>As-Built:</i> 18.5" <i>Proposed Solution:</i> Relocate existing water closet and plumbing, remount with offset closet flange to provide 18" max. from side wall. <i>Notes:</i> 	<p><i>PCODE</i> WB02C <i>ADAAG 91</i> Fig. 28 <i>ADA 2010</i> 604.2 <i>CBC 2007</i> 1115B.4.1.1 <i>CBC 2019</i> 11B-604.2</p>	<p>1 JOB \$1,500 \$1,500</p>

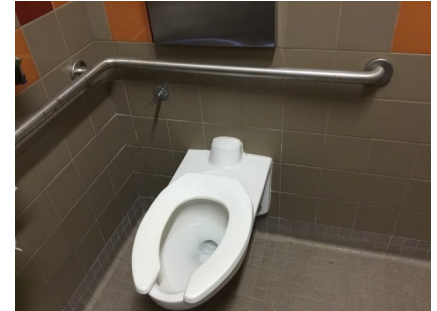
2133 • *As-Built Description:*
 Flush Control: Operating handle not mounted toward wide side of stall.
 • *Proposed Solution:*
 Replace flush control with properly mounted accessible type, or install sensor flush.

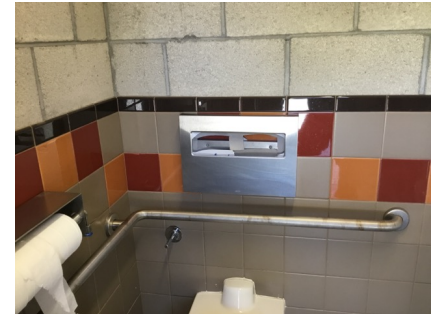
<p>2158</p> <ul style="list-style-type: none"> As-Built Description: Dispensers in sanitary facilities, such as for towels, soap, sanitary napkins, seat covers, etc., and waste receptacles more than 48" (CA only: 40") from floor to highest operating slot or control. As-Built: 43.0" high Proposed Solution: Relocate existing restroom accessories. 	<p>PCODE WG01A ADAAG 91 4.23.7 ADA 2010 308.2.1 CBC 2007 1115B.8.3 CBC 2019 11B-603.5</p>	<p>1 JOB \$300 \$300</p>
---	---	---------------------------------

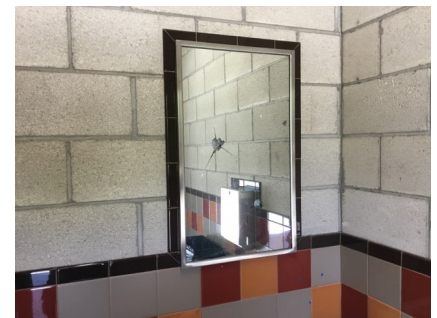
<p>2165</p> <ul style="list-style-type: none"> As-Built Description: Bottom of mirror located above lavatories or countertops more than 40" above floor. As-Built: 48.5" Proposed Solution: Relocate or provide new accessible mirror. 	<p>PCODE WG03 ADAAG 91 4.19.6 ADA 2010 603.3 CBC 2007 1115B.8.1 CBC 2019 11B-603.3</p>	<p>1 JOB \$450 \$450</p>
---	--	---------------------------------

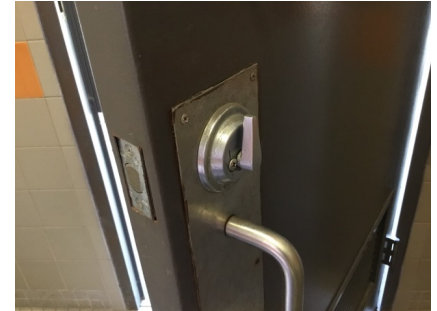
2156	<ul style="list-style-type: none"> • <i>As-Built Description:</i> Door lock, latch or handle less than 34" or more than 48" above the floor (CA only: 34" to 44"). • <i>As-Built:</i> 45.0" • <i>Proposed Solution:</i> Relocate or replace existing hardware. • <i>Notes:</i> 	<p>PCODE ID17 ADAAG 91 4.13.9 ADA 2010 404.2.7 CBC 2007 1133B.2.5.2 CBC 2019 11B-404.2.7</p> <p>Mitigated: <input type="radio"/> YES <input checked="" type="radio"/> NO</p>	1	JOB	\$900	\$900
------	---	---	---	-----	-------	-------

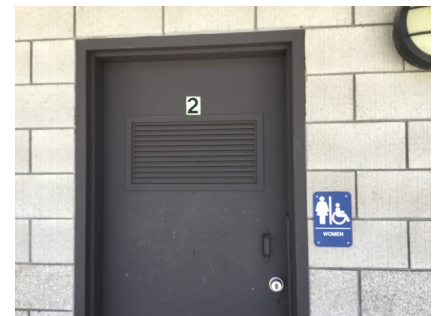
2167	<ul style="list-style-type: none"> • <i>As-Built Description:</i> Excessive force required to open door. • <i>As-Built:</i> 1.0 second • <i>Proposed Solution:</i> Adjust regular door closer to accessible standards (5 lbs. max). 	<p>PCODE ID03 ADAAG 91 4.13.11 ADA 2010 404.2.9 CBC 2007 1133B.2.5 CBC 2019 11B-404.2.9</p> <p>Mitigated: <input type="radio"/> YES <input checked="" type="radio"/> NO</p>	1	JOB	\$75	\$75
------	---	--	---	-----	------	------

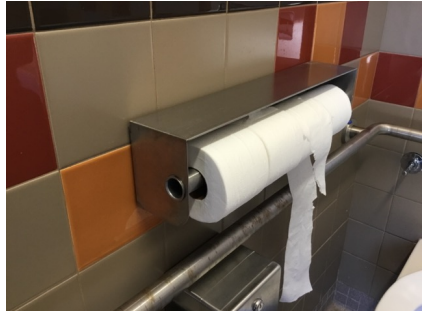
Item no., Rm no. and Name	Existing Architectural Barrier and Proposed Solution	Codes / Mitigation Info	Qty	Unit	Cost	Total
2161	<ul style="list-style-type: none"> • <i>As-Built Description:</i> Accessories/dispensers in accessible stall located closer than 1-1/2" below or 12" above grab bar impedes its use. • <i>As-Built:</i> TPD: 4.0" above grab bar • <i>Proposed Solution:</i> Relocate accessories/dispensers within applicable reach range and to be no closer than 1-1/2" below and 12" above grab bars (except if accessories are recessed, flush with wall, and have no sharp edges). 	PCODE WB07I ADAAG 91 4.26.2 ADA 2010 609.3 CBC 2007 1133B.4.2.5 CBC 2019 11B-609.3 Mitigated: <input type="radio"/> YES <input checked="" type="radio"/> NO	1	JOB	\$225	\$225

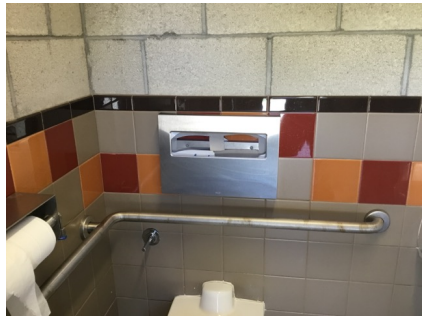
<input type="radio"/> Staff Only Priority <input checked="" type="radio"/> 3 Severity <input checked="" type="radio"/> 4						
2162	<ul style="list-style-type: none"> • <i>As-Built Description:</i> Accessories/dispensers in accessible stall located closer than 1-1/2" below or 12" above grab bar impedes its use. • <i>As-Built:</i> SCD: 3.0" above grab bar • <i>Proposed Solution:</i> Relocate accessories/dispensers within applicable reach range and to be no closer than 1-1/2" below and 12" above grab bars (except if accessories are recessed, flush with wall, and have no sharp edges). 	PCODE WB07I ADAAG 91 4.26.2 ADA 2010 609.3 CBC 2007 1133B.4.2.5 CBC 2019 11B-609.3 Mitigated: <input type="radio"/> YES <input checked="" type="radio"/> NO	1	JOB	\$225	\$225

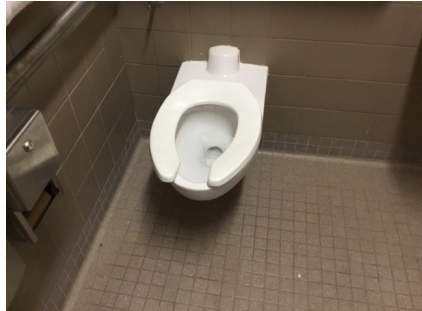
Item no., Rm no. and Name	Existing Architectural Barrier and Proposed Solution	Codes / Mitigation Info	Qty	Unit	Cost	Total
2186	<ul style="list-style-type: none"> As-Built Description: Height of water closet seat less than 17" or more than 19" from floor. As-Built: 20.0" Proposed Solution: Provide new accessible water closet. 	PCODE WB08 ADAAG 91 4.16.3 ADA 2010 604.4 CBC 2007 1115B.4.1.4 CBC 2019 11B-604.4 Mitigated: <input type="radio"/> YES <input checked="" type="radio"/> NO	1	JOB	\$4,200	\$4,200

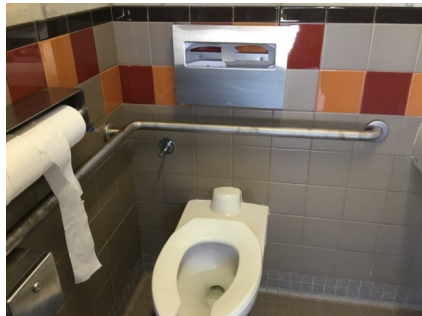
<input type="radio"/> Staff Only			
			Priority <input checked="" type="radio"/> 3			
			Severity <input checked="" type="radio"/> 3			
2163	<ul style="list-style-type: none"> As-Built Description: Flush Control: Operating handle not mounted toward wide side of stall. Proposed Solution: Replace flush control with properly mounted accessible type, or install sensor flush. 	PCODE WB10 ADAAG 91 4.16.5 ADA 2010 604.6 CBC 2007 1115B.4.1.5 CBC 2019 11B-604.6 Mitigated: <input type="radio"/> YES <input checked="" type="radio"/> NO	1	JOB	\$1,500	\$1,500

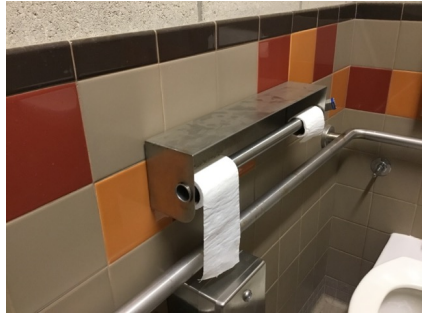
Item no., Rm no. and Name	Existing Architectural Barrier and Proposed Solution	Codes / Mitigation Info	Qty	Unit	Cost	Total
2176	<ul style="list-style-type: none"> • <i>As-Built Description:</i> Accessories/dispensers in accessible stall located closer than 1-1/2" below or 12" above grab bar impedes its use. • <i>As-Built:</i> TPD: 4.0" above grab bar • <i>Proposed Solution:</i> Relocate accessories/dispensers within applicable reach range and to be no closer than 1-1/2" below and 12" above grab bars (except if accessories are recessed, flush with wall, and have no sharp edges). 	PCODE WB07I ADAAG 91 4.26.2 ADA 2010 609.3 CBC 2007 1133B.4.2.5 CBC 2019 11B-609.3 Mitigated: <input type="radio"/> YES <input checked="" type="radio"/> NO	1	JOB	\$225	\$225

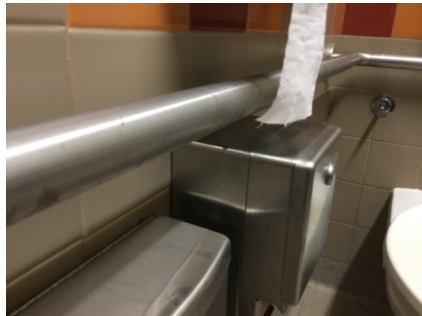
<input type="radio"/> Staff Only Priority 3 Severity 4						
2177	<ul style="list-style-type: none"> • <i>As-Built Description:</i> Accessories/dispensers in accessible stall located closer than 1-1/2" below or 12" above grab bar impedes its use. • <i>As-Built:</i> TPD: 0.75" below grab bar • <i>Proposed Solution:</i> Relocate accessories/dispensers within applicable reach range and to be no closer than 1-1/2" below and 12" above grab bars (except if accessories are recessed, flush with wall, and have no sharp edges). 	PCODE WB07I ADAAG 91 4.26.2 ADA 2010 609.3 CBC 2007 1133B.4.2.5 CBC 2019 11B-609.3 Mitigated: <input type="radio"/> YES <input checked="" type="radio"/> NO	1	JOB	\$225	\$225

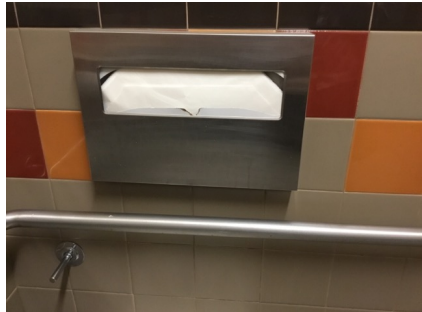
Item no., Rm no. and Name	Existing Architectural Barrier and Proposed Solution	Codes / Mitigation Info	Qty	Unit	Cost	Total
2178	<ul style="list-style-type: none"> As-Built Description: Accessories/dispensers in accessible stall located closer than 1-1/2" below or 12" above grab bar impedes its use. As-Built: SCD: 3.0" above grab bar Proposed Solution: Relocate accessories/dispensers within applicable reach range and to be no closer than 1-1/2" below and 12" above grab bars (except if accessories are recessed, flush with wall, and have no sharp edges). 	PCODE WB07I ADAAG 91 4.26.2 ADA 2010 609.3 CBC 2007 1133B.4.2.5 CBC 2019 11B-609.3 Mitigated: <input type="radio"/> YES <input checked="" type="radio"/> NO	1	JOB	\$225	\$225

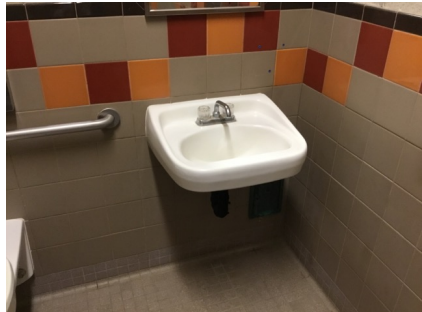
2175	<ul style="list-style-type: none"> As-Built Description: Clear floor space, 30" x 48" in front of fixture, extending 19" max. under the lavatory, not provided (CA only: Less than 18" from side wall to centerline of lavatory). As-Built: 17.0" Proposed Solution: Relocate existing lavatory. Notes: 	PCODE WD01A ADAAG 91 4.19.3 ADA 2010 606.2 CBC 2007 1115B.4.3 CBC 2019 11B-606.2, 11B-606.6 Mitigated: <input type="radio"/> YES <input checked="" type="radio"/> NO	1	JOB	\$2,700	\$2,700

This element complies with Safe Harbor if altered or constructed before March 15, 2012. The dimensional requirements in this CBC citation applied from the 2007 CBC to the code cycle at the time of this survey.

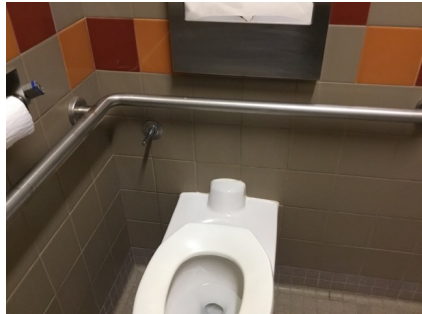
Item no., Rm no. and Name	Existing Architectural Barrier and Proposed Solution	Codes / Mitigation Info	Qty	Unit	Cost	Total
2179	<ul style="list-style-type: none"> <i>As-Built Description:</i> Flush Control: Operating handle not mounted toward wide side of stall. <i>Proposed Solution:</i> Replace flush control with properly mounted accessible type, or install sensor flush. 	PCODE WB10 ADAAG 91 4.16.5 ADA 2010 604.6 CBC 2007 1115B.4.1.5 CBC 2019 11B-604.6 Mitigated: <input type="radio"/> YES <input checked="" type="radio"/> NO	1	JOB	\$1,500	\$1,500

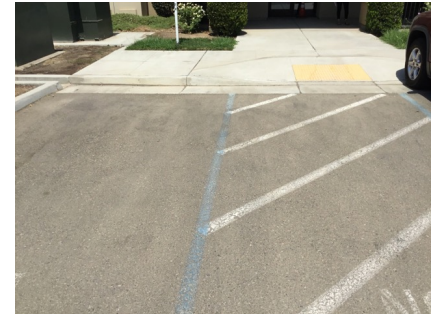
892	<ul style="list-style-type: none"> As-Built Description: CA only: The area within the blue borderlines not marked with hatched lines a maximum of 36" on center. Proposed Solution: Restripe to provide hatched lines at 36" on center within access aisle. Notes: 	PCODE EA04I CBC 2007 1129B.3.1 CBC 2019 11B-502.3.3 Mitigated: <input type="radio"/> YES <input checked="" type="radio"/> NO	1	JOB	\$300	\$300
-----	---	--	---	-----	-------	-------

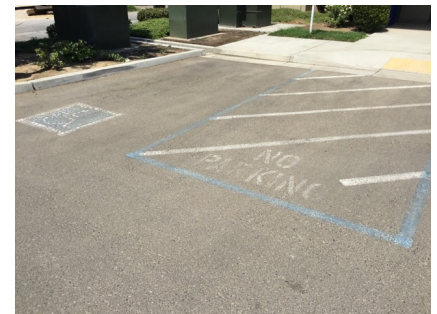
Striping faded - no contrast. Restripe

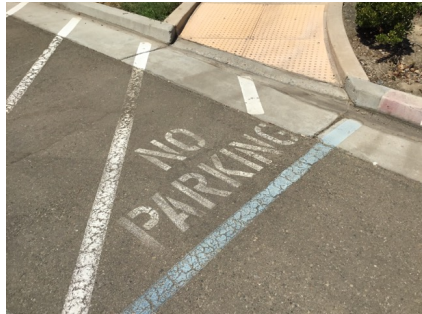
Item no., Rm no. and Name	Existing Architectural Barrier and Proposed Solution	Codes / Mitigation Info	Qty	Unit	Cost	Total
903	<ul style="list-style-type: none"> <i>As-Built Description:</i> Accessible parking space has slope greater than 1/4":12" (2%). <i>As-Built:</i> 3.1% <i>Proposed Solution:</i> Modify slope at accessible parking space. 	PCODE EA05 ADAAG 91 4.6.3 ADA 2010 502.4 CBC 2007 1129B.3.3 CBC 2019 11B-502.4 Mitigated: <input type="radio"/> YES <input checked="" type="radio"/> NO	6	SF	\$36	\$216

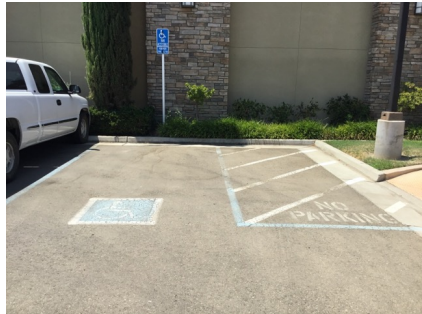
Parking

901	<ul style="list-style-type: none"> <i>As-Built Description:</i> CA only: The area within the blue borderlines not marked with hatched lines a maximum of 36" on center. <i>Proposed Solution:</i> Restripe to provide hatched lines at 36" on center within access aisle. Notes: 	PCODE EA04I CBC 2007 1129B.3.1 CBC 2019 11B-502.3.3 Mitigated: <input type="radio"/> YES <input checked="" type="radio"/> NO	1	JOB	\$300	\$300

<input type="radio"/> Staff Only						
Priority <input checked="" type="radio"/> 1						
Severity <input checked="" type="radio"/> 3						
<p>Faded striping. Consider lengthening the space and aisle to remove the slopes at the gutter from the parking space.</p>

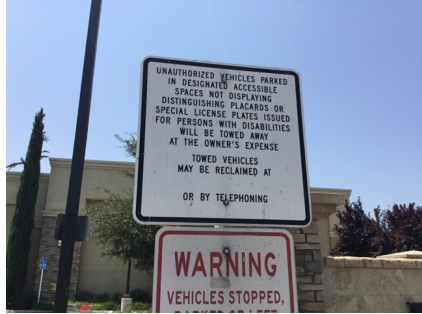
Item no., Rm no. and Name	Existing Architectural Barrier and Proposed Solution	Codes / Mitigation Info	Qty	Unit	Cost	Total
<u>Parking Signage</u>						
905	<ul style="list-style-type: none"> <i>As-Built Description:</i> No "Tow Away" sign at parking lot entrance (required in CA only). <i>Proposed Solution:</i> Provide "Tow Away" sign at parking lot entrance when altering area. 	PCODE EA04C CBC 2007 1129B.4 CBC 2019 11B-502.8.2 Mitigated: <input type="radio"/> YES <input checked="" type="radio"/> NO	3	JOB	\$975	\$2,925

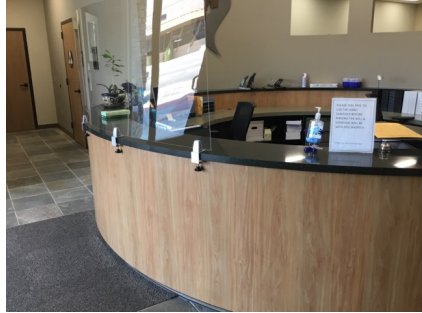
Public Counter

<p>850</p> <ul style="list-style-type: none"> <i>As-Built Description:</i> Service counter (stand-up): Accessible section min. 36" length and 36" max. height (in CA: 28" to 34" high) not provided. <i>As-Built:</i> 41.0" high <i>Proposed Solution:</i> Retrofit existing counter to provide accessible section. Interim solution: Provide auxiliary counter, table, or clipboard. 	<p>PCODE IN03 ADAAG 91 7.2(2) ADA 2010 904.4 CBC 2007 1122B.4 CBC 2019 11B-904.4</p> <p>Mitigated: <input type="radio"/> YES <input checked="" type="radio"/> NO</p>	<p>1 JOB \$6,000 \$6,000</p>

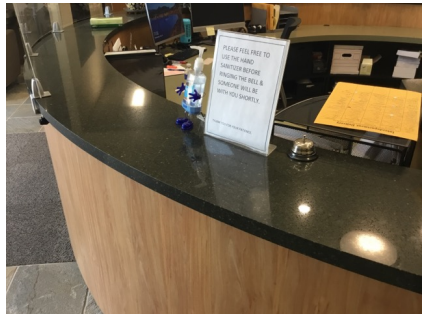
Reach Range

<p>851</p> <ul style="list-style-type: none"> <i>As-Built Description:</i> Reach height to control or access point, where side approach is available, exceeds 48" or is less than 15" in height, or exceeds 10" in depth. <i>As-Built:</i> 41.0" high obstruction <i>Proposed Solution:</i> Modify equipment or mounting. 	<p>PCODE IE02 ADAAG 91 4.2.6 ADA 2010 308.3.1 CBC 2007 1118B.6 CBC 2019 11B-308.3</p> <p>Mitigated: <input type="radio"/> YES <input checked="" type="radio"/> NO</p>	<p>1 JOB \$300 \$300</p>

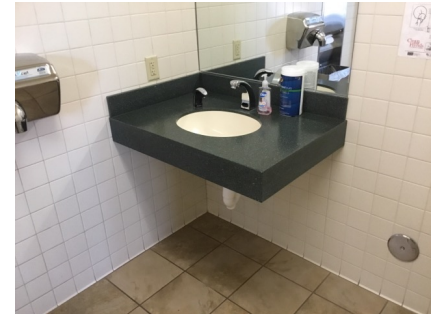
Lavatory

860	<ul style="list-style-type: none"> As-Built Description: Wheelchair clearance under lavatory apron or lavatory counter front edge less than 29" high. As-Built: 28.75" Proposed Solution: Trim apron. Notes: 	PCODE WD03 ADAAG 91 4.19.2 ADA 2010 606.3 CBC 2007 1115B.4.3.3 CBC 2019 11B-306.3.1	1	JOB	\$1,020	\$1,020
-----	---	---	---	-----	---------	---------

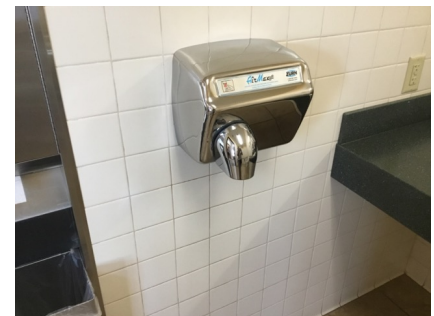
Protrusion Limits

861	<ul style="list-style-type: none"> As-Built Description: Protruding objects more than 4" from wall, when bottom of object more than 27" or less than 80" above finished floor. As-Built: Hand dryer: 8.5" at 39" high Proposed Solution: Remove/relocate protruding object. Patch existing surface. Option to install new hand dryer with depth less than 4". 	PCODE EG04 ADAAG 91 4.4.1 ADA 2010 307.2 CBC 2007 1133B.8.6.1 CBC 2019 11B-307.2	1	JOB	\$300	\$300
-----	---	--	---	-----	-------	-------

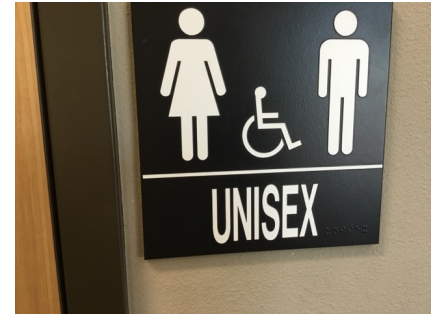
- *As-Built Description:*
Entrance to toilet or bathing facility not identified with ADAAG compliant signage.
- *As-Built:* **Height of the characters are too large for the width. Braille not below characters**
- *Proposed Solution:*
Provide ADA compliant sign mounted at 48" min. above to baseline of the lowest Braille cells and 60" max. to baseline of the highest line of raised characters on nearest adjacent wall, on latch side of a single door (located not to cause a Braille reader to stand within the door swing).

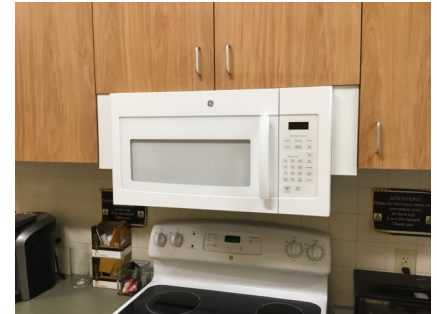
Reach Range

871	<ul style="list-style-type: none"> <i>As-Built Description:</i> Reach height to control or access point, where side approach is available, exceeds 48" or is less than 15" in height, or exceeds 10" in depth. <i>As-Built:</i> 61.0" high <i>Proposed Solution:</i> Modify equipment or mounting. 	<p>PCODE IE02 ADAAG 91 4.2.6 ADA 2010 308.3.1 CBC 2007 1118B.6 CBC 2019 11B-308.3</p> <p>Mitigated: <input type="radio"/> YES <input checked="" type="radio"/> NO</p>	1	JOB	\$300	\$300
-----	--	--	---	-----	-------	-------

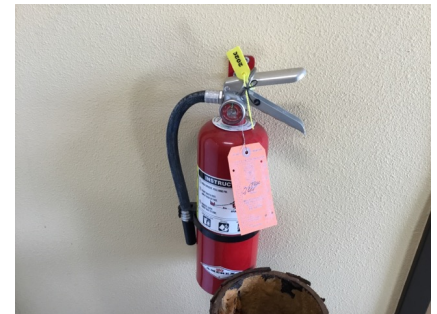
872	<ul style="list-style-type: none"> <i>As-Built Description:</i> Reach height to control or access point, where side approach is available, exceeds 48" or is less than 15" in height, or exceeds 10" in depth. <i>As-Built:</i> 51.0" high <i>Proposed Solution:</i> Modify equipment or mounting. <i>Notes:</i> 	<p>PCODE IE02 ADAAG 91 4.2.6 ADA 2010 308.3.1 CBC 2007 1118B.6 CBC 2019 11B-308.3</p> <p>Mitigated: <input type="radio"/> YES <input checked="" type="radio"/> NO</p>	1	JOB	\$300	\$300
-----	---	--	---	-----	-------	-------

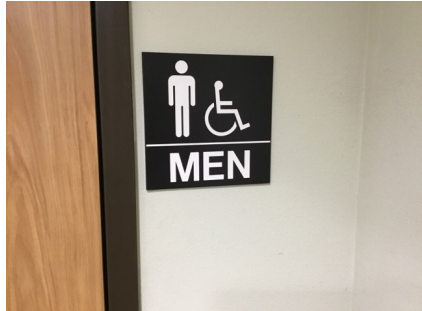
Item no., Rm no. and Name	Existing Architectural Barrier and Proposed Solution	Codes / Mitigation Info	Qty	Unit	Cost	Total
878	<ul style="list-style-type: none"> As-Built Description: Entrance to toilet or bathing facility not identified with ADAAG compliant signage. Proposed Solution: Provide ADA compliant sign mounted at 48" min. above to baseline of the lowest Braille cells and 60" max. to baseline of the highest line of raised characters on nearest adjacent wall, on latch side of a single door (located not to cause a Braille reader to stand within the door swing). Notes: 	PCODE SA11A ADAAG 91 4.1.3(16)(a) ADA 2010 216.8 CBC 2019 11B-216.8 Mitigated: <input type="radio"/> YES <input checked="" type="radio"/> NO	1	JOB	\$270	\$270

<input checked="" type="checkbox"/> Staff Only						
Priority 3						
Severity 3						
Braille not below and stroke thickness 20% of height.

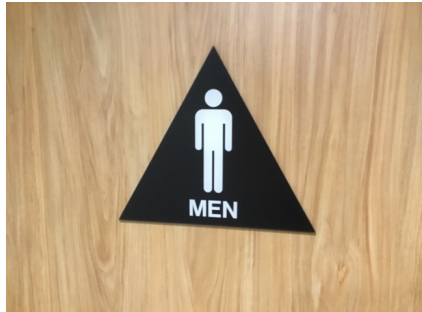
880	<ul style="list-style-type: none"> As-Built Description: Required in CA only: identification symbol centered 58" to 60" high on sanitary facility door that contrasts with the door not provided (women: 12" ø circle, men: 12" triangle, unisex: combined symbol). As-Built: Not beveled or radiused Proposed Solution: Provide properly mounted sanitary facility symbol when altering area. If wheelchair accessible, include International Symbol of Accessibility on sign. 	PCODE SA15 CBC 2007 1115B.6 CBC 2019 11B-703.7.2.6 Mitigated: <input type="radio"/> YES <input checked="" type="radio"/> NO	1	JOB	\$270	\$270

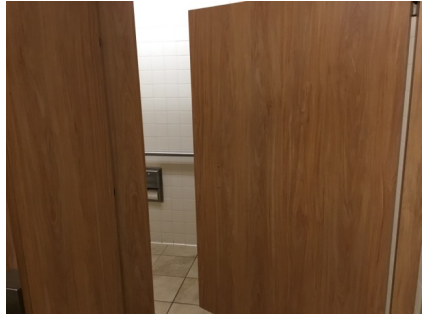
Stall Door

882	<ul style="list-style-type: none"> <i>As-Built Description:</i> Stall door to accessible compartment not self closing. <i>Proposed Solution:</i> Adjust closer. 	<p>PCODE WB05B ADAAG 91 4.22.4 ADA 2010 604.8.1.2 CBC 2007 1115B.3.1.4.4 CBC 2019 11B-604.8.1.2</p> <p>Mitigated: <input type="radio"/> YES <input checked="" type="radio"/> NO</p>	1	JOB	\$75	\$75
-----	---	---	---	-----	------	------

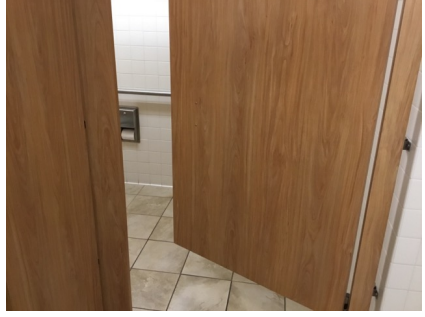
883	<ul style="list-style-type: none"> <i>As-Built Description:</i> Stall door does not have accessible operating hardware (U-pulls on both sides, flip-over or sliding lock). <i>Proposed Solution:</i> Provide new accessible locking hardware that does not require grasping, pinching, or twisting and U-pulls on both sides. 	<p>PCODE WB05C ADAAG 91 4.17.5 ADA 2010 604.8.1.2 CBC 2007 1115B.3.1.4.5 CBC 2019 11B-604.8.1.2</p> <p>Mitigated: <input type="radio"/> YES <input checked="" type="radio"/> NO</p>	1	JOB	\$300	\$300
-----	---	---	---	-----	-------	-------

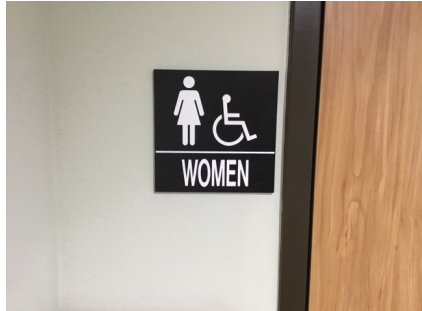
Item no., Rm no. and Name	Existing Architectural Barrier and Proposed Solution	Codes / Mitigation Info	Qty	Unit	Cost	Total
884	<ul style="list-style-type: none"> As-Built Description: Entrance to toilet or bathing facility not identified with ADAAG compliant signage. Proposed Solution: Provide ADA compliant sign mounted at 48" min. above to baseline of the lowest Braille cells and 60" max. to baseline of the highest line of raised characters on nearest adjacent wall, on latch side of a single door (located not to cause a Braille reader to stand within the door swing). Notes: 	PCODE SA11A ADAAG 91 4.1.3(16)(a) ADA 2010 216.8 CBC 2019 11B-216.8 Mitigated: <input type="radio"/> YES <input checked="" type="radio"/> NO	1	JOB	\$270	\$270

<input checked="" type="checkbox"/> Staff Only						
Priority 3						
Severity 3						
<p>Braille not below and width to height ratio incorrect.</p>

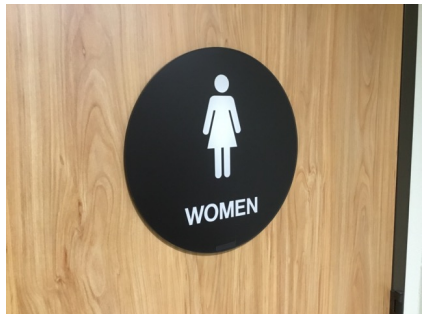
886	<ul style="list-style-type: none"> As-Built Description: Required in CA only: identification symbol centered 58" to 60" high on sanitary facility door that contrasts with the door not provided (women: 12" ø circle, men: 12" triangle, unisex: combined symbol). As-Built: Not beveled Proposed Solution: Provide properly mounted sanitary facility symbol when altering area. If wheelchair accessible, include International Symbol of Accessibility on sign. 	PCODE SA15 CBC 2007 1115B.6 CBC 2019 11B-703.7.2.6 Mitigated: <input type="radio"/> YES <input checked="" type="radio"/> NO	1	JOB	\$270	\$270

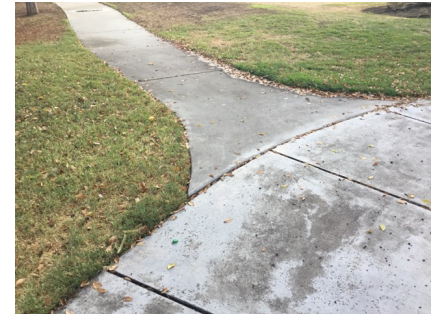
- 1249
- *As-Built Description:*
Walk: Pavement dislocation creates abrupt change in level exceeding 1/2" in accessible route.
 - *As-Built:* **Up to 2.0"**
 - *Proposed Solution:*
Remove, replace or repair area of pavement sufficient to correct abrupt change in level.

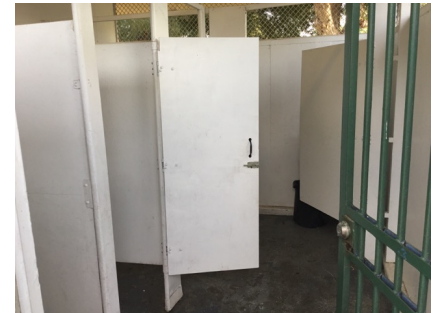
- 1256
- *As-Built Description:*
Multiple accommodation restroom not accessible; multiple compliance violations.
 - *Proposed Solution:*
Remodel area to provide accessible restroom with one accessible stall, lavatory (and one urinal at Men's).

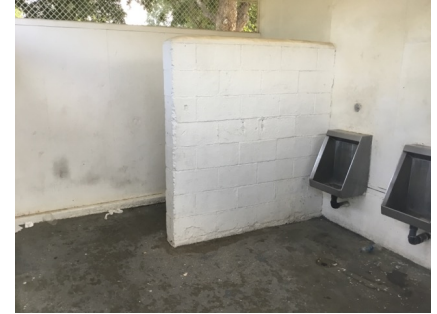
Multiple accommodation restroom not accessible; multiple compliance violations.

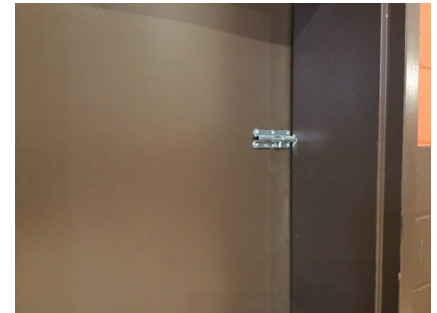
- 2021
- *As-Built Description:*
Door lock, latch or handle less than 34" or more than 48" above the floor (CA only: 34" to 44").
 - *As-Built:* **64.0" high**
 - *Proposed Solution:*
Relocate or replace existing hardware.

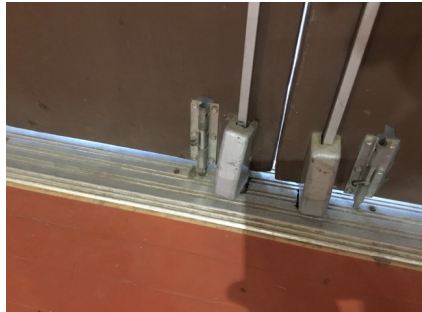
Item no., Rm no. and Name	Existing Architectural Barrier and Proposed Solution	Codes / Mitigation Info	Qty	Unit	Cost	Total
2023	<ul style="list-style-type: none"> As-Built Description: Door lock, latch or handle less than 34" or more than 48" above the floor (CA only: 34" to 44"). As-Built: 2.0" high and 79.0" high at exit door. Proposed Solution: Relocate or replace existing hardware. 	PCODE ID17 ADAAG 91 4.13.9 ADA 2010 404.2.7 CBC 2007 1133B.2.5.2 CBC 2019 11B-404.2.7 Mitigated: <input type="radio"/> YES <input checked="" type="radio"/> NO	6	JOB	\$900	\$5,400

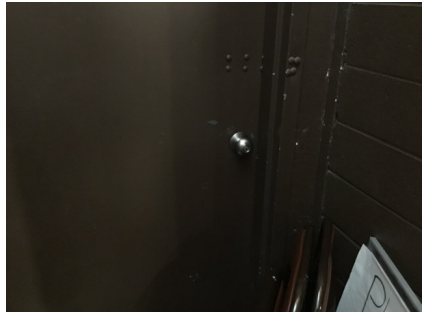
Door Hardware

2029	<ul style="list-style-type: none"> As-Built Description: Door does not have accessible operating hardware. Proposed Solution: Provide lever handle or other accessible hardware. 	PCODE ID07 ADAAG 91 4.13.9 ADA 2010 404.2.7 CBC 2007 1133B.2.5.2 CBC 2019 11B-404.2.7 Mitigated: <input type="radio"/> YES <input checked="" type="radio"/> NO	4	JOB	\$450	\$1,800

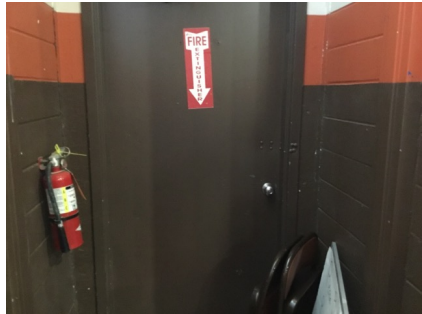
<p>2030</p> <ul style="list-style-type: none"> • <i>As-Built Description:</i> Front approach: At push side, door does not have clear and level maneuvering space measuring door width x 48" (door width plus 12" if door has both, latch and closer). • <i>As-Built:</i> 6.5" • <i>Proposed Solution:</i> Remove latch or install directional signage. 	<p>PCODE ID24A ADAAG 91 Fig. 25(a) ADA 2010 404.2.4 CBC 2007 11B-26A(a) CBC 2019 11B-404.2.4</p> <p>Mitigated: <input type="radio"/> YES <input checked="" type="radio"/> NO</p>	<p>1 JOB \$150 \$150</p>

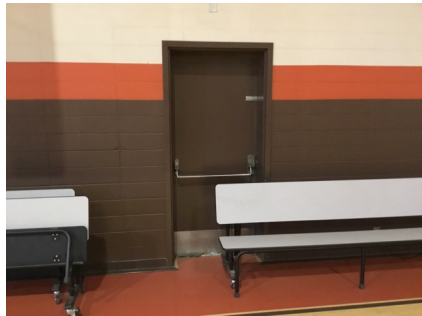
<p>2022</p> <ul style="list-style-type: none"> • <i>As-Built Description:</i> Front approach: At push side, door does not have clear and level maneuvering space measuring door width x 48" (door width plus 12" if door has both, latch and closer). • <i>As-Built:</i> 12.0" deep alcove. • <i>Proposed Solution:</i> Provide relocated new door and frame; remodel walls as needed. 	<p>PCODE ID24B ADAAG 91 Fig. 25(a) ADA 2010 404.2.4 CBC 2007 11B-26A(a) CBC 2019 11B-404.2.4</p> <p>Mitigated: <input type="radio"/> YES <input checked="" type="radio"/> NO</p>	<p>1 JOB \$7,800 \$7,800</p>

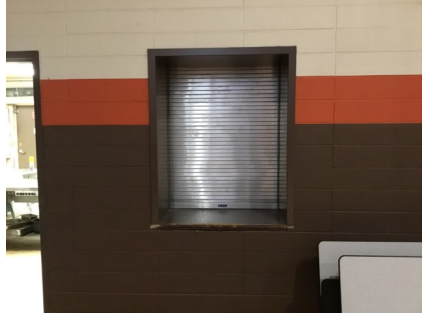
Item no., Rm no. and Name	Existing Architectural Barrier and Proposed Solution	Codes / Mitigation Info	Qty	Unit	Cost	Total
2031	<p>Tray Pass-thru</p> <ul style="list-style-type: none"> • <i>As-Built Description:</i> Food tray pass-thru at institutional cafeteria has lower edge higher than 34" above floor. • <i>As-Built:</i> 36.0" • <i>Proposed Solution:</i> Remodel pass-thru and counter to be 34" max. above floor. 	<p>PCODE FB04 ADAAG 91 5.2 ADA 2010 902.3 CBC 2007 1122B.4 CBC 2019 11B-902.3</p> <p>Mitigated: <input type="radio"/> YES <input checked="" type="radio"/> NO</p>	1	JOB	\$9,900	\$9,900

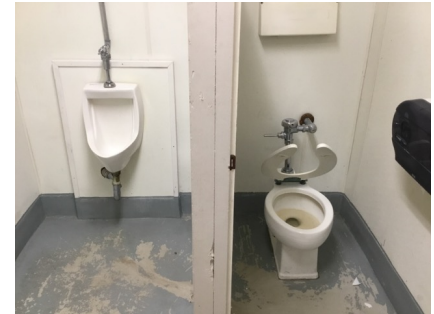
Multiple accommodation restroom not accessible; multiple compliance violations.

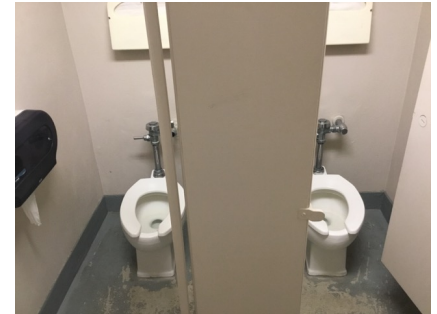
Multiple accommodation restroom not accessible; multiple compliance violations.

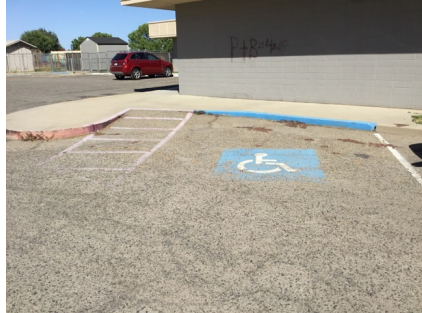
<p>2075</p> <ul style="list-style-type: none"> • <i>As-Built Description:</i> Accessible parking space has slope greater than 1/4":12" (2%). • <i>As-Built:</i> To 8.6% • <i>Proposed Solution:</i> Modify slope at accessible parking space. 	<p>PCODE EA05 ADAAG 91 4.6.3 ADA 2010 502.4 CBC 2007 1129B.3.3 CBC 2019 11B-502.4</p> <p>Mitigated: <input type="radio"/> YES <input checked="" type="radio"/> NO</p>	<p>200 SF \$36 \$7,200</p>

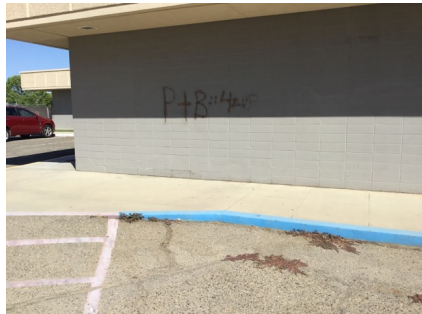
<p>2079</p> <ul style="list-style-type: none"> • <i>As-Built Description:</i> Sign for accessible parking space is missing or non-compliant. • <i>Proposed Solution:</i> Provide compliant parking signage. 	<p>PCODE EA04B ADAAG 91 4.6.4 ADA 2010 502.6 CBC 2007 1129B.4 CBC 2019 11B-502.6</p> <p>Mitigated: <input type="radio"/> YES <input checked="" type="radio"/> NO</p>	<p>1 JOB \$945 \$945</p>

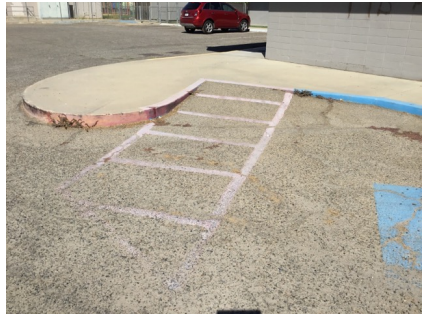
Item no., Rm no. and Name	Existing Architectural Barrier and Proposed Solution	Codes / Mitigation Info	Qty	Unit	Cost	Total
2077	<ul style="list-style-type: none"> As-Built Description: An accessible parking space shall be outlined or painted blue (required in CA only). Proposed Solution: Identify accessible parking space using blue markings. 	PCODE EA04K CBC 2019 11B-502.6 Mitigated: <input type="radio"/> YES <input checked="" type="radio"/> NO	1	JOB	\$360	\$360

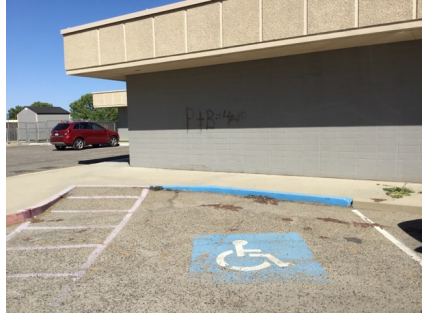
2081	<ul style="list-style-type: none"> As-Built Description: No "Tow Away" sign at parking lot entrance (required in CA only). Proposed Solution: Provide "Tow Away" sign at parking lot entrance when altering area. 	PCODE EA04C CBC 2007 1129B.4 CBC 2019 11B-502.8.2 Mitigated: <input type="radio"/> YES <input checked="" type="radio"/> NO	2	JOB	\$975	\$1,950

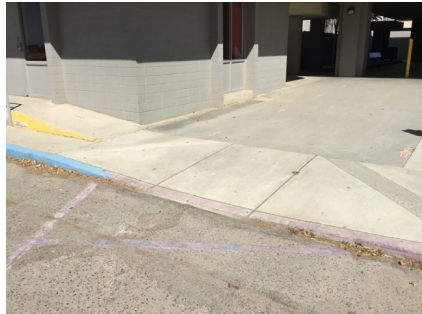
Item no., Rm no. and Name	Existing Architectural Barrier and Proposed Solution	Codes / Mitigation Info	Qty	Unit	Cost	Total
2093	<ul style="list-style-type: none"> As-Built Description: Detectable warning not provided where pedestrian crosses vehicular area. Proposed Solution: Provide detectable warning surface (i.e. in-line truncated domes) at regular curb ramp. 	PCODE EH07A ADAAG 91 4.7.7 ADA 2010 705.1 CBC 2007 1127B.5.7 CBC 2019 11B-705.1.2.2 Mitigated: <input type="radio"/> YES <input checked="" type="radio"/> NO	1	JOB	\$750	\$750

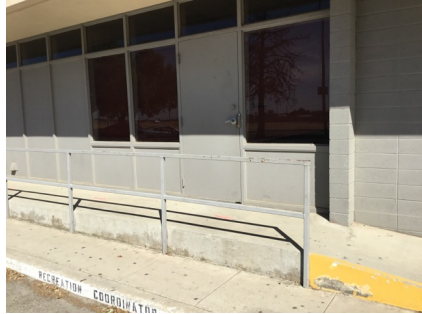
2085	<ul style="list-style-type: none"> As-Built Description: Latch approach: At pull side, door does not have clear and level maneuvering space measuring door width plus 24" x 48" or 54" if door has closer (CA only: door width plus 24" x 60"). As-Built: 43.5" Proposed Solution: Enlarge landing. 	PCODE ID27 ADAAG 91 Fig. 25(c) ADA 2010 404.2.4 CBC 2007 11B-26A(c) CBC 2019 11B-404.2.4 Mitigated: <input type="radio"/> YES <input checked="" type="radio"/> NO	1	JOB	\$9,000	\$9,000

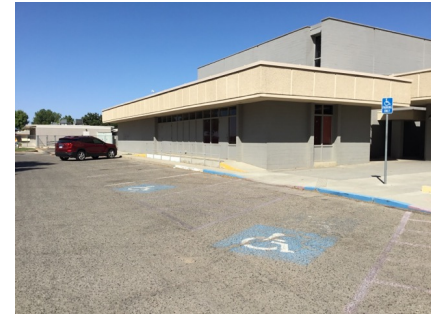
- 2087
- *As-Built Description:*
Sign for accessible parking space is missing or non-compliant.
 - *Proposed Solution:*
Provide compliant parking signage.

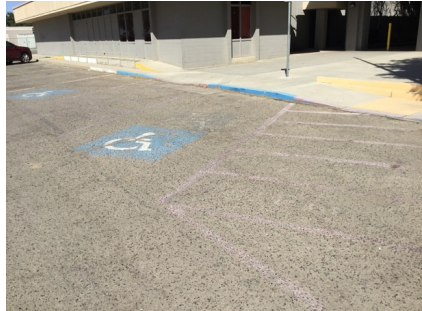
Item no., Rm no. and Name	Existing Architectural Barrier and Proposed Solution	Codes / Mitigation Info	Qty	Unit	Cost	Total
2090	<ul style="list-style-type: none"> As-Built Description: The words "NO PARKING" not painted on the ground within loading and unloading access aisle (12" min high white letters), located so that it is visible to traffic enforcement officials (required in CA only). Proposed Solution: Provide the words "NO PARKING" in each access aisle, painted in 12" high letters, when altering area. 	PCODE EA04D CBC 2007 1129B.3.1 CBC 2019 11B-502.3.3 Mitigated: <input type="radio"/> YES <input checked="" type="radio"/> NO	2	JOB	\$300	\$600

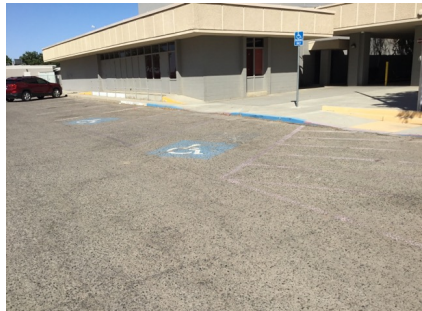
<input type="radio"/> Staff Only			
			Priority <input checked="" type="radio"/> 1			
			Severity <input checked="" type="radio"/> 4			
2089	<ul style="list-style-type: none"> As-Built Description: An accessible parking space shall be outlined or painted blue (required in CA only). Proposed Solution: Identify accessible parking space using blue markings. 	PCODE EA04K CBC 2019 11B-502.6 Mitigated: <input type="radio"/> YES <input checked="" type="radio"/> NO	2	JOB	\$360	\$720

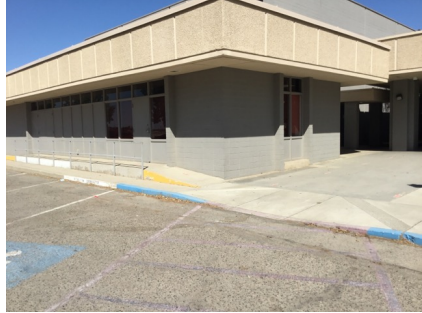
2092	<ul style="list-style-type: none"> <i>As-Built Description:</i> No "Tow Away" sign at parking lot entrance (required in CA only). <i>Proposed Solution:</i> Provide "Tow Away" sign at parking lot entrance when altering area. 	<p>PCODE EA04C</p> <p>CBC 2007 1129B.4</p> <p>CBC 2019 11B-502.8.2</p> <p>Mitigated:</p> <p><input type="radio"/> YES</p> <p><input checked="" type="radio"/> NO</p>	2	JOB	\$975	\$1,950

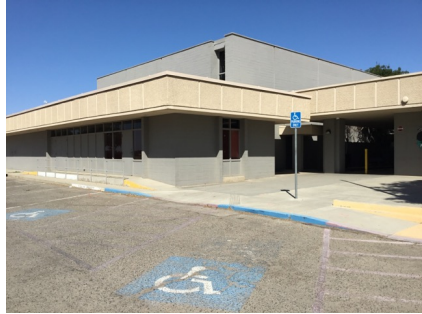
2088	<ul style="list-style-type: none"> <i>As-Built Description:</i> CA only: Additional Sign or additional language below the symbol of accessibility stating "Minimum Fine \$250" not provided. <i>Proposed Solution:</i> Provide compliant parking signage that includes fine information. 	<p>PCODE EA04G</p> <p>CBC 2007 1129B.4</p> <p>CBC 2019 11B-502.6.2</p> <p>Mitigated:</p> <p><input type="radio"/> YES</p> <p><input checked="" type="radio"/> NO</p>	2	JOB	\$300	\$600

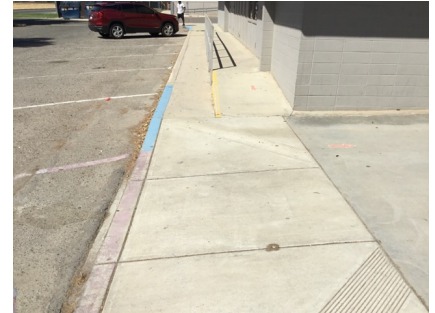
Item no., Rm no. and Name	Existing Architectural Barrier and Proposed Solution	Codes / Mitigation Info	Qty	Unit	Cost	Total
2094	<ul style="list-style-type: none"> As-Built Description: Level 2% max. landing for ramp not provided. As-Built: 10.0% Proposed Solution: Rebuild ramp to provide landings for each ramp run with slopes no greater than 2% 	PCODE EB05A ADAAG 91 4.8.4 ADA 2010 405.7.1 CBC 2007 1133B.5.4.1 CBC 2019 11B-405.7.1 Mitigated: <input type="radio"/> YES <input checked="" type="radio"/> NO	30	SF	\$300	\$9,000
<input type="radio"/> Staff Only Priority 1 Severity 1

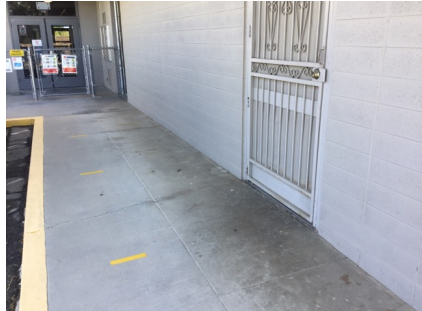
Item no., Rm no. and Name	Existing Architectural Barrier and Proposed Solution	Codes / Mitigation Info	Qty	Unit	Cost	Total
2043	<ul style="list-style-type: none"> As-Built Description: Surface of required maneuvering clearance at door slopes more than 1/4":12" (2.0%). As-Built: 3.1% Proposed Solution: Modify surface slope at door. 	PCODE ID11 ADAAG 91 4.13.6 ADA 2010 404.2.4.4 CBC 2007 1133B.2.4 CBC 2019 11B-404.2.4 Mitigated: <input type="radio"/> YES <input checked="" type="radio"/> NO	30	SF	\$120	\$3,600

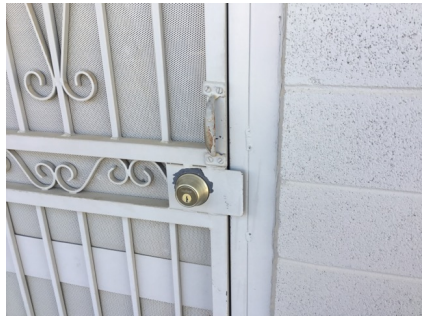
<input type="radio"/> Staff Only			
			Priority <input checked="" type="radio"/> 4			
			Severity <input checked="" type="radio"/> 4			
2067	<ul style="list-style-type: none"> As-Built Description: Door lock, latch or handle less than 34" or more than 48" above the floor (CA only: 34" to 44"). As-Built: 50.0" Proposed Solution: Relocate or replace existing hardware. 	PCODE ID17 ADAAG 91 4.13.9 ADA 2010 404.2.7 CBC 2007 1133B.2.5.2 CBC 2019 11B-404.2.7 Mitigated: <input type="radio"/> YES <input checked="" type="radio"/> NO	1	JOB	\$900	\$900

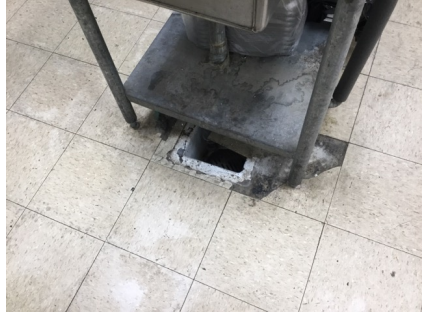
<p>2044</p> <ul style="list-style-type: none"> <i>As-Built Description:</i> Walk: Grating has grid openings greater than 1/2" along the line of traffic flow. <i>Proposed Solution:</i> Provide new grating, with grid openings 1/2" max. along the line of traffic flow. 	<p>PCODE EF04 ADAAG 91 4.3.6; 4.5.4 ADA 2010 403.2; 302.3 CBC 2007 1133B.7.2 CBC 2019 11B-403.2; 11B-302.3</p> <p>Mitigated: <input type="radio"/> YES <input checked="" type="radio"/> NO</p>	<p>1 SF \$240 \$240</p>

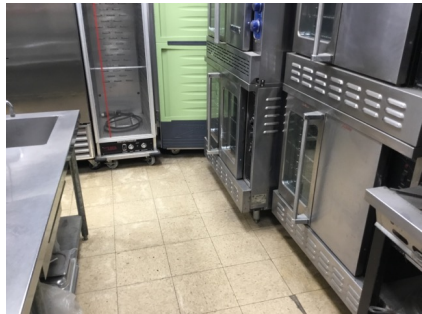
<p>2039</p> <ul style="list-style-type: none"> <i>As-Built Description:</i> Clearance between all opposing base cabinets, counter tops, appliances, or walls is not 40" minimum. <i>Proposed Solution:</i> Provide clearance by relocating obstructing walls and / or cabinets. <i>Notes:</i> 	<p>PCODE KF01 ADAAG 91 13.3.4(1) ADA 2010 804.2.1 CBC 2007 1111B.5.1 CBC 2019 11B-804.2.1</p> <p>Mitigated: <input type="radio"/> YES <input checked="" type="radio"/> NO</p>	<p>1 JOB \$7,500 \$7,500</p>

Pass through kitchen 37.0" wide.

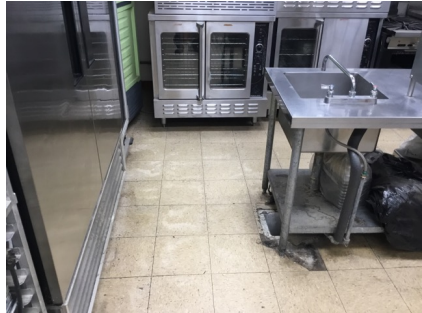
Item no., Rm no. and Name	Existing Architectural Barrier and Proposed Solution	Codes / Mitigation Info	Qty	Unit	Cost	Total
2041	<ul style="list-style-type: none"> As-Built Description: Clearance between all opposing base cabinets, counter tops, appliances, or walls is not 40" minimum. Proposed Solution: Provide clearance by relocating obstructing walls and / or cabinets. Notes: 	PCODE KF01 ADAAG 91 13.3.4(1) ADA 2010 804.2.1 CBC 2007 1111B.5.1 CBC 2019 11B-804.2.1 Mitigated: <input type="radio"/> YES <input checked="" type="radio"/> NO	1	JOB	\$7,500	\$7,500

<input type="radio"/> Staff Only						
Priority <input checked="" type="radio"/> 3 Severity <input checked="" type="radio"/> 4						
34.0" wide for 30.0" long

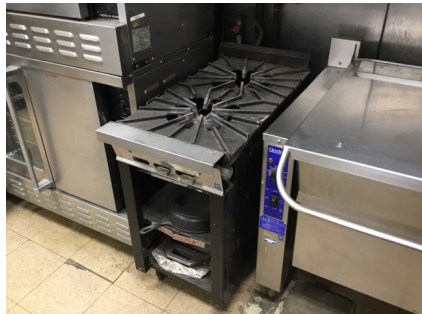
2040	<ul style="list-style-type: none"> As-Built Description: Reach height to control or access point, where side approach is available, exceeds 48" or is less than 15" in height, or exceeds 10" in depth. As-Built: The reach to the top is obstructed by the rim of the stove. Proposed Solution: Modify equipment or mounting. Notes: 	PCODE IE02 ADAAG 91 4.2.6 ADA 2010 308.3.1 CBC 2007 1118B.6 CBC 2019 11B-308.3 Mitigated: <input type="radio"/> YES <input checked="" type="radio"/> NO	1	JOB	\$300	\$300

<input type="radio"/> Staff Only						
Priority <input checked="" type="radio"/> 3 Severity <input checked="" type="radio"/> 4						
Cooktop 34.75" AFF

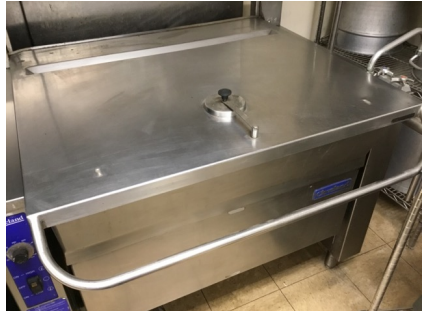
Item no., Rm no. and Name	Existing Architectural Barrier and Proposed Solution	Codes / Mitigation Info	Qty	Unit	Cost	Total
2045	<ul style="list-style-type: none"> As-Built Description: Reach height to control or access point, where side approach is available, exceeds 48" or is less than 15" in height, or exceeds 10" in depth. As-Built: 37.0" high obstruction. Proposed Solution: Modify equipment or mounting. 	PCODE IE02 ADAAG 91 4.2.6 ADA 2010 308.3.1 CBC 2007 1118B.6 CBC 2019 11B-308.3 Mitigated: <input type="radio"/> YES <input checked="" type="radio"/> NO	2	JOB	\$300	\$600

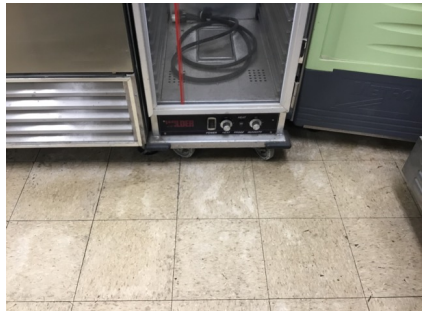
<input type="radio"/> Staff Only			
			Priority <input checked="" type="radio"/> 4			
			Severity <input checked="" type="radio"/> 4			
2047	<ul style="list-style-type: none"> As-Built Description: Reach height to control or access point, where side approach is available, exceeds 48" or is less than 15" in height, or exceeds 10" in depth. As-Built: 7.5" Proposed Solution: Modify equipment or mounting. 	PCODE IE02 ADAAG 91 4.2.6 ADA 2010 308.3.1 CBC 2007 1118B.6 CBC 2019 11B-308.3 Mitigated: <input type="radio"/> YES <input checked="" type="radio"/> NO	1	JOB	\$300	\$300
