The City of Madera

Appendix B: Facilities

Access Compliance Survey Report

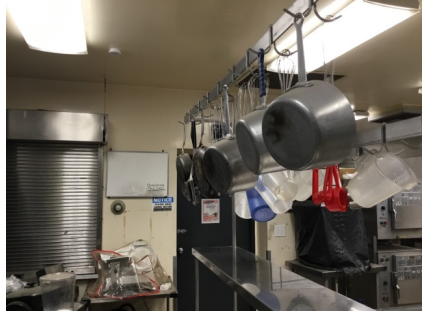
Item no., Rm no. and Name	Existing Architectural Barrier and Proposed Solution	Codes / Mitigation Info	Qty	Unit	Cost	Total
2048	<ul style="list-style-type: none"> As-Built Description: Reach height to control or access point, where side approach is available, exceeds 48" or is less than 15" in height, or exceeds 10" in depth. As-Built: Storage 67.0" Proposed Solution: Modify equipment or mounting. 	PCODE IE02 ADAAG 91 4.2.6 ADA 2010 308.3.1 CBC 2007 1118B.6 CBC 2019 11B-308.3 Mitigated: <input type="radio"/> YES <input checked="" type="radio"/> NO	1	JOB	\$300	\$300

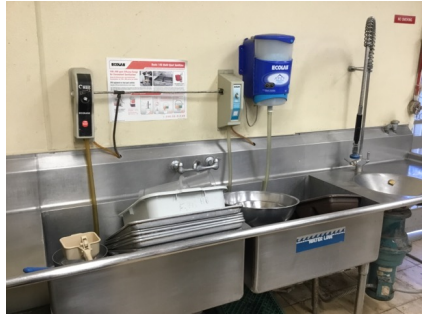
<input type="radio"/> Staff Only						
Priority <input checked="" type="radio"/> 4						
Severity <input checked="" type="radio"/> 2						
2049	<ul style="list-style-type: none"> As-Built Description: Reach height to control or access point, where side approach is available, exceeds 48" or is less than 15" in height, or exceeds 10" in depth. As-Built: 55.0" over 37.0" high obstruction. Proposed Solution: Modify equipment or mounting. 	PCODE IE02 ADAAG 91 4.2.6 ADA 2010 308.3.1 CBC 2007 1118B.6 CBC 2019 11B-308.3 Mitigated: <input type="radio"/> YES <input checked="" type="radio"/> NO	1	JOB	\$300	\$300

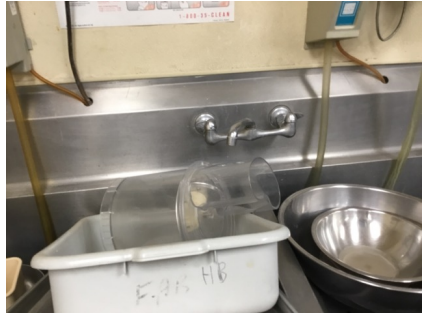
Item no., Rm no. and Name	Existing Architectural Barrier and Proposed Solution	Codes / Mitigation Info	Qty	Unit	Cost	Total
2051	<ul style="list-style-type: none"> As-Built Description: Reach height to control or access point, where side approach is available, exceeds 48" or is less than 15" in height, or exceeds 10" in depth. As-Built: 26.0" deep. Proposed Solution: Modify equipment or mounting. 	PCODE IE02 ADAAG 91 4.2.6 ADA 2010 308.3.1 CBC 2007 1118B.6 CBC 2019 11B-308.3 Mitigated: <input type="radio"/> YES <input checked="" type="radio"/> NO	1	JOB	\$300	\$300

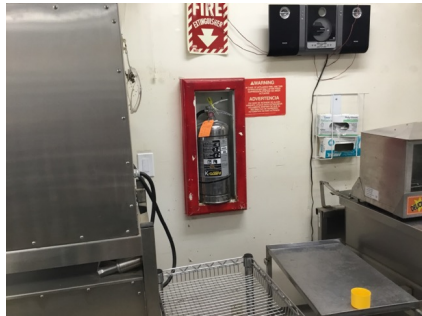
<input type="radio"/> Staff Only			
			Priority <input checked="" type="radio"/> 4			
			Severity <input checked="" type="radio"/> 4			
2071	<ul style="list-style-type: none"> As-Built Description: Reach height to control or access point, where side approach is available, exceeds 48" or is less than 15" in height, or exceeds 10" in depth. As-Built: 61.0". Blocked. Proposed Solution: Modify equipment or mounting. 	PCODE IE02 ADAAG 91 4.2.6 ADA 2010 308.3.1 CBC 2007 1118B.6 CBC 2019 11B-308.3 Mitigated: <input type="radio"/> YES <input checked="" type="radio"/> NO	1	JOB	\$300	\$300

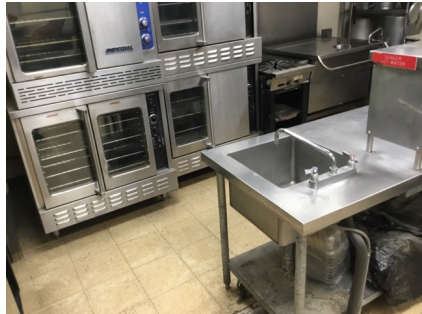
Item no., Rm no. and Name	Existing Architectural Barrier and Proposed Solution	Codes / Mitigation Info	Qty	Unit	Cost	Total
2042	<ul style="list-style-type: none"> As-Built Description: Sink does not have knee space min. 27" high x 19" deep x 30" wide. Proposed Solution: Remodel sink cabinet. 	PCODE IN06A ADAAG 91 4.24.3 ADA 2010 606.2 CBC 2007 1115B.4.7.1 CBC 2019 11B-606.2 Mitigated: <input type="radio"/> YES <input checked="" type="radio"/> NO	1	JOB	\$5,250	\$5,250

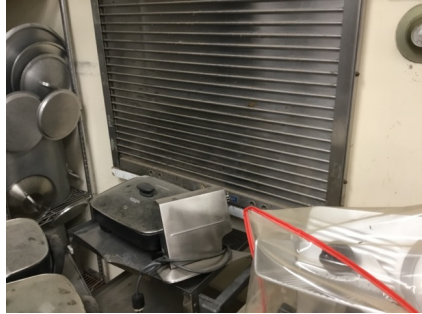
Tray Pass-thru

2038	<ul style="list-style-type: none"> As-Built Description: Food tray pass-thru at institutional cafeteria has lower edge higher than 34" above floor. Proposed Solution: Remodel pass-thru and counter to be 34" max. above floor. Notes: 	PCODE FB04NT ADAAG 91 5.2 ADA 2010 902.3 CBC 2007 1122B.4 CBC 2019 11B-902.3 Mitigated: <input type="radio"/> YES <input checked="" type="radio"/> NO	1	JOB	\$9,900	\$9,900

36.0" high tray slide. This tray slide is on the server side of the one in the gym.

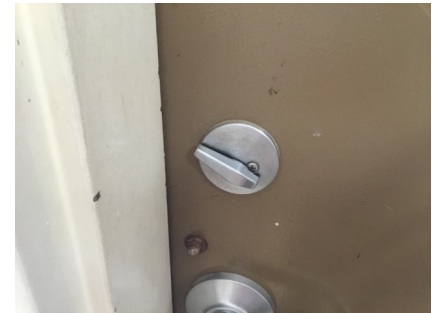
- *As-Built Description:*
Door lock, latch or handle less than 34" or more than 48" above the floor (CA only: 34" to 44").
- *As-Built:* **49.0" to 51.0"**
- *Proposed Solution:*
Relocate or replace existing hardware.

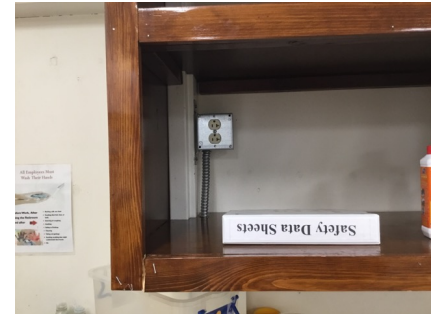
2058	<ul style="list-style-type: none"> <i>As-Built Description:</i> Electric switch or control mounted less than 15" measured to the bottom of the outlet box or greater than 48 inches measured to the top of the outlet box. <i>As-Built:</i> 70.0" high <i>Proposed Solution:</i> Relocate light switches or control to between 15" and 48" height. 	<p>PCODE IC01 ADAAG 91 4.2.5 & 6 ADA 2010 308.2.1 & 308.2.2 CBC 2007 1117B.6.3 CBC 2019 11B-308.2.1 & 11B-308.2.2</p> <p>Mitigated: <input type="radio"/> YES <input checked="" type="radio"/> NO</p>	1	JOB	\$900	\$900
------	--	--	---	-----	-------	-------

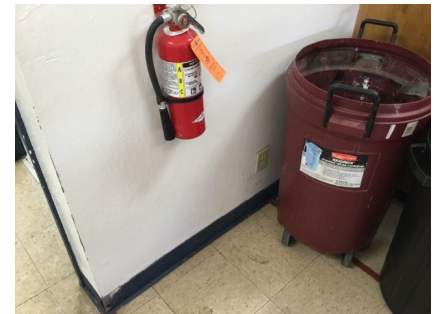
2065	<ul style="list-style-type: none"> <i>As-Built Description:</i> Electric switch or control mounted less than 15" measured to the bottom of the outlet box or greater than 48 inches measured to the top of the outlet box. <i>As-Built:</i> 14.0" to plug, 10.0" to bottom of box. <i>Proposed Solution:</i> Relocate light switches or control to between 15" and 48" height. <i>Notes:</i> 	<p>PCODE IC01 ADAAG 91 4.2.5 & 6 ADA 2010 308.2.1 & 308.2.2 CBC 2007 1117B.6.3 CBC 2019 11B-308.2.1 & 11B-308.2.2</p> <p>Mitigated: <input type="radio"/> YES <input checked="" type="radio"/> NO</p>	3	JOB	\$900	\$2,700
------	---	--	---	-----	-------	---------

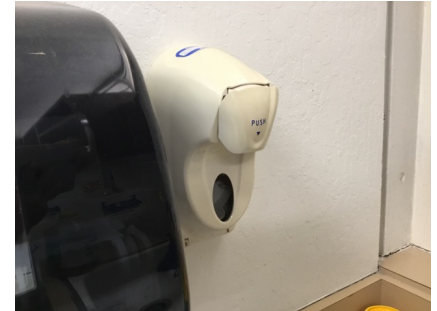
Item no., Rm no. and Name	Existing Architectural Barrier and Proposed Solution	Codes / Mitigation Info	Qty	Unit	Cost	Total
2055	<ul style="list-style-type: none"> As-Built Description: Reach height to control or access point, where side approach is available, exceeds 48" or is less than 15" in height, or exceeds 10" in depth. As-Built: 58.0" Proposed Solution: Modify equipment or mounting. 	PCODE IE02 ADAAG 91 4.2.6 ADA 2010 308.3.1 CBC 2007 1118B.6 CBC 2019 11B-308.3 Mitigated: <input type="radio"/> YES <input checked="" type="radio"/> NO	1	JOB	\$300	\$300

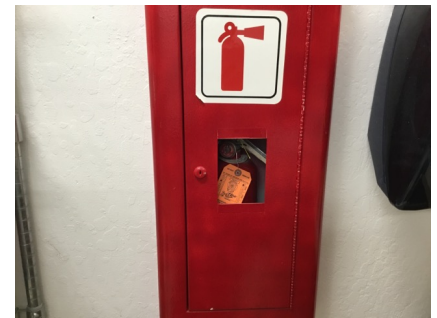
2056	<ul style="list-style-type: none"> As-Built Description: Reach height to control or access point, where side approach is available, exceeds 48" or is less than 15" in height, or exceeds 10" in depth. As-Built: 50.0" Proposed Solution: Modify equipment or mounting. Notes: 	PCODE IE02 ADAAG 91 4.2.6 ADA 2010 308.3.1 CBC 2007 1118B.6 CBC 2019 11B-308.3 Mitigated: <input type="radio"/> YES <input checked="" type="radio"/> NO	1	JOB	\$300	\$300
------	--	---	---	-----	-------	-------

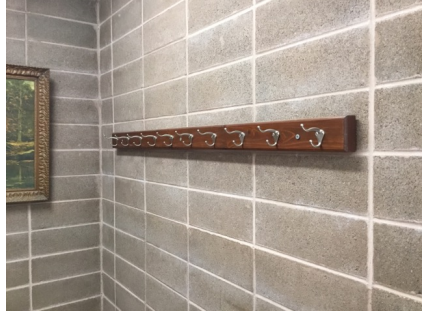
Item no., Rm no. and Name	Existing Architectural Barrier and Proposed Solution	Codes / Mitigation Info	Qty	Unit	Cost	Total
2062	<ul style="list-style-type: none"> • <i>As-Built Description:</i> Reach height to control or access point, where side approach is available, exceeds 48" or is less than 15" in height, or exceeds 10" in depth. • <i>As-Built:</i> 66.0" • <i>Proposed Solution:</i> Modify equipment or mounting. 	<p>PCODE IE02 ADAAG 91 4.2.6 ADA 2010 308.3.1 CBC 2007 1118B.6 CBC 2019 11B-308.3</p> <p>Mitigated: <input type="radio"/> YES <input checked="" type="radio"/> NO</p>	1	JOB	\$300	\$300

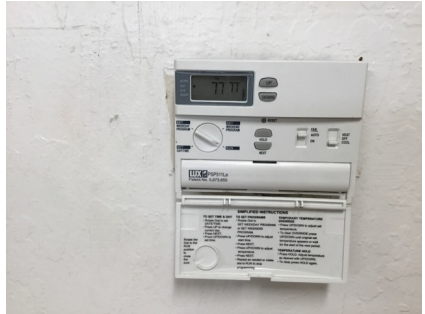
<input type="radio"/> Staff Only			
			<p>Priority <input checked="" type="radio"/> 4</p> <p>Severity <input checked="" type="radio"/> 2</p>			
2066	<ul style="list-style-type: none"> • <i>As-Built Description:</i> Reach height to control or access point, where side approach is available, exceeds 48" or is less than 15" in height, or exceeds 10" in depth. • <i>As-Built:</i> 61.0" • <i>Proposed Solution:</i> Modify equipment or mounting. 	<p>PCODE IE02 ADAAG 91 4.2.6 ADA 2010 308.3.1 CBC 2007 1118B.6 CBC 2019 11B-308.3</p> <p>Mitigated: <input type="radio"/> YES <input checked="" type="radio"/> NO</p>	1	JOB	\$300	\$300

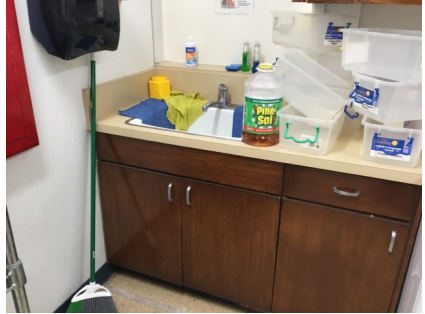
Item no., Rm no. and Name	Existing Architectural Barrier and Proposed Solution	Codes / Mitigation Info	Qty	Unit	Cost	Total
2053	<p>Sink</p> <ul style="list-style-type: none"> As-Built Description: Sink rim higher than 34" above floor. As-Built: 36.0" Proposed Solution: Remodel sink cabinet to lower sink. 	<p>PCODE IN06 ADAAG 91 4.24.2 ADA 2010 606.3 CBC 2007 1115B.4.7.1 CBC 2019 11B-606.3</p> <p>Mitigated: <input type="radio"/> YES <input checked="" type="radio"/> NO</p>	1	JOB	\$5,250	\$5,250

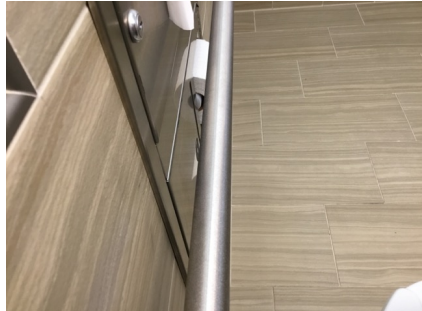
Item no., Rm no. and Name	Existing Architectural Barrier and Proposed Solution	Codes / Mitigation Info	Qty	Unit	Cost	Total
2109	<ul style="list-style-type: none"> • <i>As-Built Description:</i> Grab bar clearance not 1-1/2" from wall. • <i>As-Built:</i> 1.3" • <i>Proposed Solution:</i> Provide accessible grab bars. 	PCODE WB07E ADAAG 91 4.26.2 ADA 2010 609.3 CBC 2007 1115B.7.1 CBC 2019 11B-609.3 Mitigated: <input type="radio"/> YES <input checked="" type="radio"/> NO	1	JOB	\$1,500	\$1,500

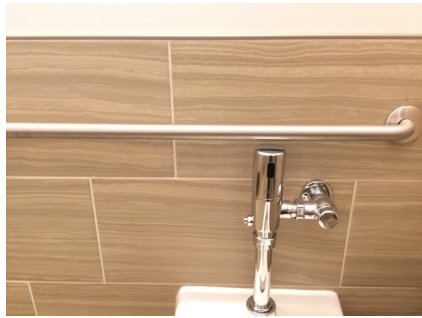
<input type="radio"/> Staff Only			
			Priority <input checked="" type="radio"/> 3			
			Severity <input checked="" type="radio"/> 4			
2108	<ul style="list-style-type: none"> • <i>As-Built Description:</i> Accessories/dispensers in accessible stall located closer than 1-1/2" below or 12" above grab bar impedes its use. • <i>As-Built:</i> Flush control: 0.3" below grab bar • <i>Proposed Solution:</i> Reconfigure plumbing. 	PCODE WB07I ADAAG 91 4.26.2 ADA 2010 609.3 CBC 2007 1133B.4.2.5 CBC 2019 11B-609.3 Mitigated: <input type="radio"/> YES <input checked="" type="radio"/> NO	1	JOB	\$225	\$225

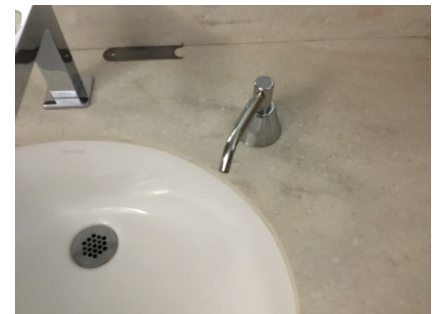
- 2104
- *As-Built Description:*
Operable part(s) require tight grasping, pinching, or twisting of the wrist with one hand.
 - *Proposed Solution:*
Modify or replace the operable part(s) to not require tight grasping, pinching, or twisting of the wrist with one hand.

PCODE **IC02**
 ADAAG 91 **4.27.4**
 ADA 2010 **309.4**
 CBC 2007 **1117B.6.4**
 CBC 2019 **11B-309.4**

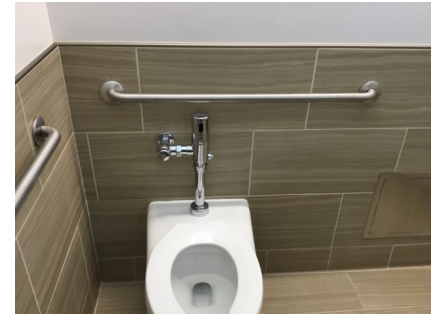
2119	<ul style="list-style-type: none"> <i>As-Built Description:</i> The rear wall grab is less than 36" min. or does not extend from the centerline of the water closet 12" min. on one side and 24" min. on the other side. <i>As-Built:</i> Extends 11.5" on narrow side <i>Proposed Solution:</i> Provide or relocate accessible rear grab bar. 	<p>PCODE WB07B ADAAG 91 4.17.6 ADA 2010 604.5.2 CBC 2007 1115B.4.1.3.2 CBC 2019 11B-604.5.2</p>	1	JOB	\$1,020	\$1,020
------	--	--	---	-----	---------	----------------

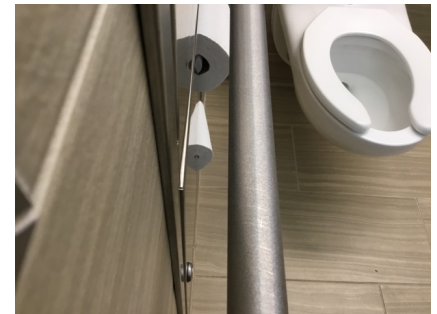
2117	<ul style="list-style-type: none"> <i>As-Built Description:</i> Grab bar clearance not 1-1/2" from wall. <i>As-Built:</i> 1.26" <i>Proposed Solution:</i> Provide accessible grab bars. 	<p>PCODE WB07E ADAAG 91 4.26.2 ADA 2010 609.3 CBC 2007 1115B.7.1 CBC 2019 11B-609.3</p>	1	JOB	\$1,500	\$1,500
------	---	--	---	-----	---------	----------------

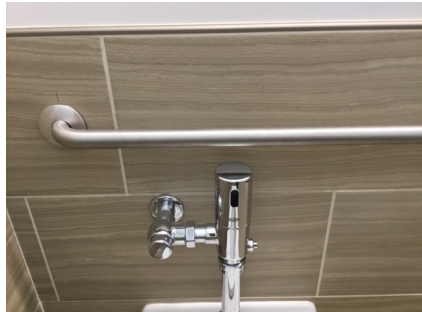
Item no., Rm no. and Name	Existing Architectural Barrier and Proposed Solution	Codes / Mitigation Info	Qty	Unit	Cost	Total
2116	<ul style="list-style-type: none"> As-Built Description: Accessories/dispensers in accessible stall located closer than 1-1/2" below or 12" above grab bar impedes its use. As-Built: Flush control: 1.2" below grab bar Proposed Solution: Reconfigure plumbing. 	PCODE WB07I ADAAG 91 4.26.2 ADA 2010 609.3 CBC 2007 1133B.4.2.5 CBC 2019 11B-609.3 Mitigated: <input type="radio"/> YES <input checked="" type="radio"/> NO	1	JOB	\$225	\$225

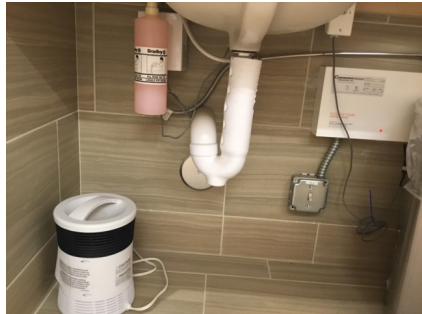
2111	<ul style="list-style-type: none"> As-Built Description: Hot or sharp-surfaced water/drain pipe not insulated or covered. Proposed Solution: Insulate or cover water/drain pipe and supply lines. 	PCODE WD05 ADAAG 91 4.19.4 ADA 2010 606.5 CBC 2007 1115B.4.3.4 CBC 2019 11B-606.5 Mitigated: <input type="radio"/> YES <input checked="" type="radio"/> NO	1	JOB	\$360	\$360

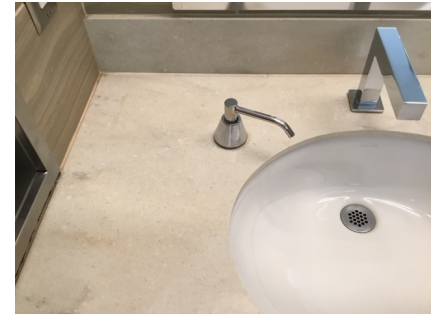
- 2113 • *As-Built Description:*
Operable part(s) require tight grasping, pinching, or twisting of the wrist with one hand.
- *Proposed Solution:*
Modify or replace the operable part(s) to not require tight grasping, pinching, or twisting of the wrist with one hand.

PCODE IC02
 ADAAG 91 4.27.4
 ADA 2010 309.4
 CBC 2007 1117B.6.4
 CBC 2019 11B-309.4

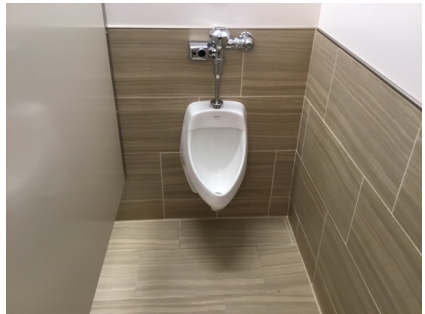
2114	<ul style="list-style-type: none"> <i>As-Built Description:</i> Fixture mounted with rim more than 17" above floor. <i>As-Built:</i> 17.5" <i>Proposed Solution:</i> Provide accessible urinal. Remodel restroom as needed. 	<p>PCODE WE02</p> <p>ADAAG 91 4.18.2</p> <p>ADA 2010 605.2</p> <p>CBC 2007 1115B.4.2.1</p> <p>CBC 2019 11B-605.2</p> <p>Mitigated:</p> <p><input type="radio"/> YES</p> <p><input checked="" type="radio"/> NO</p>	1	JOB	\$7,200	\$7,200
------	---	---	---	-----	---------	---------

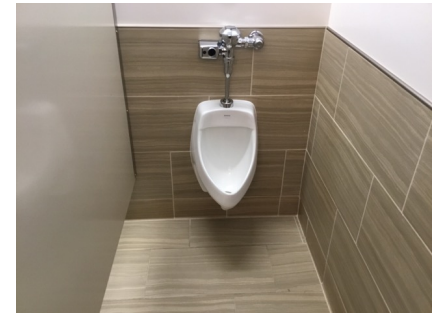
- As-Built Description:**
36" wide clearance in front of accessible urinal not provided when walls or partitions project more than 24" from the front edge of 30" x 48" clear space.
- Proposed Solution:**
Provide 36" clear floor space in front of accessible urinal. Remodel restroom as needed.

PCODE WE04A
 ADAAG 91 4.18.3
 ADA 2010 605.3
 CBC 2007 1115B.4.2.3
 CBC 2019 11B-605.3

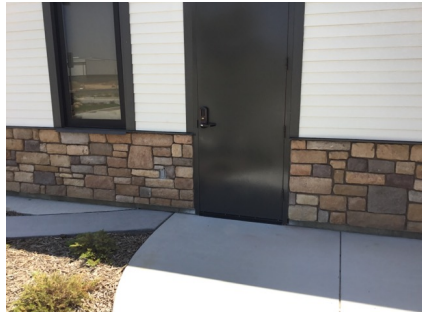
Item no., Rm no. and Name	Existing Architectural Barrier and Proposed Solution	Codes / Mitigation Info	Qty	Unit	Cost	Total
640	<ul style="list-style-type: none"> As-Built Description: Front approach: At pull side, door does not have clear and level maneuvering space measuring door width plus 18" x 60". (24" x 60" at exterior doors). As-Built: 0.0" to 12.0" Proposed Solution: Extend concrete. 	PCODE ID23C ADAAG 91 Fig. 25(a) ADA 2010 404.2.4 CBC 2007 11B-26A(a) CBC 2019 11B-404.2.4 Mitigated: <input type="radio"/> YES <input checked="" type="radio"/> NO	1	JOB	\$3,000	\$3,000

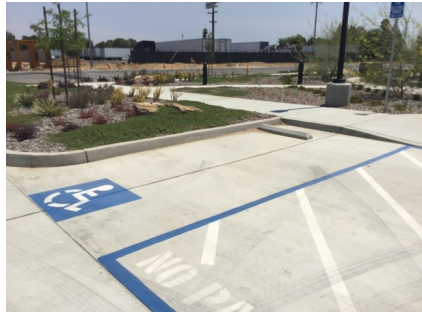
633	<ul style="list-style-type: none"> As-Built Description: Accessible parking space smaller than 8' wide (CA only: 9' x 18'). As-Built: 106.5" wide Proposed Solution: Modify parking space(s) to create accessible space. 	PCODE EA02A ADAAG 91 4.6.3 ADA 2010 502.2 CBC 2007 1129B.3.1 CBC 2019 11B-502.2 Mitigated: <input type="radio"/> YES <input checked="" type="radio"/> NO	1	JOB	\$600	\$600

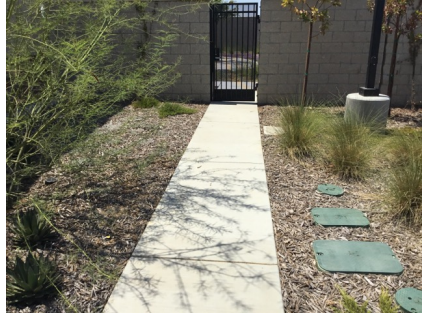
Item no., Rm no. and Name	Existing Architectural Barrier and Proposed Solution	Codes / Mitigation Info	Qty	Unit	Cost	Total
638	<p>Walk</p> <ul style="list-style-type: none"> As-Built Description: Walk more than 36" but less than 48" wide (required in CA only). As-Built: 39.5" wide Proposed Solution: Enlarge width of walk to 48". 	<p>PCODE EF08</p> <p>CBC 2007 1133B.7.1</p> <p>CBC 2019 11B-403.5.1.3</p> <p>Mitigated:</p> <p><input type="radio"/> YES</p> <p><input checked="" type="radio"/> NO</p>	150	SF	\$135	\$20,250

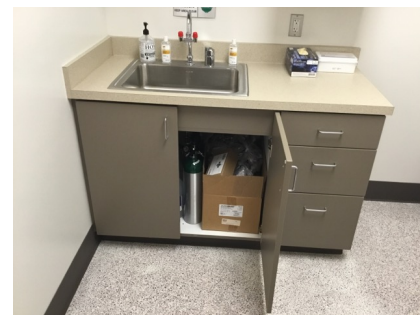
Item no., Rm no. and Name	Existing Architectural Barrier and Proposed Solution	Codes / Mitigation Info	Qty	Unit	Cost	Total
611	<ul style="list-style-type: none"> • <i>As-Built Description:</i> Sink does not have knee space min. 27" high x 19" deep x 30" wide. • <i>Proposed Solution:</i> Remodel sink cabinet. 	PCODE IN06A ADAAG 91 4.24.3 ADA 2010 606.2 CBC 2007 1115B.4.7.1 CBC 2019 11B-606.2 Mitigated: <input type="radio"/> YES <input checked="" type="radio"/> NO	1	JOB	\$5,250	\$5,250

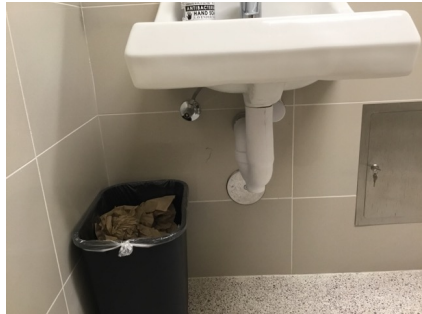
Item no., Rm no. and Name	Existing Architectural Barrier and Proposed Solution	Codes / Mitigation Info	Qty	Unit	Cost	Total
617	<ul style="list-style-type: none"> <i>As-Built Description:</i> Hot or sharp-surfaced water/drain pipe not insulated or covered. <i>Proposed Solution:</i> Insulate or cover water/drain pipe. 	PCODE WD05 ADAAG 91 4.19.4 ADA 2010 606.5 CBC 2007 1115B.4.3.4 CBC 2019 11B-606.5 Mitigated: <input type="radio"/> YES <input checked="" type="radio"/> NO	1	JOB	\$360	\$360

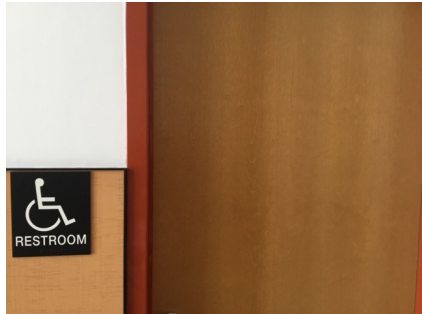
613	<ul style="list-style-type: none"> <i>As-Built Description:</i> Required in CA only: identification symbol centered 58" to 60" high on sanitary facility door that contrasts with the door not provided (women: 12" ø circle, men: 12" triangle, unisex: combined symbol). <i>Proposed Solution:</i> Provide properly mounted sanitary facility symbol when altering area. If wheelchair accessible, include International Symbol of Accessibility on sign. 	PCODE SA15 CBC 2007 1115B.6 CBC 2019 11B-703.7.2.6 Mitigated: <input type="radio"/> YES <input checked="" type="radio"/> NO	1	JOB	\$270	\$270
-----	---	---	---	-----	-------	-------

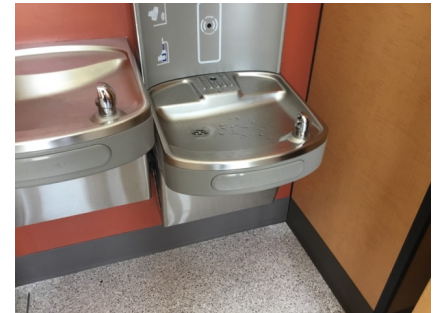
- 622 • *As-Built Description:*
Wall- and post-mounted cantilevered units: Knee space not provided at drinking fountain (27" high, 8" deep, 30" wide from front of drinking fountain). Unit in good condition.
- *As-Built:* **26.6" knee high**
- *Proposed Solution:*
Remount fountain at accessible height.

PCODE IA02A
 ADAAG 91 4.15.5(1)
 ADA 2010 602.2
 CBC 2007 1115B.4.6.2
 CBC 2019 11B-602.2

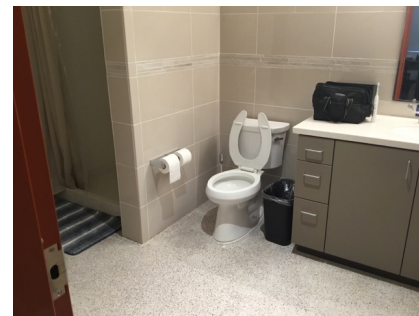
Single accommodation restroom not accessible; multiple compliance violations.

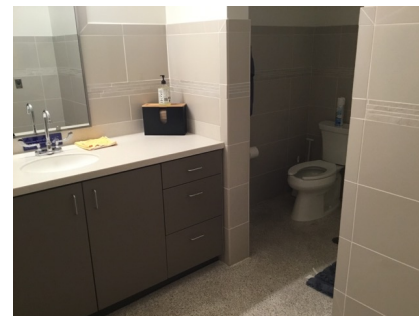
Single accommodation restroom not accessible; multiple compliance violations.

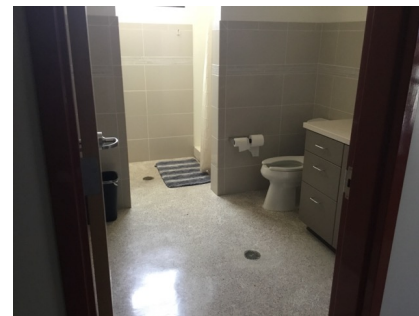
Single accommodation restroom not accessible; multiple compliance violations.

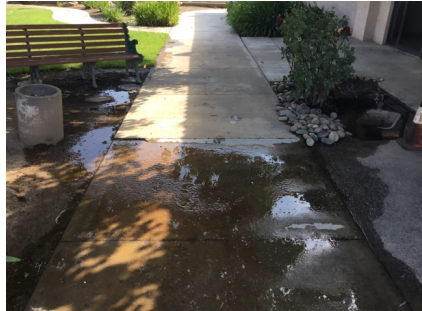
Item no., Rm no. and Name	Existing Architectural Barrier and Proposed Solution	Codes / Mitigation Info	Qty	Unit	Cost	Total
700	<ul style="list-style-type: none"> • <i>As-Built Description:</i> Walk: Pavement dislocation creates abrupt change in level exceeding 1/2" in accessible route. • <i>As-Built:</i> 2.0" • <i>Proposed Solution:</i> Remove, replace or repair area of pavement sufficient to correct abrupt change in level. 	PCODE EF03 ADAAG 91 4.3.8 ADA 2010 403.4 CBC 2007 1133B.7.4 CBC 2019 11B-403.4 Mitigated: <input type="radio"/> YES <input checked="" type="radio"/> NO	6	SF	\$300	\$1,800

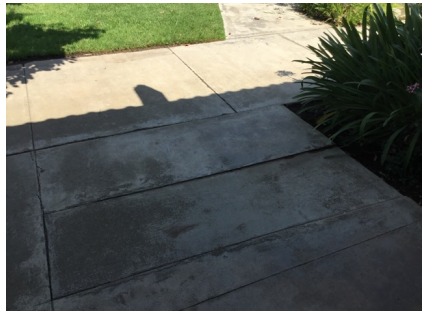
<input type="radio"/> Staff Only Priority <input checked="" type="radio"/> 1 Severity <input checked="" type="radio"/> 3						
735	<ul style="list-style-type: none"> • <i>As-Built Description:</i> Walk: Pavement dislocation creates abrupt change in level exceeding 1/2" in accessible route. • <i>As-Built:</i> 0.75" • <i>Proposed Solution:</i> Remove, replace or repair area of pavement sufficient to correct abrupt change in level. 	PCODE EF03 ADAAG 91 4.3.8 ADA 2010 403.4 CBC 2007 1133B.7.4 CBC 2019 11B-403.4 Mitigated: <input type="radio"/> YES <input checked="" type="radio"/> NO	15	LF	\$120	\$1,800

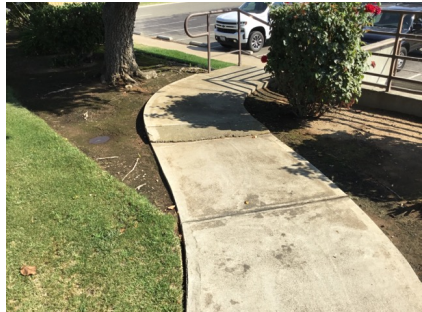
Item no., Rm no. and Name	Existing Architectural Barrier and Proposed Solution	Codes / Mitigation Info	Qty	Unit	Cost	Total
3	<ul style="list-style-type: none"> • <i>As-Built Description:</i> Walk: Pavement dislocation creates abrupt change in level exceeding 1/2" in accessible route. • <i>As-Built:</i> 2" • <i>Proposed Solution:</i> Remove, replace or repair area of pavement sufficient to correct abrupt change in level. 	PCODE EF03 ADAAG 91 4.3.8 ADA 2010 403.4 CBC 2007 1133B.7.4 CBC 2019 11B-403.4 Mitigated: <input type="radio"/> YES <input checked="" type="radio"/> NO	3	SF	\$63	\$189

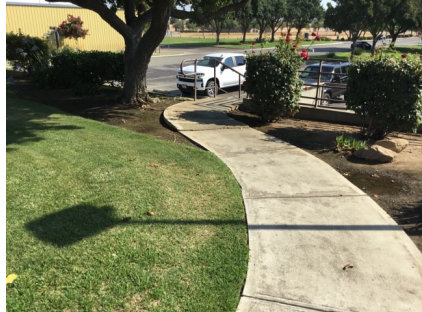
Cross Slope

689	<ul style="list-style-type: none"> • <i>As-Built Description:</i> Cross slope more than 1":48" (2.083%). • <i>As-Built:</i> 4.4% • <i>Proposed Solution:</i> Modify cross slope. 	PCODE EF07 ADAAG 91 4.3.7 ADA 2010 403.3 CBC 2007 1133B.7.1.3 CBC 2019 11B-403.3 Mitigated: <input type="radio"/> YES <input checked="" type="radio"/> NO	40	SF	\$75	\$3,000

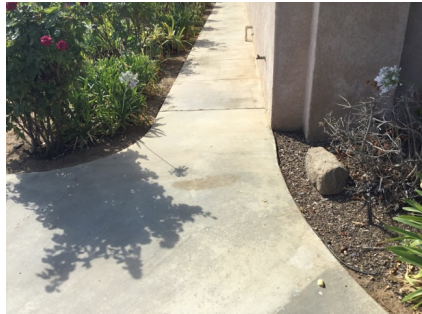
Item no., Rm no. and Name	Existing Architectural Barrier and Proposed Solution	Codes / Mitigation Info	Qty	Unit	Cost	Total
695	<ul style="list-style-type: none"> As-Built Description: Cross slope more than 1":48" (2.083%). As-Built: 4.3% Proposed Solution: Modify cross slope. 	PCODE EF07 ADAAG 91 4.3.7 ADA 2010 403.3 CBC 2007 1133B.7.1.3 CBC 2019 11B-403.3 Mitigated: <input type="radio"/> YES <input checked="" type="radio"/> NO	30	SF	\$75	\$2,250

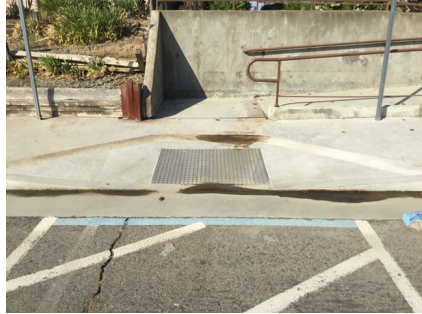
Curb Ramp

682	<ul style="list-style-type: none"> As-Built Description: Slope greater than 1:12 (8.3%). As-Built: 9.3% Proposed Solution: Demolish existing and provide new curb ramp. Notes: 	PCODE EH02A ADAAG 91 4.7.2 ADA 2010 406.1 CBC 2007 1127B.5.3 CBC 2019 11B-406.2.1 Mitigated: <input type="radio"/> YES <input checked="" type="radio"/> NO	1	JOB	\$7,500	\$7,500

Domes are 5.5" from street. Domes are not yellow. There is a level change where the domes meet the curb ramp.

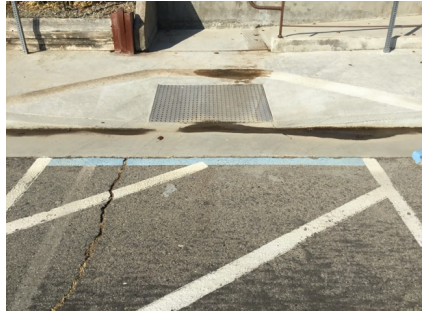
Item no., Rm no. and Name	Existing Architectural Barrier and Proposed Solution	Codes / Mitigation Info	Qty	Unit	Cost	Total
683	<ul style="list-style-type: none"> <i>As-Built Description:</i> Maximum slope of adjoining gutters, street surface at bottom of ramp exceeds 5% (1:20). <i>As-Built:</i> 6.1% <i>Proposed Solution:</i> Modify road/gutter slopes. Demolish existing and provide new curb ramp. 	PCODE EH02E ADAAG 91 4.7.2 ADA 2010 406.2 CBC 2007 1127B.5.3 CBC 2019 11B-406.5.8 Mitigated: <input type="radio"/> YES <input checked="" type="radio"/> NO	1	JOB	\$3,750	\$3,750

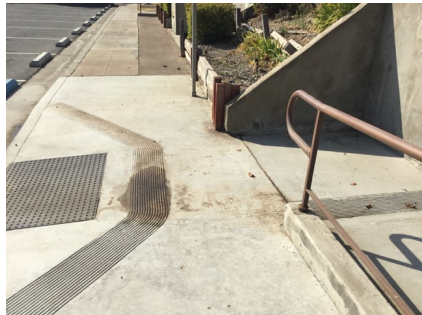
<input type="radio"/> Staff Only			
			Priority <input checked="" type="radio"/> 1			
			Severity <input checked="" type="radio"/> 4			
685	<ul style="list-style-type: none"> <i>As-Built Description:</i> Less than 48" level space at top and 1:12 flared sides not provided. <i>As-Built:</i> 45.0" deep obstructed by the ramp handrail. <i>Proposed Solution:</i> Demolish existing and provide new curb ramp. <i>Notes:</i> 	PCODE EH05B ADAAG 91 4.7.5; Fig.12(a) ADA 2010 406.4 CBC 2007 1127B.5.4 CBC 2019 11B-406.5.3 Mitigated: <input type="radio"/> YES <input checked="" type="radio"/> NO	1	JOB	\$7,500	\$7,500

<input type="radio"/> Staff Only			
			Priority <input checked="" type="radio"/> 1			
			Severity <input checked="" type="radio"/> 4			
<p>The handrail protrudes into the 48.0" required with by approximately 3.0", reducing the landing width to 45.0".</p>

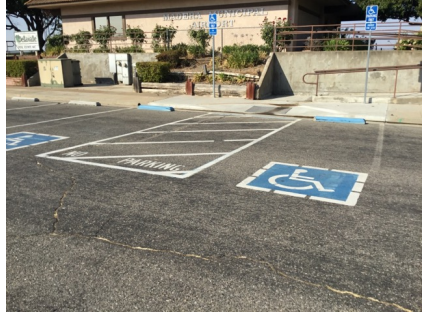
Parking

<p>678</p> <ul style="list-style-type: none"> <i>As-Built Description:</i> An accessible parking space shall be outlined or painted blue (required in CA only). <i>Proposed Solution:</i> Identify accessible parking space using blue markings. 	<p>PCODE EA04K</p> <p>CBC 2019 11B-502.6</p> <p>Mitigated:</p> <p><input type="radio"/> YES</p> <p><input checked="" type="radio"/> NO</p>	<p>1 JOB \$360 \$360</p>

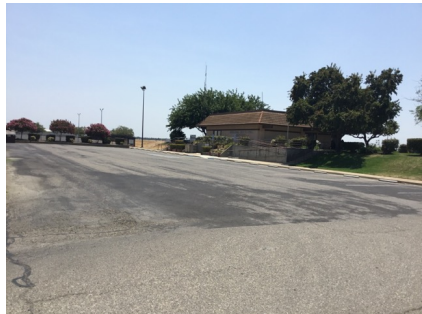
Parking Signage

<p>776</p> <ul style="list-style-type: none"> <i>As-Built Description:</i> No "Tow Away" sign at parking lot entrance (required in CA only). <i>Proposed Solution:</i> Provide "Tow Away" sign at parking lot entrance when altering area. 	<p>PCODE EA04C</p> <p>CBC 2007 1129B.4</p> <p>CBC 2019 11B-502.8.2</p> <p>Mitigated:</p> <p><input type="radio"/> YES</p> <p><input checked="" type="radio"/> NO</p>	<p>1 JOB \$975 \$975</p>

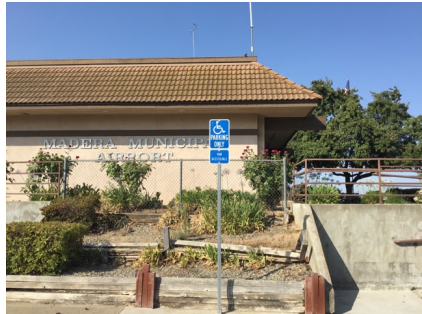
Item no., Rm no. and Name	Existing Architectural Barrier and Proposed Solution	Codes / Mitigation Info	Qty	Unit	Cost	Total
681	<ul style="list-style-type: none"> <i>As-Built Description:</i> CA only: Additional Sign or additional language below the symbol of accessibility stating "Minimum Fine \$250" not provided. <i>Proposed Solution:</i> Provide compliant parking signage that includes fine information. 	PCODE EA04G CBC 2007 1129B.4 CBC 2019 11B-502.6.2 Mitigated: <input type="radio"/> YES <input checked="" type="radio"/> NO	1	JOB	\$300	\$300

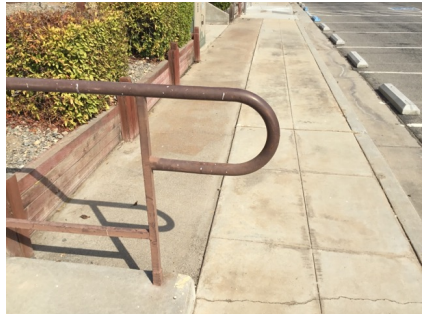
Protrusion Limits

697	<ul style="list-style-type: none"> <i>As-Built Description:</i> Protruding objects more than 4" from wall, when bottom of object more than 27" or less than 80" above finished floor. <i>As-Built:</i> Stair extension: 15.0" at 36.0" high <i>Proposed Solution:</i> Remove/relocate protruding object. Patch existing surface. <i>Notes:</i> 	PCODE EG04 ADAAG 91 4.4.1 ADA 2010 307.2 CBC 2007 1133B.8.6.1 CBC 2019 11B-307.2 Mitigated: <input type="radio"/> YES <input checked="" type="radio"/> NO	3	JOB	\$300	\$900

Both stairs.

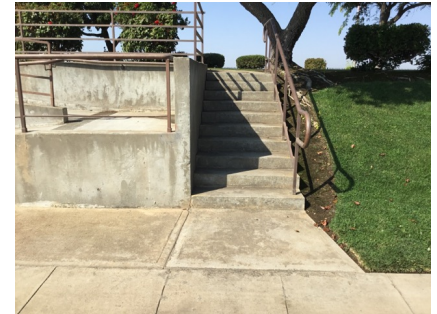
Stairways

693	<ul style="list-style-type: none"> As-Built Description: Landing at the top or bottom of stairway is not level or not provided. As-Built: 6.3% Proposed Solution: Remodel landings to provide a level clear floor space that extends the entire width of the stair. 	<p>PCODE EC10</p> <p>CBC 2019 1009.8</p> <p>Mitigated:</p> <p><input type="radio"/> YES</p> <p><input checked="" type="radio"/> NO</p>	1	JOB	\$1,500	\$1,500
-----	---	---	---	-----	---------	---------

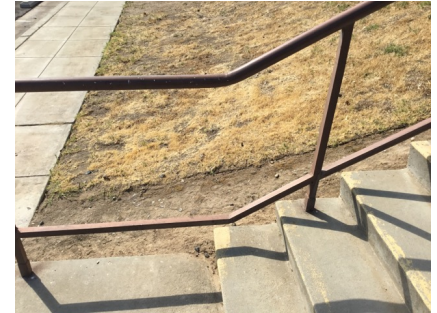
696	<ul style="list-style-type: none"> As-Built Description: Stair handrail does not extend horizontally 12" minimum beyond top nosing, and one tread width sloped, plus 12" minimum horizontally beyond the bottom nosing. Proposed Solution: Extend stair handrail at top and bottom (cost for each extension piece). 	PCODE ED06 ADAAG 91 4.9.4(2) ADA 2010 505.10.2; 505.10.3 CBC 2007 1133B.4.2.2 CBC 2019 11B-505.10.2; 11B-505.10.3 Mitigated: <input type="radio"/> YES <input checked="" type="radio"/> NO	2	JOB	\$510	\$1,020
-----	---	---	---	-----	-------	---------

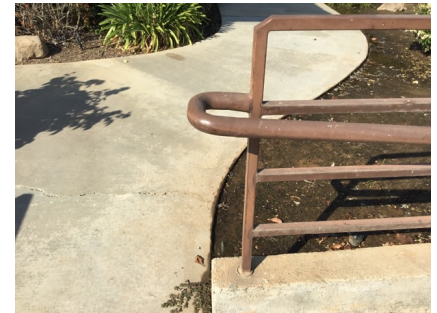
686	<ul style="list-style-type: none"> As-Built Description: Ramp handrail does not extend horizontally 12" past top and / or bottom of ramp. As-Built: 0.0" at the top. 9.0" at the bottom. Proposed Solution: Provide ramp handrail extension (cost for each extension piece). Notes: 	PCODE ED05 ADAAG 91 4.8.5(2) ADA 2010 505.10.1 CBC 2007 1133B.4.2.2 & CBC 2019 1133B.5.5.1 11B-505.10.1 Mitigated: <input type="radio"/> YES <input checked="" type="radio"/> NO	2	JOB	\$510	\$1,020
-----	--	---	---	-----	-------	---------

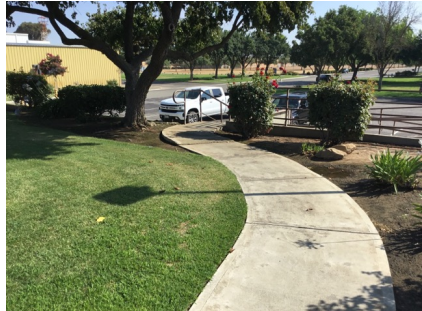
Item no., Rm no. and Name	Existing Architectural Barrier and Proposed Solution	Codes / Mitigation Info	Qty	Unit	Cost	Total
688	<ul style="list-style-type: none"> As-Built Description: Walk more than 36" but less than 48" wide (required in CA only). As-Built: 47.0" wide Proposed Solution: Enlarge width of walk to 48". 	PCODE EF08 CBC 2007 1133B.7.1 CBC 2019 11B-403.5.1.3 Mitigated: <input type="radio"/> YES <input checked="" type="radio"/> NO	80	SF	\$135	\$10,800

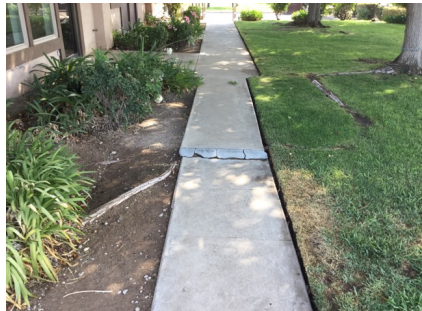
<input type="radio"/> Staff Only			
			Priority <input checked="" type="radio"/> 1			
			Severity <input checked="" type="radio"/> 4			
698	<ul style="list-style-type: none"> As-Built Description: Walk more than 36" but less than 48" wide (required in CA only). As-Built: 30.0" wide Proposed Solution: Enlarge width of walk to 48". 	PCODE EF08 CBC 2007 1133B.7.1 CBC 2019 11B-403.5.1.3 Mitigated: <input type="radio"/> YES <input checked="" type="radio"/> NO	240	SF	\$135	\$32,400

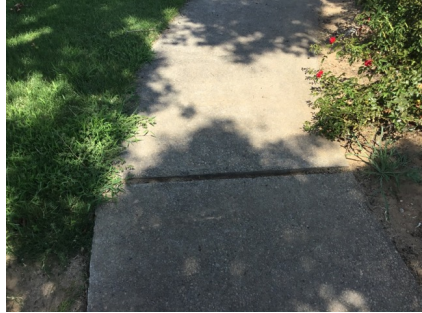
Floor or Ground Surface

<p>779</p> <ul style="list-style-type: none"> • <i>As-Built Description:</i> Walk: openings greater than 1/2" along the line of traffic flow. • <i>As-Built:</i> 2.0" • <i>Proposed Solution:</i> Fill gap or expansion joint. 	<p>PCODE EF04 ADAAG 91 4.3.6; 4.5.4 ADA 2010 403.2; 302.3 CBC 2007 1133B.7.2 CBC 2019 11B-403.2; 11B-302.3</p> <p>Mitigated: <input type="radio"/> YES <input checked="" type="radio"/> NO</p>	<p>4 SF \$120 \$480</p>

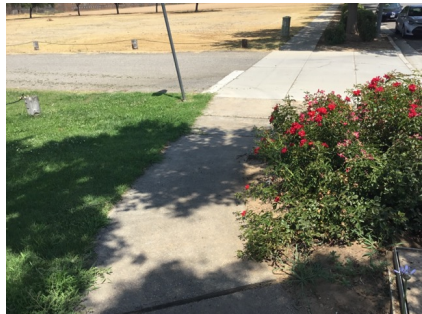
Walk

<p>777</p> <ul style="list-style-type: none"> • <i>As-Built Description:</i> Walk: Slope greater than 1:20 (5.0%), and walk does not comply with requirements for ramps. • <i>As-Built:</i> 9.6% • <i>Proposed Solution:</i> Modify walk/sidewalk slope to 1:20 or less. 	<p>PCODE EF01 ADAAG 91 4.3.7 ADA 2010 403.3 CBC 2007 1133B.7.3 CBC 2019 11B-403.3</p> <p>Mitigated: <input type="radio"/> YES <input checked="" type="radio"/> NO</p>	<p>100 SF \$75 \$7,500</p>

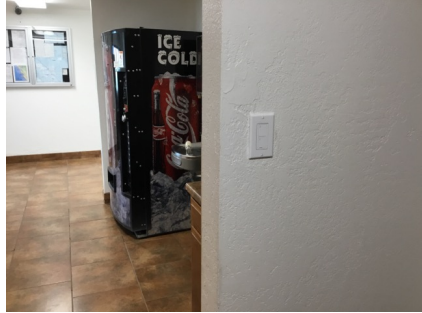
<p>708</p> <ul style="list-style-type: none"> <i>As-Built Description:</i> Electric switch or control mounted less than 15" measured to the bottom of the outlet box or greater than 48 inches measured to the top of the outlet box. <i>As-Built:</i> 54.2" high <i>Proposed Solution:</i> Relocate light switches or control to between 15" and 48" height. 	<p><i>PCODE</i> IC01 <i>ADAAG 91</i> 4.2.5 & 6 <i>ADA 2010</i> 308.2.1 & 308.2.2 <i>CBC 2007</i> 1117B.6.3 <i>CBC 2019</i> 11B-308.2.1 & 11B-308.2.2</p> <p>Mitigated: <input type="radio"/> YES <input checked="" type="radio"/> NO</p>	<p>1 JOB \$900 \$900</p>

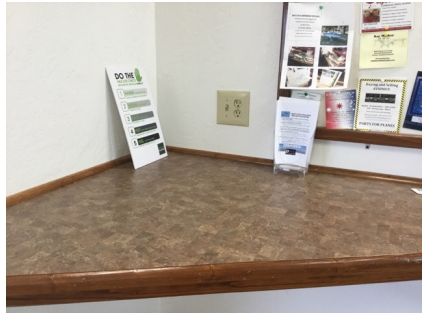
<p>734</p> <ul style="list-style-type: none"> <i>As-Built Description:</i> Electric switch or control mounted less than 15" measured to the bottom of the outlet box or greater than 48 inches measured to the top of the outlet box. <i>As-Built:</i> 20.0" side reach over 38.0" high obstruction. <i>Proposed Solution:</i> Relocate light switches or control to between 15" and 48" height. 	<p><i>PCODE</i> IC01 <i>ADAAG 91</i> 4.2.5 & 6 <i>ADA 2010</i> 308.2.1 & 308.2.2 <i>CBC 2007</i> 1117B.6.3 <i>CBC 2019</i> 11B-308.2.1 & 11B-308.2.2</p> <p>Mitigated: <input type="radio"/> YES <input checked="" type="radio"/> NO</p>	<p>1 JOB \$900 \$900</p>

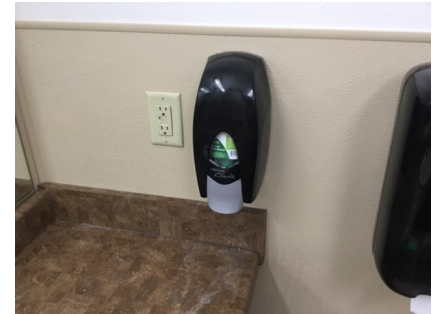
711	<ul style="list-style-type: none"> • <i>As-Built Description:</i> Dispensers in sanitary facilities, such as for towels, soap, sanitary napkins, seat covers, etc., and waste receptacles more than 48" (CA only: 40") from floor to highest operating slot or control. • <i>As-Built:</i> SD: 41.0" high • <i>Proposed Solution:</i> Relocate existing restroom accessories. • <i>Notes:</i> 	<p>PCODE WG01A ADAAG 91 4.23.7 ADA 2010 308.2.1 CBC 2007 1115B.8.3 CBC 2019 11B-603.5</p>	1	JOB	\$300	\$300
-----	--	---	---	-----	-------	-------

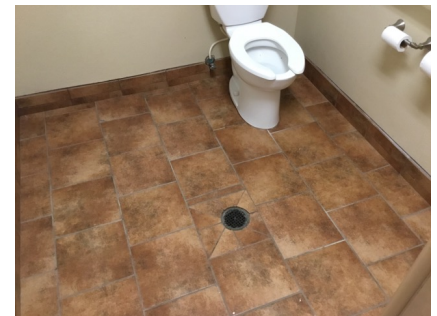
727	<ul style="list-style-type: none"> • <i>As-Built Description:</i> Walk: abrupt change in level exceeding 1/2" in accessible route due to drain. • <i>As-Built:</i> 0.5" level change 3.8% slope • <i>Proposed Solution:</i> Correct abrupt change in level and adjust drain as needed. 	<p>PCODE EF03 ADAAG 91 4.3.8 ADA 2010 403.4 CBC 2007 1133B.7.4 CBC 2019 11B-403.4</p>	25	SF	\$63	\$1,575
-----	---	---	----	----	------	---------

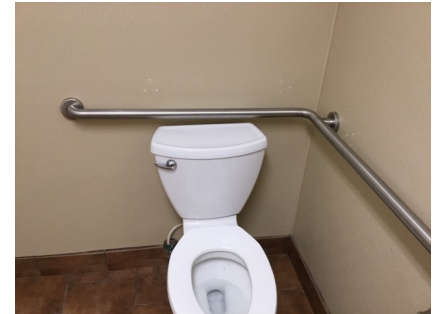
729	<ul style="list-style-type: none"> As-Built Description: The rear wall grab is less than 36" min. or does not extend from the centerline of the water closet 12" min. on one side and 24" min. on the other side. As-Built: Extends 20.0" wide side Proposed Solution: Provide new accessible rear grab bar. Notes: 	PCODE WB07B ADAAG 91 4.17.6 ADA 2010 604.5.2 CBC 2007 1115B.4.1.3.2 CBC 2019 11B-604.5.2	1	JOB	\$1,020	\$1,020
-----	--	---	---	-----	---------	---------

This element complies with Safe Harbor if altered or constructed before March 15, 2012. .

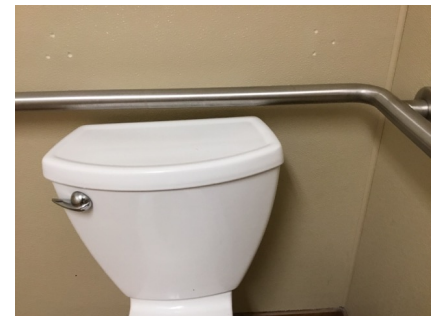
730	<ul style="list-style-type: none"> As-Built Description: Accessories/dispensers in accessible stall located closer than 1-1/2" below or 12" above grab bar impedes its use. As-Built: 1.4" Proposed Solution: Raise the grab bar. 	PCODE WB07I ADAAG 91 4.26.2 ADA 2010 609.3 CBC 2007 1133B.4.2.5 CBC 2019 11B-609.3	1	JOB	\$225	\$225
-----	---	---	---	-----	-------	-------

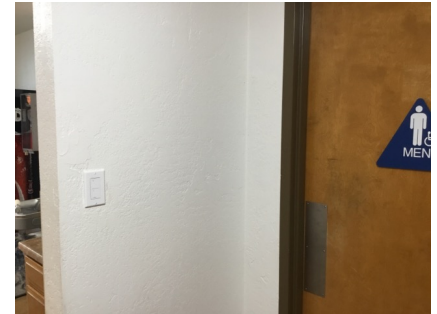
714	<ul style="list-style-type: none"> As-Built Description: Entrance to toilet or bathing facility not identified with ADAAG compliant signage. Proposed Solution: Provide ADA compliant sign mounted at 48" min. above to baseline of the lowest Braille cells and 60" max. to baseline of the highest line of raised characters on nearest adjacent wall, on latch side of a single door (located not to cause a Braille reader to stand within the door swing). 	PCODE SA11A ADAAG 91 4.1.3(16)(a) ADA 2010 216.8 CBC 2019 11B-216.8	1	JOB	\$270	\$270
-----	---	--	---	-----	-------	-------

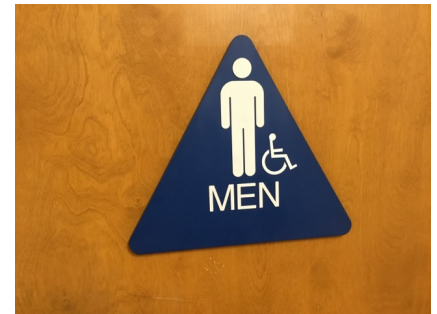
709	<ul style="list-style-type: none"> As-Built Description: Required in CA only: identification symbol centered 58" to 60" high on sanitary facility door that contrasts with the door not provided (women: 12" ø circle, men: 12" triangle, unisex: combined symbol). As-Built: Not beveled. 0.5" radius. 60.5" high. Proposed Solution: Provide properly mounted sanitary facility symbol when altering area. If wheelchair accessible, include International Symbol of Accessibility on sign. 	PCODE SA15 CBC 2007 1115B.6 CBC 2019 11B-703.7.2.6	1	JOB	\$270	\$270
-----	--	--	---	-----	-------	-------

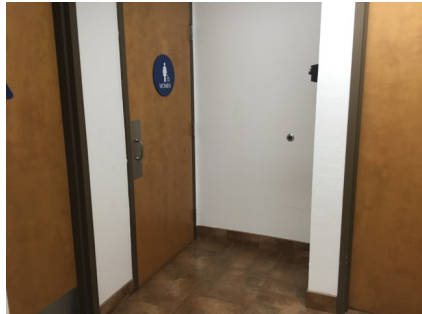
Item no., Rm no. and Name	Existing Architectural Barrier and Proposed Solution	Codes / Mitigation Info	Qty	Unit	Cost	Total
713	<ul style="list-style-type: none"> • <i>As-Built Description:</i> Latch approach: At pull side, door does not have clear and level maneuvering space measuring door width plus 24" x 48" or 54" if door has closer (CA only: door width plus 24" x 60"). • <i>As-Built:</i> 43.5" • <i>Proposed Solution:</i> Relocate door to interior. 	PCODE ID27 ADAAG 91 Fig. 25(c) ADA 2010 404.2.4 CBC 2007 11B-26A(c) CBC 2019 11B-404.2.4 Mitigated: <input type="radio"/> YES <input checked="" type="radio"/> NO	1	JOB	\$9,000	\$9,000

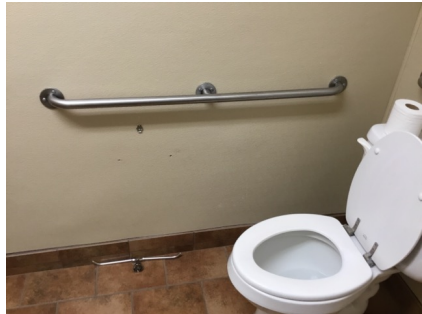
724	<ul style="list-style-type: none"> • <i>As-Built Description:</i> Side grab bar less than 42" long, or located more than 12 inches max. from the rear wall, or extending less than 54" from rear wall (CA only: front end min. 24" in front of water closet). • <i>As-Built:</i> Extends 52.5" • <i>Proposed Solution:</i> Provide or relocate accessible side grab bar. 	PCODE WB07A ADAAG 91 Fig. 29(b) ADA 2010 604.5.1 CBC 2007 1115B.4.1.3.1 CBC 2019 11B-604.5.1 Mitigated: <input type="radio"/> YES <input checked="" type="radio"/> NO	1	JOB	\$780	\$780

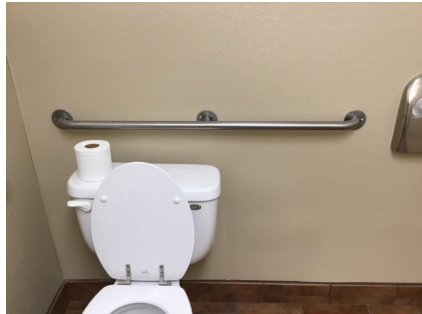
Item no., Rm no. and Name	Existing Architectural Barrier and Proposed Solution	Codes / Mitigation Info	Qty	Unit	Cost	Total
721	<ul style="list-style-type: none"> As-Built Description: Grab bars not at 33" to 36" from floor As-Built: 37.0" high Proposed Solution: Relocate accessible grab bars. 	PCODE WB07C ADAAG 91 4.16.4 ADA 2010 609.4 CBC 2007 1115B.4.1.3.1 & 2 CBC 2019 11B-609.4 Mitigated: <input type="radio"/> YES <input checked="" type="radio"/> NO	1	JOB	\$780	\$780

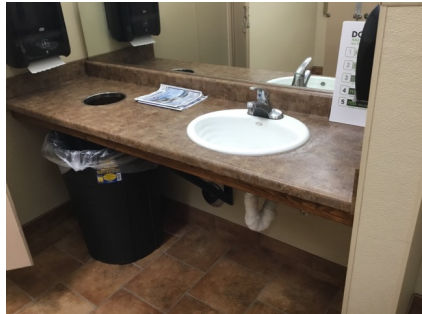
719	<ul style="list-style-type: none"> As-Built Description: Lavatory: Fixture rim or counter height more than 34" above floor. As-Built: 34.25" high Proposed Solution: Remount compliant fixture at accessible height. 	PCODE WD02A ADAAG 91 4.19.2 ADA 2010 606.3 CBC 2007 1115B.4.3 CBC 2019 11B-606.3 Mitigated: <input type="radio"/> YES <input checked="" type="radio"/> NO	1	JOB	\$2,700	\$2,700

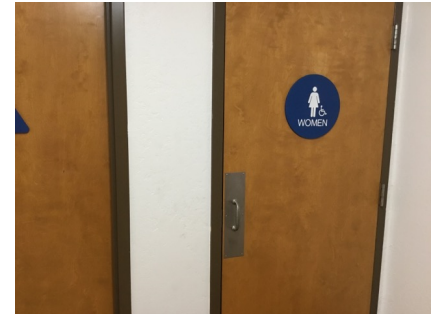
715	<ul style="list-style-type: none"> <i>As-Built Description:</i> Entrance to toilet or bathing facility not identified with ADAAG compliant signage. <i>Proposed Solution:</i> Provide ADA compliant sign mounted at 48" min. above to baseline of the lowest Braille cells and 60" max. to baseline of the highest line of raised characters on nearest adjacent wall, on latch side of a single door (located not to cause a Braille reader to stand within the door swing). <i>Notes:</i> 	<p>PCODE SA11A ADAAG 91 4.1.3(16)(a) ADA 2010 216.8 CBC 2019 11B-216.8</p> <p>Mitigated: <input type="radio"/> YES <input checked="" type="radio"/> NO</p>	1	JOB	\$270	\$270
-----	--	--	---	-----	-------	-------

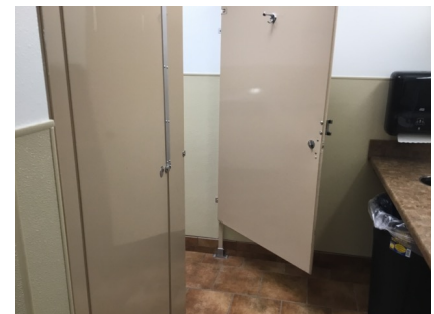
717	<ul style="list-style-type: none"> <i>As-Built Description:</i> Stall door to accessible compartment not self closing. <i>Proposed Solution:</i> Adjust closer. 	<p>PCODE WB05B ADAAG 91 4.22.4 ADA 2010 604.8.1.2 CBC 2007 1115B.3.1.4.4 CBC 2019 11B-604.8.1.2</p> <p>Mitigated: <input type="radio"/> YES <input checked="" type="radio"/> NO</p>	1	JOB	\$75	\$75
-----	---	--	---	-----	------	------

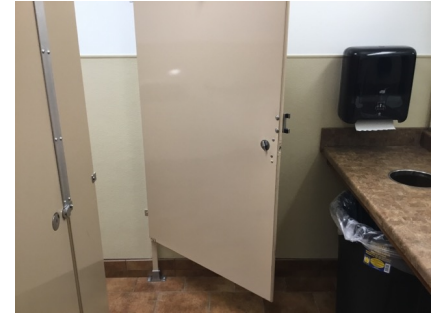
Item no., Rm no. and Name	Existing Architectural Barrier and Proposed Solution	Codes / Mitigation Info	Qty	Unit	Cost	Total
718	<ul style="list-style-type: none"> As-Built Description: Stall door does not have accessible operating hardware (U-pulls on both sides, flip-over or sliding lock). Proposed Solution: Provide new accessible locking hardware that does not require grasping, pinching, or twisting and U-pulls on both sides. 	PCODE WB05C ADAAG 91 4.17.5 ADA 2010 604.8.1.2 CBC 2007 1115B.3.1.4.5 CBC 2019 11B-604.8.1.2 Mitigated: <input type="radio"/> YES <input checked="" type="radio"/> NO	1	JOB	\$300	\$300

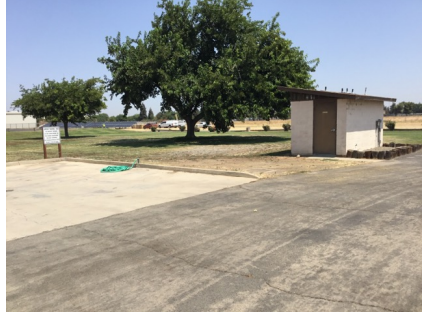
<p>742</p> <ul style="list-style-type: none"> <i>As-Built Description:</i> At parking lot with 1-25 spaces, the number of accessible spaces is less than required by code; 1 space required <i>Proposed Solution:</i> Provide required accessible parking space with sign including a minimum of one van space. 	<p>PCODE EA01A ADAAG 91 4.1.2(5) ADA 2010 208.2 CBC 2007 Tbl. 11B-6 CBC 2019 11B-208.2 Tbl. 11B-208.2</p> <p>Mitigated: <input type="radio"/> YES <input checked="" type="radio"/> NO</p>	<p>1 JOB \$900 \$900</p>

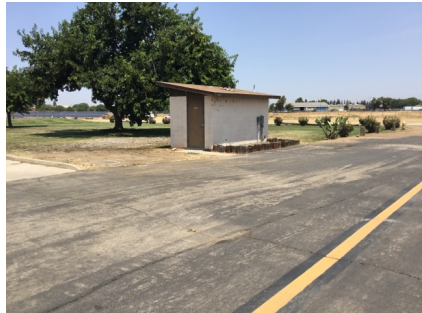
<p>775</p> <ul style="list-style-type: none"> <i>As-Built Description:</i> At parking lot with 1-25 spaces, the number of accessible spaces is less than required by code; 1 space required <i>Proposed Solution:</i> Provide required accessible parking space with sign including a minimum of one van space. 	<p>PCODE EA01A ADAAG 91 4.1.2(5) ADA 2010 208.2 CBC 2007 Tbl. 11B-6 CBC 2019 11B-208.2 Tbl. 11B-208.2</p> <p>Mitigated: <input type="radio"/> YES <input checked="" type="radio"/> NO</p>	<p>1 JOB \$900 \$900</p>

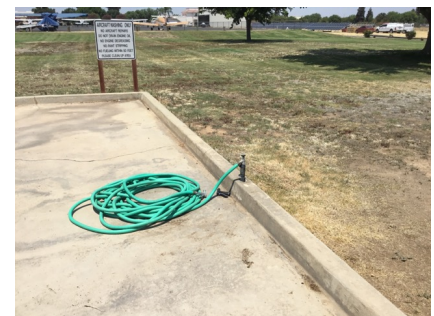
774 • *As-Built Description:*
 Operable part(s) require tight grasping, pinching, or twisting of the wrist with one hand.
 • *As-Built:* **Greater than 35.0 lbs**
 • *Proposed Solution:*
 Modify or replace the operable part(s) to not require tight grasping, pinching, or twisting of the wrist with one hand.

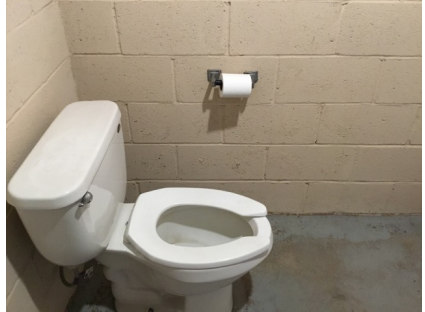
Item no., Rm no. and Name	Existing Architectural Barrier and Proposed Solution	Codes / Mitigation Info	Qty	Unit	Cost	Total
751	<ul style="list-style-type: none"> As-Built Description: Toilet paper dispenser less than 15" (CA: 19") or more than 48" above floor or not within 7" to 9" from front of water closet (Note: CA pre-2010 is allowed within 12" from front of water closet). As-Built: Behind water closet. Proposed Solution: Relocate or provide new toilet paper dispenser. 	PCODE WG02 ADAAG 91 4.16.6 ADA 2010 604.7 CBC 2007 1115B.8.4 CBC 2019 11B-604.7 Mitigated: <input type="radio"/> YES <input checked="" type="radio"/> NO	1	JOB	\$225	\$225

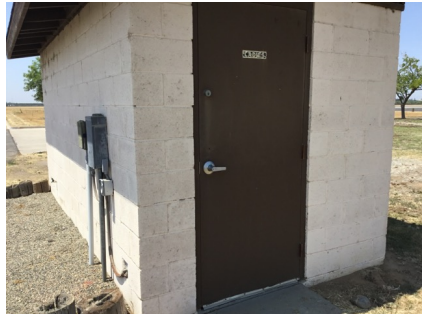
Door

745	<ul style="list-style-type: none"> As-Built Description: Surface of required maneuvering clearance at door slopes more than 1/4":12" (2.0%). As-Built: 5.0% Proposed Solution: Modify surface slope at door. 	PCODE ID11 ADAAG 91 4.13.6 ADA 2010 404.2.4.4 CBC 2007 1133B.2.4 CBC 2019 11B-404.2.4 Mitigated: <input type="radio"/> YES <input checked="" type="radio"/> NO	25	SF	\$120	\$3,000

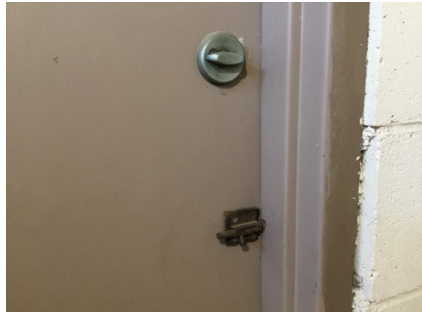
Item no., Rm no. and Name	Existing Architectural Barrier and Proposed Solution	Codes / Mitigation Info	Qty	Unit	Cost	Total
747	<ul style="list-style-type: none"> • <i>As-Built Description:</i> Door lock, latch or handle less than 34" or more than 48" above the floor (CA only: 34" to 44"). • <i>As-Built:</i> 52.0" and 60.0" high • <i>Proposed Solution:</i> Relocate or replace existing hardware. 	PCODE ID17 ADAAG 91 4.13.9 ADA 2010 404.2.7 CBC 2007 1133B.2.5.2 CBC 2019 11B-404.2.7 Mitigated: <input type="radio"/> YES <input checked="" type="radio"/> NO	1	JOB	\$900	\$900

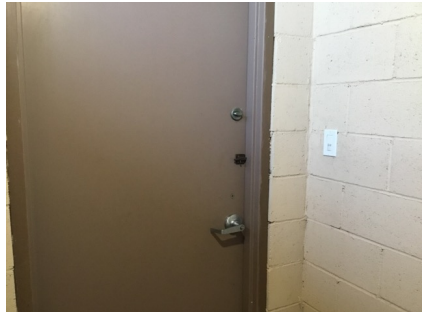
Door Swing

746	<ul style="list-style-type: none"> • <i>As-Built Description:</i> Front approach: At push side, door does not have clear and level maneuvering space measuring door width x 48" (door width plus 12" if door has both, latch and closer). • <i>As-Built:</i> 10.75" • <i>Proposed Solution:</i> Remove latch. 	PCODE ID24B ADAAG 91 Fig. 25(a) ADA 2010 404.2.4 CBC 2007 11B-26A(a) CBC 2019 11B-404.2.4 Mitigated: <input type="radio"/> YES <input checked="" type="radio"/> NO	1	JOB	\$780	\$780

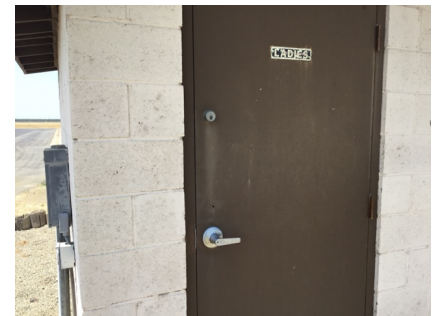
- 743
- *As-Built Description:*
Entrance to toilet or bathing facility not identified with ADAAG compliant signage.
 - *Proposed Solution:*
Provide ADA compliant sign mounted at 48" min. above to baseline of the lowest Braille cells and 60" max. to baseline of the highest line of raised characters on nearest adjacent wall, on latch side of a single door (located not to cause a Braille reader to stand within the door swing).

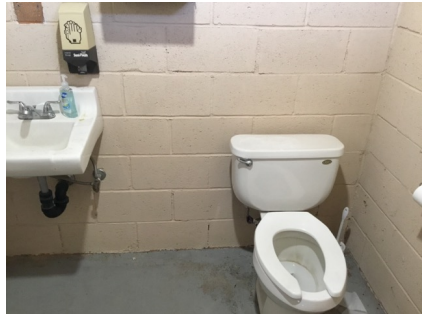
Toilet Stall

752	<ul style="list-style-type: none"> As-Built Description: 60" min. clearance around a water closet measured perpendicular from the side wall not provided (Fixtures are not allowed to overlap this clearance). As-Built: 52.5" to lavatory Proposed Solution: Relocate adjacent fixture and remodel restroom as needed. Notes: 	PCODE WB01A ADA 2010 604.3.1; 604.3.2 CBC 2007 1115B.7.1.3 CBC 2019 11B-604.3.1; 11B-604.3.2 Mitigated: <input type="radio"/> YES <input checked="" type="radio"/> NO	1	JOB	\$6,000	\$6,000
-----	---	---	---	-----	---------	---------

This element complies with Safe Harbor if altered or constructed before March 15, 2012. This element does not comply with the dimensional requirements in the 1981 to the current CBC.

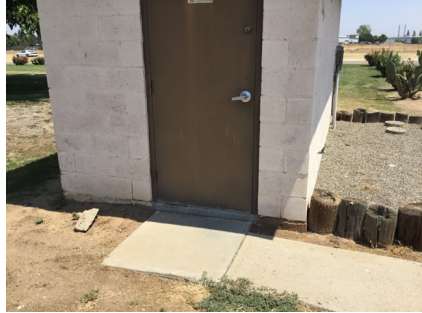
Door

<p>759</p> <ul style="list-style-type: none"> • <i>As-Built Description:</i> Surface of required maneuvering clearance at door slopes more than 1/4":12" (2.0%). • <i>As-Built:</i> 2.6% 36.0" deep • <i>Proposed Solution:</i> Install landing. 	<p><i>PCODE ID11</i> <i>ADAAG 91 4.13.6</i> <i>ADA 2010 404.2.4.4</i> <i>CBC 2007 1133B.2.4</i> <i>CBC 2019 11B-404.2.4</i></p> <p>Mitigated: <input type="radio"/> YES <input checked="" type="radio"/> NO</p>	<p>1 UNI \$900 \$900</p>

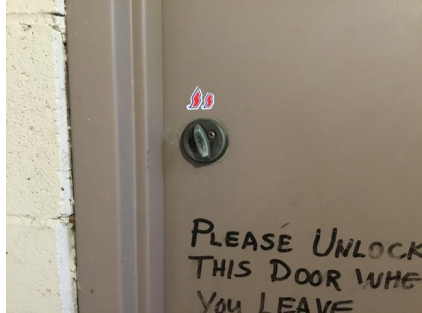
<p>764</p> <ul style="list-style-type: none"> • <i>As-Built Description:</i> Door lock, latch or handle less than 34" or more than 48" above the floor (CA only: 34" to 44"). • <i>As-Built:</i> 60.5" high • <i>Proposed Solution:</i> Relocate or replace existing hardware. 	<p><i>PCODE ID17</i> <i>ADAAG 91 4.13.9</i> <i>ADA 2010 404.2.7</i> <i>CBC 2007 1133B.2.5.2</i> <i>CBC 2019 11B-404.2.7</i></p> <p>Mitigated: <input type="radio"/> YES <input checked="" type="radio"/> NO</p>	<p>1 JOB \$900 \$900</p>

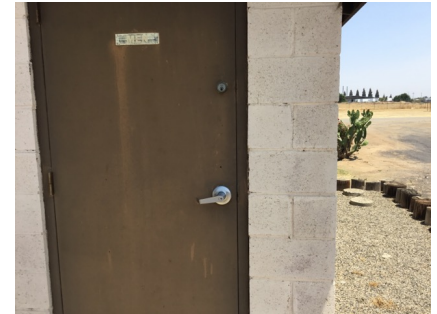
Signage

760	<ul style="list-style-type: none"> As-Built Description: Entrance to toilet or bathing facility not identified with ADAAG compliant signage. Proposed Solution: Provide ADA compliant sign mounted at 48" min. above to baseline of the lowest Braille cells and 60" max. to baseline of the highest line of raised characters on nearest adjacent wall, on latch side of a single door (located not to cause a Braille reader to stand within the door swing). 	PCODE SA11A ADAAG 91 4.1.3(16)(a) ADA 2010 216.8 CBC 2019 11B-216.8	1	JOB	\$270	\$270
-----	---	--	---	-----	-------	-------
