The City of Madera

Appendix B: Facilities

Access Compliance Survey Report

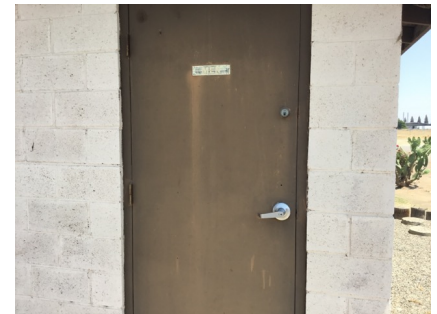
761	<ul style="list-style-type: none"> As-Built Description: Required in CA only: identification symbol centered 58" to 60" high on sanitary facility door that contrasts with the door not provided (women: 12" ø circle, men: 12" triangle, unisex: combined symbol). Proposed Solution: Provide properly mounted sanitary facility symbol when altering area. If wheelchair accessible, include International Symbol of Accessibility on sign. 	PCODE SA15 CBC 2007 1115B.6 CBC 2019 11B-703.7.2.6	1	JOB	\$270	\$270
-----	---	--	---	-----	-------	-------

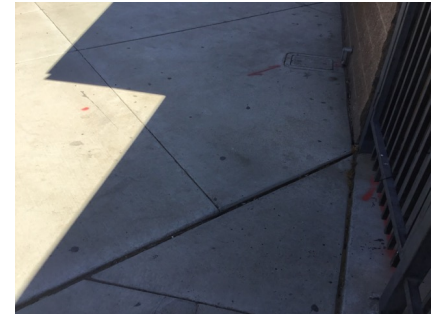
- 314
- *As-Built Description:*
Walk: Pavement dislocation creates abrupt change in level exceeding 1/2" in accessible route.
 - *As-Built:* **1.0"**
 - *Proposed Solution:*
Remove, replace or repair area of pavement sufficient to correct abrupt change in level.

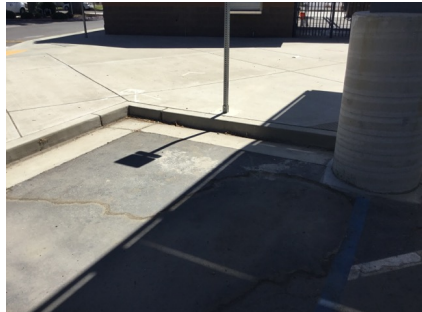
Item no., Rm no. and Name	Existing Architectural Barrier and Proposed Solution	Codes / Mitigation Info	Qty	Unit	Cost	Total
311	<ul style="list-style-type: none"> As-Built Description: Accessible parking space has slope greater than 1/4":12" (2%). As-Built: 7.5% at gutter Proposed Solution: Modify slope at accessible parking space. 	PCODE EA05 ADAAG 91 4.6.3 ADA 2010 502.4 CBC 2007 1129B.3.3 CBC 2019 11B-502.4 Mitigated: <input type="radio"/> YES <input checked="" type="radio"/> NO	20	SF	\$36	\$720

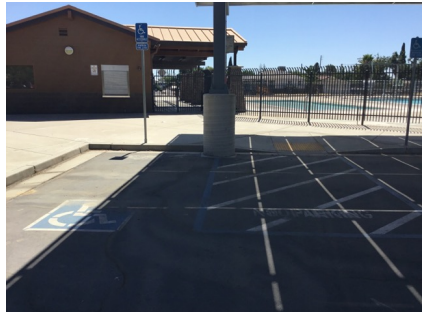
Parking

312	<ul style="list-style-type: none"> As-Built Description: Accessible parking space smaller than 8' wide (CA only: 9' x 18'). As-Built: 178.0" Proposed Solution: Modify parking space(s) to create accessible space. Notes: 	PCODE EA02A ADAAG 91 4.6.3 ADA 2010 502.2 CBC 2007 1129B.3.1 CBC 2019 11B-502.2 Mitigated: <input type="radio"/> YES <input checked="" type="radio"/> NO	1	JOB	\$600	\$600

Obstructed by pillar.

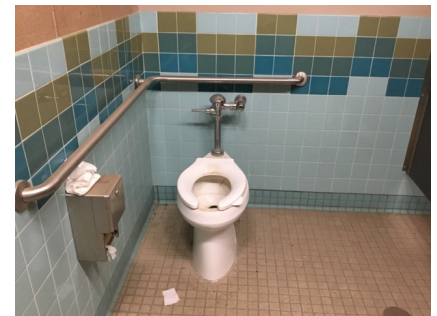
- 283
- *As-Built Description:*
Flush Control: Operating handle not mounted toward wide side of stall.
 - *Proposed Solution:*
Replace flush control with properly mounted accessible type, or install sensor flush.

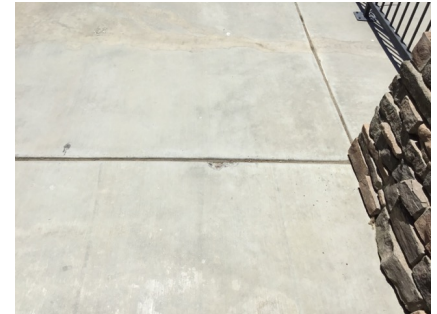
288 • *As-Built Description:*
Walk: Pavement dislocation creates abrupt change in level exceeding 1/2" in accessible route.
• *As-Built:* **0.75"**
• *Proposed Solution:*
Remove, replace or repair area of pavement sufficient to correct abrupt change in level.

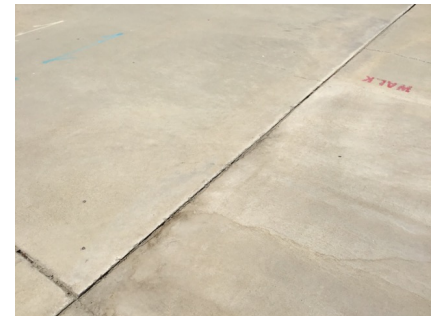
289 • *As-Built Description:*
Walk: Pavement dislocation creates abrupt change in level exceeding 1/2" in accessible route.
• *As-Built:* **0.75"**
• *Proposed Solution:*
Remove, replace or repair area of pavement sufficient to correct abrupt change in level.

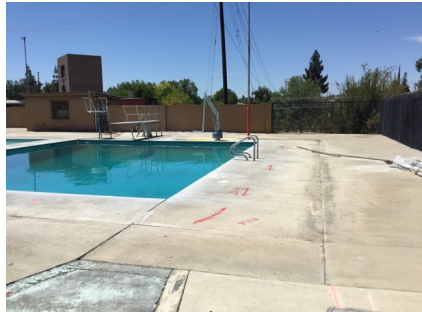
Item no., Rm no. and Name	Existing Architectural Barrier and Proposed Solution	Codes / Mitigation Info	Qty	Unit	Cost	Total
300	<ul style="list-style-type: none"> As-Built Description: Cross slope more than 1":48" (2.083%). As-Built: Up to 4.2% Proposed Solution: Modify cross slope. 	PCODE EF07 ADAAG 91 4.3.7 ADA 2010 403.3 CBC 2007 1133B.7.1.3 CBC 2019 11B-403.3 Mitigated: <input type="radio"/> YES <input checked="" type="radio"/> NO	200	SF	\$75	\$15,000

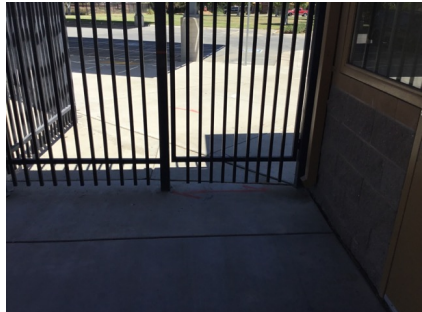
Door

285	<ul style="list-style-type: none"> As-Built Description: At push side of door on accessible route, bottom 10" does not have a smooth, uninterrupted surface. Proposed Solution: Provide 10" min. "kick plate" covering width of door when altering area. 	PCODE ID06 ADA 2010 404.2.10 CBC 2007 1133B.2.6 CBC 2019 11B-404.2.10 Mitigated: <input type="radio"/> YES <input checked="" type="radio"/> NO	3	JOB	\$300	\$900

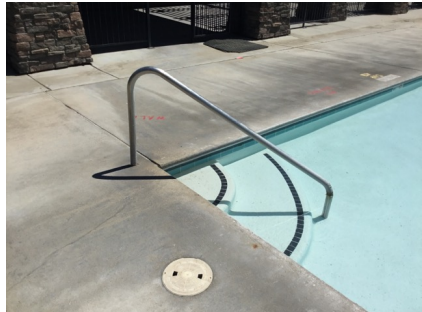
Item no., Rm no. and Name	Existing Architectural Barrier and Proposed Solution	Codes / Mitigation Info	Qty	Unit	Cost	Total
303	<ul style="list-style-type: none"> <i>As-Built Description:</i> Handrail gripping surface top not mounted between 34" and 38" above ramp surface or stair nosings. <i>As-Built:</i> 19.0" high <i>Proposed Solution:</i> Remove existing and provide new handrail. 	PCODE ED02 ADAAG 91 4.9.4(5) ADA 2010 505.4 CBC 2007 1133B.4.2.1 & B.5.5.1 CBC 2019 11B-505.4 Mitigated: <input type="radio"/> YES <input checked="" type="radio"/> NO	4	LF	\$225	\$900

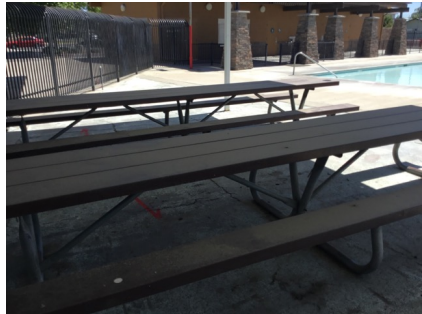
Non-Fixed Desk

298	<ul style="list-style-type: none"> <i>As-Built Description:</i> Accessible non-fixed table or desk (top 28" to 34" high; knee space at least 27" high x 19" deep x 30" wide) not provided. <i>As-Built:</i> 50 seats, 0 accessible provided. <i>Proposed Solution:</i> Provide table or desk with accessible dimensions when purchasing new furniture. 	PCODE IN02A ADAAG 91 4.32.3 & .4 ADA 2010 306.1 CBC 2007 1122B.3 & 4 CBC 2019 11B-306.1 & 11B-902.3 Mitigated: <input type="radio"/> YES <input checked="" type="radio"/> NO	3	JOB	\$1,500	\$4,500

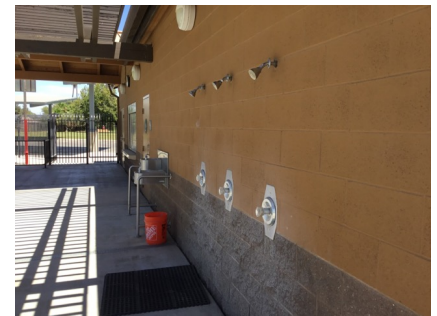
274 • *As-Built Description:*
 Shower not accessible; multiple compliance violations.

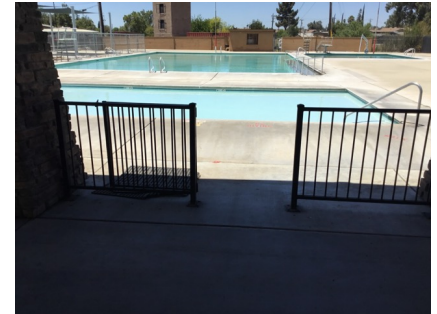
- 286
- As-Built Description:**
Exterior signage at inaccessible entrances to provide direction to accessible entrances is missing or noncompliant.
 - Proposed Solution:**
Provide signage sufficient to guide persons to accessible entrances.
 - Notes:**

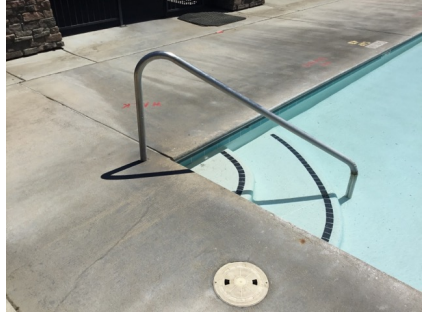
Stairs

305	<ul style="list-style-type: none"> <i>As-Built Description:</i> Stair tread width less than 11", measured horizontally from nosing to nosing. <i>Proposed Solution:</i> Rebuild stair as needed. <i>Notes:</i> 	<p>PCODE EC06 ADAAG 91 4.9.2 ADA 2010 504.2 CBC 2007 1133B.4.5.3 CBC 2019 11B-504.2 & 11B-1009.6</p> <p>Mitigated: <input type="radio"/> YES <input checked="" type="radio"/> NO</p>	10	LF	\$225	\$2,250
-----	---	---	----	----	-------	---------

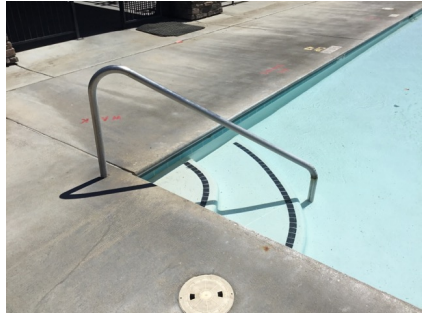
Stairways

304	<ul style="list-style-type: none"> <i>As-Built Description:</i> Landing at the top or bottom of stairway is not level or not provided. <i>As-Built:</i> 3.7% <i>Proposed Solution:</i> Remodel landings to provide a level clear floor space that extends the entire width of the ramp. 	<p>PCODE EC10 CBC 2019 1009.8</p> <p>Mitigated: <input type="radio"/> YES <input checked="" type="radio"/> NO</p>	1	JOB	\$1,500	\$1,500
-----	---	--	---	-----	---------	---------

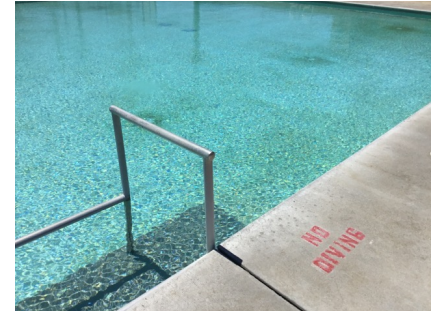
296	<ul style="list-style-type: none"> As-Built Description: Where landings are required, at least one landing shall be located 24" min and 30" max below the stationary water level. Proposed Solution: Provide complaint submerged depth level landing when constructing new sloped entry ramp. Notes: 	<p>PCODE GJ02NT ADAAG 91 pending ADA 2010 1009.3</p> <p>CBC 2019 11B-1009.3</p> <p>Mitigated: <input type="radio"/> YES <input checked="" type="radio"/> NO</p>	1	LF	\$294	\$294
-----	--	--	---	----	-------	-------

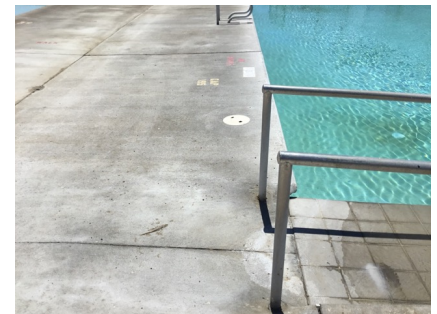
293	<ul style="list-style-type: none"> As-Built Description: Ramp handrail does not extend horizontally 12" past top of ramp. Proposed Solution: Provide ramp handrail extension (cost for each extension piece). 	<p>PCODE ED05 ADAAG 91 4.8.5(2) ADA 2010 505.10.1</p> <p>CBC 2007 1133B.4.2.2 & 1133B.5.5.1 CBC 2019 11B-505.10.1, 11B-1009.3.3</p> <p>Mitigated: <input type="radio"/> YES <input checked="" type="radio"/> NO</p>	2	JOB	\$510	\$1,020
-----	---	--	---	-----	-------	---------

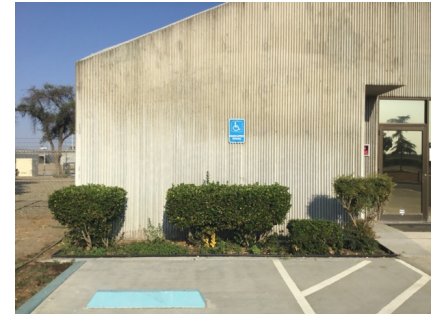
- 783
- *As-Built Description:*
Sign for accessible parking space is missing or non-compliant.
 - *Proposed Solution:*
Provide compliant parking signage.

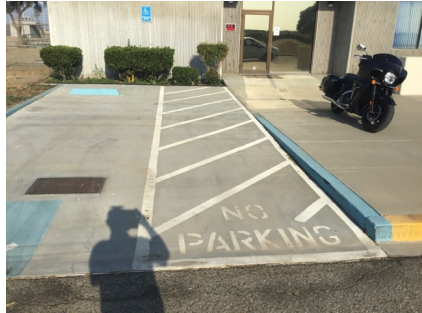
Item no., Rm no. and Name	Existing Architectural Barrier and Proposed Solution	Codes / Mitigation Info	Qty	Unit	Cost	Total
782	<ul style="list-style-type: none"> As-Built Description: An accessible parking space shall be outlined or painted blue (required in CA only). Proposed Solution: Identify accessible parking space using blue markings. 	PCODE EA04K CBC 2019 11B-502.6 Mitigated: <input type="radio"/> YES <input checked="" type="radio"/> NO	1	JOB	\$360	\$360

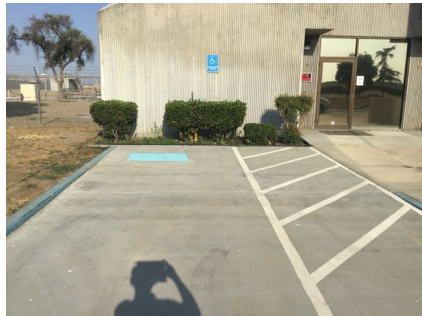
<input type="radio"/> Staff Only			
			Priority <input checked="" type="radio"/> 1			
			Severity <input checked="" type="radio"/> 3			
786	<ul style="list-style-type: none"> As-Built Description: No van parking provided (one in every 6 or fraction of 6 accessible spaces, but not less than one). Proposed Solution: Provide van parking space(s) by restriping; provide van sign. 	PCODE EA07 ADAAG 91 4.1.2(5)(b) ADA 2010 208.2; 502.1 CBC 2007 1129B.3.2 CBC 2019 11B-208.2.4 Mitigated: <input type="radio"/> YES <input checked="" type="radio"/> NO	1	JOB	\$1,050	\$1,050

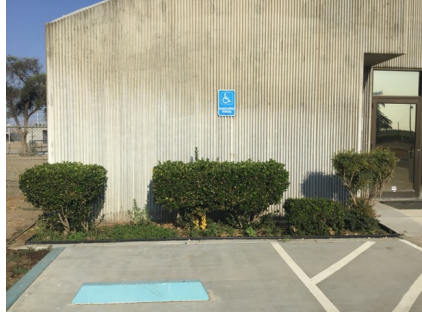
Parking Signage

784	<ul style="list-style-type: none"> <i>As-Built Description:</i> No "Tow Away" sign at parking lot entrance (required in CA only). <i>Proposed Solution:</i> Provide "Tow Away" sign at parking lot entrance when altering area. 	<p>PCODE EA04C</p> <p>CBC 2007 1129B.4</p> <p>CBC 2019 11B-502.8.2</p> <p>Mitigated:</p> <p><input type="radio"/> YES</p> <p><input checked="" type="radio"/> NO</p>	1	JOB	\$975	\$975

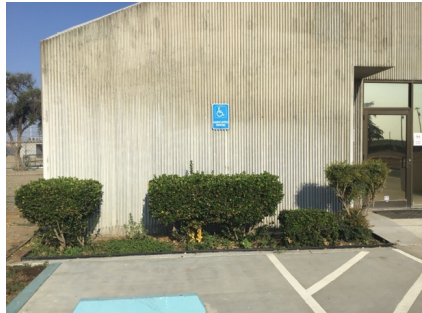
785	<ul style="list-style-type: none"> <i>As-Built Description:</i> CA only: Additional Sign or additional language below the symbol of accessibility stating "Minimum Fine \$250" not provided. <i>Proposed Solution:</i> Provide compliant parking signage that includes fine information. 	<p>PCODE EA04G</p> <p>CBC 2007 1129B.4</p> <p>CBC 2019 11B-502.6.2</p> <p>Mitigated:</p> <p><input type="radio"/> YES</p> <p><input checked="" type="radio"/> NO</p>	1	JOB	\$300	\$300

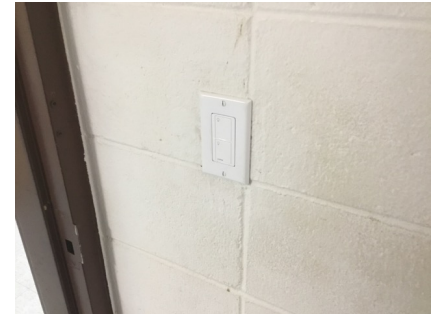
Electrical

826	<ul style="list-style-type: none"> <i>As-Built Description:</i> Electric switch or control mounted less than 15" measured to the bottom of the outlet box or greater than 48 inches measured to the top of the outlet box. <i>As-Built:</i> 50.5" high <i>Proposed Solution:</i> Relocate light switches or control to between 15" and 48" height. <i>Notes:</i> 	<p>PCODE IC01 ADAAG 91 4.2.5 & 6 ADA 2010 308.2.1 & 308.2.2 CBC 2007 1117B.6.3 CBC 2019 11B-308.2.1 & 11B-308.2.2</p> <p>Mitigated: <input type="radio"/> YES <input checked="" type="radio"/> NO</p>	50	JOB	\$900	\$45,000
-----	---	--	----	-----	-------	----------

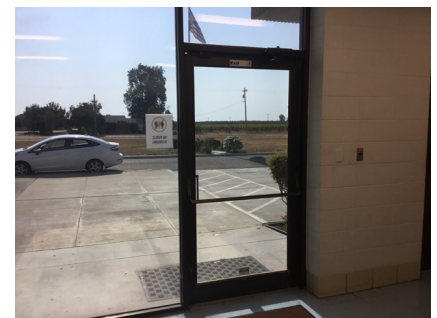
Signage

827	<ul style="list-style-type: none"> <i>As-Built Description:</i> At final exit door to exterior: Where required exit signs are installed, signs to provide exiting information for people with vision impairment are not provided. <i>Proposed Solution:</i> Provide raised letter/Braille "EXIT" sign at door. 	<p>PCODE SA10A ADAAG 91 4.1.3(16) ADA 2010 216.4.1 CBC 2007 1011.3 CBC 2019 11B-216.4.1</p> <p>Mitigated: <input type="radio"/> YES <input checked="" type="radio"/> NO</p>	20	JOB	\$270	\$5,400
-----	--	--	----	-----	-------	---------

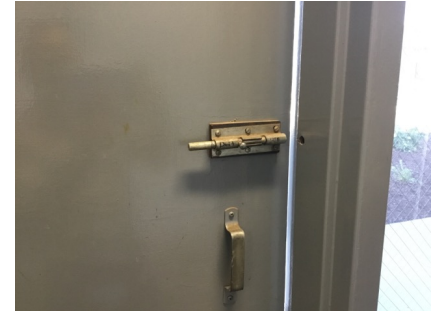
799	<ul style="list-style-type: none"> As-Built Description: Door lock, latch or handle less than 34" or more than 48" above the floor (CA only: 34" to 44"). As-Built: 56.0" high Proposed Solution: Relocate or replace existing hardware. Notes: 	PCODE ID17 ADAAG 91 4.13.9 ADA 2010 404.2.7 CBC 2007 1133B.2.5.2 CBC 2019 11B-404.2.7	1	JOB	\$900	\$900
-----	--	---	---	-----	-------	-------

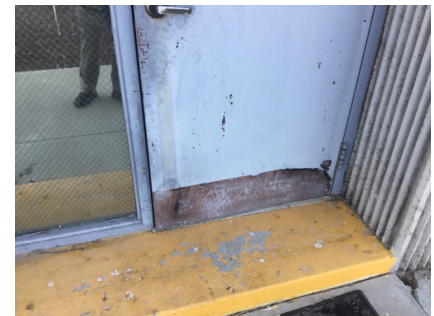
Door Threshold

800	<ul style="list-style-type: none"> As-Built Description: Door inaccessible due to threshold or step at door exceeding 1/2". As-Built: 0.6" Proposed Solution: Modify threshold to be no more than 1/2" by removing existing paving at door and providing landing with edge ramping (slope 1:20 max). 	PCODE ID02A ADAAG 91 4.13.8 ADA 2010 404.2.5 CBC 2007 1133B.2.4.1 CBC 2019 11B-404.2.5	1	JOB	\$1,200	\$1,200
-----	--	--	---	-----	---------	---------

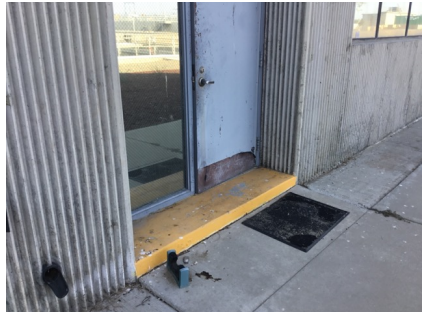
Item no., Rm no. and Name	Existing Architectural Barrier and Proposed Solution	Codes / Mitigation Info	Qty	Unit	Cost	Total
801	<ul style="list-style-type: none"> As-Built Description: Door inaccessible due to threshold or step at door exceeding 1/2". As-Built: 4.5" Proposed Solution: Modify threshold to be no more than 1/2" by removing existing paving at door and providing landing with edge ramping (slope 1:20 max). 	PCODE ID02A ADAAG 91 4.13.8 ADA 2010 404.2.5 CBC 2007 1133B.2.4.1 CBC 2019 11B-404.2.5 Mitigated: <input type="radio"/> YES <input checked="" type="radio"/> NO	1	JOB	\$1,200	\$1,200

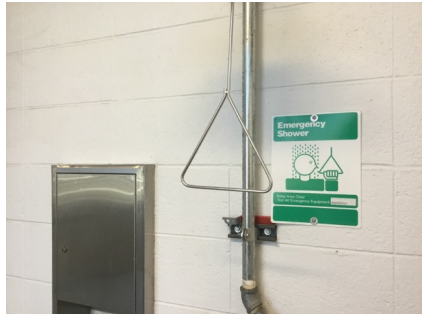
795	<ul style="list-style-type: none"> As-Built Description: Reach height to control or access point, where side approach is available, exceeds 48" or is less than 15" in height, or exceeds 10" in depth. As-Built: 62.0" high Proposed Solution: Add additional shore pull. 	PCODE IE02 ADAAG 91 4.2.6 ADA 2010 308.3.1 CBC 2007 1118B.6 CBC 2019 11B-308.3 Mitigated: <input type="radio"/> YES <input checked="" type="radio"/> NO	1	JOB	\$300	\$300

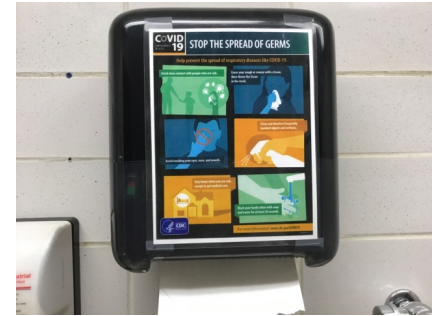
<p>804</p> <ul style="list-style-type: none"> As-Built Description: Dispensers in sanitary facilities, such as for towels, soap, sanitary napkins, seat covers, etc., and waste receptacles more than 48" (CA only: 40") from floor to highest operating slot or control. As-Built: PTD: 60.0" high Proposed Solution: Relocate existing restroom accessories. 	<p>PCODE WG01A ADAAG 91 4.23.7 ADA 2010 308.2.1 CBC 2007 1115B.8.3 CBC 2019 11B-603.5</p>	<p>1 JOB \$300 \$300</p>
--	---	---------------------------------

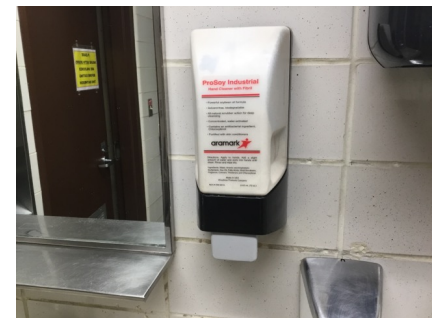
<p>805</p> <ul style="list-style-type: none"> As-Built Description: Dispensers in sanitary facilities, such as for towels, soap, sanitary napkins, seat covers, etc., and waste receptacles more than 48" (CA only: 40") from floor to highest operating slot or control. As-Built: SD: 50.0" high Proposed Solution: Relocate existing restroom accessories. 	<p>PCODE WG01A ADAAG 91 4.23.7 ADA 2010 308.2.1 CBC 2007 1115B.8.3 CBC 2019 11B-603.5</p>	<p>1 JOB \$300 \$300</p>
---	---	---------------------------------

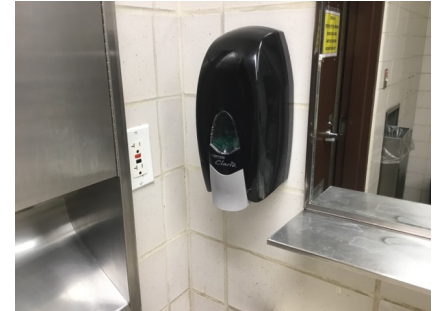
806	<ul style="list-style-type: none"> As-Built Description: Dispensers in sanitary facilities, such as for towels, soap, sanitary napkins, seat covers, etc., and waste receptacles more than 48" (CA only: 40") from floor to highest operating slot or control. As-Built: SD: 48.0" high Proposed Solution: Relocate existing restroom accessories. Notes: 	PCODE WG01A ADAAG 91 4.23.7 ADA 2010 308.2.1 CBC 2007 1115B.8.3 CBC 2019 11B-603.5	1	JOB	\$300	\$300
-----	--	--	---	-----	-------	-------

If 48" maximum AFF, this element complies with 1991 ADAAG and the 2010 ADAS. If 54" maximum AFF side reach, this element complies with Safe Harbor if constructed or altered before March 15, 2012. This element does not comply with the dimensional requirements in the 1981 to the current CBC.

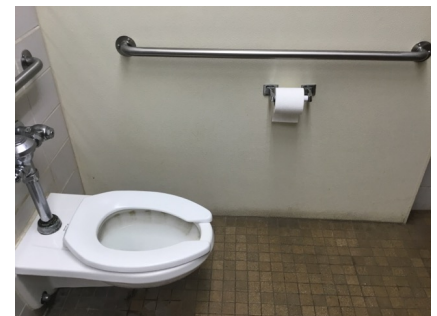
812	<ul style="list-style-type: none"> As-Built Description: Toilet paper dispenser less than 15" (CA: 19") or more than 48" above floor or not within 7" to 9" from front of water closet (Note: CA pre-2010 is allowed within 12" from front of water closet). As-Built: 11.0" in front. Proposed Solution: Relocate or provide new toilet paper dispenser. 	PCODE WG02 ADAAG 91 4.16.6 ADA 2010 604.7 CBC 2007 1115B.8.4 CBC 2019 11B-604.7	1	JOB	\$225	\$225
-----	---	---	---	-----	-------	-------

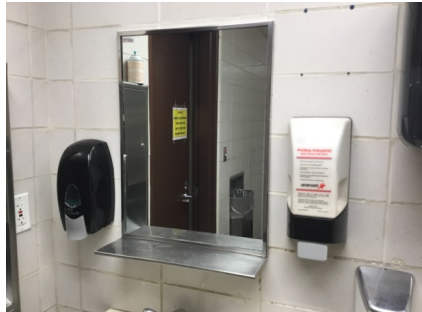
Item no., Rm no. and Name	Existing Architectural Barrier and Proposed Solution	Codes / Mitigation Info	Qty	Unit	Cost	Total
810	<ul style="list-style-type: none"> As-Built Description: Bottom of mirror located above lavatories or countertops more than 40" above floor. As-Built: 47.5" high Proposed Solution: Relocate or provide new accessible mirror. 	PCODE WG03 ADAAG 91 4.19.6 ADA 2010 603.3 CBC 2007 1115B.8.1 CBC 2019 11B-603.3 Mitigated: <input type="radio"/> YES <input checked="" type="radio"/> NO	1	JOB	\$450	\$450

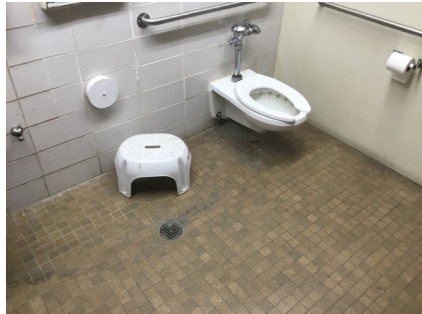
798	<ul style="list-style-type: none"> As-Built Description: Clear space has slopes greater than 1:48. Proposed Solution: Modify surface and/or adjust drain. Notes: 	PCODE NI07 ADAAG 91 16.6.6 ADA 2010 305.2 CBC 2007 1132B.1 CBC 2019 11B-305.2 Mitigated: <input type="radio"/> YES <input checked="" type="radio"/> NO	1	SF	\$1,500	\$1,500

3.9% slope within WC clear space.

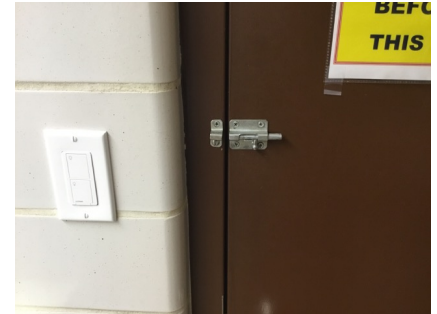
- 813
- *As-Built Description:*
Door lock, latch or handle less than 34" or more than 48" above the floor (CA only: 34" to 44").
 - *As-Built:* **52.0" high**
 - *Proposed Solution:*
Relocate or replace existing hardware.

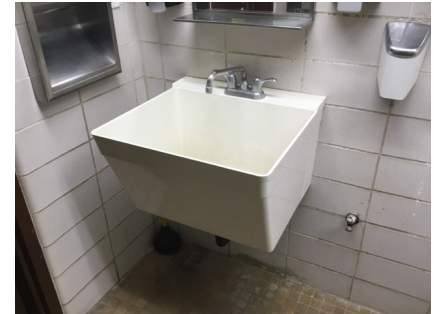
808	<ul style="list-style-type: none"> As-Built Description: Lavatory: Fixture rim or counter height more than 34" above floor. As-Built: 36.5" high Proposed Solution: Provide new accessible lavatory. Remodel restroom as needed. 	PCODE WD02 ADAAG 91 4.19.2 ADA 2010 606.3 CBC 2007 1115B.4.3 CBC 2019 11B-606.3	1	JOB	\$3,600	\$3,600
-----	--	--	---	-----	---------	---------

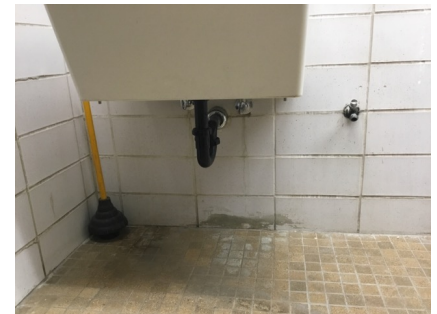
809	<ul style="list-style-type: none"> As-Built Description: Hot or sharp-surfaced water/drain pipe not insulated or covered. Proposed Solution: Insulate or cover water/drain pipe. 	PCODE WD05 ADAAG 91 4.19.4 ADA 2010 606.5 CBC 2007 1115B.4.3.4 CBC 2019 11B-606.5	1	JOB	\$360	\$360
-----	--	--	---	-----	-------	-------

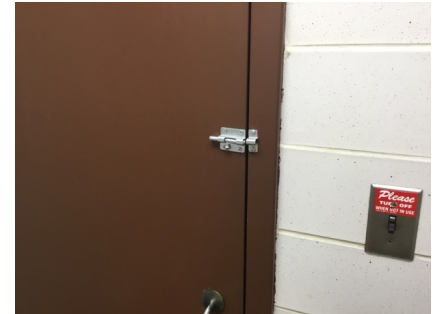
- 832
- *As-Built Description:*
Door lock, latch or handle less than 34" or more than 48" above the floor (CA only: 34" to 44").
 - *As-Built:* **54.0" high**
 - *Proposed Solution:*
Relocate or replace existing hardware.

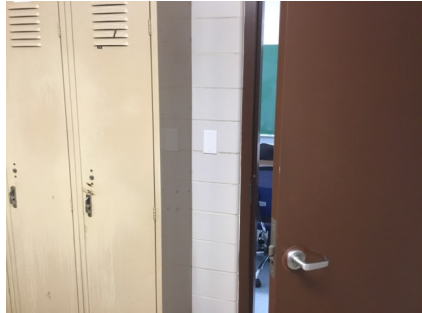
Item no., Rm no. and Name	Existing Architectural Barrier and Proposed Solution	Codes / Mitigation Info	Qty	Unit	Cost	Total
817	<ul style="list-style-type: none"> As-Built Description: Front approach: At pull side, door does not have clear and level maneuvering space measuring door width plus 18" x 60". (24" x 60" at exterior doors). As-Built: 11.5" Proposed Solution: Remove or relocate locker. 	PCODE ID23A ADAAG 91 Fig. 25(a) ADA 2010 404.2.4 CBC 2007 11B-26A(a) CBC 2019 11B-404.2.4 Mitigated: <input type="radio"/> YES <input checked="" type="radio"/> NO	1	JOB	\$1,500	\$1,500

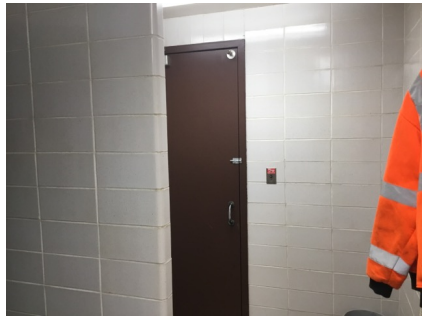
<input checked="" type="checkbox"/> Staff Only			
			Priority <input checked="" type="radio"/> 3			
			Severity <input checked="" type="radio"/> 3			
831	<ul style="list-style-type: none"> As-Built Description: Latch approach: At pull side, door does not have clear and level maneuvering space measuring door width plus 24" x 48" or 54" if door has closer (CA only: door width plus 24" x 60"). As-Built: 47.0" with closer. Proposed Solution: Remove/relocate wall. 	PCODE ID27 ADAAG 91 Fig. 25(c) ADA 2010 404.2.4 CBC 2007 11B-26A(c) CBC 2019 11B-404.2.4 Mitigated: <input type="radio"/> YES <input checked="" type="radio"/> NO	1	JOB	\$1,500	\$1,500

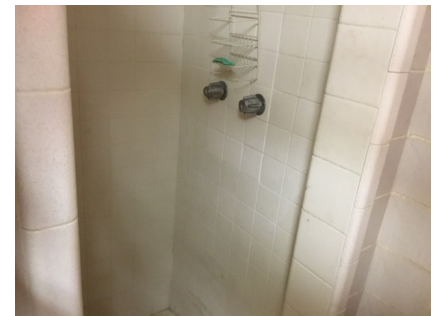
- 815
- *As-Built Description:*
Shower not accessible; multiple compliance violations.
 - *As-Built:* **34.0” long x 33.0” wide**
 - *Proposed Solution:*
Provide accessible shower.

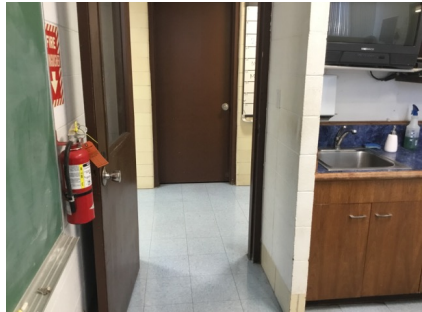
Item no., Rm no. and Name	Existing Architectural Barrier and Proposed Solution	Codes / Mitigation Info	Qty	Unit	Cost	Total
823	<ul style="list-style-type: none"> • <i>As-Built Description:</i> Front approach: At pull side, door does not have clear and level maneuvering space measuring door width plus 18" x 60". (24" x 60" at exterior doors). • <i>As-Built:</i> 2.0" • <i>Proposed Solution:</i> Provide relocated new door and frame; remodel walls as needed. 	PCODE ID23B ADAAG 91 Fig. 25(a) ADA 2010 404.2.4 CBC 2007 11B-26A(a) CBC 2019 11B-404.2.4 Mitigated: <input type="radio"/> YES <input checked="" type="radio"/> NO	1	JOB	\$7,800	\$7,800

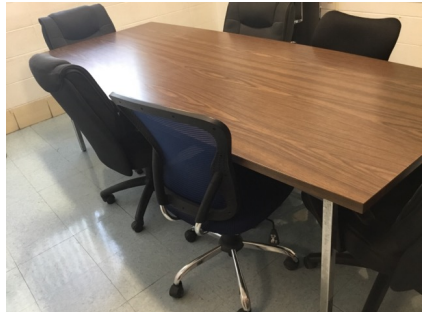
820	<ul style="list-style-type: none"> • <i>As-Built Description:</i> Accessible non-fixed table or desk (top 28" to 34" high; knee space at least 27" high x 19" deep x 30" wide) not provided. • <i>As-Built:</i> 26.0" knee high • <i>Proposed Solution:</i> Provide table or desk with accessible dimensions when purchasing new furniture. 	PCODE IN02A ADAAG 91 4.32.3 & .4 ADA 2010 306.1 CBC 2007 1122B.3 & 4 CBC 2019 11B-306.1 & 11B-902.3 Mitigated: <input type="radio"/> YES <input checked="" type="radio"/> NO	1	JOB	\$4,800	\$4,800

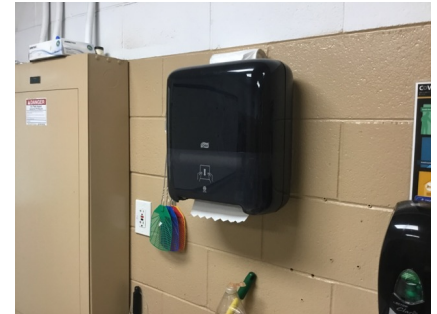
839	<ul style="list-style-type: none"> As-Built Description: Reach height to control or access point, where side approach is available, exceeds 48" or is less than 15" in height, or exceeds 10" in depth. As-Built: PTD: 57.0" high Proposed Solution: Modify equipment or mounting. 	<p>PCODE IE02 ADAAG 91 4.2.6 ADA 2010 308.3.1 CBC 2007 1118B.6 CBC 2019 11B-308.3</p> <p>Mitigated: <input type="radio"/> YES <input checked="" type="radio"/> NO</p>	1	JOB	\$300	\$300
-----	--	--	---	-----	-------	-------

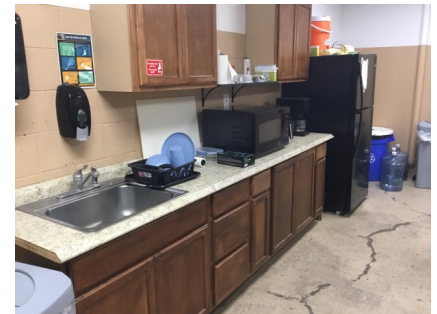
840	<ul style="list-style-type: none"> As-Built Description: Reach height to control or access point, where side approach is available, exceeds 48" or is less than 15" in height, or exceeds 10" in depth. As-Built: 35.5" high obstruction Proposed Solution: Modify equipment or mounting. 	<p>PCODE IE02 ADAAG 91 4.2.6 ADA 2010 308.3.1 CBC 2007 1118B.6 CBC 2019 11B-308.3</p> <p>Mitigated: <input type="radio"/> YES <input checked="" type="radio"/> NO</p>	1	JOB	\$300	\$300
-----	---	--	---	-----	-------	-------

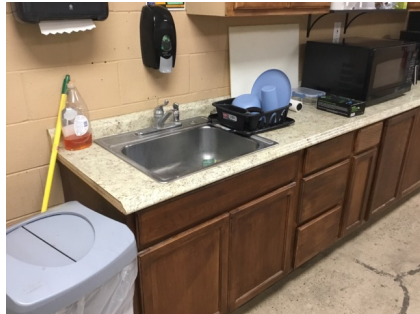
Item no., Rm no. and Name	Existing Architectural Barrier and Proposed Solution	Codes / Mitigation Info	Qty	Unit	Cost	Total
838	<p>Sink</p> <ul style="list-style-type: none"> As-Built Description: Sink rim higher than 34" above floor. As-Built: 35.5" high Proposed Solution: Remodel sink cabinet to lower sink. 	<p>PCODE IN06 ADAAG 91 4.24.2 ADA 2010 606.3 CBC 2007 1115B.4.7.1 CBC 2019 11B-606.3</p> <p>Mitigated: <input type="radio"/> YES <input checked="" type="radio"/> NO</p>	1	JOB	\$5,250	\$5,250

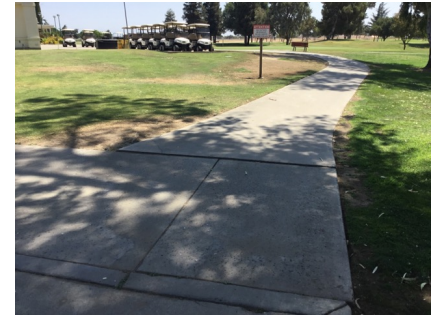
- 1164
- *As-Built Description:*
Walk: Pavement dislocation creates abrupt change in level exceeding 1/2" in accessible route.
 - *As-Built:* **1.0"**
 - *Proposed Solution:*
Remove, replace or repair area of pavement sufficient to correct abrupt change in level.

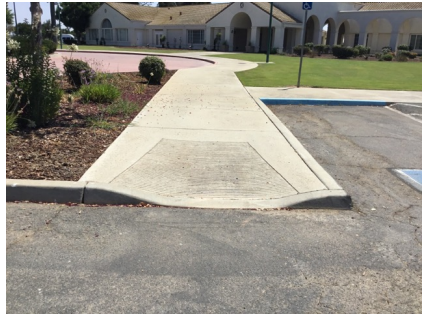
Item no., Rm no. and Name	Existing Architectural Barrier and Proposed Solution	Codes / Mitigation Info	Qty	Unit	Cost	Total
1167	<ul style="list-style-type: none"> As-Built Description: Less than 48" level space at top and 1:12 flared sides not provided. As-Built: 36.0" Proposed Solution: Demolish existing and provide new curb ramp. Notes: 	PCODE EH05B ADAAG 91 4.7.5; Fig.12(a) ADA 2010 406.4 CBC 2007 1127B.5.4 CBC 2019 11B-406.5.3 Mitigated: <input type="radio"/> YES <input checked="" type="radio"/> NO	1	JOB	\$7,500	\$7,500

No domes. 0.75" level change. 25.0% flares.

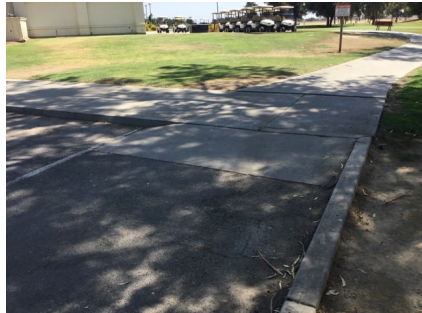
Detectable Warning

1163	<ul style="list-style-type: none"> As-Built Description: 36" wide band of truncated domes not provided at walkway or crossing adjoining a vehicular way, if surfaces are not separated by a curb, railing, or other element. Proposed Solution: Provide 36" wide, contrasting color, band of truncated domes between pedestrian and vehicular area. 	PCODE EG09 ADAAG 91 4.29.5 CBC 2007 1133B.8.5 CBC 2019 11B-705.1.2.5 Mitigated: <input type="radio"/> YES <input checked="" type="radio"/> NO	10	LF	\$81	\$810

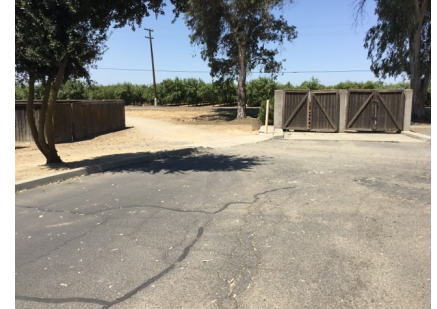
1165	<ul style="list-style-type: none"> As-Built Description: 36" wide band of truncated domes not provided at walkway or crossing adjoining a vehicular way, if surfaces are not separated by a curb, railing, or other element. Proposed Solution: Provide 36" wide, contrasting color, band of truncated domes between pedestrian and vehicular area. Notes: 	PCODE EG09 ADAAG 91 4.29.5 CBC 2007 1133B.8.5 CBC 2019 11B-705.1.2.5 Mitigated: <input type="radio"/> YES <input checked="" type="radio"/> NO	10	LF	\$81	\$810
------	--	--	----	----	------	--------------

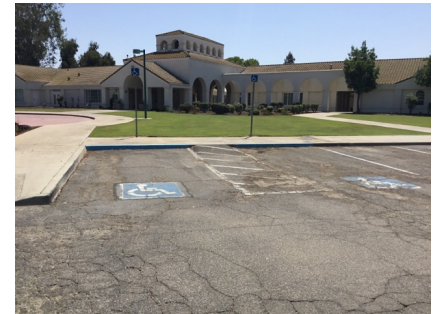
Floor or Ground Surfaces

1159	<ul style="list-style-type: none"> As-Built Description: Accessible parking space has slope greater than 1/4":12" (2%). Proposed Solution: Modify slope at accessible parking space. Notes: 	PCODE EA05 ADAAG 91 4.6.3 ADA 2010 502.4 CBC 2007 1129B.3.3 CBC 2019 11B-502.4 Mitigated: <input type="radio"/> YES <input checked="" type="radio"/> NO	144	SF	\$36	\$5,184
------	---	---	-----	----	------	----------------

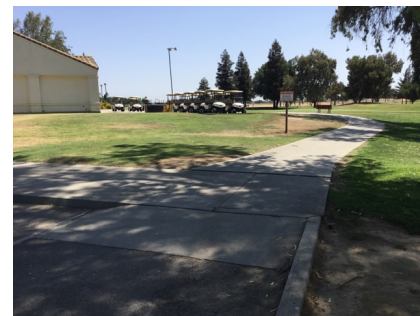
- 1162 • *As-Built Description:*
Exterior signage at inaccessible entrances to provide direction to accessible entrances is missing or noncompliant.
- *As-Built:* **Cross slopes at 6.0%**
- *Proposed Solution:*
Provide signage sufficient to guide persons to accessible entrances.
- *Notes:*

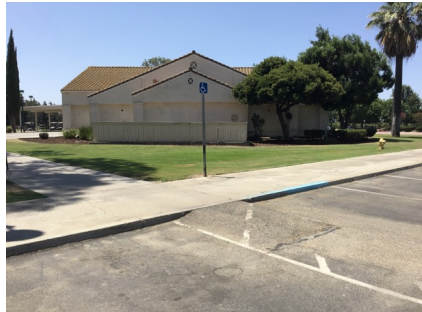
Item no., Rm no. and Name	Existing Architectural Barrier and Proposed Solution	Codes / Mitigation Info	Qty	Unit	Cost	Total
1173	<ul style="list-style-type: none"> As-Built Description: CA only: Additional Sign or additional language below the symbol of accessibility stating "Minimum Fine \$250" not provided. Proposed Solution: Provide compliant parking signage that includes fine information. 	PCODE EA04G CBC 2007 1129B.4 CBC 2019 11B-502.6.2 Mitigated: <input type="radio"/> YES <input checked="" type="radio"/> NO	1	JOB	\$300	\$300

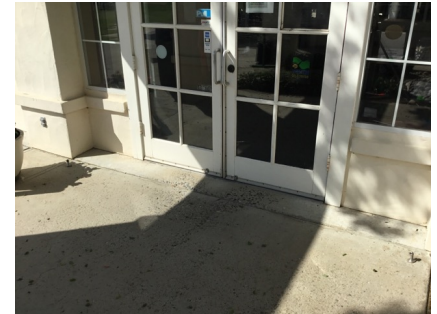
- 1074
- *As-Built Description:*
Walk: Pavement dislocation creates abrupt change in level exceeding 1/2" in accessible route.
 - *As-Built:* **1.5"**
 - *Proposed Solution:*
Remove, replace or repair area of pavement sufficient to correct abrupt change in level.

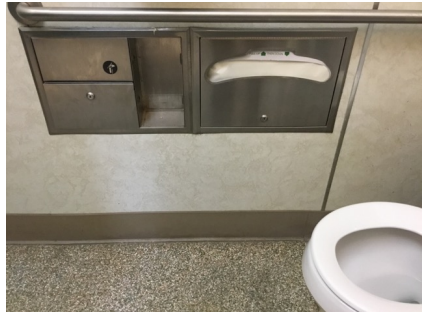
Item no., Rm no. and Name	Existing Architectural Barrier and Proposed Solution	Codes / Mitigation Info	Qty	Unit	Cost	Total
1093	<ul style="list-style-type: none"> As-Built Description: Toilet paper dispenser less than 15" (CA: 19") or more than 48" above floor or not within 7" to 9" from front of water closet (Note: CA pre-2010 is allowed within 12" from front of water closet). As-Built: 14.0" in front. Proposed Solution: Relocate or provide new toilet paper dispenser. 	PCODE WG02 ADAAG 91 4.16.6 ADA 2010 604.7 CBC 2007 1115B.8.4 CBC 2019 11B-604.7 Mitigated: <input type="radio"/> YES <input checked="" type="radio"/> NO	1	JOB	\$225	\$225

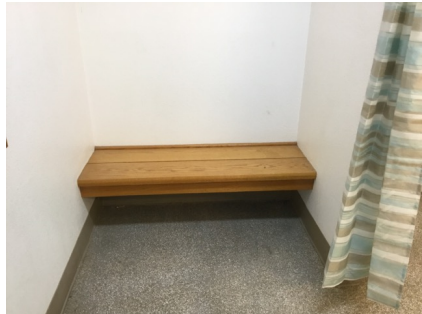
Bench

1080	<ul style="list-style-type: none"> As-Built Description: Clear floor space to allow parallel transfer onto bench not provided. Proposed Solution: Remodel dressing room to provide 30" x 48" alongside bench. 	PCODE RE04B ADAAG 91 4.35.4 ADA 2010 803.4 CBC 2007 1117B.8 CBC 2019 11B-803.4 Mitigated: <input type="radio"/> YES <input checked="" type="radio"/> NO	1	JOB	\$4,500	\$4,500

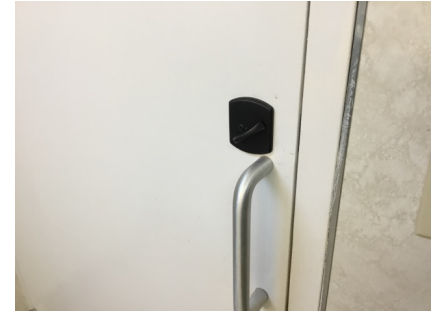
1094	<ul style="list-style-type: none"> • <i>As-Built Description:</i> Door lock, latch or handle less than 34" or more than 48" above the floor (CA only: 34" to 44"). • <i>As-Built:</i> 48.0" high • <i>Proposed Solution:</i> Relocate or replace existing hardware. • <i>Notes:</i> 	<p>PCODE ID17 ADAAG 91 4.13.9 ADA 2010 404.2.7 CBC 2007 1133B.2.5.2 CBC 2019 11B-404.2.7</p> <p>Mitigated: <input type="radio"/> YES <input checked="" type="radio"/> NO</p>	1	JOB	\$900	\$900
------	--	---	---	-----	-------	--------------

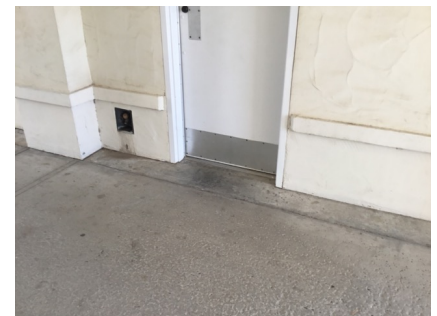
Door Threshold

1079	<ul style="list-style-type: none"> • <i>As-Built Description:</i> Door inaccessible due to threshold or step at door exceeding 1/2". • <i>As-Built:</i> 0.6" • <i>Proposed Solution:</i> Modify threshold. 	<p>PCODE ID02A ADAAG 91 4.13.8 ADA 2010 404.2.5 CBC 2007 1133B.2.4.1 CBC 2019 11B-404.2.5</p> <p>Mitigated: <input type="radio"/> YES <input checked="" type="radio"/> NO</p>	1	JOB	\$1,200	\$1,200
------	--	--	---	-----	---------	----------------

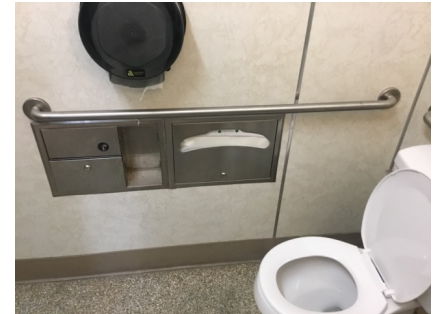
Grab Bars

1090	<ul style="list-style-type: none"> As-Built Description: Side grab bar less than 42" long, or located more than 12 inches max. from the rear wall, or extending less than 54" from rear wall (CA only: front end min. 24" in front of water closet). As-Built: Extends 52.5" Proposed Solution: Provide or relocate accessible side grab bar. 	<p>PCODE WB07A ADAAG 91 Fig. 29(b) ADA 2010 604.5.1 CBC 2007 1115B.4.1.3.1 CBC 2019 11B-604.5.1</p>	1	JOB	\$780	\$780
------	---	---	---	-----	-------	-------

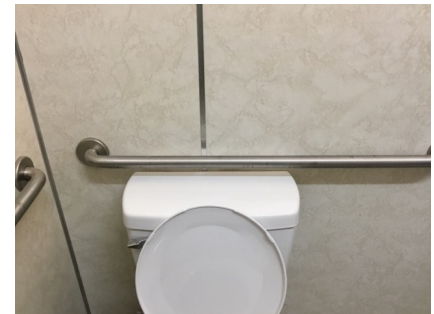
1091	<ul style="list-style-type: none"> As-Built Description: Accessories/dispensers in accessible stall located closer than 1-1/2" below or 12" above grab bar impedes its use. As-Built: 1.3" Proposed Solution: Raise the grab bar. 	<p>PCODE WB07I ADAAG 91 4.26.2 ADA 2010 609.3 CBC 2007 1133B.4.2.5 CBC 2019 11B-609.3</p>	1	JOB	\$225	\$225
------	---	---	---	-----	-------	-------

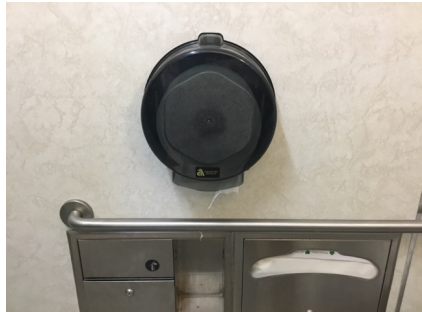
Item no., Rm no. and Name	Existing Architectural Barrier and Proposed Solution	Codes / Mitigation Info	Qty	Unit	Cost	Total
1092	<ul style="list-style-type: none"> As-Built Description: Accessories/dispensers in accessible stall located closer than 1-1/2" below or 12" above grab bar impedes its use. As-Built: TPD: 5.0" above grab bar Proposed Solution: Relocate accessories/dispensers within applicable reach range and to be no closer than 1-1/2" below and 12" above grab bars (except if accessories are recessed, flush with wall, and have no sharp edges). 	PCODE WB07I ADAAG 91 4.26.2 ADA 2010 609.3 CBC 2007 1133B.4.2.5 CBC 2019 11B-609.3 Mitigated: <input type="radio"/> YES <input checked="" type="radio"/> NO	1	JOB	\$225	\$225

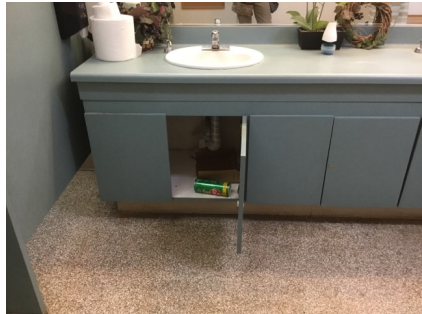
Lavatory

1083	<ul style="list-style-type: none"> As-Built Description: Lavatory: Fixture rim or counter height more than 34" above floor. As-Built: 35" high Proposed Solution: Provide new accessible lavatory. Remodel restroom as needed. Notes: 	PCODE WD02 ADAAG 91 4.19.2 ADA 2010 606.3 CBC 2007 1115B.4.3 CBC 2019 11B-606.3 Mitigated: <input type="radio"/> YES <input checked="" type="radio"/> NO	1	JOB	\$10,200	\$10,200

No knee clearance.

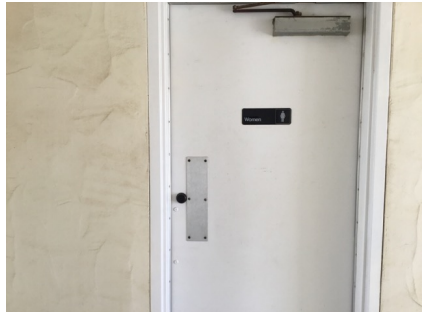
Item no., Rm no. and Name	Existing Architectural Barrier and Proposed Solution	Codes / Mitigation Info	Qty	Unit	Cost	Total
1096	<ul style="list-style-type: none"> As-Built Description: Required in CA only: identification symbol centered 58" to 60" high on sanitary facility door that contrasts with the door not provided (women: 12" ø circle, men: 12" triangle, unisex: combined symbol). Proposed Solution: Provide properly mounted sanitary facility symbol when altering area. If wheelchair accessible, include International Symbol of Accessibility on sign. 	PCODE SA15 CBC 2007 1115B.6 CBC 2019 11B-703.7.2.6 Mitigated: <input type="radio"/> YES <input checked="" type="radio"/> NO	1	JOB	\$270	\$270

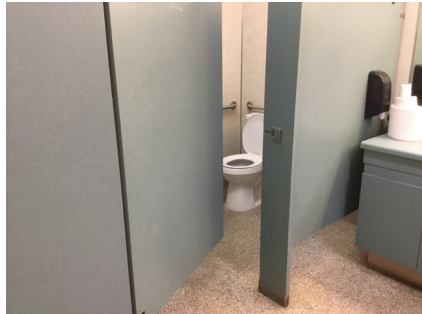
Stall Door

1085	<ul style="list-style-type: none"> As-Built Description: Stall door to accessible compartment not self closing. Proposed Solution: Adjust closer. 	PCODE WB05B ADAAG 91 4.22.4 ADA 2010 604.8.1.2 CBC 2007 1115B.3.1.4.4 CBC 2019 11B-604.8.1.2 Mitigated: <input type="radio"/> YES <input checked="" type="radio"/> NO	1	JOB	\$75	\$75

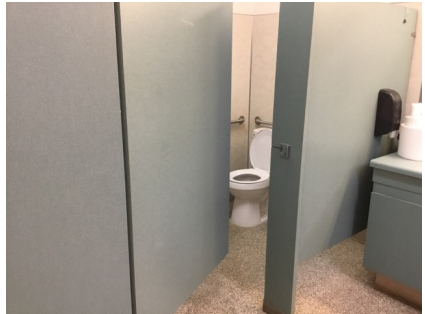
Item no., Rm no. and Name	Existing Architectural Barrier and Proposed Solution	Codes / Mitigation Info	Qty	Unit	Cost	Total
1086	<ul style="list-style-type: none"> As-Built Description: Stall door does not have accessible operating hardware (U-pulls on both sides, flip-over or sliding lock). Proposed Solution: Provide new accessible locking hardware that does not require grasping, pinching, or twisting and U-pulls on both sides. 	PCODE WB05C ADAAG 91 4.17.5 ADA 2010 604.8.1.2 CBC 2007 1115B.3.1.4.5 CBC 2019 11B-604.8.1.2 Mitigated: <input type="radio"/> YES <input checked="" type="radio"/> NO	1	JOB	\$300	\$300

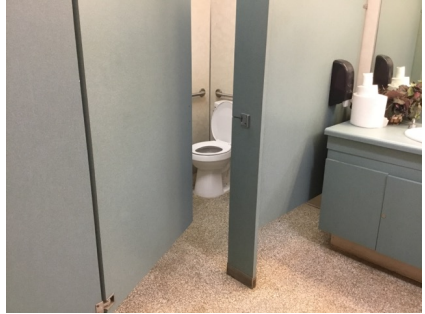
Toilet Stall

1084	<ul style="list-style-type: none"> As-Built Description: Less than 59" from back wall to front wall or door swing of toilet stall, or less than 56" if water closet is wall-hung. As-Built: 49.5" Proposed Solution: Provide new enclosure at existing water closet fixture. 	PCODE WB03 ADAAG 91 4.17.3 ADA 2010 604.8.1.1 CBC 2007 1115B.3.4.3 CBC 2019 11B-604.8.1.1 Mitigated: <input type="radio"/> YES <input checked="" type="radio"/> NO	1	JOB	\$4,500	\$4,500

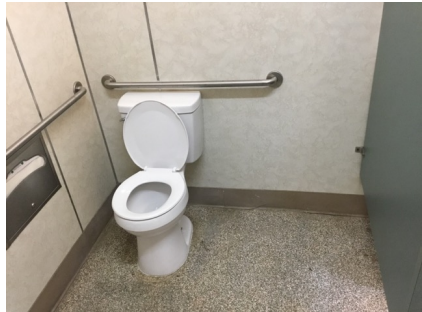
Item no., Rm no. and Name	Existing Architectural Barrier and Proposed Solution	Codes / Mitigation Info	Qty	Unit	Cost	Total
1087	<ul style="list-style-type: none"> As-Built Description: Toilet stall less than 60" wide. As-Built: 55.3" to 59.0" wide Proposed Solution: Provide new accessible stall. 	PCODE WB06 ADAAG 91 4.17.3 ADA 2010 604.8.1.1 CBC 2007 1115B.3.1.4.1 CBC 2019 11B-604.8.1.1 Mitigated: <input type="radio"/> YES <input checked="" type="radio"/> NO	1	JOB	\$4,500	\$4,500

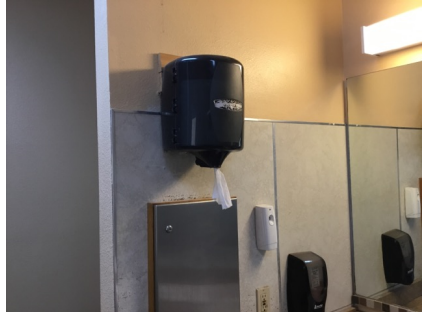
Accessories

1106	<ul style="list-style-type: none"> <i>As-Built Description:</i> Dispensers in sanitary facilities, such as for towels, soap, sanitary napkins, seat covers, etc., and waste receptacles more than 48" (CA only: 40") from floor to highest operating slot or control. <i>As-Built:</i> PTD: 65.0" high <i>Proposed Solution:</i> Relocate existing restroom accessories. 	<p>PCODE WG01A ADAAG 91 4.23.7 ADA 2010 308.2.1 CBC 2007 1115B.8.3 CBC 2019 11B-603.5</p> <p>Mitigated: <input type="radio"/> YES <input checked="" type="radio"/> NO</p>	1	JOB	\$300	\$300
------	--	--	---	-----	-------	--------------

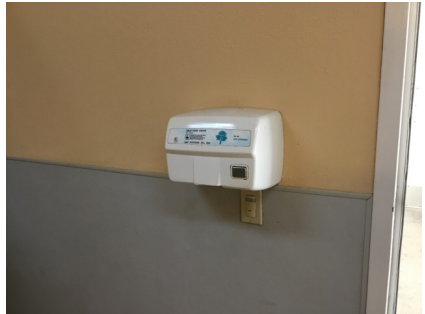
1107	<ul style="list-style-type: none"> <i>As-Built Description:</i> Dispensers in sanitary facilities, such as for towels, soap, sanitary napkins, seat covers, etc., and waste receptacles more than 48" (CA only: 40") from floor to highest operating slot or control. <i>As-Built:</i> Hand dryer: 51.5" high <i>Proposed Solution:</i> Relocate existing restroom accessories. <i>Notes:</i> 	<p>PCODE WG01A ADAAG 91 4.23.7 ADA 2010 308.2.1 CBC 2007 1115B.8.3 CBC 2019 11B-603.5</p> <p>Mitigated: <input type="radio"/> YES <input checked="" type="radio"/> NO</p>	1	JOB	\$300	\$300
------	--	--	---	-----	-------	--------------

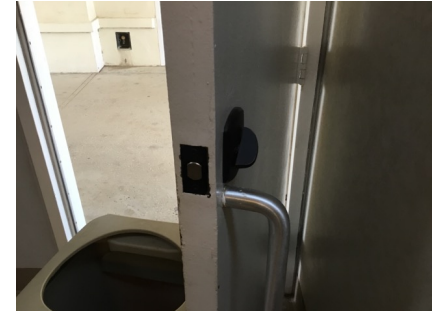
1100	<ul style="list-style-type: none"> As-Built Description: Door lock, latch or handle less than 34" or more than 48" above the floor (CA only: 34" to 44"). As-Built: 48.0" high Proposed Solution: Relocate or replace existing hardware. Notes: 	PCODE ID17 ADAAG 91 4.13.9 ADA 2010 404.2.7 CBC 2007 1133B.2.5.2 CBC 2019 11B-404.2.7	1	JOB	\$900	\$900
------	--	---	---	-----	-------	-------

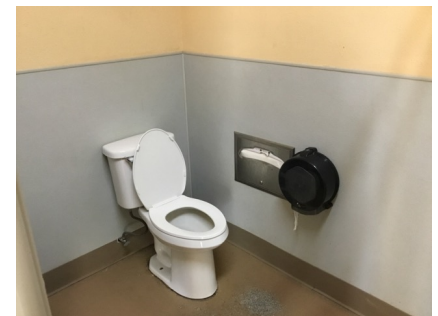
Grab Bars

1113	<ul style="list-style-type: none"> As-Built Description: Grab bars not provided or are not code compliant. Proposed Solution: Provide accessible grab bars. 	PCODE WB07 ADAAG 91 4.17.6 ADA 2010 604.5 CBC 2007 1115B.4.1.3 CBC 2019 11B-604.5	1	JOB	\$1,500	\$1,500
------	---	---	---	-----	---------	---------

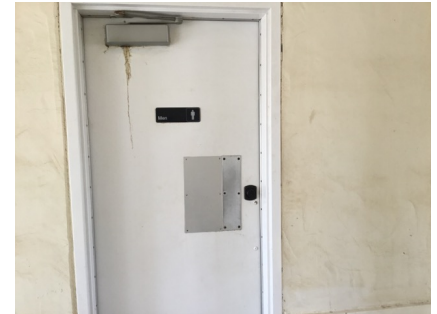
Signage

1097	<ul style="list-style-type: none"> As-Built Description: Entrance to toilet or bathing facility not identified with ADAAG compliant signage. Proposed Solution: Provide ADA compliant sign mounted at 48" min. above to baseline of the lowest Braille cells and 60" max. to baseline of the highest line of raised characters on nearest adjacent wall, on latch side of a single door (located not to cause a Braille reader to stand within the door swing). 	<p>PCODE SA11A ADAAG 91 4.1.3(16)(a) ADA 2010 216.8 CBC 2019 11B-216.8</p> <p>Mitigated: <input type="radio"/> YES <input checked="" type="radio"/> NO</p>	1	JOB	\$270	\$270
------	---	---	---	-----	-------	-------

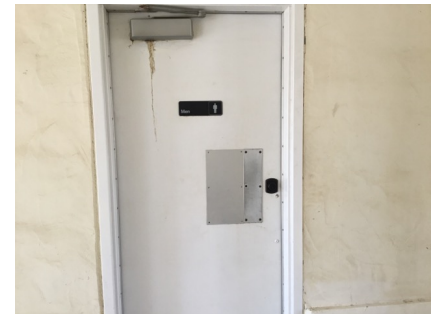
1098	<ul style="list-style-type: none"> As-Built Description: Required in CA only: identification symbol centered 58" to 60" high on sanitary facility door that contrasts with the door not provided (women: 12" ø circle, men: 12" triangle, unisex: combined symbol). Proposed Solution: Provide properly mounted sanitary facility symbol when altering area. If wheelchair accessible, include International Symbol of Accessibility on sign. 	<p>PCODE SA15 CBC 2007 1115B.6 CBC 2019 11B-703.7.2.6</p> <p>Mitigated: <input type="radio"/> YES <input checked="" type="radio"/> NO</p>	1	JOB	\$270	\$270
------	---	--	---	-----	-------	-------

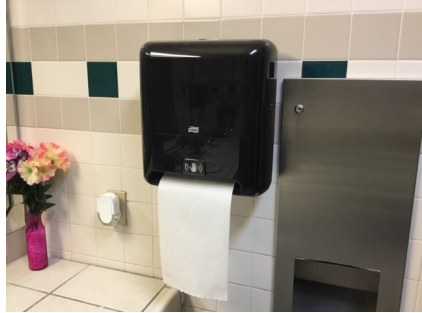
Protrusion Limits

1121	<ul style="list-style-type: none"> <i>As-Built Description:</i> Protruding objects more than 4" from wall, when bottom of object more than 27" or less than 80" above finished floor. <i>As-Built:</i> PTD: 8.0" at 50.0" high <i>Proposed Solution:</i> Remove/relocate protruding object. Patch existing surface. 	<p>PCODE EG04 ADAAG 91 4.4.1 ADA 2010 307.2 CBC 2007 1133B.8.6.1 CBC 2019 11B-307.2</p> <p>Mitigated: <input type="radio"/> YES <input checked="" type="radio"/> NO</p>	1	JOB	\$300	\$300
------	---	--	---	-----	-------	-------

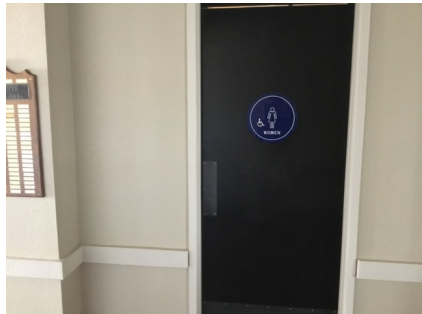
Signage

1116	<ul style="list-style-type: none"> <i>As-Built Description:</i> Entrance to toilet or bathing facility not identified with ADAAG compliant signage. <i>Proposed Solution:</i> Provide ADA compliant sign mounted at 48" min. above to baseline of the lowest Braille cells and 60" max. to baseline of the highest line of raised characters on nearest adjacent wall, on latch side of a single door (located not to cause a Braille reader to stand within the door swing). 	<p>PCODE SA11A ADAAG 91 4.1.3(16)(a) ADA 2010 216.8 CBC 2019 11B-216.8</p> <p>Mitigated: <input type="radio"/> YES <input checked="" type="radio"/> NO</p>	1	JOB	\$270	\$270
------	---	--	---	-----	-------	-------

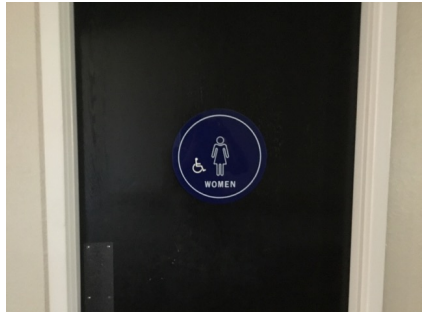
Item no., Rm no. and Name	Existing Architectural Barrier and Proposed Solution	Codes / Mitigation Info	Qty	Unit	Cost	Total
1117	<ul style="list-style-type: none"> <i>As-Built Description:</i> Required in CA only: identification symbol centered 58" to 60" high on sanitary facility door that contrasts with the door not provided (women: 12" ø circle, men: 12" triangle, unisex: combined symbol). <i>As-Built:</i> Not contrast <i>Proposed Solution:</i> Provide properly mounted sanitary facility symbol when altering area. If wheelchair accessible, include International Symbol of Accessibility on sign. 	PCODE SA15 CBC 2007 1115B.6 CBC 2019 11B-703.7.2.6 Mitigated: <input type="radio"/> YES <input checked="" type="radio"/> NO	1	JOB	\$270	\$270

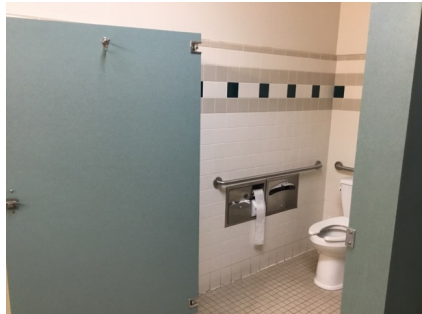
Stall Door

1124	<ul style="list-style-type: none"> <i>As-Built Description:</i> Stall door to accessible compartment not self closing. <i>Proposed Solution:</i> Adjust closer. 	PCODE WB05B ADAAG 91 4.22.4 ADA 2010 604.8.1.2 CBC 2007 1115B.3.1.4.4 CBC 2019 11B-604.8.1.2 Mitigated: <input type="radio"/> YES <input checked="" type="radio"/> NO	1	JOB	\$75	\$75

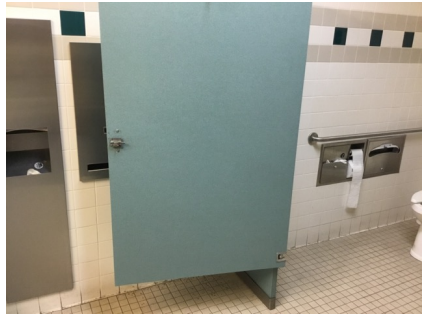
Item no., Rm no. and Name	Existing Architectural Barrier and Proposed Solution	Codes / Mitigation Info	Qty	Unit	Cost	Total
1125	<ul style="list-style-type: none"> As-Built Description: Stall door does not have accessible operating hardware (U-pulls on both sides, flip-over or sliding lock). Proposed Solution: Provide new accessible locking hardware that does not require grasping, pinching, or twisting and U-pulls on both sides. 	PCODE WB05C ADAAG 91 4.17.5 ADA 2010 604.8.1.2 CBC 2007 1115B.3.1.4.5 CBC 2019 11B-604.8.1.2 Mitigated: <input type="radio"/> YES <input checked="" type="radio"/> NO	1	JOB	\$300	\$300

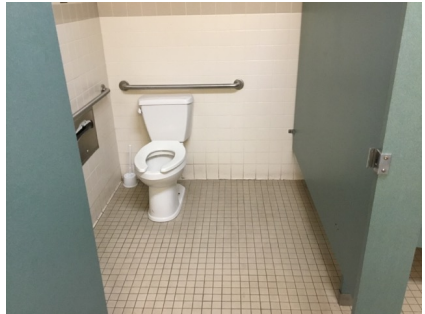
Toilet Stall

1126	<ul style="list-style-type: none"> As-Built Description: Toilet stall less than 60" wide. As-Built: 58.5" wide Proposed Solution: Provide new accessible stall. 	PCODE WB06 ADAAG 91 4.17.3 ADA 2010 604.8.1.1 CBC 2007 1115B.3.1.4.1 CBC 2019 11B-604.8.1.1 Mitigated: <input type="radio"/> YES <input checked="" type="radio"/> NO	1	JOB	\$4,500	\$4,500

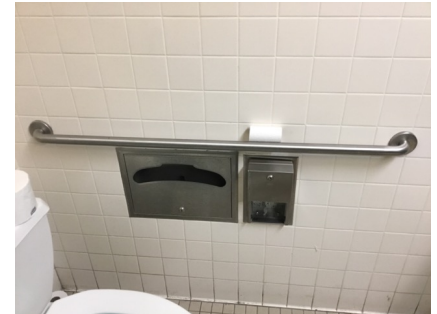
1142	<ul style="list-style-type: none"> <i>As-Built Description:</i> Side grab bar less than 42" long, or located more than 12 inches max. from the rear wall, or extending less than 54" from rear wall (CA only: front end min. 24" in front of water closet). <i>As-Built:</i> Extends 53.5" <i>Proposed Solution:</i> Provide or relocate accessible side grab bar. 	<p>PCODE WB07A ADAAG 91 Fig. 29(b) ADA 2010 604.5.1 CBC 2007 1115B.4.1.3.1 CBC 2019 11B-604.5.1</p> <p>Mitigated: <input type="radio"/> YES <input checked="" type="radio"/> NO</p>	1	JOB	\$780	\$780
------	--	---	---	-----	-------	-------

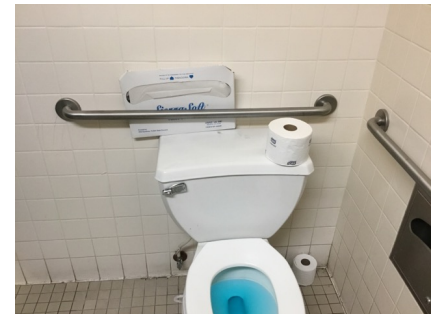
1141	<ul style="list-style-type: none"> <i>As-Built Description:</i> The rear wall grab is less than 36" min. or does not extend from the centerline of the water closet 12" min. on one side and 24" min. on the other side. <i>As-Built:</i> Extends 22.25" on wide side <i>Proposed Solution:</i> Relocate water closet. 	<p>PCODE WB07B ADAAG 91 4.17.6 ADA 2010 604.5.2 CBC 2007 1115B.4.1.3.2 CBC 2019 11B-604.5.2</p> <p>Mitigated: <input type="radio"/> YES <input checked="" type="radio"/> NO</p>	1	JOB	\$1,020	\$1,020
------	--	---	---	-----	---------	---------

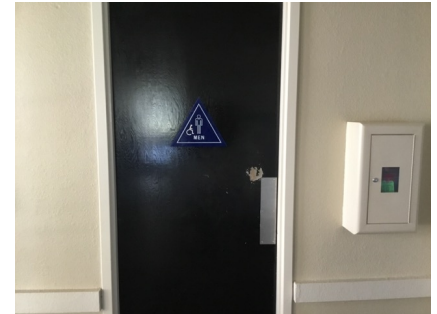
1129	<ul style="list-style-type: none"> As-Built Description: Entrance to toilet or bathing facility not identified with ADAAG compliant signage. Proposed Solution: Provide ADA compliant sign mounted at 48" min. above to baseline of the lowest Braille cells and 60" max. to baseline of the highest line of raised characters on nearest adjacent wall, on latch side of a single door (located not to cause a Braille reader to stand within the door swing). 	<p>PCODE SA11A ADAAG 91 4.1.3(16)(a) ADA 2010 216.8 CBC 2019 11B-216.8</p> <p>Mitigated: <input type="radio"/> YES <input checked="" type="radio"/> NO</p>	1	JOB	\$270	\$270
------	---	---	---	-----	-------	-------
