The City of Madera

Appendix B: Facilities

Access Compliance Survey Report

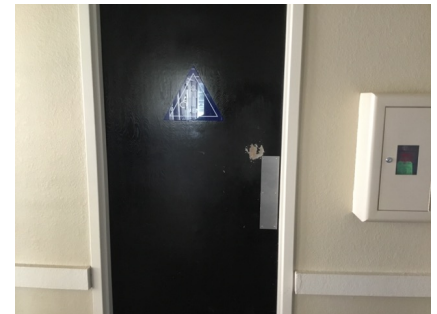
1130	<ul style="list-style-type: none"> As-Built Description: Required in CA only: identification symbol centered 58" to 60" high on sanitary facility door that contrasts with the door not provided (women: 12" ø circle, men: 12" triangle, unisex: combined symbol). As-Built: Not contrast and glare. Proposed Solution: Provide properly mounted sanitary facility symbol when altering area. If wheelchair accessible, include International Symbol of Accessibility on sign. 	<p>PCODE SA15 CBC 2007 1115B.6 CBC 2019 11B-703.7.2.6</p> <p>Mitigated: <input type="radio"/> YES <input checked="" type="radio"/> NO</p>	1	JOB	\$270	\$270
------	--	--	---	-----	-------	-------

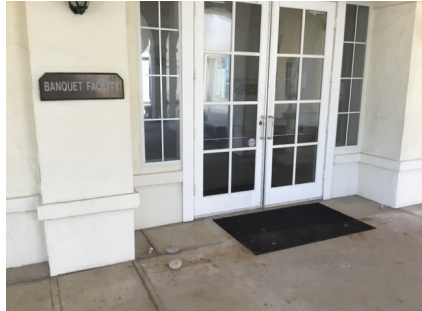
Item no., Rm no. and Name	Existing Architectural Barrier and Proposed Solution	Codes / Mitigation Info	Qty	Unit	Cost	Total
1144	<ul style="list-style-type: none"> As-Built Description: Surface of required maneuvering clearance at door slopes more than 1/4":12" (2.0%). As-Built: 3.0% Proposed Solution: Modify surface slope at door. 	PCODE ID11 ADAAG 91 4.13.6 ADA 2010 404.2.4.4 CBC 2007 1133B.2.4 CBC 2019 11B-404.2.4 Mitigated: <input type="radio"/> YES <input checked="" type="radio"/> NO	10	SF	\$120	\$1,200

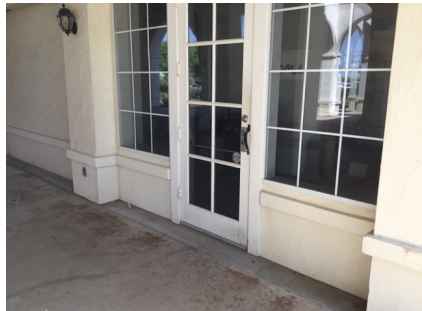
<input type="radio"/> Staff Only						
Priority 2						
Severity 4						
1145	<ul style="list-style-type: none"> As-Built Description: Surface of required maneuvering clearance at door slopes more than 1/4":12" (2.0%). As-Built: 5.0% 0.5" level change Proposed Solution: Modify surface slope at door. Notes: 	PCODE ID11 ADAAG 91 4.13.6 ADA 2010 404.2.4.4 CBC 2007 1133B.2.4 CBC 2019 11B-404.2.4 Mitigated: <input type="radio"/> YES <input checked="" type="radio"/> NO	175	SF	\$120	\$21,000

Every exterior entrance door to the restaurant has slopes >2.1%.

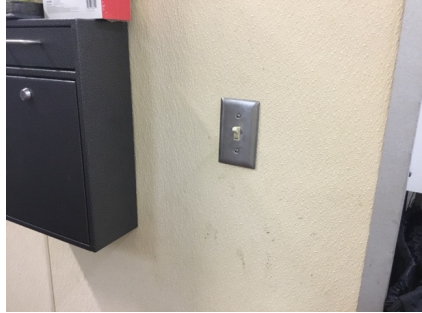
<p>1157</p> <ul style="list-style-type: none"> • <i>As-Built Description:</i> Electric switch or control mounted less than 15" measured to the bottom of the outlet box or greater than 48 inches measured to the top of the outlet box. • <i>As-Built:</i> 54.25 high • <i>Proposed Solution:</i> Relocate light switches or control to between 15" and 48" height. 	<p>PCODE IC01 ADAAG 91 4.2.5 & 6 ADA 2010 308.2.1 & 308.2.2 CBC 2007 1117B.6.3 CBC 2019 11B-308.2.1 & 11B-308.2.2</p> <p>Mitigated: <input type="radio"/> YES <input checked="" type="radio"/> NO</p>	<p>1 JOB \$900 \$900</p>

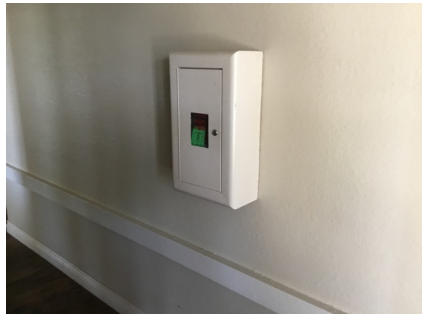
<p>1151</p> <ul style="list-style-type: none"> • <i>As-Built Description:</i> Protruding objects more than 4" from wall, when bottom of object more than 27" or less than 80" above finished floor. • <i>As-Built:</i> FE cabinet: 5.0" at 39.0" high • <i>Proposed Solution:</i> Remove/relocate protruding object. Patch existing surface. 	<p>PCODE EG04 ADAAG 91 4.4.1 ADA 2010 307.2 CBC 2007 1133B.8.6.1 CBC 2019 11B-307.2</p> <p>Mitigated: <input type="radio"/> YES <input checked="" type="radio"/> NO</p>	<p>1 JOB \$300 \$300</p>

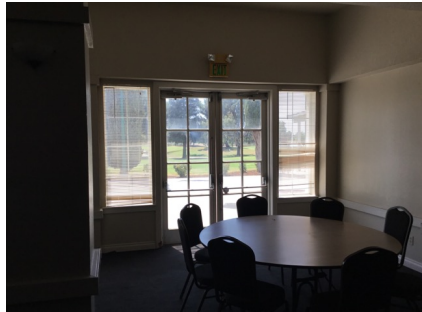
<p>1154</p> <ul style="list-style-type: none"> As-Built Description: At final exit door to exterior: Where required exit signs are installed, signs to provide exiting information for people with vision impairment are not provided. Proposed Solution: Provide raised letter/Braille "EXIT" sign at door. 	<p>PCODE SA10A ADAAG 91 4.1.3(16) ADA 2010 216.4.1 CBC 2007 1011.3 CBC 2019 11B-216.4.1</p> <p>Mitigated: <input type="radio"/> YES <input checked="" type="radio"/> NO</p>	<p>13 JOB \$270 \$3,510</p>

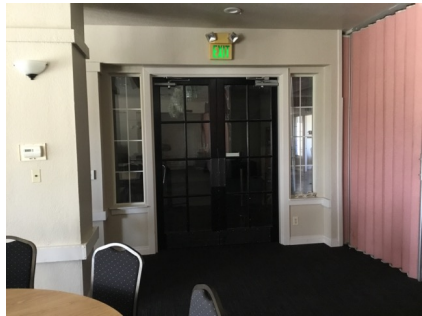
<p>1155</p> <ul style="list-style-type: none"> As-Built Description: At door leading into exit corridor: Where required exit signs are installed, signs to provide exiting information for people with vision impairment are not provided. Proposed Solution: Provide raised letter/Braille "EXIT ROUTE" sign at door. 	<p>PCODE SA10D ADAAG 91 4.1.3(16) ADA 2010 216.4.1 CBC 2007 1011.3 CBC 2019 11B-216.4.1</p> <p>Mitigated: <input type="radio"/> YES <input checked="" type="radio"/> NO</p>	<p>2 JOB \$270 \$540</p>

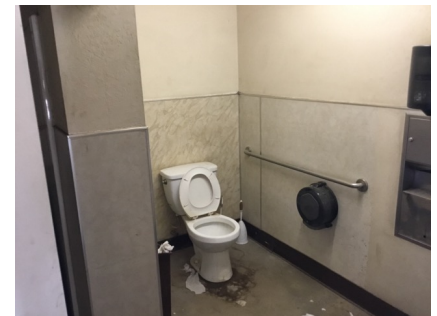
- 1176
- *As-Built Description:*
Single accommodation restroom not accessible; multiple compliance violations.
 - *As-Built:* **110.0" x 100**
 - *Proposed Solution:*
Remodel area to provide single-occupant accessible restroom.
 - *Notes:*

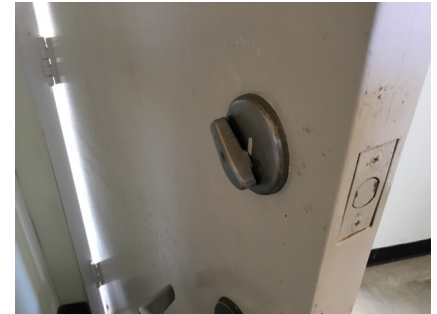
1243 • *As-Built Description:*
 Door lock, latch or handle less than 34" or more than 48" above the floor (CA only: 34" to 44").
 • *As-Built:* **48.5" high**
 • *Proposed Solution:*
 Relocate or replace existing hardware.

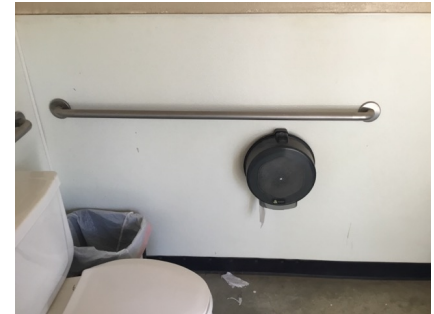
1194	<ul style="list-style-type: none"> <i>As-Built Description:</i> Side grab bar less than 42" long, or located more than 12 inches max. from the rear wall, or extending less than 54" from rear wall (CA only: front end min. 24" in front of water closet). <i>As-Built:</i> Extends 52.5" <i>Proposed Solution:</i> Provide or relocate accessible side grab bar. 	<p>PCODE WB07A ADAAG 91 Fig. 29(b) ADA 2010 604.5.1 CBC 2007 1115B.4.1.3.1 CBC 2019 11B-604.5.1</p> <p>Mitigated: <input type="radio"/> YES <input checked="" type="radio"/> NO</p>	1	JOB	\$780	\$780
------	--	---	---	-----	-------	-------

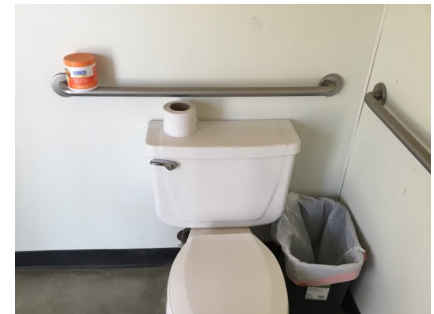
1192	<ul style="list-style-type: none"> <i>As-Built Description:</i> The rear wall grab is less than 36" min. or does not extend from the centerline of the water closet 12" min. on one side and 24" min. on the other side. <i>As-Built:</i> Extends 21.0" on wide side <i>Proposed Solution:</i> Provide or relocate accessible rear grab bar. 	<p>PCODE WB07B ADAAG 91 4.17.6 ADA 2010 604.5.2 CBC 2007 1115B.4.1.3.2 CBC 2019 11B-604.5.2</p> <p>Mitigated: <input type="radio"/> YES <input checked="" type="radio"/> NO</p>	1	JOB	\$1,020	\$1,020
------	--	---	---	-----	---------	---------

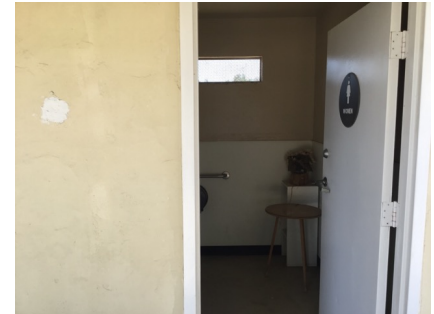
1183	<ul style="list-style-type: none"> As-Built Description: Entrance to toilet or bathing facility not identified with ADAAG compliant signage. Proposed Solution: Provide ADA compliant sign mounted at 48" min. above to baseline of the lowest Braille cells and 60" max. to baseline of the highest line of raised characters on nearest adjacent wall, on latch side of a single door (located not to cause a Braille reader to stand within the door swing). 	<p>PCODE SA11A ADAAG 91 4.1.3(16)(a) ADA 2010 216.8 CBC 2019 11B-216.8</p> <p>Mitigated: <input type="radio"/> YES <input checked="" type="radio"/> NO</p>	1	JOB	\$270	\$270
------	---	---	---	-----	-------	-------

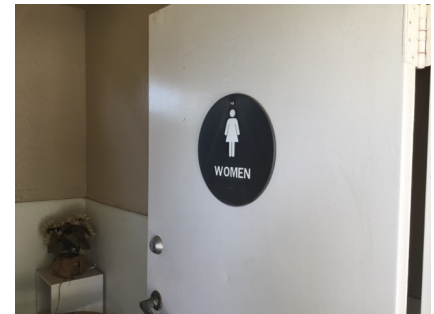
1184	<ul style="list-style-type: none"> As-Built Description: Required in CA only: identification symbol centered 58" to 60" high on sanitary facility door that contrasts with the door not provided (women: 12" ø circle, men: 12" triangle, unisex: combined symbol). As-Built: 61.5" high o.c. Proposed Solution: Provide properly mounted sanitary facility symbol when altering area. If wheelchair accessible, include International Symbol of Accessibility on sign. 	<p>PCODE SA15 CBC 2007 1115B.6 CBC 2019 11B-703.7.2.6</p> <p>Mitigated: <input type="radio"/> YES <input checked="" type="radio"/> NO</p>	1	JOB	\$270	\$270
------	--	--	---	-----	-------	-------

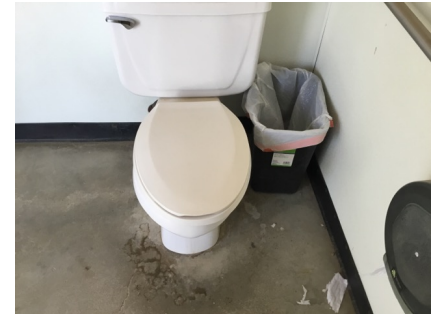
1190	<ul style="list-style-type: none"> <i>As-Built Description:</i> Water closet not 16"-18" (CA: 17"-18") from near side wall to center line of water closet (2010 ADAAG: 16"-18"). <i>As-Built:</i> 21.0" o.c. <i>Proposed Solution:</i> Relocate existing water closet and plumbing, remount with offset closet flange to provide 18" max. from side wall. 	<p>PCODE WB02C ADAAG 91 Fig. 28 ADA 2010 604.2 CBC 2007 1115B.4.1.1 CBC 2019 11B-604.2</p> <p>Mitigated: <input type="radio"/> YES <input checked="" type="radio"/> NO</p>	1	JOB	\$1,500	\$1,500
------	---	--	---	-----	---------	----------------

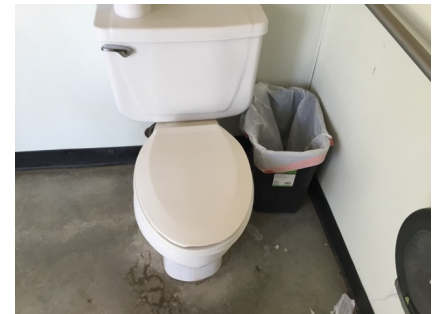
1191	<ul style="list-style-type: none"> <i>As-Built Description:</i> Height of water closet seat less than 17" or more than 19" from floor. <i>As-Built:</i> 16.0" high <i>Proposed Solution:</i> Provide riser toilet seat (CA only: in alterations, riser seat may not be higher than 2"). 	<p>PCODE WB08A ADAAG 91 4.16.3 ADA 2010 604.4 CBC 2007 1115B.4.1.4 CBC 2019 11B-604.4</p> <p>Mitigated: <input type="radio"/> YES <input checked="" type="radio"/> NO</p>	1	JOB	\$240	\$240
------	---	---	---	-----	-------	--------------

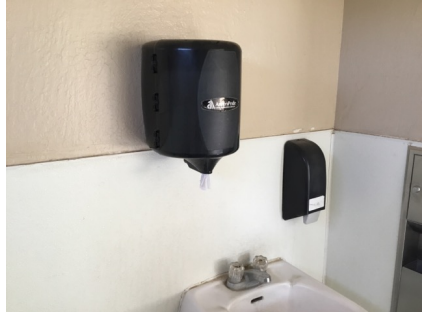
1201	<ul style="list-style-type: none"> <i>As-Built Description:</i> Dispensers in sanitary facilities, such as for towels, soap, sanitary napkins, seat covers, etc., and waste receptacles more than 48" (CA only: 40") from floor to highest operating slot or control. <i>As-Built:</i> PTD: 50.0" high <i>Proposed Solution:</i> Relocate existing restroom accessories. 	<p>PCODE WG01A ADAAG 91 4.23.7 ADA 2010 308.2.1 CBC 2007 1115B.8.3 CBC 2019 11B-603.5</p> <p>Mitigated: <input type="radio"/> YES <input checked="" type="radio"/> NO</p>	1	JOB	\$300	\$300

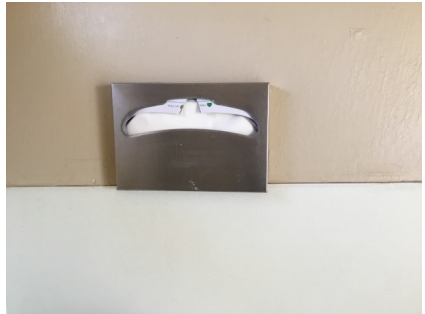
<p><input type="radio"/> Staff Only</p> <p>Priority 3</p> <p>Severity 2</p>						
1202	<ul style="list-style-type: none"> <i>As-Built Description:</i> Dispensers in sanitary facilities, such as for towels, soap, sanitary napkins, seat covers, etc., and waste receptacles more than 48" (CA only: 40") from floor to highest operating slot or control. <i>As-Built:</i> SCD: 59.0" high <i>Proposed Solution:</i> Relocate existing restroom accessories. 	<p>PCODE WG01A ADAAG 91 4.23.7 ADA 2010 308.2.1 CBC 2007 1115B.8.3 CBC 2019 11B-603.5</p> <p>Mitigated: <input type="radio"/> YES <input checked="" type="radio"/> NO</p>	1	JOB	\$300	\$300

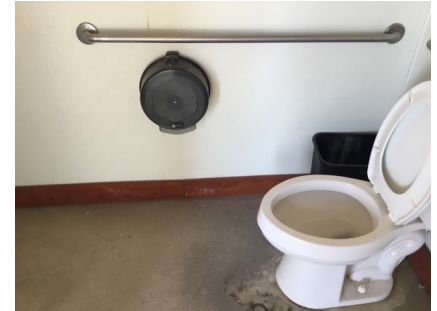
Item no., Rm no. and Name	Existing Architectural Barrier and Proposed Solution	Codes / Mitigation Info	Qty	Unit	Cost	Total
1206	<ul style="list-style-type: none"> As-Built Description: Toilet paper dispenser less than 15" (CA: 19") or more than 48" above floor or not within 7" to 9" from front of water closet (Note: CA pre-2010 is allowed within 12" from front of water closet). As-Built: 11.0" in front. Proposed Solution: Relocate or provide new toilet paper dispenser. 	PCODE WG02 ADAAG 91 4.16.6 ADA 2010 604.7 CBC 2007 1115B.8.4 CBC 2019 11B-604.7	1	JOB	\$225	\$225
		Mitigated: <input type="radio"/> YES <input checked="" type="radio"/> NO				
			<input type="radio"/> Staff Only			
			Priority <input checked="" type="radio"/> 3			
			Severity <input checked="" type="radio"/> 4

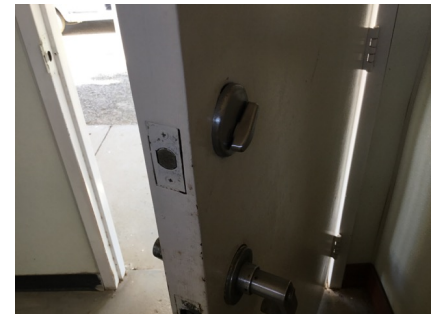
1244	<ul style="list-style-type: none"> As-Built Description: Door lock, latch or handle less than 34" or more than 48" above the floor (CA only: 34" to 44"). As-Built: 48.5" high Proposed Solution: Relocate or replace existing hardware. 	PCODE ID17 ADAAG 91 4.13.9 ADA 2010 404.2.7 CBC 2007 1133B.2.5.2 CBC 2019 11B-404.2.7	1	JOB	\$900	\$900
		Mitigated: <input type="radio"/> YES <input checked="" type="radio"/> NO				
			<input type="radio"/> Staff Only			
			Priority <input checked="" type="radio"/> 3			
			Severity <input checked="" type="radio"/> 3

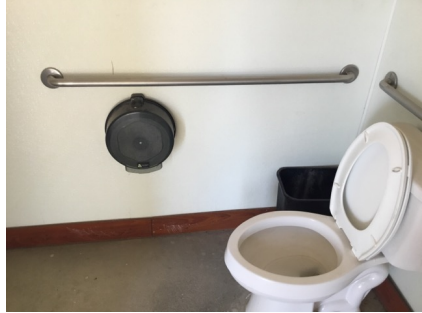
<p>1207</p> <ul style="list-style-type: none"> <i>As-Built Description:</i> Side grab bar less than 42" long, or located more than 12 inches max. from the rear wall, or extending less than 54" from rear wall (CA only: front end min. 24" in front of water closet). <i>As-Built:</i> Extends 53.0" <i>Proposed Solution:</i> Provide or relocate accessible side grab bar. 	<p><i>PCODE</i> WB07A <i>ADAAG 91</i> Fig. 29(b) <i>ADA 2010</i> 604.5.1 <i>CBC 2007</i> 1115B.4.1.3.1 <i>CBC 2019</i> 11B-604.5.1</p> <p>Mitigated: <input type="radio"/> YES <input checked="" type="radio"/> NO</p>	<p>1 JOB \$780 \$780</p>

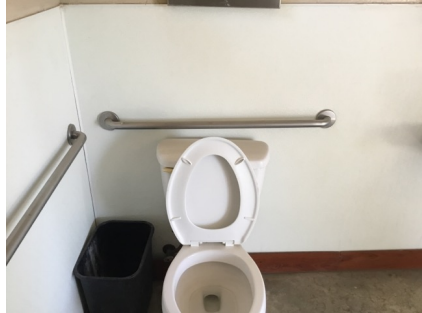
<p>1205</p> <ul style="list-style-type: none"> <i>As-Built Description:</i> The rear wall grab is less than 36" min. or does not extend from the centerline of the water closet 12" min. on one side and 24" min. on the other side. <i>As-Built:</i> Extends 19.0" on wide side <i>Proposed Solution:</i> Provide or relocate accessible rear grab bar. <i>Notes:</i> 	<p><i>PCODE</i> WB07B <i>ADAAG 91</i> 4.17.6 <i>ADA 2010</i> 604.5.2 <i>CBC 2007</i> 1115B.4.1.3.2 <i>CBC 2019</i> 11B-604.5.2</p> <p>Mitigated: <input type="radio"/> YES <input checked="" type="radio"/> NO</p>	<p>1 JOB \$1,020 \$1,020</p>

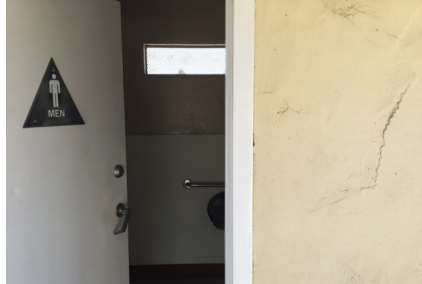
<p>1197</p> <ul style="list-style-type: none"> As-Built Description: Entrance to toilet or bathing facility not identified with ADAAG compliant signage. Proposed Solution: Provide ADA compliant sign mounted at 48" min. above to baseline of the lowest Braille cells and 60" max. to baseline of the highest line of raised characters on nearest adjacent wall, on latch side of a single door (located not to cause a Braille reader to stand within the door swing). 	<p>PCODE SA11A ADAAG 91 4.1.3(16)(a) ADA 2010 216.8 CBC 2019 11B-216.8</p> <p>Mitigated: <input type="radio"/> YES <input checked="" type="radio"/> NO</p>	<p>1 JOB \$270 \$270</p>

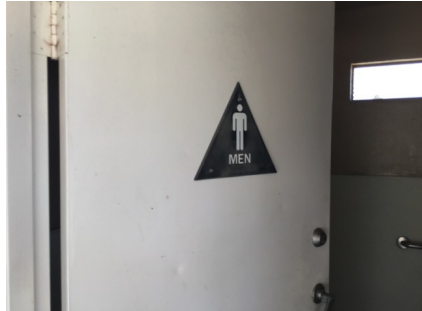
<p>1198</p> <ul style="list-style-type: none"> As-Built Description: Required in CA only: identification symbol centered 58" to 60" high on sanitary facility door that contrasts with the door not provided (women: 12" ø circle, men: 12" triangle, unisex: combined symbol). As-Built: 63.0" high o.c. Proposed Solution: Provide properly mounted sanitary facility symbol when altering area. If wheelchair accessible, include International Symbol of Accessibility on sign. 	<p>PCODE SA15 CBC 2007 1115B.6 CBC 2019 11B-703.7.2.6</p> <p>Mitigated: <input type="radio"/> YES <input checked="" type="radio"/> NO</p>	<p>1 JOB \$270 \$270</p>

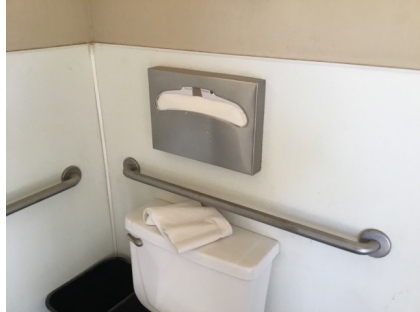
<p>1218</p> <ul style="list-style-type: none"> • <i>As-Built Description:</i> Dispensers in sanitary facilities, such as for towels, soap, sanitary napkins, seat covers, etc., and waste receptacles more than 48" (CA only: 40") from floor to highest operating slot or control. • <i>As-Built:</i> SCD: 45.0" high • <i>Proposed Solution:</i> Relocate existing restroom accessories. 	<p>PCODE WG01A ADAAG 91 4.23.7 ADA 2010 308.2.1 CBC 2007 1115B.8.3 CBC 2019 11B-603.5</p> <p>Mitigated:</p> <p><input type="radio"/> YES <input checked="" type="radio"/> NO</p>	<p>1 JOB \$300 \$300</p>

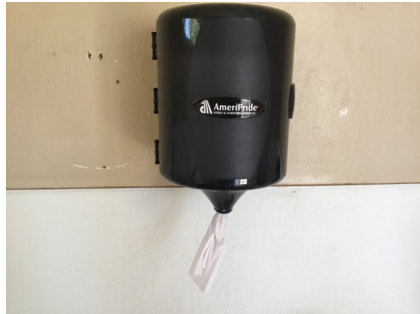
<p>1222</p> <ul style="list-style-type: none"> • <i>As-Built Description:</i> Dispensers in sanitary facilities, such as for towels, soap, sanitary napkins, seat covers, etc., and waste receptacles more than 48" (CA only: 40") from floor to highest operating slot or control. • <i>As-Built:</i> PTD: 51.0" high • <i>Proposed Solution:</i> Relocate existing restroom accessories. • <i>Notes:</i> 	<p>PCODE WG01A ADAAG 91 4.23.7 ADA 2010 308.2.1 CBC 2007 1115B.8.3 CBC 2019 11B-603.5</p> <p>Mitigated:</p> <p><input type="radio"/> YES <input checked="" type="radio"/> NO</p>	<p>1 JOB \$300 \$300</p>

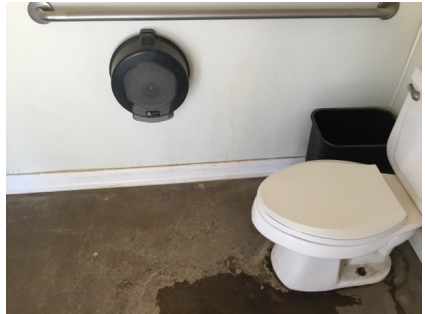
Item no., Rm no. and Name	Existing Architectural Barrier and Proposed Solution	Codes / Mitigation Info	Qty	Unit	Cost	Total
1215	<ul style="list-style-type: none"> As-Built Description: Toilet paper dispenser less than 15" (CA: 19") or more than 48" above floor or not within 7" to 9" from front of water closet (Note: CA pre-2010 is allowed within 12" from front of water closet). As-Built: 11.0" in front. Proposed Solution: Relocate or provide new toilet paper dispenser. 	PCODE WG02 ADAAG 91 4.16.6 ADA 2010 604.7 CBC 2007 1115B.8.4 CBC 2019 11B-604.7 Mitigated: <input type="radio"/> YES <input checked="" type="radio"/> NO	1	JOB	\$225	\$225

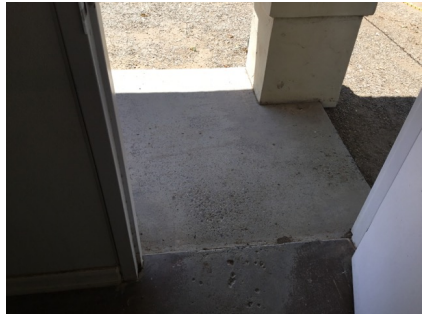
1210	<ul style="list-style-type: none"> As-Built Description: Surface of required maneuvering clearance at door slopes more than 1/4":12" (2.0%). As-Built: 5.0% Proposed Solution: Modify surface slope at door. 	PCODE ID11 ADAAG 91 4.13.6 ADA 2010 404.2.4.4 CBC 2007 1133B.2.4 CBC 2019 11B-404.2.4 Mitigated: <input type="radio"/> YES <input checked="" type="radio"/> NO	25	SF	\$120	\$3,000

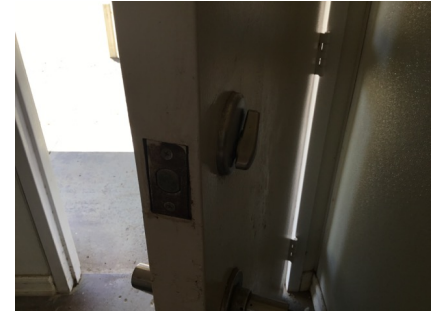
1225	<ul style="list-style-type: none"> • <i>As-Built Description:</i> Door lock, latch or handle less than 34" or more than 48" above the floor (CA only: 34" to 44"). • <i>As-Built:</i> 48.0" high • <i>Proposed Solution:</i> Relocate or replace existing hardware. • <i>Notes:</i> 	<p>PCODE ID17 ADAAG 91 4.13.9 ADA 2010 404.2.7 CBC 2007 1133B.2.5.2 CBC 2019 11B-404.2.7</p> <p>Mitigated: <input type="radio"/> YES <input checked="" type="radio"/> NO</p>	1	JOB	\$900	\$900
------	--	---	---	-----	-------	-------

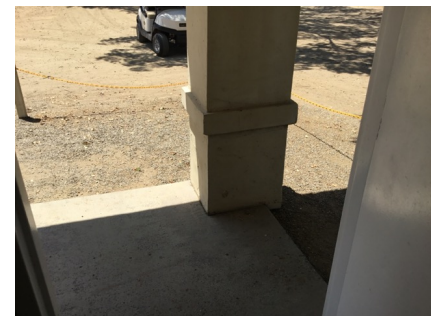
1209	<ul style="list-style-type: none"> • <i>As-Built Description:</i> Front approach: At push side, door does not have clear and level maneuvering space measuring door width x 48" (door width plus 12" if door has both, latch and closer). • <i>As-Built:</i> 38.0" • <i>Proposed Solution:</i> Provide relocated new door and frame; remodel walls as needed. 	<p>PCODE ID24B ADAAG 91 Fig. 25(a) ADA 2010 404.2.4 CBC 2007 11B-26A(a) CBC 2019 11B-404.2.4</p> <p>Mitigated: <input type="radio"/> YES <input checked="" type="radio"/> NO</p>	1	JOB	\$7,800	\$7,800
------	---	---	---	-----	---------	---------

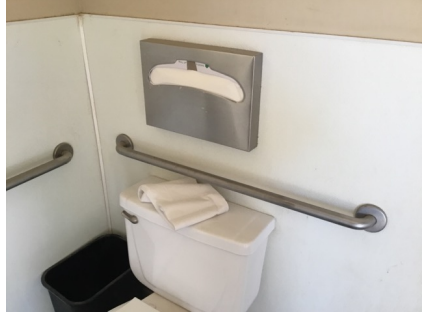
Item no., Rm no. and Name	Existing Architectural Barrier and Proposed Solution	Codes / Mitigation Info	Qty	Unit	Cost	Total
1217	<ul style="list-style-type: none"> As-Built Description: Accessories/dispensers in accessible stall located closer than 1-1/2" below or 12" above grab bar impedes its use. As-Built: SCD: 4.0" above grab bar Proposed Solution: Relocate accessories/dispensers within applicable reach range and to be no closer than 1-1/2" below and 12" above grab bars (except if accessories are recessed, flush with wall, and have no sharp edges). 	PCODE WB07I ADAAG 91 4.26.2 ADA 2010 609.3 CBC 2007 1133B.4.2.5 CBC 2019 11B-609.3 Mitigated: <input type="radio"/> YES <input checked="" type="radio"/> NO	1	JOB	\$225	\$225

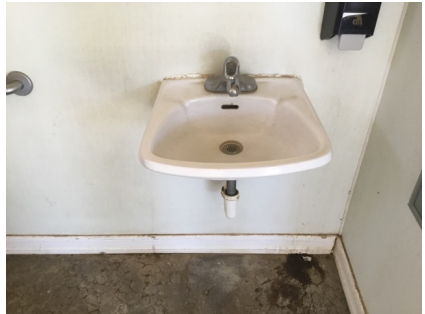
1219	<ul style="list-style-type: none"> As-Built Description: Knee clearance 27" min. high starting 8" back from the front edge of the lavatory towards the wall is not provided. As-Built: 26.8" knee high Proposed Solution: Remount compliant fixture to accessible height. 	PCODE WD04A ADAAG 91 Fig. 31 ADA 2010 306.3.3 CBC 2007 1115B.4.3 CBC 2019 11B-306.3.3 Mitigated: <input type="radio"/> YES <input checked="" type="radio"/> NO	1	JOB	\$3,000	\$3,000

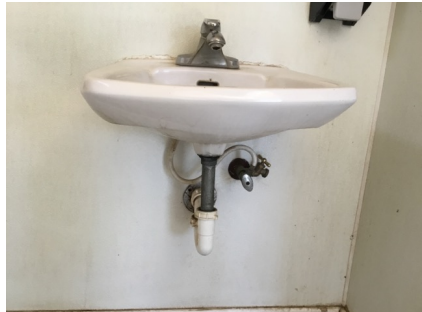
Item no., Rm no. and Name	Existing Architectural Barrier and Proposed Solution	Codes / Mitigation Info	Qty	Unit	Cost	Total
1220	<ul style="list-style-type: none"> • <i>As-Built Description:</i> Hot or sharp-surfaced water/drain pipe not insulated or covered. • <i>Proposed Solution:</i> Insulate or cover water/drain pipe. 	PCODE WD05 ADAAG 91 4.19.4 ADA 2010 606.5 CBC 2007 1115B.4.3.4 CBC 2019 11B-606.5 Mitigated: <input type="radio"/> YES <input checked="" type="radio"/> NO	1	JOB	\$360	\$360

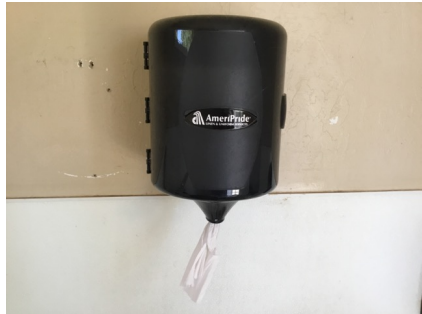
Protrusion Limits

1221	<ul style="list-style-type: none"> • <i>As-Built Description:</i> Protruding objects more than 4" from wall, when bottom of object more than 27" or less than 80" above finished floor. • <i>As-Built:</i> PTD: 9.0" at 54.0" high • <i>Proposed Solution:</i> Remove/relocate protruding object. Patch existing surface. 	PCODE EG04 ADAAG 91 4.4.1 ADA 2010 307.2 CBC 2007 1133B.8.6.1 CBC 2019 11B-307.2 Mitigated: <input type="radio"/> YES <input checked="" type="radio"/> NO	1	JOB	\$300	\$300

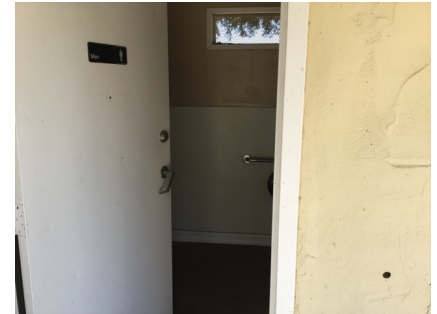
Signage

1226	<ul style="list-style-type: none"> As-Built Description: Entrance to toilet or bathing facility not identified with ADAAG compliant signage. Proposed Solution: Provide ADA compliant sign mounted at 48" min. above to baseline of the lowest Braille cells and 60" max. to baseline of the highest line of raised characters on nearest adjacent wall, on latch side of a single door (located not to cause a Braille reader to stand within the door swing). 	<p>PCODE SA11A ADAAG 91 4.1.3(16)(a) ADA 2010 216.8 CBC 2019 11B-216.8</p> <p>Mitigated: <input type="radio"/> YES <input checked="" type="radio"/> NO</p>	1	JOB	\$270	\$270
------	---	---	---	-----	-------	-------

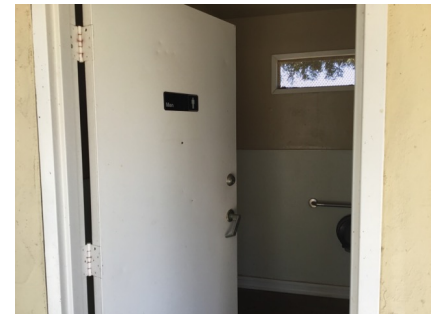
1227	<ul style="list-style-type: none"> As-Built Description: Required in CA only: identification symbol centered 58" to 60" high on sanitary facility door that contrasts with the door not provided (women: 12" ø circle, men: 12" triangle, unisex: combined symbol). Proposed Solution: Provide properly mounted sanitary facility symbol when altering area. If wheelchair accessible, include International Symbol of Accessibility on sign. 	<p>PCODE SA15 CBC 2007 1115B.6 CBC 2019 11B-703.7.2.6</p> <p>Mitigated: <input type="radio"/> YES <input checked="" type="radio"/> NO</p>	1	JOB	\$270	\$270
------	---	--	---	-----	-------	-------

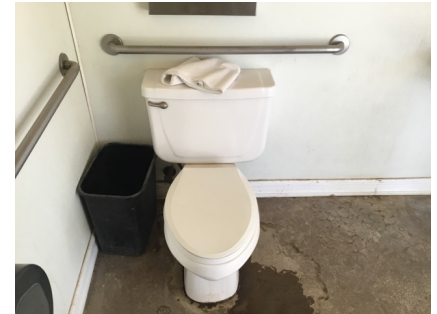
Water Closet

1212	<ul style="list-style-type: none"> <i>As-Built Description:</i> Water closet not 16"-18" (CA: 17"-18") from near side wall to center line of water closet (2010 ADAAG: 16"-18"). <i>As-Built:</i> 20.0" o.c. <i>Proposed Solution:</i> Relocate existing water closet and plumbing, remount with offset closet flange to provide 18" max. from side wall. 	<p>PCODE WB02C ADAAG 91 Fig. 28 ADA 2010 604.2 CBC 2007 1115B.4.1.1 CBC 2019 11B-604.2</p> <p>Mitigated: <input type="radio"/> YES <input checked="" type="radio"/> NO</p>	1	JOB	\$1,500	\$1,500
------	---	--	---	-----	---------	----------------

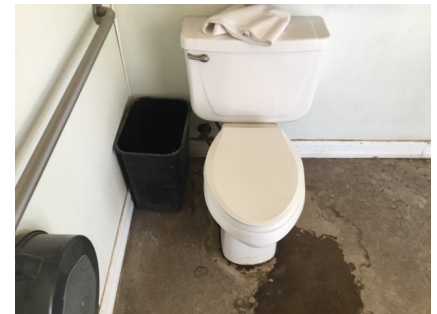
1214	<ul style="list-style-type: none"> <i>As-Built Description:</i> Height of water closet seat less than 17" or more than 19" from floor. <i>As-Built:</i> 16.0" high <i>Proposed Solution:</i> Provide riser toilet seat (CA only: in alterations, riser seat may not be higher than 2"). 	<p>PCODE WB08A ADAAG 91 4.16.3 ADA 2010 604.4 CBC 2007 1115B.4.1.4 CBC 2019 11B-604.4</p> <p>Mitigated: <input type="radio"/> YES <input checked="" type="radio"/> NO</p>	1	JOB	\$240	\$240
------	---	---	---	-----	-------	--------------

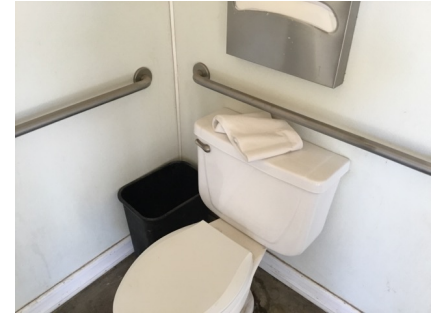
Item no., Rm no. and Name	Existing Architectural Barrier and Proposed Solution	Codes / Mitigation Info	Qty	Unit	Cost	Total
1216	<ul style="list-style-type: none"> <i>As-Built Description:</i> Flush Control: Operating handle not mounted toward wide side of stall. <i>Proposed Solution:</i> Replace flush control with properly mounted accessible type, or install sensor flush. 	PCODE WB10 ADAAG 91 4.16.5 ADA 2010 604.6 CBC 2007 1115B.4.1.5 CBC 2019 11B-604.6 Mitigated: <input type="radio"/> YES <input checked="" type="radio"/> NO	1	JOB	\$1,500	\$1,500

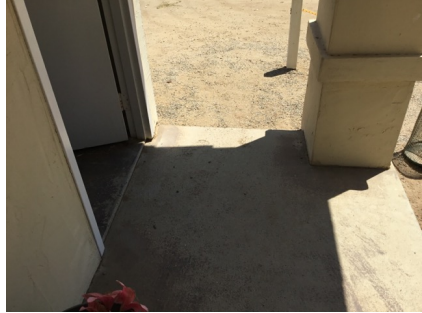
Door

<p>1230</p> <ul style="list-style-type: none"> • <i>As-Built Description:</i> Surface of required maneuvering clearance at door slopes more than 1/4":12" (2.0%). • <i>As-Built:</i> 3.9% • <i>Proposed Solution:</i> Modify surface slope at door. 	<p><i>PCODE ID11</i> ADAAG 91 4.13.6 ADA 2010 404.2.4.4 CBC 2007 1133B.2.4 CBC 2019 11B-404.2.4</p> <p>Mitigated: <input type="radio"/> YES <input checked="" type="radio"/> NO</p>	<p>25 SF \$120 \$3,000</p>

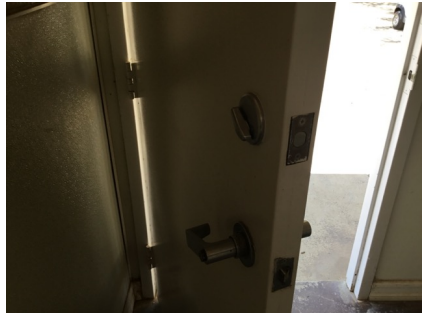
<p>1233</p> <ul style="list-style-type: none"> • <i>As-Built Description:</i> Door lock, latch or handle less than 34" or more than 48" above the floor (CA only: 34" to 44"). • <i>As-Built:</i> 48.5" high • <i>Proposed Solution:</i> Relocate or replace existing hardware. 	<p><i>PCODE ID17</i> ADAAG 91 4.13.9 ADA 2010 404.2.7 CBC 2007 1133B.2.5.2 CBC 2019 11B-404.2.7</p> <p>Mitigated: <input type="radio"/> YES <input checked="" type="radio"/> NO</p>	<p>1 JOB \$900 \$900</p>

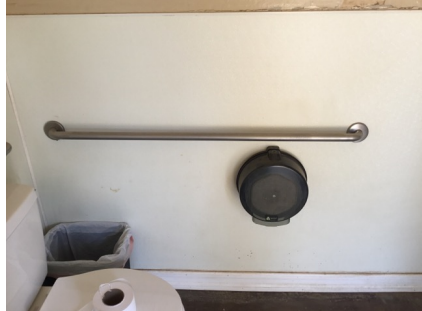
Grab Bars

<p>1241</p> <ul style="list-style-type: none"> <i>As-Built Description:</i> Side grab bar less than 42" long, or located more than 12 inches max. from the rear wall, or extending less than 54" from rear wall (CA only: front end min. 24" in front of water closet). <i>As-Built:</i> Extends 53.75" <i>Proposed Solution:</i> Provide or relocate accessible side grab bar. 	<p>PCODE WB07A ADAAG 91 Fig. 29(b) ADA 2010 604.5.1 CBC 2007 1115B.4.1.3.1 CBC 2019 11B-604.5.1</p> <p>Mitigated: <input type="radio"/> YES <input checked="" type="radio"/> NO</p>	<p>1 JOB \$780 \$780</p>

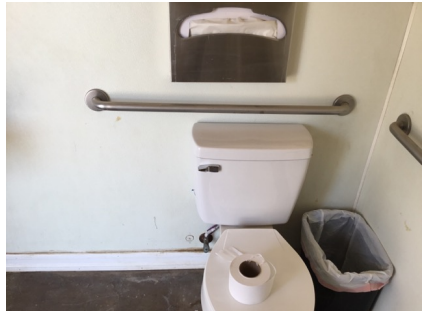
<p>1240</p> <ul style="list-style-type: none"> <i>As-Built Description:</i> The rear wall grab is less than 36" min. or does not extend from the centerline of the water closet 12" min. on one side and 24" min. on the other side. <i>As-Built:</i> Extends 22.0" on wide side. <i>Proposed Solution:</i> Provide or relocate accessible rear grab bar. 	<p>PCODE WB07B ADAAG 91 4.17.6 ADA 2010 604.5.2 CBC 2007 1115B.4.1.3.2 CBC 2019 11B-604.5.2</p> <p>Mitigated: <input type="radio"/> YES <input checked="" type="radio"/> NO</p>	<p>1 JOB \$1,020 \$1,020</p>

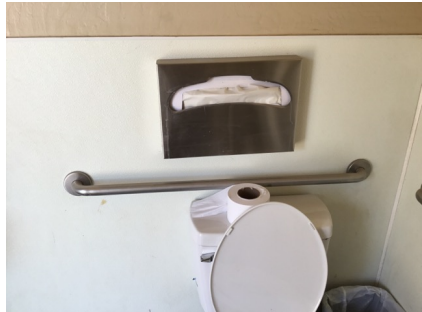
Item no., Rm no. and Name	Existing Architectural Barrier and Proposed Solution	Codes / Mitigation Info	Qty	Unit	Cost	Total
1237	<ul style="list-style-type: none"> As-Built Description: Accessories/dispensers in accessible stall located closer than 1-1/2" below or 12" above grab bar impedes its use. As-Built: SCD: 3.0" above grab bar Proposed Solution: Relocate accessories/dispensers within applicable reach range and to be no closer than 1-1/2" below and 12" above grab bars (except if accessories are recessed, flush with wall, and have no sharp edges). 	PCODE WB07I ADAAG 91 4.26.2 ADA 2010 609.3 CBC 2007 1133B.4.2.5 CBC 2019 11B-609.3 Mitigated: <input type="radio"/> YES <input checked="" type="radio"/> NO	1	JOB	\$225	\$225

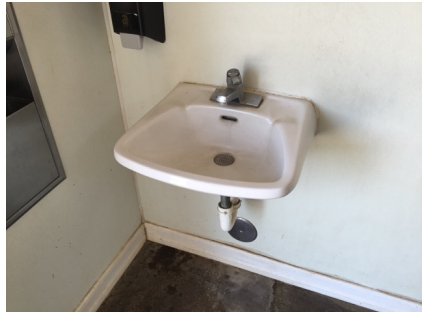
Lavatory

1234	<ul style="list-style-type: none"> As-Built Description: Knee clearance 27" min. high starting 8" back from the front edge of the lavatory towards the wall is not provided. As-Built: 26.8" knee high Proposed Solution: Remount compliant fixture to accessible height. 	PCODE WD04A ADAAG 91 Fig. 31 ADA 2010 306.3.3 CBC 2007 1115B.4.3 CBC 2019 11B-306.3.3 Mitigated: <input type="radio"/> YES <input checked="" type="radio"/> NO	1	JOB	\$3,000	\$3,000

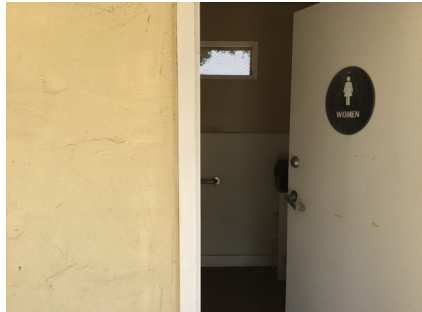
Signage

1228	<ul style="list-style-type: none"> As-Built Description: Entrance to toilet or bathing facility not identified with ADAAG compliant signage. Proposed Solution: Provide ADA compliant sign mounted at 48" min. above to baseline of the lowest Braille cells and 60" max. to baseline of the highest line of raised characters on nearest adjacent wall, on latch side of a single door (located not to cause a Braille reader to stand within the door swing). 	PCODE SA11A ADAAG 91 4.1.3(16)(a) ADA 2010 216.8 CBC 2019 11B-216.8 Mitigated: <input type="radio"/> YES <input checked="" type="radio"/> NO	1	JOB	\$270	\$270
------	---	---	---	-----	-------	-------

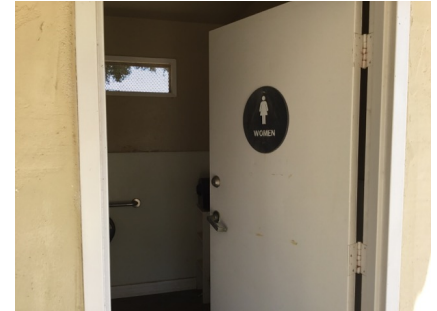
Item no., Rm no. and Name	Existing Architectural Barrier and Proposed Solution	Codes / Mitigation Info	Qty	Unit	Cost	Total
1229	<ul style="list-style-type: none"> As-Built Description: Required in CA only: identification symbol centered 58" to 60" high on sanitary facility door that contrasts with the door not provided (women: 12" ø circle, men: 12" triangle, unisex: combined symbol). Proposed Solution: Provide properly mounted sanitary facility symbol when altering area. If wheelchair accessible, include International Symbol of Accessibility on sign. 	<p>PCODE SA15</p> <p>CBC 2007 1115B.6</p> <p>CBC 2019 11B-703.7.2.6</p> <p>Mitigated:</p> <p><input type="radio"/> YES</p> <p><input checked="" type="radio"/> NO</p>	1	JOB	\$270	\$270

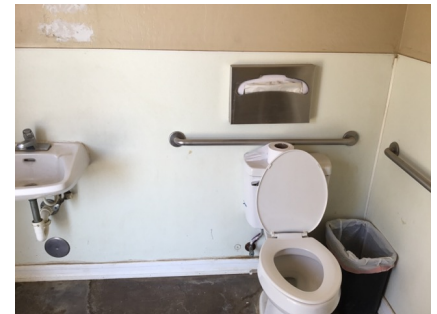
Toilet Stall

1236	<ul style="list-style-type: none"> As-Built Description: 60" min. clearance around a water closet measured perpendicular from the side wall not provided (Fixtures are not allowed to overlap this clearance). As-Built: 59.75" to lavatory Proposed Solution: Relocate adjacent fixture and remodel restroom as needed. Notes: 	<p>PCODE WB01A</p> <p>ADA 2010 604.3.1; 604.3.2</p> <p>CBC 2007 1115B.7.1.3</p> <p>CBC 2019 11B-604.3.1; 11B-604.3.2</p> <p>Mitigated:</p> <p><input type="radio"/> YES</p> <p><input checked="" type="radio"/> NO</p>	1	JOB	\$6,000	\$6,000
------	--	---	---	-----	---------	---------

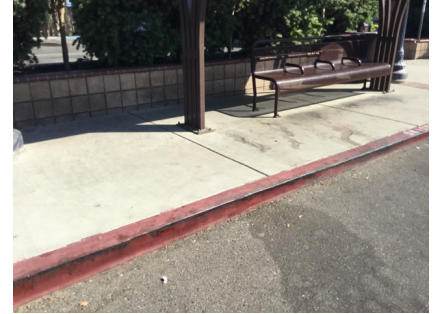
- 444
- *As-Built Description:*
Walk: Pavement dislocation creates abrupt change in level exceeding 1/2" in accessible route.
 - *As-Built:* **0.5" not properly beveled.**
 - *Proposed Solution:*
Remove, replace or repair area of pavement sufficient to correct abrupt change in level.
 - *Notes:*

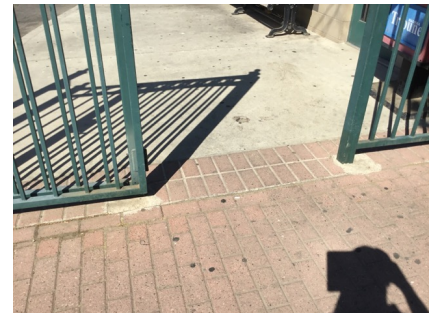
- 446
- *As-Built Description:*
Walk: Pavement dislocation creates abrupt change in level exceeding 1/2" in accessible route.
 - *As-Built:* **1.0"**
 - *Proposed Solution:*
Remove, replace or repair area of pavement sufficient to correct abrupt change in level.

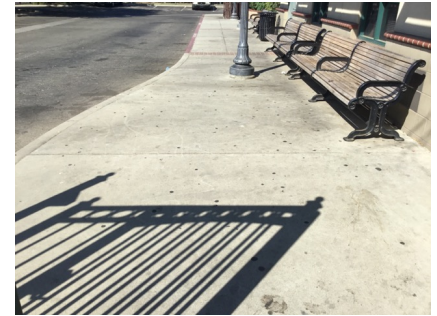
Cross Slope

445	<ul style="list-style-type: none"> As-Built Description: Cross slope more than 1":48" (2.083%). As-Built: Up to 3.1% Proposed Solution: Modify cross slope. 	PCODE EF07 ADAAG 91 4.3.7 ADA 2010 403.3 CBC 2007 1133B.7.1.3 CBC 2019 11B-403.3	100	SF	\$75	\$7,500
-----	---	--	-----	----	------	---------

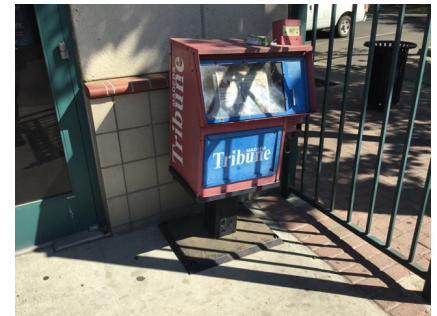
449	<ul style="list-style-type: none"> As-Built Description: Cross slope more than 1":48" (2.083%). Proposed Solution: Relocate existing newspaper stand at a location with compliant clear floor space. 	PCODE EF07NT ADAAG 91 4.3.7 ADA 2010 403.3 CBC 2007 1133B.7.1.3 CBC 2019 11B-403.3	1	JOB	\$150	\$150
-----	--	--	---	-----	-------	-------

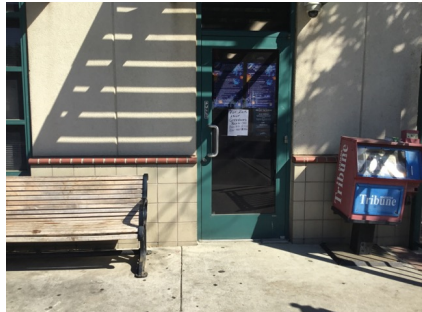
Item no., Rm no. and Name	Existing Architectural Barrier and Proposed Solution	Codes / Mitigation Info	Qty	Unit	Cost	Total
447	<ul style="list-style-type: none"> <i>As-Built Description:</i> Surface of required maneuvering clearance at door slopes more than 1/4":12" (2.0%). <i>As-Built:</i> 2.9% <i>Proposed Solution:</i> Modify surface slope at door. 	PCODE ID11 ADAAG 91 4.13.6 ADA 2010 404.2.4.4 CBC 2007 1133B.2.4 CBC 2019 11B-404.2.4 Mitigated: <input type="radio"/> YES <input checked="" type="radio"/> NO	25	SF	\$120	\$3,000

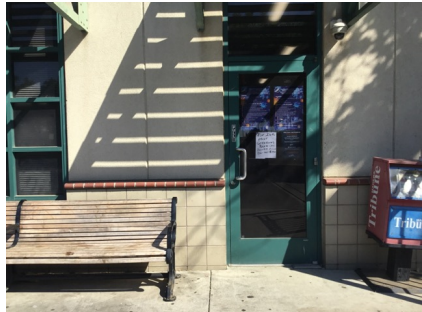
Door Swing

448	<ul style="list-style-type: none"> <i>As-Built Description:</i> Front approach: At pull side, door does not have clear and level maneuvering space measuring door width plus 18" x 60". (24" x 60" at exterior doors). <i>As-Built:</i> 21.0" <i>Proposed Solution:</i> Remove or relocate furniture or storage items. 	PCODE ID23A ADAAG 91 Fig. 25(a) ADA 2010 404.2.4 CBC 2007 11B-26A(a) CBC 2019 11B-404.2.4 Mitigated: <input type="radio"/> YES <input checked="" type="radio"/> NO	1	JOB	\$150	\$150

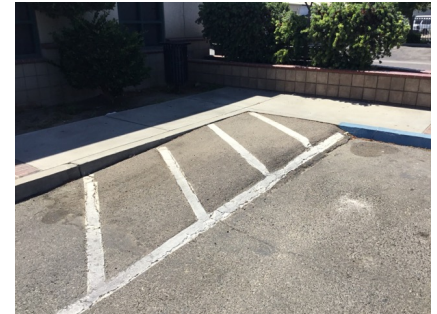
Floor or Ground Surfaces

387	<ul style="list-style-type: none"> As-Built Description: Accessible parking space has slope greater than 1/4":12" (2%). As-Built: 7.9% Proposed Solution: Modify slope at accessible parking space. 	PCODE EA05 ADAAG 91 4.6.3 ADA 2010 502.4 CBC 2007 1129B.3.3 CBC 2019 11B-502.4	80	SF	\$36	\$2,880
-----	---	--	----	----	------	---------

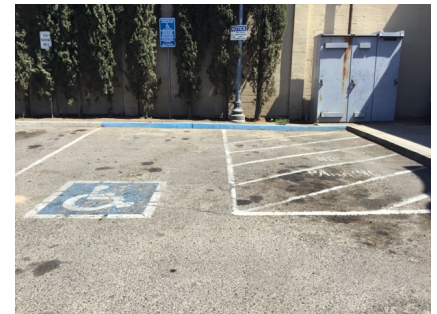
391	<ul style="list-style-type: none"> As-Built Description: Accessible parking space has slope greater than 1/4":12" (2%). As-Built: Up to 7.0% Proposed Solution: Modify slope at accessible parking space. 	PCODE EA05 ADAAG 91 4.6.3 ADA 2010 502.4 CBC 2007 1129B.3.3 CBC 2019 11B-502.4	200	SF	\$36	\$7,200
-----	---	--	-----	----	------	---------

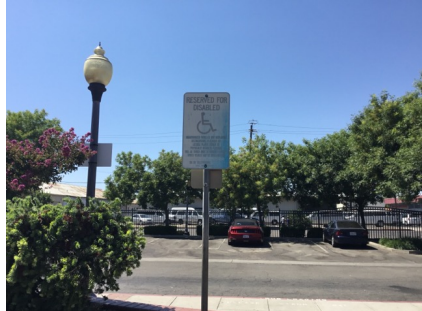
Identification

388	<ul style="list-style-type: none"> <i>As-Built Description:</i> Sign for accessible parking space is missing or non-compliant. <i>Proposed Solution:</i> Provide compliant parking signage. <i>Notes:</i> 	<p>PCODE EA04B ADAAG 91 4.6.4 ADA 2010 502.6 CBC 2007 1129B.4 CBC 2019 11B-502.6</p> <p>Mitigated: <input type="radio"/> YES <input checked="" type="radio"/> NO</p>	1	JOB	\$945	\$945
-----	--	---	---	-----	-------	-------

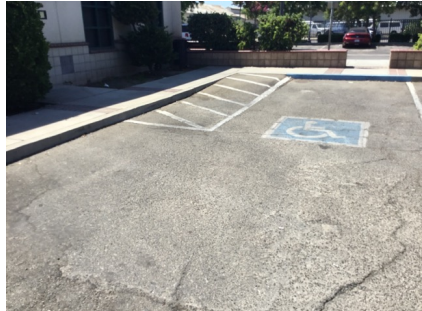
Parking

386	<ul style="list-style-type: none"> <i>As-Built Description:</i> The words "NO PARKING" not painted on the ground within loading and unloading access aisle (12" min high white letters), located so that it is visible to traffic enforcement officials (required in CA only). <i>Proposed Solution:</i> Provide the words "NO PARKING" in each access aisle, painted in 12" high letters, when altering area. 	<p>PCODE EA04D CBC 2007 1129B.3.1 CBC 2019 11B-502.3.3</p> <p>Mitigated: <input type="radio"/> YES <input checked="" type="radio"/> NO</p>	2	JOB	\$300	\$600
-----	--	---	---	-----	-------	-------

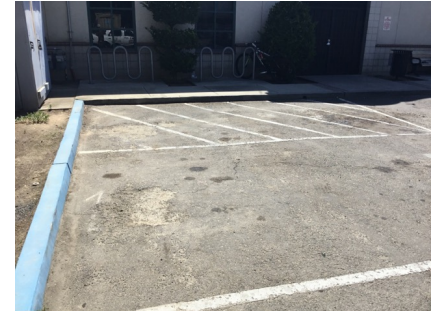
385	<ul style="list-style-type: none"> As-Built Description: An accessible parking space shall be outlined or painted blue (required in CA only). Proposed Solution: Identify accessible parking space using blue markings. 	PCODE EA04K CBC 2019 11B-502.6 Mitigated: <input type="radio"/> YES <input checked="" type="radio"/> NO	2	JOB	\$360	\$720
-----	---	--	---	-----	-------	-------

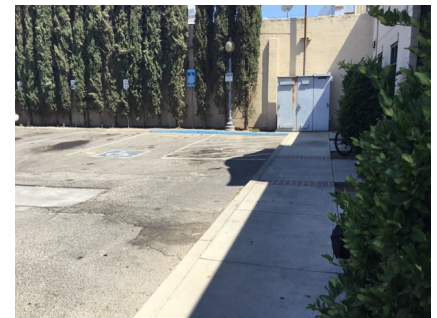
393	<ul style="list-style-type: none"> As-Built Description: Accessible parking space(s) not located close to the nearest possible entrance on an accessible route. Proposed Solution: Relocate accessible parking space(s). Notes: 	PCODE EA06 ADAAG 91 4.6.2 ADA 2010 208.3 CBC 2007 1129B.1 CBC 2019 11B-208.3.1	1	JOB	\$3,000	\$3,000
-----	---	--	---	-----	---------	---------

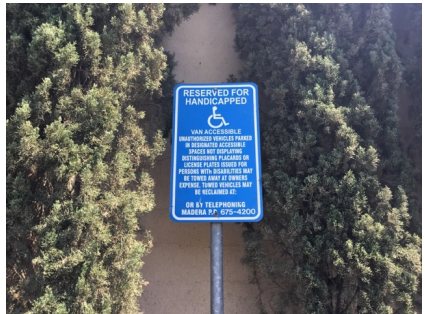
390	<ul style="list-style-type: none"> As-Built Description: CA only: Additional Sign or additional language below the symbol of accessibility stating "Minimum Fine \$250" not provided. Proposed Solution: Provide compliant parking signage that includes fine information. 	<p>PCODE EA04G</p> <p>CBC 2007 1129B.4</p> <p>CBC 2019 11B-502.6.2</p> <p>Mitigated:</p> <p><input type="radio"/> YES</p> <p><input checked="" type="radio"/> NO</p>	2	JOB	\$300	\$600
-----	--	---	---	-----	-------	-------

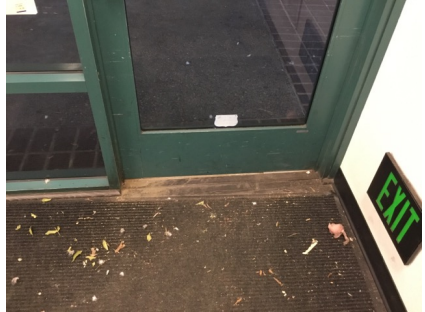
Item no., Rm no. and Name	Existing Architectural Barrier and Proposed Solution	Codes / Mitigation Info	Qty	Unit	Cost	Total
430	<ul style="list-style-type: none"> As-Built Description: Door inaccessible due to threshold or step at door exceeding 1/2". As-Built: 0.75" Proposed Solution: Modify threshold. 	PCODE ID02A ADAAG 91 4.13.8 ADA 2010 404.2.5 CBC 2007 1133B.2.4.1 CBC 2019 11B-404.2.5 Mitigated: <input type="radio"/> YES <input checked="" type="radio"/> NO	5	JOB	\$1,200	\$6,000

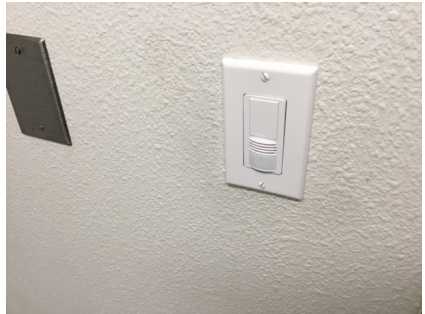
442	<ul style="list-style-type: none"> As-Built Description: Electric switch or control mounted less than 15" measured to the bottom of the outlet box or greater than 48 inches measured to the top of the outlet box. As-Built: 48.0" to switch. 49.0" to top of box. Proposed Solution: Relocate light switches or control to between 15" and 48" height. Notes: 	PCODE IC01 ADAAG 91 4.2.5 & 6 ADA 2010 308.2.1 & 308.2.2 CBC 2007 1117B.6.3 CBC 2019 11B-308.2.1 & 11B-308.2.2 Mitigated: <input type="radio"/> YES <input checked="" type="radio"/> NO	1	JOB	\$900	\$900

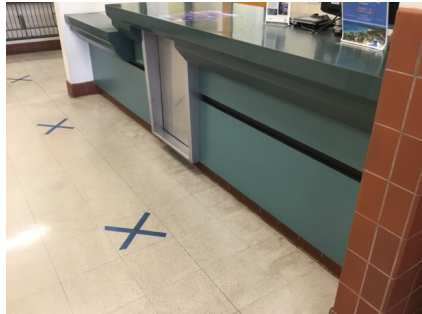
Item no., Rm no. and Name	Existing Architectural Barrier and Proposed Solution	Codes / Mitigation Info	Qty	Unit	Cost	Total
399	<ul style="list-style-type: none"> • <i>As-Built Description:</i> Protruding objects more than 4" from wall, when bottom of object more than 27" or less than 80" above finished floor. • <i>As-Built:</i> Service counter: 8.0" at 39.0" high • <i>Proposed Solution:</i> Provide cane-detectable railing to mark area of low clearance. 	PCODE EG04A ADAAG 91 4.4.1 ADA 2010 307.2 CBC 2007 1133B.8.6.1 CBC 2019 11B-307.2 Mitigated: <input type="radio"/> YES <input checked="" type="radio"/> NO	12	LF	\$300	\$3,600

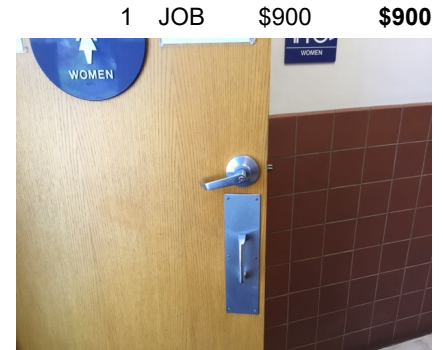
- 403 • *As-Built Description:*
Door lock, latch or handle less than 34" or more than 48" above the floor (CA only: 34" to 44").
- *As-Built:* **46.5" high**
- *Proposed Solution:*
Relocate or replace existing hardware.
- *Notes:*

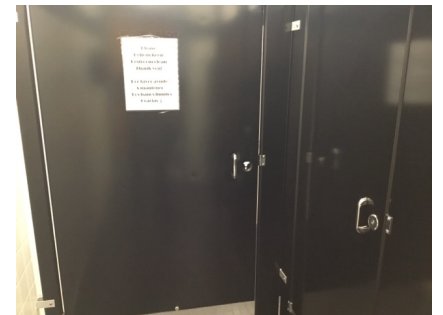
- 408 • *As-Built Description:*
Front approach: At pull side, door does not have clear and level maneuvering space measuring door width plus 18" x 60". (24" x 60" at exterior doors).
- *As-Built:* **5.0"**
- *Proposed Solution:*
Change door swing.

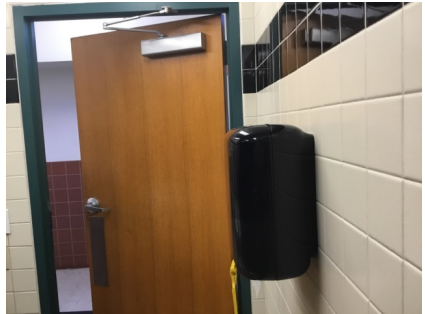
Item no., Rm no. and Name	Existing Architectural Barrier and Proposed Solution	Codes / Mitigation Info	Qty	Unit	Cost	Total
416	<ul style="list-style-type: none"> <i>As-Built Description:</i> Front approach: At push side, door does not have clear and level maneuvering space measuring door width x 48" (door width plus 12" if door has both, latch and closer). <i>Proposed Solution:</i> Relocate dispenser. 	PCODE ID24A ADAAG 91 Fig. 25(a) ADA 2010 404.2.4 CBC 2007 11B-26A(a) CBC 2019 11B-404.2.4 Mitigated: <input type="radio"/> YES <input checked="" type="radio"/> NO	1	JOB	\$150	\$150

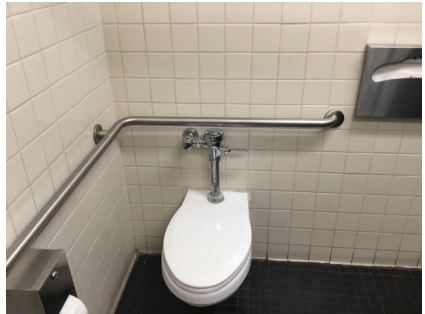
Grab Bars

413	<ul style="list-style-type: none"> <i>As-Built Description:</i> The rear wall grab is less than 36" min. or does not extend from the centerline of the water closet 12" min. on one side and 24" min. on the other side. <i>As-Built:</i> Extends 20.0" on wide side. <i>Proposed Solution:</i> Provide new accessible rear grab bar. <i>Notes:</i> 	PCODE WB07B ADAAG 91 4.17.6 ADA 2010 604.5.2 CBC 2007 1115B.4.1.3.2 CBC 2019 11B-604.5.2 Mitigated: <input type="radio"/> YES <input checked="" type="radio"/> NO	1	JOB	\$1,020	\$1,020

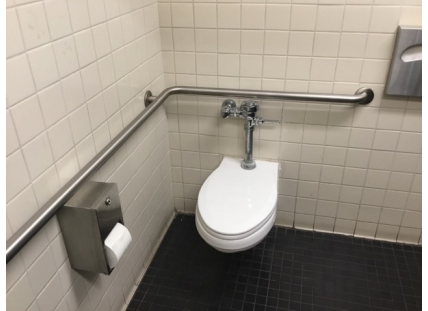
Item no., Rm no. and Name	Existing Architectural Barrier and Proposed Solution	Codes / Mitigation Info	Qty	Unit	Cost	Total
412	<ul style="list-style-type: none"> As-Built Description: Grab bars not at 33" to 36" from floor As-Built: 32.75" Proposed Solution: Relocate accessible grab bars. 	PCODE WB07C ADAAG 91 4.16.4 ADA 2010 609.4 CBC 2007 1115B.4.1.3.1 & 2 CBC 2019 11B-609.4 Mitigated: <input type="radio"/> YES <input checked="" type="radio"/> NO	1	JOB	\$780	\$780

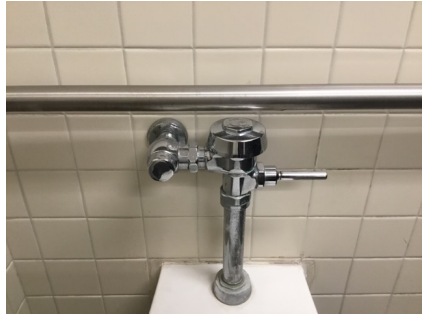
<input type="radio"/> Staff Only Priority <input checked="" type="radio"/> 3 Severity <input checked="" type="radio"/> 4			
411	<ul style="list-style-type: none"> As-Built Description: Accessories/dispensers in accessible stall located closer than 1-1/2" below or 12" above grab bar impedes its use. As-Built: 0.5 below the grab bar Proposed Solution: Relocate accessories/dispensers to be no closer than 1-1/2" below and 12" above grab bars (except if accessories are recessed, flush with wall, and have no sharp edges). 	PCODE WB07I ADAAG 91 4.26.2 ADA 2010 609.3 CBC 2007 1133B.4.2.5 CBC 2019 11B-609.3 Mitigated: <input type="radio"/> YES <input checked="" type="radio"/> NO	1	JOB	\$225	\$225

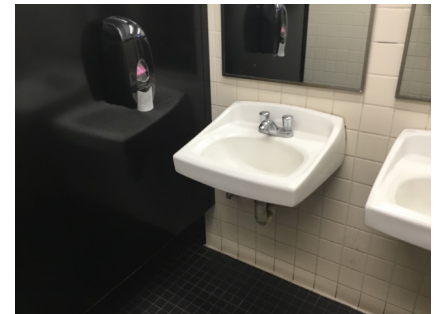
Lavatory

404	<ul style="list-style-type: none"> As-Built Description: Clear floor space, 30" x 48" in front of fixture, extending 19" max. under the lavatory, not provided (CA only: Less than 18" from side wall to centerline of lavatory). As-Built: 15.0" o.c. Proposed Solution: Relocate existing lavatory. Notes: 	PCODE WD01A ADAAG 91 4.19.3 ADA 2010 606.2 CBC 2007 1115B.4.3 CBC 2019 11B-606.2, 11B-606.6 Mitigated: <input type="radio"/> YES <input checked="" type="radio"/> NO	1	JOB	\$2,700	\$2,700
-----	---	--	---	-----	---------	---------

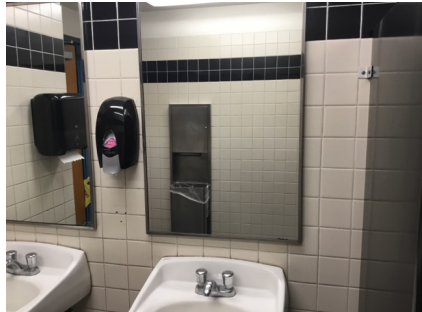
Item no., Rm no. and Name	Existing Architectural Barrier and Proposed Solution	Codes / Mitigation Info	Qty	Unit	Cost	Total
428	<ul style="list-style-type: none"> As-Built Description: Bottom of mirror located above lavatories or countertops more than 40" above floor. As-Built: 40.5" high Proposed Solution: Relocate or provide new accessible mirror. 	PCODE WG03 ADAAG 91 4.19.6 ADA 2010 603.3 CBC 2007 1115B.8.1 CBC 2019 11B-603.3 Mitigated: <input type="radio"/> YES <input checked="" type="radio"/> NO	1	JOB	\$450	\$450

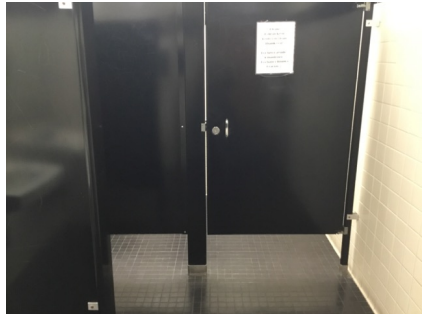
Door Swing

423	<ul style="list-style-type: none"> As-Built Description: Front approach: At pull side, door does not have clear and level maneuvering space measuring door width plus 18" x 60". (24" x 60" at exterior doors). As-Built: 15.0" Proposed Solution: Change door swing. Notes: 	PCODE ID23 ADAAG 91 Fig. 25(a) ADA 2010 404.2.4 CBC 2007 11B-26A(a) CBC 2019 11B-404.2.4 Mitigated: <input type="radio"/> YES <input checked="" type="radio"/> NO	1	JOB	\$1,500	\$1,500

Arguably, the door swings into the urinal clear floor space.

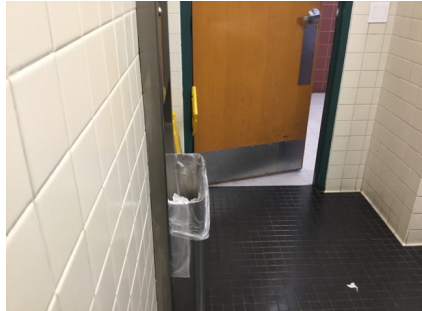
Item no., Rm no. and Name	Existing Architectural Barrier and Proposed Solution	Codes / Mitigation Info	Qty	Unit	Cost	Total
418	<ul style="list-style-type: none"> • <i>As-Built Description:</i> Front approach: At push side, door does not have clear and level maneuvering space measuring door width x 48" (door width plus 12" if door has both, latch and closer). • <i>As-Built:</i> 34.5" • <i>Proposed Solution:</i> Relocate trash can. 	PCODE ID24A ADAAG 91 Fig. 25(a) ADA 2010 404.2.4 CBC 2007 11B-26A(a) CBC 2019 11B-404.2.4 Mitigated: <input type="radio"/> YES <input checked="" type="radio"/> NO	1	JOB	\$150	\$150

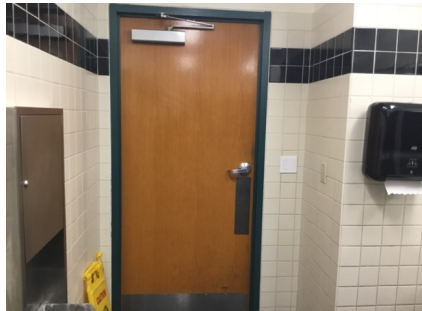
<input type="radio"/> Staff Only			
			Priority <input checked="" type="radio"/> 3			
			Severity <input checked="" type="radio"/> 2			
429	<ul style="list-style-type: none"> • <i>As-Built Description:</i> Front approach: At push side, door does not have clear and level maneuvering space measuring door width x 48" (door width plus 12" if door has both, latch and closer). • <i>Proposed Solution:</i> Provide door operator. 	PCODE ID24C ADAAG 91 Fig. 25(a) ADA 2010 404.2.4 CBC 2007 11B-26A(a) CBC 2019 11B-404.2.4 Mitigated: <input type="radio"/> YES <input checked="" type="radio"/> NO	1	JOB	\$15,000	\$15,000

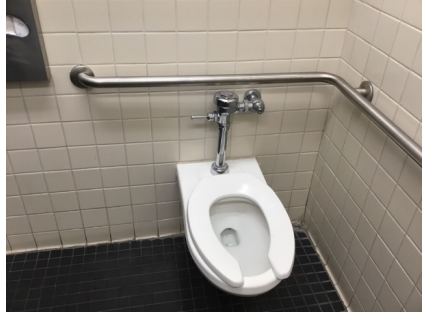
Grab Bars

<p>427</p> <ul style="list-style-type: none"> <i>As-Built Description:</i> The rear wall grab is less than 36" min. or does not extend from the centerline of the water closet 12" min. on one side and 24" min. on the other side. <i>As-Built:</i> Extends 20.0" on wide side. <i>Proposed Solution:</i> Provide new accessible rear grab bar. <i>Notes:</i> 	<p>PCODE WB07B ADAAG 91 4.17.6 ADA 2010 604.5.2 CBC 2007 1115B.4.1.3.2 CBC 2019 11B-604.5.2</p> <p>Mitigated: <input type="radio"/> YES <input checked="" type="radio"/> NO</p>	<p>1 JOB \$1,020 \$1,020</p>

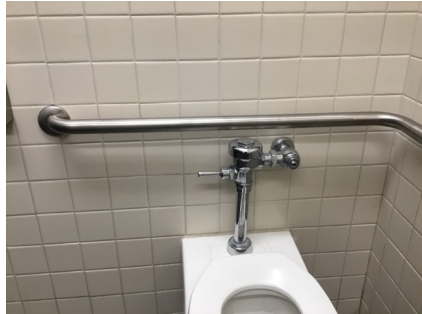
<p>425</p> <ul style="list-style-type: none"> <i>As-Built Description:</i> Accessories/dispensers in accessible stall located closer than 1-1/2" below or 12" above grab bar impedes its use. <i>As-Built:</i> 1.0" <i>Proposed Solution:</i> Relocate accessories/dispensers to be no closer than 1-1/2" below and 12" above grab bars (except if accessories are recessed, flush with wall, and have no sharp edges). 	<p>PCODE WB07I ADAAG 91 4.26.2 ADA 2010 609.3 CBC 2007 1133B.4.2.5 CBC 2019 11B-609.3</p> <p>Mitigated: <input type="radio"/> YES <input checked="" type="radio"/> NO</p>	<p>1 JOB \$225 \$225</p>

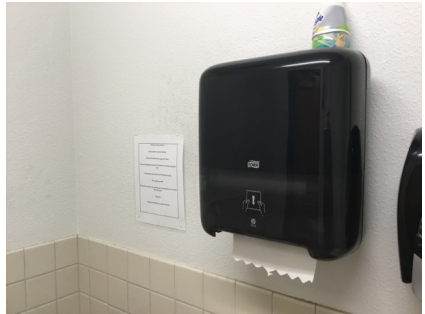
Item no., Rm no. and Name	Existing Architectural Barrier and Proposed Solution	Codes / Mitigation Info	Qty	Unit	Cost	Total
438	<ul style="list-style-type: none"> As-Built Description: Protruding objects more than 4" from wall, when bottom of object more than 27" or less than 80" above finished floor. As-Built: PTD: 8.0" at 54.0" high Proposed Solution: Remove/relocate protruding object. Patch existing surface. 	PCODE EG04 ADAAG 91 4.4.1 ADA 2010 307.2 CBC 2007 1133B.8.6.1 CBC 2019 11B-307.2 Mitigated: <input type="radio"/> YES <input checked="" type="radio"/> NO	1	JOB	\$300	\$300
