The City of Madera

Appendix B: Facilities

Access Compliance Survey Report

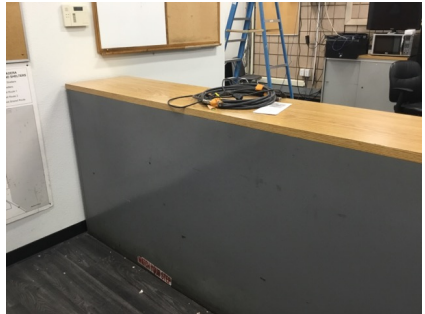
Public Counter

431	<ul style="list-style-type: none"> As-Built Description: Service counter (stand-up): Accessible section min. 36" length and 36" max. height (in CA: 28" to 34" high) not provided. As-Built: 42.0" high Proposed Solution: Retrofit existing counter to provide accessible section. Interim solution: Provide auxiliary counter, table, or clipboard. 	PCODE IN03 ADAAG 91 7.2(2) ADA 2010 904.4 CBC 2007 1122B.4 CBC 2019 11B-904.4 Mitigated: <input type="radio"/> YES <input checked="" type="radio"/> NO	1	JOB	\$6,000	\$6,000

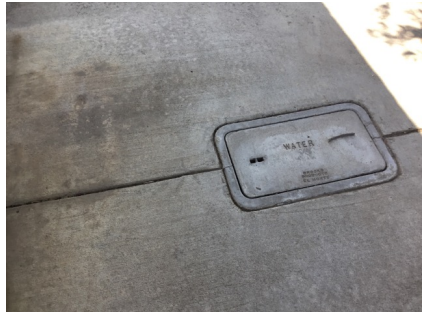
Item no., Rm no. and Name	Existing Architectural Barrier and Proposed Solution	Codes / Mitigation Info	Qty	Unit	Cost	Total
928	<ul style="list-style-type: none"> As-Built Description: Walk: opening greater than 1/2" along the line of traffic flow. As-Built: 0.75" Proposed Solution: Correct opening 1/2" max. along the line of traffic flow. 	PCODE EF04 ADAAG 91 4.3.6; 4.5.4 ADA 2010 403.2; 302.3 CBC 2007 1133B.7.2 CBC 2019 11B-403.2; 11B-302.3 Mitigated: <input type="radio"/> YES <input checked="" type="radio"/> NO	2	SF	\$240	\$480

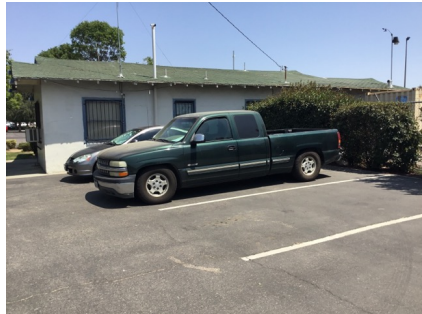
Minimum Number

929	<ul style="list-style-type: none"> As-Built Description: At parking lot with 1-25 spaces, the number of accessible spaces is less than required by code; 1 space required Proposed Solution: Provide required accessible parking space with sign including a minimum of one van space. Notes: 	PCODE EA01A ADAAG 91 4.1.2(5) ADA 2010 208.2 CBC 2007 Tbl. 11B-6 CBC 2019 11B-208.2 Tbl. 11B-208.2 Mitigated: <input type="radio"/> YES <input checked="" type="radio"/> NO	1	JOB	\$900	\$900

No accessible parking provided.

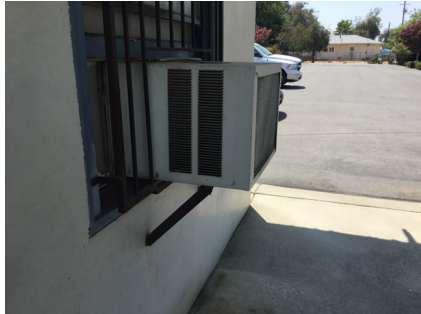
Protrusion Limits

926	<ul style="list-style-type: none"> <i>As-Built Description:</i> Protruding objects more than 4" from wall, when bottom of object more than 27" or less than 80" above finished floor. <i>As-Built:</i> AC unit: 18.0" at 39.0" high <i>Proposed Solution:</i> Remove/relocate protruding object. Patch existing surface. 	<p>PCODE EG04</p> <p>ADAAG 91 4.4.1</p> <p>ADA 2010 307.2</p> <p>CBC 2007 1133B.8.6.1</p> <p>CBC 2019 11B-307.2</p> <p>Mitigated:</p> <p><input type="radio"/> YES</p> <p><input checked="" type="radio"/> NO</p>	1	JOB	\$300	\$300
-----	--	--	---	-----	-------	-------

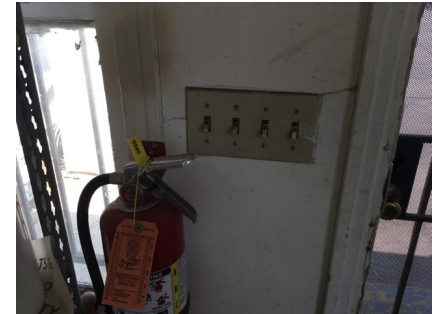
Electrical

919	<ul style="list-style-type: none"> As-Built Description: Electric switch or control mounted less than 15" measured to the bottom of the outlet box or greater than 48 inches measured to the top of the outlet box. As-Built: 49.0" to top of box Proposed Solution: Relocate light switches or control to between 15" and 48" height. Notes: 	PCODE IC01 ADAAG 91 4.2.5 & 6 ADA 2010 308.2.1 & 308.2.2 CBC 2007 1117B.6.3 CBC 2019 11B-308.2.1 & 11B-308.2.2 Mitigated: <input type="radio"/> YES <input checked="" type="radio"/> NO	6	JOB	\$900	\$5,400
-----	--	--	---	-----	-------	---------

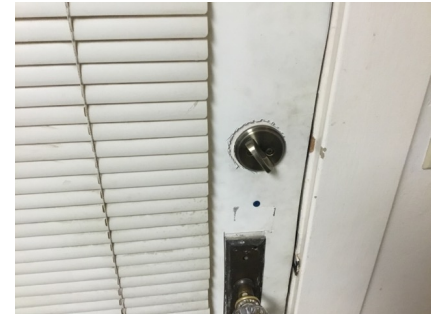
- 907
- *As-Built Description:*
Door lock, latch or handle less than 34" or more than 48" above the floor (CA only: 34" to 44").
 - *As-Built:* **48.0" high**
 - *Proposed Solution:*
Relocate or replace existing hardware.
 - *Notes:*

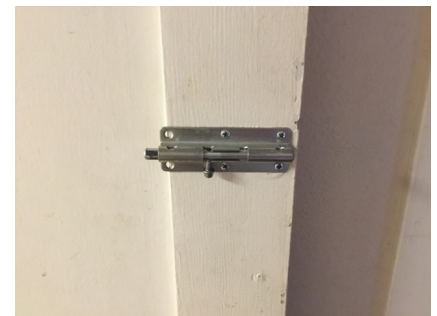
- 908
- *As-Built Description:*
Door lock, latch or handle less than 34" or more than 48" above the floor (CA only: 34" to 44").
 - *As-Built:* **54.0" high**
 - *Proposed Solution:*
Relocate or replace existing hardware.

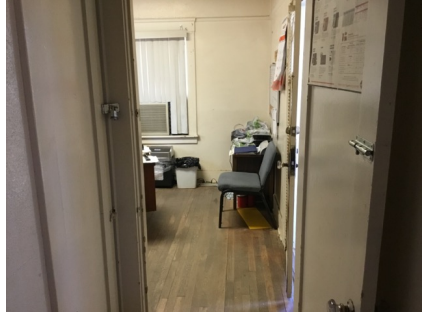
Door Swing

<p>909</p> <ul style="list-style-type: none"> • <i>As-Built Description:</i> Front approach: At pull side, door does not have clear and level maneuvering space measuring door width plus 18" x 60". (24" x 60" at exterior doors). • <i>As-Built:</i> 6.0" • <i>Proposed Solution:</i> Remove the door. 	<p>PCODE ID23 ADAAG 91 Fig. 25(a) ADA 2010 404.2.4 CBC 2007 11B-26A(a) CBC 2019 11B-404.2.4</p> <p>Mitigated:</p> <p><input type="radio"/> YES <input checked="" type="radio"/> NO</p>	<p>1 JOB \$1,500 \$1,500</p>

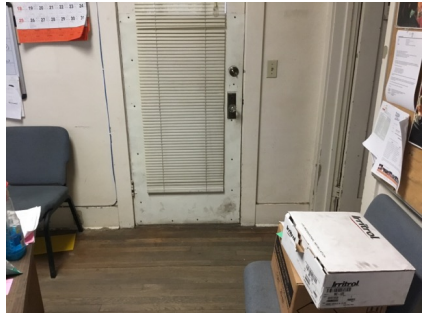
<p>906</p> <ul style="list-style-type: none"> • <i>As-Built Description:</i> Front approach: At pull side, door does not have clear and level maneuvering space measuring door width plus 18" x 60". (24" x 60" at exterior doors). • <i>Proposed Solution:</i> Remove or relocate furniture or storage items. 	<p>PCODE ID23A ADAAG 91 Fig. 25(a) ADA 2010 404.2.4 CBC 2007 11B-26A(a) CBC 2019 11B-404.2.4</p> <p>Mitigated:</p> <p><input type="radio"/> YES <input checked="" type="radio"/> NO</p>	<p>1 JOB \$150 \$150</p>

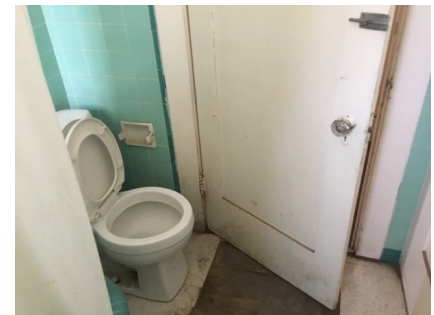
Single accommodation restroom not accessible; multiple compliance violations.

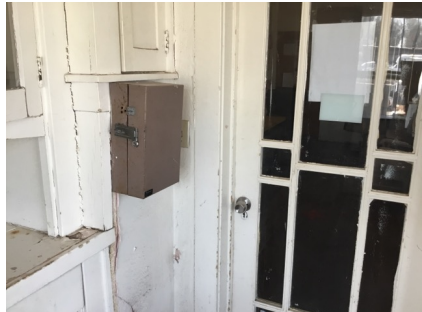
Item no., Rm no. and Name	Existing Architectural Barrier and Proposed Solution	Codes / Mitigation Info	Qty	Unit	Cost	Total
914	<ul style="list-style-type: none"> As-Built Description: Protruding objects more than 4" from wall, when bottom of object more than 27" or less than 80" above finished floor. As-Built: Drop box: 5.0" at 42.0" high Proposed Solution: Remove/relocate protruding object. Patch existing surface. 	PCODE EG04 ADAAG 91 4.4.1 ADA 2010 307.2 CBC 2007 1133B.8.6.1 CBC 2019 11B-307.2 Mitigated: <input type="radio"/> YES <input checked="" type="radio"/> NO	1	JOB	\$300	\$300

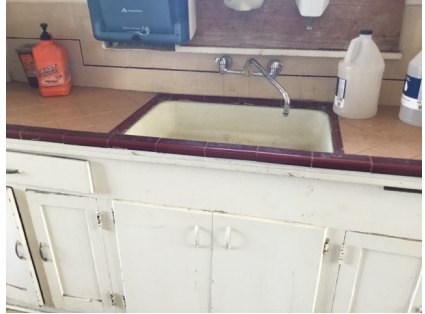
Item no., Rm no. and Name	Existing Architectural Barrier and Proposed Solution	Codes / Mitigation Info	Qty	Unit	Cost	Total
915	<p>Sink</p> <ul style="list-style-type: none"> As-Built Description: Sink rim higher than 34" above floor. As-Built: 36.5" high Proposed Solution: Remodel sink cabinet to lower sink. 	<p>PCODE IN06 ADAAG 91 4.24.2 ADA 2010 606.3 CBC 2007 1115B.4.7.1 CBC 2019 11B-606.3</p> <p>Mitigated: <input type="radio"/> YES <input checked="" type="radio"/> NO</p>	1	JOB	\$5,250	\$5,250

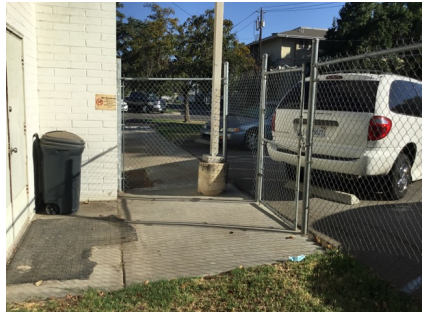
The slope is also noncompliant as a ramp.

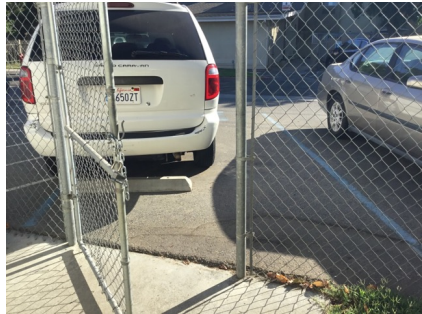
Item no., Rm no. and Name	Existing Architectural Barrier and Proposed Solution	Codes / Mitigation Info	Qty	Unit	Cost	Total
955	<ul style="list-style-type: none"> As-Built Description: Front approach: At push side, door does not have clear and level maneuvering space measuring door width x 48" (door width plus 12" if door has both, latch and closer). Proposed Solution: Remove or relocate furniture or storage items. 	PCODE ID24A ADAAG 91 Fig. 25(a) ADA 2010 404.2.4 CBC 2007 11B-26A(a) CBC 2019 11B-404.2.4 Mitigated: <input type="radio"/> YES <input checked="" type="radio"/> NO	1	JOB	\$150	\$150

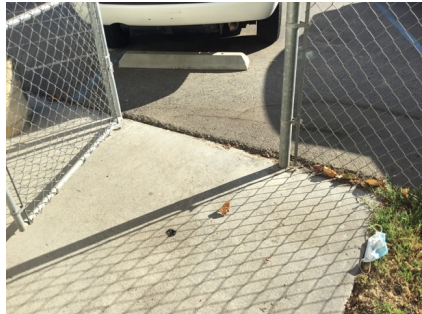
Door Threshold

953	<ul style="list-style-type: none"> As-Built Description: Door inaccessible due to threshold or step at door exceeding 1/2". As-Built: 2.0" Proposed Solution: Modify threshold. 	PCODE ID02A ADAAG 91 4.13.8 ADA 2010 404.2.5 CBC 2007 1133B.2.4.1 CBC 2019 11B-404.2.5 Mitigated: <input type="radio"/> YES <input checked="" type="radio"/> NO	1	JOB	\$1,200	\$1,200

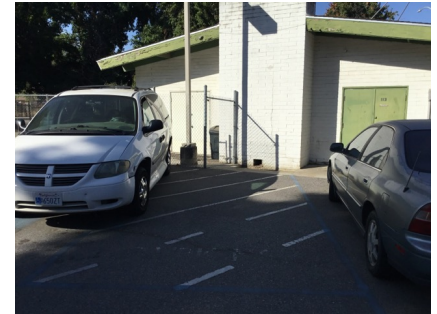
- 961
- *As-Built Description:*
Sign for accessible parking space is missing or non-compliant.
 - *Proposed Solution:*
Provide compliant parking signage.

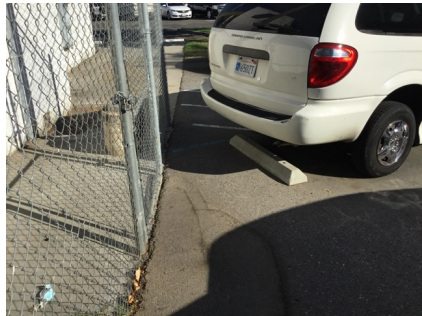
<input type="radio"/> Staff Only			
			Priority <input checked="" type="radio"/> 1			
			Severity <input checked="" type="radio"/> 4			
958	<ul style="list-style-type: none"> As-Built Description: Wheel stops provided do not effectively prevent the encroachment of vehicles over the required clear width of an adjacent accessible route. Proposed Solution: Adjust wheel stops to effectively prevent encroachment. 	PCODE EA04J CBC 2019 11B-502.7.2 Mitigated: <input type="radio"/> YES <input checked="" type="radio"/> NO	1	JOB	\$225	\$225

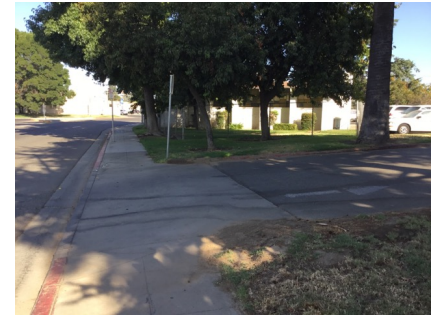
Parking Signage

963	<ul style="list-style-type: none"> <i>As-Built Description:</i> No "Tow Away" sign at parking lot entrance (required in CA only). <i>Proposed Solution:</i> Provide "Tow Away" sign at parking lot entrance when altering area. 	<p>PCODE EA04C</p> <p>CBC 2007 1129B.4</p> <p>CBC 2019 11B-502.8.2</p> <p>Mitigated:</p> <p><input type="radio"/> YES</p> <p><input checked="" type="radio"/> NO</p>	3	JOB	\$975	\$2,925
-----	---	---	---	-----	-------	---------

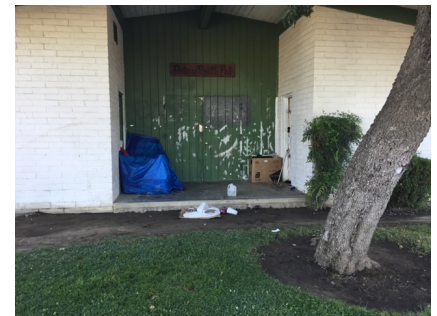
Signage

962	<ul style="list-style-type: none"> <i>As-Built Description:</i> Exterior signage at inaccessible entrances to provide direction to accessible entrances is missing or noncompliant. <i>Proposed Solution:</i> Provide signage sufficient to guide persons to accessible entrances. 	<p>PCODE SA01</p> <p>ADAAG 91 4.1.2(7)(c)</p> <p>ADA 2010 216.6</p> <p>CBC 2007 1117B.5.8.1.2</p> <p>CBC 2019 11B-216.6</p> <p>Mitigated:</p> <p><input type="radio"/> YES</p> <p><input checked="" type="radio"/> NO</p>	1	JOB	\$690	\$690
-----	--	--	---	-----	-------	-------

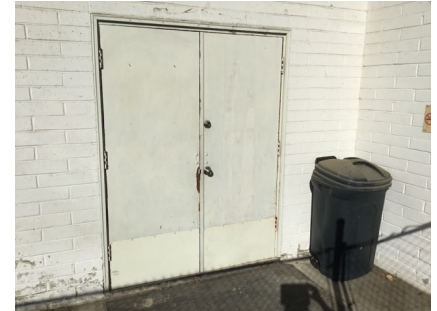
Item no., Rm no. and Name	Existing Architectural Barrier and Proposed Solution	Codes / Mitigation Info	Qty	Unit	Cost	Total
957	<ul style="list-style-type: none"> As-Built Description: Sign showing the International Symbol of Accessibility (ISA) not provided at all accessible building entrances. Proposed Solution: Provide building entrance signage with ISA signage at accessible entrance. Notes: 	PCODE SA12A ADAAG 91 28 CFR 35.163 ADA 2010 (b) 216.6 CBC 2007 1127B.3 CBC 2019 11B-216.6 Mitigated: <input type="radio"/> YES <input checked="" type="radio"/> NO	1	JOB	\$150	\$150

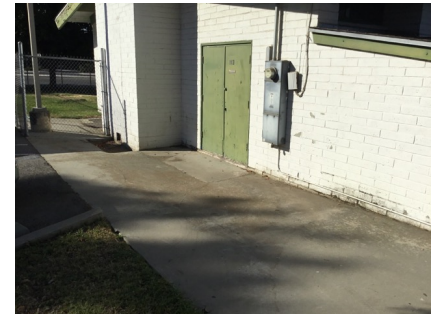
Walk

956	<ul style="list-style-type: none"> As-Built Description: Walk: Slope greater than 1:20 (5.0%), and walk does not comply with requirements for ramps. As-Built: 10.0% Proposed Solution: Modify walk/sidewalk slope to 1:20 or less. Or install directional signage. 	PCODE EF01 ADAAG 91 4.3.7 ADA 2010 403.3 CBC 2007 1133B.7.3 CBC 2019 11B-403.3 Mitigated: <input type="radio"/> YES <input checked="" type="radio"/> NO	50	SF	\$75	\$3,750
-----	---	---	----	----	------	---------

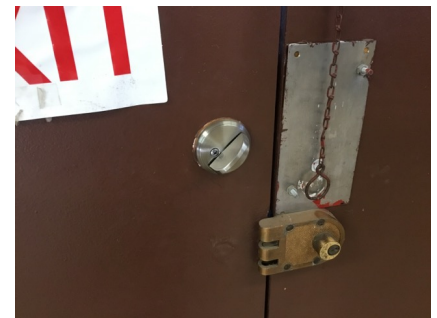
- 936
- *As-Built Description:*
Door lock, latch or handle less than 34" or more than 48" above the floor (CA only: 34" to 44").
 - *As-Built:* **52.0" high**
 - *Proposed Solution:*
Relocate or replace existing hardware.

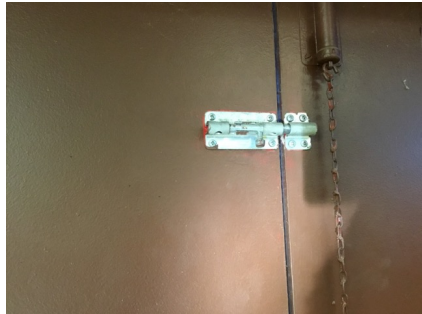
Item no., Rm no. and Name	Existing Architectural Barrier and Proposed Solution	Codes / Mitigation Info	Qty	Unit	Cost	Total
937	<ul style="list-style-type: none"> • <i>As-Built Description:</i> Door lock, latch or handle less than 34" or more than 48" above the floor (CA only: 34" to 44"). • <i>As-Built:</i> 71.0" high • <i>Proposed Solution:</i> Relocate or replace existing hardware. 	<p>PCODE ID17 ADAAG 91 4.13.9 ADA 2010 404.2.7 CBC 2007 1133B.2.5.2 CBC 2019 11B-404.2.7</p> <p>Mitigated: <input type="radio"/> YES <input checked="" type="radio"/> NO</p>	1	JOB	\$900	\$900

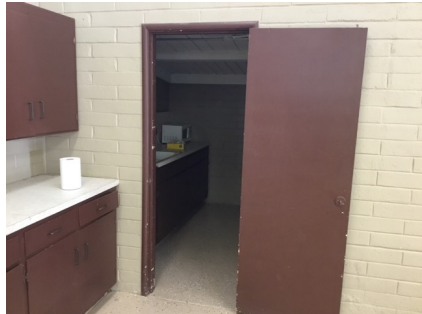
Door Clearance

938	<ul style="list-style-type: none"> • <i>As-Built Description:</i> Door on accessible route has less than 32" clear and 80" (78" min. to closer if provided) opening width when 90° open. • <i>As-Built:</i> 25.0" to 28.0" clear • <i>Proposed Solution:</i> Provide new, larger door and frame with new accessible hardware. • <i>Notes:</i> 	<p>PCODE ID01 ADAAG 91 4.13.5 ADA 2010 404.2.3 CBC 2007 1133B.1.1.1.1 CBC 2019 11B-404.2.3</p> <p>Mitigated: <input type="radio"/> YES <input checked="" type="radio"/> NO</p>	7	JOB	\$7,800	\$54,600

Includes rear exit doors.

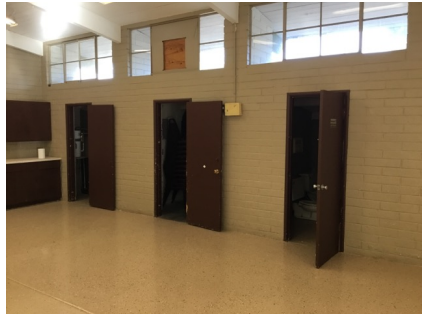
Item no., Rm no. and Name	Existing Architectural Barrier and Proposed Solution	Codes / Mitigation Info	Qty	Unit	Cost	Total
939	<ul style="list-style-type: none"> • <i>As-Built Description:</i> Door on accessible route has less than 32" clear and 80" (78" min. to closer if provided) opening width when 90° open. • <i>As-Built:</i> 78.25" high • <i>Proposed Solution:</i> Provide new, larger door and frame with new accessible hardware. 	PCODE ID01 ADAAG 91 4.13.5 ADA 2010 404.2.3 CBC 2007 1133B.1.1.1.1 CBC 2019 11B-404.2.3 Mitigated: <input type="radio"/> YES <input checked="" type="radio"/> NO	5	JOB	\$7,800	\$39,000

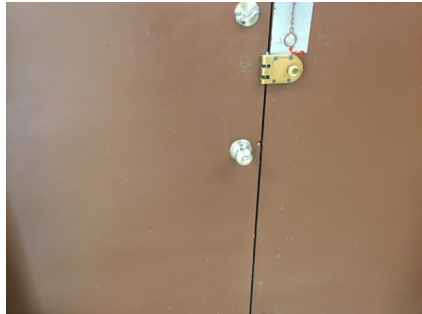
Door Hardware

935	<ul style="list-style-type: none"> • <i>As-Built Description:</i> Door does not have accessible operating hardware. • <i>Proposed Solution:</i> Provide lever handle or other accessible hardware. 	PCODE ID07 ADAAG 91 4.13.9 ADA 2010 404.2.7 CBC 2007 1133B.2.5.2 CBC 2019 11B-404.2.7 Mitigated: <input type="radio"/> YES <input checked="" type="radio"/> NO	9	JOB	\$450	\$4,050

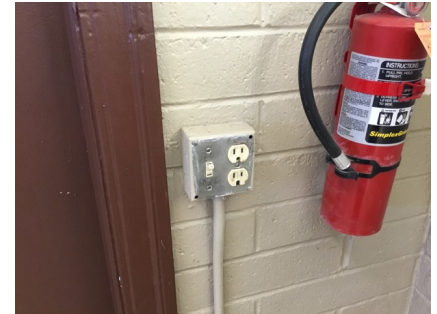
Electrical

932	<ul style="list-style-type: none"> As-Built Description: Electric switch or control mounted less than 15" measured to the bottom of the outlet box or greater than 48 inches measured to the top of the outlet box. As-Built: 50.5" to top of box Proposed Solution: Relocate light switches or control to between 15" and 48" height. Notes: 	PCODE IC01 ADAAG 91 4.2.5 & 6 ADA 2010 308.2.1 & 308.2.2 CBC 2007 1117B.6.3 CBC 2019 11B-308.2.1 & 11B-308.2.2 Mitigated: <input type="radio"/> YES <input checked="" type="radio"/> NO	2	JOB	\$900	\$1,800
-----	--	--	---	-----	-------	---------

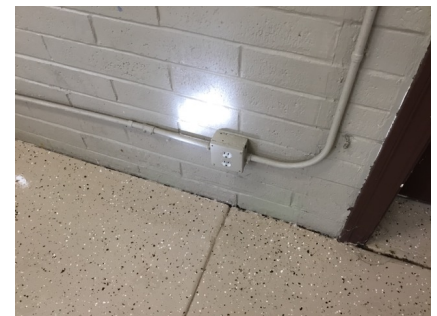
933	<ul style="list-style-type: none"> As-Built Description: Electric switch or control mounted less than 15" measured to the bottom of the outlet box or greater than 48 inches measured to the top of the outlet box. As-Built: 14.0" to the high plug 11.0" to bottom of box Proposed Solution: Relocate light switches or control to between 15" and 48" height. Notes: 	PCODE IC01 ADAAG 91 4.2.5 & 6 ADA 2010 308.2.1 & 308.2.2 CBC 2007 1117B.6.3 CBC 2019 11B-308.2.1 & 11B-308.2.2 Mitigated: <input type="radio"/> YES <input checked="" type="radio"/> NO	2	JOB	\$900	\$1,800
-----	---	--	---	-----	-------	---------

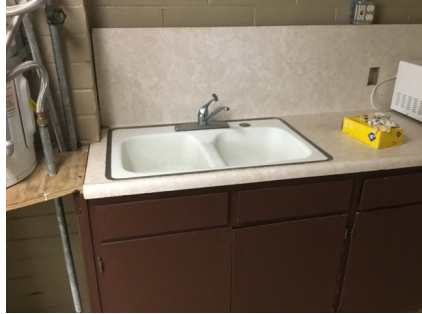
Item no., Rm no. and Name	Existing Architectural Barrier and Proposed Solution	Codes / Mitigation Info	Qty	Unit	Cost	Total
946	<p>Sink</p> <ul style="list-style-type: none"> As-Built Description: Sink rim higher than 34" above floor. As-Built: 36.5" high Proposed Solution: Remodel sink cabinet to lower sink. 	<p>PCODE IN06 ADAAG 91 4.24.2 ADA 2010 606.3 CBC 2007 1115B.4.7.1 CBC 2019 11B-606.3</p> <p>Mitigated: <input type="radio"/> YES <input checked="" type="radio"/> NO</p>	1	JOB	\$5,250	\$5,250

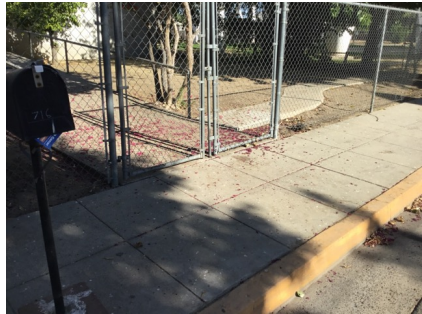
Item no., Rm no. and Name	Existing Architectural Barrier and Proposed Solution	Codes / Mitigation Info	Qty	Unit	Cost	Total
167	<ul style="list-style-type: none"> As-Built Description: Surface of required maneuvering clearance at door slopes more than 1/4":12" (2.0%). As-Built: 3.5% Proposed Solution: Modify surface slope at door. 	PCODE ID11 ADAAG 91 4.13.6 ADA 2010 404.2.4.4 CBC 2007 1133B.2.4 CBC 2019 11B-404.2.4 Mitigated: <input type="radio"/> YES <input checked="" type="radio"/> NO	25	SF	\$120	\$3,000

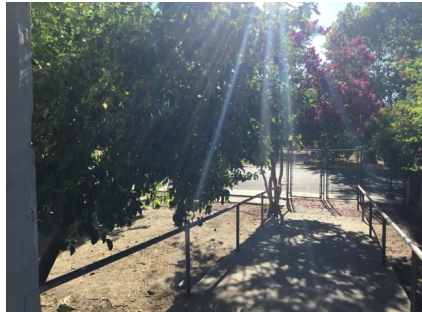
Item no., Rm no. and Name	Existing Architectural Barrier and Proposed Solution	Codes / Mitigation Info	Qty	Unit	Cost	Total
161	<ul style="list-style-type: none"> As-Built Description: Protruding objects more than 4" from wall, when bottom of object more than 27" or less than 80" above finished floor. Proposed Solution: Trim vegetation. 	PCODE EG04 ADAAG 91 4.4.1 ADA 2010 307.2 CBC 2007 1133B.8.6.1 CBC 2019 11B-307.2 Mitigated: <input type="radio"/> YES <input checked="" type="radio"/> NO	2	JOB	\$300	\$600

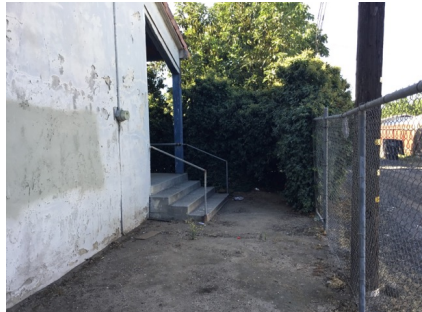
159	<ul style="list-style-type: none"> As-Built Description: Exterior signage at inaccessible entrances to provide direction to accessible entrances is missing or noncompliant. Proposed Solution: Provide signage sufficient to guide persons to accessible entrances. Notes: 	PCODE SA01 ADAAG 91 4.1.2(7)(c) ADA 2010 216.6 CBC 2007 1117B.5.8.1.2 CBC 2019 11B-216.6 Mitigated: <input type="radio"/> YES <input checked="" type="radio"/> NO	1	JOB	\$690	\$690

Place outside fence and at either end of alley.

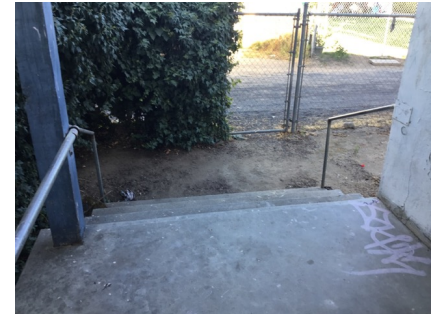
157	<ul style="list-style-type: none"> As-Built Description: Exterior stair substantially out of compliance. As-Built: Uneven risers, handrails etc. Proposed Solution: Provide complete new stair, 4 ft. wide with landing and handrails. 	PCODE EC09 ADAAG 91 4.9 ADA 2010 504 CBC 2007 1133B.4 CBC 2019 11B-504	40	IN	\$270	\$10,800
-----	--	--	----	----	-------	----------

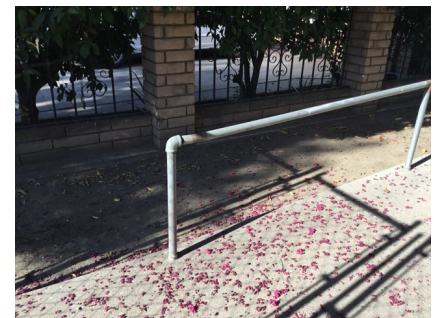
162	<ul style="list-style-type: none"> As-Built Description: Ramp handrail does not extend horizontally 12" past top and / or bottom of ramp. Proposed Solution: Provide ramp handrail extension (cost for each extension piece). 	PCODE ED05 ADAAG 91 4.8.5(2) ADA 2010 505.10.1 CBC 2007 1133B.4.2.2 & 1133B.5.5.1 CBC 2019 11B-505.10.1	4	JOB	\$510	\$2,040
-----	---	---	---	-----	-------	---------

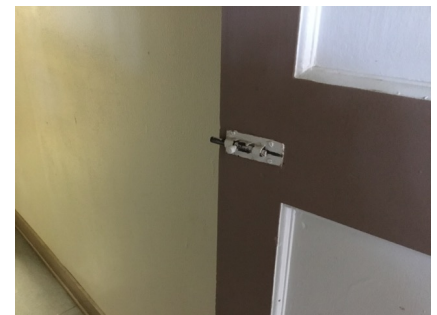
- 138
- *As-Built Description:*
Door lock, latch or handle less than 34" or more than 48" above the floor (CA only: 34" to 44").
 - *As-Built:* **52.0" high**
 - *Proposed Solution:*
Relocate or replace existing hardware.

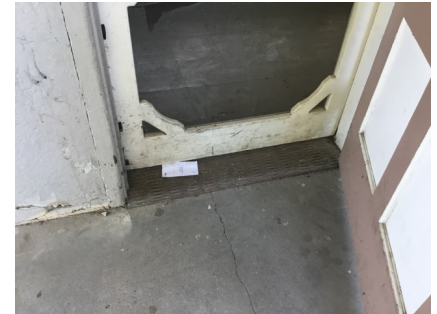
- 143
- *As-Built Description:*
Existing threshold at door is 1/2" high or less but without a beveled edge on both sides.
 - *As-Built:* **Not beveled properly.**
 - *Proposed Solution:*
Replace threshold.

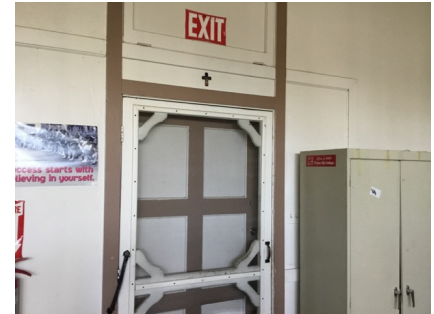
137	<ul style="list-style-type: none"> <i>As-Built Description:</i> At door leading into exit stairway: Where required exit signs are installed, signs to provide exiting information for people with vision impairment are not provided. <i>Proposed Solution:</i> Provide raised letter/Braille "EXIT RAMP/STAIR DOWN" sign at door. 	<p>PCODE SA10B ADAAG 91 4.1.3(16) ADA 2010 216.4.1 CBC 2007 1011.3 CBC 2019 11B-216.4.1</p> <p>Mitigated: <input type="radio"/> YES <input checked="" type="radio"/> NO</p>	2	JOB	\$270	\$540
-----	--	--	---	-----	-------	-------

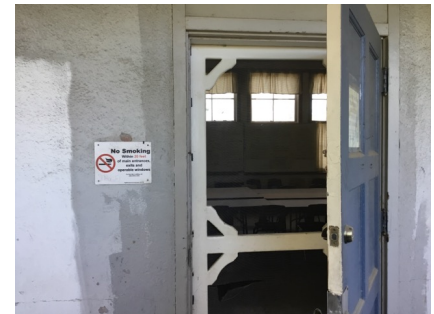
153	<ul style="list-style-type: none"> <i>As-Built Description:</i> Existing sign designating permanent room or space is noncompliant. <i>Proposed Solution:</i> Provide compliant signage. 	<p>PCODE SA13 ADAAG 91 4.1.3(16)(a) ADA 2010 216.2 CBC 2007 1117B.5 CBC 2019 11B-216.2</p> <p>Mitigated: <input type="radio"/> YES <input checked="" type="radio"/> NO</p>	7	JOB	\$450	\$3,150
-----	---	---	---	-----	-------	---------

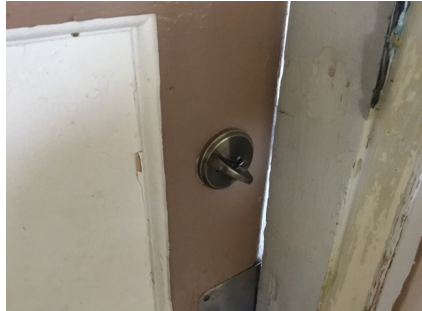
Item no., Rm no. and Name	Existing Architectural Barrier and Proposed Solution	Codes / Mitigation Info	Qty	Unit	Cost	Total
139	<ul style="list-style-type: none"> As-Built Description: Door lock, latch or handle less than 34" or more than 48" above the floor (CA only: 34" to 44"). As-Built: 50.0" high Proposed Solution: Relocate or replace existing hardware. 	PCODE ID17 ADAAG 91 4.13.9 ADA 2010 404.2.7 CBC 2007 1133B.2.5.2 CBC 2019 11B-404.2.7 Mitigated: <input type="radio"/> YES <input checked="" type="radio"/> NO	1	JOB	\$900	\$900

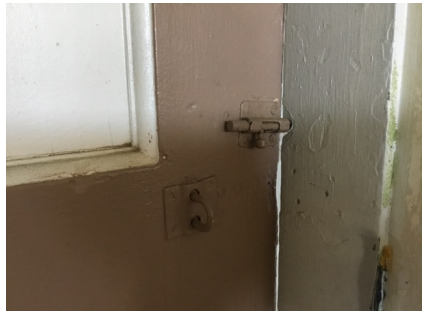
<input type="radio"/> Staff Only			
			Priority <input checked="" type="radio"/> 2			
			Severity <input checked="" type="radio"/> 3			
140	<ul style="list-style-type: none"> As-Built Description: Door lock, latch or handle less than 34" or more than 48" above the floor (CA only: 34" to 44"). As-Built: 59.5" high Proposed Solution: Relocate or replace existing hardware. 	PCODE ID17 ADAAG 91 4.13.9 ADA 2010 404.2.7 CBC 2007 1133B.2.5.2 CBC 2019 11B-404.2.7 Mitigated: <input type="radio"/> YES <input checked="" type="radio"/> NO	1	JOB	\$900	\$900

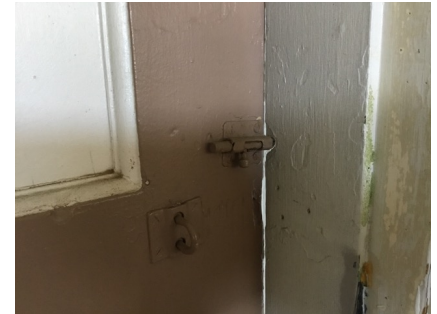
- 141
- *As-Built Description:*
Operable part(s) require tight grasping, pinching, or twisting of the wrist with one hand.
 - *Proposed Solution:*
Modify or replace the operable part(s) to not require tight grasping, pinching, or twisting of the wrist with one hand.

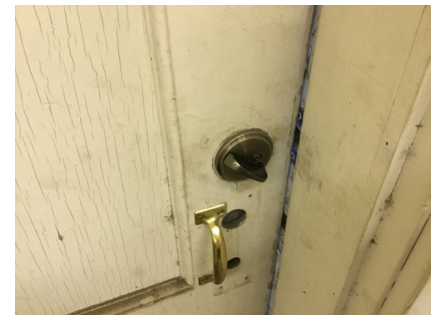
144 • *As-Built Description:*
 Operable part(s) require tight grasping, pinching, or twisting of the wrist with one hand.
 • *As-Built:* **10 lbs**
 • *Proposed Solution:*
 Modify or replace the operable part(s) to not require tight grasping, pinching, or twisting of the wrist with one hand.

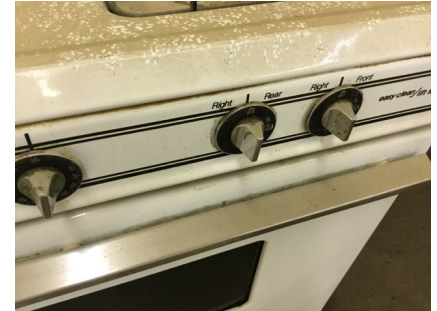
Item no., Rm no. and Name	Existing Architectural Barrier and Proposed Solution	Codes / Mitigation Info	Qty	Unit	Cost	Total
147	<ul style="list-style-type: none"> As-Built Description: Operable part(s) require tight grasping, pinching, or twisting of the wrist with one hand. Proposed Solution: Modify or replace the operable part(s) to not require tight grasping, pinching, or twisting of the wrist with one hand. 	PCODE IC02 ADAAG 91 4.27.4 ADA 2010 309.4 CBC 2007 1117B.6.4 CBC 2019 11B-309.4 Mitigated: <input type="radio"/> YES <input checked="" type="radio"/> NO	1	JOB	\$900	\$900

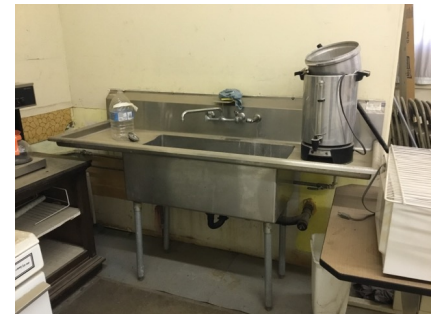
146	<ul style="list-style-type: none"> As-Built Description: Sink rim higher than 34" above floor. As-Built: 37.0" high Proposed Solution: Remodel sink cabinet to lower sink. 	PCODE IN06 ADAAG 91 4.24.2 ADA 2010 606.3 CBC 2007 1115B.4.7.1 CBC 2019 11B-606.3 Mitigated: <input type="radio"/> YES <input checked="" type="radio"/> NO	1	JOB	\$5,250	\$5,250
-----	---	--	---	-----	---------	---------

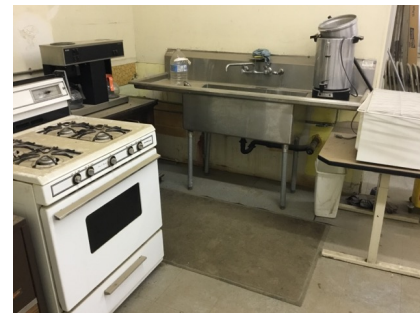
Item no., Rm no. and Name	Existing Architectural Barrier and Proposed Solution	Codes / Mitigation Info	Qty	Unit	Cost	Total
145	<ul style="list-style-type: none"> As-Built Description: Sink does not have knee space min. 27" high x 19" deep x 30" wide. Proposed Solution: Remodel sink cabinet. 	PCODE IN06A ADAAG 91 4.24.3 ADA 2010 606.2 CBC 2007 1115B.4.7.1 CBC 2019 11B-606.2 Mitigated: <input type="radio"/> YES <input checked="" type="radio"/> NO	1	JOB	\$5,250	\$5,250

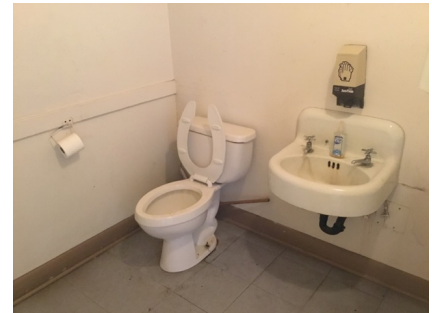
- 152
- *As-Built Description:*
Single accommodation restroom not accessible; multiple compliance violations.
 - *As-Built:* **72.0" x 81.0"**
 - *Proposed Solution:*
Remodel area to provide single-occupant accessible restroom.

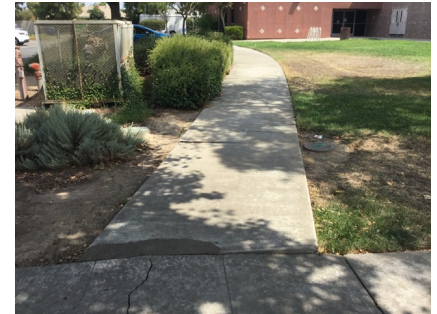
- 1365
- As-Built Description:*
Walk: Pavement dislocation creates abrupt change in level exceeding 1/2" in accessible route.
 - As-Built:* **Up to 3.0"**
 - Proposed Solution:*
Remove, replace or repair area of pavement sufficient to correct abrupt change in level.

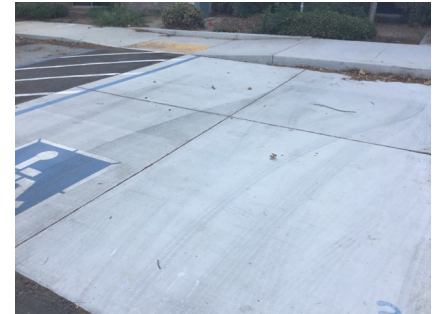
1262	<ul style="list-style-type: none"> As-Built Description: Accessible parking space has slope greater than 1/4":12" (2%). As-Built: 2.9% Proposed Solution: Modify slope at accessible parking space. 	PCODE EA05 ADAAG 91 4.6.3 ADA 2010 502.4 CBC 2007 1129B.3.3 CBC 2019 11B-502.4 Mitigated: <input type="radio"/> YES <input checked="" type="radio"/> NO	16	SF	\$36	\$576
------	---	---	----	----	------	-------

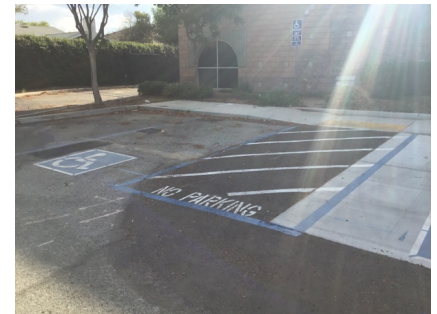
1263	<ul style="list-style-type: none"> As-Built Description: Accessible parking space has slope greater than 1/4":12" (2%). As-Built: 4.0% Proposed Solution: Modify slope at accessible parking space. 	PCODE EA05 ADAAG 91 4.6.3 ADA 2010 502.4 CBC 2007 1129B.3.3 CBC 2019 11B-502.4 Mitigated: <input type="radio"/> YES <input checked="" type="radio"/> NO	200	SF	\$36	\$7,200
------	---	---	-----	----	------	---------

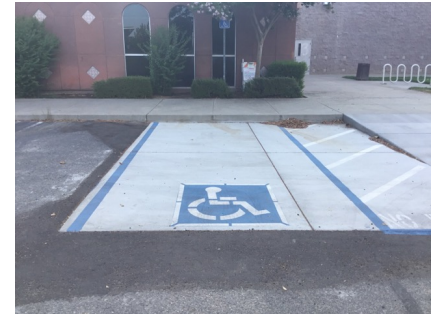
1259	<ul style="list-style-type: none"> As-Built Description: Accessible parking space smaller than 8' wide (CA only: 9' x 18'). As-Built: 107.5" wide Proposed Solution: Modify parking space(s) to create accessible space. 	PCODE EA02A ADAAG 91 4.6.3 ADA 2010 502.2 CBC 2007 1129B.3.1 CBC 2019 11B-502.2	1	JOB	\$600	\$600
------	--	---	---	-----	-------	-------

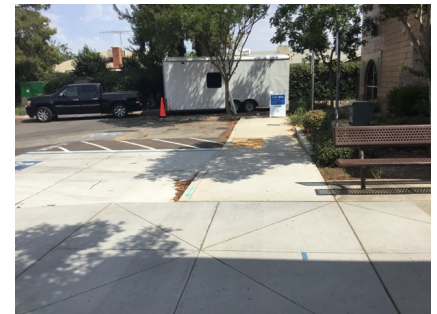
1364	<ul style="list-style-type: none"> As-Built Description: Wheel stops not provided to prevent the encroachment of vehicles over the required clear width of an adjacent accessible route. Proposed Solution: Provide wheel stops to prevent encroachment. Notes: 	PCODE EA04L CBC 2019 11B-502.7.2	1	JOB	\$225	\$225
------	--	-------------------------------------	---	-----	-------	-------

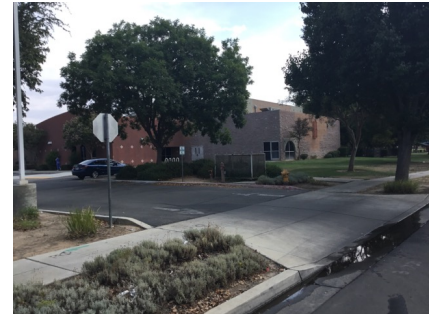
1371	<ul style="list-style-type: none"> <i>As-Built Description:</i> No "Tow Away" sign at parking lot entrance (required in CA only). <i>Proposed Solution:</i> Provide "Tow Away" sign at parking lot entrance when altering area. 	<p>PCODE EA04C</p> <p>CBC 2007 1129B.4</p> <p>CBC 2019 11B-502.8.2</p> <p>Mitigated:</p> <p><input type="radio"/> YES</p> <p><input checked="" type="radio"/> NO</p>	2	JOB	\$975	\$1,950
------	---	---	---	-----	-------	---------

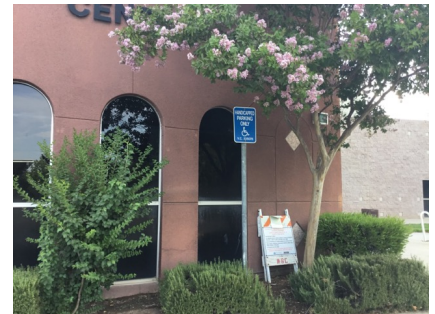
1260	<ul style="list-style-type: none"> <i>As-Built Description:</i> Sign relating to parking privileges for disabled persons is non-compliant. <i>Proposed Solution:</i> Provide compliant parking signage that does not contain the word "Handicapped". 	<p>PCODE EA04F</p> <p>ADA 2010 502.6</p> <p>CBC 2007 VC §22511.9.</p> <p>CBC 2019 11B-502.6</p> <p>Mitigated:</p> <p><input type="radio"/> YES</p> <p><input checked="" type="radio"/> NO</p>	2	JOB	\$300	\$600
------	--	--	---	-----	-------	-------

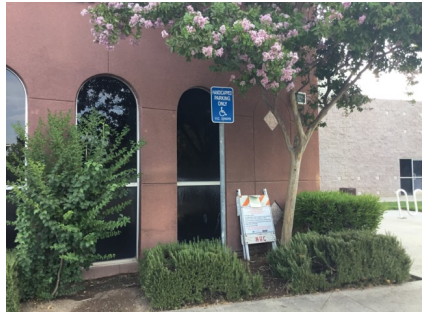
Item no., Rm no. and Name	Existing Architectural Barrier and Proposed Solution	Codes / Mitigation Info	Qty	Unit	Cost	Total
1261	<ul style="list-style-type: none"> As-Built Description: CA only: Additional Sign or additional language below the symbol of accessibility stating "Minimum Fine \$250" not provided. Proposed Solution: Provide compliant parking signage that includes fine information. 	PCODE EA04G CBC 2007 1129B.4 CBC 2019 11B-502.6.2 Mitigated: <input type="radio"/> YES <input checked="" type="radio"/> NO	2	JOB	\$300	\$600

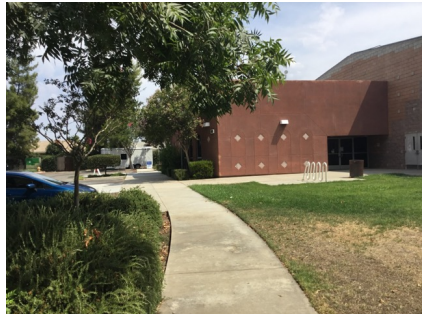
1368	<ul style="list-style-type: none"> As-Built Description: Protruding objects more than 4" from wall, when bottom of object more than 27" or less than 80" above finished floor. Proposed Solution: Trim vegetation. 	PCODE EG04 ADAAG 91 4.4.1 ADA 2010 307.2 CBC 2007 1133B.8.6.1 CBC 2019 11B-307.2 Mitigated: <input type="radio"/> YES <input checked="" type="radio"/> NO	1	JOB	\$300	\$300

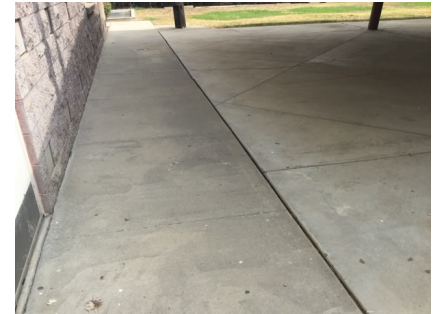
- 1360
- *As-Built Description:*
Walk: Pavement dislocation creates abrupt change in level exceeding 1/2" in accessible route.
 - *As-Built:* **1.5"**
 - *Proposed Solution:*
Remove, replace or repair area of pavement sufficient to correct abrupt change in level.
 - *Notes:*

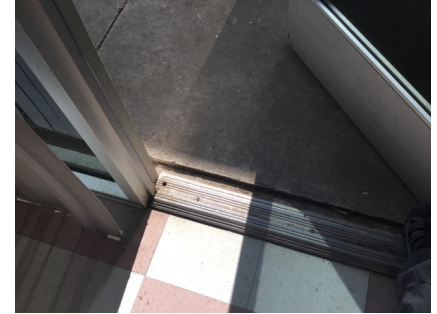
- 1265
- *As-Built Description:*
Walk: Pavement dislocation creates abrupt change in level exceeding 1/2" in accessible route.
 - *As-Built:* **1.0" in exterior door maneuvering clearance.**
 - *Proposed Solution:*
Remove, replace or repair area of pavement sufficient to correct abrupt change in level.

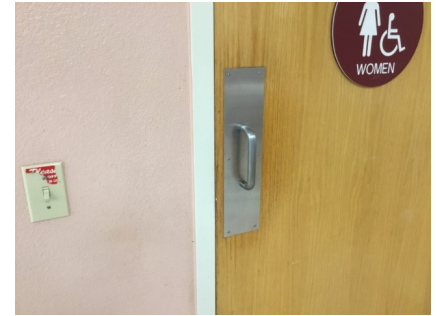
- 1268
- *As-Built Description:*
Door lock, latch or handle less than 34" or more than 48" above the floor (CA only: 34" to 44").
 - *As-Built:* **48.0" high**
 - *Proposed Solution:*
Relocate or replace existing hardware.
 - *Notes:*

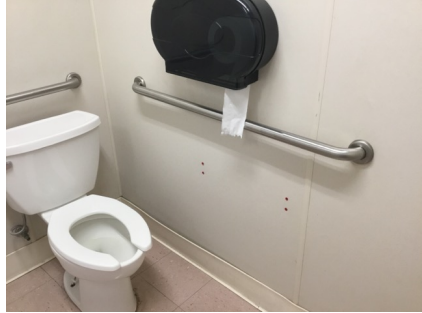
<p>1276</p> <ul style="list-style-type: none"> <i>As-Built Description:</i> Side grab bar less than 42" long, or located more than 12 inches max. from the rear wall, or extending less than 54" from rear wall (CA only: front end min. 24" in front of water closet). <i>As-Built:</i> Extends 23.0" in front of the water closet <i>Proposed Solution:</i> Provide or relocate accessible side grab bar. 	<p><i>PCODE</i> WB07A <i>ADAAG 91</i> Fig. 29(b) <i>ADA 2010</i> 604.5.1 <i>CBC 2007</i> 1115B.4.1.3.1 <i>CBC 2019</i> 11B-604.5.1</p> <p>Mitigated: <input type="radio"/> YES <input checked="" type="radio"/> NO</p>	<p>1 JOB \$780 \$780</p>

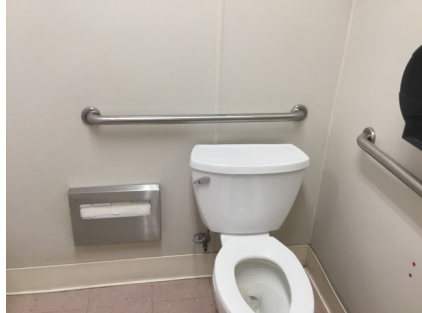
<p>1275</p> <ul style="list-style-type: none"> <i>As-Built Description:</i> The rear wall grab is less than 36" min. or does not extend from the centerline of the water closet 12" min. on one side and 24" min. on the other side. <i>As-Built:</i> Extends 10.5" on narrow side <i>Proposed Solution:</i> Provide or relocate accessible rear grab bar. <i>Notes:</i> 	<p><i>PCODE</i> WB07B <i>ADAAG 91</i> 4.17.6 <i>ADA 2010</i> 604.5.2 <i>CBC 2007</i> 1115B.4.1.3.2 <i>CBC 2019</i> 11B-604.5.2</p> <p>Mitigated: <input type="radio"/> YES <input checked="" type="radio"/> NO</p>	<p>1 JOB \$1,020 \$1,020</p>

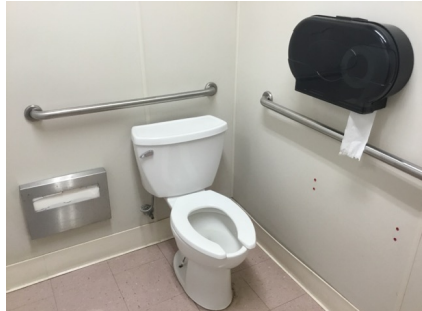
Item no., Rm no. and Name	Existing Architectural Barrier and Proposed Solution	Codes / Mitigation Info	Qty	Unit	Cost	Total
1274	<ul style="list-style-type: none"> • <i>As-Built Description:</i> Grab bars not at 33" to 36" from floor • <i>As-Built:</i> 36.6" to top • <i>Proposed Solution:</i> Relocate accessible grab bars. 	<p>PCODE WB07C ADAAG 91 4.16.4 ADA 2010 609.4 CBC 2007 1115B.4.1.3.1 CBC 2019 & 2 11B-609.4</p> <p>Mitigated: <input type="radio"/> YES <input checked="" type="radio"/> NO</p>	1	JOB	\$780	\$780

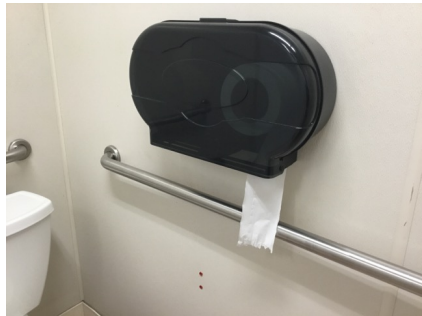
<input type="radio"/> Staff Only			
			<p>Priority <input checked="" type="radio"/> 3</p> <p>Severity <input checked="" type="radio"/> 4</p>			
1277	<ul style="list-style-type: none"> • <i>As-Built Description:</i> Accessories/dispensers in accessible stall located closer than 1-1/2" below or 12" above grab bar impedes its use. • <i>As-Built:</i> TPD: 5.0" above grab bar • <i>Proposed Solution:</i> Relocate accessories/dispensers within applicable reach range and to be no closer than 1-1/2" below and 12" above grab bars (except if accessories are recessed, flush with wall, and have no sharp edges). 	<p>PCODE WB07I ADAAG 91 4.26.2 ADA 2010 609.3 CBC 2007 1133B.4.2.5 CBC 2019 11B-609.3</p> <p>Mitigated: <input type="radio"/> YES <input checked="" type="radio"/> NO</p>	1	JOB	\$225	\$225

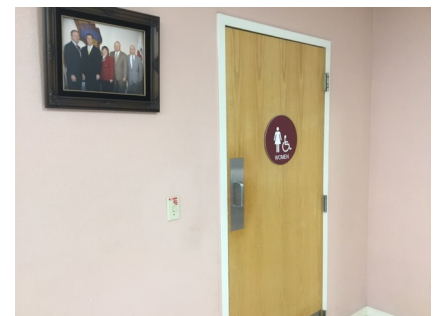
1266 • *As-Built Description:*
 Entrance to toilet or bathing facility not identified with ADAAG compliant signage.
 • *Proposed Solution:*
 Provide ADA compliant sign mounted at 48" min. above to baseline of the lowest Braille cells and 60" max. to baseline of the highest line of raised characters on nearest adjacent wall, on latch side of a single door (located not to cause a Braille reader to stand within the door swing).

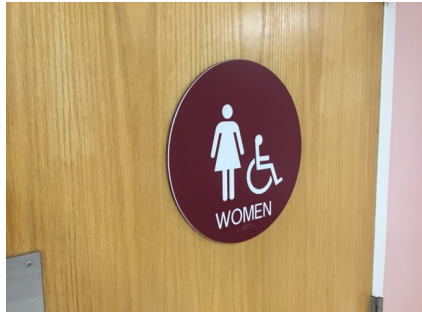
Item no., Rm no. and Name	Existing Architectural Barrier and Proposed Solution	Codes / Mitigation Info	Qty	Unit	Cost	Total
1267	<ul style="list-style-type: none"> As-Built Description: Required in CA only: identification symbol centered 58" to 60" high on sanitary facility door that contrasts with the door not provided (women: 12" ø circle, men: 12" triangle, unisex: combined symbol). As-Built: Not beveled. Proposed Solution: Provide properly mounted sanitary facility symbol when altering area. If wheelchair accessible, include International Symbol of Accessibility on sign. 	PCODE SA15 CBC 2007 1115B.6 CBC 2019 11B-703.7.2.6 Mitigated: <input type="radio"/> YES <input checked="" type="radio"/> NO	1	JOB	\$270	\$270

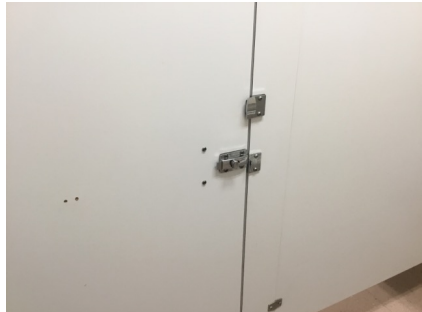
1278	<ul style="list-style-type: none"> As-Built Description: Stall door does not have accessible operating hardware (U-pulls on both sides, flip-over or sliding lock). Proposed Solution: Provide new accessible locking hardware that does not require grasping, pinching, or twisting and U-pulls on both sides. 	PCODE WB05C ADAAG 91 4.17.5 ADA 2010 604.8.1.2 CBC 2007 1115B.3.1.4.5 CBC 2019 11B-604.8.1.2 Mitigated: <input type="radio"/> YES <input checked="" type="radio"/> NO	1	JOB	\$300	\$300

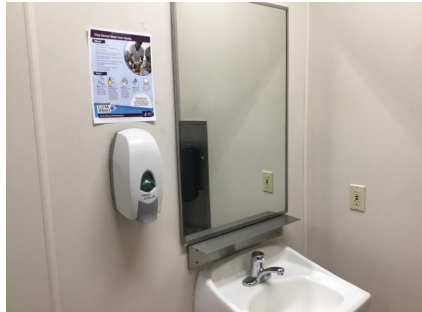
Item no., Rm no. and Name	Existing Architectural Barrier and Proposed Solution	Codes / Mitigation Info	Qty	Unit	Cost	Total
1286	<ul style="list-style-type: none"> As-Built Description: Bottom of mirror located above lavatories or countertops more than 40" above floor. As-Built: 40.75" high Proposed Solution: Relocate or provide new accessible mirror. 	PCODE WG03 ADAAG 91 4.19.6 ADA 2010 603.3 CBC 2007 1115B.8.1 CBC 2019 11B-603.3 Mitigated: <input type="radio"/> YES <input checked="" type="radio"/> NO	1	JOB	\$450	\$450

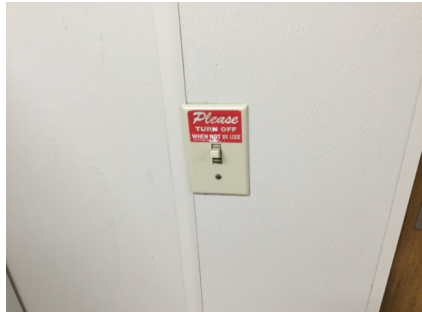
1282	<ul style="list-style-type: none"> As-Built Description: Electric switch or control mounted less than 15" measured to the bottom of the outlet box or greater than 48 inches measured to the top of the outlet box. As-Built: 48.25" and 50.0" to top of box Proposed Solution: Relocate light switches or control to between 15" and 48" height. Notes: 	PCODE IC01 ADAAG 91 4.2.5 & 6 ADA 2010 308.2.1 & 308.2.2 CBC 2007 1117B.6.3 CBC 2019 11B-308.2.1 & 11B-308.2.2 Mitigated: <input type="radio"/> YES <input checked="" type="radio"/> NO	1	JOB	\$900	\$900

This element complies with Safe Harbor if altered or constructed before March 15, 2012. This element does not comply with the dimensional requirements in the 1981 to the current CBC.

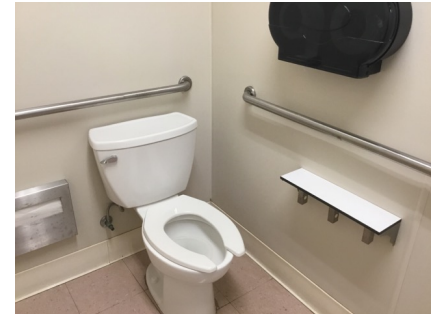
1291	<ul style="list-style-type: none"> As-Built Description: Grab bars not at 33" to 36" from floor As-Built: 36.25" to center Proposed Solution: Relocate accessible grab bars. 	PCODE WB07C ADAAG 91 4.16.4 ADA 2010 609.4 CBC 2007 1115B.4.1.3.1 & 2 CBC 2019 11B-609.4	1	JOB	\$780	\$780
------	--	--	---	-----	-------	-------

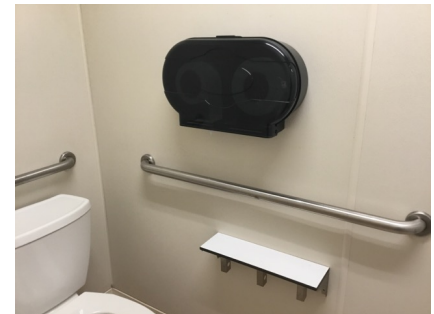
1290	<ul style="list-style-type: none"> As-Built Description: Accessories/dispensers in accessible stall located closer than 1-1/2" below or 12" above grab bar impedes its use. As-Built: TPD: 8.0" above grab bar Proposed Solution: Relocate accessories/dispensers within applicable reach range and to be no closer than 1-1/2" below and 12" above grab bars (except if accessories are recessed, flush with wall, and have no sharp edges). 	PCODE WB07I ADAAG 91 4.26.2 ADA 2010 609.3 CBC 2007 1133B.4.2.5 CBC 2019 11B-609.3	1	JOB	\$225	\$225
------	---	---	---	-----	-------	-------

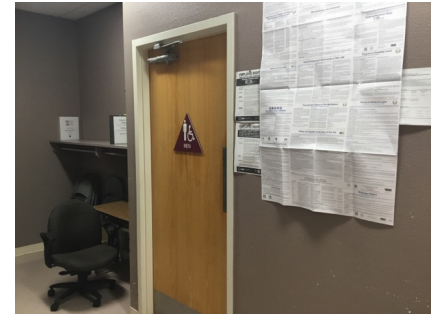
1280	<ul style="list-style-type: none"> As-Built Description: Entrance to toilet or bathing facility not identified with ADAAG compliant signage. Proposed Solution: Provide ADA compliant sign mounted at 48" min. above to baseline of the lowest Braille cells and 60" max. to baseline of the highest line of raised characters on nearest adjacent wall, on latch side of a single door (located not to cause a Braille reader to stand within the door swing). Notes: 	<p>PCODE SA11A ADAAG 91 4.1.3(16)(a) ADA 2010 216.8 CBC 2019 11B-216.8</p> <p>Mitigated: <input type="radio"/> YES <input checked="" type="radio"/> NO</p>	1	JOB	\$270	\$270
------	--	---	---	-----	-------	-------

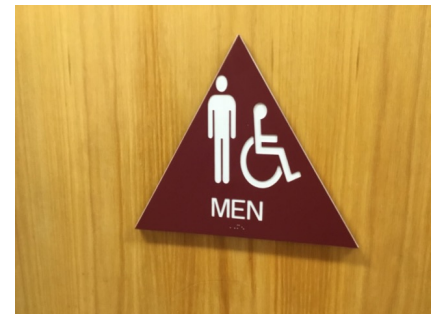
Noncompliant tactile sign on door.

1281	<ul style="list-style-type: none"> As-Built Description: Required in CA only: identification symbol centered 58" to 60" high on sanitary facility door that contrasts with the door not provided (women: 12" ø circle, men: 12" triangle, unisex: combined symbol). As-Built: Not beveled or radiused. Proposed Solution: Provide properly mounted sanitary facility symbol when altering area. If wheelchair accessible, include International Symbol of Accessibility on sign. 	<p>PCODE SA15 CBC 2007 1115B.6 CBC 2019 11B-703.7.2.6</p> <p>Mitigated: <input type="radio"/> YES <input checked="" type="radio"/> NO</p>	1	JOB	\$270	\$270
------	---	--	---	-----	-------	-------

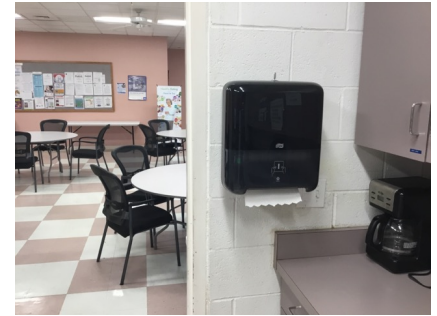
1294	<ul style="list-style-type: none"> <i>As-Built Description:</i> Protruding objects more than 4" from wall, when bottom of object more than 27" or less than 80" above finished floor. <i>As-Built:</i> PTD: 8.0" at 49.0" high <i>Proposed Solution:</i> Remove/relocate protruding object. Patch existing surface. <i>Notes:</i> 	<p>PCODE EG04 ADAAG 91 4.4.1 ADA 2010 307.2 CBC 2007 1133B.8.6.1 CBC 2019 11B-307.2</p> <p>Mitigated: <input type="radio"/> YES <input checked="" type="radio"/> NO</p>	1	JOB	\$300	\$300
------	--	--	---	-----	-------	-------

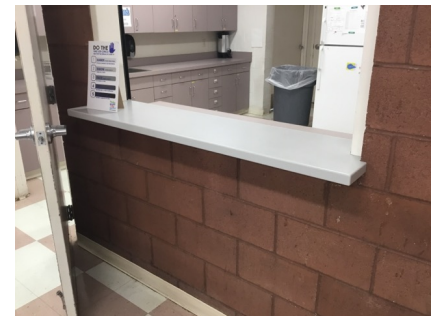
The dispenser is in the door maneuvering clearance.

1298	<ul style="list-style-type: none"> <i>As-Built Description:</i> Protruding objects more than 4" from wall, when bottom of object more than 27" or less than 80" above finished floor. <i>As-Built:</i> Tray slide: 6.0" at 41.0" high <i>Proposed Solution:</i> Remove/relocate protruding object. Patch existing surface. 	<p>PCODE EG04 ADAAG 91 4.4.1 ADA 2010 307.2 CBC 2007 1133B.8.6.1 CBC 2019 11B-307.2</p> <p>Mitigated: <input type="radio"/> YES <input checked="" type="radio"/> NO</p>	1	JOB	\$300	\$300
------	--	--	---	-----	-------	-------

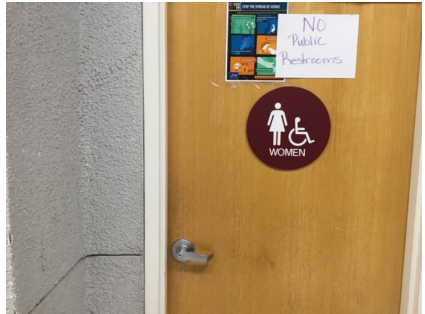
Item no., Rm no. and Name	Existing Architectural Barrier and Proposed Solution	Codes / Mitigation Info	Qty	Unit	Cost	Total
1309	<ul style="list-style-type: none"> As-Built Description: Front approach: At push side, door does not have clear and level maneuvering space measuring door width x 48" (door width plus 12" if door has both, latch and closer). As-Built: 10.5" Proposed Solution: Remove latch. 	PCODE ID24A ADAAG 91 Fig. 25(a) ADA 2010 404.2.4 CBC 2007 11B-26A(a) CBC 2019 11B-404.2.4 Mitigated: <input type="radio"/> YES <input checked="" type="radio"/> NO	1	JOB	\$150	\$150

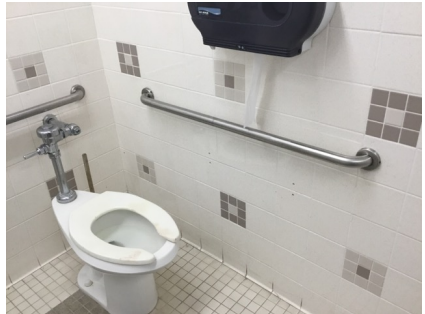
1319	<ul style="list-style-type: none"> As-Built Description: Side grab bar less than 42" long, or located more than 12 inches max. from the rear wall, or extending less than 54" from rear wall (CA only: front end min. 24" in front of water closet). As-Built: Extends 13.0" and 21.0" in front of water closet. Proposed Solution: Provide or relocate accessible side grab bar. 	PCODE WB07A ADAAG 91 Fig. 29(b) ADA 2010 604.5.1 CBC 2007 1115B.4.1.3.1 CBC 2019 11B-604.5.1 Mitigated: <input type="radio"/> YES <input checked="" type="radio"/> NO	1	JOB	\$780	\$780

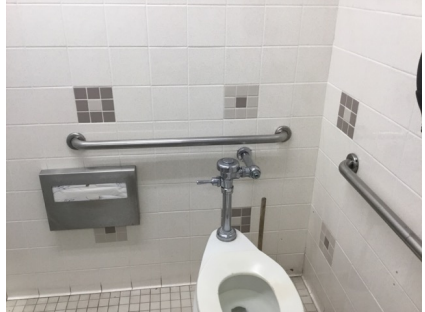
Item no., Rm no. and Name	Existing Architectural Barrier and Proposed Solution	Codes / Mitigation Info	Qty	Unit	Cost	Total
1321	<ul style="list-style-type: none"> <i>As-Built Description:</i> The rear wall grab is less than 36" min. or does not extend from the centerline of the water closet 12" min. on one side and 24" min. on the other side. <i>As-Built:</i> Extends 10.5" on narrow side <i>Proposed Solution:</i> Provide or relocate accessible rear grab bar. 	PCODE WB07B ADAAG 91 4.17.6 ADA 2010 604.5.2 CBC 2007 1115B.4.1.3.2 CBC 2019 11B-604.5.2 Mitigated: <input type="radio"/> YES <input checked="" type="radio"/> NO	1	JOB	\$1,020	\$1,020

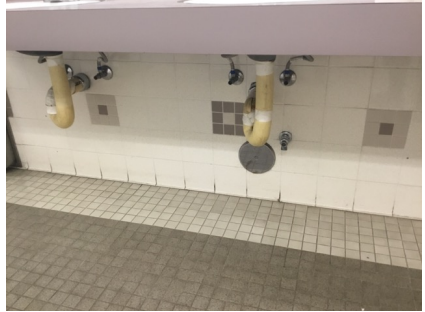
1314	<ul style="list-style-type: none"> <i>As-Built Description:</i> Hot or sharp-surfaced water/drain pipe not insulated or covered. <i>Proposed Solution:</i> Insulate or cover water/drain pipe. 	PCODE WD05 ADAAG 91 4.19.4 ADA 2010 606.5 CBC 2007 1115B.4.3.4 CBC 2019 11B-606.5 Mitigated: <input type="radio"/> YES <input checked="" type="radio"/> NO	1	JOB	\$360	\$360

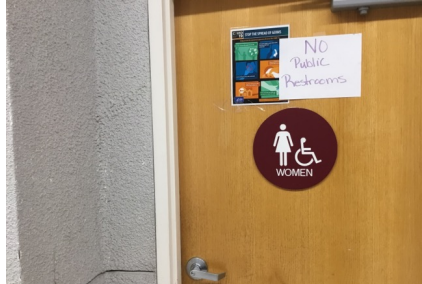
<p>1310</p> <ul style="list-style-type: none"> As-Built Description: Entrance to toilet or bathing facility not identified with ADAAG compliant signage. Proposed Solution: Provide ADA compliant sign mounted at 48" min. above to baseline of the lowest Braille cells and 60" max. to baseline of the highest line of raised characters on nearest adjacent wall, on latch side of a single door (located not to cause a Braille reader to stand within the door swing). 	<p>PCODE SA11A ADAAG 91 4.1.3(16)(a) ADA 2010 216.8 CBC 2019 11B-216.8</p> <p>Mitigated: <input type="radio"/> YES <input checked="" type="radio"/> NO</p>	<p>1 JOB \$270 \$270</p>

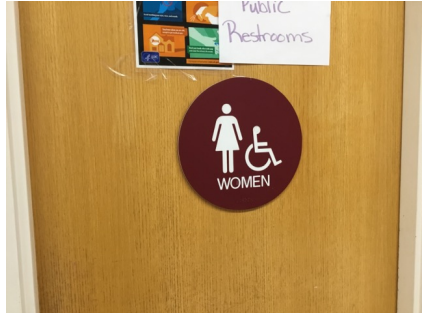
<p>1311</p> <ul style="list-style-type: none"> As-Built Description: Required in CA only: identification symbol centered 58" to 60" high on sanitary facility door that contrasts with the door not provided (women: 12" ø circle, men: 12" triangle, unisex: combined symbol). As-Built: Not beveled. Proposed Solution: Provide properly mounted sanitary facility symbol when altering area. If wheelchair accessible, include International Symbol of Accessibility on sign. 	<p>PCODE SA15 CBC 2007 1115B.6 CBC 2019 11B-703.7.2.6</p> <p>Mitigated: <input type="radio"/> YES <input checked="" type="radio"/> NO</p>	<p>1 JOB \$270 \$270</p>

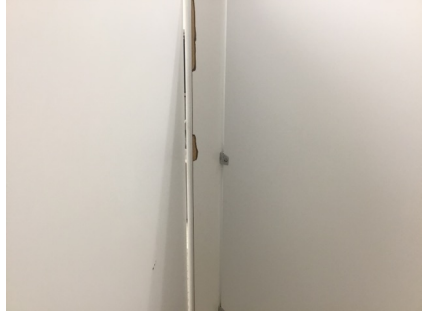
<p>1330</p> <ul style="list-style-type: none"> <i>As-Built Description:</i> The location of the stall door is not in front of the clear space (next to the water closet), with a maximum stile width of 4". <i>As-Built:</i> 4.5" <i>Proposed Solution:</i> Remodel compartment. 	<p>PCODE WB05D ADAAG 91 4.17.3 & Fig. 30(a) ADA 2010 604.8.1.2 CBC 2007 1115B.3.1.4.3 CBC 2019 11B-604.8.1.2</p> <p>Mitigated: <input type="radio"/> YES <input checked="" type="radio"/> NO</p>	<p>1 JOB \$1,500 \$1,500</p>

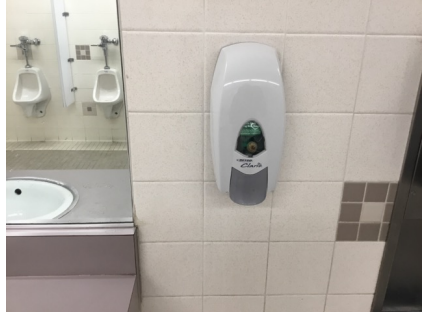
<p>1324</p> <ul style="list-style-type: none"> <i>As-Built Description:</i> Dispensers in sanitary facilities, such as for towels, soap, sanitary napkins, seat covers, etc., and waste receptacles more than 48" (CA only: 40") from floor to highest operating slot or control. <i>As-Built:</i> SD: 43.0" high <i>Proposed Solution:</i> Relocate existing restroom accessories. <i>Notes:</i> 	<p>PCODE WG01A ADAAG 91 4.23.7 ADA 2010 308.2.1 CBC 2007 1115B.8.3 CBC 2019 11B-603.5</p> <p>Mitigated: <input type="radio"/> YES <input checked="" type="radio"/> NO</p>	<p>1 JOB \$300 \$300</p>

If 48" maximum AFF, this element complies with 1991 ADAAG and the 2010 ADAS. If 54" maximum AFF side reach, this element complies with Safe Harbor if constructed or altered before March 15, 2012. This element does not comply with the dimensional requirements in the 1981 to the current CBC.

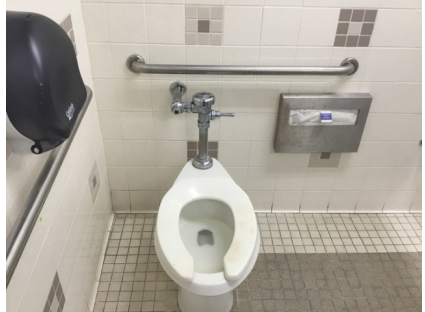
Item no., Rm no. and Name	Existing Architectural Barrier and Proposed Solution	Codes / Mitigation Info	Qty	Unit	Cost	Total
1332	<ul style="list-style-type: none"> <i>As-Built Description:</i> The rear wall grab is less than 36" min. or does not extend from the centerline of the water closet 12" min. on one side and 24" min. on the other side. <i>As-Built:</i> Extends 11.0" on narrow side <i>Proposed Solution:</i> Provide or relocate accessible rear grab bar. 	PCODE WB07B ADAAG 91 4.17.6 ADA 2010 604.5.2 CBC 2007 1115B.4.1.3.2 CBC 2019 11B-604.5.2 Mitigated: <input type="radio"/> YES <input checked="" type="radio"/> NO	1	JOB	\$1,020	\$1,020
