The City of Madera

Appendix B: Facilities

Access Compliance Survey Report

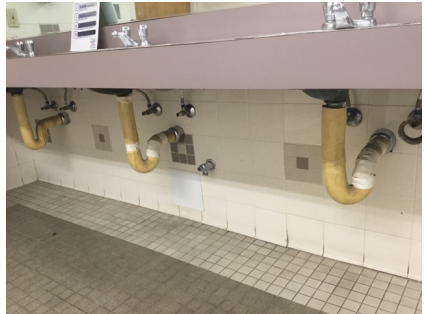
1325	<ul style="list-style-type: none"> <i>As-Built Description:</i> Hot or sharp-surfaced water/drain pipe not insulated or covered. <i>Proposed Solution:</i> Insulate or cover water/drain pipe. 	PCODE WD05 ADAAG 91 4.19.4 ADA 2010 606.5 CBC 2007 1115B.4.3.4 CBC 2019 11B-606.5 Mitigated: <input type="radio"/> YES <input checked="" type="radio"/> NO	1	JOB	\$360	\$360

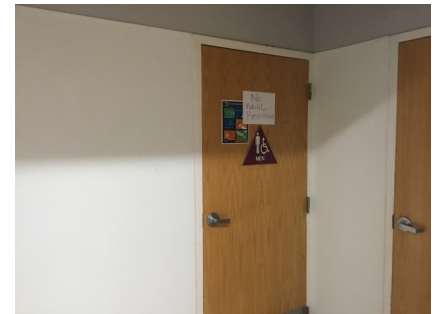
- 1323
- *As-Built Description:*
Entrance to toilet or bathing facility not identified with ADAAG compliant signage.
 - *Proposed Solution:*
Provide ADA compliant sign mounted at 48" min. above to baseline of the lowest Braille cells and 60" max. to baseline of the highest line of raised characters on nearest adjacent wall, on latch side of a single door (located not to cause a Braille reader to stand within the door swing).

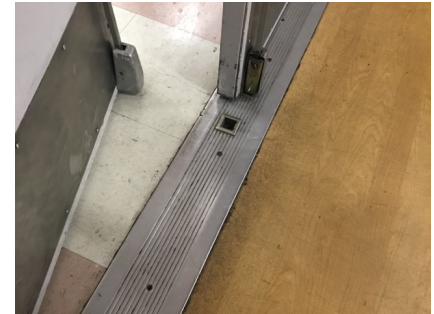
1341	<ul style="list-style-type: none"> As-Built Description: Walk: openings greater than 1/2" along the line of traffic flow. As-Built: 1.0" x 1.0" Proposed Solution: Fill opening and provide new panic door hardware. Notes: 	<p>PCODE EF04 ADAAG 91 4.3.6; 4.5.4 ADA 2010 403.2; 302.3 CBC 2007 1133B.7.2 CBC 2019 11B-403.2; 11B-302.3</p> <p>Mitigated: <input type="radio"/> YES <input checked="" type="radio"/> NO</p>	1	JOB	\$1,500	\$1,500
------	--	--	---	-----	---------	---------

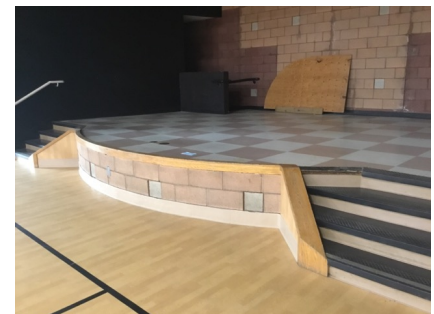
1344	<ul style="list-style-type: none"> As-Built Description: Handrail not provided at stairs or ramp, required on both sides (not required at curb ramps or adjacent to seating areas). Proposed Solution: Provide new handrail for each side including extensions. 	<p>PCODE ED01 ADAAG 91 4.8.5 & 4.9.4 ADA 2010 505.2 CBC 2007 1133B.4.1.1 & .5.5 CBC 2019 11B-505.2</p> <p>Mitigated: <input type="radio"/> YES <input checked="" type="radio"/> NO</p>	15	LF	\$285	\$4,275
------	---	--	----	----	-------	---------

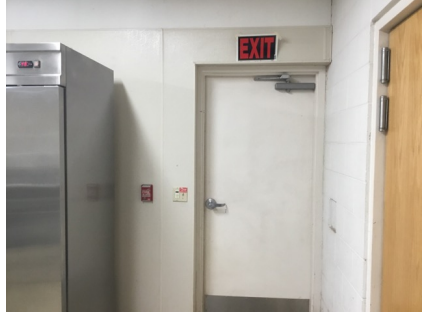
Item no., Rm no. and Name	Existing Architectural Barrier and Proposed Solution	Codes / Mitigation Info	Qty	Unit	Cost	Total
1356	<ul style="list-style-type: none"> <i>As-Built Description:</i> Front approach: At push side, door does not have clear and level maneuvering space measuring door width x 48" (door width plus 12" if door has both, latch and closer). <i>As-Built:</i> 8.75" deep alcove. <i>Proposed Solution:</i> Provide relocated new door and frame; remodel walls as needed. 	PCODE ID24B ADAAG 91 Fig. 25(a) ADA 2010 404.2.4 CBC 2007 11B-26A(a) CBC 2019 11B-404.2.4 Mitigated: <input type="radio"/> YES <input checked="" type="radio"/> NO	1	JOB	\$7,800	\$7,800

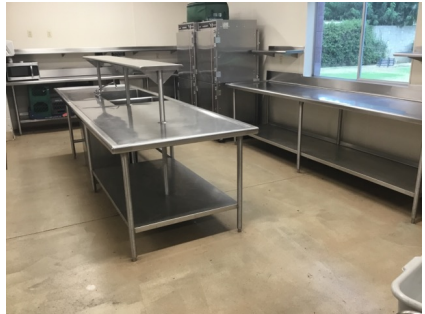
1352	<ul style="list-style-type: none"> <i>As-Built Description:</i> Accessible non-fixed kitchen work table (top 28" to 34" high; knee space at least 27" high x 19" deep x 30" wide) not provided. <i>As-Built:</i> Work surfaces less than 34.0" throughout. No knee clearance. <i>Proposed Solution:</i> Provide kitchen table with accessible dimensions. 	PCODE IN02A ADAAG 91 4.32.3 & .4 ADA 2010 306.1 CBC 2007 1122B.3 & 4 CBC 2019 11B-306.1 & 11B-902.3 Mitigated: <input type="radio"/> YES <input checked="" type="radio"/> NO	3	JOB	\$4,800	\$14,400

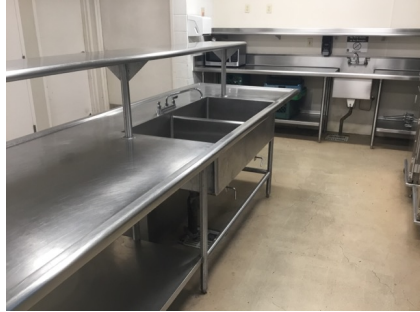
1350	<ul style="list-style-type: none"> • <i>As-Built Description:</i> Sink rim higher than 34" above floor. • <i>As-Built:</i> 36.0" high • <i>Proposed Solution:</i> Remodel existing or provide new sink. 	PCODE IN06 ADAAG 91 4.24.2 ADA 2010 606.3 CBC 2007 1115B.4.7.1 CBC 2019 11B-606.3 Mitigated: <input type="radio"/> YES <input checked="" type="radio"/> NO	4	JOB	\$5,250	\$21,000
------	---	---	---	-----	---------	----------

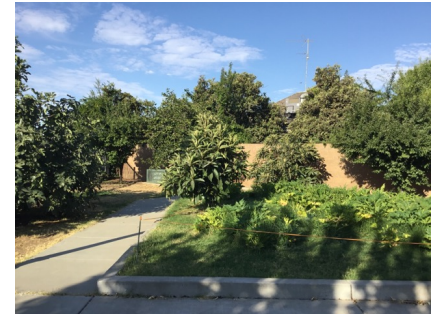
457	<ul style="list-style-type: none"> As-Built Description: Walk more than 36" but less than 48" wide (required in CA only). As-Built: 47.5" to 47.75" wide Proposed Solution: Enlarge width of walk to 48". Notes: 	<p>PCODE EF08</p> <p>CBC 2007 1133B.7.1</p> <p>CBC 2019 11B-403.5.1.3</p> <p>Mitigated:</p> <p><input type="radio"/> YES</p> <p><input checked="" type="radio"/> NO</p>	100	SF	\$135	\$13,500
-----	---	--	-----	----	-------	-----------------

Occurs at figs, persimmons, avocados, and plums. Consider whether planting these trees on an accessible route provides equivalent facilitation.

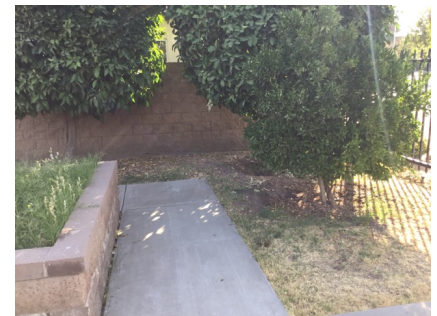
458	<ul style="list-style-type: none"> As-Built Description: Walk more than 36" but less than 48" wide (required in CA only). As-Built: 46.0" wide Proposed Solution: Enlarge width of walk to 48". Notes: 	<p>PCODE EF08</p> <p>CBC 2007 1133B.7.1</p> <p>CBC 2019 11B-403.5.1.3</p> <p>Mitigated:</p> <p><input type="radio"/> YES</p> <p><input checked="" type="radio"/> NO</p>	30	SF	\$135	\$4,050
-----	---	--	----	----	-------	----------------

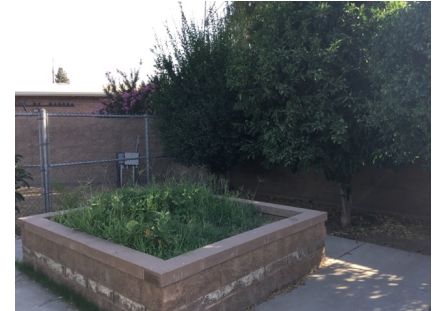
459	<ul style="list-style-type: none"> As-Built Description: Walk more than 36" but less than 48" wide (required in CA only). As-Built: 46.5" wide Proposed Solution: Enlarge width of walk to 48". Notes: 	<p>PCODE EF08</p> <p>CBC 2007 1133B.7.1</p> <p>CBC 2019 11B-403.5.1.3</p> <p>Mitigated:</p> <p><input type="radio"/> YES</p> <p><input checked="" type="radio"/> NO</p>	20	SF	\$135	\$2,700
-----	---	--	----	----	-------	----------------

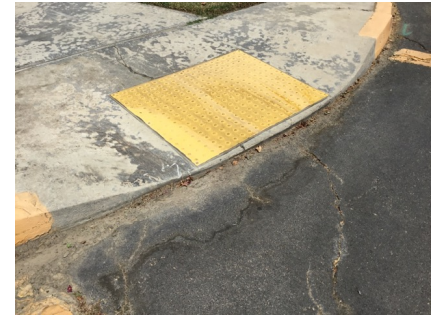
<p>118</p> <ul style="list-style-type: none"> • <i>As-Built Description:</i> Transition from curb ramp to gutter does not have a smooth transition. • <i>As-Built:</i> 2.0" • <i>Proposed Solution:</i> Grind lip. 	<p><i>PCODE</i> EH02D <i>ADAAG 91</i> 4.7.2 <i>ADA 2010</i> 406.2 <i>CBC 2007</i> 1127B.5.3 <i>CBC 2019</i> 11B-406.5.8</p>	<p>1 JOB \$300 \$300</p>
--	---	---------------------------------

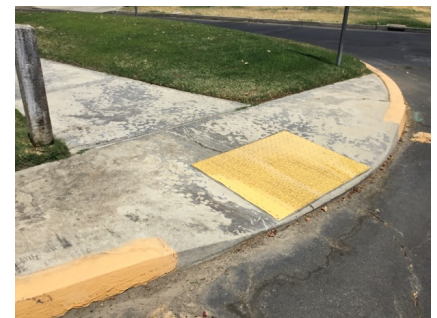
<p>119</p> <ul style="list-style-type: none"> • <i>As-Built Description:</i> Side slopes more than 1:10 (10%). • <i>As-Built:</i> 13.0% and 18.0% • <i>Proposed Solution:</i> Modify curb ramp. Demolish side slopes and replace with 1:10 side slopes if 48" level top landing is provided. 	<p><i>PCODE</i> EH05A <i>ADAAG 91</i> 4.7.5 <i>ADA 2010</i> 406.3 <i>CBC 2007</i> 1127B.5.3 <i>CBC 2019</i> 11B-406.2.2</p>	<p>2 JOB \$6,000 \$12,000</p>
--	---	--------------------------------------

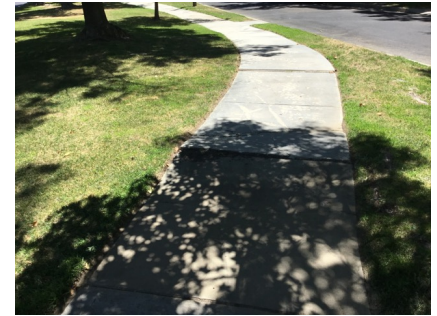
The entire path is defined by noncompliant running slopes, cross slopes to 8.0% and 3.0" high level changes that appear to be caused by tree roots which are heaving the sidewalks.

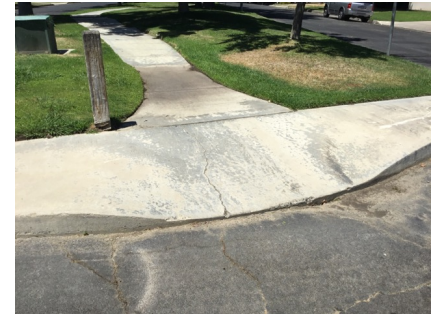
125	<ul style="list-style-type: none"> As-Built Description: Slope greater than 1:12 (8.3%). As-Built: 9.9% Proposed Solution: Demolish existing and provide new curb ramp. 	PCODE EH02A ADAAG 91 4.7.2 ADA 2010 406.1 CBC 2007 1127B.5.3 CBC 2019 11B-406.2.1	1	JOB	\$7,500	\$7,500
-----	---	---	---	-----	---------	---------

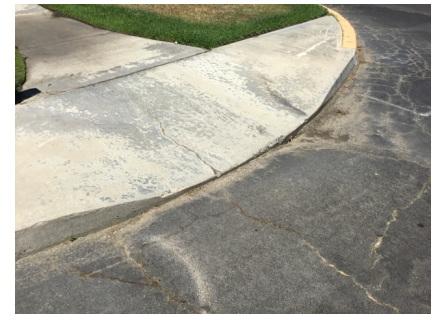
123	<ul style="list-style-type: none"> As-Built Description: Transition from curb ramp to gutter does not have a smooth transition. As-Built: 3.0" Proposed Solution: Grind lip. 	PCODE EH02D ADAAG 91 4.7.2 ADA 2010 406.2 CBC 2007 1127B.5.3 CBC 2019 11B-406.5.8	1	JOB	\$300	\$300
-----	--	---	---	-----	-------	-------

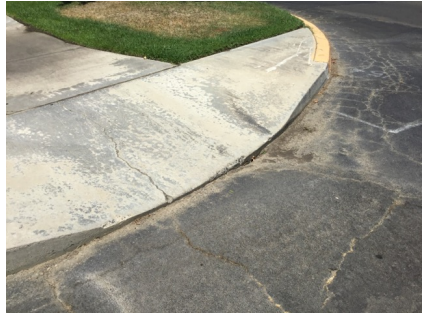
Item no., Rm no. and Name	Existing Architectural Barrier and Proposed Solution	Codes / Mitigation Info	Qty	Unit	Cost	Total
124	<ul style="list-style-type: none"> As-Built Description: Maximum slope of adjoining gutters, street surface at bottom of ramp exceeds 5% (1:20). As-Built: 6.8% Proposed Solution: Modify road/gutter slopes. Demolish existing and provide new curb ramp. 	PCODE EH02E ADAAG 91 4.7.2 ADA 2010 406.2 CBC 2007 1127B.5.3 CBC 2019 11B-406.5.8 Mitigated: <input type="radio"/> YES <input checked="" type="radio"/> NO	1	JOB	\$3,750	\$3,750

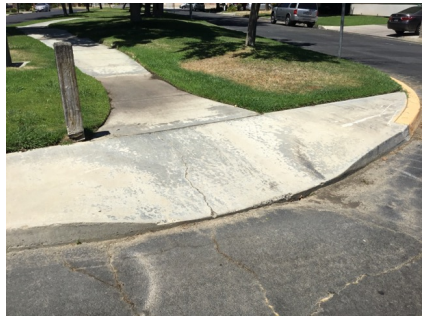
<input type="radio"/> Staff Only			
			Priority <input checked="" type="radio"/> 1			
			Severity <input checked="" type="radio"/> 4			
127	<ul style="list-style-type: none"> As-Built Description: Side slopes more than 1:10 (10%). As-Built: 14.0% and 20.0% Proposed Solution: Modify curb ramp. Demolish side slopes and replace with 1:10 side slopes if 48" level top landing is provided. 	PCODE EH05A ADAAG 91 4.7.5 ADA 2010 406.3 CBC 2007 1127B.5.3 CBC 2019 11B-406.2.2 Mitigated: <input type="radio"/> YES <input checked="" type="radio"/> NO	1	JOB	\$6,000	\$6,000

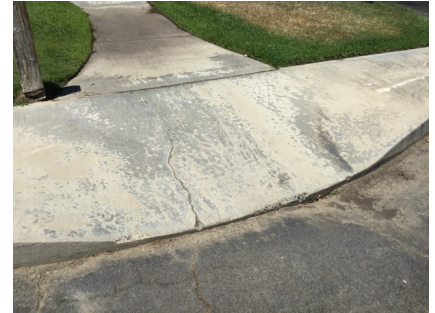
Item no., Rm no. and Name	Existing Architectural Barrier and Proposed Solution	Codes / Mitigation Info	Qty	Unit	Cost	Total
126	<ul style="list-style-type: none"> <i>As-Built Description:</i> Detectable warning not provided where pedestrian crosses vehicular area. <i>Proposed Solution:</i> Provide detectable warning surface (i.e. in-line truncated domes) at regular curb ramp. 	PCODE EH07A ADAAG 91 4.7.7 ADA 2010 705.1 CBC 2007 1127B.5.7 CBC 2019 11B-705.1.2.2 Mitigated: <input type="radio"/> YES <input checked="" type="radio"/> NO	1	JOB	\$750	\$750

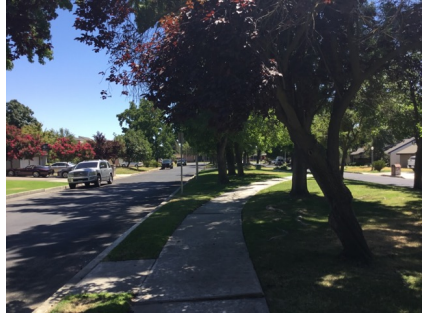
Item no., Rm no. and Name	Existing Architectural Barrier and Proposed Solution	Codes / Mitigation Info	Qty	Unit	Cost	Total
Protrusion Limits						
130	<ul style="list-style-type: none"> <i>As-Built Description:</i> Protruding objects more than 4" from wall, when bottom of object more than 27" or less than 80" above finished floor. <i>Proposed Solution:</i> Trim vegetation. 	PCODE EG04 ADAAG 91 4.4.1 ADA 2010 307.2 CBC 2007 1133B.8.6.1 CBC 2019 11B-307.2 Mitigated: <input type="radio"/> YES <input checked="" type="radio"/> NO	4	JOB	\$300	\$1,200

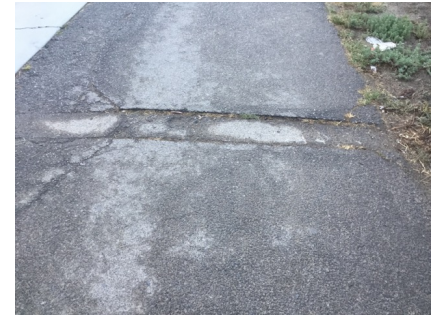
- 1984
- *As-Built Description:*
Walk: Pavement dislocation creates abrupt change in level exceeding 1/2" in accessible route.
 - *As-Built:* **0.5" not beveled**
 - *Proposed Solution:*
Remove, replace or repair area of pavement sufficient to correct abrupt change in level.

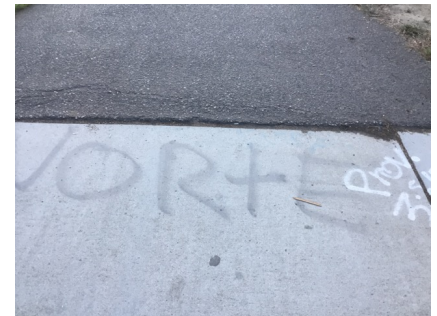
- 1985
- *As-Built Description:*
Walk: Pavement dislocation creates abrupt change in level exceeding 1/2" in accessible route.
 - *As-Built:* **1.0"**
 - *Proposed Solution:*
Remove, replace or repair area of pavement sufficient to correct abrupt change in level.

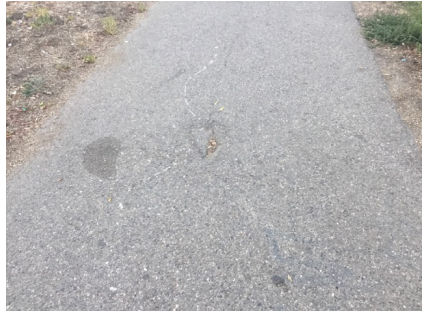
Item no., Rm no. and Name	Existing Architectural Barrier and Proposed Solution	Codes / Mitigation Info	Qty	Unit	Cost	Total
1987	<ul style="list-style-type: none"> • <i>As-Built Description:</i> Walk: Pavement dislocation creates abrupt change in level exceeding 1/2" in accessible route. • <i>As-Built:</i> Gaps 2.0" deep. • <i>Proposed Solution:</i> Remove, replace or repair area of pavement sufficient to correct abrupt change in level. • <i>Notes:</i> 	PCODE EF03 ADAAG 91 4.3.8 ADA 2010 403.4 CBC 2007 1133B.7.4 CBC 2019 11B-403.4 Mitigated: <input type="radio"/> YES <input checked="" type="radio"/> NO	5	SF	\$150	\$750

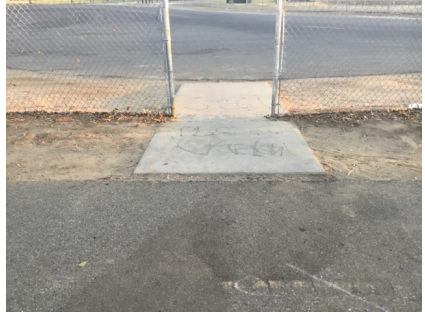
Item no., Rm no. and Name	Existing Architectural Barrier and Proposed Solution	Codes / Mitigation Info	Qty	Unit	Cost	Total
1990	<ul style="list-style-type: none"> • <i>As-Built Description:</i> Walk: Pavement dislocation creates abrupt change in level exceeding 1/2" in accessible route. • <i>As-Built:</i> 1.0" at public entrance from fairgrounds • <i>Proposed Solution:</i> Remove, replace or repair area of pavement sufficient to correct abrupt change in level. 	PCODE EF03 ADAAG 91 4.3.8 ADA 2010 403.4 CBC 2007 1133B.7.4 CBC 2019 11B-403.4 Mitigated: <input type="radio"/> YES <input checked="" type="radio"/> NO	6	LF	\$63	\$378

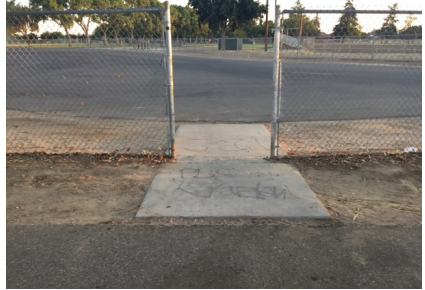
1989	<ul style="list-style-type: none"> • <i>As-Built Description:</i> Surface of required maneuvering clearance at door slopes more than 1/4":12" (2.0%). • <i>As-Built:</i> 2.8% at doorway with out a door to fairgrounds. • <i>Proposed Solution:</i> Modify surface slope at door. 	PCODE ID11 ADAAG 91 4.13.6 ADA 2010 404.2.4.4 CBC 2007 1133B.2.4 CBC 2019 11B-404.2.4 Mitigated: <input type="radio"/> YES <input checked="" type="radio"/> NO	30	SF	\$120	\$3,600

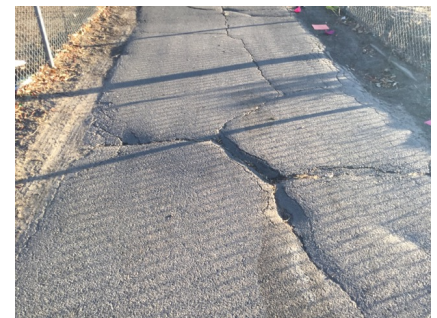
- 1998
- *As-Built Description:*
Walk: Pavement dislocation creates abrupt change in level exceeding 1/2" in accessible route.
 - *As-Built:* **Gaps. Level changes. Uneven.**
 - *Proposed Solution:*
Remove, replace or repair area of pavement sufficient to correct abrupt change in level.

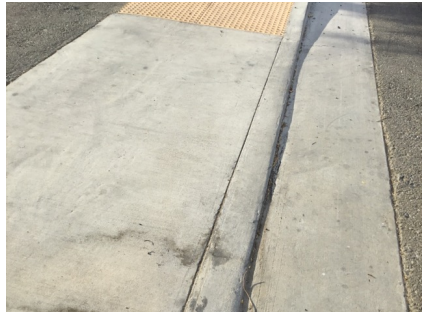
Item no., Rm no. and Name	Existing Architectural Barrier and Proposed Solution	Codes / Mitigation Info	Qty	Unit	Cost	Total
2190	<ul style="list-style-type: none"> • <i>As-Built Description:</i> Walk: Pavement dislocation creates abrupt change in level exceeding 1/2" in accessible route. • <i>As-Built:</i> To 1.0" • <i>Proposed Solution:</i> Remove, replace or repair area of pavement sufficient to correct abrupt change in level. • <i>Notes:</i> 	PCODE EF03 ADAAG 91 4.3.8 ADA 2010 403.4 CBC 2007 1133B.7.4 CBC 2019 11B-403.4 Mitigated: <input type="radio"/> YES <input checked="" type="radio"/> NO	16	LF	\$63	\$1,008

At curb cuts and where asphalt meets concrete on both sides of Schnoor.

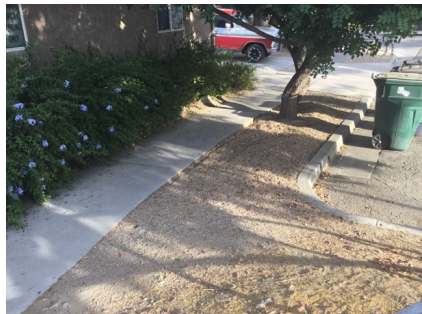
2192	<ul style="list-style-type: none"> • <i>As-Built Description:</i> Walk: Pavement dislocation creates abrupt change in level exceeding 1/2" in accessible route. • <i>As-Built:</i> 2.0" • <i>Proposed Solution:</i> Remove, replace or repair area of pavement sufficient to correct abrupt change in level. 	PCODE EF03 ADAAG 91 4.3.8 ADA 2010 403.4 CBC 2007 1133B.7.4 CBC 2019 11B-403.4 Mitigated: <input type="radio"/> YES <input checked="" type="radio"/> NO	4	SF	\$63	\$252

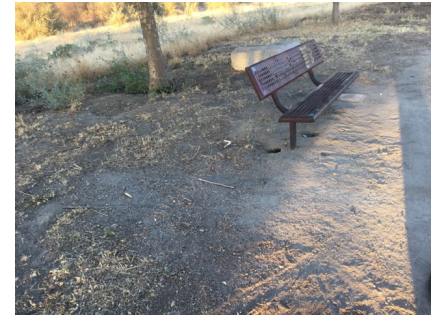
1993	<ul style="list-style-type: none"> As-Built Description: Cross slope more than 1":48" (2.083%). As-Built: 6.0% slope adjacent to benches Proposed Solution: Modify cross slope. 	PCODE EF07 ADAAG 91 4.3.7 ADA 2010 403.3 CBC 2007 1133B.7.1.3 CBC 2019 11B-403.3	24	SF	\$75	\$1,800
------	---	--	----	----	------	---------

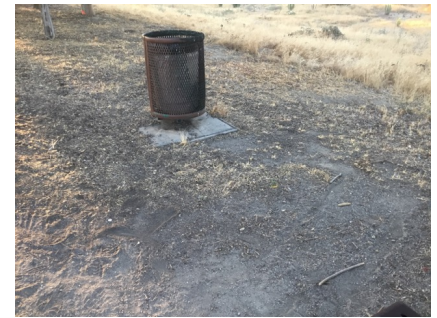
1995	<ul style="list-style-type: none"> As-Built Description: Cross slope more than 1":48" (2.083%). As-Built: Clear floor space at elements slopes 3.0% Proposed Solution: Modify cross slope. 	PCODE EF07 ADAAG 91 4.3.7 ADA 2010 403.3 CBC 2007 1133B.7.1.3 CBC 2019 11B-403.3	12	SF	\$75	\$900
------	--	--	----	----	------	-------

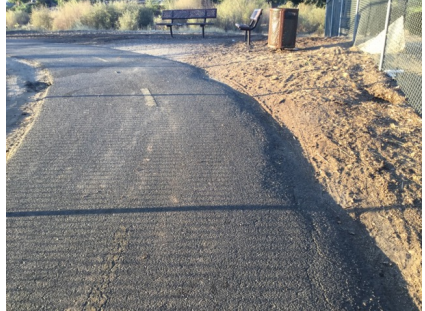
Item no., Rm no. and Name	Existing Architectural Barrier and Proposed Solution	Codes / Mitigation Info	Qty	Unit	Cost	Total
1997	<ul style="list-style-type: none"> As-Built Description: Cross slope more than 1":48" (2.083%). As-Built: 8.0% Proposed Solution: Modify cross slope. Notes: 	PCODE EF07 ADAAG 91 4.3.7 ADA 2010 403.3 CBC 2007 1133B.7.1.3 CBC 2019 11B-403.3 Mitigated: <input type="radio"/> YES <input checked="" type="radio"/> NO	20	SF	\$75	\$1,500

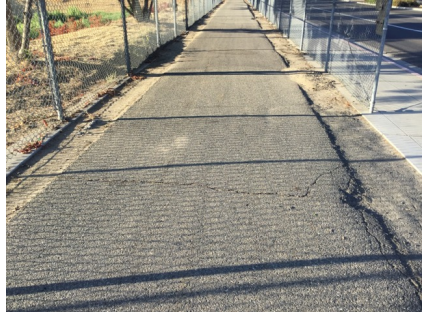
<input type="radio"/> Staff Only			
			Priority <input checked="" type="radio"/> 1			
			Severity <input checked="" type="radio"/> 2			
<p>There are approximately 36.0" between the 8.0% slopes and the dividing line.</p>						
2006	<ul style="list-style-type: none"> As-Built Description: Cross slope more than 1":48" (2.083%). As-Built: 2.4% to 5.0% Proposed Solution: Modify cross slope. 	PCODE EF07 ADAAG 91 4.3.7 ADA 2010 403.3 CBC 2007 1133B.7.1.3 CBC 2019 11B-403.3 Mitigated: <input type="radio"/> YES <input checked="" type="radio"/> NO	200	SF	\$75	\$15,000

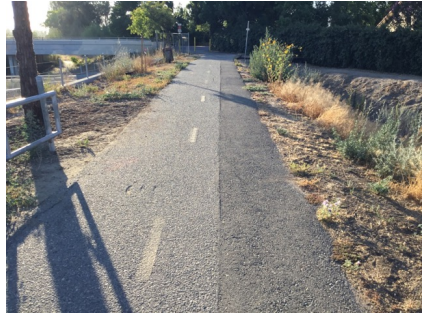
Item no., Rm no. and Name	Existing Architectural Barrier and Proposed Solution	Codes / Mitigation Info	Qty	Unit	Cost	Total
2009	<ul style="list-style-type: none"> As-Built Description: Cross slope more than 1":48" (2.083%). As-Built: Up to 6.0% Proposed Solution: Modify cross slope. Notes: 	PCODE EF07 ADAAG 91 4.3.7 ADA 2010 403.3 CBC 2007 1133B.7.1.3 CBC 2019 11B-403.3 Mitigated: <input type="radio"/> YES <input checked="" type="radio"/> NO	150	SF	\$75	\$11,250

<input type="radio"/> Staff Only						
Priority <input checked="" type="radio"/> 1						
Severity <input checked="" type="radio"/> 3						
<p>There are 48.0" level trail overall but the slopes reduce the level width on one side of the dividing line to <32.0".</p>

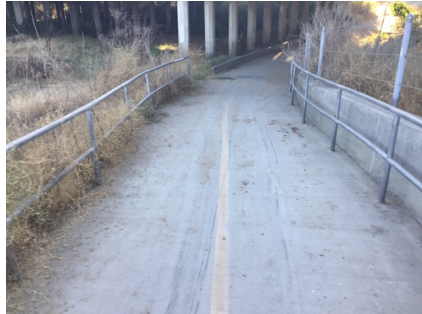
2004	<ul style="list-style-type: none"> As-Built Description: A curb or barrier has not been provided that blocks the passage of a 4-inch diameter sphere, where any portion of the sphere is within 4 inches of the finish floor or ground surface. Proposed Solution: Provide a curb or barrier that prevents the passage of a 4-inch diameter sphere, where any portion of the sphere is within 4 inches of the finish floor or ground surface. Notes: 	PCODE EB14 ADAAG 91 4.8.7 ADA 2010 405.9.2 CBC 2007 1133B.5.6 CBC 2019 11B-405.9.2 Mitigated: <input type="radio"/> YES <input checked="" type="radio"/> NO	50	LF	\$51	\$2,550

<input type="radio"/> Staff Only						
Priority <input checked="" type="radio"/> 1						
Severity <input checked="" type="radio"/> 4						
<p>Occurs both sides of Schnoor.</p>

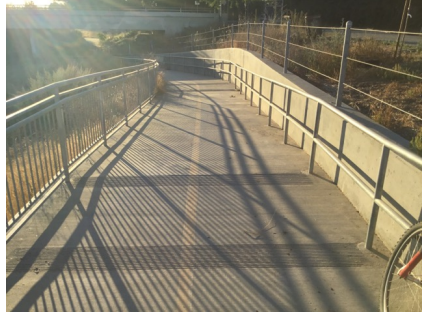
Item no., Rm no. and Name	Existing Architectural Barrier and Proposed Solution	Codes / Mitigation Info	Qty	Unit	Cost	Total
2001	<ul style="list-style-type: none"> As-Built Description: Level 2% max. landing for ramp not provided. As-Built: 2.9% Proposed Solution: Grind surface. Notes: 	PCODE EB05A ADAAG 91 4.8.4 ADA 2010 405.7.1 CBC 2007 1133B.5.4.1 CBC 2019 11B-405.7.1 Mitigated: <input type="radio"/> YES <input checked="" type="radio"/> NO	80	SF	\$150	\$12,000

Both sides of Schnoor.

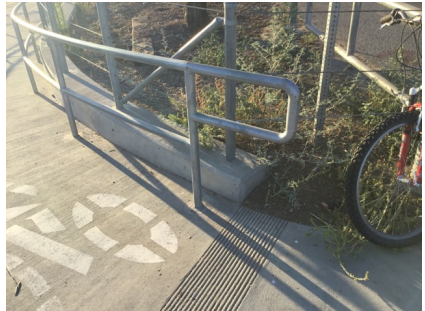
1999	<ul style="list-style-type: none"> As-Built Description: Ramp handrail does not extend horizontally 12" past top and / or bottom of ramp. As-Built: Extension is above 4.0% slope. Proposed Solution: Provide ramp handrail extension (cost for each extension piece). Notes: 	PCODE ED05 ADAAG 91 4.8.5(2) ADA 2010 505.10.1 CBC 2007 1133B.4.2.2 & 1133B.5.5.1 CBC 2019 11B-505.10.1 Mitigated: <input type="radio"/> YES <input checked="" type="radio"/> NO	3	JOB	\$510	\$1,530

Both sides of Schnoor.

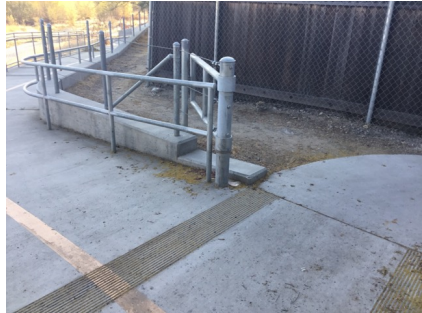
Item no., Rm no. and Name	Existing Architectural Barrier and Proposed Solution	Codes / Mitigation Info	Qty	Unit	Cost	Total
2000	<ul style="list-style-type: none"> As-Built Description: Ramp handrail does not extend horizontally 12" past top and / or bottom of ramp. Proposed Solution: Provide ramp handrail extension (cost for each extension piece). 	PCODE ED05 ADAAG 91 4.8.5(2) ADA 2010 505.10.1 CBC 2007 1133B.4.2.2 & 1133B.5.5.1 CBC 2019 11B-505.10.1 Mitigated: <input type="radio"/> YES <input checked="" type="radio"/> NO	2	JOB	\$510	\$1,020

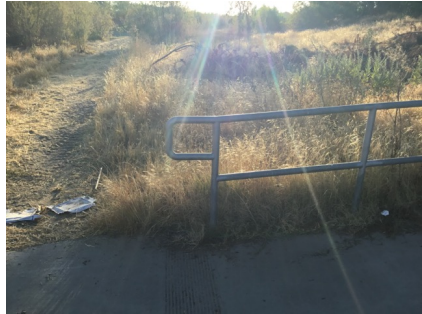
<input type="radio"/> Staff Only			
			Priority <input checked="" type="radio"/> 1			
			Severity <input checked="" type="radio"/> 1			
2005	<ul style="list-style-type: none"> As-Built Description: Ramp handrail does not extend horizontally 12" past top and / or bottom of ramp. As-Built: 11.0" to 12.0" to center of down pipe Proposed Solution: Provide ramp handrail extension (cost for each extension piece). 	PCODE ED05 ADAAG 91 4.8.5(2) ADA 2010 505.10.1 CBC 2007 1133B.4.2.2 & 1133B.5.5.1 CBC 2019 11B-505.10.1 Mitigated: <input type="radio"/> YES <input checked="" type="radio"/> NO	3	JOB	\$510	\$1,530

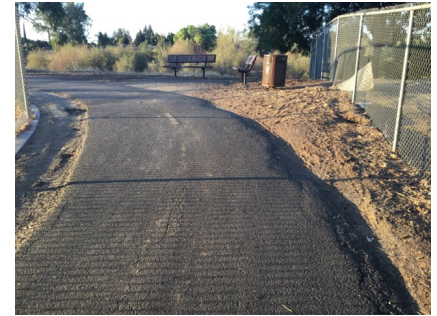
1996	<ul style="list-style-type: none"> As-Built Description: Walk: Slope greater than 1:20 (5.0%), and walk does not comply with requirements for ramps. As-Built: 5.5% Proposed Solution: Modify walk/sidewalk slope to 1:20 or less. 	<p>PCODE EF01 ADAAG 91 4.3.7 ADA 2010 403.3 CBC 2007 1133B.7.3 CBC 2019 11B-403.3</p>	150	SF	\$75	\$11,250
------	--	---	-----	----	------	----------

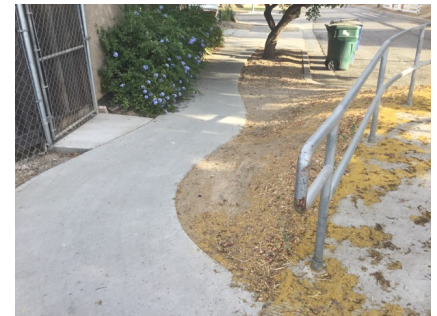
2191	<ul style="list-style-type: none"> As-Built Description: Walk more than 36" but less than 48" wide (required in CA only). As-Built: 46.5" Proposed Solution: Enlarge width of walk to 48". 	<p>PCODE EF08 CBC 2007 1133B.7.1 CBC 2019 11B-403.5.1.3</p>	60	SF	\$135	\$8,100
------	--	---	----	----	-------	---------

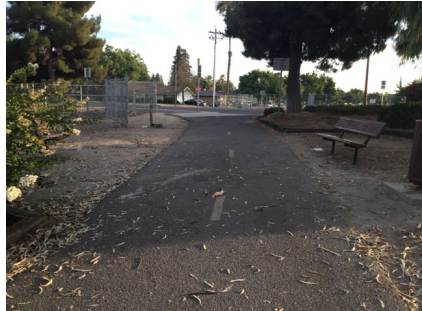
Item no., Rm no. and Name	Existing Architectural Barrier and Proposed Solution	Codes / Mitigation Info	Qty	Unit	Cost	Total
2204	<ul style="list-style-type: none"> As-Built Description: Cross slope more than 1":48" (2.083%). As-Built: To 6.4% Proposed Solution: Modify cross slope. 	PCODE EF07 ADAAG 91 4.3.7 ADA 2010 403.3 CBC 2007 1133B.7.1.3 CBC 2019 11B-403.3 Mitigated: <input type="radio"/> YES <input checked="" type="radio"/> NO	600	SF	\$75	\$45,000

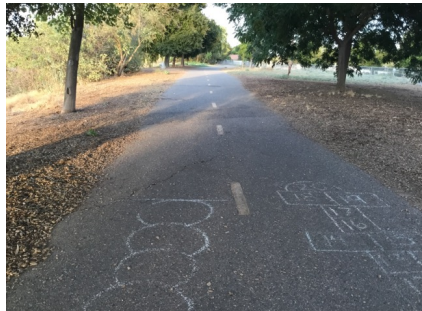
<p><input type="radio"/> Staff Only</p> <p>Priority <input checked="" type="radio"/> 1</p> <p>Severity <input checked="" type="radio"/> 3</p>
2209	<ul style="list-style-type: none"> As-Built Description: Cross slope more than 1":48" (2.083%). As-Built: To 4.8% Proposed Solution: Modify cross slope. 	PCODE EF07 ADAAG 91 4.3.7 ADA 2010 403.3 CBC 2007 1133B.7.1.3 CBC 2019 11B-403.3 Mitigated: <input type="radio"/> YES <input checked="" type="radio"/> NO	1000	SF	\$75	\$75,000

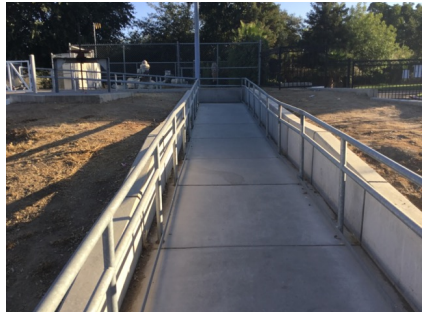
Item no., Rm no. and Name	Existing Architectural Barrier and Proposed Solution	Codes / Mitigation Info	Qty	Unit	Cost	Total
2014	<ul style="list-style-type: none"> As-Built Description: Level 2% max. landing for ramp not provided. As-Built: 4.5% Proposed Solution: Rebuild ramp to provide landings for each ramp run with slopes no greater than 2% 	PCODE EB05A ADAAG 91 4.8.4 ADA 2010 405.7.1 CBC 2007 1133B.5.4.1 CBC 2019 11B-405.7.1 Mitigated: <input type="radio"/> YES <input checked="" type="radio"/> NO	10	SF	\$300	\$3,000

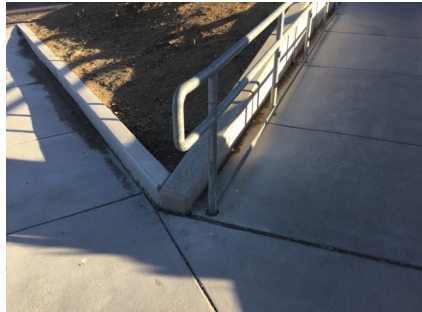
2015	<ul style="list-style-type: none"> As-Built Description: Ramp handrail does not extend horizontally 12" past top and / or bottom of ramp. As-Built: Extension is above a 2.8% slope. Proposed Solution: Provide ramp handrail extension (cost for each extension piece). 	PCODE ED05 ADAAG 91 4.8.5(2) ADA 2010 505.10.1 CBC 2007 1133B.4.2.2 & 1133B.5.5.1 CBC 2019 11B-505.10.1 Mitigated: <input type="radio"/> YES <input checked="" type="radio"/> NO	1	JOB	\$510	\$510

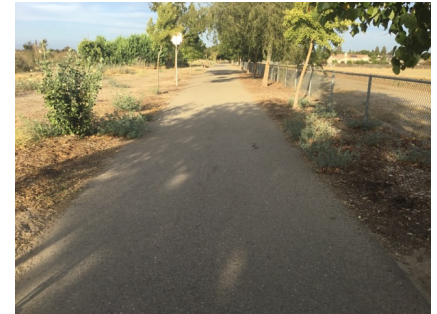
2199	<ul style="list-style-type: none"> As-Built Description: Cross slope more than 1":48" (2.083%). As-Built: To 3.7% Proposed Solution: Modify cross slope. Notes: 	PCODE EF07 ADAAG 91 4.3.7 ADA 2010 403.3 CBC 2007 1133B.7.1.3 CBC 2019 11B-403.3	1000	SF	\$75	\$75,000
------	--	--	------	----	------	----------

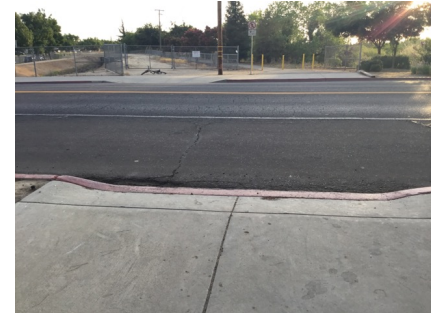
2203	<ul style="list-style-type: none"> As-Built Description: Slope greater than 1:12 (8.3%). As-Built: 10.6% and 15.0% Proposed Solution: Demolish existing and provide new curb ramp. Notes: 	PCODE EH02A ADAAG 91 4.7.2 ADA 2010 406.1 CBC 2007 1127B.5.3 CBC 2019 11B-406.2.1	2	JOB	\$7,500	\$15,000
------	--	---	---	-----	---------	----------

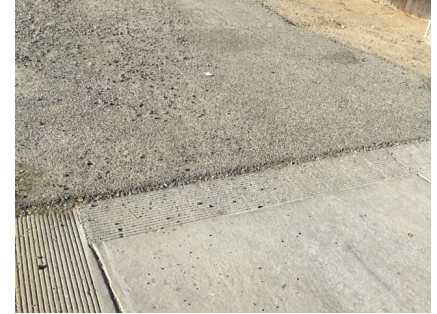
- 2280
- As-Built Description:**
Walk: Pavement dislocation creates abrupt change in level exceeding 1/2" in accessible route.
 - As-Built:** **1.5"**
 - Proposed Solution:**
Remove, replace or repair area of pavement sufficient to correct abrupt change in level.

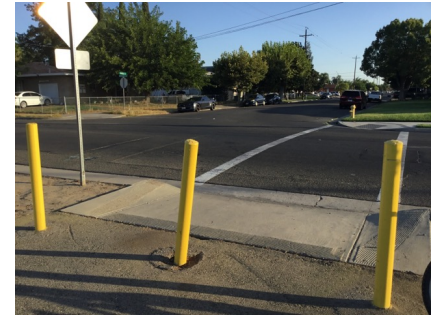
2237	<ul style="list-style-type: none"> As-Built Description: Slope greater than 1:12 (8.3%). As-Built: 10.3% Proposed Solution: Demolish existing and provide new curb ramp. Notes: 	PCODE EH02A ADAAG 91 4.7.2 ADA 2010 406.1 CBC 2007 1127B.5.3 CBC 2019 11B-406.2.1	2	JOB	\$7,500	\$15,000
------	--	---	---	-----	---------	----------

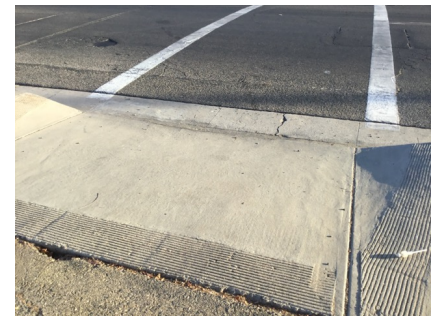
No domes. Lip at street. Large gaps at the top.

2251	<ul style="list-style-type: none"> As-Built Description: Maximum slope of adjoining gutters, street surface at bottom of ramp exceeds 5% (1:20). As-Built: 7.7% Proposed Solution: Modify road/gutter slopes. Demolish existing and provide new curb ramp. 	PCODE EH02E ADAAG 91 4.7.2 ADA 2010 406.2 CBC 2007 1127B.5.3 CBC 2019 11B-406.5.8	2	JOB	\$3,750	\$7,500
------	--	---	---	-----	---------	---------

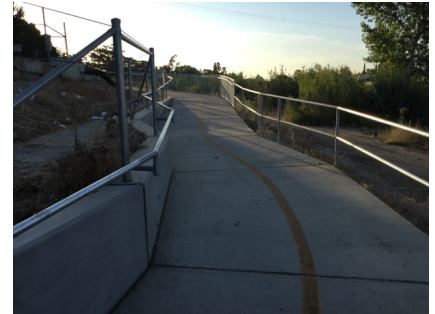
2244	<ul style="list-style-type: none"> As-Built Description: Slope greater than 1:12 (8.3%). As-Built: 9.3% Proposed Solution: Demolish existing and provide new ramp with handrails. 	PCODE EB02 ADAAG 91 4.8.2 ADA 2010 405.2 CBC 2007 1133B.5.3 CBC 2019 11B-405.2	10	SF	\$300	\$3,000
------	---	--	----	----	-------	---------

Severity **4**

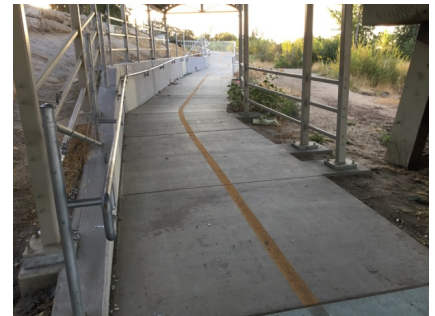
2241	<ul style="list-style-type: none"> As-Built Description: Level 2% max. landing for ramp not provided. As-Built: The landings are 48.0" to 55.0" long and/or slope 8% Proposed Solution: Rebuild ramp to provide landings for each ramp run with slopes no greater than 2% Notes: 	PCODE EB05A ADAAG 91 4.8.4 ADA 2010 405.7.1 CBC 2007 1133B.5.4.1 CBC 2019 11B-405.7.1	70	SF	\$300	\$21,000
------	---	---	----	----	-------	----------

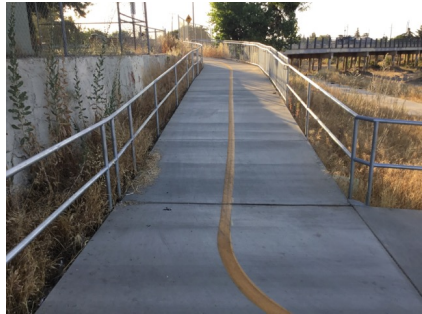
Item no., Rm no. and Name	Existing Architectural Barrier and Proposed Solution	Codes / Mitigation Info	Qty	Unit	Cost	Total
2248	<ul style="list-style-type: none"> As-Built Description: A curb or barrier has not been provided that blocks the passage of a 4-inch diameter sphere, where any portion of the sphere is within 4 inches of the finish floor or ground surface. Proposed Solution: Provide a curb or barrier that prevents the passage of a 4-inch diameter sphere, where any portion of the sphere is within 4 inches of the finish floor or ground surface. 	PCODE EB14 ADAAG 91 4.8.7 ADA 2010 405.9.2 CBC 2007 1133B.5.6 CBC 2019 11B-405.9.2 Mitigated: <input type="radio"/> YES <input checked="" type="radio"/> NO	40	LF	\$51	\$2,040

<input type="radio"/> Staff Only Priority <input checked="" type="radio"/> 1 Severity <input checked="" type="radio"/> 4

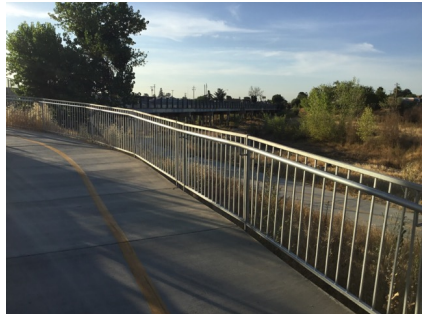
2250	<ul style="list-style-type: none"> As-Built Description: Guards (42" high) not provided at side of ramp or landing where drop-off to adjacent grade or floor exceeds 30" height (California building code requirement only). As-Built: 39.0" Proposed Solution: Provide new guards, including handrail at ramp. 	PCODE ED08 CBC 2007 1133B.5.7 CBC 2019 Section 1013.2; 1013.3 Mitigated: <input type="radio"/> YES <input checked="" type="radio"/> NO	30	LF	\$360	\$10,800

<input type="radio"/> Staff Only Priority <input checked="" type="radio"/> 1 Severity <input checked="" type="radio"/> 4

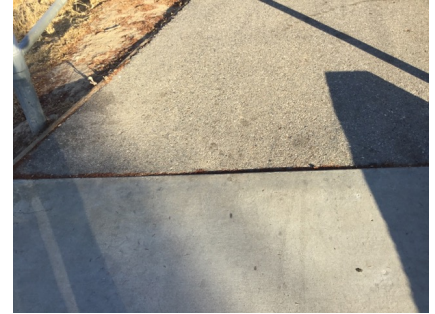
- 2254
- As-Built Description:**
Walk: Pavement dislocation creates abrupt change in level exceeding 1/2" in accessible route.
 - As-Built:** 1.0"
 - Proposed Solution:**
Remove, replace or repair area of pavement sufficient to correct abrupt change in level.

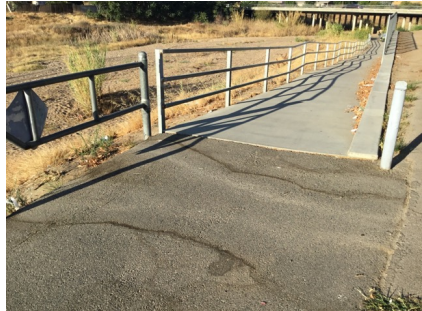
Item no., Rm no. and Name	Existing Architectural Barrier and Proposed Solution	Codes / Mitigation Info	Qty	Unit	Cost	Total
2258	<ul style="list-style-type: none"> As-Built Description: Level 2% max. landing for ramp not provided. As-Built: 4.3% Proposed Solution: Alter top landing. 	PCODE EB05A ADAAG 91 4.8.4 ADA 2010 405.7.1 CBC 2007 1133B.5.4.1 CBC 2019 11B-405.7.1 Mitigated: <input type="radio"/> YES <input checked="" type="radio"/> NO	35	SF	\$300	\$10,500

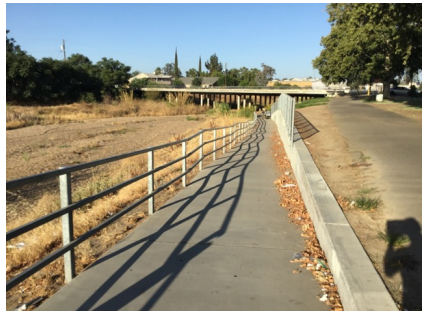
<input type="radio"/> Staff Only			
			Priority 1			
			Severity 3			
2260	<ul style="list-style-type: none"> As-Built Description: Level 2% max. landing for ramp not provided. As-Built: To 3.2% Proposed Solution: Alter surface. 	PCODE EB05A ADAAG 91 4.8.4 ADA 2010 405.7.1 CBC 2007 1133B.5.4.1 CBC 2019 11B-405.7.1 Mitigated: <input type="radio"/> YES <input checked="" type="radio"/> NO	24	SF	\$300	\$7,200

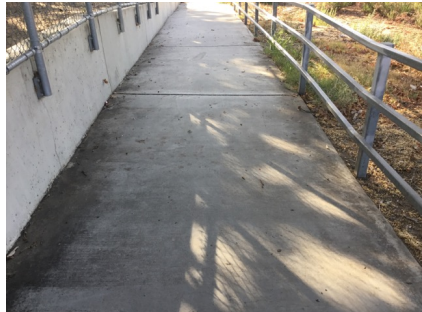
Item no., Rm no. and Name	Existing Architectural Barrier and Proposed Solution	Codes / Mitigation Info	Qty	Unit	Cost	Total
2269	<ul style="list-style-type: none"> As-Built Description: Level 2% max. landing for ramp not provided. As-Built: 3.2% Proposed Solution: Rebuild ramp to provide landings for each ramp run with slopes no greater than 2% 	PCODE EB05A ADAAG 91 4.8.4 ADA 2010 405.7.1 CBC 2007 1133B.5.4.1 CBC 2019 11B-405.7.1 Mitigated: <input type="radio"/> YES <input checked="" type="radio"/> NO	80	SF	\$300	\$24,000

<input type="radio"/> Staff Only						
Priority 1						
Severity 4

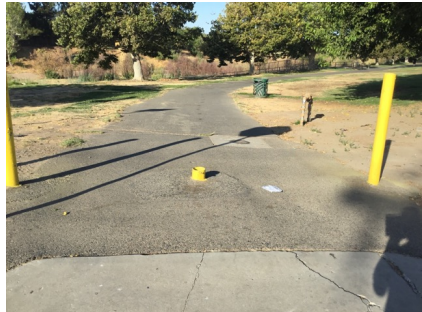
2271	<ul style="list-style-type: none"> As-Built Description: Walk: Slope greater than 1:20 (5.0%), and walk does not comply with requirements for ramps. As-Built: 7.0% Proposed Solution: Modify walk/sidewalk slope to 1:20 or less. 	PCODE EF01 ADAAG 91 4.3.7 ADA 2010 403.3 CBC 2007 1133B.7.3 CBC 2019 11B-403.3 Mitigated: <input type="radio"/> YES <input checked="" type="radio"/> NO	500	SF	\$75	\$37,500

<input type="radio"/> Staff Only						
Priority 1						
Severity 4

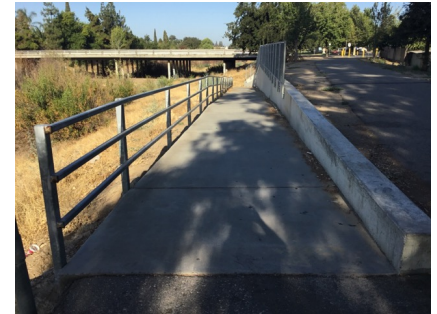
2276	<ul style="list-style-type: none"> As-Built Description: Slope greater than 1:12 (8.3%). As-Built: 9.6%. 5.5% cross slopes. Proposed Solution: Demolish existing and provide new ramp with handrails. 	PCODE EB02 ADAAG 91 4.8.2 ADA 2010 405.2 CBC 2007 1133B.5.3 CBC 2019 11B-405.2	700	SF	\$300	\$210,000
------	---	--	-----	----	-------	-----------

Severity **4**

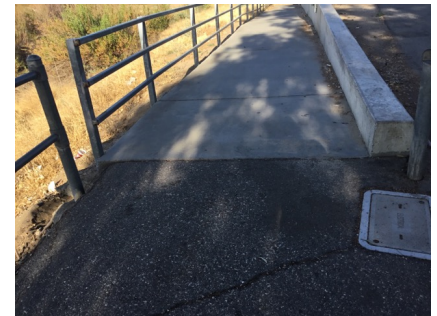
2272	<ul style="list-style-type: none"> As-Built Description: Level 2% max. landing for ramp not provided. As-Built: Top landing slopes 5.0%. Proposed Solution: Rebuild ramp to provide landings for each ramp run with slopes no greater than 2% 	PCODE EB05A ADAAG 91 4.8.4 ADA 2010 405.7.1 CBC 2007 1133B.5.4.1 CBC 2019 11B-405.7.1	40	SF	\$300	\$12,000
------	---	---	----	----	-------	----------

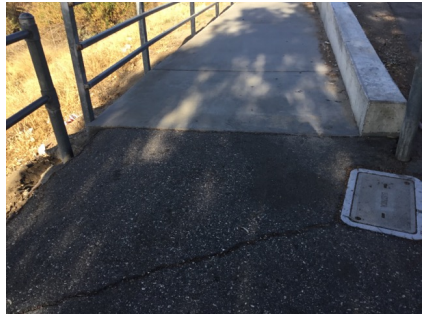
Item no., Rm no. and Name	Existing Architectural Barrier and Proposed Solution	Codes / Mitigation Info	Qty	Unit	Cost	Total
2273	<ul style="list-style-type: none"> As-Built Description: Level 2% max. landing for ramp not provided. As-Built: Top landing slopes 5.0%. Proposed Solution: Alter surface. 	PCODE EB05A ADAAG 91 4.8.4 ADA 2010 405.7.1 CBC 2007 1133B.5.4.1 CBC 2019 11B-405.7.1 Mitigated: <input type="radio"/> YES <input checked="" type="radio"/> NO	40	SF	\$300	\$12,000

<input type="radio"/> Staff Only						
Priority 1						
Severity 3

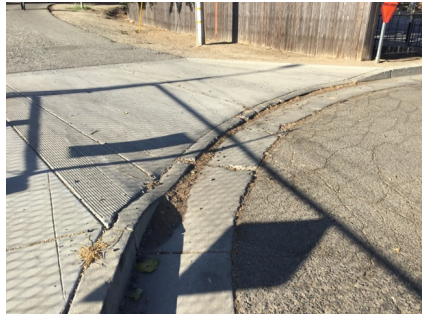
Item no., Rm no. and Name	Existing Architectural Barrier and Proposed Solution	Codes / Mitigation Info	Qty	Unit	Cost	Total
2278	<ul style="list-style-type: none"> <i>As-Built Description:</i> Detectable warning not provided where pedestrian crosses vehicular area. <i>Proposed Solution:</i> Provide detectable warning surface (i.e. in-line truncated domes) at regular curb ramp. 	PCODE EH07A ADAAG 91 4.7.7 ADA 2010 705.1 CBC 2007 1127B.5.7 CBC 2019 11B-705.1.2.2 Mitigated: <input type="radio"/> YES <input checked="" type="radio"/> NO	1	JOB	\$750	\$750

<input type="radio"/> Staff Only
						Priority <input checked="" type="radio"/> 1
						Severity <input checked="" type="radio"/> 3

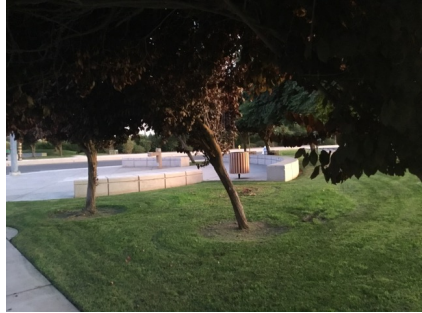
2217	<ul style="list-style-type: none"> <i>As-Built Description:</i> Protruding objects more than 4" from wall, when bottom of object more than 27" or less than 80" above finished floor. <i>Proposed Solution:</i> Trim vegetation. 	PCODE EG04 ADAAG 91 4.4.1 ADA 2010 307.2 CBC 2007 1133B.8.6.1 CBC 2019 11B-307.2 Mitigated: <input type="radio"/> YES <input checked="" type="radio"/> NO	10	JOB	\$90	\$900

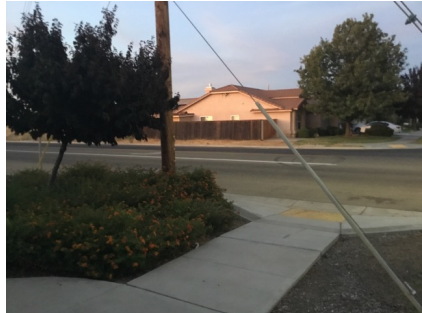
2220	<ul style="list-style-type: none"> <i>As-Built Description:</i> Protruding objects more than 4" from wall, when bottom of object more than 27" or less than 80" above finished floor. <i>As-Built:</i> Telephone pole guy wire 64.0" to 79.0" high <i>Proposed Solution:</i> Remove/relocate protruding object. Patch existing surface. 	PCODE EG04 ADAAG 91 4.4.1 ADA 2010 307.2 CBC 2007 1133B.8.6.1 CBC 2019 11B-307.2 Mitigated: <input type="radio"/> YES <input checked="" type="radio"/> NO	1	JOB	\$300	\$300

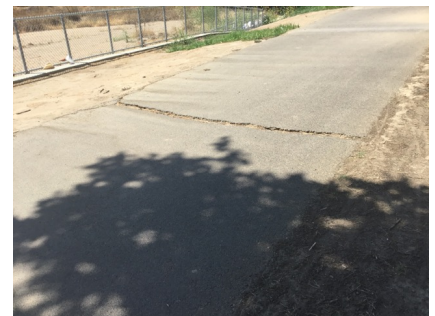
- 514
- *As-Built Description:*
Walk: Pavement dislocation creates abrupt change in level exceeding 1/2" in accessible route.
 - *As-Built: Gaps and level changes to 2.0"*
 - *Proposed Solution:*
Remove, replace or repair area of pavement sufficient to correct abrupt change in level.

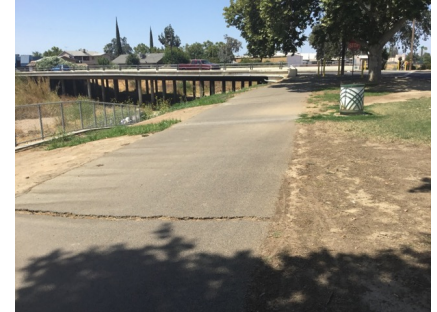
513	<ul style="list-style-type: none"> As-Built Description: Cross slope more than 1":48" (2.083%). As-Built: Up to 5.0% Proposed Solution: Modify cross slope. 	PCODE EF07 ADAAG 91 4.3.7 ADA 2010 403.3 CBC 2007 1133B.7.1.3 CBC 2019 11B-403.3	3000	SF	\$75	\$225,000
-----	---	--	------	----	------	-----------

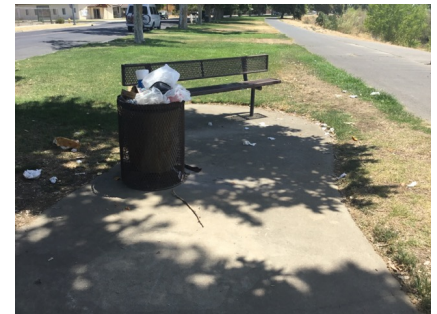
518	<ul style="list-style-type: none"> As-Built Description: Cross slope more than 1":48" (2.083%). As-Built: 4.8% slope at trash can clear floor space. Occurs throughout the park at trash cans. Also occurs at trash cans Proposed Solution: Modify cross slope, or relocate trash cans. 	PCODE EF07 ADAAG 91 4.3.7 ADA 2010 403.3 CBC 2007 1133B.7.1.3 CBC 2019 11B-403.3	50	SF	\$75	\$3,750
-----	---	--	----	----	------	---------

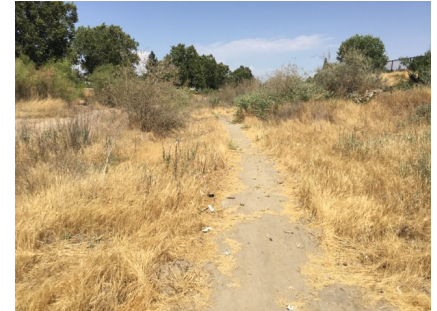
537	<ul style="list-style-type: none"> • <i>As-Built Description:</i> Cross slope more than 1":48" (2.083%). • <i>As-Built:</i> 10.0% • <i>Proposed Solution:</i> Modify cross slope. • <i>Notes:</i> 	PCODE EF07 ADAAG 91 4.3.7 ADA 2010 403.3 CBC 2007 1133B.7.1.3 CBC 2019 11B-403.3	200	SF	\$75	\$15,000
-----	--	--	-----	----	------	----------

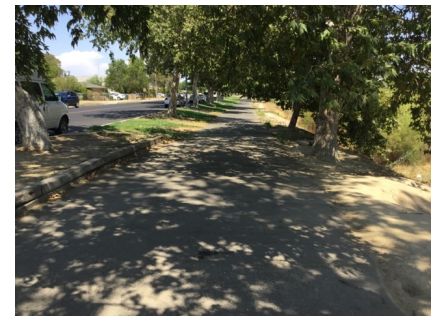
539	<ul style="list-style-type: none"> • <i>As-Built Description:</i> Protruding objects more than 4" from wall, when bottom of object more than 27" or less than 80" above finished floor. • <i>Proposed Solution:</i> Trim vegetation. 	PCODE EG04 ADAAG 91 4.4.1 ADA 2010 307.2 CBC 2007 1133B.8.6.1 CBC 2019 11B-307.2	20	JOB	\$300	\$6,000
-----	--	--	----	-----	-------	---------

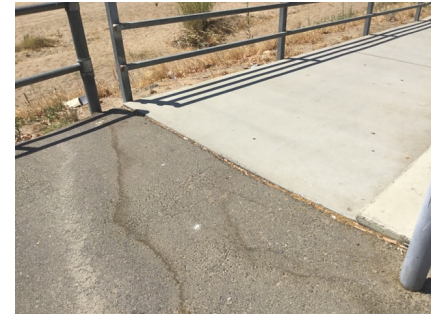
- 512
- *As-Built Description:*
Ramp: Pavement dislocation creates abrupt change in level exceeding 1/2" in ramp.
 - *As-Built:* **1.0"**
 - *Proposed Solution:*
Remove, replace or repair area of pavement sufficient to correct abrupt change in level.

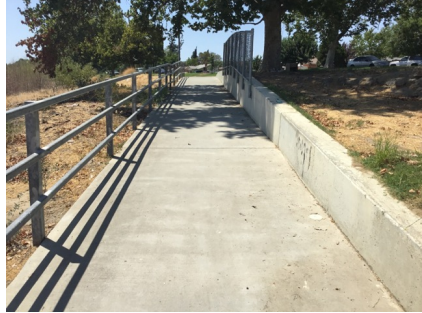
<p>531</p> <ul style="list-style-type: none"> As-Built Description: Slope greater than 1:12 (8.3%). As-Built: Up to 10.0% Proposed Solution: Demolish existing and provide new ramp with handrails. 	<p>PCODE EB02 ADAAG 91 4.8.2 ADA 2010 405.2 CBC 2007 1133B.5.3 CBC 2019 11B-405.2</p> <p>Mitigated: <input type="radio"/> YES <input checked="" type="radio"/> NO</p>	<p>80 SF \$300 \$24,000</p>

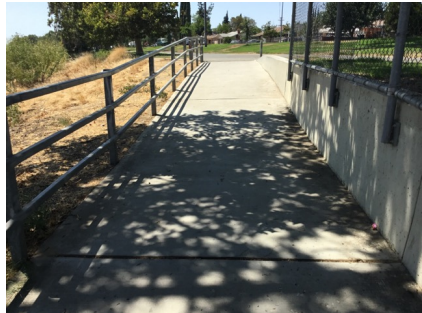
<p>530</p> <ul style="list-style-type: none"> As-Built Description: Level 2% max. landing for ramp not provided. As-Built: 2.5% to 4.0% at top, bottom and middle landing. Proposed Solution: Rebuild ramp to provide landings for each ramp run with slopes no greater than 2% 	<p>PCODE EB05A ADAAG 91 4.8.4 ADA 2010 405.7.1 CBC 2007 1133B.5.4.1 CBC 2019 11B-405.7.1</p> <p>Mitigated: <input type="radio"/> YES <input checked="" type="radio"/> NO</p>	<p>90 SF \$300 \$27,000</p>

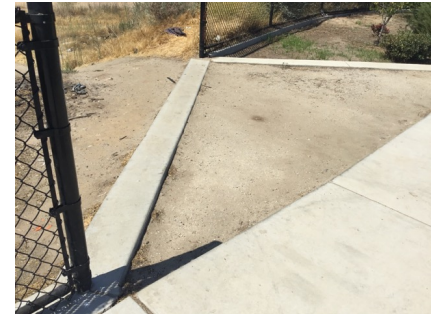
- 536
- *As-Built Description:*
Walk: Pavement dislocation creates abrupt change in level exceeding 1/2" in accessible route.
 - *As-Built:* **2.0"**
 - *Proposed Solution:*
Remove, replace or repair area of pavement sufficient to correct abrupt change in level.

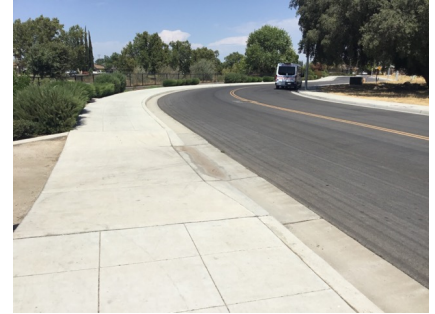
- 534
- *As-Built Description:*
Refer to notes for observation and recommendation.
 - *Proposed Solution:*
 - *Notes:*

No accessible parking and verify City on street parking requirements. The Ninth Circuit found that, despite the lack of accessibility standards, on-street parking is a “normal function” of a city and therefore must be made accessible.

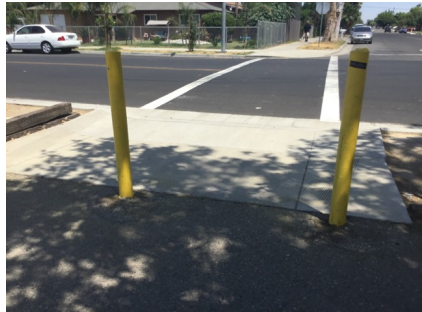
Item no., Rm no. and Name	Existing Architectural Barrier and Proposed Solution	Codes / Mitigation Info	Qty	Unit	Cost	Total
521	<ul style="list-style-type: none"> As-Built Description: Detectable warning not provided where pedestrian crosses vehicular area. Proposed Solution: Provide detectable warning surface (i.e. in-line truncated domes) at regular curb ramp. 	PCODE EH07A ADAAG 91 4.7.7 ADA 2010 705.1 CBC 2007 1127B.5.7 CBC 2019 11B-705.1.2.2 Mitigated: <input type="radio"/> YES <input checked="" type="radio"/> NO	1	JOB	\$750	\$750

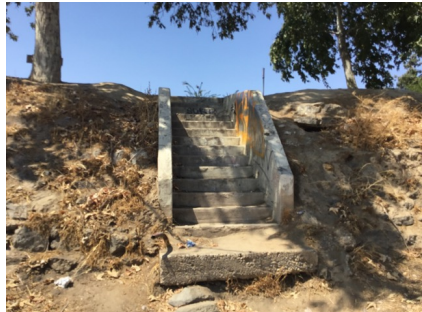
538	<ul style="list-style-type: none"> As-Built Description: Exterior stair substantially out of compliance. Proposed Solution: Provide complete new stair, 4 ft. wide with landing and handrails. 	PCODE EC09 ADAAG 91 4.9 ADA 2010 504 CBC 2007 1133B.4 CBC 2019 11B-504 Mitigated: <input type="radio"/> YES <input checked="" type="radio"/> NO	200	IN	\$270	\$54,000

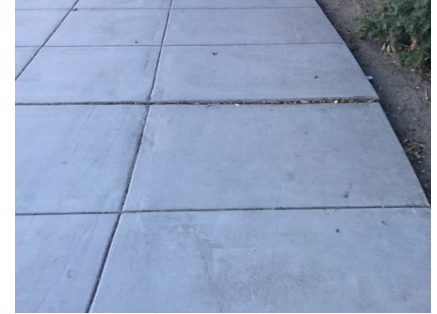
- 2225
- *As-Built Description:*
Walk: Pavement dislocation creates abrupt change in level exceeding 1/2" in accessible route.
 - *As-Built:* **2.0"**
 - *Proposed Solution:*
Remove, replace or repair area of pavement sufficient to correct abrupt change in level.

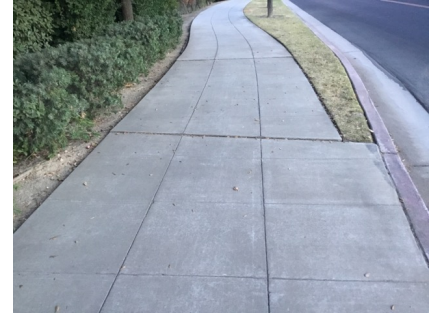
- 2229
- *As-Built Description:*
Walk: Pavement dislocation creates abrupt change in level exceeding 1/2" in accessible route.
 - *As-Built:* **1.5"**
 - *Proposed Solution:*
Remove, replace or repair area of pavement sufficient to correct abrupt change in level.

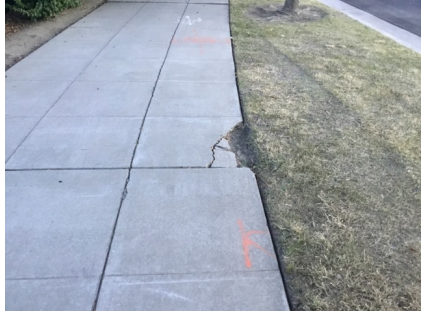
2230	<ul style="list-style-type: none"> As-Built Description: Walk: Grating has grid openings greater than 1/2" along the line of traffic flow. As-Built: 2.0" deep pothole Proposed Solution: Repair concrete. 	PCODE EF04 ADAAG 91 4.3.6; 4.5.4 ADA 2010 403.2; 302.3 CBC 2007 1133B.7.2 CBC 2019 11B-403.2; 11B-302.3 Mitigated: <input type="radio"/> YES <input checked="" type="radio"/> NO	1	SF	\$240	\$240
------	--	---	---	----	-------	-------

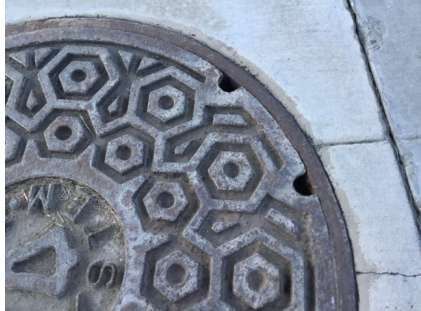
2231	<ul style="list-style-type: none"> As-Built Description: Walk: Grating has grid openings greater than 1/2" along the line of traffic flow. As-Built: 1.5" x 1.5" Proposed Solution: Provide new grating, with grid openings 1/2" max. along the line of traffic flow. 	PCODE EF04 ADAAG 91 4.3.6; 4.5.4 ADA 2010 403.2; 302.3 CBC 2007 1133B.7.2 CBC 2019 11B-403.2; 11B-302.3 Mitigated: <input type="radio"/> YES <input checked="" type="radio"/> NO	2	UNI	\$600	\$1,200
------	---	---	---	-----	-------	---------

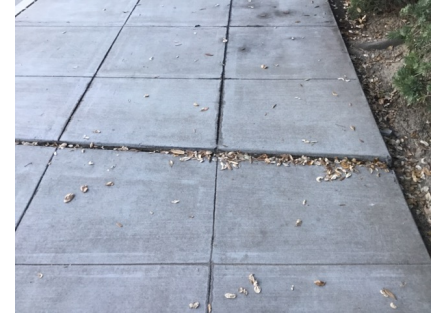
- 2232
- *As-Built Description:*
Walk: Pavement dislocation creates abrupt change in level exceeding 1/2" in accessible route.
 - *As-Built:* **2.0"**
 - *Proposed Solution:*
Remove, replace or repair area of pavement sufficient to correct abrupt change in level.

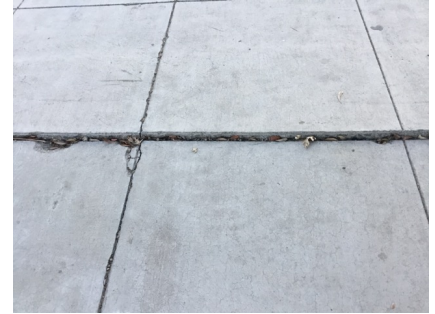
- 2234
- *As-Built Description:*
Walk: Pavement dislocation creates abrupt change in level exceeding 1/2" in accessible route.
 - *As-Built:* **2.0"**
 - *Proposed Solution:*
Remove, replace or repair area of pavement sufficient to correct abrupt change in level.
