APPENDIX B: ACCESS COMPLIANCE SURVEY REPORT OF FACILITIES

The City of Madera

Access Compliance Survey Report

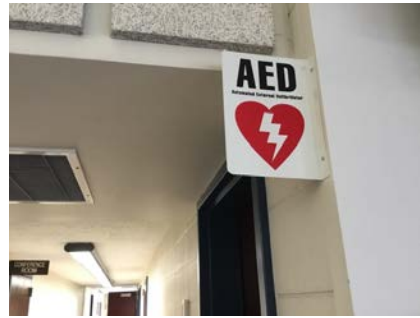
Item no., Rm no. and Name	Existing Architectural Barrier and Proposed Solution	Codes / Mitigation Info	9 Qty	10 Unit	11 Cost	12 Total
1 2 2 Foyer	<p>3 <u>Protrusion Limits</u></p> <p>2259 • <i>As-Built Description:</i></p> <p>4 Protruding objects more than 4" from wall, when bottom of object more than 27" or less than 80"</p> <p>5 above finished floor.</p> <p>• <i>As-Built:</i> AED sign: 7.0" at 76.0" high</p> <p>• <i>Proposed Solution:</i></p> <p>6 Remove/relocate protruding object. Patch existing surface.</p>	<p>7</p> <p>PCODE EG04</p> <p>ADAAG 91 4.4.1</p> <p>8 ADA 2010 307.2</p> <p>CBC 2007 1133B.8.6.1</p> <p>CBC 2019 11B-307.2</p> <p>Mitigated:</p> <p><input type="radio"/> YES</p> <p><input checked="" type="radio"/> NO</p>	1	JOB	\$300	\$300

<p><input type="radio"/> Staff Only</p>						
<p>Priority 1</p> <p>Severity 3</p>

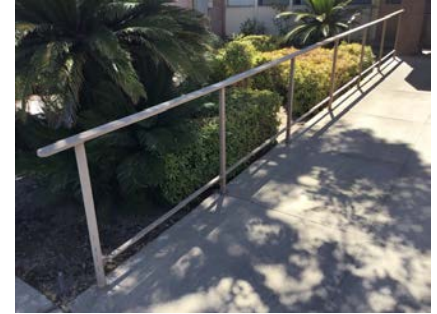
PCODE **ED03**
 ADAAG 91 **4.26.2**
 ADA 2010 **505.7**
 CBC 2007 **1133B.4.2.6**
 CBC 2019 **11B-505.7**

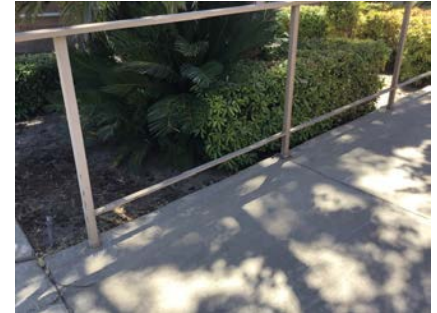
PCODE **EB14**
 ADAAG 91 **4.8.7**
 ADA 2010 **405.9.2**
 CBC 2007 **1133B.5.6**
 CBC 2019 **11B-405.9.2**

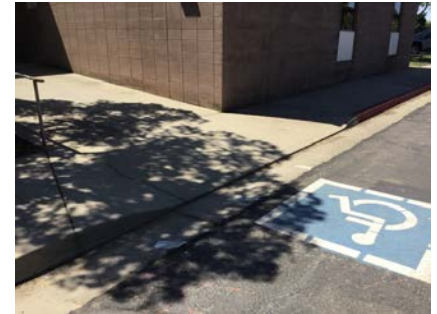
Curb Ramp

86	<ul style="list-style-type: none"> As-Built Description: Transition from curb ramp to gutter does not have a smooth transition. As-Built: 1.0" high Proposed Solution: Grind lip. 	PCODE EH02D ADAAG 91 4.7.2 ADA 2010 406.2 CBC 2007 1127B.5.3 CBC 2019 11B-406.5.8	1	JOB	\$300	\$300
----	---	--	---	-----	-------	-------

Severity **2**

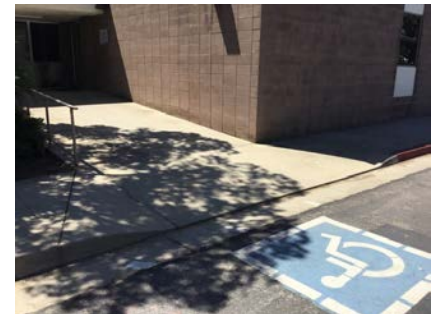
87	<ul style="list-style-type: none"> As-Built Description: Maximum slope of adjoining gutters, street surface at bottom of ramp exceeds 5% (1:20). As-Built: 9.0% Proposed Solution: Modify road/gutter slopes. Demolish existing and provide new curb ramp. 	PCODE EH02E ADAAG 91 4.7.2 ADA 2010 406.2 CBC 2007 1127B.5.3 CBC 2019 11B-406.5.8	1	JOB	\$3,750	\$3,750
----	--	--	---	-----	---------	---------

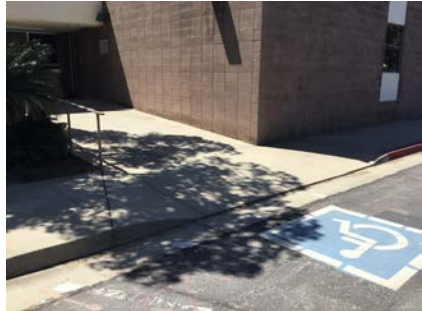
Item no., Rm no. and Name	Existing Architectural Barrier and Proposed Solution	Codes / Mitigation Info	Qty	Unit	Cost	Total
88	<ul style="list-style-type: none"> As-Built Description: Side slopes more than 1:10 (10%). As-Built: 19.0% Proposed Solution: Modify curb ramp. Demolish side slopes and replace with 1:10 side slopes if 48" level top landing is provided. 	PCODE EH05A ADAAG 91 4.7.5 ADA 2010 406.3 CBC 2007 1127B.5.3 CBC 2019 11B-406.2.2 Mitigated: <input type="radio"/> YES <input checked="" type="radio"/> NO	2	JOB	\$6,000	\$12,000

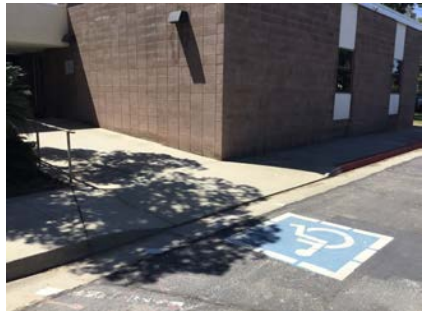
<input type="radio"/> Staff Only			
			Priority 1			
			Severity 2			
85	<ul style="list-style-type: none"> As-Built Description: Detectable warning not provided where pedestrian crosses vehicular area. Proposed Solution: Provide detectable warning surface (i.e. in-line truncated domes) at regular curb ramp. 	PCODE EH07A ADAAG 91 4.7.7 ADA 2010 705.1 CBC 2007 1127B.5.7 CBC 2019 11B-705.1.2.2 Mitigated: <input type="radio"/> YES <input checked="" type="radio"/> NO	1	JOB	\$750	\$750

<input type="radio"/> Staff Only			
			Priority 1			
			Severity 3

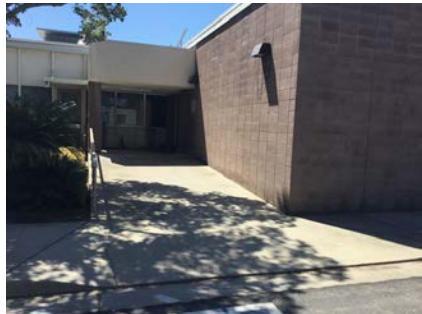
Signage

78	<ul style="list-style-type: none"> <i>As-Built Description:</i> Exterior signage at inaccessible entrances to provide direction to accessible entrances is missing or noncompliant. <i>Proposed Solution:</i> Provide signage sufficient to guide persons to accessible entrances. <i>Notes:</i> 	PCODE SA01 ADAAG 91 4.1.2(7)(c) ADA 2010 216.6 CBC 2007 1117B.5.8.1.2 CBC 2019 11B-216.6 Mitigated: <input type="radio"/> YES <input checked="" type="radio"/> NO	1	JOB	\$690	\$690
----	---	--	---	-----	-------	-------

Severity 3

Unless this entrance is modified to be accessible consider a directional sign informing drivers where they can park to access this building.

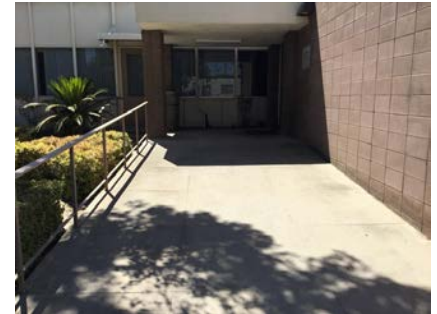
79	<ul style="list-style-type: none"> As-Built Description: Slope greater than 1:12 (8.3%). As-Built: 9.1% Proposed Solution: Modify surface. 	PCODE EB02 ADAAG 91 4.8.2 ADA 2010 405.2 CBC 2007 1133B.5.3 CBC 2019 11B-405.2	10	SF	\$300	\$3,000
----	--	---	----	----	-------	----------------

Severity **4**

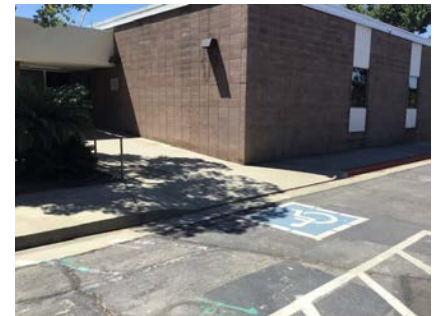
84	<ul style="list-style-type: none"> As-Built Description: Level 2% max. landing for ramp not provided. As-Built: Landing slopes 8.4% Proposed Solution: Rebuild ramp to provide landings for each ramp run with slopes no greater than 2%. Relocate the curb ramp. Notes: 	PCODE EB05A ADAAG 91 4.8.4 ADA 2010 405.7.1 CBC 2007 1133B.5.4.1 CBC 2019 11B-405.7.1	50	SF	\$300	\$15,000
----	---	--	----	----	-------	-----------------

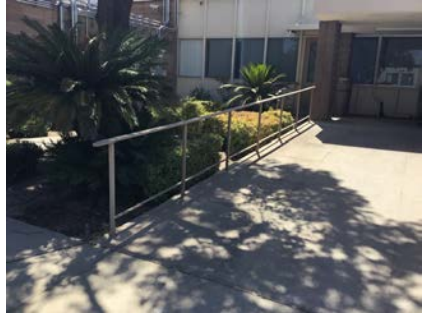
Item no., Rm no. and Name	Existing Architectural Barrier and Proposed Solution	Codes / Mitigation Info	Qty	Unit	Cost	Total
Top and Bottom Extension at						
80	<ul style="list-style-type: none"> <i>As-Built Description:</i> Ramp handrail does not extend horizontally 12" past top and / or bottom of ramp. <i>Proposed Solution:</i> Provide ramp handrail extension (cost for each extension piece). 	PCODE ED05 ADAAG 91 4.8.5(2) ADA 2010 505.10.1 CBC 2007 1133B.4.2.2 & 1133B.5.5.1 CBC 2019 11B-505.10.1 Mitigated: <input type="radio"/> YES <input checked="" type="radio"/> NO	2	JOB	\$510	\$1,020

<input type="radio"/> Staff Only			
			Priority 1			
			Severity 1

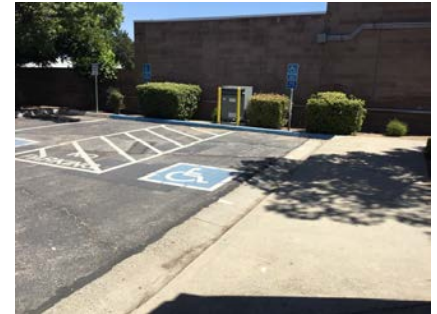
The steepest slopes are caused by the gutter slope. Other slopes are due to upheavals in the pavement and general surface slopes.

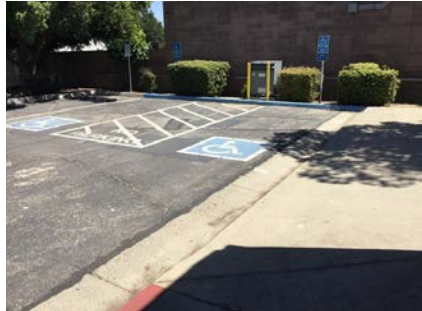
Item no., Rm no. and Name	Existing Architectural Barrier and Proposed Solution	Codes / Mitigation Info	Qty	Unit	Cost	Total
91	<ul style="list-style-type: none"> <i>As-Built Description:</i> Disabled persons must wheel or walk behind parked car(s) other than their own. <i>Proposed Solution:</i> Relocate parking and provide curb ramp to accessible route. 	PCODE EA03 ADAAG 91 Fig.9 ADA 2010 502.3 CBC 2007 1129B.3.1 CBC 2019 11B-502.7.1 Mitigated: <input type="radio"/> YES <input checked="" type="radio"/> NO	1	JOB	\$2,190	\$2,190

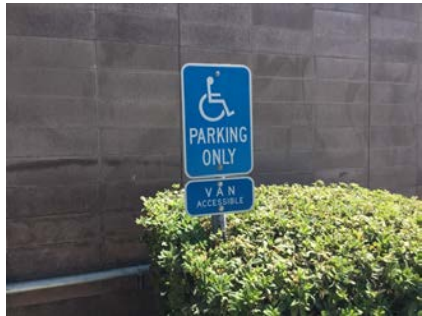
<input type="radio"/> Staff Only			
			Priority <input checked="" type="radio"/> 1			
			Severity <input checked="" type="radio"/> 3			
93	<ul style="list-style-type: none"> <i>As-Built Description:</i> Parking sign is not located between 60" and 80" above the finish floor or ground surface measured to the bottom of the sign. <i>As-Built:</i> 58.0" high <i>Proposed Solution:</i> Remount existing sign at accessible height. 	PCODE EA04H ADAAG 91 4.6.4 ADA 2010 502.7 CBC 2007 1129B.4 CBC 2019 11B-502.6 Mitigated: <input type="radio"/> YES <input checked="" type="radio"/> NO	1	JOB	\$135	\$135

<input type="radio"/> Staff Only			
			Priority <input checked="" type="radio"/> 1			
			Severity <input checked="" type="radio"/> 4

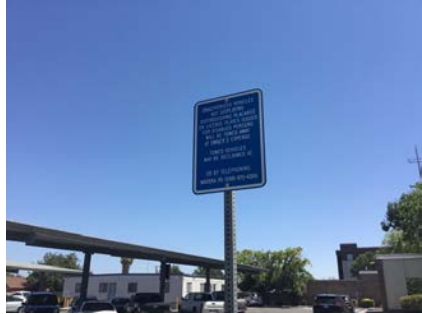
Item no., Rm no. and Name	Existing Architectural Barrier and Proposed Solution	Codes / Mitigation Info	Qty	Unit	Cost	Total
<u>Parking Signage</u>						
94	<ul style="list-style-type: none"> • <i>As-Built Description:</i> No "Tow Away" sign at parking lot entrance (required in CA only). • <i>As-Built:</i> Incomplete. Does not comply w current verbiage. • <i>Proposed Solution:</i> Provide "Tow Away" sign at parking lot entrance when altering area. 	<p>PCODE EA04C</p> <p>CBC 2007 1129B.4</p> <p>CBC 2019 11B-502.8.2</p> <p>Mitigated:</p> <p><input type="radio"/> YES</p> <p><input checked="" type="radio"/> NO</p>	1	JOB	\$975	\$975

<input type="radio"/> Staff Only			
			<p>Priority 1</p> <p>Severity 4</p>

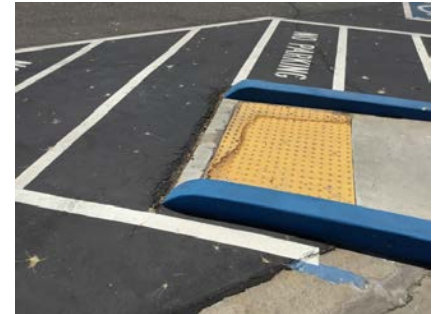
Curb Ramp

112	<ul style="list-style-type: none"> As-Built Description: Transition from curb ramp to gutter does not have a smooth transition. As-Built: 1.0" Proposed Solution: Grind lip. 	PCODE EH02D ADAAG 91 4.7.2 ADA 2010 406.2 CBC 2007 1127B.5.3 CBC 2019 11B-406.5.8	1	JOB	\$300	\$300
-----	--	--	---	-----	-------	-------

Severity **2**

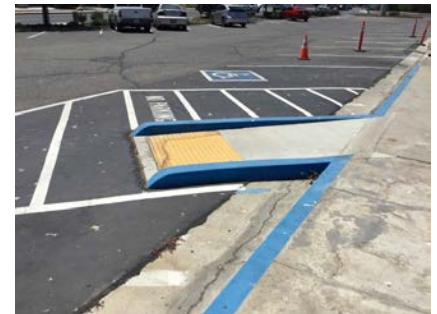
110	<ul style="list-style-type: none"> As-Built Description: Cross slope greater than 2%. As-Built: 3.0% Proposed Solution: Demolish existing and provide new curb ramp. 	PCODE EH02F ADAAG 91 4.8.6 ADA 2010 405.3 CBC 2007 1133B.5.3.1 CBC 2019 11B-406.5.7	1	JOB	\$7,500	\$7,500
-----	--	--	---	-----	---------	---------

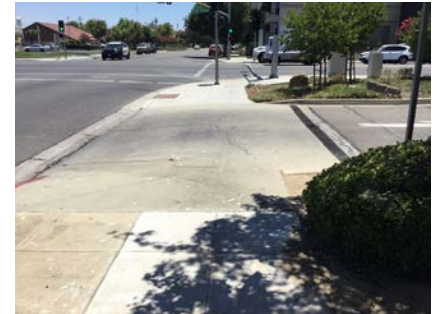
Detectable Warning

117	<ul style="list-style-type: none"> • <i>As-Built Description:</i> 36" wide band of truncated domes not provided at walkway or crossing adjoining a vehicular way, if surfaces are not separated by a curb, railing, or other element. • <i>Proposed Solution:</i> Provide 36" wide, contrasting color, band of truncated domes between pedestrian and vehicular area. • <i>Notes:</i> 	<p>PCODE EG09 ADAAG 91 4.29.5 CBC 2007 1133B.8.5 CBC 2019 11B-705.1.2.5</p> <p>Mitigated: <input type="radio"/> YES <input checked="" type="radio"/> NO</p>	30	LF	\$81	\$2,430
-----	--	--	----	----	------	---------

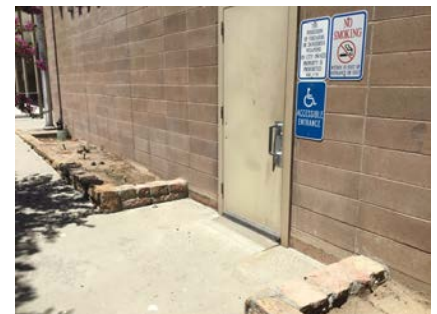
Door

95	<ul style="list-style-type: none"> • <i>As-Built Description:</i> Surface of required maneuvering clearance at door slopes more than 1/4":12" (2.0%). • <i>As-Built:</i> 3.0% • <i>Proposed Solution:</i> Modify surface slope at door. 	<p>PCODE ID11 ADAAG 91 4.13.6 ADA 2010 404.2.4.4 CBC 2007 1133B.2.4 CBC 2019 11B-404.2.4</p> <p>Mitigated: <input type="radio"/> YES <input checked="" type="radio"/> NO</p>	5	SF	\$120	\$600
----	---	---	---	----	-------	-------

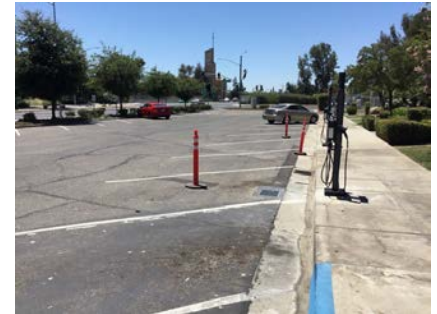
EV Parking

114	<ul style="list-style-type: none"> <i>As-Built Description:</i> Electric Vehicle is not located on an accessible route. <i>Proposed Solution:</i> Modify or relocate Electric Vehicle space so that it connects to the accessible route. Notes: 	<p>PCODE EV03</p> <p>CBC 2019 11B-812.5.1</p> <p>Mitigated:</p> <p><input type="radio"/> YES</p> <p><input checked="" type="radio"/> NO</p>	1	JOB	\$1,050	\$1,050
-----	---	---	---	-----	---------	---------

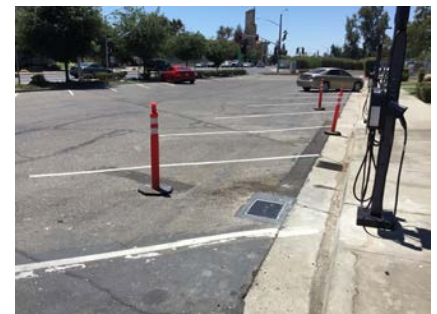
Floor or Ground Space

115	<ul style="list-style-type: none"> <i>As-Built Description:</i> Electric Vehicle space has slope greater than 1/4":12" (2%). <i>As-Built:</i> Up to 8.0%. 11.0% at gutter. <i>Proposed Solution:</i> Modify slope at Electric Vehicle space to provide a slope of 2% maximum. Notes: 	<p>PCODE EV01</p> <p>CBC 2019 11B-812.3</p> <p>Mitigated:</p> <p><input type="radio"/> YES</p> <p><input checked="" type="radio"/> NO</p>	360	SF	\$36	\$12,960
-----	--	---	-----	----	------	----------

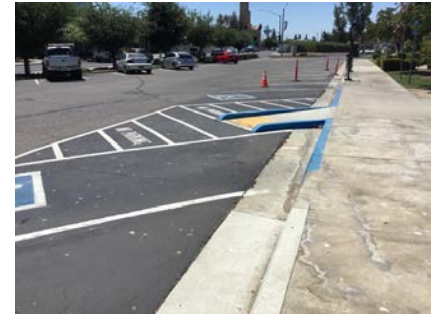
Floor or Ground Surfaces

109	<ul style="list-style-type: none"> As-Built Description: Accessible parking space has slope greater than 1/4":12" (2%). As-Built: 3.0% to 11.0% at gutter. Proposed Solution: Modify slope at accessible parking space. 	PCODE EA05 ADAAG 91 4.6.3 ADA 2010 502.4 CBC 2007 1129B.3.3 CBC 2019 11B-502.4	150	SF	\$36	\$5,400
-----	---	--	-----	----	------	---------

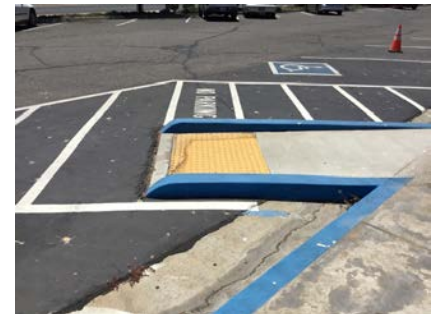
111	<ul style="list-style-type: none"> As-Built Description: Access aisle at accessible parking space has slope greater than 1/4":12" (2%). Proposed Solution: Demolish existing and provide new curb ramp outside of the access aisle. Notes: 	PCODE EA05BNT ADAAG 91 4.6.3 ADA 2010 502.4 CBC 2007 1129B.3.3 CBC 2019 11B-502.4	1	JOB	\$7,500	\$7,500
-----	---	---	---	-----	---------	---------

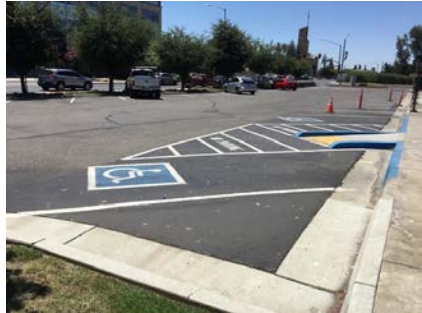
Item no., Rm no. and Name	Existing Architectural Barrier and Proposed Solution	Codes / Mitigation Info	Qty	Unit	Cost	Total
106	<ul style="list-style-type: none"> As-Built Description: Accessible parking space does not have 5' wide access aisle; 8' wide for van accessible aisle. Proposed Solution: Modify parking aisle(s) to create accessible space by restriping. Notes: 	PCODE EA02B ADAAG 91 4.6.3 ADA 2010 502.3 CBC 2007 1129B.3.1 CBC 2019 11B-502.2; 11B-502.3.1 Mitigated: <input type="radio"/> YES <input checked="" type="radio"/> NO	1	JOB	\$600	\$600

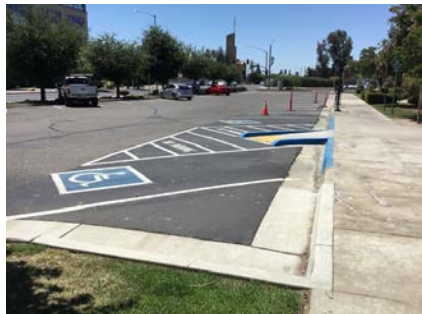
<input type="radio"/> Staff Only			
			Priority <input checked="" type="radio"/> 1			
			Severity <input checked="" type="radio"/> 3			
<p>Access aisle does not extend the length of the spaces.</p>						
108	<ul style="list-style-type: none"> As-Built Description: CA only: The area within the blue borderlines not marked with hatched lines a maximum of 36" on center. Proposed Solution: Restripe to provide hatched lines at 36" on center within access aisle. Notes: 	PCODE EA04I CBC 2007 1129B.3.1 CBC 2019 11B-502.3.3 Mitigated: <input type="radio"/> YES <input checked="" type="radio"/> NO	2	JOB	\$300	\$600

<input type="radio"/> Staff Only			
			Priority <input checked="" type="radio"/> 1			
			Severity <input checked="" type="radio"/> 3			
<p>Not diagonal.</p>

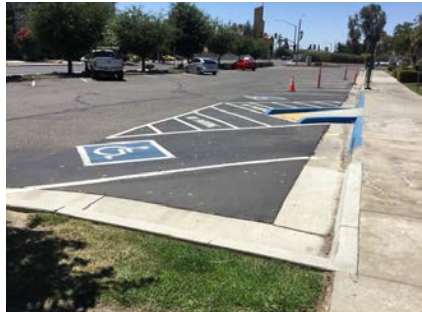
Item no., Rm no. and Name	Existing Architectural Barrier and Proposed Solution	Codes / Mitigation Info	Qty	Unit	Cost	Total
107	<ul style="list-style-type: none"> <i>As-Built Description:</i> An accessible parking space shall be outlined or painted blue (required in CA only). <i>Proposed Solution:</i> Identify accessible parking space using blue markings. 	PCODE EA04K CBC 2019 11B-502.6 Mitigated: <input type="radio"/> YES <input checked="" type="radio"/> NO	2	JOB	\$360	\$720

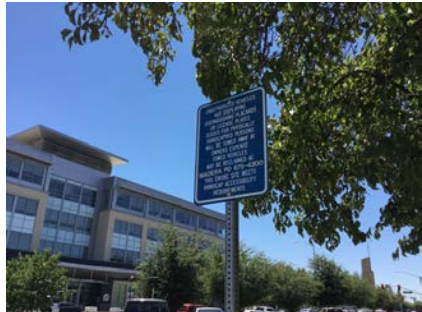
Parking Signage

116	<ul style="list-style-type: none"> <i>As-Built Description:</i> No "Tow Away" sign at parking lot entrance (required in CA only). <i>Proposed Solution:</i> Provide "Tow Away" sign at parking lot entrance when altering area. Notes: 	PCODE EA04C CBC 2007 1129B.4 CBC 2019 11B-502.8.2 Mitigated: <input type="radio"/> YES <input checked="" type="radio"/> NO	1	JOB	\$975	\$975

Verbiage. Size.

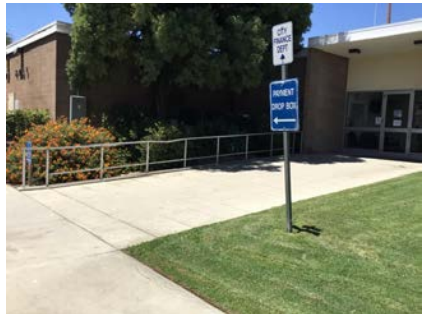
Ramp

104	<ul style="list-style-type: none"> • <i>As-Built Description:</i> Slope not steep but greater than 1:20 (5.0 %) without handrails. • <i>Proposed Solution:</i> Provide handrails for ramp. • <i>Notes:</i> 	PCODE EB03 ADAAG 91 4.8.1 ADA 2010 405.1 CBC 2007 1133B.5.5.1 CBC 2019 11B-405.8 Mitigated: <input type="radio"/> YES <input checked="" type="radio"/> NO	60	LF	\$225	\$13,500
-----	---	--	----	----	-------	----------

Multiple barriers on existing handrail. No handrail on one side.

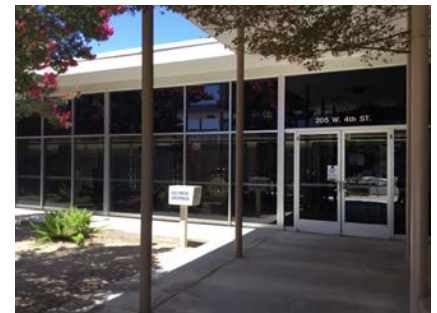
98	<ul style="list-style-type: none"> <i>As-Built Description:</i> Accessible building entrance when not all are accessible not identified with a sign showing the International Symbol of Accessibility. <i>Proposed Solution:</i> Provide building entrance sign that shows international symbol at accessible entrance. <i>Notes:</i> 	<p>PCODE SA12 ADAAG 91 4.1.2(7)(c) ADA 2010 216.6 CBC 2007 1127B.3 CBC 2019 11B-216.6</p> <p>Mitigated: <input type="radio"/> YES <input checked="" type="radio"/> NO</p>	1	JOB	\$150	\$150
----	--	---	---	-----	-------	-------

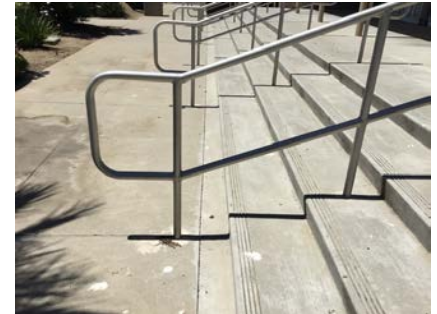
Top & Bottom Extension at Stairs

99	<ul style="list-style-type: none"> <i>As-Built Description:</i> Stair handrail does not extend horizontally 12" minimum beyond top nosing, and one tread width sloped, plus 12" minimum horizontally beyond the bottom nosings. <i>Proposed Solution:</i> Extend stair handrail at top and bottom (cost for each extension piece). 	<p>PCODE ED06 ADAAG 91 4.9.4(2) ADA 2010 505.10.2; 505.10.3 CBC 2007 1133B.4.2.2 CBC 2019 11B-505.10.2; 11B-505.10.3</p> <p>Mitigated: <input type="radio"/> YES <input checked="" type="radio"/> NO</p>	6	JOB	\$510	\$3,060
----	--	---	---	-----	-------	---------

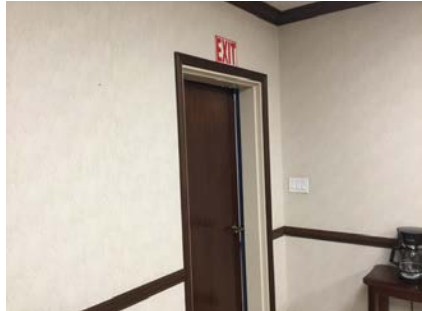
Item no., Rm no. and Name	Existing Architectural Barrier and Proposed Solution	Codes / Mitigation Info	Qty	Unit	Cost	Total
51	<ul style="list-style-type: none"> <i>As-Built Description:</i> At door leading into exit corridor: Where required exit signs are installed, signs to provide exiting information for people with vision impairment are not provided. <i>Proposed Solution:</i> Provide raised letter/Braille "EXIT ROUTE" sign at door. 	PCODE SA10D ADAAG 91 4.1.3(16) ADA 2010 216.4.1 CBC 2007 1011.3 CBC 2019 11B-216.4.1 Mitigated: <input type="radio"/> YES <input checked="" type="radio"/> NO	10	JOB	\$270	\$2,700

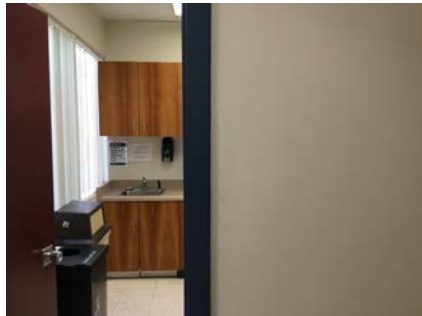
<input type="radio"/> Staff Only			
			Priority <input checked="" type="radio"/> 2			
			Severity <input checked="" type="radio"/> 3			
59	<ul style="list-style-type: none"> <i>As-Built Description:</i> Existing sign designating permanent room or space is noncompliant. <i>Proposed Solution:</i> Provide compliant signage. 	PCODE SA13 ADAAG 91 4.1.3(16)(a) ADA 2010 216.2 CBC 2007 1117B.5 CBC 2019 11B-216.2 Mitigated: <input type="radio"/> YES <input checked="" type="radio"/> NO	30	JOB	\$450	\$13,500

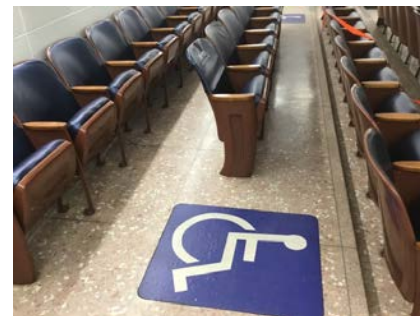
- 6
- As-Built Description:**
Wheelchair space (33"x48") not provided at fixed seating with forward or rear approach. (NOTE: Space must be adjacent to regular seating; can provide easily removable fixed seat).
 - Proposed Solution:**
Remove fixed seating and provide wheelchair space plus necessary maneuvering clearance.
 - Notes:**
- PCODE **GB01A**
 ADAAG 91 **4.1.3(19)(a)**
 ADA 2010 **221.2**
 CBC 2007 **1104B.3.6**
 CBC 2019 **11B-221.2**
- Mitigated:
 YES
 NO

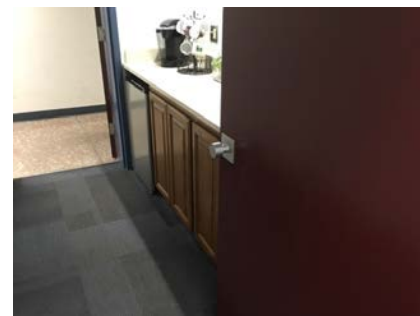
- 14
- As-Built Description:**
Door does not have accessible operating hardware.
 - Proposed Solution:**
Provide lever handle or other accessible hardware.
- PCODE **ID07**
 ADAAG 91 **4.13.9**
 ADA 2010 **404.2.7**
 CBC 2007 **1133B.2.5.2**
 CBC 2019 **11B-404.2.7**
- Mitigated:
 YES
 NO

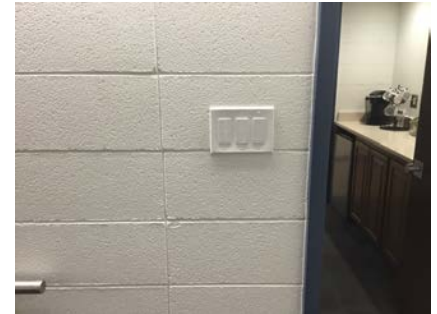
Electrical

10	<ul style="list-style-type: none"> As-Built Description: Electric switch or control mounted less than 15" measured to the bottom of the outlet box or greater than 48 inches measured to the top of the outlet box. As-Built: 54.25" high Proposed Solution: Relocate light switches or control to between 15" and 48" height. 	PCODE IC01 ADAAG 91 4.2.5 & 6 ADA 2010 308.2.1 & 308.2.2 CBC 2007 1117B.6.3 CBC 2019 11B-308.2.1 & 11B-308.2.2 Mitigated: <input type="radio"/> YES <input checked="" type="radio"/> NO	1	JOB	\$900	\$900
----	--	--	---	-----	-------	-------

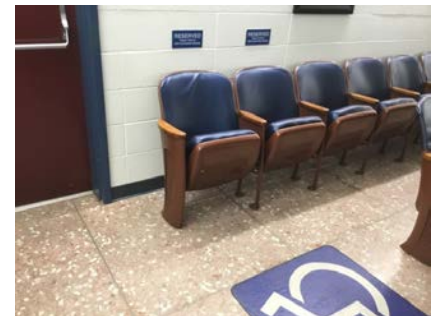
Fixed Seating

5	<ul style="list-style-type: none"> As-Built Description: Less than five percent of the total number of aisle seats are accessible. Proposed Solution: Provide aisle seats with no or removable armrest. Notes: 	PCODE GE01A ADAAG 91 4.1.2(19)a ADA 2010 221.4 CBC 2007 1104B.3.4 CBC 2019 11B-221.4 Mitigated: <input type="radio"/> YES <input checked="" type="radio"/> NO	1	EA	\$15,000	\$15,000
---	---	--	---	----	----------	----------

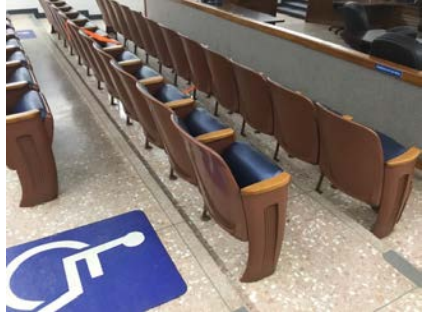
Item no., Rm no. and Name	Existing Architectural Barrier and Proposed Solution	Codes / Mitigation Info	Qty	Unit	Cost	Total
4	<ul style="list-style-type: none"> As-Built Description: CA only: Less than one percent of total seats have at least 24" clear leg space between the front of the seat and any obstruction to accommodate semi-ambulant individuals. As-Built: 12.0" leg space at semi ambulant seats. 46 seats in auditorium. Proposed Solution: Relocate seats to provide 24" clear leg room for semi-ambulant individuals. 	PCODE GE01D CBC 2007 1104B.3.8 CBC 2019 11B-221.6 Mitigated: <input type="radio"/> YES <input checked="" type="radio"/> NO	1	EA	\$15,000	\$15,000

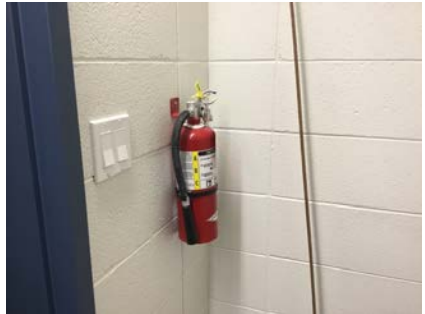
Reach Range

11	<ul style="list-style-type: none"> As-Built Description: Reach height to control or access point, where side approach is available, exceeds 48" or is less than 15" in height, or exceeds 10" in depth. As-Built: 57.0" high Proposed Solution: Modify equipment or mounting. 	PCODE IE02 ADAAG 91 4.2.6 ADA 2010 308.3.1 CBC 2007 1118B.6 CBC 2019 11B-308.3 Mitigated: <input type="radio"/> YES <input checked="" type="radio"/> NO	1	JOB	\$300	\$300

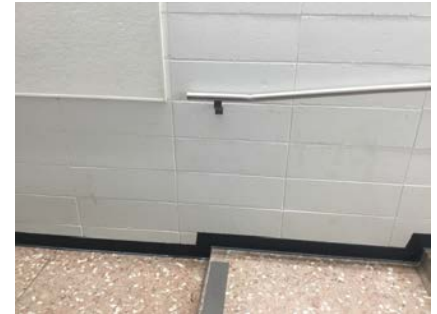
Top & Bottom Extension at Stairs

8	<ul style="list-style-type: none"> • <i>As-Built Description:</i> Stair handrail does not extend horizontally 12" minimum beyond top nosing, and one tread width sloped, plus 12" minimum horizontally beyond the bottom nosing. • <i>As-Built:</i> 4.0" extension • <i>Proposed Solution:</i> Extend stair handrail at top and bottom (cost for each extension piece). 	<p>PCODE ED06 ADAAG 91 4.9.4(2) ADA 2010 505.10.2; 505.10.3 CBC 2007 1133B.4.2.2 CBC 2019 11B-505.10.2; 11B-505.10.3</p>	4	JOB	\$510	\$2,040
---	---	---	---	-----	-------	---------

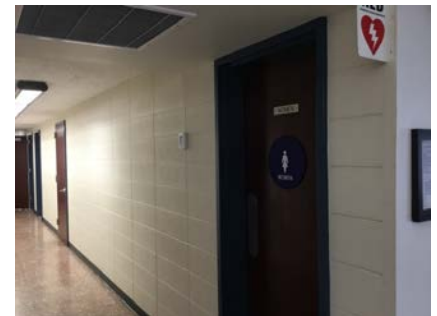
26 • *As-Built Description:*
 Sign to provide direction to or information about building functional spaces missing or non-compliant.
 • *Proposed Solution:*
 Provide compliant signage.
 • *Notes:*

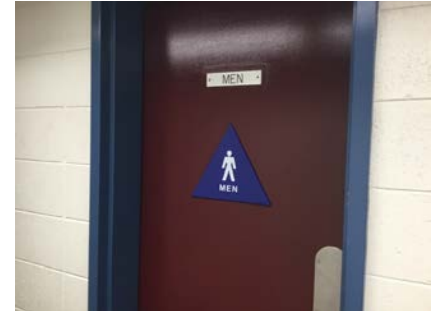
Item no., Rm no. and Name	Existing Architectural Barrier and Proposed Solution	Codes / Mitigation Info	Qty	Unit	Cost	Total
27	<ul style="list-style-type: none"> <i>As-Built Description:</i> Required in CA only: identification symbol centered 58" to 60" high on sanitary facility door that contrasts with the door not provided (women: 12" ø circle, men: 12" triangle, unisex: combined symbol). <i>As-Built:</i> 61.0" high at inaccessible men's public restroom <i>Proposed Solution:</i> Provide properly mounted sanitary facility symbol when altering area. If wheelchair accessible, include International Symbol of Accessibility on sign. 	<p>PCODE SA15</p> <p>CBC 2007 1115B.6</p> <p>CBC 2019 11B-703.7.2.6</p> <p>Mitigated:</p> <p><input type="radio"/> YES</p> <p><input checked="" type="radio"/> NO</p>	1	JOB	\$270	\$270

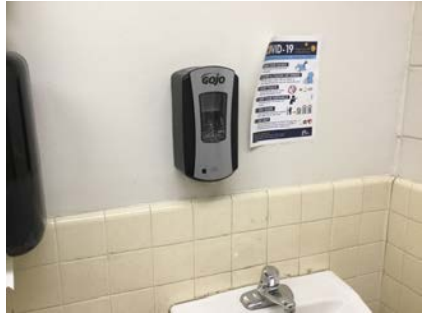
Item no., Rm no. and Name	Existing Architectural Barrier and Proposed Solution	Codes / Mitigation Info	Qty	Unit	Cost	Total
35	<ul style="list-style-type: none"> As-Built Description: Dispensers in sanitary facilities, such as for towels, soap, sanitary napkins, seat covers, etc., and waste receptacles more than 48" (CA only: 40") from floor to highest operating slot or control. As-Built: 49.0" high Proposed Solution: Relocate existing restroom accessories. 	PCODE WG01A ADAAG 91 4.23.7 ADA 2010 308.2.1 CBC 2007 1115B.8.3 CBC 2019 11B-603.5 Mitigated: <input type="radio"/> YES <input checked="" type="radio"/> NO	1	JOB	\$300	\$300

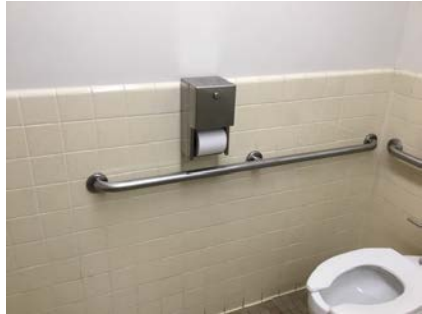
<input type="radio"/> Staff Only						
Priority <input checked="" type="radio"/> 3						
Severity <input checked="" type="radio"/> 2						
31	<ul style="list-style-type: none"> As-Built Description: Toilet paper dispenser less than 15" (CA: 19") or more than 48" above floor or not within 7" to 9" from front of water closet (Note: CA pre-2010 is allowed within 12" from front of water closet). Proposed Solution: Relocate or provide new toilet paper dispenser. 	PCODE WG02 ADAAG 91 4.16.6 ADA 2010 604.7 CBC 2007 1115B.8.4 CBC 2019 11B-604.7 Mitigated: <input type="radio"/> YES <input checked="" type="radio"/> NO	1	JOB	\$225	\$225

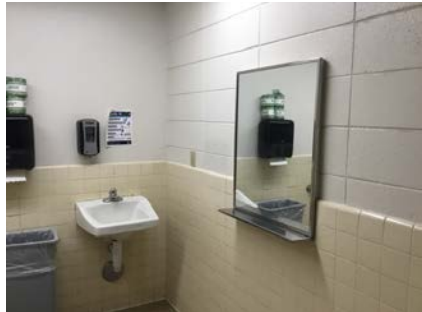
Item no., Rm no. and Name	Existing Architectural Barrier and Proposed Solution	Codes / Mitigation Info	Qty	Unit	Cost	Total
38	<ul style="list-style-type: none"> <i>As-Built Description:</i> Bottom of flat, not tilted mirror not located above lavatories or countertops mounted with bottom edge more than 35" above floor or top edge less than 74" above floor. <i>As-Built:</i> 40.75" high <i>Proposed Solution:</i> Relocate or provide new accessible mirror. 	PCODE WG03B ADAAG 91 4.19.6 ADA 2010 603.3 CBC 2007 1115B.8.1 CBC 2019 11B-603.3 Mitigated: <input type="radio"/> YES <input checked="" type="radio"/> NO	1	JOB	\$450	\$450

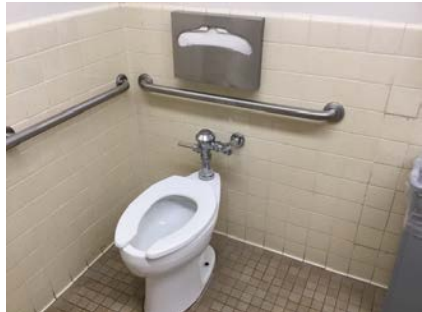
32	<ul style="list-style-type: none"> <i>As-Built Description:</i> The rear wall grab is less than 36" min. or does not extend from the centerline of the water closet 12" min. on one side and 24" min. on the other side. <i>As-Built:</i> Extends 21.0" on wide side <i>Proposed Solution:</i> Provide or relocate accessible rear grab bar. <i>Notes:</i> 	PCODE WB07B ADAAG 91 4.17.6 ADA 2010 604.5.2 CBC 2007 1115B.4.1.3.2 CBC 2019 11B-604.5.2 Mitigated: <input type="radio"/> YES <input checked="" type="radio"/> NO	1	JOB	\$1,020	\$1,020

This element complies with Safe Harbor if altered or constructed before March 15, 2012. .

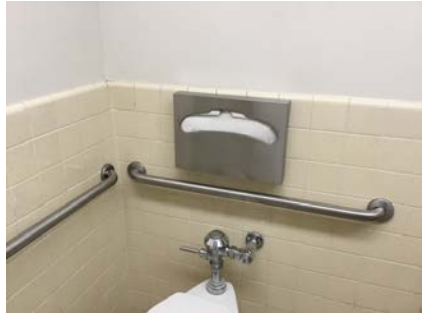
Item no., Rm no. and Name	Existing Architectural Barrier and Proposed Solution	Codes / Mitigation Info	Qty	Unit	Cost	Total
36	<ul style="list-style-type: none"> • <i>As-Built Description:</i> Accessories/dispensers in accessible stall located closer than 1-1/2" below or 12" above grab bar impedes its use. • <i>As-Built:</i> SCD: 1.6" above grab bar • <i>Proposed Solution:</i> Relocate accessories/dispensers to be no closer than 1-1/2" below and 12" above grab bars (except if accessories are recessed, flush with wall, and have no sharp edges). 	PCODE WB07I ADAAG 91 4.26.2 ADA 2010 609.3 CBC 2007 1133B.4.2.5 CBC 2019 11B-609.3 Mitigated: <input type="radio"/> YES <input checked="" type="radio"/> NO	1	JOB	\$225	\$225

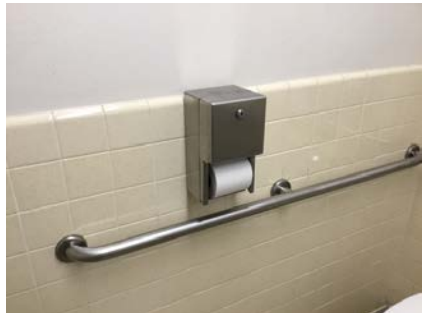
<p><input type="radio"/> Staff Only</p> <p>Priority <input checked="" type="radio"/> 3</p> <p>Severity <input checked="" type="radio"/> 4</p>
37	<ul style="list-style-type: none"> • <i>As-Built Description:</i> Accessories/dispensers in accessible stall located closer than 1-1/2" below or 12" above grab bar impedes its use. • <i>As-Built:</i> TPD: 2.7" above grab bar • <i>Proposed Solution:</i> Relocate accessories/dispensers to be no closer than 1-1/2" below and 12" above grab bars (except if accessories are recessed, flush with wall, and have no sharp edges). 	PCODE WB07I ADAAG 91 4.26.2 ADA 2010 609.3 CBC 2007 1133B.4.2.5 CBC 2019 11B-609.3 Mitigated: <input type="radio"/> YES <input checked="" type="radio"/> NO	1	JOB	\$225	\$225

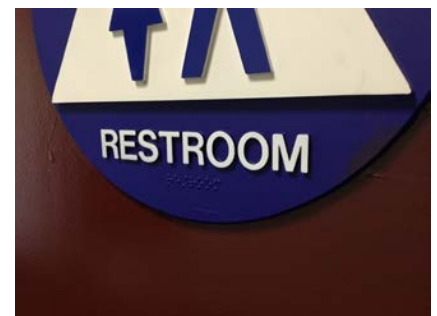
- *As-Built Description:*
Entrance to toilet or bathing facility not identified with ADAAG compliant signage.
- *As-Built:* **1/16" between raised characters.**
- *Proposed Solution:*
Provide ADA compliant sign mounted at 48" min. above to baseline of the lowest Braille cells and 60" max. to baseline of the highest line of raised characters on nearest adjacent wall, on latch side of a single door (located not to cause a Braille reader to stand within the door swing).
- *Notes:*

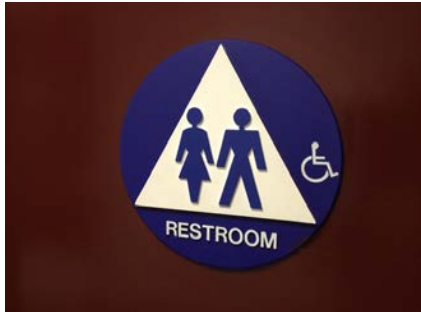
Item no., Rm no. and Name	Existing Architectural Barrier and Proposed Solution	Codes / Mitigation Info	Qty	Unit	Cost	Total
28	<ul style="list-style-type: none"> <i>As-Built Description:</i> Required in CA only: identification symbol centered 58" to 60" high on sanitary facility door that contrasts with the door not provided (women: 12" ø circle, men: 12" triangle, unisex: combined symbol). <i>As-Built:</i> Not beveled or radiused. <i>Proposed Solution:</i> Provide properly mounted sanitary facility symbol when altering area. If wheelchair accessible, include International Symbol of Accessibility on sign. 	<p>PCODE SA15</p> <p>CBC 2007 1115B.6</p> <p>CBC 2019 11B-703.7.2.6</p> <p>Mitigated:</p> <p><input type="radio"/> YES</p> <p><input checked="" type="radio"/> NO</p>	1	JOB	\$270	\$270

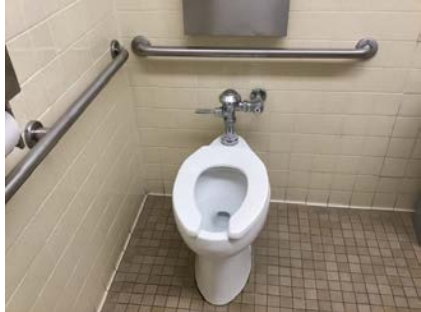
30	<ul style="list-style-type: none"> <i>As-Built Description:</i> Water closet not 16"-18" (CA: 17"-18") from near side wall to center line of water closet (2010 ADAAG: 16"-18"). <i>As-Built:</i> 18.6" o.c. <i>Proposed Solution:</i> Relocate existing water closet and plumbing, remount with offset closet flange to provide 18" max. from side wall. 	<p>PCODE WB02C</p> <p>ADAAG 91 Fig. 28</p> <p>ADA 2010 604.2</p> <p>CBC 2007 1115B.4.1.1</p> <p>CBC 2019 11B-604.2</p> <p>Mitigated:</p> <p><input type="radio"/> YES</p> <p><input checked="" type="radio"/> NO</p>	1	JOB	\$1,500	\$1,500
----	---	--	---	-----	---------	---------

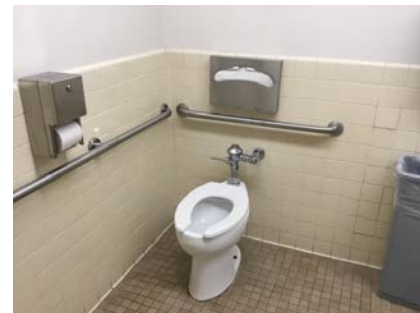
Item no., Rm no. and Name	Existing Architectural Barrier and Proposed Solution	Codes / Mitigation Info	Qty	Unit	Cost	Total
39	<ul style="list-style-type: none"> <i>As-Built Description:</i> Flush Control: Operating handle not mounted toward wide side of stall. <i>Proposed Solution:</i> Replace flush control with properly mounted accessible type, or install sensor flush. 	PCODE WB10 ADAAG 91 4.16.5 ADA 2010 604.6 CBC 2007 1115B.4.1.5 CBC 2019 11B-604.6 Mitigated: <input type="radio"/> YES <input checked="" type="radio"/> NO	1	JOB	\$1,500	\$1,500

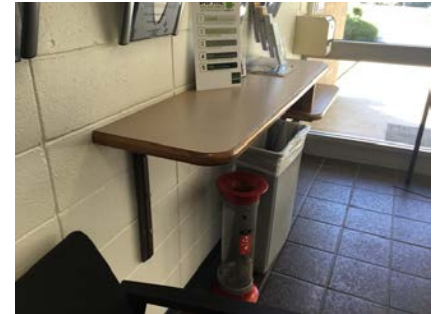
43	<ul style="list-style-type: none"> As-Built Description: Protruding objects more than 4" from wall, when bottom of object more than 27" or less than 80" above finished floor. As-Built: Shelf/writing surface: 14.5" at 41.0" high Proposed Solution: Remove/relocate protruding object. Patch existing surface. 	PCODE EG04 ADAAG 91 4.4.1 ADA 2010 307.2 CBC 2007 1133B.8.6.1 CBC 2019 11B-307.2	1	JOB	\$300	\$300
----	---	--	---	-----	-------	-------

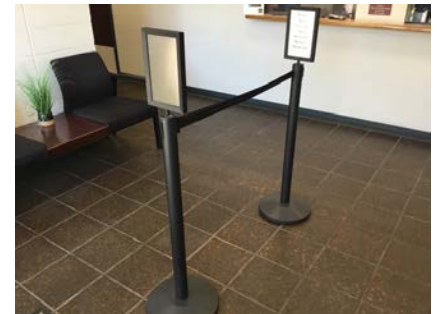
46	<ul style="list-style-type: none"> As-Built Description: Protruding objects more than 4" from wall, when bottom of object more than 27" or less than 80" above finished floor. As-Built: Stanchions 37.0" Proposed Solution: Provide cane-detectable railing to mark area of low clearance. 	PCODE EG04A ADAAG 91 4.4.1 ADA 2010 307.2 CBC 2007 1133B.8.6.1 CBC 2019 11B-307.2	4	LF	\$300	\$1,200
----	---	---	---	----	-------	---------

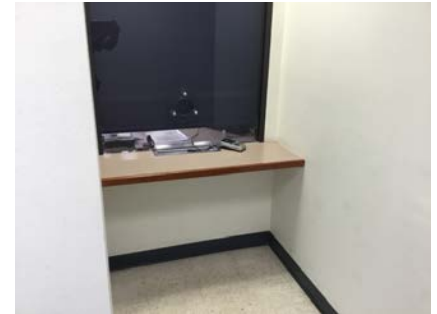
42	<ul style="list-style-type: none"> As-Built Description: Sales and service counter: Accessible section not provided (knee space min. 27" high x 19" deep x 30" wide) As-Built: 14.5" deep Proposed Solution: Retrofit existing counter to provide accessible seating section. Interim solution: Provide auxiliary counter, table, or clipboard. 	PCODE IN03A ADAAG 91 4.32.3 & 4 ADA 2010 306.3; 904.4 CBC 2007 1122B.3 & 4 CBC 2019 11B-306.3; 11B-904.4 Mitigated: <input type="radio"/> YES <input checked="" type="radio"/> NO	1	JOB	\$6,000	\$6,000
----	---	--	---	-----	---------	---------

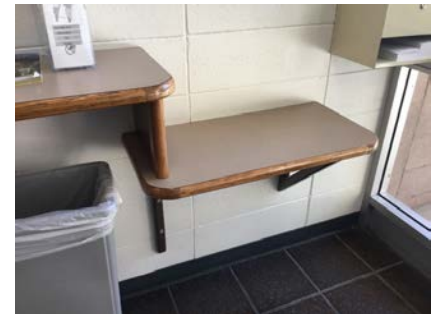
44	<ul style="list-style-type: none"> As-Built Description: Sales and service counter: Accessible section not provided (knee space min. 27" high x 19" deep x 30" wide) As-Built: 16.0" deep Proposed Solution: Retrofit existing counter to provide accessible seating section. Interim solution: Provide auxiliary counter, table, or clipboard. 	PCODE IN03A ADAAG 91 4.32.3 & 4 ADA 2010 306.3; 904.4 CBC 2007 1122B.3 & 4 CBC 2019 11B-306.3; 11B-904.4 Mitigated: <input type="radio"/> YES <input checked="" type="radio"/> NO	1	JOB	\$6,000	\$6,000
----	---	--	---	-----	---------	---------

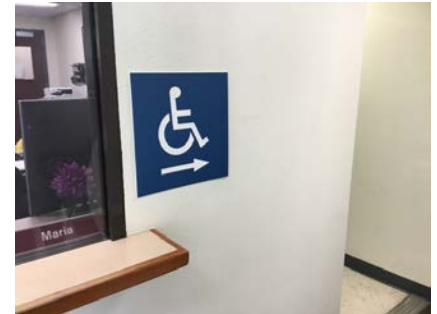
- 49 • *As-Built Description:*
Sign to provide direction to or information about building functional spaces missing or non-compliant.
- *Proposed Solution:*
Provide compliant signage.
- *Notes:*

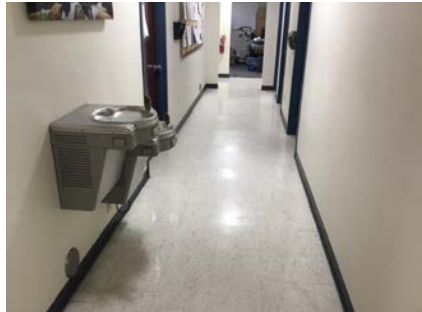
Item no., Rm no. and Name	Existing Architectural Barrier and Proposed Solution	Codes / Mitigation Info	Qty	Unit	Cost	Total
72	<ul style="list-style-type: none"> <i>As-Built Description:</i> Drinking fountain lacks protection for visually impaired persons. <i>Proposed Solution:</i> Provide cane-detectable rails. 	PCODE IA05C ADAAG 91 4.4.1 ADA 2010 307.2 CBC 2007 1115B.4.6.3 CBC 2019 11B-307.2 Mitigated: <input type="radio"/> YES <input checked="" type="radio"/> NO	1	JOB	\$1,500	\$1,500

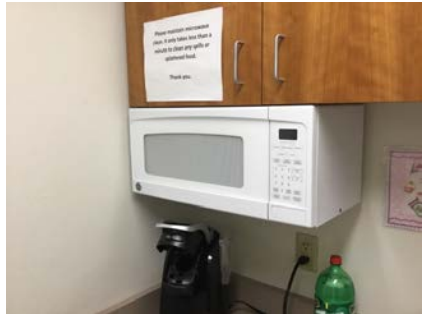
71	<ul style="list-style-type: none"> <i>As-Built Description:</i> Reach height to control or access point, where side approach is available, exceeds 48" or is less than 15" in height, or exceeds 10" in depth. <i>As-Built:</i> 59.0" high <i>Proposed Solution:</i> Modify equipment or mounting. 	PCODE IE02 ADAAG 91 4.2.6 ADA 2010 308.3.1 CBC 2007 1118B.6 CBC 2019 11B-308.3 Mitigated: <input type="radio"/> YES <input checked="" type="radio"/> NO	1	JOB	\$300	\$300

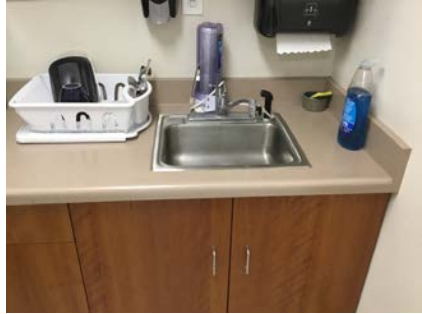
Item no., Rm no. and Name	Existing Architectural Barrier and Proposed Solution	Codes / Mitigation Info	Qty	Unit	Cost	Total
70	<p>Sink</p> <ul style="list-style-type: none"> As-Built Description: Sink rim higher than 34" above floor. As-Built: 34.25" high Proposed Solution: Remodel sink cabinet to lower sink. 	<p>PCODE IN06 ADAAG 91 4.24.2 ADA 2010 606.3 CBC 2007 1115B.4.7.1 CBC 2019 11B-606.3</p> <p>Mitigated: <input type="radio"/> YES <input checked="" type="radio"/> NO</p>	1	JOB	\$5,250	\$5,250

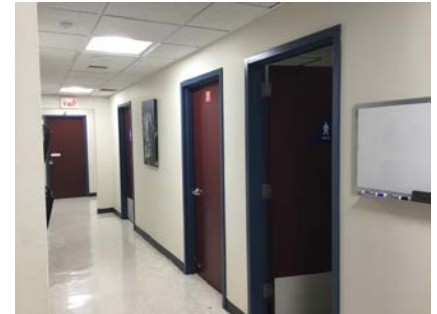
Multiple accommodation restroom not accessible; multiple compliance violations.

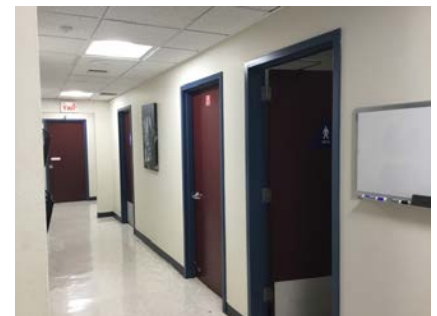
Sign to provide direction to or information about building functional spaces missing or non-compliant.

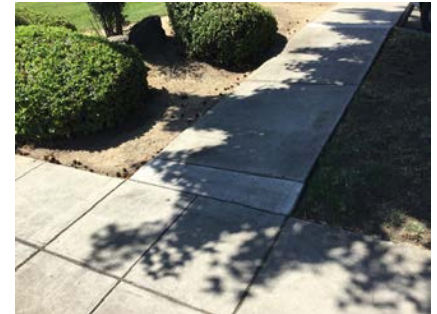
- 359
- As-Built Description:*
Walk: Pavement dislocation creates abrupt change in level exceeding 1/2" in accessible route.
 - As-Built:* **0.7" not beveled**
 - Proposed Solution:*
Remove, replace or repair area of pavement sufficient to correct abrupt change in level.

PCODE **EF03**
 ADAAG 91 **4.3.8**
 ADA 2010 **403.4**
 CBC 2007 **1133B.7.4**
 CBC 2019 **11B-403.4**

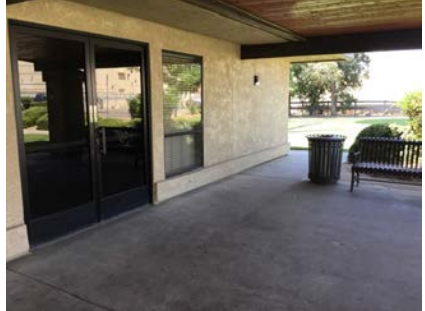
Item no., Rm no. and Name	Existing Architectural Barrier and Proposed Solution	Codes / Mitigation Info	Qty	Unit	Cost	Total
365	<ul style="list-style-type: none"> As-Built Description: Cross slope more than 1":48" (2.083%). As-Built: Up to 3.5% Proposed Solution: Modify cross slope. Notes: 	PCODE EF07 ADAAG 91 4.3.7 ADA 2010 403.3 CBC 2007 1133B.7.1.3 CBC 2019 11B-403.3 Mitigated: <input type="radio"/> YES <input checked="" type="radio"/> NO	32	SF	\$75	\$2,400

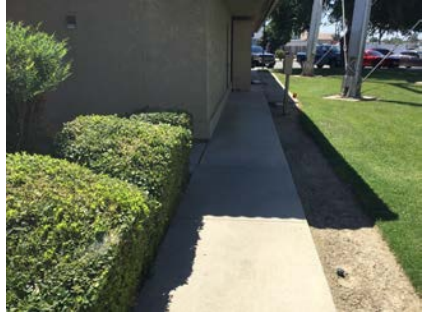
<input type="radio"/> Staff Only			
			Priority 1			
			Severity 4			
<p>The cross slope extends into the door maneuvering clearance.</p>						
367	<ul style="list-style-type: none"> As-Built Description: Cross slope more than 1":48" (2.083%). As-Built: 3.5% Proposed Solution: Modify cross slope. 	PCODE EF07 ADAAG 91 4.3.7 ADA 2010 403.3 CBC 2007 1133B.7.1.3 CBC 2019 11B-403.3 Mitigated: <input type="radio"/> YES <input checked="" type="radio"/> NO	20	SF	\$75	\$1,500

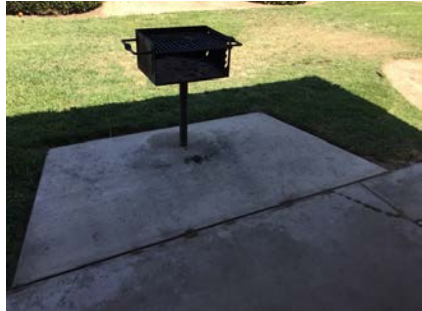
Item no., Rm no. and Name	Existing Architectural Barrier and Proposed Solution	Codes / Mitigation Info	Qty	Unit	Cost	Total
368	<ul style="list-style-type: none"> As-Built Description: Cross slope more than 1":48" (2.083%). As-Built: 2.3% Proposed Solution: Modify cross slope. 	PCODE EF07 ADAAG 91 4.3.7 ADA 2010 403.3 CBC 2007 1133B.7.1.3 CBC 2019 11B-403.3 Mitigated: <input type="radio"/> YES <input checked="" type="radio"/> NO	12	SF	\$75	\$900

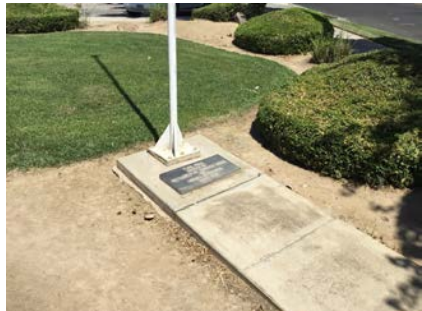
<input type="radio"/> Staff Only			
			Priority 1			
			Severity 4			
373	<ul style="list-style-type: none"> As-Built Description: Cross slope more than 1":48" (2.083%). Proposed Solution: Modify cross slope. Notes: 	PCODE EF07 ADAAG 91 4.3.7 ADA 2010 403.3 CBC 2007 1133B.7.1.3 CBC 2019 11B-403.3 Mitigated: <input type="radio"/> YES <input checked="" type="radio"/> NO	5	SF	\$75	\$375

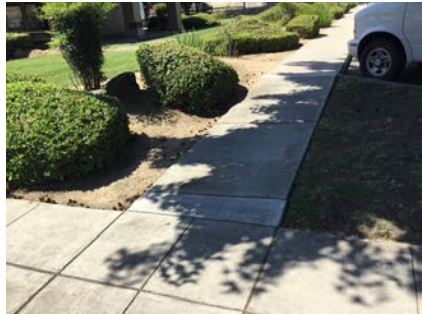
Item no., Rm no. and Name	Existing Architectural Barrier and Proposed Solution	Codes / Mitigation Info	Qty	Unit	Cost	Total
358	<ul style="list-style-type: none"> <i>As-Built Description:</i> Detectable warning not provided where pedestrian crosses vehicular area. <i>Proposed Solution:</i> Provide detectable warning surface (i.e. in-line truncated domes) at regular curb ramp. 	PCODE EH07A ADAAG 91 4.7.7 ADA 2010 705.1 CBC 2007 1127B.5.7 CBC 2019 11B-705.1.2.2 Mitigated: <input type="radio"/> YES <input checked="" type="radio"/> NO	1	JOB	\$750	\$750

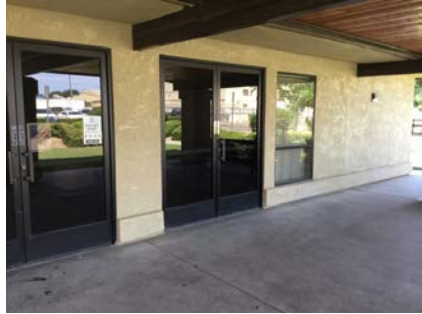
366	<ul style="list-style-type: none"> <i>As-Built Description:</i> Surface of required maneuvering clearance at door slopes more than 1/4":12" (2.0%). <i>As-Built:</i> 4.0% <i>Proposed Solution:</i> Modify surface slope at door. 	PCODE ID11 ADAAG 91 4.13.6 ADA 2010 404.2.4.4 CBC 2007 1133B.2.4 CBC 2019 11B-404.2.4 Mitigated: <input type="radio"/> YES <input checked="" type="radio"/> NO	30	SF	\$120	\$3,600

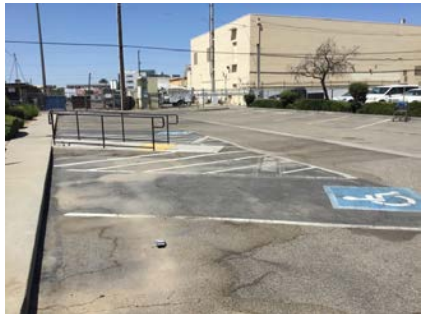
361	<ul style="list-style-type: none"> As-Built Description: Accessible parking space smaller than 8' wide (CA only: 9' x 18'). As-Built: 110.0" Proposed Solution: Modify parking space(s) to create accessible space. 	PCODE EA02A ADAAG 91 4.6.3 ADA 2010 502.2 CBC 2007 1129B.3.1 CBC 2019 11B-502.2 Mitigated: <input type="radio"/> YES <input checked="" type="radio"/> NO	2	JOB	\$600	\$1,200
-----	---	---	---	-----	-------	---------

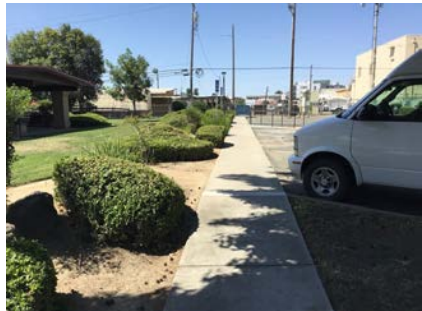
<input type="radio"/> Staff Only			
			Priority <input checked="" type="radio"/> 1			
			Severity <input checked="" type="radio"/> 3			
357	<ul style="list-style-type: none"> <i>As-Built Description:</i> Wheel stops not provided to prevent the encroachment of vehicles over the required clear width of an adjacent accessible route. <i>Proposed Solution:</i> Provide wheel stops to prevent encroachment. 	PCODE EA04L CBC 2019 11B-502.7.2 Mitigated: <input type="radio"/> YES <input checked="" type="radio"/> NO	11	JOB	\$225	\$2,475

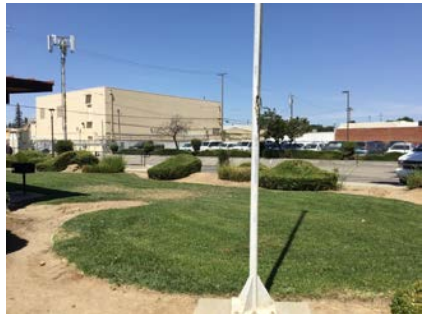
370	<ul style="list-style-type: none"> <i>As-Built Description:</i> Reach height to control or access point, exceeds 48" or is less than 15". <i>As-Built:</i> 69.0" high <i>Proposed Solution:</i> Modify equipment or mounting. 	<p>PCODE IE01</p> <p>ADAAG 91 4.2.5</p> <p>ADA 2010 308.2.1</p> <p>CBC 2007 1118B.5</p> <p>CBC 2019 11B-308.2.1</p> <p>Mitigated:</p> <p><input type="radio"/> YES</p> <p><input checked="" type="radio"/> NO</p>	1	JOB	\$300	\$300
-----	---	---	---	-----	-------	-------

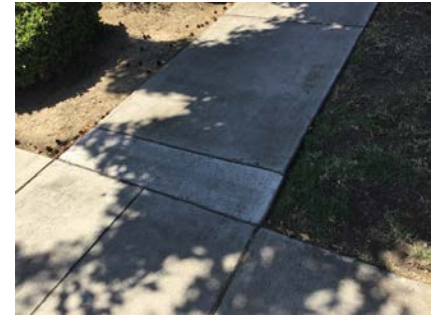
360	<ul style="list-style-type: none"> As-Built Description: Walk: Slope greater than 1:20 (5.0%), and walk does not comply with requirements for ramps. As-Built: 13.0% Proposed Solution: Modify walk/sidewalk slope to 1:20 or less. 	PCODE EF01 ADAAG 91 4.3.7 ADA 2010 403.3 CBC 2007 1133B.7.3 CBC 2019 11B-403.3	3	SF	\$75	\$225
-----	---	---	---	----	------	-------

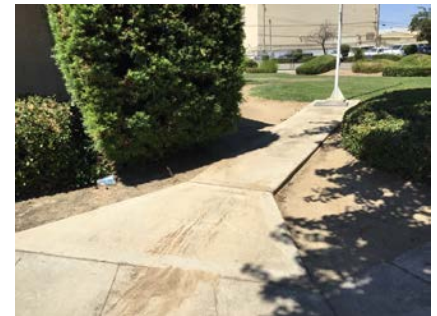
372	<ul style="list-style-type: none"> As-Built Description: Walk: Slope greater than 1:20 (5.0%), and walk does not comply with requirements for ramps. As-Built: 8.8% Proposed Solution: Modify walk/sidewalk slope to 1:20 or less. 	PCODE EF01 ADAAG 91 4.3.7 ADA 2010 403.3 CBC 2007 1133B.7.3 CBC 2019 11B-403.3	50	SF	\$75	\$3,750
-----	--	---	----	----	------	---------

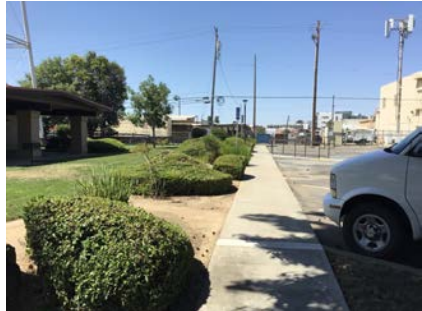
Item no., Rm no. and Name	Existing Architectural Barrier and Proposed Solution	Codes / Mitigation Info	Qty	Unit	Cost	Total
356	<ul style="list-style-type: none"> As-Built Description: Walk more than 36" but less than 48" wide (required in CA only). As-Built: 47.0" wide Proposed Solution: Enlarge width of walk to 48". 	PCODE EF08 CBC 2007 1133B.7.1 CBC 2019 11B-403.5.1.3 Mitigated: <input type="radio"/> YES <input checked="" type="radio"/> NO	100	SF	\$135	\$13,500

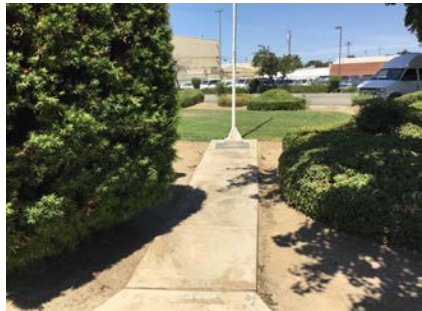
<input type="radio"/> Staff Only			
			Priority <input checked="" type="radio"/> 1			
			Severity <input checked="" type="radio"/> 4			
369	<ul style="list-style-type: none"> As-Built Description: Walk more than 36" but less than 48" wide (required in CA only). As-Built: 35" wide Proposed Solution: Enlarge width of walk to 48". 	PCODE EF08 CBC 2007 1133B.7.1 CBC 2019 11B-403.5.1.3 Mitigated: <input type="radio"/> YES <input checked="" type="radio"/> NO	50	SF	\$135	\$6,750

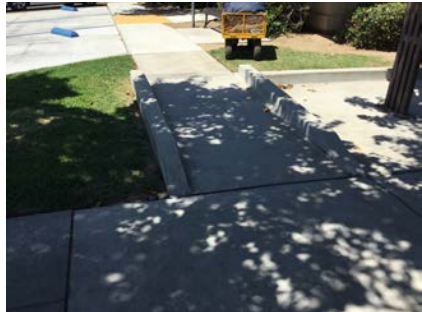
Item no., Rm no. and Name	Existing Architectural Barrier and Proposed Solution	Codes / Mitigation Info	Qty	Unit	Cost	Total
375	<ul style="list-style-type: none"> <i>As-Built Description:</i> Detectable warning not provided where pedestrian crosses vehicular area. <i>Proposed Solution:</i> Provide detectable warning surface (i.e. in-line truncated domes) at regular curb ramp. 	PCODE EH07A ADAAG 91 4.7.7 ADA 2010 705.1 CBC 2007 1127B.5.7 CBC 2019 11B-705.1.2.2 Mitigated: <input type="radio"/> YES <input checked="" type="radio"/> NO	1	JOB	\$750	\$750

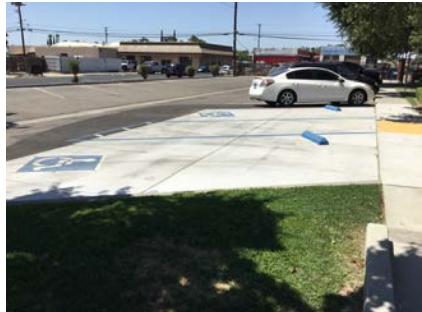
376	<ul style="list-style-type: none"> <i>As-Built Description:</i> Accessible parking space smaller than 8' wide (CA only: 9' x 18'). <i>As-Built:</i> 123.0" <i>Proposed Solution:</i> Modify parking space(s) to create accessible space. 	PCODE EA02A ADAAG 91 4.6.3 ADA 2010 502.2 CBC 2007 1129B.3.1 CBC 2019 11B-502.2 Mitigated: <input type="radio"/> YES <input checked="" type="radio"/> NO	2	JOB	\$600	\$1,200

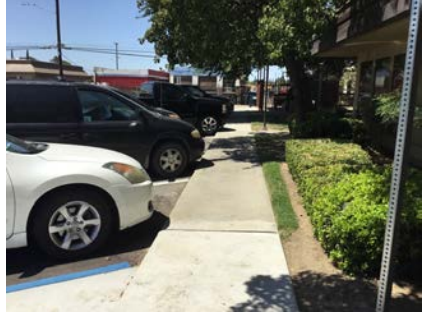
Item no., Rm no. and Name	Existing Architectural Barrier and Proposed Solution	Codes / Mitigation Info	Qty	Unit	Cost	Total
377	<ul style="list-style-type: none"> <i>As-Built Description:</i> Wheel stops not provided to prevent the encroachment of vehicles over the required clear width of an adjacent accessible route. <i>Proposed Solution:</i> Provide wheel stops to prevent encroachment. 	PCODE EA04L CBC 2019 11B-502.7.2 Mitigated: <input type="radio"/> YES <input checked="" type="radio"/> NO	8	JOB	\$225	\$1,800

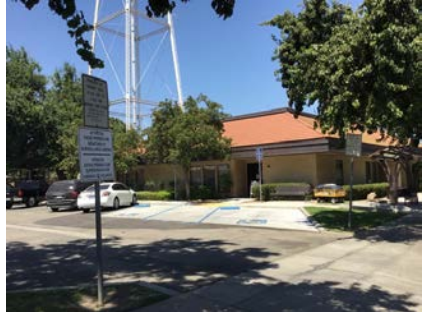
381	<ul style="list-style-type: none"> <i>As-Built Description:</i> No "Tow Away" sign at parking lot entrance (required in CA only). <i>Proposed Solution:</i> Provide "Tow Away" sign at parking lot entrance when altering area. 	PCODE EA04C CBC 2007 1129B.4 CBC 2019 11B-502.8.2 Mitigated: <input type="radio"/> YES <input checked="" type="radio"/> NO	1	JOB	\$975	\$975

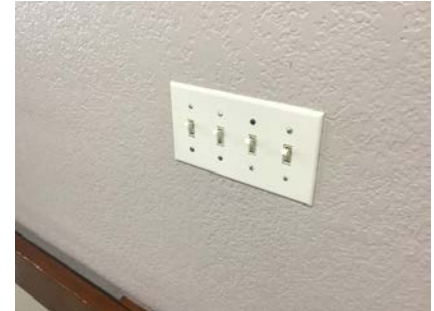
336	<ul style="list-style-type: none"> • <i>As-Built Description:</i> Electric switch or control mounted less than 15" measured to the bottom of the outlet box or greater than 48 inches measured to the top of the outlet box. • <i>As-Built:</i> 49.25" to top of box. • <i>Proposed Solution:</i> Relocate light switches or control to between 15" and 48" height. • <i>Notes:</i> 	<p>PCODE IC01 ADAAG 91 4.2.5 & 6 ADA 2010 308.2.1 & 308.2.2 CBC 2007 1117B.6.3 CBC 2019 11B-308.2.1 & 11B-308.2.2</p> <p>Mitigated: <input type="radio"/> YES <input checked="" type="radio"/> NO</p>	1	JOB	\$900	\$900
-----	--	---	---	-----	-------	-------

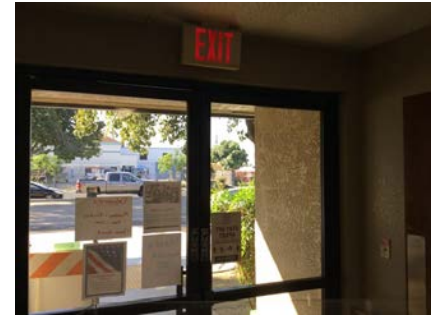
<p>328</p> <ul style="list-style-type: none"> <i>As-Built Description:</i> At final exit door to exterior: Where required exit signs are installed, signs to provide exiting information for people with vision impairment are not provided. <i>Proposed Solution:</i> Provide raised letter/Braille "EXIT" sign at door. 	<p>PCODE SA10A ADAAG 91 4.1.3(16) ADA 2010 216.4.1 CBC 2007 1011.3 CBC 2019 11B-216.4.1</p>	<p>6 JOB \$270 \$1,620</p>
---	---	----------------------------
