APPENDIX B: ACCESS COMPLIANCE SURVEY REPORT OF FACILITIES

The City of Madera

Access Compliance Survey Report

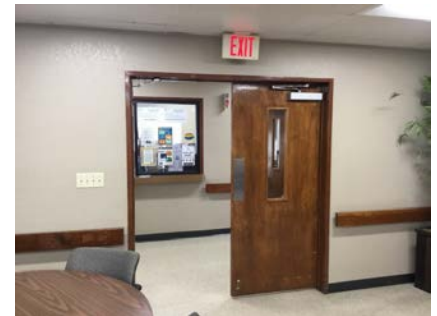
<p>329</p> <ul style="list-style-type: none"> <i>As-Built Description:</i> At door leading into exit corridor: Where required exit signs are installed, signs to provide exiting information for people with vision impairment are not provided. <i>Proposed Solution:</i> Provide raised letter/Braille "EXIT ROUTE" sign at door. 	<p>PCODE SA10D ADAAG 91 4.1.3(16) ADA 2010 216.4.1 CBC 2007 1011.3 CBC 2019 11B-216.4.1</p>	<p>3 JOB \$270 \$810</p>
---	---	--------------------------

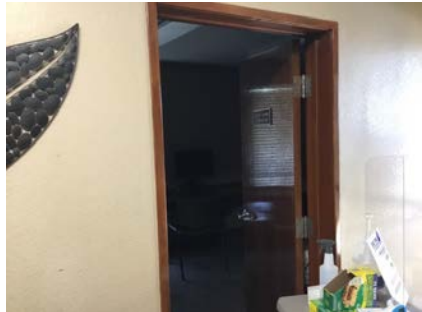
Item no., Rm no. and Name	Existing Architectural Barrier and Proposed Solution	Codes / Mitigation Info	Qty	Unit	Cost	Total
327	<ul style="list-style-type: none"> <i>As-Built Description:</i> Existing sign designating permanent room or space is noncompliant. <i>Proposed Solution:</i> Provide compliant signage. 	PCODE SA13 ADAAG 91 4.1.3(16)(a) ADA 2010 216.2 CBC 2007 1117B.5 CBC 2019 11B-216.2 Mitigated: <input type="radio"/> YES <input checked="" type="radio"/> NO	12	JOB	\$450	\$5,400

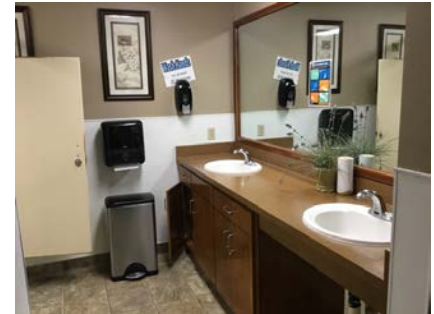
Multiple accommodation restroom not accessible; multiple compliance violations.

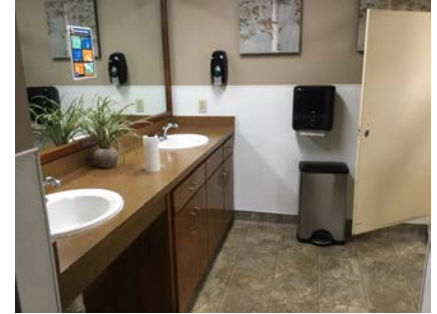
Multiple accommodation restroom not accessible; multiple compliance violations.

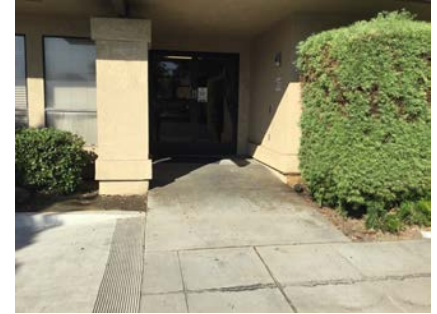
- *As-Built Description:*
Exterior signage at inaccessible entrances to provide direction to accessible entrances is missing or noncompliant.
- *Proposed Solution:*
Provide signage sufficient to guide persons to accessible entrances.
- *Notes:*

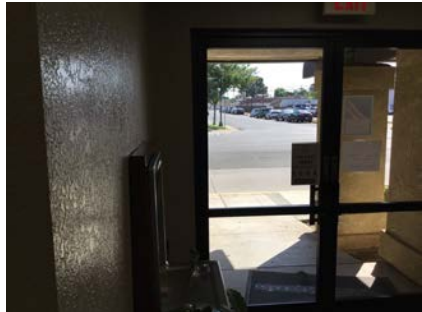
Item no., Rm no. and Name	Existing Architectural Barrier and Proposed Solution	Codes / Mitigation Info	Qty	Unit	Cost	Total
346	<ul style="list-style-type: none"> <i>As-Built Description:</i> Front approach: At push side, door does not have clear and level maneuvering space measuring door width x 48" (door width plus 12" if door has both, latch and closer). <i>As-Built:</i> 30.0" <i>Proposed Solution:</i> Remove or relocate drinking fountain. 	PCODE ID24A ADAAG 91 Fig. 25(a) ADA 2010 404.2.4 CBC 2007 11B-26A(a) CBC 2019 11B-404.2.4 Mitigated: <input type="radio"/> YES <input checked="" type="radio"/> NO	1	JOB	\$1,500	\$1,500

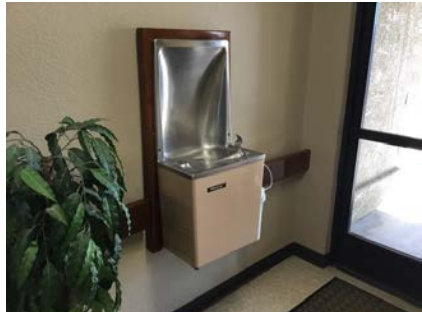
Drinking Fountain

345	<ul style="list-style-type: none"> <i>As-Built Description:</i> Where only one drinking fountain is provided per floor: Fountain is not accessible to individuals who use wheelchairs, or to those who have difficulty bending or stooping. <i>Proposed Solution:</i> Provide additional fountain or hi-lo combination fountain. 	PCODE IA01A ADAAG 91 4.1.3(10)(a) ADA 2010 211.1 CBC 2007 1115B.4.6.1 CBC 2019 11B-211.1 Mitigated: <input type="radio"/> YES <input checked="" type="radio"/> NO	1	JOB	\$6,000	\$6,000

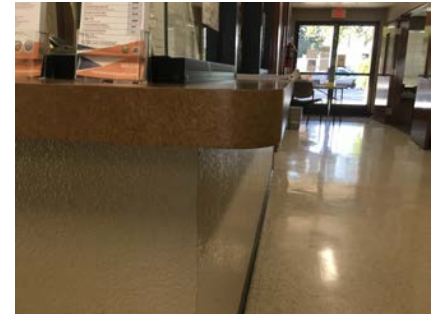
340	<ul style="list-style-type: none"> As-Built Description: Protruding objects more than 4" from wall, when bottom of object more than 27" or less than 80" above finished floor. As-Built: Service counter: 5.5" to 6.5" at 34.5" high Proposed Solution: Provide cane detectable side panels. 	PCODE EG04 ADAAG 91 4.4.1 ADA 2010 307.2 CBC 2007 1133B.8.6.1 CBC 2019 11B-307.2	1	JOB	\$1,200	\$1,200
-----	--	--	---	-----	---------	---------

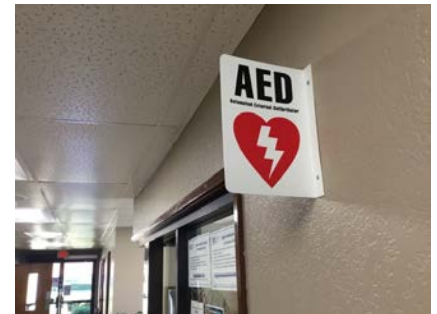
341	<ul style="list-style-type: none"> As-Built Description: Protruding objects more than 4" from wall, when bottom of object more than 27" or less than 80" above finished floor. As-Built: AED sign: 7.0" at 75.5" high Proposed Solution: Remove/relocate protruding object. Patch existing surface. 	PCODE EG04 ADAAG 91 4.4.1 ADA 2010 307.2 CBC 2007 1133B.8.6.1 CBC 2019 11B-307.2	1	JOB	\$300	\$300
-----	---	--	---	-----	-------	-------

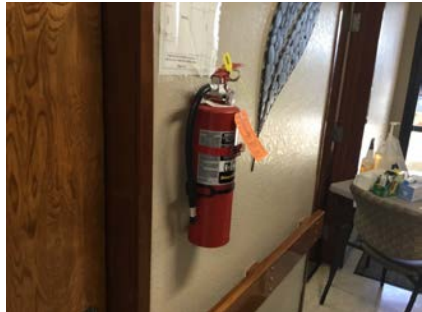
Item no., Rm no. and Name	Existing Architectural Barrier and Proposed Solution	Codes / Mitigation Info	Qty	Unit	Cost	Total
344	<ul style="list-style-type: none"> <i>As-Built Description:</i> Protruding objects more than 4" from wall, when bottom of object more than 27" or less than 80" above finished floor. <i>As-Built:</i> FE: 5.2" at 52" high <i>Proposed Solution:</i> Remove/relocate protruding object. Patch existing surface. 	PCODE EG04 ADAAG 91 4.4.1 ADA 2010 307.2 CBC 2007 1133B.8.6.1 CBC 2019 11B-307.2 Mitigated: <input type="radio"/> YES <input checked="" type="radio"/> NO	2	JOB	\$300	\$600

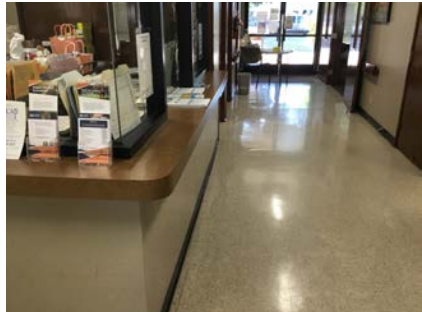
Public Counter

339	<ul style="list-style-type: none"> <i>As-Built Description:</i> Service counter (stand-up): Accessible section min. 36" length and 36" max. height (in CA: 28" to 34" high) not provided. <i>As-Built:</i> 37.7" high <i>Proposed Solution:</i> Retrofit existing counter to provide accessible section. Interim solution: Provide auxiliary counter, table, or clipboard. 	PCODE IN03 ADAAG 91 7.2(2) ADA 2010 904.4 CBC 2007 1122B.4 CBC 2019 11B-904.4 Mitigated: <input type="radio"/> YES <input checked="" type="radio"/> NO	1	JOB	\$6,000	\$6,000

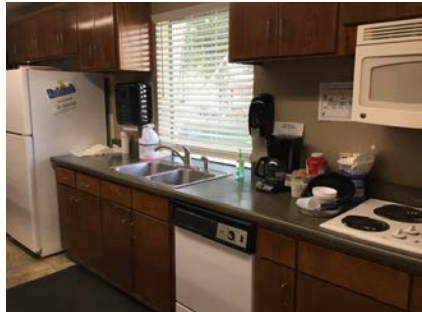
Item no., Rm no. and Name	Existing Architectural Barrier and Proposed Solution	Codes / Mitigation Info	Qty	Unit	Cost	Total
353	<ul style="list-style-type: none"> As-Built Description: Reach height to control or access point, where side approach is available, exceeds 48" or is less than 15" in height, or exceeds 10" in depth. As-Built: Obstructed reach to items by 37.0" countertop. Proposed Solution: Modify equipment or mounting. 	PCODE IE02 ADAAG 91 4.2.6 ADA 2010 308.3.1 CBC 2007 1118B.6 CBC 2019 11B-308.3 Mitigated: <input type="radio"/> YES <input checked="" type="radio"/> NO	1	JOB	\$300	\$300

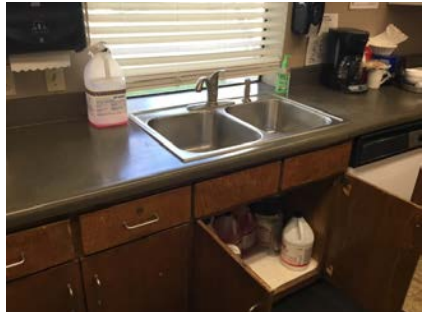
351	<ul style="list-style-type: none"> As-Built Description: Sink rim higher than 34" above floor. As-Built: 37.0" high Proposed Solution: Remodel sink cabinet to lower sink. 	PCODE IN06 ADAAG 91 4.24.2 ADA 2010 606.3 CBC 2007 1115B.4.7.1 CBC 2019 11B-606.3 Mitigated: <input type="radio"/> YES <input checked="" type="radio"/> NO	1	JOB	\$5,250	\$5,250

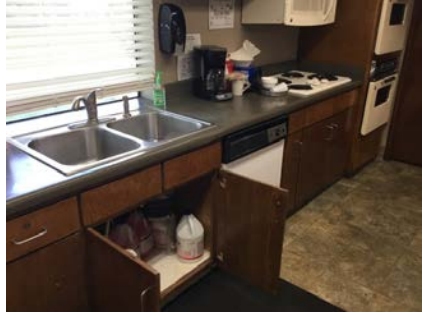
Item no., Rm no. and Name	Existing Architectural Barrier and Proposed Solution	Codes / Mitigation Info	Qty	Unit	Cost	Total
350	<ul style="list-style-type: none"> • <i>As-Built Description:</i> Sink does not have knee space min. 27" high x 19" deep x 30" wide. • <i>Proposed Solution:</i> Remodel sink cabinet. 	PCODE IN06A ADAAG 91 4.24.3 ADA 2010 606.2 CBC 2007 1115B.4.7.1 CBC 2019 11B-606.2 Mitigated: <input type="radio"/> YES <input checked="" type="radio"/> NO	1	JOB	\$5,250	\$5,250

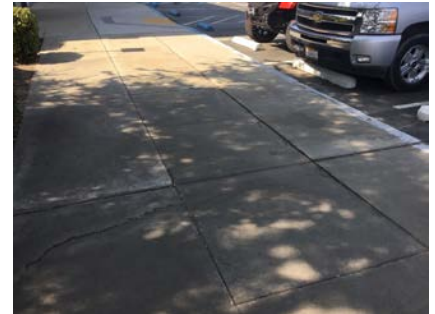
- 584
- *As-Built Description:*
Walk: Pavement dislocation creates abrupt change in level exceeding 1/2" in accessible route.
 - *As-Built:* **1.0"**
 - *Proposed Solution:*
Remove, replace or repair area of pavement sufficient to correct abrupt change in level.

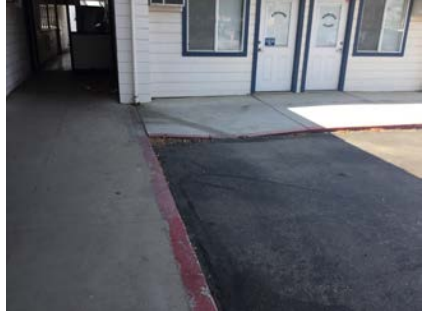
Detectable Warning

<p>586</p> <ul style="list-style-type: none"> <i>As-Built Description:</i> 36" wide band of truncated domes not provided at walkway or crossing adjoining a vehicular way, if surfaces are not separated by a curb, railing, or other element. <i>Proposed Solution:</i> Provide 36" wide, contrasting color, band of truncated domes between pedestrian and vehicular area. 	<p>PCODE EG09 ADAAG 91 4.29.5 CBC 2007 1133B.8.5 CBC 2019 11B-705.1.2.5</p> <p>Mitigated: <input type="radio"/> YES <input checked="" type="radio"/> NO</p>	<p>2 LF \$81 \$162</p>

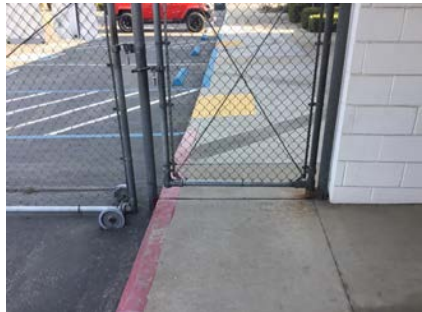
Door

<p>578</p> <ul style="list-style-type: none"> <i>As-Built Description:</i> At push side of door on accessible route, bottom 10" does not have a smooth, uninterrupted surface. <i>Proposed Solution:</i> Provide 10" min. "kick plate" covering width of door when altering area. 	<p>PCODE ID06 ADA 2010 404.2.10 CBC 2007 1133B.2.6 CBC 2019 11B-404.2.10</p> <p>Mitigated: <input type="radio"/> YES <input checked="" type="radio"/> NO</p>	<p>1 JOB \$300 \$300</p>

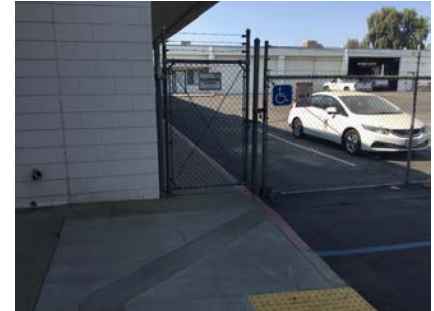
Item no., Rm no. and Name	Existing Architectural Barrier and Proposed Solution	Codes / Mitigation Info	Qty	Unit	Cost	Total
579	<ul style="list-style-type: none"> As-Built Description: Surface of required maneuvering clearance at door slopes more than 1/4":12" (2.0%). As-Built: 9.5% Proposed Solution: Modify surface slope at door. Notes: 	PCODE ID11 ADAAG 91 4.13.6 ADA 2010 404.2.4.4 CBC 2007 1133B.2.4 CBC 2019 11B-404.2.4 Mitigated: <input type="radio"/> YES <input checked="" type="radio"/> NO	.5	SF	\$120	\$60

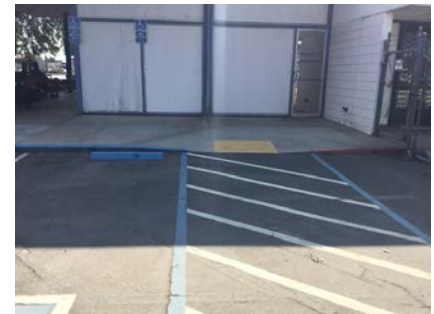
580	<ul style="list-style-type: none"> As-Built Description: Accessible parking space has slope greater than 1/4":12" (2%). As-Built: 4.3% Proposed Solution: Modify slope at accessible parking space. 	PCODE EA05 ADAAG 91 4.6.3 ADA 2010 502.4 CBC 2007 1129B.3.3 CBC 2019 11B-502.4 Mitigated: <input type="radio"/> YES <input checked="" type="radio"/> NO	100	SF	\$36	\$3,600
-----	---	--	-----	----	------	---------

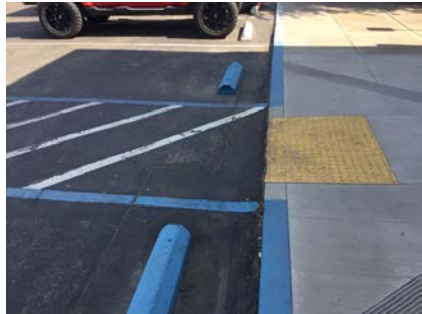
Item no., Rm no. and Name	Existing Architectural Barrier and Proposed Solution	Codes / Mitigation Info	Qty	Unit	Cost	Total
583	<ul style="list-style-type: none"> As-Built Description: Accessible parking space has slope greater than 1/4":12" (2%). As-Built: 5.8% Proposed Solution: Modify slope at accessible parking space. 	PCODE EA05 ADAAG 91 4.6.3 ADA 2010 502.4 CBC 2007 1129B.3.3 CBC 2019 11B-502.4 Mitigated: <input type="radio"/> YES <input checked="" type="radio"/> NO	10	SF	\$36	\$360

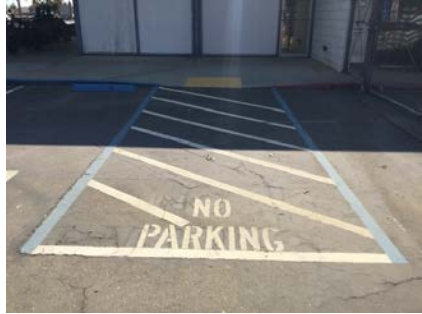
581	<ul style="list-style-type: none"> As-Built Description: Accessible parking space does not have 5' wide access aisle; 8' wide for van accessible aisle. As-Built: 95.5" wide Proposed Solution: Modify parking aisle(s) to create accessible space by restriping. 	PCODE EA02B ADAAG 91 4.6.3 ADA 2010 502.3 CBC 2007 1129B.3.1 CBC 2019 11B-502.2; 11B-502.3.1 Mitigated: <input type="radio"/> YES <input checked="" type="radio"/> NO	1	JOB	\$600	\$600

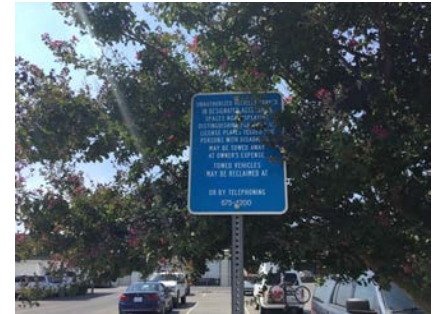
609	<ul style="list-style-type: none"> <i>As-Built Description:</i> No "Tow Away" sign at parking lot entrance (required in CA only). <i>Proposed Solution:</i> Provide "Tow Away" sign at parking lot entrance when altering area. <i>Notes:</i> 	<p>PCODE EA04C</p> <p>CBC 2007 1129B.4</p> <p>CBC 2019 11B-502.8.2</p> <p>Mitigated:</p> <p><input type="radio"/> YES</p> <p><input checked="" type="radio"/> NO</p>	1	JOB	\$975	\$975
-----	--	--	---	-----	-------	-------

Reclaim location. Sign is difficult to see trim tree.

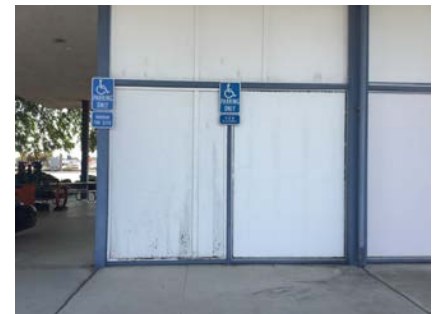
582	<ul style="list-style-type: none"> <i>As-Built Description:</i> CA only: Additional Sign or additional language below the symbol of accessibility stating "Minimum Fine \$250" not provided. <i>Proposed Solution:</i> Provide compliant parking signage that includes fine information. 	<p>PCODE EA04G</p> <p>CBC 2007 1129B.4</p> <p>CBC 2019 11B-502.6.2</p> <p>Mitigated:</p> <p><input type="radio"/> YES</p> <p><input checked="" type="radio"/> NO</p>	1	JOB	\$300	\$300
-----	--	--	---	-----	-------	-------

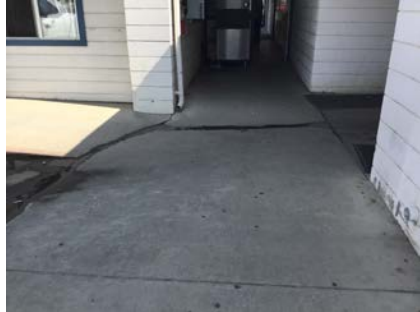
<p>587</p> <ul style="list-style-type: none"> As-Built Description: Cross slope more than 1":48" (2.083%). As-Built: Up to 4.5% Proposed Solution: Modify cross slope. 	<p>PCODE EF07 ADAAG 91 4.3.7 ADA 2010 403.3 CBC 2007 1133B.7.1.3 CBC 2019 11B-403.3</p> <p>Mitigated:</p> <p><input type="radio"/> YES</p> <p><input checked="" type="radio"/> NO</p>	<p>200 SF \$75 \$15,000</p>

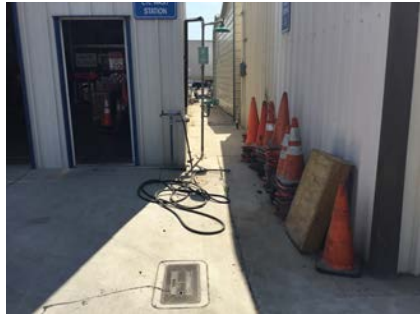
<p>604</p> <ul style="list-style-type: none"> As-Built Description: Cross slope more than 1":48" (2.083%). As-Built: 5.7% Proposed Solution: Modify cross slope. Notes: 	<p>PCODE EF07 ADAAG 91 4.3.7 ADA 2010 403.3 CBC 2007 1133B.7.1.3 CBC 2019 11B-403.3</p> <p>Mitigated:</p> <p><input type="radio"/> YES</p> <p><input checked="" type="radio"/> NO</p>	<p>60 SF \$75 \$4,500</p>

To and at eyewash station.

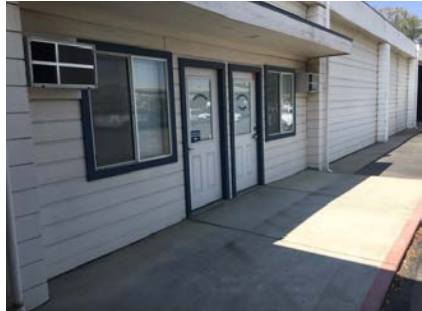
Item no., Rm no. and Name	Existing Architectural Barrier and Proposed Solution	Codes / Mitigation Info	Qty	Unit	Cost	Total
594	<ul style="list-style-type: none"> As-Built Description: Surface of required maneuvering clearance at door slopes more than 1/4":12" (2.0%). As-Built: 2.7% and 3.8% Proposed Solution: Modify surface slope at door. 	PCODE ID11 ADAAG 91 4.13.6 ADA 2010 404.2.4.4 CBC 2007 1133B.2.4 CBC 2019 11B-404.2.4 Mitigated: <input type="radio"/> YES <input checked="" type="radio"/> NO	50	SF	\$120	\$6,000

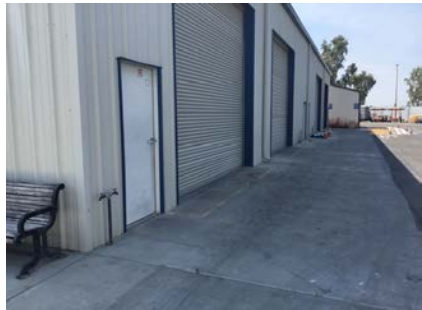
<input type="radio"/> Staff Only						
Priority <input checked="" type="radio"/> 1						
Severity <input checked="" type="radio"/> 4						
603	<ul style="list-style-type: none"> As-Built Description: Surface of required maneuvering clearance at door slopes more than 1/4":12" (2.0%). As-Built: 3.6%. Dimensions vary. Proposed Solution: Modify surface slope at door. Notes: 	PCODE ID11 ADAAG 91 4.13.6 ADA 2010 404.2.4.4 CBC 2007 1133B.2.4 CBC 2019 11B-404.2.4 Mitigated: <input type="radio"/> YES <input checked="" type="radio"/> NO	250	SF	\$120	\$30,000

Verify whether these are maintenance areas and are not required to be on an accessible route. Occurs at entrance doors to employee workstations throughout.

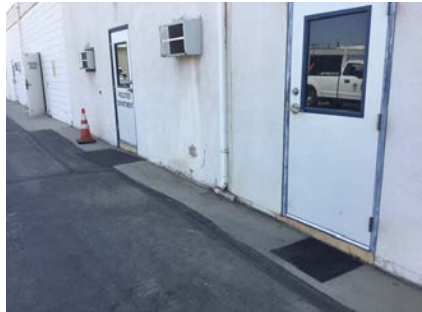
Item no., Rm no. and Name	Existing Architectural Barrier and Proposed Solution	Codes / Mitigation Info	Qty	Unit	Cost	Total
601	<ul style="list-style-type: none"> As-Built Description: Door inaccessible due to threshold or step at door exceeding 1/2". As-Built: 5.0" Proposed Solution: Modify threshold to be no more than 1/2" by removing existing paving at door and providing landing with edge ramping (slope 1:20 max). 	PCODE ID02A ADAAG 91 4.13.8 ADA 2010 404.2.5 CBC 2007 1133B.2.4.1 CBC 2019 11B-404.2.5 Mitigated: <input type="radio"/> YES <input checked="" type="radio"/> NO	2	JOB	\$1,200	\$2,400

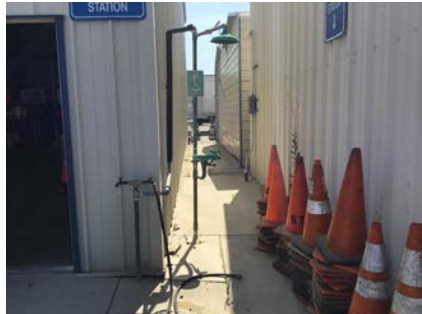
605	<ul style="list-style-type: none"> As-Built Description: Minimum of at least one of each type of sink and other specialized equipment such as fume hoods, microscopes, emergency eyewash and showers, etc., associated with the special use activity is not accessible. (CA Only) As-Built: Eyewash station: 41.0" high Proposed Solution: Remodel existing cabinet/counter/equipment to make specialized equipment accessible to disabled persons. 	PCODE LB01B CBC 2007 1106B.2 CBC 2019 11B-805.7 Mitigated: <input type="radio"/> YES <input checked="" type="radio"/> NO	1	JOB	\$3,000	\$3,000

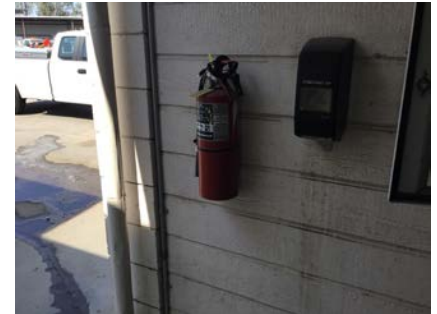
592	<ul style="list-style-type: none"> As-Built Description: Protruding objects more than 4" from wall, when bottom of object more than 27" or less than 80" above finished floor. As-Built: FE: 6.0" at 38.5" high Proposed Solution: Remove/relocate protruding object. Patch existing surface. 	PCODE EG04 ADAAG 91 4.4.1 ADA 2010 307.2 CBC 2007 1133B.8.6.1 CBC 2019 11B-307.2 Mitigated: <input type="radio"/> YES <input checked="" type="radio"/> NO	1	JOB	\$300	\$300
-----	---	--	---	-----	-------	-------

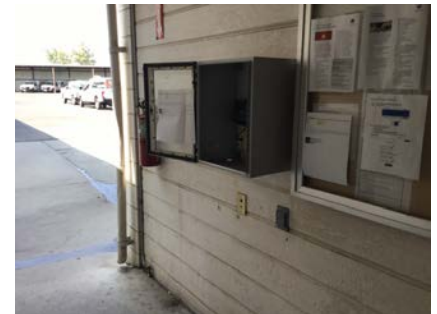
591	<ul style="list-style-type: none"> As-Built Description: Protruding objects more than 4" from wall, when bottom of object more than 27" or less than 80" above finished floor. As-Built: Utility box: 10.0" at 46.0" high Proposed Solution: Provide cane-detectable railing to mark area of low clearance. 	PCODE EG04A ADAAG 91 4.4.1 ADA 2010 307.2 CBC 2007 1133B.8.6.1 CBC 2019 11B-307.2 Mitigated: <input type="radio"/> YES <input checked="" type="radio"/> NO	1	LF	\$300	\$300
-----	---	---	---	----	-------	-------

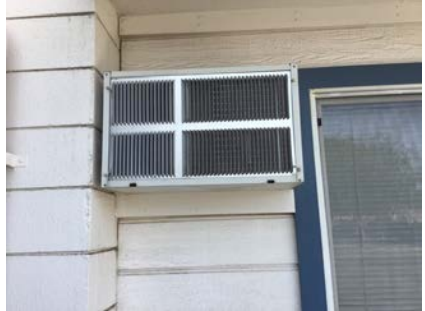
Item no., Rm no. and Name	Existing Architectural Barrier and Proposed Solution	Codes / Mitigation Info	Qty	Unit	Cost	Total
596	<ul style="list-style-type: none"> As-Built Description: Protruding objects more than 4" from wall, when bottom of object more than 27" or less than 80" above finished floor. As-Built: AC unit: 10.5" at 69.0" high Proposed Solution: Provide cane-detectable railing to mark area of low clearance. 	PCODE EG04A ADAAG 91 4.4.1 ADA 2010 307.2 CBC 2007 1133B.8.6.1 CBC 2019 11B-307.2 Mitigated: <input type="radio"/> YES <input checked="" type="radio"/> NO	4	LF	\$300	\$1,200

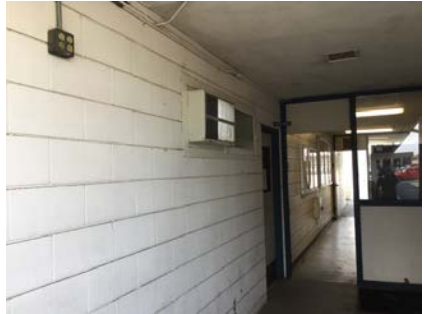
<input type="radio"/> Staff Only Priority 1 Severity 2						
597	<ul style="list-style-type: none"> As-Built Description: Protruding objects more than 4" from wall, when bottom of object more than 27" or less than 80" above finished floor. As-Built: AC Unit: 5.0" at 70.0" high Proposed Solution: Provide cane-detectable railing to mark area of low clearance. 	PCODE EG04A ADAAG 91 4.4.1 ADA 2010 307.2 CBC 2007 1133B.8.6.1 CBC 2019 11B-307.2 Mitigated: <input type="radio"/> YES <input checked="" type="radio"/> NO	4	LF	\$300	\$1,200

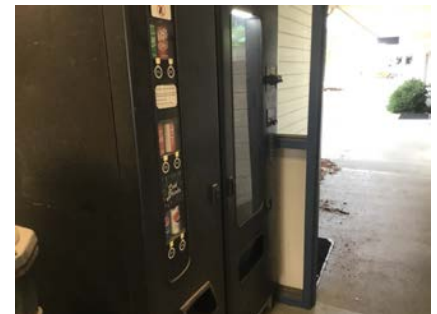
593	<ul style="list-style-type: none"> As-Built Description: Vending machine coin slot or dispensing outlet, more than 48" above the floor. As-Built: 12.0" to the bottom of the dispenser tray. 58.0" to bill insert. Proposed Solution: Advise vendor/leasing company to provide accessible vending machine with highest operable part at 48" max. 	PCODE IL02 ADAAG 91 4.2.5 ADA 2010 308.2.1 CBC 2007 1126B CBC 2019 11B-308.2.1 Mitigated: <input type="radio"/> YES <input checked="" type="radio"/> NO	1	REF		
-----	--	--	---	-----	--	--

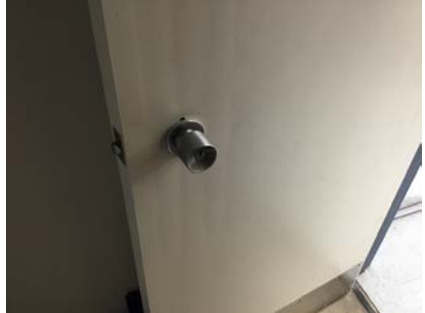
<p>552</p> <ul style="list-style-type: none"> <i>As-Built Description:</i> Door does not have accessible operating hardware. <i>Proposed Solution:</i> Provide lever handle or other accessible hardware. 	<p>PCODE ID07 ADAAG 91 4.13.9 ADA 2010 404.2.7 CBC 2007 1133B.2.5.2 CBC 2019 11B-404.2.7</p> <p>Mitigated: <input type="radio"/> YES <input checked="" type="radio"/> NO</p>	<p>30 JOB \$450 \$13,500</p>

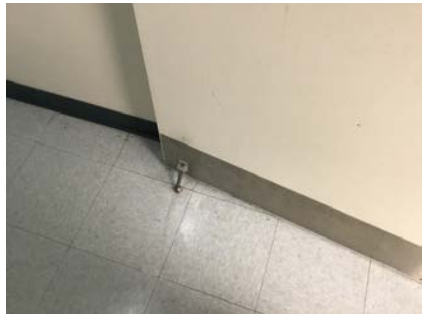
<p>554</p> <ul style="list-style-type: none"> <i>As-Built Description:</i> At push side of door on accessible route, bottom 10" does not have a smooth, uninterrupted surface. <i>Proposed Solution:</i> Remove door stopper when altering area. Provide rubber wedge. <i>Notes:</i> 	<p>PCODE ID06A ADA 2010 404.2.10 CBC 2007 1133B.2.6 CBC 2019 11B-404.2.10</p> <p>Mitigated: <input type="radio"/> YES <input checked="" type="radio"/> NO</p>	<p>50 JOB \$75 \$3,750</p>

This element complies with Safe Harbor if altered or constructed before March 15, 2012. This element does not comply with the dimensional requirements in the 1981 to the current CBC.

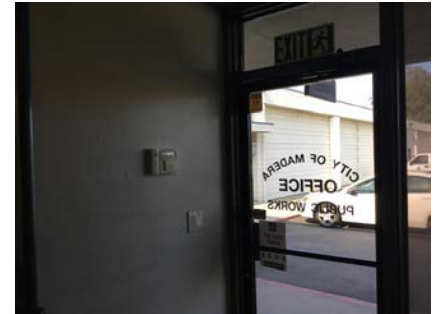
569	<ul style="list-style-type: none"> <i>As-Built Description:</i> At final exit door to exterior: Where required exit signs are installed, signs to provide exiting information for people with vision impairment are not provided. <i>Proposed Solution:</i> Provide raised letter/Braille "EXIT" sign at door. 	PCODE SA10A ADAAG 91 4.1.3(16) ADA 2010 216.4.1 CBC 2007 1011.3 CBC 2019 11B-216.4.1	20	JOB	\$270	\$5,400
-----	--	--	----	-----	-------	---------

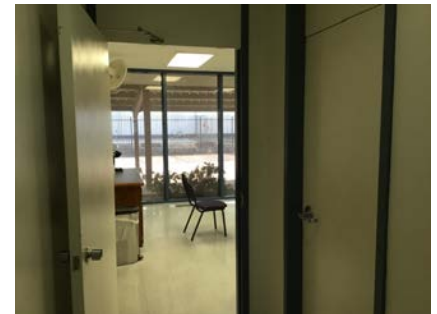
555	<ul style="list-style-type: none"> <i>As-Built Description:</i> Existing sign designating permanent room or space is noncompliant. <i>Proposed Solution:</i> Provide compliant signage. <i>Notes:</i> 	PCODE SA13 ADAAG 91 4.1.3(16)(a) ADA 2010 216.2 CBC 2007 1117B.5 CBC 2019 11B-216.2	20	JOB	\$450	\$9,000
-----	--	---	----	-----	-------	---------

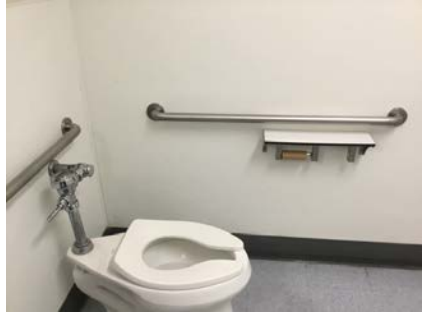
Grab Bars

<p>547</p> <ul style="list-style-type: none"> <i>As-Built Description:</i> Side grab bar less than 42" long, or located more than 12 inches max. from the rear wall, or extending less than 54" from rear wall (CA only: front end min. 24" in front of water closet). <i>As-Built:</i> Extends 13.0" <i>Proposed Solution:</i> Provide or relocate accessible side grab bar. 	<p>PCODE WB07A ADAAG 91 Fig. 29(b) ADA 2010 604.5.1 CBC 2007 1115B.4.1.3.1 CBC 2019 11B-604.5.1</p> <p>Mitigated: <input type="radio"/> YES <input checked="" type="radio"/> NO</p>	<p>1 JOB \$780 \$780</p>

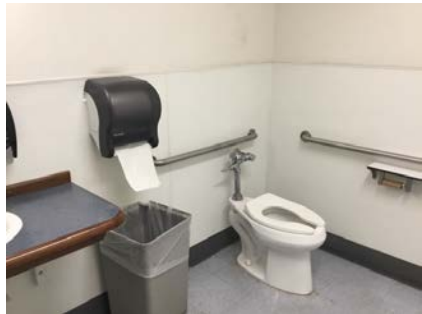
Protrusion Limits

<p>544</p> <ul style="list-style-type: none"> <i>As-Built Description:</i> Protruding objects more than 4" from wall, when bottom of object more than 27" or less than 80" above finished floor. <i>Proposed Solution:</i> Remove/relocate existing paper towel dispenser. Patch existing surface. 	<p>PCODE EG04 ADAAG 91 4.4.1 ADA 2010 307.2 CBC 2007 1133B.8.6.1 CBC 2019 11B-307.2</p> <p>Mitigated: <input type="radio"/> YES <input checked="" type="radio"/> NO</p>	<p>1 JOB \$300 \$300</p>

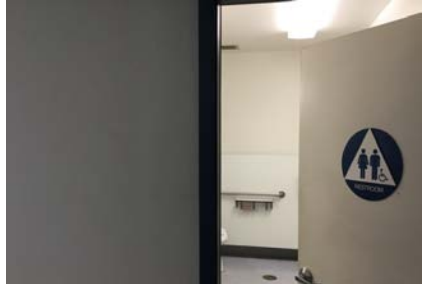
Signage

<p>541</p> <ul style="list-style-type: none"> <i>As-Built Description:</i> Entrance to toilet or bathing facility not identified with ADAAG compliant signage. <i>Proposed Solution:</i> Provide ADA compliant sign mounted at 48" min. above to baseline of the lowest Braille cells and 60" max. to baseline of the highest line of raised characters on nearest adjacent wall, on latch side of a single door (located not to cause a Braille reader to stand within the door swing). 	<p>PCODE SA11A ADAAG 91 4.1.3(16)(a) ADA 2010 216.8 CBC 2019 11B-216.8</p> <p>Mitigated: <input type="radio"/> YES <input checked="" type="radio"/> NO</p>	<p>1 JOB \$270 \$270</p>

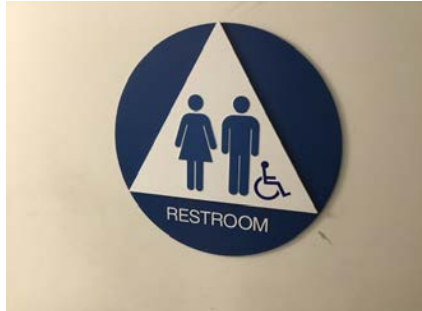
<p>540</p> <ul style="list-style-type: none"> <i>As-Built Description:</i> Required in CA only: identification symbol centered 58" to 60" high on sanitary facility door that contrasts with the door not provided (women: 12" ø circle, men: 12" triangle, unisex: combined symbol). <i>As-Built:</i> Not beveled or radiused. <i>Proposed Solution:</i> Provide properly mounted sanitary facility symbol when altering area. If wheelchair accessible, include International Symbol of Accessibility on sign. 	<p>PCODE SA15 CBC 2007 1115B.6 CBC 2019 11B-703.7.2.6</p> <p>Mitigated: <input type="radio"/> YES <input checked="" type="radio"/> NO</p>	<p>1 JOB \$270 \$270</p>

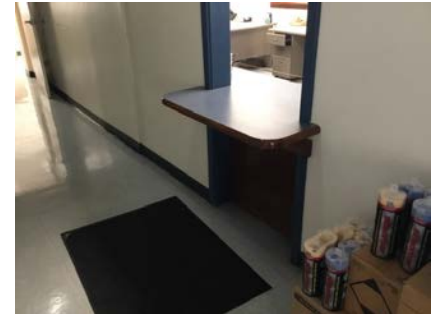
Protrusion Limits

560	<ul style="list-style-type: none"> As-Built Description: Protruding objects more than 4" from wall, when bottom of object more than 27" or less than 80" above finished floor. As-Built: Service counter: 12.5" at 32.0" high Proposed Solution: Add cane detectable side panels. 	PCODE EG04 ADAAG 91 4.4.1 ADA 2010 307.2 CBC 2007 1133B.8.6.1 CBC 2019 11B-307.2	1	JOB	\$600	\$600
-----	---	--	---	-----	-------	-------

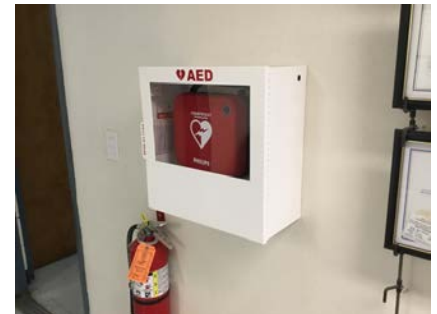
565	<ul style="list-style-type: none"> As-Built Description: Protruding objects more than 4" from wall, when bottom of object more than 27" or less than 80" above finished floor. As-Built: AED: 7.0" at 43.5" high Proposed Solution: Remove/relocate protruding object. Patch existing surface. 	PCODE EG04 ADAAG 91 4.4.1 ADA 2010 307.2 CBC 2007 1133B.8.6.1 CBC 2019 11B-307.2	1	JOB	\$300	\$300
-----	--	--	---	-----	-------	-------

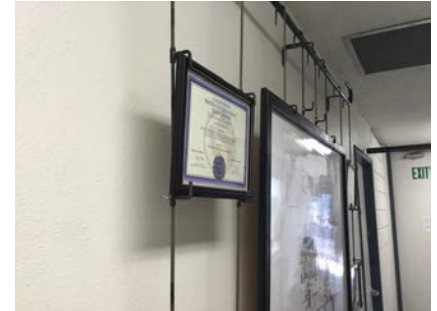
566	<ul style="list-style-type: none"> <i>As-Built Description:</i> Protruding objects more than 4" from wall, when bottom of object more than 27" or less than 80" above finished floor. <i>As-Built:</i> Display: 5.0" at 67.0" high <i>Proposed Solution:</i> Remove/relocate protruding object. Patch existing surface. <i>Notes:</i> 	PCODE EG04 ADAAG 91 4.4.1 ADA 2010 307.2 CBC 2007 1133B.8.6.1 CBC 2019 11B-307.2 Mitigated: <input type="radio"/> YES <input checked="" type="radio"/> NO	1	JOB	\$300	\$300
-----	--	--	---	-----	-------	-------

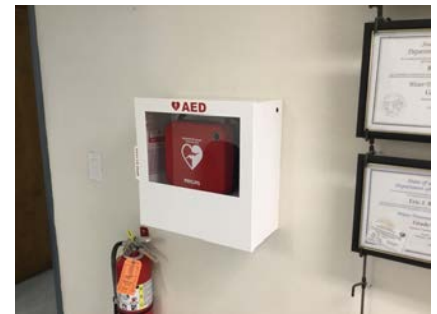
Reach Range

564	<ul style="list-style-type: none"> <i>As-Built Description:</i> Reach height to control or access point, where side approach is available, exceeds 48" or is less than 15" in height, or exceeds 10" in depth. <i>As-Built:</i> AED: 51.0" high <i>Proposed Solution:</i> Modify equipment or mounting. <i>Notes:</i> 	PCODE IE02 ADAAG 91 4.2.6 ADA 2010 308.3.1 CBC 2007 1118B.6 CBC 2019 11B-308.3 Mitigated: <input type="radio"/> YES <input checked="" type="radio"/> NO	1	JOB	\$300	\$300
-----	--	--	---	-----	-------	-------

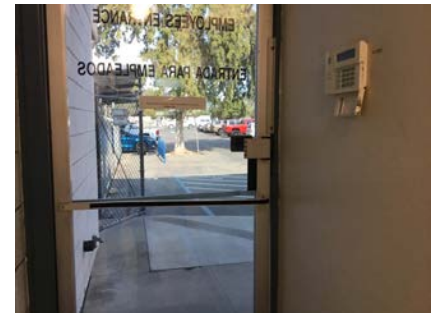
- 573
- *As-Built Description:*
Door lock, latch or handle less than 34" or more than 48" above the floor (CA only: 34" to 44").
 - *As-Built:* **51.0" high**
 - *Proposed Solution:*
Relocate or replace existing hardware.

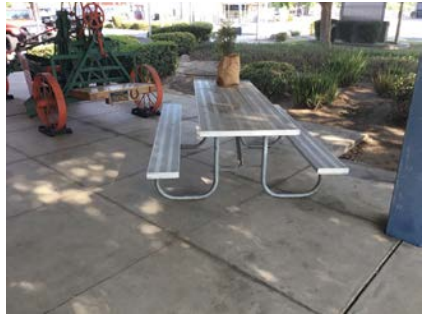
Item no., Rm no. and Name	Existing Architectural Barrier and Proposed Solution	Codes / Mitigation Info	Qty	Unit	Cost	Total
575	<ul style="list-style-type: none"> As-Built Description: Accessible non-fixed table or desk (top 28" to 34" high; knee space at least 27" high x 19" deep x 30" wide) not provided. Proposed Solution: Provide table or desk with accessible dimensions when purchasing new furniture. 	PCODE IN02A ADAAG 91 4.32.3 & .4 ADA 2010 306.1 CBC 2007 1122B.3 & 4 CBC 2019 11B-306.1 & 11B-902.3 Mitigated: <input type="radio"/> YES <input checked="" type="radio"/> NO	1	JOB	\$4,800	\$4,800

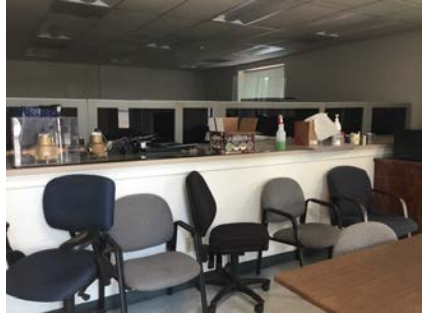
Public Counter

571	<ul style="list-style-type: none"> As-Built Description: Service counter (stand-up): Accessible section min. 36" length and 36" max. height (in CA: 28" to 34" high) not provided. As-Built: 42.0" Proposed Solution: Retrofit existing counter to provide accessible section. Interim solution: Provide auxiliary counter, table, or clipboard. Notes: 	PCODE IN03 ADAAG 91 7.2(2) ADA 2010 904.4 CBC 2007 1122B.4 CBC 2019 11B-904.4 Mitigated: <input type="radio"/> YES <input checked="" type="radio"/> NO	1	JOB	\$6,000	\$6,000

<input type="radio"/> Staff Only						
Priority <input checked="" type="radio"/> 4						
Severity <input checked="" type="radio"/> 3						
Appears unused ad counter.

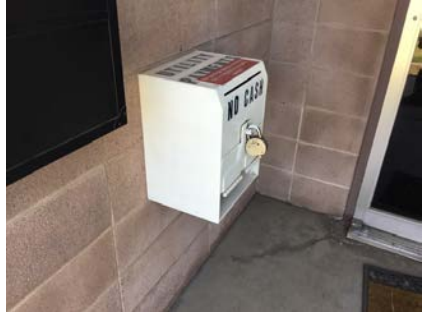
Protrusion Limits

<p>502</p> <ul style="list-style-type: none"> • <i>As-Built Description:</i> Protruding objects more than 4" from wall, when bottom of object more than 27" or less than 80" above finished floor. • <i>As-Built:</i> Metal box: 13.0" at 31.0" high • <i>Proposed Solution:</i> Remove/relocate protruding object. Patch existing surface. 	<p>PCODE EG04 ADAAG 91 4.4.1 ADA 2010 307.2 CBC 2007 1133B.8.6.1 CBC 2019 11B-307.2</p> <p>Mitigated: <input type="radio"/> YES <input checked="" type="radio"/> NO</p>	<p>1 JOB \$300 \$300</p>

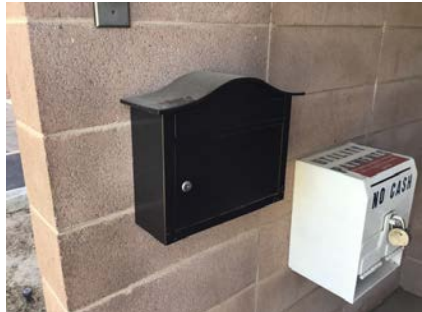
<p>505</p> <ul style="list-style-type: none"> • <i>As-Built Description:</i> Protruding objects more than 4" from wall, when bottom of object more than 27" or less than 80" above finished floor. • <i>As-Built:</i> Metal box: 6.0" at 51.0" high • <i>Proposed Solution:</i> Remove/relocate protruding object. Patch existing surface. 	<p>PCODE EG04 ADAAG 91 4.4.1 ADA 2010 307.2 CBC 2007 1133B.8.6.1 CBC 2019 11B-307.2</p> <p>Mitigated: <input type="radio"/> YES <input checked="" type="radio"/> NO</p>	<p>1 JOB \$300 \$300</p>

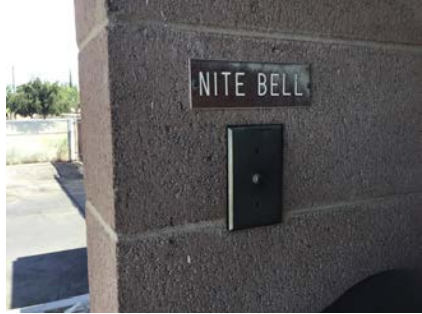
Item no., Rm no. and Name	Existing Architectural Barrier and Proposed Solution	Codes / Mitigation Info	Qty	Unit	Cost	Total
Reach Range						
506	<ul style="list-style-type: none"> As-Built Description: Reach height to control or access point, where side approach is available, exceeds 48" or is less than 15" in height, or exceeds 10" in depth. As-Built: 59.0" high Proposed Solution: Modify equipment or mounting. 	PCODE IE02 ADAAG 91 4.2.6 ADA 2010 308.3.1 CBC 2007 1118B.6 CBC 2019 11B-308.3 Mitigated: <input type="radio"/> YES <input checked="" type="radio"/> NO	1	JOB	\$300	\$300

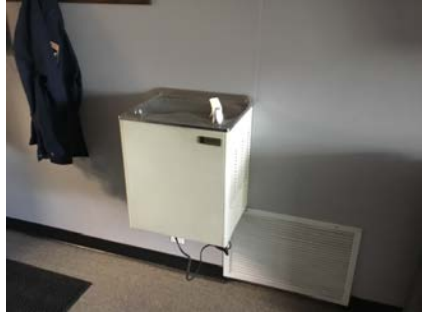
Item no., Rm no. and Name	Existing Architectural Barrier and Proposed Solution	Codes / Mitigation Info	Qty	Unit	Cost	Total
2	<ul style="list-style-type: none"> • <i>As-Built Description:</i> Drinking fountain lacks protection for visually impaired persons. • <i>Proposed Solution:</i> Provide cane-detectable rails. 	PCODE IA05C ADAAG 91 4.4.1 ADA 2010 307.2 CBC 2007 1115B.4.6.3 CBC 2019 11B-307.2 Mitigated: <input type="radio"/> YES <input checked="" type="radio"/> NO	1	JOB	\$1,500	\$1,500

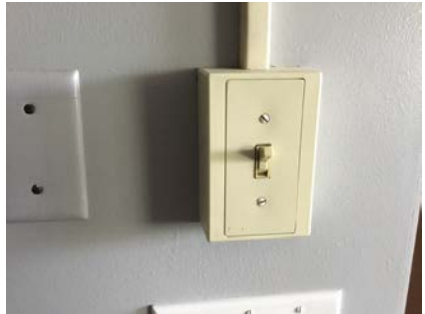
465	<ul style="list-style-type: none"> • <i>As-Built Description:</i> Electric switch or control mounted less than 15" measured to the bottom of the outlet box or greater than 48 inches measured to the top of the outlet box. • <i>As-Built:</i> Fan switch 58" high • <i>Proposed Solution:</i> Relocate light switches or control to between 15" and 48" height. 	PCODE IC01 ADAAG 91 4.2.5 & 6 ADA 2010 308.2.1 & 308.2.2 CBC 2007 1117B.6.3 CBC 2019 11B-308.2.1 & 11B-308.2.2 Mitigated: <input type="radio"/> YES <input checked="" type="radio"/> NO	1	JOB	\$900	\$900

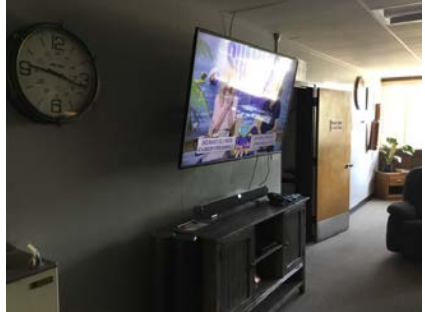
Item no., Rm no. and Name	Existing Architectural Barrier and Proposed Solution	Codes / Mitigation Info	Qty	Unit	Cost	Total
467	<ul style="list-style-type: none"> As-Built Description: Protruding objects more than 4" from wall, when bottom of object more than 27" or less than 80" above finished floor. As-Built: TV: 13.0" at 70.0" Proposed Solution: Provide cane-detectable railing to mark area of low clearance. 	PCODE EG04A ADAAG 91 4.4.1 ADA 2010 307.2 CBC 2007 1133B.8.6.1 CBC 2019 11B-307.2 Mitigated: <input type="radio"/> YES <input checked="" type="radio"/> NO	6	LF	\$300	\$1,800

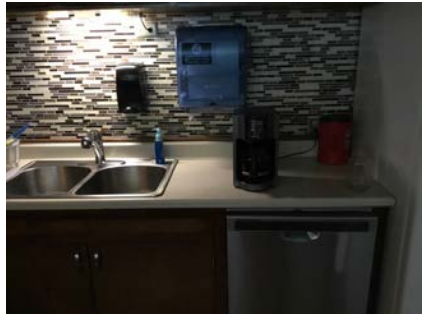
463	<ul style="list-style-type: none"> As-Built Description: Reach height to control or access point, where side approach is available, exceeds 48" or is less than 15" in height, or exceeds 10" in depth. As-Built: 36.0" high obstructed side reach. Proposed Solution: Modify equipment or mounting. 	PCODE IE02 ADAAG 91 4.2.6 ADA 2010 308.3.1 CBC 2007 1118B.6 CBC 2019 11B-308.3 Mitigated: <input type="radio"/> YES <input checked="" type="radio"/> NO	1	JOB	\$300	\$300

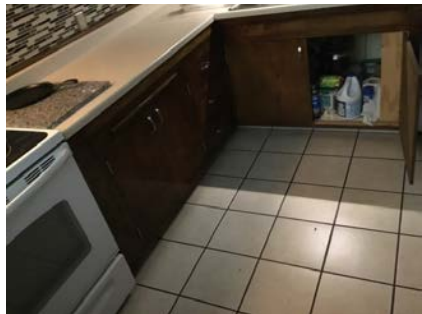
Item no., Rm no. and Name	Existing Architectural Barrier and Proposed Solution	Codes / Mitigation Info	Qty	Unit	Cost	Total
461	<ul style="list-style-type: none"> • <i>As-Built Description:</i> Sink does not have knee space min. 27" high x 19" deep x 30" wide. • <i>Proposed Solution:</i> Remodel sink cabinet. 	PCODE IN06A ADAAG 91 4.24.3 ADA 2010 606.2 CBC 2007 1115B.4.7.1 CBC 2019 11B-606.2 Mitigated: <input type="radio"/> YES <input checked="" type="radio"/> NO	1	JOB	\$5,250	\$5,250

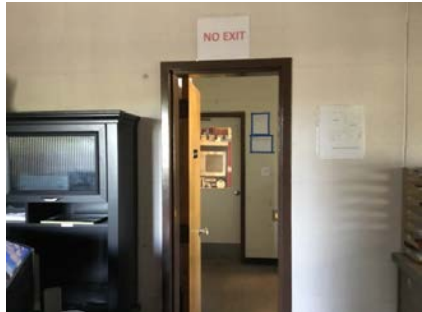
500	<ul style="list-style-type: none"> As-Built Description: Door on accessible route has less than 32" clear and 80" (78" min. to closer if provided) opening width when 90° open. As-Built: 22.0" clear Proposed Solution: Provide new, larger door and frame with new accessible hardware. 	PCODE ID01 ADAAG 91 4.13.5 ADA 2010 404.2.3 CBC 2007 1133B.1.1.1.1 CBC 2019 11B-404.2.3 Mitigated: <input type="radio"/> YES <input checked="" type="radio"/> NO	1	JOB	\$7,800	\$7,800

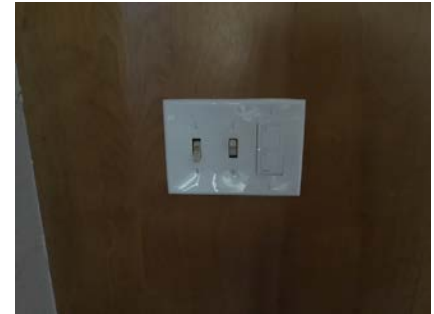
476	<ul style="list-style-type: none"> • <i>As-Built Description:</i> Electric switch or control mounted less than 15" measured to the bottom of the outlet box or greater than 48 inches measured to the top of the outlet box. • <i>As-Built:</i> 54.0" high • <i>Proposed Solution:</i> Relocate light switches or control to between 15" and 48" height. • <i>Notes:</i> 	<p>PCODE IC01 ADAAG 91 4.2.5 & 6 ADA 2010 308.2.1 & 308.2.2 CBC 2007 1117B.6.3 CBC 2019 11B-308.2.1 & 11B-308.2.2</p> <p>Mitigated: <input type="radio"/> YES <input checked="" type="radio"/> NO</p>	1	JOB	\$900	\$900
-----	---	---	---	-----	-------	-------

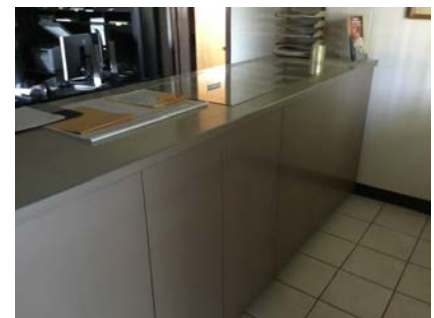
477	<ul style="list-style-type: none"> • <i>As-Built Description:</i> Service counter (stand-up): Accessible section min. 36" length and 36" max. height (in CA: 28" to 34" high) not provided. • <i>As-Built:</i> 42.0" high • <i>Proposed Solution:</i> Retrofit existing counter to provide accessible section. Interim solution: Provide auxiliary counter, table, or clipboard. 	<p>PCODE IN03 ADAAG 91 7.2(2) ADA 2010 904.4 CBC 2007 1122B.4 CBC 2019 11B-904.4</p> <p>Mitigated: <input type="radio"/> YES <input checked="" type="radio"/> NO</p>	1	JOB	\$6,000	\$6,000
-----	--	--	---	-----	---------	---------

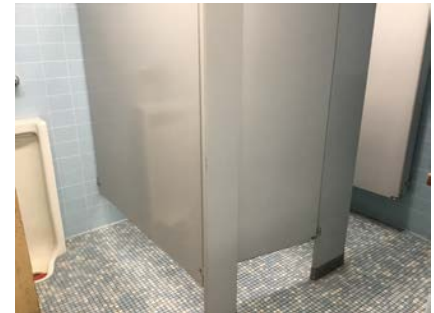
- 479
- *As-Built Description:*
Multiple accommodation restroom not accessible; multiple compliance violations.
 - *As-Built:* **137.0" x 133.0"**
 - *Proposed Solution:*
Remodel area to provide accessible restroom with one accessible stall, lavatory (and one urinal at Men's).
 - *Notes:*

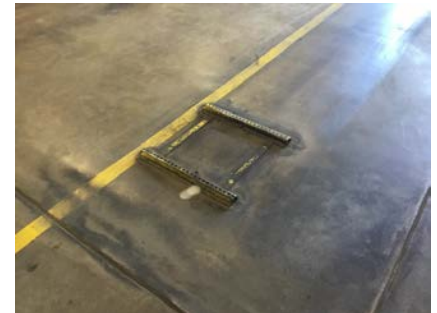
Remove, replace or repair area of pavement sufficient to correct abrupt change in level.

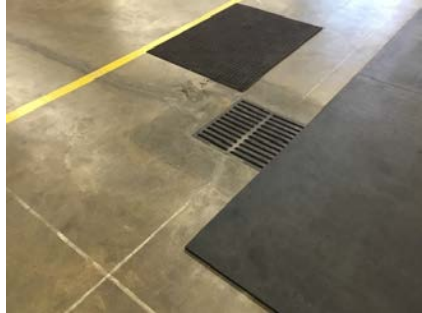
<p>487</p> <ul style="list-style-type: none"> <i>As-Built Description:</i> Walk: Grating has grid openings greater than 1/2" along the line of traffic flow. <i>Proposed Solution:</i> Provide new grating, with grid openings 1/2" max. along the line of traffic flow. 	<p>PCODE EF04 ADAAG 91 4.3.6; 4.5.4 ADA 2010 403.2; 302.3 CBC 2007 1133B.7.2 CBC 2019 11B-403.2; 11B-302.3</p> <p>Mitigated: <input type="radio"/> YES <input checked="" type="radio"/> NO</p>	<p>1 SF \$240 \$240</p>

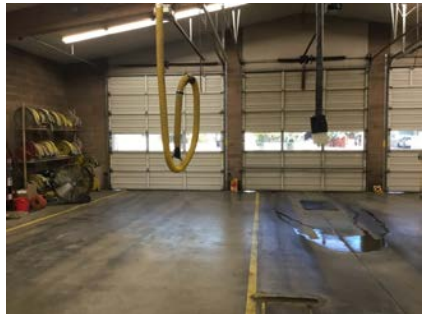
<p>489</p> <ul style="list-style-type: none"> <i>As-Built Description:</i> Protruding objects more than 4" from wall, when bottom of object more than 27" or less than 80" above finished floor. <i>As-Built:</i> 60.0" high <i>Proposed Solution:</i> Remove/relocate protruding object. Patch existing surface. <i>Notes:</i> 	<p>PCODE EG04 ADAAG 91 4.4.1 ADA 2010 307.2 CBC 2007 1133B.8.6.1 CBC 2019 11B-307.2</p> <p>Mitigated: <input type="radio"/> YES <input checked="" type="radio"/> NO</p>	<p>1 JOB \$300 \$300</p>

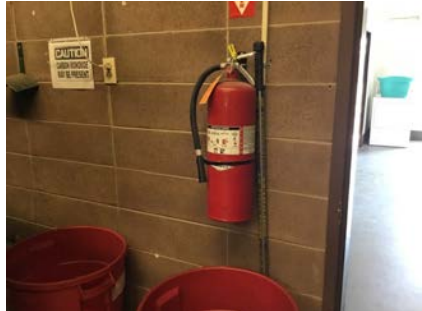
Item no., Rm no. and Name	Existing Architectural Barrier and Proposed Solution	Codes / Mitigation Info	Qty	Unit	Cost	Total
491	<ul style="list-style-type: none"> As-Built Description: Protruding objects more than 4" from wall, when bottom of object more than 27" or less than 80" above finished floor. As-Built: FE: 8.0" at 36.0" high Proposed Solution: Remove/relocate protruding object. Patch existing surface. 	PCODE EG04 ADAAG 91 4.4.1 ADA 2010 307.2 CBC 2007 1133B.8.6.1 CBC 2019 11B-307.2 Mitigated: <input type="radio"/> YES <input checked="" type="radio"/> NO	7	JOB	\$300	\$2,100

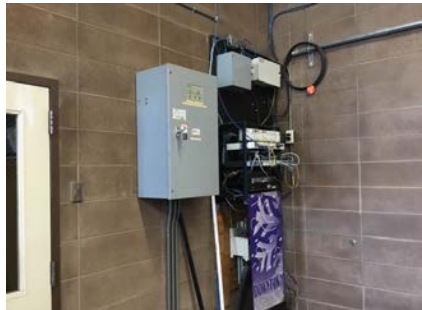
<input type="radio"/> Staff Only			
			Priority <input checked="" type="radio"/> 4			
			Severity <input checked="" type="radio"/> 3			
486	<ul style="list-style-type: none"> As-Built Description: Protruding objects more than 4" from wall, when bottom of object more than 27" or less than 80" above finished floor. As-Built: Electrical utility box: 12.0" at 57.0" high Proposed Solution: Provide cane-detectable railing to mark area of low clearance. Notes: 	PCODE EG04A ADAAG 91 4.4.1 ADA 2010 307.2 CBC 2007 1133B.8.6.1 CBC 2019 11B-307.2 Mitigated: <input type="radio"/> YES <input checked="" type="radio"/> NO	6	LF	\$300	\$1,800

<input type="radio"/> Staff Only			
			Priority <input checked="" type="radio"/> 4			
			Severity <input checked="" type="radio"/> 1			
<p>This item does not appear to be in an exit. However consider if tours are conducted in the bay some form of protection may be warranted.</p>

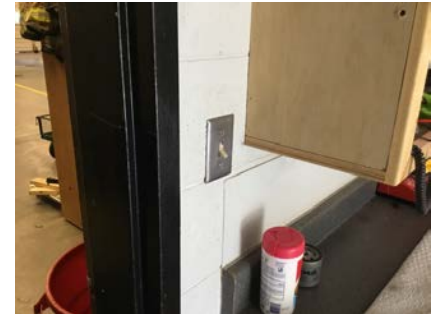
495	<ul style="list-style-type: none"> As-Built Description: Electric switch or control mounted less than 15" measured to the bottom of the outlet box or greater than 48 inches measured to the top of the outlet box. As-Built: 51.0" high Proposed Solution: Relocate light switches or control to between 15" and 48" height. Notes: 	<p>PCODE IC01</p> <p>ADAAG 91 4.2.5 & 6</p> <p>ADA 2010 308.2.1 & 308.2.2</p> <p>CBC 2007 1117B.6.3</p> <p>CBC 2019 11B-308.2.1 & 11B-308.2.2</p> <p>Mitigated:</p> <p><input type="radio"/> YES</p> <p><input checked="" type="radio"/> NO</p>	1	JOB	\$900	\$900
-----	---	--	---	-----	-------	-------

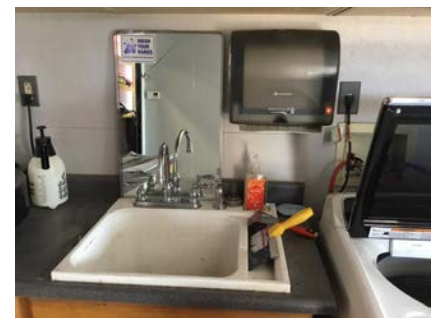
494	<ul style="list-style-type: none"> As-Built Description: Reach height to control or access point, where side approach is available, exceeds 48" or is less than 15" in height, or exceeds 10" in depth. As-Built: 52.0" high. Obstructed by 37.0" high sink. Proposed Solution: Modify equipment or mounting. 	<p>PCODE IE02</p> <p>ADAAG 91 4.2.6</p> <p>ADA 2010 308.3.1</p> <p>CBC 2007 1118B.6</p> <p>CBC 2019 11B-308.3</p> <p>Mitigated:</p> <p><input type="radio"/> YES</p> <p><input checked="" type="radio"/> NO</p>	1	JOB	\$300	\$300
-----	---	--	---	-----	-------	-------

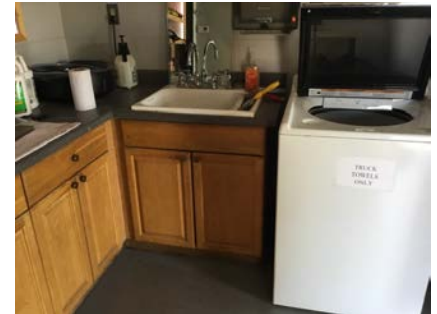
492	<ul style="list-style-type: none"> As-Built Description: Sink rim higher than 34" above floor. As-Built: 37.0" high Proposed Solution: Remodel sink cabinet to lower sink. 	PCODE IN06 ADAAG 91 4.24.2 ADA 2010 606.3 CBC 2007 1115B.4.7.1 CBC 2019 11B-606.3	1	JOB	\$5,250	\$5,250
-----	--	--	---	-----	---------	---------

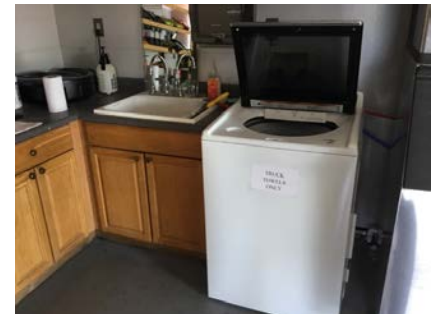
493	<ul style="list-style-type: none"> As-Built Description: Sink does not have clear floor space in front to allow for forward approach. Proposed Solution: Relocate existing washer. Notes: 	PCODE IN06ANT ADAAG 91 4.24.3 ADA 2010 606.2 CBC 2007 1115B.4.7.1 CBC 2019 11B-606.2	1	JOB	\$5,250	\$5,250
-----	--	---	---	-----	---------	---------

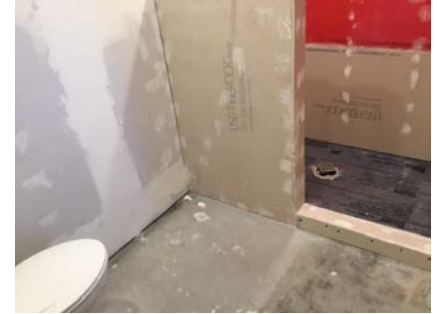
- 499
- *As-Built Description:*
Single accommodation restroom not accessible; multiple compliance violations.
 - *As-Built:* **59.5" x 109.0"**
 - *Proposed Solution:*
Remodel area to provide single-occupant accessible restroom.

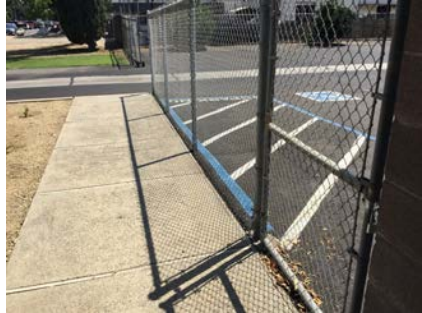
Parking

670	<ul style="list-style-type: none"> <i>As-Built Description:</i> Disabled persons must wheel or walk behind parked car(s) other than their own. <i>Proposed Solution:</i> Provide locking gate that can be used from the parking or Relocate parking and provide curb ramp to accessible route. 	<p>PCODE EA03 ADAAG 91 Fig.9 ADA 2010 502.3 CBC 2007 1129B.3.1 CBC 2019 11B-502.7.1</p> <p>Mitigated: <input type="radio"/> YES <input checked="" type="radio"/> NO</p>	1	JOB	\$2,190	\$2,190
-----	--	---	---	-----	---------	---------

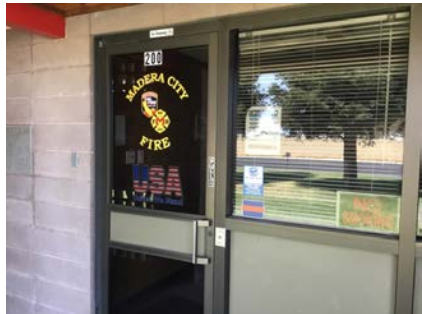
Signage

672	<ul style="list-style-type: none"> <i>As-Built Description:</i> Sign showing the International Symbol of Accessibility (ISA) not provided at all accessible building entrances. <i>Proposed Solution:</i> Provide building entrance signage with ISA signage at accessible entrance. <i>Notes:</i> 	<p>PCODE SA12A ADAAG 91 28 CFR 35.163 ADA 2010 (b) 216.6 CBC 2007 1127B.3 CBC 2019 11B-216.6</p> <p>Mitigated: <input type="radio"/> YES <input checked="" type="radio"/> NO</p>	1	JOB	\$150	\$150
-----	---	--	---	-----	-------	-------

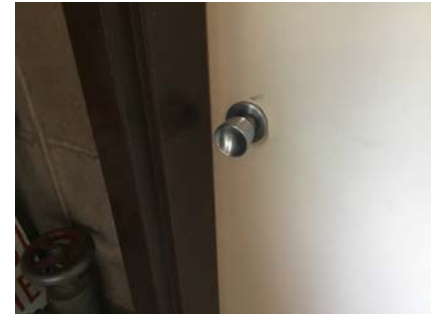
Door Hardware

658	<ul style="list-style-type: none"> • <i>As-Built Description:</i> Door does not have accessible operating hardware. • <i>Proposed Solution:</i> Provide lever handle or other accessible hardware. 	<p>PCODE ID07</p> <p>ADAAG 91 4.13.9</p> <p>ADA 2010 404.2.7</p> <p>CBC 2007 1133B.2.5.2</p> <p>CBC 2019 11B-404.2.7</p>	20	JOB	\$450	\$9,000
-----	--	--	----	-----	-------	---------

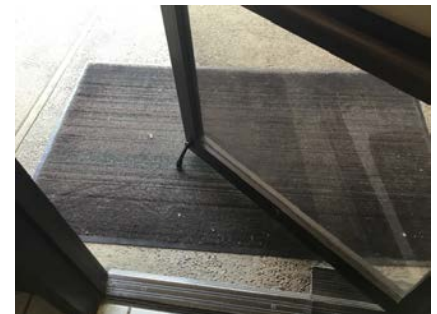
Door Stopper

665	<ul style="list-style-type: none"> • <i>As-Built Description:</i> At push side of door on accessible route, bottom 10" does not have a smooth, uninterrupted surface. • <i>Proposed Solution:</i> Remove door stopper when altering area. Provide rubber wedge. • <i>Notes:</i> 	<p>PCODE ID06A</p> <p>ADA 2010 404.2.10</p> <p>CBC 2007 1133B.2.6</p> <p>CBC 2019 11B-404.2.10</p>	10	JOB	\$75	\$750
-----	--	--	----	-----	------	-------

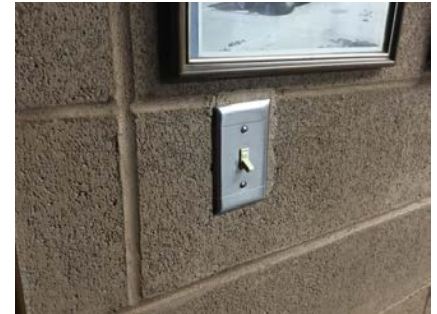
Electrical

652	<ul style="list-style-type: none"> As-Built Description: Electric switch or control mounted less than 15" measured to the bottom of the outlet box or greater than 48 inches measured to the top of the outlet box. As-Built: 54.0" high Proposed Solution: Relocate light switches or control to between 15" and 48" height. Notes: 	<p>PCODE IC01</p> <p>ADAAG 91 4.2.5 & 6</p> <p>ADA 2010 308.2.1 & 308.2.2</p> <p>CBC 2007 1117B.6.3</p> <p>CBC 2019 11B-308.2.1 & 11B-308.2.2</p> <p>Mitigated:</p> <p><input type="radio"/> YES</p> <p><input checked="" type="radio"/> NO</p>	20	JOB	\$900	\$18,000
-----	---	---	----	-----	-------	----------

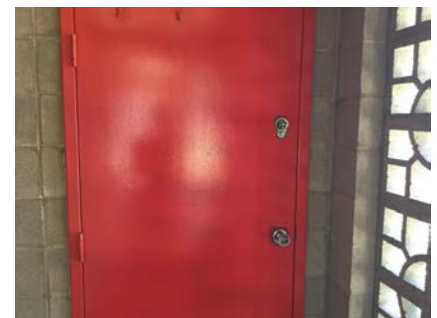
Signage

673	<ul style="list-style-type: none"> As-Built Description: Existing sign designating permanent room or space is noncompliant. Proposed Solution: Provide compliant signage. 	<p>PCODE SA13</p> <p>ADAAG 91 4.1.3(16)(a)</p> <p>ADA 2010 216.2</p> <p>CBC 2007 1117B.5</p> <p>CBC 2019 11B-216.2</p> <p>Mitigated:</p> <p><input type="radio"/> YES</p> <p><input checked="" type="radio"/> NO</p>	20	JOB	\$450	\$9,000
-----	---	--	----	-----	-------	---------

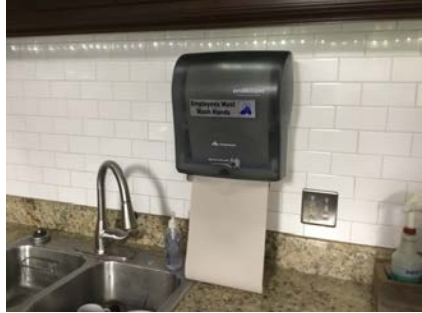
Reach Range

<p>645</p> <ul style="list-style-type: none"> • <i>As-Built Description:</i> Reach height to control or access point, where side approach is available, exceeds 48" or is less than 15" in height, or exceeds 10" in depth. • <i>As-Built:</i> 51.0" high over 36.0" high obstruction • <i>Proposed Solution:</i> Modify equipment or mounting. 	<p>PCODE IE02 ADAAG 91 4.2.6 ADA 2010 308.3.1 CBC 2007 1118B.6 CBC 2019 11B-308.3</p> <p>Mitigated: <input type="radio"/> YES <input checked="" type="radio"/> NO</p>	<p>1 JOB \$300 \$300</p>

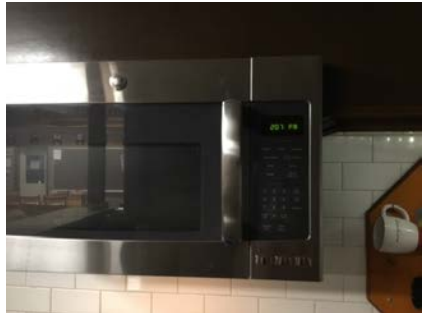
<p>647</p> <ul style="list-style-type: none"> • <i>As-Built Description:</i> Reach height to control or access point, where side approach is available, exceeds 48" or is less than 15" in height, or exceeds 10" in depth. • <i>As-Built:</i> 58.0" high • <i>Proposed Solution:</i> Modify equipment or mounting. 	<p>PCODE IE02 ADAAG 91 4.2.6 ADA 2010 308.3.1 CBC 2007 1118B.6 CBC 2019 11B-308.3</p> <p>Mitigated: <input type="radio"/> YES <input checked="" type="radio"/> NO</p>	<p>1 JOB \$300 \$300</p>

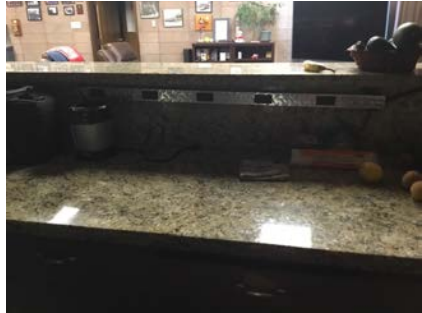
Item no., Rm no. and Name	Existing Architectural Barrier and Proposed Solution	Codes / Mitigation Info	Qty	Unit	Cost	Total
648	<ul style="list-style-type: none"> As-Built Description: Reach height to control or access point, where side approach is available, exceeds 48" or is less than 15" in height, or exceeds 10" in depth. As-Built: 25.0" deep and 36.0" high obstruction Proposed Solution: Modify equipment or mounting. 	PCODE IE02 ADAAG 91 4.2.6 ADA 2010 308.3.1 CBC 2007 1118B.6 CBC 2019 11B-308.3 Mitigated: <input type="radio"/> YES <input checked="" type="radio"/> NO	1	JOB	\$300	\$300

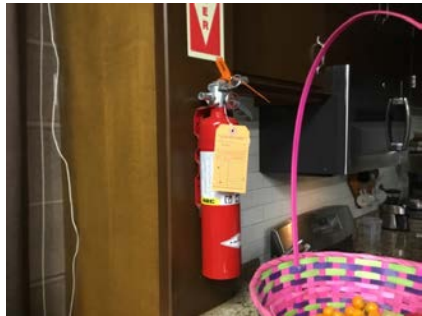
<input checked="" type="checkbox"/> Staff Only			
			Priority 4			
			Severity 4			
651	<ul style="list-style-type: none"> As-Built Description: Reach height to control or access point, where side approach is available, exceeds 48" or is less than 15" in height, or exceeds 10" in depth. As-Built: FE: 67.0" high Proposed Solution: Mount lower than 48" and higher than 15". 	PCODE IE02 ADAAG 91 4.2.6 ADA 2010 308.3.1 CBC 2007 1118B.6 CBC 2019 11B-308.3 Mitigated: <input type="radio"/> YES <input checked="" type="radio"/> NO	1	JOB	\$300	\$300
