APPENDIX B: ACCESS COMPLIANCE SURVEY REPORT OF FACILITIES

The City of Madera

Access Compliance Survey Report

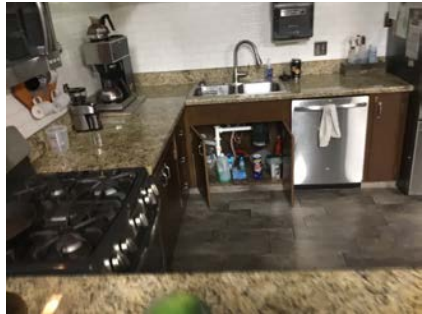
Item no., Rm no. and Name	Existing Architectural Barrier and Proposed Solution	Codes / Mitigation Info	Qty	Unit	Cost	Total
644	<ul style="list-style-type: none"> • <i>As-Built Description:</i> Sink does not have knee space min. 27" high x 19" deep x 30" wide. • <i>Proposed Solution:</i> Remodel sink cabinet. 	PCODE IN06A ADAAG 91 4.24.3 ADA 2010 606.2 CBC 2007 1115B.4.7.1 CBC 2019 11B-606.2 Mitigated: <input type="radio"/> YES <input checked="" type="radio"/> NO	1	JOB	\$5,250	\$5,250

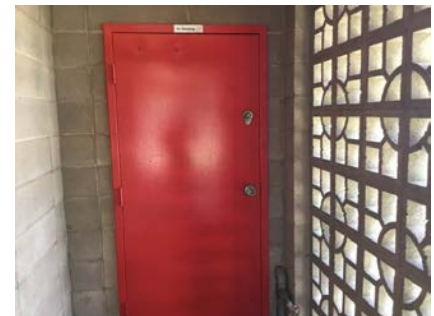
674 • *As-Built Description:*
 Exterior signage at inaccessible entrances to provide direction to accessible entrances is missing or noncompliant.
 • *Proposed Solution:*
 Provide signage sufficient to guide persons to the front bay for access.

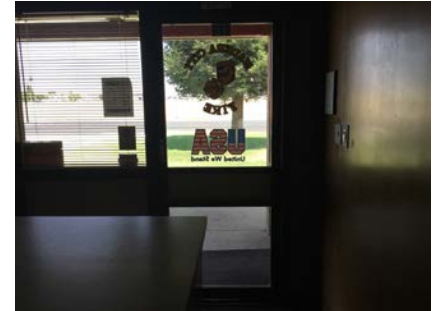
661	<ul style="list-style-type: none"> As-Built Description: Front approach: At push side, door does not have clear and level maneuvering space measuring door width x 48" (door width plus 12" if door has both, latch and closer). As-Built: 44.5" Proposed Solution: Remove or relocate furniture or storage items. Notes: 	PCODE ID24A ADAAG 91 Fig. 25(a) ADA 2010 404.2.4 CBC 2007 11B-26A(a) CBC 2019 11B-404.2.4	1	JOB	\$150	\$150
-----	--	--	---	-----	-------	-------

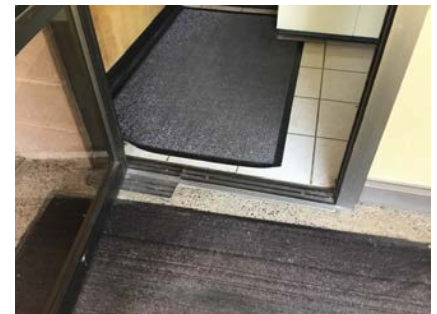
Door Threshold

666	<ul style="list-style-type: none"> As-Built Description: Existing threshold at door is 1/2" high or less but without a beveled edge on both sides. As-Built: 0.7" not beveled Proposed Solution: Modify threshold to have beveled edge on each side. 	PCODE ID02 ADAAG 91 4.1.6(3)(d)(ii) ADA 2010 404.2.5 CBC 2007 1133B.2.4.1 CBC 2019 11B-404.2.5	1	JOB	\$750	\$750
-----	--	---	---	-----	-------	-------

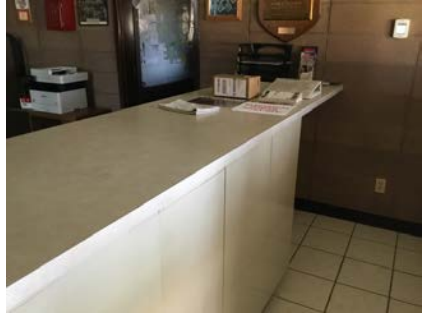
Item no., Rm no. and Name	Existing Architectural Barrier and Proposed Solution	Codes / Mitigation Info	Qty	Unit	Cost	Total
Public Counter						
662	<ul style="list-style-type: none"> As-Built Description: Service counter (stand-up): Accessible section min. 36" length and 36" max. height (in CA: 28" to 34" high) not provided. As-Built: 42.0" high Proposed Solution: Retrofit existing counter to provide accessible section. Interim solution: Provide auxiliary counter, table, or clipboard. 	PCODE IN03 ADAAG 91 7.2(2) ADA 2010 904.4 CBC 2007 1122B.4 CBC 2019 11B-904.4 Mitigated: <input type="radio"/> YES <input checked="" type="radio"/> NO	1	JOB	\$6,000	\$6,000

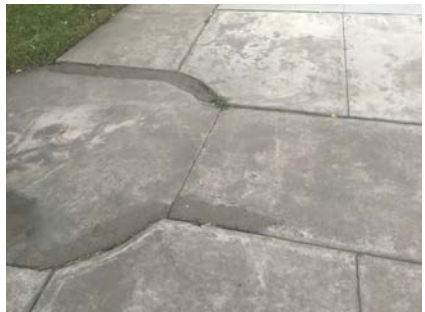
1710	<ul style="list-style-type: none"> As-Built Description: Walk: Pavement dislocation creates abrupt change in level exceeding 1/2" in accessible route. As-Built: Up to 1.0" Proposed Solution: Remove, replace or repair area of pavement sufficient to correct abrupt change in level. 	PCODE EF03 ADAAG 91 4.3.8 ADA 2010 403.4 CBC 2007 1133B.7.4 CBC 2019 11B-403.4 Mitigated: <input type="radio"/> YES <input checked="" type="radio"/> NO	40	LF	\$63	\$2,520
------	---	--	----	----	------	---------

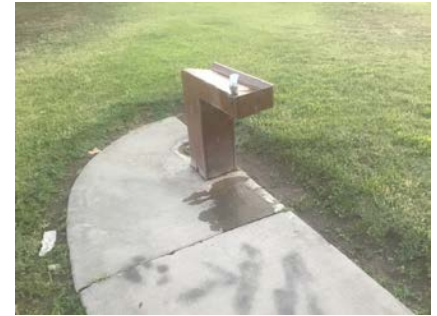
Drinking Fountain

1712	<ul style="list-style-type: none"> <i>As-Built Description:</i> Where only one drinking fountain is provided per floor: Fountain is not accessible to individuals who use wheelchairs, or to those who have difficulty bending or stooping. <i>Proposed Solution:</i> Provide additional fountain or hi-lo combination fountain. 	<p>PCODE IA01A ADAAG 91 4.1.3(10)(a) ADA 2010 211.1 CBC 2007 1115B.4.6.1 CBC 2019 11B-211.1</p> <p>Mitigated: <input type="radio"/> YES <input checked="" type="radio"/> NO</p>	1	JOB	\$6,000	\$6,000
------	--	--	---	-----	---------	----------------

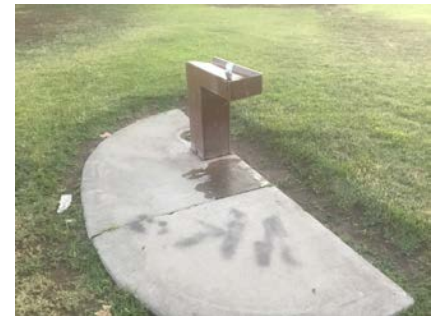
1713	<ul style="list-style-type: none"> <i>As-Built Description:</i> Drinking fountain lacks protection for visually impaired persons. <i>Proposed Solution:</i> Provide cane-detectable rails. 	<p>PCODE IA05C ADAAG 91 4.4.1 ADA 2010 307.2 CBC 2007 1115B.4.6.3 CBC 2019 11B-307.2</p> <p>Mitigated: <input type="radio"/> YES <input checked="" type="radio"/> NO</p>	1	JOB	\$1,500	\$1,500
------	--	---	---	-----	---------	----------------

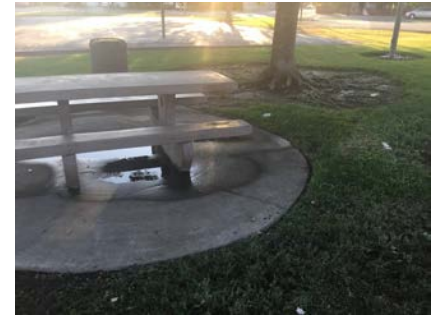
Picnic Area

1734	<ul style="list-style-type: none"> <i>As-Built Description:</i> No hard-surfaced accessible spaces at picnic table, B.B.Q. grill and/or bench. <i>Proposed Solution:</i> Provide paved accessible spaces for sitting and turning at picnic table, B.B.Q. grill and/or bench. <i>Notes:</i> 	<p>PCODE NA07</p> <p>CBC 2007 1132B.1</p> <p>CBC 2019 11B-246.5</p> <p>Mitigated:</p> <p><input type="radio"/> YES</p> <p><input checked="" type="radio"/> NO</p>	100	SF	\$18	\$1,800
------	---	---	-----	----	------	---------

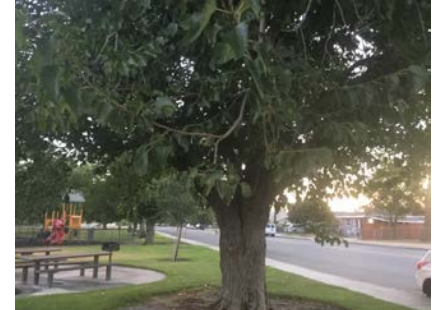
Protrusion Limits

1711	<ul style="list-style-type: none"> <i>As-Built Description:</i> Protruding objects more than 4" from wall, when bottom of object more than 27" or less than 80" above finished floor. <i>Proposed Solution:</i> Trim vegetation. 	<p>PCODE EG04</p> <p>ADAAG 91 4.4.1</p> <p>ADA 2010 307.2</p> <p>CBC 2007 1133B.8.6.1</p> <p>CBC 2019 11B-307.2</p> <p>Mitigated:</p> <p><input type="radio"/> YES</p> <p><input checked="" type="radio"/> NO</p>	8	JOB	\$300	\$2,400
------	--	---	---	-----	-------	---------

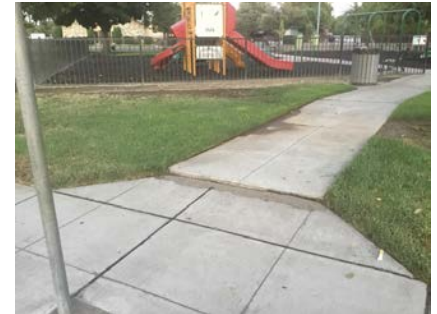
- 1709
- As-Built Description:*
Walk: Pavement dislocation creates abrupt change in level exceeding 1/2" in accessible route.
 - As-Built:* **2.0"**
 - Proposed Solution:*
Remove, replace or repair area of pavement sufficient to correct abrupt change in level.

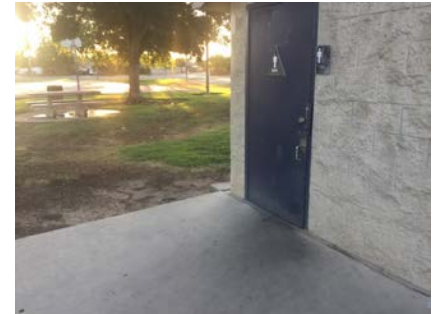
1724	<ul style="list-style-type: none"> As-Built Description: Surface of required maneuvering clearance at door slopes more than 1/4":12" (2.0%). As-Built: up to 3.0% 1.0" level change Proposed Solution: Modify surface slope at door. 	<p>PCODE ID11</p> <p>ADAAG 91 4.13.6</p> <p>ADA 2010 404.2.4.4</p> <p>CBC 2007 1133B.2.4</p> <p>CBC 2019 11B-404.2.4</p>	25	SF	\$120	\$3,000
------	--	---	----	----	-------	---------

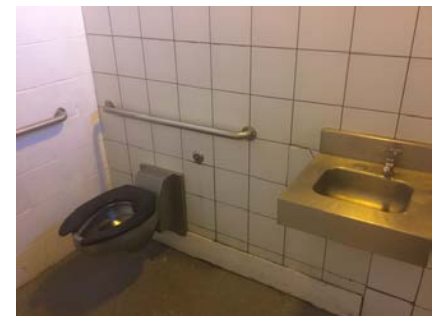
1719	<ul style="list-style-type: none"> <i>As-Built Description:</i> 60" min. clearance around a water closet measured perpendicular from the side wall not provided (Fixtures are not allowed to overlap this clearance). <i>As-Built:</i> 53.5" to lavatory <i>Proposed Solution:</i> Remove adjacent fixture and remodel restroom as needed. <i>Notes:</i> 	PCODE WB01A ADA 2010 604.3.1; 604.3.2 CBC 2007 1115B.7.1.3 CBC 2019 11B-604.3.1; 11B-604.3.2 Mitigated: <input type="radio"/> YES <input checked="" type="radio"/> NO	1	JOB	\$6,000	\$6,000
------	---	--	---	-----	---------	---------

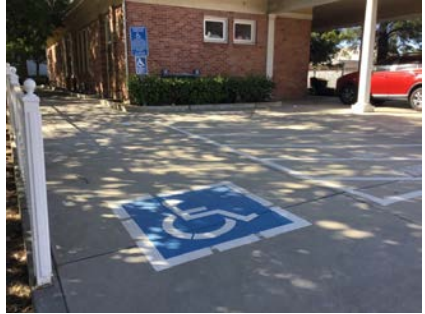
<p>171</p> <ul style="list-style-type: none"> • <i>As-Built Description:</i> Accessible parking space has slope greater than 1/4":12" (2%). • <i>As-Built:</i> Up to 4.8% • <i>Proposed Solution:</i> Modify slope at accessible parking space. 	<p>PCODE EA05 ADAAG 91 4.6.3 ADA 2010 502.4 CBC 2007 1129B.3.3 CBC 2019 11B-502.4</p> <p>Mitigated: <input type="radio"/> YES <input checked="" type="radio"/> NO</p>	<p>200 SF \$36 \$7,200</p>

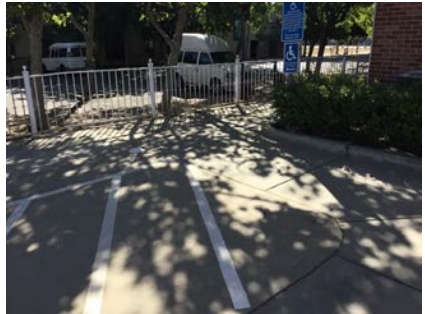
<p>174</p> <ul style="list-style-type: none"> • <i>As-Built Description:</i> Wheel stops provided do not effectively prevent the encroachment of vehicles over the required clear width of an adjacent accessible route. • <i>Proposed Solution:</i> Install wheel stops to effectively prevent encroachment. 	<p>PCODE EA04J CBC 2019 11B-502.7.2</p> <p>Mitigated: <input type="radio"/> YES <input checked="" type="radio"/> NO</p>	<p>1 JOB \$225 \$225</p>

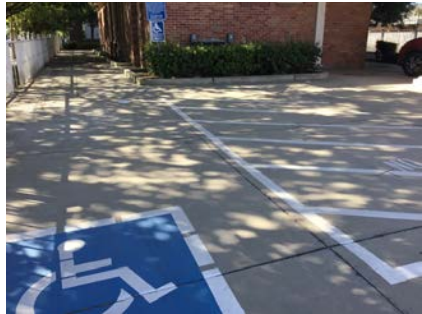
Item no., Rm no. and Name	Existing Architectural Barrier and Proposed Solution	Codes / Mitigation Info	Qty	Unit	Cost	Total
173	<ul style="list-style-type: none"> <i>As-Built Description:</i> An accessible parking space shall be outlined or painted blue (required in CA only). <i>Proposed Solution:</i> Identify accessible parking space using blue markings. 	PCODE EA04K CBC 2019 11B-502.6 Mitigated: <input type="radio"/> YES <input checked="" type="radio"/> NO	1	JOB	\$360	\$360

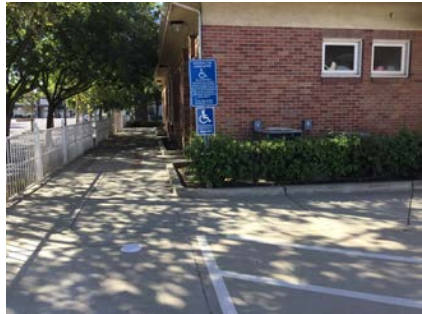
172	<ul style="list-style-type: none"> <i>As-Built Description:</i> Sign relating to parking privileges for disabled persons is non-compliant. <i>Proposed Solution:</i> Provide compliant parking signage that does not contain the word "Handicapped". Notes: 	PCODE EA04F ADA 2010 502.6 CBC 2007 VC §22511.9. CBC 2019 11B-502.6 Mitigated: <input type="radio"/> YES <input checked="" type="radio"/> NO	1	JOB	\$300	\$300

Also no fine sign.

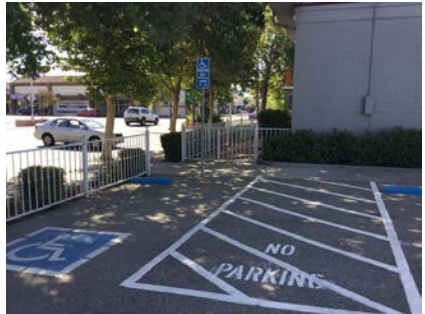
182	<ul style="list-style-type: none"> As-Built Description: Sign for accessible parking space is missing or non-compliant. Proposed Solution: Provide compliant parking signage. Notes: No van sign. 	<p>PCODE EA04B ADAAG 91 4.6.4 ADA 2010 502.6 CBC 2007 1129B.4 CBC 2019 11B-502.6</p> <p>Mitigated: <input type="radio"/> YES <input checked="" type="radio"/> NO</p>	1	JOB	\$945	\$945
-----	--	--	---	-----	-------	-------

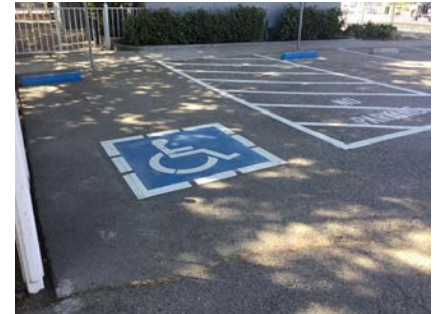
181	<ul style="list-style-type: none"> <i>As-Built Description:</i> An accessible parking space shall be outlined or painted blue (required in CA only). <i>Proposed Solution:</i> Identify accessible parking space using blue markings. 	<p>PCODE EA04K</p> <p>CBC 2019 11B-502.6</p> <p>Mitigated:</p> <p><input type="radio"/> YES</p> <p><input checked="" type="radio"/> NO</p>	1	JOB	\$360	\$360
-----	---	--	---	-----	-------	-------

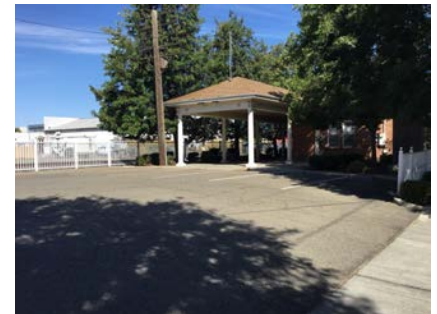
179	<ul style="list-style-type: none"> <i>As-Built Description:</i> Accessible parking space(s) not located close to the nearest possible entrance on an accessible route. <i>Proposed Solution:</i> Relocate accessible parking space(s). 	<p>PCODE EA06</p> <p>ADAAG 91 4.6.2</p> <p>ADA 2010 208.3</p> <p>CBC 2007 1129B.1</p> <p>CBC 2019 11B-208.3.1</p> <p>Mitigated:</p> <p><input type="radio"/> YES</p> <p><input checked="" type="radio"/> NO</p>	1	JOB	\$3,000	\$3,000
-----	--	---	---	-----	---------	---------

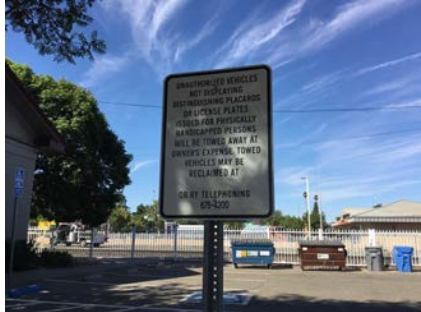
Item no., Rm no. and Name	Existing Architectural Barrier and Proposed Solution	Codes / Mitigation Info	Qty	Unit	Cost	Total
<u>Parking Signage</u>						
183	<ul style="list-style-type: none"> • <i>As-Built Description:</i> No "Tow Away" sign at parking lot entrance (required in CA only). • <i>As-Built:</i> Incomplete information. Verbiage incorrect. • <i>Proposed Solution:</i> Provide "Tow Away" sign at parking lot entrance when altering area. 	<p>PCODE EA04C</p> <p>CBC 2007 1129B.4</p> <p>CBC 2019 11B-502.8.2</p> <p>Mitigated:</p> <p><input type="radio"/> YES</p> <p><input checked="" type="radio"/> NO</p>	1	JOB	\$975	\$975

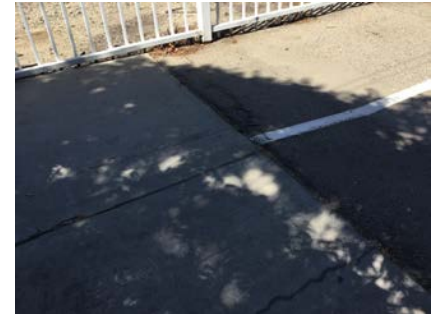
- 252
- *As-Built Description:*
Walk: Pavement dislocation creates abrupt change in level exceeding 1/2" in accessible route.
 - *As-Built:* **2.0"**
 - *Proposed Solution:*
Remove, replace or repair area of pavement sufficient to correct abrupt change in level.

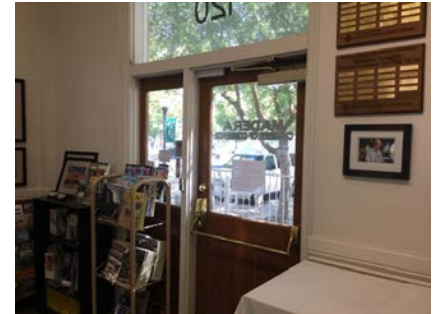
208	<ul style="list-style-type: none"> <i>As-Built Description:</i> At final exit door to exterior: Where required exit signs are installed, signs to provide exiting information for people with vision impairment are not provided. <i>Proposed Solution:</i> Provide raised letter/Braille "EXIT" sign at door. 	<p>PCODE SA10A ADAAG 91 4.1.3(16) ADA 2010 216.4.1 CBC 2007 1011.3 CBC 2019 11B-216.4.1</p> <p>Mitigated: <input type="radio"/> YES <input checked="" type="radio"/> NO</p>	4	JOB	\$270	\$1,080
-----	--	---	---	-----	-------	---------

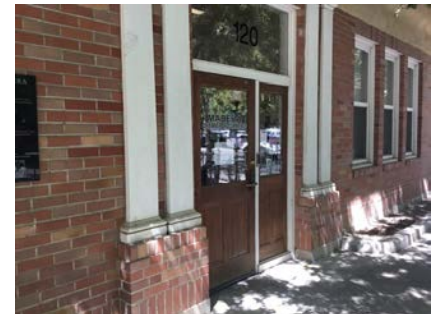
250	<ul style="list-style-type: none"> <i>As-Built Description:</i> Accessible building entrance when not all are accessible not identified with a sign showing the International Symbol of Accessibility. <i>Proposed Solution:</i> Provide building entrance sign that shows international symbol at accessible entrance. <i>Notes:</i> 	<p>PCODE SA12 ADAAG 91 4.1.2(7)(c) ADA 2010 216.6 CBC 2007 1127B.3 CBC 2019 11B-216.6</p> <p>Mitigated: <input type="radio"/> YES <input checked="" type="radio"/> NO</p>	4	JOB	\$150	\$600
-----	--	---	---	-----	-------	-------

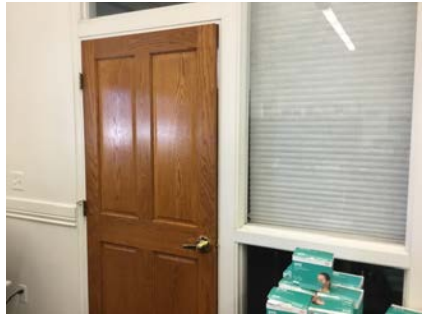
Item no., Rm no. and Name	Existing Architectural Barrier and Proposed Solution	Codes / Mitigation Info	Qty	Unit	Cost	Total
209	<ul style="list-style-type: none"> <i>As-Built Description:</i> Existing sign designating permanent room or space is noncompliant. <i>Proposed Solution:</i> Provide compliant signage. 	PCODE SA13 ADAAG 91 4.1.3(16)(a) ADA 2010 216.2 CBC 2007 1117B.5 CBC 2019 11B-216.2 Mitigated: <input type="radio"/> YES <input checked="" type="radio"/> NO	15	JOB	\$450	\$6,750

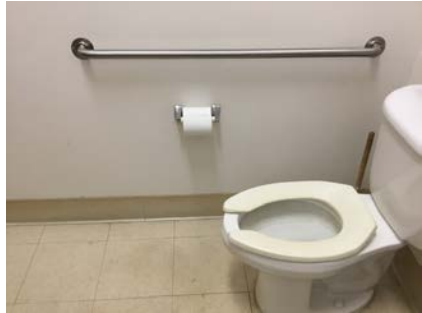
Item no., Rm no. and Name	Existing Architectural Barrier and Proposed Solution	Codes / Mitigation Info	Qty	Unit	Cost	Total
193	<ul style="list-style-type: none"> As-Built Description: Toilet paper dispenser less than 15" (CA: 19") or more than 48" above floor or not within 7" to 9" from front of water closet (Note: CA pre-2010 is allowed within 12" from front of water closet). As-Built: 4.0" in front. Proposed Solution: Relocate or provide new toilet paper dispenser. 	PCODE WG02 ADAAG 91 4.16.6 ADA 2010 604.7 CBC 2007 1115B.8.4 CBC 2019 11B-604.7 Mitigated: <input type="radio"/> YES <input checked="" type="radio"/> NO	1	JOB	\$225	\$225

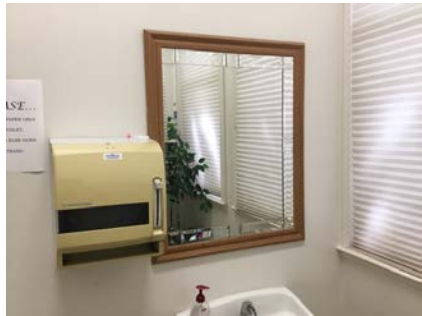
<input type="radio"/> Staff Only Priority <input checked="" type="radio"/> 3 Severity <input checked="" type="radio"/> 3			
200	<ul style="list-style-type: none"> As-Built Description: Bottom of mirror located above lavatories or countertops more than 40" above floor. As-Built: 45.7" high Proposed Solution: Relocate or provide new accessible mirror. 	PCODE WG03 ADAAG 91 4.19.6 ADA 2010 603.3 CBC 2007 1115B.8.1 CBC 2019 11B-603.3 Mitigated: <input type="radio"/> YES <input checked="" type="radio"/> NO	1	JOB	\$450	\$450

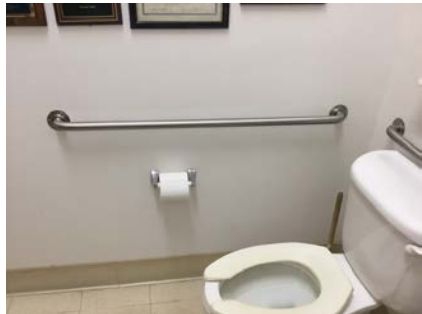
192	<ul style="list-style-type: none"> As-Built Description: Side grab bar less than 42" long, or located more than 12 inches max. from the rear wall, or extending less than 54" from rear wall (CA only: front end min. 24" in front of water closet). As-Built: Extends 49.0" Proposed Solution: Provide or relocate accessible side grab bar. 	PCODE WB07A ADAAG 91 Fig. 29(b) ADA 2010 604.5.1 CBC 2007 1115B.4.1.3.1 CBC 2019 11B-604.5.1 Mitigated: <input type="radio"/> YES <input checked="" type="radio"/> NO	1	JOB	\$780	\$780
-----	---	---	---	-----	-------	-------

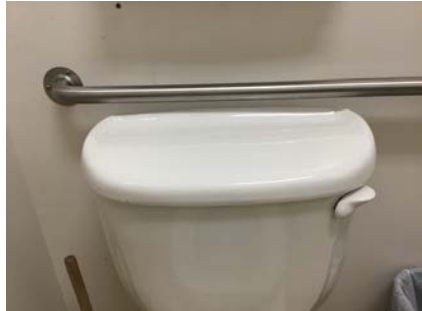
Item no., Rm no. and Name	Existing Architectural Barrier and Proposed Solution	Codes / Mitigation Info	Qty	Unit	Cost	Total
194	<ul style="list-style-type: none"> As-Built Description: Accessories/dispensers in accessible stall located closer than 1-1/2" below or 12" above grab bar impedes its use. As-Built: 0.5" below the grab bar Proposed Solution: Raise the grab bar. 	PCODE WB07I ADAAG 91 4.26.2 ADA 2010 609.3 CBC 2007 1133B.4.2.5 CBC 2019 11B-609.3 Mitigated: <input type="radio"/> YES <input checked="" type="radio"/> NO	1	JOB	\$225	\$225

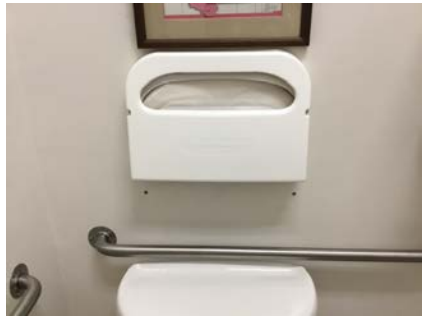
<input type="radio"/> Staff Only Priority 3 Severity 4
195	<ul style="list-style-type: none"> As-Built Description: Accessories/dispensers in accessible stall located closer than 1-1/2" below or 12" above grab bar impedes its use. As-Built: SCD: 7.7" above grab bar Proposed Solution: Relocate accessories/dispensers within applicable reach range and to be no closer than 1-1/2" below and 12" above grab bars (except if accessories are recessed, flush with wall, and have no sharp edges). 	PCODE WB07I ADAAG 91 4.26.2 ADA 2010 609.3 CBC 2007 1133B.4.2.5 CBC 2019 11B-609.3 Mitigated: <input type="radio"/> YES <input checked="" type="radio"/> NO	1	JOB	\$225	\$225

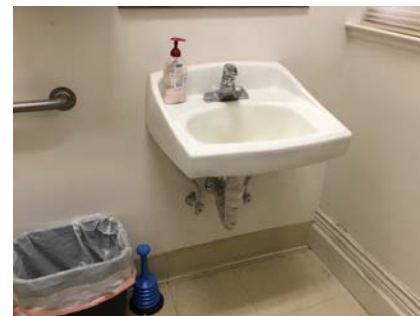
201	<ul style="list-style-type: none"> As-Built Description: Knee clearance 27" min. high starting 8" back from the front edge of the lavatory towards the wall is not provided. As-Built: 26.7" knee high Proposed Solution: Remount compliant fixture to accessible height. 	PCODE WD04A ADAAG 91 Fig. 31 ADA 2010 306.3.3 CBC 2007 1115B.4.3 CBC 2019 11B-306.3.3	1	JOB	\$3,000	\$3,000
-----	---	--	---	-----	---------	----------------

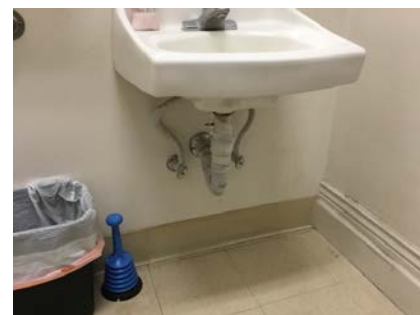
202	<ul style="list-style-type: none"> As-Built Description: Hot or sharp-surfaced water/drain pipe not insulated or covered. Proposed Solution: Insulate or cover water/drain pipe. 	PCODE WD05 ADAAG 91 4.19.4 ADA 2010 606.5 CBC 2007 1115B.4.3.4 CBC 2019 11B-606.5	1	JOB	\$360	\$360
-----	--	--	---	-----	-------	--------------

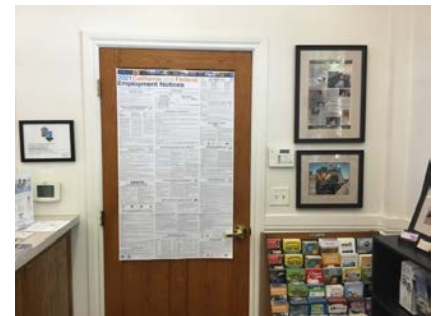
- 189
- *As-Built Description:*
Entrance to toilet or bathing facility not identified with ADAAG compliant signage.
 - *Proposed Solution:*
Provide ADA compliant sign mounted at 48" min. above to baseline of the lowest Braille cells and 60" max. to baseline of the highest line of raised characters on nearest adjacent wall, on latch side of a single door (located not to cause a Braille reader to stand within the door swing).

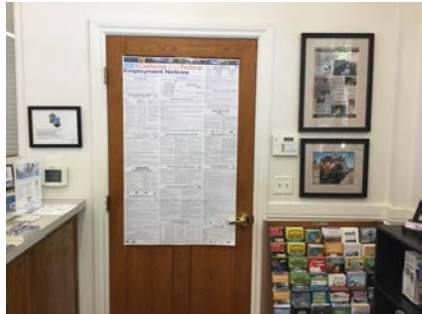
Item no., Rm no. and Name	Existing Architectural Barrier and Proposed Solution	Codes / Mitigation Info	Qty	Unit	Cost	Total
190	<ul style="list-style-type: none"> <i>As-Built Description:</i> Required in CA only: identification symbol centered 58" to 60" high on sanitary facility door that contrasts with the door not provided (women: 12" ø circle, men: 12" triangle, unisex: combined symbol). <i>Proposed Solution:</i> Provide properly mounted sanitary facility symbol when altering area. If wheelchair accessible, include International Symbol of Accessibility on sign. 	PCODE SA15 CBC 2007 1115B.6 CBC 2019 11B-703.7.2.6 Mitigated: <input type="radio"/> YES <input checked="" type="radio"/> NO	1	JOB	\$270	\$270

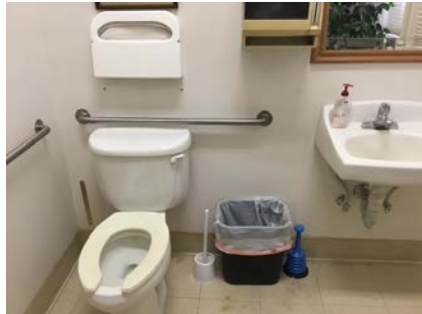
199	<ul style="list-style-type: none"> <i>As-Built Description:</i> 60" min. clearance around a water closet measured perpendicular from the side wall not provided (Fixtures are not allowed to overlap this clearance). <i>As-Built:</i> 51.0" to lavatory <i>Proposed Solution:</i> Relocate adjacent fixture and remodel restroom as needed. <i>Notes:</i> 	PCODE WB01A ADA 2010 604.3.1; 604.3.2 CBC 2007 1115B.7.1.3 CBC 2019 11B-604.3.1; 11B-604.3.2 Mitigated: <input type="radio"/> YES <input checked="" type="radio"/> NO	1	JOB	\$6,000	\$6,000
-----	---	--	---	-----	---------	---------

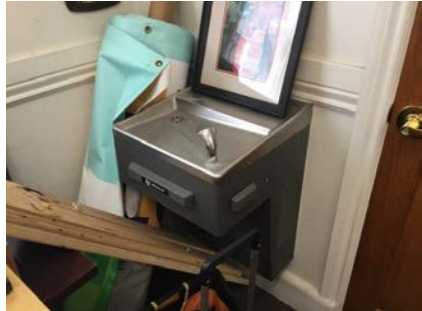
Item no., Rm no. and Name	Existing Architectural Barrier and Proposed Solution	Codes / Mitigation Info	Qty	Unit	Cost	Total
204	<ul style="list-style-type: none"> As-Built Description: Wall- and post-mounted cantilevered units: Knee space not provided at drinking fountain (27" high, 8" deep, 30" wide from front of drinking fountain). Unit in good condition. As-Built: 26.0" knee high Proposed Solution: Remount fountain at accessible height. 	PCODE IA02A ADAAG 91 4.15.5(1) ADA 2010 602.2 CBC 2007 1115B.4.6.2 CBC 2019 11B-602.2 Mitigated: <input type="radio"/> YES <input checked="" type="radio"/> NO	1	JOB	\$1,500	\$1,500

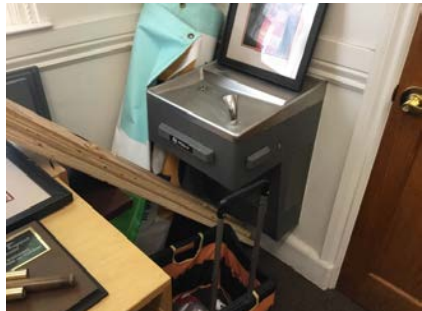
<input type="radio"/> Staff Only						
Priority 4						
Severity 2						
206	<ul style="list-style-type: none"> As-Built Description: Drinking fountain lacks protection for visually impaired persons. Proposed Solution: Provide cane-detectable rails. 	PCODE IA05C ADAAG 91 4.4.1 ADA 2010 307.2 CBC 2007 1115B.4.6.3 CBC 2019 11B-307.2 Mitigated: <input type="radio"/> YES <input checked="" type="radio"/> NO	1	JOB	\$1,500	\$1,500

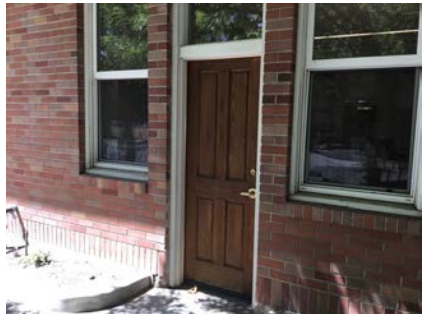
249	<ul style="list-style-type: none"> As-Built Description: Exterior signage at inaccessible entrances to provide direction to accessible entrances is missing or noncompliant. Proposed Solution: Provide signage sufficient to guide persons to accessible entrances. 	PCODE SA01 ADAAG 91 4.1.2(7)(c) ADA 2010 216.6 CBC 2007 1117B.5.8.1.2 CBC 2019 11B-216.6 Mitigated: <input type="radio"/> YES <input checked="" type="radio"/> NO	2	JOB	\$690	\$1,380
-----	--	--	---	-----	-------	---------

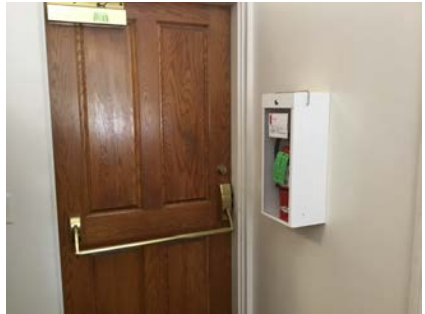
Exit door.

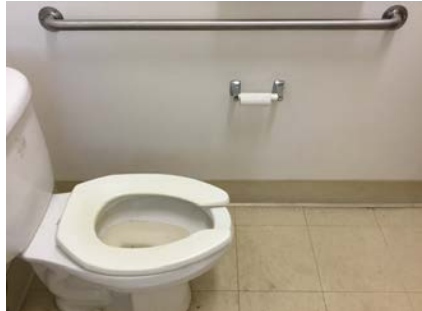
Item no., Rm no. and Name	Existing Architectural Barrier and Proposed Solution	Codes / Mitigation Info	Qty	Unit	Cost	Total
223	<ul style="list-style-type: none"> As-Built Description: Toilet paper dispenser less than 15" (CA: 19") or more than 48" above floor or not within 7" to 9" from front of water closet (Note: CA pre-2010 is allowed within 12" from front of water closet). As-Built: 4.0" in front. Proposed Solution: Relocate or provide new toilet paper dispenser. 	PCODE WG02 ADAAG 91 4.16.6 ADA 2010 604.7 CBC 2007 1115B.8.4 CBC 2019 11B-604.7 Mitigated: <input type="radio"/> YES <input checked="" type="radio"/> NO	1	JOB	\$225	\$225

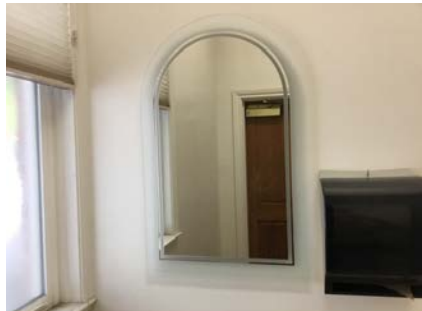
<input checked="" type="checkbox"/> Staff Only Priority 3 Severity 3			
228	<ul style="list-style-type: none"> As-Built Description: Bottom of mirror located above lavatories or countertops more than 40" above floor. As-Built: 48.0" high Proposed Solution: Relocate or provide new accessible mirror. 	PCODE WG03 ADAAG 91 4.19.6 ADA 2010 603.3 CBC 2007 1115B.8.1 CBC 2019 11B-603.3 Mitigated: <input type="radio"/> YES <input checked="" type="radio"/> NO	1	JOB	\$450	\$450

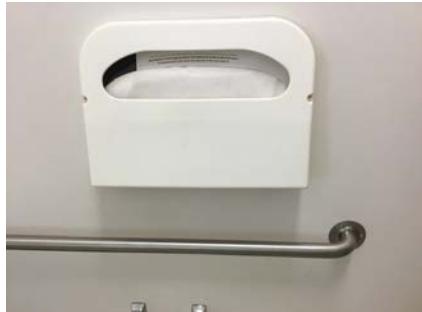
Item no., Rm no. and Name	Existing Architectural Barrier and Proposed Solution	Codes / Mitigation Info	Qty	Unit	Cost	Total
222	<ul style="list-style-type: none"> As-Built Description: Accessories/dispensers in accessible stall located closer than 1-1/2" below or 12" above grab bar impedes its use. As-Built: SCD: 5.0" above grab bar Proposed Solution: Relocate accessories/dispensers within applicable reach range and to be no closer than 1-1/2" below and 12" above grab bars (except if accessories are recessed, flush with wall, and have no sharp edges). 	PCODE WB07I ADAAG 91 4.26.2 ADA 2010 609.3 CBC 2007 1133B.4.2.5 CBC 2019 11B-609.3 Mitigated: <input type="radio"/> YES <input checked="" type="radio"/> NO	1	JOB	\$225	\$225

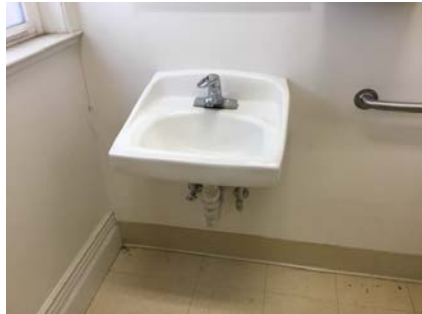
Lavatory

229	<ul style="list-style-type: none"> As-Built Description: Knee clearance 27" min. high starting 8" back from the front edge of the lavatory towards the wall is not provided. As-Built: 26.6" knee high Proposed Solution: Remount compliant fixture to accessible height. 	PCODE WD04A ADAAG 91 Fig. 31 ADA 2010 306.3.3 CBC 2007 1115B.4.3 CBC 2019 11B-306.3.3 Mitigated: <input type="radio"/> YES <input checked="" type="radio"/> NO	1	JOB	\$3,000	\$3,000

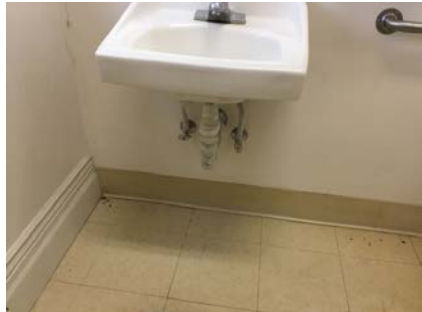
Item no., Rm no. and Name	Existing Architectural Barrier and Proposed Solution	Codes / Mitigation Info	Qty	Unit	Cost	Total
230	<ul style="list-style-type: none"> <i>As-Built Description:</i> Hot or sharp-surfaced water/drain pipe not insulated or covered. <i>Proposed Solution:</i> Insulate or cover water/drain pipe. 	PCODE WD05 ADAAG 91 4.19.4 ADA 2010 606.5 CBC 2007 1115B.4.3.4 CBC 2019 11B-606.5 Mitigated: <input type="radio"/> YES <input checked="" type="radio"/> NO	1	JOB	\$360	\$360

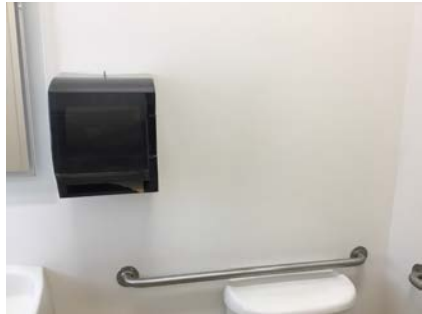
Protrusion Limits

226	<ul style="list-style-type: none"> <i>As-Built Description:</i> Protruding objects more than 4" from wall, when bottom of object more than 27" or less than 80" above finished floor. <i>Proposed Solution:</i> Remove/relocate protruding object. Patch existing surface. 	PCODE EG04 ADAAG 91 4.4.1 ADA 2010 307.2 CBC 2007 1133B.8.6.1 CBC 2019 11B-307.2 Mitigated: <input type="radio"/> YES <input checked="" type="radio"/> NO	1	JOB	\$300	\$300

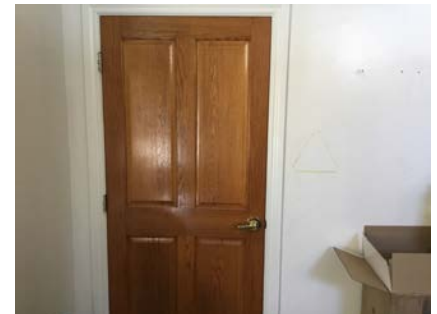
219	<ul style="list-style-type: none"> <i>As-Built Description:</i> Required in CA only: identification symbol centered 58" to 60" high on sanitary facility door that contrasts with the door not provided (women: 12" ø circle, men: 12" triangle, unisex: combined symbol). <i>Proposed Solution:</i> Provide properly mounted sanitary facility symbol when altering area. If wheelchair accessible, include International Symbol of Accessibility on sign. 	PCODE SA15 CBC 2007 1115B.6 CBC 2019 11B-703.7.2.6	1	JOB	\$270	\$270
-----	---	--	---	-----	-------	-------

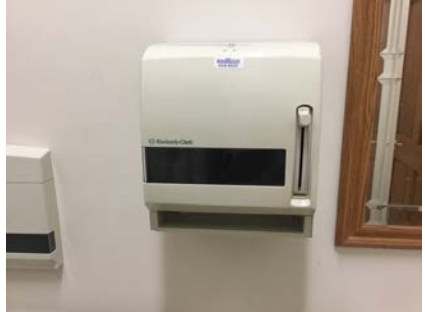
Accessories

236	<ul style="list-style-type: none"> <i>As-Built Description:</i> Dispensers in sanitary facilities, such as for towels, soap, sanitary napkins, seat covers, etc., and waste receptacles more than 48" (CA only: 40") from floor to highest operating slot or control. <i>As-Built:</i> PTD: 56.0" high <i>Proposed Solution:</i> Relocate existing restroom accessories. 	<p>PCODE WG01A ADAAG 91 4.23.7 ADA 2010 308.2.1 CBC 2007 1115B.8.3 CBC 2019 11B-603.5</p> <p>Mitigated: <input type="radio"/> YES <input checked="" type="radio"/> NO</p>	1	JOB	\$300	\$300
-----	--	--	---	-----	-------	--------------

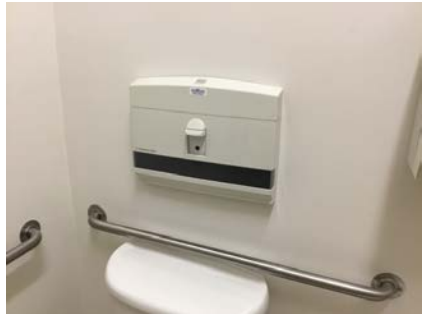
237	<ul style="list-style-type: none"> <i>As-Built Description:</i> Dispensers in sanitary facilities, such as for towels, soap, sanitary napkins, seat covers, etc., and waste receptacles more than 48" (CA only: 40") from floor to highest operating slot or control. <i>As-Built:</i> SCD: 48.0" high <i>Proposed Solution:</i> Relocate existing restroom accessories. 	<p>PCODE WG01A ADAAG 91 4.23.7 ADA 2010 308.2.1 CBC 2007 1115B.8.3 CBC 2019 11B-603.5</p> <p>Mitigated: <input type="radio"/> YES <input checked="" type="radio"/> NO</p>	1	JOB	\$300	\$300
-----	--	--	---	-----	-------	--------------

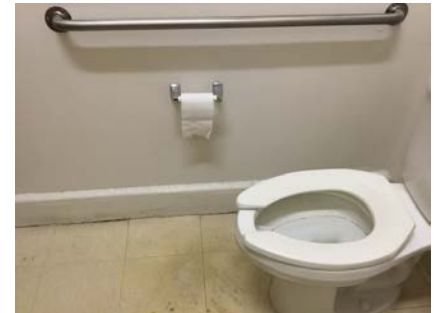
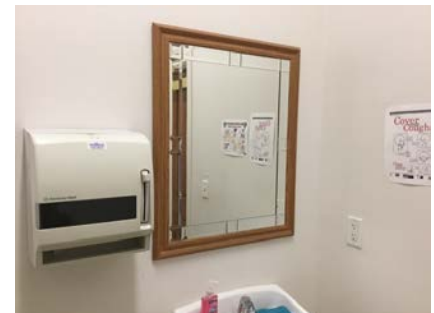
Item no., Rm no. and Name	Existing Architectural Barrier and Proposed Solution	Codes / Mitigation Info	Qty	Unit	Cost	Total
244	<ul style="list-style-type: none"> As-Built Description: Toilet paper dispenser less than 15" (CA: 19") or more than 48" above floor or not within 7" to 9" from front of water closet (Note: CA pre-2010 is allowed within 12" from front of water closet). As-Built: 4.0" in front Proposed Solution: Relocate or provide new toilet paper dispenser. 	PCODE WG02 ADAAG 91 4.16.6 ADA 2010 604.7 CBC 2007 1115B.8.4 CBC 2019 11B-604.7 Mitigated: <input type="radio"/> YES <input checked="" type="radio"/> NO	1	JOB	\$225	\$225
			<input type="radio"/> Staff Only Priority 3 Severity 3			
241	<ul style="list-style-type: none"> As-Built Description: Bottom of mirror located above lavatories or countertops more than 40" above floor. As-Built: 46.2" high Proposed Solution: Relocate or provide new accessible mirror. 	PCODE WG03 ADAAG 91 4.19.6 ADA 2010 603.3 CBC 2007 1115B.8.1 CBC 2019 11B-603.3 Mitigated: <input type="radio"/> YES <input checked="" type="radio"/> NO	1	JOB	\$450	\$450

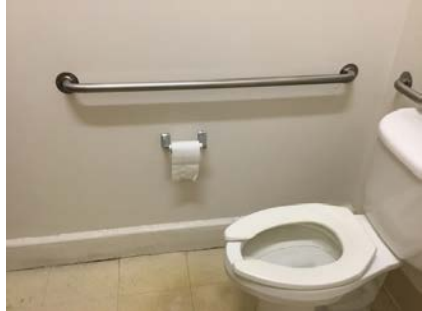
Grab Bars

<p>243</p> <ul style="list-style-type: none"> <i>As-Built Description:</i> Side grab bar less than 42" long, or located more than 12 inches max. from the rear wall, or extending less than 54" from rear wall (CA only: front end min. 24" in front of water closet). <i>As-Built:</i> Extends 49.0" <i>Proposed Solution:</i> Provide or relocate accessible side grab bar. 	<p><i>PCODE</i> WB07A <i>ADAAG 91</i> Fig. 29(b) <i>ADA 2010</i> 604.5.1 <i>CBC 2007</i> 1115B.4.1.3.1 <i>CBC 2019</i> 11B-604.5.1</p> <p>Mitigated: <input type="radio"/> YES <input checked="" type="radio"/> NO</p>	<p>1 JOB \$780 \$780</p>

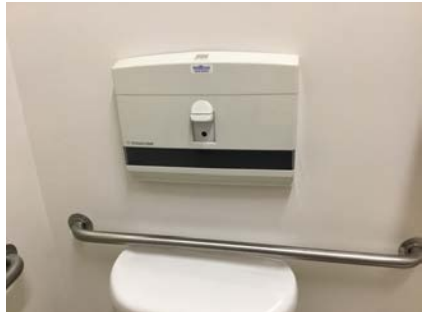
<p>240</p> <ul style="list-style-type: none"> <i>As-Built Description:</i> Accessories/dispensers in accessible stall located closer than 1-1/2" below or 12" above grab bar impedes its use. <i>As-Built:</i> SCD: 6.5" above grab bar <i>Proposed Solution:</i> Relocate accessories/dispensers within applicable reach range and to be no closer than 1-1/2" below and 12" above grab bars (except if accessories are recessed, flush with wall, and have no sharp edges). 	<p><i>PCODE</i> WB07I <i>ADAAG 91</i> 4.26.2 <i>ADA 2010</i> 609.3 <i>CBC 2007</i> 1133B.4.2.5 <i>CBC 2019</i> 11B-609.3</p> <p>Mitigated: <input type="radio"/> YES <input checked="" type="radio"/> NO</p>	<p>1 JOB \$225 \$225</p>

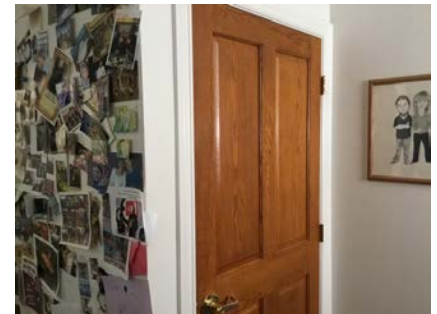
235	<ul style="list-style-type: none"> <i>As-Built Description:</i> Required in CA only: identification symbol centered 58" to 60" high on sanitary facility door that contrasts with the door not provided (women: 12" ø circle, men: 12" triangle, unisex: combined symbol). <i>Proposed Solution:</i> Provide properly mounted sanitary facility symbol when altering area. If wheelchair accessible, include International Symbol of Accessibility on sign. 	PCODE SA15 CBC 2007 1115B.6 CBC 2019 11B-703.7.2.6	1	JOB	\$270	\$270
-----	---	--	---	-----	-------	-------

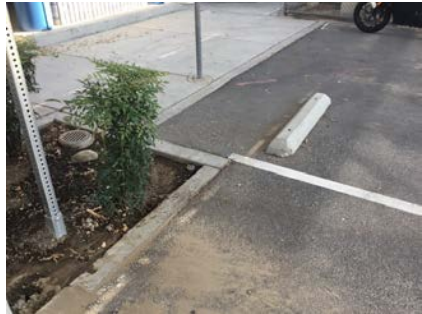
Item no., Rm no. and Name	Existing Architectural Barrier and Proposed Solution	Codes / Mitigation Info	Qty	Unit	Cost	Total
1535	<ul style="list-style-type: none"> As-Built Description: 36" wide band of truncated domes not provided at walkway or crossing adjoining a vehicular way, if surfaces are not separated by a curb, railing, or other element. Proposed Solution: Provide 36" wide, contrasting color, band of truncated domes between pedestrian and vehicular area. 	PCODE EG09 ADAAG 91 4.29.5 CBC 2007 1133B.8.5 CBC 2019 11B-705.1.2.5 Mitigated: <input type="radio"/> YES <input checked="" type="radio"/> NO	50	LF	\$81	\$4,050

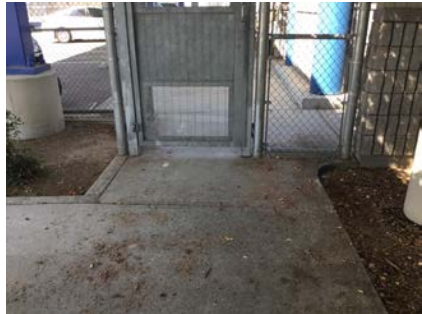
Door

1529	<ul style="list-style-type: none"> As-Built Description: At push side of door on accessible route, bottom 10" does not have a smooth, uninterrupted surface. Proposed Solution: Provide 10" min. "kick plate" covering width of door when altering area. 	PCODE ID06 ADA 2010 404.2.10 CBC 2007 1133B.2.6 CBC 2019 11B-404.2.10 Mitigated: <input type="radio"/> YES <input checked="" type="radio"/> NO	1	JOB	\$300	\$300

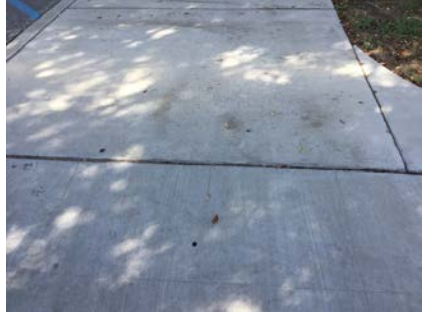
Floor or Ground Surface

<p>1528</p> <ul style="list-style-type: none"> As-Built Description: Walk: Grating has grid openings greater than 1/2" along the line of traffic flow. As-Built: Gaps 1.0" x 1.0" Proposed Solution: Fill gaps. 	<p>PCODE EF04 ADAAG 91 4.3.6; 4.5.4 ADA 2010 403.2; 302.3 CBC 2007 1133B.7.2 CBC 2019 11B-403.2; 11B-302.3</p> <p>Mitigated: <input type="radio"/> YES <input checked="" type="radio"/> NO</p>	<p>10 LF \$240 \$2,400</p>

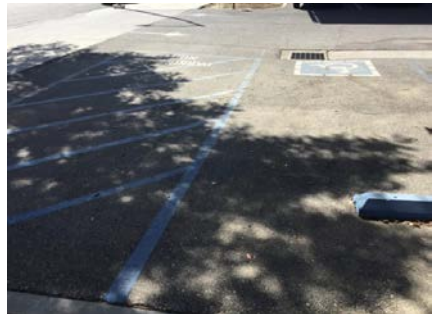
Floor or Ground Surfaces

<p>1524</p> <ul style="list-style-type: none"> As-Built Description: Accessible parking space has slope greater than 1/4":12" (2%). As-Built: Up to 5.0% Proposed Solution: Modify slope at accessible parking space. 	<p>PCODE EA05 ADAAG 91 4.6.3 ADA 2010 502.4 CBC 2007 1129B.3.3 CBC 2019 11B-502.4</p> <p>Mitigated: <input type="radio"/> YES <input checked="" type="radio"/> NO</p>	<p>300 SF \$36 \$10,800</p>

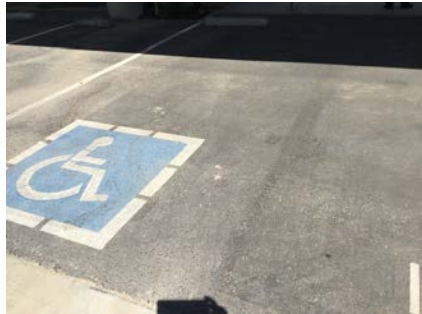
Item no., Rm no. and Name	Existing Architectural Barrier and Proposed Solution	Codes / Mitigation Info	Qty	Unit	Cost	Total
1530	<ul style="list-style-type: none"> As-Built Description: Accessible parking space has slope greater than 1/4":12" (2%). As-Built: 2.5% Proposed Solution: Modify slope at accessible parking space. 	PCODE EA05 ADAAG 91 4.6.3 ADA 2010 502.4 CBC 2007 1129B.3.3 CBC 2019 11B-502.4 Mitigated: <input type="radio"/> YES <input checked="" type="radio"/> NO	60	SF	\$36	\$2,160

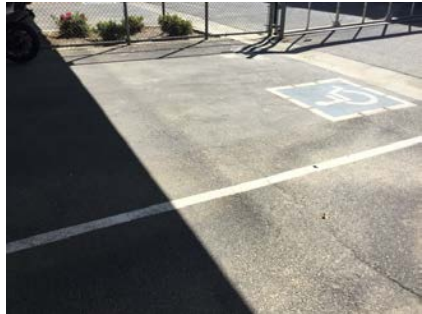
Parking

1534	<ul style="list-style-type: none"> As-Built Description: Accessible parking space does not have 5' wide access aisle; 8' wide for van accessible aisle. As-Built: Space and aisle together are 16.0' wide. Proposed Solution: Modify parking aisle(s) to create accessible space by restriping. 	PCODE EA02B ADAAG 91 4.6.3 ADA 2010 502.3 CBC 2007 1129B.3.1 CBC 2019 11B-502.2; 11B-502.3.1 Mitigated: <input type="radio"/> YES <input checked="" type="radio"/> NO	1	JOB	\$600	\$600

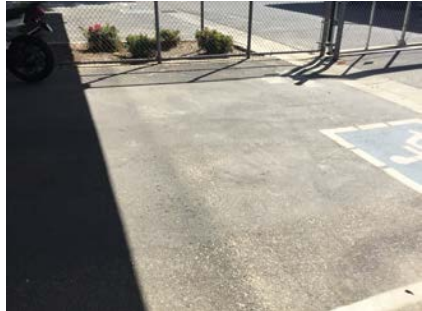
Item no., Rm no. and Name	Existing Architectural Barrier and Proposed Solution	Codes / Mitigation Info	Qty	Unit	Cost	Total
1531	<ul style="list-style-type: none"> <i>As-Built Description:</i> An accessible parking space shall be outlined or painted blue (required in CA only). <i>Proposed Solution:</i> Identify accessible parking space using blue markings. 	PCODE EA04K CBC 2019 11B-502.6 Mitigated: <input type="radio"/> YES <input checked="" type="radio"/> NO	1	JOB	\$360	\$360

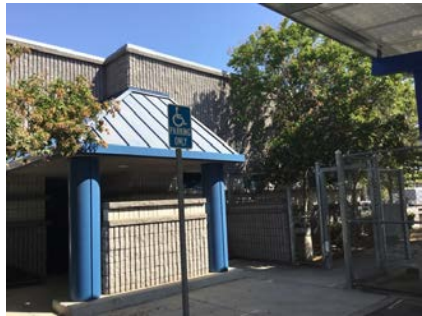
<input checked="" type="checkbox"/> Staff Only			
			Priority 1			
			Severity 3			
1533	<ul style="list-style-type: none"> <i>As-Built Description:</i> No van parking provided (one in every 6 or fraction of 6 accessible spaces, but not less than one). <i>Proposed Solution:</i> Provide van parking space(s) by restriping; provide van sign. 	PCODE EA07 ADAAG 91 4.1.2(5)(b) ADA 2010 208.2; 502.1 CBC 2007 1129B.3.2 CBC 2019 11B-208.2.4 Mitigated: <input type="radio"/> YES <input checked="" type="radio"/> NO	1	JOB	\$1,050	\$1,050

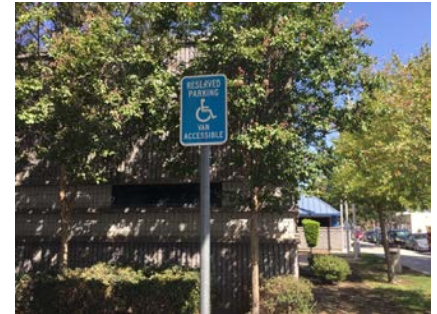
Parking Signage

1526	<ul style="list-style-type: none"> <i>As-Built Description:</i> No "Tow Away" sign at parking lot entrance (required in CA only). <i>Proposed Solution:</i> Provide "Tow Away" sign at parking lot entrance when altering area. 	<p>PCODE EA04C</p> <p>CBC 2007 1129B.4</p> <p>CBC 2019 11B-502.8.2</p> <p>Mitigated:</p> <p><input type="radio"/> YES</p> <p><input checked="" type="radio"/> NO</p>	1	JOB	\$975	\$975
------	---	--	---	-----	-------	-------

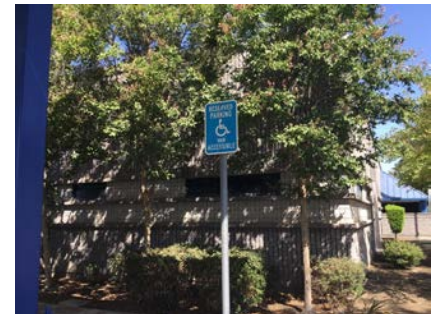
1525	<ul style="list-style-type: none"> <i>As-Built Description:</i> CA only: Additional Sign or additional language below the symbol of accessibility stating "Minimum Fine \$250" not provided. <i>Proposed Solution:</i> Provide compliant parking signage that includes fine information. 	<p>PCODE EA04G</p> <p>CBC 2007 1129B.4</p> <p>CBC 2019 11B-502.6.2</p> <p>Mitigated:</p> <p><input type="radio"/> YES</p> <p><input checked="" type="radio"/> NO</p>	1	JOB	\$300	\$300
------	--	--	---	-----	-------	-------

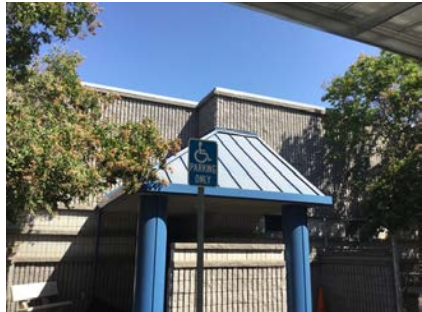
Item no., Rm no. and Name	Existing Architectural Barrier and Proposed Solution	Codes / Mitigation Info	Qty	Unit	Cost	Total
1532	<ul style="list-style-type: none"> <i>As-Built Description:</i> CA only: Additional Sign or additional language below the symbol of accessibility stating "Minimum Fine \$250" not provided. <i>Proposed Solution:</i> Provide compliant parking signage that includes fine information. 	PCODE EA04G CBC 2007 1129B.4 CBC 2019 11B-502.6.2 Mitigated: <input type="radio"/> YES <input checked="" type="radio"/> NO	1	JOB	\$300	\$300

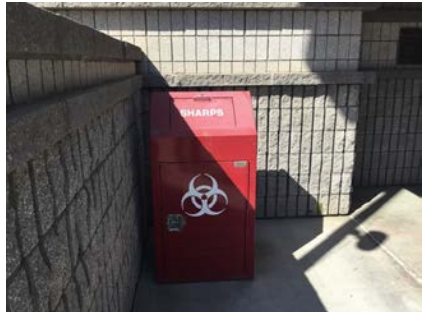
1523	<ul style="list-style-type: none"> <i>As-Built Description:</i> Reach height to control or access point, where side approach is available, exceeds 48" or is less than 15" in height, or exceeds 10" in depth. <i>As-Built:</i> 49.5" high <i>Proposed Solution:</i> Modify equipment or mounting. <i>Notes:</i> 	PCODE IE02 ADAAG 91 4.2.6 ADA 2010 308.3.1 CBC 2007 1118B.6 CBC 2019 11B-308.3 Mitigated: <input type="radio"/> YES <input checked="" type="radio"/> NO	1	JOB	\$300	\$300

This element complied with Safe Harbor and the CBC if altered or constructed before March 15, 2012.

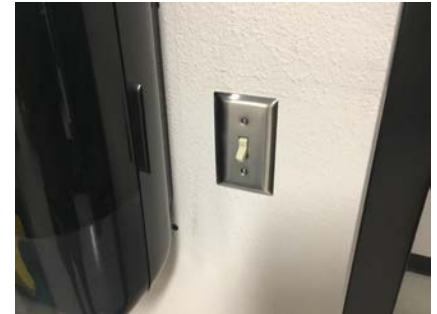
1477	<ul style="list-style-type: none"> <i>As-Built Description:</i> Electric switch or control mounted less than 15" measured to the bottom of the outlet box or greater than 48 inches measured to the top of the outlet box. <i>As-Built:</i> 48.25" high 50.0" to top of box <i>Proposed Solution:</i> Relocate light switches or control to between 15" and 48" height. <i>Notes:</i> 	<p>PCODE IC01 ADAAG 91 4.2.5 & 6 ADA 2010 308.2.1 & 308.2.2 CBC 2007 1117B.6.3 CBC 2019 11B-308.2.1 & 11B-308.2.2</p> <p>Mitigated: <input type="radio"/> YES <input checked="" type="radio"/> NO</p>	30	JOB	\$900	\$27,000
------	---	---	----	-----	-------	----------

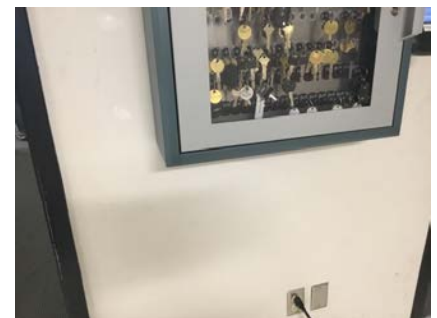
1468	<ul style="list-style-type: none"> <i>As-Built Description:</i> Protruding objects more than 4" from wall, when bottom of object more than 27" or less than 80" above finished floor. <i>As-Built:</i> Key cabinet: 8.0" at 45.0" high <i>Proposed Solution:</i> Remove/relocate protruding object. Patch existing surface. <i>Notes:</i> 	<p>PCODE EG04 ADAAG 91 4.4.1 ADA 2010 307.2 CBC 2007 1133B.8.6.1 CBC 2019 11B-307.2</p> <p>Mitigated: <input type="radio"/> YES <input checked="" type="radio"/> NO</p>	1	JOB	\$300	\$300
------	--	---	---	-----	-------	-------

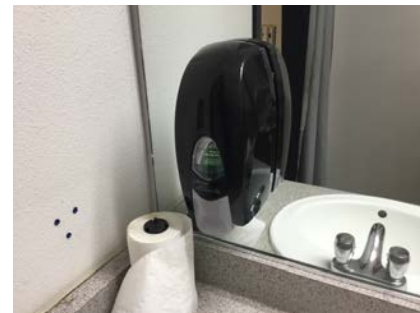
1443	<ul style="list-style-type: none"> As-Built Description: Dispensers in sanitary facilities, such as for towels, soap, sanitary napkins, seat covers, etc., and waste receptacles more than 48" (CA only: 40") from floor to highest operating slot or control. As-Built: Shower room SD: 42.0" high Proposed Solution: Relocate existing restroom accessories. Notes: 	PCODE WG01A ADAAG 91 4.23.7 ADA 2010 308.2.1 CBC 2007 1115B.8.3 CBC 2019 11B-603.5 Mitigated: <input type="radio"/> YES <input checked="" type="radio"/> NO	1	JOB	\$300	\$300
------	--	--	---	-----	-------	-------

If 48" maximum AFF, this element complies with 1991 ADAAG and the 2010 ADAS. If 54" maximum AFF side reach, this element complies with Safe Harbor if constructed or altered before March 15, 2012. This element does not comply with the dimensional requirements in the 1981 to the current CBC.

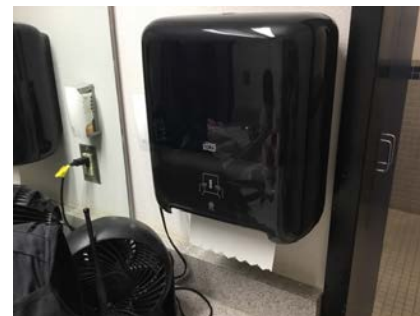
1444	<ul style="list-style-type: none"> As-Built Description: Dispensers in sanitary facilities, such as for towels, soap, sanitary napkins, seat covers, etc., and waste receptacles more than 48" (CA only: 40") from floor to highest operating slot or control. As-Built: Shower room PTD: 45.0" high Proposed Solution: Relocate existing restroom accessories. Notes: 	PCODE WG01A ADAAG 91 4.23.7 ADA 2010 308.2.1 CBC 2007 1115B.8.3 CBC 2019 11B-603.5 Mitigated: <input type="radio"/> YES <input checked="" type="radio"/> NO	1	JOB	\$300	\$300
------	---	--	---	-----	-------	-------

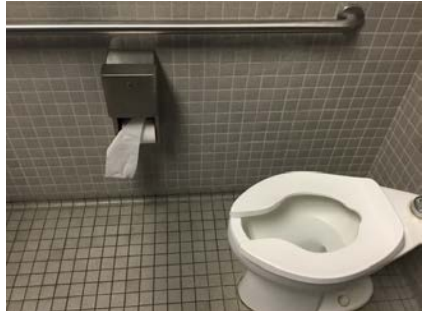
Item no., Rm no. and Name	Existing Architectural Barrier and Proposed Solution	Codes / Mitigation Info	Qty	Unit	Cost	Total
1435	<ul style="list-style-type: none"> As-Built Description: Toilet paper dispenser less than 15" (CA: 19") or more than 48" above floor or not within 7" to 9" from front of water closet (Note: CA pre-2010 is allowed within 12" from front of water closet). As-Built: 10.0" in front. Proposed Solution: Relocate or provide new toilet paper dispenser. 	PCODE WG02 ADAAG 91 4.16.6 ADA 2010 604.7 CBC 2007 1115B.8.4 CBC 2019 11B-604.7 Mitigated: <input type="radio"/> YES <input checked="" type="radio"/> NO	1	JOB	\$225	\$225

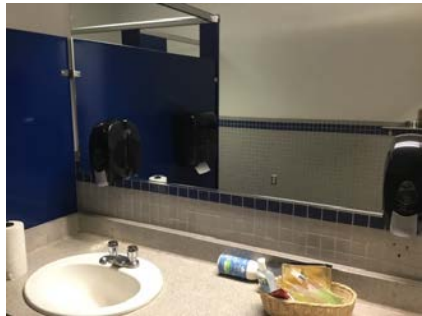
<input checked="" type="checkbox"/> Staff Only			
			Priority 3			
			Severity 4			
1429	<ul style="list-style-type: none"> As-Built Description: Bottom of mirror located above lavatories or countertops more than 40" above floor. As-Built: 45.5" high Proposed Solution: Relocate or provide new accessible mirror. 	PCODE WG03 ADAAG 91 4.19.6 ADA 2010 603.3 CBC 2007 1115B.8.1 CBC 2019 11B-603.3 Mitigated: <input type="radio"/> YES <input checked="" type="radio"/> NO	1	JOB	\$450	\$450

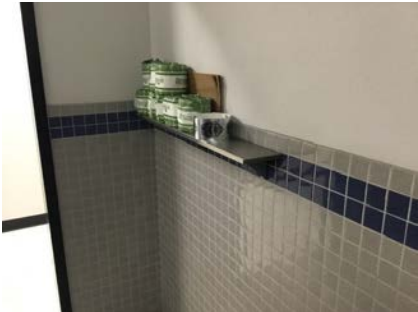
Item no., Rm no. and Name	Existing Architectural Barrier and Proposed Solution	Codes / Mitigation Info	Qty	Unit	Cost	Total
1436	<ul style="list-style-type: none"> • <i>As-Built Description:</i> Protruding objects more than 4" from wall, when bottom of object more than 27" or less than 80" above finished floor. • <i>As-Built:</i> Shelf: 5.0" at 47.0" high • <i>Proposed Solution:</i> Remove/relocate protruding object. Patch existing surface. 	PCODE EG04 ADAAG 91 4.4.1 ADA 2010 307.2 CBC 2007 1133B.8.6.1 CBC 2019 11B-307.2 Mitigated: <input type="radio"/> YES <input checked="" type="radio"/> NO	1	JOB	\$300	\$300

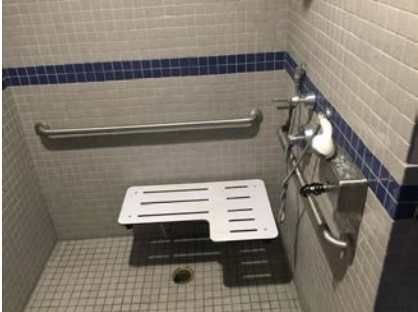
1440	<ul style="list-style-type: none"> • <i>As-Built Description:</i> Shower not accessible; multiple compliance violations. • <i>Proposed Solution:</i> Provide accessible shower. • <i>Notes:</i> 	PCODE WF01 ADAAG 91 4.21 ADA 2010 608.1 CBC 2019 11B-608.1 Mitigated: <input type="radio"/> YES <input checked="" type="radio"/> NO	1	JOB	\$12,000	\$12,000

Incorrect configuration.

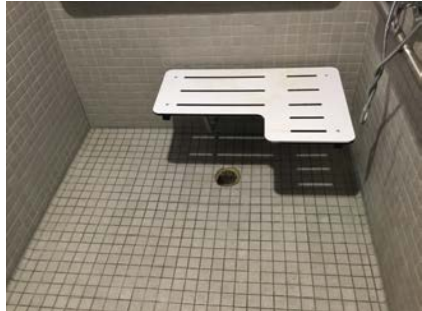
Item no., Rm no. and Name	Existing Architectural Barrier and Proposed Solution	Codes / Mitigation Info	Qty	Unit	Cost	Total
1438	<ul style="list-style-type: none"> As-Built Description: Floor surface sloped greater than 2.0% (1:48) due to drain. As-Built: 4.0% Proposed Solution: Remodel floor surface to compliance. 	PCODE WF06A ADA 2010 608.9 CBC 2019 11B-608.9 Mitigated: <input type="radio"/> YES <input checked="" type="radio"/> NO	1	JOB	\$1,500	\$1,500

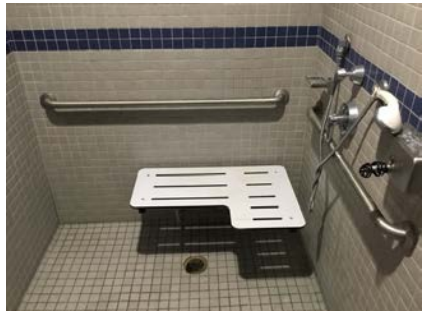
<input checked="" type="checkbox"/> Staff Only			
			Priority 3			
			Severity 3			
1439	<ul style="list-style-type: none"> As-Built Description: ADAAG: L-shaped shower seat extending the full depth of the stall does not have a seat located 1-1/2" max. from the wall and/or have the front of the seat (nearest to the opening) extend 16" max. from the wall. The back of the seat (against the back wall) shall extend 23" max. from the side wall and shall be 15" max. deep. As-Built: 4.5" from wall and below grab bar. Proposed Solution: Provide new, or relocate, folding wall-mounted shower seat. 	PCODE WF07AREF ADAAG 91 4.21.3 ADA 2010 610.3.2 CBC 2007 1115B.4.4.8.1 CBC 2019 11B-610.3.2 Mitigated: <input type="radio"/> YES <input checked="" type="radio"/> NO	1	JOB	\$1,650	\$1,650

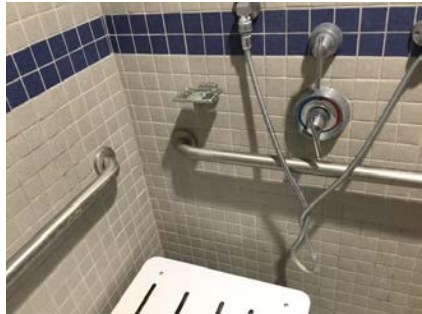
Item no., Rm no. and Name	Existing Architectural Barrier and Proposed Solution	Codes / Mitigation Info	Qty	Unit	Cost	Total
1441	<ul style="list-style-type: none"> <i>As-Built Description:</i> Grab bar not mounted between 33" to 36" above the shower floor. <i>Proposed Solution:</i> Remount grab bar in shower. <i>Notes:</i> 	PCODE WF08 ADAAG 91 Fig. 37(a) ADA 2010 608.3 CBC 2007 1115B.4.4.8.2 CBC 2019 11B-608.3 Mitigated: <input type="radio"/> YES <input checked="" type="radio"/> NO	1	JOB	\$1,500	\$1,500

Grab bar 6.2" from wall.

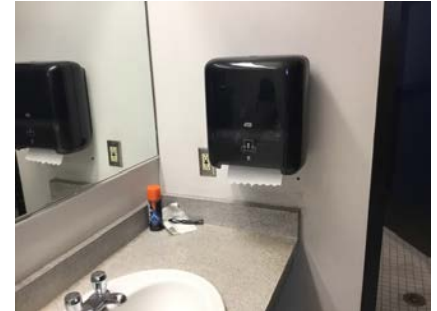
Item no., Rm no. and Name	Existing Architectural Barrier and Proposed Solution	Codes / Mitigation Info	Qty	Unit	Cost	Total
1449	<ul style="list-style-type: none"> As-Built Description: Dispensers in sanitary facilities, such as for towels, soap, sanitary napkins, seat covers, etc., and waste receptacles more than 48" (CA only: 40") from floor to highest operating slot or control. As-Built: PTD: 45.0" high Proposed Solution: Relocate existing restroom accessories. Notes: 	PCODE WG01A ADAAG 91 4.23.7 ADA 2010 308.2.1 CBC 2007 1115B.8.3 CBC 2019 11B-603.5 Mitigated: <input type="radio"/> YES <input checked="" type="radio"/> NO	1	JOB	\$300	\$300

If 48" maximum AFF, this element complies with 1991 ADAAG and the 2010 ADAS. If 54" maximum AFF side reach, this element complies with Safe Harbor if constructed or altered before March 15, 2012. This element does not comply with the dimensional requirements in the 1981 to the current CBC.

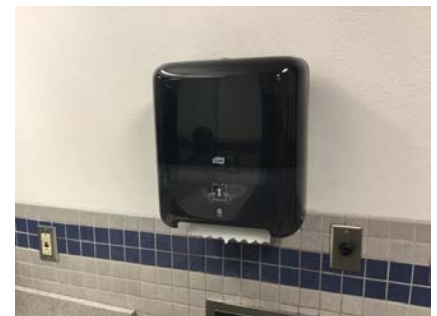
1457	<ul style="list-style-type: none"> As-Built Description: Dispensers in sanitary facilities, such as for towels, soap, sanitary napkins, seat covers, etc., and waste receptacles more than 48" (CA only: 40") from floor to highest operating slot or control. As-Built: PTD: 51.0" high Proposed Solution: Relocate existing restroom accessories. 	PCODE WG01A ADAAG 91 4.23.7 ADA 2010 308.2.1 CBC 2007 1115B.8.3 CBC 2019 11B-603.5 Mitigated: <input type="radio"/> YES <input checked="" type="radio"/> NO	1	JOB	\$300	\$300
------	---	--	---	-----	-------	-------
