APPENDIX B: ACCESS COMPLIANCE SURVEY REPORT OF FACILITIES

The City of Madera

Access Compliance Survey Report

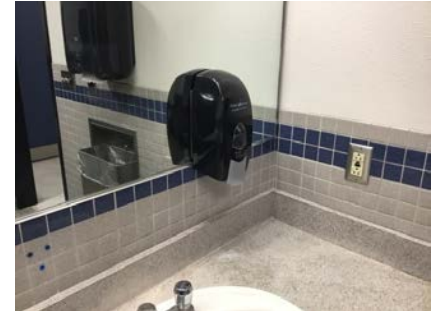
1458	<ul style="list-style-type: none"> As-Built Description: Dispensers in sanitary facilities, such as for towels, soap, sanitary napkins, seat covers, etc., and waste receptacles more than 48" (CA only: 40") from floor to highest operating slot or control. As-Built: SD: 45.0" high Proposed Solution: Relocate existing restroom accessories. Notes: 	PCODE WG01A ADAAG 91 4.23.7 ADA 2010 308.2.1 CBC 2007 1115B.8.3 CBC 2019 11B-603.5 Mitigated: <input type="radio"/> YES <input checked="" type="radio"/> NO	1	JOB	\$300	\$300
------	--	--	---	-----	-------	-------

If 48" maximum AFF, this element complies with 1991 ADAAG and the 2010 ADAS. If 54" maximum AFF side reach, this element complies with Safe Harbor if constructed or altered before March 15, 2012. This element does not comply with the dimensional requirements in the 1981 to the current CBC.

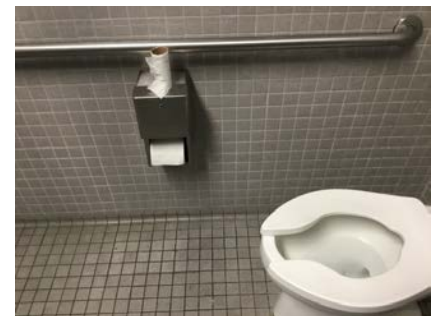
1464	<ul style="list-style-type: none"> As-Built Description: Toilet paper dispenser less than 15" (CA: 19") or more than 48" above floor or not within 7" to 9" from front of water closet (Note: CA pre-2010 is allowed within 12" from front of water closet). As-Built: 11.0" in front Proposed Solution: Relocate or provide new toilet paper dispenser. 	PCODE WG02 ADAAG 91 4.16.6 ADA 2010 604.7 CBC 2007 1115B.8.4 CBC 2019 11B-604.7 Mitigated: <input type="radio"/> YES <input checked="" type="radio"/> NO	1	JOB	\$225	\$225
------	--	---	---	-----	-------	-------

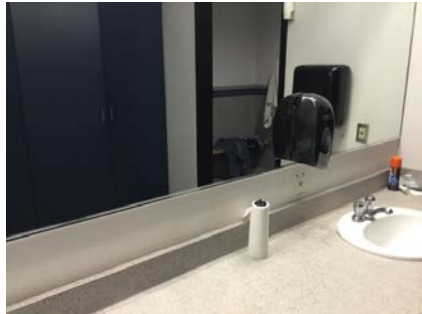
Item no., Rm no. and Name	Existing Architectural Barrier and Proposed Solution	Codes / Mitigation Info	Qty	Unit	Cost	Total
1448	<ul style="list-style-type: none"> As-Built Description: Bottom of mirror located above lavatories or countertops more than 40" above floor. As-Built: 45.0" high Proposed Solution: Relocate or provide new accessible mirror. Notes: 	PCODE WG03 ADAAG 91 4.19.6 ADA 2010 603.3 CBC 2007 1115B.8.1 CBC 2019 11B-603.3 Mitigated: <input type="radio"/> YES <input checked="" type="radio"/> NO	1	JOB	\$450	\$450

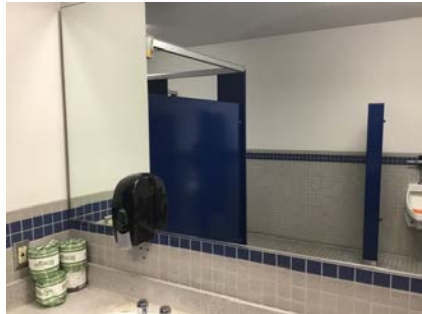
1459	<ul style="list-style-type: none"> As-Built Description: Bottom of mirror located above lavatories or countertops more than 40" above floor. As-Built: 45.0" high Proposed Solution: Relocate or provide new accessible mirror. 	PCODE WG03 ADAAG 91 4.19.6 ADA 2010 603.3 CBC 2007 1115B.8.1 CBC 2019 11B-603.3 Mitigated: <input type="radio"/> YES <input checked="" type="radio"/> NO	1	JOB	\$450	\$450

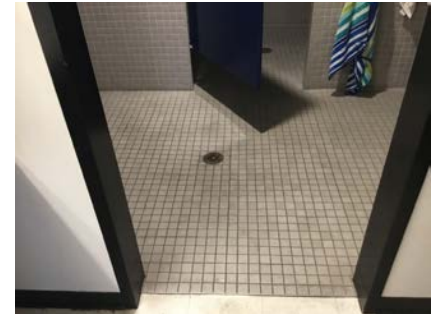
Cross Slope

1452	<ul style="list-style-type: none"> As-Built Description: Cross slope more than 1":48" (2.083%). As-Built: 4.0% Proposed Solution: Modify cross slope. Notes: 	PCODE EF07 ADAAG 91 4.3.7 ADA 2010 403.3 CBC 2007 1133B.7.1.3 CBC 2019 11B-403.3	16	SF	\$75	\$1,200
------	---	---	----	----	------	---------

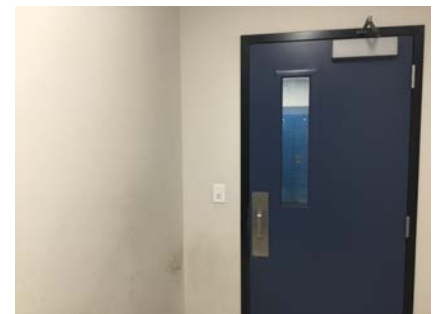
Door Swing

1456	<ul style="list-style-type: none"> As-Built Description: Front approach: At pull side, door does not have clear and level maneuvering space measuring door width plus 18" x 60". (24" x 60" at exterior doors). As-Built: 17.0" Proposed Solution: Provide relocated new door and frame; remodel walls as needed. 	PCODE ID23B ADAAG 91 Fig. 25(a) ADA 2010 404.2.4 CBC 2007 11B-26A(a) CBC 2019 11B-404.2.4	2	JOB	\$7,800	\$15,600
------	---	--	---	-----	---------	----------

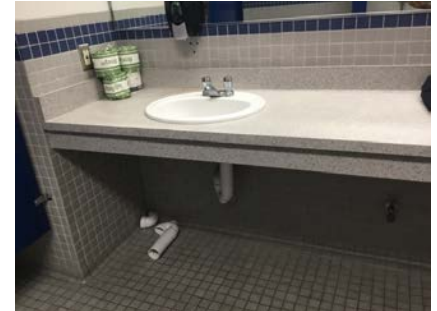
1460	<ul style="list-style-type: none"> As-Built Description: Wheelchair clearance under lavatory apron or lavatory counter front edge less than 29" high. As-Built: 28.2" high Proposed Solution: Trim apron. Notes: 	PCODE WD03 ADAAG 91 4.19.2 ADA 2010 606.3 CBC 2007 1115B.4.3.3 CBC 2019 11B-306.3.1	1	JOB	\$1,500	\$1,500
------	---	--	---	-----	---------	----------------

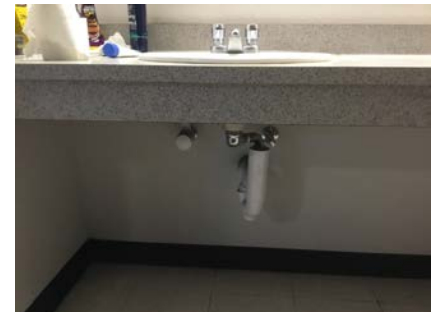
1451	<ul style="list-style-type: none"> As-Built Description: Hot or sharp-surfaced water/drain pipe not insulated or covered. Proposed Solution: Insulate or cover water/drain pipe. Notes: 	PCODE WD05 ADAAG 91 4.19.4 ADA 2010 606.5 CBC 2007 1115B.4.3.4 CBC 2019 11B-606.5	1	JOB	\$360	\$360
------	--	--	---	-----	-------	--------------

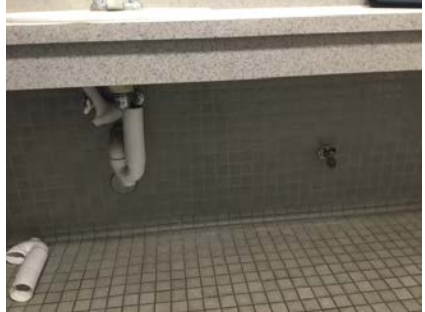
Item no., Rm no. and Name	Existing Architectural Barrier and Proposed Solution	Codes / Mitigation Info	Qty	Unit	Cost	Total
1461	<ul style="list-style-type: none"> <i>As-Built Description:</i> Hot or sharp-surfaced water/drain pipe not insulated or covered. <i>Proposed Solution:</i> Insulate or cover water/drain pipe. 	PCODE WD05 ADAAG 91 4.19.4 ADA 2010 606.5 CBC 2007 1115B.4.3.4 CBC 2019 11B-606.5 Mitigated: <input type="radio"/> YES <input checked="" type="radio"/> NO	1	JOB	\$360	\$360

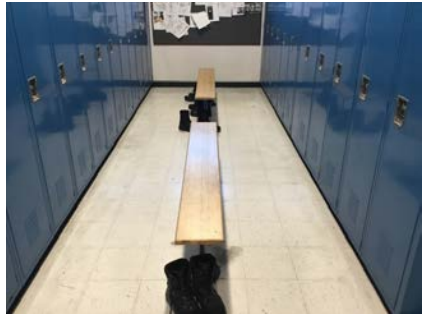
Locker Facilities

1446	<ul style="list-style-type: none"> <i>As-Built Description:</i> No section of bench provided adjacent to designated accessible locker, measuring minimum 20-24" deep, 48" wide, and 17-19" high, and fixed to a wall along the longer dimension. <i>Proposed Solution:</i> Provide a new bench, fixed to a wall along the longer dimension, close to the accessible locker. 	PCODE GG03 ADAAG 91 4.35.4 ADA 2010 803.4 CBC 2007 1117B.8 CBC 2019 11B-803.4 Mitigated: <input type="radio"/> YES <input checked="" type="radio"/> NO	1	JOB	\$2,250	\$2,250

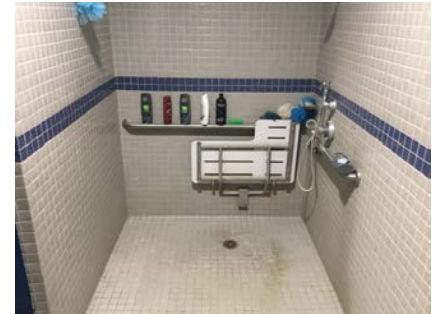
- 1455 • *As-Built Description:*
Shower not accessible; multiple compliance violations.
- *Proposed Solution:*
Provide accessible shower.
- **Notes:**

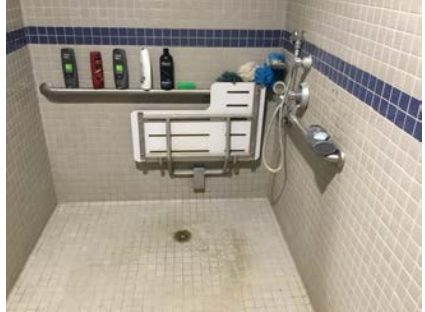
Item no., Rm no. and Name	Existing Architectural Barrier and Proposed Solution	Codes / Mitigation Info	Qty	Unit	Cost	Total
1454	<ul style="list-style-type: none"> <i>As-Built Description:</i> ADAAG: L-shaped shower seat extending the full depth of the stall does not have a seat located 1-1/2" max. from the wall and/or have the front of the seat (nearest to the opening) extend 16" max. from the wall. The back of the seat (against the back wall) shall extend 23" max. from the side wall and shall be 15" max. deep. <i>As-Built:</i> 4.5" from wall. Below grab bar. <i>Proposed Solution:</i> Provide new, or relocate, folding wall-mounted shower seat. 	PCODE WF07AREF ADAAG 91 4.21.3 ADA 2010 610.3.2 CBC 2007 1115B.4.4.8.1 CBC 2019 11B-610.3.2 Mitigated: <input type="radio"/> YES <input checked="" type="radio"/> NO	1	JOB	\$1,650	\$1,650

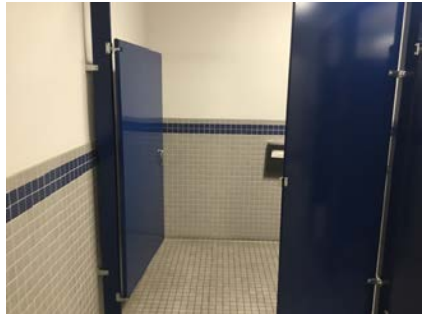
Stall Door

1462	<ul style="list-style-type: none"> <i>As-Built Description:</i> Stall door to accessible compartment not self closing. <i>Proposed Solution:</i> Adjust closer. 	PCODE WB05B ADAAG 91 4.22.4 ADA 2010 604.8.1.2 CBC 2007 1115B.3.1.4.4 CBC 2019 11B-604.8.1.2 Mitigated: <input type="radio"/> YES <input checked="" type="radio"/> NO	1	JOB	\$75	\$75

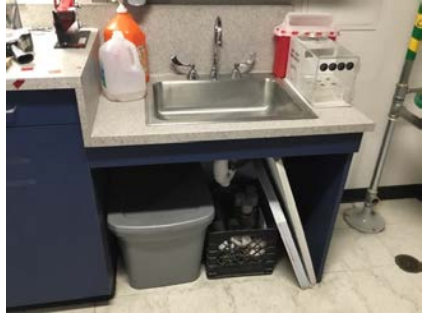
Item no., Rm no. and Name	Existing Architectural Barrier and Proposed Solution	Codes / Mitigation Info	Qty	Unit	Cost	Total
Lavatory						
1475	<ul style="list-style-type: none"> As-Built Description: Lavatory: Fixture rim or counter height more than 34" above floor. As-Built: 34.5" high Proposed Solution: Remount compliant fixture at accessible height. 	PCODE WD02A ADAAG 91 4.19.2 ADA 2010 606.3 CBC 2007 1115B.4.3 CBC 2019 11B-606.3	1	JOB	\$2,700	\$2,700
		Mitigated: <input type="radio"/> YES <input checked="" type="radio"/> NO

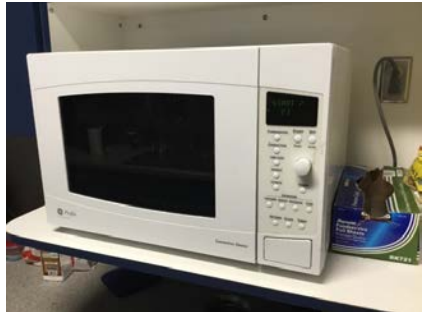
Item no., Rm no. and Name	Existing Architectural Barrier and Proposed Solution	Codes / Mitigation Info	Qty	Unit	Cost	Total
1480	<ul style="list-style-type: none"> As-Built Description: Reach height to control or access point, where side approach is available, exceeds 48" or is less than 15" in height, or exceeds 10" in depth. As-Built: 57.0" high Proposed Solution: Modify equipment or mounting. 	PCODE IE02 ADAAG 91 4.2.6 ADA 2010 308.3.1 CBC 2007 1118B.6 CBC 2019 11B-308.3 Mitigated: <input type="radio"/> YES <input checked="" type="radio"/> NO	1	JOB	\$300	\$300

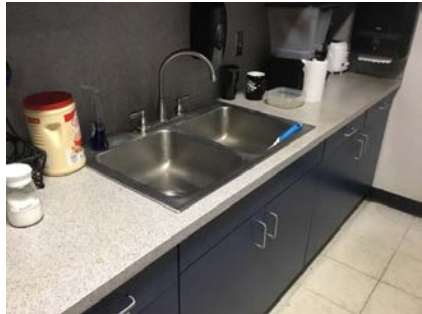
1478	<ul style="list-style-type: none"> As-Built Description: Sink rim higher than 34" above floor. As-Built: 34.2" high Proposed Solution: Remodel sink cabinet to lower sink. 	PCODE IN06 ADAAG 91 4.24.2 ADA 2010 606.3 CBC 2007 1115B.4.7.1 CBC 2019 11B-606.3 Mitigated: <input type="radio"/> YES <input checked="" type="radio"/> NO	1	JOB	\$5,250	\$5,250

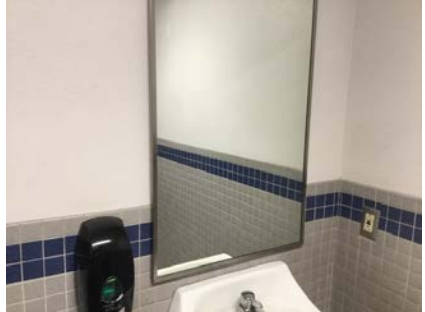
Item no., Rm no. and Name	Existing Architectural Barrier and Proposed Solution	Codes / Mitigation Info	Qty	Unit	Cost	Total
1488	<ul style="list-style-type: none"> As-Built Description: Bottom of mirror located above lavatories or countertops more than 40" above floor. As-Built: 40.5" high Proposed Solution: Relocate or provide new accessible mirror. 	PCODE WG03 ADAAG 91 4.19.6 ADA 2010 603.3 CBC 2007 1115B.8.1 CBC 2019 11B-603.3 Mitigated: <input type="radio"/> YES <input checked="" type="radio"/> NO	1	JOB	\$450	\$450

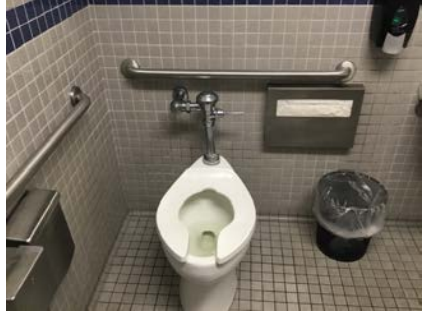
Grab Bars

1491	<ul style="list-style-type: none"> As-Built Description: The rear wall grab is less than 36" min. or does not extend from the centerline of the water closet 12" min. on one side and 24" min. on the other side. As-Built: Extends 21.5" on wide side Proposed Solution: Provide or relocate accessible rear grab bar. Notes: 	PCODE WB07B ADAAG 91 4.17.6 ADA 2010 604.5.2 CBC 2007 1115B.4.1.3.2 CBC 2019 11B-604.5.2 Mitigated: <input type="radio"/> YES <input checked="" type="radio"/> NO	1	JOB	\$1,020	\$1,020

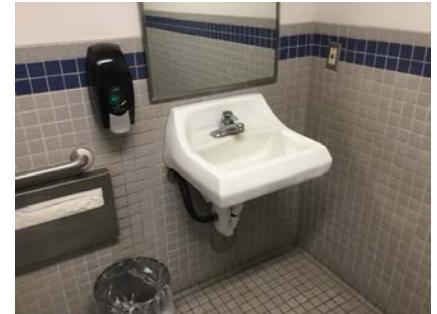
Lavatory

1489	<ul style="list-style-type: none"> As-Built Description: Wheelchair clearance under lavatory apron or lavatory counter front edge less than 29" high. As-Built: 28.75" high Proposed Solution: Remount compliant fixture to accessible height. Notes: 	<p>PCODE WD03A</p> <p>ADAAG 91 4.19.2</p> <p>ADA 2010 606.3</p> <p>CBC 2007 1115B.4.3.3</p> <p>CBC 2019 11B-306.3.1</p> <p>Mitigated:</p> <p><input type="radio"/> YES</p> <p><input checked="" type="radio"/> NO</p>	1	JOB	\$3,000	\$3,000
------	--	--	---	-----	---------	---------

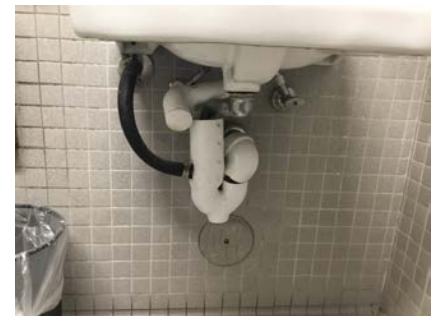
1490	<ul style="list-style-type: none"> As-Built Description: Hot or sharp-surfaced water/drain pipe not insulated or covered. Proposed Solution: Insulate or cover water/drain pipe. 	<p>PCODE WD05</p> <p>ADAAG 91 4.19.4</p> <p>ADA 2010 606.5</p> <p>CBC 2007 1115B.4.3.4</p> <p>CBC 2019 11B-606.5</p> <p>Mitigated:</p> <p><input type="radio"/> YES</p> <p><input checked="" type="radio"/> NO</p>	1	JOB	\$360	\$360
------	--	---	---	-----	-------	-------

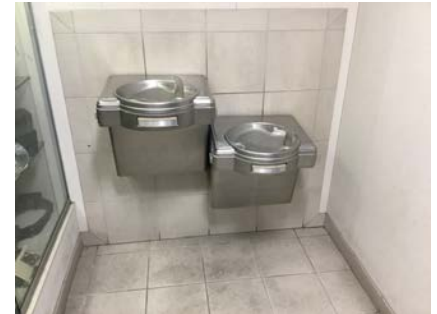
- 1498
- *As-Built Description:*
Wall- and post-mounted cantilevered units: Knee space not provided at drinking fountain (27" high, 8" deep, 30" wide from front of drinking fountain). Unit in good condition.
 - *As-Built:* **25.75" knee high**
 - *Proposed Solution:*
Remount fountain at accessible height.

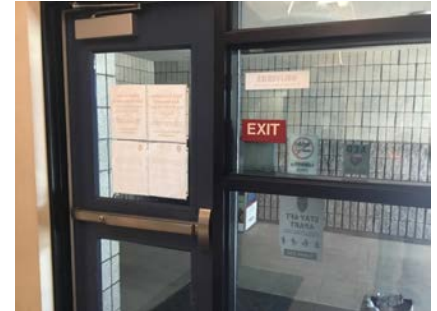
1497	<ul style="list-style-type: none"> As-Built Description: Sign not located on latch side of door and/or not located at 48" min. above to baseline of the lowest Braille cells and 60" max. to baseline of the highest line of raised characters. As-Built: Sign reader not within 3.0" of sign. Proposed Solution: Install sign on shim. Notes: 	PCODE SA07 ADAAG 91 4.30.6 ADA 2010 703.4.1 CBC 2007 1117B.5.7 CBC 2019 11B-703.4.1 Mitigated: <input type="radio"/> YES <input checked="" type="radio"/> NO	1	JOB	\$150	\$150
------	---	---	---	-----	-------	-------

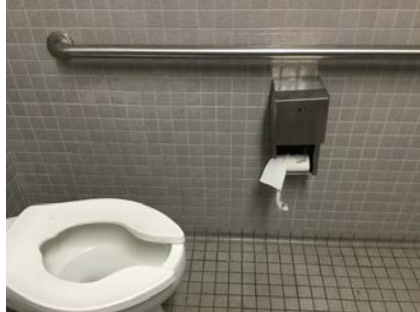
<p>1501</p> <ul style="list-style-type: none"> <i>As-Built Description:</i> Toilet paper dispenser less than 15" (CA: 19") or more than 48" above floor or not within 7" to 9" from front of water closet (Note: CA pre-2010 is allowed within 12" from front of water closet). <i>As-Built:</i> 12.5" in front <i>Proposed Solution:</i> Relocate or provide new toilet paper dispenser. 	<p>PCODE WG02 ADAAG 91 4.16.6 ADA 2010 604.7 CBC 2007 1115B.8.4 CBC 2019 11B-604.7</p>	<p>1 JOB \$225 \$225</p>

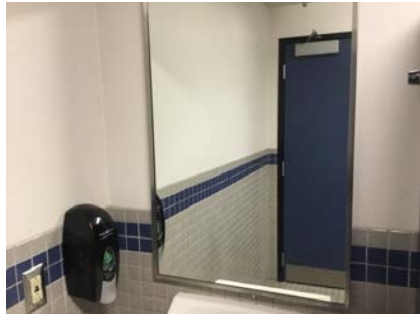
<p>1503</p> <ul style="list-style-type: none"> <i>As-Built Description:</i> Bottom of mirror located above lavatories or countertops more than 40" above floor. <i>As-Built:</i> 40.5" high <i>Proposed Solution:</i> Relocate or provide new accessible mirror. 	<p>PCODE WG03 ADAAG 91 4.19.6 ADA 2010 603.3 CBC 2007 1115B.8.1 CBC 2019 11B-603.3</p>	<p>1 JOB \$450 \$450</p>

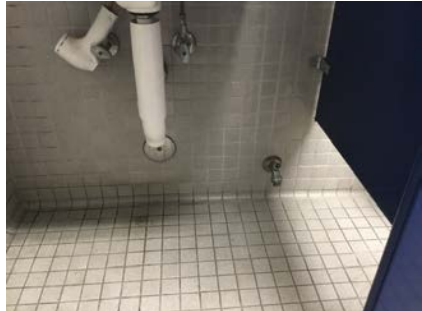
Item no., Rm no. and Name	Existing Architectural Barrier and Proposed Solution	Codes / Mitigation Info	Qty	Unit	Cost	Total
1505	<ul style="list-style-type: none"> • <i>As-Built Description:</i> Hot or sharp-surfaced water/drain pipe not insulated or covered. • <i>Proposed Solution:</i> Insulate or cover water/drain pipe. 	PCODE WD05 ADAAG 91 4.19.4 ADA 2010 606.5 CBC 2007 1115B.4.3.4 CBC 2019 11B-606.5 Mitigated: <input type="radio"/> YES <input checked="" type="radio"/> NO	1	JOB	\$360	\$360

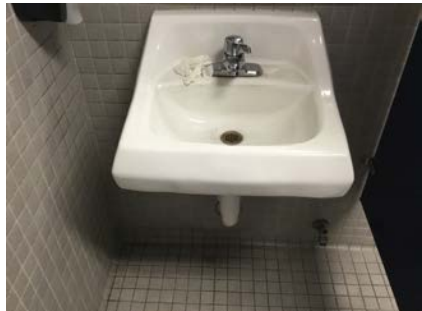
<input type="radio"/> Staff Only			
			Priority <input checked="" type="radio"/> 3			
			Severity <input checked="" type="radio"/> 3			
1507	<ul style="list-style-type: none"> • <i>As-Built Description:</i> Lavatory: Self-closing faucet at accessible lavatory does not remain open for at least 10 seconds. • <i>Proposed Solution:</i> Adjust self-closing faucet at accessible lavatory. 	PCODE WD07 ADAAG 91 4.19.5 ADA 2010 606.4 CBC 2007 1115B.4.3 CBC 2019 11B-606.4 Mitigated: <input type="radio"/> YES <input checked="" type="radio"/> NO	1	JOB	\$150	\$150

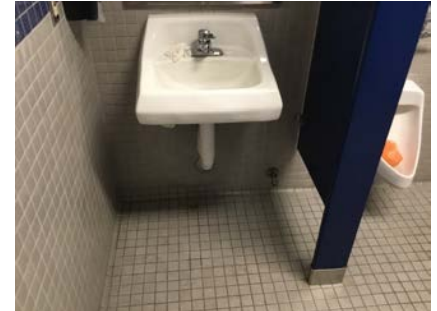
1506	<ul style="list-style-type: none"> As-Built Description: Lavatory/sink not accessible due to location within an inaccessible alcove of less than 36" wide. Proposed Solution: Remodel partitions to provide necessary maneuvering space within the alcove. Notes: 	PCODE WD11 ADA 2010 305.7.1 CBC 2019 11B-305.7.1 Mitigated: <input type="radio"/> YES <input checked="" type="radio"/> NO	1	JOB	\$1,500	\$1,500
------	---	---	---	-----	---------	----------------

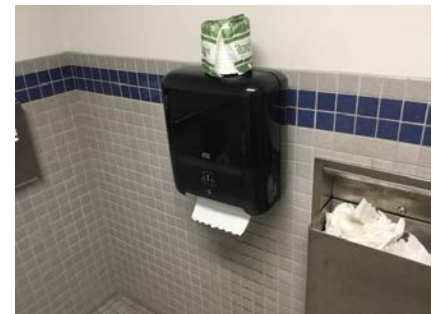
1500	<ul style="list-style-type: none"> As-Built Description: Protruding objects more than 4" from wall, when bottom of object more than 27" or less than 80" above finished floor. As-Built: PTD: 8.0" at 35.0" high Proposed Solution: Remove/relocate protruding object. Patch existing surface. 	PCODE EG04 ADAAG 91 4.4.1 ADA 2010 307.2 CBC 2007 1133B.8.6.1 CBC 2019 11B-307.2 Mitigated: <input type="radio"/> YES <input checked="" type="radio"/> NO	1	JOB	\$300	\$300
------	--	---	---	-----	-------	--------------

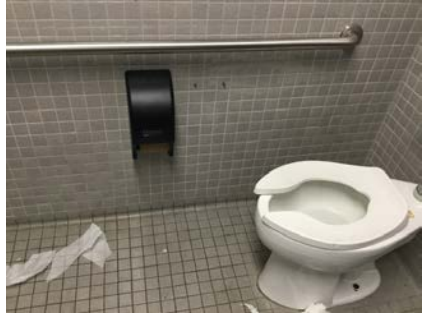
<p>1518</p> <ul style="list-style-type: none"> <i>As-Built Description:</i> Toilet paper dispenser less than 15" (CA: 19") or more than 48" above floor or not within 7" to 9" from front of water closet (Note: CA pre-2010 is allowed within 12" from front of water closet). <i>As-Built:</i> 12.0" in front. <i>Proposed Solution:</i> Relocate or provide new toilet paper dispenser. 	<p>PCODE WG02 ADAAG 91 4.16.6 ADA 2010 604.7 CBC 2007 1115B.8.4 CBC 2019 11B-604.7</p>	<p>1 JOB \$225 \$225</p>
--	---	---------------------------------

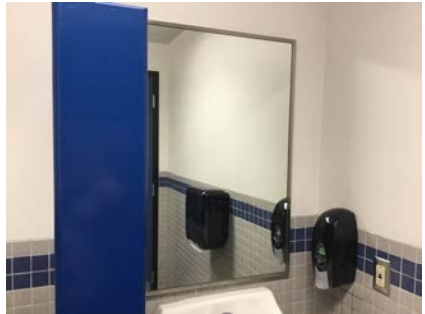
<p>1517</p> <ul style="list-style-type: none"> <i>As-Built Description:</i> Bottom of mirror located above lavatories or countertops more than 40" above floor. <i>As-Built:</i> 40.7" high <i>Proposed Solution:</i> Relocate or provide new accessible mirror. 	<p>PCODE WG03 ADAAG 91 4.19.6 ADA 2010 603.3 CBC 2007 1115B.8.1 CBC 2019 11B-603.3</p>	<p>1 JOB \$450 \$450</p>
--	---	---------------------------------

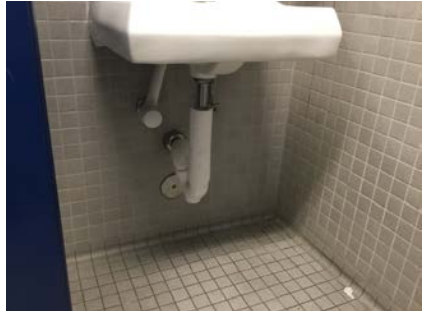
Item no., Rm no. and Name	Existing Architectural Barrier and Proposed Solution	Codes / Mitigation Info	Qty	Unit	Cost	Total
1516	<ul style="list-style-type: none"> <i>As-Built Description:</i> Hot or sharp-surfaced water/drain pipe not insulated or covered. <i>Proposed Solution:</i> Insulate or cover water/drain pipe. 	PCODE WD05 ADAAG 91 4.19.4 ADA 2010 606.5 CBC 2007 1115B.4.3.4 CBC 2019 11B-606.5 Mitigated: <input type="radio"/> YES <input checked="" type="radio"/> NO	1	JOB	\$360	\$360

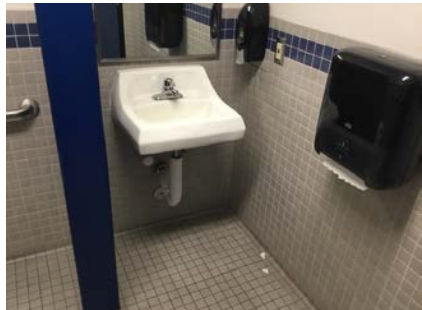
<input type="radio"/> Staff Only						
Priority <input checked="" type="radio"/> 3						
Severity <input checked="" type="radio"/> 3						
1513	<ul style="list-style-type: none"> <i>As-Built Description:</i> Lavatory/sink not accessible due to location within an inaccessible alcove of less than 36" wide. <i>Proposed Solution:</i> Remodel partitions to provide necessary maneuvering space within the alcove. <i>Notes:</i> 	PCODE WD11 ADA 2010 305.7.1 CBC 2019 11B-305.7.1 Mitigated: <input type="radio"/> YES <input checked="" type="radio"/> NO	1	JOB	\$1,500	\$1,500

<input type="radio"/> Staff Only						
Priority <input checked="" type="radio"/> 3						
Severity <input checked="" type="radio"/> 2						
<p>34.0" wide x 24.5" deep alcove. 25.0" wide including paper towel dispenser. Remove partition.</p>

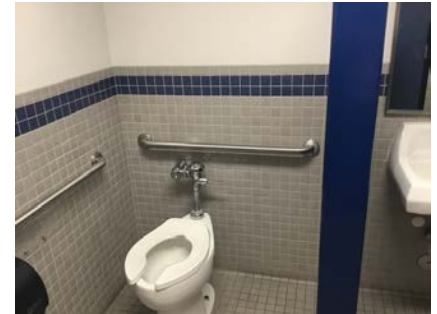
1510	<ul style="list-style-type: none"> As-Built Description: 60" min. clearance around a water closet measured perpendicular from the side wall not provided (Fixtures are not allowed to overlap this clearance). As-Built: 43.0" to partition. Proposed Solution: Remove adjacent fixture and provide new enclosure at accessible water closet. 	<p>PCODE WB01A</p> <p>ADA 2010 604.3.1; 604.3.2</p> <p>CBC 2007 1115B.7.1.3</p> <p>CBC 2019 11B-604.3.1; 11B-604.3.2</p> <p>Mitigated:</p> <p><input type="radio"/> YES</p> <p><input checked="" type="radio"/> NO</p>	1	JOB	\$6,000	\$6,000
------	---	--	---	-----	---------	----------------

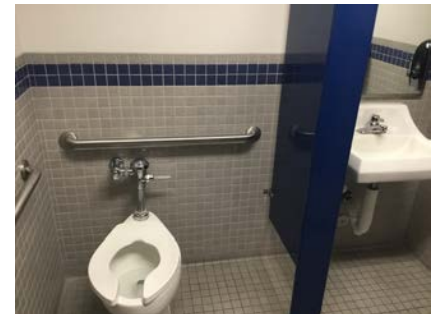
1511	<ul style="list-style-type: none"> As-Built Description: 60" min. clearance around a water closet measured perpendicular from the side wall not provided (Fixtures are not allowed to overlap this clearance). As-Built: 54.0" Proposed Solution: Remove adjacent fixture and provide new enclosure at accessible water closet. Notes: 	<p>PCODE WB01A</p> <p>ADA 2010 604.3.1; 604.3.2</p> <p>CBC 2007 1115B.7.1.3</p> <p>CBC 2019 11B-604.3.1; 11B-604.3.2</p> <p>Mitigated:</p> <p><input type="radio"/> YES</p> <p><input checked="" type="radio"/> NO</p>	1	JOB	\$6,000	\$6,000
------	---	--	---	-----	---------	----------------

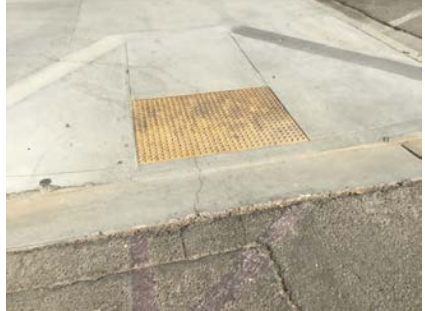
Item no., Rm no. and Name	Existing Architectural Barrier and Proposed Solution	Codes / Mitigation Info	Qty	Unit	Cost	Total
1804	<ul style="list-style-type: none"> <i>As-Built Description:</i> Maximum slope of adjoining gutters, street surface at bottom of ramp exceeds 5% (1:20). <i>As-Built:</i> 7.3% <i>Proposed Solution:</i> Modify road/gutter slopes. Demolish existing and provide new curb ramp. 	PCODE EH02E ADAAG 91 4.7.2 ADA 2010 406.2 CBC 2007 1127B.5.3 CBC 2019 11B-406.5.8 Mitigated: <input type="radio"/> YES <input checked="" type="radio"/> NO	1	JOB	\$3,750	\$3,750

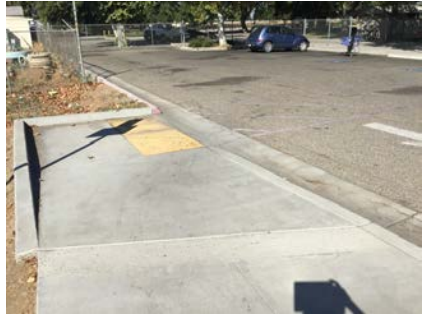
<input type="radio"/> Staff Only			
			Priority <input checked="" type="radio"/> 1			
			Severity <input checked="" type="radio"/> 4			
1807	<ul style="list-style-type: none"> <i>As-Built Description:</i> Maximum slope of adjoining gutters, street surface at bottom of ramp exceeds 5% (1:20). <i>As-Built:</i> 8.0% <i>Proposed Solution:</i> Modify road/gutter slopes. Demolish existing and provide new curb ramp. 	PCODE EH02E ADAAG 91 4.7.2 ADA 2010 406.2 CBC 2007 1127B.5.3 CBC 2019 11B-406.5.8 Mitigated: <input type="radio"/> YES <input checked="" type="radio"/> NO	1	JOB	\$3,750	\$3,750

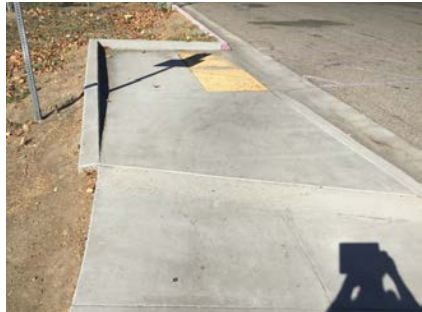
Item no., Rm no. and Name	Existing Architectural Barrier and Proposed Solution	Codes / Mitigation Info	Qty	Unit	Cost	Total
1808	<ul style="list-style-type: none"> As-Built Description: Cross slope greater than 2%. As-Built: 5.0% Proposed Solution: Demolish existing and provide new curb ramp. 	PCODE EH02F ADAAG 91 4.8.6 ADA 2010 405.3 CBC 2007 1133B.5.3.1 CBC 2019 11B-406.5.7 Mitigated: <input type="radio"/> YES <input checked="" type="radio"/> NO	1	JOB	\$7,500	\$7,500

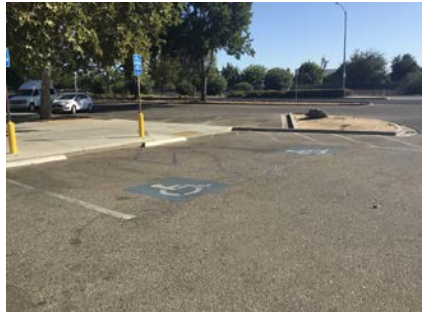
1799	<ul style="list-style-type: none"> As-Built Description: Accessible parking space has slope greater than 1/4":12" (2%). As-Built: Up to 6.1% Proposed Solution: Modify slope at accessible parking space. 	PCODE EA05 ADAAG 91 4.6.3 ADA 2010 502.4 CBC 2007 1129B.3.3 CBC 2019 11B-502.4 Mitigated: <input type="radio"/> YES <input checked="" type="radio"/> NO	450	SF	\$36	\$16,200

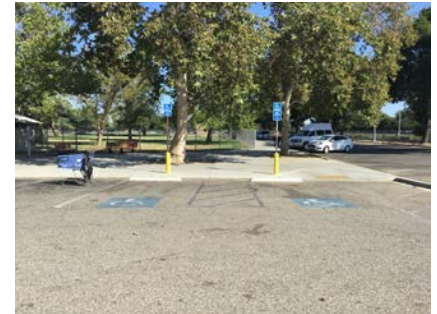
1806	<ul style="list-style-type: none"> <i>As-Built Description:</i> Disabled persons must wheel or walk behind parked car(s) other than their own. <i>Proposed Solution:</i> Relocate parking and provide curb ramp to accessible route. 	PCODE EA03 ADAAG 91 Fig.9 ADA 2010 502.3 CBC 2007 1129B.3.1 CBC 2019 11B-502.7.1 Mitigated: <input type="radio"/> YES <input checked="" type="radio"/> NO	1	JOB	\$2,190	\$2,190
------	--	--	---	-----	---------	---------

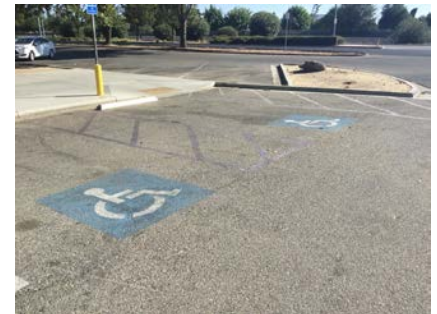
1801	<ul style="list-style-type: none"> <i>As-Built Description:</i> The words "NO PARKING" not painted on the ground within loading and unloading access aisle (12" min high white letters), located so that it is visible to traffic enforcement officials (required in CA only). <i>Proposed Solution:</i> Provide the words "NO PARKING" in each access aisle, painted in 12" high letters, when altering area. 	PCODE EA04D CBC 2007 1129B.3.1 CBC 2019 11B-502.3.3 Mitigated: <input type="radio"/> YES <input checked="" type="radio"/> NO	2	JOB	\$300	\$600
------	--	---	---	-----	-------	-------

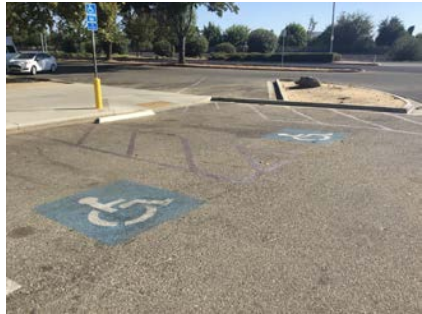
Item no., Rm no. and Name	Existing Architectural Barrier and Proposed Solution	Codes / Mitigation Info	Qty	Unit	Cost	Total
1800	<ul style="list-style-type: none"> <i>As-Built Description:</i> An accessible parking space shall be outlined or painted blue (required in CA only). <i>Proposed Solution:</i> Identify accessible parking space using blue markings. 	PCODE EA04K CBC 2019 11B-502.6 Mitigated: <input type="radio"/> YES <input checked="" type="radio"/> NO	2	JOB	\$360	\$720

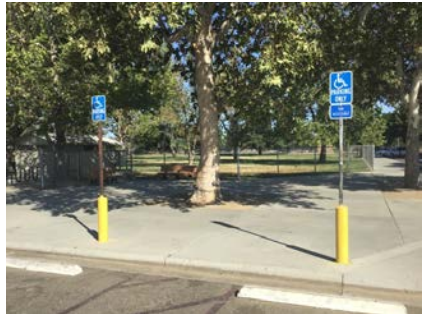
1802	<ul style="list-style-type: none"> <i>As-Built Description:</i> No "Tow Away" sign at parking lot entrance (required in CA only). <i>Proposed Solution:</i> Provide "Tow Away" sign at parking lot entrance when altering area. 	PCODE EA04C CBC 2007 1129B.4 CBC 2019 11B-502.8.2 Mitigated: <input type="radio"/> YES <input checked="" type="radio"/> NO	1	JOB	\$975	\$975

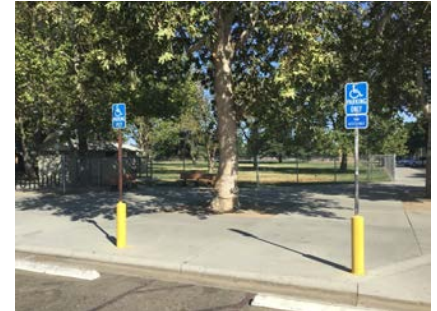
1803	<ul style="list-style-type: none"> <i>As-Built Description:</i> CA only: Additional Sign or additional language below the symbol of accessibility stating "Minimum Fine \$250" not provided. <i>Proposed Solution:</i> Provide compliant parking signage that includes fine information. 	<p>PCODE EA04G</p> <p>CBC 2007 1129B.4</p> <p>CBC 2019 11B-502.6.2</p> <p>Mitigated:</p> <p><input type="radio"/> YES</p> <p><input checked="" type="radio"/> NO</p>	2	JOB	\$300	\$600
------	--	--	---	-----	-------	-------

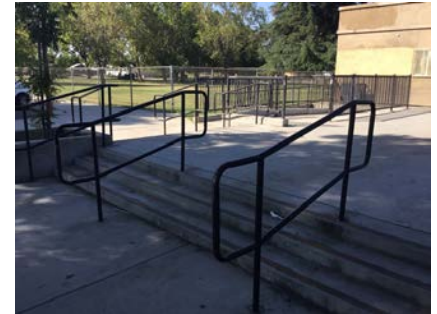
Top & Bottom Extension at Stairs

1811	<ul style="list-style-type: none"> As-Built Description: Stair handrail does not extend horizontally 12" minimum beyond top nosing, and one tread width sloped, plus 12" minimum horizontally beyond the bottom nosing. As-Built: 10.0" to bend. 12+" to center of down tube. Includes ramp. Proposed Solution: Extend stair handrail at top and bottom (cost for each extension piece). 	<p>PCODE ED06 ADAAG 91 4.9.4(2) ADA 2010 505.10.2; 505.10.3 CBC 2007 1133B.4.2.2 CBC 2019 11B-505.10.2; 11B-505.10.3</p> <p>Mitigated: <input type="radio"/> YES <input checked="" type="radio"/> NO</p>	16	JOB	\$510	\$8,160
------	--	---	----	-----	-------	---------

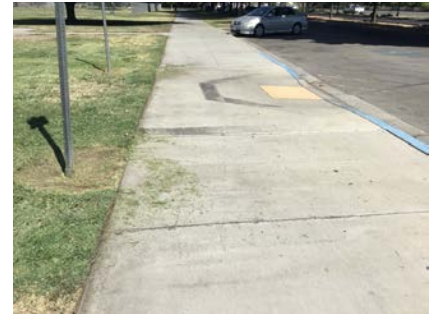
- 1839
- *As-Built Description:*
Walk: Pavement dislocation creates abrupt change in level exceeding 1/2" in accessible route.
 - *As-Built:* **0.7"**
 - *Proposed Solution:*
Remove, replace or repair area of pavement sufficient to correct abrupt change in level.

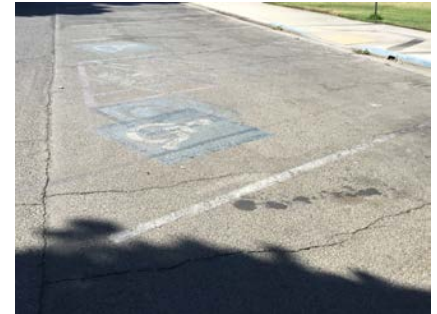
Parking

1816	<ul style="list-style-type: none"> As-Built Description: Accessible parking space smaller than 8' wide (CA only: 9' x 18'). As-Built: Approximately 170.0' long reduced by diagonal parking access aisle. Proposed Solution: Stripe straight in parking. 	PCODE EA02A ADAAG 91 4.6.3 ADA 2010 502.2 CBC 2007 1129B.3.1 CBC 2019 11B-502.2	2	JOB	\$600	\$1,200
------	--	---	---	-----	-------	---------

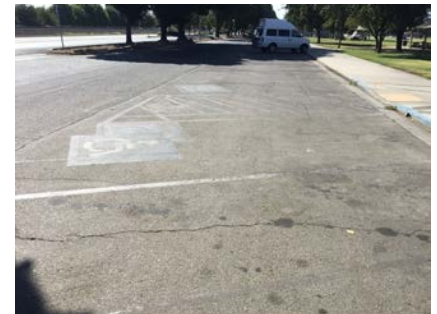
1817	<ul style="list-style-type: none"> As-Built Description: An accessible parking space shall be outlined or painted blue (required in CA only). Proposed Solution: Identify accessible parking space using blue markings. 	PCODE EA04K CBC 2019 11B-502.6	1	JOB	\$360	\$360
------	---	-----------------------------------	---	-----	-------	-------

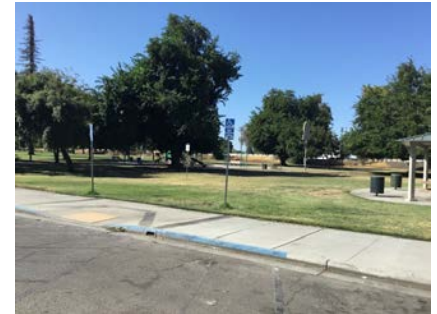
Parking Signage

1815	<ul style="list-style-type: none"> • <i>As-Built Description:</i> No "Tow Away" sign at parking lot entrance (required in CA only). • <i>Proposed Solution:</i> Provide "Tow Away" sign at parking lot entrance when altering area. 	<p>PCODE EA04C</p> <p>CBC 2007 1129B.4</p> <p>CBC 2019 11B-502.8.2</p> <p>Mitigated:</p> <p><input type="radio"/> YES</p> <p><input checked="" type="radio"/> NO</p>	1	JOB	\$975	\$975
------	---	--	---	-----	-------	-------

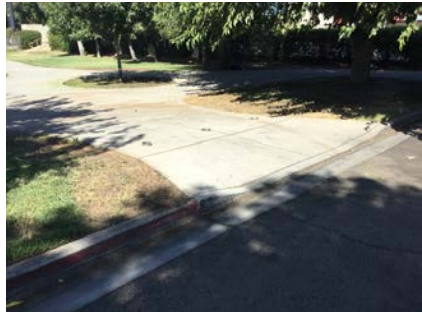
Item no., Rm no. and Name	Existing Architectural Barrier and Proposed Solution	Codes / Mitigation Info	Qty	Unit	Cost	Total
1832	<ul style="list-style-type: none"> <i>As-Built Description:</i> Maximum slope of adjoining gutters, street surface at bottom of ramp exceeds 5% (1:20). <i>As-Built:</i> 11.0% <i>Proposed Solution:</i> Modify road/gutter slopes. Demolish existing and provide new curb ramp. 	PCODE EH02E ADAAG 91 4.7.2 ADA 2010 406.2 CBC 2007 1127B.5.3 CBC 2019 11B-406.5.8 Mitigated: <input type="radio"/> YES <input checked="" type="radio"/> NO	1	JOB	\$3,750	\$3,750

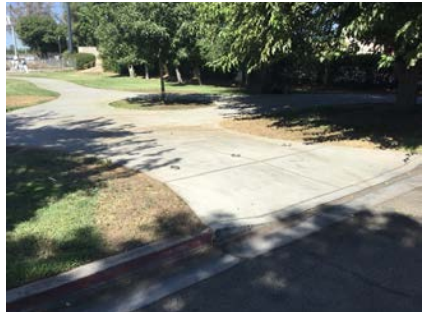
Detectable Warning

1830	<ul style="list-style-type: none"> <i>As-Built Description:</i> 36" wide band of truncated domes not provided at walkway or crossing adjoining a vehicular way, if surfaces are not separated by a curb, railing, or other element. <i>Proposed Solution:</i> Provide 36" wide, contrasting color, band of truncated domes between pedestrian and vehicular area. 	PCODE EG09 ADAAG 91 4.29.5 CBC 2007 1133B.8.5 CBC 2019 11B-705.1.2.5 Mitigated: <input type="radio"/> YES <input checked="" type="radio"/> NO	10	LF	\$81	\$810

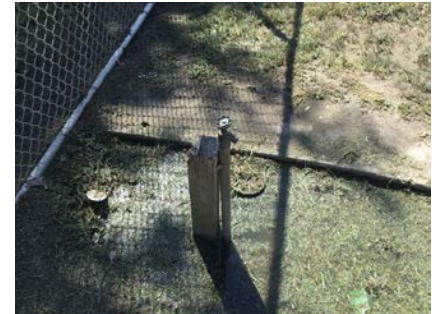
• *Proposed Solution:*
Modify or replace the operable part(s) to not require tight grasping, pinching, or twisting of the wrist with one hand.

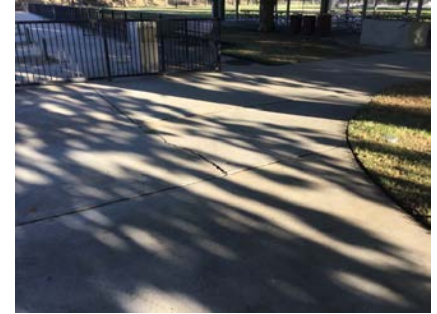
- 2019
- *As-Built Description:*
Walk: Pavement dislocation creates abrupt change in level exceeding 1/2" in accessible route.
 - *As-Built:* **Up to 1.0"**
 - *Proposed Solution:*
Remove, replace or repair area of pavement sufficient to correct abrupt change in level.

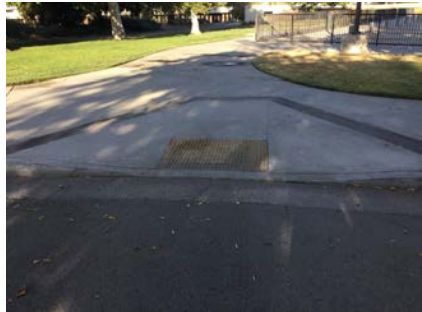
Item no., Rm no. and Name	Existing Architectural Barrier and Proposed Solution	Codes / Mitigation Info	Qty	Unit	Cost	Total
2017	<ul style="list-style-type: none"> As-Built Description: Transition from curb ramp to gutter does not have a smooth transition. As-Built: 0.5" Proposed Solution: Grind lip. 	PCODE EH02D ADAAG 91 4.7.2 ADA 2010 406.2 CBC 2007 1127B.5.3 CBC 2019 11B-406.5.8 Mitigated: <input type="radio"/> YES <input checked="" type="radio"/> NO	1	JOB	\$300	\$300

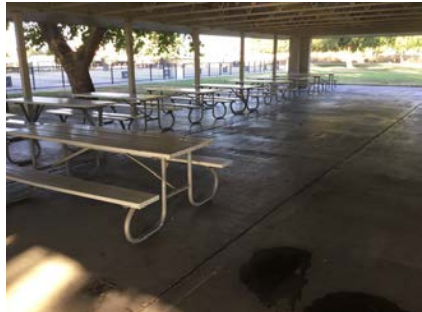
Non-Fixed Desk

2016	<ul style="list-style-type: none"> As-Built Description: Accessible non-fixed table or desk (top 28" to 34" high; knee space at least 27" high x 19" deep x 30" wide) not provided. As-Built: 200 seats, 0 accessible provided. Proposed Solution: Provide table or desk with accessible dimensions when purchasing new furniture. 	PCODE IN02A ADAAG 91 4.32.3 & .4 ADA 2010 306.1 CBC 2007 1122B.3 & 4 CBC 2019 11B-306.1 & 11B-902.3 Mitigated: <input type="radio"/> YES <input checked="" type="radio"/> NO	10	JOB	\$1,500	\$15,000

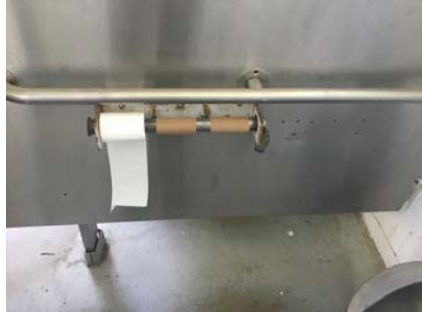
Grab Bars

<p>1756</p> <ul style="list-style-type: none"> <i>As-Built Description:</i> Side grab bar less than 42" long, or located more than 12 inches max. from the rear wall, or extending less than 54" from rear wall (CA only: front end min. 24" in front of water closet). <i>As-Built:</i> Extends 51.0" <i>Proposed Solution:</i> Provide or relocate accessible side grab bar. 	<p>PCODE WB07A ADAAG 91 Fig. 29(b) ADA 2010 604.5.1 CBC 2007 1115B.4.1.3.1 CBC 2019 11B-604.5.1</p> <p>Mitigated: <input type="radio"/> YES <input checked="" type="radio"/> NO</p>	<p>1 JOB \$780 \$780</p>

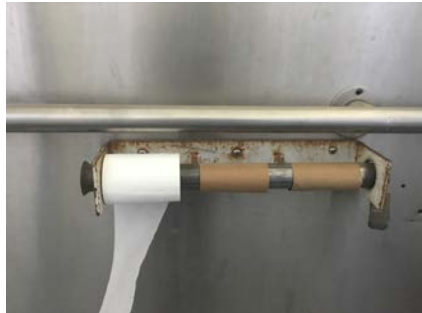
<p>1755</p> <ul style="list-style-type: none"> <i>As-Built Description:</i> Accessories/dispensers in accessible stall located closer than 1-1/2" below or 12" above grab bar impedes its use. <i>As-Built:</i> TPD: 1.0" below grab bar <i>Proposed Solution:</i> Relocate accessories/dispensers within applicable reach range and to be no closer than 1-1/2" below and 12" above grab bars (except if accessories are recessed, flush with wall, and have no sharp edges). 	<p>PCODE WB07I ADAAG 91 4.26.2 ADA 2010 609.3 CBC 2007 1133B.4.2.5 CBC 2019 11B-609.3</p> <p>Mitigated: <input type="radio"/> YES <input checked="" type="radio"/> NO</p>	<p>1 JOB \$225 \$225</p>

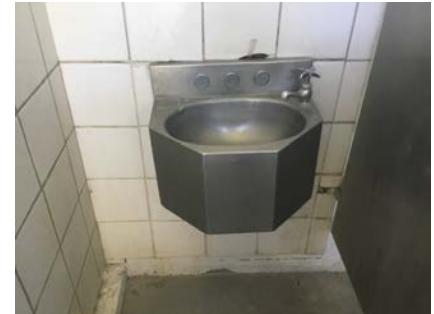
Lavatory

1759	<ul style="list-style-type: none"> • <i>As-Built Description:</i> Knee clearance 27" min. high starting 8" back from the front edge of the lavatory towards the wall is not provided. • <i>As-Built:</i> 24.0". knee high 12.0" deep toe clearance. • <i>Proposed Solution:</i> Provide new accessible lavatory. Remodel restroom as needed. 	<p>PCODE WD04 ADAAG 91 Fig. 31 ADA 2010 306.3.3 CBC 2007 1115B.4.3 CBC 2019 11B-306.3.3</p> <p>Mitigated: <input type="radio"/> YES <input checked="" type="radio"/> NO</p>	1	JOB	\$6,000	\$6,000
------	---	--	---	-----	---------	---------

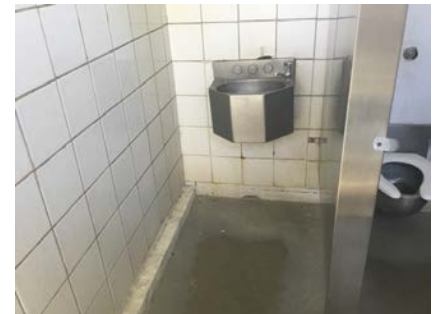
1758	<ul style="list-style-type: none"> • <i>As-Built Description:</i> Lavatory/sink not accessible due to location within an inaccessible alcove of less than 36" wide. • <i>Proposed Solution:</i> Remodel partitions to provide necessary maneuvering space within the alcove. • <i>Notes:</i> 	<p>PCODE WD11 ADA 2010 305.7.1 CBC 2019 11B-305.7.1</p> <p>Mitigated: <input type="radio"/> YES <input checked="" type="radio"/> NO</p>	1	REF		
------	---	--	---	-----	--	--

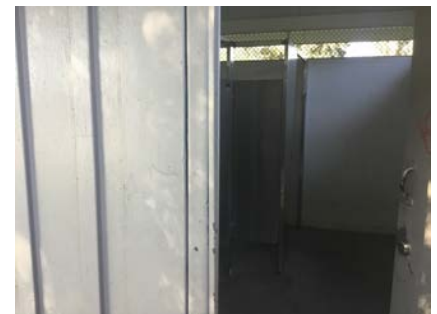
- 1760 • *As-Built Description:*
Entrance to toilet or bathing facility not identified with ADAAG compliant signage.
- *Proposed Solution:*
Provide ADA compliant sign mounted at 48" min. above to baseline of the lowest Braille cells and 60" max. to baseline of the highest line of raised characters on nearest adjacent wall, on latch side of a single door (located not to cause a Braille reader to stand within the door swing).

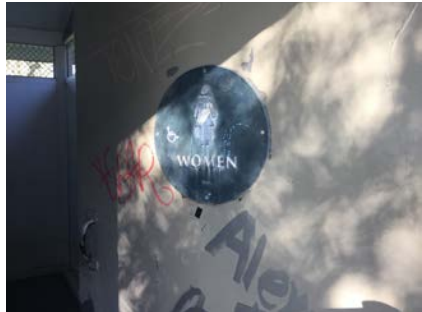
Item no., Rm no. and Name	Existing Architectural Barrier and Proposed Solution	Codes / Mitigation Info	Qty	Unit	Cost	Total
1761	<ul style="list-style-type: none"> <i>As-Built Description:</i> Required in CA only: identification symbol centered 58" to 60" high on sanitary facility door that contrasts with the door not provided (women: 12" ø circle, men: 12" triangle, unisex: combined symbol). <i>As-Built:</i> 62.0" high o.c. <i>Proposed Solution:</i> Provide properly mounted sanitary facility symbol when altering area. If wheelchair accessible, include International Symbol of Accessibility on sign. 	PCODE SA15 CBC 2007 1115B.6 CBC 2019 11B-703.7.2.6 Mitigated: <input type="radio"/> YES <input checked="" type="radio"/> NO	1	JOB	\$270	\$270

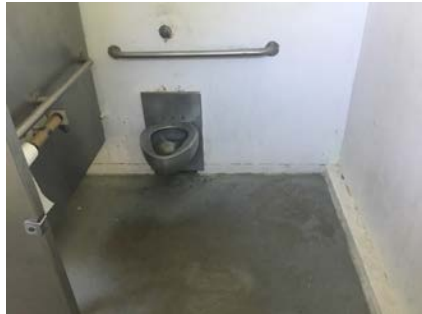
Toilet Stall

1751	<ul style="list-style-type: none"> <i>As-Built Description:</i> Toilet stall less than 60" wide. <i>As-Built:</i> 58.75" wide <i>Proposed Solution:</i> Provide new accessible stall. 	PCODE WB06 ADAAG 91 4.17.3 ADA 2010 604.8.1.1 CBC 2007 1115B.3.1.4.1 CBC 2019 11B-604.8.1.1 Mitigated: <input type="radio"/> YES <input checked="" type="radio"/> NO	1	JOB	\$4,500	\$4,500

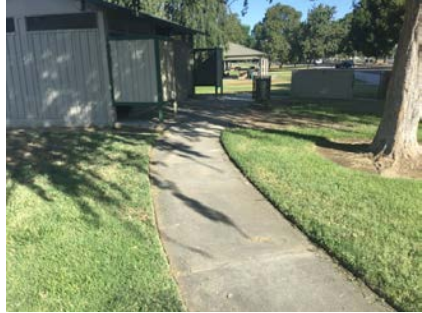
Cross Slope

<p>1774</p> <ul style="list-style-type: none"> • <i>As-Built Description:</i> Cross slope more than 1":48" (2.083%). • <i>As-Built:</i> Up to 3.9% • <i>Proposed Solution:</i> Modify cross slope. 	<p>PCODE EF07 ADAAG 91 4.3.7 ADA 2010 403.3 CBC 2007 1133B.7.1.3 CBC 2019 11B-403.3</p> <p>Mitigated: <input type="radio"/> YES <input checked="" type="radio"/> NO</p>	<p>160 SF \$75 \$12,000</p>

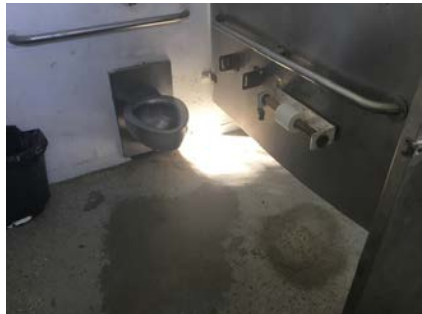
Door Swing

<p>1771</p> <ul style="list-style-type: none"> • <i>As-Built Description:</i> Front approach: At push side, door does not have clear and level maneuvering space measuring door width x 48" (door width plus 12" if door has both, latch and closer). • <i>As-Built:</i> 47.5" • <i>Proposed Solution:</i> Install lower profile water closet or provide relocated new door and frame; remodel walls as needed. 	<p>PCODE ID24B ADAAG 91 Fig. 25(a) ADA 2010 404.2.4 CBC 2007 11B-26A(a) CBC 2019 11B-404.2.4</p> <p>Mitigated: <input type="radio"/> YES <input checked="" type="radio"/> NO</p>	<p>1 JOB \$7,800 \$7,800</p>

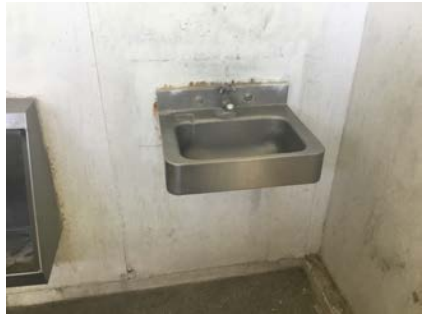
Item no., Rm no. and Name	Existing Architectural Barrier and Proposed Solution	Codes / Mitigation Info	Qty	Unit	Cost	Total
1764	<ul style="list-style-type: none"> As-Built Description: Knee clearance 27" min. high starting 8" back from the front edge of the lavatory towards the wall is not provided. As-Built: 15.0" deep toe clearance Proposed Solution: Provide new accessible lavatory. Remodel restroom as needed. 	PCODE WD04 ADAAG 91 Fig. 31 ADA 2010 306.3.3 CBC 2007 1115B.4.3 CBC 2019 11B-306.3.3 Mitigated: <input type="radio"/> YES <input checked="" type="radio"/> NO	1	JOB	\$6,000	\$6,000

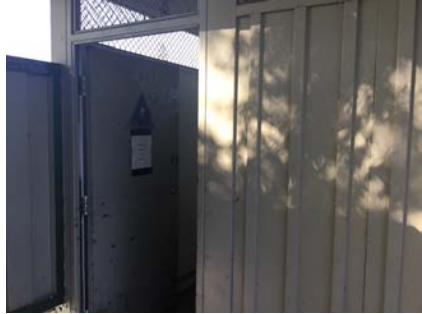
Signage

1762	<ul style="list-style-type: none"> As-Built Description: Required in CA only: identification symbol centered 58" to 60" high on sanitary facility door that contrasts with the door not provided (women: 12" ø circle, men: 12" triangle, unisex: combined symbol). Proposed Solution: Provide properly mounted sanitary facility symbol when altering area. If wheelchair accessible, include International Symbol of Accessibility on sign. 	PCODE SA15 CBC 2007 1115B.6 CBC 2019 11B-703.7.2.6 Mitigated: <input type="radio"/> YES <input checked="" type="radio"/> NO	1	JOB	\$270	\$270

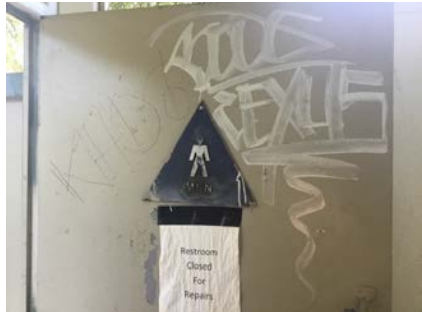
Item no., Rm no. and Name	Existing Architectural Barrier and Proposed Solution	Codes / Mitigation Info	Qty	Unit	Cost	Total
1763	<ul style="list-style-type: none"> <i>As-Built Description:</i> Required in CA only: identification symbol centered 58" to 60" high on sanitary facility door that contrasts with the door not provided (women: 12" ø circle, men: 12" triangle, unisex: combined symbol). <i>As-Built:</i> 65.0" high o.c. <i>Proposed Solution:</i> Provide properly mounted sanitary facility symbol when altering area. If wheelchair accessible, include International Symbol of Accessibility on sign. 	PCODE SA15 CBC 2007 1115B.6 CBC 2019 11B-703.7.2.6 Mitigated: <input type="radio"/> YES <input checked="" type="radio"/> NO	1	JOB	\$270	\$270

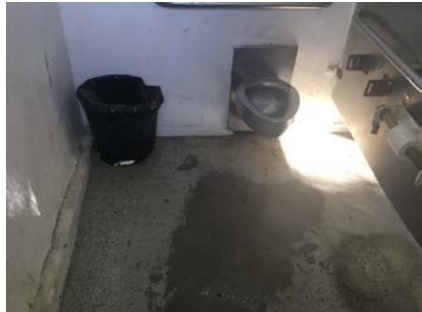
Toilet Stall

1770	<ul style="list-style-type: none"> <i>As-Built Description:</i> Toilet stall less than 60" wide. <i>As-Built:</i> 57.5" wide <i>Proposed Solution:</i> Provide new accessible stall. 	PCODE WB06 ADAAG 91 4.17.3 ADA 2010 604.8.1.1 CBC 2007 1115B.3.1.4.1 CBC 2019 11B-604.8.1.1 Mitigated: <input type="radio"/> YES <input checked="" type="radio"/> NO	1	JOB	\$4,500	\$4,500

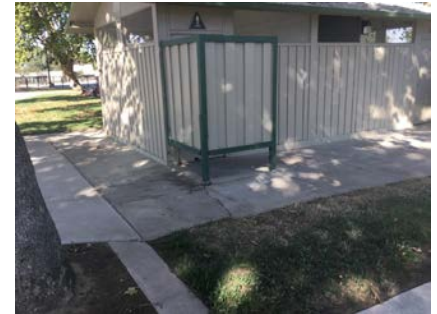
1797 • *As-Built Description:*
Walk: Pavement dislocation creates abrupt change in level exceeding 1/2" in accessible route.
• *As-Built:* **Up to 0.7"**
• *Proposed Solution:*
Remove, replace or repair area of pavement sufficient to correct abrupt change in level.

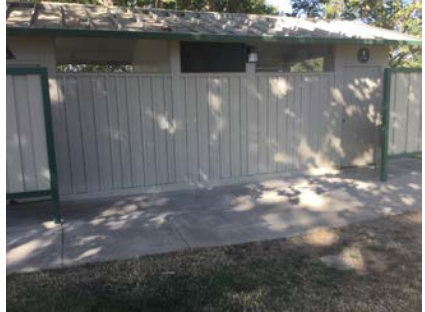
Item no., Rm no. and Name	Existing Architectural Barrier and Proposed Solution	Codes / Mitigation Info	Qty	Unit	Cost	Total
1798	<ul style="list-style-type: none"> As-Built Description: Cross slope more than 1":48" (2.083%). As-Built: Up to 3.1% Proposed Solution: Modify cross slope. 	PCODE EF07 ADAAG 91 4.3.7 ADA 2010 403.3 CBC 2007 1133B.7.1.3 CBC 2019 11B-403.3 Mitigated: <input type="radio"/> YES <input checked="" type="radio"/> NO	60	SF	\$75	\$4,500

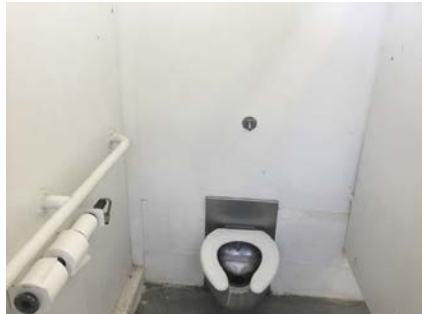
Grab Bars

1794	<ul style="list-style-type: none"> As-Built Description: Grab bars not provided or are not code compliant. Proposed Solution: Provide accessible grab bars. 	PCODE WB07 ADAAG 91 4.17.6 ADA 2010 604.5 CBC 2007 1115B.4.1.3 CBC 2019 11B-604.5 Mitigated: <input type="radio"/> YES <input checked="" type="radio"/> NO	1	JOB	\$1,500	\$1,500

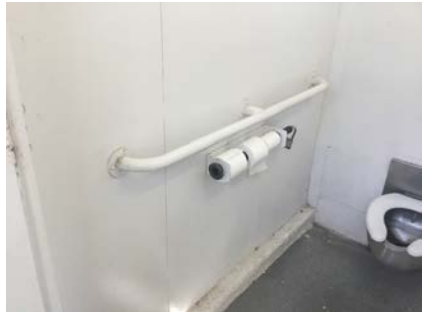
Item no., Rm no. and Name	Existing Architectural Barrier and Proposed Solution	Codes / Mitigation Info	Qty	Unit	Cost	Total
1795	<ul style="list-style-type: none"> As-Built Description: Grab bars not at 33" to 36" from floor As-Built: 37.0" high Proposed Solution: Relocate accessible grab bars. 	PCODE WB07C ADAAG 91 4.16.4 ADA 2010 609.4 CBC 2007 1115B.4.1.3.1 & 2 CBC 2019 11B-609.4 Mitigated: <input type="radio"/> YES <input checked="" type="radio"/> NO	1	JOB	\$780	\$780

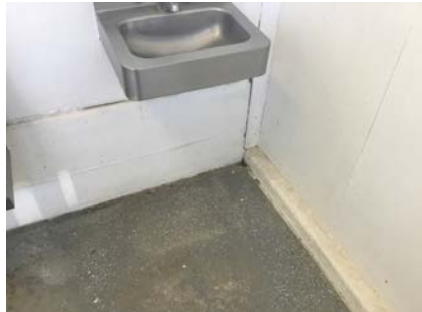
Lavatory

1788	<ul style="list-style-type: none"> As-Built Description: Clear floor space, 30" x 48" in front of fixture, extending 19" max. under the lavatory, not provided (CA only: Less than 18" from side wall to centerline of lavatory). As-Built: 16.5" o.c. Proposed Solution: Provide new accessible lavatory. Remodel restroom as needed. Notes: 	PCODE WD01 ADAAG 91 4.19.3 ADA 2010 606.2 CBC 2007 1115B.4.3 CBC 2019 11B-606.2, 11B-606.6 Mitigated: <input type="radio"/> YES <input checked="" type="radio"/> NO	1	JOB	\$10,200	\$10,200

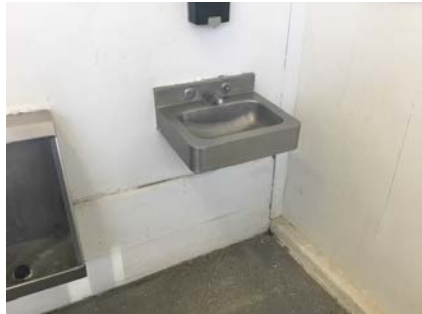
Item no., Rm no. and Name	Existing Architectural Barrier and Proposed Solution	Codes / Mitigation Info	Qty	Unit	Cost	Total
1789	<ul style="list-style-type: none"> • <i>As-Built Description:</i> Knee clearance 27" min. high starting 8" back from the front edge of the lavatory towards the wall is not provided. • <i>As-Built:</i> 15.0" deep toe clearance. • <i>Proposed Solution:</i> Provide new accessible lavatory. Remodel restroom as needed. 	PCODE WD04 ADAAG 91 Fig. 31 ADA 2010 306.3.3 CBC 2007 1115B.4.3 CBC 2019 11B-306.3.3 Mitigated: <input type="radio"/> YES <input checked="" type="radio"/> NO	1	JOB	\$6,000	\$6,000

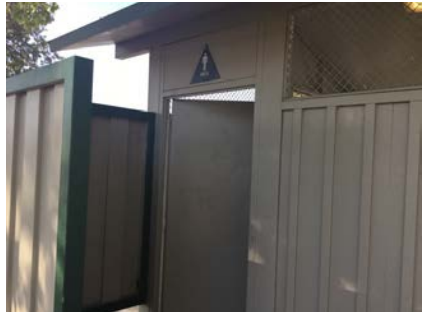
Item no., Rm no. and Name	Existing Architectural Barrier and Proposed Solution	Codes / Mitigation Info	Qty	Unit	Cost	Total
1785	<ul style="list-style-type: none"> As-Built Description: Required in CA only: identification symbol centered 58" to 60" high on sanitary facility door that contrasts with the door not provided (women: 12" ø circle, men: 12" triangle, unisex: combined symbol). Proposed Solution: Provide properly mounted sanitary facility symbol when altering area. If wheelchair accessible, include International Symbol of Accessibility on sign. 	PCODE SA15 CBC 2007 1115B.6 CBC 2019 11B-703.7.2.6 Mitigated: <input type="radio"/> YES <input checked="" type="radio"/> NO	1	JOB	\$270	\$270

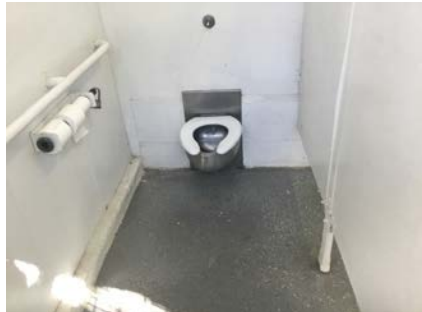
Toilet Stall

1792	<ul style="list-style-type: none"> As-Built Description: Toilet stall less than 60" wide. As-Built: 43.0" wide Proposed Solution: Provide new accessible stall. 	PCODE WB06 ADAAG 91 4.17.3 ADA 2010 604.8.1.1 CBC 2007 1115B.3.1.4.1 CBC 2019 11B-604.8.1.1 Mitigated: <input type="radio"/> YES <input checked="" type="radio"/> NO	1	JOB	\$4,500	\$4,500

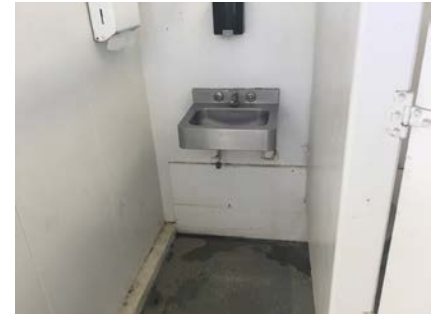
Lavatory

1782	<ul style="list-style-type: none"> • <i>As-Built Description:</i> Knee clearance 27" min. high starting 8" back from the front edge of the lavatory towards the wall is not provided. • <i>As-Built:</i> 15.0" deep toe clearance. • <i>Proposed Solution:</i> Provide new accessible lavatory. Remodel restroom as needed. 	<p>PCODE WD04 ADAAG 91 Fig. 31 ADA 2010 306.3.3 CBC 2007 1115B.4.3 CBC 2019 11B-306.3.3</p> <p>Mitigated: <input type="radio"/> YES <input checked="" type="radio"/> NO</p>	1	JOB	\$6,000	\$6,000
------	---	--	---	-----	---------	---------

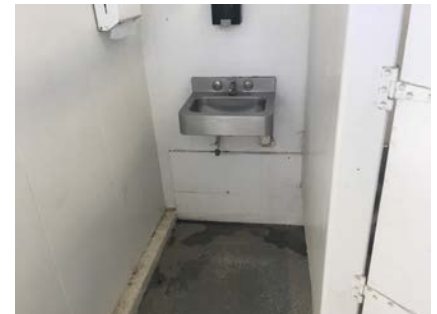
1781	<ul style="list-style-type: none"> • <i>As-Built Description:</i> Lavatory/sink not accessible due to location within an inaccessible alcove of less than 36" wide. • <i>Proposed Solution:</i> Remodel partitions to provide necessary maneuvering space within the alcove. • <i>Notes:</i> 	<p>PCODE WD11 ADA 2010 305.7.1 CBC 2019 11B-305.7.1</p> <p>Mitigated: <input type="radio"/> YES <input checked="" type="radio"/> NO</p>	1	REF		
------	---	--	---	-----	--	--

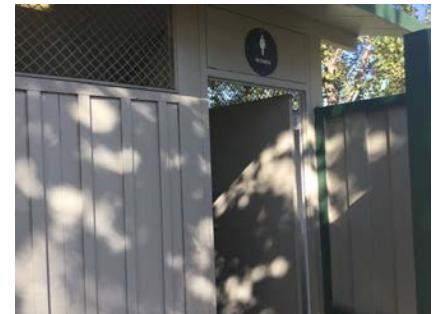
1776	<ul style="list-style-type: none"> <i>As-Built Description:</i> Required in CA only: identification symbol centered 58" to 60" high on sanitary facility door that contrasts with the door not provided (women: 12" ø circle, men: 12" triangle, unisex: combined symbol). <i>Proposed Solution:</i> Provide properly mounted sanitary facility symbol when altering area. If wheelchair accessible, include International Symbol of Accessibility on sign. 	<p>PCODE SA15 CBC 2007 1115B.6 CBC 2019 11B-703.7.2.6</p> <p>Mitigated: <input type="radio"/> YES <input checked="" type="radio"/> NO</p>	1	JOB	\$270	\$270
------	---	---	---	-----	-------	-------

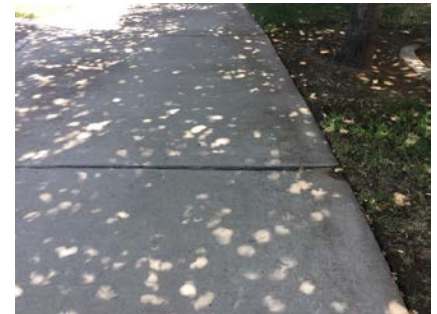
- 1874
- *As-Built Description:*
Walk: Pavement dislocation creates abrupt change in level exceeding 1/2" in accessible route.
 - *As-Built: **Up to 1.0”***
 - *Proposed Solution:*
Remove, replace or repair area of pavement sufficient to correct abrupt change in level.

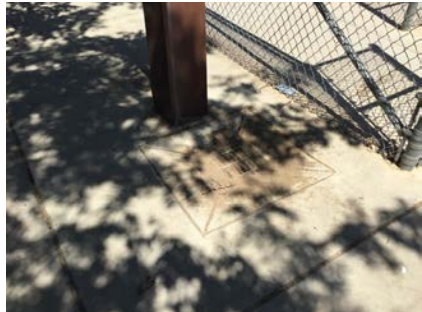
Item no., Rm no. and Name	Existing Architectural Barrier and Proposed Solution	Codes / Mitigation Info	Qty	Unit	Cost	Total
1867	<ul style="list-style-type: none"> As-Built Description: Cross slope more than 1":48" (2.083%). As-Built: 14.0% Proposed Solution: Modify cross slope. 	PCODE EF07 ADAAG 91 4.3.7 ADA 2010 403.3 CBC 2007 1133B.7.1.3 CBC 2019 11B-403.3 Mitigated: <input type="radio"/> YES <input checked="" type="radio"/> NO	30	SF	\$75	\$2,250

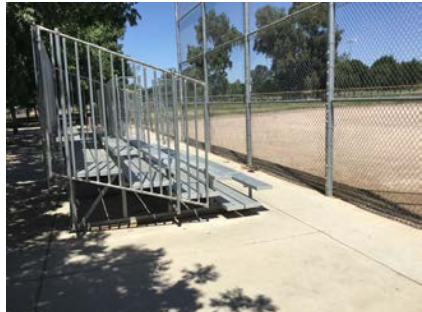
1858	<ul style="list-style-type: none"> As-Built Description: Wheelchair space (33"x48") not provided at fixed seating with forward or rear approach. (NOTE: Space must be adjacent to regular seating; can provide easily removable fixed seat). Proposed Solution: Relocate bleachers. Notes: 	PCODE GB01A ADAAG 91 4.1.3(19)(a) ADA 2010 221.2 CBC 2007 1104B.3.6 CBC 2019 11B-221.2 Mitigated: <input type="radio"/> YES <input checked="" type="radio"/> NO	4	JOB	\$1,350	\$5,400

Wheelchair seats block circulation path.
