APPENDIX B: ACCESS COMPLIANCE SURVEY REPORT OF FACILITIES

The City of Madera

Access Compliance Survey Report

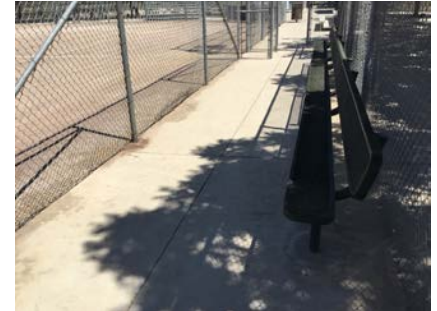
Item no., Rm no. and Name	Existing Architectural Barrier and Proposed Solution	Codes / Mitigation Info	Qty	Unit	Cost	Total
1868	<ul style="list-style-type: none"> <i>As-Built Description:</i> Wheelchair space (33"x48") not provided at fixed seating with forward or rear approach. (NOTE: Space must be adjacent to regular seating; can provide easily removable fixed seat). <i>Proposed Solution:</i> Remove fixed seating and provide wheelchair space plus necessary maneuvering clearance. <i>Notes:</i> 	PCODE GB01A ADAAG 91 4.1.3(19)(a) ADA 2010 221.2 CBC 2007 1104B.3.6 CBC 2019 11B-221.2 Mitigated: <input type="radio"/> YES <input checked="" type="radio"/> NO	4	JOB	\$1,350	\$5,400

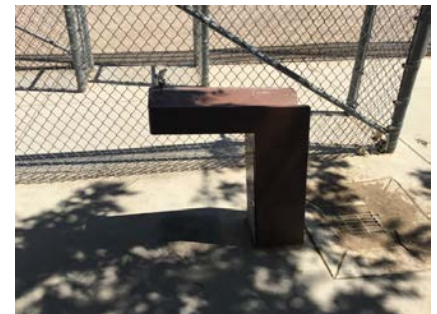
1862	<ul style="list-style-type: none"> <i>As-Built Description:</i> Where only one drinking fountain is provided per floor: Fountain is not accessible to individuals who use wheelchairs, or to those who have difficulty bending or stooping. <i>Proposed Solution:</i> Provide additional fountain or hi-lo combination fountain. 	PCODE IA01A ADAAG 91 4.1.3(10)(a) ADA 2010 211.1 CBC 2007 1115B.4.6.1 CBC 2019 11B-211.1 Mitigated: <input type="radio"/> YES <input checked="" type="radio"/> NO	4	JOB	\$6,000	\$24,000
------	--	--	---	-----	---------	----------

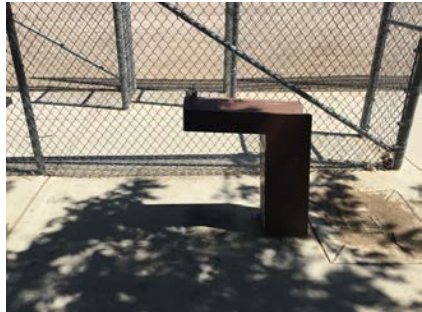
Item no., Rm no. and Name	Existing Architectural Barrier and Proposed Solution	Codes / Mitigation Info	Qty	Unit	Cost	Total
1863	<ul style="list-style-type: none"> <i>As-Built Description:</i> Drinking fountain lacks protection for visually impaired persons. <i>Proposed Solution:</i> Provide cane-detectable rails. 	PCODE IA05C ADAAG 91 4.4.1 ADA 2010 307.2 CBC 2007 1115B.4.6.3 CBC 2019 11B-307.2 Mitigated: <input type="radio"/> YES <input checked="" type="radio"/> NO	8	JOB	\$1,500	\$12,000

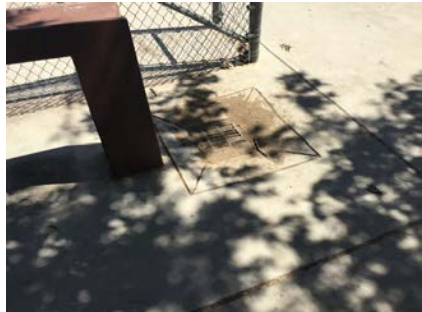
1864	<ul style="list-style-type: none"> <i>As-Built Description:</i> Walk: Grating has grid openings greater than 1/2" along the line of traffic flow. <i>As-Built:</i> 1.0" x 4.0" <i>Proposed Solution:</i> Provide new grating, with grid openings 1/2" max. along the line of traffic flow. 	PCODE EF04 ADAAG 91 4.3.6; 4.5.4 ADA 2010 403.2; 302.3 CBC 2007 1133B.7.2 CBC 2019 11B-403.2; 11B-302.3 Mitigated: <input type="radio"/> YES <input checked="" type="radio"/> NO	8	SF	\$240	\$1,920

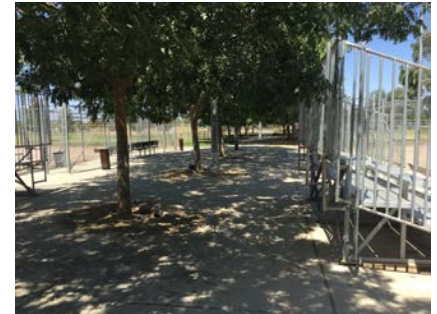
1859	<ul style="list-style-type: none"> <i>As-Built Description:</i> Protruding objects more than 4" from wall, when bottom of object more than 27" or less than 80" above finished floor. <i>Proposed Solution:</i> Trim vegetation. 	<p>PCODE EG04 ADAAG 91 4.4.1 ADA 2010 307.2 CBC 2007 1133B.8.6.1 CBC 2019 11B-307.2</p> <p>Mitigated: <input type="radio"/> YES <input checked="" type="radio"/> NO</p>	10	JOB	\$300	\$3,000
------	--	---	----	-----	-------	---------

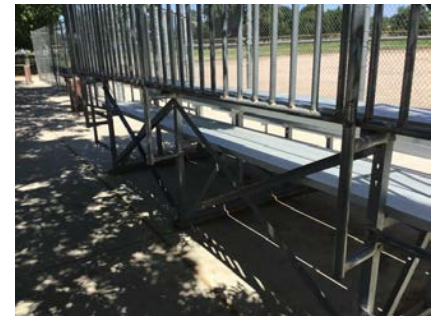
1860	<ul style="list-style-type: none"> <i>As-Built Description:</i> Protruding objects more than 4" from wall, when bottom of object more than 27" or less than 80" above finished floor. <i>As-Built:</i> Bleacher: 9.0" at 47.0" high <i>Proposed Solution:</i> Add cane detection. 	<p>PCODE EG04 ADAAG 91 4.4.1 ADA 2010 307.2 CBC 2007 1133B.8.6.1 CBC 2019 11B-307.2</p> <p>Mitigated: <input type="radio"/> YES <input checked="" type="radio"/> NO</p>	4	JOB	\$300	\$1,200
------	---	---	---	-----	-------	---------

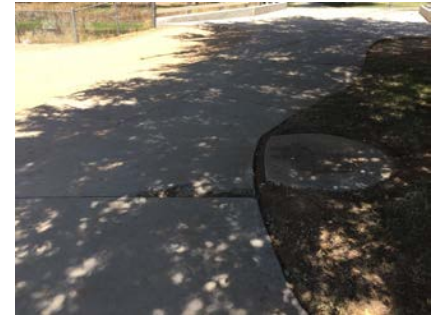
- 1871
- *As-Built Description:*
Walk: Pavement dislocation creates abrupt change in level exceeding 1/2" in accessible route.
 - *As-Built:* **Up to 2.0"**
 - *Proposed Solution:*
Remove, replace or repair area of pavement sufficient to correct abrupt change in level.

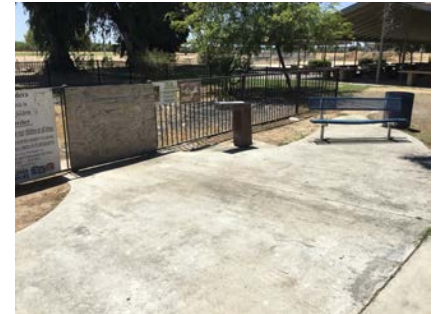
1918	<ul style="list-style-type: none"> <i>As-Built Description:</i> Where only one drinking fountain is provided per floor: Fountain is not accessible to individuals who use wheelchairs, or to those who have difficulty bending or stooping. <i>Proposed Solution:</i> Provide additional fountain or hi-lo combination fountain. 	<p>PCODE IA01A ADAAG 91 4.1.3(10)(a) ADA 2010 211.1 CBC 2007 1115B.4.6.1 CBC 2019 11B-211.1</p> <p>Mitigated: <input type="radio"/> YES <input checked="" type="radio"/> NO</p>	1	JOB	\$6,000	\$6,000
------	--	---	---	-----	---------	---------

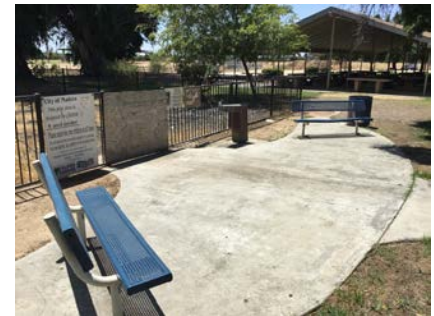
1917	<ul style="list-style-type: none"> <i>As-Built Description:</i> Drinking fountain lacks protection for visually impaired persons. <i>Proposed Solution:</i> Provide cane-detectable rails. 	<p>PCODE IA05C ADAAG 91 4.4.1 ADA 2010 307.2 CBC 2007 1115B.4.6.3 CBC 2019 11B-307.2</p> <p>Mitigated: <input type="radio"/> YES <input checked="" type="radio"/> NO</p>	1	JOB	\$1,500	\$1,500
------	--	--	---	-----	---------	---------

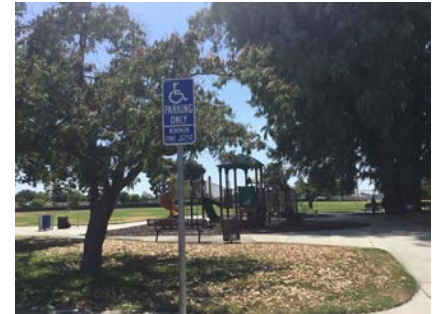
- 1973
- *As-Built Description:*
Sign for accessible parking space is missing or non-compliant.
 - *Proposed Solution:*
Provide compliant parking signage.
 - *Notes:*

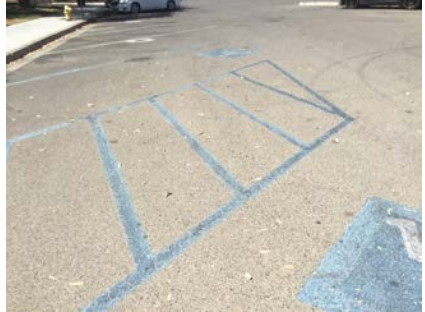
Item no., Rm no. and Name	Existing Architectural Barrier and Proposed Solution	Codes / Mitigation Info	Qty	Unit	Cost	Total
1971	<ul style="list-style-type: none"> As-Built Description: The words "NO PARKING" not painted on the ground within loading and unloading access aisle (12" min high white letters), located so that it is visible to traffic enforcement officials (required in CA only). Proposed Solution: Provide the words "NO PARKING" in each access aisle, painted in 12" high letters, when altering area. 	PCODE EA04D CBC 2007 1129B.3.1 CBC 2019 11B-502.3.3 Mitigated: <input type="radio"/> YES <input checked="" type="radio"/> NO	1	JOB	\$300	\$300

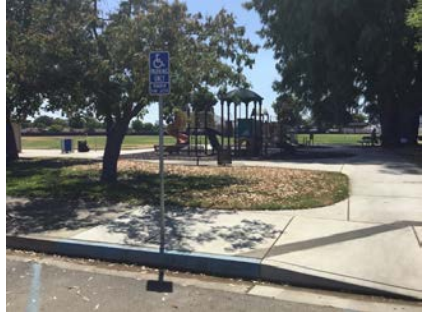
1974	<ul style="list-style-type: none"> As-Built Description: No "Tow Away" sign at parking lot entrance (required in CA only). Proposed Solution: Provide "Tow Away" sign at parking lot entrance when altering area. 	PCODE EA04C CBC 2007 1129B.4 CBC 2019 11B-502.8.2 Mitigated: <input type="radio"/> YES <input checked="" type="radio"/> NO	1	JOB	\$975	\$975

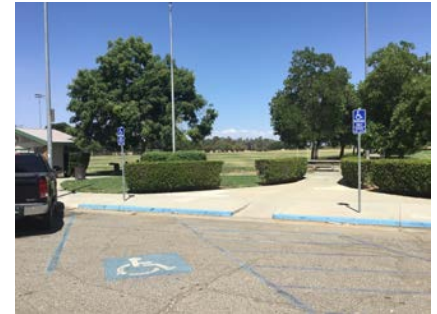
- 1975
- *As-Built Description:*
Sign for accessible parking space is missing or non-compliant.
 - *Proposed Solution:*
Provide compliant parking signage.
 - *Notes:*

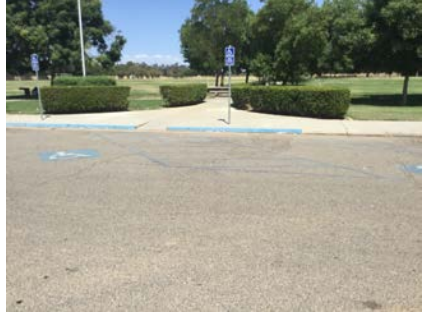
Consider straight in parking.

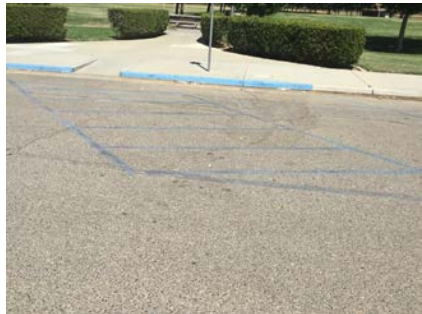
1976	<ul style="list-style-type: none"> As-Built Description: The words "NO PARKING" not painted on the ground within loading and unloading access aisle (12" min high white letters), located so that it is visible to traffic enforcement officials (required in CA only). Proposed Solution: Provide the words "NO PARKING" in each access aisle, painted in 12" high letters, when altering area. 	<p>PCODE EA04D CBC 2007 1129B.3.1 CBC 2019 11B-502.3.3</p> <p>Mitigated: <input type="radio"/> YES <input checked="" type="radio"/> NO</p>	1	JOB	\$300	\$300
------	--	--	---	-----	-------	-------

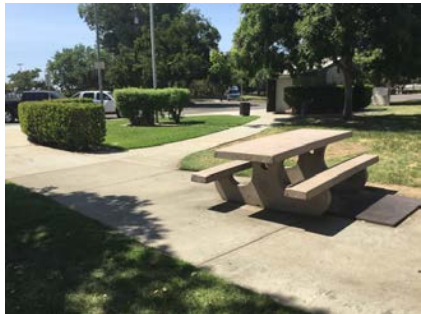
1981	<ul style="list-style-type: none"> <i>As-Built Description:</i> Walk more than 36" but less than 48" wide (required in CA only). <i>As-Built:</i> 44.0" wide at picnic table. <i>Proposed Solution:</i> Enlarge width of walk to 48". <i>Notes:</i> 	<p>PCODE EF08</p> <p>CBC 2007 1133B.7.1</p> <p>CBC 2019 11B-403.5.1.3</p> <p>Mitigated:</p> <p><input type="radio"/> YES</p> <p><input checked="" type="radio"/> NO</p>	5	SF	\$135	\$675
------	--	---	---	----	-------	-------

The table appears to temporarily cover a hole.

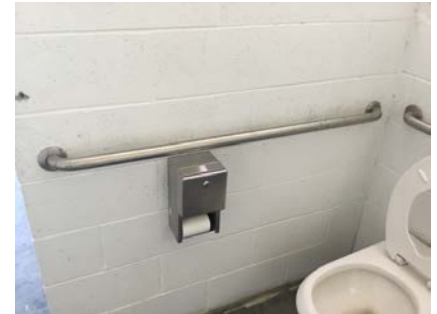
Grab Bars

1845	<ul style="list-style-type: none"> As-Built Description: Side grab bar less than 42" long, or located more than 12 inches max. from the rear wall, or extending less than 54" from rear wall (CA only: front end min. 24" in front of water closet). As-Built: Extends 52.0" Proposed Solution: Provide or relocate accessible side grab bar. 	<p>PCODE WB07A ADAAG 91 Fig. 29(b) ADA 2010 604.5.1 CBC 2007 1115B.4.1.3.1 CBC 2019 11B-604.5.1</p> <p>Mitigated: <input type="radio"/> YES <input checked="" type="radio"/> NO</p>	1	JOB	\$780	\$780
------	---	--	---	-----	-------	-------

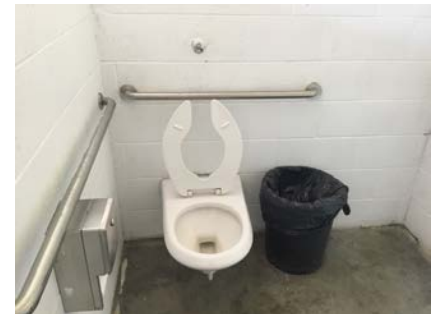
1844	<ul style="list-style-type: none"> As-Built Description: The rear wall grab is less than 36" min. or does not extend from the centerline of the water closet 12" min. on one side and 24" min. on the other side. As-Built: Extends 22.5" on wide side Proposed Solution: Provide or relocate accessible rear grab bar. Notes: 	<p>PCODE WB07B ADAAG 91 4.17.6 ADA 2010 604.5.2 CBC 2007 1115B.4.1.3.2 CBC 2019 11B-604.5.2</p> <p>Mitigated: <input type="radio"/> YES <input checked="" type="radio"/> NO</p>	1	JOB	\$1,020	\$1,020
------	---	--	---	-----	---------	---------

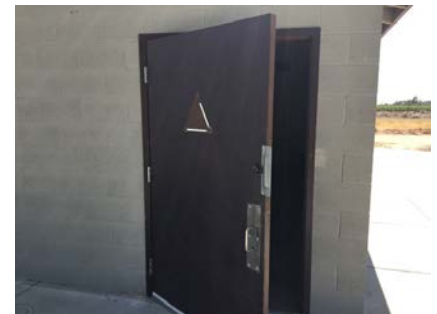
- 1841
- *As-Built Description:*
Entrance to toilet or bathing facility not identified with ADAAG compliant signage.
 - *Proposed Solution:*
Provide ADA compliant sign mounted at 48" min. above to baseline of the lowest Braille cells and 60" max. to baseline of the highest line of raised characters on nearest adjacent wall, on latch side of a single door (located not to cause a Braille reader to stand within the door swing).

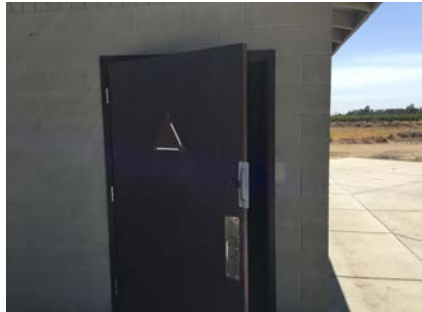
Item no., Rm no. and Name	Existing Architectural Barrier and Proposed Solution	Codes / Mitigation Info	Qty	Unit	Cost	Total
1840	<ul style="list-style-type: none"> As-Built Description: Required in CA only: identification symbol centered 58" to 60" high on sanitary facility door that contrasts with the door not provided (women: 12" ø circle, men: 12" triangle, unisex: combined symbol). Proposed Solution: Provide properly mounted sanitary facility symbol when altering area. If wheelchair accessible, include International Symbol of Accessibility on sign. 	PCODE SA15 CBC 2007 1115B.6 CBC 2019 11B-703.7.2.6 Mitigated: <input type="radio"/> YES <input checked="" type="radio"/> NO	1	JOB	\$270	\$270

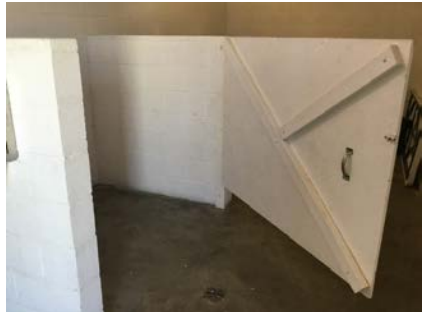
Stall Door

1846	<ul style="list-style-type: none"> As-Built Description: Stall door to accessible compartment not self closing. Proposed Solution: Adjust closer. 	PCODE WB05B ADAAG 91 4.22.4 ADA 2010 604.8.1.2 CBC 2007 1115B.3.1.4.4 CBC 2019 11B-604.8.1.2 Mitigated: <input type="radio"/> YES <input checked="" type="radio"/> NO	1	JOB	\$75	\$75

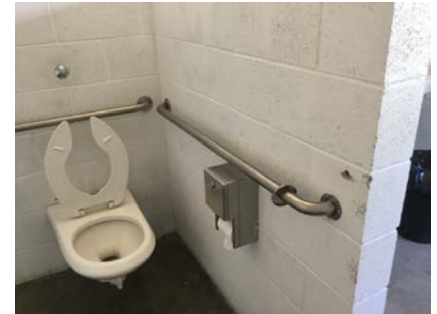
Grab Bars

1855	<ul style="list-style-type: none"> <i>As-Built Description:</i> Side grab bar less than 42" long, or located more than 12 inches max. from the rear wall, or extending less than 54" from rear wall (CA only: front end min. 24" in front of water closet). <i>As-Built:</i> Extends 52.0" <i>Proposed Solution:</i> Provide or relocate accessible side grab bar. 	<p>PCODE WB07A ADAAG 91 Fig. 29(b) ADA 2010 604.5.1 CBC 2007 1115B.4.1.3.1 CBC 2019 11B-604.5.1</p> <p>Mitigated: <input type="radio"/> YES <input checked="" type="radio"/> NO</p>	1	JOB	\$780	\$780
------	--	--	---	-----	-------	-------

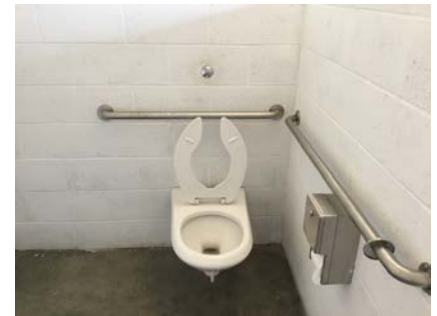
1856	<ul style="list-style-type: none"> <i>As-Built Description:</i> The rear wall grab is less than 36" min. or does not extend from the centerline of the water closet 12" min. on one side and 24" min. on the other side. <i>As-Built:</i> Extends 22.0" on wide side <i>Proposed Solution:</i> Provide or relocate accessible rear grab bar. <i>Notes:</i> 	<p>PCODE WB07B ADAAG 91 4.17.6 ADA 2010 604.5.2 CBC 2007 1115B.4.1.3.2 CBC 2019 11B-604.5.2</p> <p>Mitigated: <input type="radio"/> YES <input checked="" type="radio"/> NO</p>	1	JOB	\$1,020	\$1,020
------	---	--	---	-----	---------	---------

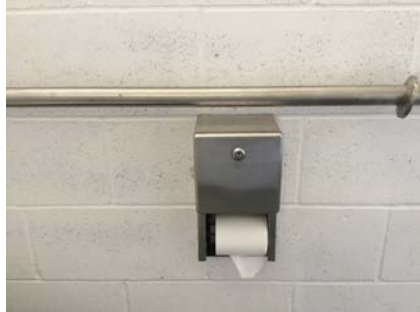
Item no., Rm no. and Name	Existing Architectural Barrier and Proposed Solution	Codes / Mitigation Info	Qty	Unit	Cost	Total
1857	<ul style="list-style-type: none"> <i>As-Built Description:</i> Accessories/dispensers in accessible stall located closer than 1-1/2" below or 12" above grab bar impedes its use. <i>As-Built:</i> TPD: 1.0" below grab bar <i>Proposed Solution:</i> Relocate accessories/dispensers within applicable reach range and to be no closer than 1-1/2" below and 12" above grab bars (except if accessories are recessed, flush with wall, and have no sharp edges). 	PCODE WB07I ADAAG 91 4.26.2 ADA 2010 609.3 CBC 2007 1133B.4.2.5 CBC 2019 11B-609.3 Mitigated: <input type="radio"/> YES <input checked="" type="radio"/> NO	1	JOB	\$225	\$225

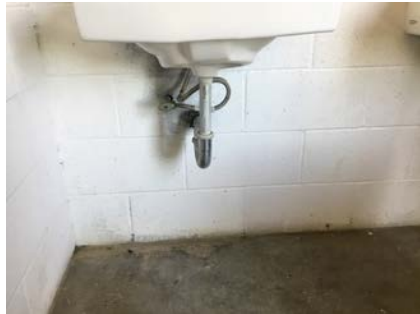
Lavatory

1851	<ul style="list-style-type: none"> <i>As-Built Description:</i> Hot or sharp-surfaced water/drain pipe not insulated or covered. <i>Proposed Solution:</i> Insulate or cover water/drain pipe. 	PCODE WD05 ADAAG 91 4.19.4 ADA 2010 606.5 CBC 2007 1115B.4.3.4 CBC 2019 11B-606.5 Mitigated: <input type="radio"/> YES <input checked="" type="radio"/> NO	1	JOB	\$360	\$360

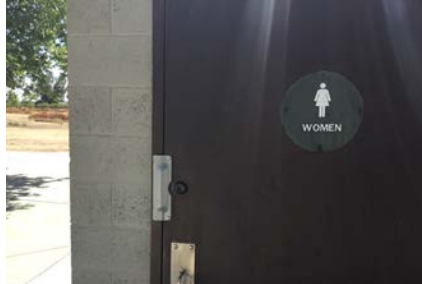
Signage

<p>1849</p> <ul style="list-style-type: none"> <i>As-Built Description:</i> Entrance to toilet or bathing facility not identified with ADAAG compliant signage. <i>Proposed Solution:</i> Provide ADA compliant sign mounted at 48" min. above to baseline of the lowest Braille cells and 60" max. to baseline of the highest line of raised characters on nearest adjacent wall, on latch side of a single door (located not to cause a Braille reader to stand within the door swing). 	<p>PCODE SA11A ADAAG 91 4.1.3(16)(a) ADA 2010 216.8 CBC 2019 11B-216.8</p> <p>Mitigated: <input type="radio"/> YES <input checked="" type="radio"/> NO</p>	<p>1 JOB \$270 \$270</p>

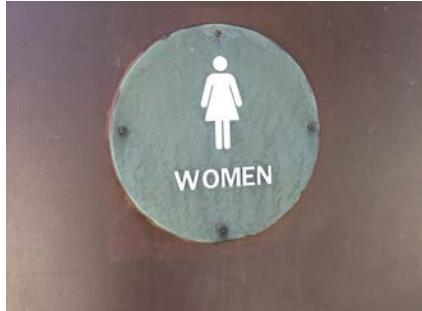
<p>1850</p> <ul style="list-style-type: none"> <i>As-Built Description:</i> Required in CA only: identification symbol centered 58" to 60" high on sanitary facility door that contrasts with the door not provided (women: 12" ø circle, men: 12" triangle, unisex: combined symbol). <i>As-Built:</i> 61.5" <i>Proposed Solution:</i> Provide properly mounted sanitary facility symbol when altering area. If wheelchair accessible, include International Symbol of Accessibility on sign. 	<p>PCODE SA15 CBC 2007 1115B.6 CBC 2019 11B-703.7.2.6</p> <p>Mitigated: <input type="radio"/> YES <input checked="" type="radio"/> NO</p>	<p>1 JOB \$270 \$270</p>

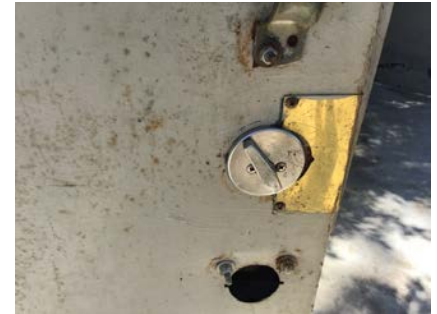
- 1884
- *As-Built Description:*
Door lock, latch or handle less than 34" or more than 48" above the floor (CA only: 34" to 44").
 - *As-Built:* **48.0" high**
 - *Proposed Solution:*
Relocate or replace existing hardware.
 - *Notes:*

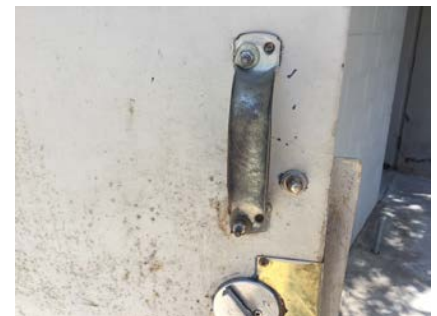
- 1885
- *As-Built Description:*
Door lock, latch or handle less than 34" or more than 48" above the floor (CA only: 34" to 44").
 - *As-Built:* **53.0" high**
 - *Proposed Solution:*
Relocate or replace existing hardware.

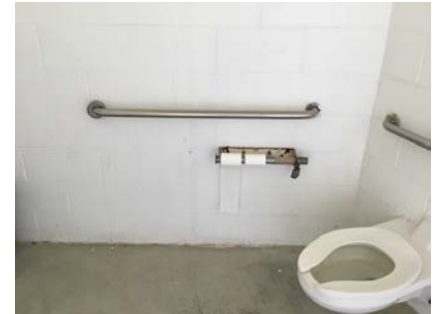
Grab Bars

1881	<ul style="list-style-type: none"> <i>As-Built Description:</i> Side grab bar less than 42" long, or located more than 12 inches max. from the rear wall, or extending less than 54" from rear wall (CA only: front end min. 24" in front of water closet). <i>As-Built:</i> Extends 52.0" <i>Proposed Solution:</i> Provide or relocate accessible side grab bar. 	PCODE WB07A ADAAG 91 Fig. 29(b) ADA 2010 604.5.1 CBC 2007 1115B.4.1.3.1 CBC 2019 11B-604.5.1	1	JOB	\$780	\$780
------	--	---	---	-----	-------	-------

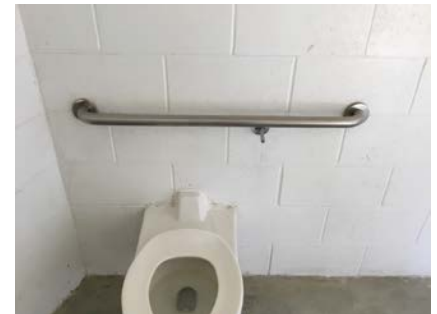
1880	<ul style="list-style-type: none"> <i>As-Built Description:</i> The rear wall grab is less than 36" min. or does not extend from the centerline of the water closet 12" min. on one side and 24" min. on the other side. <i>As-Built:</i> Extends 23.0" on wide side <i>Proposed Solution:</i> Provide or relocate accessible rear grab bar. <i>Notes:</i> 	PCODE WB07B ADAAG 91 4.17.6 ADA 2010 604.5.2 CBC 2007 1115B.4.1.3.2 CBC 2019 11B-604.5.2	1	JOB	\$1,020	\$1,020
------	---	---	---	-----	---------	---------

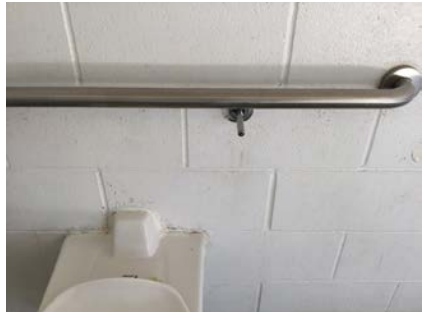
Item no., Rm no. and Name	Existing Architectural Barrier and Proposed Solution	Codes / Mitigation Info	Qty	Unit	Cost	Total
1883	<ul style="list-style-type: none"> As-Built Description: Accessories/dispensers in accessible stall located closer than 1-1/2" below or 12" above grab bar impedes its use. As-Built: Flush control: 1.3" below grab bar Proposed Solution: Raise the grab bar. 	PCODE WB07I ADAAG 91 4.26.2 ADA 2010 609.3 CBC 2007 1133B.4.2.5 CBC 2019 11B-609.3 Mitigated: <input type="radio"/> YES <input checked="" type="radio"/> NO	1	JOB	\$225	\$225

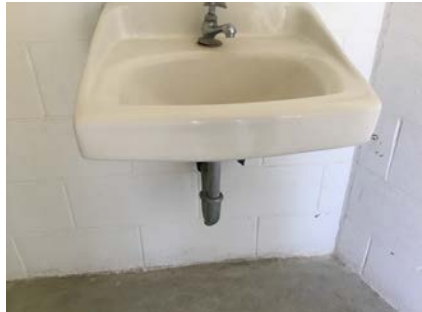
Lavatory

1877	<ul style="list-style-type: none"> As-Built Description: Wheelchair clearance under lavatory apron or lavatory counter front edge less than 29" high. As-Built: 28.7" high Proposed Solution: Remount compliant fixture to accessible height. Notes: 	PCODE WD03A ADAAG 91 4.19.2 ADA 2010 606.3 CBC 2007 1115B.4.3.3 CBC 2019 11B-306.3.1 Mitigated: <input type="radio"/> YES <input checked="" type="radio"/> NO	1	JOB	\$3,000	\$3,000

This element complies with 1991 ADAAG and the 2010 ADAS. The dimensional requirements in this CBC citation applied from the 2007 CBC to the code cycle at the time of this survey

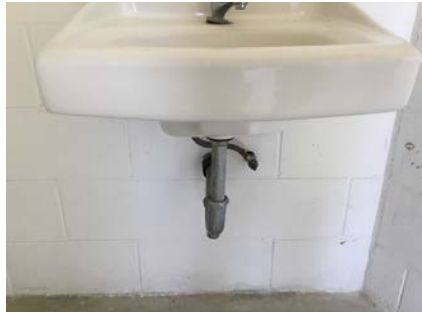
Item no., Rm no. and Name	Existing Architectural Barrier and Proposed Solution	Codes / Mitigation Info	Qty	Unit	Cost	Total
1878	<ul style="list-style-type: none"> <i>As-Built Description:</i> Hot or sharp-surfaced water/drain pipe not insulated or covered. <i>Proposed Solution:</i> Insulate or cover water/drain pipe. 	PCODE WD05 ADAAG 91 4.19.4 ADA 2010 606.5 CBC 2007 1115B.4.3.4 CBC 2019 11B-606.5 Mitigated: <input type="radio"/> YES <input checked="" type="radio"/> NO	1	JOB	\$360	\$360

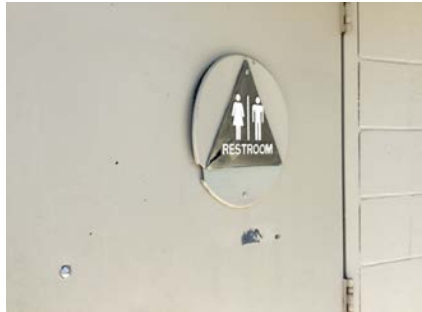
Item no., Rm no. and Name	Existing Architectural Barrier and Proposed Solution	Codes / Mitigation Info	Qty	Unit	Cost	Total
1876	<ul style="list-style-type: none"> <i>As-Built Description:</i> Required in CA only: identification symbol centered 58" to 60" high on sanitary facility door that contrasts with the door not provided (women: 12" ø circle, men: 12" triangle, unisex: combined symbol). <i>As-Built:</i> Not contrast. 64.0" high o.c. <i>Proposed Solution:</i> Provide properly mounted sanitary facility symbol when altering area. If wheelchair accessible, include International Symbol of Accessibility on sign. 	PCODE SA15 CBC 2007 1115B.6 CBC 2019 11B-703.7.2.6 Mitigated: <input type="radio"/> YES <input checked="" type="radio"/> NO	1	JOB	\$270	\$270

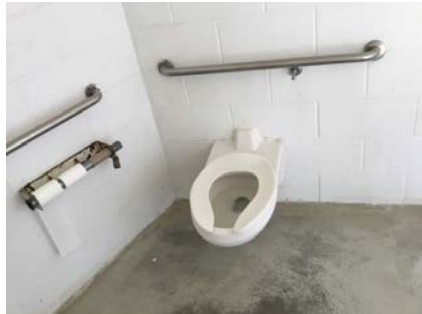
Water Closet

1879	<ul style="list-style-type: none"> <i>As-Built Description:</i> Water closet not 16"-18" (CA: 17"-18") from near side wall to center line of water closet (2010 ADAAG: 16"-18"). <i>As-Built:</i> 19.0" to 26.0" due to diagonal wall. <i>Proposed Solution:</i> Relocate existing water closet and plumbing, remount with offset closet flange to provide 18" max. from side wall. Adjust side wall as needed. 	PCODE WB02C ADAAG 91 Fig. 28 ADA 2010 604.2 CBC 2007 1115B.4.1.1 CBC 2019 11B-604.2 Mitigated: <input type="radio"/> YES <input checked="" type="radio"/> NO	1	JOB	\$3,000	\$3,000
------	---	---	---	-----	---------	---------

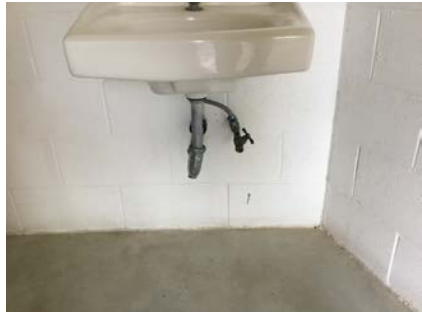
Item no., Rm no. and Name	Existing Architectural Barrier and Proposed Solution	Codes / Mitigation Info	Qty	Unit	Cost	Total
1895	<ul style="list-style-type: none"> <i>As-Built Description:</i> Hot or sharp-surfaced water/drain pipe not insulated or covered. <i>Proposed Solution:</i> Insulate or cover water/drain pipe. 	PCODE WD05 ADAAG 91 4.19.4 ADA 2010 606.5 CBC 2007 1115B.4.3.4 CBC 2019 11B-606.5 Mitigated: <input type="radio"/> YES <input checked="" type="radio"/> NO	1	JOB	\$360	\$360

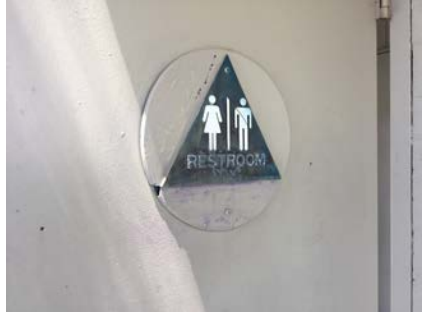
Item no., Rm no. and Name	Existing Architectural Barrier and Proposed Solution	Codes / Mitigation Info	Qty	Unit	Cost	Total
1889	<ul style="list-style-type: none"> <i>As-Built Description:</i> Required in CA only: identification symbol centered 58" to 60" high on sanitary facility door that contrasts with the door not provided (women: 12" ø circle, men: 12" triangle, unisex: combined symbol). <i>As-Built:</i> Not contrast 65.0" high o.c. <i>Proposed Solution:</i> Provide properly mounted sanitary facility symbol when altering area. If wheelchair accessible, include International Symbol of Accessibility on sign. 	PCODE SA15 CBC 2007 1115B.6 CBC 2019 11B-703.7.2.6 Mitigated: <input type="radio"/> YES <input checked="" type="radio"/> NO	1	JOB	\$270	\$270

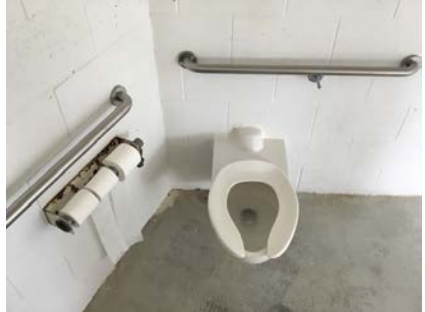
Water Closet

1892	<ul style="list-style-type: none"> <i>As-Built Description:</i> Water closet not 16"-18" (CA: 17"-18") from near side wall to center line of water closet (2010 ADAAG: 16"-18"). <i>As-Built:</i> 16.75" to 26.0" o.c. <i>Proposed Solution:</i> Relocate existing water closet and plumbing, remount with offset closet flange to provide 18" max. from side wall. Adjust wall as needed. 	PCODE WB02C ADAAG 91 Fig. 28 ADA 2010 604.2 CBC 2007 1115B.4.1.1 CBC 2019 11B-604.2 Mitigated: <input type="radio"/> YES <input checked="" type="radio"/> NO	1	JOB	\$3,000	\$3,000

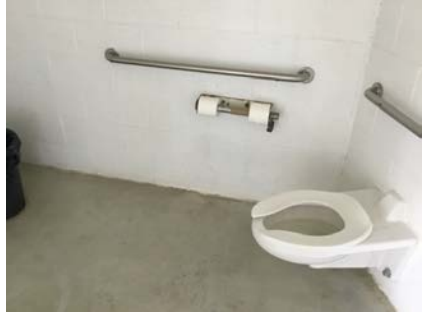
Grab Bars

<p>1901</p> <ul style="list-style-type: none"> <i>As-Built Description:</i> Side grab bar less than 42" long, or located more than 12 inches max. from the rear wall, or extending less than 54" from rear wall (CA only: front end min. 24" in front of water closet). <i>As-Built:</i> Extends 51.0" <i>Proposed Solution:</i> Provide or relocate accessible side grab bar. 	<p>PCODE WB07A ADAAG 91 Fig. 29(b) ADA 2010 604.5.1 CBC 2007 1115B.4.1.3.1 CBC 2019 11B-604.5.1</p> <p>Mitigated: <input type="radio"/> YES <input checked="" type="radio"/> NO</p>	<p>1 JOB \$780 \$780</p>

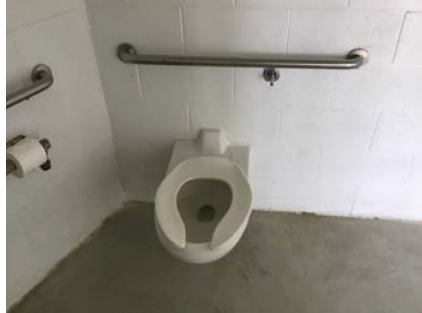
<p>1902</p> <ul style="list-style-type: none"> <i>As-Built Description:</i> The rear wall grab is less than 36" min. or does not extend from the centerline of the water closet 12" min. on one side and 24" min. on the other side. <i>As-Built:</i> Extends 22.0" on wide side <i>Proposed Solution:</i> Provide or relocate accessible rear grab bar. <i>Notes:</i> 	<p>PCODE WB07B ADAAG 91 4.17.6 ADA 2010 604.5.2 CBC 2007 1115B.4.1.3.2 CBC 2019 11B-604.5.2</p> <p>Mitigated: <input type="radio"/> YES <input checked="" type="radio"/> NO</p>	<p>1 JOB \$1,020 \$1,020</p>

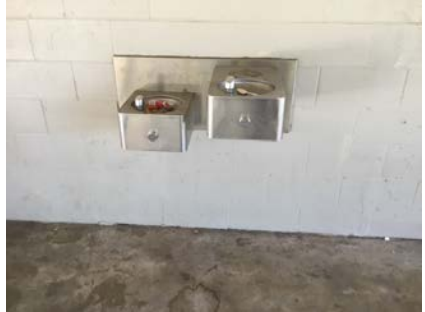
Item no., Rm no. and Name	Existing Architectural Barrier and Proposed Solution	Codes / Mitigation Info	Qty	Unit	Cost	Total
1913	<ul style="list-style-type: none"> <i>As-Built Description:</i> Drinking fountain lacks protection for visually impaired persons. <i>Proposed Solution:</i> Provide cane-detectable rails. 	PCODE IA05C ADAAG 91 4.4.1 ADA 2010 307.2 CBC 2007 1115B.4.6.3 CBC 2019 11B-307.2 Mitigated: <input type="radio"/> YES <input checked="" type="radio"/> NO	1	JOB	\$1,500	\$1,500

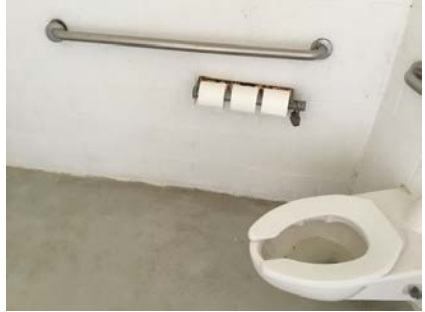
Grab Bars

1907	<ul style="list-style-type: none"> <i>As-Built Description:</i> Side grab bar less than 42" long, or located more than 12 inches max. from the rear wall, or extending less than 54" from rear wall (CA only: front end min. 24" in front of water closet). <i>As-Built:</i> Extends 51.0" <i>Proposed Solution:</i> Provide or relocate accessible side grab bar. 	PCODE WB07A ADAAG 91 Fig. 29(b) ADA 2010 604.5.1 CBC 2007 1115B.4.1.3.1 CBC 2019 11B-604.5.1 Mitigated: <input type="radio"/> YES <input checked="" type="radio"/> NO	1	JOB	\$780	\$780

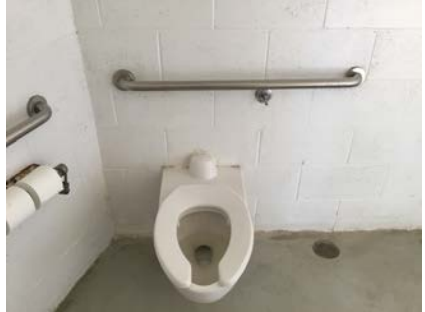
Item no., Rm no. and Name	Existing Architectural Barrier and Proposed Solution	Codes / Mitigation Info	Qty	Unit	Cost	Total
1905	<ul style="list-style-type: none"> <i>As-Built Description:</i> The rear wall grab is less than 36" min. or does not extend from the centerline of the water closet 12" min. on one side and 24" min. on the other side. <i>As-Built:</i> Extends 22.5" on wide side <i>Proposed Solution:</i> Provide or relocate accessible rear grab bar. 	PCODE WB07B ADAAG 91 4.17.6 ADA 2010 604.5.2 CBC 2007 1115B.4.1.3.2 CBC 2019 11B-604.5.2 Mitigated: <input type="radio"/> YES <input checked="" type="radio"/> NO	1	JOB	\$1,020	\$1,020

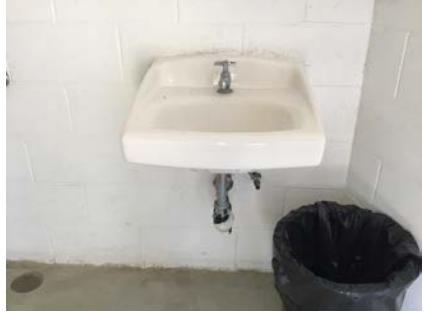
Lavatory

1909	<ul style="list-style-type: none"> <i>As-Built Description:</i> Wheelchair clearance under lavatory apron or lavatory counter front edge less than 29" high. <i>As-Built:</i> 28.8" high <i>Proposed Solution:</i> Remount compliant fixture to accessible height. Notes: 	PCODE WD03A ADAAG 91 4.19.2 ADA 2010 606.3 CBC 2007 1115B.4.3.3 CBC 2019 11B-306.3.1 Mitigated: <input type="radio"/> YES <input checked="" type="radio"/> NO	1	JOB	\$3,000	\$3,000

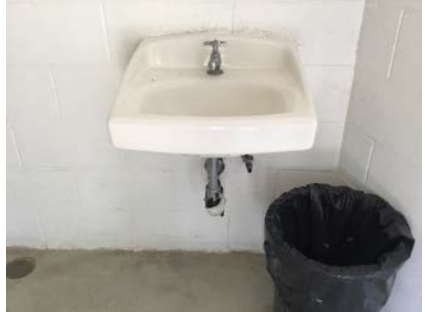
Item no., Rm no. and Name	Existing Architectural Barrier and Proposed Solution	Codes / Mitigation Info	Qty	Unit	Cost	Total
1908	<ul style="list-style-type: none"> <i>As-Built Description:</i> Hot or sharp-surfaced water/drain pipe not insulated or covered. <i>Proposed Solution:</i> Insulate or cover water/drain pipe. 	PCODE WD05 ADAAG 91 4.19.4 ADA 2010 606.5 CBC 2007 1115B.4.3.4 CBC 2019 11B-606.5 Mitigated: <input type="radio"/> YES <input checked="" type="radio"/> NO	1	JOB	\$360	\$360

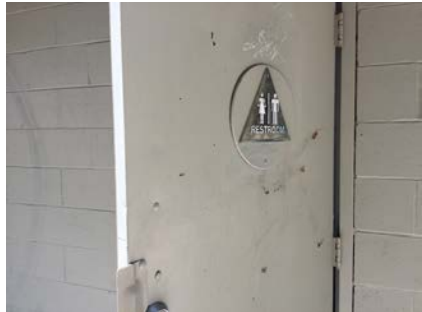
Item no., Rm no. and Name	Existing Architectural Barrier and Proposed Solution	Codes / Mitigation Info	Qty	Unit	Cost	Total
1911	<ul style="list-style-type: none"> <i>As-Built Description:</i> Required in CA only: identification symbol centered 58" to 60" high on sanitary facility door that contrasts with the door not provided (women: 12" ø circle, men: 12" triangle, unisex: combined symbol). <i>As-Built:</i> Not contrast. 65.0" high o.c. <i>Proposed Solution:</i> Provide properly mounted sanitary facility symbol when altering area. If wheelchair accessible, include International Symbol of Accessibility on sign. 	PCODE SA15 CBC 2007 1115B.6 CBC 2019 11B-703.7.2.6 Mitigated: <input type="radio"/> YES <input checked="" type="radio"/> NO	1	JOB	\$270	\$270

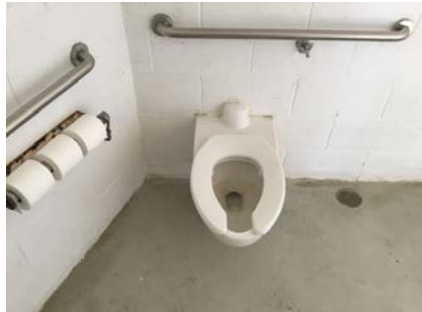
Water Closet

1906	<ul style="list-style-type: none"> <i>As-Built Description:</i> Water closet not 16"-18" (CA: 17"-18") from near side wall to center line of water closet (2010 ADAAG: 16"-18"). <i>As-Built:</i> 18.0" to 28.0" o.c. <i>Proposed Solution:</i> Relocate existing water closet and plumbing, remount with offset closet flange to provide 18" max. from side wall. Adjust wall as needed. 	PCODE WB02C ADAAG 91 Fig. 28 ADA 2010 604.2 CBC 2007 1115B.4.1.1 CBC 2019 11B-604.2 Mitigated: <input type="radio"/> YES <input checked="" type="radio"/> NO	1	JOB	\$3,000	\$3,000

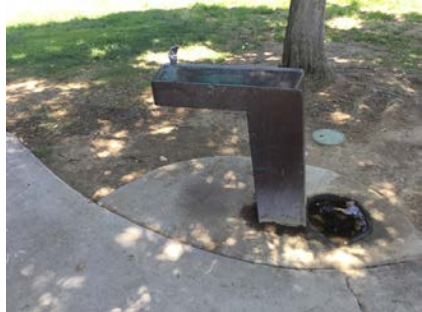
Drinking Fountain

1938	<ul style="list-style-type: none"> As-Built Description: Where only one drinking fountain is provided per floor: Fountain is not accessible to individuals who use wheelchairs, or to those who have difficulty bending or stooping. Proposed Solution: Provide additional fountain or hi-lo combination fountain. 	PCODE IA01A ADAAG 91 4.1.3(10)(a) ADA 2010 211.1 CBC 2007 1115B.4.6.1 CBC 2019 11B-211.1 Mitigated: <input type="radio"/> YES <input checked="" type="radio"/> NO	1	JOB	\$6,000	\$6,000

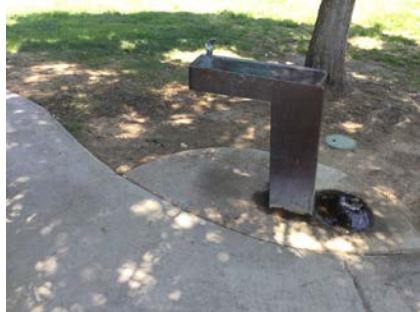
Item no., Rm no. and Name	Existing Architectural Barrier and Proposed Solution	Codes / Mitigation Info	Qty	Unit	Cost	Total
1939	<ul style="list-style-type: none"> <i>As-Built Description:</i> Drinking fountain lacks protection for visually impaired persons. <i>Proposed Solution:</i> Provide cane-detectable rails. 	PCODE IA05C ADAAG 91 4.4.1 ADA 2010 307.2 CBC 2007 1115B.4.6.3 CBC 2019 11B-307.2 Mitigated: <input type="radio"/> YES <input checked="" type="radio"/> NO	1	JOB	\$1,500	\$1,500

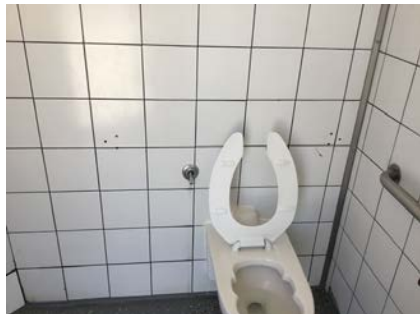
Grab Bars

1933	<ul style="list-style-type: none"> <i>As-Built Description:</i> Grab bars not provided or are not code compliant. <i>Proposed Solution:</i> Provide accessible grab bars. 	PCODE WB07 ADAAG 91 4.17.6 ADA 2010 604.5 CBC 2007 1115B.4.1.3 CBC 2019 11B-604.5 Mitigated: <input type="radio"/> YES <input checked="" type="radio"/> NO	1	JOB	\$1,500	\$1,500

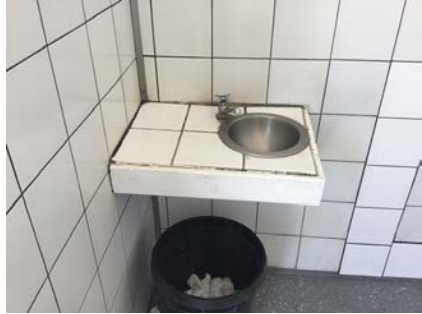
Lavatory

1936	<ul style="list-style-type: none"> <i>As-Built Description:</i> Clear floor space, 30" x 48" in front of fixture, extending 19" max. under the lavatory, not provided (CA only: Less than 18" from side wall to centerline of lavatory). <i>As-Built:</i> 17.25" o.c. <i>Proposed Solution:</i> Provide new accessible lavatory. Remodel restroom as needed. <i>Notes:</i> 	PCODE WD01 ADAAG 91 4.19.3 ADA 2010 606.2 CBC 2007 1115B.4.3 CBC 2019 11B-606.2, 11B-606.6 Mitigated: <input type="radio"/> YES <input checked="" type="radio"/> NO	1	JOB	\$3,000	\$3,000
------	---	---	---	-----	---------	----------------

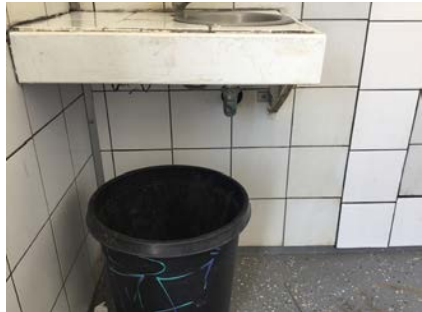
Item no., Rm no. and Name	Existing Architectural Barrier and Proposed Solution	Codes / Mitigation Info	Qty	Unit	Cost	Total
1935	<ul style="list-style-type: none"> <i>As-Built Description:</i> Hot or sharp-surfaced water/drain pipe not insulated or covered. <i>Proposed Solution:</i> Insulate or cover water/drain pipe. 	PCODE WD05 ADAAG 91 4.19.4 ADA 2010 606.5 CBC 2007 1115B.4.3.4 CBC 2019 11B-606.5 Mitigated: <input type="radio"/> YES <input checked="" type="radio"/> NO	1	JOB	\$360	\$360

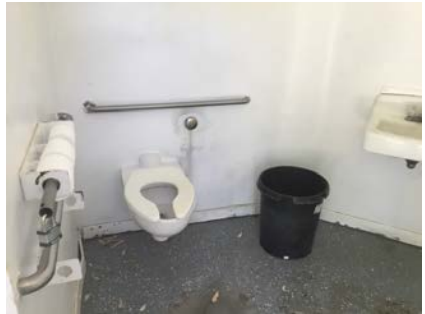
Item no., Rm no. and Name	Existing Architectural Barrier and Proposed Solution	Codes / Mitigation Info	Qty	Unit	Cost	Total
1961	<ul style="list-style-type: none"> As-Built Description: 60" min. clearance around a water closet measured perpendicular from the side wall not provided (Fixtures are not allowed to overlap this clearance). As-Built: 51.0" to diagonal wall Proposed Solution: Relocate adjacent fixture and remodel restroom as needed. 	PCODE WB01A ADA 2010 604.3.1; 604.3.2 CBC 2007 1115B.7.1.3 CBC 2019 11B-604.3.1; 11B-604.3.2 Mitigated: <input type="radio"/> YES <input checked="" type="radio"/> NO	1	JOB	\$3,000	\$3,000

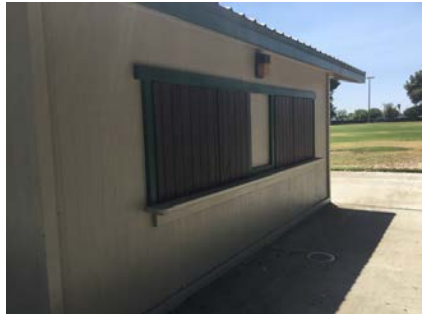
Tray Pass-thru

1962	<ul style="list-style-type: none"> As-Built Description: Food tray pass-thru at institutional cafeteria has lower edge higher than 34" above floor. As-Built: 36.0" high. Proposed Solution: Remodel pass-thru and counter to be 34" max. above floor. 	PCODE FB04 ADAAG 91 5.2 ADA 2010 902.3 CBC 2007 1122B.4 CBC 2019 11B-902.3 Mitigated: <input type="radio"/> YES <input checked="" type="radio"/> NO	15	JOB	\$9,900	\$148,500

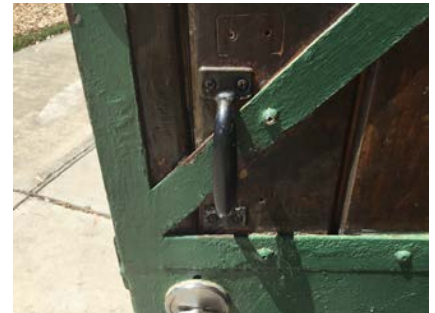
- 1952
- *As-Built Description:*
Door lock, latch or handle less than 34" or more than 48" above the floor (CA only: 34" to 44").
 - *As-Built:* **48.0" high**
 - *Proposed Solution:*
Relocate or replace existing hardware.
 - *Notes:*

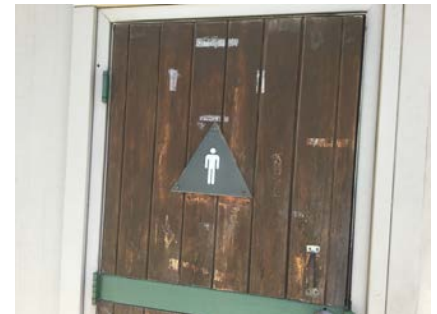
1951	<ul style="list-style-type: none"> <i>As-Built Description:</i> Required in CA only: identification symbol centered 58" to 60" high on sanitary facility door that contrasts with the door not provided (women: 12" ø circle, men: 12" triangle, unisex: combined symbol). <i>As-Built:</i> 61.0" high o.c. <i>Proposed Solution:</i> Provide properly mounted sanitary facility symbol when altering area. If wheelchair accessible, include International Symbol of Accessibility on sign. 	PCODE SA15 CBC 2007 1115B.6 CBC 2019 11B-703.7.2.6	1	JOB	\$270	\$270
------	--	--	---	-----	-------	-------

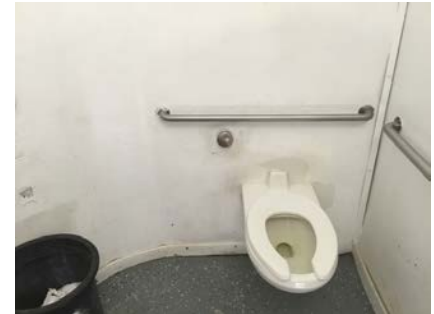
Toilet Stall

1955	<ul style="list-style-type: none"> As-Built Description: 60" min. clearance around a water closet measured perpendicular from the side wall not provided (Fixtures are not allowed to overlap this clearance). As-Built: 43.0" to diagonal wall. Proposed Solution: Remodel restroom. Notes: 	<p>PCODE WB01A</p> <p>ADA 2010 604.3.1; 604.3.2</p> <p>CBC 2007 1115B.7.1.3</p> <p>CBC 2019 11B-604.3.1; 11B-604.3.2</p> <p>Mitigated:</p> <p><input type="radio"/> YES</p> <p><input checked="" type="radio"/> NO</p>	1	JOB	\$3,000	\$3,000
------	---	--	---	-----	---------	---------

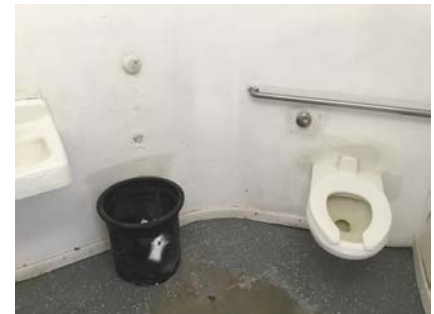
1956	<ul style="list-style-type: none"> As-Built Description: 60" min. clearance around a water closet measured perpendicular from the side wall not provided (Fixtures are not allowed to overlap this clearance). As-Built: 59.5" to lavatory Proposed Solution: Relocate adjacent fixture and remodel restroom as needed. Notes: 	<p>PCODE WB01A</p> <p>ADA 2010 604.3.1; 604.3.2</p> <p>CBC 2007 1115B.7.1.3</p> <p>CBC 2019 11B-604.3.1; 11B-604.3.2</p> <p>Mitigated:</p> <p><input type="radio"/> YES</p> <p><input checked="" type="radio"/> NO</p>	1	JOB	\$3,000	\$3,000
------	---	--	---	-----	---------	---------

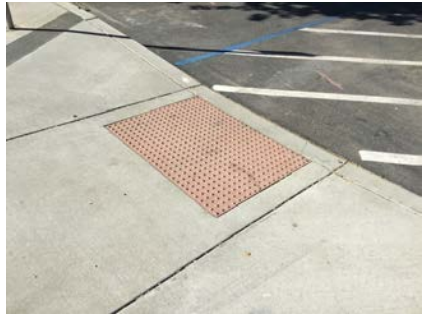
Domes 6.0” from sides.

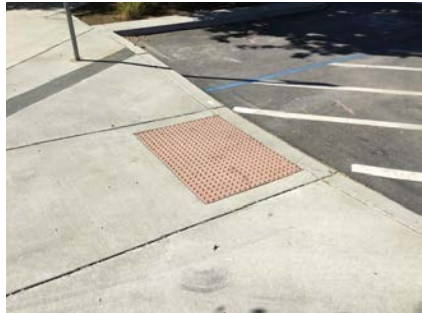
Detectable warning not contrast.

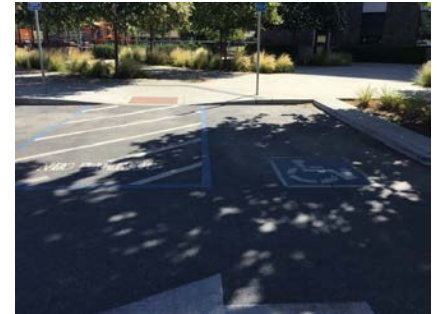
972	<ul style="list-style-type: none"> As-Built Description: Accessible parking space has slope greater than 1/4":12" (2%). As-Built: 5.0% Proposed Solution: Modify slope at accessible parking space. Notes: 	PCODE EA05 ADAAG 91 4.6.3 ADA 2010 502.4 CBC 2007 1129B.3.3 CBC 2019 11B-502.4 Mitigated: <input type="radio"/> YES <input checked="" type="radio"/> NO	30	SF	\$36	\$1,080
-----	---	--	----	----	------	---------

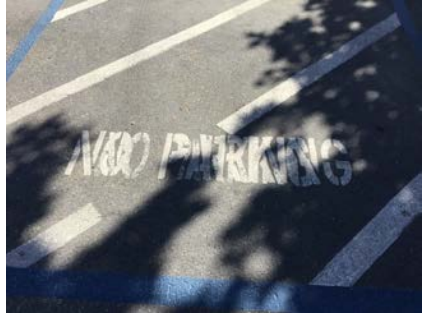
Illegible.

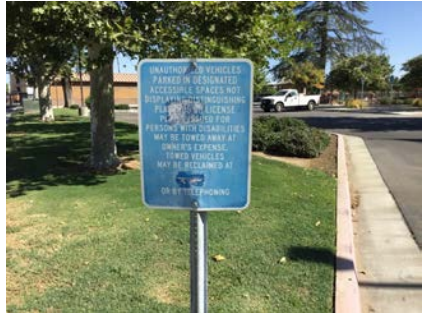
Info. Words obscured.

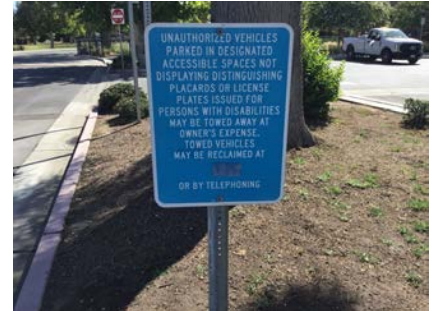
Item no., Rm no. and Name	Existing Architectural Barrier and Proposed Solution	Codes / Mitigation Info	Qty	Unit	Cost	Total
975	<ul style="list-style-type: none"> <i>As-Built Description:</i> No "Tow Away" sign at parking lot entrance (required in CA only). <i>Proposed Solution:</i> Provide "Tow Away" sign at parking lot entrance when altering area. <i>Notes:</i> 	<p>PCODE EA04C</p> <p>CBC 2007 1129B.4</p> <p>CBC 2019 11B-502.8.2</p> <p>Mitigated:</p> <p><input type="radio"/> YES</p> <p><input checked="" type="radio"/> NO</p>	1	JOB	\$975	\$975

Info. Size and color.

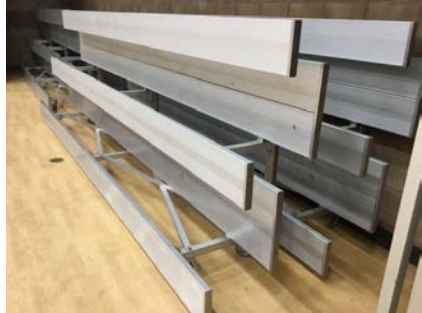
Fixed Seating

<p>977</p> <ul style="list-style-type: none"> <i>As-Built Description:</i> At least one fixed companion seat next to each wheelchair seating area is not provided. <i>Proposed Solution:</i> Provide one companion seat next to each accessible wheelchair space(s). Notes: 	<p>PCODE GE01B ADAAG 91 4.33.3 ADA 2010 221.3 CBC 2007 1104B.3.5 CBC 2019 11B-221.3</p> <p>Mitigated: <input type="radio"/> YES <input checked="" type="radio"/> NO</p>	<p>1 EA \$1,050 \$1,050</p>

No companion seat. Verify.

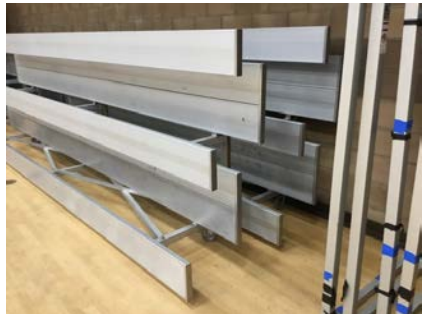
<p>976</p> <ul style="list-style-type: none"> <i>As-Built Description:</i> Proper amount of seating for disabled persons at public seating is not provided (>25=1; >50=2; >300=4; >500=6; +500=6=1%). <i>Proposed Solution:</i> Modify seating to provide clear and level wheelchair space 33" x 48" or 33" x 60", including companion seat, as required. Notes: 	<p>PCODE GE01NT ADAAG 91 4.1.2(19)a ADA 2010 221.2.1 CBC 2007 1104B.3.4.1 CBC 2019 11B-221.2.1</p> <p>Mitigated: <input type="radio"/> YES <input checked="" type="radio"/> NO</p>	<p>1 EA \$1,800 \$1,800</p>

No integral wheelchair seating. Verify.

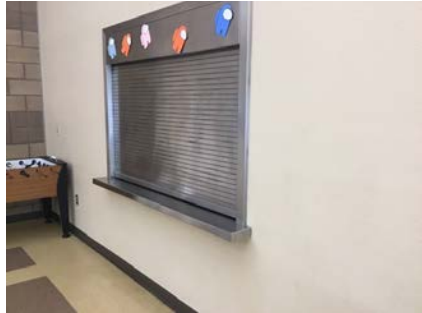
Item no., Rm no. and Name	Existing Architectural Barrier and Proposed Solution	Codes / Mitigation Info	Qty	Unit	Cost	Total
980	<ul style="list-style-type: none"> As-Built Description: Protruding objects more than 4" from wall, when bottom of object more than 27" or less than 80" above finished floor. As-Built: Service counter: 6.0" at 31.5" high Proposed Solution: Provide cane-detectable railing to mark area of low clearance. 	PCODE EG04A ADAAG 91 4.4.1 ADA 2010 307.2 CBC 2007 1133B.8.6.1 CBC 2019 11B-307.2 Mitigated: <input type="radio"/> YES <input checked="" type="radio"/> NO	7	LF	\$300	\$2,100

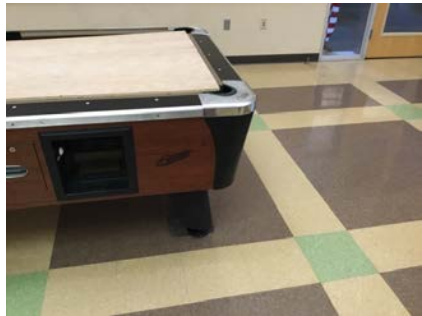
<input type="radio"/> Staff Only						
Priority <input checked="" type="radio"/> 2						
Severity <input checked="" type="radio"/> 3						
983	<ul style="list-style-type: none"> As-Built Description: Protruding objects more than 4" from wall, when bottom of object more than 27" or less than 80" above finished floor. As-Built: Pool table: 9.0" at 30.0" high Proposed Solution: Provide cane-detectable railing to mark area of low clearance. 	PCODE EG04A ADAAG 91 4.4.1 ADA 2010 307.2 CBC 2007 1133B.8.6.1 CBC 2019 11B-307.2 Mitigated: <input type="radio"/> YES <input checked="" type="radio"/> NO	24	LF	\$300	\$7,200

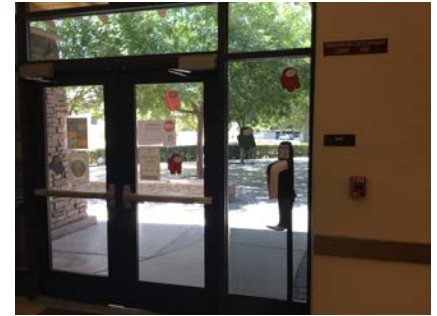
1017	<ul style="list-style-type: none"> <i>As-Built Description:</i> Sign not located on latch side of door and/or not located at 48" min. above to baseline of the lowest Braille cells and 60" max. to baseline of the highest line of raised characters. <i>As-Built:</i> Not adjacent <i>Proposed Solution:</i> Provide compliant signage including tactile characters and Grade II Braille on latch side of door located at compliant height. 	PCODE SA07 ADAAG 91 4.30.6 ADA 2010 703.4.1 CBC 2007 1117B.5.7 CBC 2019 11B-703.4.1 Mitigated: <input type="radio"/> YES <input checked="" type="radio"/> NO	1	JOB	\$150	\$150
------	---	---	---	-----	-------	-------

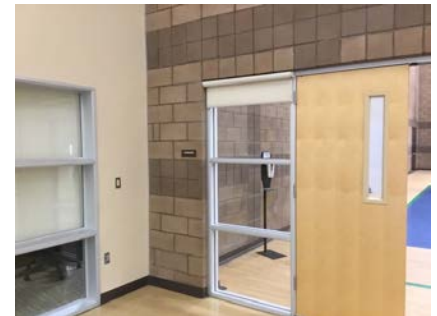
1018	<ul style="list-style-type: none"> <i>As-Built Description:</i> Sign not located on latch side of door and/or not located at 48" min. above to baseline of the lowest Braille cells and 60" max. to baseline of the highest line of raised characters. <i>As-Built:</i> Wrong side <i>Proposed Solution:</i> Provide compliant signage including tactile characters and Grade II Braille on latch side of door located at compliant height. 	PCODE SA07 ADAAG 91 4.30.6 ADA 2010 703.4.1 CBC 2007 1117B.5.7 CBC 2019 11B-703.4.1 Mitigated: <input type="radio"/> YES <input checked="" type="radio"/> NO	1	JOB	\$150	\$150
------	---	---	---	-----	-------	-------

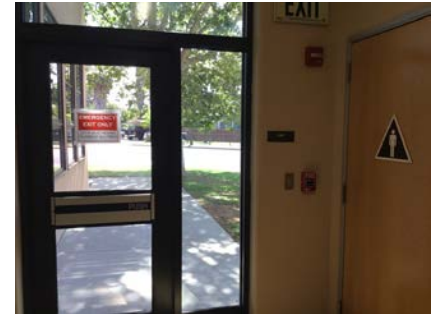
1005	<ul style="list-style-type: none"> <i>As-Built Description:</i> Sign not located on latch side of door and/or not located at 48" min. above to baseline of the lowest Braille cells and 60" max. to baseline of the highest line of raised characters. <i>Proposed Solution:</i> Provide compliant signage including tactile characters and Grade II Braille on latch side of door located at compliant height. <i>Notes:</i> 	PCODE SA07 ADAAG 91 4.30.6 ADA 2010 703.4.1 CBC 2007 1117B.5.7 CBC 2019 11B-703.4.1	1	JOB	\$150	\$150
------	--	---	---	-----	-------	-------

Not adjacent to door. Exit Sign is blocked when restroom doors is held open.

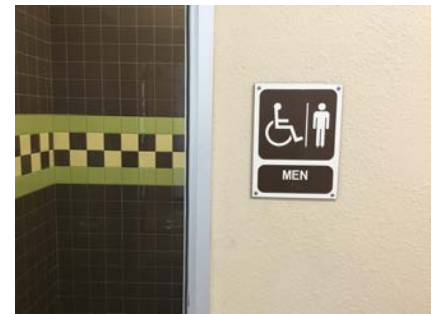
990	<ul style="list-style-type: none"> <i>As-Built Description:</i> Signs containing tactile characters is not located so that a clear floor space of 18" min x 18" min., centered on the tactile characters, is provided beyond the arc of any door swing between the closed position and 45 degree open position. <i>As-Built:</i> 7.6" to door swing <i>Proposed Solution:</i> Relocate compliant signage on latch side of door located at compliant height with a clear floor space. <i>Notes:</i> 	PCODE SA07B ADA 2010 703.4.2 CBC 2019 11B-703.4.2	1	JOB	\$150	\$150
-----	---	---	---	-----	-------	-------

Before the 2010 ADA there was no measurement defining what it meant to stand outside of the door swing, and no requirement that the CLFS be centered, therefore consider whether this condition complies with 1991 ADA and is a Safe Harbor if installed before March 15, 2012.

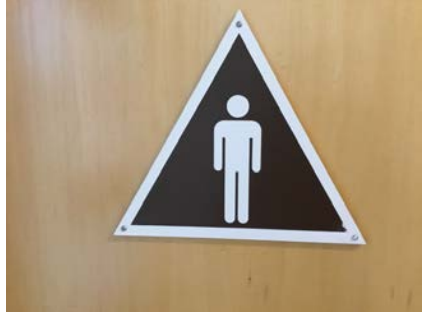
Item no., Rm no. and Name	Existing Architectural Barrier and Proposed Solution	Codes / Mitigation Info	Qty	Unit	Cost	Total
989	<ul style="list-style-type: none"> <i>As-Built Description:</i> Required in CA only: identification symbol centered 58" to 60" high on sanitary facility door that contrasts with the door not provided (women: 12" ø circle, men: 12" triangle, unisex: combined symbol). <i>As-Built:</i> No beveled or radiused. 60.4" high <i>Proposed Solution:</i> Provide properly mounted sanitary facility symbol when altering area. If wheelchair accessible, include International Symbol of Accessibility on sign. 	PCODE SA15 CBC 2007 1115B.6 CBC 2019 11B-703.7.2.6 Mitigated: <input type="radio"/> YES <input checked="" type="radio"/> NO	1	JOB	\$270	\$270

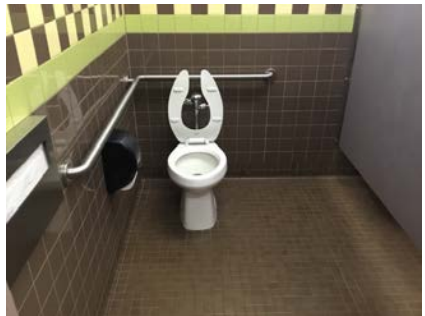
985	<ul style="list-style-type: none"> <i>As-Built Description:</i> Toilet stall less than 60" wide. <i>As-Built:</i> 59.75" <i>Proposed Solution:</i> Provide new accessible stall. 	PCODE WB06 ADAAG 91 4.17.3 ADA 2010 604.8.1.1 CBC 2007 1115B.3.1.4.1 CBC 2019 11B-604.8.1.1 Mitigated: <input type="radio"/> YES <input checked="" type="radio"/> NO	1	JOB	\$4,500	\$4,500

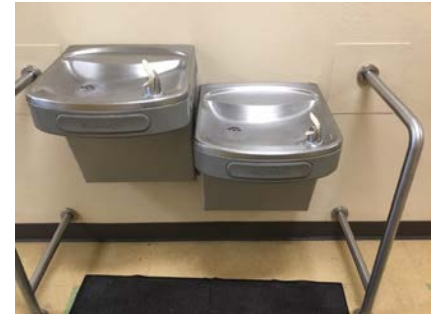
- 998
- *As-Built Description:*
Wall- and post-mounted cantilevered units: Knee space not provided at drinking fountain (27" high, 8" deep, 30" wide from front of drinking fountain). Unit in good condition.
 - *As-Built:* **26.3" knee high**
 - *Proposed Solution:*
Remount fountain at accessible height.

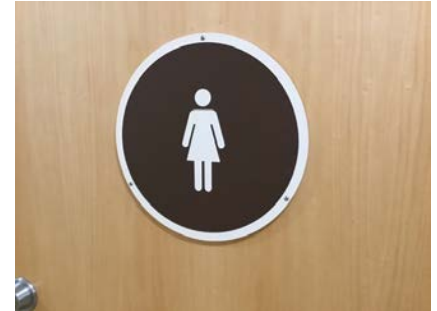
Item no., Rm no. and Name	Existing Architectural Barrier and Proposed Solution	Codes / Mitigation Info	Qty	Unit	Cost	Total
992	<ul style="list-style-type: none"> <i>As-Built Description:</i> Required in CA only: identification symbol centered 58" to 60" high on sanitary facility door that contrasts with the door not provided (women: 12" ø circle, men: 12" triangle, unisex: combined symbol). <i>As-Built:</i> Not beveled <i>Proposed Solution:</i> Provide properly mounted sanitary facility symbol when altering area. If wheelchair accessible, include International Symbol of Accessibility on sign. 	<p>PCODE SA15</p> <p>CBC 2007 1115B.6</p> <p>CBC 2019 11B-703.7.2.6</p> <p>Mitigated:</p> <p><input type="radio"/> YES</p> <p><input checked="" type="radio"/> NO</p>	1	JOB	\$270	\$270

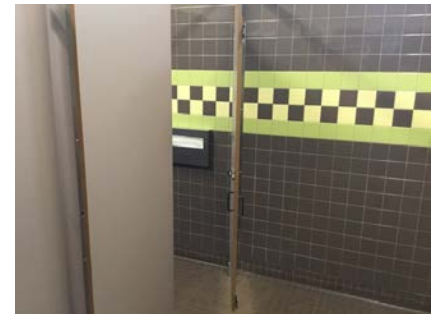
Stall Door

997	<ul style="list-style-type: none"> <i>As-Built Description:</i> Stall door to accessible compartment not self closing. <i>Proposed Solution:</i> Adjust closer. 	<p>PCODE WB05B</p> <p>ADAAG 91 4.22.4</p> <p>ADA 2010 604.8.1.2</p> <p>CBC 2007 1115B.3.1.4.4</p> <p>CBC 2019 11B-604.8.1.2</p> <p>Mitigated:</p> <p><input type="radio"/> YES</p> <p><input checked="" type="radio"/> NO</p>	1	JOB	\$75	\$75
-----	---	---	---	-----	------	------

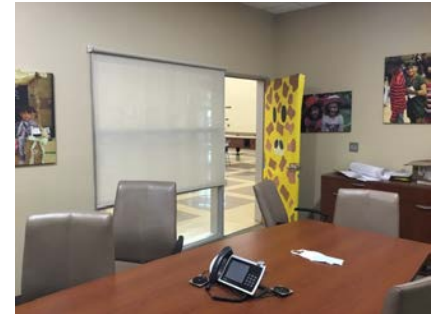
1011	<ul style="list-style-type: none"> <i>As-Built Description:</i> At door leading into exit corridor: Where required exit signs are installed, signs to provide exiting information for people with vision impairment are not provided. <i>Proposed Solution:</i> Provide raised letter/Braille "EXIT ROUTE" sign at door. 	<p>PCODE SA10D ADAAG 91 4.1.3(16) ADA 2010 216.4.1 CBC 2007 1011.3 CBC 2019 11B-216.4.1</p> <p>Mitigated: <input type="radio"/> YES <input checked="" type="radio"/> NO</p>	2	JOB	\$270	\$540
------	--	---	---	-----	-------	-------

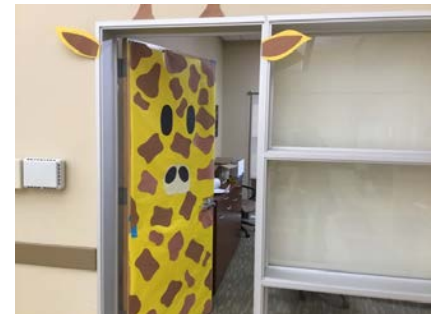
1012	<ul style="list-style-type: none"> <i>As-Built Description:</i> Existing sign designating permanent room or space is noncompliant. <i>Proposed Solution:</i> Provide compliant signage. 	<p>PCODE SA13 ADAAG 91 4.1.3(16)(a) ADA 2010 216.2 CBC 2007 1117B.5 CBC 2019 11B-216.2</p> <p>Mitigated: <input type="radio"/> YES <input checked="" type="radio"/> NO</p>	1	JOB	\$450	\$450
------	---	--	---	-----	-------	-------
