APPENDIX B: ACCESS COMPLIANCE SURVEY REPORT OF FACILITIES

The City of Madera

Access Compliance Survey Report

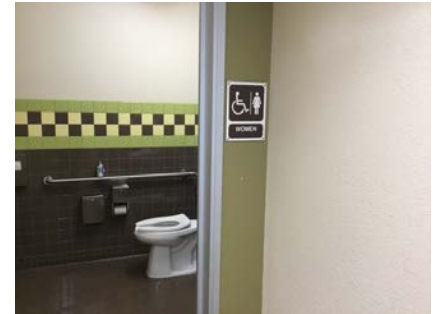
1019	<ul style="list-style-type: none"> <i>As-Built Description:</i> Signs containing tactile characters is not located so that a clear floor space of 18" min x 18" min., centered on the tactile characters, is provided beyond the arc of any door swing between the closed position and 45 degree open position. <i>As-Built:</i> Clear floor space not center <i>Proposed Solution:</i> Relocate compliant signage on latch side of door located at compliant height with a clear floor space. <i>Notes:</i> 	<p>PCODE SA07B ADA 2010 703.4.2 CBC 2019 11B-703.4.2</p> <p>Mitigated: <input type="radio"/> YES <input checked="" type="radio"/> NO</p>	1	JOB	\$150	\$150
------	---	--	---	-----	-------	-------

Before the 2010 ADA there was no measurement defining what it meant to stand outside of the door swing, and no requirement that the CLFS be centered, therefore consider whether this condition complies with 1991 ADA and is a Safe Harbor if installed before March 15, 2012.

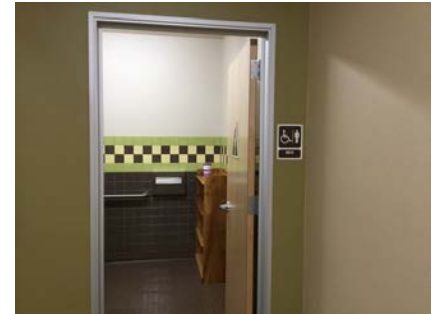
1036	<ul style="list-style-type: none"> <i>As-Built Description:</i> Sign not located on latch side of door and/or not located at 48" min. above to baseline of the lowest Braille cells and 60" max. to baseline of the highest line of raised characters. <i>As-Built:</i> Wrong side. Clear floor space not center. <i>Proposed Solution:</i> Provide compliant signage including tactile characters and Grade II Braille on latch side of door located at compliant height. 	<p>PCODE SA07 ADAAG 91 4.30.6 ADA 2010 703.4.1 CBC 2007 1117B.5.7 CBC 2019 11B-703.4.1</p> <p>Mitigated: <input type="radio"/> YES <input checked="" type="radio"/> NO</p>	1	JOB	\$150	\$150
------	--	--	---	-----	-------	-------

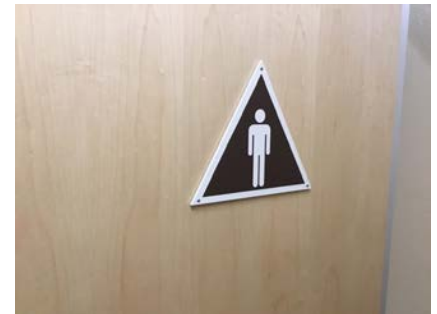
1037	<ul style="list-style-type: none"> <i>As-Built Description:</i> Required in CA only: identification symbol centered 58" to 60" high on sanitary facility door that contrasts with the door not provided (women: 12" ø circle, men: 12" triangle, unisex: combined symbol). <i>As-Built:</i> Not beveled or radiused. <i>Proposed Solution:</i> Provide properly mounted sanitary facility symbol when altering area. If wheelchair accessible, include International Symbol of Accessibility on sign. 	<p>PCODE SA15 CBC 2007 1115B.6 CBC 2019 11B-703.7.2.6</p> <p>Mitigated: <input type="radio"/> YES <input checked="" type="radio"/> NO</p>	1	JOB	\$270	\$270
------	---	---	---	-----	-------	-------

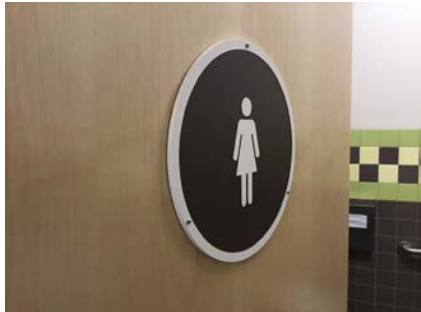
Item no., Rm no. and Name	Existing Architectural Barrier and Proposed Solution	Codes / Mitigation Info	Qty	Unit	Cost	Total
1041	<ul style="list-style-type: none"> <i>As-Built Description:</i> Required in CA only: identification symbol centered 58" to 60" high on sanitary facility door that contrasts with the door not provided (women: 12" ø circle, men: 12" triangle, unisex: combined symbol). <i>As-Built:</i> Not beveled. <i>Proposed Solution:</i> Provide properly mounted sanitary facility symbol when altering area. If wheelchair accessible, include International Symbol of Accessibility on sign. 	PCODE SA15 CBC 2007 1115B.6 CBC 2019 11B-703.7.2.6 Mitigated: <input type="radio"/> YES <input checked="" type="radio"/> NO	1	JOB	\$270	\$270

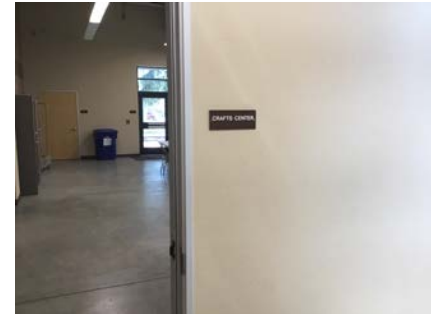
1006	<ul style="list-style-type: none"> <i>As-Built Description:</i> Sign not located on latch side of door and/or not located at 48" min. above to baseline of the lowest Braille cells and 60" max. to baseline of the highest line of raised characters. <i>As-Built:</i> 60.0" to center 60.0" to bottom of characters <i>Proposed Solution:</i> Provide compliant signage including tactile characters and Grade II Braille on latch side of door located at compliant height. 	PCODE SA07 ADAAG 91 4.30.6 ADA 2010 703.4.1 CBC 2007 1117B.5.7 CBC 2019 11B-703.4.1 Mitigated: <input type="radio"/> YES <input checked="" type="radio"/> NO	20	JOB	\$150	\$3,000
------	--	---	----	-----	-------	---------

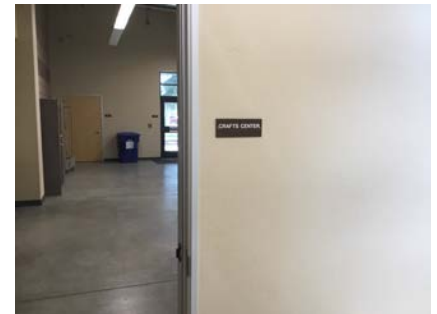
1004	<ul style="list-style-type: none"> <i>As-Built Description:</i> Signs containing tactile characters is not located so that a clear floor space of 18" min x 18" min., centered on the tactile characters, is provided beyond the arc of any door swing between the closed position and 45 degree open position. <i>As-Built:</i> Less than 9.0" to center of sign from door swing <i>Proposed Solution:</i> Relocate compliant signage on latch side of door located at compliant height with a clear floor space. <i>Notes:</i> 	PCODE SA07B ADA 2010 703.4.2 CBC 2019 11B-703.4.2 Mitigated: <input type="radio"/> YES <input checked="" type="radio"/> NO	1	JOB	\$150	\$150
------	---	---	---	-----	-------	-------

Before the 2010 ADA there was no measurement defining what it meant to stand outside of the door swing, and no requirement that the CLFS be centered, therefore consider whether this condition complies with 1991 ADA and is a Safe Harbor if installed before March 15, 2012.

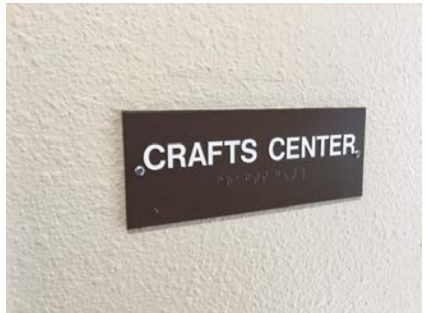
Priority 2
Severity 3

Braille dots touch and/or almost touch, Braille is <3/8" from characters, characters <1/16" spacing. Throughout.

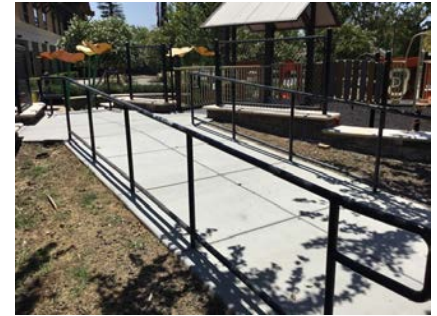
1051	<ul style="list-style-type: none"> <i>As-Built Description:</i> The rise for any ramp run connecting elevated play component shall be 12" maximum. <i>Proposed Solution:</i> Demolish existing and provide new compliant ramp with handrails. <i>Notes:</i> 	PCODE EB02NT ADAAG 91 4.8.2 ADA 2010 405.2 CBC 2007 1133B.5.3 CBC 2019 11B-1008.2.5	200	SF	\$300	\$60,000
------	--	--	-----	----	-------	-----------------

Code calls for 1:16 slope on ramps connecting ground level play components. This ramp does connect elevated play components to ground level components. This ramp slopes 1:12. Verify original design intent.

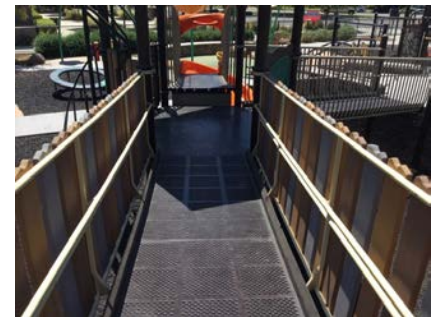
1052	<ul style="list-style-type: none"> <i>As-Built Description:</i> The rise for any ramp run connecting elevated play component shall be 12" maximum. <i>Proposed Solution:</i> Provide new compliant ramp with handrails. <i>Notes:</i> 	PCODE EB02NT ADAAG 91 4.8.2 ADA 2010 405.2 CBC 2007 1133B.5.3 CBC 2019 11B-405.2	80	SF	\$300	\$24,000
------	--	---	----	----	-------	-----------------

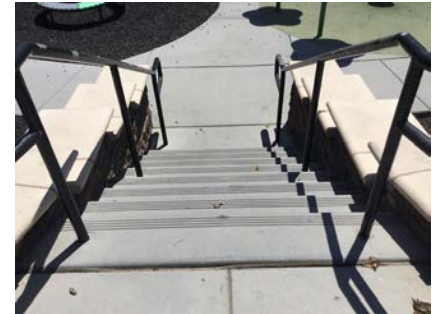
1055	<ul style="list-style-type: none"> <i>As-Built Description:</i> Landing at the top or bottom of stairway is not level or not provided. <i>Proposed Solution:</i> Remodel landings to provide a level clear floor space that extends the entire width of the ramp. 	PCODE EC10 CBC 2019 1009.8 Mitigated: <input type="radio"/> YES <input checked="" type="radio"/> NO	1	JOB	\$1,500	\$1,500
------	---	---	---	-----	---------	---------

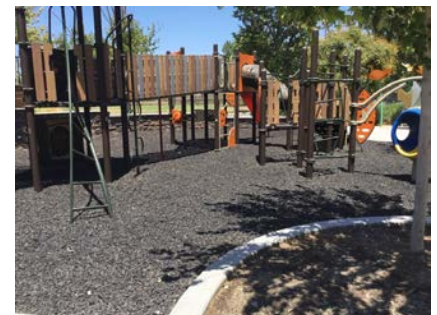
1047	<ul style="list-style-type: none"> <i>As-Built Description:</i> Ground surface complies with ASTM F1951 connecting to play equipment is not provided. Ground surface shall be inspected and maintained regularly and frequently to ensure continued compliance with ASTM F1951 <i>Proposed Solution:</i> Provide required resilient surfacing around play structure. Clear width of accessible routes connecting play components shall provide a clear width comply with section 11B-1008.2.4. 	PCODE OA01 ADAAG 91 36 CFR Part ADA 2010 1191 1008.2.6 CBC 2007 DSA 99-02 CBC 2019 11B-1008.2.6	1000	SF	\$27	\$27,000
------	--	--	------	----	------	----------

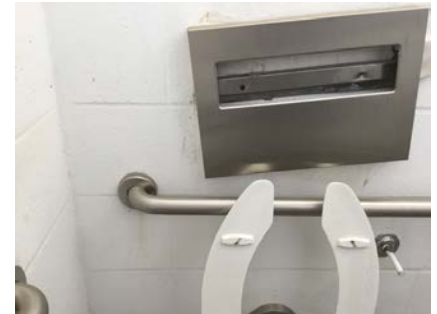
1062	<ul style="list-style-type: none"> As-Built Description: Accessories/dispensers in accessible stall located closer than 1-1/2" below or 12" above grab bar impedes its use. As-Built: SCD: 2.0" above grab bar Proposed Solution: Relocate accessories/dispensers to be no closer than 1-1/2" below and 12" above grab bars (except if accessories are recessed, flush with wall, and have no sharp edges). 	PCODE WB07I ADAAG 91 4.26.2 ADA 2010 609.3 CBC 2007 1133B.4.2.5 CBC 2019 11B-609.3 Mitigated: <input type="radio"/> YES <input checked="" type="radio"/> NO	1	JOB	\$225	\$225
------	---	---	---	-----	-------	-------

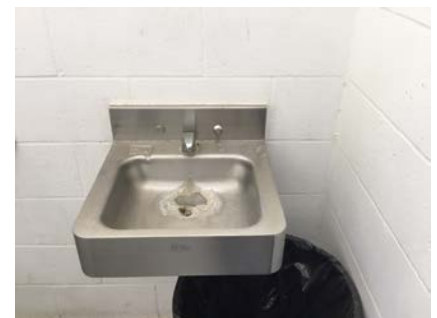
1058	<ul style="list-style-type: none"> As-Built Description: Clear floor space, 30" x 48" in front of fixture, extending 19" max. under the lavatory, not provided (CA only: Less than 18" from side wall to centerline of lavatory). As-Built: 17.5" o.c. Proposed Solution: Relocate existing lavatory. Notes: 	PCODE WD01A ADAAG 91 4.19.3 ADA 2010 606.2 CBC 2007 1115B.4.3 CBC 2019 11B-606.2, 11B-606.6 Mitigated: <input type="radio"/> YES <input checked="" type="radio"/> NO	1	JOB	\$2,700	\$2,700
------	---	--	---	-----	---------	---------

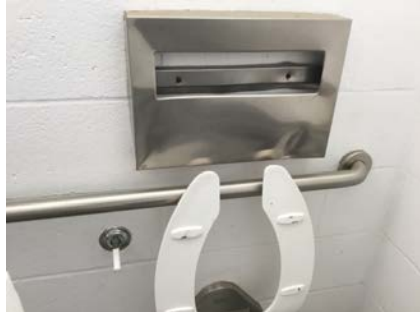
<p>1065</p> <ul style="list-style-type: none"> <i>As-Built Description:</i> Dispensers in sanitary facilities, such as for towels, soap, sanitary napkins, seat covers, etc., and waste receptacles more than 48" (CA only: 40") from floor to highest operating slot or control. <i>As-Built:</i> SCD: 44.0" high <i>Proposed Solution:</i> Relocate existing restroom accessories. 	<p>PCODE WG01A ADAAG 91 4.23.7 ADA 2010 308.2.1 CBC 2007 1115B.8.3 CBC 2019 11B-603.5</p>	<p>1 JOB \$300 \$300</p>

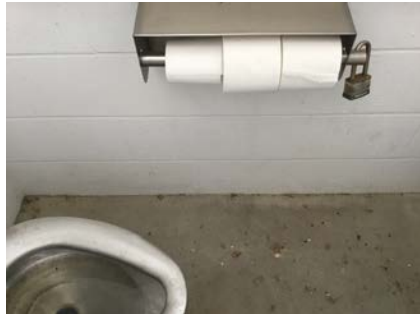
<p>1067</p> <ul style="list-style-type: none"> <i>As-Built Description:</i> Toilet paper dispenser less than 15" (CA: 19") or more than 48" above floor or not within 7" to 9" from front of water closet (Note: CA pre-2010 is allowed within 12" from front of water closet). <i>As-Built:</i> 4.5" in front <i>Proposed Solution:</i> Relocate or provide new toilet paper dispenser. 	<p>PCODE WG02 ADAAG 91 4.16.6 ADA 2010 604.7 CBC 2007 1115B.8.4 CBC 2019 11B-604.7</p>	<p>1 JOB \$225 \$225</p>

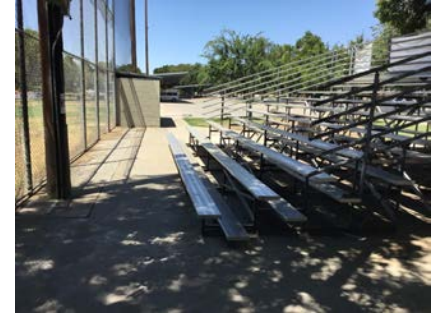
1583	<ul style="list-style-type: none"> <i>As-Built Description:</i> Proper amount of seating for disabled persons at public seating is not provided (>25=1; >50=2; >300=4; >500=6; +500=6=1%). <i>Proposed Solution:</i> Modify seating to provide clear and level wheelchair space 33" x 48" or 33" x 60", including companion seat, as required. <i>Notes:</i> 	PCODE GE01NT ADAAG 91 4.1.2(19)a ADA 2010 221.2.1 CBC 2007 1104B.3.4.1 CBC 2019 11B-221.2.1	1	EA	\$1,800	\$1,800
------	---	---	---	----	---------	---------

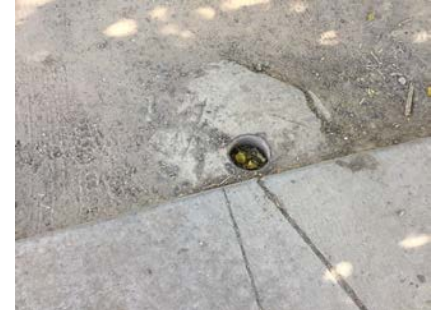
1695	<ul style="list-style-type: none"> <i>As-Built Description:</i> Walk: openings greater than 1/2" along the line of traffic flow. <i>As-Built:</i> 5.0" x 3.0" deep <i>Proposed Solution:</i> Fill gap/opening along the line of traffic flow. 	PCODE EF04 ADAAG 91 4.3.6; 4.5.4 ADA 2010 403.2; 302.3 CBC 2007 1133B.7.2 CBC 2019 11B-403.2; 11B-302.3	10	SF	\$240	\$2,400
------	---	--	----	----	-------	---------

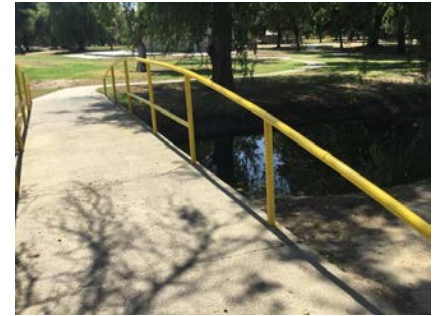
1422	<ul style="list-style-type: none"> <i>As-Built Description:</i> Protruding objects more than 4" from wall, when bottom of object more than 27" or less than 80" above finished floor. <i>Proposed Solution:</i> Remove/relocate protruding object. Patch existing surface. <i>Notes:</i> 	<p>PCODE EG04 ADAAG 91 4.4.1 ADA 2010 307.2 CBC 2007 1133B.8.6.1 CBC 2019 11B-307.2</p> <p>Mitigated: <input type="radio"/> YES <input checked="" type="radio"/> NO</p>	1	JOB	\$300	\$300
------	---	---	---	-----	-------	-------

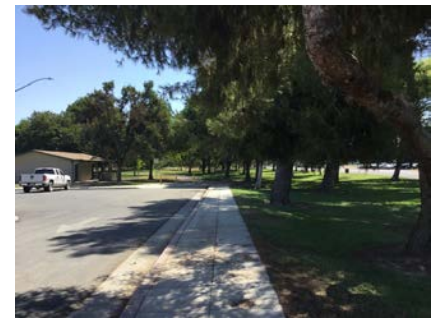
Guards protrude 41.0" throughout.

1554	<ul style="list-style-type: none"> <i>As-Built Description:</i> Protruding objects more than 4" from wall, when bottom of object more than 27" or less than 80" above finished floor. <i>Proposed Solution:</i> Trim vegetation. 	<p>PCODE EG04 ADAAG 91 4.4.1 ADA 2010 307.2 CBC 2007 1133B.8.6.1 CBC 2019 11B-307.2</p> <p>Mitigated: <input type="radio"/> YES <input checked="" type="radio"/> NO</p>	50	JOB	\$300	\$15,000
------	--	---	----	-----	-------	----------

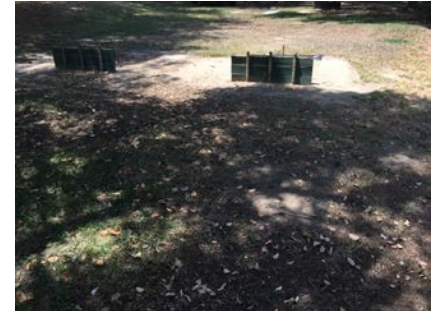
Item no., Rm no. and Name	Existing Architectural Barrier and Proposed Solution	Codes / Mitigation Info	Qty	Unit	Cost	Total
1402	<ul style="list-style-type: none"> <i>As-Built Description:</i> No walk / sidewalk provided to connect accessible facilities or elements that are on the same site. <i>Proposed Solution:</i> Grade and re sod path to horse shoe pits. <i>Notes:</i> 	PCODE EF13 ADAAG 91 4.3.2 ADA 2010 206.1 CBC 2007 1114B.1.2 CBC 2019 11B-206.1 Mitigated: <input type="radio"/> YES <input checked="" type="radio"/> NO	40	LF	\$135	\$5,400

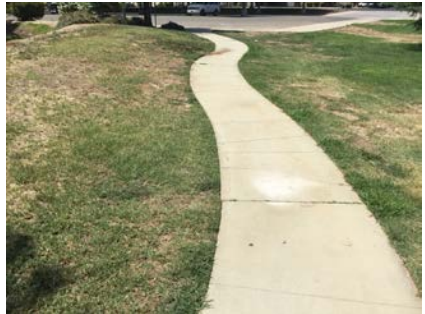
1418	<ul style="list-style-type: none"> As-Built Description: Cross slope more than 1":48" (2.083%). As-Built: Up to 3.5% Proposed Solution: Modify cross slope. 	PCODE EF07 ADAAG 91 4.3.7 ADA 2010 403.3 CBC 2007 1133B.7.1.3 CBC 2019 11B-403.3 Mitigated: <input type="radio"/> YES <input checked="" type="radio"/> NO	100	SF	\$75	\$7,500

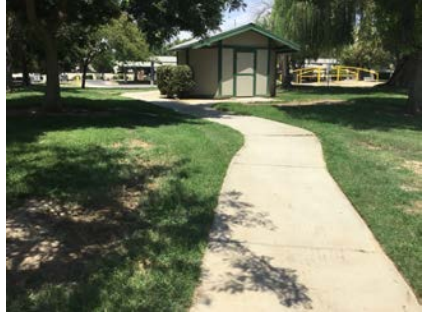
<p>1397</p> <ul style="list-style-type: none"> As-Built Description: Walk: Slope greater than 1:20 (5.0%), and walk does not comply with requirements for ramps. As-Built: 6.4% Proposed Solution: Modify walk/sidewalk slope to 1:20 or less. 	<p>PCODE EF01 ADAAG 91 4.3.7 ADA 2010 403.3 CBC 2007 1133B.7.3 CBC 2019 11B-403.3</p> <p>Mitigated: <input type="radio"/> YES <input checked="" type="radio"/> NO</p>	<p>40 SF \$75 \$3,000</p>

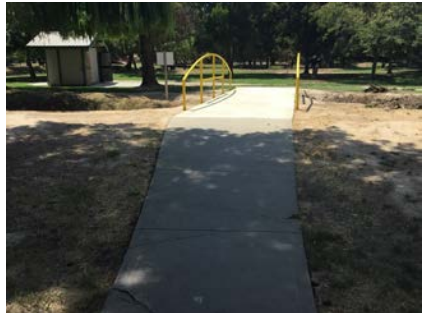
<p>1405</p> <ul style="list-style-type: none"> As-Built Description: Walk: Slope greater than 1:20 (5.0%), and walk does not comply with requirements for ramps. As-Built: Up to 7.3% Proposed Solution: Modify walk/sidewalk slope to 1:20 or less. 	<p>PCODE EF01 ADAAG 91 4.3.7 ADA 2010 403.3 CBC 2007 1133B.7.3 CBC 2019 11B-403.3</p> <p>Mitigated: <input type="radio"/> YES <input checked="" type="radio"/> NO</p>	<p>100 SF \$75 \$7,500</p>

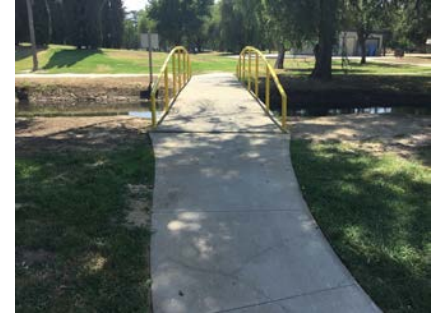
- 1420
- *As-Built Description:*
Walk: Pavement dislocation creates abrupt change in level exceeding 1/2" in accessible route.
 - *As-Built:* **1.0"**
 - *Proposed Solution:*
Remove, replace or repair area of pavement sufficient to correct abrupt change in level.

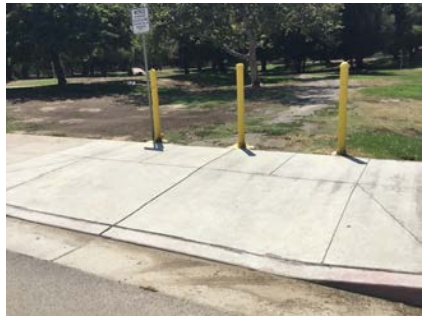
<input type="radio"/> Staff Only			
			Priority <input checked="" type="radio"/> 1			
			Severity <input checked="" type="radio"/> 2			
1415	<ul style="list-style-type: none"> As-Built Description: Side slopes more than 1:10 (10%). As-Built: 15.0% Proposed Solution: Modify curb ramp. Demolish side slopes and replace with 1:10 side slopes if 48" level top landing is provided. Notes: 	PCODE EH05A ADAAG 91 4.7.5 ADA 2010 406.3 CBC 2007 1127B.5.3 CBC 2019 11B-406.2.2 Mitigated: <input type="radio"/> YES <input checked="" type="radio"/> NO	1	JOB	\$6,000	\$6,000

There is a 48.0" level top landing.

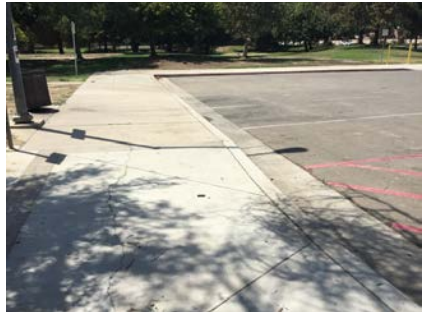
Item no., Rm no. and Name	Existing Architectural Barrier and Proposed Solution	Codes / Mitigation Info	Qty	Unit	Cost	Total
1406	<ul style="list-style-type: none"> <i>As-Built Description:</i> Detectable warning not provided where pedestrian crosses vehicular area. <i>Proposed Solution:</i> Provide detectable warning surface (i.e. in-line truncated domes) at regular curb ramp. 	PCODE EH07A ADAAG 91 4.7.7 ADA 2010 705.1 CBC 2007 1127B.5.7 CBC 2019 11B-705.1.2.2 Mitigated: <input type="radio"/> YES <input checked="" type="radio"/> NO	4	JOB	\$750	\$3,000

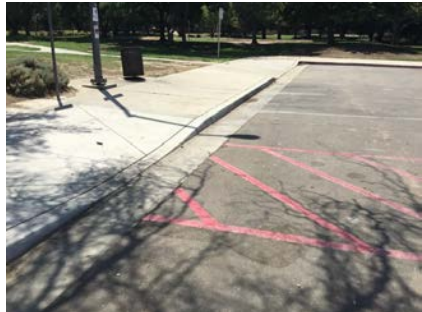
1411	<ul style="list-style-type: none"> <i>As-Built Description:</i> Accessible parking space has slope greater than 1/4":12" (2%). <i>As-Built:</i> 2.9% <i>Proposed Solution:</i> Modify slope at accessible parking space. 	PCODE EA05 ADAAG 91 4.6.3 ADA 2010 502.4 CBC 2007 1129B.3.3 CBC 2019 11B-502.4 Mitigated: <input type="radio"/> YES <input checked="" type="radio"/> NO	30	SF	\$36	\$1,080

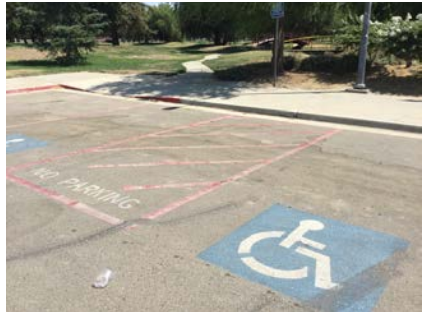
Item no., Rm no. and Name	Existing Architectural Barrier and Proposed Solution	Codes / Mitigation Info	Qty	Unit	Cost	Total
1417	<ul style="list-style-type: none"> As-Built Description: Accessible parking space has slope greater than 1/4":12" (2%). As-Built: Up to 3.3% Proposed Solution: Modify slope at accessible parking space. 	PCODE EA05 ADAAG 91 4.6.3 ADA 2010 502.4 CBC 2007 1129B.3.3 CBC 2019 11B-502.4 Mitigated: <input type="radio"/> YES <input checked="" type="radio"/> NO	50	SF	\$36	\$1,800

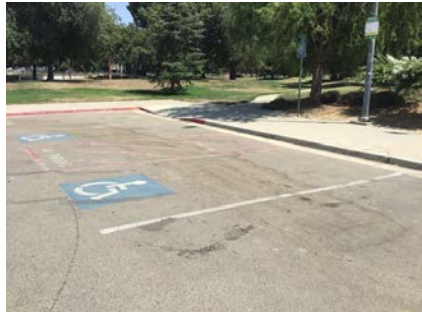
1416	<ul style="list-style-type: none"> As-Built Description: Disabled persons must wheel or walk behind parked car(s) other than their own. Proposed Solution: Relocate parking and provide curb ramp to accessible route. 	PCODE EA03 ADAAG 91 Fig.9 ADA 2010 502.3 CBC 2007 1129B.3.1 CBC 2019 11B-502.7.1 Mitigated: <input type="radio"/> YES <input checked="" type="radio"/> NO	1	JOB	\$2,190	\$2,190

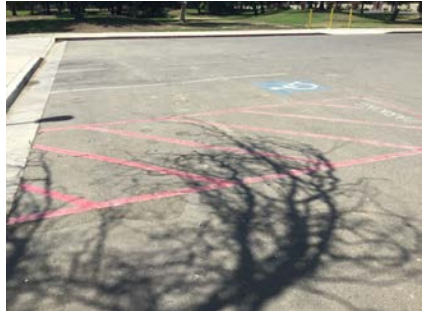
Item no., Rm no. and Name	Existing Architectural Barrier and Proposed Solution	Codes / Mitigation Info	Qty	Unit	Cost	Total
1410	<ul style="list-style-type: none"> As-Built Description: An accessible parking space shall be outlined or painted blue (required in CA only). Proposed Solution: Identify accessible parking space using blue markings. 	PCODE EA04K CBC 2019 11B-502.6 Mitigated: <input type="radio"/> YES <input checked="" type="radio"/> NO	2	JOB	\$360	\$720

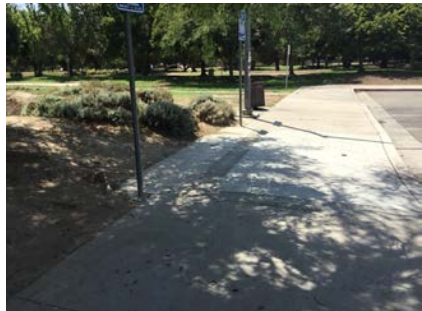
<input type="radio"/> Staff Only			
			Priority <input checked="" type="radio"/> 1			
			Severity <input checked="" type="radio"/> 3			
1412	<ul style="list-style-type: none"> As-Built Description: Wheel stops not provided to prevent the encroachment of vehicles over the required clear width of an adjacent accessible route. Proposed Solution: Provide wheel stops to prevent encroachment. Notes: 	PCODE EA04L CBC 2019 11B-502.7.2 Mitigated: <input type="radio"/> YES <input checked="" type="radio"/> NO	4	JOB	\$225	\$900

Top landing running slope 2.9%.

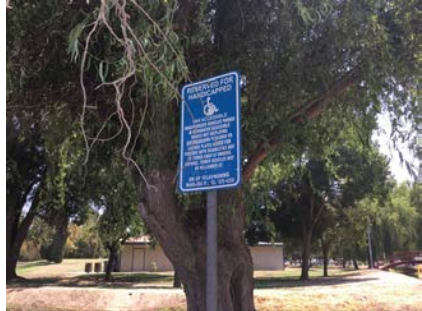
1408	<ul style="list-style-type: none"> <i>As-Built Description:</i> Sign relating to parking privileges for disabled persons is non-compliant. <i>Proposed Solution:</i> Provide compliant parking signage that does not contain the word "Handicapped". 	<p>PCODE EA04F ADA 2010 502.6 CBC 2007 VC §22511.9. CBC 2019 11B-502.6</p> <p>Mitigated: <input type="radio"/> YES <input checked="" type="radio"/> NO</p>	4	JOB	\$300	\$1,200

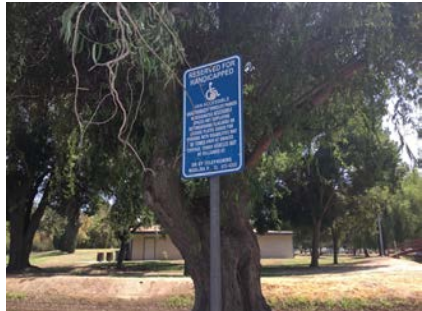
1409	<ul style="list-style-type: none"> <i>As-Built Description:</i> CA only: Additional Sign or additional language below the symbol of accessibility stating "Minimum Fine \$250" not provided. <i>Proposed Solution:</i> Provide compliant parking signage that includes fine information. 	<p>PCODE EA04G CBC 2007 1129B.4 CBC 2019 11B-502.6.2</p> <p>Mitigated: <input type="radio"/> YES <input checked="" type="radio"/> NO</p>	4	JOB	\$300	\$1,200

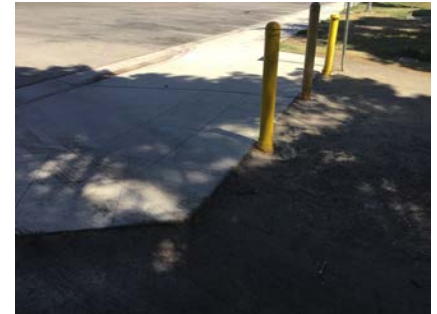
- 1555
- *As-Built Description:*
Walk: Pavement dislocation creates abrupt change in level exceeding 1/2" in accessible route.
 - *As-Built:* **Up to 3.0"**
 - *Proposed Solution:*
Remove, replace or repair area of pavement sufficient to correct abrupt change in level.
 - *Notes:*

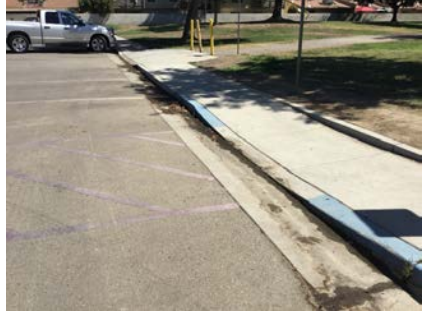
Item no., Rm no. and Name	Existing Architectural Barrier and Proposed Solution	Codes / Mitigation Info	Qty	Unit	Cost	Total
1543	<ul style="list-style-type: none"> As-Built Description: Maximum slope of adjoining gutters, street surface at bottom of ramp exceeds 5% (1:20). As-Built: Up to 9.1% Proposed Solution: Modify road/gutter slopes. Demolish existing and provide new curb ramp. 	PCODE EH02E ADAAG 91 4.7.2 ADA 2010 406.2 CBC 2007 1127B.5.3 CBC 2019 11B-406.5.8 Mitigated: <input type="radio"/> YES <input checked="" type="radio"/> NO	4	JOB	\$3,750	\$15,000

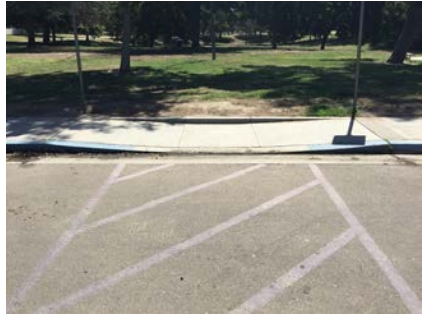
<input type="radio"/> Staff Only			
			Priority <input checked="" type="radio"/> 1			
			Severity <input checked="" type="radio"/> 3			
1541	<ul style="list-style-type: none"> As-Built Description: Cross slope greater than 2%. As-Built: Up to 3.8% Proposed Solution: Demolish existing and provide new curb ramp. Notes: 	PCODE EH02F ADAAG 91 4.8.6 ADA 2010 405.3 CBC 2007 1133B.5.3.1 CBC 2019 11B-406.5.7 Mitigated: <input type="radio"/> YES <input checked="" type="radio"/> NO	4	JOB	\$7,500	\$30,000

<input type="radio"/> Staff Only			
			Priority <input checked="" type="radio"/> 1			
			Severity <input checked="" type="radio"/> 4			
<p>Landing at parallel curb ramp also slopes 3.3%. Gutter lip 0.7”.</p>

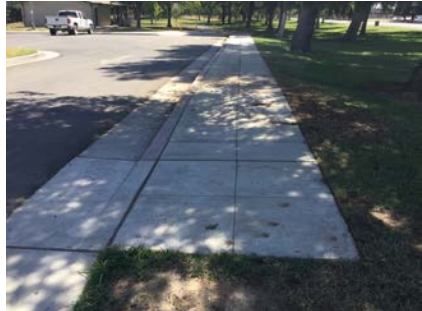
Item no., Rm no. and Name	Existing Architectural Barrier and Proposed Solution	Codes / Mitigation Info	Qty	Unit	Cost	Total
1551	<ul style="list-style-type: none"> As-Built Description: Cross slope greater than 2%. As-Built: 2.8% Proposed Solution: Demolish existing and provide new curb ramp. 	PCODE EH02F ADAAG 91 4.8.6 ADA 2010 405.3 CBC 2007 1133B.5.3.1 CBC 2019 11B-406.5.7 Mitigated: <input type="radio"/> YES <input checked="" type="radio"/> NO	1	JOB	\$7,500	\$7,500

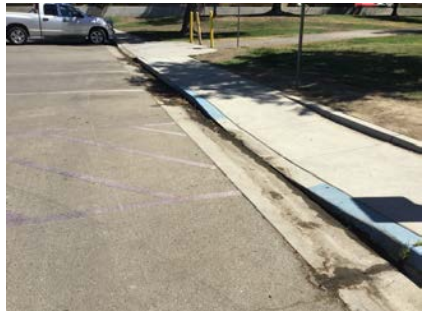
<input type="radio"/> Staff Only			
			Priority <input checked="" type="radio"/> 1			
			Severity <input checked="" type="radio"/> 4			
1542	<ul style="list-style-type: none"> As-Built Description: Detectable warning not provided where pedestrian crosses vehicular area. Proposed Solution: Provide detectable warning surface (i.e. in-line truncated domes) at regular curb ramp. 	PCODE EH07A ADAAG 91 4.7.7 ADA 2010 705.1 CBC 2007 1127B.5.7 CBC 2019 11B-705.1.2.2 Mitigated: <input type="radio"/> YES <input checked="" type="radio"/> NO	4	JOB	\$750	\$3,000

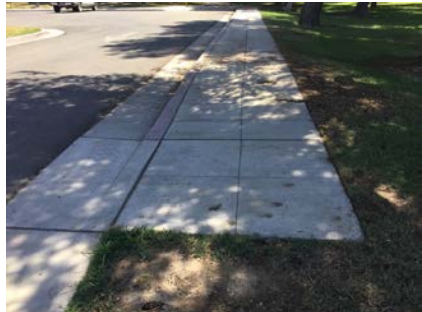
Item no., Rm no. and Name	Existing Architectural Barrier and Proposed Solution	Codes / Mitigation Info	Qty	Unit	Cost	Total
1552	<ul style="list-style-type: none"> <i>As-Built Description:</i> Detectable warning not provided where pedestrian crosses vehicular area. <i>Proposed Solution:</i> Provide detectable warning surface (i.e. in-line truncated domes) at regular curb ramp. 	PCODE EH07A ADAAG 91 4.7.7 ADA 2010 705.1 CBC 2007 1127B.5.7 CBC 2019 11B-705.1.2.2 Mitigated: <input type="radio"/> YES <input checked="" type="radio"/> NO	1	JOB	\$750	\$750

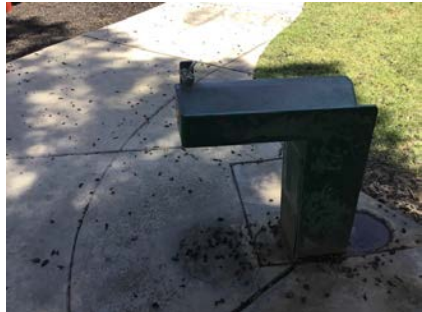
1561	<ul style="list-style-type: none"> <i>As-Built Description:</i> Where only one drinking fountain is provided per floor: Fountain is not accessible to individuals who use wheelchairs, or to those who have difficulty bending or stooping. <i>Proposed Solution:</i> Provide additional fountain or hi-lo combination fountain. 	PCODE IA01A ADAAG 91 4.1.3(10)(a) ADA 2010 211.1 CBC 2007 1115B.4.6.1 CBC 2019 11B-211.1 Mitigated: <input type="radio"/> YES <input checked="" type="radio"/> NO	1	JOB	\$6,000	\$6,000

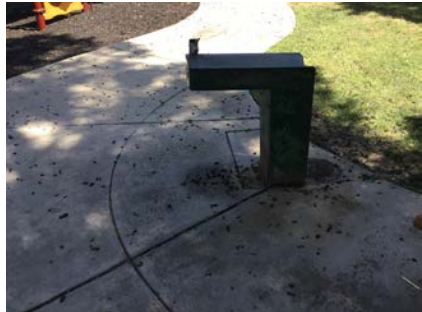
Item no., Rm no. and Name	Existing Architectural Barrier and Proposed Solution	Codes / Mitigation Info	Qty	Unit	Cost	Total
1562	<ul style="list-style-type: none"> <i>As-Built Description:</i> Drinking fountain lacks protection for visually impaired persons. <i>Proposed Solution:</i> Provide cane-detectable rails. 	PCODE IA05C ADAAG 91 4.4.1 ADA 2010 307.2 CBC 2007 1115B.4.6.3 CBC 2019 11B-307.2 Mitigated: <input type="radio"/> YES <input checked="" type="radio"/> NO	1	JOB	\$1,500	\$1,500

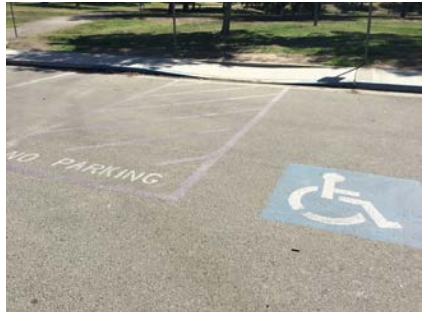
1537	<ul style="list-style-type: none"> <i>As-Built Description:</i> Accessible parking space has slope greater than 1/4":12" (2%). <i>As-Built:</i> Up to 2.7% <i>Proposed Solution:</i> Modify slope at accessible parking space. 	PCODE EA05 ADAAG 91 4.6.3 ADA 2010 502.4 CBC 2007 1129B.3.3 CBC 2019 11B-502.4 Mitigated: <input type="radio"/> YES <input checked="" type="radio"/> NO	300	SF	\$36	\$10,800

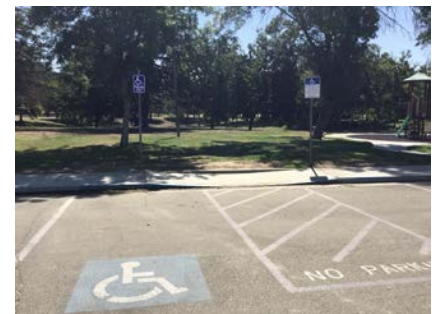
- 1536
- *As-Built Description:*
Sign for accessible parking space is missing or non-compliant.
 - *Proposed Solution:*
Provide compliant parking signage.
 - *Notes:*

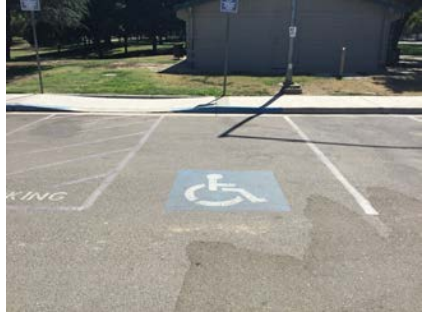
1548	<ul style="list-style-type: none"> As-Built Description: Accessible parking space smaller than 8' wide (CA only: 9' x 18'). As-Built: 107.5" wide Proposed Solution: Modify parking space(s) to create accessible space. 	PCODE EA02A ADAAG 91 4.6.3 ADA 2010 502.2 CBC 2007 1129B.3.1 CBC 2019 11B-502.2 Mitigated: <input type="radio"/> YES <input checked="" type="radio"/> NO	1	JOB	\$600	\$600

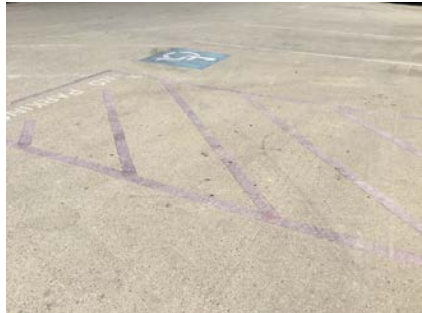
1540	<ul style="list-style-type: none"> As-Built Description: Accessible parking space does not have 5' wide access aisle; 8' wide for van accessible aisle. As-Built: 95.25" wide Proposed Solution: Modify parking aisle(s) to create accessible space by restriping. 	PCODE EA02B ADAAG 91 4.6.3 ADA 2010 502.3 CBC 2007 1129B.3.1 CBC 2019 11B-502.2; 11B-502.3.1 Mitigated: <input type="radio"/> YES <input checked="" type="radio"/> NO	1	JOB	\$600	\$600

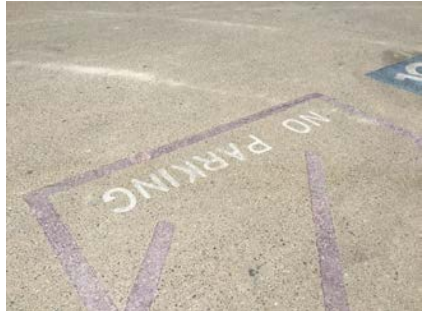
Item no., Rm no. and Name	Existing Architectural Barrier and Proposed Solution	Codes / Mitigation Info	Qty	Unit	Cost	Total
1539	<ul style="list-style-type: none"> <i>As-Built Description:</i> The words "NO PARKING" not painted on the ground within loading and unloading access aisle (12" min high white letters), located so that it is visible to traffic enforcement officials (required in CA only). <i>As-Built:</i> 9.0" <i>Proposed Solution:</i> Provide the words "NO PARKING" in each access aisle, painted in 12" high letters, when altering area. 	PCODE EA04D CBC 2007 1129B.3.1 CBC 2019 11B-502.3.3 Mitigated: <input type="radio"/> YES <input checked="" type="radio"/> NO	2	JOB	\$300	\$600

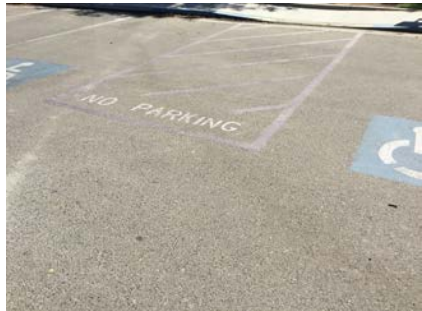
<input type="radio"/> Staff Only			
			Priority <input checked="" type="radio"/> 1 Severity <input checked="" type="radio"/> 4			
1538	<ul style="list-style-type: none"> <i>As-Built Description:</i> An accessible parking space shall be outlined or painted blue (required in CA only). <i>Proposed Solution:</i> Identify accessible parking space using blue markings. 	PCODE EA04K CBC 2019 11B-502.6 Mitigated: <input type="radio"/> YES <input checked="" type="radio"/> NO	2	JOB	\$360	\$720

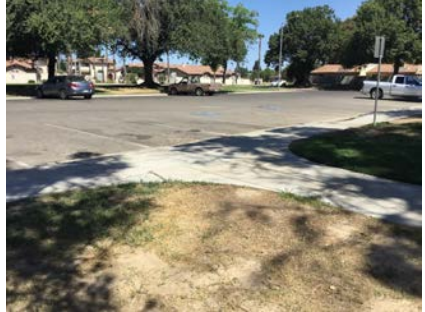
Item no., Rm no. and Name	Existing Architectural Barrier and Proposed Solution	Codes / Mitigation Info	Qty	Unit	Cost	Total
1544	<ul style="list-style-type: none"> <i>As-Built Description:</i> Wheel stops not provided to prevent the encroachment of vehicles over the required clear width of an adjacent accessible route. <i>Proposed Solution:</i> Provide wheel stops to prevent encroachment. 	PCODE EA04L CBC 2019 11B-502.7.2 Mitigated: <input type="radio"/> YES <input checked="" type="radio"/> NO	40	JOB	\$225	\$9,000

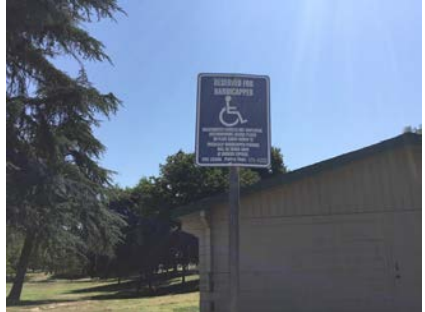
1547	<ul style="list-style-type: none"> <i>As-Built Description:</i> No "Tow Away" sign at parking lot entrance (required in CA only). <i>Proposed Solution:</i> Provide "Tow Away" sign at parking lot entrance when altering area. 	PCODE EA04C CBC 2007 1129B.4 CBC 2019 11B-502.8.2 Mitigated: <input type="radio"/> YES <input checked="" type="radio"/> NO	2	JOB	\$975	\$1,950

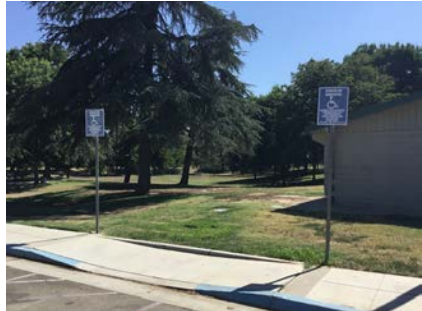
Item no., Rm no. and Name	Existing Architectural Barrier and Proposed Solution	Codes / Mitigation Info	Qty	Unit	Cost	Total
1546	<ul style="list-style-type: none"> <i>As-Built Description:</i> Sign relating to parking privileges for disabled persons is non-compliant. <i>Proposed Solution:</i> Provide compliant parking signage that does not contain the word "Handicapped". 	PCODE EA04F ADA 2010 502.6 CBC 2007 VC §22511.9. CBC 2019 11B-502.6 Mitigated: <input type="radio"/> YES <input checked="" type="radio"/> NO	2	JOB	\$300	\$600

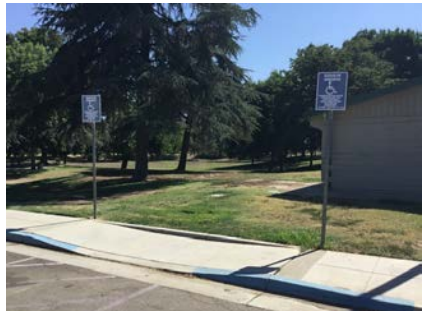
<input type="radio"/> Staff Only			
			Priority <input checked="" type="radio"/> 1 Severity <input checked="" type="radio"/> 4			
1545	<ul style="list-style-type: none"> <i>As-Built Description:</i> CA only: Additional Sign or additional language below the symbol of accessibility stating "Minimum Fine \$250" not provided. <i>Proposed Solution:</i> Provide compliant parking signage that includes fine information. 	PCODE EA04G CBC 2007 1129B.4 CBC 2019 11B-502.6.2 Mitigated: <input type="radio"/> YES <input checked="" type="radio"/> NO	4	JOB	\$300	\$1,200

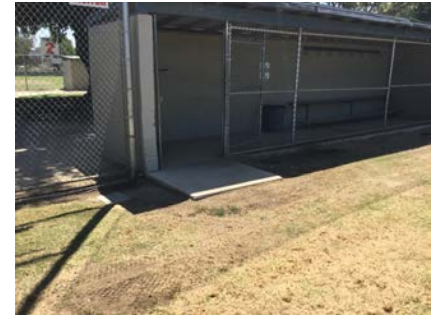
- 1575
- *As-Built Description:*
Walk: Pavement dislocation creates abrupt change in level exceeding 1/2" in accessible route.
 - *As-Built:* **Up to 3.0"**
 - *Proposed Solution:*
Remove, replace or repair area of pavement sufficient to correct abrupt change in level.
 - *Notes:*

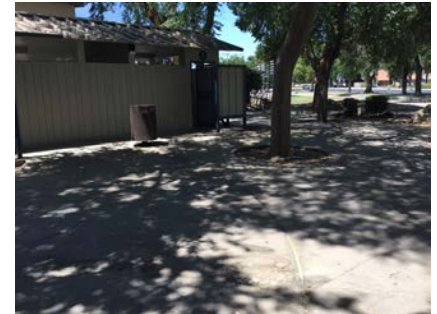
1582	<ul style="list-style-type: none"> As-Built Description: Cross slope more than 1":48" (2.083%). As-Built: Up to 7.3% Proposed Solution: Modify cross slope. Notes: 	PCODE EF07 ADAAG 91 4.3.7 ADA 2010 403.3 CBC 2007 1133B.7.1.3 CBC 2019 11B-403.3	500	SF	\$75	\$37,500
------	---	--	-----	----	------	----------

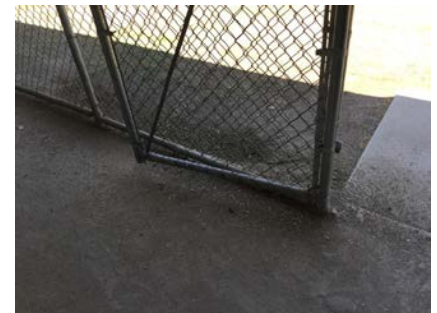
1576	<ul style="list-style-type: none"> As-Built Description: At push side of door on accessible route, bottom 10" does not have a smooth, uninterrupted surface. Proposed Solution: Provide 10" min. "kick plate" covering width of door when altering area. 	PCODE ID06 ADA 2010 404.2.10 CBC 2007 1133B.2.6 CBC 2019 11B-404.2.10	4	JOB	\$300	\$1,200
------	--	--	---	-----	-------	---------

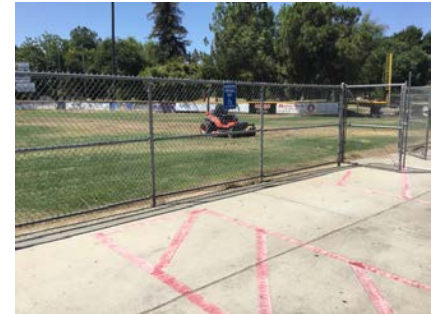
- 1572
- *As-Built Description:*
Sign for accessible parking space is missing or non-compliant.
 - *Proposed Solution:*
Provide compliant parking signage.
 - **Notes:**

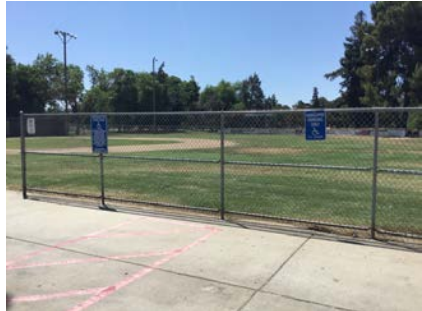
Item no., Rm no. and Name	Existing Architectural Barrier and Proposed Solution	Codes / Mitigation Info	Qty	Unit	Cost	Total
1566	<ul style="list-style-type: none"> <i>As-Built Description:</i> Parking sign is not located between 60" and 80" above the finish floor or ground surface measured to the bottom of the sign. <i>As-Built:</i> 54.0" high <i>Proposed Solution:</i> Remount existing sign at accessible height. 	PCODE EA04H ADAAG 91 4.6.4 ADA 2010 502.7 CBC 2007 1129B.4 CBC 2019 11B-502.6 Mitigated: <input type="radio"/> YES <input checked="" type="radio"/> NO	2	JOB	\$135	\$270

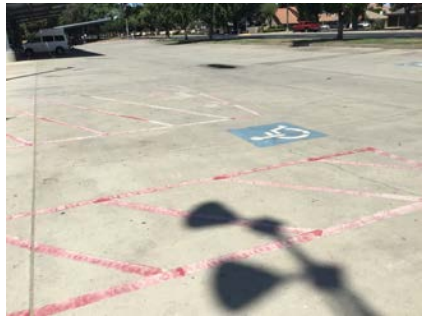
<input type="radio"/> Staff Only			
			Priority <input checked="" type="radio"/> 1			
			Severity <input checked="" type="radio"/> 4			
1570	<ul style="list-style-type: none"> <i>As-Built Description:</i> An accessible parking space shall be outlined or painted blue (required in CA only). <i>Proposed Solution:</i> Identify accessible parking space using blue markings. 	PCODE EA04K CBC 2019 11B-502.6 Mitigated: <input type="radio"/> YES <input checked="" type="radio"/> NO	2	JOB	\$360	\$720

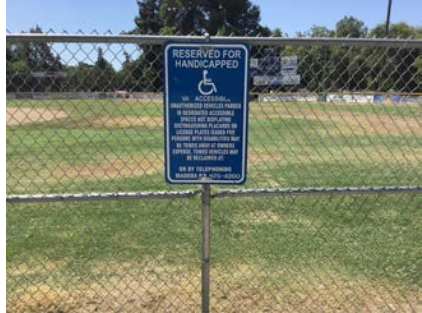
1568	<ul style="list-style-type: none"> <i>As-Built Description:</i> No "Tow Away" sign at parking lot entrance (required in CA only). <i>Proposed Solution:</i> Provide "Tow Away" sign at parking lot entrance when altering area. 	<p>PCODE EA04C</p> <p>CBC 2007 1129B.4</p> <p>CBC 2019 11B-502.8.2</p> <p>Mitigated:</p> <p><input type="radio"/> YES</p> <p><input checked="" type="radio"/> NO</p>	2	JOB	\$975	\$1,950

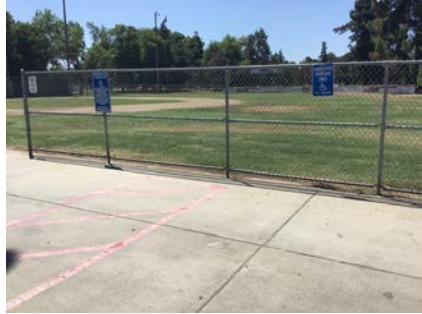
1567	<ul style="list-style-type: none"> <i>As-Built Description:</i> Sign relating to parking privileges for disabled persons is non-compliant. <i>Proposed Solution:</i> Provide compliant parking signage that does not contain the word "Handicapped". 	<p>PCODE EA04F</p> <p>ADA 2010 502.6</p> <p>CBC 2007 VC §22511.9.</p> <p>CBC 2019 11B-502.6</p> <p>Mitigated:</p> <p><input type="radio"/> YES</p> <p><input checked="" type="radio"/> NO</p>	2	JOB	\$300	\$600

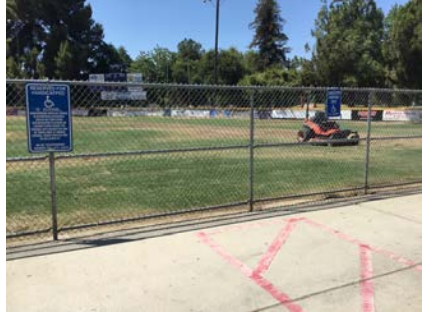
Item no., Rm no. and Name	Existing Architectural Barrier and Proposed Solution	Codes / Mitigation Info	Qty	Unit	Cost	Total
1571	<ul style="list-style-type: none"> As-Built Description: CA only: Additional Sign or additional language below the symbol of accessibility stating "Minimum Fine \$250" not provided. Proposed Solution: Provide compliant parking signage that includes fine information. 	PCODE EA04G CBC 2007 1129B.4 CBC 2019 11B-502.6.2 Mitigated: <input type="radio"/> YES <input checked="" type="radio"/> NO	2	JOB	\$300	\$600

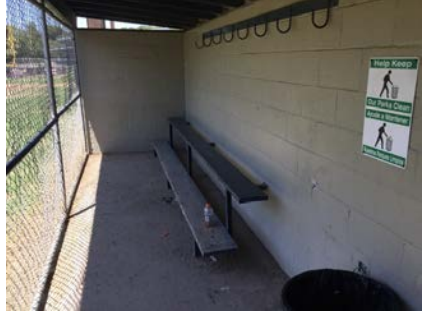
1573	<ul style="list-style-type: none"> As-Built Description: An accessible path of travel is not provided to and from all participation and activity areas, including athletic team rooms/facilities, playing fields/running tracks, baseball/softball player dugouts and sanitary/locker facilities (home and guest). Proposed Solution: Provide an accessible path of travel to all participation areas. Notes: 	PCODE GF07ANT ADAAG 91 4.1.1 (1) CBC 2007 1104B.4.3 CBC 2019 11B-206.2.18 Mitigated: <input type="radio"/> YES <input checked="" type="radio"/> NO	4	JOB	\$15,000	\$60,000

Wheelchair space at dugouts blocks circulation path. Enlarge all dugouts.

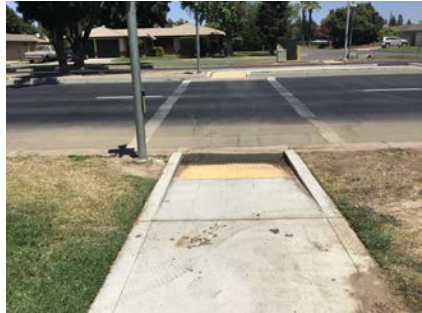
Item no., Rm no. and Name	Existing Architectural Barrier and Proposed Solution	Codes / Mitigation Info	Qty	Unit	Cost	Total
1585	<ul style="list-style-type: none"> <i>As-Built Description:</i> Maximum slope of adjoining gutters, street surface at bottom of ramp exceeds 5% (1:20). <i>As-Built:</i> 5.4% <i>Proposed Solution:</i> Modify road/gutter slopes. Demolish existing and provide new curb ramp. 	PCODE EH02E ADAAG 91 4.7.2 ADA 2010 406.2 CBC 2007 1127B.5.3 CBC 2019 11B-406.5.8 Mitigated: <input type="radio"/> YES <input checked="" type="radio"/> NO	1	JOB	\$3,750	\$3,750

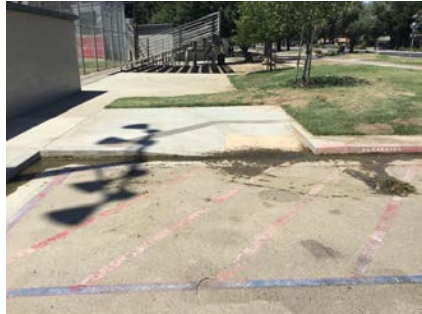
<input type="radio"/> Staff Only			
			Priority <input checked="" type="radio"/> 1			
			Severity <input checked="" type="radio"/> 4			
1591	<ul style="list-style-type: none"> <i>As-Built Description:</i> Maximum slope of adjoining gutters, street surface at bottom of ramp exceeds 5% (1:20). <i>As-Built:</i> 7.5% <i>Proposed Solution:</i> Modify road/gutter slopes. Demolish existing and provide new curb ramp. 	PCODE EH02E ADAAG 91 4.7.2 ADA 2010 406.2 CBC 2007 1127B.5.3 CBC 2019 11B-406.5.8 Mitigated: <input type="radio"/> YES <input checked="" type="radio"/> NO	1	JOB	\$3,750	\$3,750

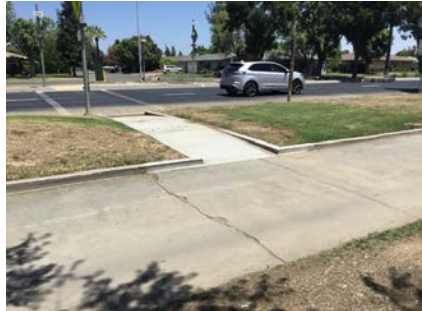
Item no., Rm no. and Name	Existing Architectural Barrier and Proposed Solution	Codes / Mitigation Info	Qty	Unit	Cost	Total
1587	<ul style="list-style-type: none"> <i>As-Built Description:</i> Detectable warning not provided where pedestrian crosses vehicular area. <i>Proposed Solution:</i> Provide detectable warning surface (i.e. in-line truncated domes) at regular curb ramp. 	PCODE EH07A ADAAG 91 4.7.7 ADA 2010 705.1 CBC 2007 1127B.5.7 CBC 2019 11B-705.1.2.2 Mitigated: <input type="radio"/> YES <input checked="" type="radio"/> NO	1	JOB	\$750	\$750

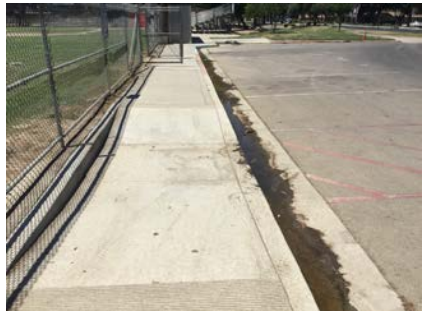
<input type="radio"/> Staff Only			
			Priority <input checked="" type="radio"/> 1 Severity <input checked="" type="radio"/> 3			
1595	<ul style="list-style-type: none"> <i>As-Built Description:</i> Detectable warning not provided where pedestrian crosses vehicular area. <i>Proposed Solution:</i> Provide detectable warning surface (i.e. in-line truncated domes) at regular curb ramp. 	PCODE EH07A ADAAG 91 4.7.7 ADA 2010 705.1 CBC 2007 1127B.5.7 CBC 2019 11B-705.1.2.2 Mitigated: <input type="radio"/> YES <input checked="" type="radio"/> NO	1	JOB	\$750	\$750

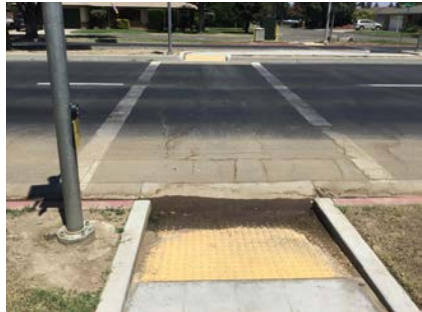
Item no., Rm no. and Name	Existing Architectural Barrier and Proposed Solution	Codes / Mitigation Info	Qty	Unit	Cost	Total
1586	<ul style="list-style-type: none"> <i>As-Built Description:</i> Curb ramp or 48" level space at bottom of ramp not provided. <i>Proposed Solution:</i> Modify bottom landing to have slope in all direction 1:48 maximum. <i>Notes:</i> 	PCODE EH09NT ADAAG 91 4.7.9 + 10 ADA 2010 406.5 CBC 2007 1127B.5.9 CBC 2019 11B-406.3.2 Mitigated: <input type="radio"/> YES <input checked="" type="radio"/> NO	25	LF	\$60	\$1,500

Bottom landing slopes 7.2% running, outside of gutter.

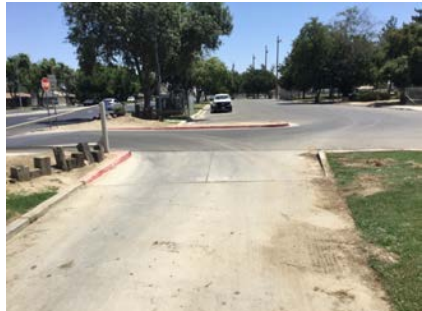
Detectable Warning

1589	<ul style="list-style-type: none"> <i>As-Built Description:</i> 36" wide band of truncated domes not provided at walkway or crossing adjoining a vehicular way, if surfaces are not separated by a curb, railing, or other element. <i>Proposed Solution:</i> Provide 36" wide, contrasting color, band of truncated domes between pedestrian and vehicular area. 	PCODE EG09 ADAAG 91 4.29.5 CBC 2007 1133B.8.5 CBC 2019 11B-705.1.2.5 Mitigated: <input type="radio"/> YES <input checked="" type="radio"/> NO	20	LF	\$81	\$1,620

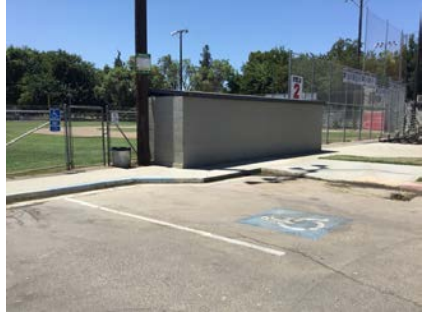
Multiple compliance issues at van space including 10.0% slope.

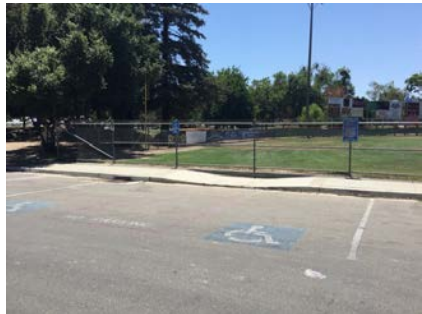
Multiple compliance issues including slopes up to 7.2% and signage at 50.0" AFF that does not include fine signs.

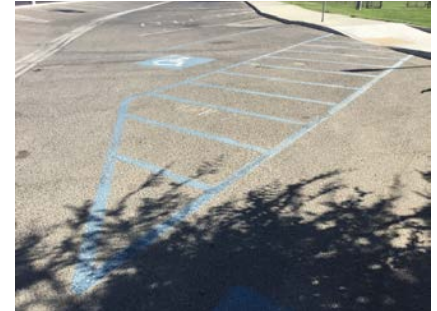
1672	<ul style="list-style-type: none"> As-Built Description: The words "NO PARKING" not painted on the ground within loading and unloading access aisle (12" min high white letters), located so that it is visible to traffic enforcement officials (required in CA only). Proposed Solution: Provide the words "NO PARKING" in each access aisle, painted in 12" high letters, when altering area. 	PCODE EA04D CBC 2007 1129B.3.1 CBC 2019 11B-502.3.3 Mitigated: <input type="radio"/> YES <input checked="" type="radio"/> NO	1	JOB	\$300	\$300
------	--	---	---	-----	-------	-------

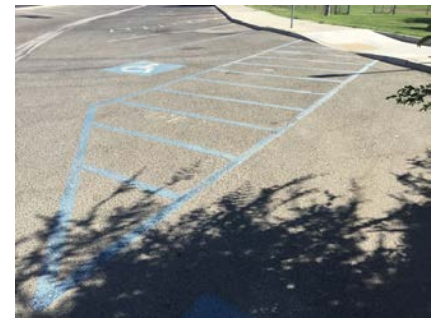
1673	<ul style="list-style-type: none"> As-Built Description: Cross hatching within access aisle is not provided or incorrect. Proposed Solution: Provide cross hatching that is 36" maximum on center and contrasting to the surface of the access aisle. Notes: 	PCODE EA04I CBC 2007 1129B.3.1 CBC 2019 11B-502.3.3 Mitigated: <input type="radio"/> YES <input checked="" type="radio"/> NO	1	JOB	\$300	\$300
------	--	---	---	-----	-------	-------

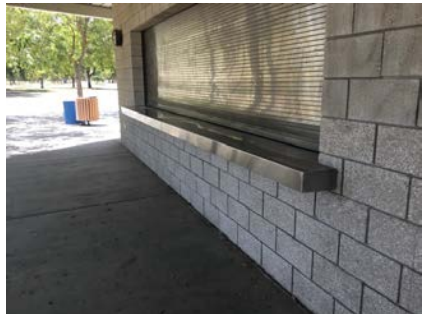
Protrusion Limits

1628	<ul style="list-style-type: none"> <i>As-Built Description:</i> Protruding objects more than 4" from wall, when bottom of object more than 27" or less than 80" above finished floor. <i>As-Built:</i> Counter: 8.5" at 33" high <i>Proposed Solution:</i> Remove/relocate protruding object. Patch existing surface. 	<p>PCODE EG04</p> <p>ADAAG 91 4.4.1</p> <p>ADA 2010 307.2</p> <p>CBC 2007 1133B.8.6.1</p> <p>CBC 2019 11B-307.2</p> <p>Mitigated:</p> <p><input type="radio"/> YES</p> <p><input checked="" type="radio"/> NO</p>	1	JOB	\$300	\$300
------	---	---	---	-----	-------	-------

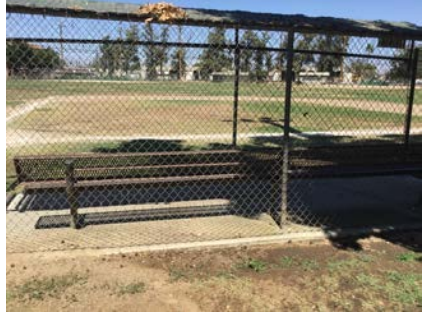
Item no., Rm no. and Name	Existing Architectural Barrier and Proposed Solution	Codes / Mitigation Info	Qty	Unit	Cost	Total
1634	<ul style="list-style-type: none"> As-Built Description: Wheelchair space (33"x48") not provided at fixed seating with forward or rear approach. (NOTE: Space must be adjacent to regular seating; can provide easily removable fixed seat). Proposed Solution: Remove fixed seating and provide wheelchair space plus necessary maneuvering clearance. Enlarge dugouts as needed. Notes: 	<p>PCODE GB01A ADAAG 91 4.1.3(19)(a) ADA 2010 221.2 CBC 2007 1104B.3.6 CBC 2019 11B-221.2</p> <p>Mitigated: <input type="radio"/> YES <input checked="" type="radio"/> NO</p>	1	JOB	\$6,000	\$6,000

In dugouts.

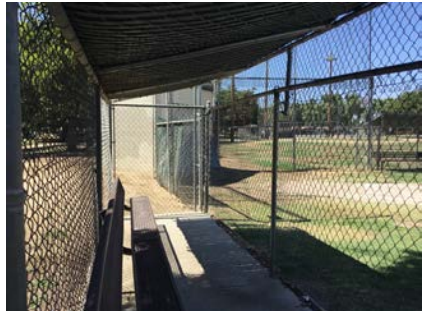
Protrusion Limits

1635	<ul style="list-style-type: none"> As-Built Description: Protruding objects more than 4" from wall, when bottom of object more than 27" or less than 80" above finished floor. As-Built: 73.0" headroom in dugouts. Proposed Solution: Remove/relocate protruding object. Patch existing surface. 	<p>PCODE EG04 ADAAG 91 4.4.1 ADA 2010 307.2 CBC 2007 1133B.8.6.1 CBC 2019 11B-307.2</p> <p>Mitigated: <input type="radio"/> YES <input checked="" type="radio"/> NO</p>	2	JOB	\$6,000	\$12,000

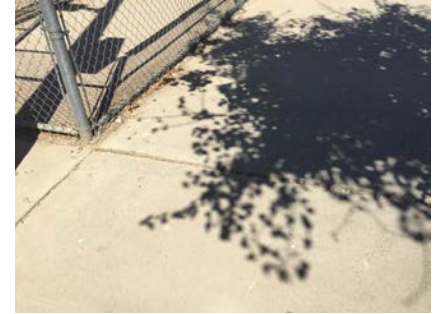
- 1641
- *As-Built Description:*
Walk: Pavement dislocation creates abrupt change in level exceeding 1/2" in accessible route.
 - *As-Built:* **0.7 not beveled**
 - *Proposed Solution:*
Remove, replace or repair area of pavement sufficient to correct abrupt change in level.

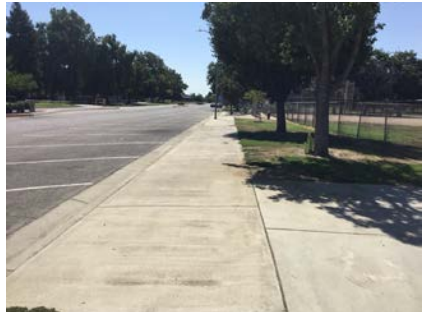
Item no., Rm no. and Name	Existing Architectural Barrier and Proposed Solution	Codes / Mitigation Info	Qty	Unit	Cost	Total
1655	<ul style="list-style-type: none"> As-Built Description: Cross slope more than 1":48" (2.083%). As-Built: 4.4% Proposed Solution: Modify cross slope. 	PCODE EF07 ADAAG 91 4.3.7 ADA 2010 403.3 CBC 2007 1133B.7.1.3 CBC 2019 11B-403.3 Mitigated: <input type="radio"/> YES <input checked="" type="radio"/> NO	500	SF	\$75	\$37,500

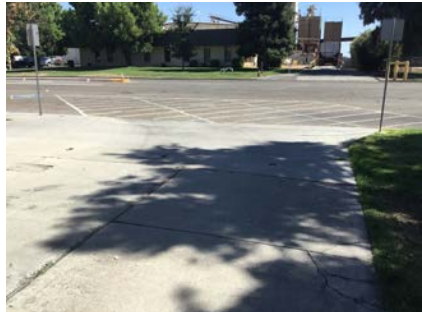
Curb Ramp

1653	<ul style="list-style-type: none"> As-Built Description: Transition from curb ramp to gutter does not have a smooth transition. As-Built: 1.0" Proposed Solution: Grind lip. Notes: 	PCODE EH02D ADAAG 91 4.7.2 ADA 2010 406.2 CBC 2007 1127B.5.3 CBC 2019 11B-406.5.8 Mitigated: <input type="radio"/> YES <input checked="" type="radio"/> NO	1	JOB	\$300	\$300

Consider whether this and others like it are intended for pedestrian traffic

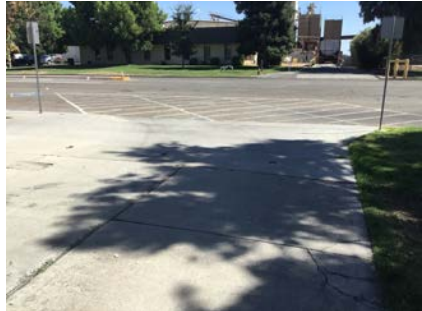
Item no., Rm no. and Name	Existing Architectural Barrier and Proposed Solution	Codes / Mitigation Info	Qty	Unit	Cost	Total
1654	<ul style="list-style-type: none"> <i>As-Built Description:</i> Detectable warning not provided where pedestrian crosses vehicular area. <i>Proposed Solution:</i> Provide detectable warning surface (i.e. in-line truncated domes) at regular curb ramp. <i>Notes:</i> 	PCODE EH07A ADAAG 91 4.7.7 ADA 2010 705.1 CBC 2007 1127B.5.7 CBC 2019 11B-705.1.2.2 Mitigated: <input type="radio"/> YES <input checked="" type="radio"/> NO	1	JOB	\$750	\$750

<input type="radio"/> Staff Only						
Priority <input checked="" type="radio"/> 1 Severity <input checked="" type="radio"/> 3						
<p>Consider whether this and others like it are intended for pedestrian traffic. Certainly there are no domes where pedestrians meet traffic.</p>

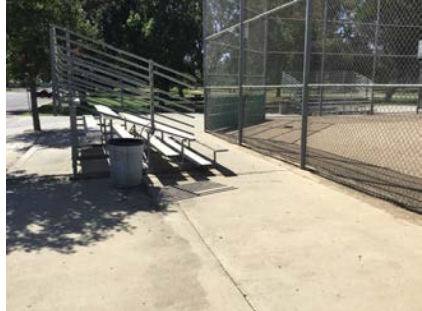
1642	<ul style="list-style-type: none"> <i>As-Built Description:</i> Wheelchair space (33"x48") not provided at fixed seating with forward or rear approach. (NOTE: Space must be adjacent to regular seating; can provide easily removable fixed seat). <i>As-Built:</i> Seating is within circulation path. <i>Proposed Solution:</i> Relocate bleacher and provide wheelchair space plus necessary maneuvering clearance. 	PCODE GB01A ADAAG 91 4.1.3(19)(a) ADA 2010 221.2 CBC 2007 1104B.3.6 CBC 2019 11B-221.2 Mitigated: <input type="radio"/> YES <input checked="" type="radio"/> NO	1	JOB	\$1,350	\$1,350

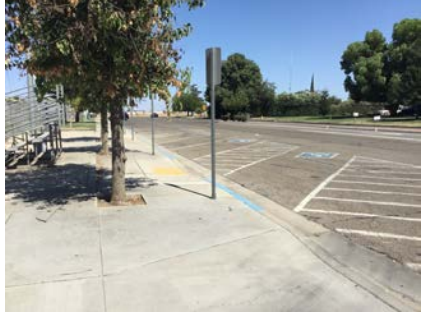
1636	<ul style="list-style-type: none"> As-Built Description: Accessible parking space smaller than 8' wide (CA only: 9' x 18'). As-Built: Diagonal spaces approximately 108.0" to 120.0" long, reduced by adjacent access aisle. Proposed Solution: Modify parking space(s) to create accessible space. 	PCODE EA02A ADAAG 91 4.6.3 ADA 2010 502.2 CBC 2007 1129B.3.1 CBC 2019 11B-502.2 Mitigated: <input type="radio"/> YES <input checked="" type="radio"/> NO	4	JOB	\$600	\$2,400
------	---	---	---	-----	-------	---------
