APPENDIX B: ACCESS COMPLIANCE SURVEY REPORT OF FACILITIES

The City of Madera

Access Compliance Survey Report

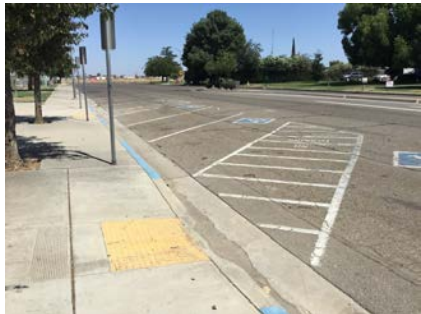
Item no., Rm no. and Name	Existing Architectural Barrier and Proposed Solution	Codes / Mitigation Info	Qty	Unit	Cost	Total
1639	<ul style="list-style-type: none"> As-Built Description: Accessible parking space smaller than 8' wide (CA only: 9' x 18'). As-Built: 96.5" wide Proposed Solution: Modify parking space(s) to create accessible space. 	PCODE EA02A ADAAG 91 4.6.3 ADA 2010 502.2 CBC 2007 1129B.3.1 CBC 2019 11B-502.2 Mitigated: <input type="radio"/> YES <input checked="" type="radio"/> NO	1	JOB	\$600	\$600

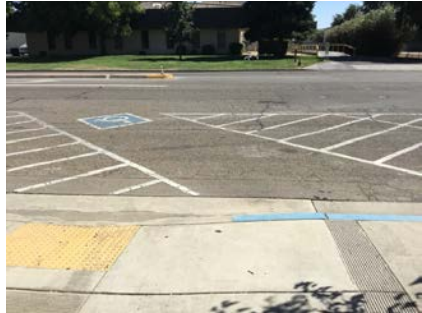
<input type="radio"/> Staff Only			
			Priority 1			
			Severity 2			
1638	<ul style="list-style-type: none"> As-Built Description: Cross hatching within access aisle is not provided or incorrect. Proposed Solution: Provide cross hatching that is 36" maximum on center and contrasting to the surface of the access aisle. Notes: 	PCODE EA04I CBC 2007 1129B.3.1 CBC 2019 11B-502.3.3 Mitigated: <input type="radio"/> YES <input checked="" type="radio"/> NO	2	JOB	\$300	\$600

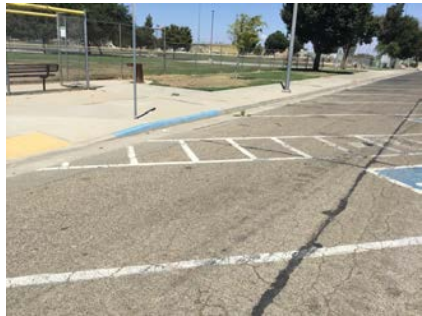
Lines are not diagonal.

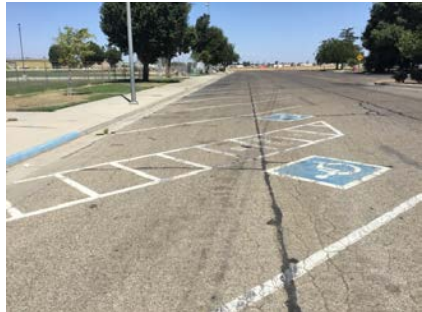
Item no., Rm no. and Name	Existing Architectural Barrier and Proposed Solution	Codes / Mitigation Info	Qty	Unit	Cost	Total
1637	<ul style="list-style-type: none"> <i>As-Built Description:</i> An accessible parking space shall be outlined or painted blue (required in CA only). <i>Proposed Solution:</i> Identify accessible parking space using blue markings. 	PCODE EA04K CBC 2019 11B-502.6 Mitigated: <input type="radio"/> YES <input checked="" type="radio"/> NO	2	JOB	\$360	\$720

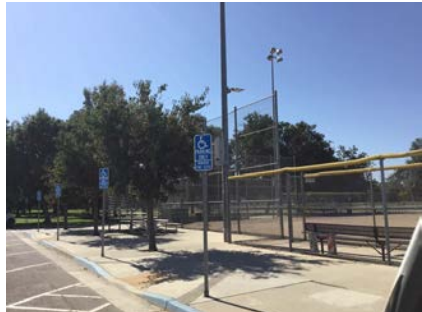
1678	<ul style="list-style-type: none"> <i>As-Built Description:</i> No "Tow Away" sign at parking lot entrance (required in CA only). <i>Proposed Solution:</i> Provide "Tow Away" sign at parking lot entrance when altering area. 	PCODE EA04C CBC 2007 1129B.4 CBC 2019 11B-502.8.2 Mitigated: <input type="radio"/> YES <input checked="" type="radio"/> NO	4	JOB	\$975	\$3,900

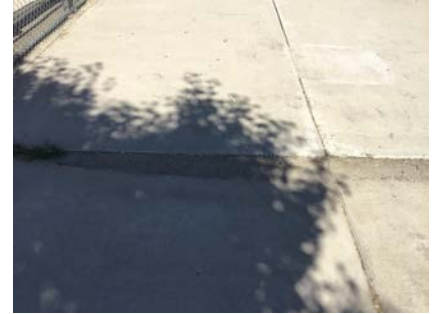
- 1656
- *As-Built Description:*
Walk: Pavement dislocation creates abrupt change in level exceeding 1/2" in accessible route.
 - *As-Built:* **Up to 0.7"**
 - *Proposed Solution:*
Remove, replace or repair area of pavement sufficient to correct abrupt change in level.

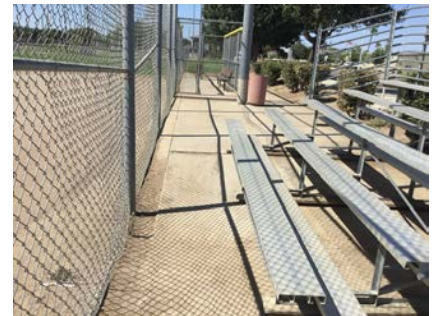
- 1659
- *As-Built Description:*
Walk: Pavement dislocation creates abrupt change in level exceeding 1/2" in accessible route.
 - *As-Built:* **2.0"**
 - *Proposed Solution:*
Remove, replace or repair area of pavement sufficient to correct abrupt change in level.

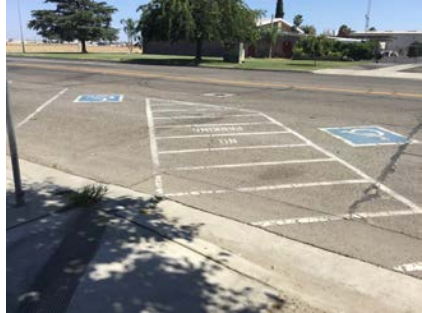
<p>1650</p> <ul style="list-style-type: none"> As-Built Description: Accessible parking space has slope greater than 1/4":12" (2%). As-Built: Up to 5.2% Proposed Solution: Modify slope at accessible parking space. 	<p>PCODE EA05 ADAAG 91 4.6.3 ADA 2010 502.4 CBC 2007 1129B.3.3 CBC 2019 11B-502.4</p> <p>Mitigated: <input type="radio"/> YES <input checked="" type="radio"/> NO</p>	<p>300 SF \$36 \$10,800</p>

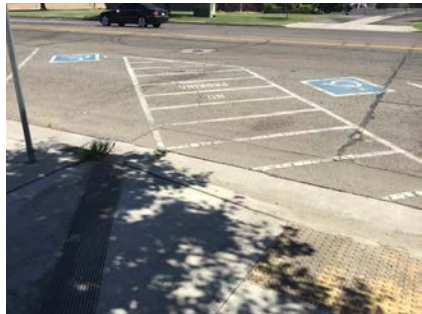
<p>1647</p> <ul style="list-style-type: none"> As-Built Description: Accessible parking space smaller than 8' wide (CA only: 9' x 18'). As-Built: Approximately 86.0" to 104.0" long limited by adjacent access aisle. Proposed Solution: Modify parking space(s) to create accessible space. 	<p>PCODE EA02A ADAAG 91 4.6.3 ADA 2010 502.2 CBC 2007 1129B.3.1 CBC 2019 11B-502.2</p> <p>Mitigated: <input type="radio"/> YES <input checked="" type="radio"/> NO</p>	<p>2 JOB \$600 \$1,200</p>

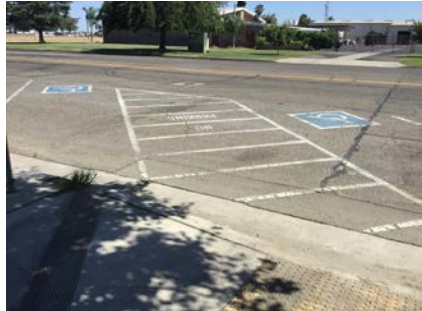
Item no., Rm no. and Name	Existing Architectural Barrier and Proposed Solution	Codes / Mitigation Info	Qty	Unit	Cost	Total
1649	<ul style="list-style-type: none"> As-Built Description: Cross hatching within access aisle is not provided or incorrect. Proposed Solution: Provide cross hatching that is 36" maximum on center and contrasting to the surface of the access aisle. Notes: 	<p>PCODE EA04I</p> <p>CBC 2007 1129B.3.1</p> <p>CBC 2019 11B-502.3.3</p> <p>Mitigated:</p> <p><input type="radio"/> YES</p> <p><input checked="" type="radio"/> NO</p>	2	JOB	\$300	\$600

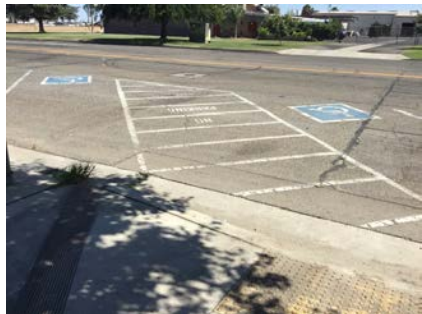
<input type="radio"/> Staff Only			
			Priority <input checked="" type="radio"/> 1			
			Severity <input checked="" type="radio"/> 3			
Not diagonal.						
1648	<ul style="list-style-type: none"> As-Built Description: An accessible parking space shall be outlined or painted blue (required in CA only). Proposed Solution: Identify accessible parking space using blue markings. 	<p>PCODE EA04K</p> <p>CBC 2019 11B-502.6</p> <p>Mitigated:</p> <p><input type="radio"/> YES</p> <p><input checked="" type="radio"/> NO</p>	1	JOB	\$360	\$360

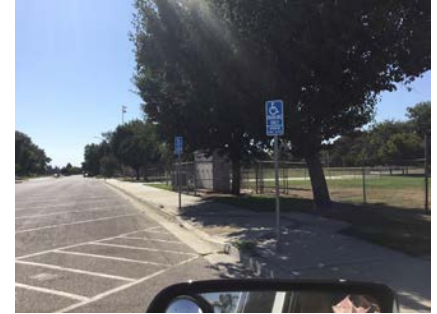
1677	<ul style="list-style-type: none"> <i>As-Built Description:</i> No "Tow Away" sign at parking lot entrance (required in CA only). <i>Proposed Solution:</i> Provide "Tow Away" sign at parking lot entrance when altering area. 	<p>PCODE EA04C</p> <p>CBC 2007 1129B.4</p> <p>CBC 2019 11B-502.8.2</p> <p>Mitigated:</p> <p><input type="radio"/> YES</p> <p><input checked="" type="radio"/> NO</p>	1	JOB	\$975	\$975
------	---	--	---	-----	-------	-------

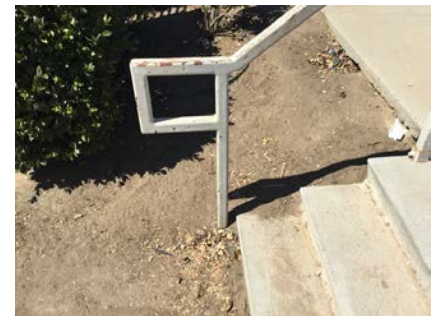
1660	<ul style="list-style-type: none"> <i>As-Built Description:</i> Stair handrail does not extend horizontally 12" minimum beyond top nosing, and one tread width sloped, plus 12" minimum horizontally beyond the bottom nosing. <i>Proposed Solution:</i> Extend stair handrail at top and bottom (cost for each extension piece). 	<p>PCODE ED06</p> <p>ADAAG 91 4.9.4(2)</p> <p>ADA 2010 505.10.2; 505.10.3</p> <p>CBC 2007 1133B.4.2.2</p> <p>CBC 2019 11B-505.10.2; 11B-505.10.3</p> <p>Mitigated:</p> <p><input type="radio"/> YES</p> <p><input checked="" type="radio"/> NO</p>	6	JOB	\$510	\$3,060
------	---	--	---	-----	-------	---------

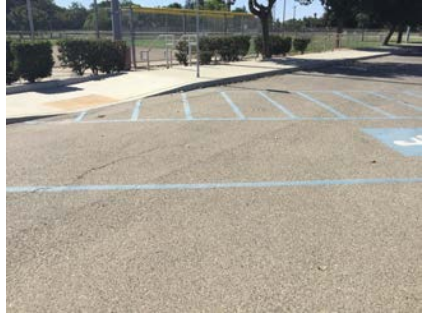
<p>1664</p> <ul style="list-style-type: none"> As-Built Description: Accessible parking space has slope greater than 1/4":12" (2%). As-Built: Up to 7.3% Proposed Solution: Modify slope at accessible parking space. 	<p>PCODE EA05 ADAAG 91 4.6.3 ADA 2010 502.4 CBC 2007 1129B.3.3 CBC 2019 11B-502.4</p> <p>Mitigated: <input type="radio"/> YES <input checked="" type="radio"/> NO</p>	<p>50 SF \$36 \$1,800</p>

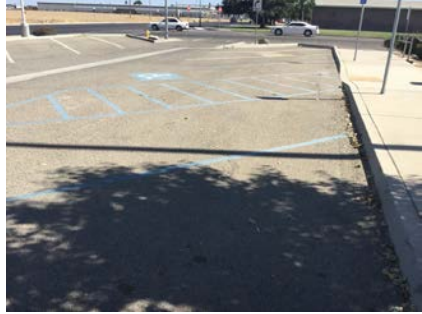
<p>1663</p> <ul style="list-style-type: none"> As-Built Description: Accessible parking space smaller than 8' wide (CA only: 9' x 18'). As-Built: Approximately 120.0" to 145.0" reduced by adjacent access aisle. Proposed Solution: Modify parking space(s) to create accessible space. 	<p>PCODE EA02A ADAAG 91 4.6.3 ADA 2010 502.2 CBC 2007 1129B.3.1 CBC 2019 11B-502.2</p> <p>Mitigated: <input type="radio"/> YES <input checked="" type="radio"/> NO</p>	<p>2 JOB \$600 \$1,200</p>

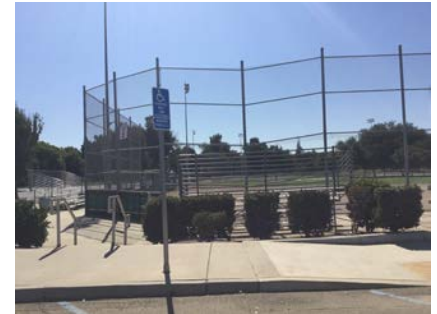
1665	<ul style="list-style-type: none"> <i>As-Built Description:</i> No "Tow Away" sign at parking lot entrance (required in CA only). <i>Proposed Solution:</i> Provide "Tow Away" sign at parking lot entrance when altering area. 	<p>PCODE EA04C</p> <p>CBC 2007 1129B.4</p> <p>CBC 2019 11B-502.8.2</p> <p>Mitigated:</p> <p><input type="radio"/> YES</p> <p><input checked="" type="radio"/> NO</p>	2	JOB	\$975	\$1,950
------	---	--	---	-----	-------	---------

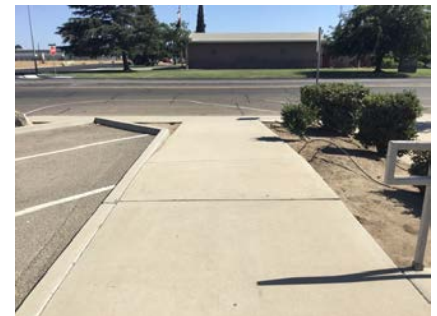
1668	<ul style="list-style-type: none"> <i>As-Built Description:</i> Slope not steep but greater than 1:20 (5.0 %) without handrails. <i>Proposed Solution:</i> Provide handrails for ramp. 	<p>PCODE EB03</p> <p>ADAAG 91 4.8.1</p> <p>ADA 2010 405.1</p> <p>CBC 2007 1133B.5.5.1</p> <p>CBC 2019 11B-405.8</p> <p>Mitigated:</p> <p><input type="radio"/> YES</p> <p><input checked="" type="radio"/> NO</p>	20	LF	\$225	\$4,500
------	--	---	----	----	-------	---------

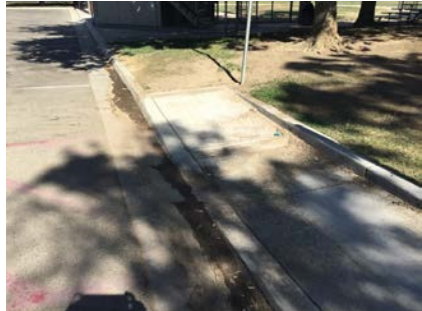
Item no., Rm no. and Name	Existing Architectural Barrier and Proposed Solution	Codes / Mitigation Info	Qty	Unit	Cost	Total
1686	<ul style="list-style-type: none"> As-Built Description: Cross slope greater than 2%. As-Built: 2.8% Proposed Solution: Demolish existing and provide new curb ramp. 	PCODE EH02F ADAAG 91 4.8.6 ADA 2010 405.3 CBC 2007 1133B.5.3.1 CBC 2019 11B-406.5.7 Mitigated: <input type="radio"/> YES <input checked="" type="radio"/> NO	1	JOB	\$7,500	\$7,500

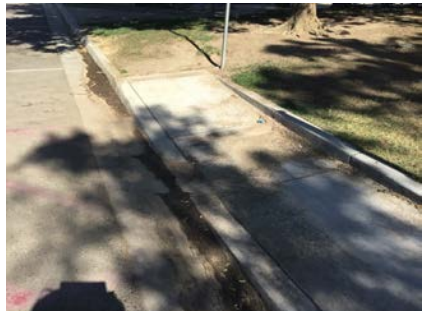
<input type="radio"/> Staff Only			
			Priority <input checked="" type="radio"/> 1			
			Severity <input checked="" type="radio"/> 4			
1687	<ul style="list-style-type: none"> As-Built Description: Detectable warning not provided where pedestrian crosses vehicular area. Proposed Solution: Provide detectable warning surface (i.e. in-line truncated domes) at regular curb ramp. 	PCODE EH07A ADAAG 91 4.7.7 ADA 2010 705.1 CBC 2007 1127B.5.7 CBC 2019 11B-705.1.2.2 Mitigated: <input type="radio"/> YES <input checked="" type="radio"/> NO	1	JOB	\$750	\$750

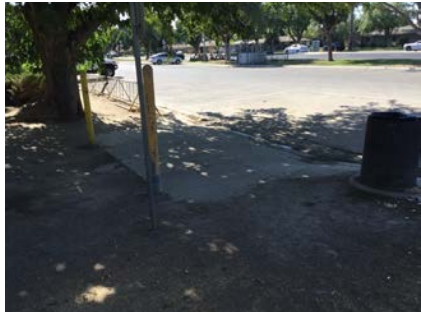
Verify if intended for pedestrian traffic.

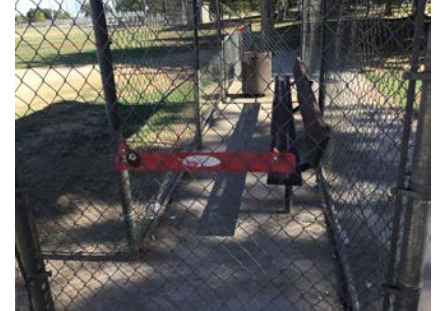
1690	<ul style="list-style-type: none"> <i>As-Built Description:</i> Wheelchair space (33"x48") not provided at fixed seating with forward or rear approach. (NOTE: Space must be adjacent to regular seating; can provide easily removable fixed seat). <i>As-Built:</i> Wheelchair space within circulation path. <i>Proposed Solution:</i> Remove fixed seating and provide wheelchair space plus necessary maneuvering clearance. Enlarge dugouts as needed. <i>Notes:</i> 	<p>PCODE GB01A ADAAG 91 4.1.3(19)(a) ADA 2010 221.2 CBC 2007 1104B.3.6 CBC 2019 11B-221.2</p> <p>Mitigated: <input type="radio"/> YES <input checked="" type="radio"/> NO</p>	2	JOB	\$6,000	\$12,000
------	--	--	---	-----	---------	-----------------

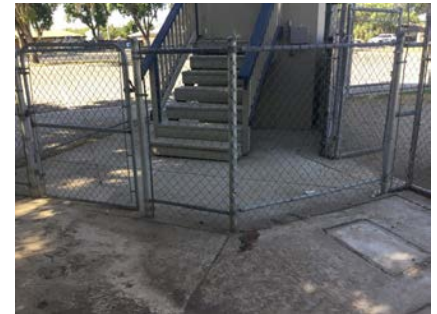
1691	<ul style="list-style-type: none"> <i>As-Built Description:</i> At push side of door on accessible route, bottom 10" does not have a smooth, uninterrupted surface. <i>Proposed Solution:</i> Provide 10" min. "kick plate" covering width of door when altering area. 	<p>PCODE ID06 ADA 2010 404.2.10 CBC 2007 1133B.2.6 CBC 2019 11B-404.2.10</p> <p>Mitigated: <input type="radio"/> YES <input checked="" type="radio"/> NO</p>	2	JOB	\$300	\$600
------	--	---	---	-----	-------	--------------

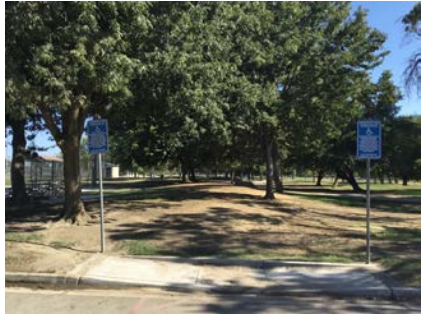
1679	<ul style="list-style-type: none"> As-Built Description: Sign for accessible parking space is missing or non-compliant. Proposed Solution: Provide compliant parking signage. 	PCODE EA04B ADAAG 91 4.6.4 ADA 2010 502.6 CBC 2007 1129B.4 CBC 2019 11B-502.6 Mitigated: <input type="radio"/> YES <input checked="" type="radio"/> NO	2	JOB	\$945	\$1,890
------	---	---	---	-----	-------	---------

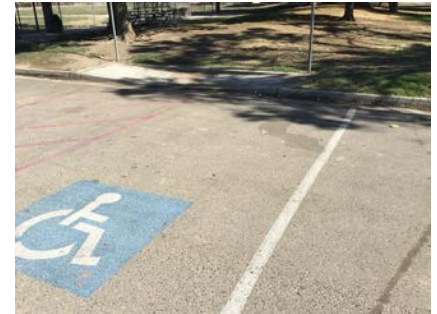
1684	<ul style="list-style-type: none"> As-Built Description: Accessible parking space smaller than 8' wide (CA only: 9' x 18'). As-Built: 107.0" wide Proposed Solution: Modify parking space(s) to create accessible space. 	PCODE EA02A ADAAG 91 4.6.3 ADA 2010 502.2 CBC 2007 1129B.3.1 CBC 2019 11B-502.2	1	JOB	\$600	\$600
------	--	---	---	-----	-------	-------

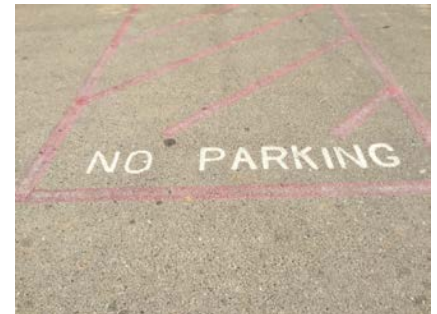
1682	<ul style="list-style-type: none"> As-Built Description: The words "NO PARKING" not painted on the ground within loading and unloading access aisle (12" min high white letters), located so that it is visible to traffic enforcement officials (required in CA only). As-Built: 8.0" high characters. Proposed Solution: Provide the words "NO PARKING" in each access aisle, painted in 12" high letters, when altering area. 	PCODE EA04D CBC 2007 1129B.3.1 CBC 2019 11B-502.3.3	1	JOB	\$300	\$300
------	--	---	---	-----	-------	-------

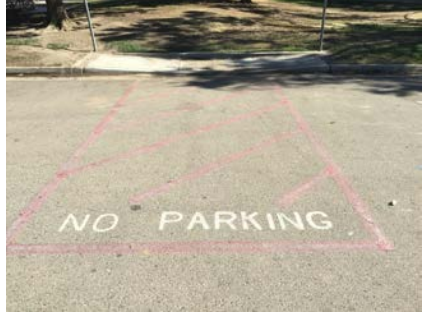
Item no., Rm no. and Name	Existing Architectural Barrier and Proposed Solution	Codes / Mitigation Info	Qty	Unit	Cost	Total
1681	<ul style="list-style-type: none"> <i>As-Built Description:</i> An accessible parking space shall be outlined or painted blue (required in CA only). <i>Proposed Solution:</i> Identify accessible parking space using blue markings. 	PCODE EA04K CBC 2019 11B-502.6 Mitigated: <input type="radio"/> YES <input checked="" type="radio"/> NO	1	JOB	\$360	\$360

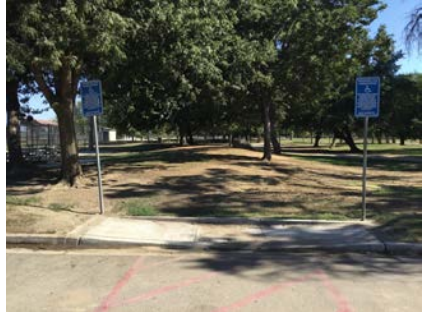
Parking Signage

1680	<ul style="list-style-type: none"> <i>As-Built Description:</i> CA only: Additional Sign or additional language below the symbol of accessibility stating “Minimum Fine \$250” not provided. <i>Proposed Solution:</i> Provide compliant parking signage that includes fine information. 	PCODE EA04G CBC 2007 1129B.4 CBC 2019 11B-502.6.2 Mitigated: <input type="radio"/> YES <input checked="" type="radio"/> NO	2	JOB	\$300	\$600

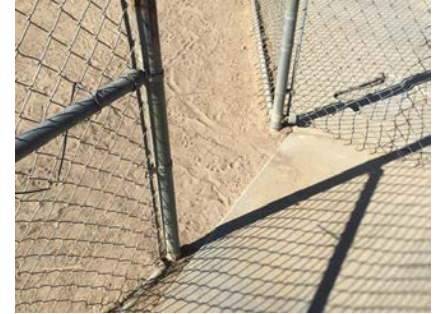
- 1698 • *As-Built Description:*
Walk: Pavement dislocation creates abrupt change in level exceeding 1/2" in accessible route.
- *As-Built:* **2.0" at dugouts.**
- *Proposed Solution:*
Remove, replace or repair area of pavement sufficient to correct abrupt change in level.

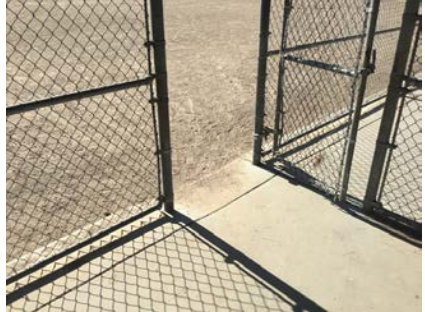
Item no., Rm no. and Name	Existing Architectural Barrier and Proposed Solution	Codes / Mitigation Info	Qty	Unit	Cost	Total
1703	<ul style="list-style-type: none"> As-Built Description: Surface of required maneuvering clearance at door slopes more than 1/4":12" (2.0%). As-Built: 8.0% Proposed Solution: Modify surface slope at door. 	PCODE ID11 ADAAG 91 4.13.6 ADA 2010 404.2.4.4 CBC 2007 1133B.2.4 CBC 2019 11B-404.2.4 Mitigated: <input type="radio"/> YES <input checked="" type="radio"/> NO	50	SF	\$120	\$6,000

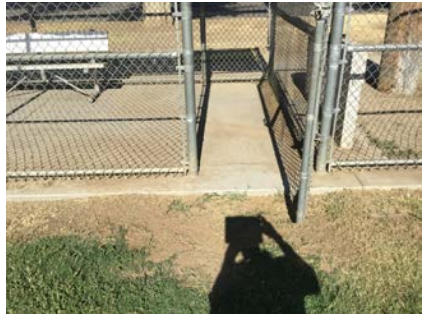
Door Threshold

1704	<ul style="list-style-type: none"> As-Built Description: Door inaccessible due to threshold or step at door exceeding 1/2". As-Built: Up to 3.0" Proposed Solution: Modify threshold to be no more than 1/2" by removing existing paving at door and providing landing with edge ramping (slope 1:20 max). Notes: 	PCODE ID02A ADAAG 91 4.13.8 ADA 2010 404.2.5 CBC 2007 1133B.2.4.1 CBC 2019 11B-404.2.5 Mitigated: <input type="radio"/> YES <input checked="" type="radio"/> NO	4	JOB	\$1,200	\$4,800

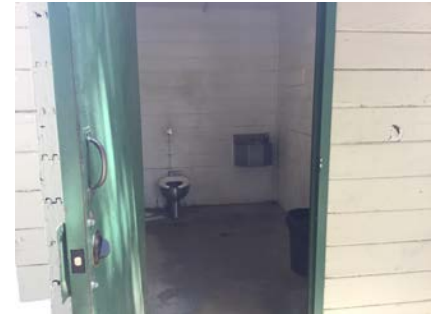
Single accommodation restroom not accessible; multiple compliance violations.

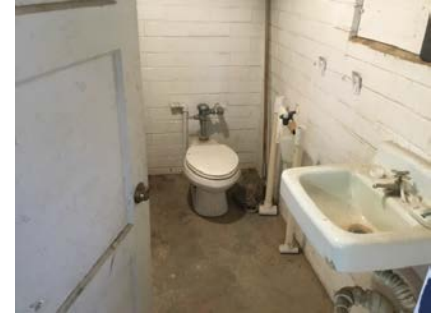
- *As-Built Description:*
Single accommodation restroom not accessible; multiple compliance violations.
- *As-Built:* **96.0" x 72.0"**
- *Proposed Solution:*
Remodel area to provide single-occupant accessible restroom.

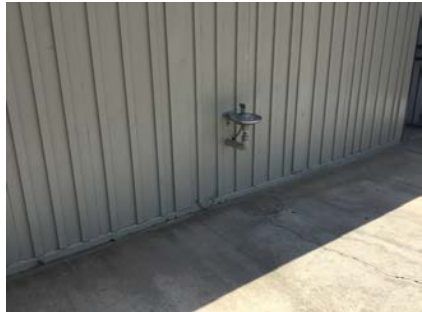
Item no., Rm no. and Name	Existing Architectural Barrier and Proposed Solution	Codes / Mitigation Info	Qty	Unit	Cost	Total
1378	<ul style="list-style-type: none"> <i>As-Built Description:</i> Drinking fountain lacks protection for visually impaired persons. <i>Proposed Solution:</i> Provide cane-detectable rails. 	PCODE IA05C ADAAG 91 4.4.1 ADA 2010 307.2 CBC 2007 1115B.4.6.3 CBC 2019 11B-307.2 Mitigated: <input type="radio"/> YES <input checked="" type="radio"/> NO	1	JOB	\$1,500	\$1,500

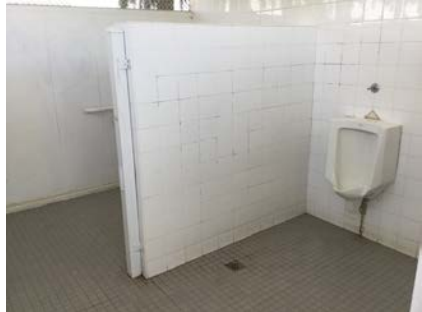
Restroom

1375	<ul style="list-style-type: none"> <i>As-Built Description:</i> Multiple accommodation restroom not accessible; multiple compliance violations. <i>As-Built:</i> 140.0" x 112.0" <i>Proposed Solution:</i> Remodel area to provide accessible restroom with one accessible stall, lavatory (and one urinal at Men's). 	PCODE WA01A ADAAG 91 4.22 ADA 2010 603.1 CBC 2007 1115B.3.1 CBC 2019 11B-603.1 Mitigated: <input type="radio"/> YES <input checked="" type="radio"/> NO	2	JOB	?	\$210,000

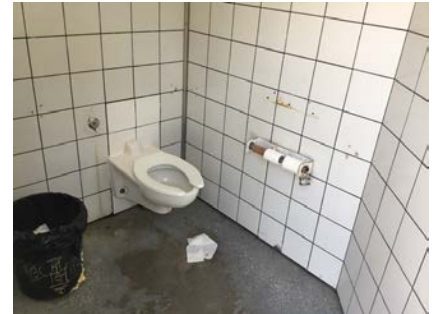
Single accommodation restroom not accessible; multiple compliance violations.

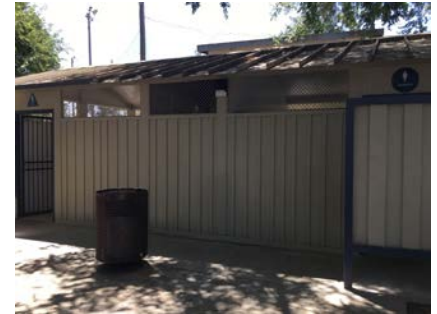
Multiple accommodation restroom not accessible; multiple compliance violations.

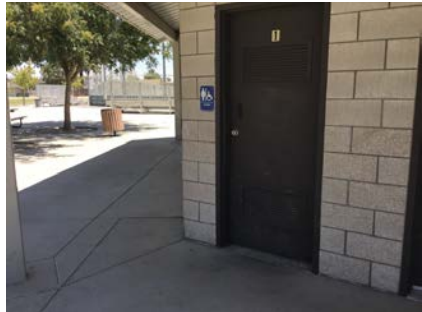
Item no., Rm no. and Name	Existing Architectural Barrier and Proposed Solution	Codes / Mitigation Info	Qty	Unit	Cost	Total
2170	<ul style="list-style-type: none"> As-Built Description: Surface of required maneuvering clearance at door slopes more than 1/4":12" (2.0%). As-Built: 3.8% Proposed Solution: Modify surface slope at door. 	PCODE ID11 ADAAG 91 4.13.6 ADA 2010 404.2.4.4 CBC 2007 1133B.2.4 CBC 2019 11B-404.2.4 Mitigated: <input type="radio"/> YES <input checked="" type="radio"/> NO	25	SF	\$120	\$3,000

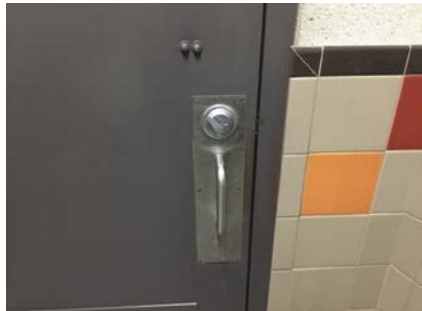
1600	<ul style="list-style-type: none"> As-Built Description: Door lock, latch or handle less than 34" or more than 48" above the floor (CA only: 34" to 44"). As-Built: 45.0" high Proposed Solution: Relocate or replace existing hardware. Notes: 	PCODE ID17 ADAAG 91 4.13.9 ADA 2010 404.2.7 CBC 2007 1133B.2.5.2 CBC 2019 11B-404.2.7 Mitigated: <input type="radio"/> YES <input checked="" type="radio"/> NO	1	JOB	\$900	\$900

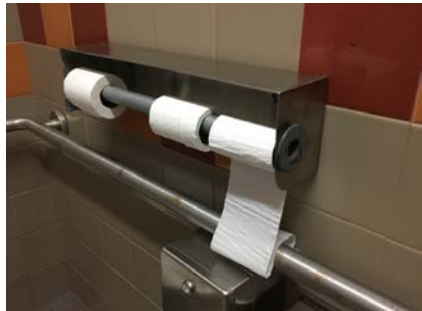
1603	<ul style="list-style-type: none"> • <i>As-Built Description:</i> Accessories/dispensers in accessible stall located closer than 1-1/2" below or 12" above grab bar impedes its use. • <i>As-Built:</i> TPD: 5.0" above grab bar • <i>Proposed Solution:</i> Relocate accessories/dispensers within applicable reach range and to be no closer than 1-1/2" below and 12" above grab bars (except if accessories are recessed, flush with wall, and have no sharp edges). 	PCODE WB07I ADAAG 91 4.26.2 ADA 2010 609.3 CBC 2007 1133B.4.2.5 CBC 2019 11B-609.3 Mitigated: <input type="radio"/> YES <input checked="" type="radio"/> NO	1	JOB	\$225	\$225

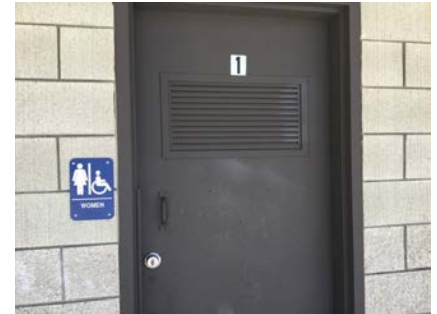
1598	<ul style="list-style-type: none"> <i>As-Built Description:</i> Required in CA only: identification symbol centered 58" to 60" high on sanitary facility door that contrasts with the door not provided (women: 12" ø circle, men: 12" triangle, unisex: combined symbol). <i>Proposed Solution:</i> Provide properly mounted sanitary facility symbol when altering area. If wheelchair accessible, include International Symbol of Accessibility on sign. 	<p>PCODE SA15</p> <p>CBC 2007 1115B.6</p> <p>CBC 2019 11B-703.7.2.6</p> <p>Mitigated:</p> <p><input type="radio"/> YES</p> <p><input checked="" type="radio"/> NO</p>	1	JOB	\$270	\$270
------	---	---	---	-----	-------	-------

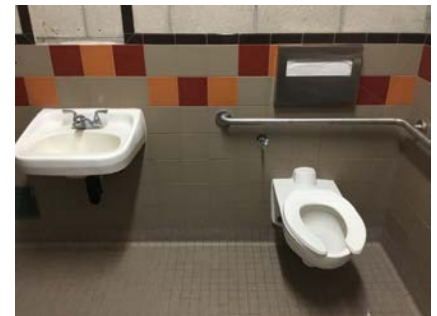
1608	<ul style="list-style-type: none"> <i>As-Built Description:</i> 60" min. clearance around a water closet measured perpendicular from the side wall not provided (Fixtures are not allowed to overlap this clearance). <i>As-Built:</i> 53.0" to lavatory <i>Proposed Solution:</i> Remove adjacent fixture and remodel restroom as needed. <i>Notes:</i> 	<p>PCODE WB01A</p> <p>ADA 2010 604.3.1; 604.3.2</p> <p>CBC 2007 1115B.7.1.3</p> <p>CBC 2019 11B-604.3.1; 11B-604.3.2</p> <p>Mitigated:</p> <p><input type="radio"/> YES</p> <p><input checked="" type="radio"/> NO</p>	1	JOB	\$6,000	\$6,000
------	---	--	---	-----	---------	---------

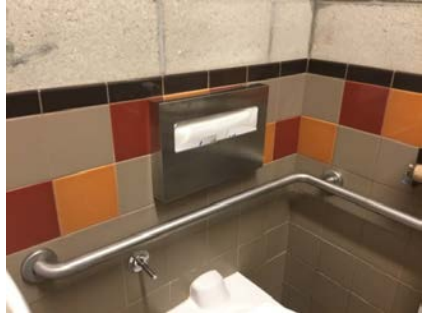
<p>1624</p> <ul style="list-style-type: none"> <i>As-Built Description:</i> Dispensers in sanitary facilities, such as for towels, soap, sanitary napkins, seat covers, etc., and waste receptacles more than 48" (CA only: 40") from floor to highest operating slot or control. <i>As-Built:</i> SCD: 43.0" high <i>Proposed Solution:</i> Relocate existing restroom accessories. 	<p>PCODE WG01A ADAAG 91 4.23.7 ADA 2010 308.2.1 CBC 2007 1115B.8.3 CBC 2019 11B-603.5</p>	<p>1 JOB \$300 \$300</p>

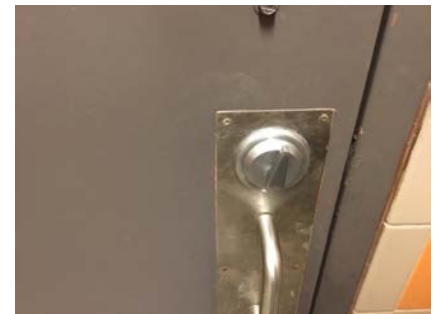
- 1615 • *As-Built Description:*
Door lock, latch or handle less than 34" or more than 48" above the floor (CA only: 34" to 44").
- *As-Built:* **45.0" high**
- *Proposed Solution:*
Relocate or replace existing hardware.
- **Notes:**

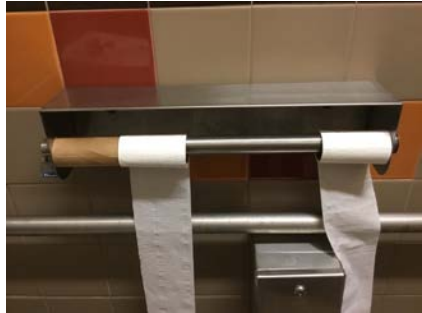
Item no., Rm no. and Name	Existing Architectural Barrier and Proposed Solution	Codes / Mitigation Info	Qty	Unit	Cost	Total
1620	<ul style="list-style-type: none"> • <i>As-Built Description:</i> Accessories/dispensers in accessible stall located closer than 1-1/2" below or 12" above grab bar impedes its use. • <i>As-Built:</i> TPD: 4.0" above grab bar • <i>Proposed Solution:</i> Relocate accessories/dispensers within applicable reach range and to be no closer than 1-1/2" below and 12" above grab bars (except if accessories are recessed, flush with wall, and have no sharp edges). 	PCODE WB07I ADAAG 91 4.26.2 ADA 2010 609.3 CBC 2007 1133B.4.2.5 CBC 2019 11B-609.3 Mitigated: <input type="radio"/> YES <input checked="" type="radio"/> NO	1	JOB	\$225	\$225

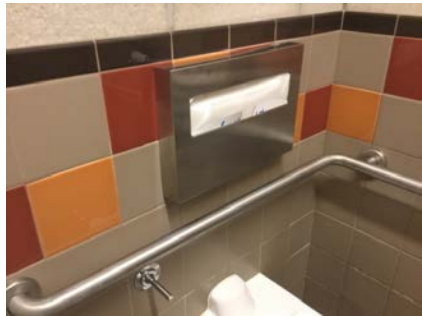
<input type="radio"/> Staff Only			
			Priority 3			
			Severity 4			
1621	<ul style="list-style-type: none"> • <i>As-Built Description:</i> Accessories/dispensers in accessible stall located closer than 1-1/2" below or 12" above grab bar impedes its use. • <i>As-Built:</i> SCD: 2.0" above grab bar • <i>Proposed Solution:</i> Relocate accessories/dispensers within applicable reach range and to be no closer than 1-1/2" below and 12" above grab bars (except if accessories are recessed, flush with wall, and have no sharp edges). 	PCODE WB07I ADAAG 91 4.26.2 ADA 2010 609.3 CBC 2007 1133B.4.2.5 CBC 2019 11B-609.3 Mitigated: <input type="radio"/> YES <input checked="" type="radio"/> NO	1	JOB	\$225	\$225

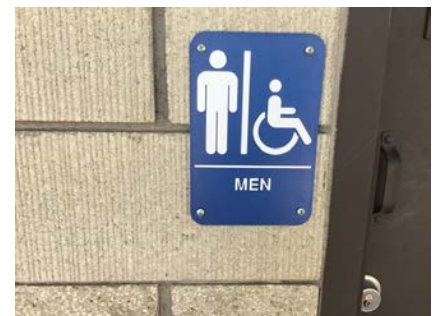
- 1612 • *As-Built Description:*
Entrance to toilet or bathing facility not identified with ADAAG compliant signage.
- *As-Built:* **Braille 0.75" from characters.**
- *Proposed Solution:*
Provide ADA compliant sign mounted at 48" min. above to baseline of the lowest Braille cells and 60" max. to baseline of the highest line of raised characters on nearest adjacent wall, on latch side of a single door (located not to cause a Braille reader to stand within the door swing).
- *Notes:*

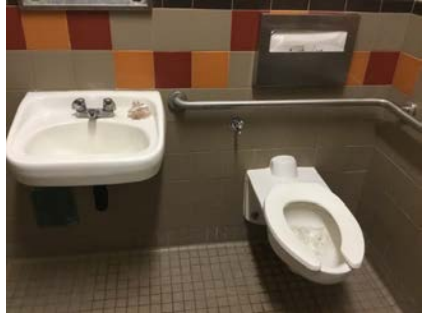
1616	<ul style="list-style-type: none"> As-Built Description: 60" min. clearance around a water closet measured perpendicular from the side wall not provided (Fixtures are not allowed to overlap this clearance). As-Built: 40.0" to lavatory Proposed Solution: Remove adjacent fixture and remodel restroom as needed. Notes: 	PCODE WB01A ADA 2010 604.3.1; 604.3.2 CBC 2007 1115B.7.1.3 CBC 2019 11B-604.3.1; 11B-604.3.2 Mitigated: <input type="radio"/> YES <input checked="" type="radio"/> NO	1	JOB	\$6,000	\$6,000
------	---	--	---	-----	---------	---------

This element complies with Safe Harbor if altered or constructed before March 15, 2012. This element does not comply with the dimensional requirements in the 1981 to the current CBC.

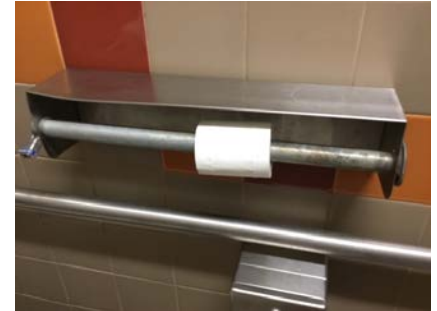
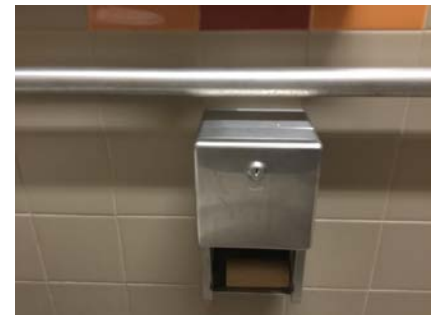
Item no., Rm no. and Name	Existing Architectural Barrier and Proposed Solution	Codes / Mitigation Info	Qty	Unit	Cost	Total
2150	<ul style="list-style-type: none"> • <i>As-Built Description:</i> Accessories/dispensers in accessible stall located closer than 1-1/2" below or 12" above grab bar impedes its use. • <i>As-Built:</i> PTD: 4.0" above grab bar • <i>Proposed Solution:</i> Relocate accessories/dispensers within applicable reach range and to be no closer than 1-1/2" below and 12" above grab bars (except if accessories are recessed, flush with wall, and have no sharp edges). 	PCODE WB07I ADAAG 91 4.26.2 ADA 2010 609.3 CBC 2007 1133B.4.2.5 CBC 2019 11B-609.3 Mitigated: <input type="radio"/> YES <input checked="" type="radio"/> NO	1	JOB	\$225	\$225
						<input type="radio"/> Staff Only Priority 3 Severity 4
2151	<ul style="list-style-type: none"> • <i>As-Built Description:</i> Accessories/dispensers in accessible stall located closer than 1-1/2" below or 12" above grab bar impedes its use. • <i>As-Built:</i> PTD: 1.3" below grab bar • <i>Proposed Solution:</i> Raise the grab bar. 	PCODE WB07I ADAAG 91 4.26.2 ADA 2010 609.3 CBC 2007 1133B.4.2.5 CBC 2019 11B-609.3 Mitigated: <input type="radio"/> YES <input checked="" type="radio"/> NO	1	JOB	\$225	\$225

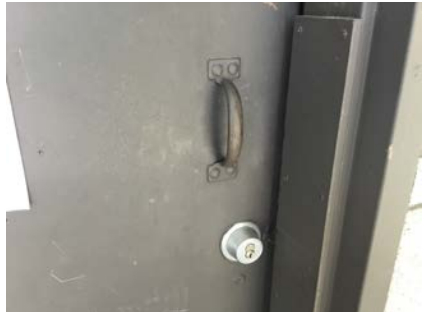
Item no., Rm no. and Name	Existing Architectural Barrier and Proposed Solution	Codes / Mitigation Info	Qty	Unit	Cost	Total
2130	<ul style="list-style-type: none"> As-Built Description: Door lock, latch or handle less than 34" or more than 48" above the floor (CA only: 34" to 44"). As-Built: 51.0" Proposed Solution: Relocate or replace existing hardware. Notes: 	PCODE ID17 ADAAG 91 4.13.9 ADA 2010 404.2.7 CBC 2007 1133B.2.5.2 CBC 2019 11B-404.2.7 Mitigated: <input type="radio"/> YES <input checked="" type="radio"/> NO	6	JOB	\$900	\$5,400

Occurs at each restroom at the hexagon.

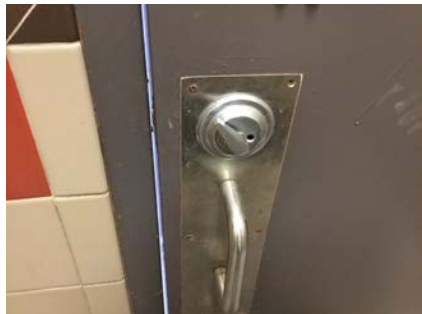
2154	<ul style="list-style-type: none"> As-Built Description: Door lock, latch or handle less than 34" or more than 48" above the floor (CA only: 34" to 44"). As-Built: 44.75" Proposed Solution: Relocate or replace existing hardware. Notes: 	PCODE ID17 ADAAG 91 4.13.9 ADA 2010 404.2.7 CBC 2007 1133B.2.5.2 CBC 2019 11B-404.2.7 Mitigated: <input type="radio"/> YES <input checked="" type="radio"/> NO	1	JOB	\$900	\$900
------	--	---	---	-----	-------	-------

This element complies with Safe Harbor if altered or constructed before March 15, 2012. The dimensional requirements in this CBC citation applied from the 1998 CBC to the code cycle at the time of this survey.

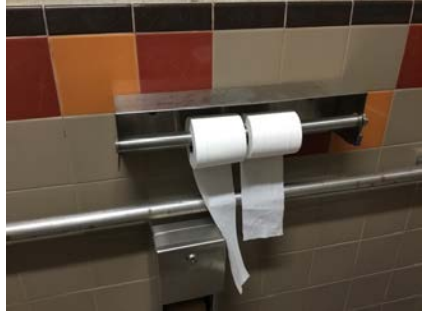
Item no., Rm no. and Name	Existing Architectural Barrier and Proposed Solution	Codes / Mitigation Info	Qty	Unit	Cost	Total
2136	<ul style="list-style-type: none"> • <i>As-Built Description:</i> Accessories/dispensers in accessible stall located closer than 1-1/2" below or 12" above grab bar impedes its use. • <i>As-Built:</i> PTD: 3.5" above grab bar • <i>Proposed Solution:</i> Relocate accessories/dispensers within applicable reach range and to be no closer than 1-1/2" below and 12" above grab bars (except if accessories are recessed, flush with wall, and have no sharp edges). 	PCODE WB07I ADAAG 91 4.26.2 ADA 2010 609.3 CBC 2007 1133B.4.2.5 CBC 2019 11B-609.3 Mitigated: <input type="radio"/> YES <input checked="" type="radio"/> NO	1	JOB	\$225	\$225

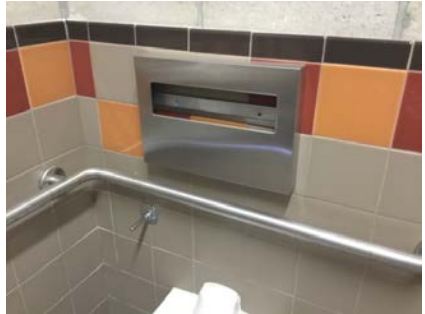
2137	<ul style="list-style-type: none"> • <i>As-Built Description:</i> Accessories/dispensers in accessible stall located closer than 1-1/2" below or 12" above grab bar impedes its use. • <i>As-Built:</i> SCD: 3.0" above grab bar • <i>Proposed Solution:</i> Relocate accessories/dispensers within applicable reach range and to be no closer than 1-1/2" below and 12" above grab bars (except if accessories are recessed, flush with wall, and have no sharp edges). 	PCODE WB07I ADAAG 91 4.26.2 ADA 2010 609.3 CBC 2007 1133B.4.2.5 CBC 2019 11B-609.3 Mitigated: <input type="radio"/> YES <input checked="" type="radio"/> NO	1	JOB	\$225	\$225

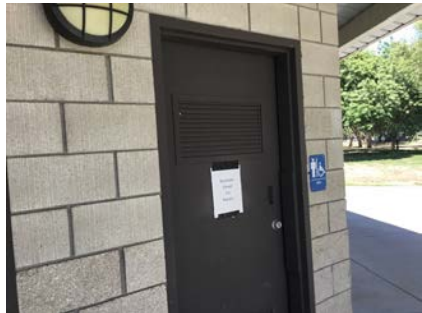
Item no., Rm no. and Name	Existing Architectural Barrier and Proposed Solution	Codes / Mitigation Info	Qty	Unit	Cost	Total
2144	<ul style="list-style-type: none"> As-Built Description: Required in CA only: identification symbol centered 58" to 60" high on sanitary facility door that contrasts with the door not provided (women: 12" ø circle, men: 12" triangle, unisex: combined symbol). Proposed Solution: Provide properly mounted sanitary facility symbol when altering area. If wheelchair accessible, include International Symbol of Accessibility on sign. Notes: 	PCODE SA15 CBC 2007 1115B.6 CBC 2019 11B-703.7.2.6 Mitigated: <input type="radio"/> YES <input checked="" type="radio"/> NO	6	JOB	\$270	\$1,620

<input type="radio"/> Staff Only						
Priority <input checked="" type="radio"/> 3						
Severity <input checked="" type="radio"/> 3						
<p>Occurs at all restrooms at the hexagon.</p>

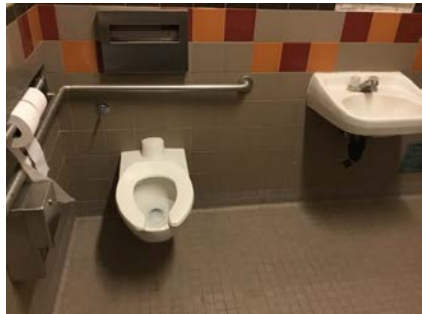
Toilet Stall

2138	<ul style="list-style-type: none"> As-Built Description: 60" min. clearance around a water closet measured perpendicular from the side wall not provided (Fixtures are not allowed to overlap this clearance). As-Built: 53.5" to lavatory Proposed Solution: Relocate adjacent fixture and remodel restroom as needed. Notes: 	PCODE WB01A ADA 2010 604.3.1; 604.3.2 CBC 2007 1115B.7.1.3 CBC 2019 11B-604.3.1; 11B-604.3.2 Mitigated: <input type="radio"/> YES <input checked="" type="radio"/> NO	1	JOB	\$6,000	\$6,000

This element complies with Safe Harbor if altered or constructed before March 15, 2012. This element does not comply with the dimensional requirements in the 1981 to the current CBC.

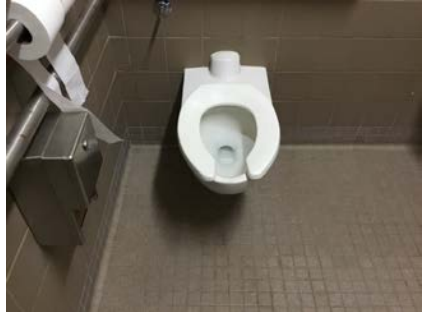
Water Closet

<p>2134</p> <ul style="list-style-type: none"> <i>As-Built Description:</i> Water closet not 16"-18" (CA: 17"-18") from near side wall to center line of water closet (2010 ADAAG: 16"-18"). <i>As-Built:</i> 18.5" <i>Proposed Solution:</i> Relocate existing water closet and plumbing, remount with offset closet flange to provide 18" max. from side wall. 	<p><i>PCODE</i> WB02C <i>ADAAG 91</i> Fig. 28 <i>ADA 2010</i> 604.2 <i>CBC 2007</i> 1115B.4.1.1 <i>CBC 2019</i> 11B-604.2</p> <p>Mitigated: <input type="radio"/> YES <input checked="" type="radio"/> NO</p>	<p>1 JOB \$1,500 \$1,500</p>

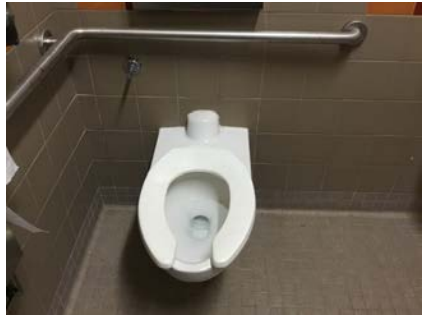
<p>2152</p> <ul style="list-style-type: none"> <i>As-Built Description:</i> Water closet not 16"-18" (CA: 17"-18") from near side wall to center line of water closet (2010 ADAAG: 16"-18"). <i>As-Built:</i> 18.5" <i>Proposed Solution:</i> Relocate existing water closet and plumbing, remount with offset closet flange to provide 18" max. from side wall. <i>Notes:</i> 	<p><i>PCODE</i> WB02C <i>ADAAG 91</i> Fig. 28 <i>ADA 2010</i> 604.2 <i>CBC 2007</i> 1115B.4.1.1 <i>CBC 2019</i> 11B-604.2</p> <p>Mitigated: <input type="radio"/> YES <input checked="" type="radio"/> NO</p>	<p>1 JOB \$1,500 \$1,500</p>

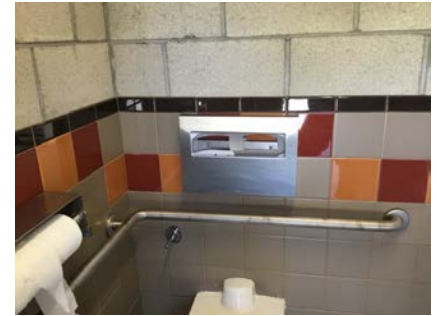
Accessories

<p>2158</p> <ul style="list-style-type: none"> <i>As-Built Description:</i> Dispensers in sanitary facilities, such as for towels, soap, sanitary napkins, seat covers, etc., and waste receptacles more than 48" (CA only: 40") from floor to highest operating slot or control. <i>As-Built:</i> 43.0" high <i>Proposed Solution:</i> Relocate existing restroom accessories. 	<p><i>PCODE</i> WG01A <i>ADAAG 91</i> 4.23.7 <i>ADA 2010</i> 308.2.1 <i>CBC 2007</i> 1115B.8.3 <i>CBC 2019</i> 11B-603.5</p>	<p>1 JOB \$300 \$300</p>
---	---	---------------------------------

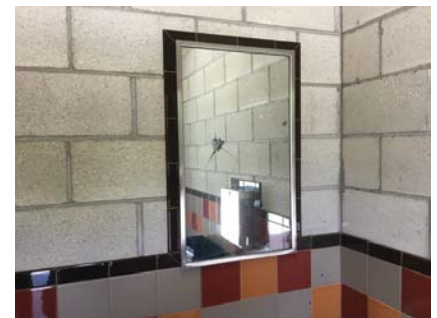
<p>2165</p> <ul style="list-style-type: none"> <i>As-Built Description:</i> Bottom of mirror located above lavatories or countertops more than 40" above floor. <i>As-Built:</i> 48.5" <i>Proposed Solution:</i> Relocate or provide new accessible mirror. 	<p><i>PCODE</i> WG03 <i>ADAAG 91</i> 4.19.6 <i>ADA 2010</i> 603.3 <i>CBC 2007</i> 1115B.8.1 <i>CBC 2019</i> 11B-603.3</p>	<p>1 JOB \$450 \$450</p>
---	--	---------------------------------

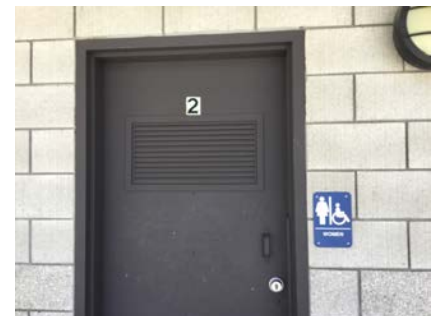
Door Closer

2167	<ul style="list-style-type: none"> As-Built Description: Excessive force required to open door. As-Built: 1.0 second Proposed Solution: Adjust regular door closer to accessible standards (5 lbs. max). 	PCODE ID03 ADAAG 91 4.13.11 ADA 2010 404.2.9 CBC 2007 1133B.2.5 CBC 2019 11B-404.2.9	1	JOB	\$75	\$75
------	--	--	---	-----	------	------

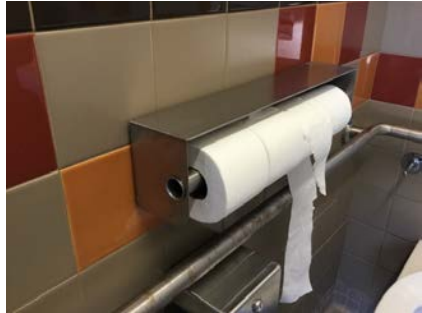
Item no., Rm no. and Name	Existing Architectural Barrier and Proposed Solution	Codes / Mitigation Info	Qty	Unit	Cost	Total
2161	<ul style="list-style-type: none"> • <i>As-Built Description:</i> Accessories/dispensers in accessible stall located closer than 1-1/2" below or 12" above grab bar impedes its use. • <i>As-Built:</i> TPD: 4.0" above grab bar • <i>Proposed Solution:</i> Relocate accessories/dispensers within applicable reach range and to be no closer than 1-1/2" below and 12" above grab bars (except if accessories are recessed, flush with wall, and have no sharp edges). 	PCODE WB07I ADAAG 91 4.26.2 ADA 2010 609.3 CBC 2007 1133B.4.2.5 CBC 2019 11B-609.3 Mitigated: <input type="radio"/> YES <input checked="" type="radio"/> NO	1	JOB	\$225	\$225

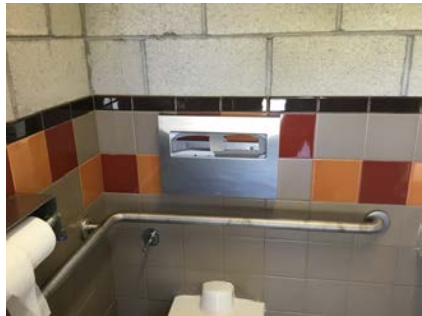
2162	<ul style="list-style-type: none"> • <i>As-Built Description:</i> Accessories/dispensers in accessible stall located closer than 1-1/2" below or 12" above grab bar impedes its use. • <i>As-Built:</i> SCD: 3.0" above grab bar • <i>Proposed Solution:</i> Relocate accessories/dispensers within applicable reach range and to be no closer than 1-1/2" below and 12" above grab bars (except if accessories are recessed, flush with wall, and have no sharp edges). 	PCODE WB07I ADAAG 91 4.26.2 ADA 2010 609.3 CBC 2007 1133B.4.2.5 CBC 2019 11B-609.3 Mitigated: <input type="radio"/> YES <input checked="" type="radio"/> NO	1	JOB	\$225	\$225

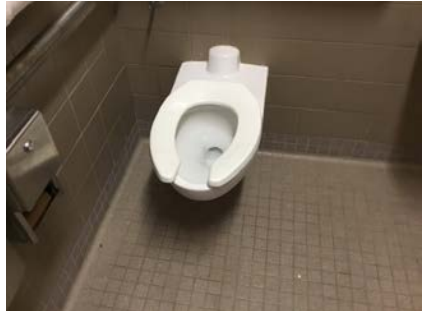
Item no., Rm no. and Name	Existing Architectural Barrier and Proposed Solution	Codes / Mitigation Info	Qty	Unit	Cost	Total
2186	<ul style="list-style-type: none"> As-Built Description: Height of water closet seat less than 17" or more than 19" from floor. As-Built: 20.0" Proposed Solution: Provide new accessible water closet. 	PCODE WB08 ADAAG 91 4.16.3 ADA 2010 604.4 CBC 2007 1115B.4.1.4 CBC 2019 11B-604.4 Mitigated: <input type="radio"/> YES <input checked="" type="radio"/> NO	1	JOB	\$4,200	\$4,200

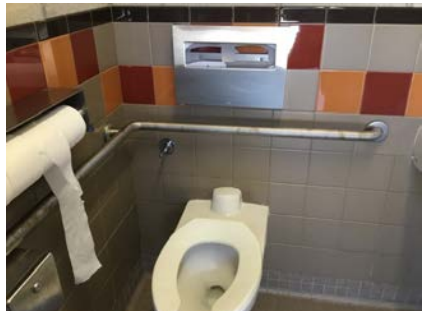
<input type="radio"/> Staff Only			
			Priority <input checked="" type="radio"/> 3			
			Severity <input checked="" type="radio"/> 3			
2163	<ul style="list-style-type: none"> As-Built Description: Flush Control: Operating handle not mounted toward wide side of stall. Proposed Solution: Replace flush control with properly mounted accessible type, or install sensor flush. 	PCODE WB10 ADAAG 91 4.16.5 ADA 2010 604.6 CBC 2007 1115B.4.1.5 CBC 2019 11B-604.6 Mitigated: <input type="radio"/> YES <input checked="" type="radio"/> NO	1	JOB	\$1,500	\$1,500

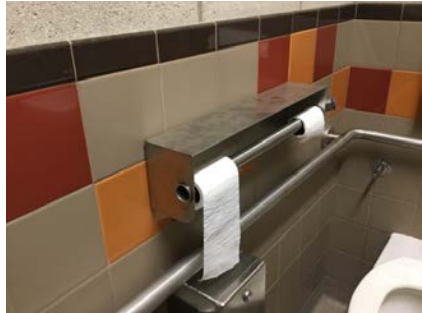
Item no., Rm no. and Name	Existing Architectural Barrier and Proposed Solution	Codes / Mitigation Info	Qty	Unit	Cost	Total
2176	<ul style="list-style-type: none"> <i>As-Built Description:</i> Accessories/dispensers in accessible stall located closer than 1-1/2" below or 12" above grab bar impedes its use. <i>As-Built:</i> TPD: 4.0" above grab bar <i>Proposed Solution:</i> Relocate accessories/dispensers within applicable reach range and to be no closer than 1-1/2" below and 12" above grab bars (except if accessories are recessed, flush with wall, and have no sharp edges). 	PCODE WB07I ADAAG 91 4.26.2 ADA 2010 609.3 CBC 2007 1133B.4.2.5 CBC 2019 11B-609.3 Mitigated: <input type="radio"/> YES <input checked="" type="radio"/> NO	1	JOB	\$225	\$225

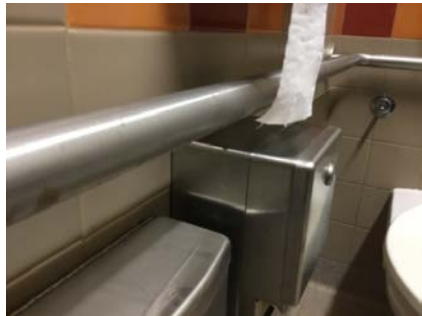
<input type="radio"/> Staff Only						
Priority 3						
Severity 4						
2177	<ul style="list-style-type: none"> <i>As-Built Description:</i> Accessories/dispensers in accessible stall located closer than 1-1/2" below or 12" above grab bar impedes its use. <i>As-Built:</i> TPD: 0.75" below grab bar <i>Proposed Solution:</i> Relocate accessories/dispensers within applicable reach range and to be no closer than 1-1/2" below and 12" above grab bars (except if accessories are recessed, flush with wall, and have no sharp edges). 	PCODE WB07I ADAAG 91 4.26.2 ADA 2010 609.3 CBC 2007 1133B.4.2.5 CBC 2019 11B-609.3 Mitigated: <input type="radio"/> YES <input checked="" type="radio"/> NO	1	JOB	\$225	\$225

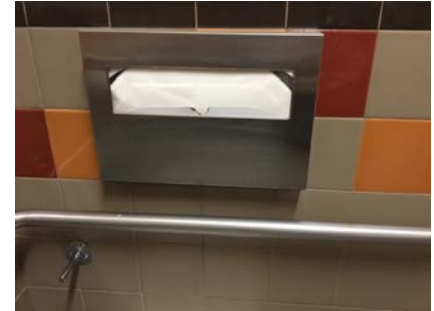
Item no., Rm no. and Name	Existing Architectural Barrier and Proposed Solution	Codes / Mitigation Info	Qty	Unit	Cost	Total
2178	<ul style="list-style-type: none"> <i>As-Built Description:</i> Accessories/dispensers in accessible stall located closer than 1-1/2" below or 12" above grab bar impedes its use. <i>As-Built:</i> SCD: 3.0" above grab bar <i>Proposed Solution:</i> Relocate accessories/dispensers within applicable reach range and to be no closer than 1-1/2" below and 12" above grab bars (except if accessories are recessed, flush with wall, and have no sharp edges). 	PCODE WB07I ADAAG 91 4.26.2 ADA 2010 609.3 CBC 2007 1133B.4.2.5 CBC 2019 11B-609.3 Mitigated: <input type="radio"/> YES <input checked="" type="radio"/> NO	1	JOB	\$225	\$225

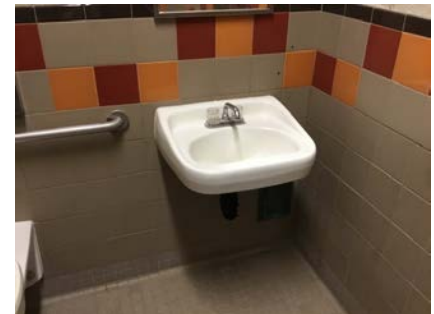
Lavatory

2175	<ul style="list-style-type: none"> <i>As-Built Description:</i> Clear floor space, 30" x 48" in front of fixture, extending 19" max. under the lavatory, not provided (CA only: Less than 18" from side wall to centerline of lavatory). <i>As-Built:</i> 17.0" <i>Proposed Solution:</i> Relocate existing lavatory. <i>Notes:</i> 	PCODE WD01A ADAAG 91 4.19.3 ADA 2010 606.2 CBC 2007 1115B.4.3 CBC 2019 11B-606.2, 11B-606.6 Mitigated: <input type="radio"/> YES <input checked="" type="radio"/> NO	1	JOB	\$2,700	\$2,700
------	--	--	---	-----	---------	----------------

This element complies with Safe Harbor if altered or constructed before March 15, 2012. The dimensional requirements in this CBC citation applied from the 2007 CBC to the code cycle at the time of this survey.

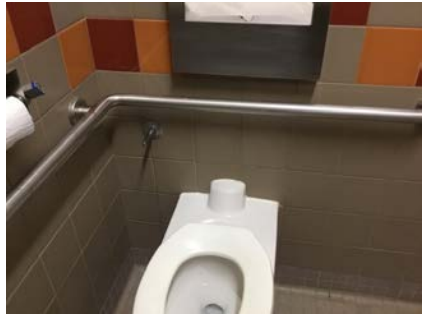
Item no., Rm no. and Name	Existing Architectural Barrier and Proposed Solution	Codes / Mitigation Info	Qty	Unit	Cost	Total
2179	<ul style="list-style-type: none"> • <i>As-Built Description:</i> Flush Control: Operating handle not mounted toward wide side of stall. • <i>Proposed Solution:</i> Replace flush control with properly mounted accessible type, or install sensor flush. 	PCODE WB10 ADAAG 91 4.16.5 ADA 2010 604.6 CBC 2007 1115B.4.1.5 CBC 2019 11B-604.6 Mitigated: <input type="radio"/> YES <input checked="" type="radio"/> NO	1	JOB	\$1,500	\$1,500

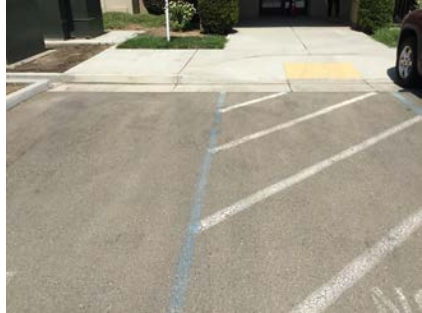
Floor or Ground Surfaces

<p>891</p> <ul style="list-style-type: none"> <i>As-Built Description:</i> Accessible parking space has slope greater than 1/4":12" (2%). <i>As-Built:</i> 5.5% at gutter <i>Proposed Solution:</i> Modify slope at accessible parking space or lengthen striping. 	<p>PCODE EA05 ADAAG 91 4.6.3 ADA 2010 502.4 CBC 2007 1129B.3.3 CBC 2019 11B-502.4</p> <p>Mitigated: <input type="radio"/> YES <input checked="" type="radio"/> NO</p>	<p>40 SF \$36 \$1,440</p>

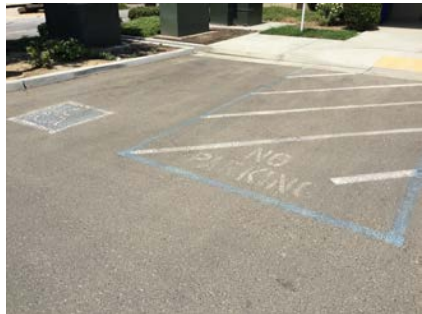
Parking

<p>892</p> <ul style="list-style-type: none"> <i>As-Built Description:</i> CA only: The area within the blue borderlines not marked with hatched lines a maximum of 36" on center. <i>Proposed Solution:</i> Restripe to provide hatched lines at 36" on center within access aisle. <i>Notes:</i> 	<p>PCODE EA04I CBC 2007 1129B.3.1 CBC 2019 11B-502.3.3</p> <p>Mitigated: <input type="radio"/> YES <input checked="" type="radio"/> NO</p>	<p>1 JOB \$300 \$300</p>

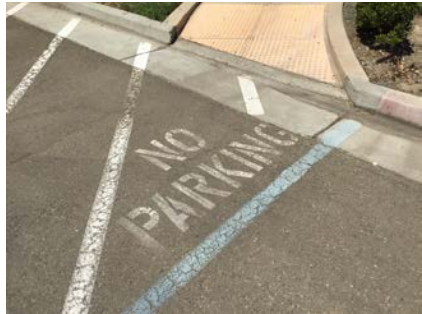
Item no., Rm no. and Name	Existing Architectural Barrier and Proposed Solution	Codes / Mitigation Info	Qty	Unit	Cost	Total
903	<ul style="list-style-type: none"> As-Built Description: Accessible parking space has slope greater than 1/4":12" (2%). As-Built: 3.1% Proposed Solution: Modify slope at accessible parking space. 	PCODE EA05 ADAAG 91 4.6.3 ADA 2010 502.4 CBC 2007 1129B.3.3 CBC 2019 11B-502.4 Mitigated: <input type="radio"/> YES <input checked="" type="radio"/> NO	6	SF	\$36	\$216

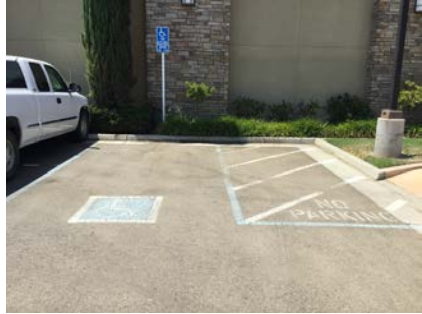
Parking

901	<ul style="list-style-type: none"> As-Built Description: CA only: The area within the blue borderlines not marked with hatched lines a maximum of 36" on center. Proposed Solution: Restripe to provide hatched lines at 36" on center within access aisle. Notes: 	PCODE EA04I CBC 2007 1129B.3.1 CBC 2019 11B-502.3.3 Mitigated: <input type="radio"/> YES <input checked="" type="radio"/> NO	1	JOB	\$300	\$300

<input type="radio"/> Staff Only						
Priority <input checked="" type="radio"/> 1						
Severity <input checked="" type="radio"/> 3						
<p>Faded striping. Consider lengthening the space and aisle to remove the slopes at the gutter from the parking space.</p>

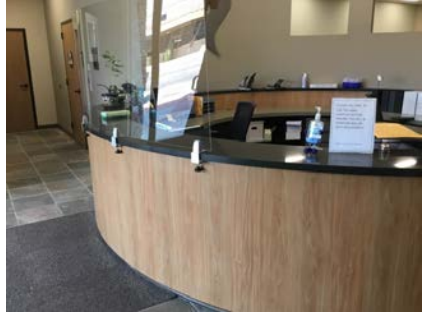
Public Counter

850	<ul style="list-style-type: none"> <i>As-Built Description:</i> Service counter (stand-up): Accessible section min. 36" length and 36" max. height (in CA: 28" to 34" high) not provided. <i>As-Built:</i> 41.0" high <i>Proposed Solution:</i> Retrofit existing counter to provide accessible section. Interim solution: Provide auxiliary counter, table, or clipboard. 	<p>PCODE IN03 ADAAG 91 7.2(2) ADA 2010 904.4 CBC 2007 1122B.4 CBC 2019 11B-904.4</p> <p>Mitigated: <input type="radio"/> YES <input checked="" type="radio"/> NO</p>	1	JOB	\$6,000	\$6,000
-----	--	---	---	-----	---------	---------

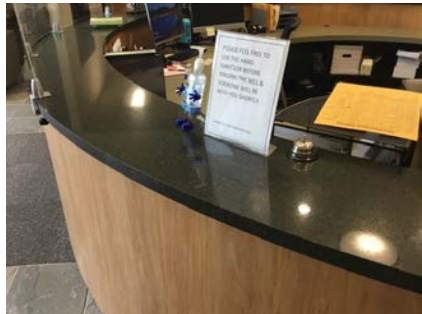
Reach Range

851	<ul style="list-style-type: none"> <i>As-Built Description:</i> Reach height to control or access point, where side approach is available, exceeds 48" or is less than 15" in height, or exceeds 10" in depth. <i>As-Built:</i> 41.0" high obstruction <i>Proposed Solution:</i> Modify equipment or mounting. 	<p>PCODE IE02 ADAAG 91 4.2.6 ADA 2010 308.3.1 CBC 2007 1118B.6 CBC 2019 11B-308.3</p> <p>Mitigated: <input type="radio"/> YES <input checked="" type="radio"/> NO</p>	1	JOB	\$300	\$300
-----	--	--	---	-----	-------	-------

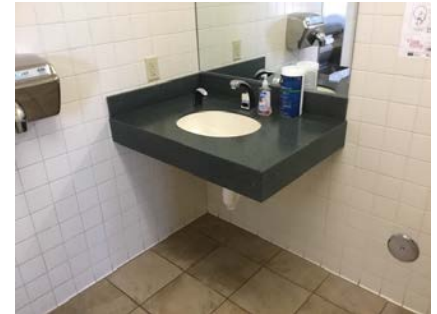
Lavatory

860	<ul style="list-style-type: none"> As-Built Description: Wheelchair clearance under lavatory apron or lavatory counter front edge less than 29" high. As-Built: 28.75" Proposed Solution: Trim apron. Notes: 	PCODE WD03 ADAAG 91 4.19.2 ADA 2010 606.3 CBC 2007 1115B.4.3.3 CBC 2019 11B-306.3.1	1	JOB	\$1,020	\$1,020
-----	---	--	---	-----	---------	---------

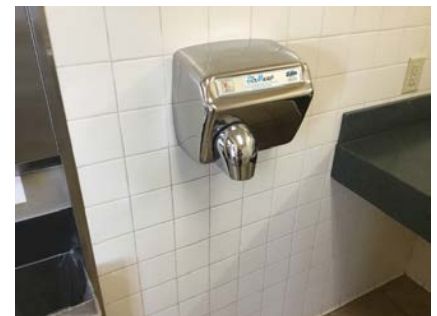
Protrusion Limits

861	<ul style="list-style-type: none"> As-Built Description: Protruding objects more than 4" from wall, when bottom of object more than 27" or less than 80" above finished floor. As-Built: Hand dryer: 8.5" at 39" high Proposed Solution: Remove/relocate protruding object. Patch existing surface. Option to install new hand dryer with depth less than 4". 	PCODE EG04 ADAAG 91 4.4.1 ADA 2010 307.2 CBC 2007 1133B.8.6.1 CBC 2019 11B-307.2	1	JOB	\$300	\$300
-----	---	---	---	-----	-------	-------

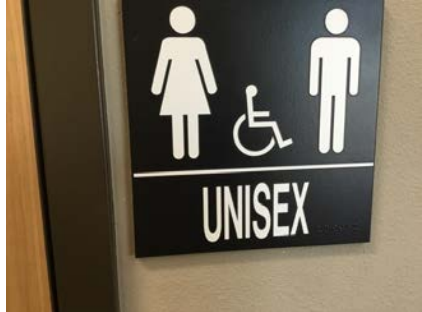
Signage

<p>856</p> <ul style="list-style-type: none"> • <i>As-Built Description:</i> Entrance to toilet or bathing facility not identified with ADAAG compliant signage. • <i>As-Built:</i> Height of the characters are too large for the width. Braille not below characters • <i>Proposed Solution:</i> Provide ADA compliant sign mounted at 48" min. above to baseline of the lowest Braille cells and 60" max. to baseline of the highest line of raised characters on nearest adjacent wall, on latch side of a single door (located not to cause a Braille reader to stand within the door swing). 	<p>PCODE SA11A ADAAG 91 4.1.3(16)(a) ADA 2010 216.8 CBC 2019 11B-216.8</p> <p>Mitigated: <input type="radio"/> YES <input checked="" type="radio"/> NO</p>	<table border="1"> <tr> <td>1</td> <td>JOB</td> <td>\$270</td> <td>\$270</td> </tr> </table>

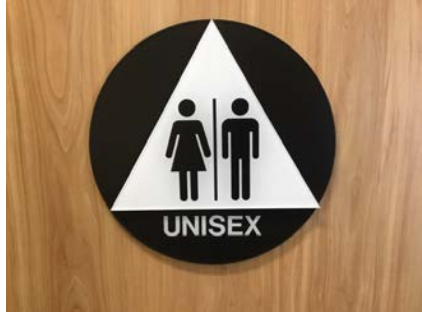
<p>857</p> <ul style="list-style-type: none"> • <i>As-Built Description:</i> Required in CA only: identification symbol centered 58" to 60" high on sanitary facility door that contrasts with the door not provided (women: 12" ø circle, men: 12" triangle, unisex: combined symbol). • <i>As-Built:</i> Not beveled or radiused. • <i>Proposed Solution:</i> Provide properly mounted sanitary facility symbol when altering area. If wheelchair accessible, include International Symbol of Accessibility on sign. 	<p>PCODE SA15 CBC 2007 1115B.6 CBC 2019 11B-703.7.2.6</p> <p>Mitigated: <input type="radio"/> YES <input checked="" type="radio"/> NO</p>	<table border="1"> <tr> <td>1</td> <td>JOB</td> <td>\$270</td> <td>\$270</td> </tr> </table>
