APPENDIX B: ACCESS COMPLIANCE SURVEY REPORT OF FACILITIES

The City of Madera

Access Compliance Survey Report

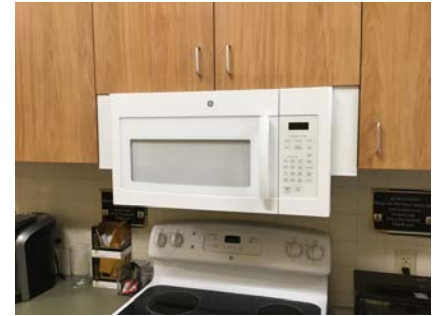
871	<ul style="list-style-type: none"> As-Built Description: Reach height to control or access point, where side approach is available, exceeds 48" or is less than 15" in height, or exceeds 10" in depth. As-Built: 61.0" high Proposed Solution: Modify equipment or mounting. 	PCODE IE02 ADAAG 91 4.2.6 ADA 2010 308.3.1 CBC 2007 1118B.6 CBC 2019 11B-308.3	1	JOB	\$300	\$300
-----	---	---	---	-----	-------	-------

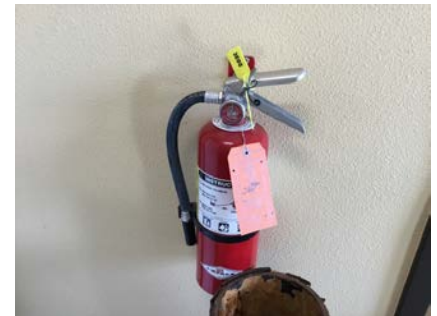
872	<ul style="list-style-type: none"> As-Built Description: Reach height to control or access point, where side approach is available, exceeds 48" or is less than 15" in height, or exceeds 10" in depth. As-Built: 51.0" high Proposed Solution: Modify equipment or mounting. Notes: 	PCODE IE02 ADAAG 91 4.2.6 ADA 2010 308.3.1 CBC 2007 1118B.6 CBC 2019 11B-308.3	1	JOB	\$300	\$300
-----	---	---	---	-----	-------	-------

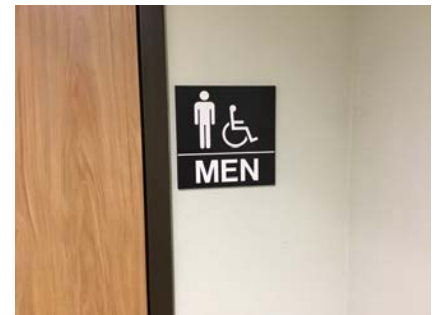
Before the 2010 ADA there was no measurement defining what it meant to stand outside of the door swing, and no requirement that the CLFS be centered, therefore consider whether this condition complies with 1991 ADA and is a Safe Harbor if installed before March 15, 2012.

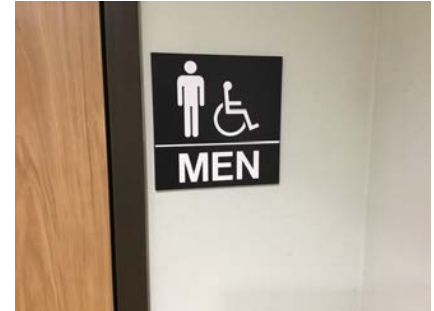
878	<ul style="list-style-type: none"> As-Built Description: Entrance to toilet or bathing facility not identified with ADAAG compliant signage. Proposed Solution: Provide ADA compliant sign mounted at 48" min. above to baseline of the lowest Braille cells and 60" max. to baseline of the highest line of raised characters on nearest adjacent wall, on latch side of a single door (located not to cause a Braille reader to stand within the door swing). Notes: 	PCODE SA11A ADAAG 91 4.1.3(16)(a) ADA 2010 216.8 CBC 2019 11B-216.8 Mitigated: <input type="radio"/> YES <input checked="" type="radio"/> NO	1	JOB	\$270	\$270
-----	--	--	---	-----	-------	-------

Braille not below and stroke thickness 20% of height.

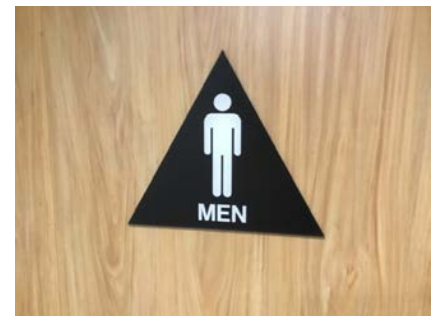
880	<ul style="list-style-type: none"> As-Built Description: Required in CA only: identification symbol centered 58" to 60" high on sanitary facility door that contrasts with the door not provided (women: 12" ø circle, men: 12" triangle, unisex: combined symbol). As-Built: Not beveled or radiused Proposed Solution: Provide properly mounted sanitary facility symbol when altering area. If wheelchair accessible, include International Symbol of Accessibility on sign. 	PCODE SA15 CBC 2007 1115B.6 CBC 2019 11B-703.7.2.6 Mitigated: <input type="radio"/> YES <input checked="" type="radio"/> NO	1	JOB	\$270	\$270
-----	--	--	---	-----	-------	-------

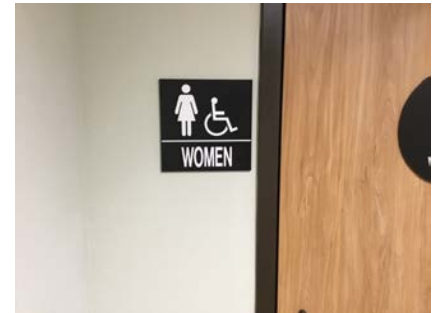
Before the 2010 ADA there was no measurement defining what it meant to stand outside of the door swing, and no requirement that the CLFS be centered, therefore consider whether this condition complies with 1991 ADA and is a Safe Harbor if installed before March 15, 2012.

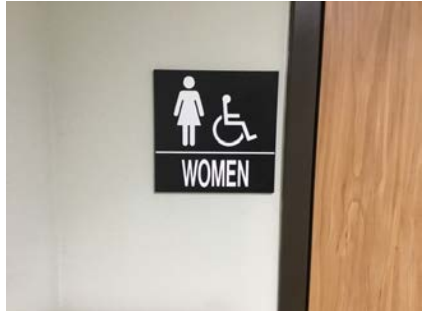
Item no., Rm no. and Name	Existing Architectural Barrier and Proposed Solution	Codes / Mitigation Info	Qty	Unit	Cost	Total
884	<ul style="list-style-type: none"> As-Built Description: Entrance to toilet or bathing facility not identified with ADAAG compliant signage. Proposed Solution: Provide ADA compliant sign mounted at 48" min. above to baseline of the lowest Braille cells and 60" max. to baseline of the highest line of raised characters on nearest adjacent wall, on latch side of a single door (located not to cause a Braille reader to stand within the door swing). Notes: 	PCODE SA11A ADAAG 91 4.1.3(16)(a) ADA 2010 216.8 CBC 2019 11B-216.8 Mitigated: <input type="radio"/> YES <input checked="" type="radio"/> NO	1	JOB	\$270	\$270

<p>Braille not below and width to height ratio incorrect.</p>

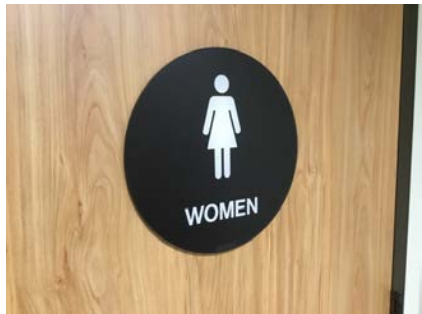
886	<ul style="list-style-type: none"> As-Built Description: Required in CA only: identification symbol centered 58" to 60" high on sanitary facility door that contrasts with the door not provided (women: 12" ø circle, men: 12" triangle, unisex: combined symbol). As-Built: Not beveled Proposed Solution: Provide properly mounted sanitary facility symbol when altering area. If wheelchair accessible, include International Symbol of Accessibility on sign. 	PCODE SA15 CBC 2007 1115B.6 CBC 2019 11B-703.7.2.6 Mitigated: <input type="radio"/> YES <input checked="" type="radio"/> NO	1	JOB	\$270	\$270

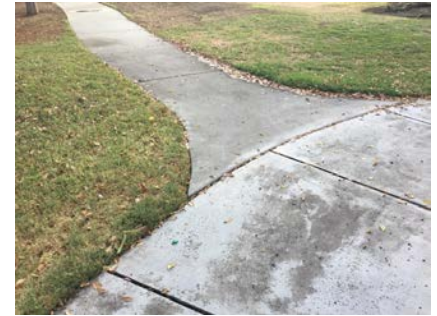
- 1249
- *As-Built Description:*
Walk: Pavement dislocation creates abrupt change in level exceeding 1/2" in accessible route.
 - *As-Built:* **Up to 2.0"**
 - *Proposed Solution:*
Remove, replace or repair area of pavement sufficient to correct abrupt change in level.

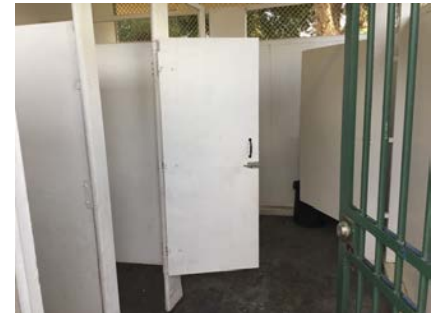
- 1256
- As-Built Description: Multiple accommodation restroom not accessible; multiple compliance violations.
 - Proposed Solution: Remodel area to provide accessible restroom with one accessible stall, lavatory (and one urinal at Men's).

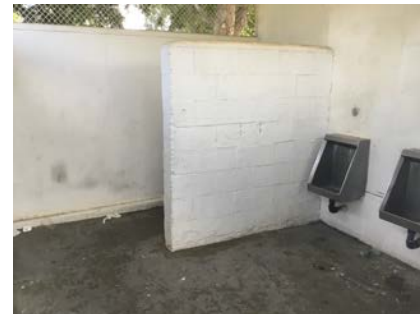
Multiple accommodation restroom not accessible; multiple compliance violations.

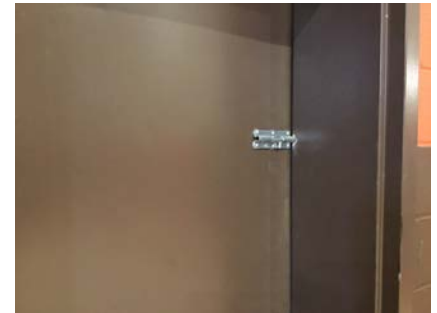
- 2021
- *As-Built Description:*
Door lock, latch or handle less than 34" or more than 48" above the floor (CA only: 34" to 44").
 - *As-Built:* **64.0" high**
 - *Proposed Solution:*
Relocate or replace existing hardware.

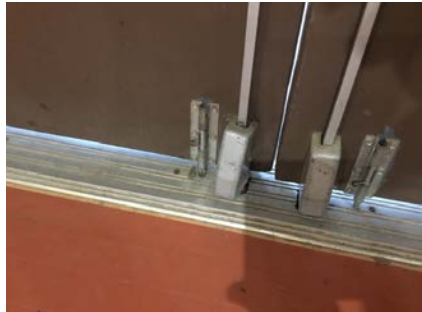
Item no., Rm no. and Name	Existing Architectural Barrier and Proposed Solution	Codes / Mitigation Info	Qty	Unit	Cost	Total
2023	<ul style="list-style-type: none"> As-Built Description: Door lock, latch or handle less than 34" or more than 48" above the floor (CA only: 34" to 44"). As-Built: 2.0" high and 79.0" high at exit door. Proposed Solution: Relocate or replace existing hardware. 	PCODE ID17 ADAAG 91 4.13.9 ADA 2010 404.2.7 CBC 2007 1133B.2.5.2 CBC 2019 11B-404.2.7 Mitigated: <input type="radio"/> YES <input checked="" type="radio"/> NO	6	JOB	\$900	\$5,400

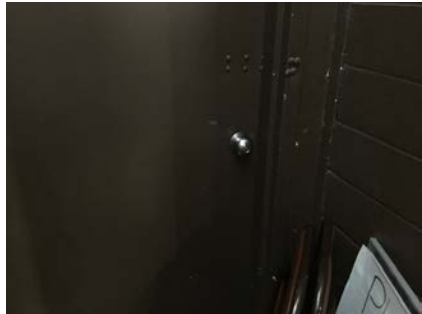
Door Hardware

2029	<ul style="list-style-type: none"> As-Built Description: Door does not have accessible operating hardware. Proposed Solution: Provide lever handle or other accessible hardware. 	PCODE ID07 ADAAG 91 4.13.9 ADA 2010 404.2.7 CBC 2007 1133B.2.5.2 CBC 2019 11B-404.2.7 Mitigated: <input type="radio"/> YES <input checked="" type="radio"/> NO	4	JOB	\$450	\$1,800

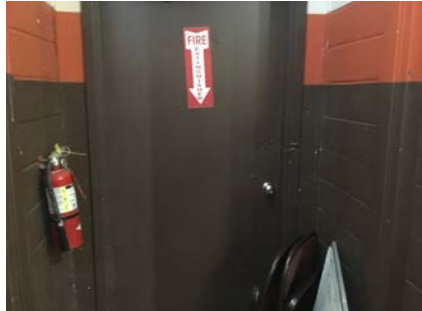
Item no., Rm no. and Name	Existing Architectural Barrier and Proposed Solution	Codes / Mitigation Info	Qty	Unit	Cost	Total
2030	<ul style="list-style-type: none"> As-Built Description: Front approach: At push side, door does not have clear and level maneuvering space measuring door width x 48" (door width plus 12" if door has both, latch and closer). As-Built: 6.5" Proposed Solution: Remove latch or install directional signage. 	PCODE ID24A ADAAG 91 Fig. 25(a) ADA 2010 404.2.4 CBC 2007 11B-26A(a) CBC 2019 11B-404.2.4 Mitigated: <input type="radio"/> YES <input checked="" type="radio"/> NO	1	JOB	\$150	\$150

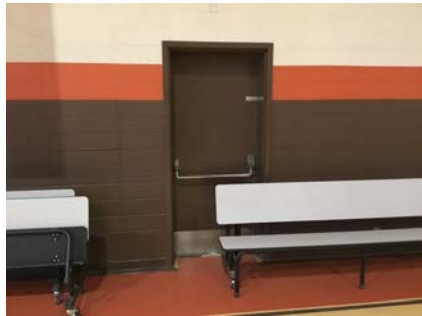
<input type="radio"/> Staff Only			
			Priority <input checked="" type="radio"/> 2			
			Severity <input checked="" type="radio"/> 3			
2022	<ul style="list-style-type: none"> As-Built Description: Front approach: At push side, door does not have clear and level maneuvering space measuring door width x 48" (door width plus 12" if door has both, latch and closer). As-Built: 12.0" deep alcove. Proposed Solution: Provide relocated new door and frame; remodel walls as needed. 	PCODE ID24B ADAAG 91 Fig. 25(a) ADA 2010 404.2.4 CBC 2007 11B-26A(a) CBC 2019 11B-404.2.4 Mitigated: <input type="radio"/> YES <input checked="" type="radio"/> NO	1	JOB	\$7,800	\$7,800

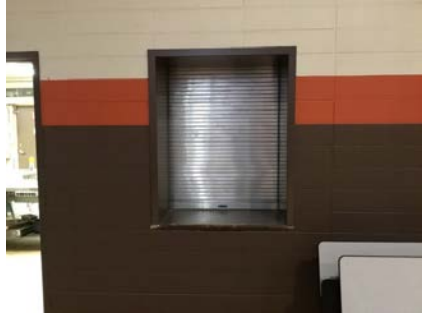
Item no., Rm no. and Name	Existing Architectural Barrier and Proposed Solution	Codes / Mitigation Info	Qty	Unit	Cost	Total
2031	<p>Tray Pass-thru</p> <ul style="list-style-type: none"> As-Built Description: Food tray pass-thru at institutional cafeteria has lower edge higher than 34" above floor. As-Built: 36.0" Proposed Solution: Remodel pass-thru and counter to be 34" max. above floor. 	<p>PCODE FB04 ADAAG 91 5.2 ADA 2010 902.3 CBC 2007 1122B.4 CBC 2019 11B-902.3</p> <p>Mitigated: <input type="radio"/> YES <input checked="" type="radio"/> NO</p>	1	JOB	\$9,900	\$9,900

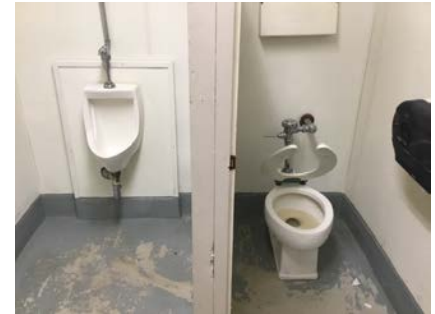
• *As-Built Description:*
Multiple accommodation restroom not accessible; multiple compliance violations.

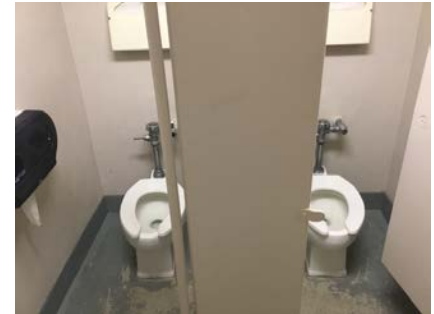
Multiple accommodation restroom not accessible; multiple compliance violations.

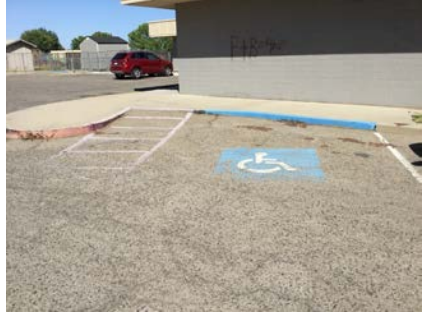
Floor or Ground Surfaces

<p>2075</p> <ul style="list-style-type: none"> • <i>As-Built Description:</i> Accessible parking space has slope greater than 1/4":12" (2%). • <i>As-Built:</i> To 8.6% • <i>Proposed Solution:</i> Modify slope at accessible parking space. 	<p>PCODE EA05 ADAAG 91 4.6.3 ADA 2010 502.4 CBC 2007 1129B.3.3 CBC 2019 11B-502.4</p> <p>Mitigated: <input type="radio"/> YES <input checked="" type="radio"/> NO</p>	<p>200 SF \$36 \$7,200</p>

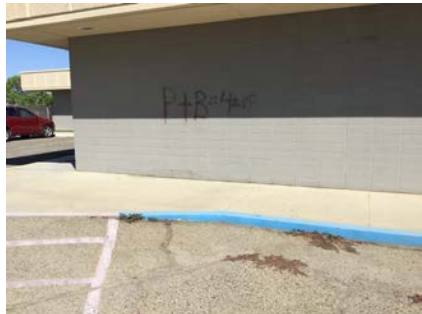
Identification

<p>2079</p> <ul style="list-style-type: none"> • <i>As-Built Description:</i> Sign for accessible parking space is missing or non-compliant. • <i>Proposed Solution:</i> Provide compliant parking signage. 	<p>PCODE EA04B ADAAG 91 4.6.4 ADA 2010 502.6 CBC 2007 1129B.4 CBC 2019 11B-502.6</p> <p>Mitigated: <input type="radio"/> YES <input checked="" type="radio"/> NO</p>	<p>1 JOB \$945 \$945</p>

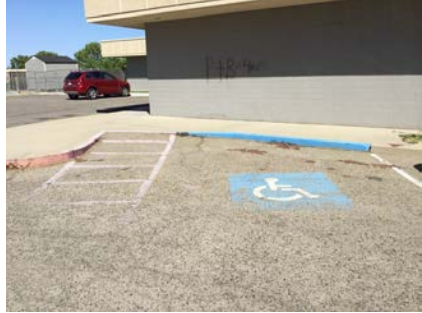
Parking

<p>2080</p> <ul style="list-style-type: none"> • <i>As-Built Description:</i> Accessible parking space smaller than 8' wide (CA only: 9' x 18'). • <i>As-Built:</i> 130.0" long. • <i>Proposed Solution:</i> Modify parking space(s) to create accessible space. • <i>Notes:</i> 	<p>PCODE EA02A ADAAG 91 4.6.3 ADA 2010 502.2 CBC 2007 1129B.3.1 CBC 2019 11B-502.2</p> <p>Mitigated: <input type="radio"/> YES <input checked="" type="radio"/> NO</p>	<p>1 JOB \$600 \$600</p>

Consider straight in parking.

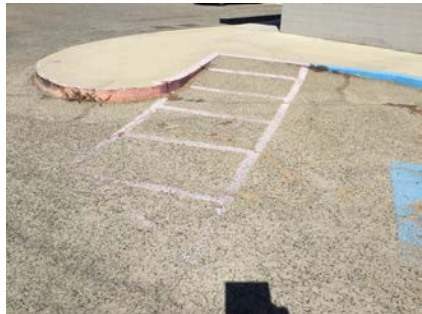
<p>2078</p> <ul style="list-style-type: none"> • <i>As-Built Description:</i> The words "NO PARKING" not painted on the ground within loading and unloading access aisle (12" min high white letters), located so that it is visible to traffic enforcement officials (required in CA only). • <i>Proposed Solution:</i> Provide the words "NO PARKING" in each access aisle, painted in 12" high letters, when altering area. 	<p>PCODE EA04D CBC 2007 1129B.3.1 CBC 2019 11B-502.3.3</p> <p>Mitigated: <input type="radio"/> YES <input checked="" type="radio"/> NO</p>	<p>1 JOB \$300 \$300</p>

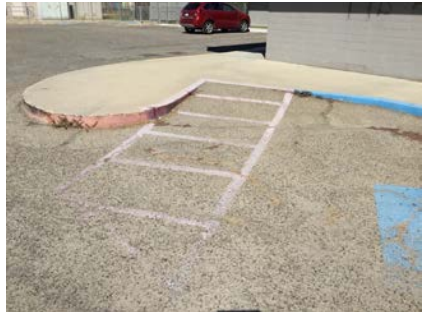
Item no., Rm no. and Name	Existing Architectural Barrier and Proposed Solution	Codes / Mitigation Info	Qty	Unit	Cost	Total
2077	<ul style="list-style-type: none"> <i>As-Built Description:</i> An accessible parking space shall be outlined or painted blue (required in CA only). <i>Proposed Solution:</i> Identify accessible parking space using blue markings. 	PCODE EA04K CBC 2019 11B-502.6 Mitigated: <input type="radio"/> YES <input checked="" type="radio"/> NO	1	JOB	\$360	\$360

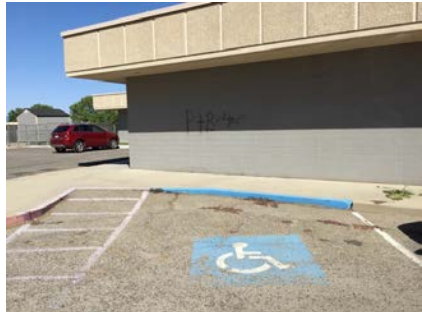
Parking Signage

2081	<ul style="list-style-type: none"> <i>As-Built Description:</i> No "Tow Away" sign at parking lot entrance (required in CA only). <i>Proposed Solution:</i> Provide "Tow Away" sign at parking lot entrance when altering area. 	PCODE EA04C CBC 2007 1129B.4 CBC 2019 11B-502.8.2 Mitigated: <input type="radio"/> YES <input checked="" type="radio"/> NO	2	JOB	\$975	\$1,950

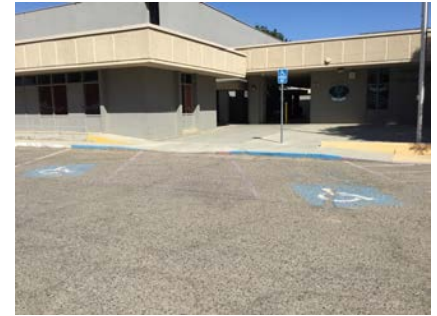
- 2091
- As-Built Description:*
Walk: Pavement dislocation creates abrupt change in level exceeding 1/2" in accessible route.
 - As-Built:* **To 1.0"**
 - Proposed Solution:*
Remove, replace or repair area of pavement sufficient to correct abrupt change in level.

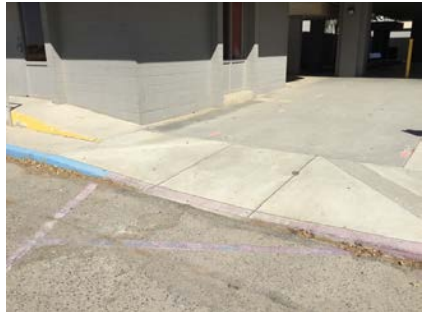
Item no., Rm no. and Name	Existing Architectural Barrier and Proposed Solution	Codes / Mitigation Info	Qty	Unit	Cost	Total
2093	<ul style="list-style-type: none"> <i>As-Built Description:</i> Detectable warning not provided where pedestrian crosses vehicular area. <i>Proposed Solution:</i> Provide detectable warning surface (i.e. in-line truncated domes) at regular curb ramp. 	PCODE EH07A ADAAG 91 4.7.7 ADA 2010 705.1 CBC 2007 1127B.5.7 CBC 2019 11B-705.1.2.2 Mitigated: <input type="radio"/> YES <input checked="" type="radio"/> NO	1	JOB	\$750	\$750

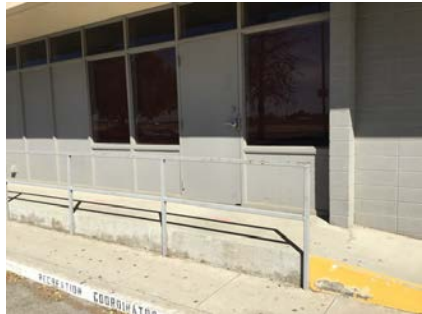
Door Swing

2085	<ul style="list-style-type: none"> <i>As-Built Description:</i> Latch approach: At pull side, door does not have clear and level maneuvering space measuring door width plus 24" x 48" or 54" if door has closer (CA only: door width plus 24" x 60"). <i>As-Built:</i> 43.5" <i>Proposed Solution:</i> Enlarge landing. 	PCODE ID27 ADAAG 91 Fig. 25(c) ADA 2010 404.2.4 CBC 2007 11B-26A(c) CBC 2019 11B-404.2.4 Mitigated: <input type="radio"/> YES <input checked="" type="radio"/> NO	1	JOB	\$9,000	\$9,000

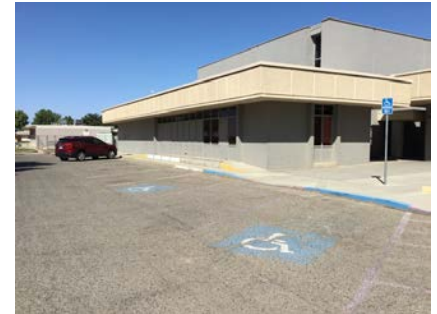
- 2087
- *As-Built Description:*
Sign for accessible parking space is missing or non-compliant.
 - *Proposed Solution:*
Provide compliant parking signage.

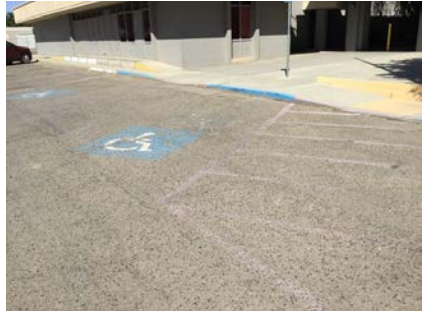
Item no., Rm no. and Name	Existing Architectural Barrier and Proposed Solution	Codes / Mitigation Info	Qty	Unit	Cost	Total
2090	<ul style="list-style-type: none"> <i>As-Built Description:</i> The words "NO PARKING" not painted on the ground within loading and unloading access aisle (12" min high white letters), located so that it is visible to traffic enforcement officials (required in CA only). <i>Proposed Solution:</i> Provide the words "NO PARKING" in each access aisle, painted in 12" high letters, when altering area. 	PCODE EA04D CBC 2007 1129B.3.1 CBC 2019 11B-502.3.3 Mitigated: <input type="radio"/> YES <input checked="" type="radio"/> NO	2	JOB	\$300	\$600

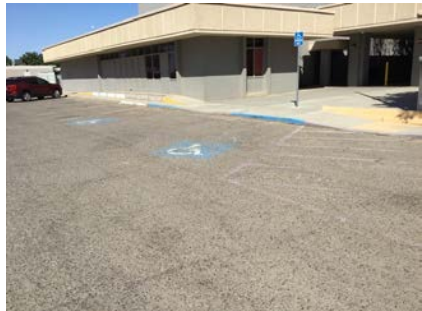
<input type="radio"/> Staff Only			
			Priority <input checked="" type="radio"/> 1 Severity <input checked="" type="radio"/> 4			
2089	<ul style="list-style-type: none"> <i>As-Built Description:</i> An accessible parking space shall be outlined or painted blue (required in CA only). <i>Proposed Solution:</i> Identify accessible parking space using blue markings. 	PCODE EA04K CBC 2019 11B-502.6 Mitigated: <input type="radio"/> YES <input checked="" type="radio"/> NO	2	JOB	\$360	\$720

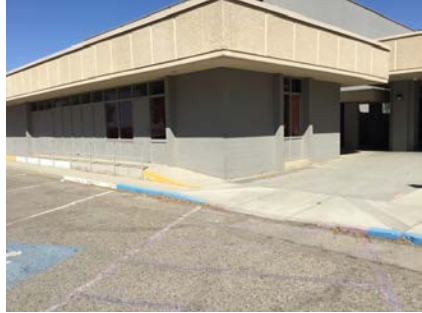
Parking Signage

2092	<ul style="list-style-type: none"> <i>As-Built Description:</i> No "Tow Away" sign at parking lot entrance (required in CA only). <i>Proposed Solution:</i> Provide "Tow Away" sign at parking lot entrance when altering area. 	<p>PCODE EA04C</p> <p>CBC 2007 1129B.4</p> <p>CBC 2019 11B-502.8.2</p> <p>Mitigated:</p> <p><input type="radio"/> YES</p> <p><input checked="" type="radio"/> NO</p>	2	JOB	\$975	\$1,950

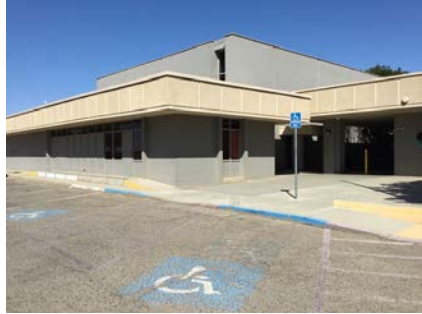
2088	<ul style="list-style-type: none"> <i>As-Built Description:</i> CA only: Additional Sign or additional language below the symbol of accessibility stating "Minimum Fine \$250" not provided. <i>Proposed Solution:</i> Provide compliant parking signage that includes fine information. 	<p>PCODE EA04G</p> <p>CBC 2007 1129B.4</p> <p>CBC 2019 11B-502.6.2</p> <p>Mitigated:</p> <p><input type="radio"/> YES</p> <p><input checked="" type="radio"/> NO</p>	2	JOB	\$300	\$600

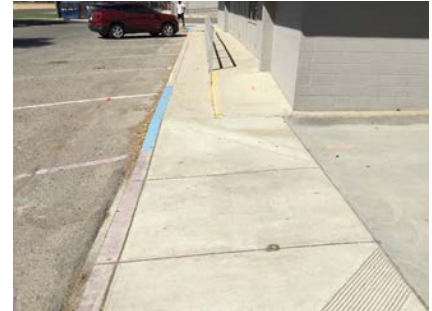
Item no., Rm no. and Name	Existing Architectural Barrier and Proposed Solution	Codes / Mitigation Info	Qty	Unit	Cost	Total
2094	<ul style="list-style-type: none"> As-Built Description: Level 2% max. landing for ramp not provided. As-Built: 10.0% Proposed Solution: Rebuild ramp to provide landings for each ramp run with slopes no greater than 2% 	PCODE EB05A ADAAG 91 4.8.4 ADA 2010 405.7.1 CBC 2007 1133B.5.4.1 CBC 2019 11B-405.7.1 Mitigated: <input type="radio"/> YES <input checked="" type="radio"/> NO	30	SF	\$300	\$9,000
<input type="radio"/> Staff Only Priority 1 Severity 1

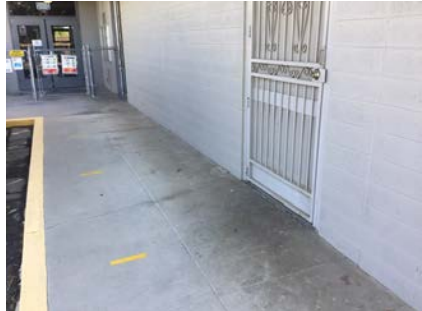
Item no., Rm no. and Name	Existing Architectural Barrier and Proposed Solution	Codes / Mitigation Info	Qty	Unit	Cost	Total
2043	<ul style="list-style-type: none"> As-Built Description: Surface of required maneuvering clearance at door slopes more than 1/4":12" (2.0%). As-Built: 3.1% Proposed Solution: Modify surface slope at door. 	PCODE ID11 ADAAG 91 4.13.6 ADA 2010 404.2.4.4 CBC 2007 1133B.2.4 CBC 2019 11B-404.2.4 Mitigated: <input type="radio"/> YES <input checked="" type="radio"/> NO	30	SF	\$120	\$3,600

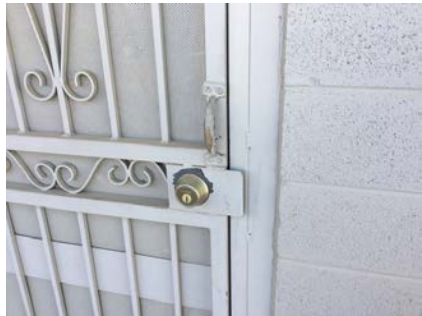
<input type="radio"/> Staff Only			
			Priority <input checked="" type="radio"/> 4			
			Severity <input checked="" type="radio"/> 4			
2067	<ul style="list-style-type: none"> As-Built Description: Door lock, latch or handle less than 34" or more than 48" above the floor (CA only: 34" to 44"). As-Built: 50.0" Proposed Solution: Relocate or replace existing hardware. 	PCODE ID17 ADAAG 91 4.13.9 ADA 2010 404.2.7 CBC 2007 1133B.2.5.2 CBC 2019 11B-404.2.7 Mitigated: <input type="radio"/> YES <input checked="" type="radio"/> NO	1	JOB	\$900	\$900

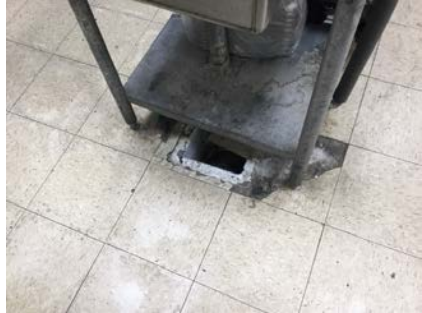
Floor or Ground Surface

<p>2044</p> <ul style="list-style-type: none"> <i>As-Built Description:</i> Walk: Grating has grid openings greater than 1/2" along the line of traffic flow. <i>Proposed Solution:</i> Provide new grating, with grid openings 1/2" max. along the line of traffic flow. 	<p>PCODE EF04 ADAAG 91 4.3.6; 4.5.4 ADA 2010 403.2; 302.3 CBC 2007 1133B.7.2 CBC 2019 11B-403.2; 11B-302.3</p> <p>Mitigated: <input type="radio"/> YES <input checked="" type="radio"/> NO</p>	<p>1 SF \$240 \$240</p>

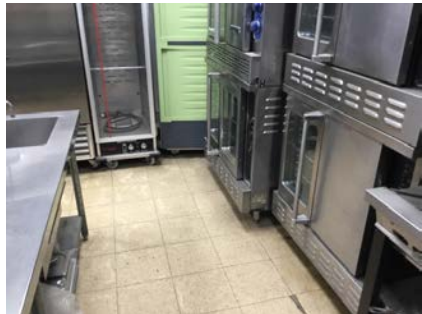
Maneuvering Clearance

<p>2039</p> <ul style="list-style-type: none"> <i>As-Built Description:</i> Clearance between all opposing base cabinets, counter tops, appliances, or walls is not 40" minimum. <i>Proposed Solution:</i> Provide clearance by relocating obstructing walls and / or cabinets. <i>Notes:</i> 	<p>PCODE KF01 ADAAG 91 13.3.4(1) ADA 2010 804.2.1 CBC 2007 1111B.5.1 CBC 2019 11B-804.2.1</p> <p>Mitigated: <input type="radio"/> YES <input checked="" type="radio"/> NO</p>	<p>1 JOB \$7,500 \$7,500</p>

Pass through kitchen 37.0" wide.

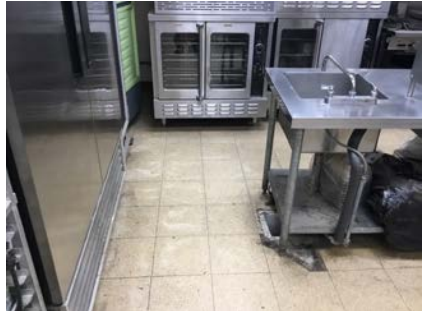
Item no., Rm no. and Name	Existing Architectural Barrier and Proposed Solution	Codes / Mitigation Info	Qty	Unit	Cost	Total
2041	<ul style="list-style-type: none"> <i>As-Built Description:</i> Clearance between all opposing base cabinets, counter tops, appliances, or walls is not 40" minimum. <i>Proposed Solution:</i> Provide clearance by relocating obstructing walls and / or cabinets. <i>Notes:</i> 	PCODE KF01 ADAAG 91 13.3.4(1) ADA 2010 804.2.1 CBC 2007 1111B.5.1 CBC 2019 11B-804.2.1 Mitigated: <input type="radio"/> YES <input checked="" type="radio"/> NO	1	JOB	\$7,500	\$7,500

<input type="radio"/> Staff Only						
Priority <input checked="" type="radio"/> 3						
Severity <input checked="" type="radio"/> 4						
34.0" wide for 30.0" long

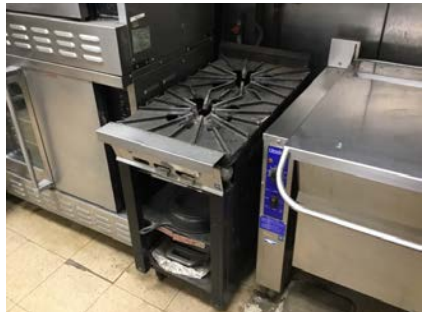
Reach Range

2040	<ul style="list-style-type: none"> <i>As-Built Description:</i> Reach height to control or access point, where side approach is available, exceeds 48" or is less than 15" in height, or exceeds 10" in depth. <i>As-Built:</i> The reach to the top is obstructed by the rim of the stove. <i>Proposed Solution:</i> Modify equipment or mounting. <i>Notes:</i> 	PCODE IE02 ADAAG 91 4.2.6 ADA 2010 308.3.1 CBC 2007 1118B.6 CBC 2019 11B-308.3 Mitigated: <input type="radio"/> YES <input checked="" type="radio"/> NO	1	JOB	\$300	\$300

<input type="radio"/> Staff Only						
Priority <input checked="" type="radio"/> 3						
Severity <input checked="" type="radio"/> 4						
Cooktop 34.75" AFF

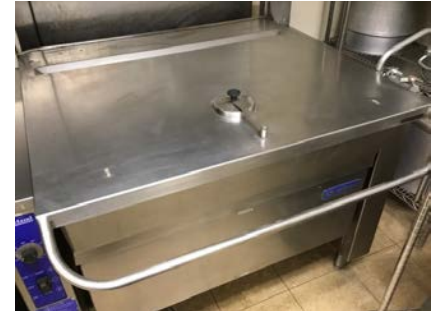
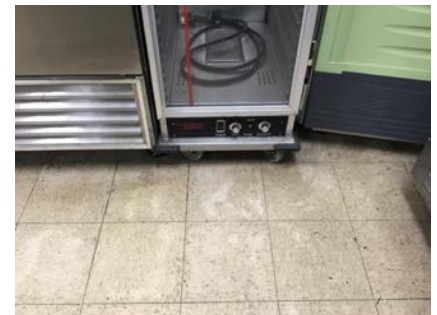
Item no., Rm no. and Name	Existing Architectural Barrier and Proposed Solution	Codes / Mitigation Info	Qty	Unit	Cost	Total
2045	<ul style="list-style-type: none"> As-Built Description: Reach height to control or access point, where side approach is available, exceeds 48" or is less than 15" in height, or exceeds 10" in depth. As-Built: 37.0" high obstruction. Proposed Solution: Modify equipment or mounting. 	PCODE IE02 ADAAG 91 4.2.6 ADA 2010 308.3.1 CBC 2007 1118B.6 CBC 2019 11B-308.3 Mitigated: <input type="radio"/> YES <input checked="" type="radio"/> NO	2	JOB	\$300	\$600
			<input type="radio"/> Staff Only Priority 4 Severity 4			
2047	<ul style="list-style-type: none"> As-Built Description: Reach height to control or access point, where side approach is available, exceeds 48" or is less than 15" in height, or exceeds 10" in depth. As-Built: 7.5" Proposed Solution: Modify equipment or mounting. 	PCODE IE02 ADAAG 91 4.2.6 ADA 2010 308.3.1 CBC 2007 1118B.6 CBC 2019 11B-308.3 Mitigated: <input type="radio"/> YES <input checked="" type="radio"/> NO	1	JOB	\$300	\$300

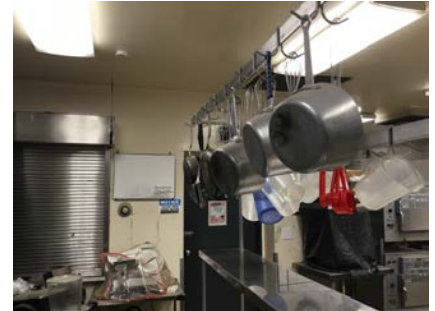
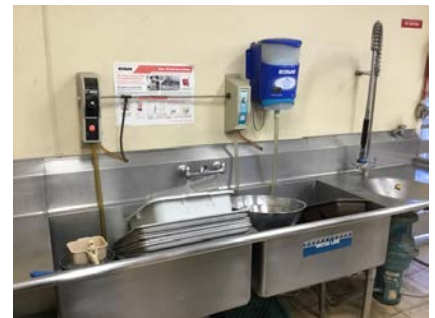
Item no., Rm no. and Name	Existing Architectural Barrier and Proposed Solution	Codes / Mitigation Info	Qty	Unit	Cost	Total
2048	<ul style="list-style-type: none"> As-Built Description: Reach height to control or access point, where side approach is available, exceeds 48" or is less than 15" in height, or exceeds 10" in depth. As-Built: Storage 67.0" Proposed Solution: Modify equipment or mounting. 	PCODE IE02 ADAAG 91 4.2.6 ADA 2010 308.3.1 CBC 2007 1118B.6 CBC 2019 11B-308.3 Mitigated: <input type="radio"/> YES <input checked="" type="radio"/> NO	1	JOB	\$300	\$300
<input type="radio"/> Staff Only Priority 4 Severity 2						
2049	<ul style="list-style-type: none"> As-Built Description: Reach height to control or access point, where side approach is available, exceeds 48" or is less than 15" in height, or exceeds 10" in depth. As-Built: 55.0" over 37.0" high obstruction. Proposed Solution: Modify equipment or mounting. 	PCODE IE02 ADAAG 91 4.2.6 ADA 2010 308.3.1 CBC 2007 1118B.6 CBC 2019 11B-308.3 Mitigated: <input type="radio"/> YES <input checked="" type="radio"/> NO	1	JOB	\$300	\$300

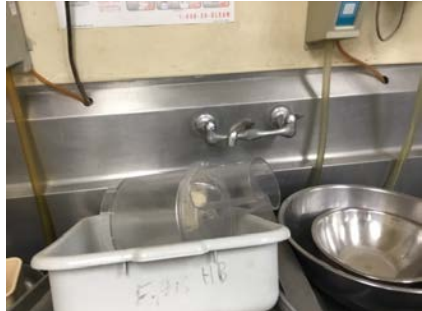
Item no., Rm no. and Name	Existing Architectural Barrier and Proposed Solution	Codes / Mitigation Info	Qty	Unit	Cost	Total
2051	<ul style="list-style-type: none"> As-Built Description: Reach height to control or access point, where side approach is available, exceeds 48" or is less than 15" in height, or exceeds 10" in depth. As-Built: 26.0" deep. Proposed Solution: Modify equipment or mounting. 	PCODE IE02 ADAAG 91 4.2.6 ADA 2010 308.3.1 CBC 2007 1118B.6 CBC 2019 11B-308.3 Mitigated: <input type="radio"/> YES <input checked="" type="radio"/> NO	1	JOB	\$300	\$300

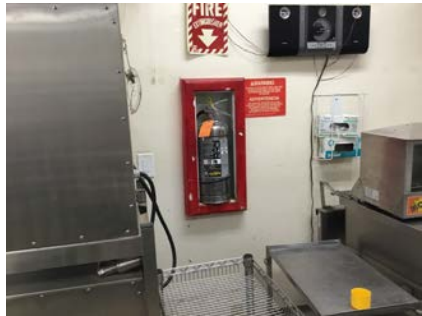
<input type="radio"/> Staff Only Priority 4 Severity 4						
2071	<ul style="list-style-type: none"> As-Built Description: Reach height to control or access point, where side approach is available, exceeds 48" or is less than 15" in height, or exceeds 10" in depth. As-Built: 61.0". Blocked. Proposed Solution: Modify equipment or mounting. 	PCODE IE02 ADAAG 91 4.2.6 ADA 2010 308.3.1 CBC 2007 1118B.6 CBC 2019 11B-308.3 Mitigated: <input type="radio"/> YES <input checked="" type="radio"/> NO	1	JOB	\$300	\$300

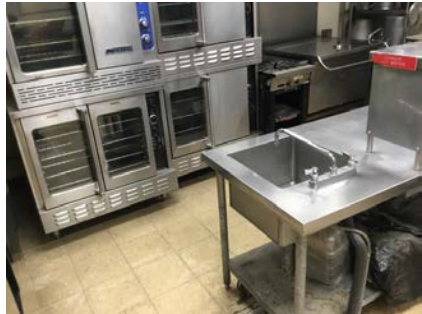
Item no., Rm no. and Name	Existing Architectural Barrier and Proposed Solution	Codes / Mitigation Info	Qty	Unit	Cost	Total
2042	<ul style="list-style-type: none"> <i>As-Built Description:</i> Sink does not have knee space min. 27" high x 19" deep x 30" wide. <i>Proposed Solution:</i> Remodel sink cabinet. 	PCODE IN06A ADAAG 91 4.24.3 ADA 2010 606.2 CBC 2007 1115B.4.7.1 CBC 2019 11B-606.2 Mitigated: <input type="radio"/> YES <input checked="" type="radio"/> NO	1	JOB	\$5,250	\$5,250

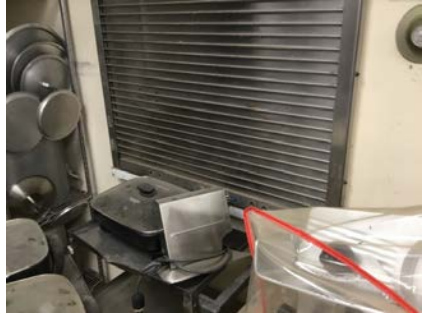
Tray Pass-thru

2038	<ul style="list-style-type: none"> <i>As-Built Description:</i> Food tray pass-thru at institutional cafeteria has lower edge higher than 34" above floor. <i>Proposed Solution:</i> Remodel pass-thru and counter to be 34" max. above floor. <i>Notes:</i> 	PCODE FB04NT ADAAG 91 5.2 ADA 2010 902.3 CBC 2007 1122B.4 CBC 2019 11B-902.3 Mitigated: <input type="radio"/> YES <input checked="" type="radio"/> NO	1	JOB	\$9,900	\$9,900

<input type="radio"/> Staff Only						
Priority <input checked="" type="radio"/> 4						
Severity <input checked="" type="radio"/> 3						
<p>36.0" high tray slide. This tray slide is on the server side of the one in the gym.</p>

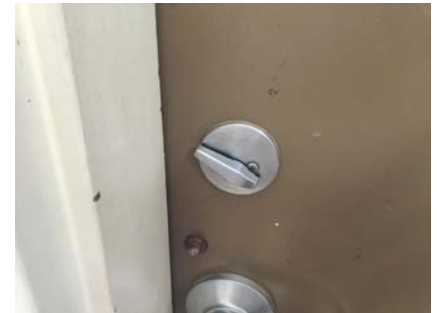
- *As-Built Description:*
Door lock, latch or handle less than 34" or more than 48" above the floor (CA only: 34" to 44").
- *As-Built:* **49.0" to 51.0"**
- *Proposed Solution:*
Relocate or replace existing hardware.

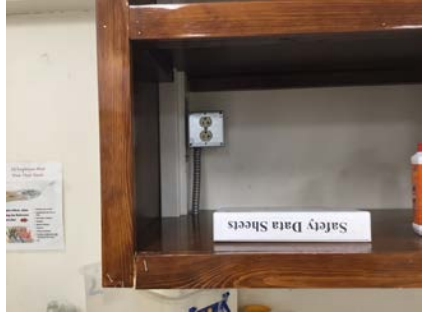
Electrical

2058	<ul style="list-style-type: none"> <i>As-Built Description:</i> Electric switch or control mounted less than 15" measured to the bottom of the outlet box or greater than 48 inches measured to the top of the outlet box. <i>As-Built:</i> 70.0" high <i>Proposed Solution:</i> Relocate light switches or control to between 15" and 48" height. 	<p>PCODE IC01 ADAAG 91 4.2.5 & 6 ADA 2010 308.2.1 & 308.2.2 CBC 2007 1117B.6.3 CBC 2019 11B-308.2.1 & 11B-308.2.2</p> <p>Mitigated: <input type="radio"/> YES <input checked="" type="radio"/> NO</p>	1	JOB	\$900	\$900
------	--	---	---	-----	-------	-------

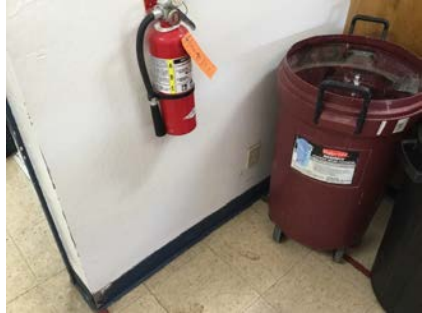
2065	<ul style="list-style-type: none"> <i>As-Built Description:</i> Electric switch or control mounted less than 15" measured to the bottom of the outlet box or greater than 48 inches measured to the top of the outlet box. <i>As-Built:</i> 14.0" to plug, 10.0" to bottom of box. <i>Proposed Solution:</i> Relocate light switches or control to between 15" and 48" height. <i>Notes:</i> 	<p>PCODE IC01 ADAAG 91 4.2.5 & 6 ADA 2010 308.2.1 & 308.2.2 CBC 2007 1117B.6.3 CBC 2019 11B-308.2.1 & 11B-308.2.2</p> <p>Mitigated: <input type="radio"/> YES <input checked="" type="radio"/> NO</p>	3	JOB	\$900	\$2,700
------	---	---	---	-----	-------	---------

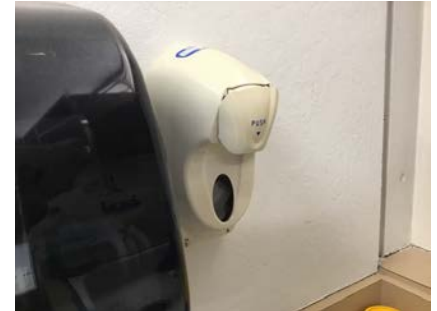
2055	<ul style="list-style-type: none"> <i>As-Built Description:</i> Reach height to control or access point, where side approach is available, exceeds 48" or is less than 15" in height, or exceeds 10" in depth. <i>As-Built:</i> 58.0" <i>Proposed Solution:</i> Modify equipment or mounting. 	PCODE IE02 ADAAG 91 4.2.6 ADA 2010 308.3.1 CBC 2007 1118B.6 CBC 2019 11B-308.3	1	JOB	\$300	\$300
------	---	---	---	-----	-------	--------------

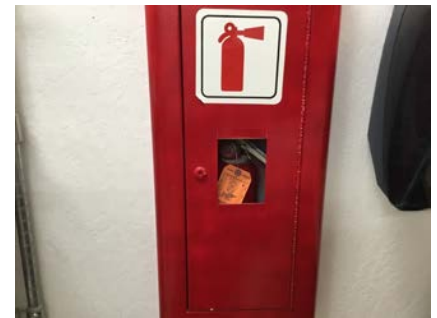
2056	<ul style="list-style-type: none"> <i>As-Built Description:</i> Reach height to control or access point, where side approach is available, exceeds 48" or is less than 15" in height, or exceeds 10" in depth. <i>As-Built:</i> 50.0" <i>Proposed Solution:</i> Modify equipment or mounting. <i>Notes:</i> 	PCODE IE02 ADAAG 91 4.2.6 ADA 2010 308.3.1 CBC 2007 1118B.6 CBC 2019 11B-308.3	1	JOB	\$300	\$300
------	--	---	---	-----	-------	--------------

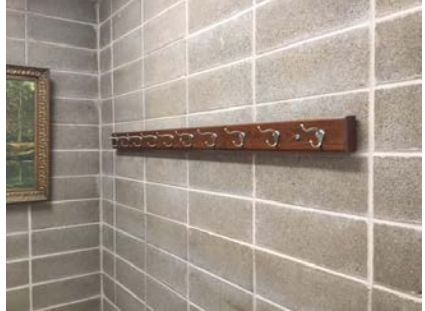
Item no., Rm no. and Name	Existing Architectural Barrier and Proposed Solution	Codes / Mitigation Info	Qty	Unit	Cost	Total
2062	<ul style="list-style-type: none"> As-Built Description: Reach height to control or access point, where side approach is available, exceeds 48" or is less than 15" in height, or exceeds 10" in depth. As-Built: 66.0" Proposed Solution: Modify equipment or mounting. 	PCODE IE02 ADAAG 91 4.2.6 ADA 2010 308.3.1 CBC 2007 1118B.6 CBC 2019 11B-308.3 Mitigated: <input type="radio"/> YES <input checked="" type="radio"/> NO	1	JOB	\$300	\$300

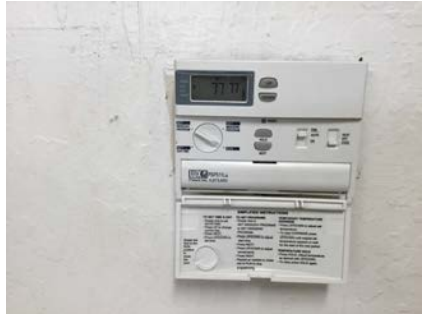
<input type="radio"/> Staff Only			
			Priority <input checked="" type="radio"/> 4			
			Severity <input checked="" type="radio"/> 2			
2066	<ul style="list-style-type: none"> As-Built Description: Reach height to control or access point, where side approach is available, exceeds 48" or is less than 15" in height, or exceeds 10" in depth. As-Built: 61.0" Proposed Solution: Modify equipment or mounting. 	PCODE IE02 ADAAG 91 4.2.6 ADA 2010 308.3.1 CBC 2007 1118B.6 CBC 2019 11B-308.3 Mitigated: <input type="radio"/> YES <input checked="" type="radio"/> NO	1	JOB	\$300	\$300

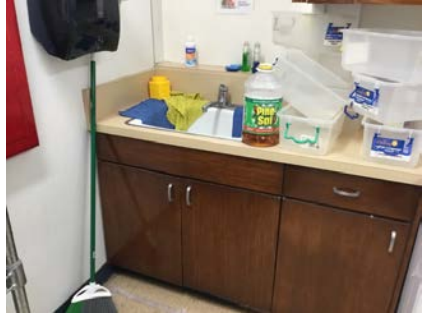
Item no., Rm no. and Name	Existing Architectural Barrier and Proposed Solution	Codes / Mitigation Info	Qty	Unit	Cost	Total
2053	<p>Sink</p> <ul style="list-style-type: none"> As-Built Description: Sink rim higher than 34" above floor. As-Built: 36.0" Proposed Solution: Remodel sink cabinet to lower sink. 	<p>PCODE IN06 ADAAG 91 4.24.2 ADA 2010 606.3 CBC 2007 1115B.4.7.1 CBC 2019 11B-606.3</p> <p>Mitigated: <input type="radio"/> YES <input checked="" type="radio"/> NO</p>	1	JOB	\$5,250	\$5,250

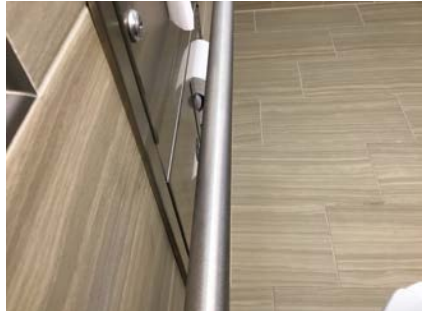
Item no., Rm no. and Name	Existing Architectural Barrier and Proposed Solution	Codes / Mitigation Info	Qty	Unit	Cost	Total
2109	<ul style="list-style-type: none"> As-Built Description: Grab bar clearance not 1-1/2" from wall. As-Built: 1.3" Proposed Solution: Provide accessible grab bars. 	PCODE WB07E ADAAG 91 4.26.2 ADA 2010 609.3 CBC 2007 1115B.7.1 CBC 2019 11B-609.3 Mitigated: <input type="radio"/> YES <input checked="" type="radio"/> NO	1	JOB	\$1,500	\$1,500

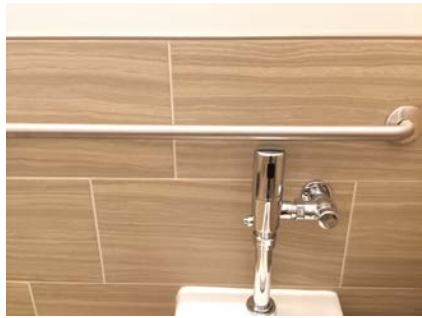
<input type="radio"/> Staff Only			
			Priority <input checked="" type="radio"/> 3			
			Severity <input checked="" type="radio"/> 4			
2108	<ul style="list-style-type: none"> As-Built Description: Accessories/dispensers in accessible stall located closer than 1-1/2" below or 12" above grab bar impedes its use. As-Built: Flush control: 0.3" below grab bar Proposed Solution: Reconfigure plumbing. 	PCODE WB07I ADAAG 91 4.26.2 ADA 2010 609.3 CBC 2007 1133B.4.2.5 CBC 2019 11B-609.3 Mitigated: <input type="radio"/> YES <input checked="" type="radio"/> NO	1	JOB	\$225	\$225

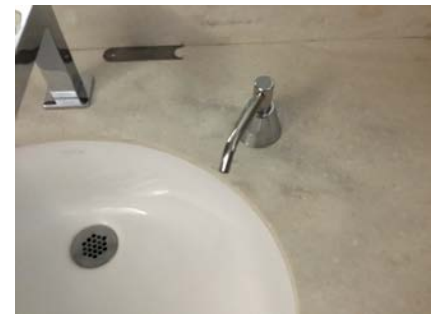
- 2104
- *As-Built Description:*
Operable part(s) require tight grasping, pinching, or twisting of the wrist with one hand.
 - *Proposed Solution:*
Modify or replace the operable part(s) to not require tight grasping, pinching, or twisting of the wrist with one hand.

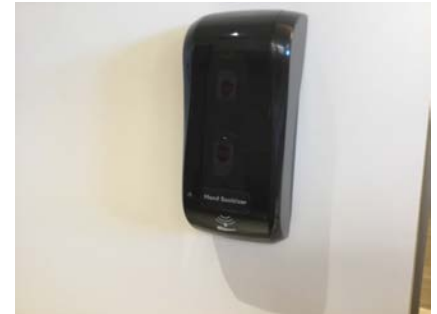
2112	<ul style="list-style-type: none"> <i>As-Built Description:</i> Dispensers in sanitary facilities, such as for towels, soap, sanitary napkins, seat covers, etc., and waste receptacles more than 48" (CA only: 40") from floor to highest operating slot or control. <i>As-Built:</i> 54.0" high <i>Proposed Solution:</i> Relocate existing restroom accessories. 	<p>PCODE WG01A ADAAG 91 4.23.7 ADA 2010 308.2.1 CBC 2007 1115B.8.3 CBC 2019 11B-603.5</p> <p>Mitigated: <input type="radio"/> YES <input checked="" type="radio"/> NO</p>	1	JOB	\$300	\$300
------	---	--	---	-----	-------	--------------

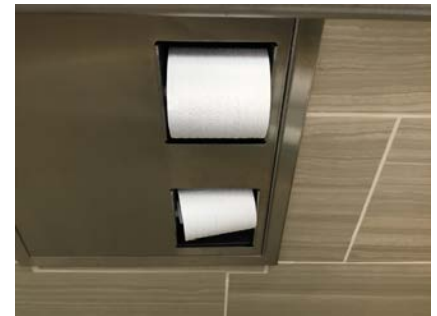
2118	<ul style="list-style-type: none"> <i>As-Built Description:</i> Toilet paper dispenser less than 15" (CA: 19") or more than 48" above floor or not within 7" to 9" from front of water closet (Note: CA pre-2010 is allowed within 12" from front of water closet). <i>As-Built:</i> 4.0" in front. To center of rolls. 8.5" to center of dispenser housing. <i>Proposed Solution:</i> Relocate or provide new toilet paper dispenser. 	<p>PCODE WG02 ADAAG 91 4.16.6 ADA 2010 604.7 CBC 2007 1115B.8.4 CBC 2019 11B-604.7</p> <p>Mitigated: <input type="radio"/> YES <input checked="" type="radio"/> NO</p>	1	JOB	\$225	\$225
------	--	---	---	-----	-------	--------------

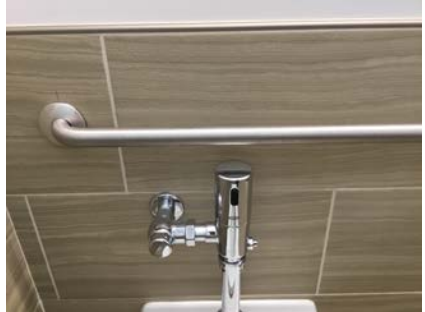
Item no., Rm no. and Name	Existing Architectural Barrier and Proposed Solution	Codes / Mitigation Info	Qty	Unit	Cost	Total
2116	<ul style="list-style-type: none"> As-Built Description: Accessories/dispensers in accessible stall located closer than 1-1/2" below or 12" above grab bar impedes its use. As-Built: Flush control: 1.2" below grab bar Proposed Solution: Reconfigure plumbing. 	PCODE WB07I ADAAG 91 4.26.2 ADA 2010 609.3 CBC 2007 1133B.4.2.5 CBC 2019 11B-609.3 Mitigated: <input type="radio"/> YES <input checked="" type="radio"/> NO	1	JOB	\$225	\$225

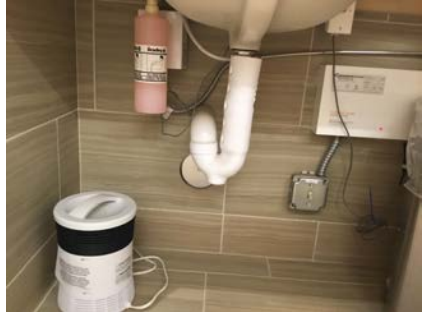
Lavatory

2111	<ul style="list-style-type: none"> As-Built Description: Hot or sharp-surfaced water/drain pipe not insulated or covered. Proposed Solution: Insulate or cover water/drain pipe and supply lines. 	PCODE WD05 ADAAG 91 4.19.4 ADA 2010 606.5 CBC 2007 1115B.4.3.4 CBC 2019 11B-606.5 Mitigated: <input type="radio"/> YES <input checked="" type="radio"/> NO	1	JOB	\$360	\$360

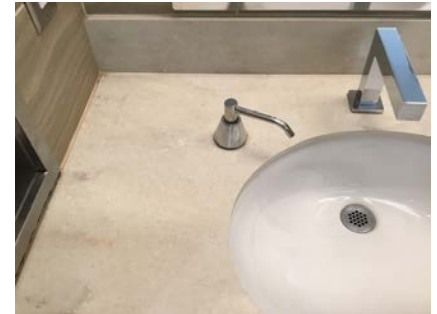
- 2113
- *As-Built Description:*
Operable part(s) require tight grasping, pinching, or twisting of the wrist with one hand.
 - *Proposed Solution:*
Modify or replace the operable part(s) to not require tight grasping, pinching, or twisting of the wrist with one hand.

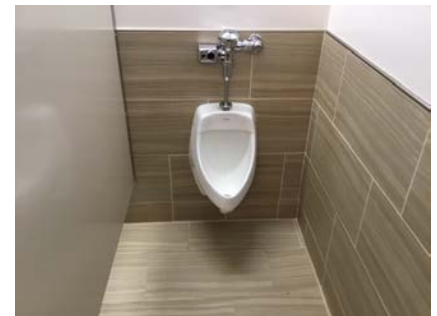
Urinal

2114	<ul style="list-style-type: none"> <i>As-Built Description:</i> Fixture mounted with rim more than 17" above floor. <i>As-Built:</i> 17.5" <i>Proposed Solution:</i> Provide accessible urinal. Remodel restroom as needed. 	<p>PCODE WE02</p> <p>ADAAG 91 4.18.2</p> <p>ADA 2010 605.2</p> <p>CBC 2007 1115B.4.2.1</p> <p>CBC 2019 11B-605.2</p> <p>Mitigated:</p> <p><input type="radio"/> YES</p> <p><input checked="" type="radio"/> NO</p>	1	JOB	\$7,200	\$7,200
------	---	--	---	-----	---------	---------

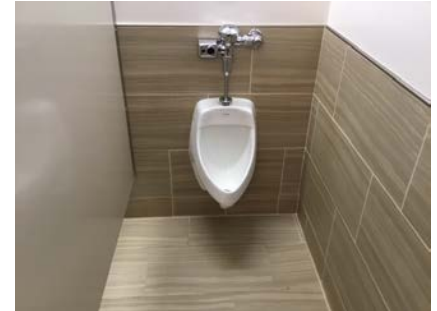
1	<ul style="list-style-type: none"> <i>As-Built Description:</i> 36" wide clearance in front of accessible urinal not provided when walls or partitions project more than 24" from the front edge of 30" x 48" clear space. <i>Proposed Solution:</i> Provide 36" clear floor space in front of accessible urinal. Remodel restroom as needed. 	PCODE WE04A ADAAG 91 4.18.3 ADA 2010 605.3 CBC 2007 1115B.4.2.3 CBC 2019 11B-605.3	1	JOB	\$4,500	\$4,500
---	---	--	---	-----	---------	---------

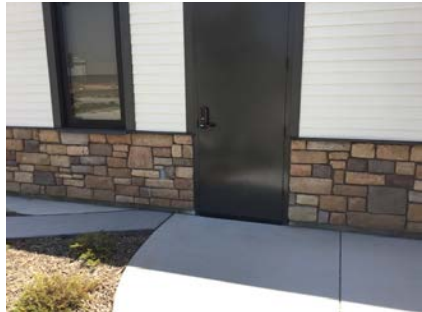
Item no., Rm no. and Name	Existing Architectural Barrier and Proposed Solution	Codes / Mitigation Info	Qty	Unit	Cost	Total
640	<ul style="list-style-type: none"> As-Built Description: Front approach: At pull side, door does not have clear and level maneuvering space measuring door width plus 18" x 60". (24" x 60" at exterior doors). As-Built: 0.0" to 12.0" Proposed Solution: Extend concrete. 	PCODE ID23C ADAAG 91 Fig. 25(a) ADA 2010 404.2.4 CBC 2007 11B-26A(a) CBC 2019 11B-404.2.4 Mitigated: <input type="radio"/> YES <input checked="" type="radio"/> NO	1	JOB	\$3,000	\$3,000

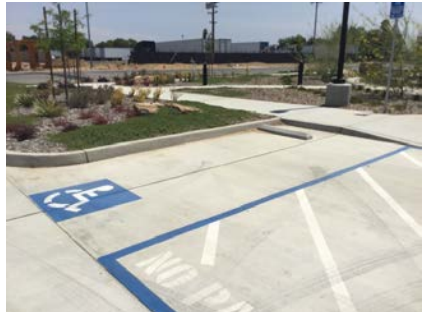
Parking

633	<ul style="list-style-type: none"> As-Built Description: Accessible parking space smaller than 8' wide (CA only: 9' x 18'). As-Built: 106.5" wide Proposed Solution: Modify parking space(s) to create accessible space. 	PCODE EA02A ADAAG 91 4.6.3 ADA 2010 502.2 CBC 2007 1129B.3.1 CBC 2019 11B-502.2 Mitigated: <input type="radio"/> YES <input checked="" type="radio"/> NO	1	JOB	\$600	\$600

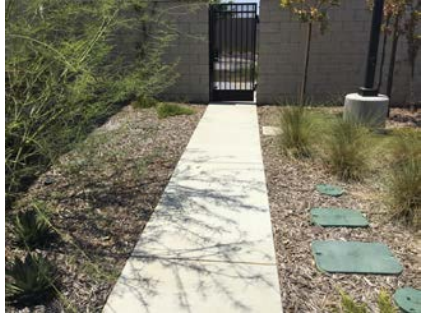
Item no., Rm no. and Name	Existing Architectural Barrier and Proposed Solution	Codes / Mitigation Info	Qty	Unit	Cost	Total
638	<p>Walk</p> <ul style="list-style-type: none"> As-Built Description: Walk more than 36" but less than 48" wide (required in CA only). As-Built: 39.5" wide Proposed Solution: Enlarge width of walk to 48". 	<p>PCODE EF08</p> <p>CBC 2007 1133B.7.1</p> <p>CBC 2019 11B-403.5.1.3</p> <p>Mitigated:</p> <p><input type="radio"/> YES</p> <p><input checked="" type="radio"/> NO</p>	150	SF	\$135	\$20,250

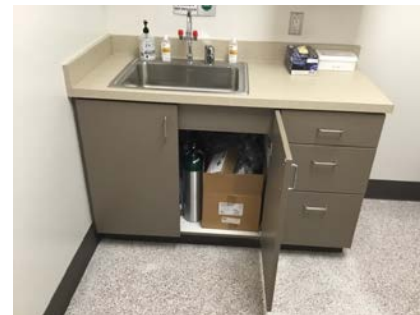
Item no., Rm no. and Name	Existing Architectural Barrier and Proposed Solution	Codes / Mitigation Info	Qty	Unit	Cost	Total
611	<ul style="list-style-type: none"> • <i>As-Built Description:</i> Sink does not have knee space min. 27" high x 19" deep x 30" wide. • <i>Proposed Solution:</i> Remodel sink cabinet. 	PCODE IN06A ADAAG 91 4.24.3 ADA 2010 606.2 CBC 2007 1115B.4.7.1 CBC 2019 11B-606.2 Mitigated: <input type="radio"/> YES <input checked="" type="radio"/> NO	1	JOB	\$5,250	\$5,250

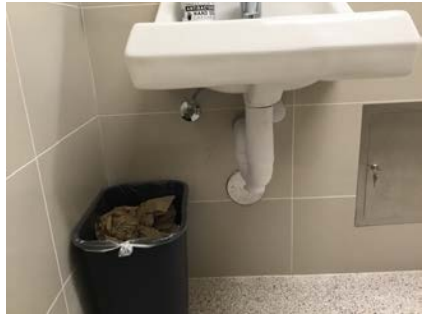
Item no., Rm no. and Name	Existing Architectural Barrier and Proposed Solution	Codes / Mitigation Info	Qty	Unit	Cost	Total
617	<ul style="list-style-type: none"> <i>As-Built Description:</i> Hot or sharp-surfaced water/drain pipe not insulated or covered. <i>Proposed Solution:</i> Insulate or cover water/drain pipe. 	PCODE WD05 ADAAG 91 4.19.4 ADA 2010 606.5 CBC 2007 1115B.4.3.4 CBC 2019 11B-606.5 Mitigated: <input type="radio"/> YES <input checked="" type="radio"/> NO	1	JOB	\$360	\$360

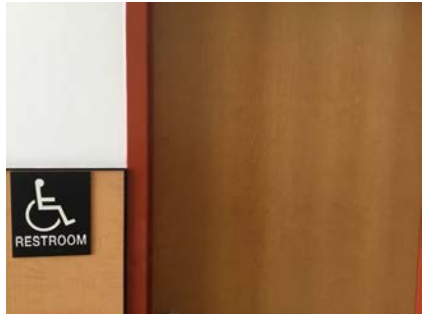
Signage

613	<ul style="list-style-type: none"> <i>As-Built Description:</i> Required in CA only: identification symbol centered 58" to 60" high on sanitary facility door that contrasts with the door not provided (women: 12" ø circle, men: 12" triangle, unisex: combined symbol). <i>Proposed Solution:</i> Provide properly mounted sanitary facility symbol when altering area. If wheelchair accessible, include International Symbol of Accessibility on sign. 	PCODE SA15 CBC 2007 1115B.6 CBC 2019 11B-703.7.2.6 Mitigated: <input type="radio"/> YES <input checked="" type="radio"/> NO	1	JOB	\$270	\$270

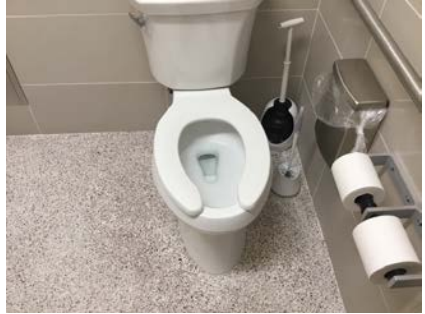
Item no., Rm no. and Name	Existing Architectural Barrier and Proposed Solution	Codes / Mitigation Info	Qty	Unit	Cost	Total
Water Closet						
619	<ul style="list-style-type: none"> • <i>As-Built Description:</i> Water closet not 16"-18" (CA: 17"-18") from near side wall to center line of water closet (2010 ADAAG: 16"-18"). • <i>As-Built:</i> 16.5" o.c. • <i>Proposed Solution:</i> Relocate existing water closet and plumbing, remount with offset closet flange to provide 18" max. from side wall. 	<p>PCODE WB02C</p> <p>ADAAG 91 Fig. 28</p> <p>ADA 2010 604.2</p> <p>CBC 2007 1115B.4.1.1</p> <p>CBC 2019 11B-604.2</p> <p>Mitigated:</p> <p><input type="radio"/> YES</p> <p><input checked="" type="radio"/> NO</p>	1	JOB	\$1,500	\$1,500

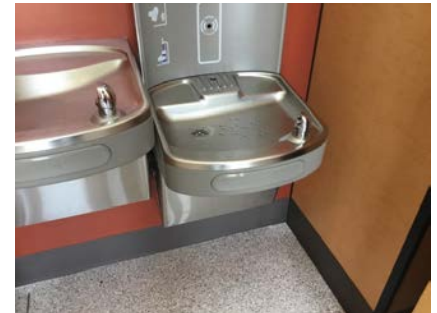
- 622 • *As-Built Description:*
Wall- and post-mounted cantilevered units: Knee space not provided at drinking fountain (27" high, 8" deep, 30" wide from front of drinking fountain). Unit in good condition.
- *As-Built:* **26.6" knee high**
- *Proposed Solution:*
Remount fountain at accessible height.

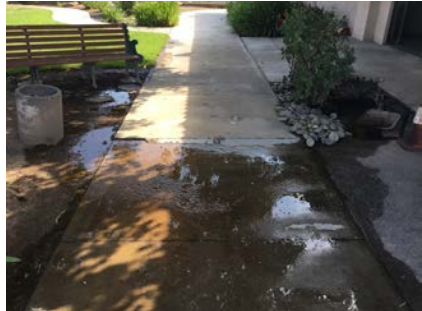
Item no., Rm no. and Name	Existing Architectural Barrier and Proposed Solution	Codes / Mitigation Info	Qty	Unit	Cost	Total
700	<ul style="list-style-type: none"> As-Built Description: Walk: Pavement dislocation creates abrupt change in level exceeding 1/2" in accessible route. As-Built: 2.0" Proposed Solution: Remove, replace or repair area of pavement sufficient to correct abrupt change in level. 	PCODE EF03 ADAAG 91 4.3.8 ADA 2010 403.4 CBC 2007 1133B.7.4 CBC 2019 11B-403.4 Mitigated: <input type="radio"/> YES <input checked="" type="radio"/> NO	6	SF	\$300	\$1,800

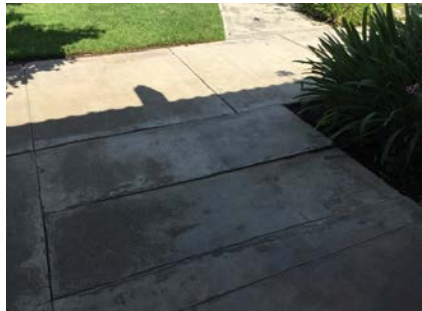
<input type="radio"/> Staff Only						
Priority <input checked="" type="radio"/> 1						
Severity <input checked="" type="radio"/> 3						
735	<ul style="list-style-type: none"> As-Built Description: Walk: Pavement dislocation creates abrupt change in level exceeding 1/2" in accessible route. As-Built: 0.75" Proposed Solution: Remove, replace or repair area of pavement sufficient to correct abrupt change in level. 	PCODE EF03 ADAAG 91 4.3.8 ADA 2010 403.4 CBC 2007 1133B.7.4 CBC 2019 11B-403.4 Mitigated: <input type="radio"/> YES <input checked="" type="radio"/> NO	15	LF	\$120	\$1,800

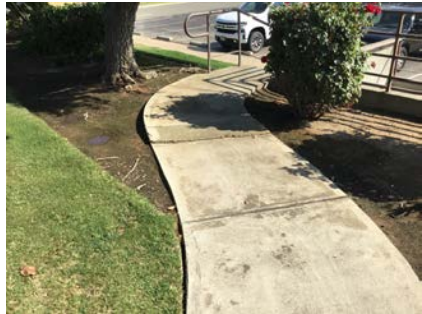
Item no., Rm no. and Name	Existing Architectural Barrier and Proposed Solution	Codes / Mitigation Info	Qty	Unit	Cost	Total
3	<ul style="list-style-type: none"> <i>As-Built Description:</i> Walk: Pavement dislocation creates abrupt change in level exceeding 1/2" in accessible route. <i>As-Built:</i> 2" <i>Proposed Solution:</i> Remove, replace or repair area of pavement sufficient to correct abrupt change in level. 	PCODE EF03 ADAAG 91 4.3.8 ADA 2010 403.4 CBC 2007 1133B.7.4 CBC 2019 11B-403.4 Mitigated: <input type="radio"/> YES <input checked="" type="radio"/> NO	3	SF	\$63	\$189

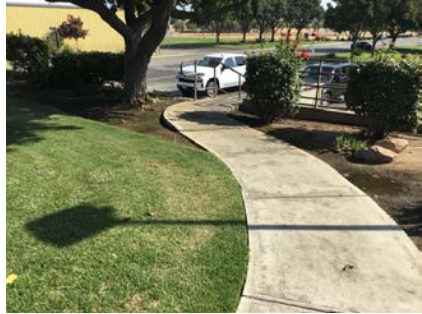
Cross Slope

689	<ul style="list-style-type: none"> <i>As-Built Description:</i> Cross slope more than 1":48" (2.083%). <i>As-Built:</i> 4.4% <i>Proposed Solution:</i> Modify cross slope. 	PCODE EF07 ADAAG 91 4.3.7 ADA 2010 403.3 CBC 2007 1133B.7.1.3 CBC 2019 11B-403.3 Mitigated: <input type="radio"/> YES <input checked="" type="radio"/> NO	40	SF	\$75	\$3,000

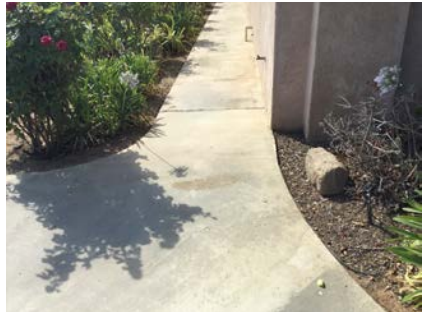
Item no., Rm no. and Name	Existing Architectural Barrier and Proposed Solution	Codes / Mitigation Info	Qty	Unit	Cost	Total
695	<ul style="list-style-type: none"> As-Built Description: Cross slope more than 1":48" (2.083%). As-Built: 4.3% Proposed Solution: Modify cross slope. 	PCODE EF07 ADAAG 91 4.3.7 ADA 2010 403.3 CBC 2007 1133B.7.1.3 CBC 2019 11B-403.3 Mitigated: <input type="radio"/> YES <input checked="" type="radio"/> NO	30	SF	\$75	\$2,250

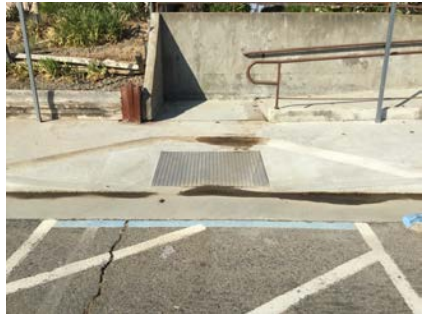
Curb Ramp

682	<ul style="list-style-type: none"> As-Built Description: Slope greater than 1:12 (8.3%). As-Built: 9.3% Proposed Solution: Demolish existing and provide new curb ramp. Notes: 	PCODE EH02A ADAAG 91 4.7.2 ADA 2010 406.1 CBC 2007 1127B.5.3 CBC 2019 11B-406.2.1 Mitigated: <input type="radio"/> YES <input checked="" type="radio"/> NO	1	JOB	\$7,500	\$7,500

Domes are 5.5" from street. Domes are not yellow. There is a level change where the domes meet the curb ramp.

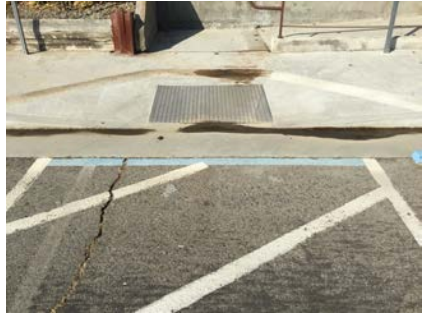
Item no., Rm no. and Name	Existing Architectural Barrier and Proposed Solution	Codes / Mitigation Info	Qty	Unit	Cost	Total
683	<ul style="list-style-type: none"> <i>As-Built Description:</i> Maximum slope of adjoining gutters, street surface at bottom of ramp exceeds 5% (1:20). <i>As-Built:</i> 6.1% <i>Proposed Solution:</i> Modify road/gutter slopes. Demolish existing and provide new curb ramp. 	PCODE EH02E ADAAG 91 4.7.2 ADA 2010 406.2 CBC 2007 1127B.5.3 CBC 2019 11B-406.5.8 Mitigated: <input type="radio"/> YES <input checked="" type="radio"/> NO	1	JOB	\$3,750	\$3,750
