APPENDIX B: ACCESS COMPLIANCE SURVEY REPORT OF FACILITIES

The City of Madera

Access Compliance Survey Report

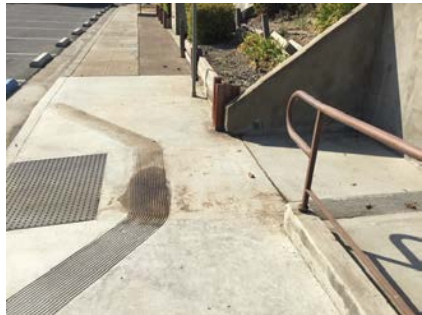
<input type="radio"/> Staff Only			
			Priority <input checked="" type="radio"/> 1			
			Severity <input checked="" type="radio"/> 4			
685	<ul style="list-style-type: none"> <i>As-Built Description:</i> Less than 48" level space at top and 1:12 flared sides not provided. <i>As-Built:</i> 45.0" deep obstructed by the ramp handrail. <i>Proposed Solution:</i> Demolish existing and provide new curb ramp. <i>Notes:</i> 	PCODE EH05B ADAAG 91 4.7.5; Fig.12(a) ADA 2010 406.4 CBC 2007 1127B.5.4 CBC 2019 11B-406.5.3 Mitigated: <input type="radio"/> YES <input checked="" type="radio"/> NO	1	JOB	\$7,500	\$7,500

<input type="radio"/> Staff Only			
			Priority <input checked="" type="radio"/> 1			
			Severity <input checked="" type="radio"/> 4			
<p>The handrail protrudes into the 48.0" required with by approximately 3.0", reducing the landing width to 45.0".</p>

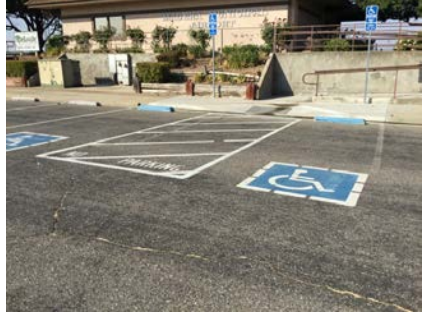
Parking

<p>678</p> <ul style="list-style-type: none"> <i>As-Built Description:</i> An accessible parking space shall be outlined or painted blue (required in CA only). <i>Proposed Solution:</i> Identify accessible parking space using blue markings. 	<p>PCODE EA04K</p> <p>CBC 2019 11B-502.6</p> <p>Mitigated:</p> <p><input type="radio"/> YES</p> <p><input checked="" type="radio"/> NO</p>	<p>1 JOB \$360 \$360</p>

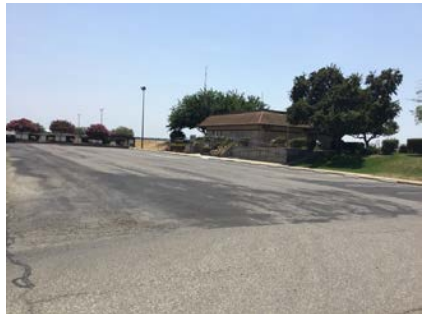
Parking Signage

<p>776</p> <ul style="list-style-type: none"> <i>As-Built Description:</i> No "Tow Away" sign at parking lot entrance (required in CA only). <i>Proposed Solution:</i> Provide "Tow Away" sign at parking lot entrance when altering area. 	<p>PCODE EA04C</p> <p>CBC 2007 1129B.4</p> <p>CBC 2019 11B-502.8.2</p> <p>Mitigated:</p> <p><input type="radio"/> YES</p> <p><input checked="" type="radio"/> NO</p>	<p>1 JOB \$975 \$975</p>

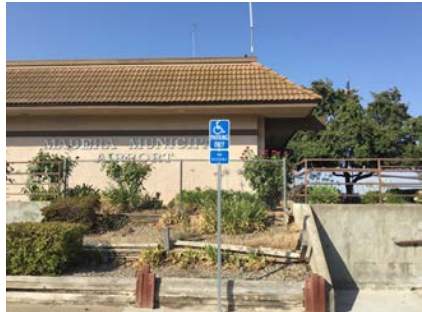
Item no., Rm no. and Name	Existing Architectural Barrier and Proposed Solution	Codes / Mitigation Info	Qty	Unit	Cost	Total
681	<ul style="list-style-type: none"> <i>As-Built Description:</i> CA only: Additional Sign or additional language below the symbol of accessibility stating "Minimum Fine \$250" not provided. <i>Proposed Solution:</i> Provide compliant parking signage that includes fine information. 	PCODE EA04G CBC 2007 1129B.4 CBC 2019 11B-502.6.2 Mitigated: <input type="radio"/> YES <input checked="" type="radio"/> NO	1	JOB	\$300	\$300

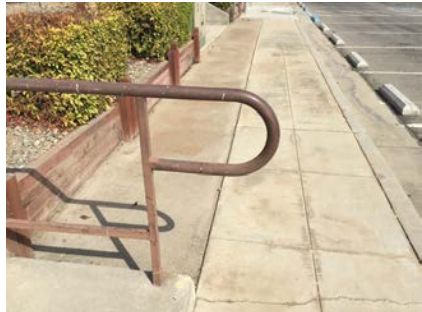
Protrusion Limits

697	<ul style="list-style-type: none"> <i>As-Built Description:</i> Protruding objects more than 4" from wall, when bottom of object more than 27" or less than 80" above finished floor. <i>As-Built:</i> Stair extension: 15.0" at 36.0" high <i>Proposed Solution:</i> Remove/relocate protruding object. Patch existing surface. <i>Notes:</i> 	PCODE EG04 ADAAG 91 4.4.1 ADA 2010 307.2 CBC 2007 1133B.8.6.1 CBC 2019 11B-307.2 Mitigated: <input type="radio"/> YES <input checked="" type="radio"/> NO	3	JOB	\$300	\$900

Both stairs.

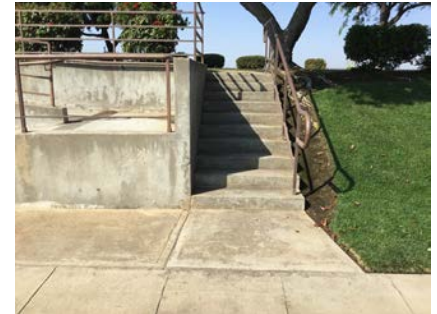
Stairways

693	<ul style="list-style-type: none"> As-Built Description: Landing at the top or bottom of stairway is not level or not provided. As-Built: 6.3% Proposed Solution: Remodel landings to provide a level clear floor space that extends the entire width of the stair. 	<p>PCODE EC10</p> <p>CBC 2019 1009.8</p> <p>Mitigated:</p> <p><input type="radio"/> YES</p> <p><input checked="" type="radio"/> NO</p>	1	JOB	\$1,500	\$1,500
-----	---	--	---	-----	---------	---------

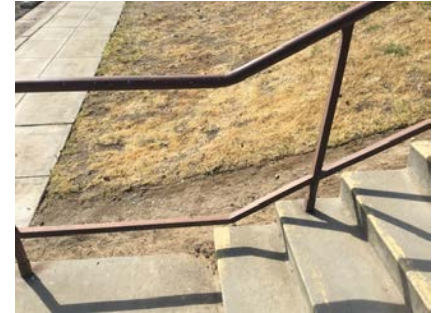
Item no., Rm no. and Name	Existing Architectural Barrier and Proposed Solution	Codes / Mitigation Info	Qty	Unit	Cost	Total
696	<ul style="list-style-type: none"> <i>As-Built Description:</i> Stair handrail does not extend horizontally 12" minimum beyond top nosing, and one tread width sloped, plus 12" minimum horizontally beyond the bottom nosing. <i>Proposed Solution:</i> Extend stair handrail at top and bottom (cost for each extension piece). 	PCODE ED06 ADAAG 91 4.9.4(2) ADA 2010 505.10.2; 505.10.3 CBC 2007 1133B.4.2.2 CBC 2019 11B-505.10.2; 11B-505.10.3 Mitigated: <input type="radio"/> YES <input checked="" type="radio"/> NO	2	JOB	\$510	\$1,020

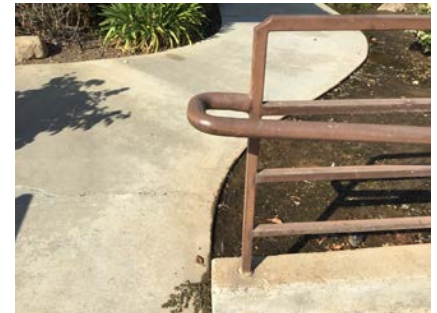
Top and Bottom Extension at

686	<ul style="list-style-type: none"> <i>As-Built Description:</i> Ramp handrail does not extend horizontally 12" past top and / or bottom of ramp. <i>As-Built:</i> 0.0" at the top. 9.0" at the bottom. <i>Proposed Solution:</i> Provide ramp handrail extension (cost for each extension piece). <i>Notes:</i> 	PCODE ED05 ADAAG 91 4.8.5(2) ADA 2010 505.10.1 CBC 2007 1133B.4.2.2 & CBC 2019 1133B.5.5.1 11B-505.10.1 Mitigated: <input type="radio"/> YES <input checked="" type="radio"/> NO	2	JOB	\$510	\$1,020
-----	--	--	---	-----	-------	---------

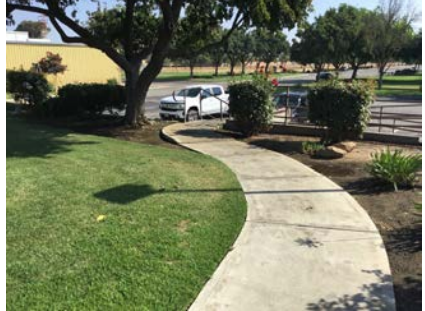
Item no., Rm no. and Name	Existing Architectural Barrier and Proposed Solution	Codes / Mitigation Info	Qty	Unit	Cost	Total
688	<ul style="list-style-type: none"> As-Built Description: Walk more than 36" but less than 48" wide (required in CA only). As-Built: 47.0" wide Proposed Solution: Enlarge width of walk to 48". 	PCODE EF08 CBC 2007 1133B.7.1 CBC 2019 11B-403.5.1.3 Mitigated: <input type="radio"/> YES <input checked="" type="radio"/> NO	80	SF	\$135	\$10,800

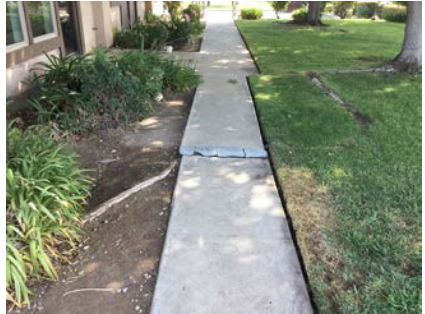
<input type="radio"/> Staff Only			
			Priority <input checked="" type="radio"/> 1			
			Severity <input checked="" type="radio"/> 4			
698	<ul style="list-style-type: none"> As-Built Description: Walk more than 36" but less than 48" wide (required in CA only). As-Built: 30.0" wide Proposed Solution: Enlarge width of walk to 48". 	PCODE EF08 CBC 2007 1133B.7.1 CBC 2019 11B-403.5.1.3 Mitigated: <input type="radio"/> YES <input checked="" type="radio"/> NO	240	SF	\$135	\$32,400

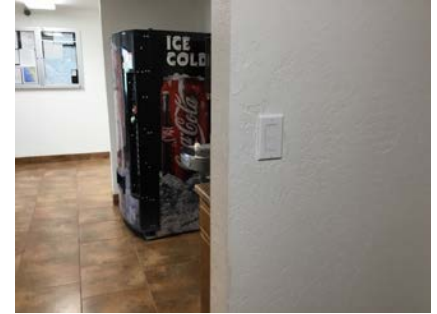
Electrical

708	<ul style="list-style-type: none"> <i>As-Built Description:</i> Electric switch or control mounted less than 15" measured to the bottom of the outlet box or greater than 48 inches measured to the top of the outlet box. <i>As-Built:</i> 54.2" high <i>Proposed Solution:</i> Relocate light switches or control to between 15" and 48" height. 	<p>PCODE IC01 ADAAG 91 4.2.5 & 6 ADA 2010 308.2.1 & 308.2.2 CBC 2007 1117B.6.3 CBC 2019 11B-308.2.1 & 11B-308.2.2</p> <p>Mitigated: <input type="radio"/> YES <input checked="" type="radio"/> NO</p>	1	JOB	\$900	\$900
-----	--	---	---	-----	-------	-------

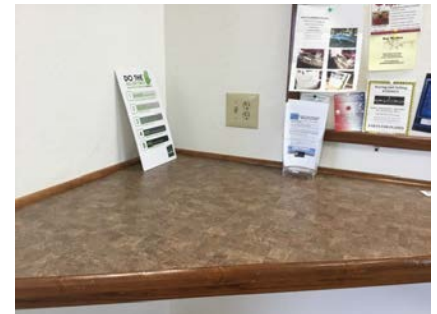
734	<ul style="list-style-type: none"> <i>As-Built Description:</i> Electric switch or control mounted less than 15" measured to the bottom of the outlet box or greater than 48 inches measured to the top of the outlet box. <i>As-Built:</i> 20.0" side reach over 38.0" high obstruction. <i>Proposed Solution:</i> Relocate light switches or control to between 15" and 48" height. 	<p>PCODE IC01 ADAAG 91 4.2.5 & 6 ADA 2010 308.2.1 & 308.2.2 CBC 2007 1117B.6.3 CBC 2019 11B-308.2.1 & 11B-308.2.2</p> <p>Mitigated: <input type="radio"/> YES <input checked="" type="radio"/> NO</p>	1	JOB	\$900	\$900
-----	---	---	---	-----	-------	-------

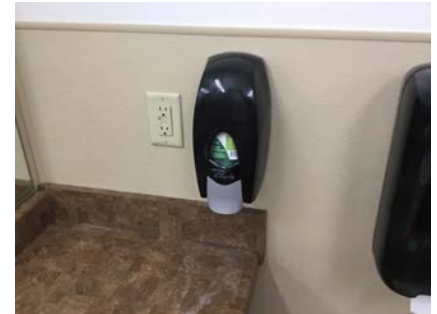
Accessories

711	<ul style="list-style-type: none"> As-Built Description: Dispensers in sanitary facilities, such as for towels, soap, sanitary napkins, seat covers, etc., and waste receptacles more than 48" (CA only: 40") from floor to highest operating slot or control. As-Built: SD: 41.0" high Proposed Solution: Relocate existing restroom accessories. Notes: 	PCODE WG01A ADAAG 91 4.23.7 ADA 2010 308.2.1 CBC 2007 1115B.8.3 CBC 2019 11B-603.5	1	JOB	\$300	\$300
-----	--	---	---	-----	-------	-------

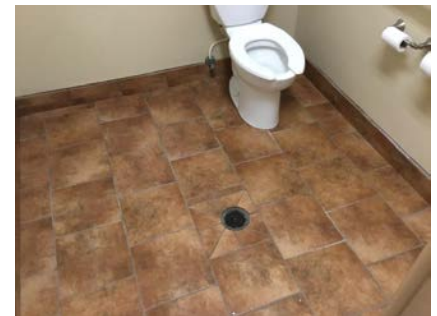
Changes in Level

727	<ul style="list-style-type: none"> As-Built Description: Walk: abrupt change in level exceeding 1/2" in accessible route due to drain. As-Built: 0.5" level change 3.8% slope Proposed Solution: Correct abrupt change in level and adjust drain as needed. 	PCODE EF03 ADAAG 91 4.3.8 ADA 2010 403.4 CBC 2007 1133B.7.4 CBC 2019 11B-403.4	25	SF	\$63	\$1,575
-----	--	---	----	----	------	---------

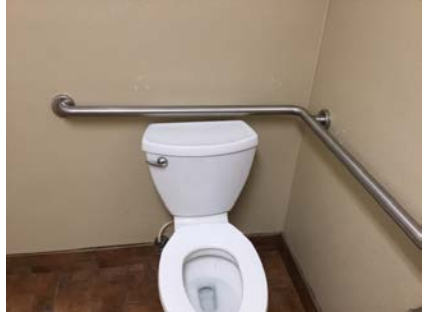
Grab Bars

<p>729</p> <ul style="list-style-type: none"> • <i>As-Built Description:</i> The rear wall grab is less than 36" min. or does not extend from the centerline of the water closet 12" min. on one side and 24" min. on the other side. • <i>As-Built:</i> Extends 20.0" wide side • <i>Proposed Solution:</i> Provide new accessible rear grab bar. • <i>Notes:</i> 	<p>PCODE WB07B ADAAG 91 4.17.6 ADA 2010 604.5.2 CBC 2007 1115B.4.1.3.2 CBC 2019 11B-604.5.2</p> <p>Mitigated: <input type="radio"/> YES <input checked="" type="radio"/> NO</p>	<p>1 JOB \$1,020 \$1,020</p>

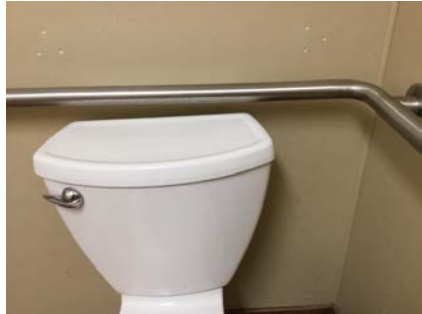
<p>730</p> <ul style="list-style-type: none"> • <i>As-Built Description:</i> Accessories/dispensers in accessible stall located closer than 1-1/2" below or 12" above grab bar impedes its use. • <i>As-Built:</i> 1.4" • <i>Proposed Solution:</i> Raise the grab bar. 	<p>PCODE WB07I ADAAG 91 4.26.2 ADA 2010 609.3 CBC 2007 1133B.4.2.5 CBC 2019 11B-609.3</p> <p>Mitigated: <input type="radio"/> YES <input checked="" type="radio"/> NO</p>	<p>1 JOB \$225 \$225</p>

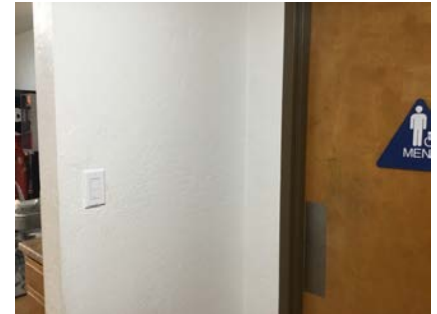
Signage

714	<ul style="list-style-type: none"> <i>As-Built Description:</i> Entrance to toilet or bathing facility not identified with ADAAG compliant signage. <i>Proposed Solution:</i> Provide ADA compliant sign mounted at 48" min. above to baseline of the lowest Braille cells and 60" max. to baseline of the highest line of raised characters on nearest adjacent wall, on latch side of a single door (located not to cause a Braille reader to stand within the door swing). 	<p>PCODE SA11A ADAAG 91 4.1.3(16)(a) ADA 2010 216.8 CBC 2019 11B-216.8</p> <p>Mitigated: <input type="radio"/> YES <input checked="" type="radio"/> NO</p>	1	JOB	\$270	\$270
-----	---	--	---	-----	-------	-------

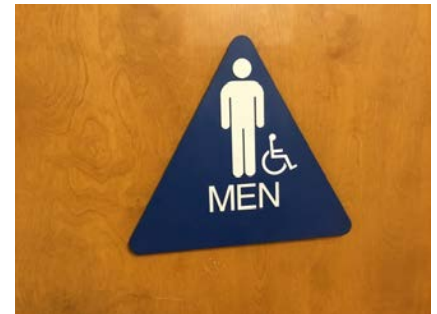
709	<ul style="list-style-type: none"> <i>As-Built Description:</i> Required in CA only: identification symbol centered 58" to 60" high on sanitary facility door that contrasts with the door not provided (women: 12" ø circle, men: 12" triangle, unisex: combined symbol). <i>As-Built:</i> Not beveled. 0.5" radius. 60.5" high. <i>Proposed Solution:</i> Provide properly mounted sanitary facility symbol when altering area. If wheelchair accessible, include International Symbol of Accessibility on sign. 	<p>PCODE SA15 CBC 2007 1115B.6 CBC 2019 11B-703.7.2.6</p> <p>Mitigated: <input type="radio"/> YES <input checked="" type="radio"/> NO</p>	1	JOB	\$270	\$270
-----	--	---	---	-----	-------	-------

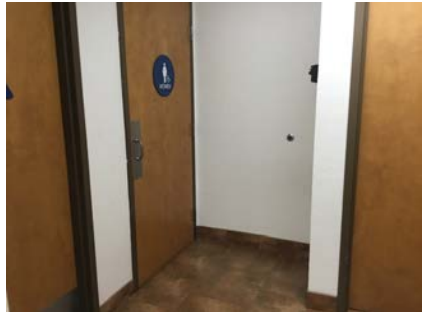
Item no., Rm no. and Name	Existing Architectural Barrier and Proposed Solution	Codes / Mitigation Info	Qty	Unit	Cost	Total
713	<ul style="list-style-type: none"> As-Built Description: Latch approach: At pull side, door does not have clear and level maneuvering space measuring door width plus 24" x 48" or 54" if door has closer (CA only: door width plus 24" x 60"). As-Built: 43.5" Proposed Solution: Relocate door to interior. 	PCODE ID27 ADAAG 91 Fig. 25(c) ADA 2010 404.2.4 CBC 2007 11B-26A(c) CBC 2019 11B-404.2.4 Mitigated: <input type="radio"/> YES <input checked="" type="radio"/> NO	1	JOB	\$9,000	\$9,000

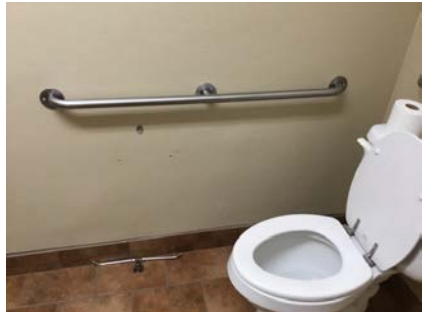
Grab Bars

724	<ul style="list-style-type: none"> As-Built Description: Side grab bar less than 42" long, or located more than 12 inches max. from the rear wall, or extending less than 54" from rear wall (CA only: front end min. 24" in front of water closet). As-Built: Extends 52.5" Proposed Solution: Provide or relocate accessible side grab bar. 	PCODE WB07A ADAAG 91 Fig. 29(b) ADA 2010 604.5.1 CBC 2007 1115B.4.1.3.1 CBC 2019 11B-604.5.1 Mitigated: <input type="radio"/> YES <input checked="" type="radio"/> NO	1	JOB	\$780	\$780

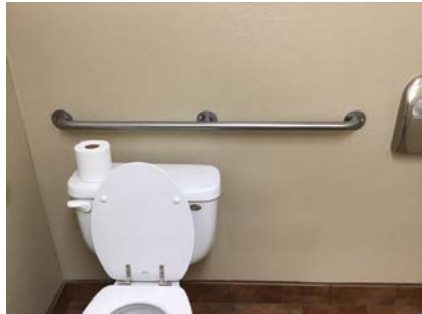
Item no., Rm no. and Name	Existing Architectural Barrier and Proposed Solution	Codes / Mitigation Info	Qty	Unit	Cost	Total
721	<ul style="list-style-type: none"> As-Built Description: Grab bars not at 33" to 36" from floor As-Built: 37.0" high Proposed Solution: Relocate accessible grab bars. 	PCODE WB07C ADAAG 91 4.16.4 ADA 2010 609.4 CBC 2007 1115B.4.1.3.1 CBC 2019 & 2 11B-609.4 Mitigated: <input type="radio"/> YES <input checked="" type="radio"/> NO	1	JOB	\$780	\$780

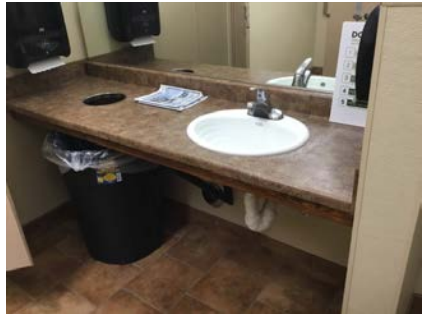
Lavatory

719	<ul style="list-style-type: none"> As-Built Description: Lavatory: Fixture rim or counter height more than 34" above floor. As-Built: 34.25" high Proposed Solution: Remount compliant fixture at accessible height. 	PCODE WD02A ADAAG 91 4.19.2 ADA 2010 606.3 CBC 2007 1115B.4.3 CBC 2019 11B-606.3 Mitigated: <input type="radio"/> YES <input checked="" type="radio"/> NO	1	JOB	\$2,700	\$2,700

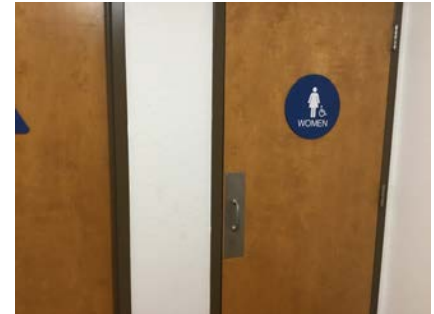
Signage

715	<ul style="list-style-type: none"> <i>As-Built Description:</i> Entrance to toilet or bathing facility not identified with ADAAG compliant signage. <i>Proposed Solution:</i> Provide ADA compliant sign mounted at 48" min. above to baseline of the lowest Braille cells and 60" max. to baseline of the highest line of raised characters on nearest adjacent wall, on latch side of a single door (located not to cause a Braille reader to stand within the door swing). <i>Notes:</i> 	<p>PCODE SA11A ADAAG 91 4.1.3(16)(a) ADA 2010 216.8 CBC 2019 11B-216.8</p> <p>Mitigated: <input type="radio"/> YES <input checked="" type="radio"/> NO</p>	1	JOB	\$270	\$270
-----	--	---	---	-----	-------	-------

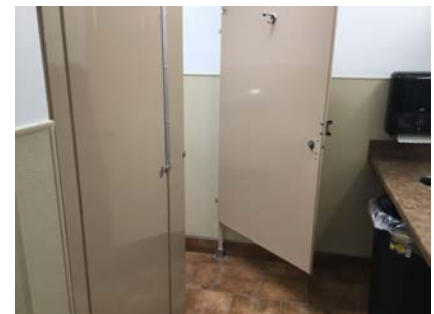
Stall Door

717	<ul style="list-style-type: none"> <i>As-Built Description:</i> Stall door to accessible compartment not self closing. <i>Proposed Solution:</i> Adjust closer. 	<p>PCODE WB05B ADAAG 91 4.22.4 ADA 2010 604.8.1.2 CBC 2007 1115B.3.1.4.4 CBC 2019 11B-604.8.1.2</p> <p>Mitigated: <input type="radio"/> YES <input checked="" type="radio"/> NO</p>	1	JOB	\$75	\$75
-----	---	---	---	-----	------	------

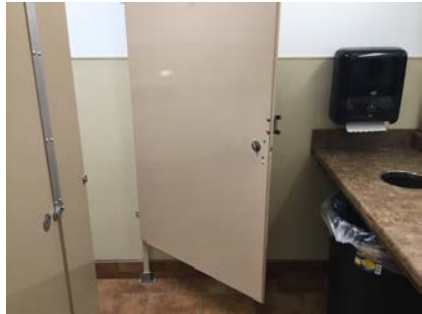
Item no., Rm no. and Name	Existing Architectural Barrier and Proposed Solution	Codes / Mitigation Info	Qty	Unit	Cost	Total
718	<ul style="list-style-type: none"> <i>As-Built Description:</i> Stall door does not have accessible operating hardware (U-pulls on both sides, flip-over or sliding lock). <i>Proposed Solution:</i> Provide new accessible locking hardware that does not require grasping, pinching, or twisting and U-pulls on both sides. 	PCODE WB05C ADAAG 91 4.17.5 ADA 2010 604.8.1.2 CBC 2007 1115B.3.1.4.5 CBC 2019 11B-604.8.1.2 Mitigated: <input type="radio"/> YES <input checked="" type="radio"/> NO	1	JOB	\$300	\$300

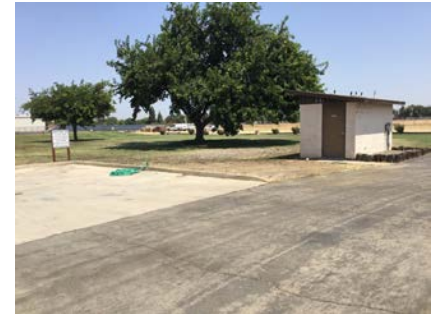
Minimum Number

742	<ul style="list-style-type: none"> <i>As-Built Description:</i> At parking lot with 1-25 spaces, the number of accessible spaces is less than required by code; 1 space required <i>Proposed Solution:</i> Provide required accessible parking space with sign including a minimum of one van space. 	PCODE EA01A ADAAG 91 4.1.2(5) ADA 2010 208.2 CBC 2007 Tbl. 11B-6 CBC 2019 11B-208.2 Tbl. 11B-208.2 Mitigated: <input type="radio"/> YES <input checked="" type="radio"/> NO	1	JOB	\$900	\$900
-----	--	--	---	-----	-------	-------

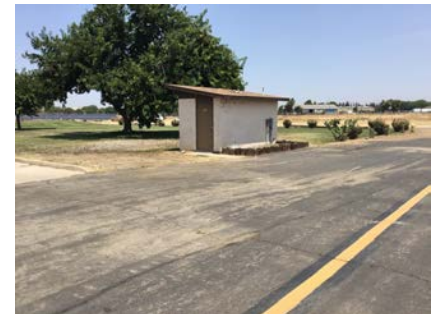
775	<ul style="list-style-type: none"> <i>As-Built Description:</i> At parking lot with 1-25 spaces, the number of accessible spaces is less than required by code; 1 space required <i>Proposed Solution:</i> Provide required accessible parking space with sign including a minimum of one van space. 	PCODE EA01A ADAAG 91 4.1.2(5) ADA 2010 208.2 CBC 2007 Tbl. 11B-6 CBC 2019 11B-208.2 Tbl. 11B-208.2 Mitigated: <input type="radio"/> YES <input checked="" type="radio"/> NO	1	JOB	\$900	\$900
-----	--	--	---	-----	-------	-------

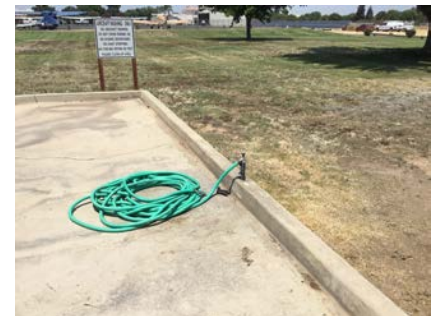
774 • *As-Built Description:*
 Operable part(s) require tight grasping, pinching, or twisting of the wrist with one hand.
 • *As-Built:* **Greater than 35.0 lbs**
 • *Proposed Solution:*
 Modify or replace the operable part(s) to not require tight grasping, pinching, or twisting of the wrist with one hand.

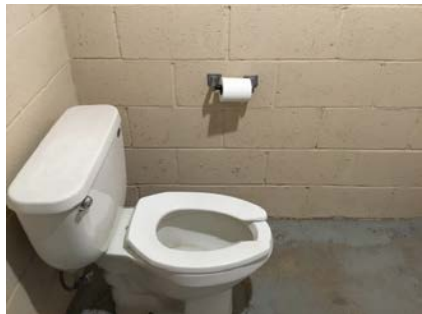
Item no., Rm no. and Name	Existing Architectural Barrier and Proposed Solution	Codes / Mitigation Info	Qty	Unit	Cost	Total
751	<ul style="list-style-type: none"> As-Built Description: Toilet paper dispenser less than 15" (CA: 19") or more than 48" above floor or not within 7" to 9" from front of water closet (Note: CA pre-2010 is allowed within 12" from front of water closet). As-Built: Behind water closet. Proposed Solution: Relocate or provide new toilet paper dispenser. 	PCODE WG02 ADAAG 91 4.16.6 ADA 2010 604.7 CBC 2007 1115B.8.4 CBC 2019 11B-604.7 Mitigated: <input type="radio"/> YES <input checked="" type="radio"/> NO	1	JOB	\$225	\$225

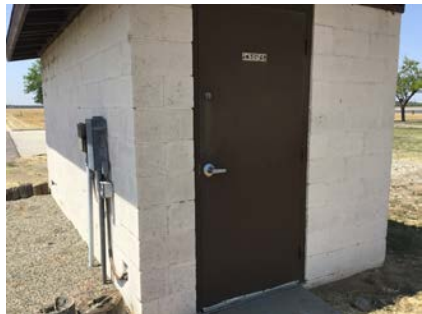
Door

745	<ul style="list-style-type: none"> As-Built Description: Surface of required maneuvering clearance at door slopes more than 1/4":12" (2.0%). As-Built: 5.0% Proposed Solution: Modify surface slope at door. 	PCODE ID11 ADAAG 91 4.13.6 ADA 2010 404.2.4.4 CBC 2007 1133B.2.4 CBC 2019 11B-404.2.4 Mitigated: <input type="radio"/> YES <input checked="" type="radio"/> NO	25	SF	\$120	\$3,000

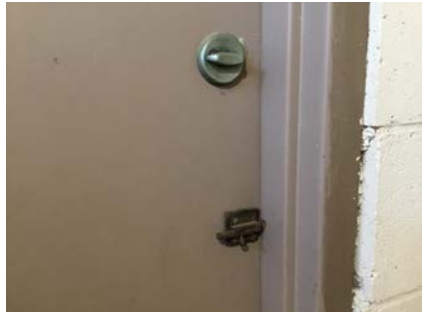
Item no., Rm no. and Name	Existing Architectural Barrier and Proposed Solution	Codes / Mitigation Info	Qty	Unit	Cost	Total
747	<ul style="list-style-type: none"> As-Built Description: Door lock, latch or handle less than 34" or more than 48" above the floor (CA only: 34" to 44"). As-Built: 52.0" and 60.0" high Proposed Solution: Relocate or replace existing hardware. 	PCODE ID17 ADAAG 91 4.13.9 ADA 2010 404.2.7 CBC 2007 1133B.2.5.2 CBC 2019 11B-404.2.7 Mitigated: <input type="radio"/> YES <input checked="" type="radio"/> NO	1	JOB	\$900	\$900

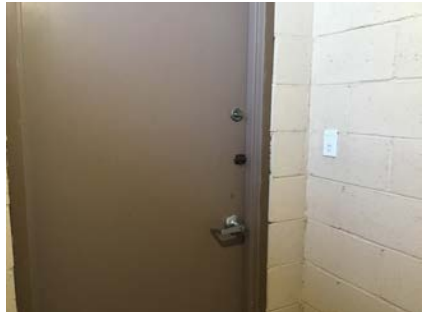
Door Swing

746	<ul style="list-style-type: none"> As-Built Description: Front approach: At push side, door does not have clear and level maneuvering space measuring door width x 48" (door width plus 12" if door has both, latch and closer). As-Built: 10.75" Proposed Solution: Remove latch. 	PCODE ID24B ADAAG 91 Fig. 25(a) ADA 2010 404.2.4 CBC 2007 11B-26A(a) CBC 2019 11B-404.2.4 Mitigated: <input type="radio"/> YES <input checked="" type="radio"/> NO	1	JOB	\$780	\$780

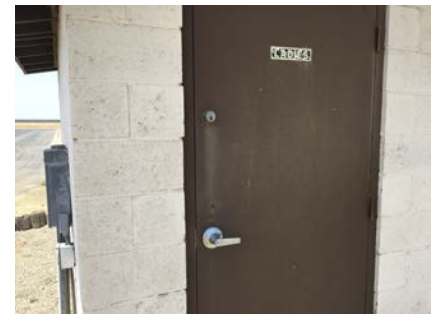
- 743
- *As-Built Description:*
Entrance to toilet or bathing facility not identified with ADAAG compliant signage.
 - *Proposed Solution:*
Provide ADA compliant sign mounted at 48" min. above to baseline of the lowest Braille cells and 60" max. to baseline of the highest line of raised characters on nearest adjacent wall, on latch side of a single door (located not to cause a Braille reader to stand within the door swing).

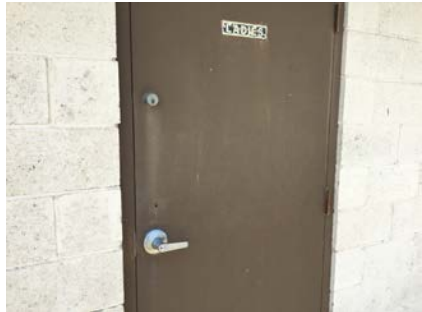
Item no., Rm no. and Name	Existing Architectural Barrier and Proposed Solution	Codes / Mitigation Info	Qty	Unit	Cost	Total
744	<ul style="list-style-type: none"> As-Built Description: Required in CA only: identification symbol centered 58" to 60" high on sanitary facility door that contrasts with the door not provided (women: 12" ø circle, men: 12" triangle, unisex: combined symbol). Proposed Solution: Provide properly mounted sanitary facility symbol when altering area. If wheelchair accessible, include International Symbol of Accessibility on sign. 	<p>PCODE SA15</p> <p>CBC 2007 1115B.6</p> <p>CBC 2019 11B-703.7.2.6</p> <p>Mitigated:</p> <p><input type="radio"/> YES</p> <p><input checked="" type="radio"/> NO</p>	1	JOB	\$270	\$270

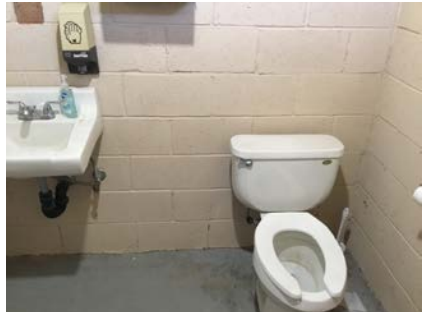
Toilet Stall

752	<ul style="list-style-type: none"> As-Built Description: 60" min. clearance around a water closet measured perpendicular from the side wall not provided (Fixtures are not allowed to overlap this clearance). As-Built: 52.5" to lavatory Proposed Solution: Relocate adjacent fixture and remodel restroom as needed. Notes: 	<p>PCODE WB01A</p> <p>ADA 2010 604.3.1; 604.3.2</p> <p>CBC 2007 1115B.7.1.3</p> <p>CBC 2019 11B-604.3.1; 11B-604.3.2</p> <p>Mitigated:</p> <p><input type="radio"/> YES</p> <p><input checked="" type="radio"/> NO</p>	1	JOB	\$6,000	\$6,000
-----	---	--	---	-----	---------	---------

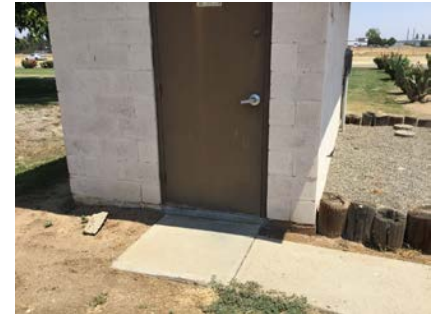
Door

759	<ul style="list-style-type: none"> • <i>As-Built Description:</i> Surface of required maneuvering clearance at door slopes more than 1/4":12" (2.0%). • <i>As-Built:</i> 2.6% 36.0" deep • <i>Proposed Solution:</i> Install landing. 	<p>PCODE ID11 ADAAG 91 4.13.6 ADA 2010 404.2.4.4 CBC 2007 1133B.2.4 CBC 2019 11B-404.2.4</p>	1	UNI	\$900	\$900
-----	--	---	---	-----	-------	-------

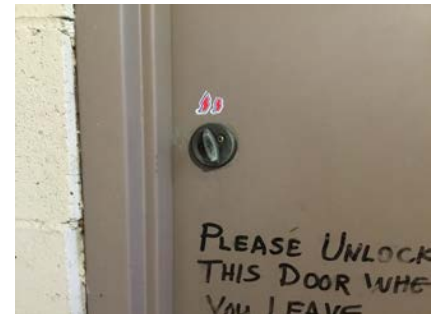
764	<ul style="list-style-type: none"> • <i>As-Built Description:</i> Door lock, latch or handle less than 34" or more than 48" above the floor (CA only: 34" to 44"). • <i>As-Built:</i> 60.5" high • <i>Proposed Solution:</i> Relocate or replace existing hardware. 	<p>PCODE ID17 ADAAG 91 4.13.9 ADA 2010 404.2.7 CBC 2007 1133B.2.5.2 CBC 2019 11B-404.2.7</p>	1	JOB	\$900	\$900
-----	---	---	---	-----	-------	-------

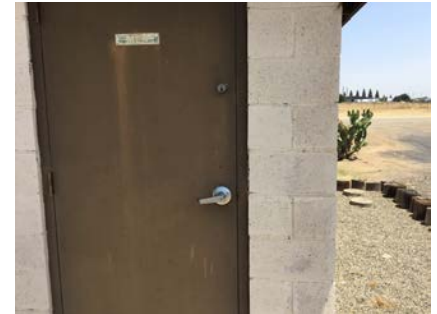
760	<ul style="list-style-type: none"> <i>As-Built Description:</i> Entrance to toilet or bathing facility not identified with ADAAG compliant signage. <i>Proposed Solution:</i> Provide ADA compliant sign mounted at 48" min. above to baseline of the lowest Braille cells and 60" max. to baseline of the highest line of raised characters on nearest adjacent wall, on latch side of a single door (located not to cause a Braille reader to stand within the door swing). 	PCODE SA11A ADAAG 91 4.1.3(16)(a) ADA 2010 216.8 CBC 2019 11B-216.8	1	JOB	\$270	\$270
-----	---	--	---	-----	-------	-------

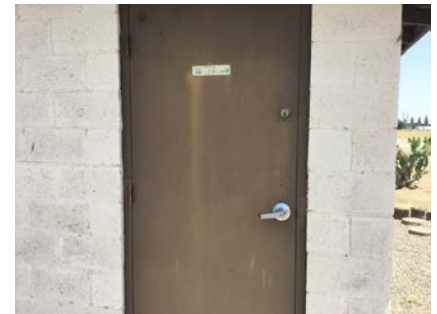
761	<ul style="list-style-type: none"> <i>As-Built Description:</i> Required in CA only: identification symbol centered 58" to 60" high on sanitary facility door that contrasts with the door not provided (women: 12" ø circle, men: 12" triangle, unisex: combined symbol). <i>Proposed Solution:</i> Provide properly mounted sanitary facility symbol when altering area. If wheelchair accessible, include International Symbol of Accessibility on sign. 	PCODE SA15 CBC 2007 1115B.6 CBC 2019 11B-703.7.2.6	1	JOB	\$270	\$270
-----	---	--	---	-----	-------	-------

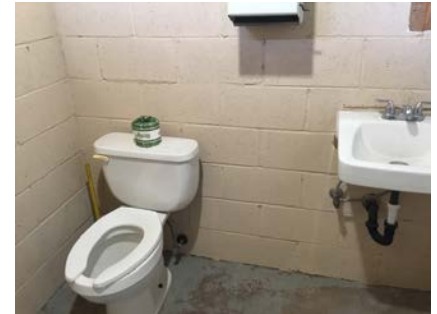
770	<ul style="list-style-type: none"> As-Built Description: 60" min. clearance around a water closet measured perpendicular from the side wall not provided (Fixtures are not allowed to overlap this clearance). As-Built: 53.5" to lavatory Proposed Solution: Relocate adjacent fixture and remodel restroom as needed. Notes: 	PCODE WB01A ADA 2010 604.3.1; 604.3.2 CBC 2007 1115B.7.1.3 CBC 2019 11B-604.3.1; 11B-604.3.2	1	JOB	\$6,000	\$6,000
-----	---	---	---	-----	---------	---------

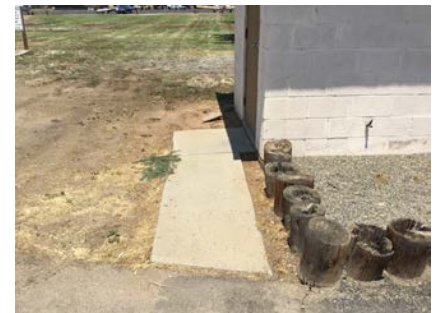
758	<ul style="list-style-type: none"> As-Built Description: Walk more than 36" but less than 48" wide (required in CA only). As-Built: 29.0" wide Proposed Solution: Enlarge width of walk to 48". 	PCODE EF08 CBC 2007 1133B.7.1 CBC 2019 11B-403.5.1.3	40	SF	\$135	\$5,400
-----	---	---	----	----	-------	---------

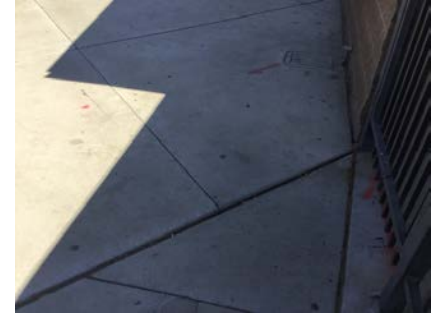
- 314
- *As-Built Description:*
Walk: Pavement dislocation creates abrupt change in level exceeding 1/2" in accessible route.
 - *As-Built:* **1.0"**
 - *Proposed Solution:*
Remove, replace or repair area of pavement sufficient to correct abrupt change in level.

PCODE **EF03**
 ADAAG 91 **4.3.8**
 ADA 2010 **403.4**
 CBC 2007 **1133B.7.4**
 CBC 2019 **11B-403.4**

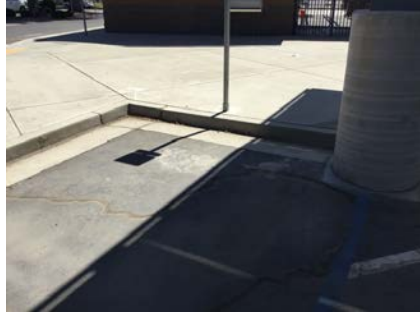
Item no., Rm no. and Name	Existing Architectural Barrier and Proposed Solution	Codes / Mitigation Info	Qty	Unit	Cost	Total
311	<ul style="list-style-type: none"> As-Built Description: Accessible parking space has slope greater than 1/4":12" (2%). As-Built: 7.5% at gutter Proposed Solution: Modify slope at accessible parking space. 	PCODE EA05 ADAAG 91 4.6.3 ADA 2010 502.4 CBC 2007 1129B.3.3 CBC 2019 11B-502.4 Mitigated: <input type="radio"/> YES <input checked="" type="radio"/> NO	20	SF	\$36	\$720

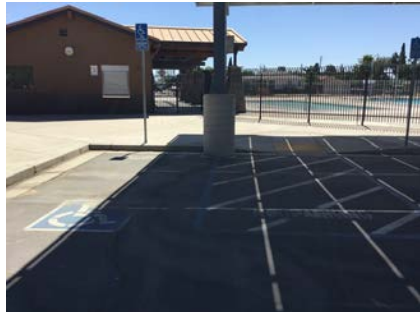
312	<ul style="list-style-type: none"> As-Built Description: Accessible parking space smaller than 8' wide (CA only: 9' x 18'). As-Built: 178.0" Proposed Solution: Modify parking space(s) to create accessible space. Notes: 	PCODE EA02A ADAAG 91 4.6.3 ADA 2010 502.2 CBC 2007 1129B.3.1 CBC 2019 11B-502.2 Mitigated: <input type="radio"/> YES <input checked="" type="radio"/> NO	1	JOB	\$600	\$600

Obstructed by pillar.

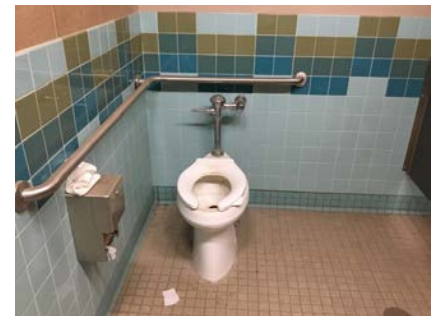
- 283
- *As-Built Description:*
Flush Control: Operating handle not mounted toward wide side of stall.
 - *Proposed Solution:*
Replace flush control with properly mounted accessible type, or install sensor flush.

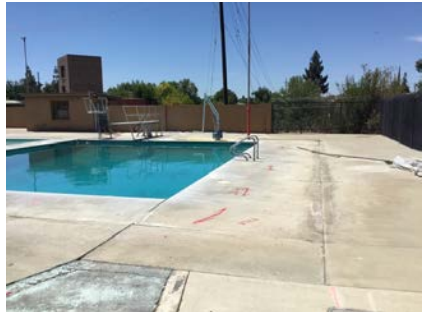
Item no., Rm no. and Name	Existing Architectural Barrier and Proposed Solution	Codes / Mitigation Info	Qty	Unit	Cost	Total
300	<ul style="list-style-type: none"> As-Built Description: Cross slope more than 1":48" (2.083%). As-Built: Up to 4.2% Proposed Solution: Modify cross slope. 	PCODE EF07 ADAAG 91 4.3.7 ADA 2010 403.3 CBC 2007 1133B.7.1.3 CBC 2019 11B-403.3 Mitigated: <input type="radio"/> YES <input checked="" type="radio"/> NO	200	SF	\$75	\$15,000

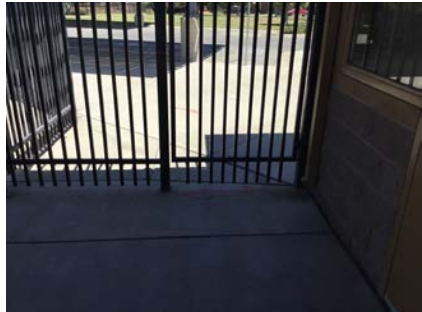
Door

285	<ul style="list-style-type: none"> As-Built Description: At push side of door on accessible route, bottom 10" does not have a smooth, uninterrupted surface. Proposed Solution: Provide 10" min. "kick plate" covering width of door when altering area. 	PCODE ID06 ADA 2010 404.2.10 CBC 2007 1133B.2.6 CBC 2019 11B-404.2.10 Mitigated: <input type="radio"/> YES <input checked="" type="radio"/> NO	3	JOB	\$300	\$900

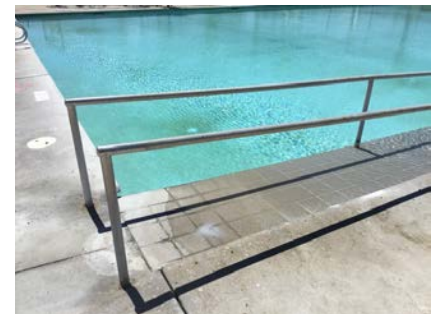
Missing seat unable to veto dimensions.

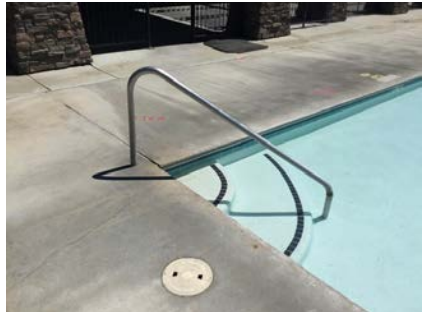
Item no., Rm no. and Name	Existing Architectural Barrier and Proposed Solution	Codes / Mitigation Info	Qty	Unit	Cost	Total
303	<ul style="list-style-type: none"> As-Built Description: Handrail gripping surface top not mounted between 34" and 38" above ramp surface or stair nosings. As-Built: 19.0" high Proposed Solution: Remove existing and provide new handrail. 	PCODE ED02 ADAAG 91 4.9.4(5) ADA 2010 505.4 CBC 2007 1133B.4.2.1 & B.5.5.1 CBC 2019 11B-505.4 Mitigated: <input type="radio"/> YES <input checked="" type="radio"/> NO	4	LF	\$225	\$900

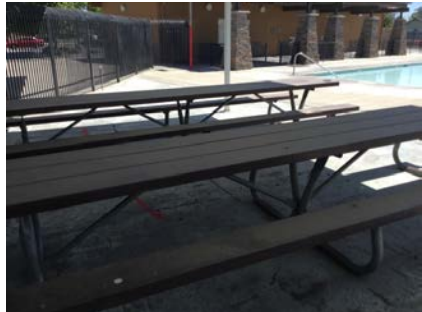
Non-Fixed Desk

298	<ul style="list-style-type: none"> As-Built Description: Accessible non-fixed table or desk (top 28" to 34" high; knee space at least 27" high x 19" deep x 30" wide) not provided. As-Built: 50 seats, 0 accessible provided. Proposed Solution: Provide table or desk with accessible dimensions when purchasing new furniture. 	PCODE IN02A ADAAG 91 4.32.3 & .4 ADA 2010 306.1 CBC 2007 1122B.3 & 4 CBC 2019 11B-306.1 & 11B-902.3 Mitigated: <input type="radio"/> YES <input checked="" type="radio"/> NO	3	JOB	\$1,500	\$4,500

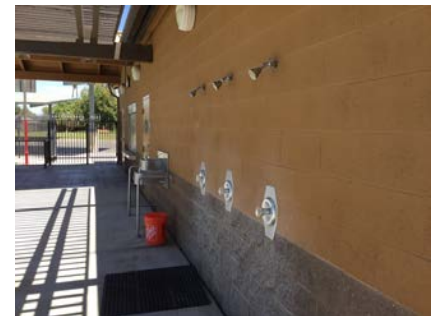
274 • *As-Built Description:*
 Shower not accessible; multiple compliance violations.
 • *Proposed Solution:*
 Provide accessible shower.
 • *Notes:*

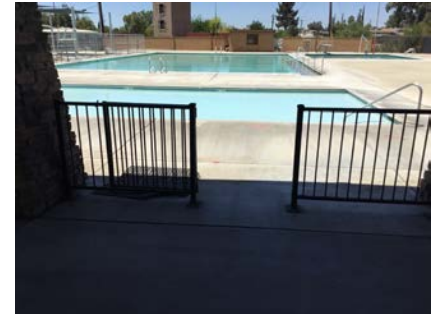
286 • *As-Built Description:*
Exterior signage at inaccessible entrances to provide direction to accessible entrances is missing or noncompliant.

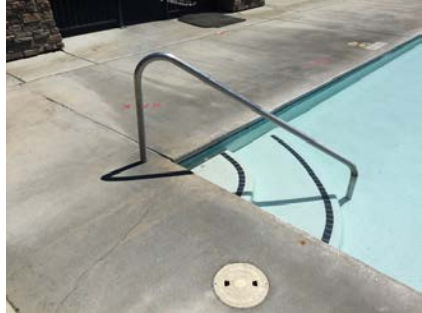
Stairs

305	<ul style="list-style-type: none"> <i>As-Built Description:</i> Stair tread width less than 11", measured horizontally from nosing to nosing. <i>Proposed Solution:</i> Rebuild stair as needed. <i>Notes:</i> 	<p>PCODE EC06 ADAAG 91 4.9.2 ADA 2010 504.2 CBC 2007 1133B.4.5.3 CBC 2019 11B-504.2 & 11B-1009.6</p> <p>Mitigated: <input type="radio"/> YES <input checked="" type="radio"/> NO</p>	10	LF	\$225	\$2,250
-----	---	--	----	----	-------	---------

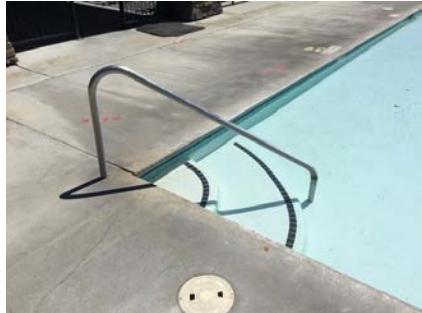
Stairways

304	<ul style="list-style-type: none"> <i>As-Built Description:</i> Landing at the top or bottom of stairway is not level or not provided. <i>As-Built:</i> 3.7% <i>Proposed Solution:</i> Remodel landings to provide a level clear floor space that extends the entire width of the ramp. 	<p>PCODE EC10 CBC 2019 1009.8</p> <p>Mitigated: <input type="radio"/> YES <input checked="" type="radio"/> NO</p>	1	JOB	\$1,500	\$1,500
-----	---	--	---	-----	---------	---------

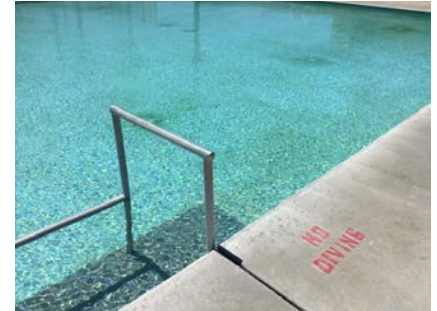
Item no., Rm no. and Name	Existing Architectural Barrier and Proposed Solution	Codes / Mitigation Info	Qty	Unit	Cost	Total
296	<ul style="list-style-type: none"> <i>As-Built Description:</i> Where landings are required, at least one landing shall be located 24" min and 30" max below the stationary water level. <i>Proposed Solution:</i> Provide complaint submerged depth level landing when constructing new sloped entry ramp. <i>Notes:</i> 	PCODE GJ02NT ADAAG 91 pending ADA 2010 1009.3 CBC 2019 11B-1009.3 Mitigated: <input type="radio"/> YES <input checked="" type="radio"/> NO	1	LF	\$294	\$294

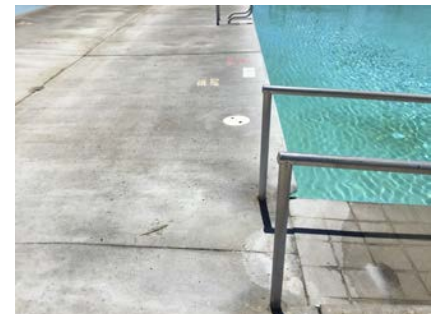
293	<ul style="list-style-type: none"> <i>As-Built Description:</i> Ramp handrail does not extend horizontally 12" past top of ramp. <i>Proposed Solution:</i> Provide ramp handrail extension (cost for each extension piece). 	PCODE ED05 ADAAG 91 4.8.5(2) ADA 2010 505.10.1 CBC 2007 1133B.4.2.2 & 1133B.5.5.1 CBC 2019 11B-505.10.1, 11B-1009.3.3 Mitigated: <input type="radio"/> YES <input checked="" type="radio"/> NO	2	JOB	\$510	\$1,020
-----	---	---	---	-----	-------	---------

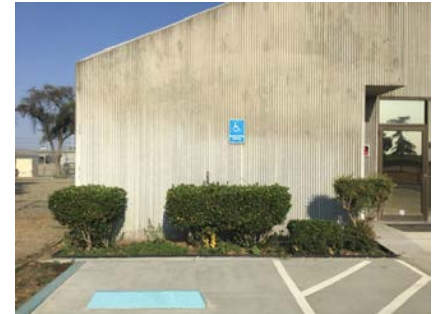
- 783
- *As-Built Description:*
Sign for accessible parking space is missing or non-compliant.
 - *Proposed Solution:*
Provide compliant parking signage.

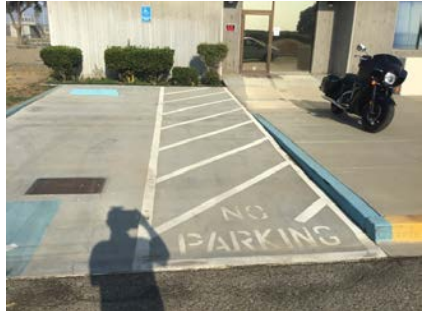
Item no., Rm no. and Name	Existing Architectural Barrier and Proposed Solution	Codes / Mitigation Info	Qty	Unit	Cost	Total
782	<ul style="list-style-type: none"> <i>As-Built Description:</i> An accessible parking space shall be outlined or painted blue (required in CA only). <i>Proposed Solution:</i> Identify accessible parking space using blue markings. 	PCODE EA04K CBC 2019 11B-502.6 Mitigated: <input type="radio"/> YES <input checked="" type="radio"/> NO	1	JOB	\$360	\$360

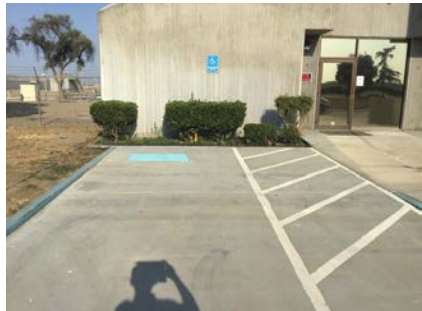
<input type="radio"/> Staff Only			
			Priority <input checked="" type="radio"/> 1			
			Severity <input checked="" type="radio"/> 3			
786	<ul style="list-style-type: none"> <i>As-Built Description:</i> No van parking provided (one in every 6 or fraction of 6 accessible spaces, but not less than one). <i>Proposed Solution:</i> Provide van parking space(s) by restriping; provide van sign. 	PCODE EA07 ADAAG 91 4.1.2(5)(b) ADA 2010 208.2; 502.1 CBC 2007 1129B.3.2 CBC 2019 11B-208.2.4 Mitigated: <input type="radio"/> YES <input checked="" type="radio"/> NO	1	JOB	\$1,050	\$1,050

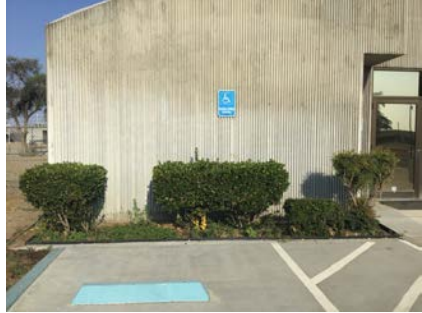
Parking Signage

784	<ul style="list-style-type: none"> <i>As-Built Description:</i> No "Tow Away" sign at parking lot entrance (required in CA only). <i>Proposed Solution:</i> Provide "Tow Away" sign at parking lot entrance when altering area. 	<p>PCODE EA04C</p> <p>CBC 2007 1129B.4</p> <p>CBC 2019 11B-502.8.2</p> <p>Mitigated:</p> <p><input type="radio"/> YES</p> <p><input checked="" type="radio"/> NO</p>	1	JOB	\$975	\$975

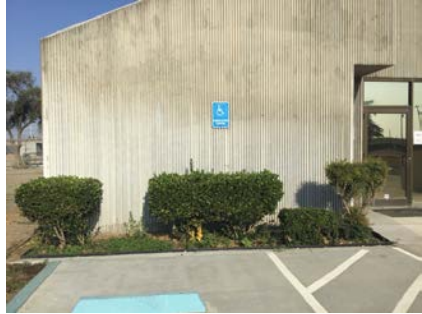
785	<ul style="list-style-type: none"> <i>As-Built Description:</i> CA only: Additional Sign or additional language below the symbol of accessibility stating "Minimum Fine \$250" not provided. <i>Proposed Solution:</i> Provide compliant parking signage that includes fine information. 	<p>PCODE EA04G</p> <p>CBC 2007 1129B.4</p> <p>CBC 2019 11B-502.6.2</p> <p>Mitigated:</p> <p><input type="radio"/> YES</p> <p><input checked="" type="radio"/> NO</p>	1	JOB	\$300	\$300

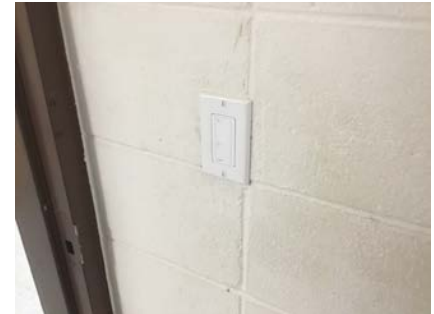
826	<ul style="list-style-type: none"> As-Built Description: Electric switch or control mounted less than 15" measured to the bottom of the outlet box or greater than 48 inches measured to the top of the outlet box. As-Built: 50.5" high Proposed Solution: Relocate light switches or control to between 15" and 48" height. Notes: 	<p>PCODE IC01</p> <p>ADAAG 91 4.2.5 & 6</p> <p>ADA 2010 308.2.1 & 308.2.2</p> <p>CBC 2007 1117B.6.3</p> <p>CBC 2019 11B-308.2.1 & 11B-308.2.2</p> <p>Mitigated:</p> <p><input type="radio"/> YES</p> <p><input checked="" type="radio"/> NO</p>	50	JOB	\$900	\$45,000
-----	---	---	----	-----	-------	----------

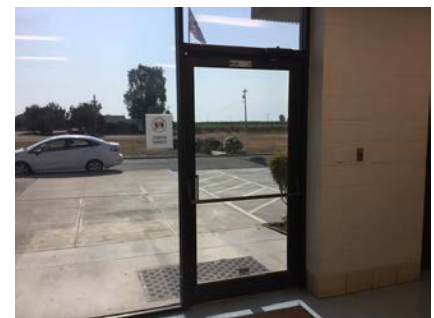
827	<ul style="list-style-type: none"> As-Built Description: At final exit door to exterior: Where required exit signs are installed, signs to provide exiting information for people with vision impairment are not provided. Proposed Solution: Provide raised letter/Braille "EXIT" sign at door. 	<p>PCODE SA10A</p> <p>ADAAG 91 4.1.3(16)</p> <p>ADA 2010 216.4.1</p> <p>CBC 2007 1011.3</p> <p>CBC 2019 11B-216.4.1</p> <p>Mitigated:</p> <p><input type="radio"/> YES</p> <p><input checked="" type="radio"/> NO</p>	20	JOB	\$270	\$5,400
-----	--	---	----	-----	-------	---------

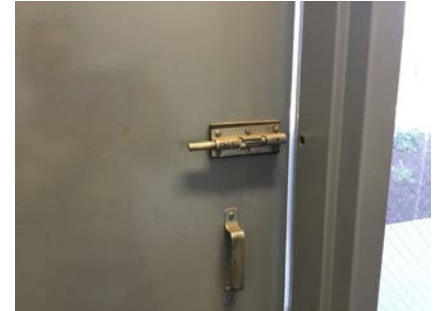
799	<ul style="list-style-type: none"> As-Built Description: Door lock, latch or handle less than 34" or more than 48" above the floor (CA only: 34" to 44"). As-Built: 56.0" high Proposed Solution: Relocate or replace existing hardware. Notes: 	PCODE ID17 ADAAG 91 4.13.9 ADA 2010 404.2.7 CBC 2007 1133B.2.5.2 CBC 2019 11B-404.2.7	1	JOB	\$900	\$900
-----	--	---	---	-----	-------	-------

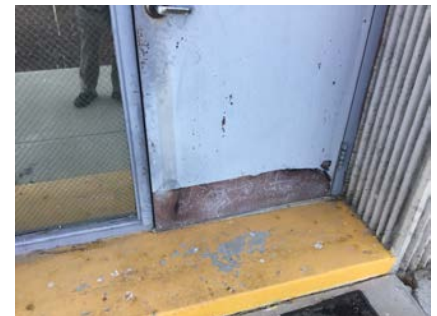
800	<ul style="list-style-type: none"> As-Built Description: Door inaccessible due to threshold or step at door exceeding 1/2". As-Built: 0.6" Proposed Solution: Modify threshold to be no more than 1/2" by removing existing paving at door and providing landing with edge ramping (slope 1:20 max). 	PCODE ID02A ADAAG 91 4.13.8 ADA 2010 404.2.5 CBC 2007 1133B.2.4.1 CBC 2019 11B-404.2.5	1	JOB	\$1,200	\$1,200
-----	--	--	---	-----	---------	---------

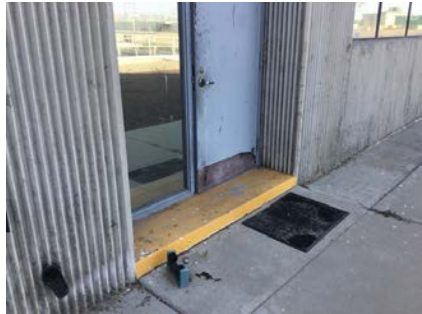
Item no., Rm no. and Name	Existing Architectural Barrier and Proposed Solution	Codes / Mitigation Info	Qty	Unit	Cost	Total
801	<ul style="list-style-type: none"> <i>As-Built Description:</i> Door inaccessible due to threshold or step at door exceeding 1/2". <i>As-Built:</i> 4.5" <i>Proposed Solution:</i> Modify threshold to be no more than 1/2" by removing existing paving at door and providing landing with edge ramping (slope 1:20 max). 	PCODE ID02A ADAAG 91 4.13.8 ADA 2010 404.2.5 CBC 2007 1133B.2.4.1 CBC 2019 11B-404.2.5 Mitigated: <input type="radio"/> YES <input checked="" type="radio"/> NO	1	JOB	\$1,200	\$1,200

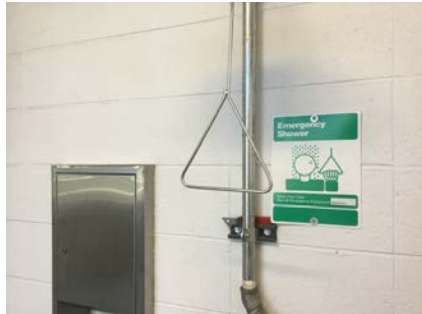
795	<ul style="list-style-type: none"> <i>As-Built Description:</i> Reach height to control or access point, where side approach is available, exceeds 48" or is less than 15" in height, or exceeds 10" in depth. <i>As-Built:</i> 62.0" high <i>Proposed Solution:</i> Add additional shore pull. 	PCODE IE02 ADAAG 91 4.2.6 ADA 2010 308.3.1 CBC 2007 1118B.6 CBC 2019 11B-308.3 Mitigated: <input type="radio"/> YES <input checked="" type="radio"/> NO	1	JOB	\$300	\$300

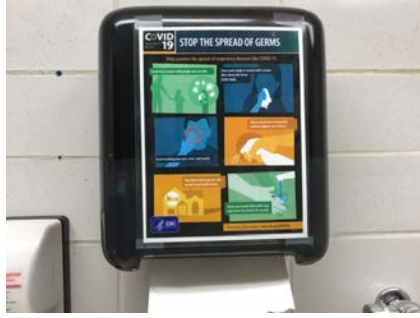
<p>804</p> <ul style="list-style-type: none"> As-Built Description: Dispensers in sanitary facilities, such as for towels, soap, sanitary napkins, seat covers, etc., and waste receptacles more than 48" (CA only: 40") from floor to highest operating slot or control. As-Built: PTD: 60.0" high Proposed Solution: Relocate existing restroom accessories. 	<p>PCODE WG01A ADAAG 91 4.23.7 ADA 2010 308.2.1 CBC 2007 1115B.8.3 CBC 2019 11B-603.5</p>	<p>1 JOB \$300 \$300</p>
--	--	---------------------------------

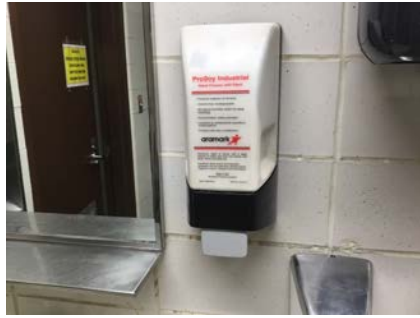
<p>805</p> <ul style="list-style-type: none"> As-Built Description: Dispensers in sanitary facilities, such as for towels, soap, sanitary napkins, seat covers, etc., and waste receptacles more than 48" (CA only: 40") from floor to highest operating slot or control. As-Built: SD: 50.0" high Proposed Solution: Relocate existing restroom accessories. 	<p>PCODE WG01A ADAAG 91 4.23.7 ADA 2010 308.2.1 CBC 2007 1115B.8.3 CBC 2019 11B-603.5</p>	<p>1 JOB \$300 \$300</p>
---	--	---------------------------------

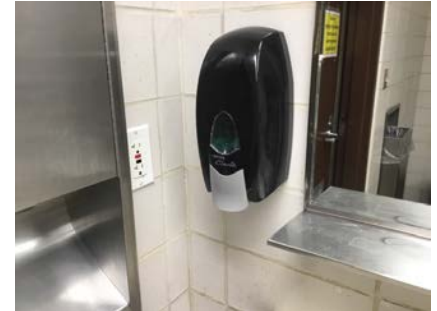
806	<ul style="list-style-type: none"> As-Built Description: Dispensers in sanitary facilities, such as for towels, soap, sanitary napkins, seat covers, etc., and waste receptacles more than 48" (CA only: 40") from floor to highest operating slot or control. As-Built: SD: 48.0" high Proposed Solution: Relocate existing restroom accessories. Notes: 	PCODE WG01A ADAAG 91 4.23.7 ADA 2010 308.2.1 CBC 2007 1115B.8.3 CBC 2019 11B-603.5 Mitigated: <input type="radio"/> YES <input checked="" type="radio"/> NO	1	JOB	\$300	\$300
-----	--	--	---	-----	-------	-------

If 48" maximum AFF, this element complies with 1991 ADAAG and the 2010 ADAS. If 54" maximum AFF side reach, this element complies with Safe Harbor if constructed or altered before March 15, 2012. This element does not comply with the dimensional requirements in the 1981 to the current CBC.

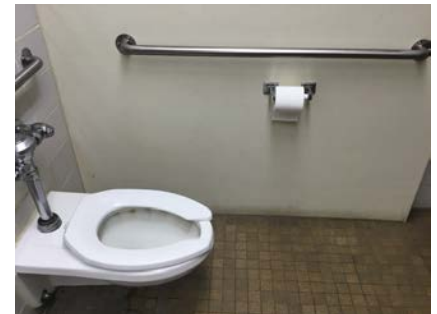
812	<ul style="list-style-type: none"> As-Built Description: Toilet paper dispenser less than 15" (CA: 19") or more than 48" above floor or not within 7" to 9" from front of water closet (Note: CA pre-2010 is allowed within 12" from front of water closet). As-Built: 11.0" in front. Proposed Solution: Relocate or provide new toilet paper dispenser. 	PCODE WG02 ADAAG 91 4.16.6 ADA 2010 604.7 CBC 2007 1115B.8.4 CBC 2019 11B-604.7 Mitigated: <input type="radio"/> YES <input checked="" type="radio"/> NO	1	JOB	\$225	\$225
-----	---	---	---	-----	-------	-------

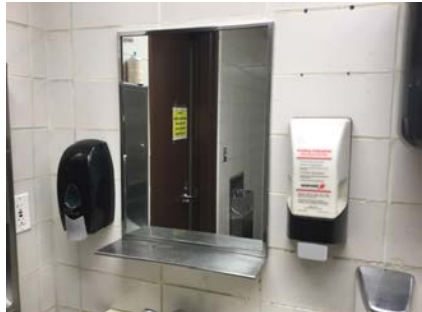
Item no., Rm no. and Name	Existing Architectural Barrier and Proposed Solution	Codes / Mitigation Info	Qty	Unit	Cost	Total
810	<ul style="list-style-type: none"> <i>As-Built Description:</i> Bottom of mirror located above lavatories or countertops more than 40" above floor. <i>As-Built:</i> 47.5" high <i>Proposed Solution:</i> Relocate or provide new accessible mirror. 	PCODE WG03 ADAAG 91 4.19.6 ADA 2010 603.3 CBC 2007 1115B.8.1 CBC 2019 11B-603.3 Mitigated: <input type="radio"/> YES <input checked="" type="radio"/> NO	1	JOB	\$450	\$450

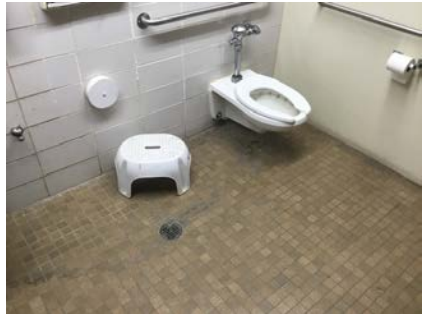
798	<ul style="list-style-type: none"> <i>As-Built Description:</i> Clear space has slopes greater than 1:48. <i>Proposed Solution:</i> Modify surface and/or adjust drain. <i>Notes:</i> 	PCODE NI07 ADAAG 91 16.6.6 ADA 2010 305.2 CBC 2007 1132B.1 CBC 2019 11B-305.2 Mitigated: <input type="radio"/> YES <input checked="" type="radio"/> NO	1	SF	\$1,500	\$1,500

3.9% slope within WC clear space.

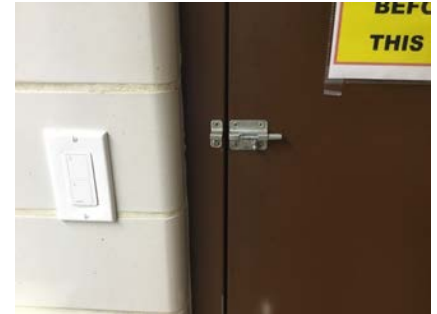
- 813
- *As-Built Description:*
Door lock, latch or handle less than 34" or more than 48" above the floor (CA only: 34" to 44").
 - *As-Built:* **52.0" high**
 - *Proposed Solution:*
Relocate or replace existing hardware.

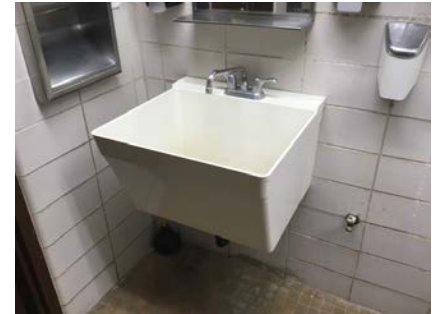
808	<ul style="list-style-type: none"> As-Built Description: Lavatory: Fixture rim or counter height more than 34" above floor. As-Built: 36.5" high Proposed Solution: Provide new accessible lavatory. Remodel restroom as needed. 	PCODE WD02 ADAAG 91 4.19.2 ADA 2010 606.3 CBC 2007 1115B.4.3 CBC 2019 11B-606.3	1	JOB	\$3,600	\$3,600
-----	--	--	---	-----	---------	----------------

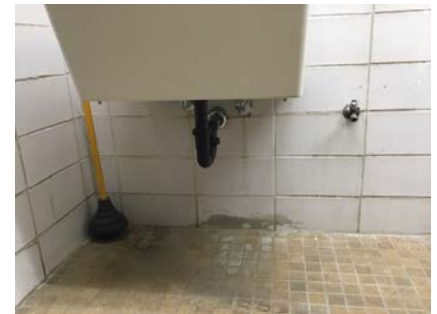
809	<ul style="list-style-type: none"> As-Built Description: Hot or sharp-surfaced water/drain pipe not insulated or covered. Proposed Solution: Insulate or cover water/drain pipe. 	PCODE WD05 ADAAG 91 4.19.4 ADA 2010 606.5 CBC 2007 1115B.4.3.4 CBC 2019 11B-606.5	1	JOB	\$360	\$360
-----	--	--	---	-----	-------	--------------

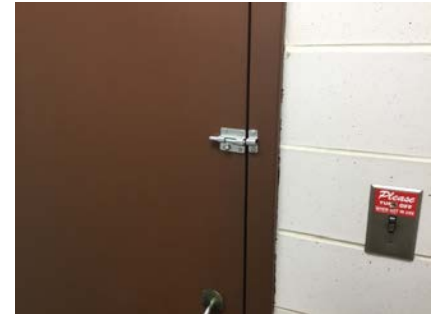
- 832
- *As-Built Description:*
Door lock, latch or handle less than 34" or more than 48" above the floor (CA only: 34" to 44").
 - *As-Built:* **54.0" high**
 - *Proposed Solution:*
Relocate or replace existing hardware.

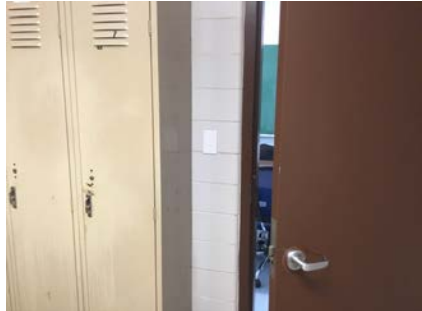
Item no., Rm no. and Name	Existing Architectural Barrier and Proposed Solution	Codes / Mitigation Info	Qty	Unit	Cost	Total
817	<ul style="list-style-type: none"> As-Built Description: Front approach: At pull side, door does not have clear and level maneuvering space measuring door width plus 18" x 60". (24" x 60" at exterior doors). As-Built: 11.5" Proposed Solution: Remove or relocate locker. 	PCODE ID23A ADAAG 91 Fig. 25(a) ADA 2010 404.2.4 CBC 2007 11B-26A(a) CBC 2019 11B-404.2.4 Mitigated: <input type="radio"/> YES <input checked="" type="radio"/> NO	1	JOB	\$1,500	\$1,500

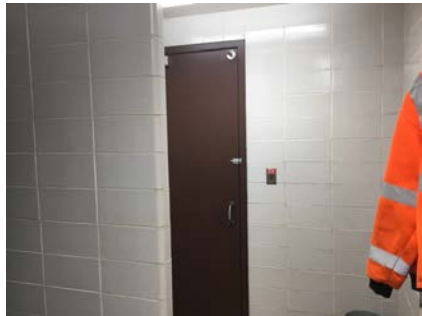
<input checked="" type="checkbox"/> Staff Only			
			Priority 3			
			Severity 3			
831	<ul style="list-style-type: none"> As-Built Description: Latch approach: At pull side, door does not have clear and level maneuvering space measuring door width plus 24" x 48" or 54" if door has closer (CA only: door width plus 24" x 60"). As-Built: 47.0" with closer. Proposed Solution: Remove/relocate wall. 	PCODE ID27 ADAAG 91 Fig. 25(c) ADA 2010 404.2.4 CBC 2007 11B-26A(c) CBC 2019 11B-404.2.4 Mitigated: <input type="radio"/> YES <input checked="" type="radio"/> NO	1	JOB	\$1,500	\$1,500

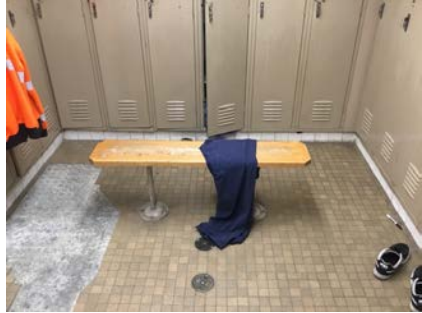
<p>814</p> <ul style="list-style-type: none"> <i>As-Built Description:</i> No section of bench provided adjacent to designated accessible locker, measuring minimum 20-24" deep, 48" wide, and 17-19" high, and fixed to a wall along the longer dimension. <i>Proposed Solution:</i> Provide a new bench, fixed to a wall along the longer dimension, close to the accessible locker. 	<p>PCODE GG03 ADAAG 91 4.35.4 ADA 2010 803.4 CBC 2007 1117B.8 CBC 2019 11B-803.4</p> <p>Mitigated: <input type="radio"/> YES <input checked="" type="radio"/> NO</p>	<p>1 JOB \$2,250 \$2,250</p>

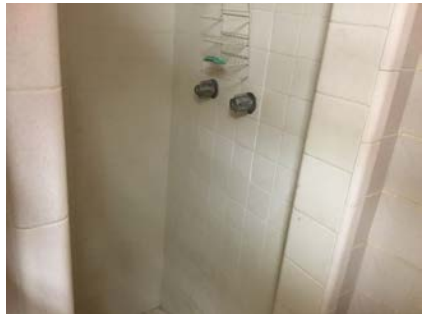
<p>815</p> <ul style="list-style-type: none"> <i>As-Built Description:</i> Shower not accessible; multiple compliance violations. <i>As-Built:</i> 34.0" long x 33.0" wide <i>Proposed Solution:</i> Provide accessible shower. 	<p>PCODE WF01 ADAAG 91 4.21 ADA 2010 608.1 CBC 2019 11B-608.1</p> <p>Mitigated: <input type="radio"/> YES <input checked="" type="radio"/> NO</p>	<p>1 JOB \$12,000 \$12,000</p>
