APPENDIX B: ACCESS COMPLIANCE SURVEY REPORT OF FACILITIES

The City of Madera

Access Compliance Survey Report

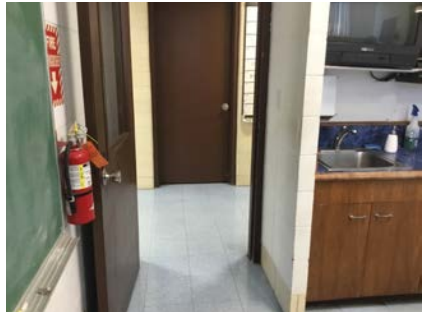
Item no., Rm no. and Name	Existing Architectural Barrier and Proposed Solution	Codes / Mitigation Info	Qty	Unit	Cost	Total
823	<ul style="list-style-type: none"> • <i>As-Built Description:</i> Front approach: At pull side, door does not have clear and level maneuvering space measuring door width plus 18" x 60". (24" x 60" at exterior doors). • <i>As-Built:</i> 2.0" • <i>Proposed Solution:</i> Provide relocated new door and frame; remodel walls as needed. 	<p>PCODE ID23B ADAAG 91 Fig. 25(a) ADA 2010 404.2.4 CBC 2007 11B-26A(a) CBC 2019 11B-404.2.4</p> <p>Mitigated: <input type="radio"/> YES <input checked="" type="radio"/> NO</p>	1	JOB	\$7,800	\$7,800

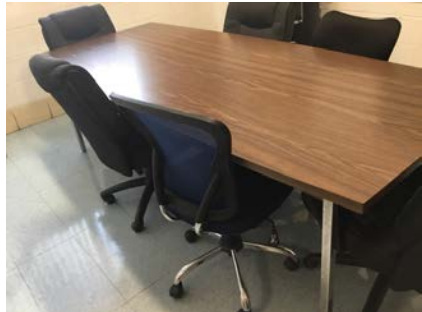
820	<ul style="list-style-type: none"> • <i>As-Built Description:</i> Accessible non-fixed table or desk (top 28" to 34" high; knee space at least 27" high x 19" deep x 30" wide) not provided. • <i>As-Built:</i> 26.0" knee high • <i>Proposed Solution:</i> Provide table or desk with accessible dimensions when purchasing new furniture. 	<p>PCODE IN02A ADAAG 91 4.32.3 & .4 ADA 2010 306.1 CBC 2007 1122B.3 & 4 CBC 2019 11B-306.1 & 11B-902.3</p> <p>Mitigated: <input type="radio"/> YES <input checked="" type="radio"/> NO</p>	1	JOB	\$4,800	\$4,800

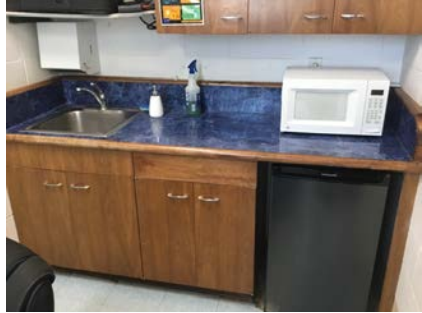
<p>819</p> <ul style="list-style-type: none"> As-Built Description: Reach height to control or access point, where side approach is available, exceeds 48" or is less than 15" in height, or exceeds 10" in depth. As-Built: 36.0" high obstruction Proposed Solution: Modify equipment or mounting. 	<p>PCODE IE02 ADAAG 91 4.2.6 ADA 2010 308.3.1 CBC 2007 1118B.6 CBC 2019 11B-308.3</p> <p>Mitigated: <input type="radio"/> YES <input checked="" type="radio"/> NO</p>	<table border="0"> <tr> <td>1</td> <td>JOB</td> <td>\$300</td> <td>\$300</td> </tr> </table>

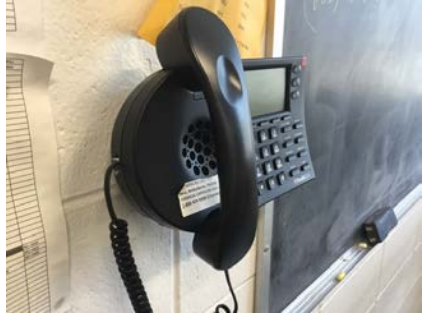
<p>828</p> <ul style="list-style-type: none"> As-Built Description: Reach height to control or access point, where side approach is available, exceeds 48" or is less than 15" in height, or exceeds 10" in depth. As-Built: 60.0" high Proposed Solution: Modify equipment or mounting. 	<p>PCODE IE02 ADAAG 91 4.2.6 ADA 2010 308.3.1 CBC 2007 1118B.6 CBC 2019 11B-308.3</p> <p>Mitigated: <input type="radio"/> YES <input checked="" type="radio"/> NO</p>	<table border="0"> <tr> <td>1</td> <td>JOB</td> <td>\$300</td> <td>\$300</td> </tr> </table>

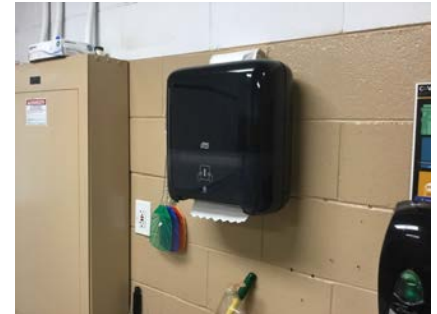
839	<ul style="list-style-type: none"> As-Built Description: Reach height to control or access point, where side approach is available, exceeds 48" or is less than 15" in height, or exceeds 10" in depth. As-Built: PTD: 57.0" high Proposed Solution: Modify equipment or mounting. 	PCODE IE02 ADAAG 91 4.2.6 ADA 2010 308.3.1 CBC 2007 1118B.6 CBC 2019 11B-308.3 Mitigated: <input type="radio"/> YES <input checked="" type="radio"/> NO	1	JOB	\$300	\$300
-----	--	---	---	-----	-------	-------

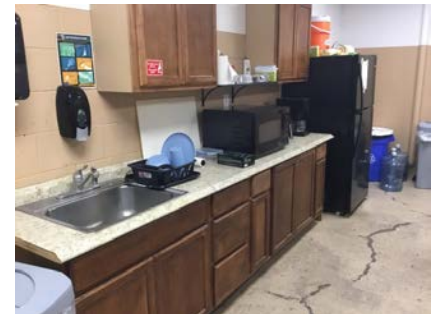
840	<ul style="list-style-type: none"> As-Built Description: Reach height to control or access point, where side approach is available, exceeds 48" or is less than 15" in height, or exceeds 10" in depth. As-Built: 35.5" high obstruction Proposed Solution: Modify equipment or mounting. 	PCODE IE02 ADAAG 91 4.2.6 ADA 2010 308.3.1 CBC 2007 1118B.6 CBC 2019 11B-308.3 Mitigated: <input type="radio"/> YES <input checked="" type="radio"/> NO	1	JOB	\$300	\$300
-----	---	---	---	-----	-------	-------

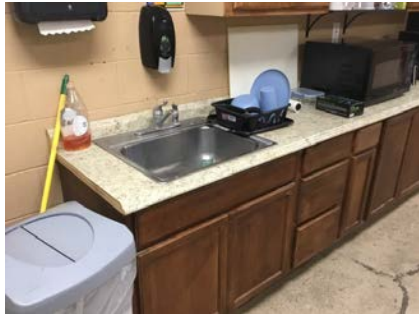
Item no., Rm no. and Name	Existing Architectural Barrier and Proposed Solution	Codes / Mitigation Info	Qty	Unit	Cost	Total
838	<p>Sink</p> <ul style="list-style-type: none"> As-Built Description: Sink rim higher than 34" above floor. As-Built: 35.5" high Proposed Solution: Remodel sink cabinet to lower sink. 	<p>PCODE IN06</p> <p>ADAAG 91 4.24.2</p> <p>ADA 2010 606.3</p> <p>CBC 2007 1115B.4.7.1</p> <p>CBC 2019 11B-606.3</p> <p>Mitigated:</p> <p><input type="radio"/> YES</p> <p><input checked="" type="radio"/> NO</p>	1	JOB	\$5,250	\$5,250

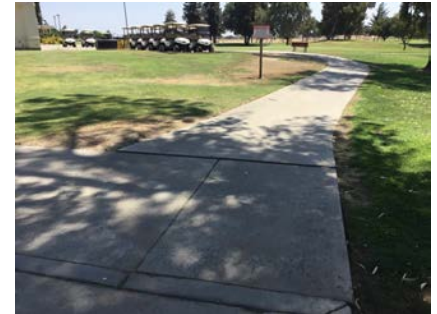
- 1164
- *As-Built Description:*
Walk: Pavement dislocation creates abrupt change in level exceeding 1/2" in accessible route.
 - *As-Built:* **1.0"**
 - *Proposed Solution:*
Remove, replace or repair area of pavement sufficient to correct abrupt change in level.

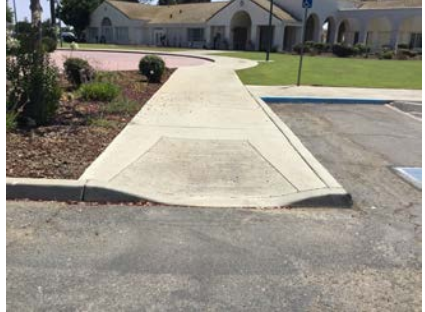
Item no., Rm no. and Name	Existing Architectural Barrier and Proposed Solution	Codes / Mitigation Info	Qty	Unit	Cost	Total
1167	<ul style="list-style-type: none"> As-Built Description: Less than 48" level space at top and 1:12 flared sides not provided. As-Built: 36.0" Proposed Solution: Demolish existing and provide new curb ramp. Notes: 	PCODE EH05B ADAAG 91 4.7.5; Fig.12(a) ADA 2010 406.4 CBC 2007 1127B.5.4 CBC 2019 11B-406.5.3 Mitigated: <input type="radio"/> YES <input checked="" type="radio"/> NO	1	JOB	\$7,500	\$7,500

No domes. 0.75" level change. 25.0% flares.

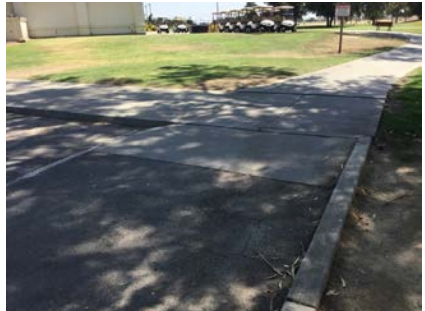
1163	<ul style="list-style-type: none"> As-Built Description: 36" wide band of truncated domes not provided at walkway or crossing adjoining a vehicular way, if surfaces are not separated by a curb, railing, or other element. Proposed Solution: Provide 36" wide, contrasting color, band of truncated domes between pedestrian and vehicular area. 	PCODE EG09 ADAAG 91 4.29.5 CBC 2007 1133B.8.5 CBC 2019 11B-705.1.2.5 Mitigated: <input type="radio"/> YES <input checked="" type="radio"/> NO	10	LF	\$81	\$810

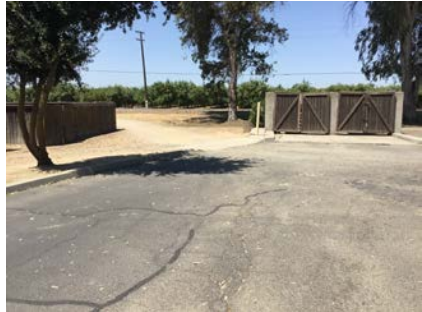
Item no., Rm no. and Name	Existing Architectural Barrier and Proposed Solution	Codes / Mitigation Info	Qty	Unit	Cost	Total
1165	<ul style="list-style-type: none"> As-Built Description: 36" wide band of truncated domes not provided at walkway or crossing adjoining a vehicular way, if surfaces are not separated by a curb, railing, or other element. Proposed Solution: Provide 36" wide, contrasting color, band of truncated domes between pedestrian and vehicular area. Notes: 	PCODE EG09 ADAAG 91 4.29.5 CBC 2007 1133B.8.5 CBC 2019 11B-705.1.2.5 Mitigated: <input type="radio"/> YES <input checked="" type="radio"/> NO	10	LF	\$81	\$810

<input type="radio"/> Staff Only						
Priority <input checked="" type="radio"/> 1						
Severity <input checked="" type="radio"/> 3						
<p>This appears to be a curb cut but not a curb ramp and also appears to be a golf cart passage. Verify intent.</p>

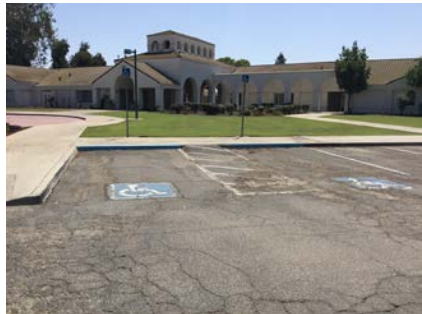
1159	<ul style="list-style-type: none"> As-Built Description: Accessible parking space has slope greater than 1/4":12" (2%). Proposed Solution: Modify slope at accessible parking space. Notes: 	PCODE EA05 ADAAG 91 4.6.3 ADA 2010 502.4 CBC 2007 1129B.3.3 CBC 2019 11B-502.4 Mitigated: <input type="radio"/> YES <input checked="" type="radio"/> NO	144	SF	\$36	\$5,184

<input type="radio"/> Staff Only						
Priority <input checked="" type="radio"/> 1						
Severity <input checked="" type="radio"/> 3						
<p>Multiple compliance issues at accessible parking. Noncompliant slopes, striping, stall and or aisle size and signage.</p>

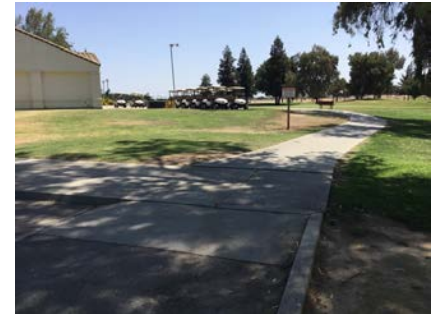
- 1162 • *As-Built Description:*
Exterior signage at inaccessible entrances to provide direction to accessible entrances is missing or noncompliant.
- *As-Built:* **Cross slopes at 6.0%**
- *Proposed Solution:*
Provide signage sufficient to guide persons to accessible entrances.
- *Notes:*

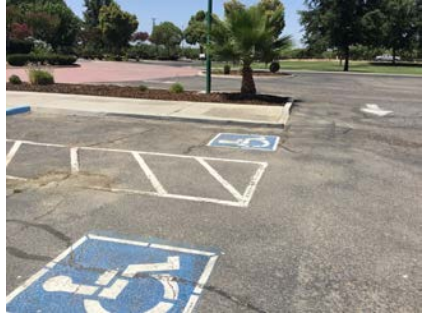
Item no., Rm no. and Name	Existing Architectural Barrier and Proposed Solution	Codes / Mitigation Info	Qty	Unit	Cost	Total
Parking						
1169	<ul style="list-style-type: none"> <i>As-Built Description:</i> Disabled persons must wheel or walk behind parked car(s) other than their own. <i>Proposed Solution:</i> Relocate parking and provide curb ramp to accessible route. 	PCODE EA03 ADAAG 91 Fig.9 ADA 2010 502.3 CBC 2007 1129B.3.1 CBC 2019 11B-502.7.1 Mitigated: <input type="radio"/> YES <input checked="" type="radio"/> NO	1	JOB	\$2,190	\$2,190

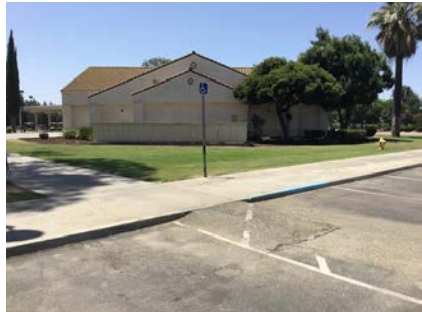
Item no., Rm no. and Name	Existing Architectural Barrier and Proposed Solution	Codes / Mitigation Info	Qty	Unit	Cost	Total
1173	<ul style="list-style-type: none"> <i>As-Built Description:</i> CA only: Additional Sign or additional language below the symbol of accessibility stating "Minimum Fine \$250" not provided. <i>Proposed Solution:</i> Provide compliant parking signage that includes fine information. 	PCODE EA04G CBC 2007 1129B.4 CBC 2019 11B-502.6.2 Mitigated: <input type="radio"/> YES <input checked="" type="radio"/> NO	1	JOB	\$300	\$300

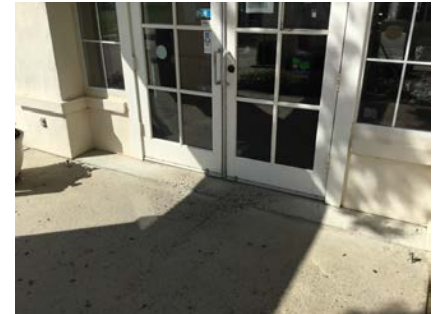
- 1074
- *As-Built Description:*
Walk: Pavement dislocation creates abrupt change in level exceeding 1/2" in accessible route.
 - *As-Built:* **1.5"**
 - *Proposed Solution:*
Remove, replace or repair area of pavement sufficient to correct abrupt change in level.

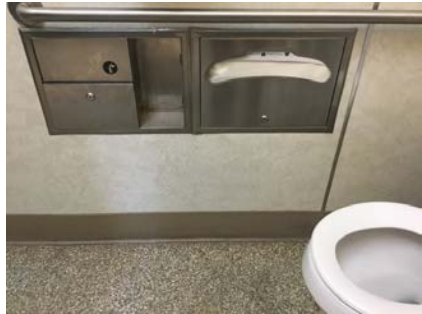
Item no., Rm no. and Name	Existing Architectural Barrier and Proposed Solution	Codes / Mitigation Info	Qty	Unit	Cost	Total
1093	<ul style="list-style-type: none"> As-Built Description: Toilet paper dispenser less than 15" (CA: 19") or more than 48" above floor or not within 7" to 9" from front of water closet (Note: CA pre-2010 is allowed within 12" from front of water closet). As-Built: 14.0" in front. Proposed Solution: Relocate or provide new toilet paper dispenser. 	PCODE WG02 ADAAG 91 4.16.6 ADA 2010 604.7 CBC 2007 1115B.8.4 CBC 2019 11B-604.7 Mitigated: <input type="radio"/> YES <input checked="" type="radio"/> NO	1	JOB	\$225	\$225

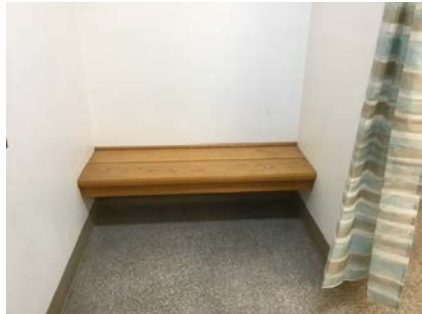
Bench

1080	<ul style="list-style-type: none"> As-Built Description: Clear floor space to allow parallel transfer onto bench not provided. Proposed Solution: Remodel dressing room to provide 30" x 48" alongside bench. 	PCODE RE04B ADAAG 91 4.35.4 ADA 2010 803.4 CBC 2007 1117B.8 CBC 2019 11B-803.4 Mitigated: <input type="radio"/> YES <input checked="" type="radio"/> NO	1	JOB	\$4,500	\$4,500

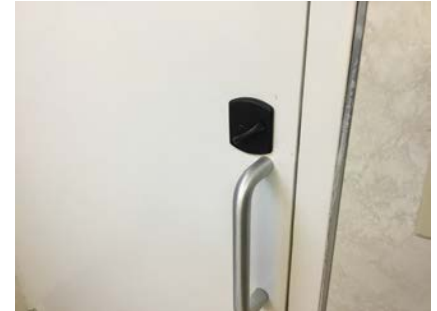
1094	<ul style="list-style-type: none"> As-Built Description: Door lock, latch or handle less than 34" or more than 48" above the floor (CA only: 34" to 44"). As-Built: 48.0" high Proposed Solution: Relocate or replace existing hardware. Notes: 	PCODE ID17 ADAAG 91 4.13.9 ADA 2010 404.2.7 CBC 2007 1133B.2.5.2 CBC 2019 11B-404.2.7	1	JOB	\$900	\$900
------	--	---	---	-----	-------	-------

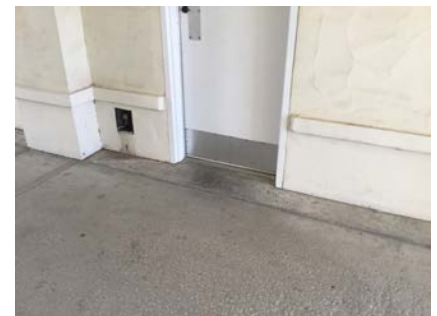
Door Threshold

1079	<ul style="list-style-type: none"> As-Built Description: Door inaccessible due to threshold or step at door exceeding 1/2". As-Built: 0.6" Proposed Solution: Modify threshold. 	PCODE ID02A ADAAG 91 4.13.8 ADA 2010 404.2.5 CBC 2007 1133B.2.4.1 CBC 2019 11B-404.2.5	1	JOB	\$1,200	\$1,200
------	---	--	---	-----	---------	---------

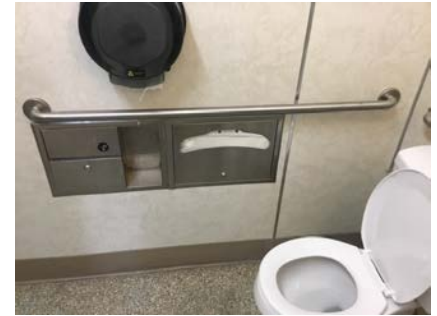
Grab Bars

1090	<ul style="list-style-type: none"> As-Built Description: Side grab bar less than 42" long, or located more than 12 inches max. from the rear wall, or extending less than 54" from rear wall (CA only: front end min. 24" in front of water closet). As-Built: Extends 52.5" Proposed Solution: Provide or relocate accessible side grab bar. 	PCODE WB07A ADAAG 91 Fig. 29(b) ADA 2010 604.5.1 CBC 2007 1115B.4.1.3.1 CBC 2019 11B-604.5.1 Mitigated: <input type="radio"/> YES <input checked="" type="radio"/> NO	1	JOB	\$780	\$780
------	---	---	---	-----	-------	-------

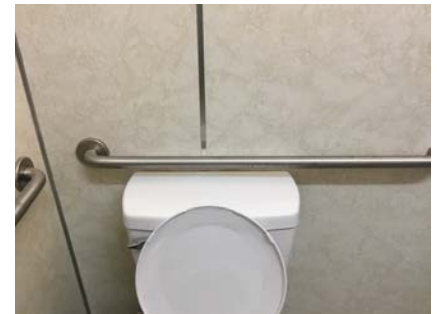
1091	<ul style="list-style-type: none"> As-Built Description: Accessories/dispensers in accessible stall located closer than 1-1/2" below or 12" above grab bar impedes its use. As-Built: 1.3" Proposed Solution: Raise the grab bar. 	PCODE WB07I ADAAG 91 4.26.2 ADA 2010 609.3 CBC 2007 1133B.4.2.5 CBC 2019 11B-609.3 Mitigated: <input type="radio"/> YES <input checked="" type="radio"/> NO	1	JOB	\$225	\$225
------	---	---	---	-----	-------	-------

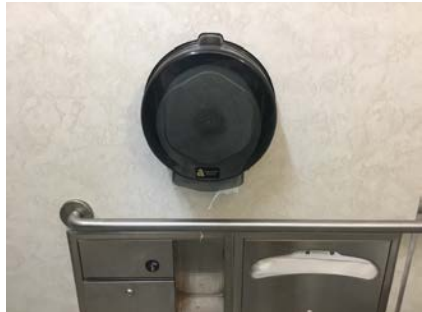
Item no., Rm no. and Name	Existing Architectural Barrier and Proposed Solution	Codes / Mitigation Info	Qty	Unit	Cost	Total
1092	<ul style="list-style-type: none"> <i>As-Built Description:</i> Accessories/dispensers in accessible stall located closer than 1-1/2" below or 12" above grab bar impedes its use. <i>As-Built:</i> TPD: 5.0" above grab bar <i>Proposed Solution:</i> Relocate accessories/dispensers within applicable reach range and to be no closer than 1-1/2" below and 12" above grab bars (except if accessories are recessed, flush with wall, and have no sharp edges). 	PCODE WB07I ADAAG 91 4.26.2 ADA 2010 609.3 CBC 2007 1133B.4.2.5 CBC 2019 11B-609.3 Mitigated: <input type="radio"/> YES <input checked="" type="radio"/> NO	1	JOB	\$225	\$225

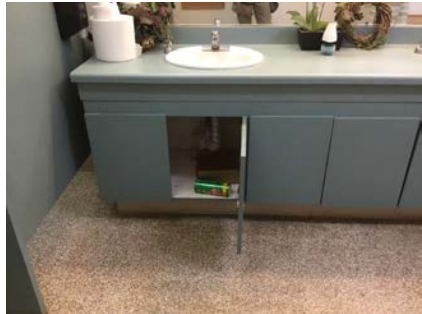
Lavatory

1083	<ul style="list-style-type: none"> <i>As-Built Description:</i> Lavatory: Fixture rim or counter height more than 34" above floor. <i>As-Built:</i> 35" high <i>Proposed Solution:</i> Provide new accessible lavatory. Remodel restroom as needed. <i>Notes:</i> 	PCODE WD02 ADAAG 91 4.19.2 ADA 2010 606.3 CBC 2007 1115B.4.3 CBC 2019 11B-606.3 Mitigated: <input type="radio"/> YES <input checked="" type="radio"/> NO	1	JOB	\$10,200	\$10,200

No knee clearance.

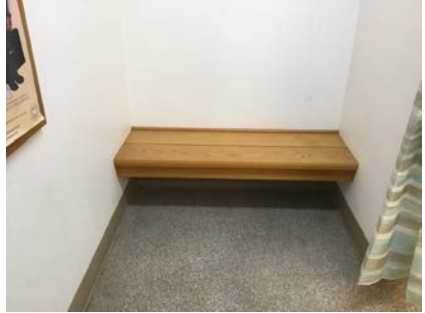
Locker Facilities

<p>1081</p> <ul style="list-style-type: none"> <i>As-Built Description:</i> No section of bench provided adjacent to designated accessible locker, measuring minimum 20-24" deep, 48" wide, and 17-19" high, and fixed to a wall along the longer dimension. <i>As-Built:</i> 18.0" deep <i>Proposed Solution:</i> Provide a new bench, fixed to a wall along the longer dimension, close to the accessible locker. 	<p>PCODE GG03 ADAAG 91 4.35.4 ADA 2010 803.4 CBC 2007 1117B.8 CBC 2019 11B-803.4</p> <p>Mitigated: <input type="radio"/> YES <input checked="" type="radio"/> NO</p>	<p>1 JOB \$2,250 \$2,250</p>

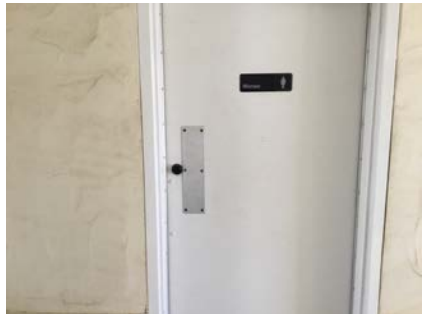
Signage

<p>1095</p> <ul style="list-style-type: none"> <i>As-Built Description:</i> Entrance to toilet or bathing facility not identified with ADAAG compliant signage. <i>Proposed Solution:</i> Provide ADA compliant sign mounted at 48" min. above to baseline of the lowest Braille cells and 60" max. to baseline of the highest line of raised characters on nearest adjacent wall, on latch side of a single door (located not to cause a Braille reader to stand within the door swing). 	<p>PCODE SA11A ADAAG 91 4.1.3(16)(a) ADA 2010 216.8 CBC 2019 11B-216.8</p> <p>Mitigated: <input type="radio"/> YES <input checked="" type="radio"/> NO</p>	<p>1 JOB \$270 \$270</p>

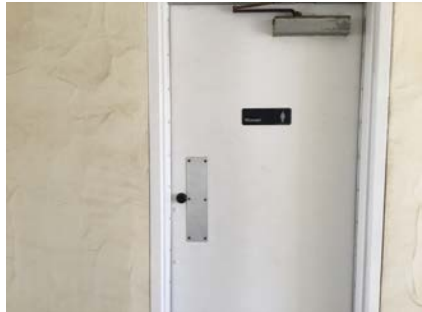
Item no., Rm no. and Name	Existing Architectural Barrier and Proposed Solution	Codes / Mitigation Info	Qty	Unit	Cost	Total
1096	<ul style="list-style-type: none"> As-Built Description: Required in CA only: identification symbol centered 58" to 60" high on sanitary facility door that contrasts with the door not provided (women: 12" ø circle, men: 12" triangle, unisex: combined symbol). Proposed Solution: Provide properly mounted sanitary facility symbol when altering area. If wheelchair accessible, include International Symbol of Accessibility on sign. 	PCODE SA15 CBC 2007 1115B.6 CBC 2019 11B-703.7.2.6 Mitigated: <input type="radio"/> YES <input checked="" type="radio"/> NO	1	JOB	\$270	\$270

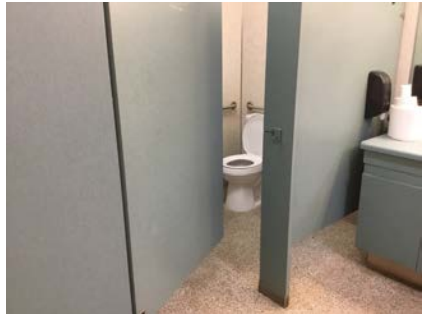
Stall Door

1085	<ul style="list-style-type: none"> As-Built Description: Stall door to accessible compartment not self closing. Proposed Solution: Adjust closer. 	PCODE WB05B ADAAG 91 4.22.4 ADA 2010 604.8.1.2 CBC 2007 1115B.3.1.4.4 CBC 2019 11B-604.8.1.2 Mitigated: <input type="radio"/> YES <input checked="" type="radio"/> NO	1	JOB	\$75	\$75

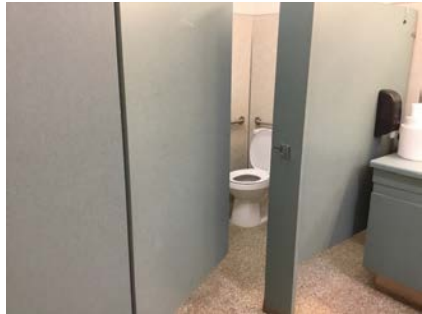
Item no., Rm no. and Name	Existing Architectural Barrier and Proposed Solution	Codes / Mitigation Info	Qty	Unit	Cost	Total
1086	<ul style="list-style-type: none"> As-Built Description: Stall door does not have accessible operating hardware (U-pulls on both sides, flip-over or sliding lock). Proposed Solution: Provide new accessible locking hardware that does not require grasping, pinching, or twisting and U-pulls on both sides. 	PCODE WB05C ADAAG 91 4.17.5 ADA 2010 604.8.1.2 CBC 2007 1115B.3.1.4.5 CBC 2019 11B-604.8.1.2 Mitigated: <input type="radio"/> YES <input checked="" type="radio"/> NO	1	JOB	\$300	\$300

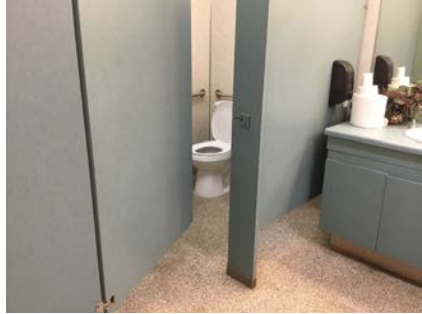
Toilet Stall

1084	<ul style="list-style-type: none"> As-Built Description: Less than 59" from back wall to front wall or door swing of toilet stall, or less than 56" if water closet is wall-hung. As-Built: 49.5" Proposed Solution: Provide new enclosure at existing water closet fixture. 	PCODE WB03 ADAAG 91 4.17.3 ADA 2010 604.8.1.1 CBC 2007 1115B.3.4.3 CBC 2019 11B-604.8.1.1 Mitigated: <input type="radio"/> YES <input checked="" type="radio"/> NO	1	JOB	\$4,500	\$4,500

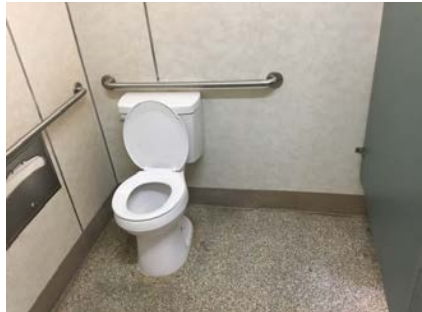
Item no., Rm no. and Name	Existing Architectural Barrier and Proposed Solution	Codes / Mitigation Info	Qty	Unit	Cost	Total
1087	<ul style="list-style-type: none"> As-Built Description: Toilet stall less than 60" wide. As-Built: 55.3" to 59.0" wide Proposed Solution: Provide new accessible stall. 	PCODE WB06 ADAAG 91 4.17.3 ADA 2010 604.8.1.1 CBC 2007 1115B.3.1.4.1 CBC 2019 11B-604.8.1.1 Mitigated: <input type="radio"/> YES <input checked="" type="radio"/> NO	1	JOB	\$4,500	\$4,500

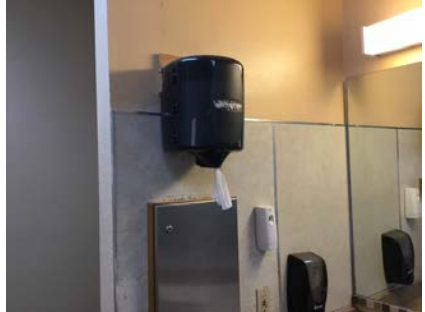
Accessories

1106	<ul style="list-style-type: none"> <i>As-Built Description:</i> Dispensers in sanitary facilities, such as for towels, soap, sanitary napkins, seat covers, etc., and waste receptacles more than 48" (CA only: 40") from floor to highest operating slot or control. <i>As-Built:</i> PTD: 65.0" high <i>Proposed Solution:</i> Relocate existing restroom accessories. 	<p>PCODE WG01A ADAAG 91 4.23.7 ADA 2010 308.2.1 CBC 2007 1115B.8.3 CBC 2019 11B-603.5</p> <p>Mitigated: <input type="radio"/> YES <input checked="" type="radio"/> NO</p>	1	JOB	\$300	\$300
------	--	--	---	-----	-------	--------------

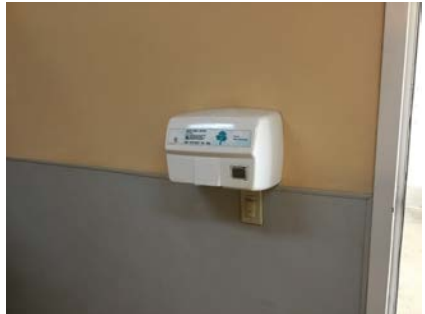
1107	<ul style="list-style-type: none"> <i>As-Built Description:</i> Dispensers in sanitary facilities, such as for towels, soap, sanitary napkins, seat covers, etc., and waste receptacles more than 48" (CA only: 40") from floor to highest operating slot or control. <i>As-Built:</i> Hand dryer: 51.5" high <i>Proposed Solution:</i> Relocate existing restroom accessories. <i>Notes:</i> 	<p>PCODE WG01A ADAAG 91 4.23.7 ADA 2010 308.2.1 CBC 2007 1115B.8.3 CBC 2019 11B-603.5</p> <p>Mitigated: <input type="radio"/> YES <input checked="" type="radio"/> NO</p>	1	JOB	\$300	\$300
------	--	--	---	-----	-------	--------------

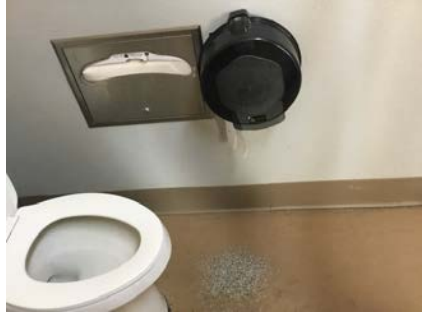
Item no., Rm no. and Name	Existing Architectural Barrier and Proposed Solution	Codes / Mitigation Info	Qty	Unit	Cost	Total
1112	<ul style="list-style-type: none"> As-Built Description: Toilet paper dispenser less than 15" (CA: 19") or more than 48" above floor or not within 7" to 9" from front of water closet (Note: CA pre-2010 is allowed within 12" from front of water closet). As-Built: 10.0" in front. Proposed Solution: Relocate or provide new toilet paper dispenser. 	PCODE WG02 ADAAG 91 4.16.6 ADA 2010 604.7 CBC 2007 1115B.8.4 CBC 2019 11B-604.7 Mitigated: <input type="radio"/> YES <input checked="" type="radio"/> NO	1	JOB	\$225	\$225

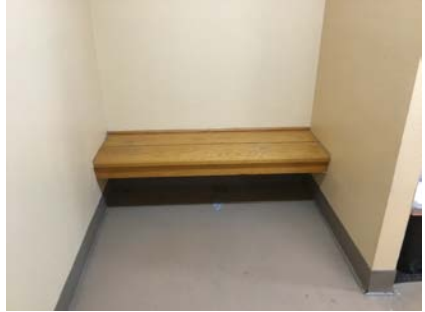
Bench

1102	<ul style="list-style-type: none"> As-Built Description: Clear floor space to allow parallel transfer onto bench not provided. Proposed Solution: Remodel dressing room to provide 30" x 48" alongside bench. 	PCODE RE04B ADAAG 91 4.35.4 ADA 2010 803.4 CBC 2007 1117B.8 CBC 2019 11B-803.4 Mitigated: <input type="radio"/> YES <input checked="" type="radio"/> NO	1	JOB	\$4,500	\$4,500
------	---	---	---	-----	---------	---------

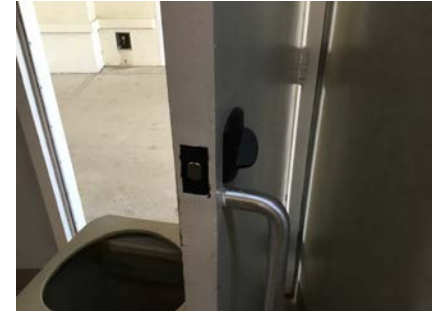
Item no., Rm no. and Name	Existing Architectural Barrier and Proposed Solution	Codes / Mitigation Info	Qty	Unit	Cost	Total
1100	<ul style="list-style-type: none"> As-Built Description: Door lock, latch or handle less than 34" or more than 48" above the floor (CA only: 34" to 44"). As-Built: 48.0" high Proposed Solution: Relocate or replace existing hardware. Notes: 	PCODE ID17 ADAAG 91 4.13.9 ADA 2010 404.2.7 CBC 2007 1133B.2.5.2 CBC 2019 11B-404.2.7 Mitigated: <input type="radio"/> YES <input checked="" type="radio"/> NO	1	JOB	\$900	\$900

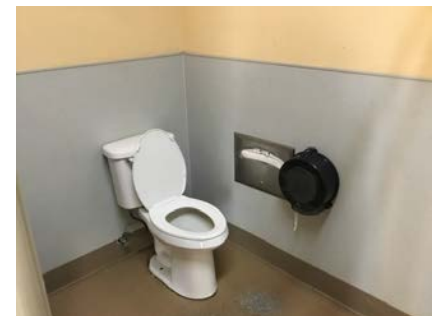
Grab Bars

1113	<ul style="list-style-type: none"> As-Built Description: Grab bars not provided or are not code compliant. Proposed Solution: Provide accessible grab bars. 	PCODE WB07 ADAAG 91 4.17.6 ADA 2010 604.5 CBC 2007 1115B.4.1.3 CBC 2019 11B-604.5 Mitigated: <input type="radio"/> YES <input checked="" type="radio"/> NO	1	JOB	\$1,500	\$1,500
------	---	---	---	-----	---------	---------

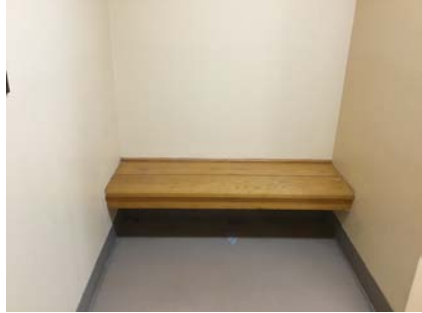
Locker Facilities

<p>1103</p> <ul style="list-style-type: none"> <i>As-Built Description:</i> No section of bench provided adjacent to designated accessible locker, measuring minimum 20-24" deep, 48" wide, and 17-19" high, and fixed to a wall along the longer dimension. <i>As-Built:</i> 18.0" deep <i>Proposed Solution:</i> Provide a new bench, fixed to a wall along the longer dimension, close to the accessible locker. 	<p>PCODE GG03 ADAAG 91 4.35.4 ADA 2010 803.4 CBC 2007 1117B.8 CBC 2019 11B-803.4</p> <p>Mitigated: <input type="radio"/> YES <input checked="" type="radio"/> NO</p>	<p>1 JOB \$2,250 \$2,250</p>

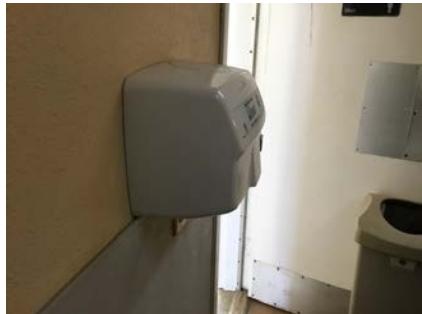
Protrusion Limits

<p>1101</p> <ul style="list-style-type: none"> <i>As-Built Description:</i> Protruding objects more than 4" from wall, when bottom of object more than 27" or less than 80" above finished floor. <i>As-Built:</i> Hand dryer: 6.5" at 53.0" high <i>Proposed Solution:</i> Remove/relocate protruding object. Patch existing surface. Option to install new hand dryer with depth less than 4". 	<p>PCODE EG04 ADAAG 91 4.4.1 ADA 2010 307.2 CBC 2007 1133B.8.6.1 CBC 2019 11B-307.2</p> <p>Mitigated: <input type="radio"/> YES <input checked="" type="radio"/> NO</p>	<p>1 JOB \$300 \$300</p>

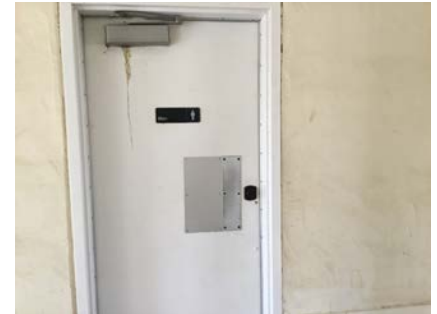
1097	<ul style="list-style-type: none"> <i>As-Built Description:</i> Entrance to toilet or bathing facility not identified with ADAAG compliant signage. <i>Proposed Solution:</i> Provide ADA compliant sign mounted at 48" min. above to baseline of the lowest Braille cells and 60" max. to baseline of the highest line of raised characters on nearest adjacent wall, on latch side of a single door (located not to cause a Braille reader to stand within the door swing). 	PCODE SA11A ADAAG 91 4.1.3(16)(a) ADA 2010 216.8 CBC 2019 11B-216.8	1	JOB	\$270	\$270
------	---	--	---	-----	-------	-------

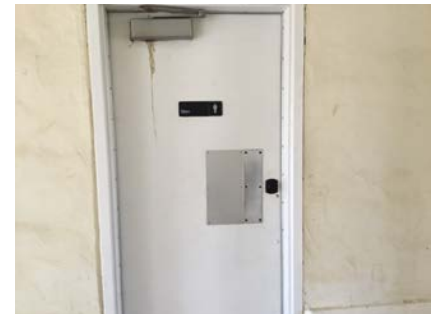
1098	<ul style="list-style-type: none"> <i>As-Built Description:</i> Required in CA only: identification symbol centered 58" to 60" high on sanitary facility door that contrasts with the door not provided (women: 12" ø circle, men: 12" triangle, unisex: combined symbol). <i>Proposed Solution:</i> Provide properly mounted sanitary facility symbol when altering area. If wheelchair accessible, include International Symbol of Accessibility on sign. 	PCODE SA15 CBC 2007 1115B.6 CBC 2019 11B-703.7.2.6	1	JOB	\$270	\$270
------	---	--	---	-----	-------	-------

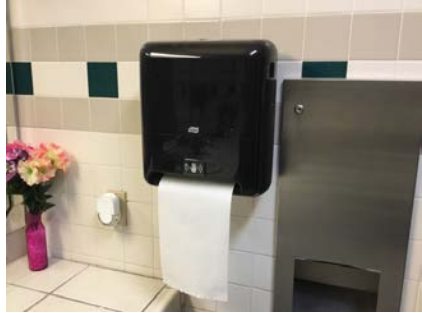
1121	<ul style="list-style-type: none"> As-Built Description: Protruding objects more than 4" from wall, when bottom of object more than 27" or less than 80" above finished floor. As-Built: PTD: 8.0" at 50.0" high Proposed Solution: Remove/relocate protruding object. Patch existing surface. 	<p>PCODE EG04 ADAAG 91 4.4.1 ADA 2010 307.2 CBC 2007 1133B.8.6.1 CBC 2019 11B-307.2</p> <p>Mitigated: <input type="radio"/> YES <input checked="" type="radio"/> NO</p>	1	JOB	\$300	\$300
------	--	---	---	-----	-------	-------

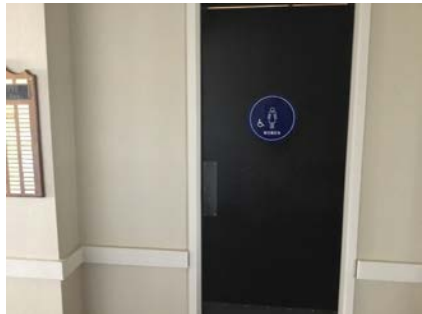
1116	<ul style="list-style-type: none"> As-Built Description: Entrance to toilet or bathing facility not identified with ADAAG compliant signage. Proposed Solution: Provide ADA compliant sign mounted at 48" min. above to baseline of the lowest Braille cells and 60" max. to baseline of the highest line of raised characters on nearest adjacent wall, on latch side of a single door (located not to cause a Braille reader to stand within the door swing). 	<p>PCODE SA11A ADAAG 91 4.1.3(16)(a) ADA 2010 216.8 CBC 2019 11B-216.8</p> <p>Mitigated: <input type="radio"/> YES <input checked="" type="radio"/> NO</p>	1	JOB	\$270	\$270
------	---	---	---	-----	-------	-------

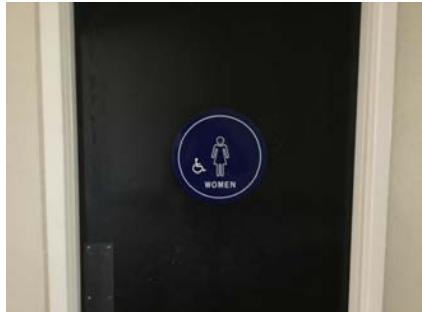
Item no., Rm no. and Name	Existing Architectural Barrier and Proposed Solution	Codes / Mitigation Info	Qty	Unit	Cost	Total
1117	<ul style="list-style-type: none"> <i>As-Built Description:</i> Required in CA only: identification symbol centered 58" to 60" high on sanitary facility door that contrasts with the door not provided (women: 12" ø circle, men: 12" triangle, unisex: combined symbol). <i>As-Built:</i> Not contrast <i>Proposed Solution:</i> Provide properly mounted sanitary facility symbol when altering area. If wheelchair accessible, include International Symbol of Accessibility on sign. 	PCODE SA15 CBC 2007 1115B.6 CBC 2019 11B-703.7.2.6 Mitigated: <input type="radio"/> YES <input checked="" type="radio"/> NO	1	JOB	\$270	\$270

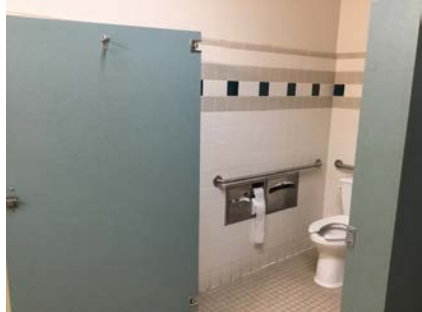
1124	<ul style="list-style-type: none"> <i>As-Built Description:</i> Stall door to accessible compartment not self closing. <i>Proposed Solution:</i> Adjust closer. 	PCODE WB05B ADAAG 91 4.22.4 ADA 2010 604.8.1.2 CBC 2007 1115B.3.1.4.4 CBC 2019 11B-604.8.1.2 Mitigated: <input type="radio"/> YES <input checked="" type="radio"/> NO	1	JOB	\$75	\$75

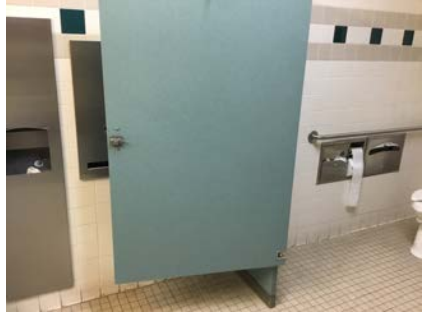
Item no., Rm no. and Name	Existing Architectural Barrier and Proposed Solution	Codes / Mitigation Info	Qty	Unit	Cost	Total
1125	<ul style="list-style-type: none"> <i>As-Built Description:</i> Stall door does not have accessible operating hardware (U-pulls on both sides, flip-over or sliding lock). <i>Proposed Solution:</i> Provide new accessible locking hardware that does not require grasping, pinching, or twisting and U-pulls on both sides. 	PCODE WB05C ADAAG 91 4.17.5 ADA 2010 604.8.1.2 CBC 2007 1115B.3.1.4.5 CBC 2019 11B-604.8.1.2 Mitigated: <input type="radio"/> YES <input checked="" type="radio"/> NO	1	JOB	\$300	\$300

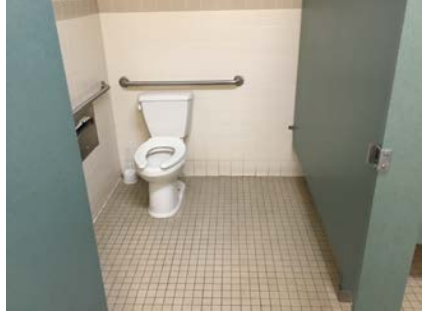
1126	<ul style="list-style-type: none"> <i>As-Built Description:</i> Toilet stall less than 60" wide. <i>As-Built:</i> 58.5" wide <i>Proposed Solution:</i> Provide new accessible stall. 	PCODE WB06 ADAAG 91 4.17.3 ADA 2010 604.8.1.1 CBC 2007 1115B.3.1.4.1 CBC 2019 11B-604.8.1.1 Mitigated: <input type="radio"/> YES <input checked="" type="radio"/> NO	1	JOB	\$4,500	\$4,500

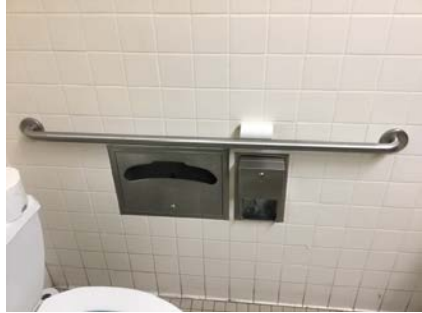
<p>1142</p> <ul style="list-style-type: none"> • <i>As-Built Description:</i> Side grab bar less than 42" long, or located more than 12 inches max. from the rear wall, or extending less than 54" from rear wall (CA only: front end min. 24" in front of water closet). • <i>As-Built:</i> Extends 53.5" • <i>Proposed Solution:</i> Provide or relocate accessible side grab bar. 	<p>PCODE WB07A ADAAG 91 Fig. 29(b) ADA 2010 604.5.1 CBC 2007 1115B.4.1.3.1 CBC 2019 11B-604.5.1</p> <p>Mitigated: <input type="radio"/> YES <input checked="" type="radio"/> NO</p>	<p>1 JOB \$780 \$780</p>

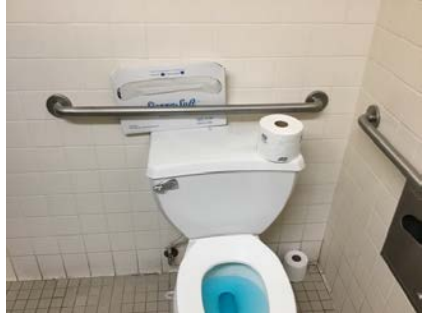
<p>1141</p> <ul style="list-style-type: none"> • <i>As-Built Description:</i> The rear wall grab is less than 36" min. or does not extend from the centerline of the water closet 12" min. on one side and 24" min. on the other side. • <i>As-Built:</i> Extends 22.25" on wide side • <i>Proposed Solution:</i> Relocate water closet. 	<p>PCODE WB07B ADAAG 91 4.17.6 ADA 2010 604.5.2 CBC 2007 1115B.4.1.3.2 CBC 2019 11B-604.5.2</p> <p>Mitigated: <input type="radio"/> YES <input checked="" type="radio"/> NO</p>	<p>1 JOB \$1,020 \$1,020</p>

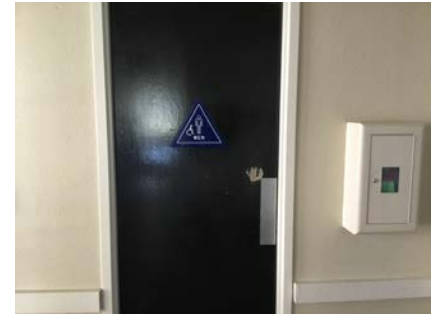
1129	<ul style="list-style-type: none"> <i>As-Built Description:</i> Entrance to toilet or bathing facility not identified with ADAAG compliant signage. <i>Proposed Solution:</i> Provide ADA compliant sign mounted at 48" min. above to baseline of the lowest Braille cells and 60" max. to baseline of the highest line of raised characters on nearest adjacent wall, on latch side of a single door (located not to cause a Braille reader to stand within the door swing). 	<p>PCODE SA11A ADAAG 91 4.1.3(16)(a) ADA 2010 216.8 CBC 2019 11B-216.8</p> <p>Mitigated: <input type="radio"/> YES <input checked="" type="radio"/> NO</p>	1	JOB	\$270	\$270
------	---	--	---	-----	-------	-------

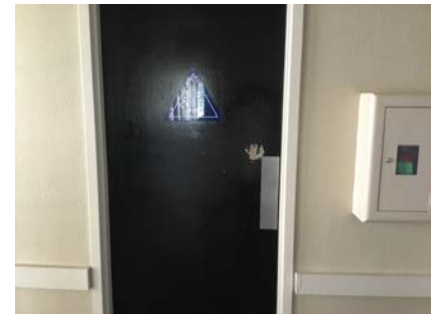
1130	<ul style="list-style-type: none"> <i>As-Built Description:</i> Required in CA only: identification symbol centered 58" to 60" high on sanitary facility door that contrasts with the door not provided (women: 12" ø circle, men: 12" triangle, unisex: combined symbol). <i>As-Built:</i> Not contrast and glare. <i>Proposed Solution:</i> Provide properly mounted sanitary facility symbol when altering area. If wheelchair accessible, include International Symbol of Accessibility on sign. 	<p>PCODE SA15 CBC 2007 1115B.6 CBC 2019 11B-703.7.2.6</p> <p>Mitigated: <input type="radio"/> YES <input checked="" type="radio"/> NO</p>	1	JOB	\$270	\$270
------	--	---	---	-----	-------	-------

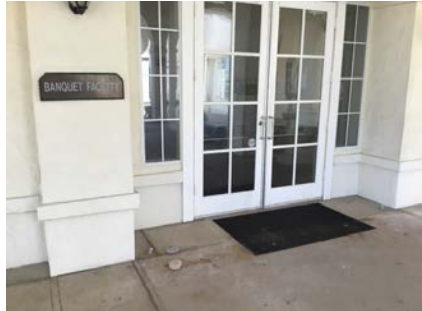
Item no., Rm no. and Name	Existing Architectural Barrier and Proposed Solution	Codes / Mitigation Info	Qty	Unit	Cost	Total
1144	<ul style="list-style-type: none"> As-Built Description: Surface of required maneuvering clearance at door slopes more than 1/4":12" (2.0%). As-Built: 3.0% Proposed Solution: Modify surface slope at door. 	PCODE ID11 ADAAG 91 4.13.6 ADA 2010 404.2.4.4 CBC 2007 1133B.2.4 CBC 2019 11B-404.2.4 Mitigated: <input type="radio"/> YES <input checked="" type="radio"/> NO	10	SF	\$120	\$1,200

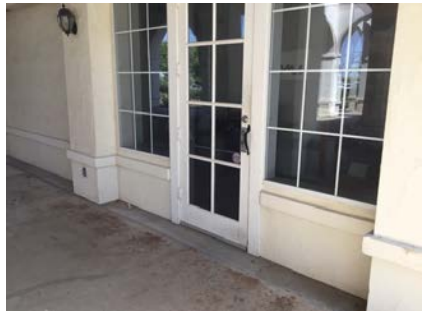
<input type="radio"/> Staff Only			
			Priority <input checked="" type="radio"/> 2			
			Severity <input checked="" type="radio"/> 4			
1145	<ul style="list-style-type: none"> As-Built Description: Surface of required maneuvering clearance at door slopes more than 1/4":12" (2.0%). As-Built: 5.0% 0.5" level change Proposed Solution: Modify surface slope at door. Notes: 	PCODE ID11 ADAAG 91 4.13.6 ADA 2010 404.2.4.4 CBC 2007 1133B.2.4 CBC 2019 11B-404.2.4 Mitigated: <input type="radio"/> YES <input checked="" type="radio"/> NO	175	SF	\$120	\$21,000

Every exterior entrance door to the restaurant has slopes >2.1%.

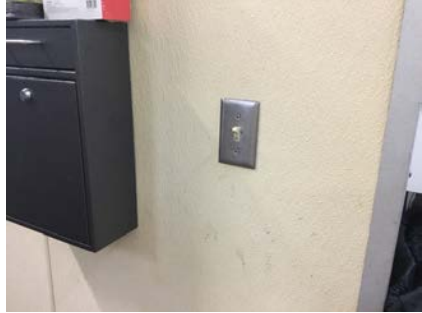
<p>1157</p> <ul style="list-style-type: none"> <i>As-Built Description:</i> Electric switch or control mounted less than 15" measured to the bottom of the outlet box or greater than 48 inches measured to the top of the outlet box. <i>As-Built:</i> 54.25 high <i>Proposed Solution:</i> Relocate light switches or control to between 15" and 48" height. 	<p>PCODE IC01 ADAAG 91 4.2.5 & 6 ADA 2010 308.2.1 & 308.2.2 CBC 2007 1117B.6.3 CBC 2019 11B-308.2.1 & 11B-308.2.2</p> <p>Mitigated: <input type="radio"/> YES <input checked="" type="radio"/> NO</p>	<p>1 JOB \$900 \$900</p>

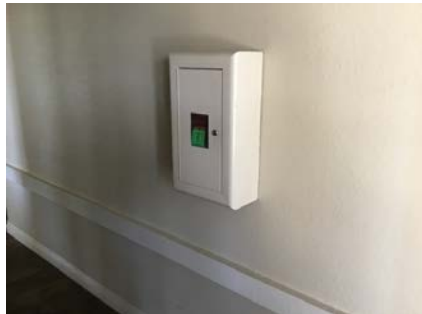
<p>1151</p> <ul style="list-style-type: none"> <i>As-Built Description:</i> Protruding objects more than 4" from wall, when bottom of object more than 27" or less than 80" above finished floor. <i>As-Built:</i> FE cabinet: 5.0" at 39.0" high <i>Proposed Solution:</i> Remove/relocate protruding object. Patch existing surface. 	<p>PCODE EG04 ADAAG 91 4.4.1 ADA 2010 307.2 CBC 2007 1133B.8.6.1 CBC 2019 11B-307.2</p> <p>Mitigated: <input type="radio"/> YES <input checked="" type="radio"/> NO</p>	<p>1 JOB \$300 \$300</p>

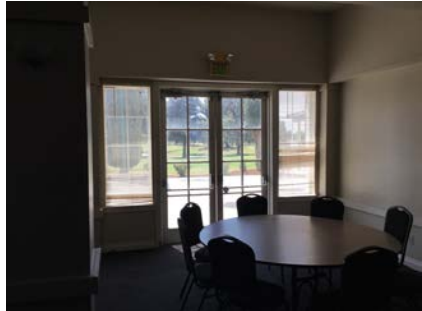
Item no., Rm no. and Name	Existing Architectural Barrier and Proposed Solution	Codes / Mitigation Info	Qty	Unit	Cost	Total
1154	<ul style="list-style-type: none"> As-Built Description: At final exit door to exterior: Where required exit signs are installed, signs to provide exiting information for people with vision impairment are not provided. Proposed Solution: Provide raised letter/Braille "EXIT" sign at door. 	PCODE SA10A ADAAG 91 4.1.3(16) ADA 2010 216.4.1 CBC 2007 1011.3 CBC 2019 11B-216.4.1 Mitigated: <input type="radio"/> YES <input checked="" type="radio"/> NO	13	JOB	\$270	\$3,510

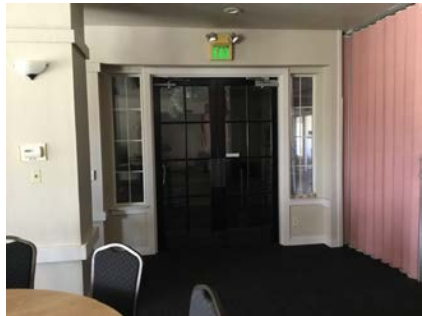
<input type="radio"/> Staff Only			
			Priority <input checked="" type="radio"/> 2			
			Severity <input checked="" type="radio"/> 3			
1155	<ul style="list-style-type: none"> As-Built Description: At door leading into exit corridor: Where required exit signs are installed, signs to provide exiting information for people with vision impairment are not provided. Proposed Solution: Provide raised letter/Braille "EXIT ROUTE" sign at door. 	PCODE SA10D ADAAG 91 4.1.3(16) ADA 2010 216.4.1 CBC 2007 1011.3 CBC 2019 11B-216.4.1 Mitigated: <input type="radio"/> YES <input checked="" type="radio"/> NO	2	JOB	\$270	\$540

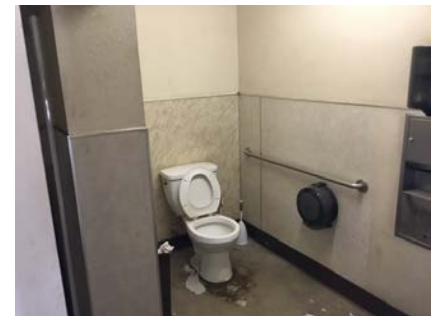
- 1176
- *As-Built Description:*
Single accommodation restroom not accessible; multiple compliance violations.
 - *As-Built:* **110.0" x 100**
 - *Proposed Solution:*
Remodel area to provide single-occupant accessible restroom.
 - *Notes:*

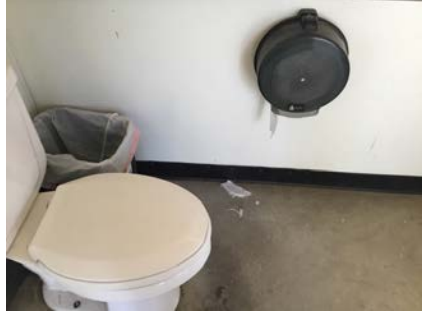
Item no., Rm no. and Name	Existing Architectural Barrier and Proposed Solution	Codes / Mitigation Info	Qty	Unit	Cost	Total
1193	<ul style="list-style-type: none"> As-Built Description: Toilet paper dispenser less than 15" (CA: 19") or more than 48" above floor or not within 7" to 9" from front of water closet (Note: CA pre-2010 is allowed within 12" from front of water closet). As-Built: 9.5" in front. Proposed Solution: Relocate or provide new toilet paper dispenser. 	PCODE WG02 ADAAG 91 4.16.6 ADA 2010 604.7 CBC 2007 1115B.8.4 CBC 2019 11B-604.7 Mitigated: <input type="radio"/> YES <input checked="" type="radio"/> NO	1	JOB	\$225	\$225

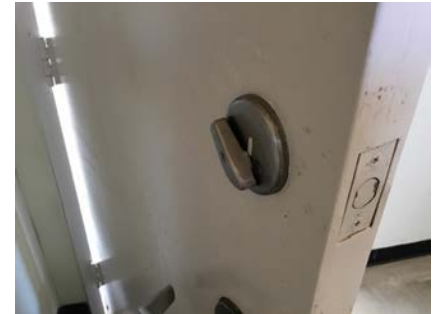
1243 • *As-Built Description:*
 Door lock, latch or handle less than 34" or more than 48" above the floor (CA only: 34" to 44").
 • *As-Built:* **48.5" high**
 • *Proposed Solution:*
 Relocate or replace existing hardware.

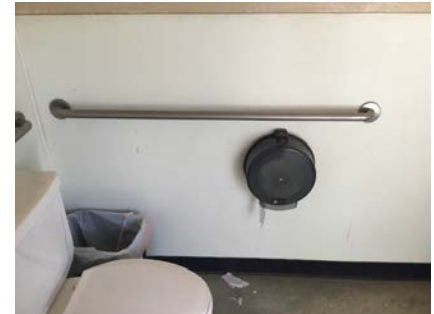
1194	<ul style="list-style-type: none"> <i>As-Built Description:</i> Side grab bar less than 42" long, or located more than 12 inches max. from the rear wall, or extending less than 54" from rear wall (CA only: front end min. 24" in front of water closet). <i>As-Built:</i> Extends 52.5" <i>Proposed Solution:</i> Provide or relocate accessible side grab bar. 	<p>PCODE WB07A ADAAG 91 Fig. 29(b) ADA 2010 604.5.1 CBC 2007 1115B.4.1.3.1 CBC 2019 11B-604.5.1</p> <p>Mitigated: <input type="radio"/> YES <input checked="" type="radio"/> NO</p>	1	JOB	\$780	\$780
------	--	--	---	-----	-------	-------

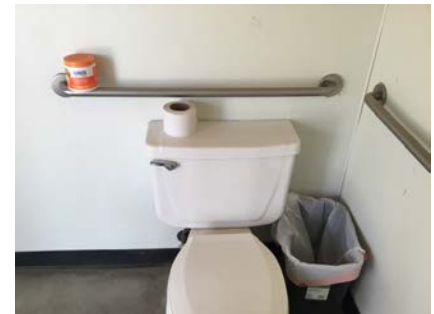
1192	<ul style="list-style-type: none"> <i>As-Built Description:</i> The rear wall grab is less than 36" min. or does not extend from the centerline of the water closet 12" min. on one side and 24" min. on the other side. <i>As-Built:</i> Extends 21.0" on wide side <i>Proposed Solution:</i> Provide or relocate accessible rear grab bar. 	<p>PCODE WB07B ADAAG 91 4.17.6 ADA 2010 604.5.2 CBC 2007 1115B.4.1.3.2 CBC 2019 11B-604.5.2</p> <p>Mitigated: <input type="radio"/> YES <input checked="" type="radio"/> NO</p>	1	JOB	\$1,020	\$1,020
------	--	--	---	-----	---------	---------

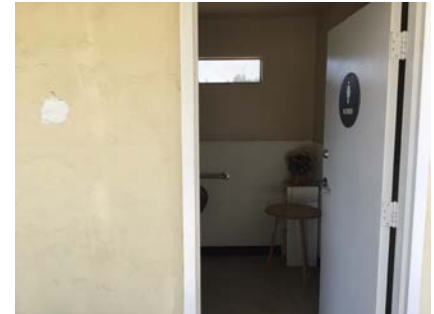
1183	<ul style="list-style-type: none"> <i>As-Built Description:</i> Entrance to toilet or bathing facility not identified with ADAAG compliant signage. <i>Proposed Solution:</i> Provide ADA compliant sign mounted at 48" min. above to baseline of the lowest Braille cells and 60" max. to baseline of the highest line of raised characters on nearest adjacent wall, on latch side of a single door (located not to cause a Braille reader to stand within the door swing). 	<p>PCODE SA11A ADAAG 91 4.1.3(16)(a) ADA 2010 216.8 CBC 2019 11B-216.8</p> <p>Mitigated: <input type="radio"/> YES <input checked="" type="radio"/> NO</p>	1	JOB	\$270	\$270
------	---	--	---	-----	-------	-------

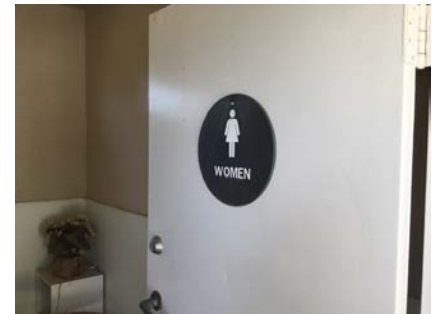
1184	<ul style="list-style-type: none"> <i>As-Built Description:</i> Required in CA only: identification symbol centered 58" to 60" high on sanitary facility door that contrasts with the door not provided (women: 12" ø circle, men: 12" triangle, unisex: combined symbol). <i>As-Built:</i> 61.5" high o.c. <i>Proposed Solution:</i> Provide properly mounted sanitary facility symbol when altering area. If wheelchair accessible, include International Symbol of Accessibility on sign. 	<p>PCODE SA15 CBC 2007 1115B.6 CBC 2019 11B-703.7.2.6</p> <p>Mitigated: <input type="radio"/> YES <input checked="" type="radio"/> NO</p>	1	JOB	\$270	\$270
------	--	---	---	-----	-------	-------

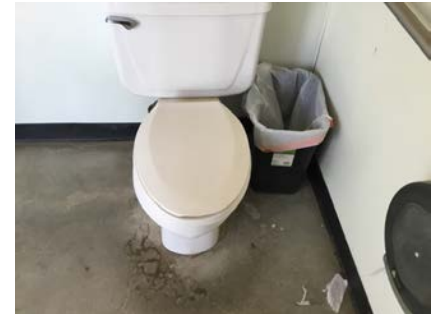
1190	<ul style="list-style-type: none"> <i>As-Built Description:</i> Water closet not 16"-18" (CA: 17"-18") from near side wall to center line of water closet (2010 ADAAG: 16"-18"). <i>As-Built:</i> 21.0" o.c. <i>Proposed Solution:</i> Relocate existing water closet and plumbing, remount with offset closet flange to provide 18" max. from side wall. 	<p>PCODE WB02C ADAAG 91 Fig. 28 ADA 2010 604.2 CBC 2007 1115B.4.1.1 CBC 2019 11B-604.2</p> <p>Mitigated: <input type="radio"/> YES <input checked="" type="radio"/> NO</p>	1	JOB	\$1,500	\$1,500
------	---	---	---	-----	---------	---------

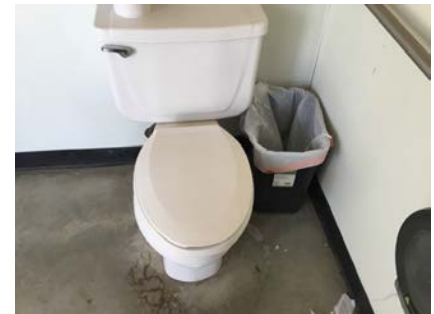
1191	<ul style="list-style-type: none"> <i>As-Built Description:</i> Height of water closet seat less than 17" or more than 19" from floor. <i>As-Built:</i> 16.0" high <i>Proposed Solution:</i> Provide riser toilet seat (CA only: in alterations, riser seat may not be higher than 2"). 	<p>PCODE WB08A ADAAG 91 4.16.3 ADA 2010 604.4 CBC 2007 1115B.4.1.4 CBC 2019 11B-604.4</p> <p>Mitigated: <input type="radio"/> YES <input checked="" type="radio"/> NO</p>	1	JOB	\$240	\$240
------	---	--	---	-----	-------	-------

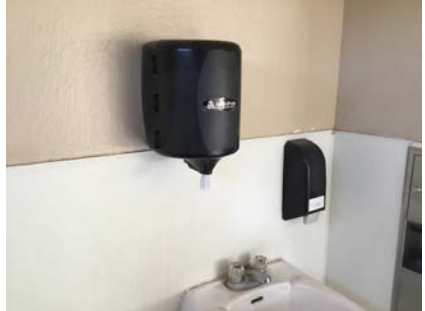
<p>1201</p> <ul style="list-style-type: none"> <i>As-Built Description:</i> Dispensers in sanitary facilities, such as for towels, soap, sanitary napkins, seat covers, etc., and waste receptacles more than 48" (CA only: 40") from floor to highest operating slot or control. <i>As-Built:</i> PTD: 50.0" high <i>Proposed Solution:</i> Relocate existing restroom accessories. 	<p>PCODE WG01A ADAAG 91 4.23.7 ADA 2010 308.2.1 CBC 2007 1115B.8.3 CBC 2019 11B-603.5</p> <p>Mitigated: <input type="radio"/> YES <input checked="" type="radio"/> NO</p>	<p>1 JOB \$300 \$300</p>

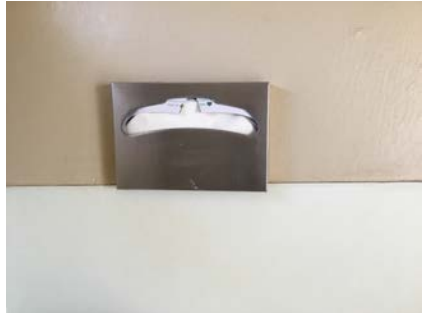
<p>1202</p> <ul style="list-style-type: none"> <i>As-Built Description:</i> Dispensers in sanitary facilities, such as for towels, soap, sanitary napkins, seat covers, etc., and waste receptacles more than 48" (CA only: 40") from floor to highest operating slot or control. <i>As-Built:</i> SCD: 59.0" high <i>Proposed Solution:</i> Relocate existing restroom accessories. 	<p>PCODE WG01A ADAAG 91 4.23.7 ADA 2010 308.2.1 CBC 2007 1115B.8.3 CBC 2019 11B-603.5</p> <p>Mitigated: <input type="radio"/> YES <input checked="" type="radio"/> NO</p>	<p>1 JOB \$300 \$300</p>

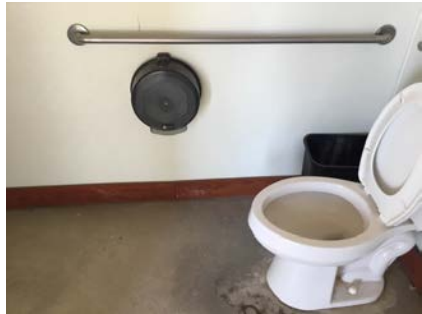
Item no., Rm no. and Name	Existing Architectural Barrier and Proposed Solution	Codes / Mitigation Info	Qty	Unit	Cost	Total
1206	<ul style="list-style-type: none"> As-Built Description: Toilet paper dispenser less than 15" (CA: 19") or more than 48" above floor or not within 7" to 9" from front of water closet (Note: CA pre-2010 is allowed within 12" from front of water closet). As-Built: 11.0" in front. Proposed Solution: Relocate or provide new toilet paper dispenser. 	PCODE WG02 ADAAG 91 4.16.6 ADA 2010 604.7 CBC 2007 1115B.8.4 CBC 2019 11B-604.7 Mitigated: <input type="radio"/> YES <input checked="" type="radio"/> NO	1	JOB	\$225	\$225

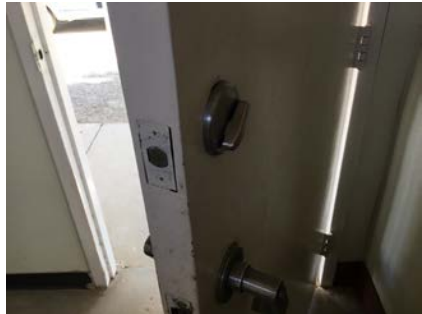
1244	<ul style="list-style-type: none"> As-Built Description: Door lock, latch or handle less than 34" or more than 48" above the floor (CA only: 34" to 44"). As-Built: 48.5" high Proposed Solution: Relocate or replace existing hardware. 	PCODE ID17 ADAAG 91 4.13.9 ADA 2010 404.2.7 CBC 2007 1133B.2.5.2 CBC 2019 11B-404.2.7 Mitigated: <input type="radio"/> YES <input checked="" type="radio"/> NO	1	JOB	\$900	\$900

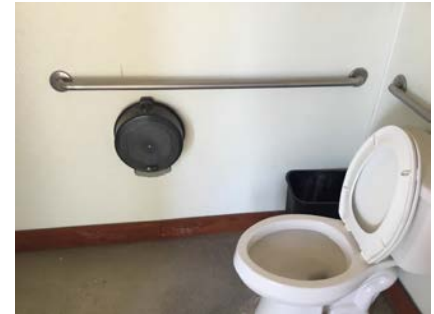
1207	<ul style="list-style-type: none"> <i>As-Built Description:</i> Side grab bar less than 42" long, or located more than 12 inches max. from the rear wall, or extending less than 54" from rear wall (CA only: front end min. 24" in front of water closet). <i>As-Built:</i> Extends 53.0" <i>Proposed Solution:</i> Provide or relocate accessible side grab bar. 	PCODE WB07A ADAAG 91 Fig. 29(b) ADA 2010 604.5.1 CBC 2007 1115B.4.1.3.1 CBC 2019 11B-604.5.1	1	JOB	\$780	\$780
------	--	---	---	-----	-------	-------

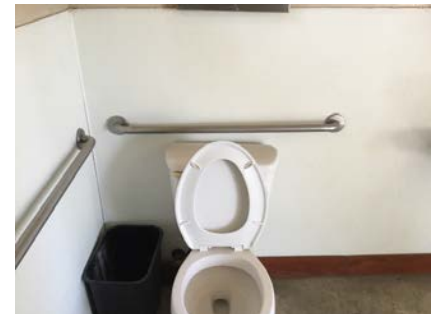
1205	<ul style="list-style-type: none"> <i>As-Built Description:</i> The rear wall grab is less than 36" min. or does not extend from the centerline of the water closet 12" min. on one side and 24" min. on the other side. <i>As-Built:</i> Extends 19.0" on wide side <i>Proposed Solution:</i> Provide or relocate accessible rear grab bar. <i>Notes:</i> 	PCODE WB07B ADAAG 91 4.17.6 ADA 2010 604.5.2 CBC 2007 1115B.4.1.3.2 CBC 2019 11B-604.5.2	1	JOB	\$1,020	\$1,020
------	---	---	---	-----	---------	---------

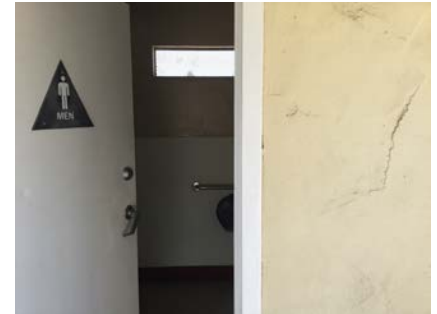
1197	<ul style="list-style-type: none"> <i>As-Built Description:</i> Entrance to toilet or bathing facility not identified with ADAAG compliant signage. <i>Proposed Solution:</i> Provide ADA compliant sign mounted at 48" min. above to baseline of the lowest Braille cells and 60" max. to baseline of the highest line of raised characters on nearest adjacent wall, on latch side of a single door (located not to cause a Braille reader to stand within the door swing). 	<p>PCODE SA11A ADAAG 91 4.1.3(16)(a) ADA 2010 216.8 CBC 2019 11B-216.8</p> <p>Mitigated: <input type="radio"/> YES <input checked="" type="radio"/> NO</p>	1	JOB	\$270	\$270
------	---	--	---	-----	-------	-------

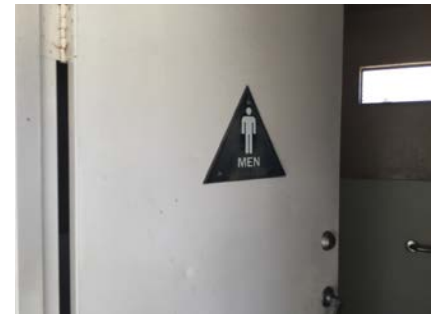
1198	<ul style="list-style-type: none"> <i>As-Built Description:</i> Required in CA only: identification symbol centered 58" to 60" high on sanitary facility door that contrasts with the door not provided (women: 12" ø circle, men: 12" triangle, unisex: combined symbol). <i>As-Built:</i> 63.0" high o.c. <i>Proposed Solution:</i> Provide properly mounted sanitary facility symbol when altering area. If wheelchair accessible, include International Symbol of Accessibility on sign. 	<p>PCODE SA15 CBC 2007 1115B.6 CBC 2019 11B-703.7.2.6</p> <p>Mitigated: <input type="radio"/> YES <input checked="" type="radio"/> NO</p>	1	JOB	\$270	\$270
------	--	---	---	-----	-------	-------

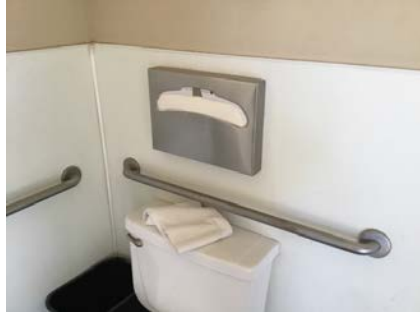
<p>1218</p> <ul style="list-style-type: none"> As-Built Description: Dispensers in sanitary facilities, such as for towels, soap, sanitary napkins, seat covers, etc., and waste receptacles more than 48" (CA only: 40") from floor to highest operating slot or control. As-Built: SCD: 45.0" high Proposed Solution: Relocate existing restroom accessories. 	<p>PCODE WG01A ADAAG 91 4.23.7 ADA 2010 308.2.1 CBC 2007 1115B.8.3 CBC 2019 11B-603.5</p>	<p>1 JOB \$300 \$300</p>

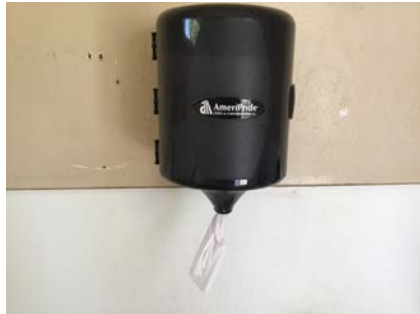
<p>1222</p> <ul style="list-style-type: none"> As-Built Description: Dispensers in sanitary facilities, such as for towels, soap, sanitary napkins, seat covers, etc., and waste receptacles more than 48" (CA only: 40") from floor to highest operating slot or control. As-Built: PTD: 51.0" high Proposed Solution: Relocate existing restroom accessories. Notes: 	<p>PCODE WG01A ADAAG 91 4.23.7 ADA 2010 308.2.1 CBC 2007 1115B.8.3 CBC 2019 11B-603.5</p>	<p>1 JOB \$300 \$300</p>
