APPENDIX B: ACCESS COMPLIANCE SURVEY REPORT OF FACILITIES

The City of Madera

Access Compliance Survey Report

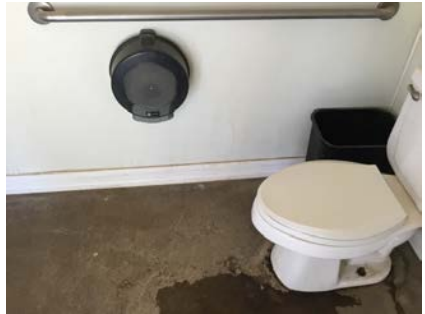
Item no., Rm no. and Name	Existing Architectural Barrier and Proposed Solution	Codes / Mitigation Info	Qty	Unit	Cost	Total
1215	<ul style="list-style-type: none"> As-Built Description: Toilet paper dispenser less than 15" (CA: 19") or more than 48" above floor or not within 7" to 9" from front of water closet (Note: CA pre-2010 is allowed within 12" from front of water closet). As-Built: 11.0" in front. Proposed Solution: Relocate or provide new toilet paper dispenser. 	PCODE WG02 ADAAG 91 4.16.6 ADA 2010 604.7 CBC 2007 1115B.8.4 CBC 2019 11B-604.7 Mitigated: <input type="radio"/> YES <input checked="" type="radio"/> NO	1	JOB	\$225	\$225

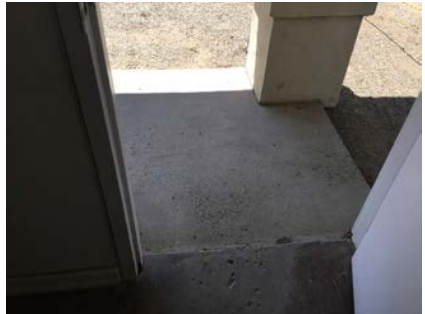
1210	<ul style="list-style-type: none"> As-Built Description: Surface of required maneuvering clearance at door slopes more than 1/4":12" (2.0%). As-Built: 5.0% Proposed Solution: Modify surface slope at door. 	PCODE ID11 ADAAG 91 4.13.6 ADA 2010 404.2.4.4 CBC 2007 1133B.2.4 CBC 2019 11B-404.2.4 Mitigated: <input type="radio"/> YES <input checked="" type="radio"/> NO	25	SF	\$120	\$3,000

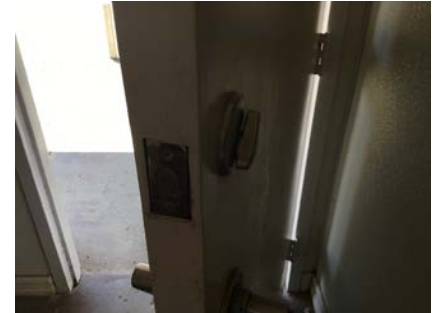
1225	<ul style="list-style-type: none"> • <i>As-Built Description:</i> Door lock, latch or handle less than 34" or more than 48" above the floor (CA only: 34" to 44"). • <i>As-Built:</i> 48.0" high • <i>Proposed Solution:</i> Relocate or replace existing hardware. • <i>Notes:</i> 	<p>PCODE ID17 ADAAG 91 4.13.9 ADA 2010 404.2.7 CBC 2007 1133B.2.5.2 CBC 2019 11B-404.2.7</p> <p>Mitigated: <input type="radio"/> YES <input checked="" type="radio"/> NO</p>	1	JOB	\$900	\$900
------	--	--	---	-----	-------	-------

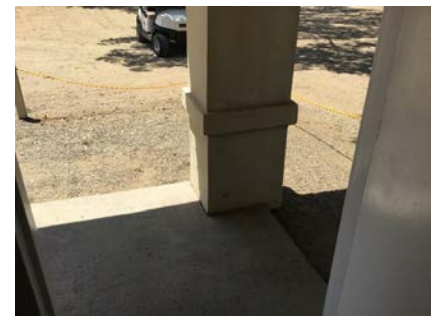
1209	<ul style="list-style-type: none"> • <i>As-Built Description:</i> Front approach: At push side, door does not have clear and level maneuvering space measuring door width x 48" (door width plus 12" if door has both, latch and closer). • <i>As-Built:</i> 38.0" • <i>Proposed Solution:</i> Provide relocated new door and frame; remodel walls as needed. 	<p>PCODE ID24B ADAAG 91 Fig. 25(a) ADA 2010 404.2.4 CBC 2007 11B-26A(a) CBC 2019 11B-404.2.4</p> <p>Mitigated: <input type="radio"/> YES <input checked="" type="radio"/> NO</p>	1	JOB	\$7,800	\$7,800
------	---	--	---	-----	---------	---------

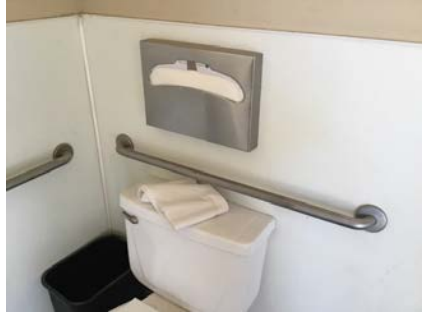
Item no., Rm no. and Name	Existing Architectural Barrier and Proposed Solution	Codes / Mitigation Info	Qty	Unit	Cost	Total
1217	<ul style="list-style-type: none"> As-Built Description: Accessories/dispensers in accessible stall located closer than 1-1/2" below or 12" above grab bar impedes its use. As-Built: SCD: 4.0" above grab bar Proposed Solution: Relocate accessories/dispensers within applicable reach range and to be no closer than 1-1/2" below and 12" above grab bars (except if accessories are recessed, flush with wall, and have no sharp edges). 	PCODE WB07I ADAAG 91 4.26.2 ADA 2010 609.3 CBC 2007 1133B.4.2.5 CBC 2019 11B-609.3 Mitigated: <input type="radio"/> YES <input checked="" type="radio"/> NO	1	JOB	\$225	\$225

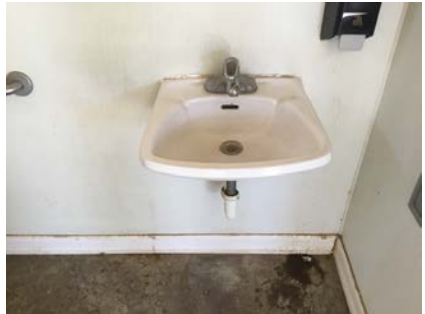
1219	<ul style="list-style-type: none"> As-Built Description: Knee clearance 27" min. high starting 8" back from the front edge of the lavatory towards the wall is not provided. As-Built: 26.8" knee high Proposed Solution: Remount compliant fixture to accessible height. 	PCODE WD04A ADAAG 91 Fig. 31 ADA 2010 306.3.3 CBC 2007 1115B.4.3 CBC 2019 11B-306.3.3 Mitigated: <input type="radio"/> YES <input checked="" type="radio"/> NO	1	JOB	\$3,000	\$3,000

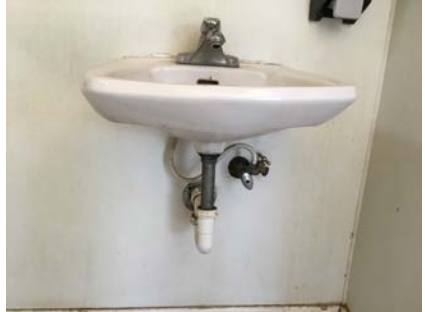
Item no., Rm no. and Name	Existing Architectural Barrier and Proposed Solution	Codes / Mitigation Info	Qty	Unit	Cost	Total
1220	<ul style="list-style-type: none"> <i>As-Built Description:</i> Hot or sharp-surfaced water/drain pipe not insulated or covered. <i>Proposed Solution:</i> Insulate or cover water/drain pipe. 	PCODE WD05 ADAAG 91 4.19.4 ADA 2010 606.5 CBC 2007 1115B.4.3.4 CBC 2019 11B-606.5 Mitigated: <input type="radio"/> YES <input checked="" type="radio"/> NO	1	JOB	\$360	\$360

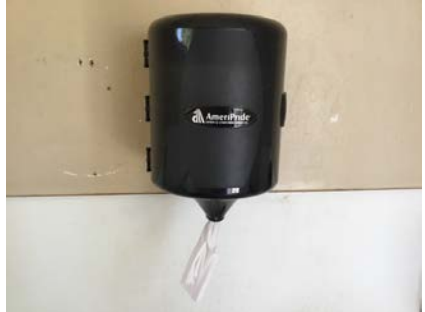
1221	<ul style="list-style-type: none"> <i>As-Built Description:</i> Protruding objects more than 4" from wall, when bottom of object more than 27" or less than 80" above finished floor. <i>As-Built:</i> PTD: 9.0" at 54.0" high <i>Proposed Solution:</i> Remove/relocate protruding object. Patch existing surface. 	PCODE EG04 ADAAG 91 4.4.1 ADA 2010 307.2 CBC 2007 1133B.8.6.1 CBC 2019 11B-307.2 Mitigated: <input type="radio"/> YES <input checked="" type="radio"/> NO	1	JOB	\$300	\$300

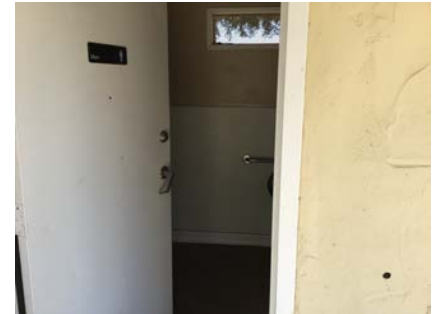
1226	<ul style="list-style-type: none"> <i>As-Built Description:</i> Entrance to toilet or bathing facility not identified with ADAAG compliant signage. <i>Proposed Solution:</i> Provide ADA compliant sign mounted at 48" min. above to baseline of the lowest Braille cells and 60" max. to baseline of the highest line of raised characters on nearest adjacent wall, on latch side of a single door (located not to cause a Braille reader to stand within the door swing). 	PCODE SA11A ADAAG 91 4.1.3(16)(a) ADA 2010 216.8 CBC 2019 11B-216.8	1	JOB	\$270	\$270
------	---	--	---	-----	-------	-------

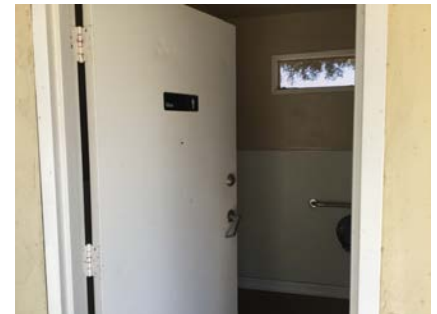
1227	<ul style="list-style-type: none"> <i>As-Built Description:</i> Required in CA only: identification symbol centered 58" to 60" high on sanitary facility door that contrasts with the door not provided (women: 12" ø circle, men: 12" triangle, unisex: combined symbol). <i>Proposed Solution:</i> Provide properly mounted sanitary facility symbol when altering area. If wheelchair accessible, include International Symbol of Accessibility on sign. 	PCODE SA15 CBC 2007 1115B.6 CBC 2019 11B-703.7.2.6	1	JOB	\$270	\$270
------	---	--	---	-----	-------	-------

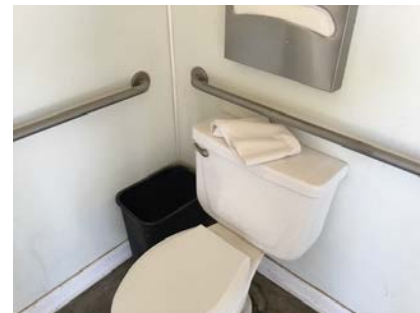
Item no., Rm no. and Name	Existing Architectural Barrier and Proposed Solution	Codes / Mitigation Info	Qty	Unit	Cost	Total
1216	<ul style="list-style-type: none"> <i>As-Built Description:</i> Flush Control: Operating handle not mounted toward wide side of stall. <i>Proposed Solution:</i> Replace flush control with properly mounted accessible type, or install sensor flush. 	PCODE WB10 ADAAG 91 4.16.5 ADA 2010 604.6 CBC 2007 1115B.4.1.5 CBC 2019 11B-604.6 Mitigated: <input type="radio"/> YES <input checked="" type="radio"/> NO	1	JOB	\$1,500	\$1,500
<input type="radio"/> Staff Only						
Priority 3						
Severity 3

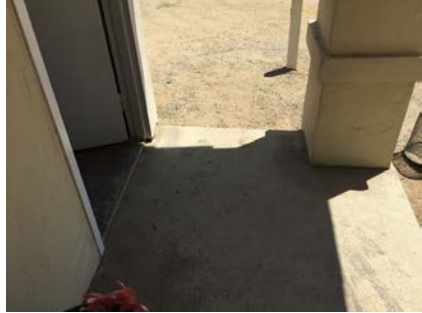
<p>1230</p> <ul style="list-style-type: none"> • <i>As-Built Description:</i> Surface of required maneuvering clearance at door slopes more than 1/4":12" (2.0%). • <i>As-Built:</i> 3.9% • <i>Proposed Solution:</i> Modify surface slope at door. 	<p><i>PCODE ID11</i> <i>ADAAG 91 4.13.6</i> <i>ADA 2010 404.2.4.4</i> <i>CBC 2007 1133B.2.4</i> <i>CBC 2019 11B-404.2.4</i></p> <p>Mitigated: <input type="radio"/> YES <input checked="" type="radio"/> NO</p>	<p>25 SF \$120 \$3,000</p>

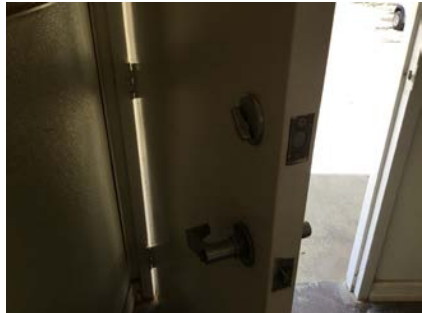
<p>1233</p> <ul style="list-style-type: none"> • <i>As-Built Description:</i> Door lock, latch or handle less than 34" or more than 48" above the floor (CA only: 34" to 44"). • <i>As-Built:</i> 48.5" high • <i>Proposed Solution:</i> Relocate or replace existing hardware. 	<p><i>PCODE ID17</i> <i>ADAAG 91 4.13.9</i> <i>ADA 2010 404.2.7</i> <i>CBC 2007 1133B.2.5.2</i> <i>CBC 2019 11B-404.2.7</i></p> <p>Mitigated: <input type="radio"/> YES <input checked="" type="radio"/> NO</p>	<p>1 JOB \$900 \$900</p>

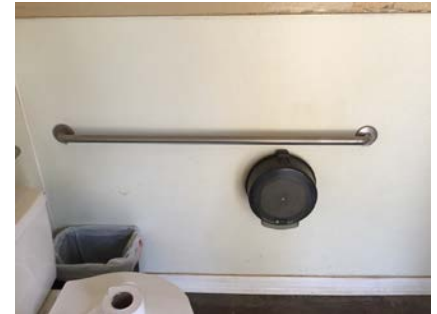
1241	<ul style="list-style-type: none"> <i>As-Built Description:</i> Side grab bar less than 42" long, or located more than 12 inches max. from the rear wall, or extending less than 54" from rear wall (CA only: front end min. 24" in front of water closet). <i>As-Built:</i> Extends 53.75" <i>Proposed Solution:</i> Provide or relocate accessible side grab bar. 	<p>PCODE WB07A ADAAG 91 Fig. 29(b) ADA 2010 604.5.1 CBC 2007 1115B.4.1.3.1 CBC 2019 11B-604.5.1</p> <p>Mitigated: <input type="radio"/> YES <input checked="" type="radio"/> NO</p>	1	JOB	\$780	\$780
------	---	--	---	-----	-------	-------

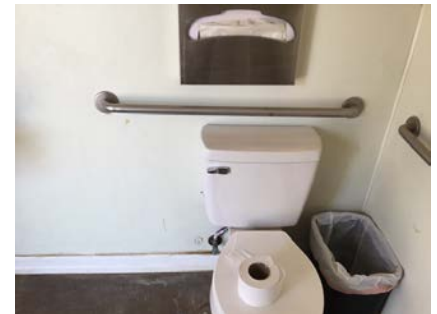
1240	<ul style="list-style-type: none"> <i>As-Built Description:</i> The rear wall grab is less than 36" min. or does not extend from the centerline of the water closet 12" min. on one side and 24" min. on the other side. <i>As-Built:</i> Extends 22.0" on wide side. <i>Proposed Solution:</i> Provide or relocate accessible rear grab bar. 	<p>PCODE WB07B ADAAG 91 4.17.6 ADA 2010 604.5.2 CBC 2007 1115B.4.1.3.2 CBC 2019 11B-604.5.2</p> <p>Mitigated: <input type="radio"/> YES <input checked="" type="radio"/> NO</p>	1	JOB	\$1,020	\$1,020
------	---	--	---	-----	---------	---------

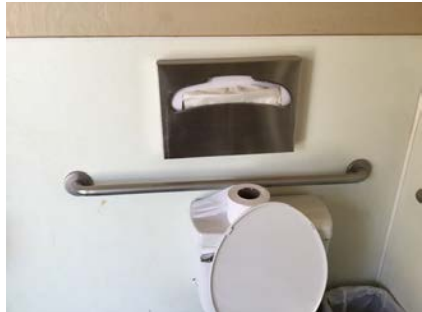
Item no., Rm no. and Name	Existing Architectural Barrier and Proposed Solution	Codes / Mitigation Info	Qty	Unit	Cost	Total
1237	<ul style="list-style-type: none"> <i>As-Built Description:</i> Accessories/dispensers in accessible stall located closer than 1-1/2" below or 12" above grab bar impedes its use. <i>As-Built:</i> SCD: 3.0" above grab bar <i>Proposed Solution:</i> Relocate accessories/dispensers within applicable reach range and to be no closer than 1-1/2" below and 12" above grab bars (except if accessories are recessed, flush with wall, and have no sharp edges). 	PCODE WB07I ADAAG 91 4.26.2 ADA 2010 609.3 CBC 2007 1133B.4.2.5 CBC 2019 11B-609.3 Mitigated: <input type="radio"/> YES <input checked="" type="radio"/> NO	1	JOB	\$225	\$225

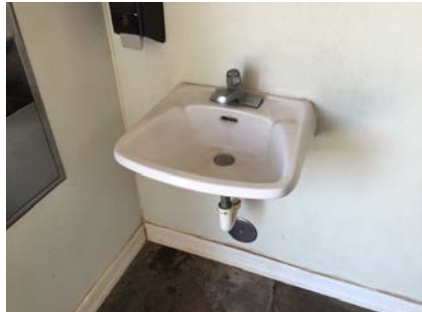
1234	<ul style="list-style-type: none"> <i>As-Built Description:</i> Knee clearance 27" min. high starting 8" back from the front edge of the lavatory towards the wall is not provided. <i>As-Built:</i> 26.8" knee high <i>Proposed Solution:</i> Remount compliant fixture to accessible height. 	PCODE WD04A ADAAG 91 Fig. 31 ADA 2010 306.3.3 CBC 2007 1115B.4.3 CBC 2019 11B-306.3.3 Mitigated: <input type="radio"/> YES <input checked="" type="radio"/> NO	1	JOB	\$3,000	\$3,000

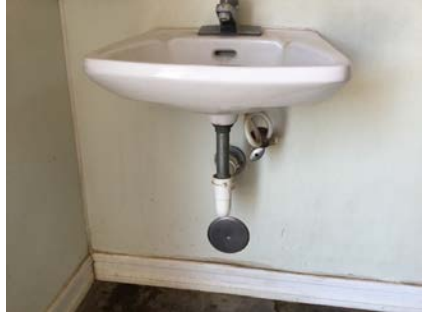
Item no., Rm no. and Name	Existing Architectural Barrier and Proposed Solution	Codes / Mitigation Info	Qty	Unit	Cost	Total
1235	<ul style="list-style-type: none"> <i>As-Built Description:</i> Hot or sharp-surfaced water/drain pipe not insulated or covered. <i>Proposed Solution:</i> Insulate or cover water/drain pipe. 	PCODE WD05 ADAAG 91 4.19.4 ADA 2010 606.5 CBC 2007 1115B.4.3.4 CBC 2019 11B-606.5 Mitigated: <input type="radio"/> YES <input checked="" type="radio"/> NO	1	JOB	\$360	\$360

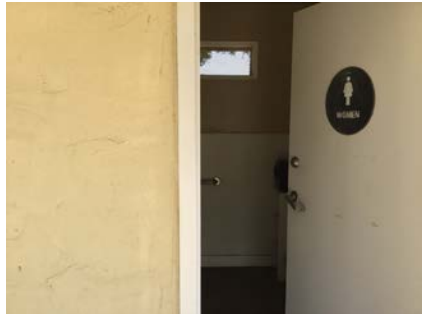
1228	<ul style="list-style-type: none"> <i>As-Built Description:</i> Entrance to toilet or bathing facility not identified with ADAAG compliant signage. <i>Proposed Solution:</i> Provide ADA compliant sign mounted at 48" min. above to baseline of the lowest Braille cells and 60" max. to baseline of the highest line of raised characters on nearest adjacent wall, on latch side of a single door (located not to cause a Braille reader to stand within the door swing). 	PCODE SA11A ADAAG 91 4.1.3(16)(a) ADA 2010 216.8 CBC 2019 11B-216.8 Mitigated: <input type="radio"/> YES <input checked="" type="radio"/> NO	1	JOB	\$270	\$270

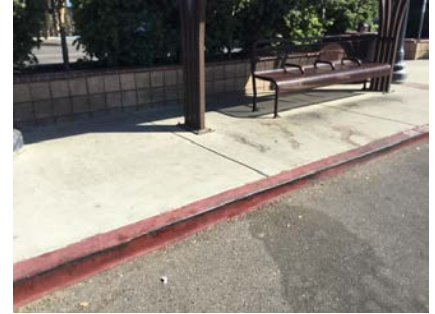
- 444
- *As-Built Description:*
Walk: Pavement dislocation creates abrupt change in level exceeding 1/2" in accessible route.
 - *As-Built:* **0.5" not properly beveled.**
 - *Proposed Solution:*
Remove, replace or repair area of pavement sufficient to correct abrupt change in level.
 - *Notes:*

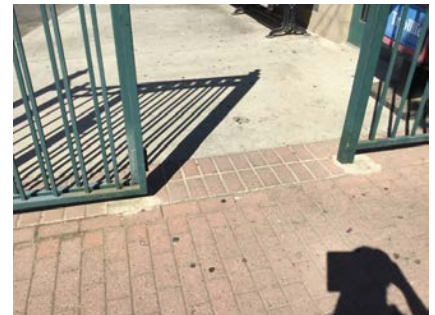
- 446
- *As-Built Description:*
Walk: Pavement dislocation creates abrupt change in level exceeding 1/2" in accessible route.
 - *As-Built:* **1.0"**
 - *Proposed Solution:*
Remove, replace or repair area of pavement sufficient to correct abrupt change in level.

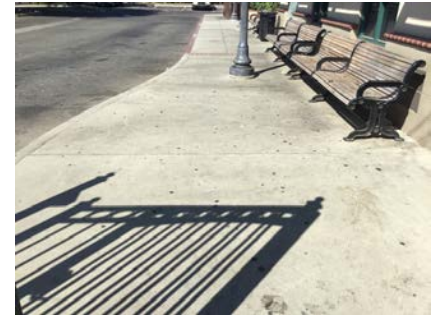
Cross Slope

445	<ul style="list-style-type: none"> As-Built Description: Cross slope more than 1":48" (2.083%). As-Built: Up to 3.1% Proposed Solution: Modify cross slope. 	PCODE EF07 ADAAG 91 4.3.7 ADA 2010 403.3 CBC 2007 1133B.7.1.3 CBC 2019 11B-403.3	100	SF	\$75	\$7,500
-----	---	---	-----	----	------	---------

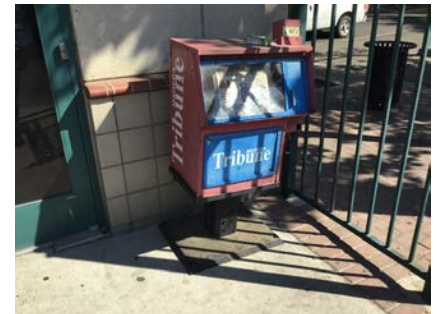
449	<ul style="list-style-type: none"> As-Built Description: Cross slope more than 1":48" (2.083%). Proposed Solution: Relocate existing newspaper stand at a location with compliant clear floor space. 	PCODE EF07NT ADAAG 91 4.3.7 ADA 2010 403.3 CBC 2007 1133B.7.1.3 CBC 2019 11B-403.3	1	JOB	\$150	\$150
-----	--	---	---	-----	-------	-------

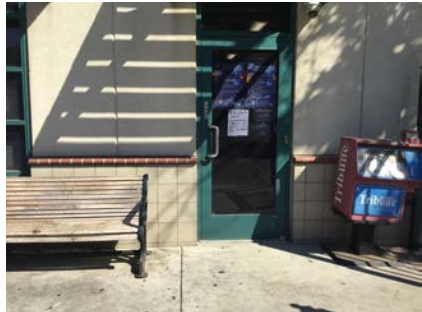
Item no., Rm no. and Name	Existing Architectural Barrier and Proposed Solution	Codes / Mitigation Info	Qty	Unit	Cost	Total
447	<ul style="list-style-type: none"> <i>As-Built Description:</i> Surface of required maneuvering clearance at door slopes more than 1/4":12" (2.0%). <i>As-Built:</i> 2.9% <i>Proposed Solution:</i> Modify surface slope at door. 	PCODE ID11 ADAAG 91 4.13.6 ADA 2010 404.2.4.4 CBC 2007 1133B.2.4 CBC 2019 11B-404.2.4 Mitigated: <input type="radio"/> YES <input checked="" type="radio"/> NO	25	SF	\$120	\$3,000

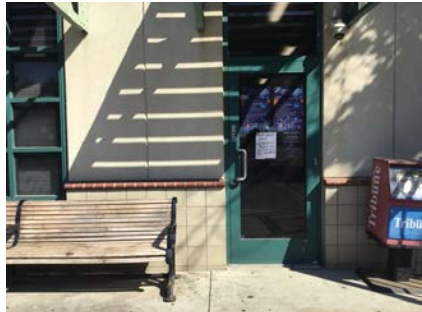
Door Swing

448	<ul style="list-style-type: none"> <i>As-Built Description:</i> Front approach: At pull side, door does not have clear and level maneuvering space measuring door width plus 18" x 60". (24" x 60" at exterior doors). <i>As-Built:</i> 21.0" <i>Proposed Solution:</i> Remove or relocate furniture or storage items. 	PCODE ID23A ADAAG 91 Fig. 25(a) ADA 2010 404.2.4 CBC 2007 11B-26A(a) CBC 2019 11B-404.2.4 Mitigated: <input type="radio"/> YES <input checked="" type="radio"/> NO	1	JOB	\$150	\$150

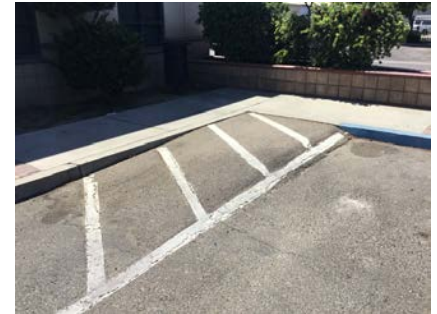
387	<ul style="list-style-type: none"> As-Built Description: Accessible parking space has slope greater than 1/4":12" (2%). As-Built: 7.9% Proposed Solution: Modify slope at accessible parking space. 	PCODE EA05 ADAAG 91 4.6.3 ADA 2010 502.4 CBC 2007 1129B.3.3 CBC 2019 11B-502.4	80	SF	\$36	\$2,880
-----	---	--	----	----	------	---------

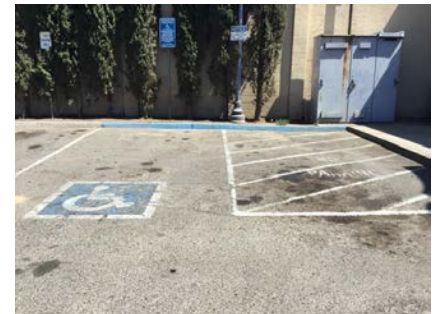
391	<ul style="list-style-type: none"> As-Built Description: Accessible parking space has slope greater than 1/4":12" (2%). As-Built: Up to 7.0% Proposed Solution: Modify slope at accessible parking space. 	PCODE EA05 ADAAG 91 4.6.3 ADA 2010 502.4 CBC 2007 1129B.3.3 CBC 2019 11B-502.4	200	SF	\$36	\$7,200
-----	---	--	-----	----	------	---------

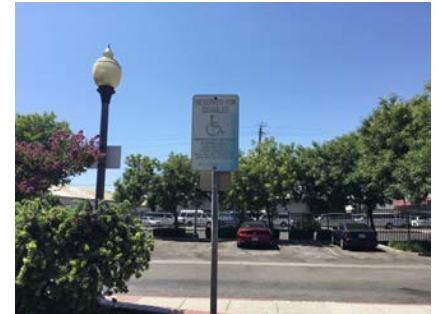
- 388
- *As-Built Description:*
Sign for accessible parking space is missing or non-compliant.
 - *Proposed Solution:*
Provide compliant parking signage.
 - **Notes:**

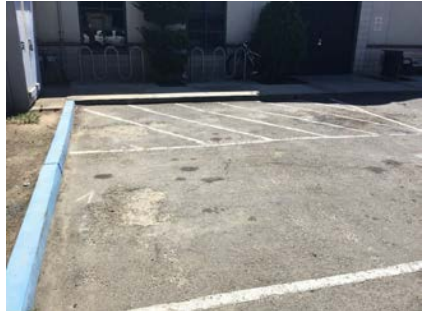
Item no., Rm no. and Name	Existing Architectural Barrier and Proposed Solution	Codes / Mitigation Info	Qty	Unit	Cost	Total
385	<ul style="list-style-type: none"> <i>As-Built Description:</i> An accessible parking space shall be outlined or painted blue (required in CA only). <i>Proposed Solution:</i> Identify accessible parking space using blue markings. 	PCODE EA04K CBC 2019 11B-502.6 Mitigated: <input type="radio"/> YES <input checked="" type="radio"/> NO	2	JOB	\$360	\$720

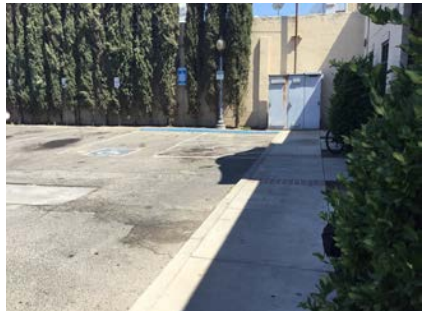
<input type="radio"/> Staff Only			
			Priority <input checked="" type="radio"/> 1			
			Severity <input checked="" type="radio"/> 3			
393	<ul style="list-style-type: none"> <i>As-Built Description:</i> Accessible parking space(s) not located close to the nearest possible entrance on an accessible route. <i>Proposed Solution:</i> Relocate accessible parking space(s). <i>Notes:</i> 	PCODE EA06 ADAAG 91 4.6.2 ADA 2010 208.3 CBC 2007 1129B.1 CBC 2019 11B-208.3.1 Mitigated: <input type="radio"/> YES <input checked="" type="radio"/> NO	1	JOB	\$3,000	\$3,000

<input type="radio"/> Staff Only			
			Priority <input checked="" type="radio"/> 1			
			Severity <input checked="" type="radio"/> 3			
<p>Circuitous route to entrance.</p>

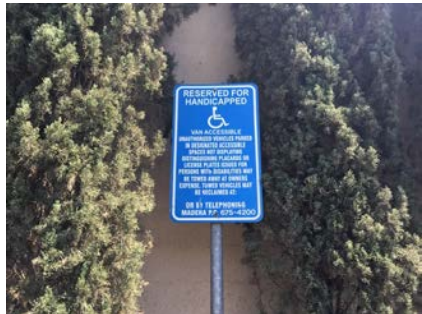
390	<ul style="list-style-type: none"> <i>As-Built Description:</i> CA only: Additional Sign or additional language below the symbol of accessibility stating "Minimum Fine \$250" not provided. <i>Proposed Solution:</i> Provide compliant parking signage that includes fine information. 	<p>PCODE EA04G</p> <p>CBC 2007 1129B.4</p> <p>CBC 2019 11B-502.6.2</p> <p>Mitigated:</p> <p><input type="radio"/> YES</p> <p><input checked="" type="radio"/> NO</p>	2	JOB	\$300	\$600
-----	--	--	---	-----	-------	-------

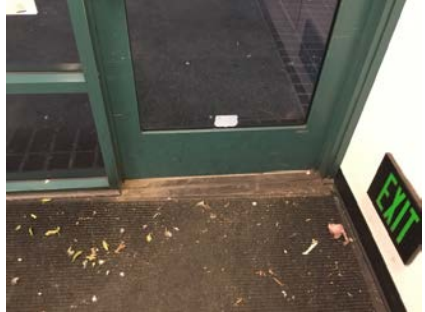
Item no., Rm no. and Name	Existing Architectural Barrier and Proposed Solution	Codes / Mitigation Info	Qty	Unit	Cost	Total
430	<ul style="list-style-type: none"> As-Built Description: Door inaccessible due to threshold or step at door exceeding 1/2". As-Built: 0.75" Proposed Solution: Modify threshold. 	PCODE ID02A ADAAG 91 4.13.8 ADA 2010 404.2.5 CBC 2007 1133B.2.4.1 CBC 2019 11B-404.2.5 Mitigated: <input type="radio"/> YES <input checked="" type="radio"/> NO	5	JOB	\$1,200	\$6,000

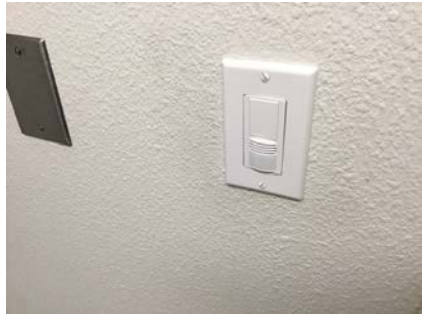
Electrical

442	<ul style="list-style-type: none"> As-Built Description: Electric switch or control mounted less than 15" measured to the bottom of the outlet box or greater than 48 inches measured to the top of the outlet box. As-Built: 48.0" to switch. 49.0" to top of box. Proposed Solution: Relocate light switches or control to between 15" and 48" height. Notes: 	PCODE IC01 ADAAG 91 4.2.5 & 6 ADA 2010 308.2.1 & 308.2.2 CBC 2007 1117B.6.3 CBC 2019 11B-308.2.1 & 11B-308.2.2 Mitigated: <input type="radio"/> YES <input checked="" type="radio"/> NO	1	JOB	\$900	\$900

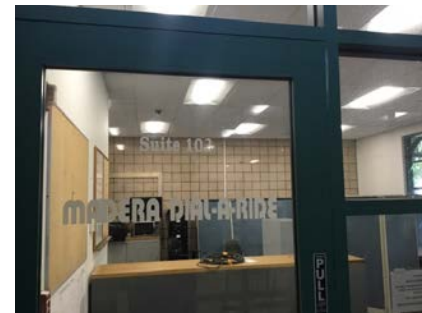
Item no., Rm no. and Name	Existing Architectural Barrier and Proposed Solution	Codes / Mitigation Info	Qty	Unit	Cost	Total
443	<ul style="list-style-type: none"> <i>As-Built Description:</i> Existing sign designating permanent room or space is noncompliant. <i>Proposed Solution:</i> Provide compliant signage. 	PCODE SA13 ADAAG 91 4.1.3(16)(a) ADA 2010 216.2 CBC 2007 1117B.5 CBC 2019 11B-216.2 Mitigated: <input type="radio"/> YES <input checked="" type="radio"/> NO	5	JOB	\$450	\$2,250

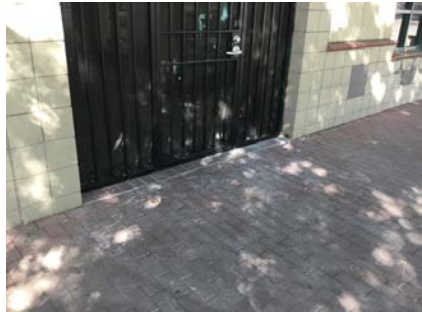
Item no., Rm no. and Name	Existing Architectural Barrier and Proposed Solution	Codes / Mitigation Info	Qty	Unit	Cost	Total
450	<ul style="list-style-type: none"> As-Built Description: Surface of required maneuvering clearance at door slopes more than 1/4":12" (2.0%). As-Built: 2.7% Proposed Solution: Modify surface slope at door. 	PCODE ID11 ADAAG 91 4.13.6 ADA 2010 404.2.4.4 CBC 2007 1133B.2.4 CBC 2019 11B-404.2.4 Mitigated: <input type="radio"/> YES <input checked="" type="radio"/> NO	20	SF	\$120	\$2,400

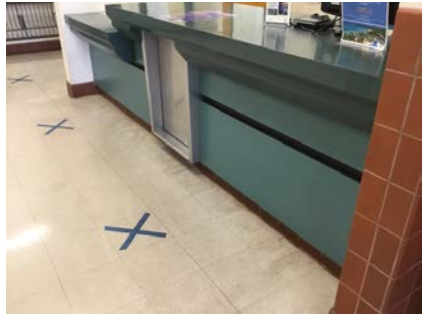
Item no., Rm no. and Name	Existing Architectural Barrier and Proposed Solution	Codes / Mitigation Info	Qty	Unit	Cost	Total
399	<ul style="list-style-type: none"> As-Built Description: Protruding objects more than 4" from wall, when bottom of object more than 27" or less than 80" above finished floor. As-Built: Service counter: 8.0" at 39.0" high Proposed Solution: Provide cane-detectable railing to mark area of low clearance. 	PCODE EG04A ADAAG 91 4.4.1 ADA 2010 307.2 CBC 2007 1133B.8.6.1 CBC 2019 11B-307.2 Mitigated: <input type="radio"/> YES <input checked="" type="radio"/> NO	12	LF	\$300	\$3,600

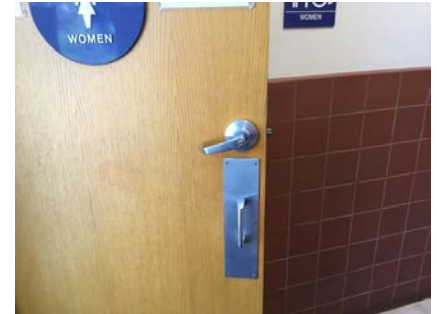
- 403 • *As-Built Description:*
Door lock, latch or handle less than 34" or more than 48" above the floor (CA only: 34" to 44").
- *As-Built:* **46.5" high**
- *Proposed Solution:*
Relocate or replace existing hardware.
- *Notes:*

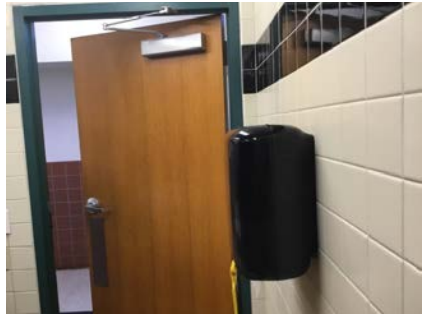
Item no., Rm no. and Name	Existing Architectural Barrier and Proposed Solution	Codes / Mitigation Info	Qty	Unit	Cost	Total
416	<ul style="list-style-type: none"> <i>As-Built Description:</i> Front approach: At push side, door does not have clear and level maneuvering space measuring door width x 48" (door width plus 12" if door has both, latch and closer). <i>Proposed Solution:</i> Relocate dispenser. 	PCODE ID24A ADAAG 91 Fig. 25(a) ADA 2010 404.2.4 CBC 2007 11B-26A(a) CBC 2019 11B-404.2.4 Mitigated: <input type="radio"/> YES <input checked="" type="radio"/> NO	1	JOB	\$150	\$150

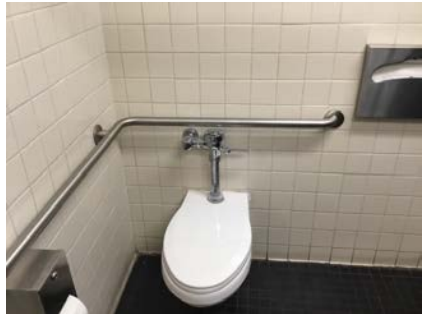
Grab Bars

413	<ul style="list-style-type: none"> <i>As-Built Description:</i> The rear wall grab is less than 36" min. or does not extend from the centerline of the water closet 12" min. on one side and 24" min. on the other side. <i>As-Built:</i> Extends 20.0" on wide side. <i>Proposed Solution:</i> Provide new accessible rear grab bar. <i>Notes:</i> 	PCODE WB07B ADAAG 91 4.17.6 ADA 2010 604.5.2 CBC 2007 1115B.4.1.3.2 CBC 2019 11B-604.5.2 Mitigated: <input type="radio"/> YES <input checked="" type="radio"/> NO	1	JOB	\$1,020	\$1,020

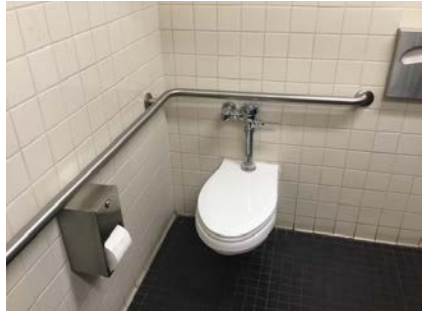
Item no., Rm no. and Name	Existing Architectural Barrier and Proposed Solution	Codes / Mitigation Info	Qty	Unit	Cost	Total
412	<ul style="list-style-type: none"> As-Built Description: Grab bars not at 33" to 36" from floor As-Built: 32.75" Proposed Solution: Relocate accessible grab bars. 	PCODE WB07C ADAAG 91 4.16.4 ADA 2010 609.4 CBC 2007 1115B.4.1.3.1 & 2 CBC 2019 11B-609.4 Mitigated: <input type="radio"/> YES <input checked="" type="radio"/> NO	1	JOB	\$780	\$780

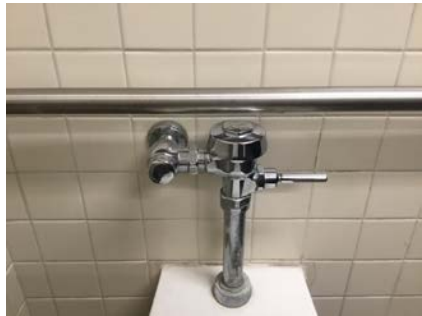
<input type="radio"/> Staff Only			
			Priority 3			
			Severity 4			
411	<ul style="list-style-type: none"> As-Built Description: Accessories/dispensers in accessible stall located closer than 1-1/2" below or 12" above grab bar impedes its use. As-Built: 0.5 below the grab bar Proposed Solution: Relocate accessories/dispensers to be no closer than 1-1/2" below and 12" above grab bars (except if accessories are recessed, flush with wall, and have no sharp edges). 	PCODE WB07I ADAAG 91 4.26.2 ADA 2010 609.3 CBC 2007 1133B.4.2.5 CBC 2019 11B-609.3 Mitigated: <input type="radio"/> YES <input checked="" type="radio"/> NO	1	JOB	\$225	\$225

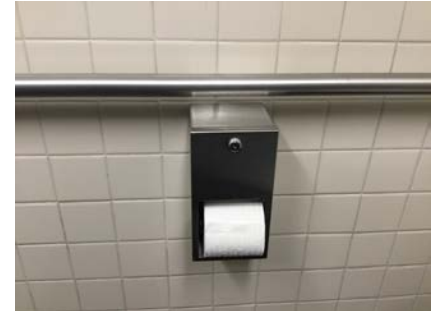
Item no., Rm no. and Name	Existing Architectural Barrier and Proposed Solution	Codes / Mitigation Info	Qty	Unit	Cost	Total
414	<ul style="list-style-type: none"> <i>As-Built Description:</i> Accessories/dispensers in accessible stall located closer than 1-1/2" below or 12" above grab bar impedes its use. <i>As-Built:</i> 1.25" <i>Proposed Solution:</i> Relocate accessories/dispensers to be no closer than 1-1/2" below and 12" above grab bars (except if accessories are recessed, flush with wall, and have no sharp edges). 	PCODE WB07I ADAAG 91 4.26.2 ADA 2010 609.3 CBC 2007 1133B.4.2.5 CBC 2019 11B-609.3 Mitigated: <input type="radio"/> YES <input checked="" type="radio"/> NO	1	JOB	\$225	\$225

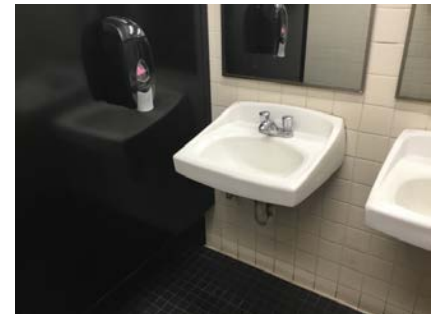
Lavatory

404	<ul style="list-style-type: none"> <i>As-Built Description:</i> Clear floor space, 30" x 48" in front of fixture, extending 19" max. under the lavatory, not provided (CA only: Less than 18" from side wall to centerline of lavatory). <i>As-Built:</i> 15.0" o.c. <i>Proposed Solution:</i> Relocate existing lavatory. <i>Notes:</i> 	PCODE WD01A ADAAG 91 4.19.3 ADA 2010 606.2 CBC 2007 1115B.4.3 CBC 2019 11B-606.2, 11B-606.6 Mitigated: <input type="radio"/> YES <input checked="" type="radio"/> NO	1	JOB	\$2,700	\$2,700
-----	---	--	---	-----	---------	----------------

This element complies with Safe Harbor if altered or constructed before March 15, 2012. The dimensional requirements in this CBC citation applied from the 2007 CBC to the code cycle at the time of this survey.

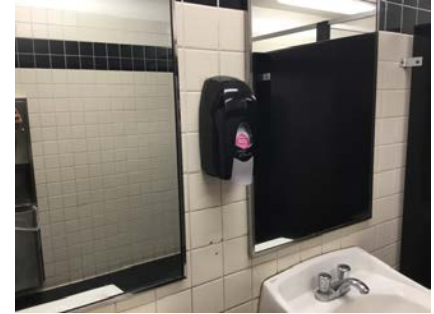
Accessories

419	<ul style="list-style-type: none"> <i>As-Built Description:</i> Dispensers in sanitary facilities, such as for towels, soap, sanitary napkins, seat covers, etc., and waste receptacles more than 48" (CA only: 40") from floor to highest operating slot or control. <i>As-Built:</i> SD: 51.0" high <i>Proposed Solution:</i> Relocate existing restroom accessories. 	<p>PCODE WG01A ADAAG 91 4.23.7 ADA 2010 308.2.1 CBC 2007 1115B.8.3 CBC 2019 11B-603.5</p> <p>Mitigated: <input type="radio"/> YES <input checked="" type="radio"/> NO</p>	1	JOB	\$300	\$300
-----	---	--	---	-----	-------	--------------

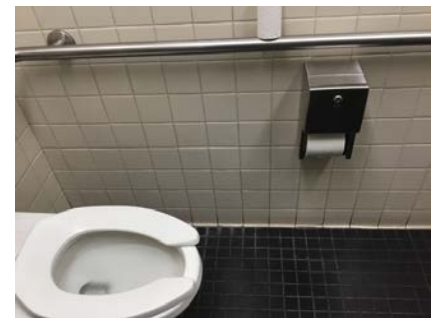
424	<ul style="list-style-type: none"> <i>As-Built Description:</i> Toilet paper dispenser less than 15" (CA: 19") or more than 48" above floor or not within 7" to 9" from front of water closet (Note: CA pre-2010 is allowed within 12" from front of water closet). <i>As-Built:</i> 14.0" in front. <i>Proposed Solution:</i> Relocate or provide new toilet paper dispenser. 	<p>PCODE WG02 ADAAG 91 4.16.6 ADA 2010 604.7 CBC 2007 1115B.8.4 CBC 2019 11B-604.7</p> <p>Mitigated: <input type="radio"/> YES <input checked="" type="radio"/> NO</p>	1	JOB	\$225	\$225
-----	--	---	---	-----	-------	--------------

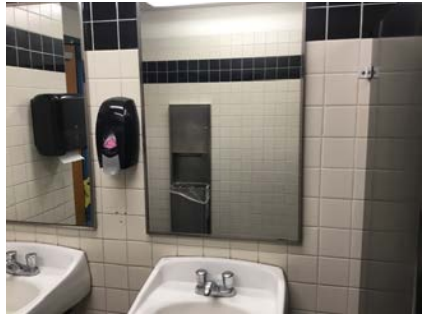
Item no., Rm no. and Name	Existing Architectural Barrier and Proposed Solution	Codes / Mitigation Info	Qty	Unit	Cost	Total
428	<ul style="list-style-type: none"> As-Built Description: Bottom of mirror located above lavatories or countertops more than 40" above floor. As-Built: 40.5" high Proposed Solution: Relocate or provide new accessible mirror. 	PCODE WG03 ADAAG 91 4.19.6 ADA 2010 603.3 CBC 2007 1115B.8.1 CBC 2019 11B-603.3 Mitigated: <input type="radio"/> YES <input checked="" type="radio"/> NO	1	JOB	\$450	\$450

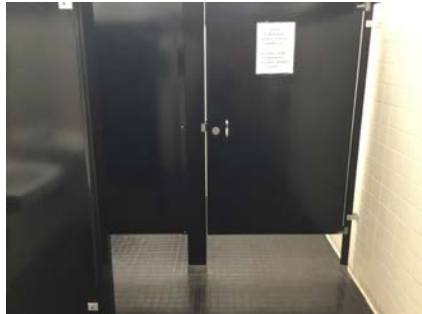
Door Swing

423	<ul style="list-style-type: none"> As-Built Description: Front approach: At pull side, door does not have clear and level maneuvering space measuring door width plus 18" x 60". (24" x 60" at exterior doors). As-Built: 15.0" Proposed Solution: Change door swing. Notes: 	PCODE ID23 ADAAG 91 Fig. 25(a) ADA 2010 404.2.4 CBC 2007 11B-26A(a) CBC 2019 11B-404.2.4 Mitigated: <input type="radio"/> YES <input checked="" type="radio"/> NO	1	JOB	\$1,500	\$1,500

Arguably, the door swings into the urinal clear floor space.

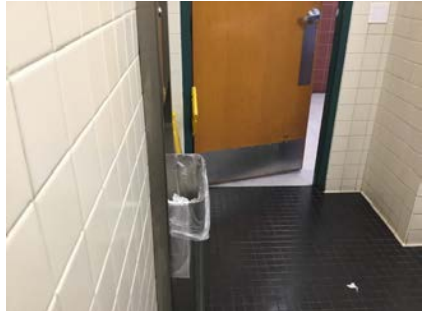
Item no., Rm no. and Name	Existing Architectural Barrier and Proposed Solution	Codes / Mitigation Info	Qty	Unit	Cost	Total
418	<ul style="list-style-type: none"> • <i>As-Built Description:</i> Front approach: At push side, door does not have clear and level maneuvering space measuring door width x 48" (door width plus 12" if door has both, latch and closer). • <i>As-Built:</i> 34.5" • <i>Proposed Solution:</i> Relocate trash can. 	PCODE ID24A ADAAG 91 Fig. 25(a) ADA 2010 404.2.4 CBC 2007 11B-26A(a) CBC 2019 11B-404.2.4 Mitigated: <input type="radio"/> YES <input checked="" type="radio"/> NO	1	JOB	\$150	\$150

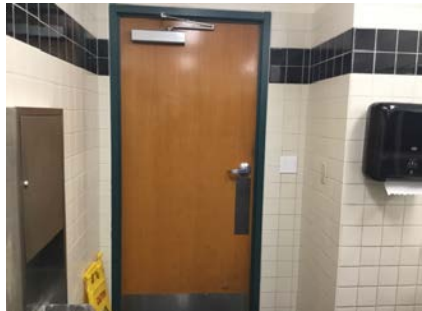
<input type="radio"/> Staff Only			
			Priority <input checked="" type="radio"/> 3			
			Severity <input checked="" type="radio"/> 2			
429	<ul style="list-style-type: none"> • <i>As-Built Description:</i> Front approach: At push side, door does not have clear and level maneuvering space measuring door width x 48" (door width plus 12" if door has both, latch and closer). • <i>Proposed Solution:</i> Provide door operator. 	PCODE ID24C ADAAG 91 Fig. 25(a) ADA 2010 404.2.4 CBC 2007 11B-26A(a) CBC 2019 11B-404.2.4 Mitigated: <input type="radio"/> YES <input checked="" type="radio"/> NO	1	JOB	\$15,000	\$15,000

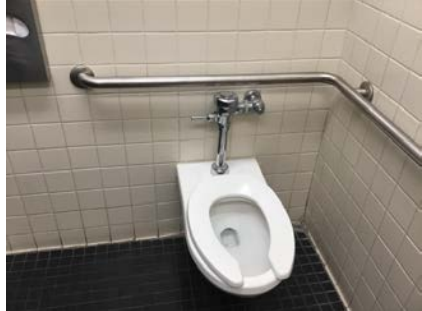
Grab Bars

<p>427</p> <ul style="list-style-type: none"> <i>As-Built Description:</i> The rear wall grab is less than 36" min. or does not extend from the centerline of the water closet 12" min. on one side and 24" min. on the other side. <i>As-Built:</i> Extends 20.0" on wide side. <i>Proposed Solution:</i> Provide new accessible rear grab bar. <i>Notes:</i> 	<p>PCODE WB07B ADAAG 91 4.17.6 ADA 2010 604.5.2 CBC 2007 1115B.4.1.3.2 CBC 2019 11B-604.5.2</p> <p>Mitigated: <input type="radio"/> YES <input checked="" type="radio"/> NO</p>	<p>1 JOB \$1,020 \$1,020</p>

This element complies with Safe Harbor if altered or constructed before March 15, 2012. .

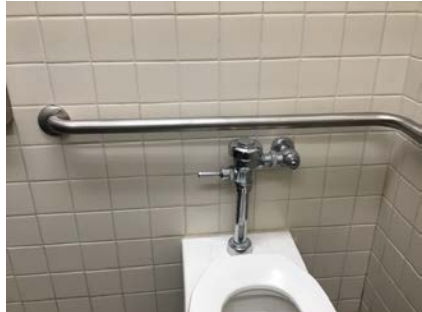
<p>425</p> <ul style="list-style-type: none"> <i>As-Built Description:</i> Accessories/dispensers in accessible stall located closer than 1-1/2" below or 12" above grab bar impedes its use. <i>As-Built:</i> 1.0" <i>Proposed Solution:</i> Relocate accessories/dispensers to be no closer than 1-1/2" below and 12" above grab bars (except if accessories are recessed, flush with wall, and have no sharp edges). 	<p>PCODE WB07I ADAAG 91 4.26.2 ADA 2010 609.3 CBC 2007 1133B.4.2.5 CBC 2019 11B-609.3</p> <p>Mitigated: <input type="radio"/> YES <input checked="" type="radio"/> NO</p>	<p>1 JOB \$225 \$225</p>

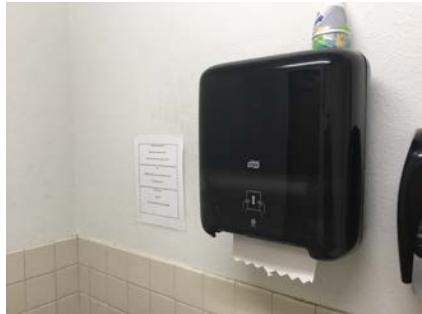
Item no., Rm no. and Name	Existing Architectural Barrier and Proposed Solution	Codes / Mitigation Info	Qty	Unit	Cost	Total
438	<ul style="list-style-type: none"> <i>As-Built Description:</i> Protruding objects more than 4" from wall, when bottom of object more than 27" or less than 80" above finished floor. <i>As-Built:</i> PTD: 8.0" at 54.0" high <i>Proposed Solution:</i> Remove/relocate protruding object. Patch existing surface. 	PCODE EG04 ADAAG 91 4.4.1 ADA 2010 307.2 CBC 2007 1133B.8.6.1 CBC 2019 11B-307.2 Mitigated: <input type="radio"/> YES <input checked="" type="radio"/> NO	1	JOB	\$300	\$300

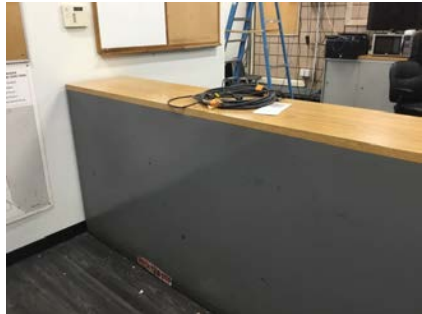
Public Counter

431	<ul style="list-style-type: none"> <i>As-Built Description:</i> Service counter (stand-up): Accessible section min. 36" length and 36" max. height (in CA: 28" to 34" high) not provided. <i>As-Built:</i> 42.0" high <i>Proposed Solution:</i> Retrofit existing counter to provide accessible section. Interim solution: Provide auxiliary counter, table, or clipboard. 	PCODE IN03 ADAAG 91 7.2(2) ADA 2010 904.4 CBC 2007 1122B.4 CBC 2019 11B-904.4 Mitigated: <input type="radio"/> YES <input checked="" type="radio"/> NO	1	JOB	\$6,000	\$6,000

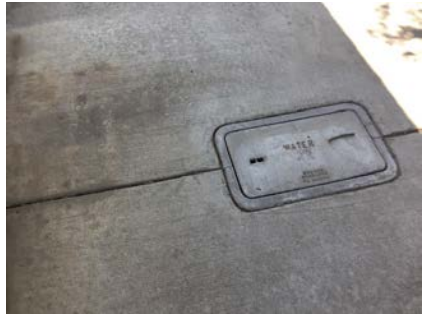
Item no., Rm no. and Name	Existing Architectural Barrier and Proposed Solution	Codes / Mitigation Info	Qty	Unit	Cost	Total
928	<ul style="list-style-type: none"> As-Built Description: Walk: opening greater than 1/2" along the line of traffic flow. As-Built: 0.75" Proposed Solution: Correct opening 1/2" max. along the line of traffic flow. 	PCODE EF04 ADAAG 91 4.3.6; 4.5.4 ADA 2010 403.2; 302.3 CBC 2007 1133B.7.2 CBC 2019 11B-403.2; 11B-302.3 Mitigated: <input type="radio"/> YES <input checked="" type="radio"/> NO	2	SF	\$240	\$480

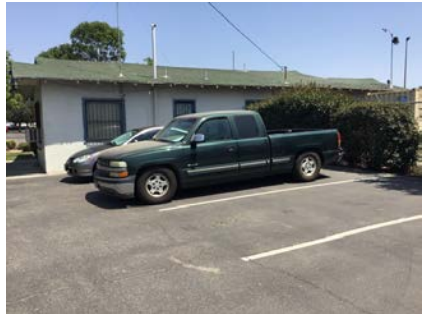
Minimum Number

929	<ul style="list-style-type: none"> As-Built Description: At parking lot with 1-25 spaces, the number of accessible spaces is less than required by code; 1 space required Proposed Solution: Provide required accessible parking space with sign including a minimum of one van space. Notes: 	PCODE EA01A ADAAG 91 4.1.2(5) ADA 2010 208.2 CBC 2007 Tbl. 11B-6 CBC 2019 11B-208.2 Tbl. 11B-208.2 Mitigated: <input type="radio"/> YES <input checked="" type="radio"/> NO	1	JOB	\$900	\$900

No accessible parking provided.

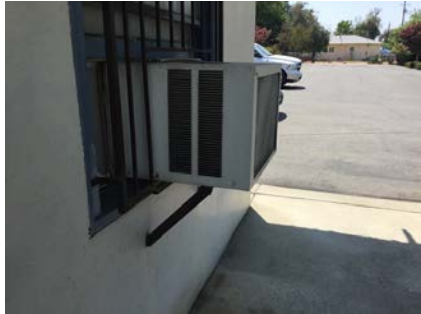
Protrusion Limits

926	<ul style="list-style-type: none"> <i>As-Built Description:</i> Protruding objects more than 4" from wall, when bottom of object more than 27" or less than 80" above finished floor. <i>As-Built:</i> AC unit: 18.0" at 39.0" high <i>Proposed Solution:</i> Remove/relocate protruding object. Patch existing surface. 	<p>PCODE EG04</p> <p>ADAAG 91 4.4.1</p> <p>ADA 2010 307.2</p> <p>CBC 2007 1133B.8.6.1</p> <p>CBC 2019 11B-307.2</p> <p>Mitigated:</p> <p><input type="radio"/> YES</p> <p><input checked="" type="radio"/> NO</p>	1	JOB	\$300	\$300
-----	--	---	---	-----	-------	-------

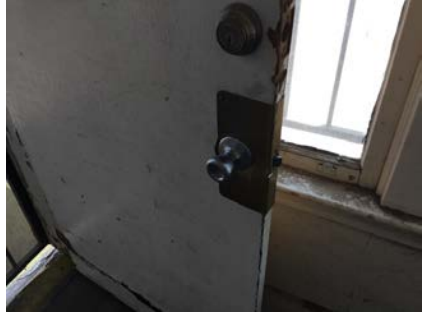
Door Hardware

918	<ul style="list-style-type: none"> • <i>As-Built Description:</i> Door does not have accessible operating hardware. • <i>Proposed Solution:</i> Provide lever handle or other accessible hardware. 	<p>PCODE ID07</p> <p>ADAAG 91 4.13.9</p> <p>ADA 2010 404.2.7</p> <p>CBC 2007 1133B.2.5.2</p> <p>CBC 2019 11B-404.2.7</p> <p>Mitigated:</p> <p><input type="radio"/> YES</p> <p><input checked="" type="radio"/> NO</p>	7	JOB	\$450	\$3,150
-----	--	--	---	-----	-------	---------

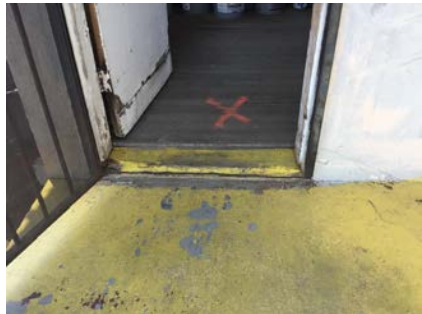
Door Threshold

920	<ul style="list-style-type: none"> • <i>As-Built Description:</i> Door inaccessible due to threshold or step at door exceeding 1/2". • <i>As-Built:</i> Roughly 3.0" • <i>Proposed Solution:</i> Modify threshold to be no more than 1/2" by removing existing paving at door and providing landing with edge ramping (slope 1:20 max). • <i>Notes:</i> 	<p>PCODE ID02A</p> <p>ADAAG 91 4.13.8</p> <p>ADA 2010 404.2.5</p> <p>CBC 2007 1133B.2.4.1</p> <p>CBC 2019 11B-404.2.5</p> <p>Mitigated:</p> <p><input type="radio"/> YES</p> <p><input checked="" type="radio"/> NO</p>	3	JOB	\$1,200	\$3,600
-----	--	---	---	-----	---------	---------

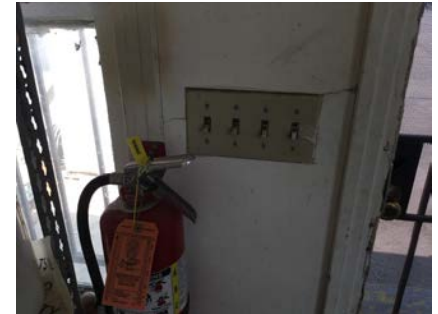
Electrical

919	<ul style="list-style-type: none"> As-Built Description: Electric switch or control mounted less than 15" measured to the bottom of the outlet box or greater than 48 inches measured to the top of the outlet box. As-Built: 49.0" to top of box Proposed Solution: Relocate light switches or control to between 15" and 48" height. Notes: 	PCODE IC01 ADAAG 91 4.2.5 & 6 ADA 2010 308.2.1 & 308.2.2 CBC 2007 1117B.6.3 CBC 2019 11B-308.2.1 & 11B-308.2.2 Mitigated: <input type="radio"/> YES <input checked="" type="radio"/> NO	6	JOB	\$900	\$5,400
-----	--	--	---	-----	-------	---------

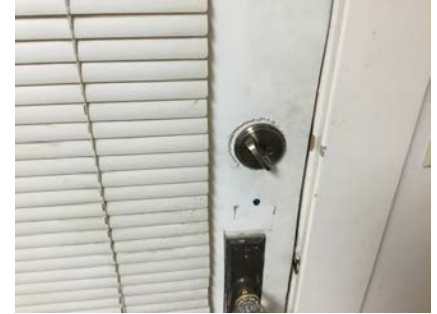
- *As-Built Description:*
Door lock, latch or handle less than 34" or more than 48" above the floor (CA only: 34" to 44").
- *As-Built:* **48.0" high**
- *Proposed Solution:*
Relocate or replace existing hardware.
- *Notes:*

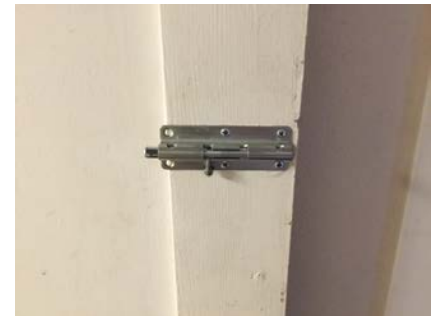
- *As-Built Description:*
Door lock, latch or handle less than 34" or more than 48" above the floor (CA only: 34" to 44").
- *As-Built:* **54.0" high**
- *Proposed Solution:*
Relocate or replace existing hardware.

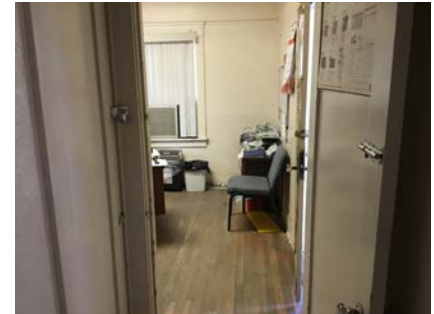
Door Swing

909	<ul style="list-style-type: none"> • <i>As-Built Description:</i> Front approach: At pull side, door does not have clear and level maneuvering space measuring door width plus 18" x 60". (24" x 60" at exterior doors). • <i>As-Built:</i> 6.0" • <i>Proposed Solution:</i> Remove the door. 	<p>PCODE ID23 ADAAG 91 Fig. 25(a) ADA 2010 404.2.4 CBC 2007 11B-26A(a) CBC 2019 11B-404.2.4</p> <p>Mitigated: <input type="radio"/> YES <input checked="" type="radio"/> NO</p>	1	JOB	\$1,500	\$1,500
-----	---	--	---	-----	---------	---------

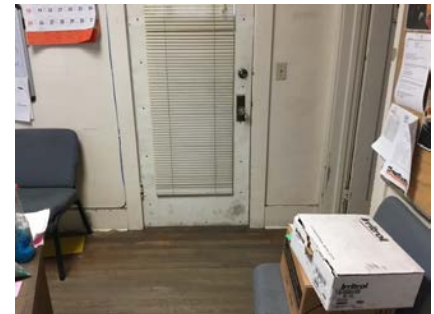
906	<ul style="list-style-type: none"> • <i>As-Built Description:</i> Front approach: At pull side, door does not have clear and level maneuvering space measuring door width plus 18" x 60". (24" x 60" at exterior doors). • <i>Proposed Solution:</i> Remove or relocate furniture or storage items. 	<p>PCODE ID23A ADAAG 91 Fig. 25(a) ADA 2010 404.2.4 CBC 2007 11B-26A(a) CBC 2019 11B-404.2.4</p> <p>Mitigated: <input type="radio"/> YES <input checked="" type="radio"/> NO</p>	1	JOB	\$150	\$150
-----	---	---	---	-----	-------	-------

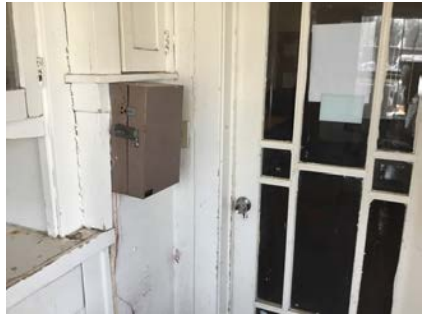
Item no., Rm no. and Name	Existing Architectural Barrier and Proposed Solution	Codes / Mitigation Info	Qty	Unit	Cost	Total
914	<ul style="list-style-type: none"> As-Built Description: Protruding objects more than 4" from wall, when bottom of object more than 27" or less than 80" above finished floor. As-Built: Drop box: 5.0" at 42.0" high Proposed Solution: Remove/relocate protruding object. Patch existing surface. 	PCODE EG04 ADAAG 91 4.4.1 ADA 2010 307.2 CBC 2007 1133B.8.6.1 CBC 2019 11B-307.2 Mitigated: <input type="radio"/> YES <input checked="" type="radio"/> NO	1	JOB	\$300	\$300

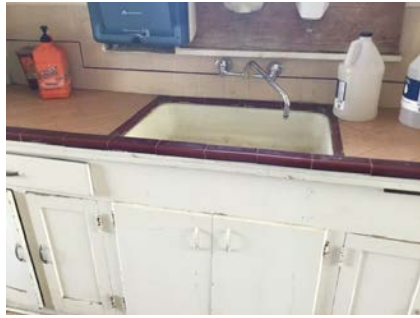
Item no., Rm no. and Name	Existing Architectural Barrier and Proposed Solution	Codes / Mitigation Info	Qty	Unit	Cost	Total
915	<p>Sink</p> <ul style="list-style-type: none"> As-Built Description: Sink rim higher than 34" above floor. As-Built: 36.5" high Proposed Solution: Remodel sink cabinet to lower sink. 	<p>PCODE IN06 ADAAG 91 4.24.2 ADA 2010 606.3 CBC 2007 1115B.4.7.1 CBC 2019 11B-606.3</p> <p>Mitigated: <input type="radio"/> YES <input checked="" type="radio"/> NO</p>	1	JOB	\$5,250	\$5,250

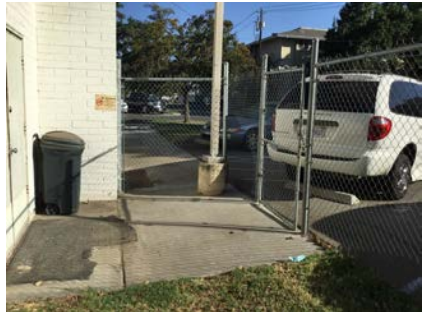
The slope is also noncompliant as a ramp.

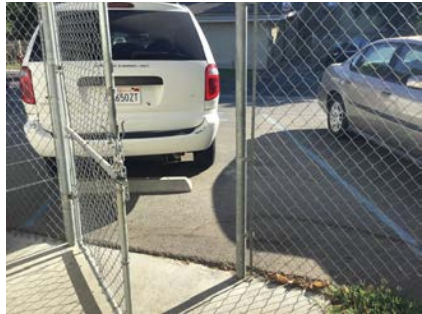
Item no., Rm no. and Name	Existing Architectural Barrier and Proposed Solution	Codes / Mitigation Info	Qty	Unit	Cost	Total
955	<ul style="list-style-type: none"> <i>As-Built Description:</i> Front approach: At push side, door does not have clear and level maneuvering space measuring door width x 48" (door width plus 12" if door has both, latch and closer). <i>Proposed Solution:</i> Remove or relocate furniture or storage items. 	PCODE ID24A ADAAG 91 Fig. 25(a) ADA 2010 404.2.4 CBC 2007 11B-26A(a) CBC 2019 11B-404.2.4 Mitigated: <input type="radio"/> YES <input checked="" type="radio"/> NO	1	JOB	\$150	\$150

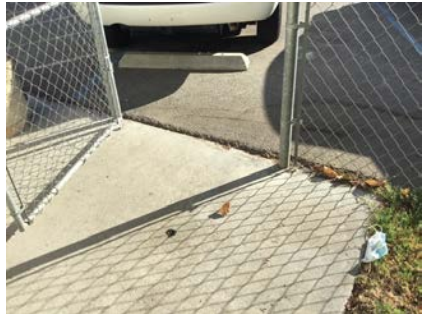
Door Threshold

953	<ul style="list-style-type: none"> <i>As-Built Description:</i> Door inaccessible due to threshold or step at door exceeding 1/2". <i>As-Built:</i> 2.0" <i>Proposed Solution:</i> Modify threshold. 	PCODE ID02A ADAAG 91 4.13.8 ADA 2010 404.2.5 CBC 2007 1133B.2.4.1 CBC 2019 11B-404.2.5 Mitigated: <input type="radio"/> YES <input checked="" type="radio"/> NO	1	JOB	\$1,200	\$1,200

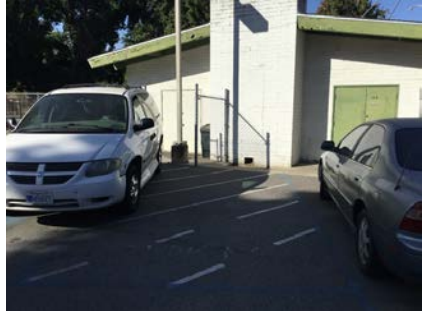
961	<ul style="list-style-type: none"> <i>As-Built Description:</i> Sign for accessible parking space is missing or non-compliant. <i>Proposed Solution:</i> Provide compliant parking signage. 	PCODE EA04B ADAAG 91 4.6.4 ADA 2010 502.6 CBC 2007 1129B.4 CBC 2019 11B-502.6 Mitigated: <input type="radio"/> YES <input checked="" type="radio"/> NO	2	JOB	\$945	\$1,890
-----	---	---	---	-----	-------	---------

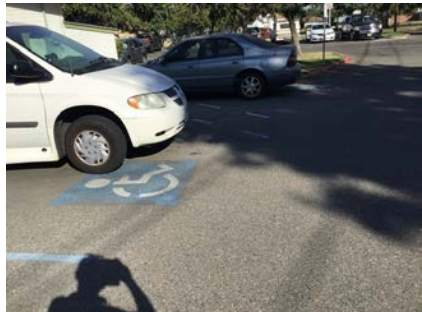
Parking

959	<ul style="list-style-type: none"> <i>As-Built Description:</i> Accessible parking space smaller than 8' wide (CA only: 9' x 18'). <i>As-Built:</i> 11.0' to 15.0'. Aisle is not even with space. <i>Proposed Solution:</i> Modify parking space(s) to create accessible space. <i>Notes:</i> 	PCODE EA02A ADAAG 91 4.6.3 ADA 2010 502.2 CBC 2007 1129B.3.1 CBC 2019 11B-502.2 Mitigated: <input type="radio"/> YES <input checked="" type="radio"/> NO	2	JOB	\$600	\$1,200
-----	--	---	---	-----	-------	---------

Occurs at both spaces.

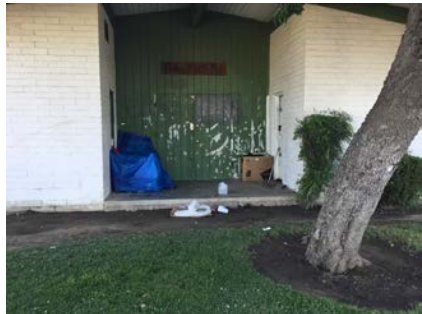
Signage

962	<ul style="list-style-type: none"> <i>As-Built Description:</i> Exterior signage at inaccessible entrances to provide direction to accessible entrances is missing or noncompliant. <i>Proposed Solution:</i> Provide signage sufficient to guide persons to accessible entrances. 	<p>PCODE SA01</p> <p>ADAAG 91 4.1.2(7)(c)</p> <p>ADA 2010 216.6</p> <p>CBC 2007 1117B.5.8.1.2</p> <p>CBC 2019 11B-216.6</p> <p>Mitigated:</p> <p><input type="radio"/> YES</p> <p><input checked="" type="radio"/> NO</p>	1	JOB	\$690	\$690
-----	--	---	---	-----	-------	-------

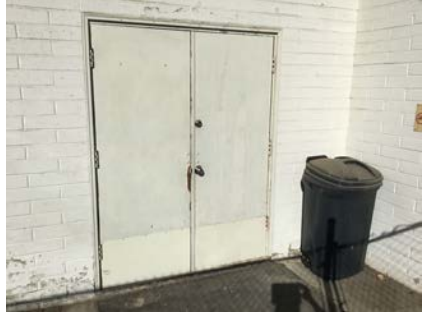
Item no., Rm no. and Name	Existing Architectural Barrier and Proposed Solution	Codes / Mitigation Info	Qty	Unit	Cost	Total
957	<ul style="list-style-type: none"> As-Built Description: Sign showing the International Symbol of Accessibility (ISA) not provided at all accessible building entrances. Proposed Solution: Provide building entrance signage with ISA signage at accessible entrance. Notes: 	PCODE SA12A ADAAG 91 28 CFR 35.163 ADA 2010 (b) 216.6 CBC 2007 1127B.3 CBC 2019 11B-216.6 Mitigated: <input type="radio"/> YES <input checked="" type="radio"/> NO	1	JOB	\$150	\$150

No ISA at “accessible “ door. Only applies if door is made accessible.

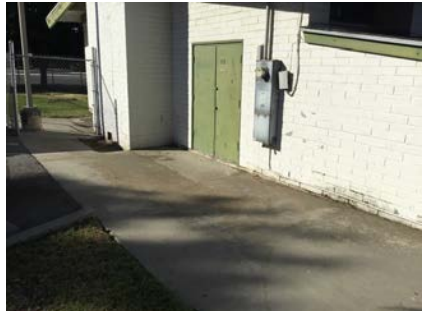
Walk

956	<ul style="list-style-type: none"> As-Built Description: Walk: Slope greater than 1:20 (5.0%), and walk does not comply with requirements for ramps. As-Built: 10.0% Proposed Solution: Modify walk/sidewalk slope to 1:20 or less. Or install directional signage. 	PCODE EF01 ADAAG 91 4.3.7 ADA 2010 403.3 CBC 2007 1133B.7.3 CBC 2019 11B-403.3 Mitigated: <input type="radio"/> YES <input checked="" type="radio"/> NO	50	SF	\$75	\$3,750

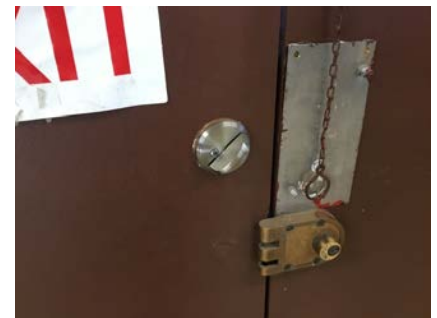
- 936
- *As-Built Description:*
Door lock, latch or handle less than 34" or more than 48" above the floor (CA only: 34" to 44").
 - *As-Built:* **52.0" high**
 - *Proposed Solution:*
Relocate or replace existing hardware.

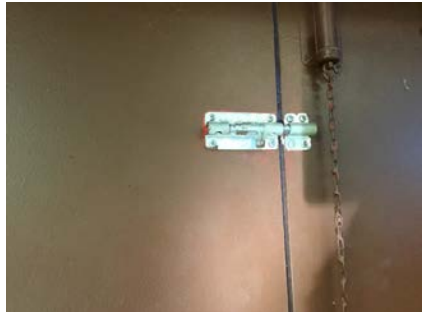
Item no., Rm no. and Name	Existing Architectural Barrier and Proposed Solution	Codes / Mitigation Info	Qty	Unit	Cost	Total
937	<ul style="list-style-type: none"> As-Built Description: Door lock, latch or handle less than 34" or more than 48" above the floor (CA only: 34" to 44"). As-Built: 71.0" high Proposed Solution: Relocate or replace existing hardware. 	PCODE ID17 ADAAG 91 4.13.9 ADA 2010 404.2.7 CBC 2007 1133B.2.5.2 CBC 2019 11B-404.2.7 Mitigated: <input type="radio"/> YES <input checked="" type="radio"/> NO	1	JOB	\$900	\$900

<input type="radio"/> Staff Only						
Priority <input checked="" type="radio"/> 2						
Severity <input checked="" type="radio"/> 2

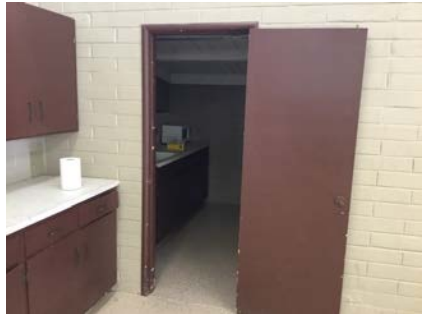
Door Clearance

938	<ul style="list-style-type: none"> As-Built Description: Door on accessible route has less than 32" clear and 80" (78" min. to closer if provided) opening width when 90° open. As-Built: 25.0" to 28.0" clear Proposed Solution: Provide new, larger door and frame with new accessible hardware. Notes: 	PCODE ID01 ADAAG 91 4.13.5 ADA 2010 404.2.3 CBC 2007 1133B.1.1.1.1 CBC 2019 11B-404.2.3 Mitigated: <input type="radio"/> YES <input checked="" type="radio"/> NO	7	JOB	\$7,800	\$54,600

<input type="radio"/> Staff Only						
Priority <input checked="" type="radio"/> 2						
Severity <input checked="" type="radio"/> 2

Includes rear exit doors.

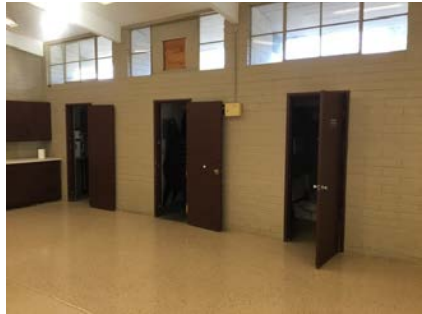
Item no., Rm no. and Name	Existing Architectural Barrier and Proposed Solution	Codes / Mitigation Info	Qty	Unit	Cost	Total
939	<ul style="list-style-type: none"> As-Built Description: Door on accessible route has less than 32" clear and 80" (78" min. to closer if provided) opening width when 90° open. As-Built: 78.25" high Proposed Solution: Provide new, larger door and frame with new accessible hardware. 	PCODE ID01 ADAAG 91 4.13.5 ADA 2010 404.2.3 CBC 2007 1133B.1.1.1.1 CBC 2019 11B-404.2.3 Mitigated: <input type="radio"/> YES <input checked="" type="radio"/> NO	5	JOB	\$7,800	\$39,000

<input type="radio"/> Staff Only						
Priority 2						
Severity 4

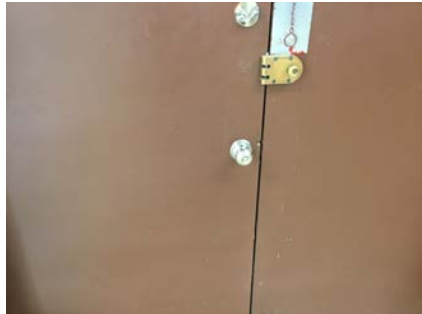
Door Hardware

935	<ul style="list-style-type: none"> As-Built Description: Door does not have accessible operating hardware. Proposed Solution: Provide lever handle or other accessible hardware. 	PCODE ID07 ADAAG 91 4.13.9 ADA 2010 404.2.7 CBC 2007 1133B.2.5.2 CBC 2019 11B-404.2.7 Mitigated: <input type="radio"/> YES <input checked="" type="radio"/> NO	9	JOB	\$450	\$4,050

<input type="radio"/> Staff Only						
Priority 2						
Severity 3
