APPENDIX B: ACCESS COMPLIANCE SURVEY REPORT OF FACILITIES

The City of Madera

Access Compliance Survey Report

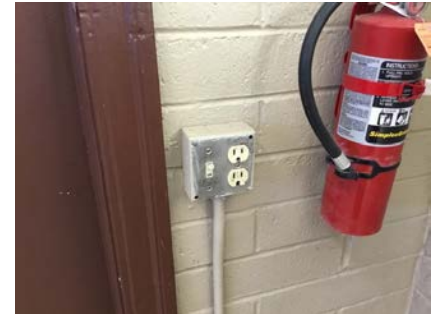
Electrical

932	<ul style="list-style-type: none"> As-Built Description: Electric switch or control mounted less than 15" measured to the bottom of the outlet box or greater than 48 inches measured to the top of the outlet box. As-Built: 50.5" to top of box Proposed Solution: Relocate light switches or control to between 15" and 48" height. Notes: 	PCODE IC01 ADAAG 91 4.2.5 & 6 ADA 2010 308.2.1 & 308.2.2 CBC 2007 1117B.6.3 CBC 2019 11B-308.2.1 & 11B-308.2.2 Mitigated: <input type="radio"/> YES <input checked="" type="radio"/> NO	2	JOB	\$900	\$1,800
-----	--	--	---	-----	-------	---------

Priority **2**

This element complies with Safe Harbor if altered or constructed before March 15, 2012. The dimensional requirements in this CBC citation applied from the 2010 CBC to the code cycle at the time of this survey.

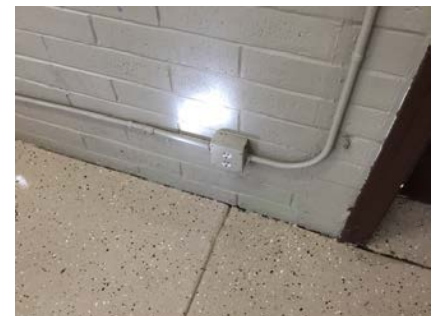
933	<ul style="list-style-type: none"> As-Built Description: Electric switch or control mounted less than 15" measured to the bottom of the outlet box or greater than 48 inches measured to the top of the outlet box. As-Built: 14.0" to the high plug 11.0" to bottom of box Proposed Solution: Relocate light switches or control to between 15" and 48" height. Notes: 	PCODE IC01 ADAAG 91 4.2.5 & 6 ADA 2010 308.2.1 & 308.2.2 CBC 2007 1117B.6.3 CBC 2019 11B-308.2.1 & 11B-308.2.2 Mitigated: <input type="radio"/> YES <input checked="" type="radio"/> NO	2	JOB	\$900	\$1,800
-----	---	--	---	-----	-------	---------

Priority **2**

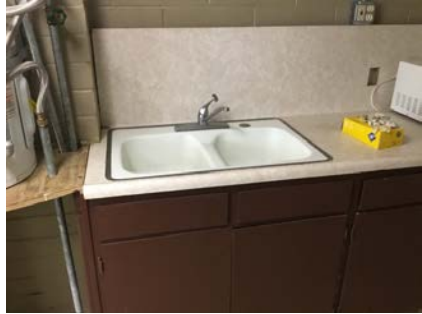
Item no., Rm no. and Name	Existing Architectural Barrier and Proposed Solution	Codes / Mitigation Info	Qty	Unit	Cost	Total
946	<p>Sink</p> <ul style="list-style-type: none"> As-Built Description: Sink rim higher than 34" above floor. As-Built: 36.5" high Proposed Solution: Remodel sink cabinet to lower sink. 	<p>PCODE IN06 ADAAG 91 4.24.2 ADA 2010 606.3 CBC 2007 1115B.4.7.1 CBC 2019 11B-606.3</p> <p>Mitigated: <input type="radio"/> YES <input checked="" type="radio"/> NO</p>	1	JOB	\$5,250	\$5,250

<p><input type="radio"/> Staff Only</p> <p>Priority 4</p> <p>Severity 4</p>

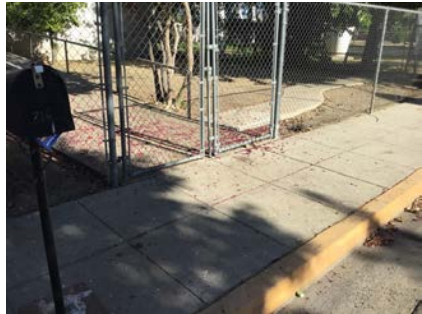
Item no., Rm no. and Name	Existing Architectural Barrier and Proposed Solution	Codes / Mitigation Info	Qty	Unit	Cost	Total
167	<ul style="list-style-type: none"> As-Built Description: Surface of required maneuvering clearance at door slopes more than 1/4":12" (2.0%). As-Built: 3.5% Proposed Solution: Modify surface slope at door. 	PCODE ID11 ADAAG 91 4.13.6 ADA 2010 404.2.4.4 CBC 2007 1133B.2.4 CBC 2019 11B-404.2.4 Mitigated: <input type="radio"/> YES <input checked="" type="radio"/> NO	25	SF	\$120	\$3,000

<input type="radio"/> Staff Only						
Priority <input checked="" type="radio"/> 1						
Severity <input checked="" type="radio"/> 4

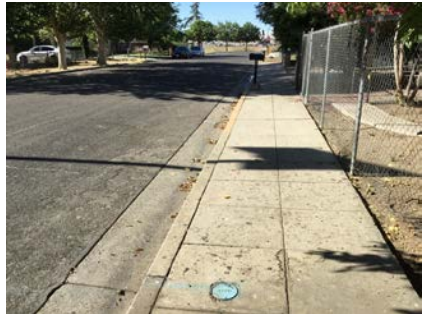
Floor or Ground Surfaces

170	<ul style="list-style-type: none"> As-Built Description: Accessible parking space has slope greater than 1/4":12" (2%). As-Built: 3.7% on asphalt. 7% at gutter. Proposed Solution: Modify slope at accessible parking space. 	PCODE EA05 ADAAG 91 4.6.3 ADA 2010 502.4 CBC 2007 1129B.3.3 CBC 2019 11B-502.4 Mitigated: <input type="radio"/> YES <input checked="" type="radio"/> NO	162	SF	\$36	\$5,832

<input type="radio"/> Staff Only						
Priority <input checked="" type="radio"/> 1						
Severity <input checked="" type="radio"/> 2

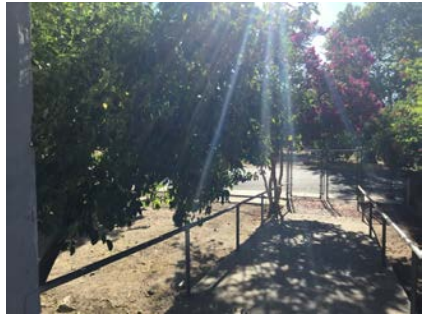
Item no., Rm no. and Name	Existing Architectural Barrier and Proposed Solution	Codes / Mitigation Info	Qty	Unit	Cost	Total
161	<ul style="list-style-type: none"> <i>As-Built Description:</i> Protruding objects more than 4" from wall, when bottom of object more than 27" or less than 80" above finished floor. <i>Proposed Solution:</i> Trim vegetation. 	PCODE EG04 ADAAG 91 4.4.1 ADA 2010 307.2 CBC 2007 1133B.8.6.1 CBC 2019 11B-307.2 Mitigated: <input type="radio"/> YES <input checked="" type="radio"/> NO	2	JOB	\$300	\$600

<input type="radio"/> Staff Only						
Priority <input checked="" type="radio"/> 1						
Severity <input checked="" type="radio"/> 2

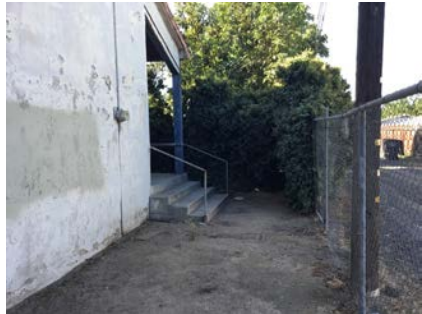
Signage

159	<ul style="list-style-type: none"> <i>As-Built Description:</i> Exterior signage at inaccessible entrances to provide direction to accessible entrances is missing or noncompliant. <i>Proposed Solution:</i> Provide signage sufficient to guide persons to accessible entrances. <i>Notes:</i> 	PCODE SA01 ADAAG 91 4.1.2(7)(c) ADA 2010 216.6 CBC 2007 1117B.5.8.1.2 CBC 2019 11B-216.6 Mitigated: <input type="radio"/> YES <input checked="" type="radio"/> NO	1	JOB	\$690	\$690

<input type="radio"/> Staff Only						
Priority <input checked="" type="radio"/> 1						
Severity <input checked="" type="radio"/> 3

Place outside fence and at either end of alley.

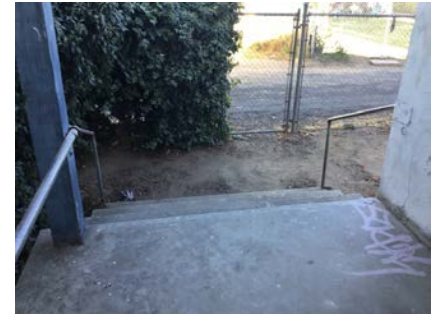
Stairways

157	<ul style="list-style-type: none"> As-Built Description: Exterior stair substantially out of compliance. As-Built: Uneven risers, handrails etc. Proposed Solution: Provide complete new stair, 4 ft. wide with landing and handrails. 	PCODE EC09 ADAAG 91 4.9 ADA 2010 504 CBC 2007 1133B.4 CBC 2019 11B-504	40	IN	\$270	\$10,800
-----	--	--	----	----	-------	----------

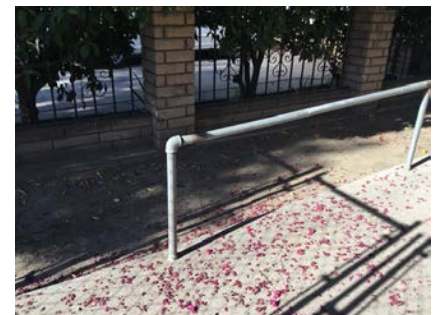
Top and Bottom Extension at

162	<ul style="list-style-type: none"> As-Built Description: Ramp handrail does not extend horizontally 12" past top and / or bottom of ramp. Proposed Solution: Provide ramp handrail extension (cost for each extension piece). 	PCODE ED05 ADAAG 91 4.8.5(2) ADA 2010 505.10.1 CBC 2007 1133B.4.2.2 & 1133B.5.5.1 CBC 2019 11B-505.10.1	4	JOB	\$510	\$2,040
-----	---	---	---	-----	-------	---------

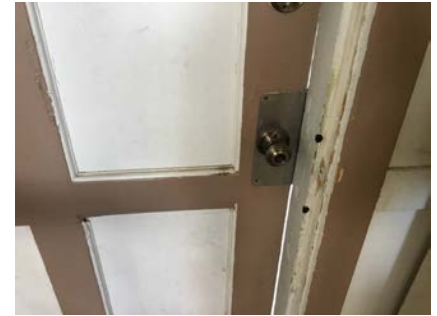
Door Hardware

132	<ul style="list-style-type: none"> • <i>As-Built Description:</i> Door does not have accessible operating hardware. • <i>Proposed Solution:</i> Provide lever handle or other accessible hardware. 	<p>PCODE ID07</p> <p>ADAAG 91 4.13.9</p> <p>ADA 2010 404.2.7</p> <p>CBC 2007 1133B.2.5.2</p> <p>CBC 2019 11B-404.2.7</p>	6	JOB	\$450	\$2,700
-----	--	--	---	-----	-------	---------

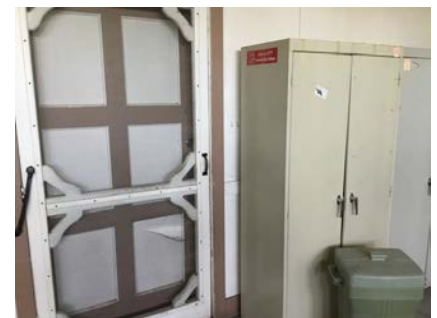
Door Swing

135	<ul style="list-style-type: none"> • <i>As-Built Description:</i> Front approach: At push side, door does not have clear and level maneuvering space measuring door width x 48" (door width plus 12" if door has both, latch and closer). • <i>Proposed Solution:</i> Remove or relocate furniture or storage items. 	<p>PCODE ID24A</p> <p>ADAAG 91 Fig. 25(a)</p> <p>ADA 2010 404.2.4</p> <p>CBC 2007 11B-26A(a)</p> <p>CBC 2019 11B-404.2.4</p>	1	JOB	\$150	\$150
-----	--	--	---	-----	-------	-------

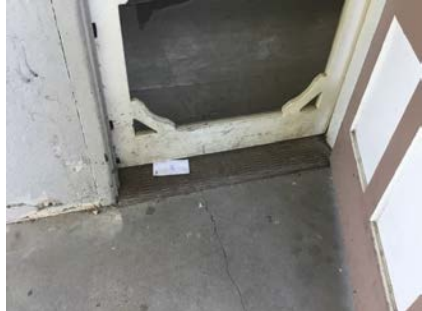
Door Threshold

<p>143</p> <ul style="list-style-type: none"> As-Built Description: Existing threshold at door is 1/2" high or less but without a beveled edge on both sides. As-Built: Not beveled properly. Proposed Solution: Replace threshold. 	<p>PCODE ID02 ADAAG 91 4.1.6(3)(d)(ii) ADA 2010 404.2.5 CBC 2007 1133B.2.4.1 CBC 2019 11B-404.2.5</p> <p>Mitigated: <input type="radio"/> YES <input checked="" type="radio"/> NO</p>	<p>3 JOB \$750 \$2,250</p>

<p><input type="radio"/> Staff Only</p> <p>Priority <input checked="" type="radio"/> 2 Severity <input checked="" type="radio"/> 1</p>
---	---	---

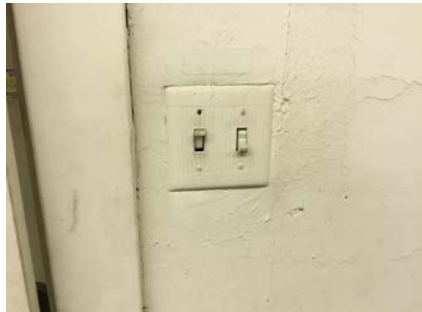
Electrical

<p>133</p> <ul style="list-style-type: none"> As-Built Description: Electric switch or control mounted less than 15" measured to the bottom of the outlet box or greater than 48 inches measured to the top of the outlet box. As-Built: 53.5" high Proposed Solution: Relocate light switches or control to between 15" and 48" height. Notes: 	<p>PCODE IC01 ADAAG 91 4.2.5 & 6 ADA 2010 308.2.1 & 308.2.2 CBC 2007 1117B.6.3 CBC 2019 11B-308.2.1 & 11B-308.2.2</p> <p>Mitigated: <input type="radio"/> YES <input checked="" type="radio"/> NO</p>	<p>3 JOB \$900 \$2,700</p>

<p><input type="radio"/> Staff Only</p> <p>Priority <input checked="" type="radio"/> 4 Severity <input checked="" type="radio"/> 4</p>
--	---	---

This element complies with Safe Harbor if altered or constructed before March 15, 2012. This element does not comply with the dimensional requirements in the 1981 to the current CBC.

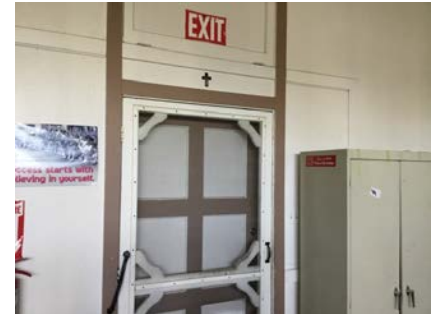
Signage

137	<ul style="list-style-type: none"> <i>As-Built Description:</i> At door leading into exit stairway: Where required exit signs are installed, signs to provide exiting information for people with vision impairment are not provided. <i>Proposed Solution:</i> Provide raised letter/Braille "EXIT RAMP/STAIR DOWN" sign at door. 	<p>PCODE SA10B ADAAG 91 4.1.3(16) ADA 2010 216.4.1 CBC 2007 1011.3 CBC 2019 11B-216.4.1</p> <p>Mitigated: <input type="radio"/> YES <input checked="" type="radio"/> NO</p>	2	JOB	\$270	\$540
-----	--	---	---	-----	-------	-------

Priority **2**

Severity **3**

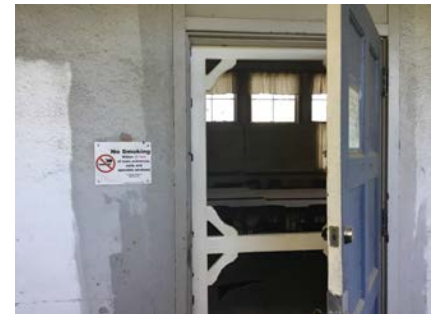
153	<ul style="list-style-type: none"> <i>As-Built Description:</i> Existing sign designating permanent room or space is noncompliant. <i>Proposed Solution:</i> Provide compliant signage. 	<p>PCODE SA13 ADAAG 91 4.1.3(16)(a) ADA 2010 216.2 CBC 2007 1117B.5 CBC 2019 11B-216.2</p> <p>Mitigated: <input type="radio"/> YES <input checked="" type="radio"/> NO</p>	7	JOB	\$450	\$3,150
-----	---	--	---	-----	-------	---------

Priority **2**

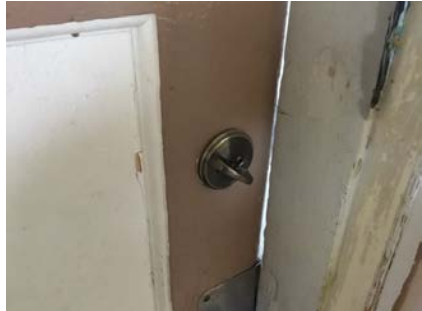
Item no., Rm no. and Name	Existing Architectural Barrier and Proposed Solution	Codes / Mitigation Info	Qty	Unit	Cost	Total
139	<ul style="list-style-type: none"> • <i>As-Built Description:</i> Door lock, latch or handle less than 34" or more than 48" above the floor (CA only: 34" to 44"). • <i>As-Built:</i> 50.0" high • <i>Proposed Solution:</i> Relocate or replace existing hardware. 	PCODE ID17 ADAAG 91 4.13.9 ADA 2010 404.2.7 CBC 2007 1133B.2.5.2 CBC 2019 11B-404.2.7 Mitigated: <input type="radio"/> YES <input checked="" type="radio"/> NO	1	JOB	\$900	\$900

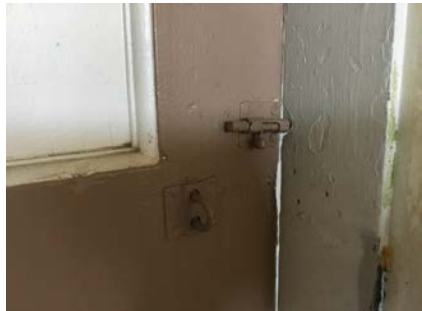
<input type="radio"/> Staff Only			
			Priority 2			
			Severity 3			
140	<ul style="list-style-type: none"> • <i>As-Built Description:</i> Door lock, latch or handle less than 34" or more than 48" above the floor (CA only: 34" to 44"). • <i>As-Built:</i> 59.5" high • <i>Proposed Solution:</i> Relocate or replace existing hardware. 	PCODE ID17 ADAAG 91 4.13.9 ADA 2010 404.2.7 CBC 2007 1133B.2.5.2 CBC 2019 11B-404.2.7 Mitigated: <input type="radio"/> YES <input checked="" type="radio"/> NO	1	JOB	\$900	\$900

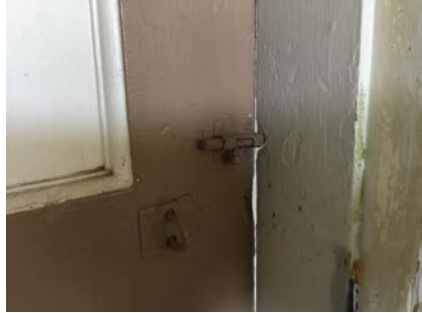
Operable Part

<p>141</p> <ul style="list-style-type: none"> <i>As-Built Description:</i> Operable part(s) require tight grasping, pinching, or twisting of the wrist with one hand. <i>Proposed Solution:</i> Modify or replace the operable part(s) to not require tight grasping, pinching, or twisting of the wrist with one hand. 	<p>PCODE IC02 ADAAG 91 4.27.4 ADA 2010 309.4 CBC 2007 1117B.6.4 CBC 2019 11B-309.4</p> <p>Mitigated: <input type="radio"/> YES <input checked="" type="radio"/> NO</p>	<p>1 JOB \$900 \$900</p>

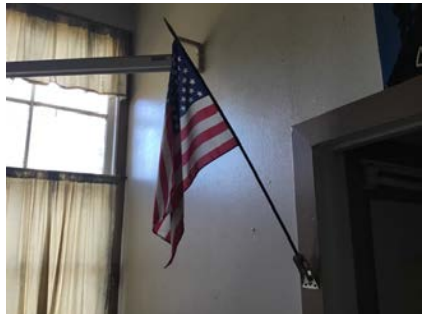
Protrusion Limits

<p>155</p> <ul style="list-style-type: none"> <i>As-Built Description:</i> Protruding objects more than 4" from wall, when bottom of object more than 27" or less than 80" above finished floor. <i>As-Built:</i> Flag: 5.0" at 74.0" high <i>Proposed Solution:</i> Remove/relocate protruding object. Patch existing surface. 	<p>PCODE EG04 ADAAG 91 4.4.1 ADA 2010 307.2 CBC 2007 1133B.8.6.1 CBC 2019 11B-307.2</p> <p>Mitigated: <input type="radio"/> YES <input checked="" type="radio"/> NO</p>	<p>1 JOB \$300 \$300</p>

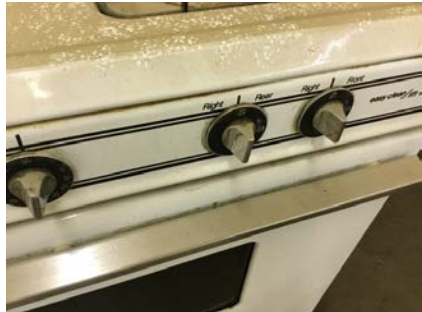
Item no., Rm no. and Name	Existing Architectural Barrier and Proposed Solution	Codes / Mitigation Info	Qty	Unit	Cost	Total
147	<ul style="list-style-type: none"> <i>As-Built Description:</i> Operable part(s) require tight grasping, pinching, or twisting of the wrist with one hand. <i>Proposed Solution:</i> Modify or replace the operable part(s) to not require tight grasping, pinching, or twisting of the wrist with one hand. 	PCODE IC02 ADAAG 91 4.27.4 ADA 2010 309.4 CBC 2007 1117B.6.4 CBC 2019 11B-309.4 Mitigated: <input type="radio"/> YES <input checked="" type="radio"/> NO	1	JOB	\$900	\$900

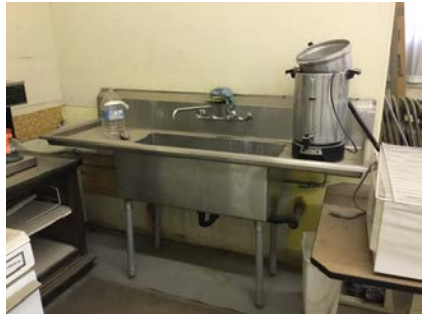
146	<ul style="list-style-type: none"> <i>As-Built Description:</i> Sink rim higher than 34" above floor. <i>As-Built:</i> 37.0" high <i>Proposed Solution:</i> Remodel sink cabinet to lower sink. 	PCODE IN06 ADAAG 91 4.24.2 ADA 2010 606.3 CBC 2007 1115B.4.7.1 CBC 2019 11B-606.3 Mitigated: <input type="radio"/> YES <input checked="" type="radio"/> NO	1	JOB	\$5,250	\$5,250

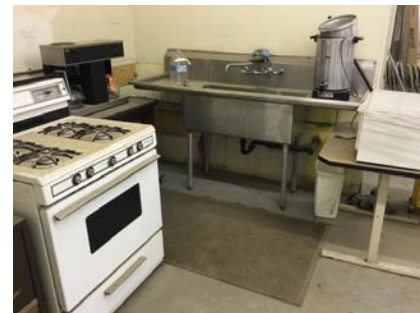
Item no., Rm no. and Name	Existing Architectural Barrier and Proposed Solution	Codes / Mitigation Info	Qty	Unit	Cost	Total
145	<ul style="list-style-type: none"> As-Built Description: Sink does not have knee space min. 27" high x 19" deep x 30" wide. Proposed Solution: Remodel sink cabinet. 	PCODE IN06A ADAAG 91 4.24.3 ADA 2010 606.2 CBC 2007 1115B.4.7.1 CBC 2019 11B-606.2 Mitigated: <input type="radio"/> YES <input checked="" type="radio"/> NO	1	JOB	\$5,250	\$5,250
<input type="radio"/> Staff Only						
Priority 2						
Severity 2

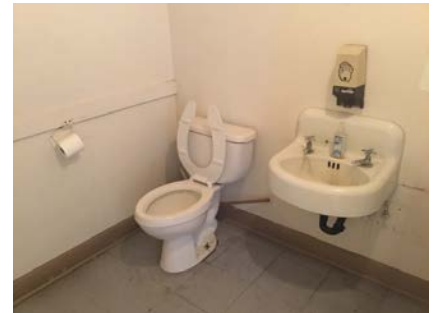
- 152
- *As-Built Description:*
Single accommodation restroom not accessible; multiple compliance violations.
 - *As-Built:* **72.0" x 81.0"**
 - *Proposed Solution:*
Remodel area to provide single-occupant accessible restroom.

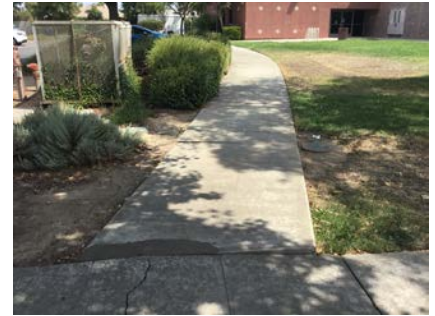
- 1365
- As-Built Description:*
Walk: Pavement dislocation creates abrupt change in level exceeding 1/2" in accessible route.
 - As-Built:* **Up to 3.0"**
 - Proposed Solution:*
Remove, replace or repair area of pavement sufficient to correct abrupt change in level.

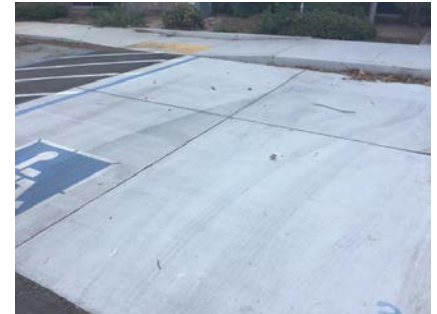
Floor or Ground Surfaces

1262	<ul style="list-style-type: none"> As-Built Description: Accessible parking space has slope greater than 1/4":12" (2%). As-Built: 2.9% Proposed Solution: Modify slope at accessible parking space. 	PCODE EA05 ADAAG 91 4.6.3 ADA 2010 502.4 CBC 2007 1129B.3.3 CBC 2019 11B-502.4	16	SF	\$36	\$576
------	---	--	----	----	------	-------

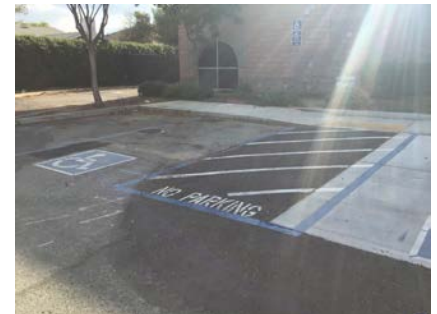
1263	<ul style="list-style-type: none"> As-Built Description: Accessible parking space has slope greater than 1/4":12" (2%). As-Built: 4.0% Proposed Solution: Modify slope at accessible parking space. 	PCODE EA05 ADAAG 91 4.6.3 ADA 2010 502.4 CBC 2007 1129B.3.3 CBC 2019 11B-502.4	200	SF	\$36	\$7,200
------	---	--	-----	----	------	---------

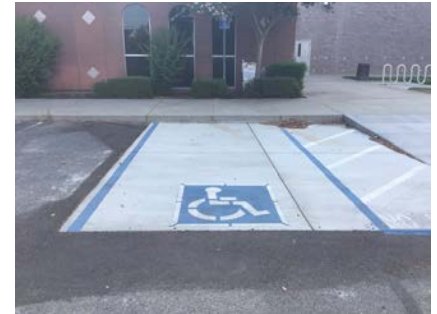
Parking

1259	<ul style="list-style-type: none"> As-Built Description: Accessible parking space smaller than 8' wide (CA only: 9' x 18'). As-Built: 107.5" wide Proposed Solution: Modify parking space(s) to create accessible space. 	PCODE EA02A ADAAG 91 4.6.3 ADA 2010 502.2 CBC 2007 1129B.3.1 CBC 2019 11B-502.2	1	JOB	\$600	\$600
------	--	---	---	-----	-------	-------

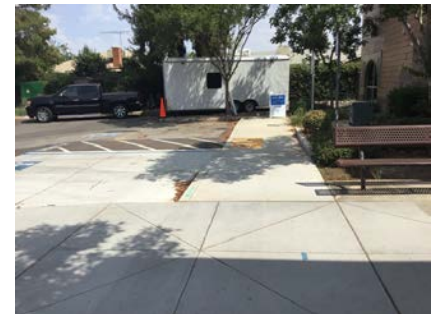
1364	<ul style="list-style-type: none"> As-Built Description: Wheel stops not provided to prevent the encroachment of vehicles over the required clear width of an adjacent accessible route. Proposed Solution: Provide wheel stops to prevent encroachment. Notes: 	PCODE EA04L CBC 2019 11B-502.7.2	1	JOB	\$225	\$225
------	--	-------------------------------------	---	-----	-------	-------

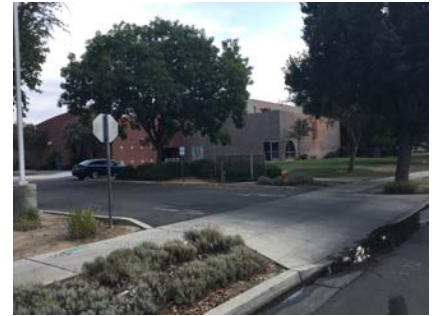
Parking Signage

1371	<ul style="list-style-type: none"> <i>As-Built Description:</i> No "Tow Away" sign at parking lot entrance (required in CA only). <i>Proposed Solution:</i> Provide "Tow Away" sign at parking lot entrance when altering area. 	<p>PCODE EA04C</p> <p>CBC 2007 1129B.4</p> <p>CBC 2019 11B-502.8.2</p> <p>Mitigated:</p> <p><input type="radio"/> YES</p> <p><input checked="" type="radio"/> NO</p>	2	JOB	\$975	\$1,950
------	---	--	---	-----	-------	---------

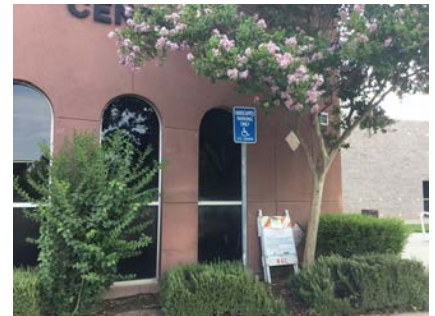
1260	<ul style="list-style-type: none"> <i>As-Built Description:</i> Sign relating to parking privileges for disabled persons is non-compliant. <i>Proposed Solution:</i> Provide compliant parking signage that does not contain the word "Handicapped". 	<p>PCODE EA04F</p> <p>ADA 2010 502.6</p> <p>CBC 2007 VC §22511.9.</p> <p>CBC 2019 11B-502.6</p> <p>Mitigated:</p> <p><input type="radio"/> YES</p> <p><input checked="" type="radio"/> NO</p>	2	JOB	\$300	\$600
------	--	---	---	-----	-------	-------

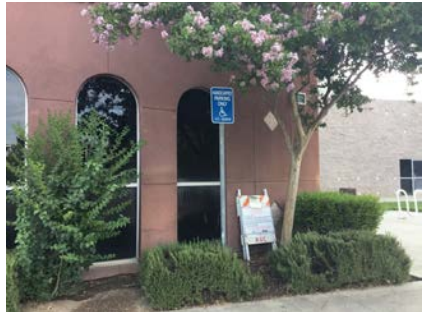
Item no., Rm no. and Name	Existing Architectural Barrier and Proposed Solution	Codes / Mitigation Info	Qty	Unit	Cost	Total
1261	<ul style="list-style-type: none"> <i>As-Built Description:</i> CA only: Additional Sign or additional language below the symbol of accessibility stating "Minimum Fine \$250" not provided. <i>Proposed Solution:</i> Provide compliant parking signage that includes fine information. 	PCODE EA04G CBC 2007 1129B.4 CBC 2019 11B-502.6.2 Mitigated: <input type="radio"/> YES <input checked="" type="radio"/> NO	2	JOB	\$300	\$600

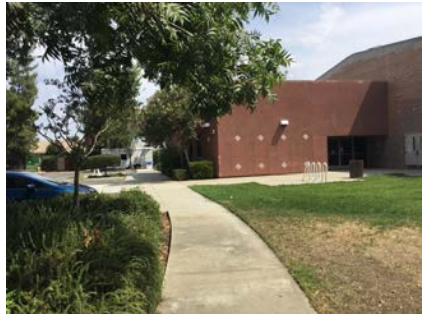
Protrusion Limits

1368	<ul style="list-style-type: none"> <i>As-Built Description:</i> Protruding objects more than 4" from wall, when bottom of object more than 27" or less than 80" above finished floor. <i>Proposed Solution:</i> Trim vegetation. 	PCODE EG04 ADAAG 91 4.4.1 ADA 2010 307.2 CBC 2007 1133B.8.6.1 CBC 2019 11B-307.2 Mitigated: <input type="radio"/> YES <input checked="" type="radio"/> NO	1	JOB	\$300	\$300

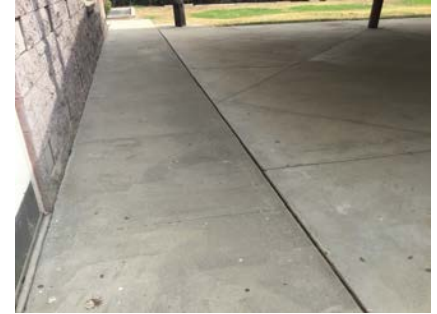
- 1360
- As-Built Description:**
Walk: Pavement dislocation creates abrupt change in level exceeding 1/2" in accessible route.
 - As-Built:** **1.5"**
 - Proposed Solution:**
Remove, replace or repair area of pavement sufficient to correct abrupt change in level.
 - Notes:**

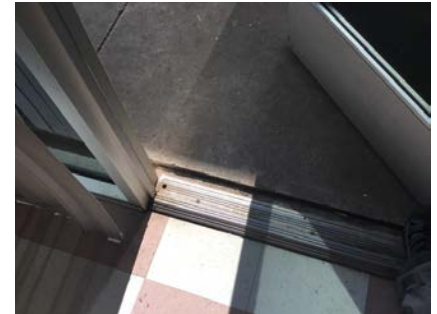
- 1265 • *As-Built Description:*
Walk: Pavement dislocation creates abrupt change in level exceeding 1/2" in accessible route.
- *As-Built:* **1.0" in exterior door maneuvering clearance.**
- *Proposed Solution:*
Remove, replace or repair area of pavement sufficient to correct abrupt change in level.

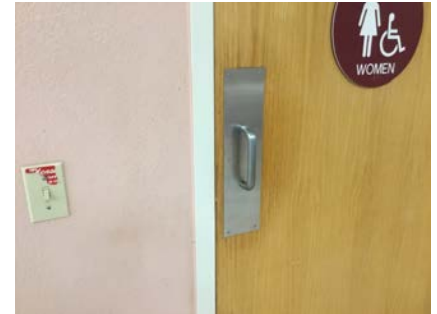
- 1268
- *As-Built Description:*
Door lock, latch or handle less than 34" or more than 48" above the floor (CA only: 34" to 44").
 - *As-Built:* **48.0" high**
 - *Proposed Solution:*
Relocate or replace existing hardware.
 - *Notes:*

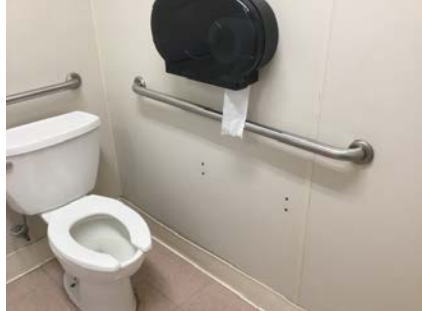
<p>1276</p> <ul style="list-style-type: none"> <i>As-Built Description:</i> Side grab bar less than 42" long, or located more than 12 inches max. from the rear wall, or extending less than 54" from rear wall (CA only: front end min. 24" in front of water closet). <i>As-Built:</i> Extends 23.0" in front of the water closet <i>Proposed Solution:</i> Provide or relocate accessible side grab bar. 	<p><i>PCODE</i> WB07A <i>ADAAG 91</i> Fig. 29(b) <i>ADA 2010</i> 604.5.1 <i>CBC 2007</i> 1115B.4.1.3.1 <i>CBC 2019</i> 11B-604.5.1</p> <p>Mitigated: <input type="radio"/> YES <input checked="" type="radio"/> NO</p>	<p>1 JOB \$780 \$780</p>

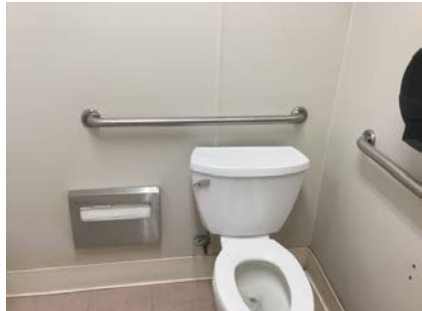
<p>1275</p> <ul style="list-style-type: none"> <i>As-Built Description:</i> The rear wall grab is less than 36" min. or does not extend from the centerline of the water closet 12" min. on one side and 24" min. on the other side. <i>As-Built:</i> Extends 10.5" on narrow side <i>Proposed Solution:</i> Provide or relocate accessible rear grab bar. <i>Notes:</i> 	<p><i>PCODE</i> WB07B <i>ADAAG 91</i> 4.17.6 <i>ADA 2010</i> 604.5.2 <i>CBC 2007</i> 1115B.4.1.3.2 <i>CBC 2019</i> 11B-604.5.2</p> <p>Mitigated: <input type="radio"/> YES <input checked="" type="radio"/> NO</p>	<p>1 JOB \$1,020 \$1,020</p>

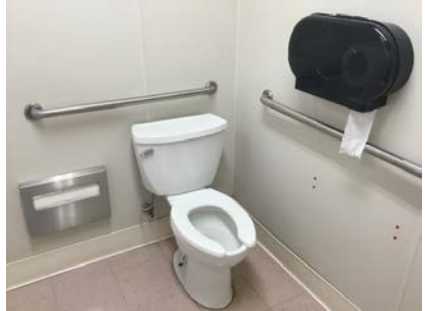
Item no., Rm no. and Name	Existing Architectural Barrier and Proposed Solution	Codes / Mitigation Info	Qty	Unit	Cost	Total
1274	<ul style="list-style-type: none"> As-Built Description: Grab bars not at 33" to 36" from floor As-Built: 36.6" to top Proposed Solution: Relocate accessible grab bars. 	PCODE WB07C ADAAG 91 4.16.4 ADA 2010 609.4 CBC 2007 1115B.4.1.3.1 CBC 2019 & 2 11B-609.4 Mitigated: <input type="radio"/> YES <input checked="" type="radio"/> NO	1	JOB	\$780	\$780

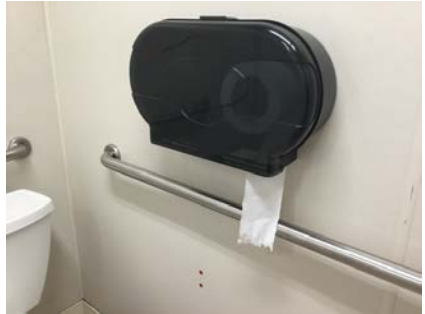
<input type="radio"/> Staff Only Priority 3 Severity 4						
1277	<ul style="list-style-type: none"> As-Built Description: Accessories/dispensers in accessible stall located closer than 1-1/2" below or 12" above grab bar impedes its use. As-Built: TPD: 5.0" above grab bar Proposed Solution: Relocate accessories/dispensers within applicable reach range and to be no closer than 1-1/2" below and 12" above grab bars (except if accessories are recessed, flush with wall, and have no sharp edges). 	PCODE WB07I ADAAG 91 4.26.2 ADA 2010 609.3 CBC 2007 1133B.4.2.5 CBC 2019 11B-609.3 Mitigated: <input type="radio"/> YES <input checked="" type="radio"/> NO	1	JOB	\$225	\$225

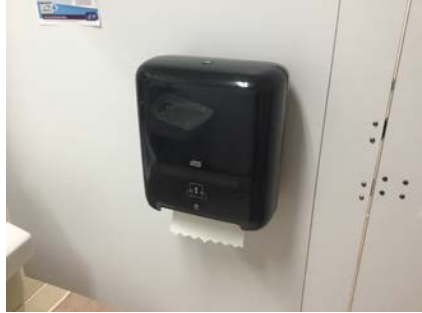
1272	<ul style="list-style-type: none"> As-Built Description: Protruding objects more than 4" from wall, when bottom of object more than 27" or less than 80" above finished floor. As-Built: PTD: 8.0" at 37.0" high Proposed Solution: Remove/relocate protruding object. Patch existing surface. 	PCODE EG04 ADAAG 91 4.4.1 ADA 2010 307.2 CBC 2007 1133B.8.6.1 CBC 2019 11B-307.2 Mitigated: <input type="radio"/> YES <input checked="" type="radio"/> NO	1	JOB	\$300	\$300
------	--	--	---	-----	-------	-------

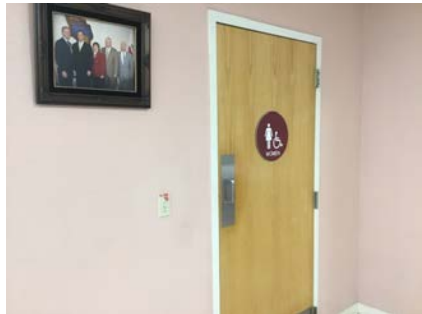
1266	<ul style="list-style-type: none"> As-Built Description: Entrance to toilet or bathing facility not identified with ADAAG compliant signage. Proposed Solution: Provide ADA compliant sign mounted at 48" min. above to baseline of the lowest Braille cells and 60" max. to baseline of the highest line of raised characters on nearest adjacent wall, on latch side of a single door (located not to cause a Braille reader to stand within the door swing). 	PCODE SA11A ADAAG 91 4.1.3(16)(a) ADA 2010 216.8 CBC 2019 11B-216.8 Mitigated: <input type="radio"/> YES <input checked="" type="radio"/> NO	1	JOB	\$270	\$270
------	---	--	---	-----	-------	-------

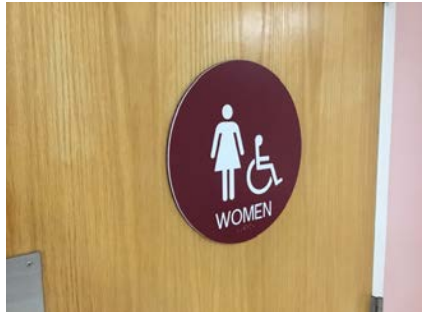
Item no., Rm no. and Name	Existing Architectural Barrier and Proposed Solution	Codes / Mitigation Info	Qty	Unit	Cost	Total
1267	<ul style="list-style-type: none"> <i>As-Built Description:</i> Required in CA only: identification symbol centered 58" to 60" high on sanitary facility door that contrasts with the door not provided (women: 12" ø circle, men: 12" triangle, unisex: combined symbol). <i>As-Built:</i> Not beveled. <i>Proposed Solution:</i> Provide properly mounted sanitary facility symbol when altering area. If wheelchair accessible, include International Symbol of Accessibility on sign. 	PCODE SA15 CBC 2007 1115B.6 CBC 2019 11B-703.7.2.6 Mitigated: <input type="radio"/> YES <input checked="" type="radio"/> NO	1	JOB	\$270	\$270

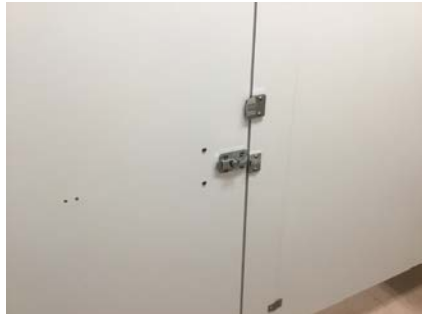
1278	<ul style="list-style-type: none"> <i>As-Built Description:</i> Stall door does not have accessible operating hardware (U-pulls on both sides, flip-over or sliding lock). <i>Proposed Solution:</i> Provide new accessible locking hardware that does not require grasping, pinching, or twisting and U-pulls on both sides. 	PCODE WB05C ADAAG 91 4.17.5 ADA 2010 604.8.1.2 CBC 2007 1115B.3.1.4.5 CBC 2019 11B-604.8.1.2 Mitigated: <input type="radio"/> YES <input checked="" type="radio"/> NO	1	JOB	\$300	\$300

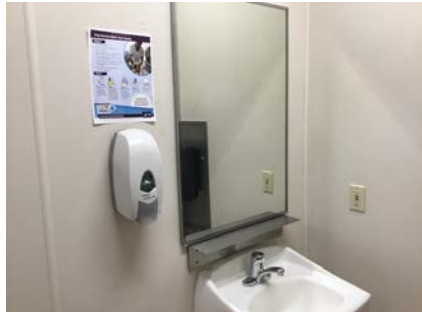
Item no., Rm no. and Name	Existing Architectural Barrier and Proposed Solution	Codes / Mitigation Info	Qty	Unit	Cost	Total
1286	<ul style="list-style-type: none"> As-Built Description: Bottom of mirror located above lavatories or countertops more than 40" above floor. As-Built: 40.75" high Proposed Solution: Relocate or provide new accessible mirror. 	PCODE WG03 ADAAG 91 4.19.6 ADA 2010 603.3 CBC 2007 1115B.8.1 CBC 2019 11B-603.3 Mitigated: <input type="radio"/> YES <input checked="" type="radio"/> NO	1	JOB	\$450	\$450

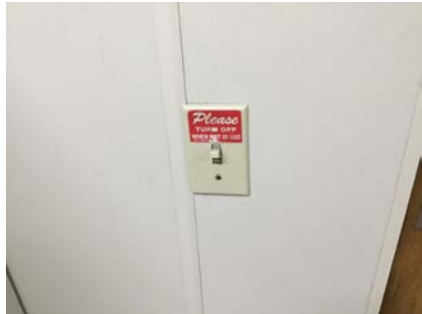
1282	<ul style="list-style-type: none"> As-Built Description: Electric switch or control mounted less than 15" measured to the bottom of the outlet box or greater than 48 inches measured to the top of the outlet box. As-Built: 48.25" and 50.0" to top of box Proposed Solution: Relocate light switches or control to between 15" and 48" height. Notes: 	PCODE IC01 ADAAG 91 4.2.5 & 6 ADA 2010 308.2.1 & 308.2.2 CBC 2007 1117B.6.3 CBC 2019 11B-308.2.1 & 11B-308.2.2 Mitigated: <input type="radio"/> YES <input checked="" type="radio"/> NO	1	JOB	\$900	\$900

This element complies with Safe Harbor if altered or constructed before March 15, 2012. This element does not comply with the dimensional requirements in the 1981 to the current CBC.

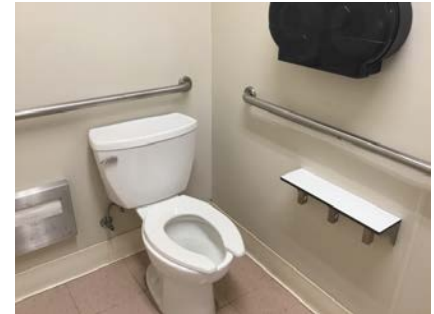
1291	<ul style="list-style-type: none"> As-Built Description: Grab bars not at 33" to 36" from floor As-Built: 36.25" to center Proposed Solution: Relocate accessible grab bars. 	PCODE WB07C ADAAG 91 4.16.4 ADA 2010 609.4 CBC 2007 1115B.4.1.3.1 & 2 CBC 2019 11B-609.4	1	JOB	\$780	\$780
------	--	--	---	-----	-------	-------

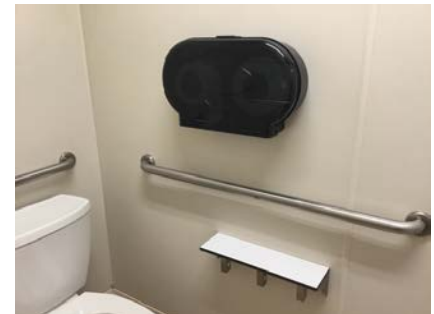
1290	<ul style="list-style-type: none"> As-Built Description: Accessories/dispensers in accessible stall located closer than 1-1/2" below or 12" above grab bar impedes its use. As-Built: TPD: 8.0" above grab bar Proposed Solution: Relocate accessories/dispensers within applicable reach range and to be no closer than 1-1/2" below and 12" above grab bars (except if accessories are recessed, flush with wall, and have no sharp edges). 	PCODE WB07I ADAAG 91 4.26.2 ADA 2010 609.3 CBC 2007 1133B.4.2.5 CBC 2019 11B-609.3	1	JOB	\$225	\$225
------	---	---	---	-----	-------	-------

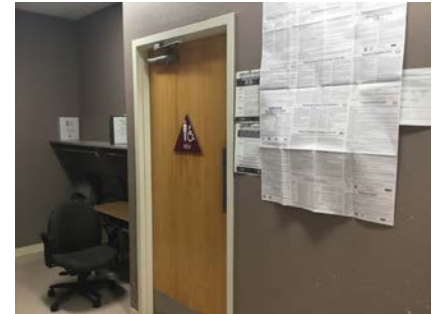
1280	<ul style="list-style-type: none"> <i>As-Built Description:</i> Entrance to toilet or bathing facility not identified with ADAAG compliant signage. <i>Proposed Solution:</i> Provide ADA compliant sign mounted at 48" min. above to baseline of the lowest Braille cells and 60" max. to baseline of the highest line of raised characters on nearest adjacent wall, on latch side of a single door (located not to cause a Braille reader to stand within the door swing). <i>Notes:</i> 	<p>PCODE SA11A ADAAG 91 4.1.3(16)(a) ADA 2010 216.8 CBC 2019 11B-216.8</p> <p>Mitigated: <input type="radio"/> YES <input checked="" type="radio"/> NO</p>	1	JOB	\$270	\$270
------	--	---	---	-----	-------	-------

Noncompliant tactile sign on door.

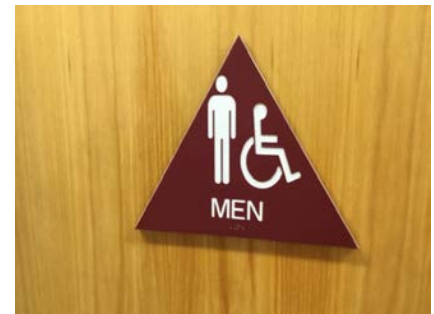
1281	<ul style="list-style-type: none"> <i>As-Built Description:</i> Required in CA only: identification symbol centered 58" to 60" high on sanitary facility door that contrasts with the door not provided (women: 12" ø circle, men: 12" triangle, unisex: combined symbol). <i>As-Built:</i> Not beveled or radiused. <i>Proposed Solution:</i> Provide properly mounted sanitary facility symbol when altering area. If wheelchair accessible, include International Symbol of Accessibility on sign. 	<p>PCODE SA15 CBC 2007 1115B.6 CBC 2019 11B-703.7.2.6</p> <p>Mitigated: <input type="radio"/> YES <input checked="" type="radio"/> NO</p>	1	JOB	\$270	\$270
------	---	---	---	-----	-------	-------

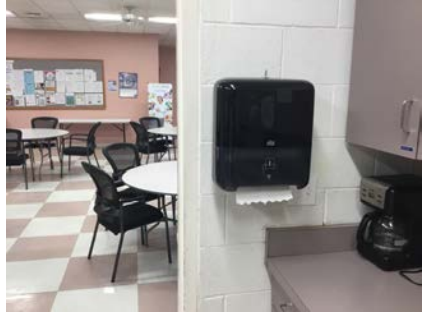
<p>1294</p> <ul style="list-style-type: none"> <i>As-Built Description:</i> Protruding objects more than 4" from wall, when bottom of object more than 27" or less than 80" above finished floor. <i>As-Built:</i> PTD: 8.0" at 49.0" high <i>Proposed Solution:</i> Remove/relocate protruding object. Patch existing surface. <i>Notes:</i> 	<p>PCODE EG04 ADAAG 91 4.4.1 ADA 2010 307.2 CBC 2007 1133B.8.6.1 CBC 2019 11B-307.2</p> <p>Mitigated: <input type="radio"/> YES <input checked="" type="radio"/> NO</p>	<p>1 JOB \$300 \$300</p>

The dispenser is in the door maneuvering clearance.

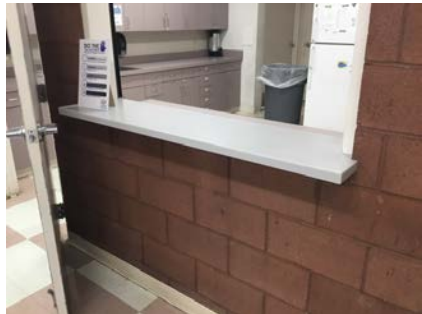
<p>1298</p> <ul style="list-style-type: none"> <i>As-Built Description:</i> Protruding objects more than 4" from wall, when bottom of object more than 27" or less than 80" above finished floor. <i>As-Built:</i> Tray slide: 6.0" at 41.0" high <i>Proposed Solution:</i> Remove/relocate protruding object. Patch existing surface. 	<p>PCODE EG04 ADAAG 91 4.4.1 ADA 2010 307.2 CBC 2007 1133B.8.6.1 CBC 2019 11B-307.2</p> <p>Mitigated: <input type="radio"/> YES <input checked="" type="radio"/> NO</p>	<p>1 JOB \$300 \$300</p>

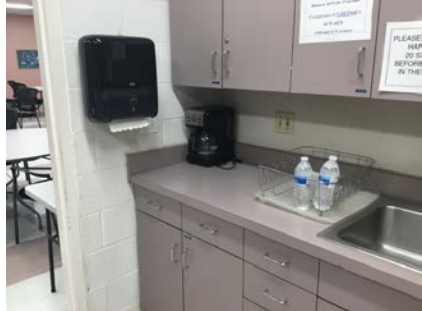
<p>1295</p> <ul style="list-style-type: none"> • <i>As-Built Description:</i> Reach height to control or access point, where side approach is available, exceeds 48" or is less than 15" in height, or exceeds 10" in depth. • <i>As-Built:</i> 36.0" high obstructed reach to controls on the counters and switches. • <i>Proposed Solution:</i> Lower the counters. 	<p>PCODE IE02 ADAAG 91 4.2.6 ADA 2010 308.3.1 CBC 2007 1118B.6 CBC 2019 11B-308.3</p> <p>Mitigated: <input type="radio"/> YES <input checked="" type="radio"/> NO</p>	<table border="0"> <tr> <td>1</td> <td>JOB</td> <td>\$300</td> <td>\$300</td> </tr> </table>

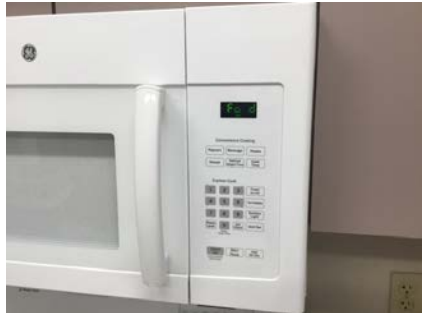
<p>1296</p> <ul style="list-style-type: none"> • <i>As-Built Description:</i> Reach height to control or access point, where side approach is available, exceeds 48" or is less than 15" in height, or exceeds 10" in depth. • <i>As-Built:</i> 59.0" high • <i>Proposed Solution:</i> Modify equipment or mounting. 	<p>PCODE IE02 ADAAG 91 4.2.6 ADA 2010 308.3.1 CBC 2007 1118B.6 CBC 2019 11B-308.3</p> <p>Mitigated: <input type="radio"/> YES <input checked="" type="radio"/> NO</p>	<table border="0"> <tr> <td>1</td> <td>JOB</td> <td>\$300</td> <td>\$300</td> </tr> </table>

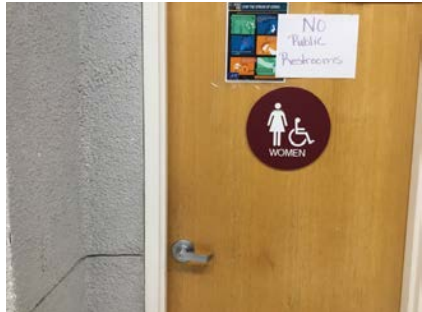
Item no., Rm no. and Name	Existing Architectural Barrier and Proposed Solution	Codes / Mitigation Info	Qty	Unit	Cost	Total
1309	<ul style="list-style-type: none"> As-Built Description: Front approach: At push side, door does not have clear and level maneuvering space measuring door width x 48" (door width plus 12" if door has both, latch and closer). As-Built: 10.5" Proposed Solution: Remove latch. 	PCODE ID24A ADAAG 91 Fig. 25(a) ADA 2010 404.2.4 CBC 2007 11B-26A(a) CBC 2019 11B-404.2.4 Mitigated: <input type="radio"/> YES <input checked="" type="radio"/> NO	1	JOB	\$150	\$150

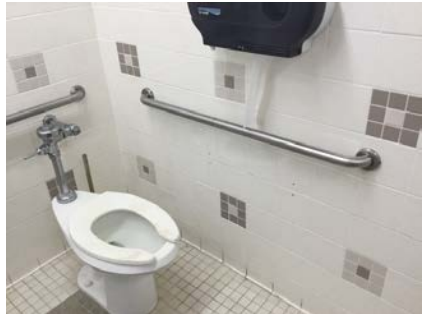
1319	<ul style="list-style-type: none"> As-Built Description: Side grab bar less than 42" long, or located more than 12 inches max. from the rear wall, or extending less than 54" from rear wall (CA only: front end min. 24" in front of water closet). As-Built: Extends 13.0" and 21.0" in front of water closet. Proposed Solution: Provide or relocate accessible side grab bar. 	PCODE WB07A ADAAG 91 Fig. 29(b) ADA 2010 604.5.1 CBC 2007 1115B.4.1.3.1 CBC 2019 11B-604.5.1 Mitigated: <input type="radio"/> YES <input checked="" type="radio"/> NO	1	JOB	\$780	\$780

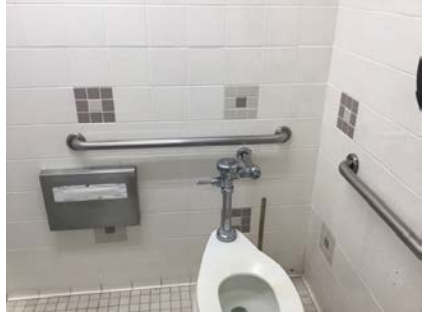
Item no., Rm no. and Name	Existing Architectural Barrier and Proposed Solution	Codes / Mitigation Info	Qty	Unit	Cost	Total
1321	<ul style="list-style-type: none"> <i>As-Built Description:</i> The rear wall grab is less than 36" min. or does not extend from the centerline of the water closet 12" min. on one side and 24" min. on the other side. <i>As-Built:</i> Extends 10.5" on narrow side <i>Proposed Solution:</i> Provide or relocate accessible rear grab bar. 	PCODE WB07B ADAAG 91 4.17.6 ADA 2010 604.5.2 CBC 2007 1115B.4.1.3.2 CBC 2019 11B-604.5.2 Mitigated: <input type="radio"/> YES <input checked="" type="radio"/> NO	1	JOB	\$1,020	\$1,020

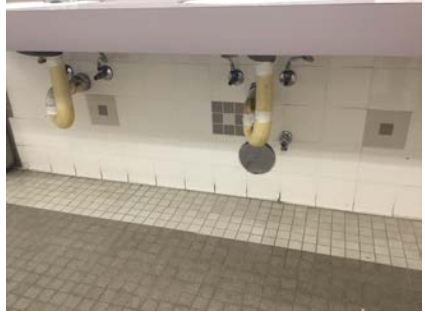
1314	<ul style="list-style-type: none"> <i>As-Built Description:</i> Hot or sharp-surfaced water/drain pipe not insulated or covered. <i>Proposed Solution:</i> Insulate or cover water/drain pipe. 	PCODE WD05 ADAAG 91 4.19.4 ADA 2010 606.5 CBC 2007 1115B.4.3.4 CBC 2019 11B-606.5 Mitigated: <input type="radio"/> YES <input checked="" type="radio"/> NO	1	JOB	\$360	\$360

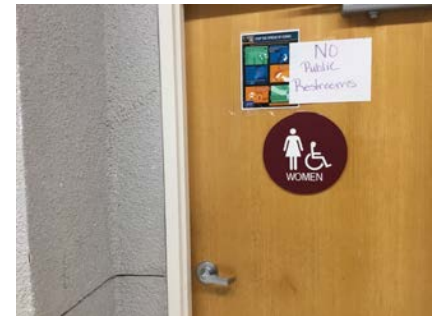
1310	<ul style="list-style-type: none"> <i>As-Built Description:</i> Entrance to toilet or bathing facility not identified with ADAAG compliant signage. <i>Proposed Solution:</i> Provide ADA compliant sign mounted at 48" min. above to baseline of the lowest Braille cells and 60" max. to baseline of the highest line of raised characters on nearest adjacent wall, on latch side of a single door (located not to cause a Braille reader to stand within the door swing). 	<p>PCODE SA11A ADAAG 91 4.1.3(16)(a) ADA 2010 216.8 CBC 2019 11B-216.8</p> <p>Mitigated: <input type="radio"/> YES <input checked="" type="radio"/> NO</p>	1	JOB	\$270	\$270
------	---	--	---	-----	-------	-------

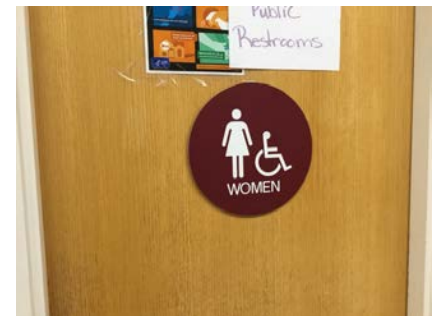
1311	<ul style="list-style-type: none"> <i>As-Built Description:</i> Required in CA only: identification symbol centered 58" to 60" high on sanitary facility door that contrasts with the door not provided (women: 12" ø circle, men: 12" triangle, unisex: combined symbol). <i>As-Built:</i> Not beveled. <i>Proposed Solution:</i> Provide properly mounted sanitary facility symbol when altering area. If wheelchair accessible, include International Symbol of Accessibility on sign. 	<p>PCODE SA15 CBC 2007 1115B.6 CBC 2019 11B-703.7.2.6</p> <p>Mitigated: <input type="radio"/> YES <input checked="" type="radio"/> NO</p>	1	JOB	\$270	\$270
------	---	---	---	-----	-------	-------

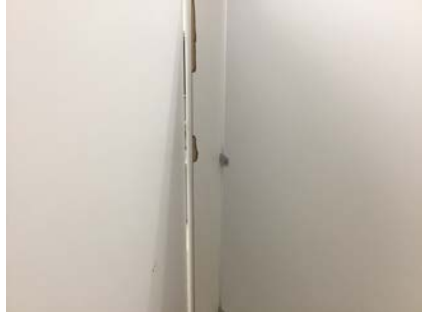
<p>1330</p> <ul style="list-style-type: none"> <i>As-Built Description:</i> The location of the stall door is not in front of the clear space (next to the water closet), with a maximum stile width of 4". <i>As-Built:</i> 4.5" <i>Proposed Solution:</i> Remodel compartment. 	<p><i>PCODE</i> WB05D <i>ADAAG 91</i> 4.17.3 & Fig. 30(a) <i>ADA 2010</i> 604.8.1.2 <i>CBC 2007</i> 1115B.3.1.4.3 <i>CBC 2019</i> 11B-604.8.1.2</p> <p>Mitigated: <input type="radio"/> YES <input checked="" type="radio"/> NO</p>	<p>1 JOB \$1,500 \$1,500</p>

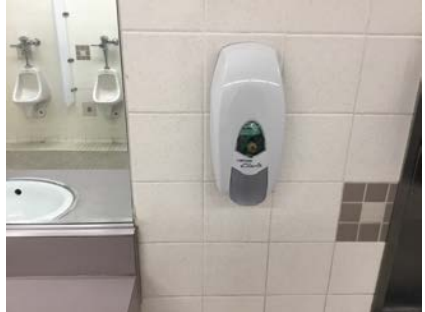
<p>1324</p> <ul style="list-style-type: none"> <i>As-Built Description:</i> Dispensers in sanitary facilities, such as for towels, soap, sanitary napkins, seat covers, etc., and waste receptacles more than 48" (CA only: 40") from floor to highest operating slot or control. <i>As-Built:</i> SD: 43.0" high <i>Proposed Solution:</i> Relocate existing restroom accessories. <i>Notes:</i> 	<p><i>PCODE</i> WG01A <i>ADAAG 91</i> 4.23.7 <i>ADA 2010</i> 308.2.1 <i>CBC 2007</i> 1115B.8.3 <i>CBC 2019</i> 11B-603.5</p> <p>Mitigated: <input type="radio"/> YES <input checked="" type="radio"/> NO</p>	<p>1 JOB \$300 \$300</p>

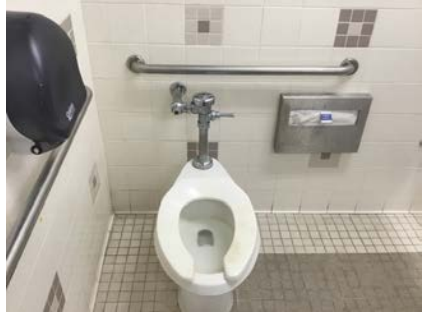
Item no., Rm no. and Name	Existing Architectural Barrier and Proposed Solution	Codes / Mitigation Info	Qty	Unit	Cost	Total
1332	<ul style="list-style-type: none"> <i>As-Built Description:</i> The rear wall grab is less than 36" min. or does not extend from the centerline of the water closet 12" min. on one side and 24" min. on the other side. <i>As-Built:</i> Extends 11.0" on narrow side <i>Proposed Solution:</i> Provide or relocate accessible rear grab bar. 	PCODE WB07B ADAAG 91 4.17.6 ADA 2010 604.5.2 CBC 2007 1115B.4.1.3.2 CBC 2019 11B-604.5.2 Mitigated: <input type="radio"/> YES <input checked="" type="radio"/> NO	1	JOB	\$1,020	\$1,020

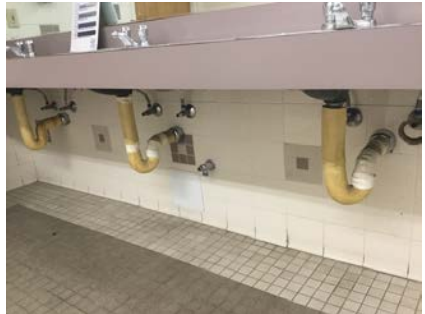
1325	<ul style="list-style-type: none"> <i>As-Built Description:</i> Hot or sharp-surfaced water/drain pipe not insulated or covered. <i>Proposed Solution:</i> Insulate or cover water/drain pipe. 	PCODE WD05 ADAAG 91 4.19.4 ADA 2010 606.5 CBC 2007 1115B.4.3.4 CBC 2019 11B-606.5 Mitigated: <input type="radio"/> YES <input checked="" type="radio"/> NO	1	JOB	\$360	\$360

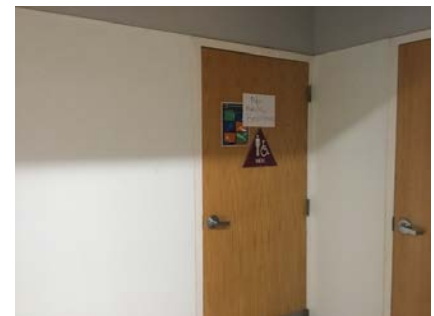
- 1323
- *As-Built Description:*
Entrance to toilet or bathing facility not identified with ADAAG compliant signage.
 - *Proposed Solution:*
Provide ADA compliant sign mounted at 48" min. above to baseline of the lowest Braille cells and 60" max. to baseline of the highest line of raised characters on nearest adjacent wall, on latch side of a single door (located not to cause a Braille reader to stand within the door swing).

PCODE **SA11A**
 ADAAG 91 **4.1.3(16)(a)**
 ADA 2010 **216.8**
 CBC 2019 **11B-216.8**

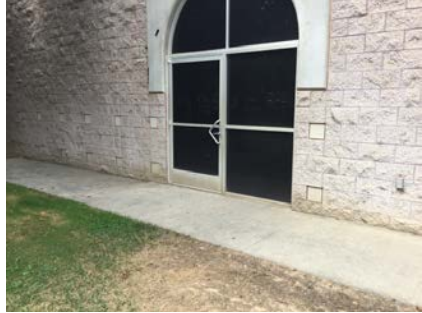
<p>1358</p> <ul style="list-style-type: none"> <i>As-Built Description:</i> Surface of required maneuvering clearance at door slopes more than 1/4":12" (2.0%). <i>As-Built:</i> 3.1% <i>Proposed Solution:</i> Modify surface slope at door. <i>Notes:</i> 	<p>PCODE ID11 ADAAG 91 4.13.6 ADA 2010 404.2.4.4 CBC 2007 1133B.2.4 CBC 2019 11B-404.2.4</p> <p>Mitigated: <input type="radio"/> YES <input checked="" type="radio"/> NO</p>	<p>25 SF \$120 \$3,000</p>

Or install directional signs inside and out.

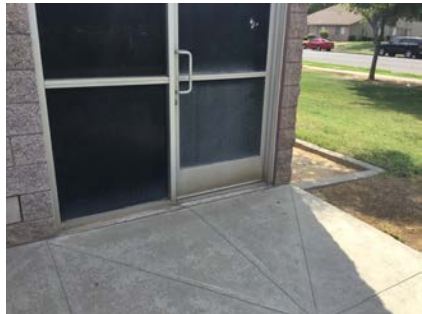
<p>1367</p> <ul style="list-style-type: none"> <i>As-Built Description:</i> Surface of required maneuvering clearance at door slopes more than 1/4":12" (2.0%). <i>As-Built:</i> 0.6" level change <i>Proposed Solution:</i> Modify surface slope at door. 	<p>PCODE ID11 ADAAG 91 4.13.6 ADA 2010 404.2.4.4 CBC 2007 1133B.2.4 CBC 2019 11B-404.2.4</p> <p>Mitigated: <input type="radio"/> YES <input checked="" type="radio"/> NO</p>	<p>25 SF \$120 \$3,000</p>

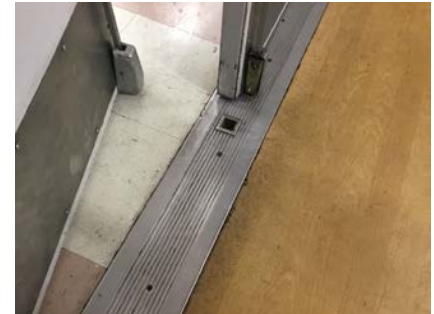
1341	<ul style="list-style-type: none"> As-Built Description: Walk: openings greater than 1/2" along the line of traffic flow. As-Built: 1.0" x 1.0" Proposed Solution: Fill opening and provide new panic door hardware. Notes: 	<p>PCODE EF04</p> <p>ADAAG 91 4.3.6; 4.5.4</p> <p>ADA 2010 403.2; 302.3</p> <p>CBC 2007 1133B.7.2</p> <p>CBC 2019 11B-403.2; 11B-302.3</p> <p>Mitigated:</p> <p><input type="radio"/> YES</p> <p><input checked="" type="radio"/> NO</p>	1	JOB	\$1,500	\$1,500
------	--	--	---	-----	---------	---------

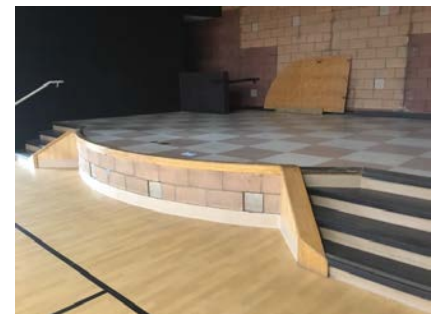
1344	<ul style="list-style-type: none"> As-Built Description: Handrail not provided at stairs or ramp, required on both sides (not required at curb ramps or adjacent to seating areas). Proposed Solution: Provide new handrail for each side including extensions. 	<p>PCODE ED01</p> <p>ADAAG 91 4.8.5 & 4.9.4</p> <p>ADA 2010 505.2</p> <p>CBC 2007 1133B.4.1.1 & .5.5</p> <p>CBC 2019 11B-505.2</p> <p>Mitigated:</p> <p><input type="radio"/> YES</p> <p><input checked="" type="radio"/> NO</p>	15	LF	\$285	\$4,275
------	---	--	----	----	-------	---------

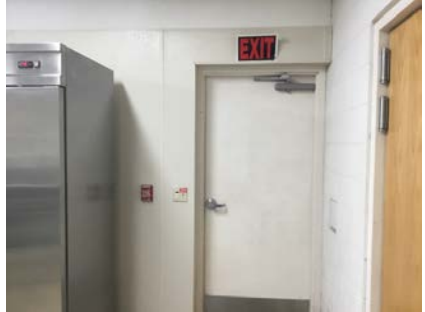
Item no., Rm no. and Name	Existing Architectural Barrier and Proposed Solution	Codes / Mitigation Info	Qty	Unit	Cost	Total
1356	<ul style="list-style-type: none"> As-Built Description: Front approach: At push side, door does not have clear and level maneuvering space measuring door width x 48" (door width plus 12" if door has both, latch and closer). As-Built: 8.75" deep alcove. Proposed Solution: Provide relocated new door and frame; remodel walls as needed. 	PCODE ID24B ADAAG 91 Fig. 25(a) ADA 2010 404.2.4 CBC 2007 11B-26A(a) CBC 2019 11B-404.2.4 Mitigated: <input type="radio"/> YES <input checked="" type="radio"/> NO	1	JOB	\$7,800	\$7,800

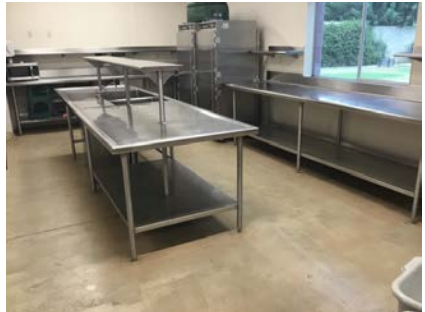
Non-Fixed Desk

1352	<ul style="list-style-type: none"> As-Built Description: Accessible non-fixed kitchen work table (top 28" to 34" high; knee space at least 27" high x 19" deep x 30" wide) not provided. As-Built: Work surfaces less than 34.0" throughout. No knee clearance. Proposed Solution: Provide kitchen table with accessible dimensions. 	PCODE IN02A ADAAG 91 4.32.3 & .4 ADA 2010 306.1 CBC 2007 1122B.3 & 4 CBC 2019 11B-306.1 & 11B-902.3 Mitigated: <input type="radio"/> YES <input checked="" type="radio"/> NO	3	JOB	\$4,800	\$14,400

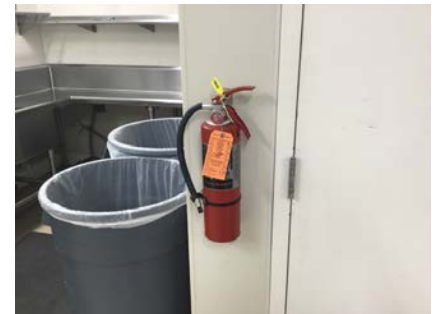
1354	<ul style="list-style-type: none"> As-Built Description: Reach height to control or access point, where side approach is available, exceeds 48" or is less than 15" in height, or exceeds 10" in depth. As-Built: 52.0" high Proposed Solution: Modify equipment or mounting. Notes: 	PCODE IE02 ADAAG 91 4.2.6 ADA 2010 308.3.1 CBC 2007 1118B.6 CBC 2019 11B-308.3	1	JOB	\$300	\$300
		Mitigated:				
		<input type="radio"/> YES				
		<input checked="" type="radio"/> NO				
		<input type="radio"/> Staff Only				
		Priority 4				
		Severity 4

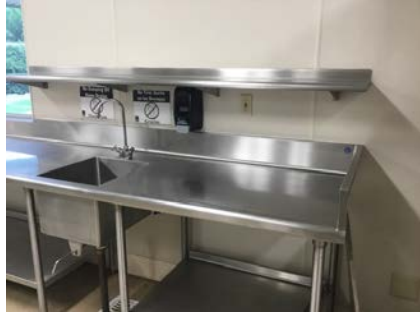
Item no., Rm no. and Name	Existing Architectural Barrier and Proposed Solution	Codes / Mitigation Info	Qty	Unit	Cost	Total
1355	<ul style="list-style-type: none"> As-Built Description: Reach height to control or access point, where side approach is available, exceeds 48" or is less than 15" in height, or exceeds 10" in depth. As-Built: Controls and outlets at counters are obstructed by counters greater than 34.0" high. Proposed Solution: Modify equipment or mounting. 	PCODE IE02 ADAAG 91 4.2.6 ADA 2010 308.3.1 CBC 2007 1118B.6 CBC 2019 11B-308.3 Mitigated: <input type="radio"/> YES <input checked="" type="radio"/> NO	1	JOB	\$300	\$300

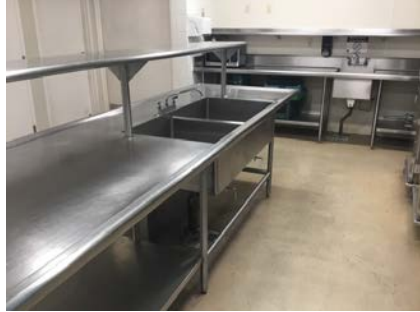
1350	<ul style="list-style-type: none"> As-Built Description: Sink rim higher than 34" above floor. As-Built: 36.0" high Proposed Solution: Remodel existing or provide new sink. 	PCODE IN06 ADAAG 91 4.24.2 ADA 2010 606.3 CBC 2007 1115B.4.7.1 CBC 2019 11B-606.3 Mitigated: <input type="radio"/> YES <input checked="" type="radio"/> NO	4	JOB	\$5,250	\$21,000

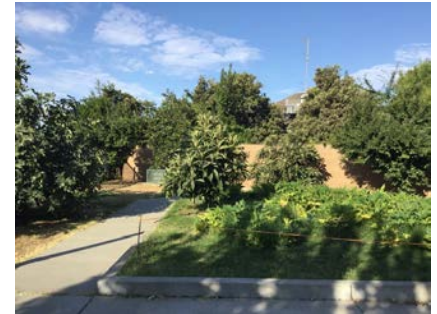
457	<ul style="list-style-type: none"> As-Built Description: Walk more than 36" but less than 48" wide (required in CA only). As-Built: 47.5" to 47.75" wide Proposed Solution: Enlarge width of walk to 48". Notes: 	PCODE EF08 CBC 2007 1133B.7.1 CBC 2019 11B-403.5.1.3 Mitigated: <input type="radio"/> YES <input checked="" type="radio"/> NO	100	SF	\$135	\$13,500
-----	---	--	-----	----	-------	----------

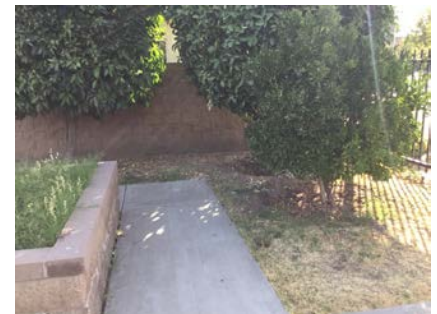
458	<ul style="list-style-type: none"> As-Built Description: Walk more than 36" but less than 48" wide (required in CA only). As-Built: 46.0" wide Proposed Solution: Enlarge width of walk to 48". Notes: 	PCODE EF08 CBC 2007 1133B.7.1 CBC 2019 11B-403.5.1.3 Mitigated: <input type="radio"/> YES <input checked="" type="radio"/> NO	30	SF	\$135	\$4,050
-----	---	--	----	----	-------	---------

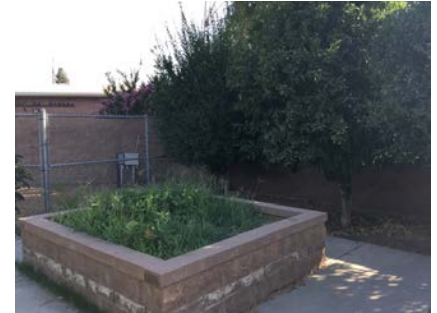
459	<ul style="list-style-type: none"> As-Built Description: Walk more than 36" but less than 48" wide (required in CA only). As-Built: 46.5" wide Proposed Solution: Enlarge width of walk to 48". Notes: 	<p>PCODE EF08</p> <p>CBC 2007 1133B.7.1</p> <p>CBC 2019 11B-403.5.1.3</p> <p>Mitigated:</p> <p><input type="radio"/> YES</p> <p><input checked="" type="radio"/> NO</p>	20	SF	\$135	\$2,700
-----	---	---	----	----	-------	----------------

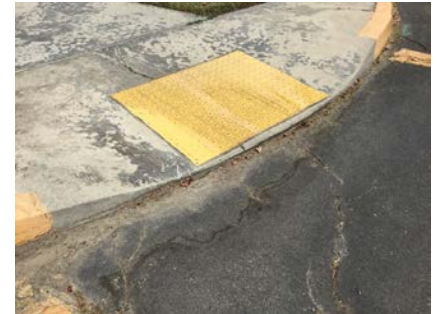
<p>118</p> <ul style="list-style-type: none"> • <i>As-Built Description:</i> Transition from curb ramp to gutter does not have a smooth transition. • <i>As-Built:</i> 2.0" • <i>Proposed Solution:</i> Grind lip. 	<p><i>PCODE</i> EH02D <i>ADAAG 91</i> 4.7.2 <i>ADA 2010</i> 406.2 <i>CBC 2007</i> 1127B.5.3 <i>CBC 2019</i> 11B-406.5.8</p>	<p>1 JOB \$300 \$300</p>
--	--	---------------------------------

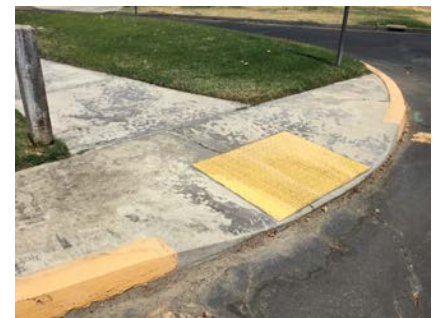
<p>119</p> <ul style="list-style-type: none"> • <i>As-Built Description:</i> Side slopes more than 1:10 (10%). • <i>As-Built:</i> 13.0% and 18.0% • <i>Proposed Solution:</i> Modify curb ramp. Demolish side slopes and replace with 1:10 side slopes if 48" level top landing is provided. 	<p><i>PCODE</i> EH05A <i>ADAAG 91</i> 4.7.5 <i>ADA 2010</i> 406.3 <i>CBC 2007</i> 1127B.5.3 <i>CBC 2019</i> 11B-406.2.2</p>	<p>2 JOB \$6,000 \$12,000</p>
--	--	--------------------------------------
