APPENDIX B: ACCESS COMPLIANCE SURVEY REPORT OF FACILITIES

The City of Madera

Access Compliance Survey Report

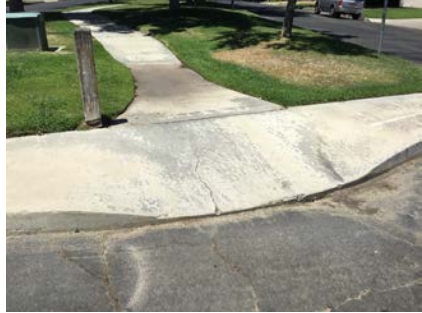
125	<ul style="list-style-type: none"> As-Built Description: Slope greater than 1:12 (8.3%). As-Built: 9.9% Proposed Solution: Demolish existing and provide new curb ramp. 	PCODE EH02A ADAAG 91 4.7.2 ADA 2010 406.1 CBC 2007 1127B.5.3 CBC 2019 11B-406.2.1 Mitigated: <input type="radio"/> YES <input checked="" type="radio"/> NO	1	JOB	\$7,500	\$7,500

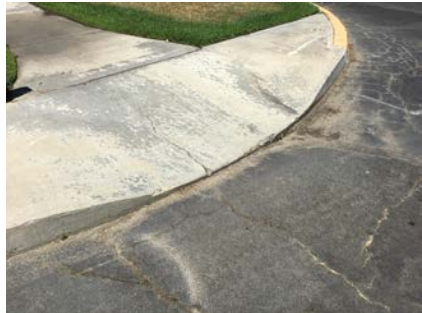
123	<ul style="list-style-type: none"> As-Built Description: Transition from curb ramp to gutter does not have a smooth transition. As-Built: 3.0" Proposed Solution: Grind lip. 	PCODE EH02D ADAAG 91 4.7.2 ADA 2010 406.2 CBC 2007 1127B.5.3 CBC 2019 11B-406.5.8 Mitigated: <input type="radio"/> YES <input checked="" type="radio"/> NO	1	JOB	\$300	\$300

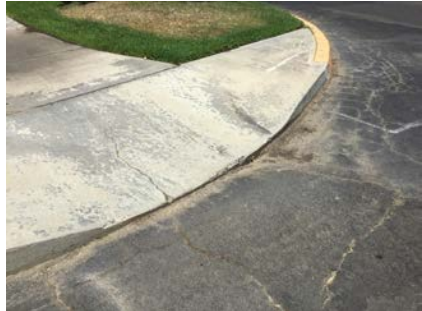
Item no., Rm no. and Name	Existing Architectural Barrier and Proposed Solution	Codes / Mitigation Info	Qty	Unit	Cost	Total
124	<ul style="list-style-type: none"> As-Built Description: Maximum slope of adjoining gutters, street surface at bottom of ramp exceeds 5% (1:20). As-Built: 6.8% Proposed Solution: Modify road/gutter slopes. Demolish existing and provide new curb ramp. 	PCODE EH02E ADAAG 91 4.7.2 ADA 2010 406.2 CBC 2007 1127B.5.3 CBC 2019 11B-406.5.8 Mitigated: <input type="radio"/> YES <input checked="" type="radio"/> NO	1	JOB	\$3,750	\$3,750

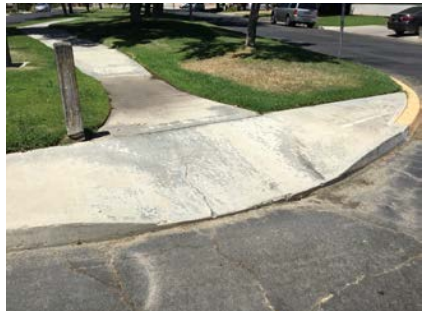
<input type="radio"/> Staff Only			
			Priority <input checked="" type="radio"/> 1			
			Severity <input checked="" type="radio"/> 4			
127	<ul style="list-style-type: none"> As-Built Description: Side slopes more than 1:10 (10%). As-Built: 14.0% and 20.0% Proposed Solution: Modify curb ramp. Demolish side slopes and replace with 1:10 side slopes if 48" level top landing is provided. 	PCODE EH05A ADAAG 91 4.7.5 ADA 2010 406.3 CBC 2007 1127B.5.3 CBC 2019 11B-406.2.2 Mitigated: <input type="radio"/> YES <input checked="" type="radio"/> NO	1	JOB	\$6,000	\$6,000

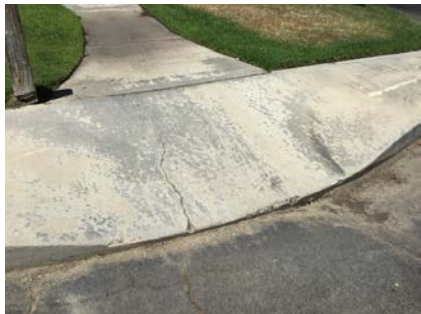
Item no., Rm no. and Name	Existing Architectural Barrier and Proposed Solution	Codes / Mitigation Info	Qty	Unit	Cost	Total
126	<ul style="list-style-type: none"> <i>As-Built Description:</i> Detectable warning not provided where pedestrian crosses vehicular area. <i>Proposed Solution:</i> Provide detectable warning surface (i.e. in-line truncated domes) at regular curb ramp. 	PCODE EH07A ADAAG 91 4.7.7 ADA 2010 705.1 CBC 2007 1127B.5.7 CBC 2019 11B-705.1.2.2 Mitigated: <input type="radio"/> YES <input checked="" type="radio"/> NO	1	JOB	\$750	\$750

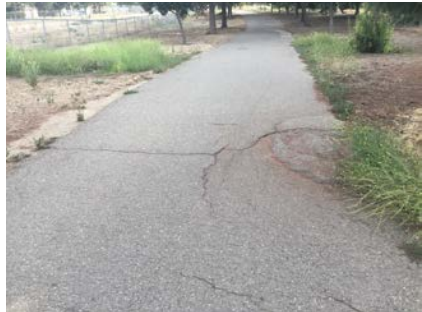
Item no., Rm no. and Name	Existing Architectural Barrier and Proposed Solution	Codes / Mitigation Info	Qty	Unit	Cost	Total
2201	<ul style="list-style-type: none"> As-Built Description: Cross slope more than 1":48" (2.083%). As-Built: Roughly 8.0% Proposed Solution: Modify cross slope. Notes: 	PCODE EF07 ADAAG 91 4.3.7 ADA 2010 403.3 CBC 2007 1133B.7.1.3 CBC 2019 11B-403.3 Mitigated: <input type="radio"/> YES <input checked="" type="radio"/> NO	400	SF	\$75	\$30,000

<input type="radio"/> Staff Only						
Priority <input checked="" type="radio"/> 1						
Severity <input checked="" type="radio"/> 2						
<p>Sunken asphalt at the side of the trail creates noncompliant slopes and level changes. There are 48.0" of compliant slopes to the side of these areas. Consider whether future dividing lines may put the noncompliant slopes in one of the lanes or whether the slopes are hazardous to people who do not see them.</p>

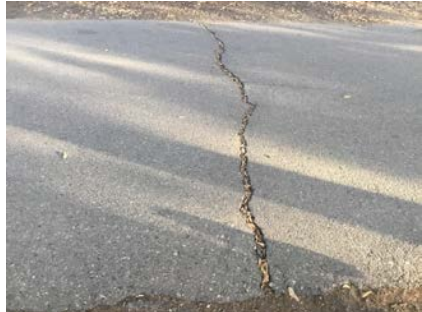
2202	<ul style="list-style-type: none"> As-Built Description: Walk: Grating has grid openings greater than 1/2" along the line of traffic flow. As-Built: Gaps to 3.0" wide and 3.0" deep. Proposed Solution: Fill gaps. Notes: 	PCODE EF04 ADAAG 91 4.3.6; 4.5.4 ADA 2010 403.2; 302.3 CBC 2007 1133B.7.2 CBC 2019 11B-403.2; 11B-302.3 Mitigated: <input type="radio"/> YES <input checked="" type="radio"/> NO	600	LF	\$60	\$36,000

<input type="radio"/> Staff Only						
Priority <input checked="" type="radio"/> 1						
Severity <input checked="" type="radio"/> 2						
<p>Cracks nearly identical to the one shown here appear ubiquitous along the entire trail. There are also potholes up to 6.0" deep and 10.0" wide along the path and particularly at the edges of the path.</p>

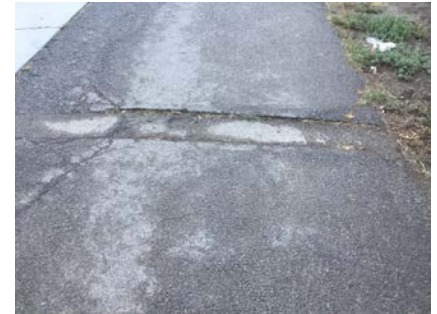
- 1984
- *As-Built Description:*
Walk: Pavement dislocation creates abrupt change in level exceeding 1/2" in accessible route.
 - *As-Built:* **0.5" not beveled**
 - *Proposed Solution:*
Remove, replace or repair area of pavement sufficient to correct abrupt change in level.

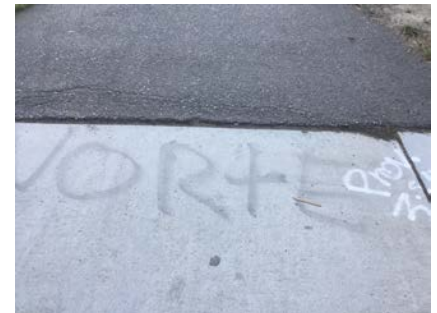
- 1985
- *As-Built Description:*
Walk: Pavement dislocation creates abrupt change in level exceeding 1/2" in accessible route.
 - *As-Built:* **1.0"**
 - *Proposed Solution:*
Remove, replace or repair area of pavement sufficient to correct abrupt change in level.

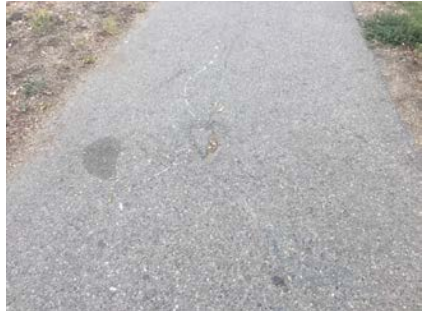
Item no., Rm no. and Name	Existing Architectural Barrier and Proposed Solution	Codes / Mitigation Info	Qty	Unit	Cost	Total
1987	<ul style="list-style-type: none"> As-Built Description: Walk: Pavement dislocation creates abrupt change in level exceeding 1/2" in accessible route. As-Built: Gaps 2.0" deep. Proposed Solution: Remove, replace or repair area of pavement sufficient to correct abrupt change in level. Notes: 	PCODE EF03 ADAAG 91 4.3.8 ADA 2010 403.4 CBC 2007 1133B.7.4 CBC 2019 11B-403.4 Mitigated: <input type="radio"/> YES <input checked="" type="radio"/> NO	5	SF	\$150	\$750

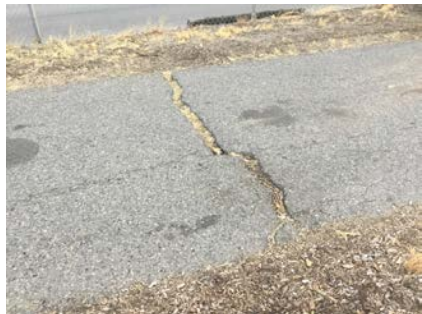
<input type="radio"/> Staff Only						
Priority <input checked="" type="radio"/> 1 Severity <input checked="" type="radio"/> 3						
Tripping hazard.						
1988	<ul style="list-style-type: none"> As-Built Description: Walk: Pavement dislocation creates abrupt change in level exceeding 1/2" in accessible route. As-Built: Gaps 3.0" deep and 3.0" wide. Proposed Solution: Remove, replace or repair area of pavement sufficient to correct abrupt change in level. Notes: 	PCODE EF03 ADAAG 91 4.3.8 ADA 2010 403.4 CBC 2007 1133B.7.4 CBC 2019 11B-403.4 Mitigated: <input type="radio"/> YES <input checked="" type="radio"/> NO	5	SF	\$150	\$750

<input type="radio"/> Staff Only						
Priority <input checked="" type="radio"/> 1 Severity <input checked="" type="radio"/> 2						
Tripping hazard.

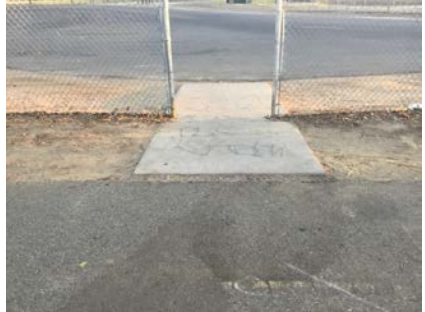
Item no., Rm no. and Name	Existing Architectural Barrier and Proposed Solution	Codes / Mitigation Info	Qty	Unit	Cost	Total
1990	<ul style="list-style-type: none"> <i>As-Built Description:</i> Walk: Pavement dislocation creates abrupt change in level exceeding 1/2" in accessible route. <i>As-Built:</i> 1.0" at public entrance from fairgrounds <i>Proposed Solution:</i> Remove, replace or repair area of pavement sufficient to correct abrupt change in level. 	PCODE EF03 ADAAG 91 4.3.8 ADA 2010 403.4 CBC 2007 1133B.7.4 CBC 2019 11B-403.4 Mitigated: <input type="radio"/> YES <input checked="" type="radio"/> NO	6	LF	\$63	\$378

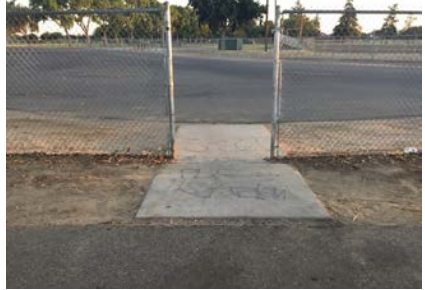
Door

1989	<ul style="list-style-type: none"> <i>As-Built Description:</i> Surface of required maneuvering clearance at door slopes more than 1/4":12" (2.0%). <i>As-Built:</i> 2.8% at doorway with out a door to fairgrounds. <i>Proposed Solution:</i> Modify surface slope at door. 	PCODE ID11 ADAAG 91 4.13.6 ADA 2010 404.2.4.4 CBC 2007 1133B.2.4 CBC 2019 11B-404.2.4 Mitigated: <input type="radio"/> YES <input checked="" type="radio"/> NO	30	SF	\$120	\$3,600

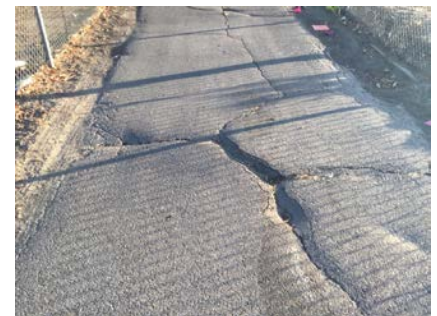
- 1998
- *As-Built Description:*
Walk: Pavement dislocation creates abrupt change in level exceeding 1/2" in accessible route.
 - *As-Built:* **Gaps. Level changes. Uneven.**
 - *Proposed Solution:*
Remove, replace or repair area of pavement sufficient to correct abrupt change in level.

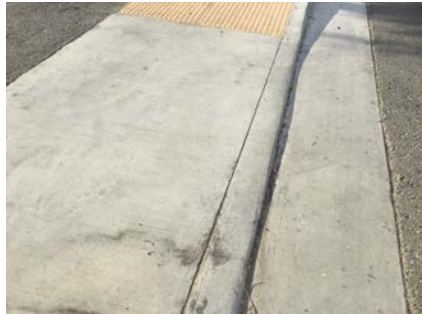
Item no., Rm no. and Name	Existing Architectural Barrier and Proposed Solution	Codes / Mitigation Info	Qty	Unit	Cost	Total
2190	<ul style="list-style-type: none"> As-Built Description: Walk: Pavement dislocation creates abrupt change in level exceeding 1/2" in accessible route. As-Built: To 1.0" Proposed Solution: Remove, replace or repair area of pavement sufficient to correct abrupt change in level. Notes: 	PCODE EF03 ADAAG 91 4.3.8 ADA 2010 403.4 CBC 2007 1133B.7.4 CBC 2019 11B-403.4 Mitigated: <input type="radio"/> YES <input checked="" type="radio"/> NO	16	LF	\$63	\$1,008

At curb cuts and where asphalt meets concrete on both sides of Schnoor.

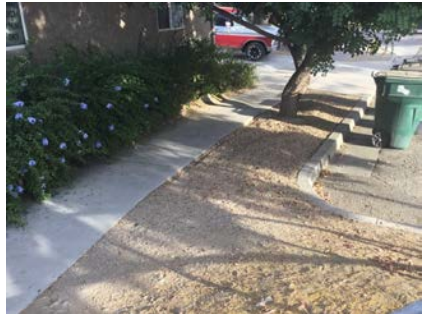
2192	<ul style="list-style-type: none"> As-Built Description: Walk: Pavement dislocation creates abrupt change in level exceeding 1/2" in accessible route. As-Built: 2.0" Proposed Solution: Remove, replace or repair area of pavement sufficient to correct abrupt change in level. 	PCODE EF03 ADAAG 91 4.3.8 ADA 2010 403.4 CBC 2007 1133B.7.4 CBC 2019 11B-403.4 Mitigated: <input type="radio"/> YES <input checked="" type="radio"/> NO	4	SF	\$63	\$252

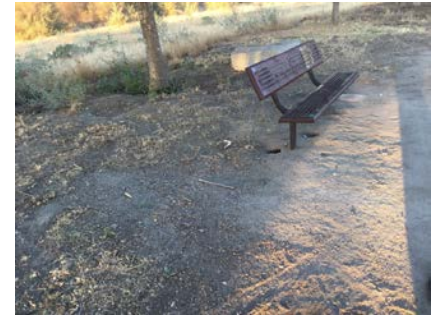
Cross Slope

1993	<ul style="list-style-type: none"> As-Built Description: Cross slope more than 1":48" (2.083%). As-Built: 6.0% slope adjacent to benches Proposed Solution: Modify cross slope. 	PCODE EF07 ADAAG 91 4.3.7 ADA 2010 403.3 CBC 2007 1133B.7.1.3 CBC 2019 11B-403.3 Mitigated: <input type="radio"/> YES <input checked="" type="radio"/> NO	24	SF	\$75	\$1,800
------	---	--	----	----	------	---------

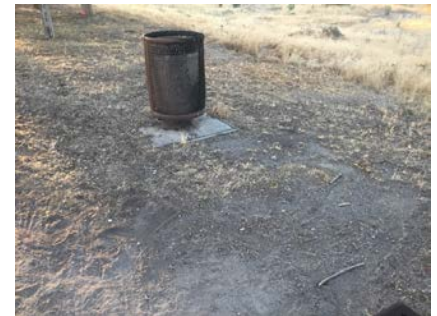
1995	<ul style="list-style-type: none"> As-Built Description: Cross slope more than 1":48" (2.083%). As-Built: Clear floor space at elements slopes 3.0% Proposed Solution: Modify cross slope. 	PCODE EF07 ADAAG 91 4.3.7 ADA 2010 403.3 CBC 2007 1133B.7.1.3 CBC 2019 11B-403.3 Mitigated: <input type="radio"/> YES <input checked="" type="radio"/> NO	12	SF	\$75	\$900
------	--	--	----	----	------	-------

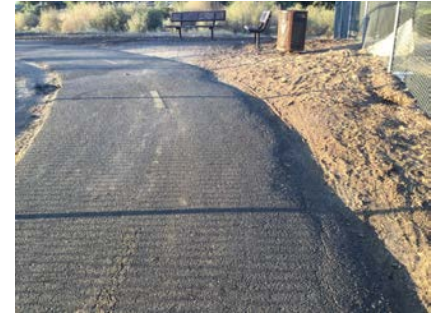
Item no., Rm no. and Name	Existing Architectural Barrier and Proposed Solution	Codes / Mitigation Info	Qty	Unit	Cost	Total
1997	<ul style="list-style-type: none"> As-Built Description: Cross slope more than 1":48" (2.083%). As-Built: 8.0% Proposed Solution: Modify cross slope. Notes: 	PCODE EF07 ADAAG 91 4.3.7 ADA 2010 403.3 CBC 2007 1133B.7.1.3 CBC 2019 11B-403.3 Mitigated: <input type="radio"/> YES <input checked="" type="radio"/> NO	20	SF	\$75	\$1,500

There are approximately 36.0" between the 8.0% slopes and the dividing line.

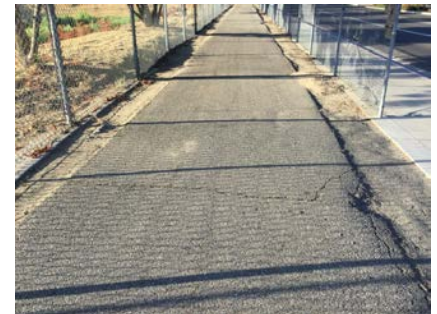
2006	<ul style="list-style-type: none"> As-Built Description: Cross slope more than 1":48" (2.083%). As-Built: 2.4% to 5.0% Proposed Solution: Modify cross slope. 	PCODE EF07 ADAAG 91 4.3.7 ADA 2010 403.3 CBC 2007 1133B.7.1.3 CBC 2019 11B-403.3 Mitigated: <input type="radio"/> YES <input checked="" type="radio"/> NO	200	SF	\$75	\$15,000
------	---	--	-----	----	------	----------

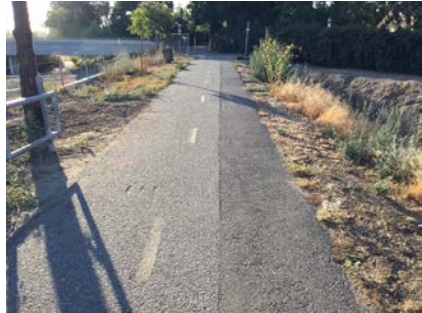
Item no., Rm no. and Name	Existing Architectural Barrier and Proposed Solution	Codes / Mitigation Info	Qty	Unit	Cost	Total
2009	<ul style="list-style-type: none"> As-Built Description: Cross slope more than 1":48" (2.083%). As-Built: Up to 6.0% Proposed Solution: Modify cross slope. Notes: 	PCODE EF07 ADAAG 91 4.3.7 ADA 2010 403.3 CBC 2007 1133B.7.1.3 CBC 2019 11B-403.3 Mitigated: <input type="radio"/> YES <input checked="" type="radio"/> NO	150	SF	\$75	\$11,250

<input type="radio"/> Staff Only						
Priority <input checked="" type="radio"/> 1 Severity <input checked="" type="radio"/> 3						
<p>There are 48.0" level trail overall but the slopes reduce the level width on one side of the dividing line to <32.0".</p>

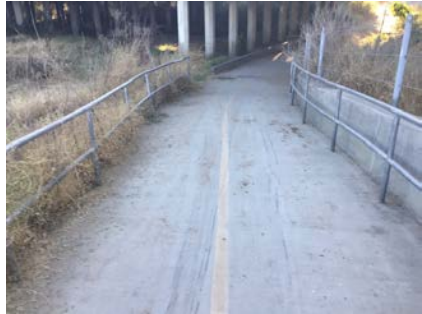
Curb or Barrier

2004	<ul style="list-style-type: none"> As-Built Description: A curb or barrier has not been provided that blocks the passage of a 4-inch diameter sphere, where any portion of the sphere is within 4 inches of the finish floor or ground surface. Proposed Solution: Provide a curb or barrier that prevents the passage of a 4-inch diameter sphere, where any portion of the sphere is within 4 inches of the finish floor or ground surface. Notes: 	PCODE EB14 ADAAG 91 4.8.7 ADA 2010 405.9.2 CBC 2007 1133B.5.6 CBC 2019 11B-405.9.2 Mitigated: <input type="radio"/> YES <input checked="" type="radio"/> NO	50	LF	\$51	\$2,550

<input type="radio"/> Staff Only						
Priority <input checked="" type="radio"/> 1 Severity <input checked="" type="radio"/> 4						
<p>Occurs both sides of Schnoor.</p>

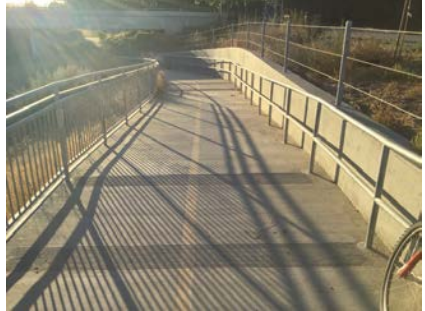
Item no., Rm no. and Name	Existing Architectural Barrier and Proposed Solution	Codes / Mitigation Info	Qty	Unit	Cost	Total
2001	<ul style="list-style-type: none"> As-Built Description: Level 2% max. landing for ramp not provided. As-Built: 2.9% Proposed Solution: Grind surface. Notes: 	PCODE EB05A ADAAG 91 4.8.4 ADA 2010 405.7.1 CBC 2007 1133B.5.4.1 CBC 2019 11B-405.7.1 Mitigated: <input type="radio"/> YES <input checked="" type="radio"/> NO	80	SF	\$150	\$12,000

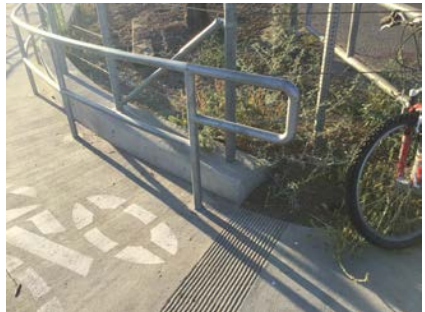
1999	<ul style="list-style-type: none"> As-Built Description: Ramp handrail does not extend horizontally 12" past top and / or bottom of ramp. As-Built: Extension is above 4.0% slope. Proposed Solution: Provide ramp handrail extension (cost for each extension piece). Notes: 	PCODE ED05 ADAAG 91 4.8.5(2) ADA 2010 505.10.1 CBC 2007 1133B.4.2.2 & 1133B.5.5.1 CBC 2019 11B-505.10.1 Mitigated: <input type="radio"/> YES <input checked="" type="radio"/> NO	3	JOB	\$510	\$1,530

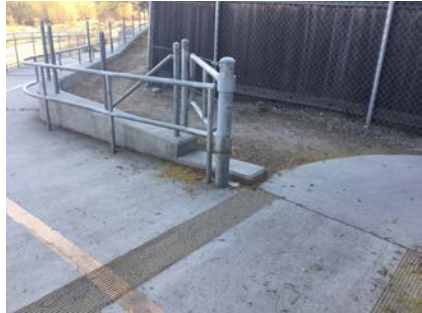
Item no., Rm no. and Name	Existing Architectural Barrier and Proposed Solution	Codes / Mitigation Info	Qty	Unit	Cost	Total
2000	<ul style="list-style-type: none"> <i>As-Built Description:</i> Ramp handrail does not extend horizontally 12" past top and / or bottom of ramp. <i>Proposed Solution:</i> Provide ramp handrail extension (cost for each extension piece). 	PCODE ED05 ADAAG 91 4.8.5(2) ADA 2010 505.10.1 CBC 2007 1133B.4.2.2 & 1133B.5.5.1 CBC 2019 11B-505.10.1 Mitigated: <input type="radio"/> YES <input checked="" type="radio"/> NO	2	JOB	\$510	\$1,020

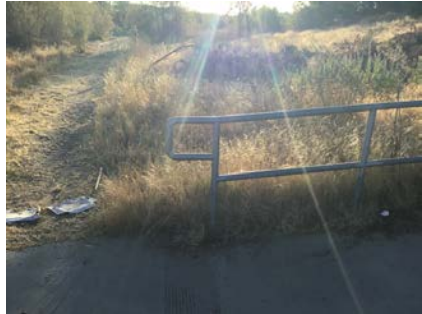
<input type="radio"/> Staff Only Priority <input checked="" type="radio"/> 1 Severity <input checked="" type="radio"/> 1			
2005	<ul style="list-style-type: none"> <i>As-Built Description:</i> Ramp handrail does not extend horizontally 12" past top and / or bottom of ramp. <i>As-Built:</i> 11.0" to 12.0" to center of down pipe <i>Proposed Solution:</i> Provide ramp handrail extension (cost for each extension piece). 	PCODE ED05 ADAAG 91 4.8.5(2) ADA 2010 505.10.1 CBC 2007 1133B.4.2.2 & 1133B.5.5.1 CBC 2019 11B-505.10.1 Mitigated: <input type="radio"/> YES <input checked="" type="radio"/> NO	3	JOB	\$510	\$1,530

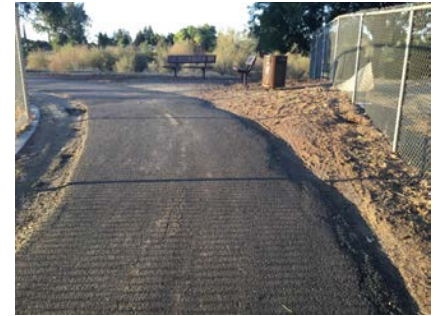
Walk

1996	<ul style="list-style-type: none"> As-Built Description: Walk: Slope greater than 1:20 (5.0%), and walk does not comply with requirements for ramps. As-Built: 5.5% Proposed Solution: Modify walk/sidewalk slope to 1:20 or less. 	<p>PCODE EF01 ADAAG 91 4.3.7 ADA 2010 403.3 CBC 2007 1133B.7.3 CBC 2019 11B-403.3</p> <p>Mitigated: <input type="radio"/> YES <input checked="" type="radio"/> NO</p>	150	SF	\$75	\$11,250
------	--	--	-----	----	------	----------

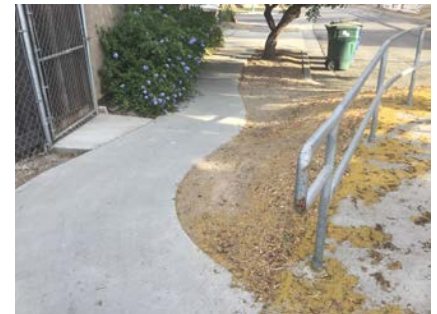
2191	<ul style="list-style-type: none"> As-Built Description: Walk more than 36" but less than 48" wide (required in CA only). As-Built: 46.5" Proposed Solution: Enlarge width of walk to 48". 	<p>PCODE EF08 CBC 2007 1133B.7.1 CBC 2019 11B-403.5.1.3</p> <p>Mitigated: <input type="radio"/> YES <input checked="" type="radio"/> NO</p>	60	SF	\$135	\$8,100
------	--	--	----	----	-------	---------

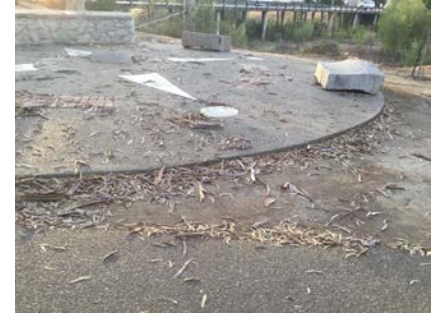
- 2206
- *As-Built Description:*
Walk: Pavement dislocation creates abrupt change in level exceeding 1/2" in accessible route.
 - *As-Built:* **3.0"**
 - *Proposed Solution:*
Remove, replace or repair area of pavement sufficient to correct abrupt change in level.

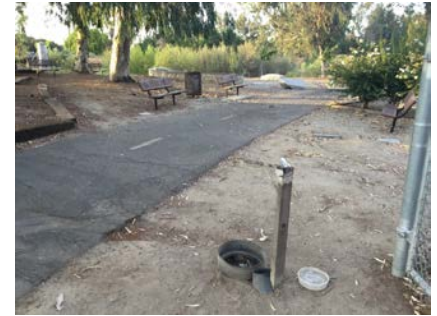
Drinking Fountain

2207	<ul style="list-style-type: none"> <i>As-Built Description:</i> Where only one drinking fountain is provided per floor: Fountain is not accessible to individuals who use wheelchairs, or to those who have difficulty bending or stooping. <i>Proposed Solution:</i> Provide additional fountain or hi-lo combination fountain. 	PCODE IA01A ADAAG 91 4.1.3(10)(a) ADA 2010 211.1 CBC 2007 1115B.4.6.1 CBC 2019 11B-211.1 Mitigated: <input type="radio"/> YES <input checked="" type="radio"/> NO	1	JOB	\$6,000	\$6,000
------	--	---	---	-----	---------	---------

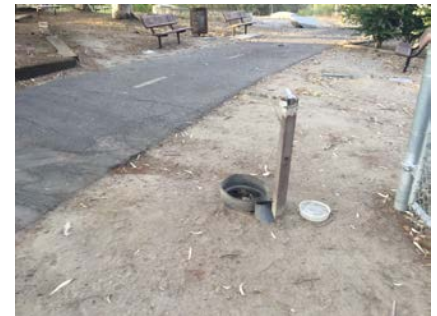
2208	<ul style="list-style-type: none"> <i>As-Built Description:</i> Drinking fountain lacks protection for visually impaired persons. <i>Proposed Solution:</i> Provide cane-detectable rails. 	PCODE IA05C ADAAG 91 4.4.1 ADA 2010 307.2 CBC 2007 1115B.4.6.3 CBC 2019 11B-307.2 Mitigated: <input type="radio"/> YES <input checked="" type="radio"/> NO	1	JOB	\$1,500	\$1,500
------	--	--	---	-----	---------	---------

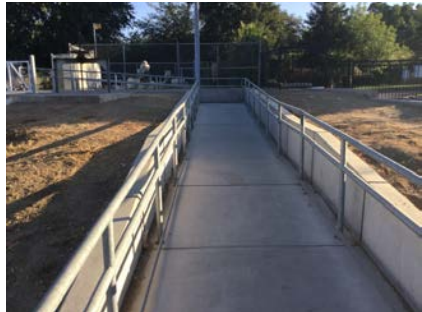
Item no., Rm no. and Name	Existing Architectural Barrier and Proposed Solution	Codes / Mitigation Info	Qty	Unit	Cost	Total
2014	<ul style="list-style-type: none"> As-Built Description: Level 2% max. landing for ramp not provided. As-Built: 4.5% Proposed Solution: Rebuild ramp to provide landings for each ramp run with slopes no greater than 2% 	PCODE EB05A ADAAG 91 4.8.4 ADA 2010 405.7.1 CBC 2007 1133B.5.4.1 CBC 2019 11B-405.7.1 Mitigated: <input type="radio"/> YES <input checked="" type="radio"/> NO	10	SF	\$300	\$3,000

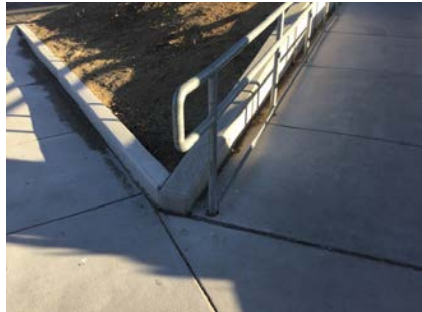
2015	<ul style="list-style-type: none"> As-Built Description: Ramp handrail does not extend horizontally 12" past top and / or bottom of ramp. As-Built: Extension is above a 2.8% slope. Proposed Solution: Provide ramp handrail extension (cost for each extension piece). 	PCODE ED05 ADAAG 91 4.8.5(2) ADA 2010 505.10.1 CBC 2007 1133B.4.2.2 & 1133B.5.5.1 CBC 2019 11B-505.10.1 Mitigated: <input type="radio"/> YES <input checked="" type="radio"/> NO	1	JOB	\$510	\$510

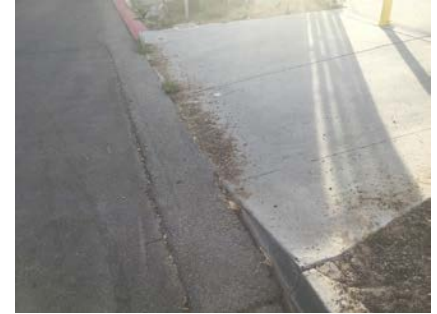
- 2196
- *As-Built Description:*
Walk: Pavement dislocation creates abrupt change in level exceeding 1/2" in accessible route.
 - *As-Built:* **1.0"**
 - *Proposed Solution:*
Remove, replace or repair area of pavement sufficient to correct abrupt change in level.

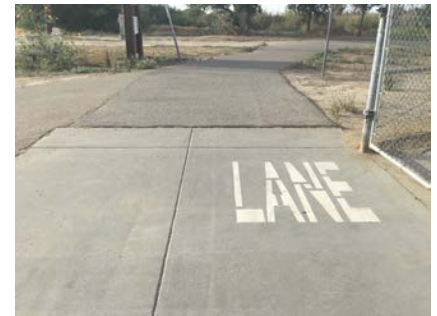
- 2197
- *As-Built Description:*
Walk: Pavement dislocation creates abrupt change in level exceeding 1/2" in accessible route.
 - *As-Built:* **1.5"**
 - *Proposed Solution:*
Remove, replace or repair area of pavement sufficient to correct abrupt change in level.

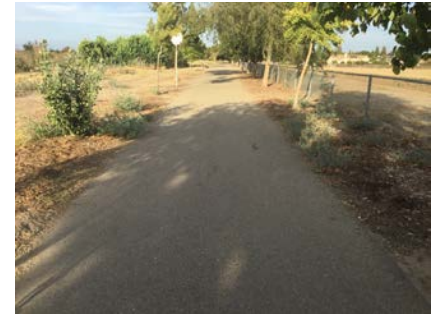
Cross Slope

2199	<ul style="list-style-type: none"> As-Built Description: Cross slope more than 1":48" (2.083%). As-Built: To 3.7% Proposed Solution: Modify cross slope. Notes: 	PCODE EF07 ADAAG 91 4.3.7 ADA 2010 403.3 CBC 2007 1133B.7.1.3 CBC 2019 11B-403.3	1000	SF	\$75	\$75,000
------	--	---	------	----	------	-----------------

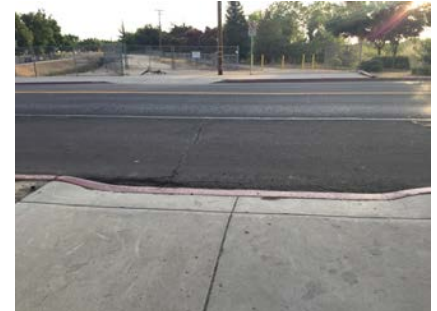
Curb Ramp

2203	<ul style="list-style-type: none"> As-Built Description: Slope greater than 1:12 (8.3%). As-Built: 10.6% and 15.0% Proposed Solution: Demolish existing and provide new curb ramp. Notes: 	PCODE EH02A ADAAG 91 4.7.2 ADA 2010 406.1 CBC 2007 1127B.5.3 CBC 2019 11B-406.2.1	2	JOB	\$7,500	\$15,000
------	--	--	---	-----	---------	-----------------

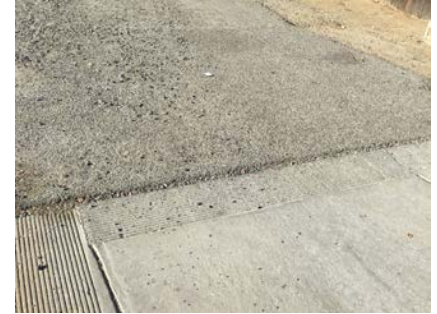
- 2280
- As-Built Description:*
Walk: Pavement dislocation creates abrupt change in level exceeding 1/2" in accessible route.
 - As-Built:* **1.5"**
 - Proposed Solution:*
Remove, replace or repair area of pavement sufficient to correct abrupt change in level.

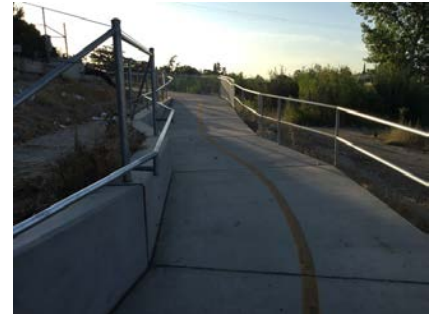
2244	<ul style="list-style-type: none"> As-Built Description: Slope greater than 1:12 (8.3%). As-Built: 9.3% Proposed Solution: Demolish existing and provide new ramp with handrails. 	PCODE EB02 ADAAG 91 4.8.2 ADA 2010 405.2 CBC 2007 1133B.5.3 CBC 2019 11B-405.2	10	SF	\$300	\$3,000
------	---	---	----	----	-------	---------

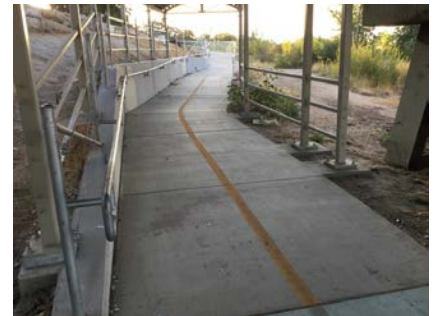
2241	<ul style="list-style-type: none"> As-Built Description: Level 2% max. landing for ramp not provided. As-Built: The landings are 48.0" to 55.0" long and/or slope 8% Proposed Solution: Rebuild ramp to provide landings for each ramp run with slopes no greater than 2% Notes: 	PCODE EB05A ADAAG 91 4.8.4 ADA 2010 405.7.1 CBC 2007 1133B.5.4.1 CBC 2019 11B-405.7.1	70	SF	\$300	\$21,000
------	---	--	----	----	-------	----------

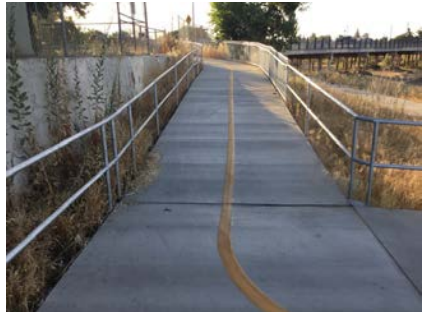
Item no., Rm no. and Name	Existing Architectural Barrier and Proposed Solution	Codes / Mitigation Info	Qty	Unit	Cost	Total
2248	<ul style="list-style-type: none"> As-Built Description: A curb or barrier has not been provided that blocks the passage of a 4-inch diameter sphere, where any portion of the sphere is within 4 inches of the finish floor or ground surface. Proposed Solution: Provide a curb or barrier that prevents the passage of a 4-inch diameter sphere, where any portion of the sphere is within 4 inches of the finish floor or ground surface. 	PCODE EB14 ADAAG 91 4.8.7 ADA 2010 405.9.2 CBC 2007 1133B.5.6 CBC 2019 11B-405.9.2 Mitigated: <input type="radio"/> YES <input checked="" type="radio"/> NO	40	LF	\$51	\$2,040

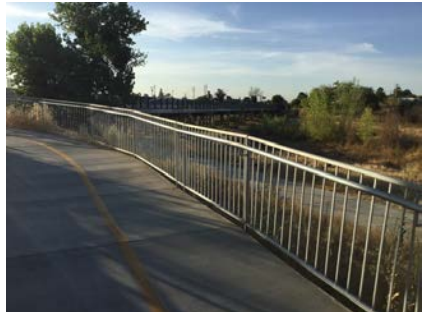
Handrail

2250	<ul style="list-style-type: none"> As-Built Description: Guards (42" high) not provided at side of ramp or landing where drop-off to adjacent grade or floor exceeds 30" height (California building code requirement only). As-Built: 39.0" Proposed Solution: Provide new guards, including handrail at ramp. 	PCODE ED08 CBC 2007 1133B.5.7 CBC 2019 Section 1013.2; 1013.3 Mitigated: <input type="radio"/> YES <input checked="" type="radio"/> NO	30	LF	\$360	\$10,800

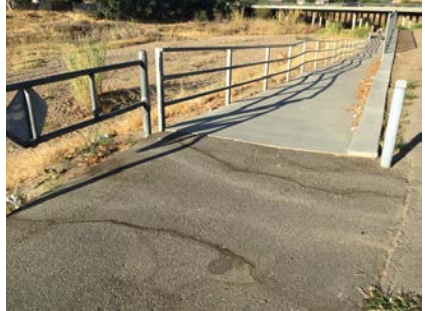
Item no., Rm no. and Name	Existing Architectural Barrier and Proposed Solution	Codes / Mitigation Info	Qty	Unit	Cost	Total
2258	<ul style="list-style-type: none"> As-Built Description: Level 2% max. landing for ramp not provided. As-Built: 4.3% Proposed Solution: Alter top landing. 	PCODE EB05A ADAAG 91 4.8.4 ADA 2010 405.7.1 CBC 2007 1133B.5.4.1 CBC 2019 11B-405.7.1 Mitigated: <input type="radio"/> YES <input checked="" type="radio"/> NO	35	SF	\$300	\$10,500

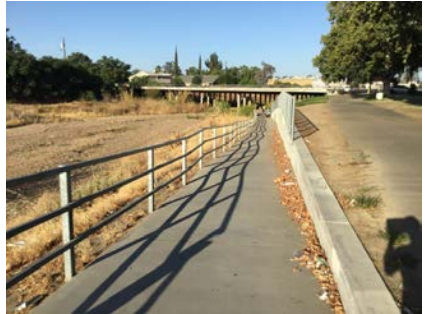
<input type="radio"/> Staff Only			
			Priority <input checked="" type="radio"/> 1			
			Severity <input checked="" type="radio"/> 3			
2260	<ul style="list-style-type: none"> As-Built Description: Level 2% max. landing for ramp not provided. As-Built: To 3.2% Proposed Solution: Alter surface. 	PCODE EB05A ADAAG 91 4.8.4 ADA 2010 405.7.1 CBC 2007 1133B.5.4.1 CBC 2019 11B-405.7.1 Mitigated: <input type="radio"/> YES <input checked="" type="radio"/> NO	24	SF	\$300	\$7,200

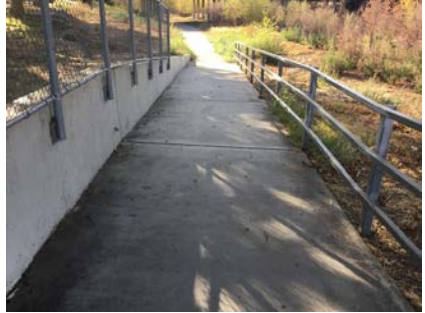
<p>2268</p> <ul style="list-style-type: none"> • <i>As-Built Description:</i> Slope greater than 1:12 (8.3%). • <i>As-Built:</i> 8.6% • <i>Proposed Solution:</i> Demolish existing and provide new ramp with handrails. 	<p>PCODE EB02 ADAAG 91 4.8.2 ADA 2010 405.2 CBC 2007 1133B.5.3 CBC 2019 11B-405.2</p> <p>Mitigated: <input type="radio"/> YES <input checked="" type="radio"/> NO</p>	<p>20 SF \$300 \$6,000</p>

<p><input type="radio"/> Staff Only</p> <p>Priority 1</p> <p>Severity 4</p>
--	--	--

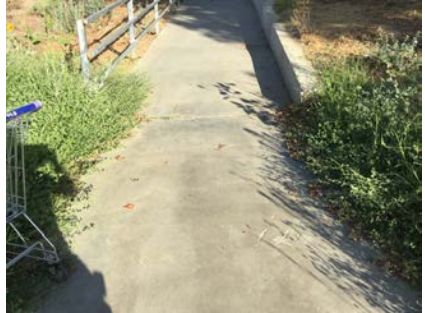
<p>2264</p> <ul style="list-style-type: none"> • <i>As-Built Description:</i> Level 2% max. landing for ramp not provided. • <i>As-Built:</i> 3.3% • <i>Proposed Solution:</i> Alter surface. 	<p>PCODE EB05A ADAAG 91 4.8.4 ADA 2010 405.7.1 CBC 2007 1133B.5.4.1 CBC 2019 11B-405.7.1</p> <p>Mitigated: <input type="radio"/> YES <input checked="" type="radio"/> NO</p>	<p>30 SF \$300 \$9,000</p>

<p><input type="radio"/> Staff Only</p> <p>Priority 1</p> <p>Severity 4</p>
---	---	---

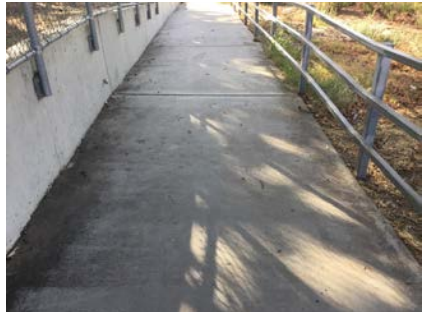
Item no., Rm no. and Name	Existing Architectural Barrier and Proposed Solution	Codes / Mitigation Info	Qty	Unit	Cost	Total
2269	<ul style="list-style-type: none"> As-Built Description: Level 2% max. landing for ramp not provided. As-Built: 3.2% Proposed Solution: Rebuild ramp to provide landings for each ramp run with slopes no greater than 2% 	PCODE EB05A ADAAG 91 4.8.4 ADA 2010 405.7.1 CBC 2007 1133B.5.4.1 CBC 2019 11B-405.7.1 Mitigated: <input type="radio"/> YES <input checked="" type="radio"/> NO	80	SF	\$300	\$24,000

<input type="radio"/> Staff Only						
Priority <input checked="" type="radio"/> 1						
Severity <input checked="" type="radio"/> 4

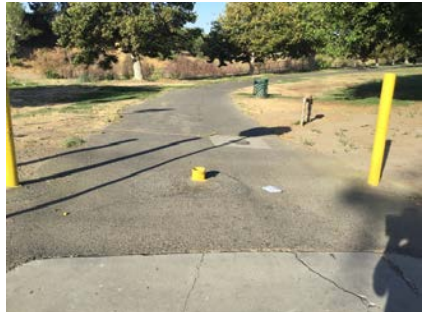
2271	<ul style="list-style-type: none"> As-Built Description: Walk: Slope greater than 1:20 (5.0%), and walk does not comply with requirements for ramps. As-Built: 7.0% Proposed Solution: Modify walk/sidewalk slope to 1:20 or less. 	PCODE EF01 ADAAG 91 4.3.7 ADA 2010 403.3 CBC 2007 1133B.7.3 CBC 2019 11B-403.3 Mitigated: <input type="radio"/> YES <input checked="" type="radio"/> NO	500	SF	\$75	\$37,500

<input type="radio"/> Staff Only						
Priority <input checked="" type="radio"/> 1						
Severity <input checked="" type="radio"/> 4

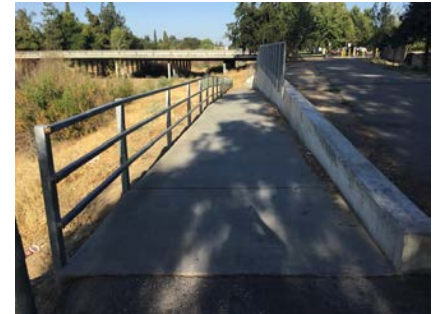
2276	<ul style="list-style-type: none"> As-Built Description: Slope greater than 1:12 (8.3%). As-Built: 9.6%. 5.5% cross slopes. Proposed Solution: Demolish existing and provide new ramp with handrails. 	PCODE EB02 ADAAG 91 4.8.2 ADA 2010 405.2 CBC 2007 1133B.5.3 CBC 2019 11B-405.2	700	SF	\$300	\$210,000
------	---	---	-----	----	-------	------------------

Severity **4**

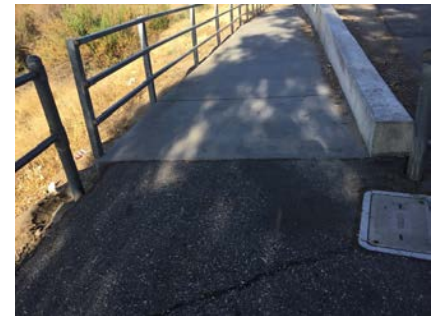
2272	<ul style="list-style-type: none"> As-Built Description: Level 2% max. landing for ramp not provided. As-Built: Top landing slopes 5.0%. Proposed Solution: Rebuild ramp to provide landings for each ramp run with slopes no greater than 2% 	PCODE EB05A ADAAG 91 4.8.4 ADA 2010 405.7.1 CBC 2007 1133B.5.4.1 CBC 2019 11B-405.7.1	40	SF	\$300	\$12,000
------	---	--	----	----	-------	-----------------

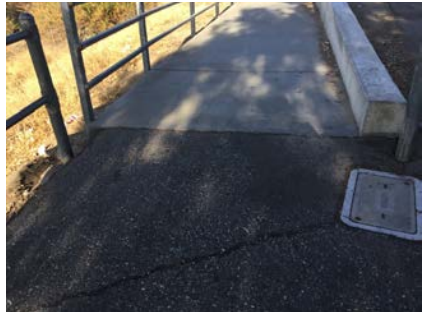
Item no., Rm no. and Name	Existing Architectural Barrier and Proposed Solution	Codes / Mitigation Info	Qty	Unit	Cost	Total
2273	<ul style="list-style-type: none"> As-Built Description: Level 2% max. landing for ramp not provided. As-Built: Top landing slopes 5.0%. Proposed Solution: Alter surface. 	PCODE EB05A ADAAG 91 4.8.4 ADA 2010 405.7.1 CBC 2007 1133B.5.4.1 CBC 2019 11B-405.7.1 Mitigated: <input type="radio"/> YES <input checked="" type="radio"/> NO	40	SF	\$300	\$12,000

<input type="radio"/> Staff Only						
Priority 1						
Severity 3

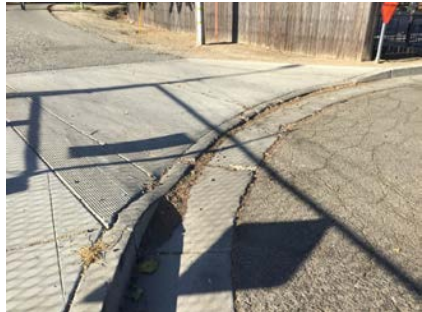
Item no., Rm no. and Name	Existing Architectural Barrier and Proposed Solution	Codes / Mitigation Info	Qty	Unit	Cost	Total
2278	<ul style="list-style-type: none"> <i>As-Built Description:</i> Detectable warning not provided where pedestrian crosses vehicular area. <i>Proposed Solution:</i> Provide detectable warning surface (i.e. in-line truncated domes) at regular curb ramp. 	PCODE EH07A ADAAG 91 4.7.7 ADA 2010 705.1 CBC 2007 1127B.5.7 CBC 2019 11B-705.1.2.2 Mitigated: <input type="radio"/> YES <input checked="" type="radio"/> NO	1	JOB	\$750	\$750

<input type="radio"/> Staff Only			
			Priority <input checked="" type="radio"/> 1			
			Severity <input checked="" type="radio"/> 3

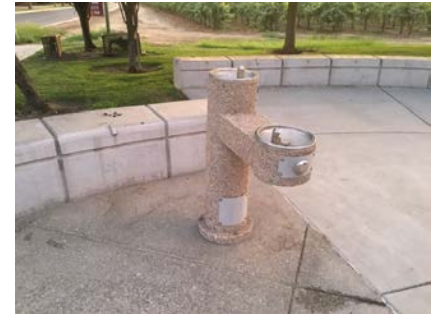
2215	<ul style="list-style-type: none"> As-Built Description: Wall- and post-mounted cantilevered units: Knee space not provided at drinking fountain (27" high, 8" deep, 30" wide from front of drinking fountain). As-Built: 26.25" Proposed Solution: Provide new, accessible fountain. 	PCODE IA02 ADAAG 91 4.15.5(1) ADA 2010 602.2 CBC 2007 1115B.4.6.2 CBC 2019 11B-602.2 Mitigated: <input type="radio"/> YES <input checked="" type="radio"/> NO	1	JOB	\$9,600	\$9,600
------	---	---	---	-----	---------	---------

Severity **2**

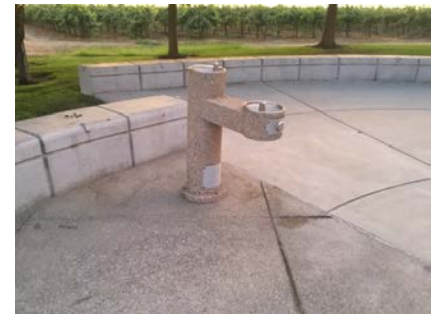
2216	<ul style="list-style-type: none"> As-Built Description: Drinking fountain lacks protection for visually impaired persons. Proposed Solution: Provide cane-detectable rails. 	PCODE IA05C ADAAG 91 4.4.1 ADA 2010 307.2 CBC 2007 1115B.4.6.3 CBC 2019 11B-307.2 Mitigated: <input type="radio"/> YES <input checked="" type="radio"/> NO	1	JOB	\$1,500	\$1,500
------	--	--	---	-----	---------	---------

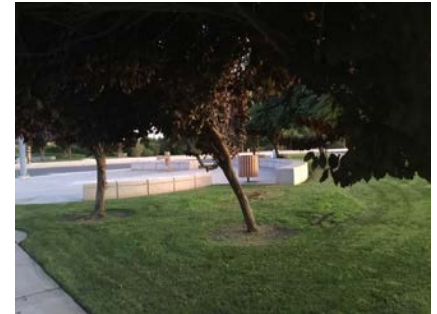
2217	<ul style="list-style-type: none"> <i>As-Built Description:</i> Protruding objects more than 4" from wall, when bottom of object more than 27" or less than 80" above finished floor. <i>Proposed Solution:</i> Trim vegetation. 	PCODE EG04 ADAAG 91 4.4.1 ADA 2010 307.2 CBC 2007 1133B.8.6.1 CBC 2019 11B-307.2 Mitigated: <input type="radio"/> YES <input checked="" type="radio"/> NO	10	JOB	\$90	\$900
------	--	--	----	-----	------	-------

Severity **2**

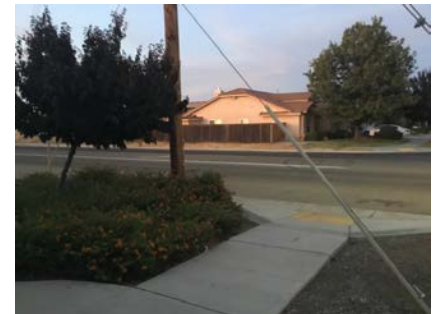
2220	<ul style="list-style-type: none"> <i>As-Built Description:</i> Protruding objects more than 4" from wall, when bottom of object more than 27" or less than 80" above finished floor. <i>As-Built:</i> Telephone pole guy wire 64.0" to 79.0" high <i>Proposed Solution:</i> Remove/relocate protruding object. Patch existing surface. 	PCODE EG04 ADAAG 91 4.4.1 ADA 2010 307.2 CBC 2007 1133B.8.6.1 CBC 2019 11B-307.2 Mitigated: <input type="radio"/> YES <input checked="" type="radio"/> NO	1	JOB	\$300	\$300
------	---	--	---	-----	-------	-------

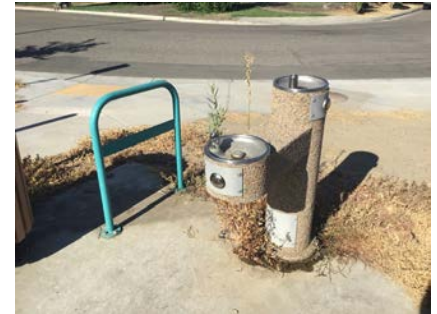
2283	<ul style="list-style-type: none"> <i>As-Built Description:</i> Wall- and post-mounted cantilevered units: Knee space not provided at drinking fountain (27" high, 8" deep, 30" wide from front of drinking fountain). <i>As-Built:</i> 26.0" <i>Proposed Solution:</i> Provide new, accessible fountain. 	<p>PCODE IA02 ADAAG 91 4.15.5(1) ADA 2010 602.2 CBC 2007 1115B.4.6.2 CBC 2019 11B-602.2</p> <p>Mitigated: <input type="radio"/> YES <input checked="" type="radio"/> NO</p>	1	JOB	\$9,600	\$9,600
------	---	--	---	-----	---------	---------

Severity **2**

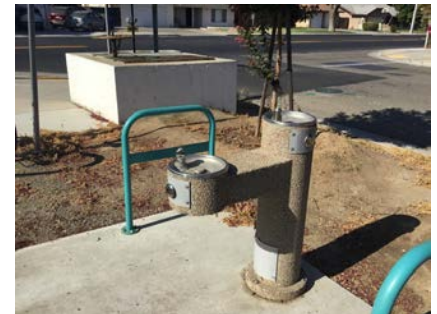
2285	<ul style="list-style-type: none"> <i>As-Built Description:</i> Wall- and post-mounted cantilevered units: Knee space not provided at drinking fountain (27" high, 8" deep, 30" wide from front of drinking fountain). <i>As-Built:</i> 26.4" <i>Proposed Solution:</i> Provide new, accessible fountain. 	<p>PCODE IA02 ADAAG 91 4.15.5(1) ADA 2010 602.2 CBC 2007 1115B.4.6.2 CBC 2019 11B-602.2</p> <p>Mitigated: <input type="radio"/> YES <input checked="" type="radio"/> NO</p>	1	JOB	\$9,600	\$9,600
------	---	--	---	-----	---------	---------

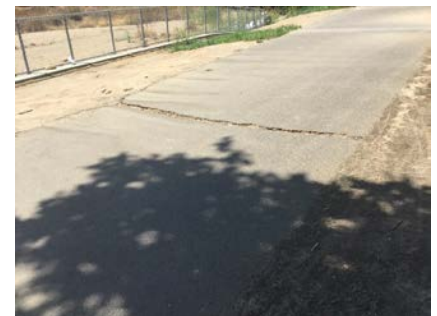
- 514
- *As-Built Description:*
Walk: Pavement dislocation creates abrupt change in level exceeding 1/2" in accessible route.
 - *As-Built: Gaps and level changes to 2.0"*
 - *Proposed Solution:*
Remove, replace or repair area of pavement sufficient to correct abrupt change in level.

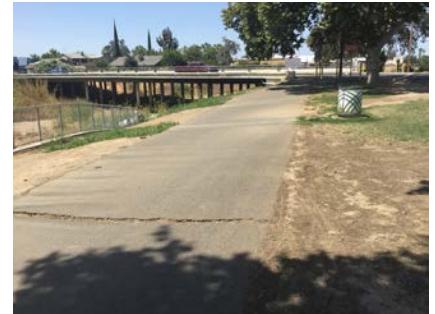
513	<ul style="list-style-type: none"> As-Built Description: Cross slope more than 1":48" (2.083%). As-Built: Up to 5.0% Proposed Solution: Modify cross slope. 	PCODE EF07 ADAAG 91 4.3.7 ADA 2010 403.3 CBC 2007 1133B.7.1.3 CBC 2019 11B-403.3	3000	SF	\$75	\$225,000
-----	---	--	------	----	------	-----------

Severity **3**

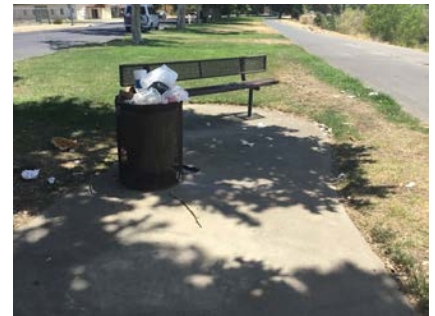
518	<ul style="list-style-type: none"> As-Built Description: Cross slope more than 1":48" (2.083%). As-Built: 4.8% slope at trash can clear floor space. Occurs throughout the park at trash cans. Also occurs at trash cans Proposed Solution: Modify cross slope, or relocate trash cans. 	PCODE EF07 ADAAG 91 4.3.7 ADA 2010 403.3 CBC 2007 1133B.7.1.3 CBC 2019 11B-403.3	50	SF	\$75	\$3,750
-----	---	--	----	----	------	---------

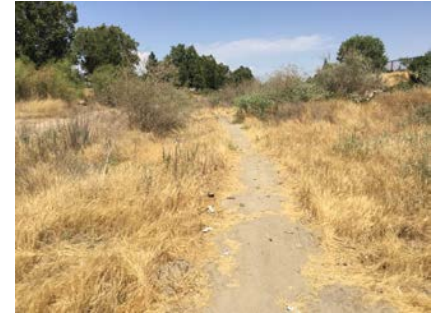
Item no., Rm no. and Name	Existing Architectural Barrier and Proposed Solution	Codes / Mitigation Info	Qty	Unit	Cost	Total
537	<ul style="list-style-type: none"> As-Built Description: Cross slope more than 1":48" (2.083%). As-Built: 10.0% Proposed Solution: Modify cross slope. Notes: 	PCODE EF07 ADAAG 91 4.3.7 ADA 2010 403.3 CBC 2007 1133B.7.1.3 CBC 2019 11B-403.3	200	SF	\$75	\$15,000

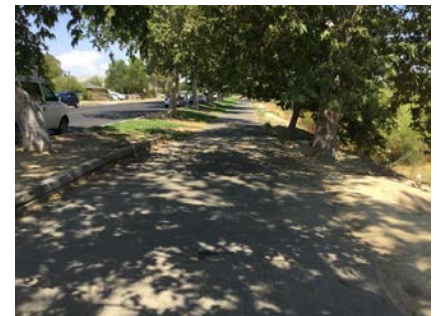
539	<ul style="list-style-type: none"> As-Built Description: Protruding objects more than 4" from wall, when bottom of object more than 27" or less than 80" above finished floor. Proposed Solution: Trim vegetation. 	PCODE EG04 ADAAG 91 4.4.1 ADA 2010 307.2 CBC 2007 1133B.8.6.1 CBC 2019 11B-307.2	20	JOB	\$300	\$6,000
-----	--	--	----	-----	-------	---------

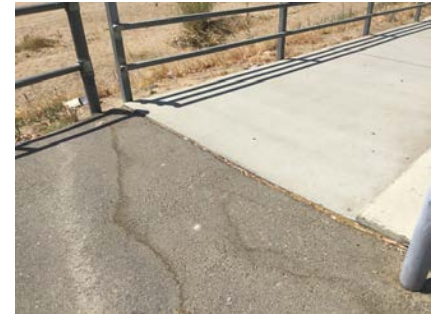
- 512
- *As-Built Description:*
Ramp: Pavement dislocation creates abrupt change in level exceeding 1/2" in ramp.
 - *As-Built:* **1.0"**
 - *Proposed Solution:*
Remove, replace or repair area of pavement sufficient to correct abrupt change in level.

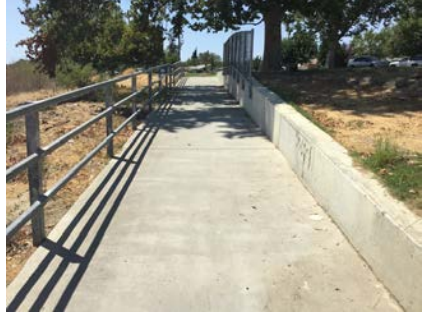
<p>531</p> <ul style="list-style-type: none"> As-Built Description: Slope greater than 1:12 (8.3%). As-Built: Up to 10.0% Proposed Solution: Demolish existing and provide new ramp with handrails. 	<p>PCODE EB02 ADAAG 91 4.8.2 ADA 2010 405.2 CBC 2007 1133B.5.3 CBC 2019 11B-405.2</p> <p>Mitigated: <input type="radio"/> YES <input checked="" type="radio"/> NO</p>	<p>80 SF \$300 \$24,000</p>

<p><input type="radio"/> Staff Only</p> <p>Priority 1</p> <p>Severity 4</p>
---	--	--

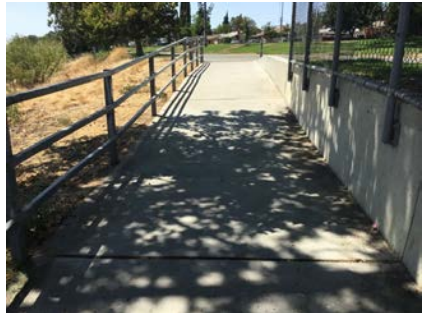
<p>530</p> <ul style="list-style-type: none"> As-Built Description: Level 2% max. landing for ramp not provided. As-Built: 2.5% to 4.0% at top, bottom and middle landing. Proposed Solution: Rebuild ramp to provide landings for each ramp run with slopes no greater than 2% 	<p>PCODE EB05A ADAAG 91 4.8.4 ADA 2010 405.7.1 CBC 2007 1133B.5.4.1 CBC 2019 11B-405.7.1</p> <p>Mitigated: <input type="radio"/> YES <input checked="" type="radio"/> NO</p>	<p>90 SF \$300 \$27,000</p>

<p><input type="radio"/> Staff Only</p> <p>Priority 1</p> <p>Severity 3</p>
---	---	---

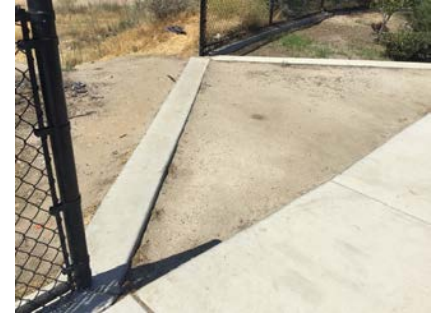
- 536 • *As-Built Description:*
Walk: Pavement dislocation creates abrupt change in level exceeding 1/2" in accessible route.
- *As-Built:* **2.0"**
- *Proposed Solution:*
Remove, replace or repair area of pavement sufficient to correct abrupt change in level.

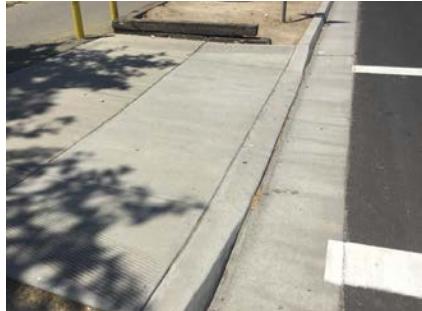
Item no., Rm no. and Name	Existing Architectural Barrier and Proposed Solution	Codes / Mitigation Info	Qty	Unit	Cost	Total
524	<ul style="list-style-type: none"> As-Built Description: Side slopes more than 1:10 (10%). As-Built: 16.0% Proposed Solution: Modify curb ramp. Demolish side slopes and replace with 1:10 side slopes if 48" level top landing is provided. 	PCODE EH05A ADAAG 91 4.7.5 ADA 2010 406.3 CBC 2007 1127B.5.3 CBC 2019 11B-406.2.2 Mitigated: <input type="radio"/> YES <input checked="" type="radio"/> NO	2	JOB	\$1,950	\$3,900

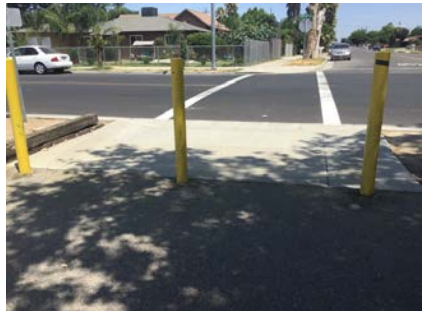
<input type="radio"/> Staff Only			
			Priority <input checked="" type="radio"/> 1			
			Severity <input checked="" type="radio"/> 2			
520	<ul style="list-style-type: none"> As-Built Description: Less than 48" level space at top not provided. Proposed Solution: Demolish existing and provide new landing. Notes: 	PCODE EH05B ADAAG 91 4.7.5; Fig.12(a) ADA 2010 406.4 CBC 2007 1127B.5.4 CBC 2019 11B-406.5.3 Mitigated: <input type="radio"/> YES <input checked="" type="radio"/> NO	1	JOB	\$3,000	\$3,000

<input type="radio"/> Staff Only			
			Priority <input checked="" type="radio"/> 1			
			Severity <input checked="" type="radio"/> 4			
<p>Top landing slopes 4.7%.</p>

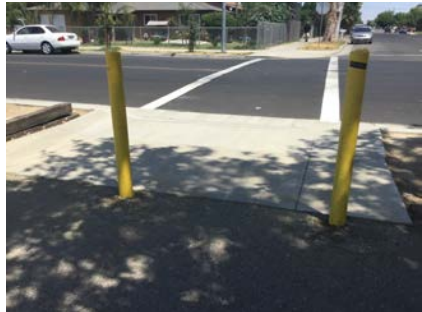
Item no., Rm no. and Name	Existing Architectural Barrier and Proposed Solution	Codes / Mitigation Info	Qty	Unit	Cost	Total
521	<ul style="list-style-type: none"> <i>As-Built Description:</i> Detectable warning not provided where pedestrian crosses vehicular area. <i>Proposed Solution:</i> Provide detectable warning surface (i.e. in-line truncated domes) at regular curb ramp. 	PCODE EH07A ADAAG 91 4.7.7 ADA 2010 705.1 CBC 2007 1127B.5.7 CBC 2019 11B-705.1.2.2 Mitigated: <input type="radio"/> YES <input checked="" type="radio"/> NO	1	JOB	\$750	\$750

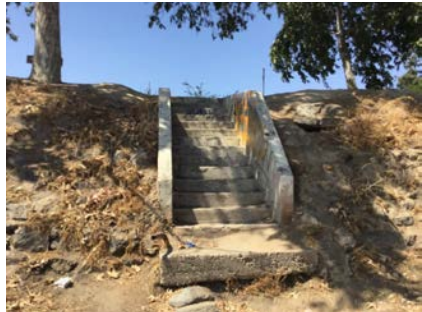
538	<ul style="list-style-type: none"> <i>As-Built Description:</i> Exterior stair substantially out of compliance. <i>Proposed Solution:</i> Provide complete new stair, 4 ft. wide with landing and handrails. 	PCODE EC09 ADAAG 91 4.9 ADA 2010 504 CBC 2007 1133B.4 CBC 2019 11B-504 Mitigated: <input type="radio"/> YES <input checked="" type="radio"/> NO	200	IN	\$270	\$54,000

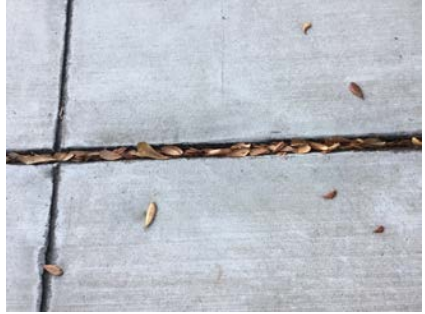
<p>2236</p> <ul style="list-style-type: none"> • <i>As-Built Description:</i> Walk: Grating has grid openings greater than 1/2" along the line of traffic flow. • <i>As-Built:</i> Gaps 1.0" wide • <i>Proposed Solution:</i> Fill joints 	<p>PCODE EF04 ADAAG 91 4.3.6; 4.5.4 ADA 2010 403.2; 302.3 CBC 2007 1133B.7.2 CBC 2019 11B-403.2; 11B-302.3</p> <p>Mitigated: <input type="radio"/> YES <input checked="" type="radio"/> NO</p>	<p>40 LF \$60 \$2,400</p>

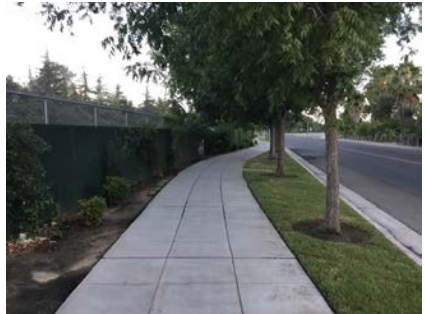
<p>2235</p> <ul style="list-style-type: none"> • <i>As-Built Description:</i> Protruding objects more than 4" from wall, when bottom of object more than 27" or less than 80" above finished floor. • <i>Proposed Solution:</i> Trim vegetation. 	<p>PCODE EG04 ADAAG 91 4.4.1 ADA 2010 307.2 CBC 2007 1133B.8.6.1 CBC 2019 11B-307.2</p> <p>Mitigated: <input type="radio"/> YES <input checked="" type="radio"/> NO</p>	<p>20 JOB \$300 \$6,000</p>

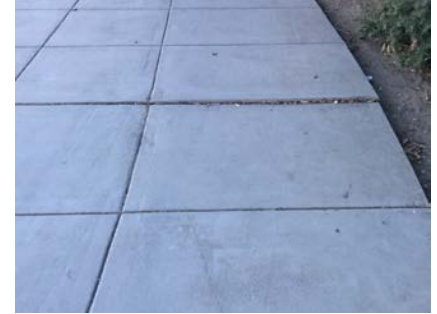
- 2225
- *As-Built Description:*
Walk: Pavement dislocation creates abrupt change in level exceeding 1/2" in accessible route.
 - *As-Built:* **2.0"**
 - *Proposed Solution:*
Remove, replace or repair area of pavement sufficient to correct abrupt change in level.

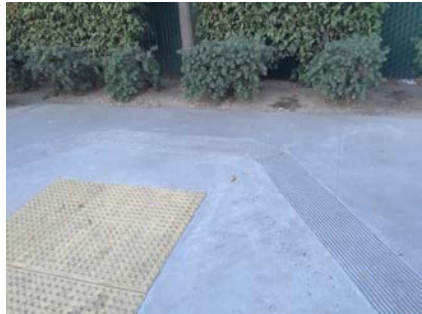
Item no., Rm no. and Name	Existing Architectural Barrier and Proposed Solution	Codes / Mitigation Info	Qty	Unit	Cost	Total
2228	<ul style="list-style-type: none"> As-Built Description: Less than 48" level space at top and 1:12 flared sides not provided. As-Built: 46.0" Proposed Solution: Demolish existing and provide new curb ramp. 	PCODE EH05B ADAAG 91 4.7.5; Fig.12(a) ADA 2010 406.4 CBC 2007 1127B.5.4 CBC 2019 11B-406.5.3 Mitigated: <input type="radio"/> YES <input checked="" type="radio"/> NO	1	JOB	\$7,500	\$7,500

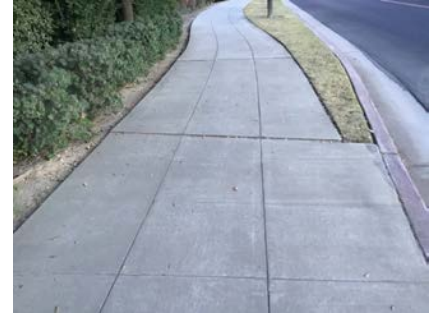
- 2229
- *As-Built Description:*
Walk: Pavement dislocation creates abrupt change in level exceeding 1/2" in accessible route.
 - *As-Built:* **1.5"**
 - *Proposed Solution:*
Remove, replace or repair area of pavement sufficient to correct abrupt change in level.

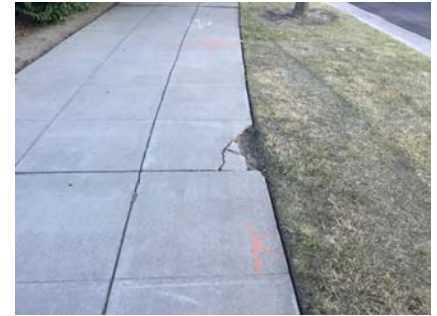
2230	<ul style="list-style-type: none"> As-Built Description: Walk: Grating has grid openings greater than 1/2" along the line of traffic flow. As-Built: 2.0" deep pothole Proposed Solution: Repair concrete. 	PCODE EF04 ADAAG 91 4.3.6; 4.5.4 ADA 2010 403.2; 302.3 CBC 2007 1133B.7.2 CBC 2019 11B-403.2; 11B-302.3 Mitigated: <input type="radio"/> YES <input checked="" type="radio"/> NO	1	SF	\$240	\$240
------	--	--	---	----	-------	-------

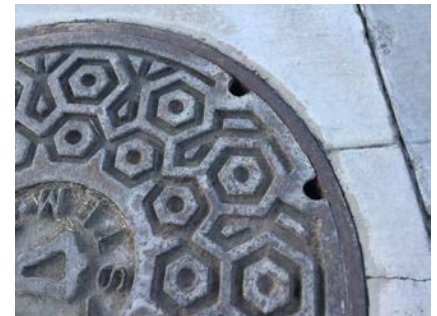
2231	<ul style="list-style-type: none"> As-Built Description: Walk: Grating has grid openings greater than 1/2" along the line of traffic flow. As-Built: 1.5" x 1.5" Proposed Solution: Provide new grating, with grid openings 1/2" max. along the line of traffic flow. 	PCODE EF04 ADAAG 91 4.3.6; 4.5.4 ADA 2010 403.2; 302.3 CBC 2007 1133B.7.2 CBC 2019 11B-403.2; 11B-302.3 Mitigated: <input type="radio"/> YES <input checked="" type="radio"/> NO	2	UNI	\$600	\$1,200
------	---	--	---	-----	-------	---------

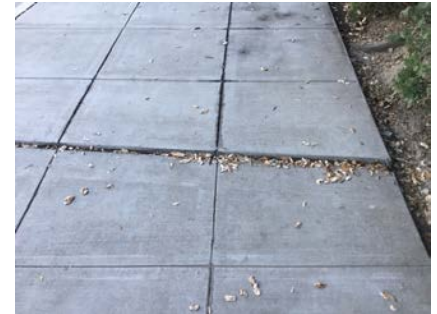
- 2232
- *As-Built Description:*
Walk: Pavement dislocation creates abrupt change in level exceeding 1/2" in accessible route.
 - *As-Built:* **2.0"**
 - *Proposed Solution:*
Remove, replace or repair area of pavement sufficient to correct abrupt change in level.

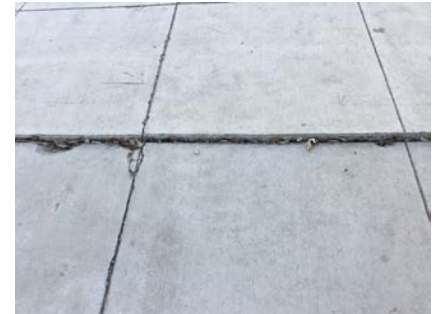
- 2234
- *As-Built Description:*
Walk: Pavement dislocation creates abrupt change in level exceeding 1/2" in accessible route.
 - *As-Built:* **2.0"**
 - *Proposed Solution:*
Remove, replace or repair area of pavement sufficient to correct abrupt change in level.
